TOPOGRAPHICAL SURVEY OF MILODZA COMMUNITY
DAY SECONDARY SCHOOL

REVISION:	CONSULTANT:		PROJECT TITLE:	THE PROJECT FOR RE-CONSTRUCTION AND EXPANSION OF SELECTED COMMUNITY DAY SECONDARY SCHOOLS (CDSSs) IN MALAWI (PHASE II)	DRAWING TITLE:	ZOMBA URBAN	SHEET NO.:	U4
	DRAWN BY:		PROJECT NO.:		DRAWN BY:			
	CHECKED BY:		DATE:	SEPT. 2013	CHECKED BY:			
			APPROVED BY:		APPROVED BY:		SCALE:	1:1000

**THE POLYTECHNIC
CIVIL ENGINEERING DEPARTMENT**

**REPORT ON GEOTECHNICAL INVESTIGATIONS ON
CHIMWALIRA CDSS IN ZOMBA, KABEKERE CDSS IN
NTCHEU DISTRICT, MUHASUWA CDSS IN
CHIRADZULU, UMBWI SS IN DEDZA AND ZOMBA
URBAN CDSS IN ZOMBA CITY**

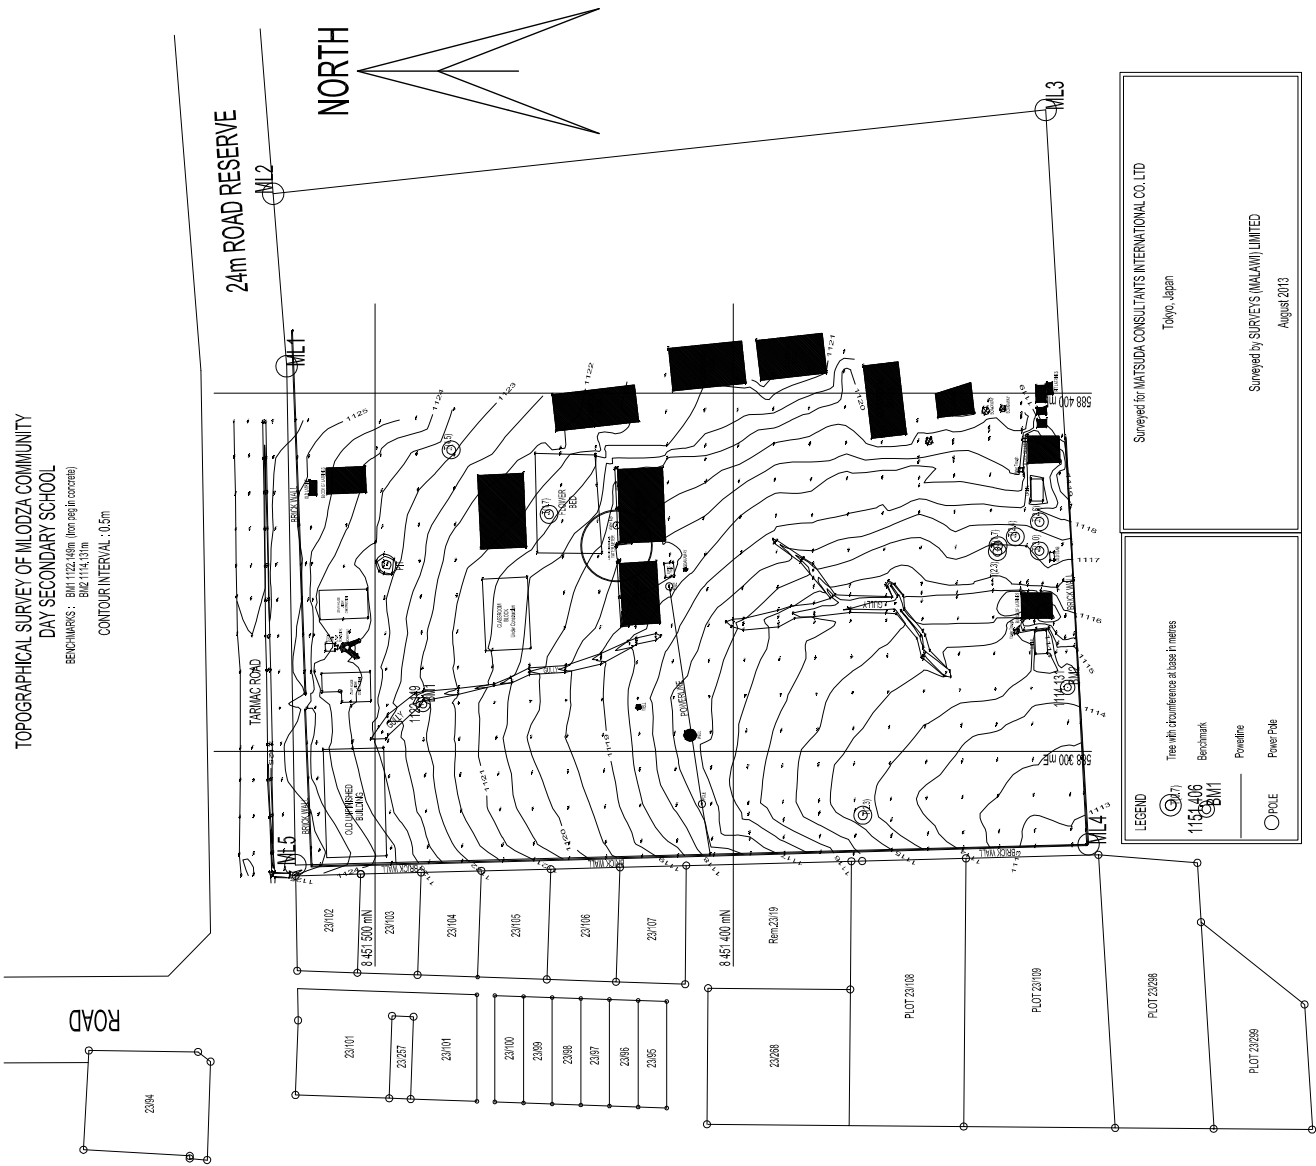
BENCHMARKS : BM 1122, 484m (iron nail in concrete)
BM 1114, 131m

CONTOUR INTERVAL : 0.5m

2.6 Mlodza CDSS

Six trial pits for sample collection and testing were dug at and around Mlodza CDSS. In addition three more pits were dug for Water penetration test. Furthermore 73 points were selected for DCP testing.

Observations on trial pits at 2m depth and classification tests indicated that the soils were basically reddish stiff gravelly clays of Intermediate plasticity with traces of sand size particles.

From the triaxial test, the worst case scenario was observed on Pit no. 3 which gave an angle of friction of 8. degrees and cohesion intercept of 68kN/m^2 . Using Terzaghis Ultimate bearing capacity equation and assuming a 1m deep foundation and 690mm wide strip footing, the ultimate bearing capacity of the soil is 544kN/m^2 . Applying a Factor of safety of two the safe bearing capacity is 272kN/m^2 which is adequate to support foundation loads from the buildings.

From the DCP test it was observed that most areas had a Penetration index of less than 14mm/blow (approx CBR of 14.4). This indicates that basically the surface at Mlodza CDSS is stable and sound. Foundations can safely be placed at depth of not less than 1m from the surface.

The water penetration results gave an average percolation value of 1.7mm/min
