## 6-3 Borehole survey Reports (Extract)

The Project for Reconstruction and Expansion of Selected Community Day Secondary Schools and Conventional Secondary Schools (Phase III)  
in The Republic of Malawi

### Borehole Survey Report

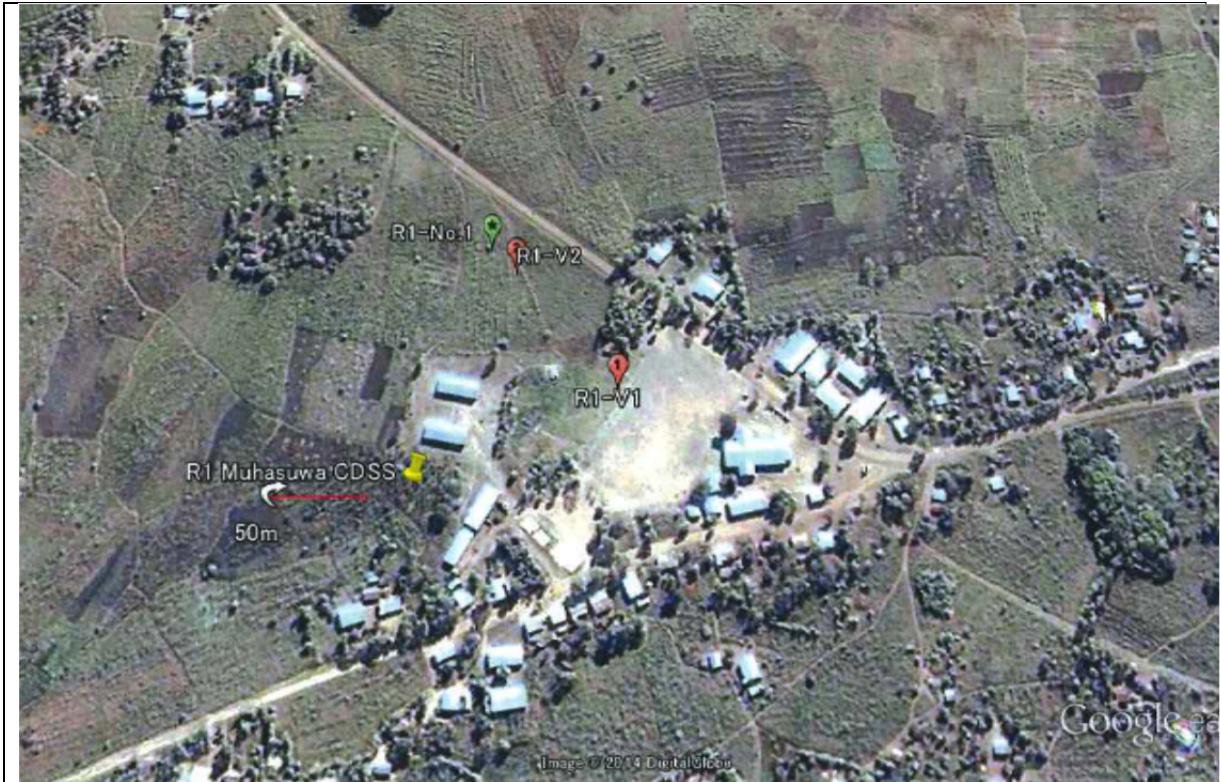
Fig 1 Muhasuwa CDSS : R1- No.1 Successful test borehole (in green)

The exact location of each test borehole at six sites was determined using the GPS as shown in Table 1 and their locations were plotted on a Google Earth map (see Fig. 1 to Fig. 6).

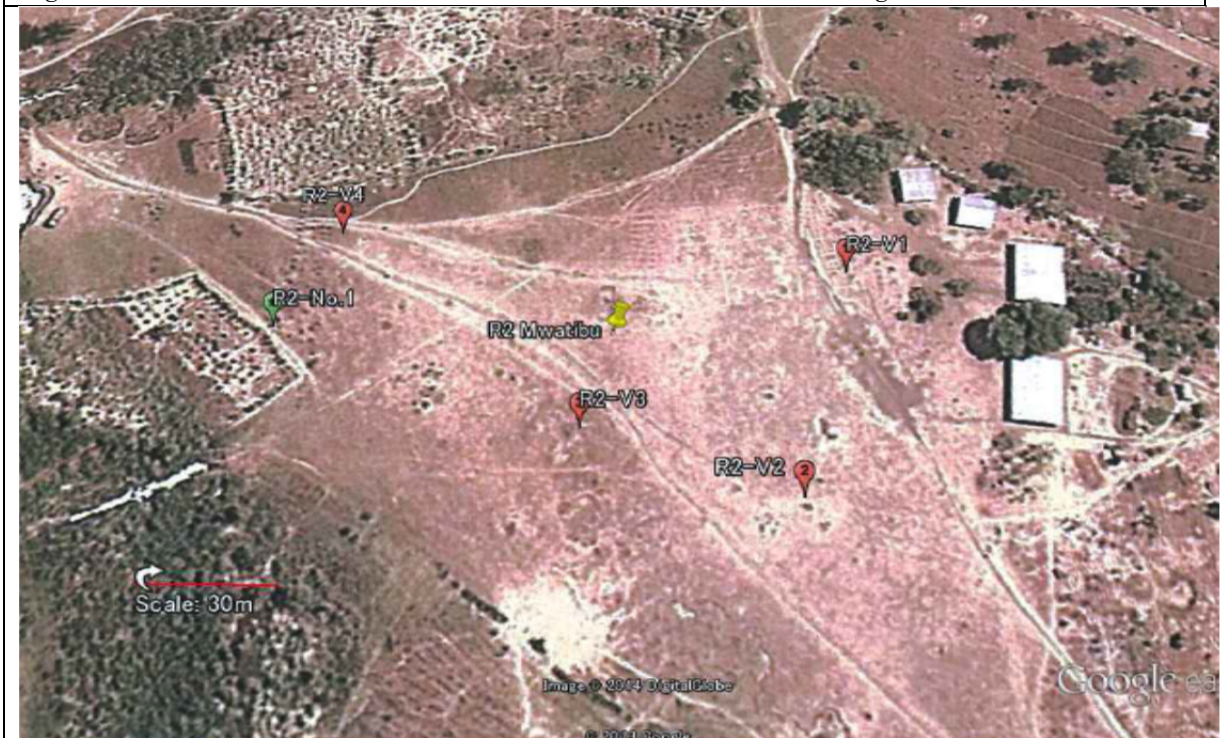
Fig. 2 Mwatibu CDSS: R2-No.1 Successful test borehole (in green)

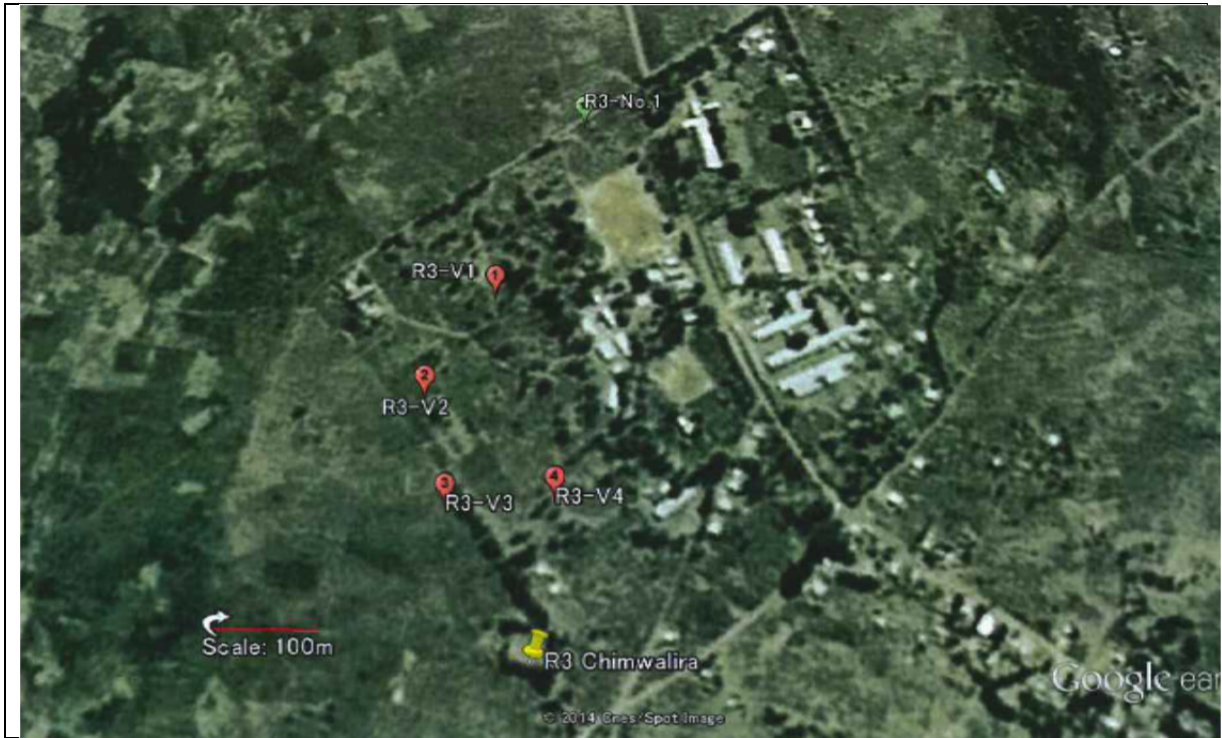
Fig. 3 Chimwalira CDSS: R2-No.1 Successful test borehole (in green)

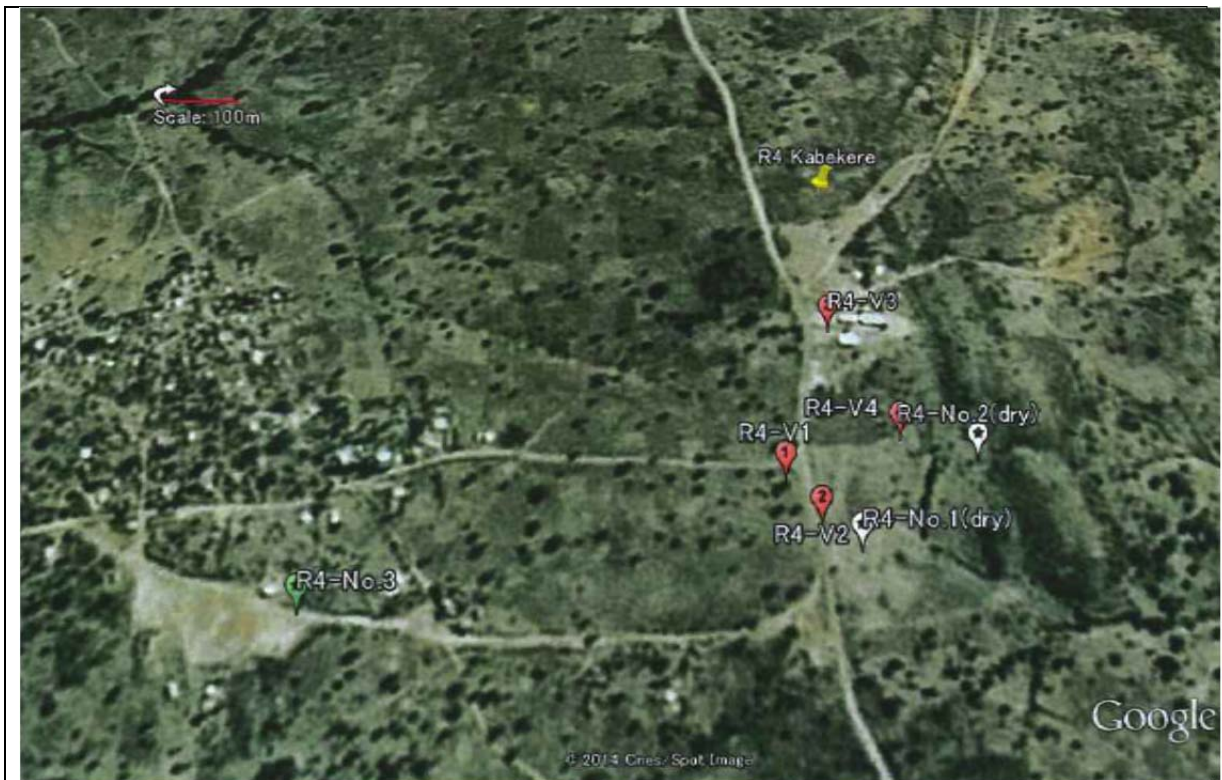
Fig. 4 Kabekere: R4- No.3 Successful test borehole (in green), R4-No.1 & No.2 Dry (in white)

We had the six successful test boreholes at six sites however test boreholes were drilled totally nine including three dry holes due to hydrogeological difficulty of R4Kabekere and R6Mzoma. Especially R4Kabekere CDSS located on the top of rocky hill and two dry holes were counted within the CDSS boundary. Therefore, the third one was drilled in village and found successful groundwater discharge. On the other hand, the first test borehole of R6Mzoma was collapsed due to soft formation, and the second one drilled successfully within the same area of CDSS boundary.

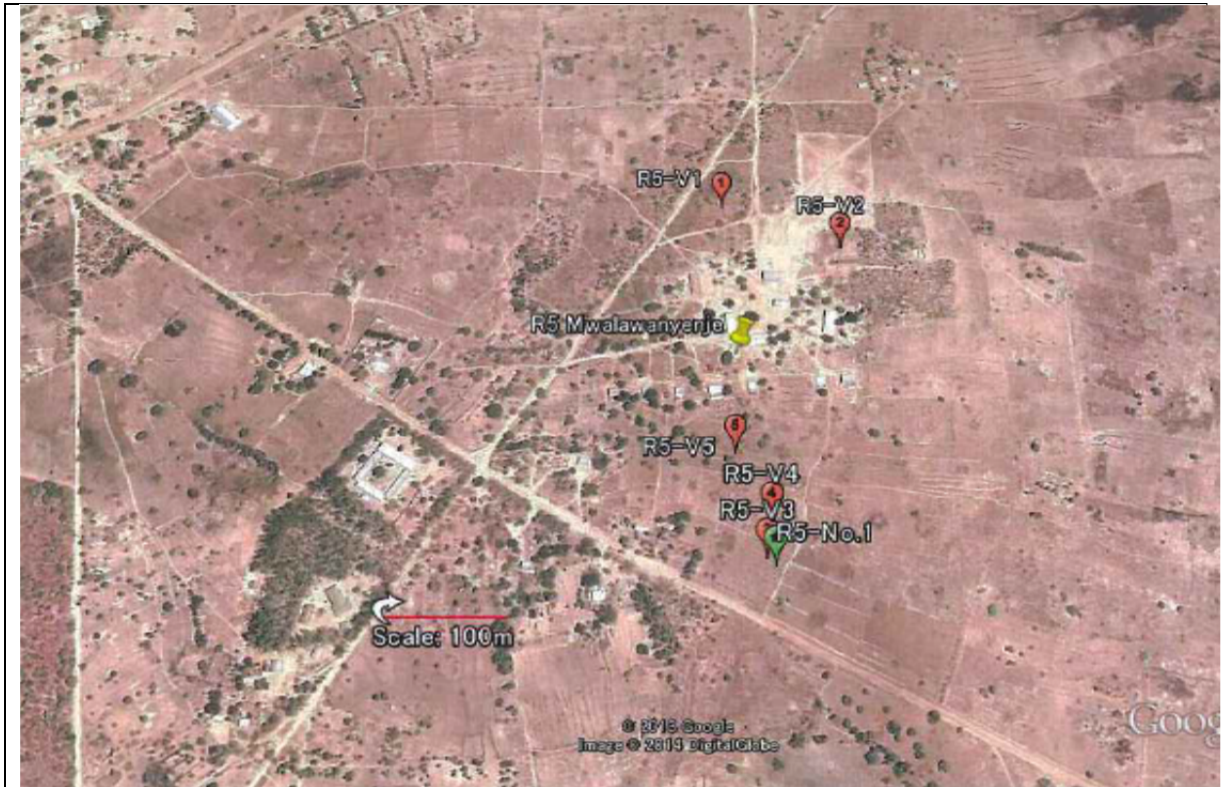
Fig. 5 Mwalawanyenje CDSS: R5- No.1 Successful test borehole (in green)

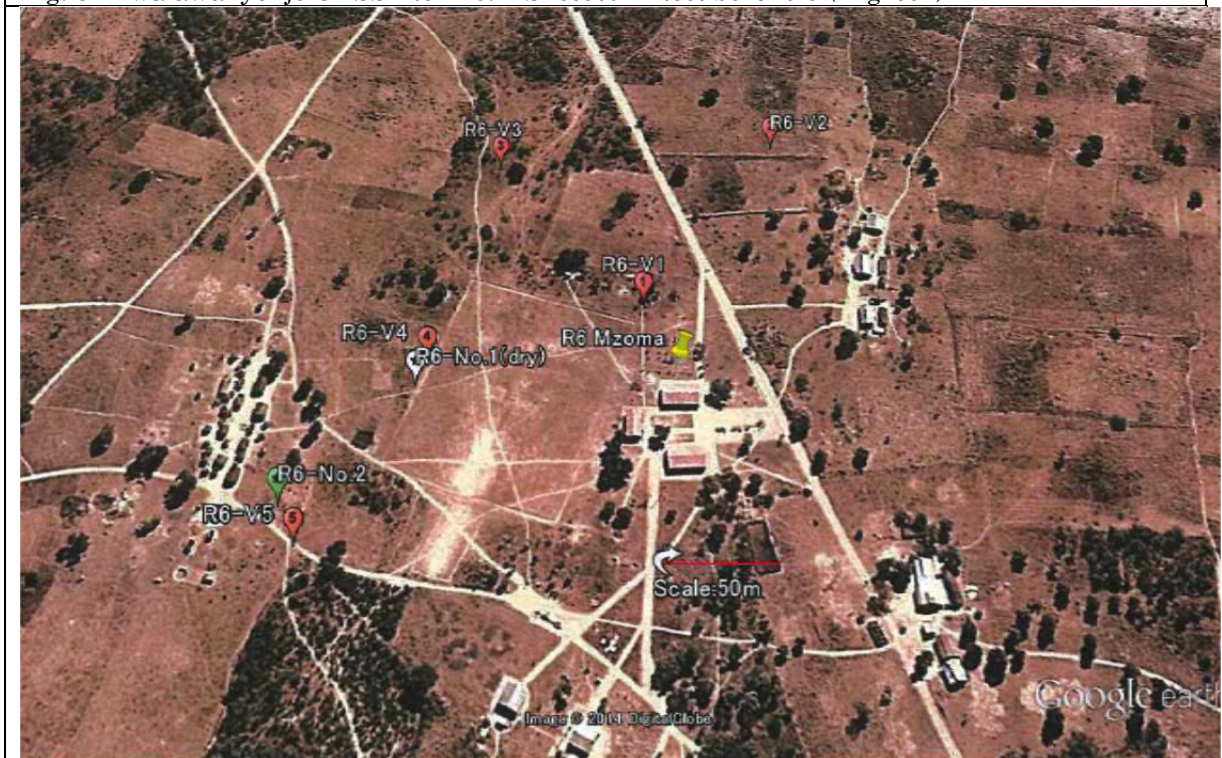
Fig. 6 Mzoma CDSS: R6- No.2 Successful test borehole (in green), R6-No.1 Dry (in white)
