2. BOREHOLE DRILLING AND CONSTRUCTION

A Direct Air Drilling and circulatory mud method was applied. Borehole construction materials used for drilling were temporary casings, plain casing, slotted casing and gravel packing. The details of each site boreholes are separated below.

**R1 Muhasuwa CDSS Phase 3 Test Drilling Working Record,
November to December 2013**

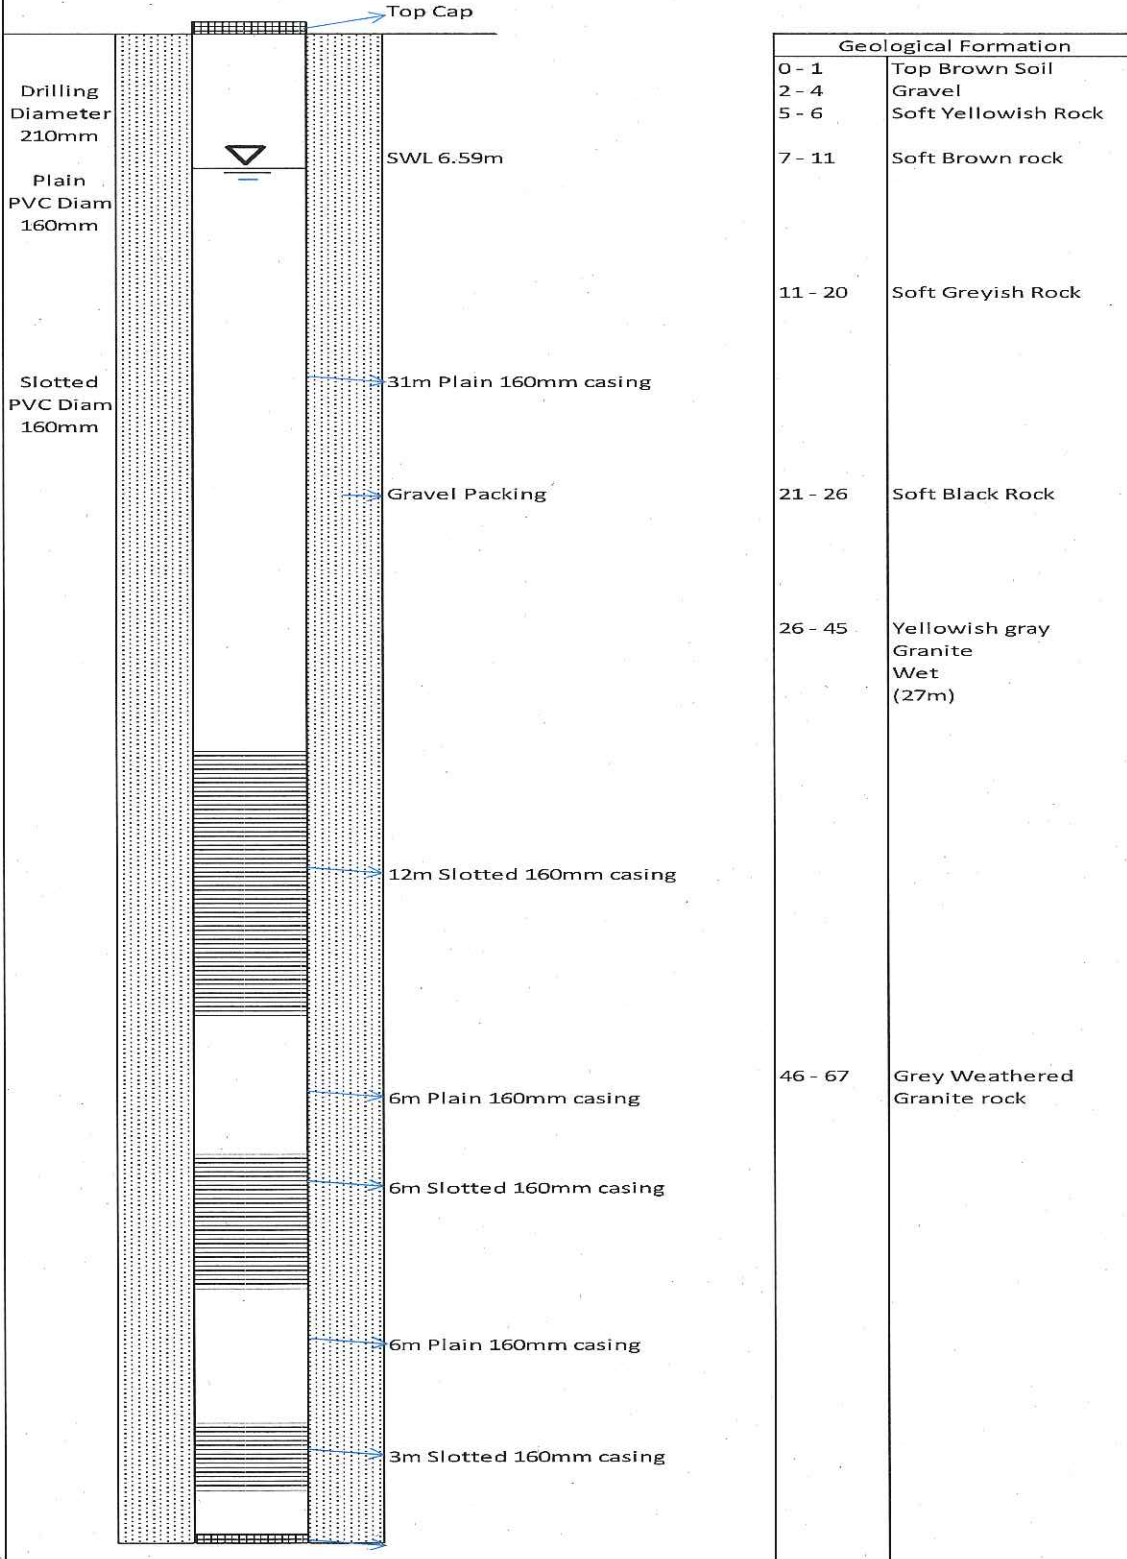
BOREHOLE STRUCTURE - WET

The details of the borehole which includes lithology and borehole design are as shown in the figure below.

Project Name: C. D. S. S Phase III
 Site Name: MUHASUWA C. D. S. S
 Borehole No.: No. R1 - No1
 Starting Date: 29th November 2013
 Completion Date: 29th November 2013

Drilling Depth 67 m
 Casing Depth 67 m
 Casing Diam 160mm

Geological Formation	
0 - 1	Top Brown Soil
2 - 4	Gravel
5 - 6	Soft Yellowish Rock
7 - 11	Soft Brown rock
11 - 20	Soft Greyish Rock
21 - 26	Soft Black Rock
26 - 45	Yellowish gray Granite Wet (27m)
46 - 67	Grey Weathered Granite rock

DEPTH (m)	LITHOLOGY
0 – 1	Top Brown Soil
2 – 4	Gravel
5 – 6	Soft Yellowish Rock
7 – 11	Soft Brown rock
11 – 20	Soft Greyish rock
21 – 26	Soft Black Rock
27 – 45	Yellowish gray granite
46 – 67	Grey weathered granite rock

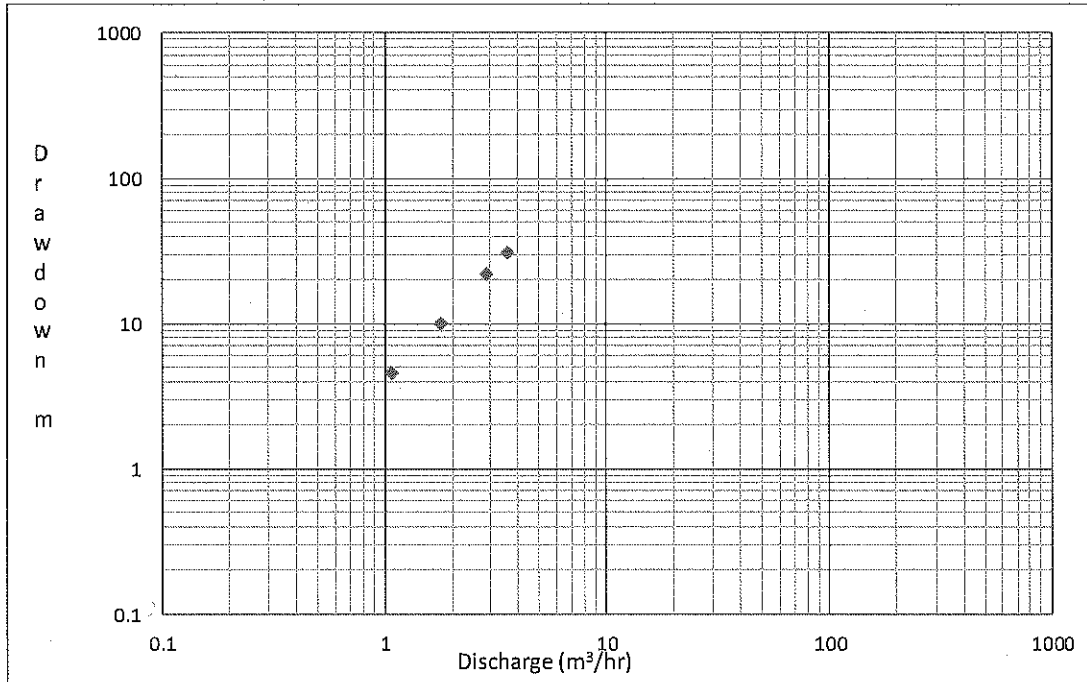
STEP DRAWDOWN TEST

Project Name	C. D. S. S PHASE III		
Borehole No	R1 - No 1	Static Water Level	6.59 M
Site	MUHASUWA C. D. S. S	Date	01/12/2013

Step	Discharge (m3/hr)	Dynamic Level (m)	Drawdown (m)
First (1st)	1.08	11.25	4.66
Second (2nd)	1.8	16.8	10.21
Third (3rd)	2.88	28.85	22.26
Forth (4th)	3.6	38.15	31.56

Pumping test of the borehole at Muhasuwa CDSS was done in 4 Step Drawn test of 120 minutes. The four steps tests were set at 0.3l/s, 0.5l/s, 0.8l/s and 1.0l/s. The pump was set at a depth of 45m. This was followed by Constant Discharge Pumping test for 24 hours at the yield of 1.0l/s and followed by Recovery test. The below table shows the Step Draw down Test and Constant Pump Test results at Muhasuwa CDSS

Step No.	Duration (Min)	Discharge	Drawdown (m)	Water Cleanliness
1	120	0.3 L/s	4.66	Clean
2	120	0.5 L/s	10.21	Clean
3	120	0.8 L/s	22.26	Clean
4	120	1.0 L/s	31.56	Clean

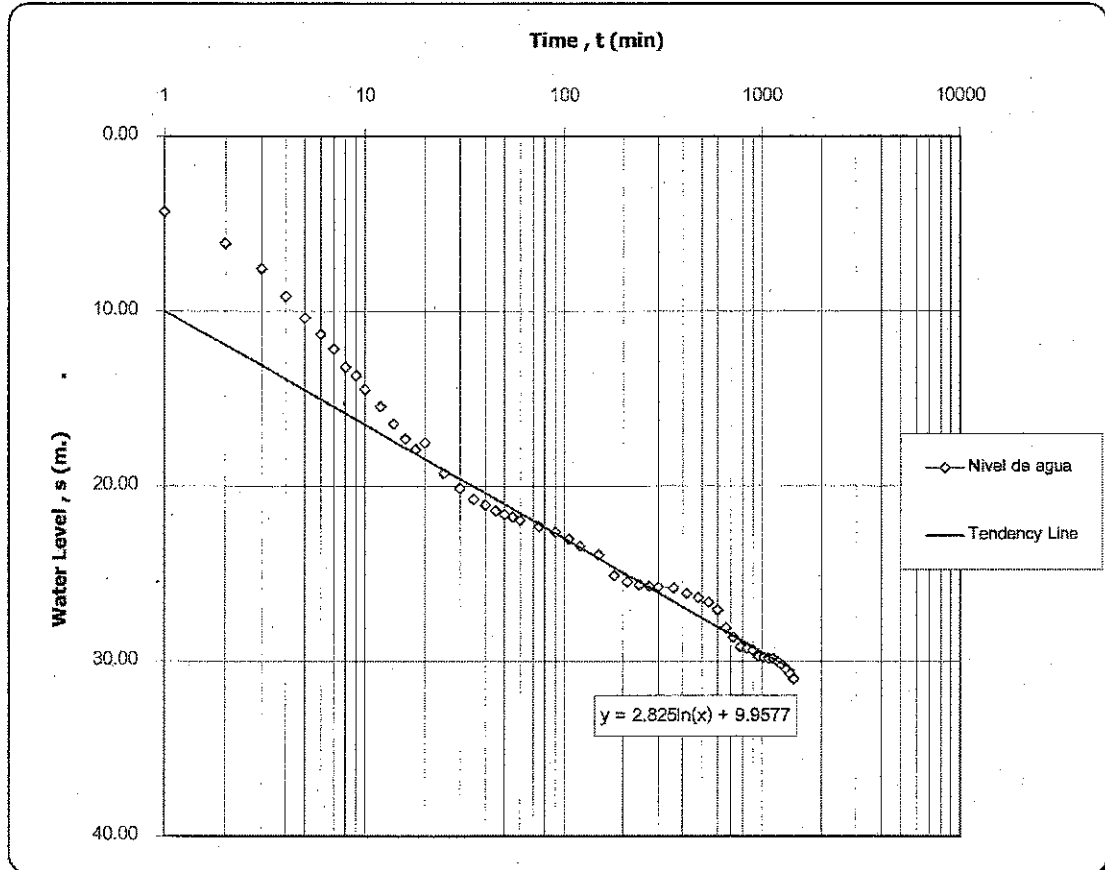
CONSTANT DISCHARGE TEST

PROJECT NAME	Malawi CDSS Phase 3		
BOREHOLE No.	R1 No.1	STATIC WATER LEVEL	6.59 m.
SITE	Muhasuwa CDSS	DATE	02/12/13

DESCRIPTION	
Discharge, Q (m ³ /hr.)	3.60 m ³ /hr.
water Level ,ΔS (m.)	6.67 m. ←
Transmissivity , T (m ² /hr.)	
$T = (2.30 Q)/(4\pi\Delta S)$	0.099 m ² /hr. ←
Screen Length , b (m.)	21.00 m. ←
Hydraulic Gradient , K (m./hr.)	
$K = T/b$	4.704E-03 m./hr.

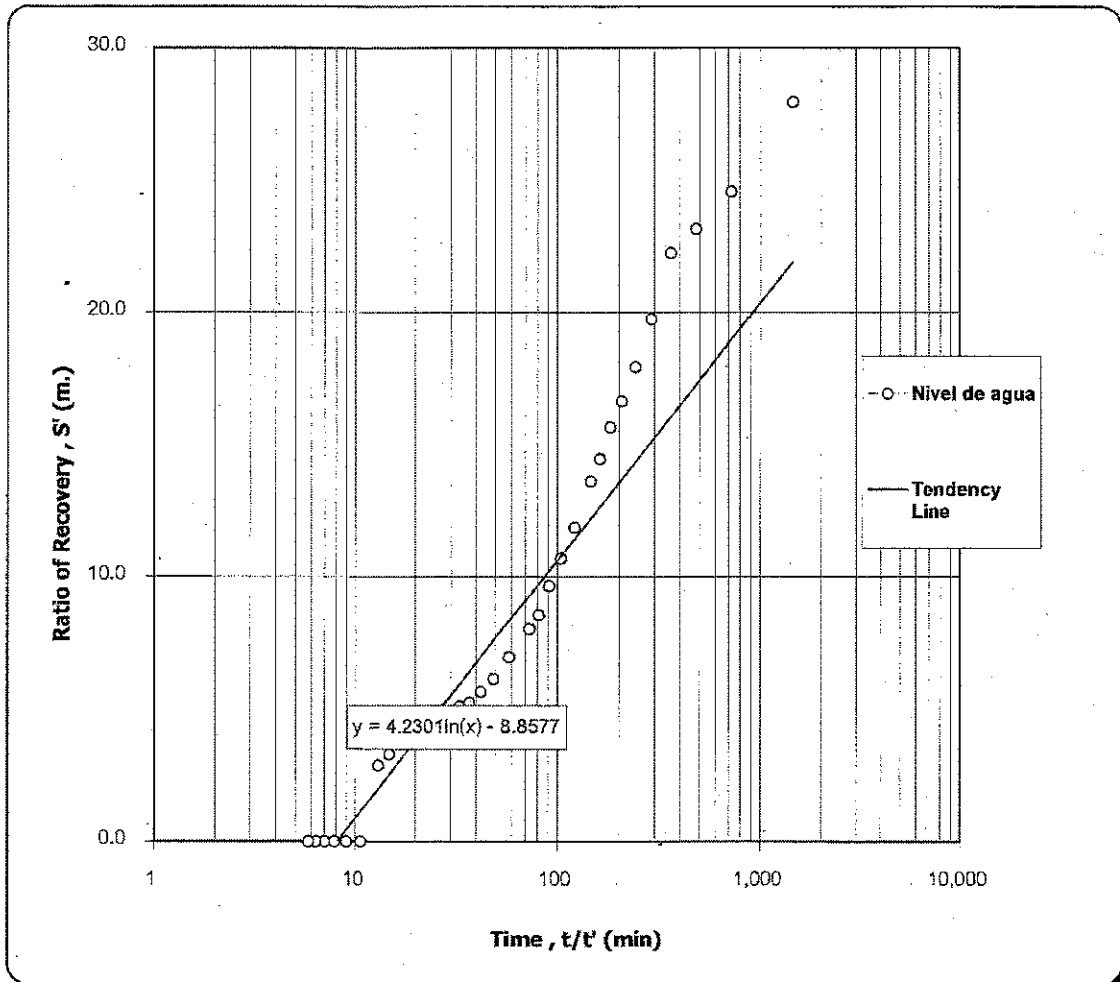
WATER LEVEL RECOVERY TEST

PROJECT NAME	Malawi CDSS Phase 3		
BOREHOLE No.	R1 No.1	STATIC WATER LEVEL	6.59 m.
SITE	Muhasuwa CDSS	DATE	03/12/13

DESCRIPTION	
Discharge, Q ($m^3/hr.$)	3.60 $m^3/hr.$
Water Level, ΔS (m.)	9.50 m.
Transmissivity, T ($m^2/hr.$)	
$T = (2.30 Q)/(4\pi\Delta S)$	0.07 $m^2/hr.$
Screen Length, b (m.)	21.00 m.
Hydraulic Gradient, K (m./hr.)	
$K = T/b$	3.303E-03 m./hr.

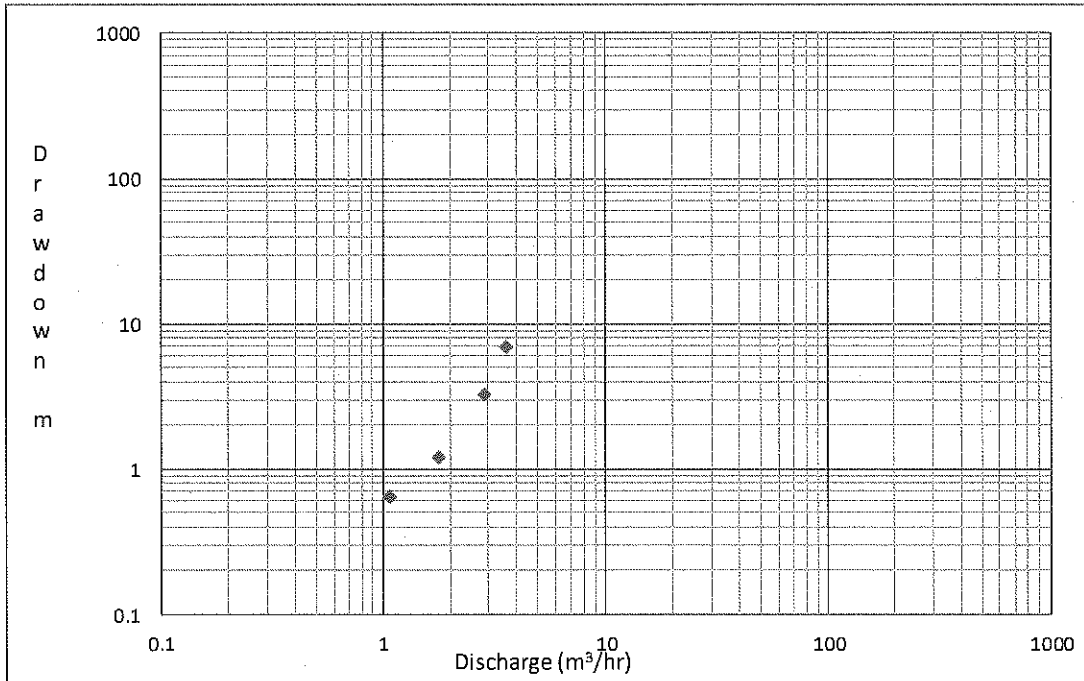
STEP DRAWDOWN TEST

Project Name	C. D. S. S PHASE III		
Borehole No	R2 - No. 1	Static Water Level	2.27 M
Site	MWATIBU C. D. S. S	Date	17/10/2013

Step	Discharge (m ³ /hr)	Dynamic Level (m)	Drawdown (m)
First (1st)	1.08	2.93	0.66
Second (2nd)	1.8	3.5	1.23
Third (3rd)	2.88	5.56	3.29
Forth (4th)	3.6	9.34	7.07

Pumping test of the borehole at Mwatibu CDSS was done in 4 Step Drawn test of 120 minutes. The four steps tests were set at 0.3l/s, 0.5l/s, 0.8l/s and 1.0l/s. The pump was set at a depth of 42m. This was followed by Constant Discharge Pumping test for 24 hours at the yield of 1.11l/s and followed by Recovery test. The below table shows the Step Draw down Test and Constant Pump Test results at Mwatibu CDSS

Step No.	Duration (Min)	Discharge	Drawdown (m)	Water Cleanliness
1	120	0.3 L/s	0.66	Clean
2	120	0.5 L/s	1.23	Clean
3	120	0.8 L/s	3.29	Clean
4	120	1.0 L/s	7.07	Clean

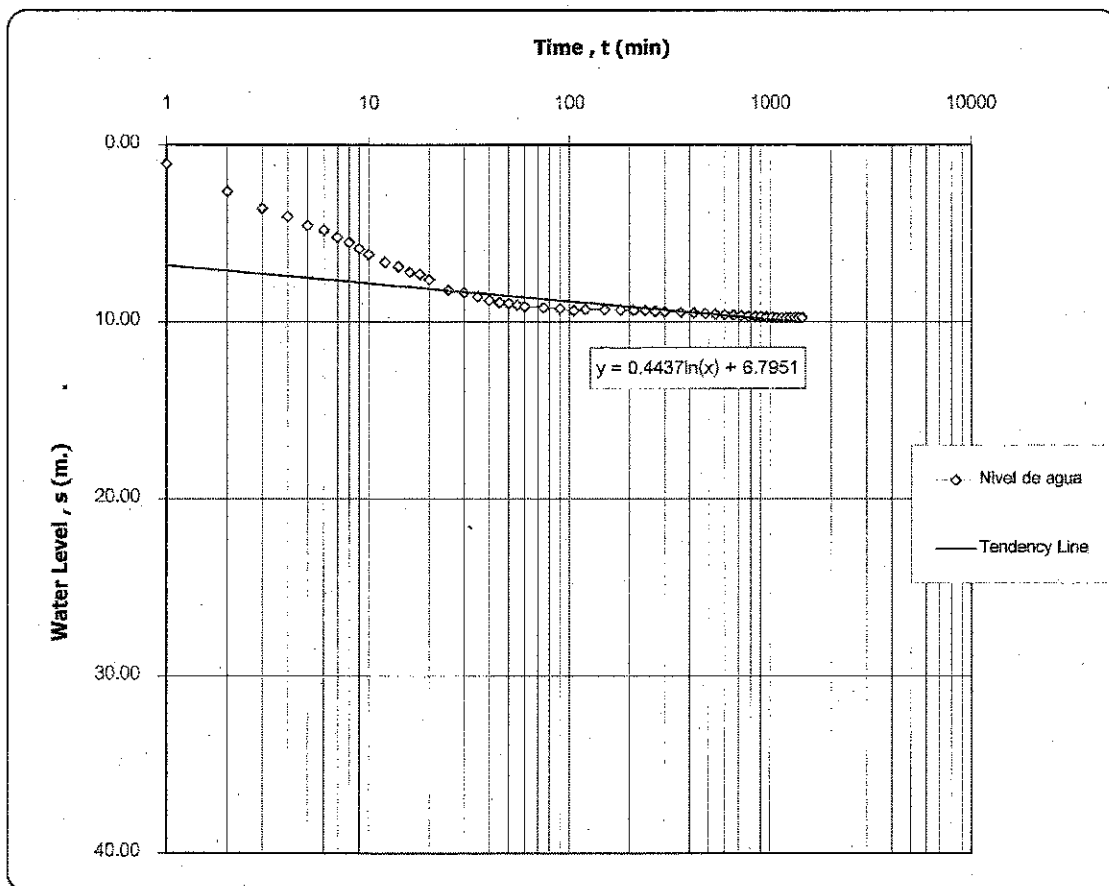
CONSTANT DISCHARGE TEST

PROJECT NAME	Malawi CDSS Phase 3		
BOREHOLE No.	R2 No.1	STATIC WATER LEVEL	2.27 m.
SITE	Mwatibu CDSS	DATE	18/10/13

DESCRIPTION	
Discharge, Q (m ³ /hr.)	3.96 m ³ /hr.
water Level ,ΔS (m.)	1.10 m.
Transmissivity , T (m ² /hr.)	
$T = (2.30 Q) / (4\pi\Delta S)$	0.659 m ² /hr.
Screen Length , b (m.)	21.00 m.
Hydraulic Gradient , K (m./hr.)	
$K = T/b$	3.138E-02 m./hr.

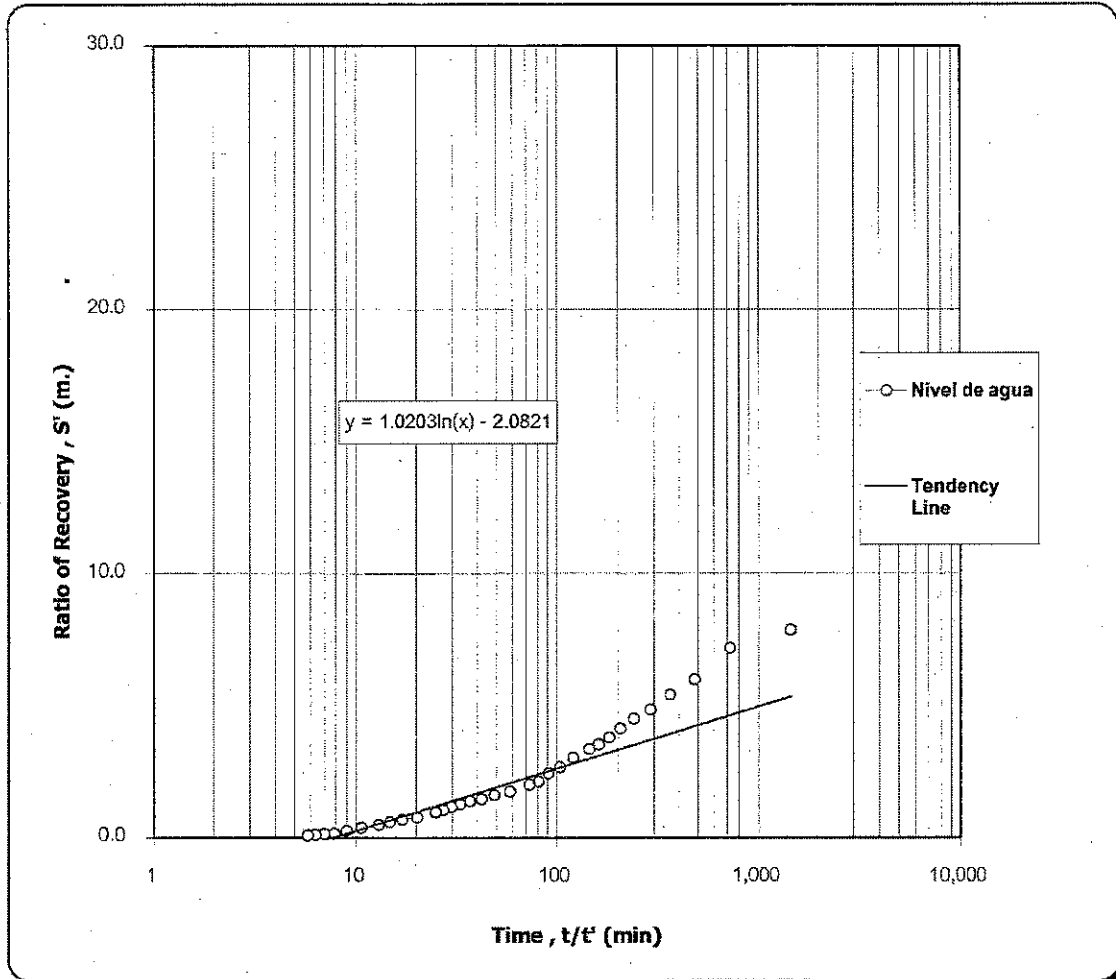
WATER LEVEL RECOVERY TEST

PROJECT NAME	Malawi CDSS Phase 3		
BOREHOLE No.	R2 no.1	STATIC WATER LEVEL	2.27 m.
SITE	Mwatibu CDSS	DATE	19/10/13

DESCRIPTION	
Discharge, Q (m ³ /hr.)	3.96 m ³ /hr.
Water Level, ΔS (m.)	2.27 m.
Transmissivity, T (m ² /hr.)	
$T = (2.30 Q) / (4\pi\Delta S)$	0.32 m ² /hr.
Screen Length, b (m.)	21.00 m.
Hydraulic Gradient, K (m./hr.)	
$K = T/b$	1.520E-02 m./hr.

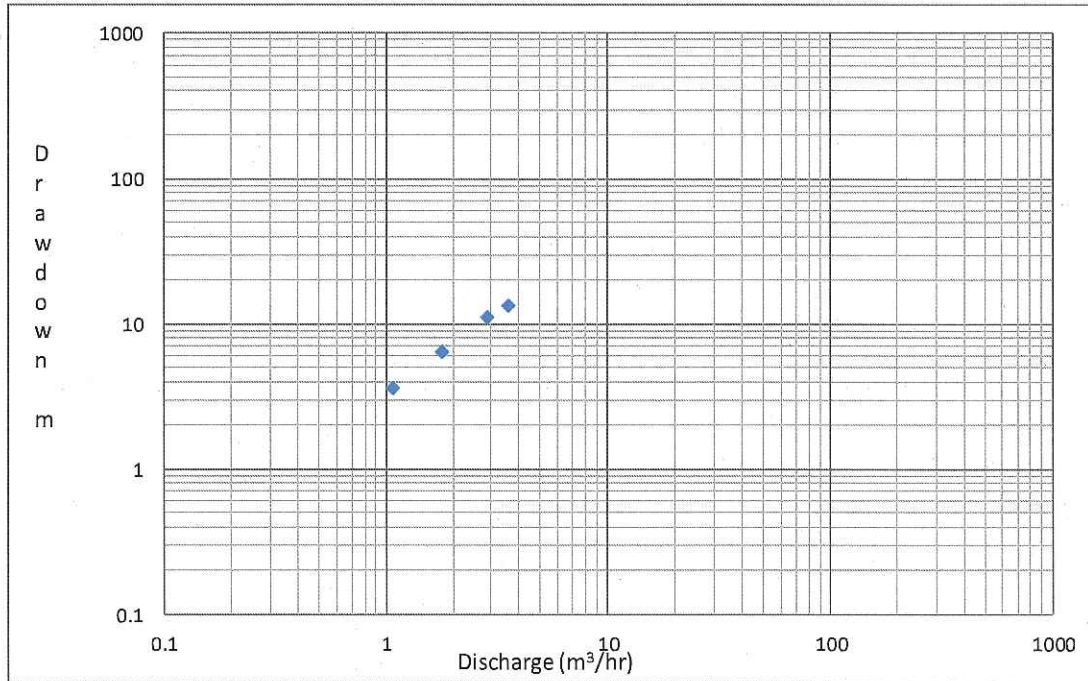
Project Name	C. D. S. S PHASE III		
Borehole No	R3 - No 1	Static Water Level	9.9 M
Site	CHIMWALIRA C. D. S. S	Date	02/12/2013

Step	Discharge (m ³ /hr)	Dynamic Level (m)	Drawdown (m)
First (1st)	1.08	13.62	3.72
Second (2nd)	1.8	16.48	6.58
Third (3rd)	2.88	21.1	11.2
Forth (4th)	3.6	23.64	13.74

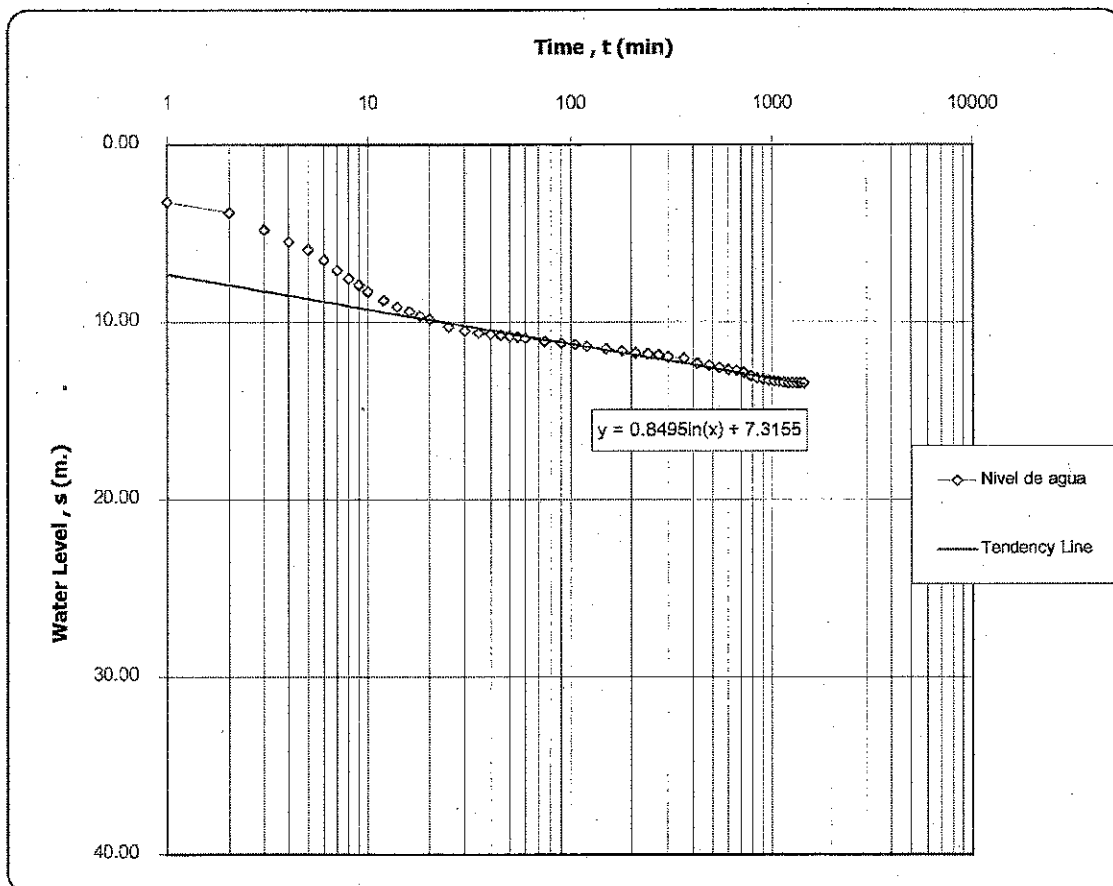
PROJECT NAME	Malawi CDSS Phase 3		
BOREHOLE No.	R3 No.1	STATIC WATER LEVEL	9.90 m.
SITE	Chimwalira CDSS	DATE	03/12/13

DESCRIPTION	
Discharge, Q (m ³ /hr.)	3.60 m ³ /hr.
water Level, ΔS (m.)	2.10 m.
Transmissivity, T (m ² /hr.)	
$T = (2.30 Q) / (4\pi\Delta S)$	0.314 m ² /hr.
Screen Length, b (m.)	21.00 m.
Hydraulic Gradient, K (m./hr.)	
$K = T/b$	1.494E-02 m./hr.

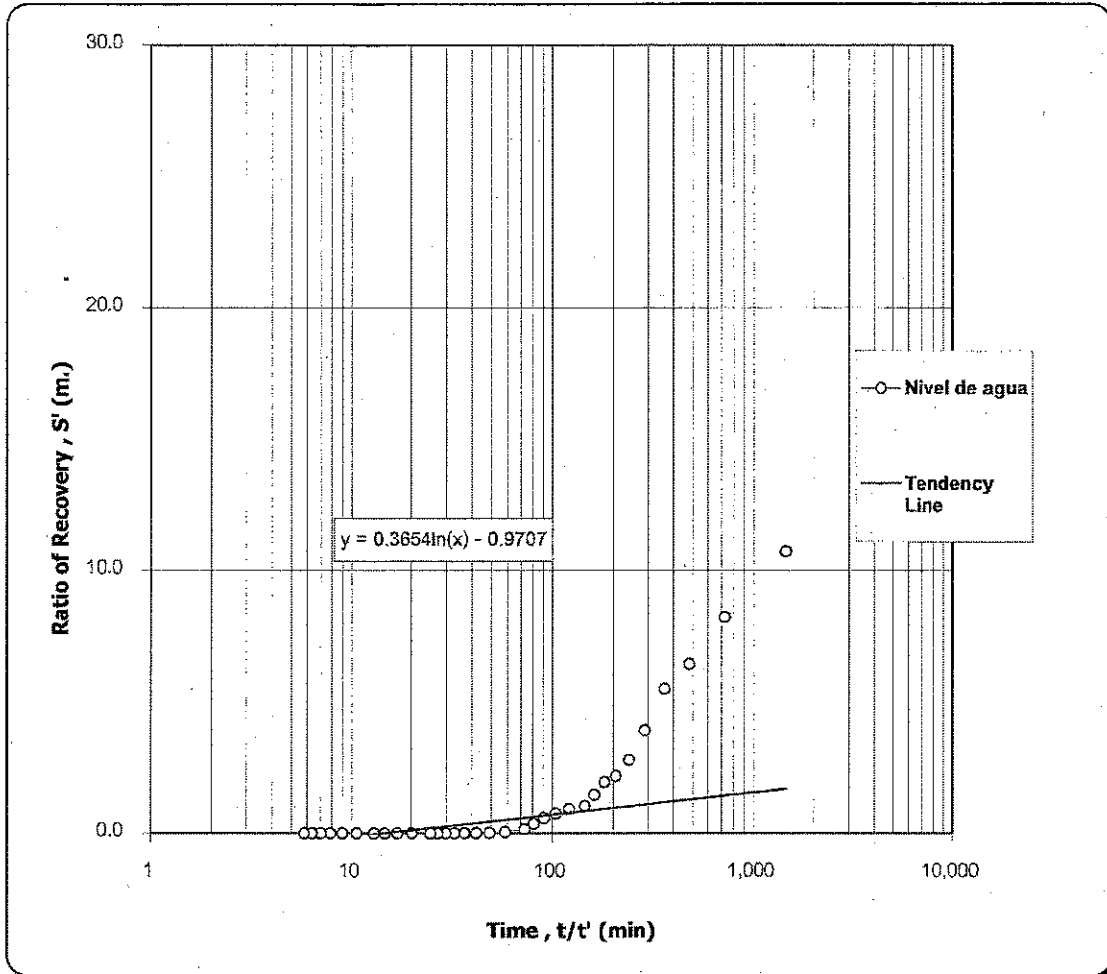
PROJECT NAME	Malawi CDSS Phase 3		
BOREHOLE No.	R3 No.1	STATIC WATER LEVEL	9.90 m.
SITE	Chimwalira CDSS	DATE	04/12/13

DESCRIPTION	
Discharge, Q (m ³ /hr.)	3.60 m ³ /hr.
Water Level ,ΔS (m.)	0.85 m.
Transmissivity , T (m ² /hr.)	
$T = (2.30 Q)/(4\pi\Delta S)$	0.78 m ² /hr.
Screen Length , b (m.)	21.00 m.
Hydraulic Gradient , K (m./hr.)	
$K = T/b$	3.691E-02 m./hr.

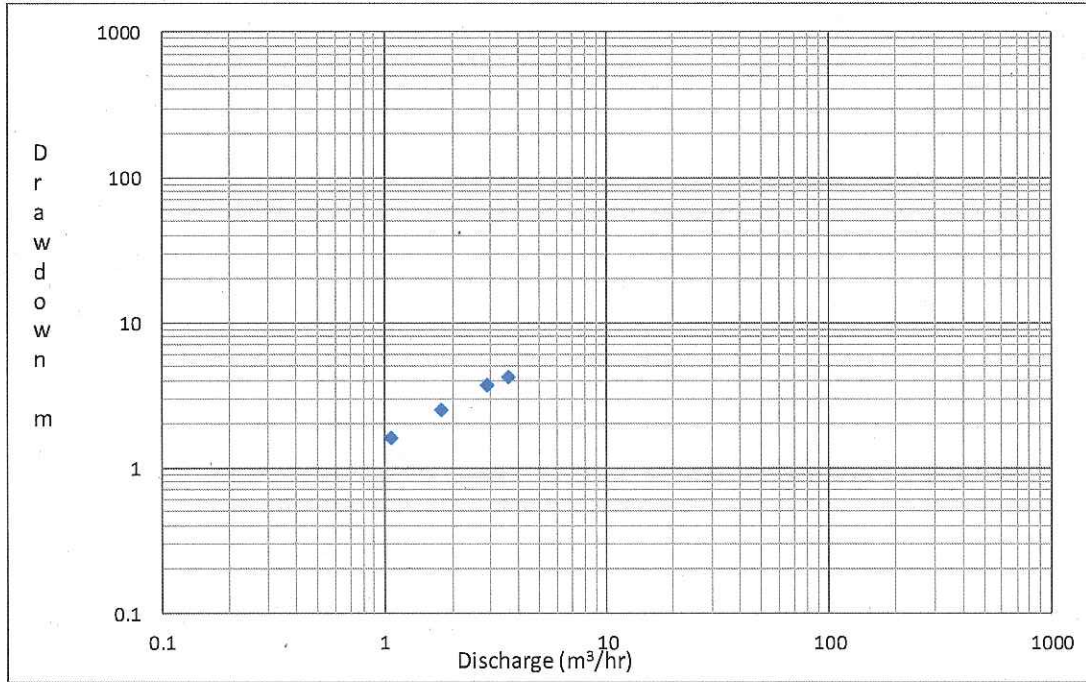
Project Name	C. D. S. S PHASE III		
Borehole No	R4 - No 3	Static Water Level	10.93 M
Site	KABEKERE C. D. S. S	Date	26/11/2013

Step	Discharge (m3/hr)	Dynamic Level (m)	Drawdown (m)
First (1st)	1.08	12.55	1.62
Second (2nd)	1.8	13.48	2.55
Third (3rd)	2.88	14.66	3.73
Forth (4th)	3.6	15.22	4.29

Pumping test of the borehole at Kabekere CDSS was done in 4 Step Drawn test of 120 minutes. The four steps tests were set at 0.3l/s, 0.5l/s, 0.8l/s and 1.0l/s. The pump was set at a depth of 47m. This was followed by Constant Discharge Pumping test for 24 hours at the yield of 1.0l/s and followed by Recovery test. The below table shows the Step Draw down Test and Constant Pump Test results at Kabekere CDSS

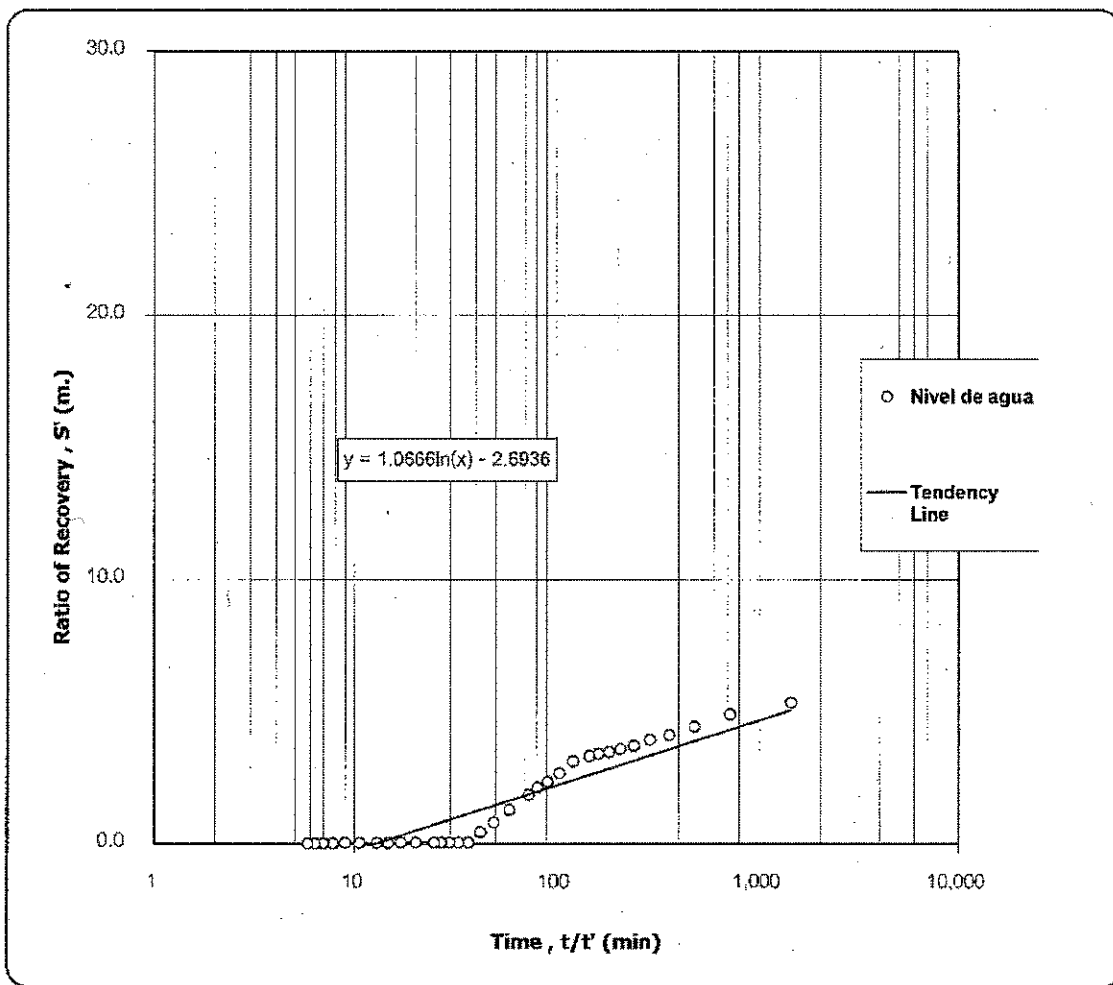
PROJECT NAME	Malawi CDSS Phase 3		
BOREHOLE No.	R4 No.3	STATIC WATER LEVEL	10.93 m.
SITE	Kabekere CDSS	DATE	28/11/13

DESCRIPTION	
Discharge, Q (m ³ /hr.)	3.60 m ³ /hr.
Water Level, ΔS (m.)	2.38 m.
Transmissivity, T (m ² /hr.)	0.28 m ² /hr.
$T = (2.30 Q) / (4\pi \Delta S)$	0.28 m ² /hr.
Screen Length, b (m.)	21.00 m.
Hydraulic Gradient, K (m./hr.)	1.318E-02 m./hr.
$K = T/b$	1.318E-02 m./hr.

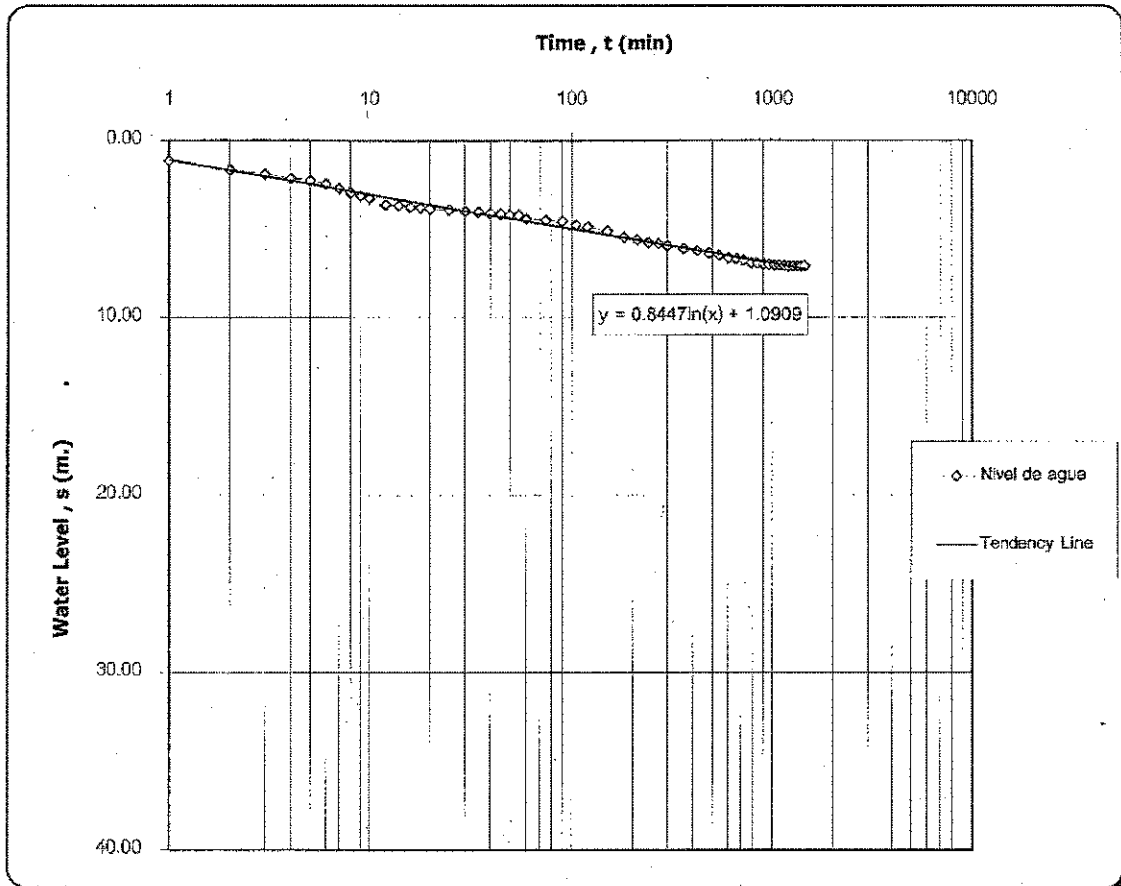
PROJECT NAME	Malawi CDSS Phase 3		
BOREHOLE No.	R4 No.3	STATIC WATER LEVEL	10.93 m.
SITE	Kabekere CDSS	DATE	27/11/13

DESCRIPTION	
Discharge, Q (m ³ /hr.)	3.60 m ³ /hr.
water Level ,ΔS (m.)	2.18 m. ←
Transmissivity , T (m ² /hr.)	
$T = (2.30 Q)/(4\pi\Delta S)$	0.302 m ² /hr.
Screen Length , b (m.)	21.00 m. ←
Hydraulic Gradient , K (m./hr.)	
$K = T/b$	1.439E-02 m./hr.

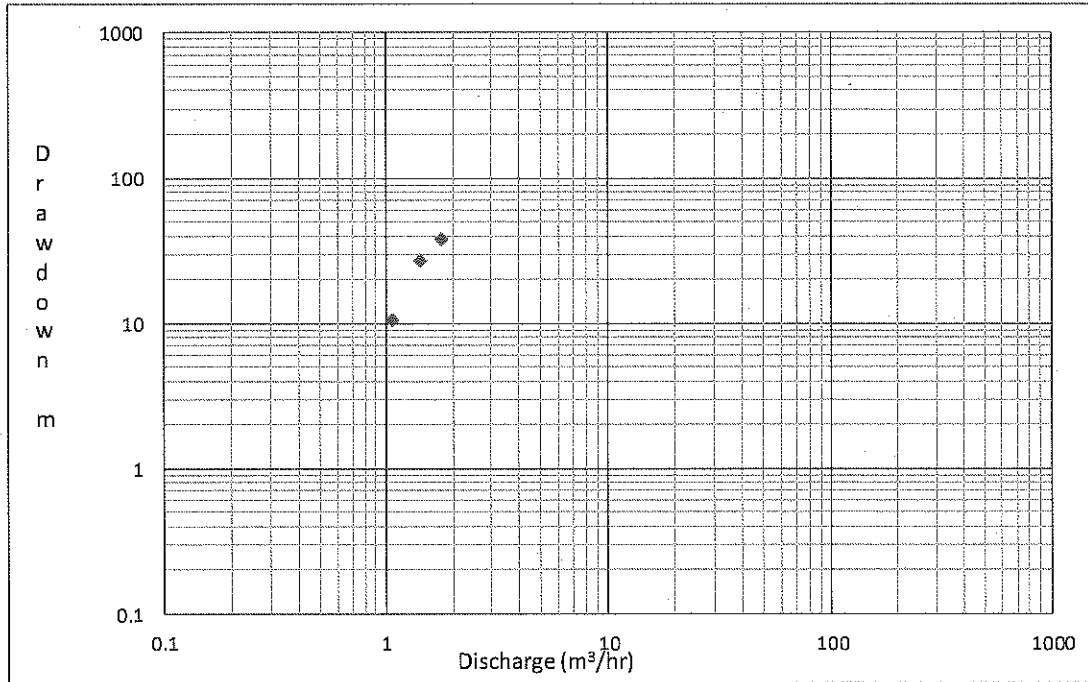
Project Name	C. D. S. S PHASE III		
Borehole No	R5 - No 1	Static Water Level	7.13 M
Site	MWALAWANYENJE C. D. S. S	Date	28/10/2013

Step	Discharge (m ³ /hr)	Dynamic Level (m)	Drawdown (m)
First (1st)	1.08	17.96	10.83
Second (2nd)	1.44	34.67	27.54
Third (3rd)	1.8	45.74	38.61
Forth (4th)	3.6	0	0

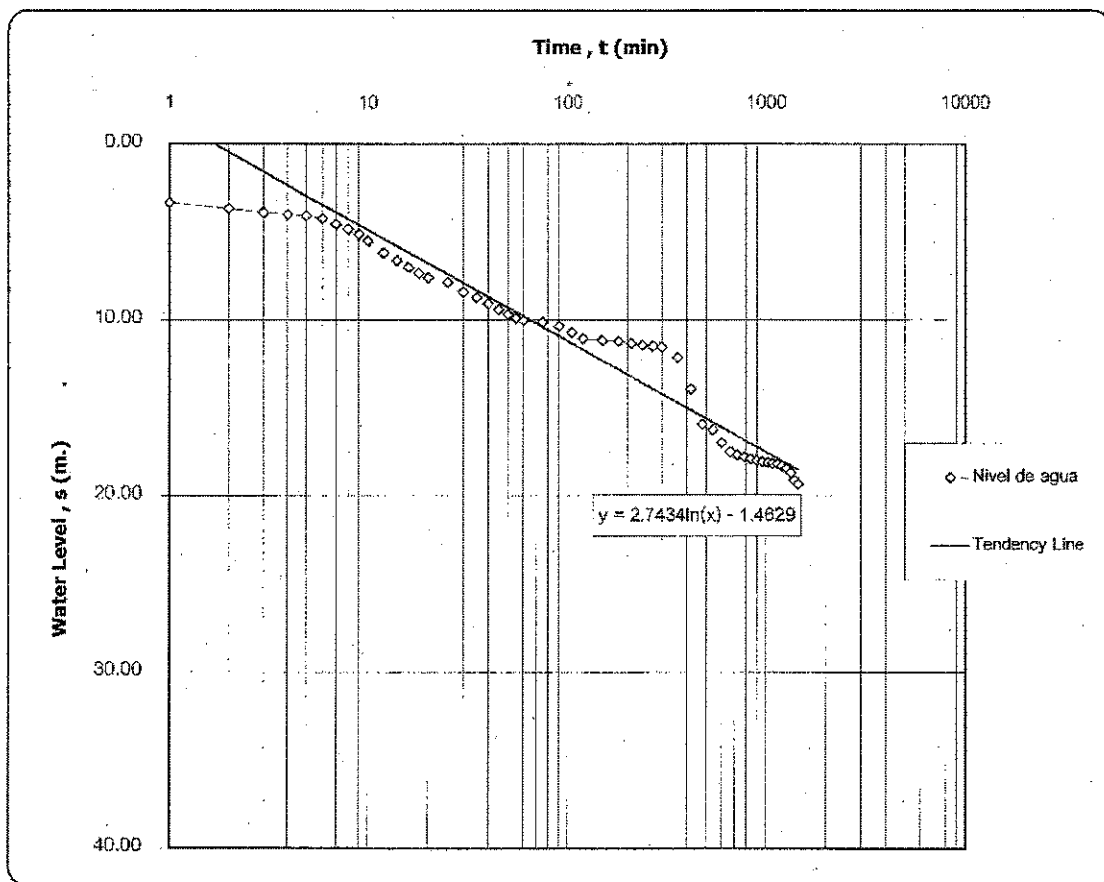
PROJECT NAME	Malawi CDSS Phase 3		
BOREHOLE No.	R5 No.1	STATIC WATER LEVEL	7.13 m.
SITE	Mwalawanyenje CDSS	DATE	29/10/13

DESCRIPTION	
Discharge, Q (m ³ /hr.)	1.30 m ³ /hr.
water Level ΔS (m.)	6.36 m.
Transmissivity, T (m ² /hr.)	
$T = (2.30 Q) / (4\pi\Delta S)$	0.037 m ² /hr.
Screen Length, b (m.)	21.00 m.
Hydraulic Gradient, K (m./hr.)	
$K = T/b$	1.776E-03 m./hr.

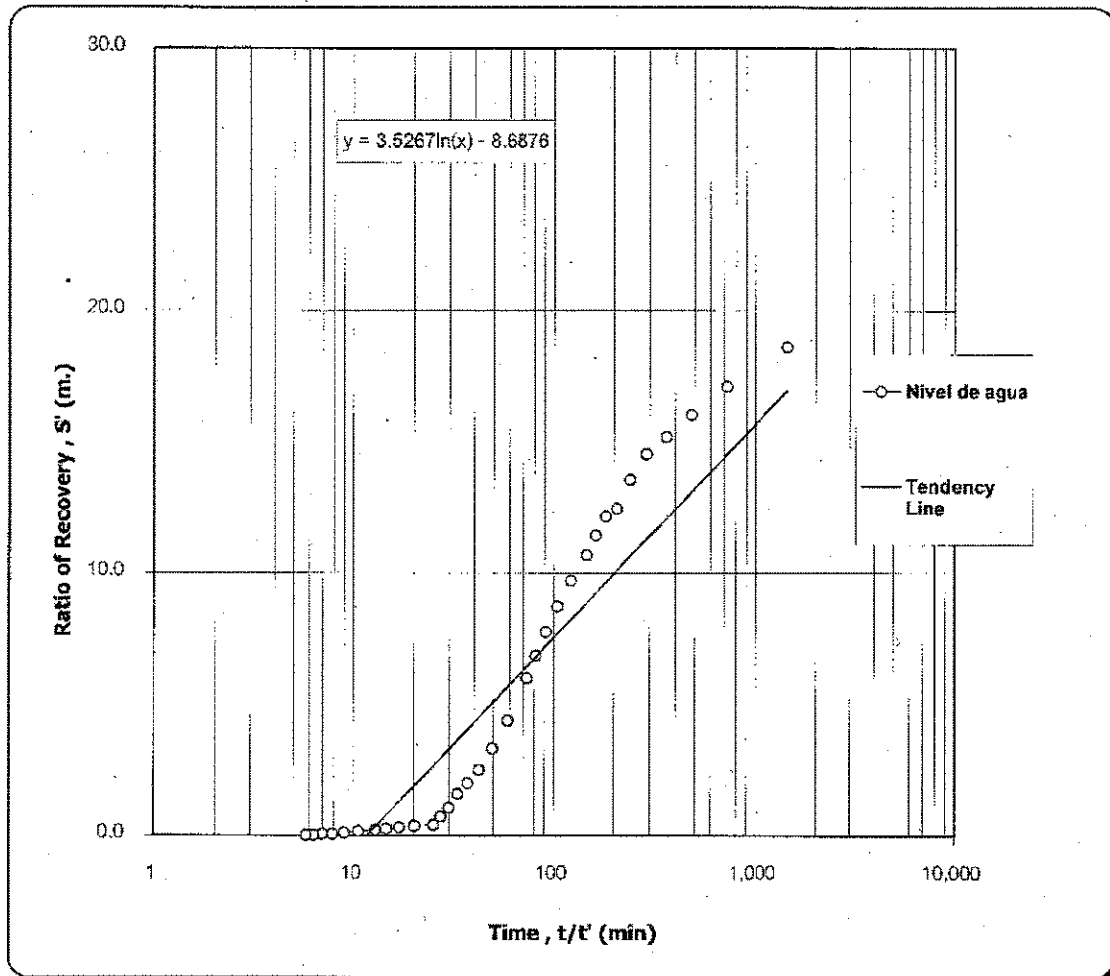
PROJECT NAME	Malawi CDSS Phase 3		
BOREHOLE No.	R5 No.1	STATIC WATER LEVEL	7.13 m.
SITE	Mwalawanyenje CDSS	DATE	30/10/13

DESCRIPTION	
Discharge, Q (m ³ /hr.)	1.30 m ³ /hr.
Water Level, ΔS (m.)	9.38 m.
Transmissivity, T (m ² /hr.)	
$T = (2.30 Q) / (4\pi \Delta S)$	0.03 m ² /hr.
Screen Length, b (m.)	21.00 m.
Hydraulic Gradient, K (m./hr.)	
$K = T/b$	1.205E-03 m./hr.

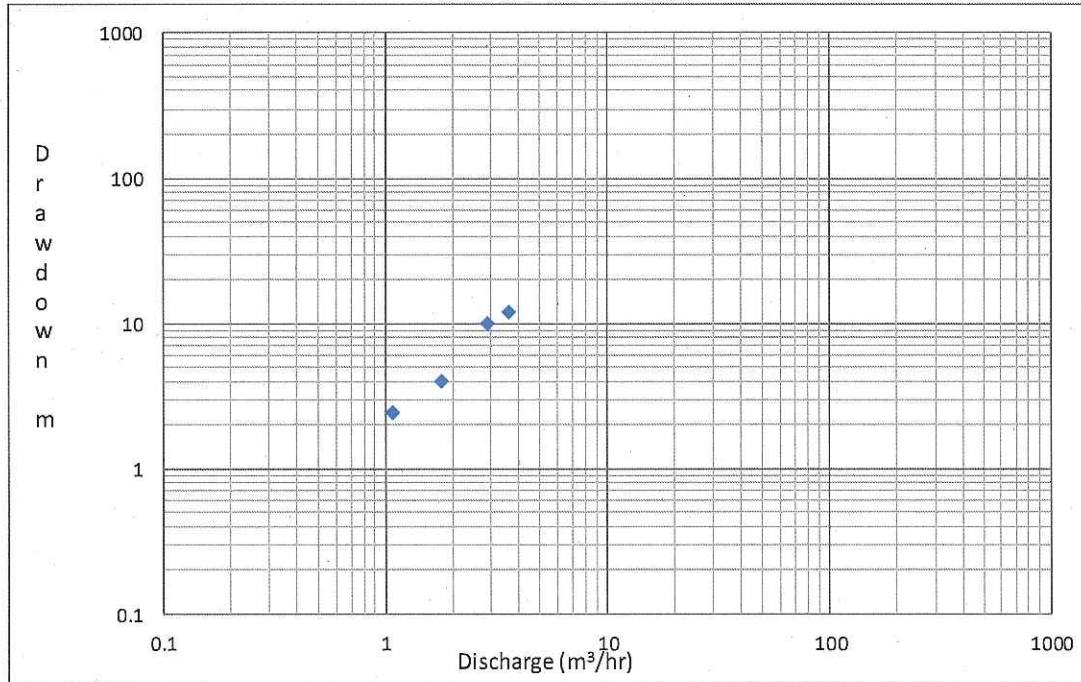
Project Name	C. D. S. S PHASE III		
Borehole No	R6 - No 2	Static Water Level	8.75 M
Site	MZOMA C. D. S. S	Date	16/11/2013

Step	Discharge (m3/hr)	Dynamic Level (m)	Drawdown (m)
First (1st)	1.08	11.22	2.47
Second (2nd)	1.8	12.85	4.1
Third (3rd)	2.88	18.8	10.05
Forth (4th)	3.6	21.13	12.38

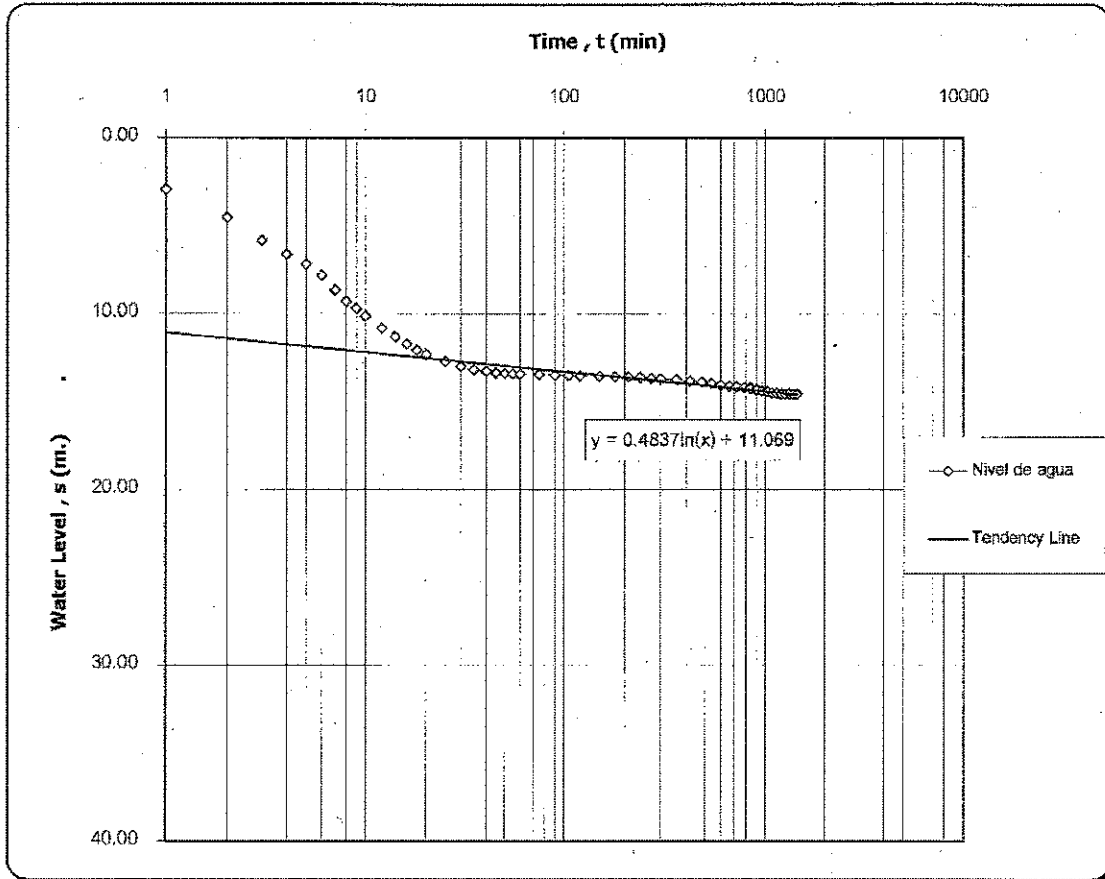
PROJECT NAME	Malawi CDSS Phase 3		
BOREHOLE No.	R6 No.2	STATIC WATER LEVEL	8.75 m.
SITE	Mzoma CDSS	DATE	17/11/13

DESCRIPTION	
Discharge, Q (m ³ /hr.)	3.60 m ³ /hr.
water Level ΔS (m.)	1.16 m.
Transmissivity, T (m ² /hr.)	
$T = (2.30 Q) / (4\pi\Delta S)$	0.568 m ² /hr.
Screen Length, b (m.)	21.00 m.
Hydraulic Gradient, K (m./hr.)	
$K = T/b$	2.705E-02 m./hr.

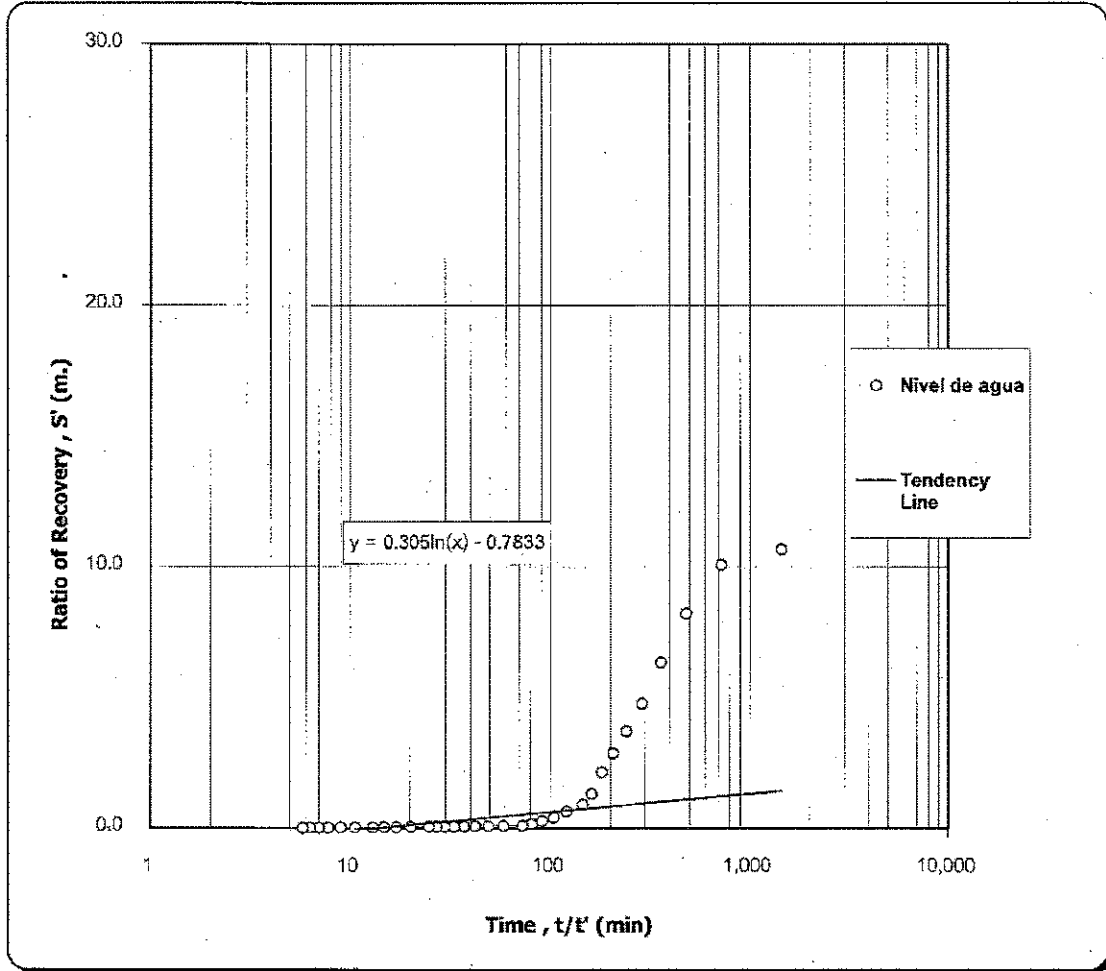
PROJECT NAME	Malawi CDSS Phase 3		
BOREHOLE No.	R6 No.2	STATIC WATER LEVEL	8.75 m.
SITE	Mzoma CDSS	DATE	18/11/13

DESCRIPTION	
Discharge, Q (m ³ /hr.)	3.60 m ³ /hr.
Water Level, ΔS (m.)	0.65 m.
Transmissivity, T (m ² /hr.)	
$T = (2.30 Q) / (4\pi \Delta S)$	1.01 m ² /hr.
Screen Length, b (m.)	21.00 m.
Hydraulic Gradient, K (m./hr.)	
$K = T/b$	4.827E-02 m./hr.

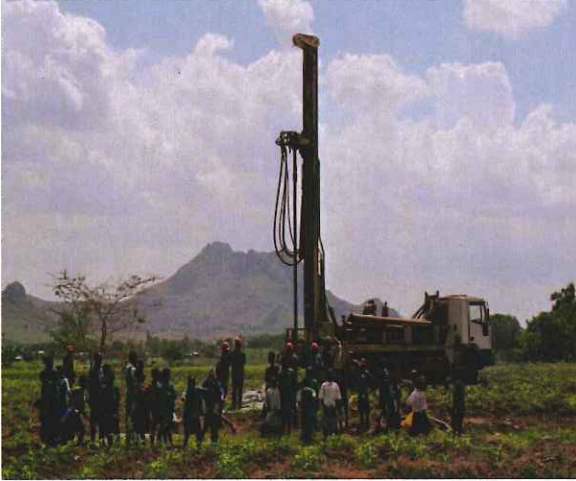
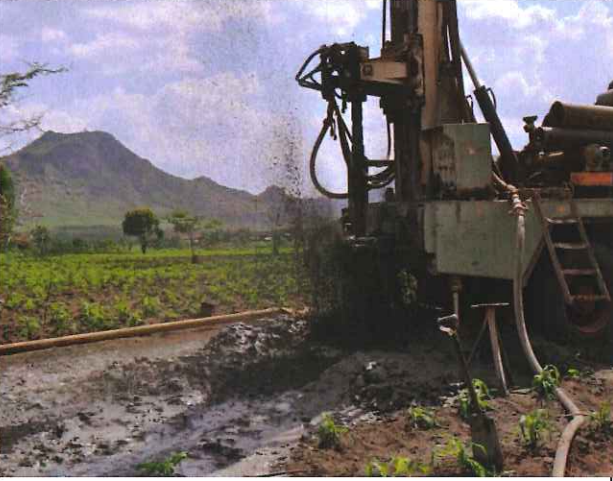
<p>1. R1-No.1 Muhasuwa CDSS Drilling Point (R1-No.1) November 2013</p>	<p>2. R1-No.1 Muhasuwa CDSS Test Drilling (R1-No.1) December 2013</p>

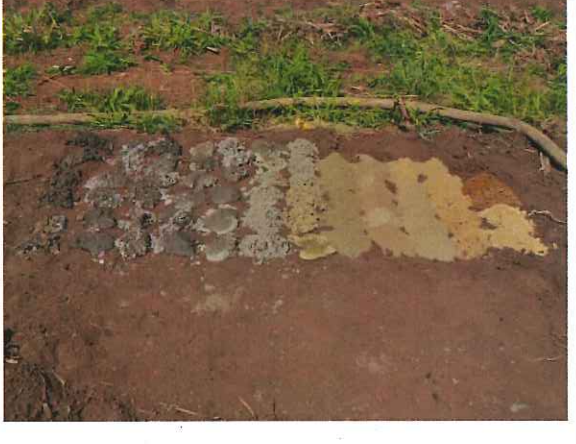
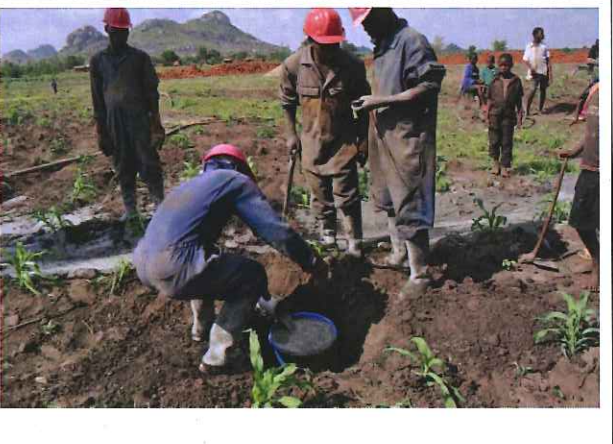
<p>3. R1-No.1 Muhasuwa CDSS Geological Sample (R1-No.1) December 2013</p>	<p>4. R1-No.1 Muhasuwa CDSS Discharge Test (R1-No.1) December 2013</p>

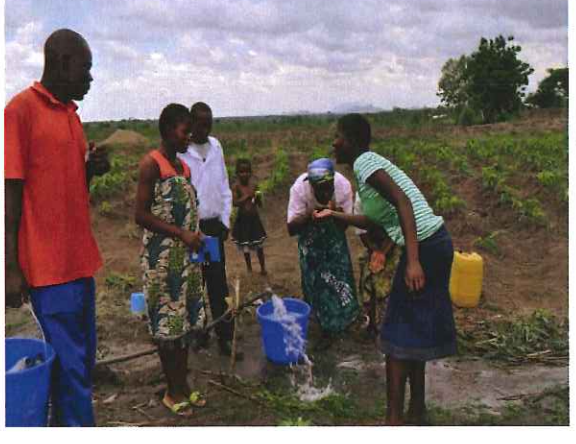
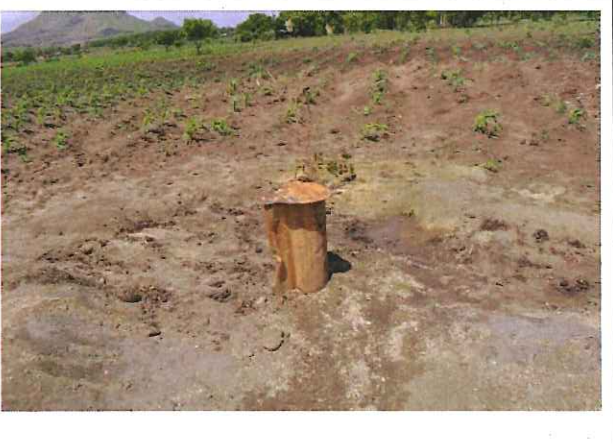
<p>5. R1-No.1 Muhasuwa CDSS Pumping Test (R1-No.1) December 2013</p>	<p>6. R1-No.1 Muhasuwa CDSS Completed and Protected Borehole (R1-No.1) December 2013</p>
