2. BOREHOLE DRILLING AND CONSTRUCTION

A Direct Air Drilling and circulatory mud method was applied. Borehole construction materials used for drilling were temporary casings, plain casing, slotted casing and gravel packing. The details of each site boreholes are separated below.

**R1 Muhasuwa CDSS Phase 3 Test Drilling Working Record,
November to December 2013**

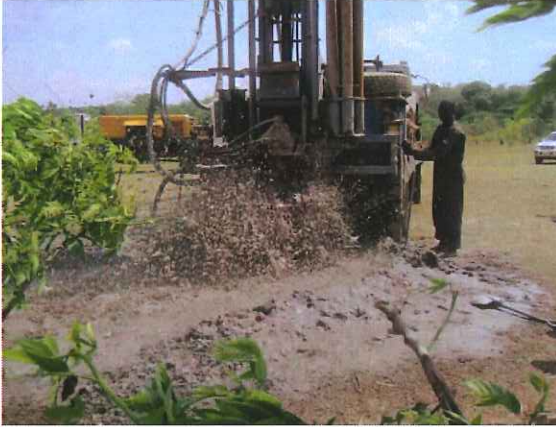
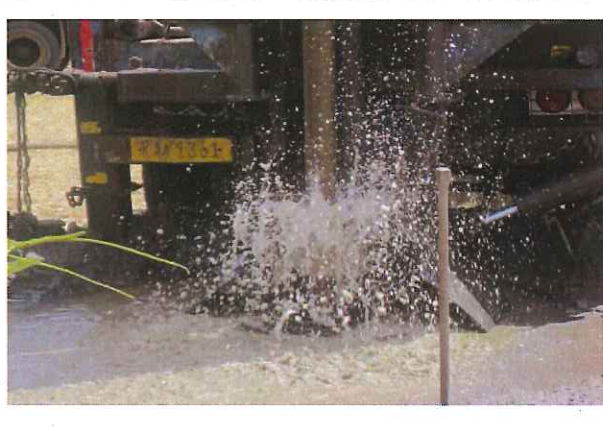
<p>1. R2-No.1 Mwatibu CDSS Drilling (R2-No.1) October 2013</p>	<p>2. R2-No.1 Mwatibu CDSS Drilling (R2-No.1) October 2013</p>

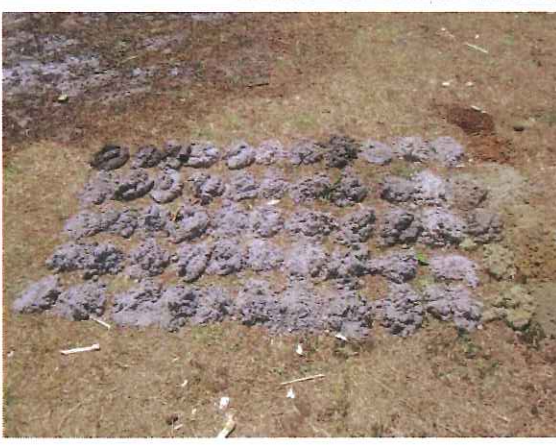
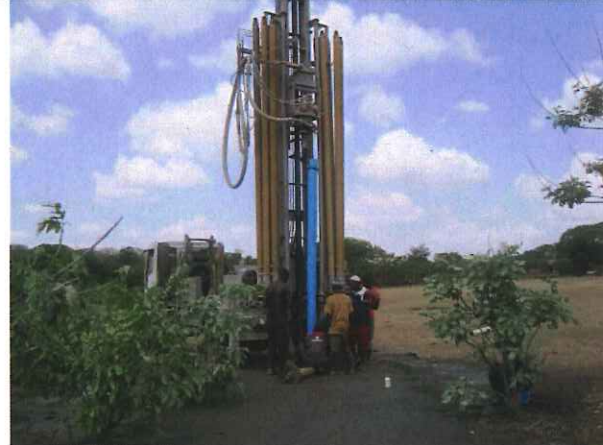
<p>3. R2-No.1 Mwatibu CDSS Geological Sample (R2-No.1) October 2013</p>	<p>4. R2-No.1 Mwatibu CDSS Casing & Screen Installation (R2-No.1) October 2013</p>

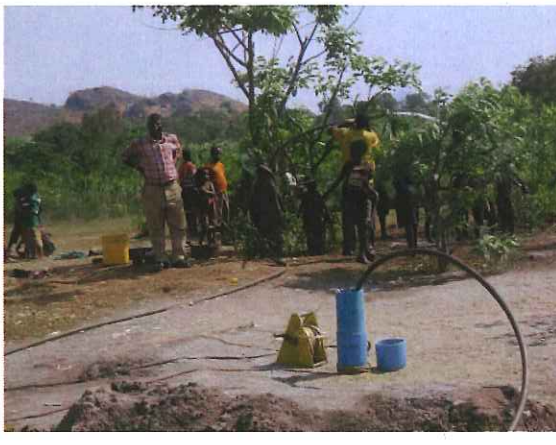
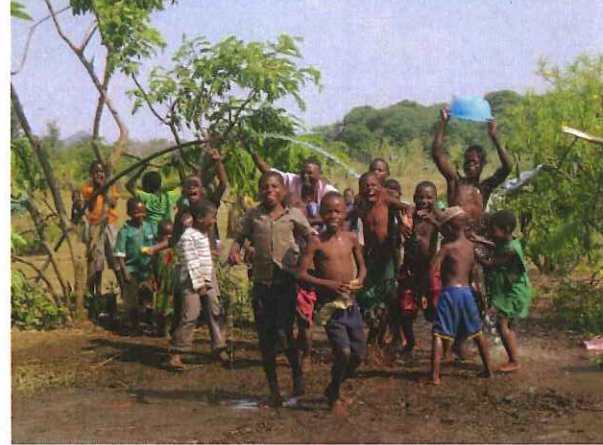
<p>5. R2-No.1 Mwatibu CDSS Pumping Test (R2-No.1) October 2013</p>	<p>6. R2-No.1 Mwatibu CDSS Pumping Test (R2-No.1) October 2013</p>

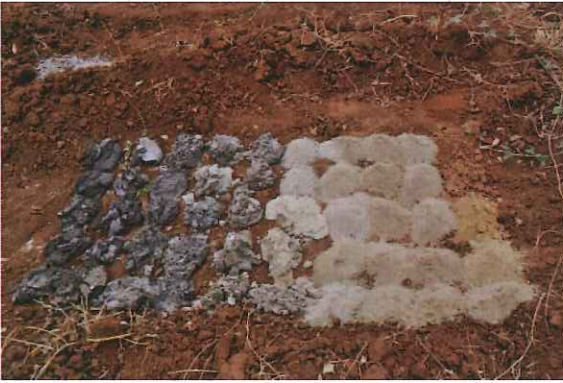
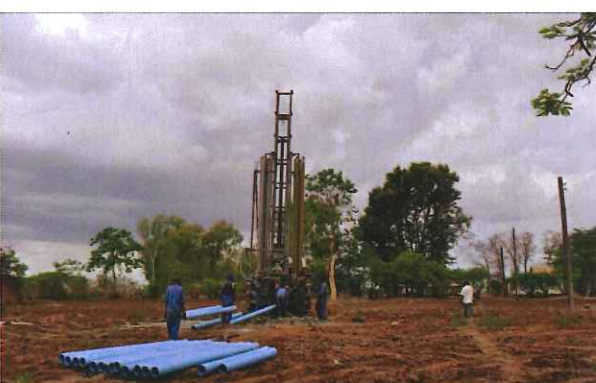
<p>1. R3-No.1 Chimwalira CDSS Geological Sample (R3-No.1) December 2013</p>	<p>2. R3-No.1 Chimwalira CDSS Casing & Screen Installation (R3-No.1) December 2013</p>

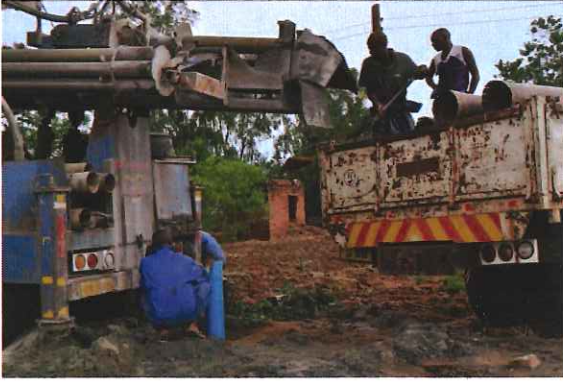
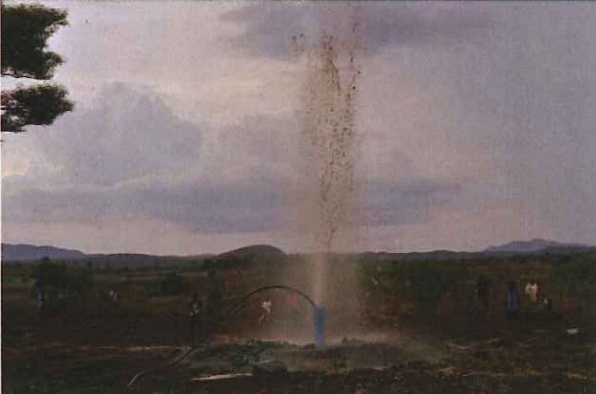
<p>3. R3-No.1 Chimwalira CDSS Gravel Packing (R3-No.1) December 2013</p>	<p>4. R3-No.1 Chimwalira CDSS Development (R3-No.1) December 2013</p>

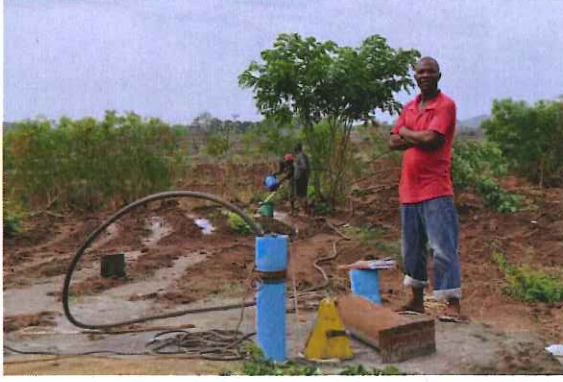
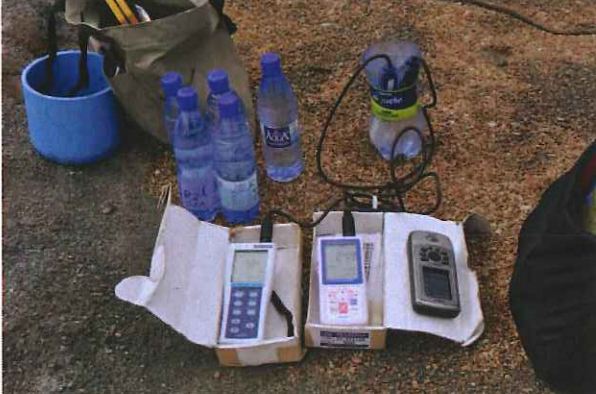
<p>5. R3-No.1 Chimwalira CDSS Pumping Test (R3-No.1) December 2013</p>	<p>6. R3-No.1 Chimwalira CDSS Water Quality Test (R3-No.1) December 2013</p>

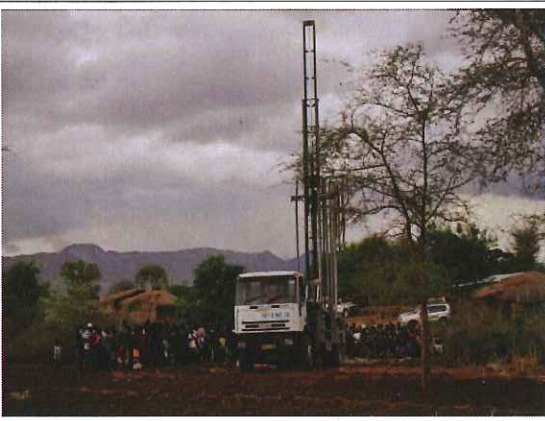
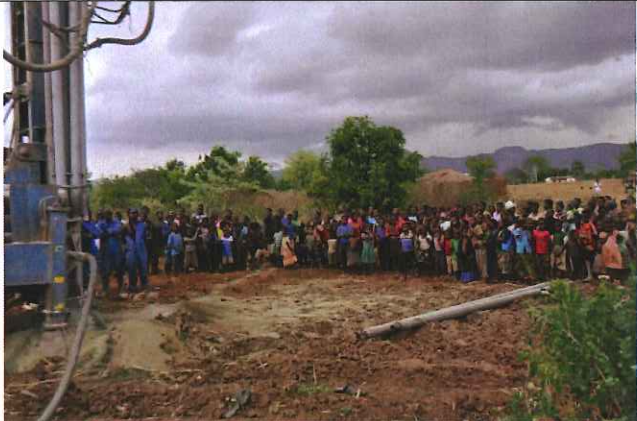
<p>1. R4-No.3 Kabekere CDSS Test Drilling (R3- No.3 Successful Borehole)</p>	<p>2. R4-No.3 Kabekere CDSS Drilling (R4- No.3 Successful Borehole in the Village)</p>

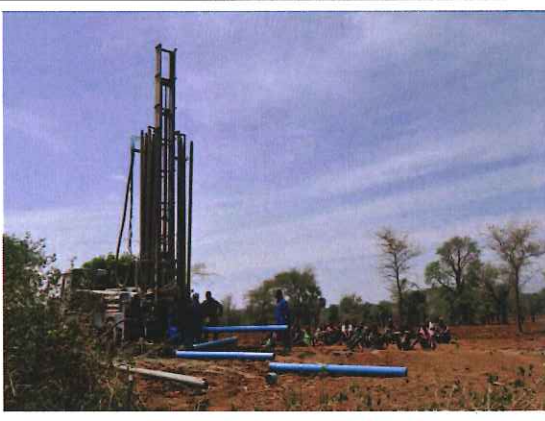
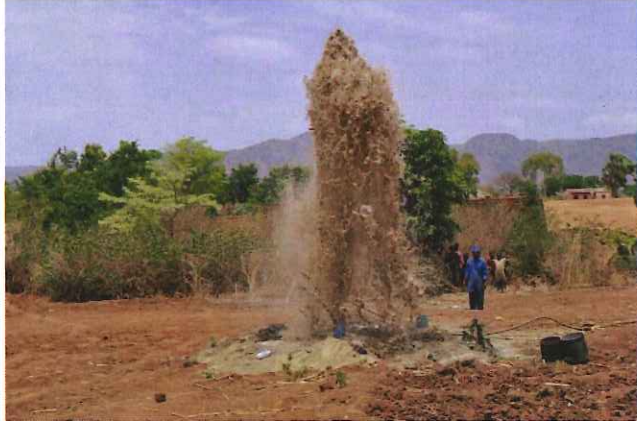
<p>3. R4-No.3 Kabekere CDSS Casing & Screen Installation, November 2013</p>	<p>4. R4-No.3 Kabekere CDSS Development (R4- No.3) November 2013</p>

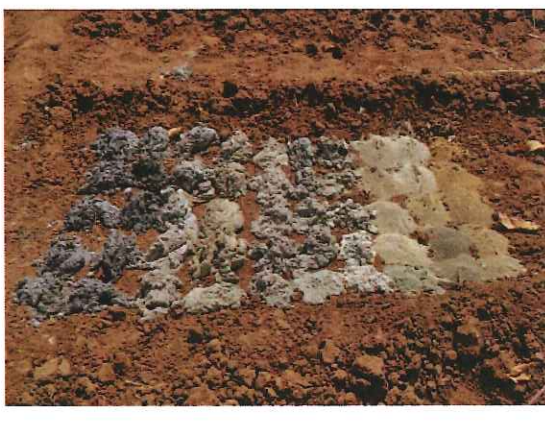
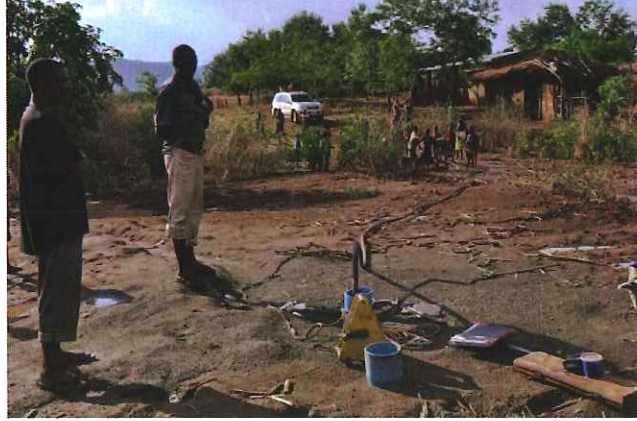
<p>5. R4 Kabekere CDSS Geological Sample (R4- No.3) November 2013</p>	<p>6. R4 Kabekere CDSS No.3 Pumping Test (R4- No.3) November 2013</p>

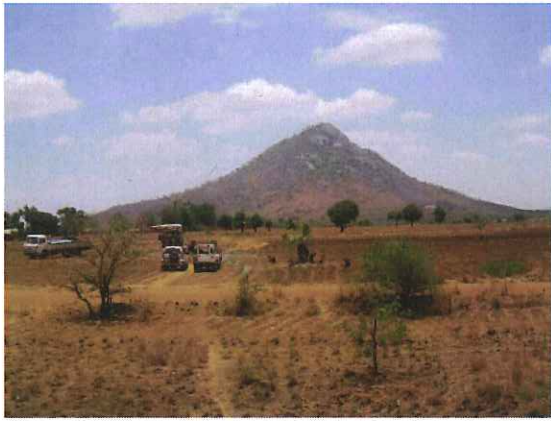
<p>1. R5 Mwalawanyenje CDSS Drilling Point (R5- No.1) Octobor 2013</p>	<p>2. R5 Mwalawanyenje CDSS Confirmation of Drilling Point with Mrs. Head Teacher, Octobor 2013</p>

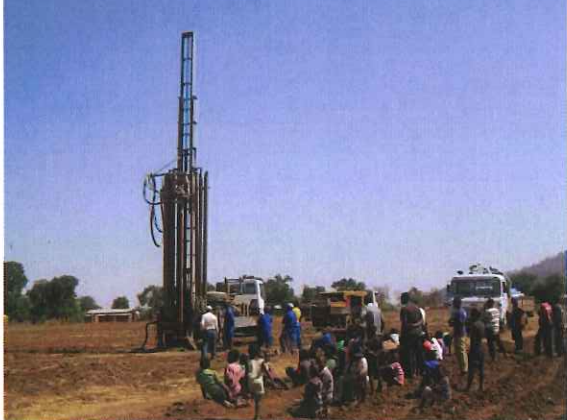
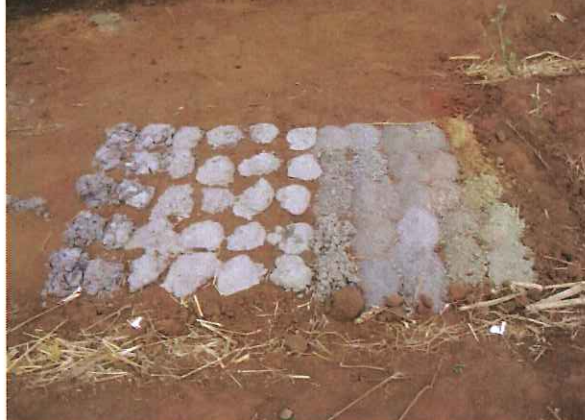
<p>3. R5 Mwalawanyenje CDSS Borehole Drilling (R5- No.1) Octobor 2013</p>	<p>4. R5 Mwalawanyenje CDSS Geological Sample (R5- No.1) Octobor 2013</p>

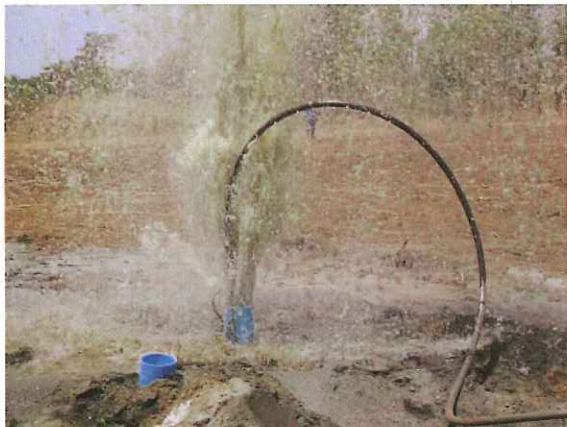
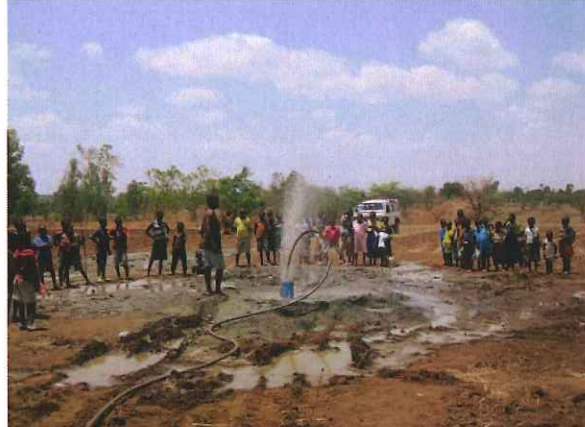
<p>5. R5 Mwalawanyenje CDSS Borehole Development (R5- No.1) Octobor 2013</p>	<p>6. R5 Mwalawanyenje CDSS Borehole Development (R5- No.1) Octobor 2013</p>

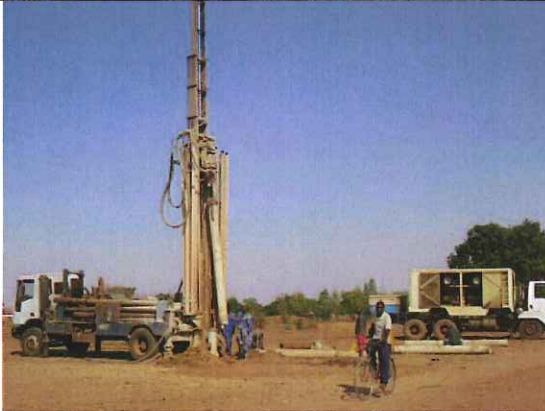
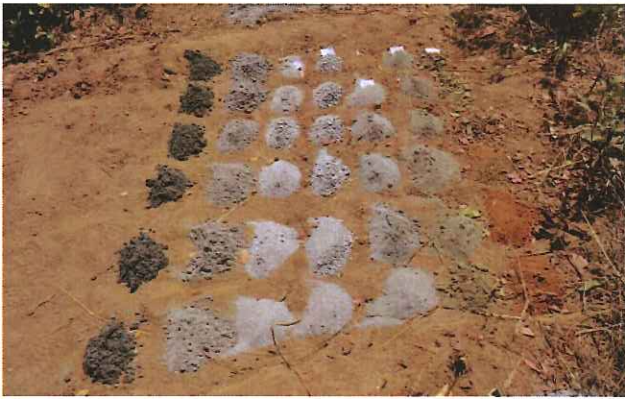
<p>1. R6 Mzoma CDSS Test Drilling (R6- No.1 Unsuccessful Well)</p>	<p>2. R6 Mzoma CDSS Test Drilling Geological Sample (R6- No.1 Unsuccessful but There is Water)</p>

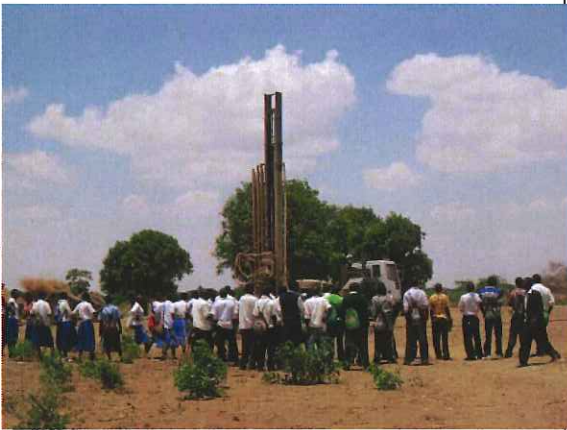
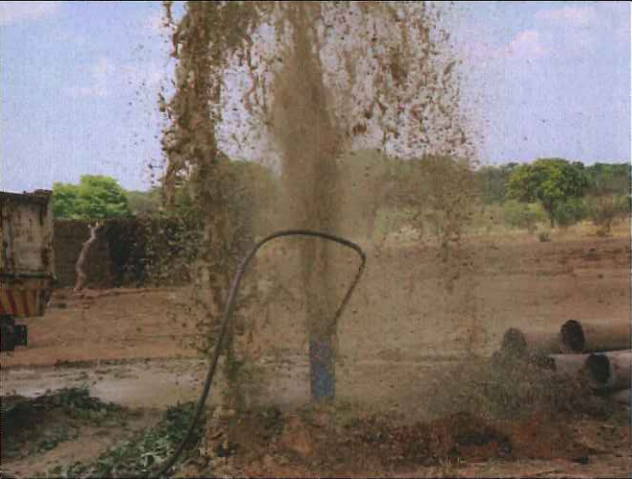
<p>3. R6 Mzoma CDSS Test Drilling No.2 (R6- No.2) November 2013</p>	<p>4. R6 Mzoma CDSS No.2 Development (R6- No.2) November 2013</p>

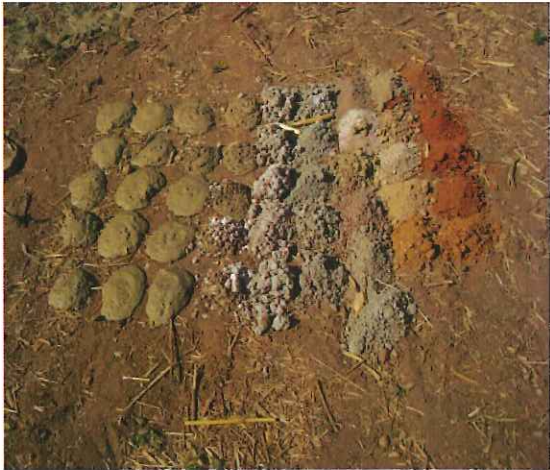
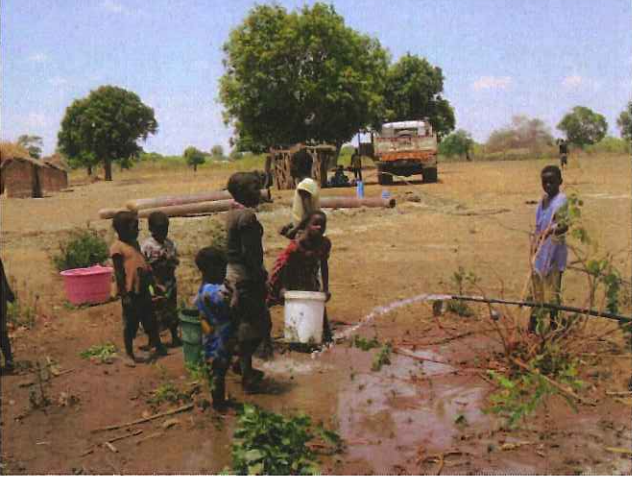
<p>5. R6 Mzoma CDSS No.2 Geological Sample (R6- No.2) November 2013</p>	<p>6. R6 Mzoma CDSS No.2 Pumping Test (R6- No.2) November 2013</p>
