PREPARATORY SURVEY ON
THE PROJECT OF RIVER TRAINING FOR
THE PROTECTION OF MOLA BRIDGE
IN
THE DEMOCRATIC REPUBLIC OF
TIMOR-LESTE
FINAL REPORT

FEBRUARY, 2013

JAPAN INTERNATIONAL COOPERATION AGENCY (JICA)
EIGHT-JAPAN ENGINEERING CONSULTANTS INC.

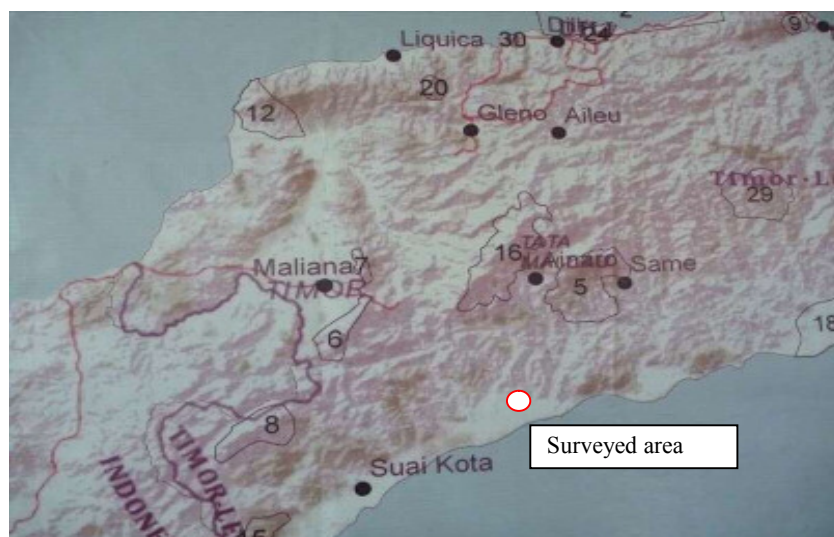
Fig 1.3.2 Distribution of natural reserves in the west part of East Timor

East Timor currently has 30 natural reserves. The following Fig. 1.3.2 shows the distribution of the natural reserves on the west part of East Timor where the surveyed area is located. The natural reserves closest to the surveyed area are Mount of Cablaque and Lake of Welenas (5 in the figure) and Mount Tatamailau and Talobu/Laumeta (16 in the figure), which are both more than 30km distant from the surveyed area.

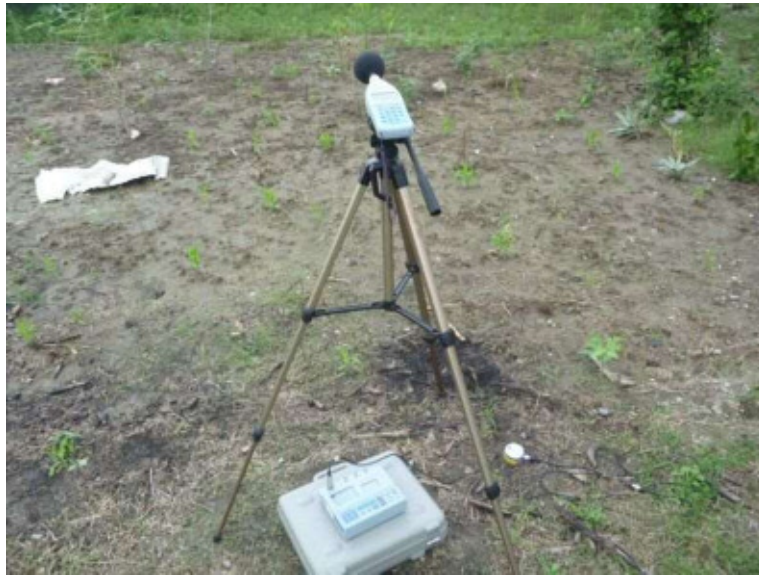
Fig. 1.3.5 Instruments for noise and vibration measurement

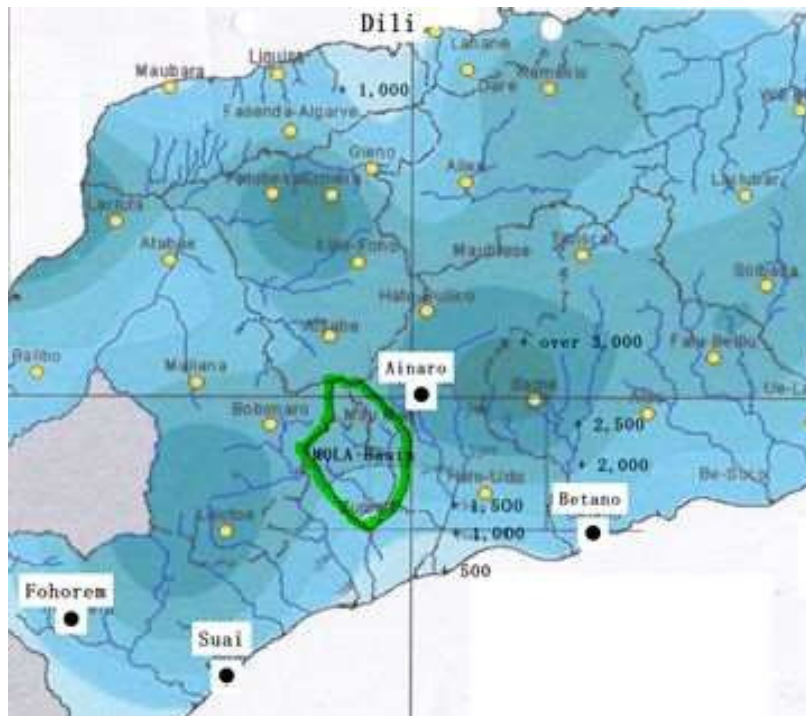
Division	Rainfall in the Division	Rainfall for Division Area (mm)	Division Area (%)
a-1	2,000mm~2,500mm	2,250	64.35
a-2	1,500mm~2,000mm	1,750	29.55
a-3	1,000mm~1,500mm	1,250	6.10
Total		2,041.3	100.00

Fig 2.2.1 Isohyetal Map and Basin Divide Map of Mola River’s Watershed Area (source: ALGIS)

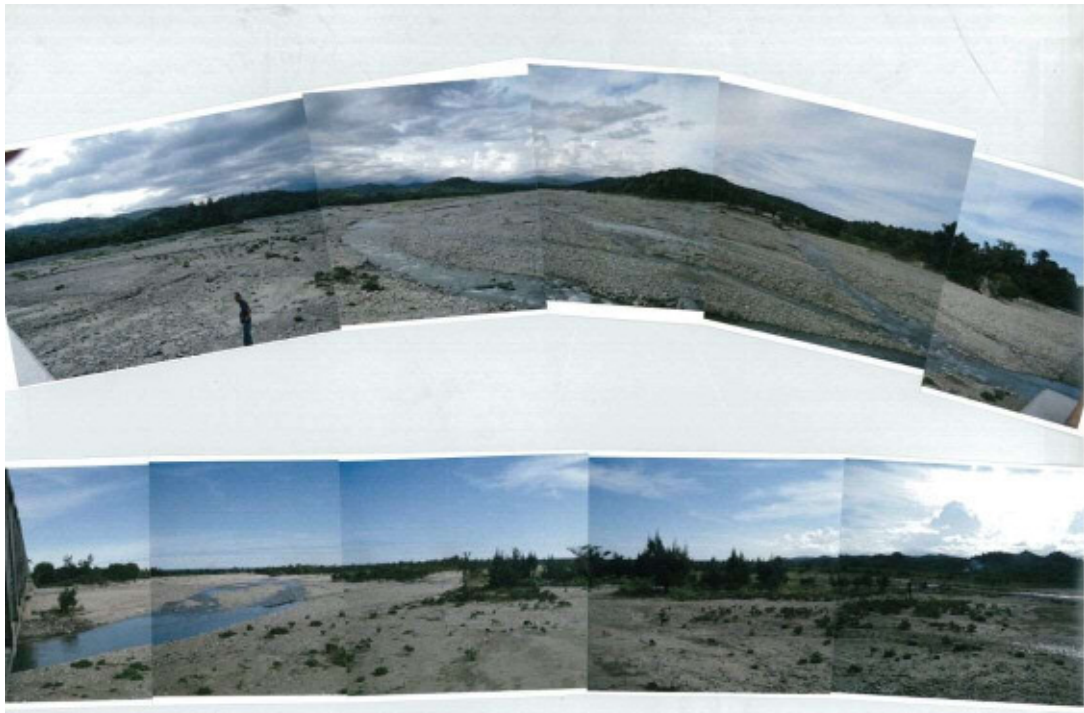
- Parts of the existing revetment in the upstream area of the right-bank side fell off due to the flood that occurred on May 22, 2012. The damaged area is identical to the area eroded by the flood that came in August 2010. This location seems to become a water colliding front during flood events. Thus, the zone where the exiting revetment has been already built may be regarded as valid for design considerations.

Fig. 2.2.2 Present Water Route in the Mola River (photographed on June 2, 2012)
 (Upper: Overlooking the upstream side from the center of the Mola Bridge/ Lower: Overlooking the downstream side from the center of the Mola Bridge)

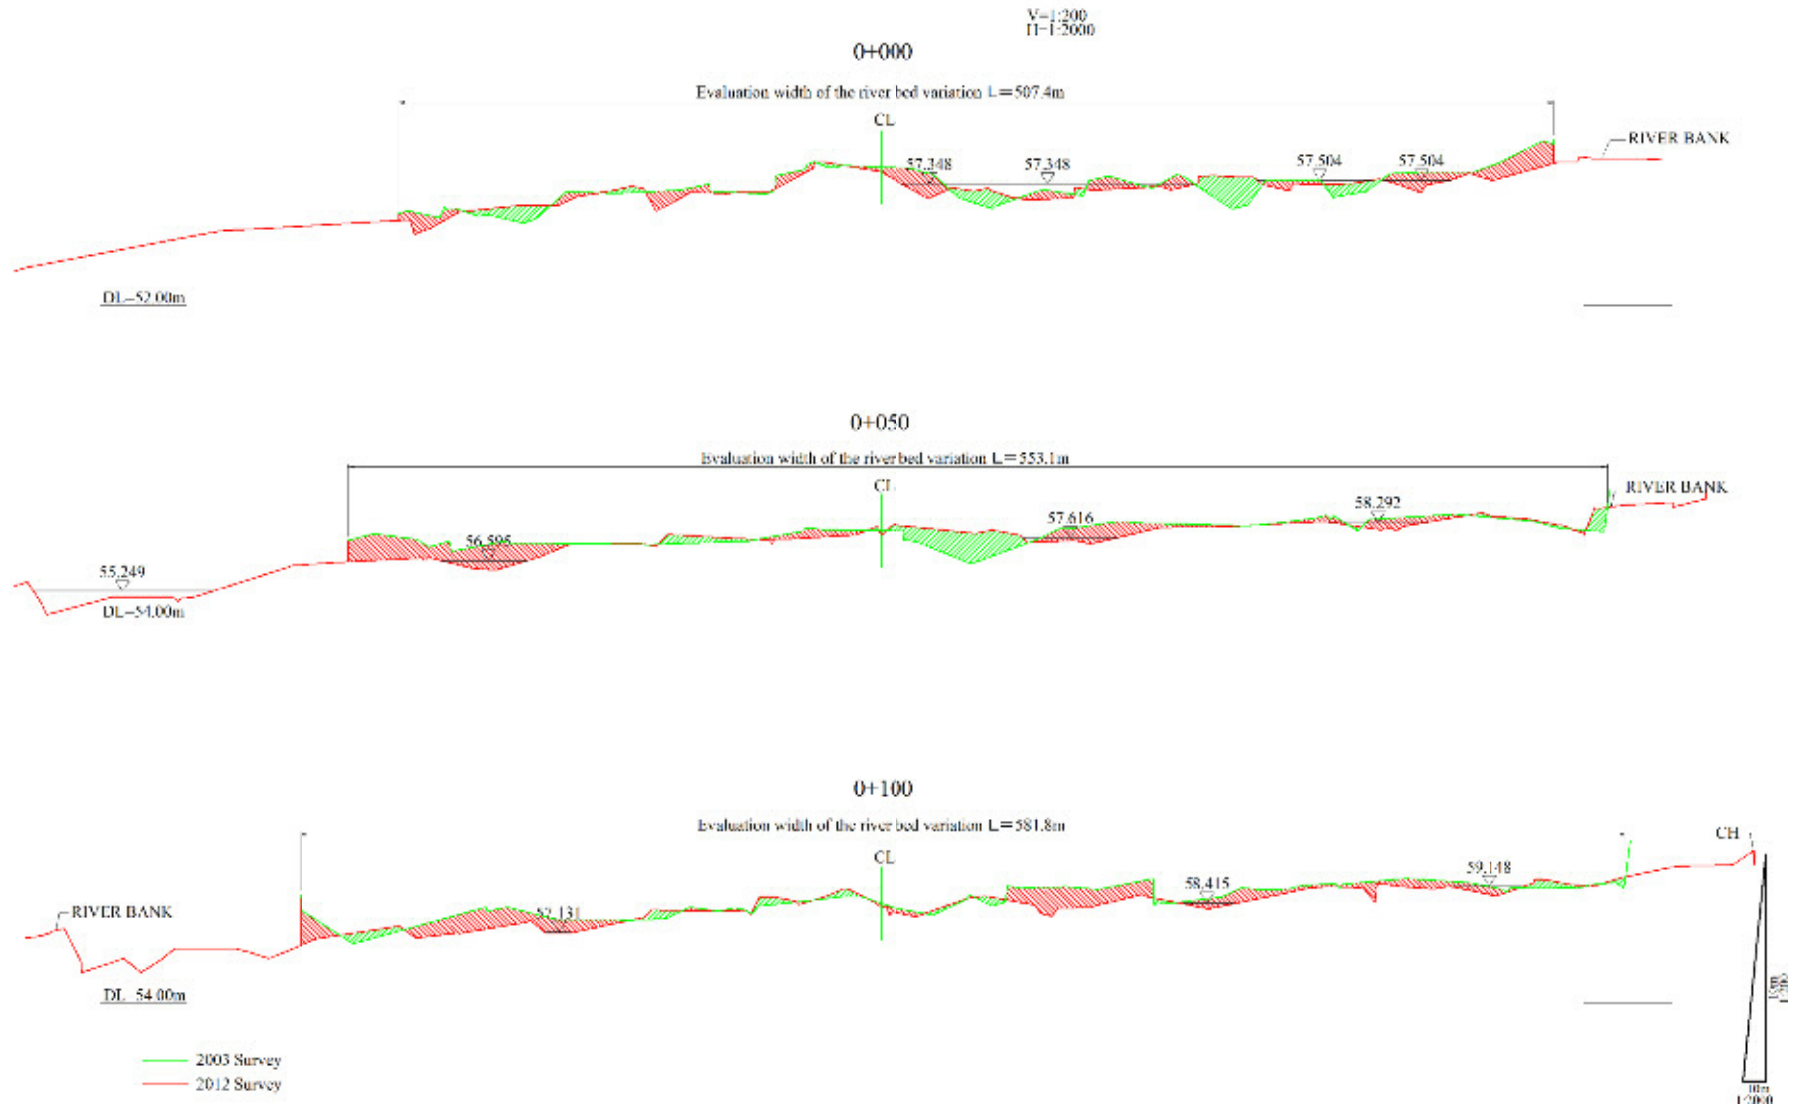
Fig. 2.2.3 Topographic Variations based on the Comparison of Cross-Sections (1/4)

However, since the average value of riverbed variations in this study was calculated based on the data obtained from only two rounds of survey (in 2003 and 2012), it may be possible that a momentary degradation of riverbed took place during the 9 years inbetween 2003 and 2009. Therefore, in this project, in order to respond to more severe riverbed degradation than expected, a steel-sheet pile of 2m in length (that serves as measures to prevent soil piping) is determined to be installed under the base of the revetment. The quantity of the data obtained from two rounds of survey is too small to exactly understand what the riverbed variations of the Mola River are. Therefore, a continuous monitoring is recommended.

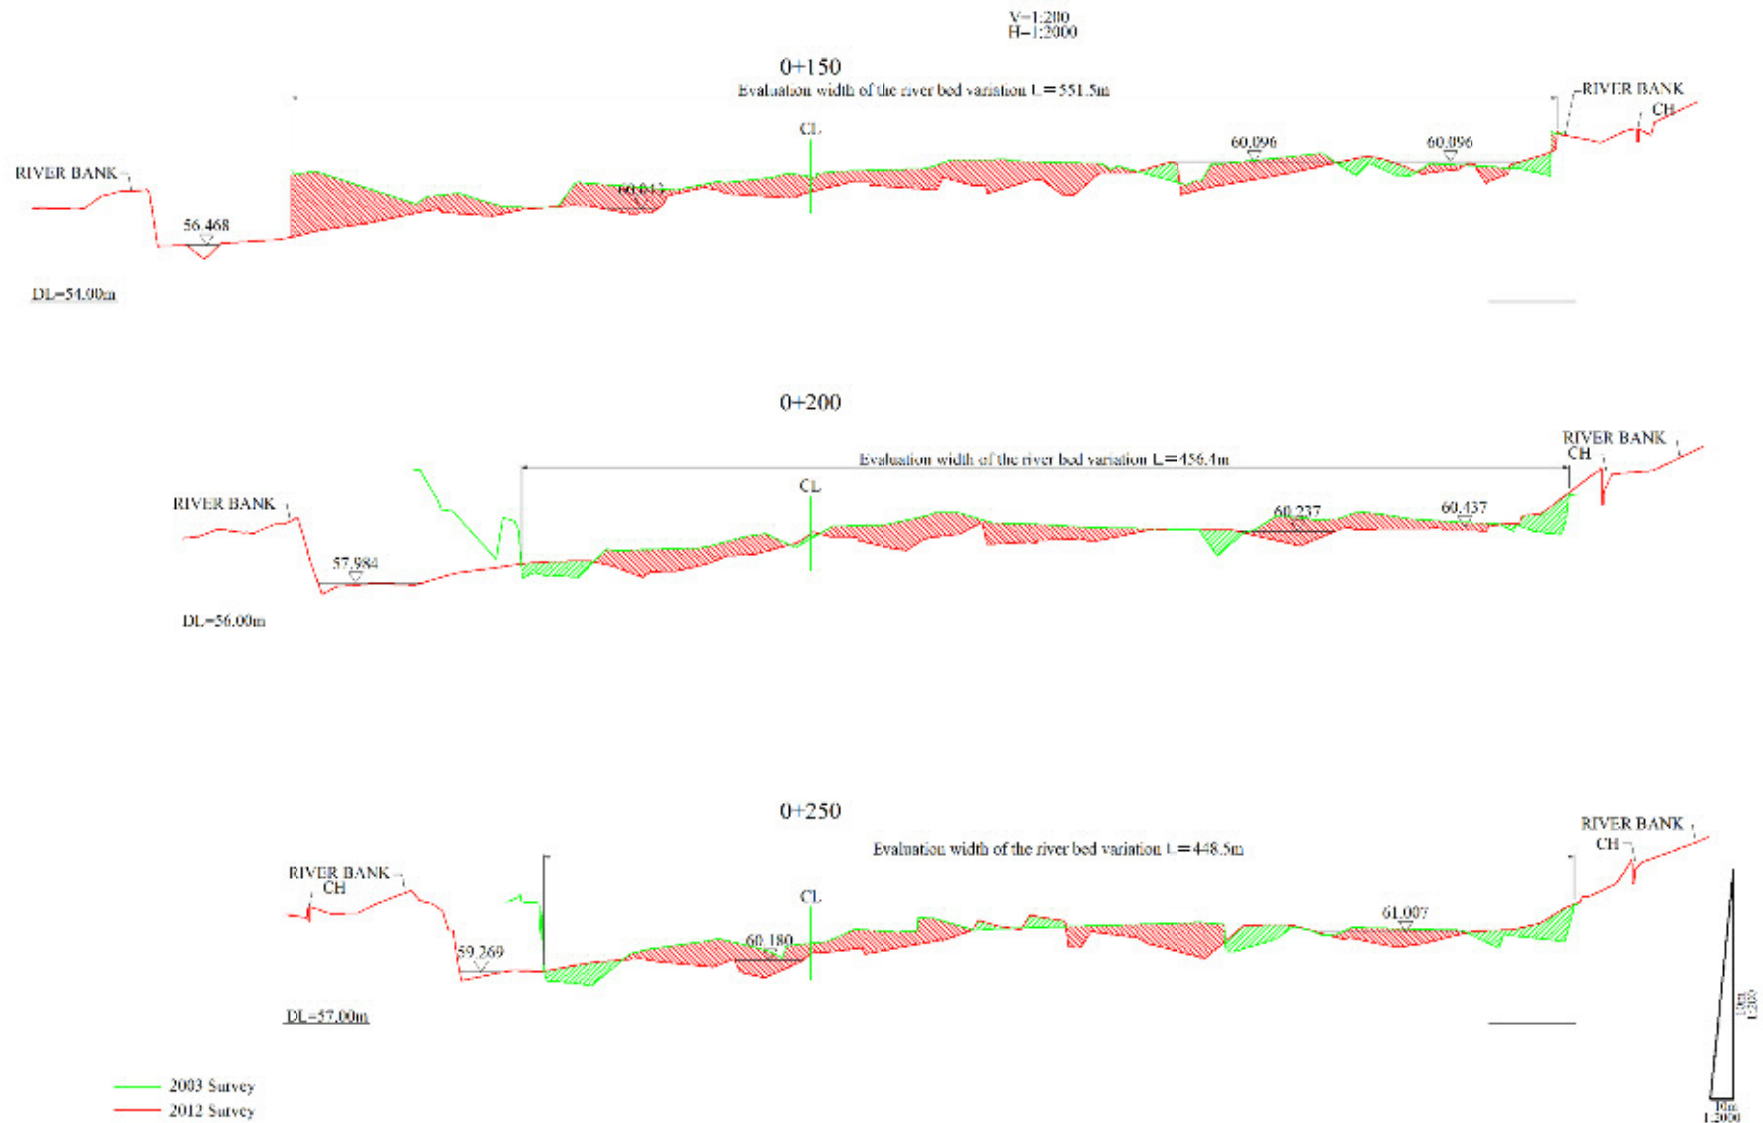
Fig. 2.2.4 Topographic Variations based on the Comparison of Cross-Sections (2/4)

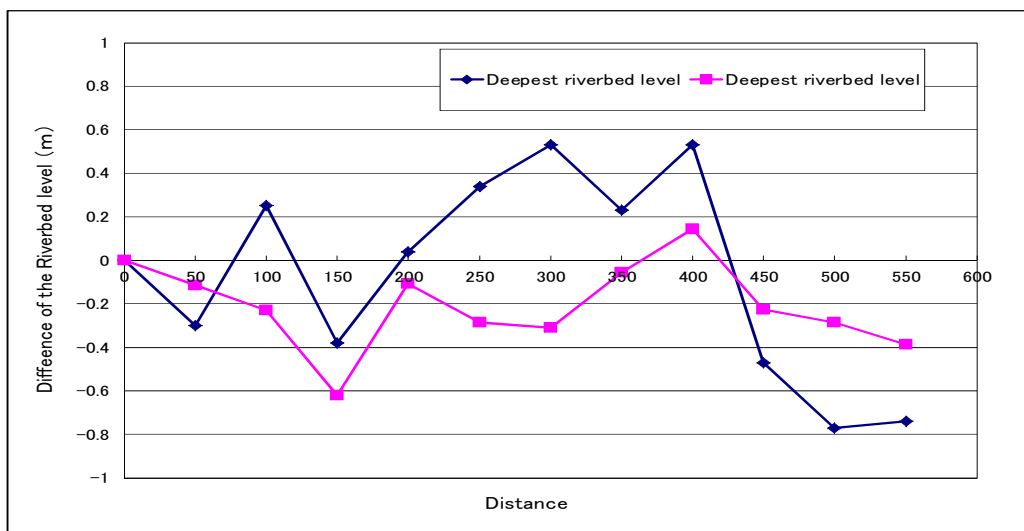
Fig. 2.2.7 represents that riverbed levels in the range of a survey point between 100m and 400m are higher than those in the up-stream and down-stream side of the range. The riverbed levels in this range are considered to gradually go lower in the future due to the riverbed variations in the longitudinal direction. Design riverbed levels for revetment design need to be determined using an envelope created by connecting two deepest riverbed levels outside the range (i.e., points 100 and 450), thereby determining the required depth of footing.

Fig 2.2.7 Changes in Deepest Riverbed Level and Average Riverbed Level

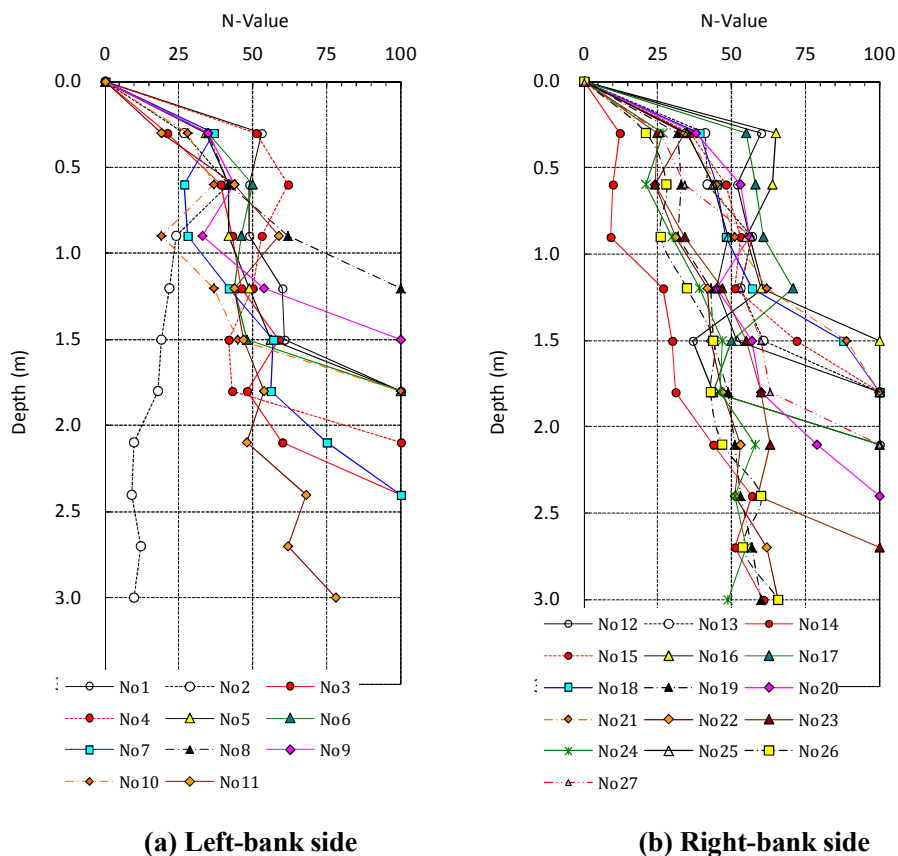
Due to the presence of too many cobbles and boulders, many attempts of the test resulted in an N value of 50 in a layer shallower than 3m or experienced difficulty in further penetration. However, only one attempt for the left-bank side shows an N value of around 10 even at a depth of 3m. In this test hole, luckily, the sampler did not encounter any boulder. For these reasons, it may be considered that the sediment trapped between cobbles or boulders have a similar degree of compaction.

Fig. 2.2.10 The Results of SPT for the Riverbed Ground

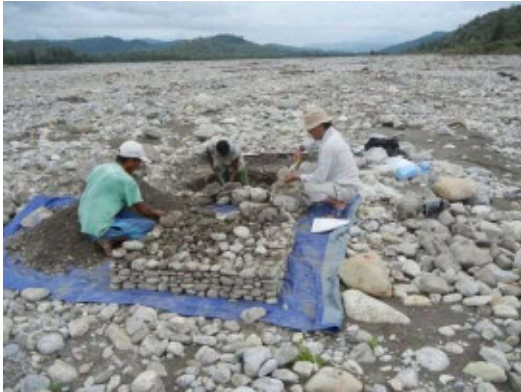
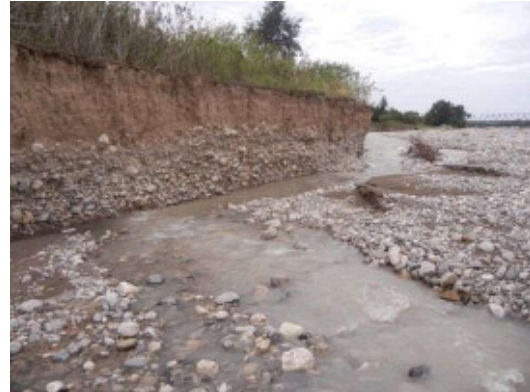
A grain size distribution curve for river deposit materials is given in Fig. 2.2.12. Since it is difficult to perform laboratory grain size tests on samples containing cobbles/boulders, firstly, as shown in Fig. 2.2.11, the separation of cobbles and boulders that are suited for grain size analysis was performed and then, the resultant soil samples underwent laboratory grain size tests. The results also took into consideration the volume of the separated cobbles and boulders, to give the grain size distribution curve.

(a) Collecting Riverbed Samples

(b) Bank Scouring and River Deposit Material

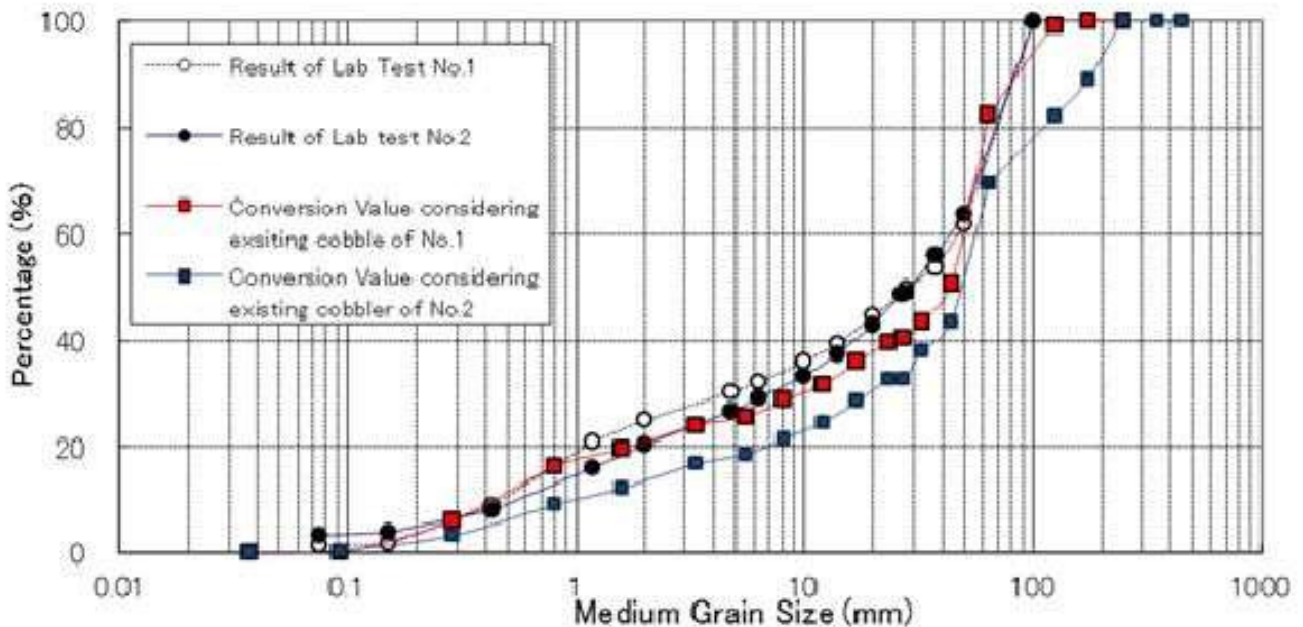
Fig. 2.2.12 Grain Size Distribution Curve

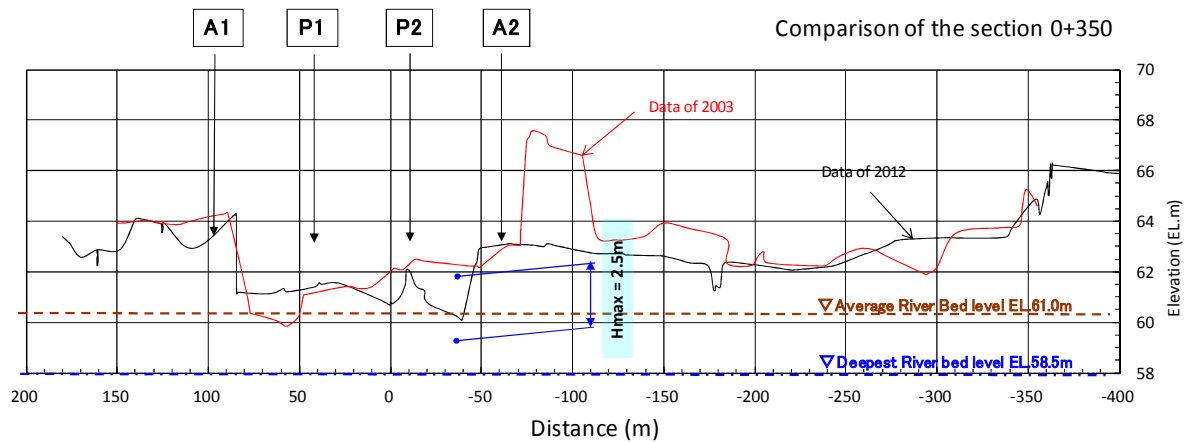
The riverbed height used for scouring preventive design is EL. 58.5 m at the No. 350 point of the planned riverbed height (maximum riverbed height envelope curve). It is positioned 1.5 m deeper in the river longitudinal direction shown in Fig. 2.2.13.

Fig. 2.2.13 River Cross-Section at Bridge Pier Position

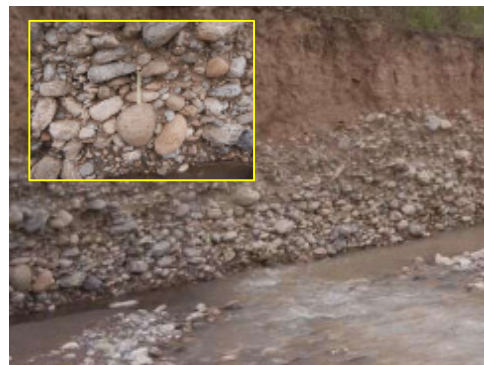
Fig. 2.2.16 Existing gravel and deposition layer at riverside

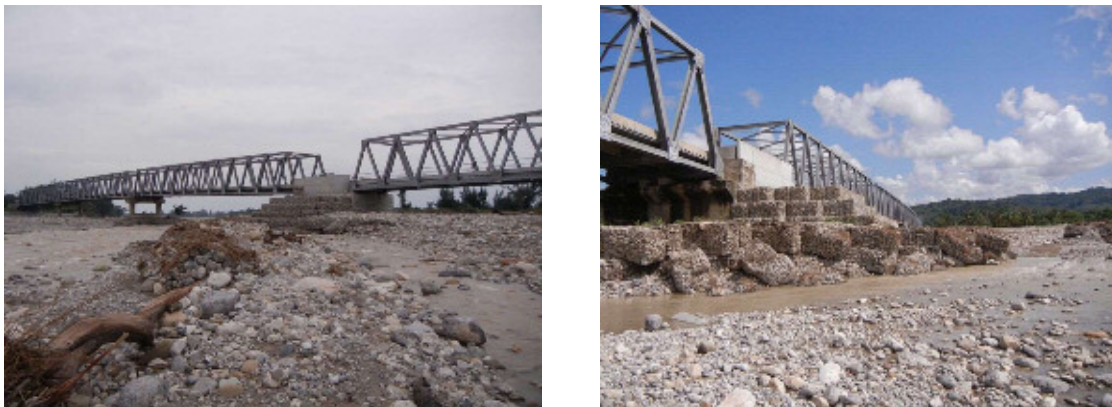
Photo 2.2.18 Current Situation of Bridge Pier Provided with Protection Work

As shown in Fig.2.2.17 and Fig. 2.2.18, the periphery of the abutment A2 of the old bridge and that of the abutment A1 of the new bridge located in the central part of the Mola River are protected by piled gabion works in order to protect the surrounding ground. When a survey was conducted in middle of May 2012, there was 18-m flat ground in the front of the abutment, but it has been quickly eroded since then and an area protected by the gabions has been reduced to about 11 m for the moment (June 2012). Scouring at the foot of the gabions has also progressed; some of them have been washed out on the upstream side and the river bed has been scoured, wrapping around the abutment. In order to prevent collapse and destruction of the currently installed gabions by river bed scouring, the relevant ground area is protected by entirely enclosing it, including the abutment of the new bridge.

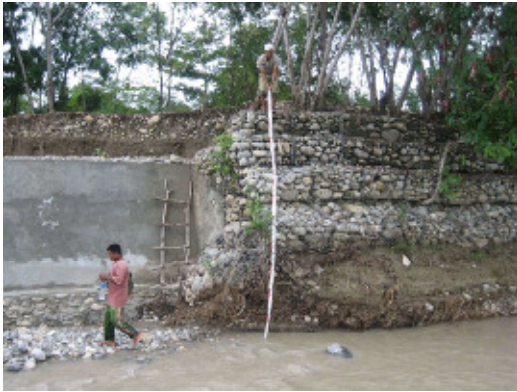
Fig. 2.2.21 Current Situation of Upstream End (Right Bank)

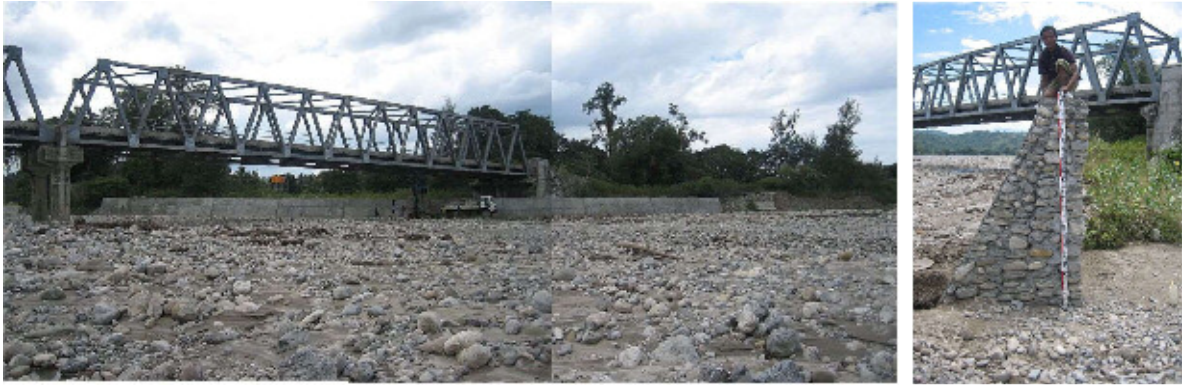
Since the upstream and downstream ends of the revetment are not closed to the landform and the side surfaces are released, rear backfill has been washed out, resulting in the unstable condition. The structure is the same mortar masonry as on the right bank. There is a problem in its strength because mortar has not been fully filled in. Since a large mainstream water route tends to be formed at the position where the revetment has been improved, it is highly likely to become a water colliding front, requiring installation of a rigid revetment. For this reason, a revetment will be improved over an extension of about 100 m in order to prevent scouring of the abutment foundation.

Fig. 2.2.23 Revetment Condition on Left Bank Side of Mola Bridge

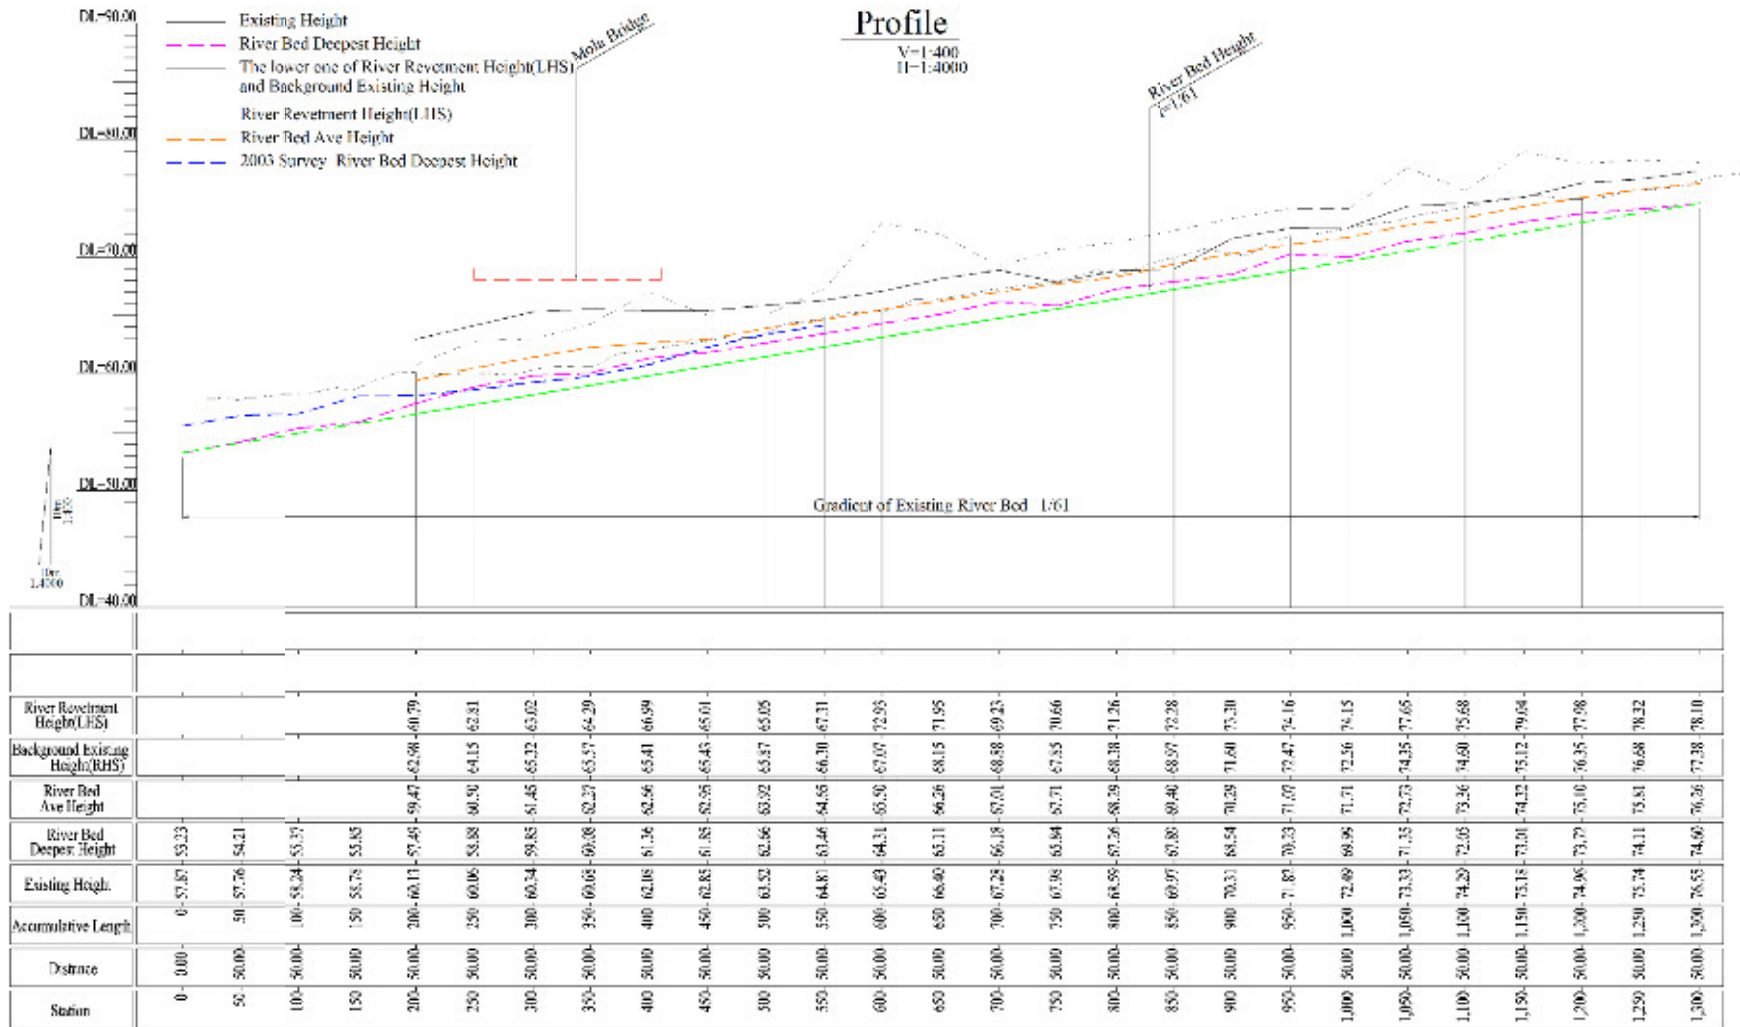
Fig. 2.2.26 Revetment Work Longitudinal Profile

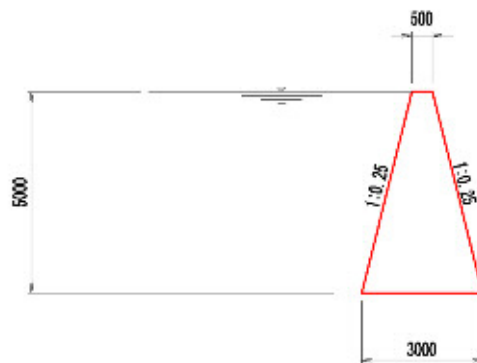
Front slope gradient	Rear slope gradient	Item	Stability condition	Case (1) (Normal time)	Case (2) (At flood)	Case (3) (At rainfall)
0.2	0.2	Tilting condition	$e \leq 0.417$	0.378	0.322	0.441
				○	○	×
		Sliding condition	$n \geq 1.5$	1.641	1.928	1.384
				○	○	×
		Bearing capacity condition	$\sigma \leq 300 \text{ kN/m}^2$	172.667	86.392	1158.919
○	○			○		
Stability evaluation result				×		
0.25	0.25	Tilting condition	$e \leq 0.5$	0.275	0.234	0.345
				○	○	○
		Sliding condition	$n \geq 1.5$	1.832	2.154	1.557
				○	○	○
		Bearing capacity condition	$\sigma \leq 300 \text{ kN/m}^2$	136.004	69.400	126.008
○	○			○		
Stability evaluation result				○

Fig. 2.2.29 Standard Cross-Section of Right-Bank Revetment (Wall Height: 5.0 m)

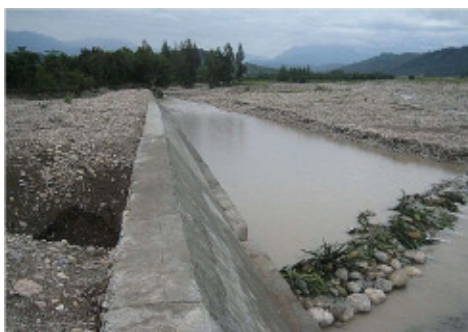
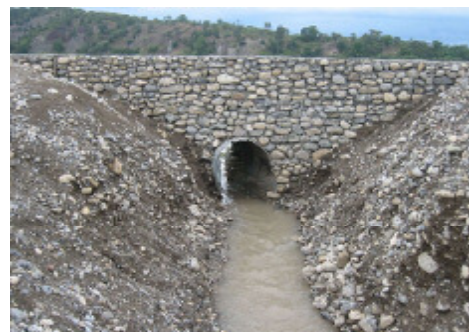
Fig. 2.2.32 Current Situation of Intake Facilities

Intake facilities are installed in one place on the right bank side of the Mola River as an auxiliary water source for domestic water for the residents and irrigation water. River water is led to the rear side of the revetment through a $\phi 1,000$ mm corrugated pipe penetrating the existing masonry wall and flows to the farming land through a waterway excavated open channel. On the river side, the ground has been excavated 10 m wide and 0.5 to 1.0 m deep to build a weir by rubble works. This weir raises the water level to facilitate drawing of water. At the time of every flood, however, these rubble works have been washed out and repaired by the residents. The following shows the current situation.

(River side)

(Rear side)
