**Republic of Cuba
Project for
Improvement of Capacity on Solid
Waste Management in Havana City**

Project Completion Report

September 2014

**Japan International Cooperation Agency (JICA)
EX Research Institute Ltd.**

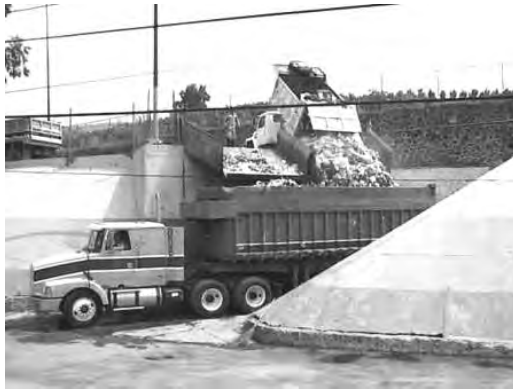
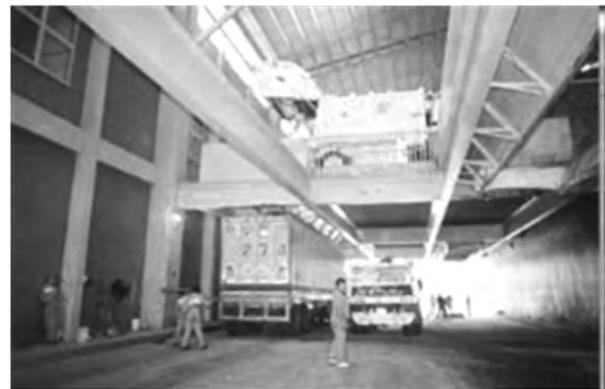
Photo 1-2: Transfer Station, Mexico's Cases

- d) A transfer station operating with tractor-trailers and transfer containers having a capacity of 60-70 m³ may be designed in a simple way so that the collection vehicles unload the wastes into the transfer container one after the other, as shown in the picture referred to above, or in a way in which several collection vehicles may unload their wastes simultaneously into several transfer containers, as shown in the second picture. However, the design will depend on the amount of wastes to be daily handled at the station and on the discharge frequency and hours of the collection vehicles. These points should be identified prior to the design of the transfer station.

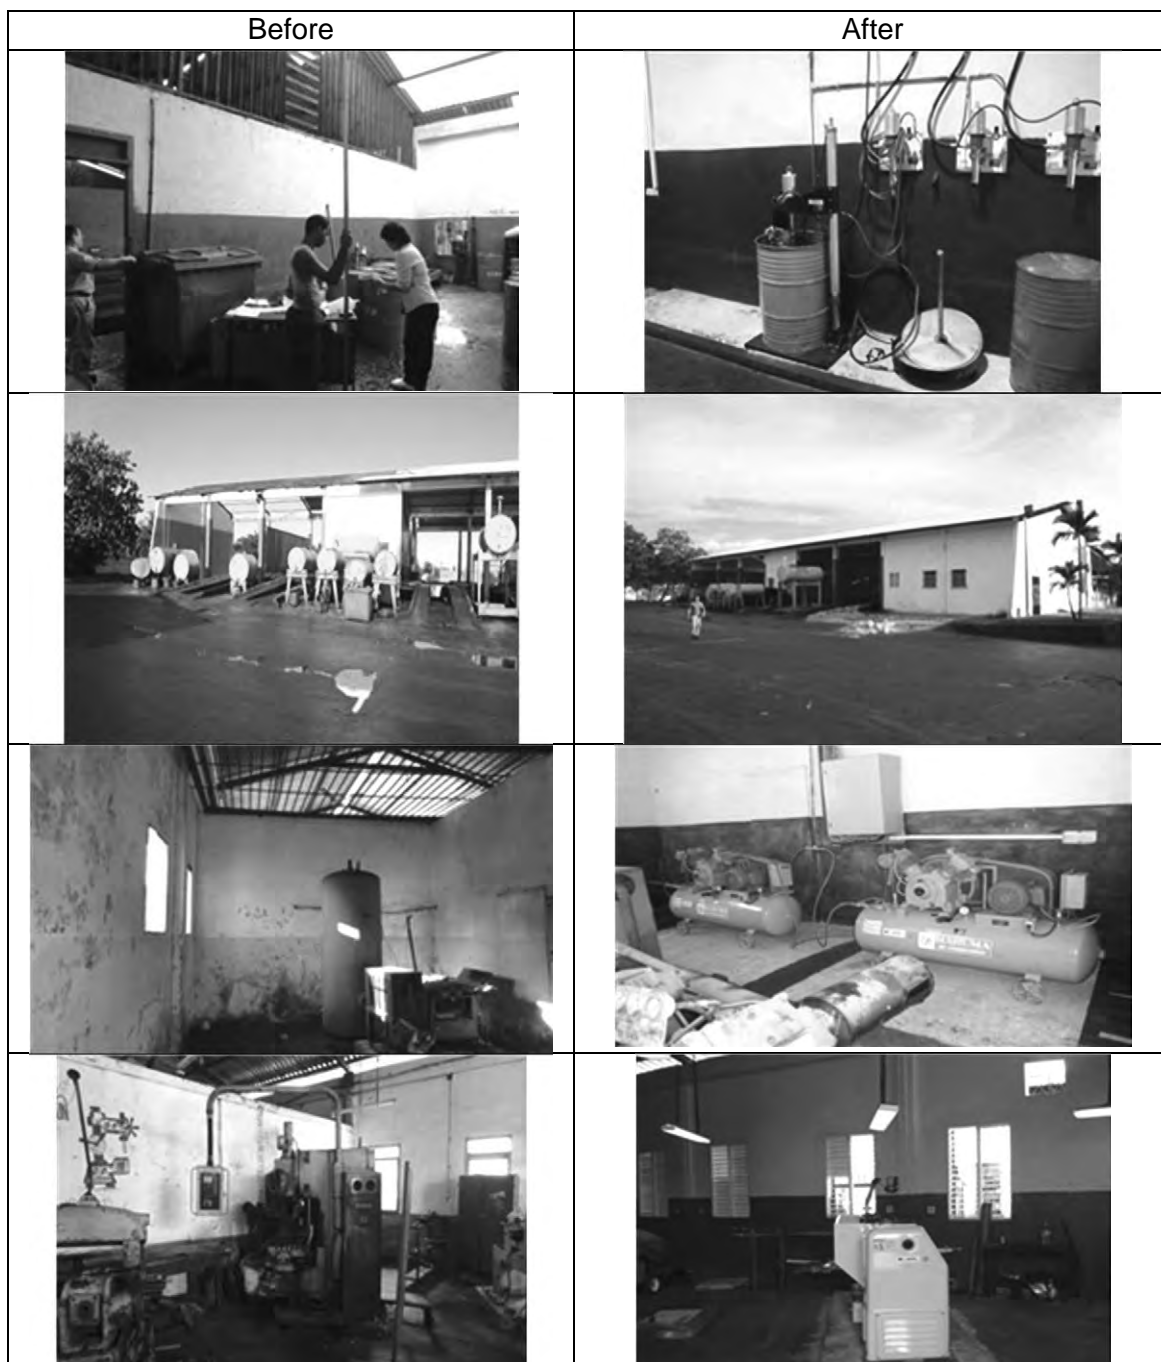
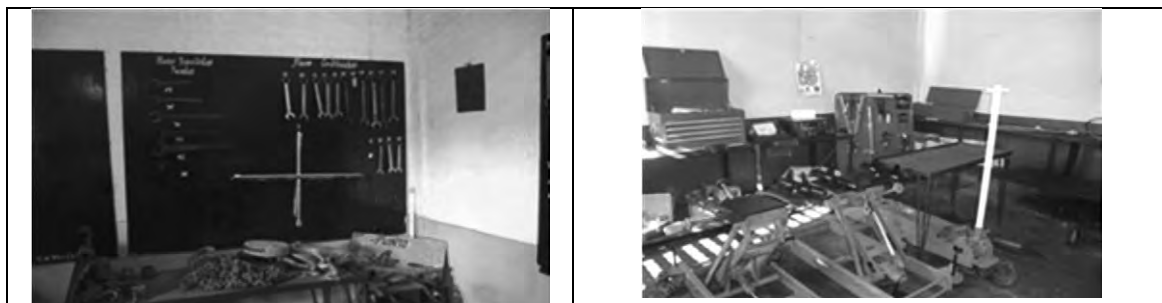
Photo 3: Renovation Works at the Central Workshop

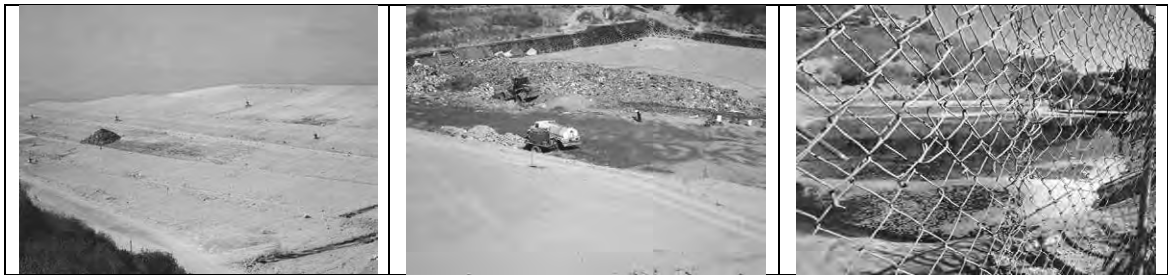
Photo 1-2: TLANEPANTLA de BAEZ sanitary landfill

- ✓ The cell slopes are 1V:2.5H. They do not compact the cover material to reach high densities. They just wet and compact it to cover the wastes. They use 30 cm thick layers of clayey material containing little slime to prevent mud. In order to wet the cover material, leachate from the pond is used.
- ✓ The berms are 4 m wide and 4 m high. The storm water drainage is composed of ditches covered by HDPE liners to prevent surface water from getting in contact with the wastes and to reduce leachate generation.
- ✓ The inner roads do have a proper compaction and they are maintained throughout the operations. Differential settlements occur during operations and they have to be stabilized.

- ✓ They own 2 dump trucks and 1 compactor. They work until 10 pm using portable lighting towers equipped with 4 lamps. They can generate up to 3 megawatts using landfill gas.
- ✓ The leachate generated amounts to 0.4 L/sec in the dry season and 1.1 L/sec in the rainy season.
- ✓ This landfill site proves that landfill gas can be produced 1 year after the beginning of operations, when the gas begins to be burned. The equipment used for landfill operations is replaced every 10 years. Site improvements are ongoing. A pilot plant using a physical and chemical process was unsuccessfully used for leachate treatment. The site staff is composed of 25 workers, including management and operators.

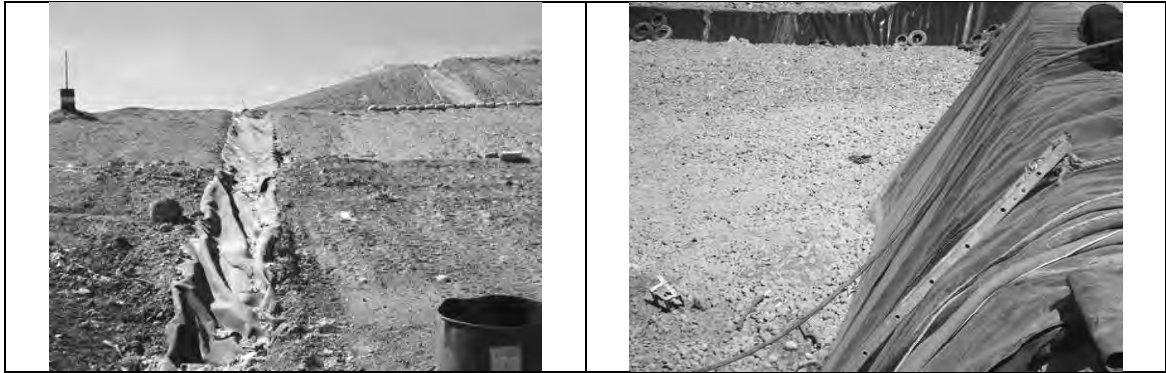
Photo 1-3: Surface drainage and Impermeable Liner

- ✓ The roads used during the site operations should be included in the initial design.
- ✓ The way the geomembrane is installed inside the slope should be evaluated. The liner anchoring plan should be checked. A viable solution was proposed in the project, which may be modified.

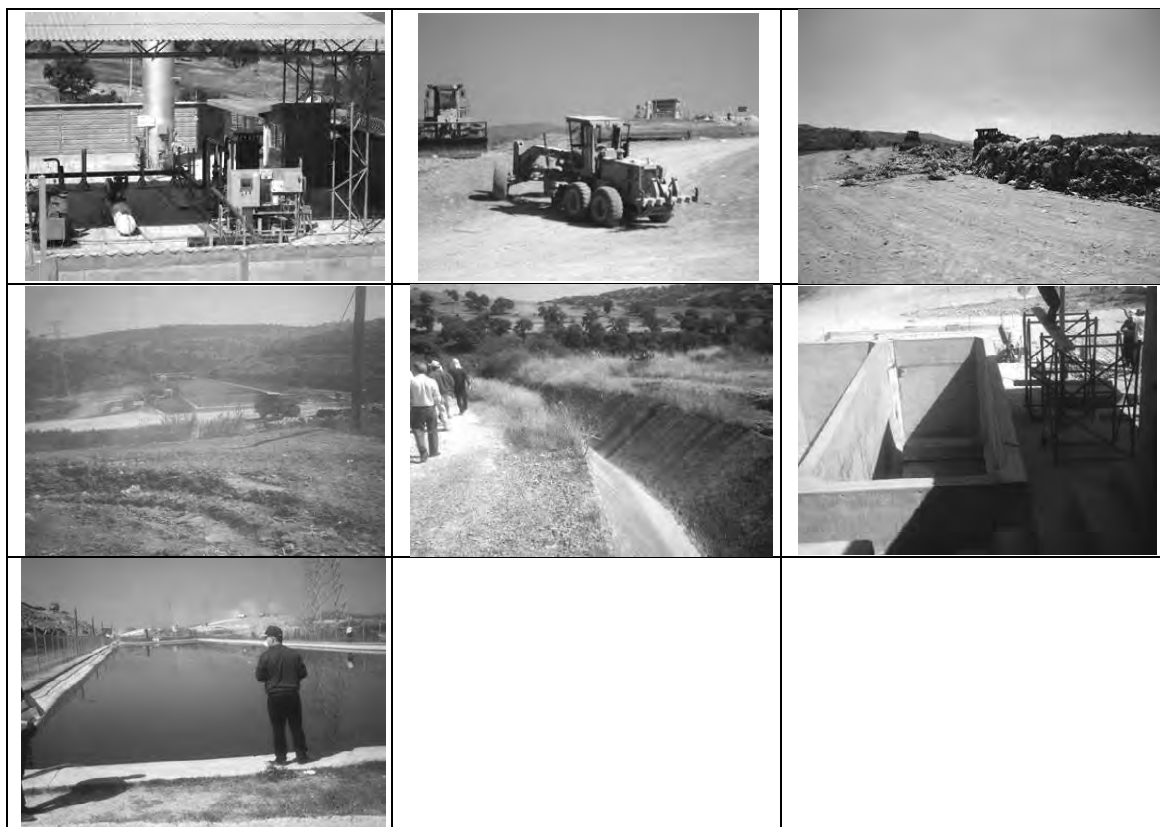
Photo 1-5: Puebla Sanitary Landfill Site

- ✓ The 3 ponds has a storage capacity of 15,000, 20,000, and 35,000 m³ respectively. Leachate is recirculated to the landfill. Sprinklers are used for leachate irrigation. Recirculation is carried out 12 hours a day. The pH of the leachate is higher than 8. Portable pumps are used to pump it from the sumps at the cell base to the ponds. Leachate is pumped from the pond having a larger storage capacity. Untreated leachate dumping into rivers is forbidden by Mexican standards.

- ✓ The site has 2 sheep-foot compactors, 4 Caterpillar bulldozers, and 60 trucks. Each truck has 1 driver and 3 operators. The site staff is composed of 80 workers.

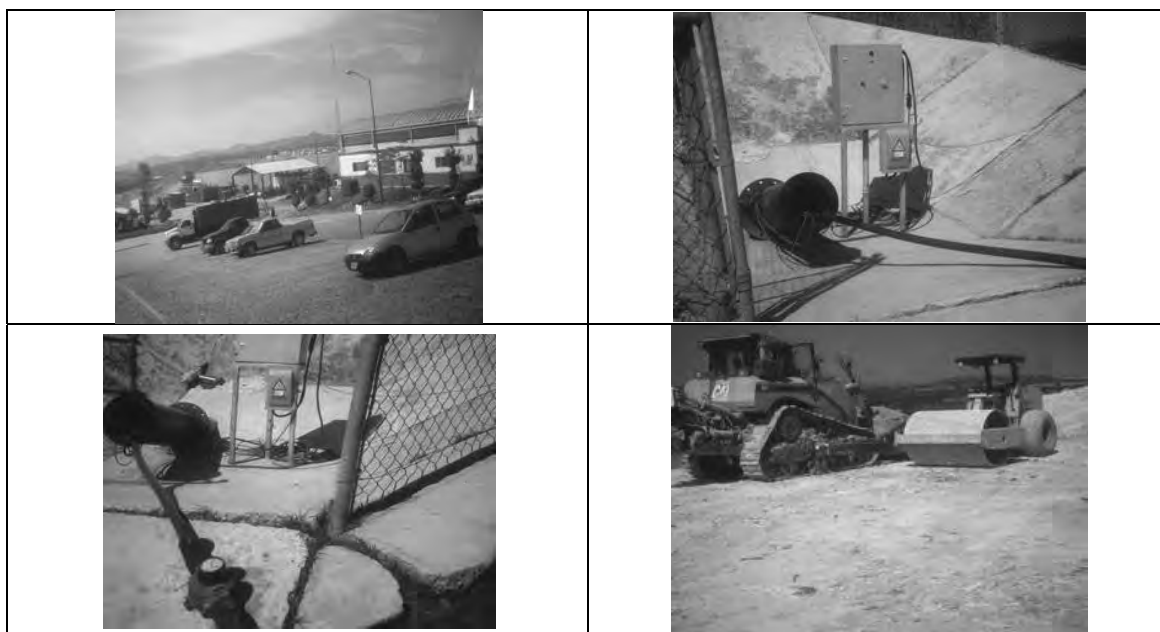
Photo 1-6: Facilities at Puebla Sanitary Landfill Site

- ✓ Order and discipline were noticeable during operations and the construction of the new cell.
- ✓ The current use of sprinklers for leachate recirculation, which may generate aerosols and affect the environment, should be evaluated.

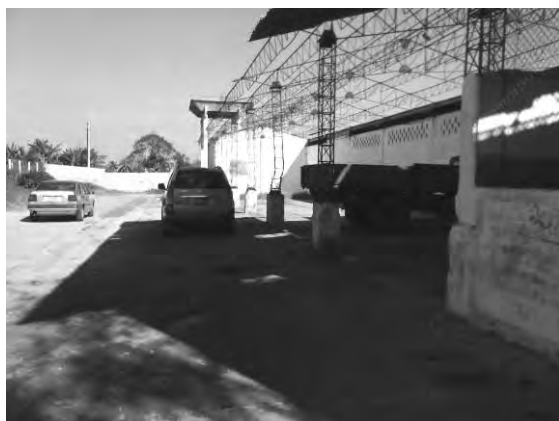
Photo 1-3: The site before the beginning of construction works (picture taken on February 17, 2011)

Responding the recommendation of intermediate evaluation (described in 1.4.4), the Pilot Project began on November 13, 2011, at the former tire repair shop within the Central Workshop (Photo 1-3 and Photo 1-4). Therefore, construction works were carried out simultaneously with the operation of the pilot project. The necessary construction materials were gradually acquired and the works went ahead as they were made available (Photo 1-5 to Photo 1-14) until the plant was finally finished in May, 2012.

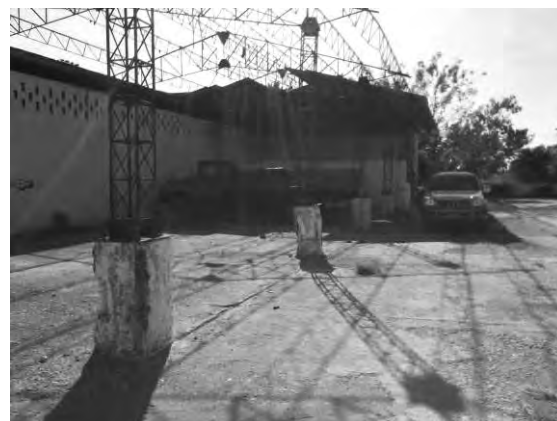
Photo 1-4: The site before the beginning of construction works (February, 2011)

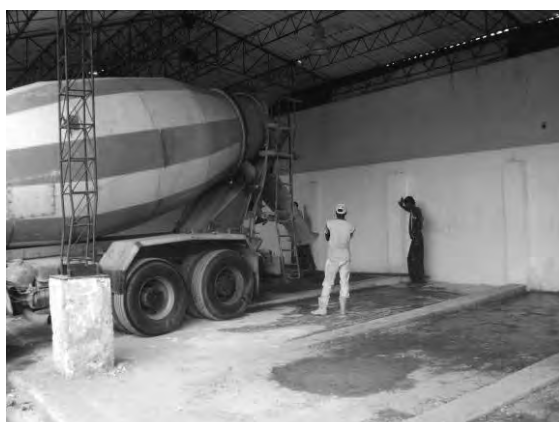
Photo 1-5: Pouring concrete for the plant floor (February 13, 2012)

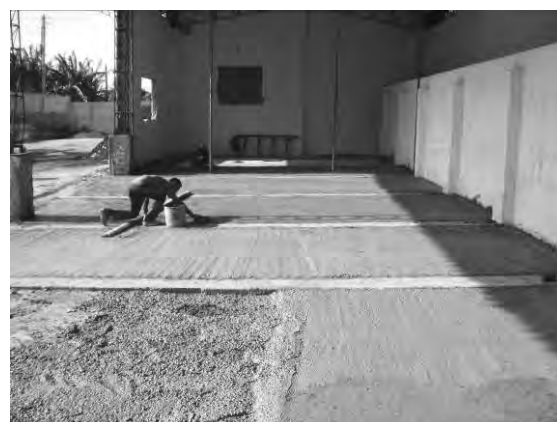
Photo 1-6: Floor building (February 13, 2012)¹

¹ The floor works were suspended for some time until floor concreting was resumed and completed by late April, 2012.

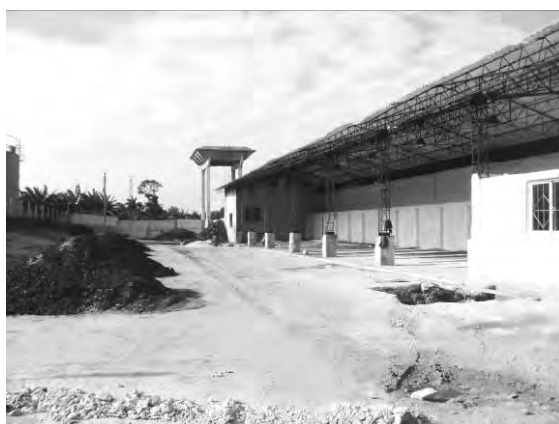
Photo 1-7: Compost was moved out to allow construction works (February 14, 2012)

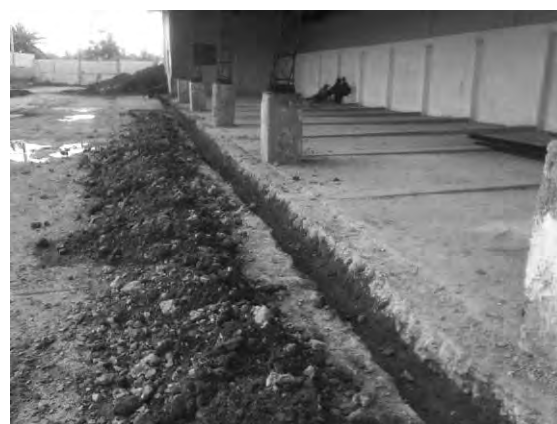
Photo 1-8: Drainage works (February 8, 2012)

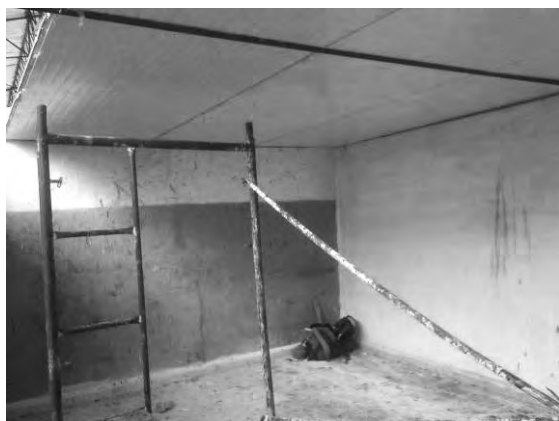
Photo 1-9: Works for the office/training room (February 7, 2012)

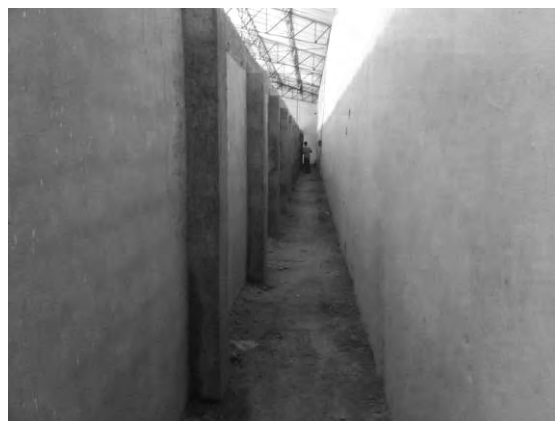
Photo 1-10: Construction of the wall separating the plant from the warehouse (right side) (February 11, 2012)

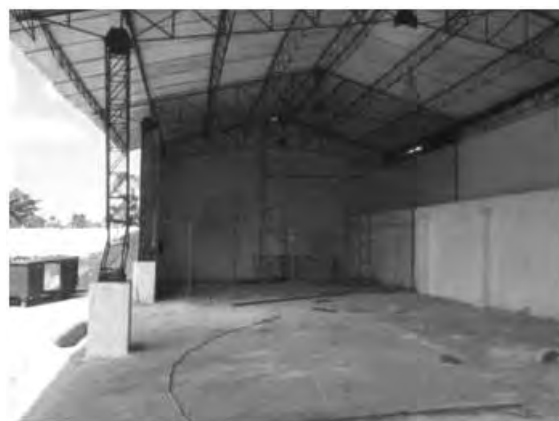
Photo 1-11: Installation of the fence to separate the shredder area (February 17, 2012)

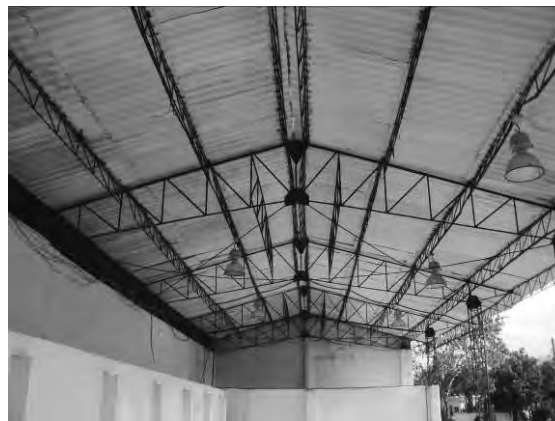
Photo 1-12: Roof installation (February 14, 2012)

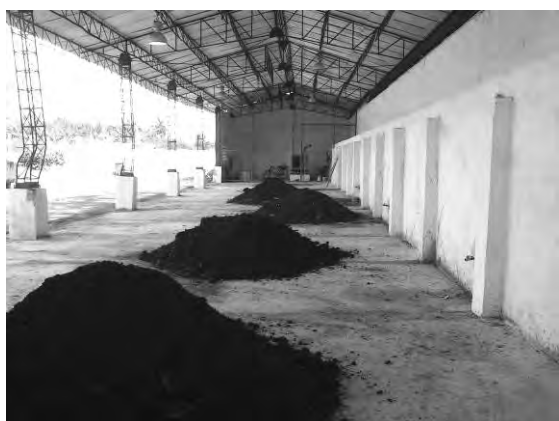
Photo 1-13: Finished compost plant

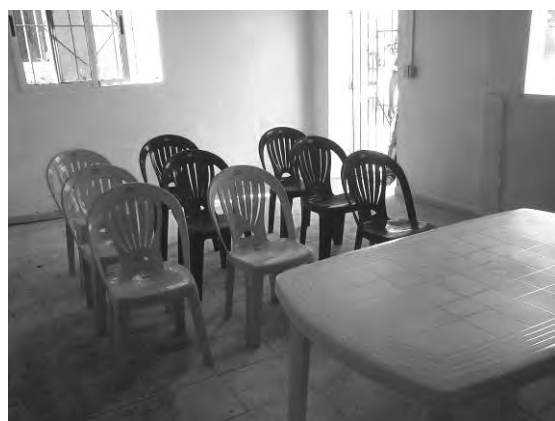
Photo 1-14 : Finished office/training room

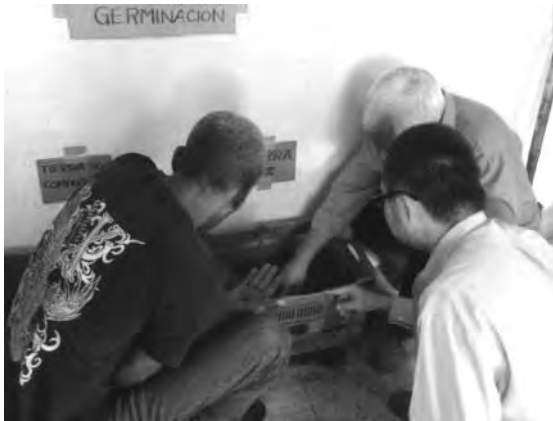
Photo 1-22: C/P members preparing the germination test

The quality of the produced compost has not been verified as the Laboratory for Waste Tests (LARE) was shut down and the equipment at the Ministry of Agriculture's Soil Research Institute is out of order. Germination tests are currently being run at the compost plant facilities (see Photo 1-22 and Photo 1-23) using rape seeds pertaining to the broccoli and chard family. The results of the germination tests are shown in the table below.

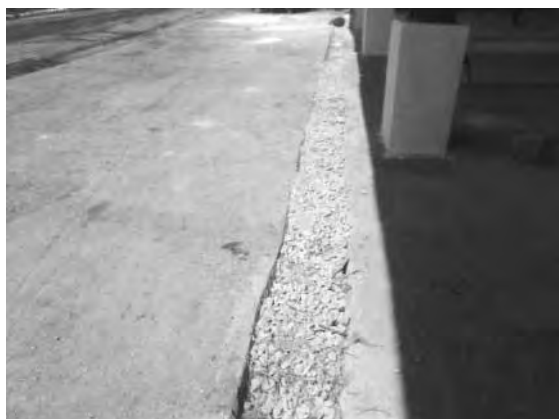
Photo 1-24: Drainage using gravel

On the other hand, some complaints were made regarding the flow of leachate from the compost and the cigarette waste into the premises of the Central Workshop. Therefore, the sand in the gravel drain (see Photo 1-24) was removed to facilitate drainage (Photo 1-25).

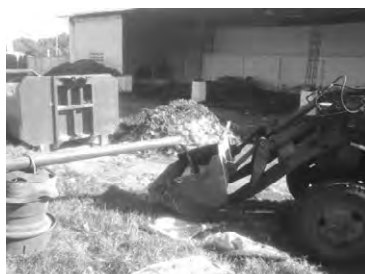
Photo 1-30:
The wheel loader receiving
fermentation liquid from the
anaerobic fermentation tank

Tap water is supplied according to necessity when compost is too dry in order to control the moisture in compost, but frequent stops of water supply make it difficult to control the moisture. On the other hand, the operation of the biogas plant, located next to the compost yard, started in November 2012 and surplus fermentation liquid is being produced from an anaerobic fermentation tank. The C/Ps started using this liquid for controlling the moisture of the compost from December 2012 (Photo 1-30). The quality of the compost moisturized by the liquid must be examined by germination tests.

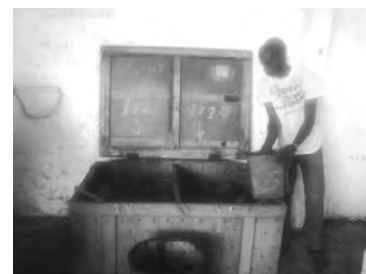
Photo 1-31:
Composting with green waste and
tobacco waste

increase, and this can contribute to a reduction of final disposal amounts. Meanwhile, other organic waste such as green waste which cannot be used for pig farming is dumped in final disposal sites. In order to find a way to use the waste, we started a trial production of composts with the green waste and tobacco waste which neither can be used for feeding animals (Photo 1-31).

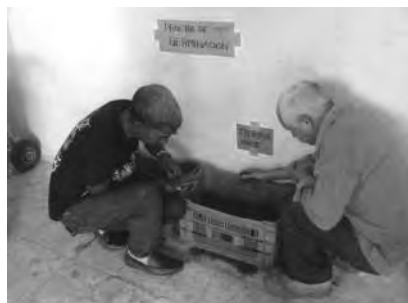
Photo 1-43: Germination Test

Size of grain of produced compost is acceptable as shown in Photo 1-42. The safety is tested by germination tests (Photo 1-43 and Photo 1-44). Germination tests are implemented almost every half year. A planter having only soils and one mixed 1/3 of produced compost and 2/3 of soil are used for comparison. The period of this test is about 10days. Germination ratio (number of germinated seeds at a planter having only soil / number of germinated seed at a planter with compost) are about 90%. The result explains that the compost is ensured for germination of plants. In order to ensure the compost, the amount of carbon and nitrogen contest, heavy metals

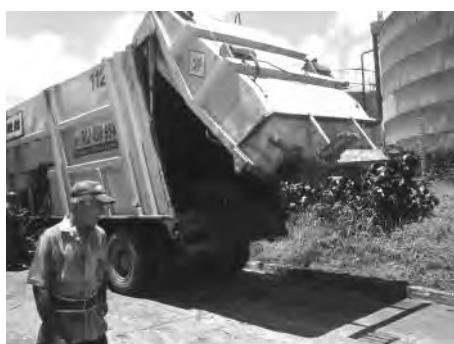
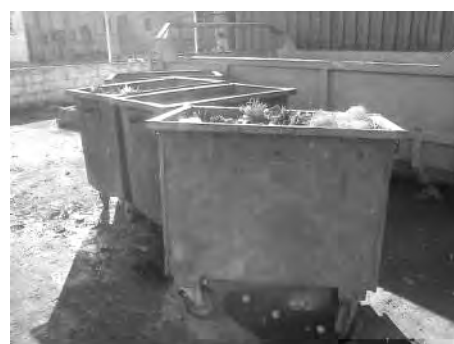
Photo 1-45: Compactor truck and middle sized containers

- Ratio of Capacity Load (Waste volume to be collected / Capacity Load of a vehicle) is low.
 - The compactor truck may collect other containers having unsegregated waste in order to increase waste collection amount because collection amount reflects their salary.
 - The efficiency of collection may be improved if number of cooperators is increased.

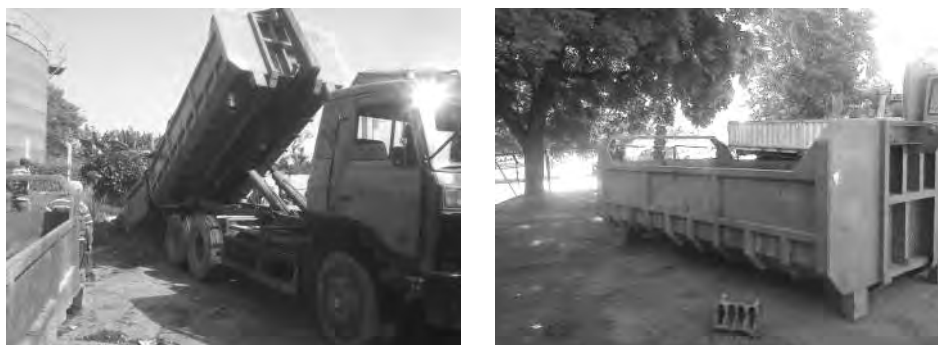
Photo 1-46: Arm roll typed truck and large sized containers (20m³)

- Ratio of Capacity Load (Waste volume to be collected / Capacity Load of a vehicle) is low.
 - The containers may not be collected until it became full capacity.
 - It is appropriate for organizations generating much waste.
- Two containers are required for one place because it is replaced at a site.

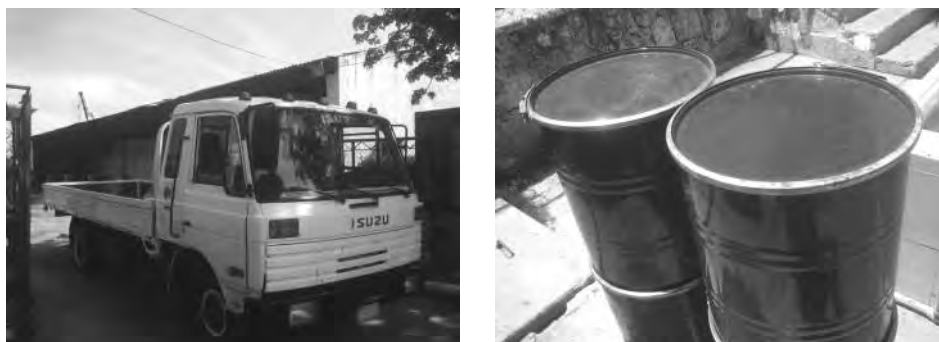
Photo 1-47: A truck and small sized containers (50L)

- Number of trips for waste collection is increased.
- It can be collected from generators producing small amount of organic waste.
- Containers are replaced at the sites, then numbers of containers is increased (e.g., if 4 containers are introduced at a site, other 4 containers are required for replacement.)
- Workload for labors is increased because containers are carried and loaded manually to the truck.
- Special equipment for trucks are not necessary, then any kinds of trucks can be used for waste collection.

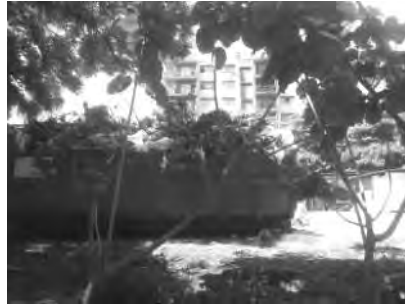
Photo 1-49: Uncollected waste at a agricultural market

- Some vegetables in containers uncollected were stolen and these are sold.
 - Harmful insects occur from uncollected containers
 - Problems become serious in summer because of high temperature and much rain.

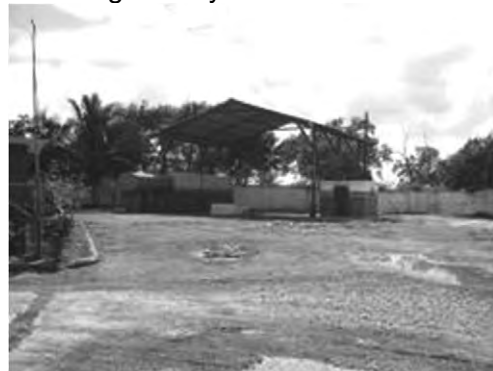
Washing Facility

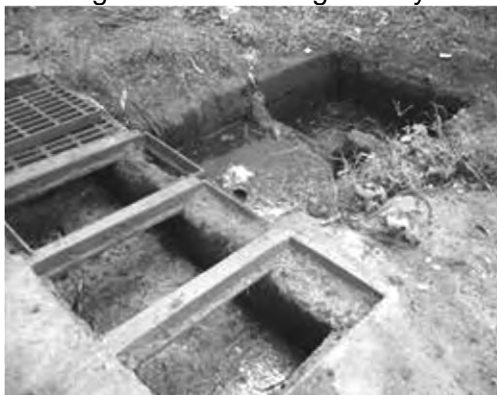
Drainage at the Washing Facility

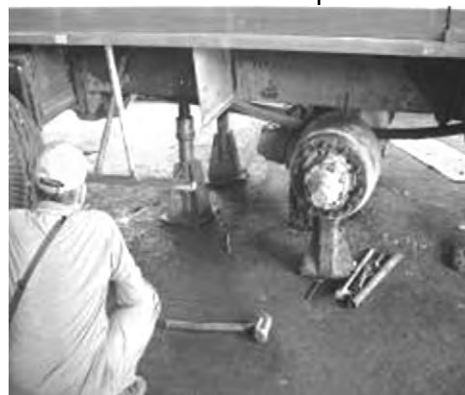
Photo 2-3: Areas and Equipments of Central Workshop

Area for Mechanical Repair

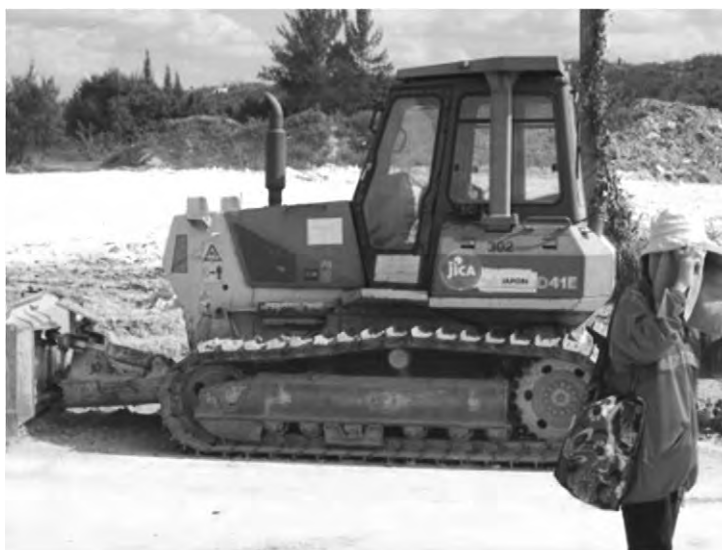
The target heavy equipment for repair is a bulldozer of Komatsu donated in 2006 as part of follow-up assistance. The bulldozer type is D41E-6C, and is classified as middle sized one. It had been working for two years and for 2,475 hours net at November 2009 and remained nonoperational state.

The engine has proved unable to start even though we tried starting by ranking. This implied that the pressure of compression inside the cylinder did not reach the enough level to start. Then we judged the situation was caused by an abnormal abrasion of piston ring and that it was necessary to disassemble the entire engine for further examination and repair. We also assumed that the abnormal abrasion was caused by inferior maintenance of air filter.

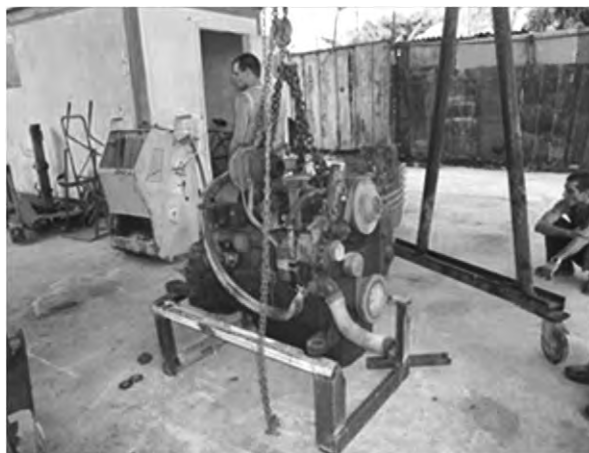
Photo 3-1: Hasty engine stand

We have got 6 plastic boxes for the use of containing disassembled parts owing to the intermediation of Mr. Fernando Vice-Director of Logistics. In addition, we went to collect angle steel to the scrap yard included in the jurisdiction of landfill site. We intended to use the angle steel for putting up an engine stand by ourselves. We have got several pieces of angle steel with appropriate shape and size at the scrap yard. We ordered a person in charge of welding to cut the pieces of angle steel into the indicated size by the Japanese expert and built up an engine stand by welding.

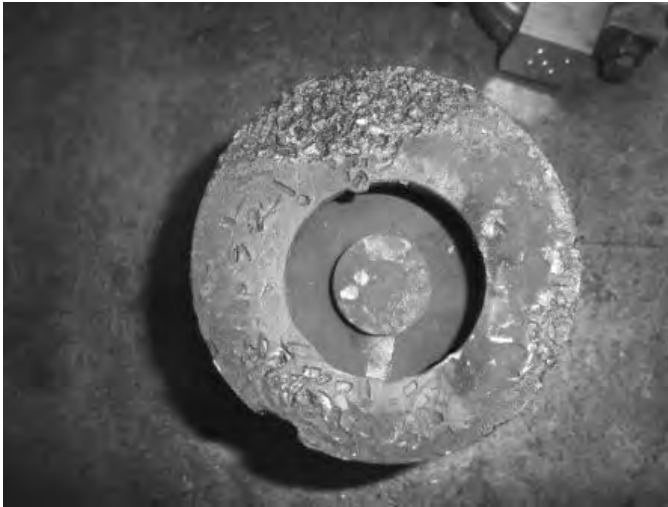
situation of the top surface of piston

There are traces of collision by small metal pieces that was formed by the damage of piston ring due to the abnormal combustion.

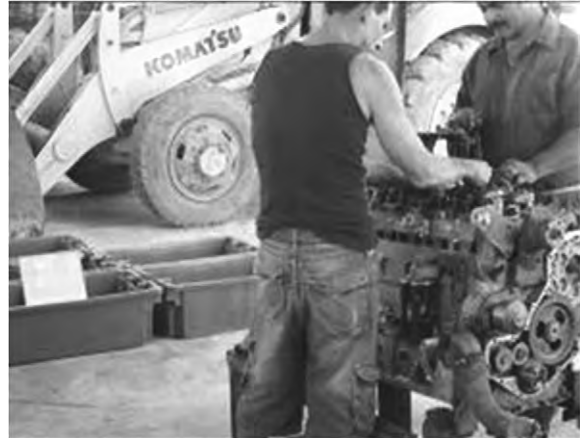
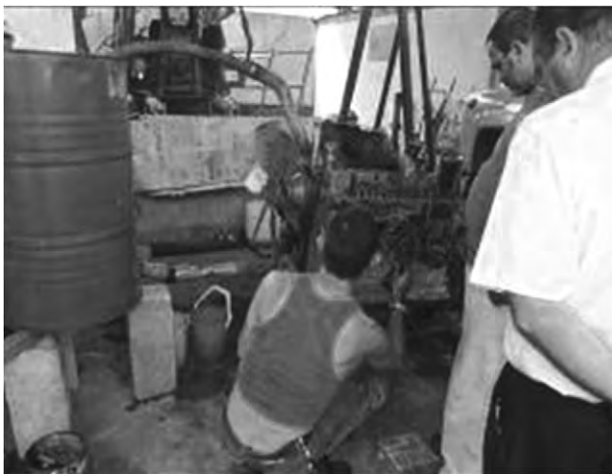
Nov. 26 (Fri.) We guided The master mechanic and his subordinate mechanics in adjustment of valve clearance as OJT. Small white boards were used to make the explanation clearer. The boards were given to The master mechanic to use them in similar occasion of instruction. Prior to mounting the fuel injection nozzle, we indicated the proper screwing torque to The master mechanic. A control table of bolt screwing torque written in Spanish would be delivered at the lecture on Dec. 6th. We mounted fuel pump, turbo-supercharger and new fuel and lubricant filter.

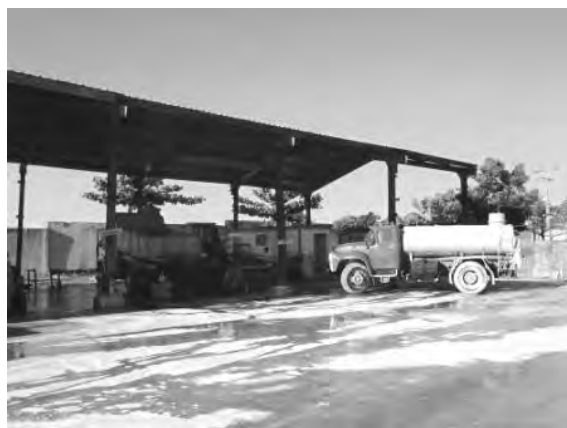
Workshop for heavy equipment: 12m x 42m = 504 m²

Paving of adjacent area of workshop for heavy equipment was completed in October 2010 and the area covers 1,020 m². In addition, paving of the parking area for heavy equipment has been implemented for an area of 4,745m² and has been achieved at about 80 % as of the end of Nov. 2010, and is expected to complete at the end of December.

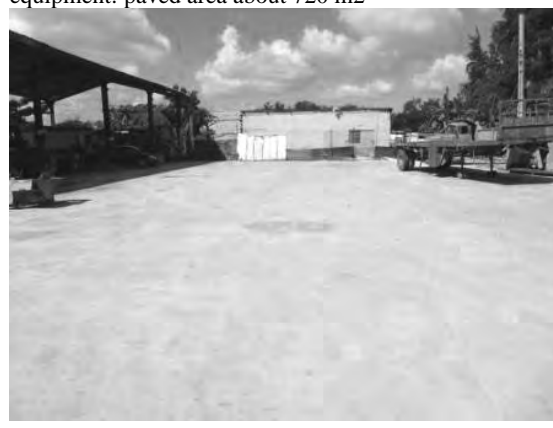
Paving of adjacent area of workshop for heavy equipment: paved area about 720 m²

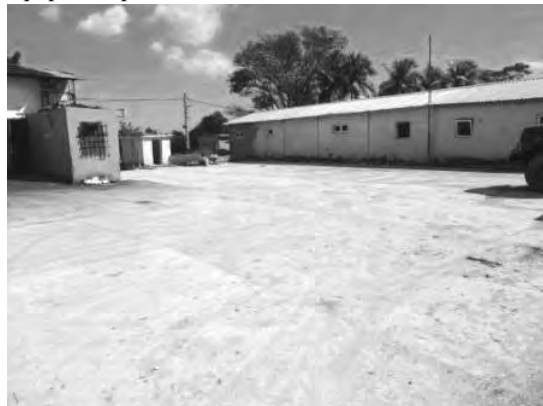
Paving of entrance passage of workshop for heavy equipment: paved area about 300 m²

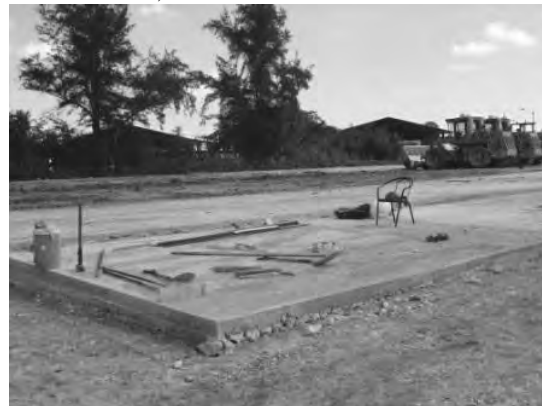
Paving of parking area for heavy equipment: paved area 65m x 73m = 4,745 m²

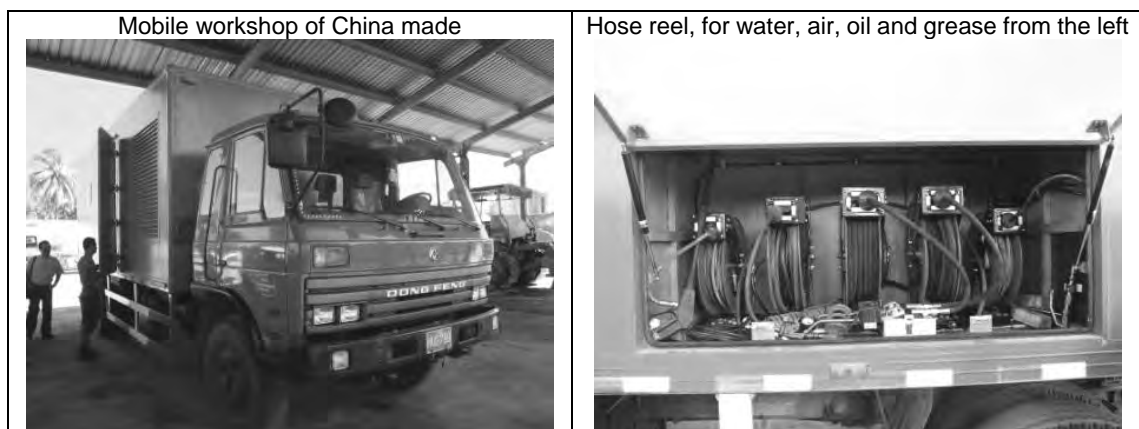
Chief operator of the mobile workshop is the master mechanic and forms a crew with a few mechanics in mobilization. The instruction of mobilization was ordered by the head of the workshop Mr. Quintana, member of C/P. They mobilize the mobile workshop 4 to 5 times a month on average. They conduct maintenance work, welding and repair the malfunctioning with the mobile workshop as in situ service. The mobile workshop is not equipped with those which can meet the major repair, so that the seriously damaged vehicle is brought to the stationary workshop to repair.

- a. Hose reel (to supply water, air, oil and grease)
- b. Bench drilling machine, capacity $\phi 20\text{mm}$
- c. Bench grinder 220V 120w
- d. Plug outlet 220V x 10A, 380V x 16A
- e. Air compressor 5.5 kW
- f. Water tank 500L
- g. Generator 460 kVA, engine 27.9 kW
- h. Oil drum 200L, air pump
- i. Electric-powered crane 500 kg

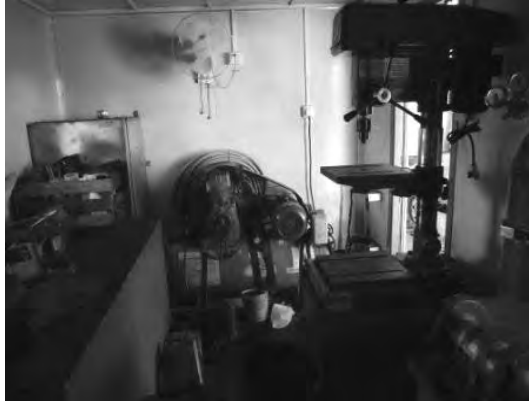
Drilling machine and electric-powered grinder

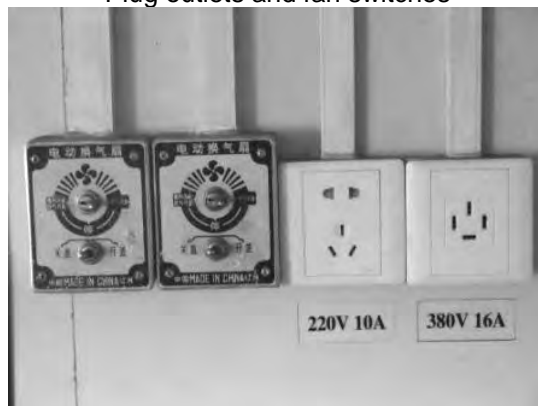
Plug outlets and fan switches

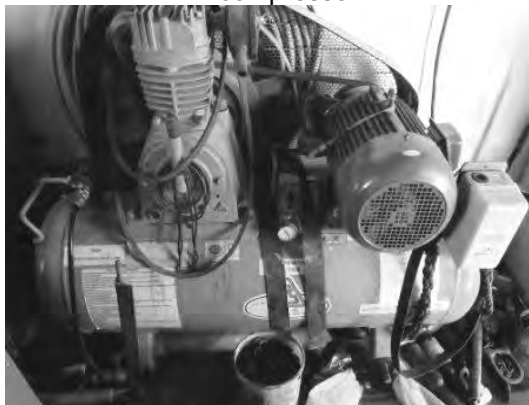
Air compressor

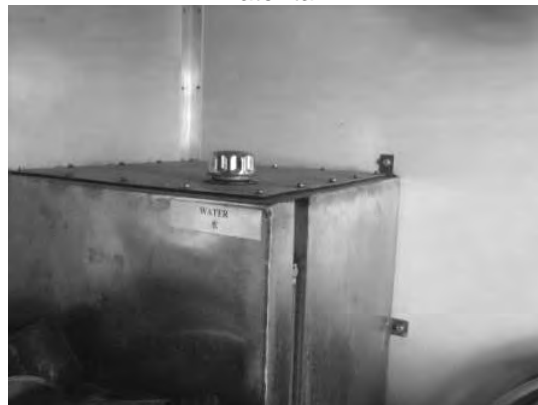
Water tank

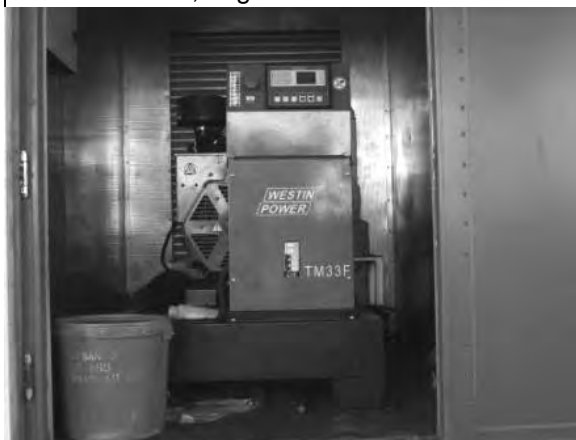
Generator, engine of Mitsubishi made

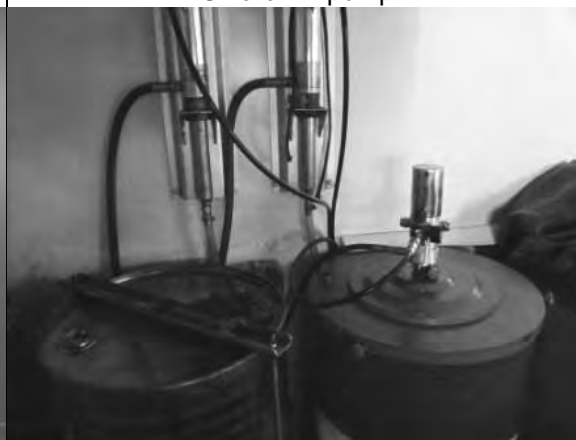
Oil drum & pump

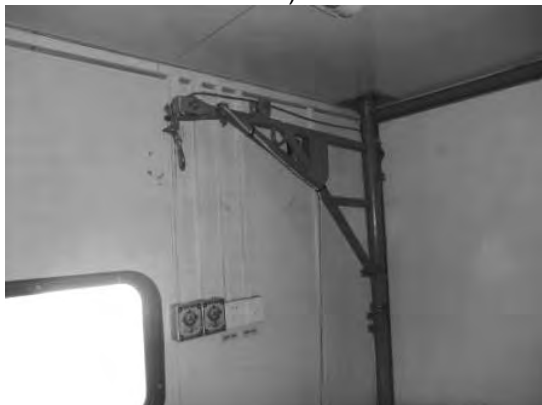
Electric-powered crane (rotary jib stretches out)

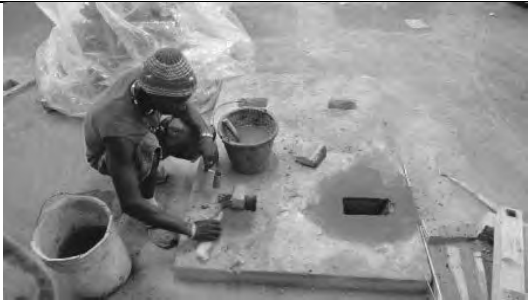
- Guidance to adjust the holes for the anchoring bolts required to install the machine tools. Similarly, as the holes for the anchoring bolts to install the lathe, the milling machine and the upright drill machine are bigger than required, made-to-measure leveling plates were brought from Japan in an ad-hoc manner.
- The position of the electric wires for the lathe connection was adjusted.
- The position of the holes on the walls was marked to guide piping work for lubrication system.
- As the pipes required for the lubrication system were lacking, used pipes were employed provided that they were not dirty. Similarly, the pipes packed together with the donated equipment, which were originally planned to be used differently, were also employed.

Inappropriate holes to anchor the milling machine	Adjustment of the anchoring holes for the milling machine

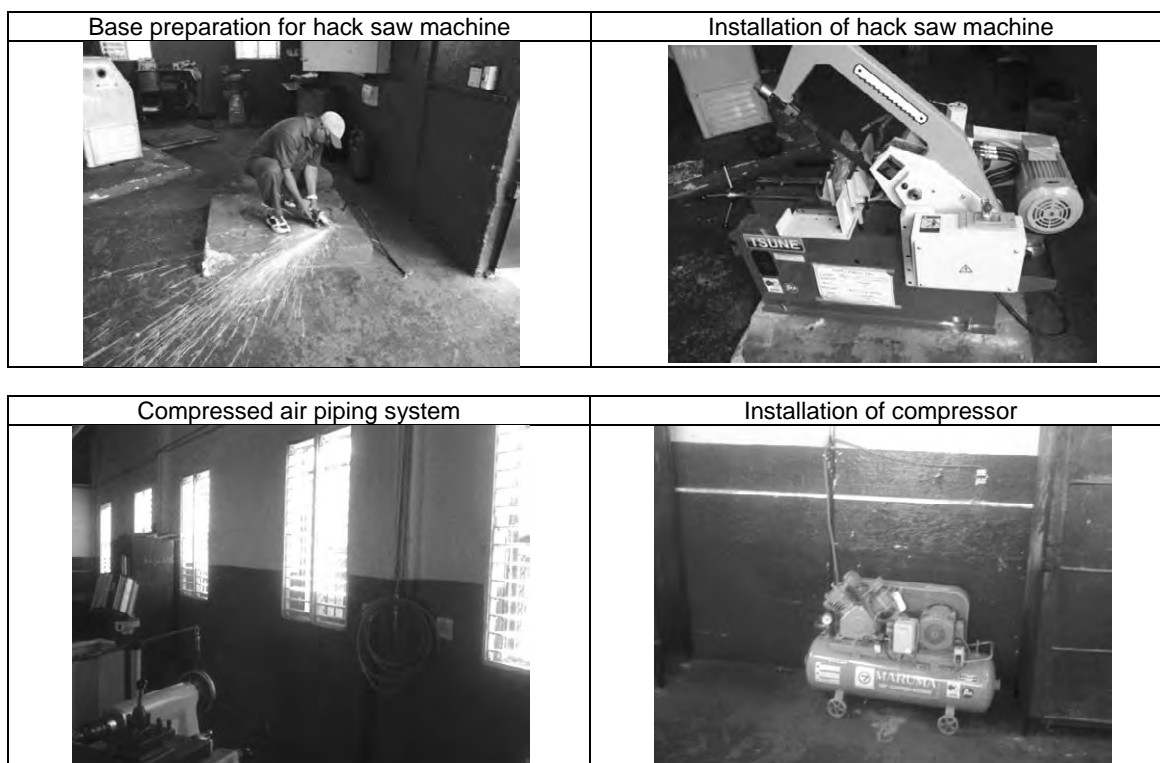
Photo 7-2: Machine Workshop (Hack Saw and Air Piping System)

New equipment: Hack saw machine

It was installed on July, and operated without problems, but further adjustment is desirable.

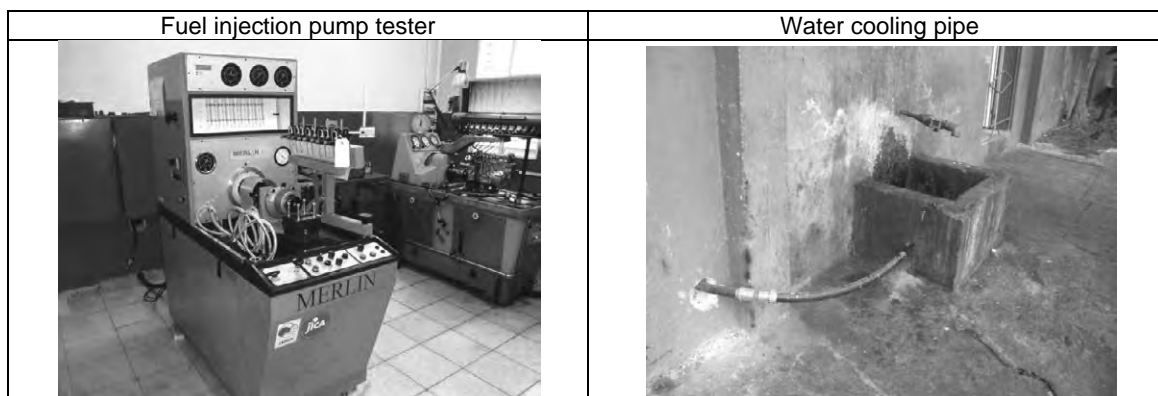
Photo 7-5: Fuel Injection Pump Tester

On June, electric wiring and cooling water piping were prepared for new fuel injection pump tester, and air conditioning machine was installed to improve the condition of this room.

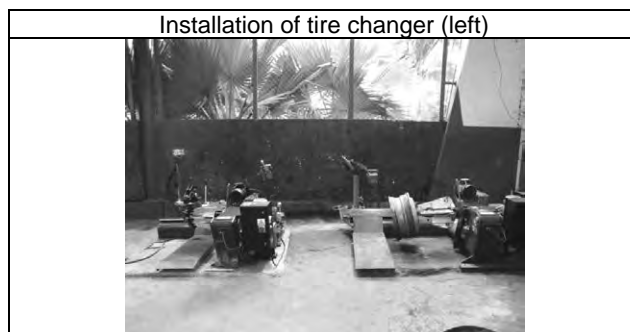
Photo 7-6: Tire Changer

Preparation of base and electric wiring was done for new tire changer installation. This preparation work was planned when this room was constructed.

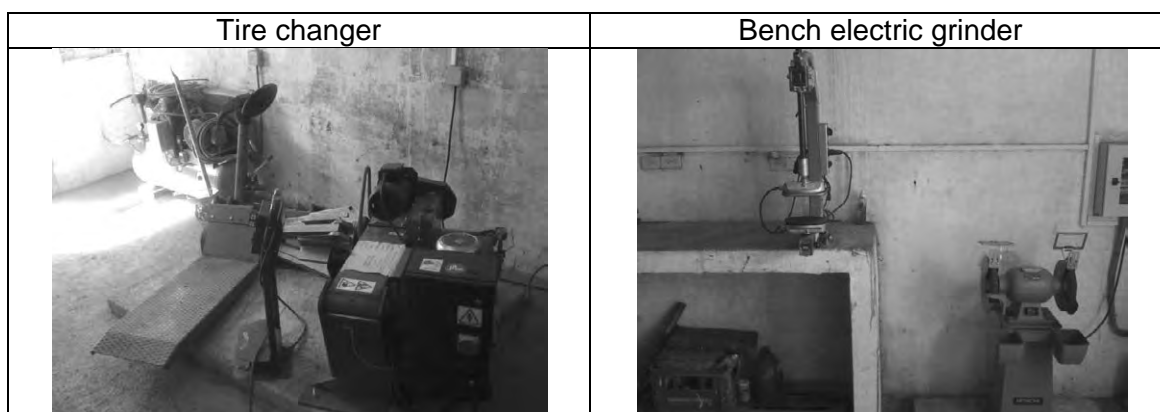
Photo 7-7: Tire repair shop at heavy equipment maintenance yard

Preparation work of base and electric wiring was conducted in this room, to install tire changer, compressor and bench electric grinder with foundation. Those works were planned when this room was constructed.

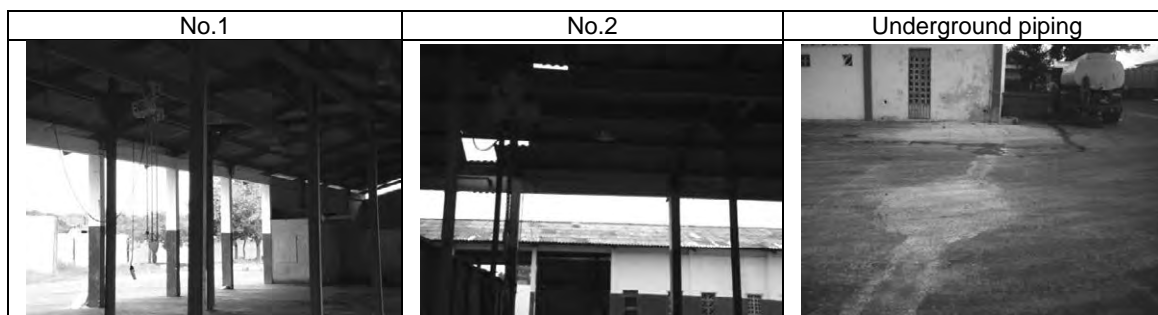
Photo 7-8: No.1 and No.2 Workshop

2 Electric chain blocks were installed,
Compressed air piping connecting between No. 1 and No. 2 workshop through underground was buried.

All of electric work described in this chapter was done by GEYSEL, construction work like base was done by ASECON, and installation of electric chain block was done by Nuevas Técnicas.

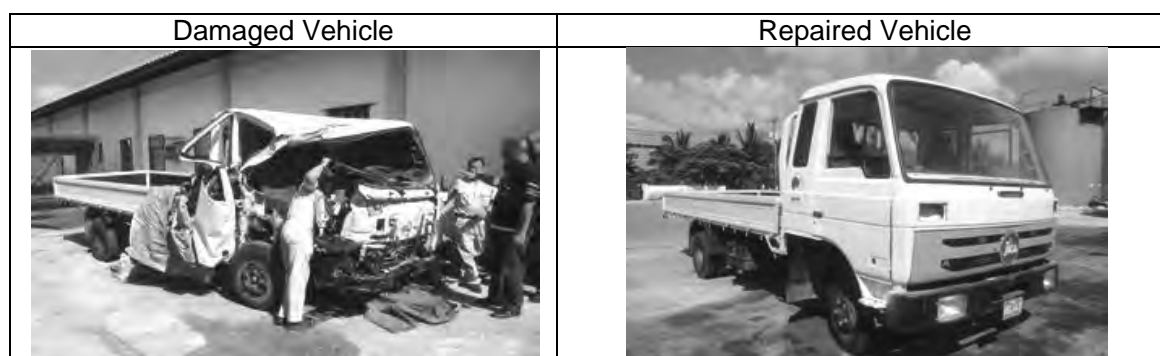
Photo 8-3: Repair of Damaged Vehicle

The truck is in a perfect condition. A new driver is expected to be hired soon.

As the donated truck for transport of compost material was seriously damaged by a traffic accident, the procurement of parts from the manufacturer was initially tried. However, this was quite difficult in Cuba. Therefore, the works to repair the damaged truck were finished by using second hand materials

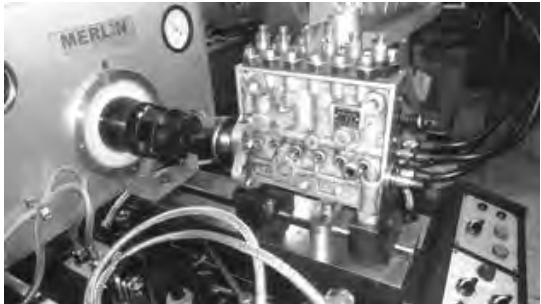
<p>Injection pump tester</p>

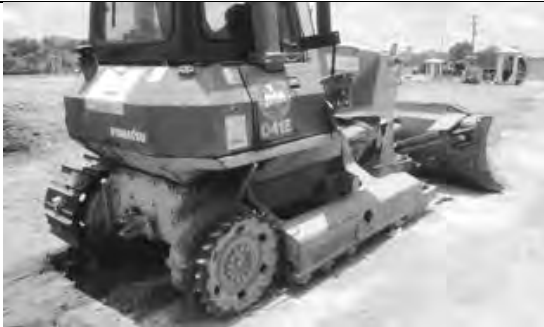
<p>Komatsu bulldozer</p>

<p>Abrasion of pins & bushes of caterpillar</p>
