**Republic of Cuba
Project for
Improvement of Capacity on Solid
Waste Management in Havana City**

Project Completion Report

September 2014

**Japan International Cooperation Agency (JICA)
EX Research Institute Ltd.**

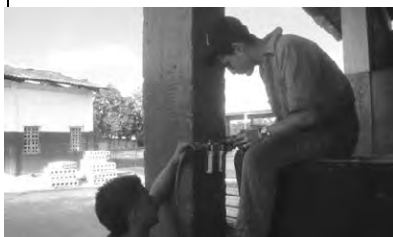
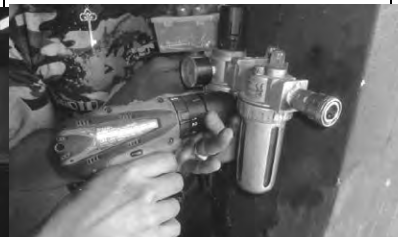
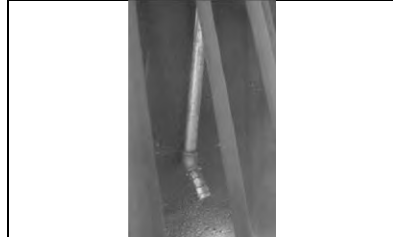
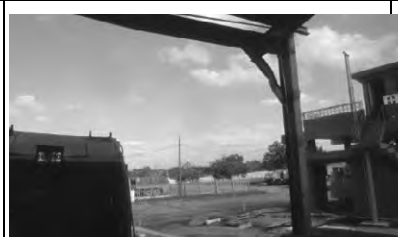
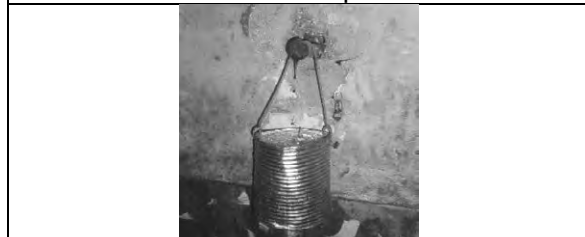
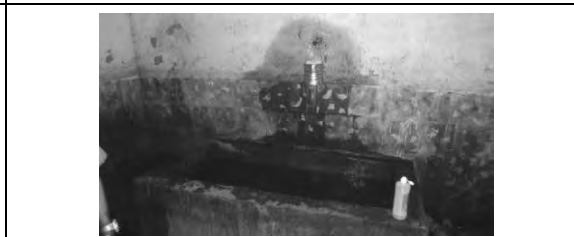
Photo 9-1: Improvement of air and water piping system

Fix air regulator	Fix air regulator by concrete drill	Extension of air pipe at workshop (1)

Extension of air pipe at workshop (2)	Extension of air pipe at tire repair workshop (1)	Extension of air pipe at tire repair workshop (2)

Extension of water pipe at tire repair workshop		Water tank at tire repair workshop

At this time (November, 2013), 2 types of air tool were brought to Cuba for efficient maintenance of brake system. One is a “rivet gun” to drive rivets to stick brake lining to brake shoe, and the other one is a “belt drive grinder” to grind rough surface of brake lining to be smooth. Furthermore, 4 air regulators were brought to Cuba. By using those items, dramatic reduction of maintenance time is expected. Moreover, “concrete drill” was brought to Cuba and fixed existing air regulators to concrete pillars. On the other hand, Cuban side extended air pipe and installed a valve at the workshop. As for tire repair workshop, both air and water pipes were extended for efficient maintenance work. See Photo 9-1 and Figure 9-2.

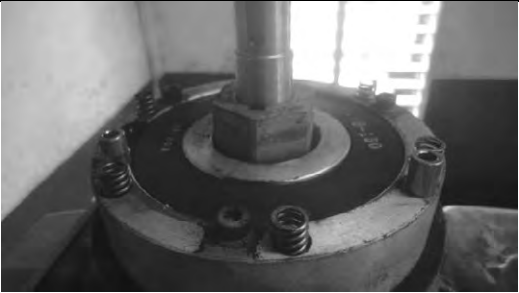
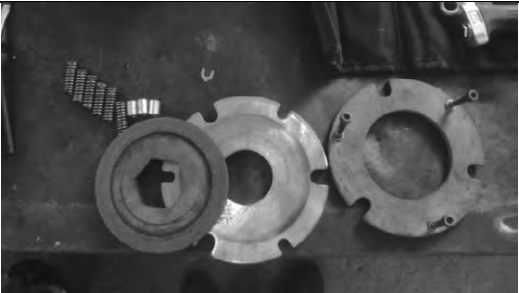
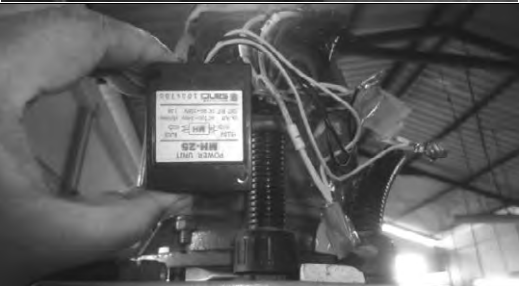
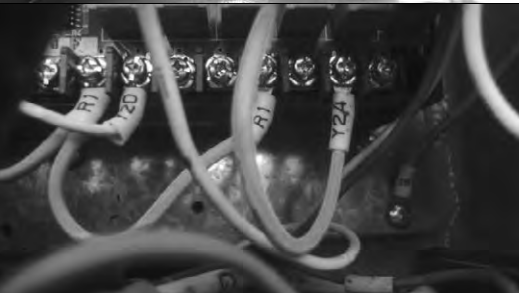
Photo 9-4: Bench Drill Repair

Magnetic brake disassembly

As the disk and other parts of the brake were rusty, they were polished using the newly donated grinding machine.

Both primary and secondary brake rectifiers showed 0 voltages.

The yellow wire of "Y24" of the primary brake rectifier showed 0 voltage.

It was found that the electric circuit was damaged, so no current passed to the motor brake. As it was impossible to repair the electric circuit, the springs and the rotary disk of the motor brake were removed, thus allowing the drill to get started. (See Photo 9-4)

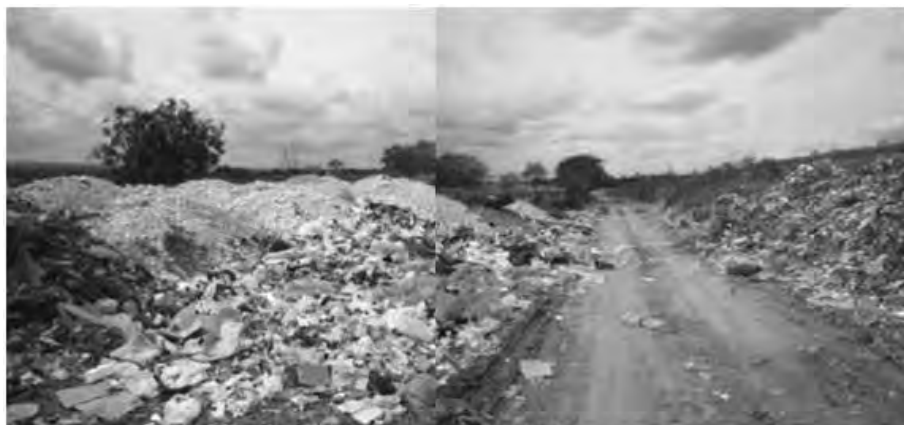
Photo 3-1: Situation of the 8 Vías access road

In this respect, a vicious circle was observed; the access road was not well maintained, and the waste was dumped along the margins of the access road, the driving conditions became deteriorated, elevating the possibility of puncturing or blasting tires, which made the drivers prefer dumping the waste along the margins.

Although the C/P recognized that the access road repair was essential, its priority was low due to the unavailability of the heavy machines and the lack of fuel.

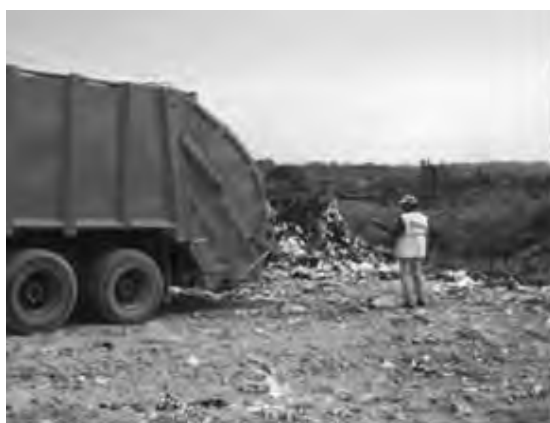
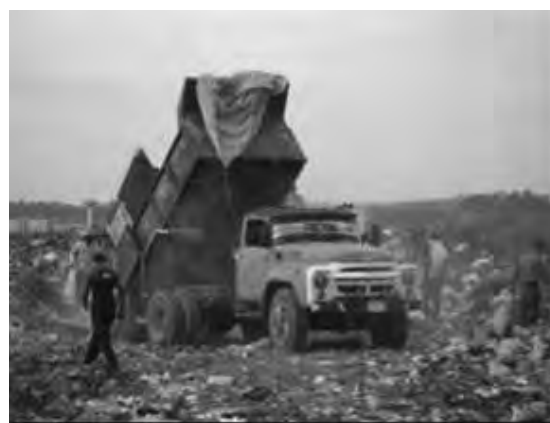
Photo 3-2: The guidance conducted at the dumping yard in the Calle100 final disposal landfill

Their working condition was very dangerous. If the guidance was appropriately done, they would be warned about the approaching vehicle, but if there was no guiding staff at the stage, accidents could occur causing bodily injuries.

ZONA-I In front of the trench

ZONA-IV

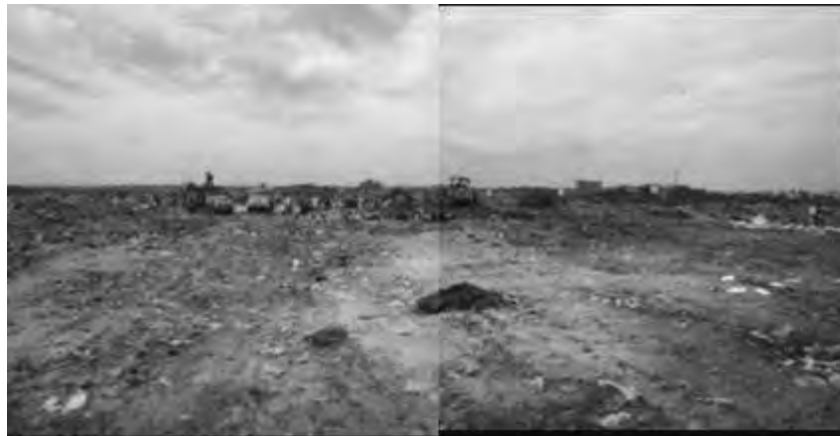
Photo 3-3: Dumping stage at Calle100

Although the dumping stage was arranged using bulldozer(s), the majority of the area was uneven and the waste was not sufficiently covered, which made the driving conditions for waste collection vehicles worse.

The Japanese Expert observed that there were stuck vehicles in the waste. The guiding staffs and the collectors were pushing it and later a bulldozer was pulling it up.

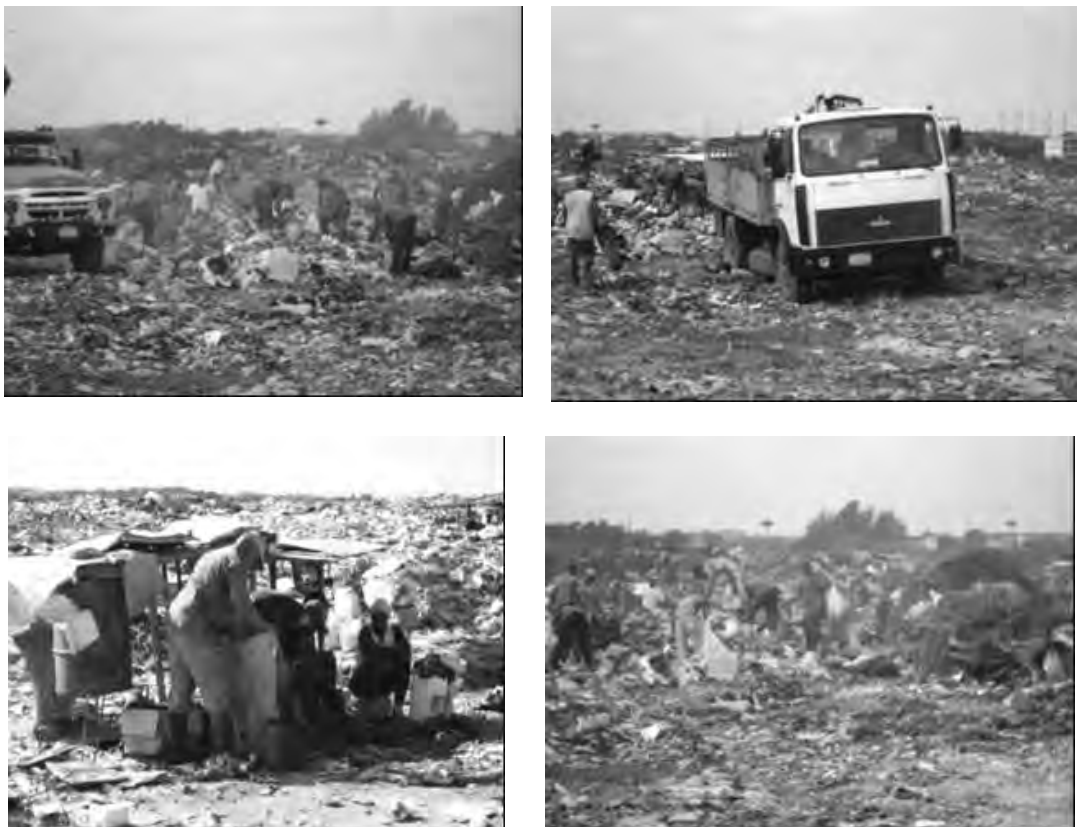
Photo 3-4: Raw material collection near the dumping stage

Many UPPH staffs were working to collect the raw materials near the dumping stage. The Expert were concerned about the safety of them. When plural vehicles were moving around at the dumping site, they would not notice an approaching vehicle from loud noise.

The guiding staffs and the raw material collecting staffs didn't wear any masks or gloves. They were working under the scorching sun without shady area in the dumping site which reeked of foul odors. Their working conditions were very poor.

The preparation of some rest area and the supply of protectors are necessary.

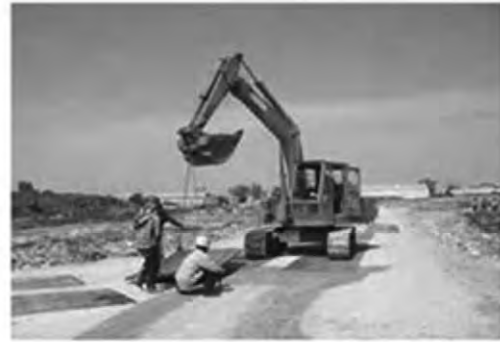
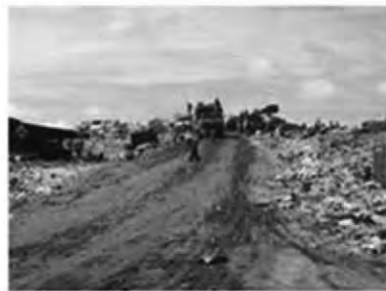
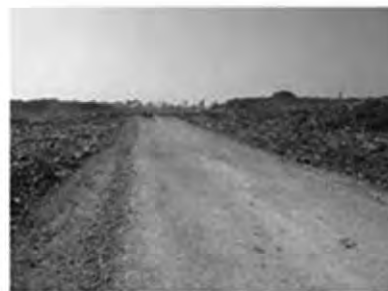
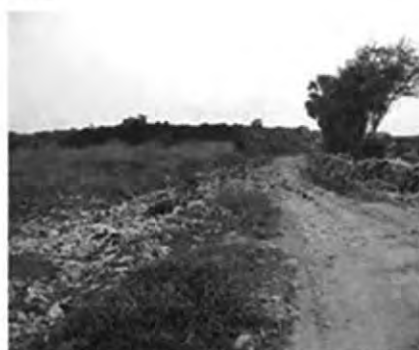
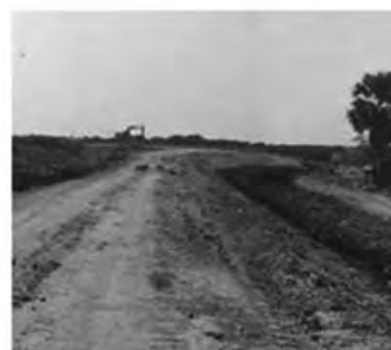
Figure 3-1: Access road construction within the landfill

Construction of Main Road

Before

After

Enclosing Bank

Therefore, the Expert presented some examples of the modifications conducted in other countries, such as a road arrangement with an iron plate and a preparation of small enclosing bank to guide vehicles, preventing them from dumping on the way to the proper dumping site.

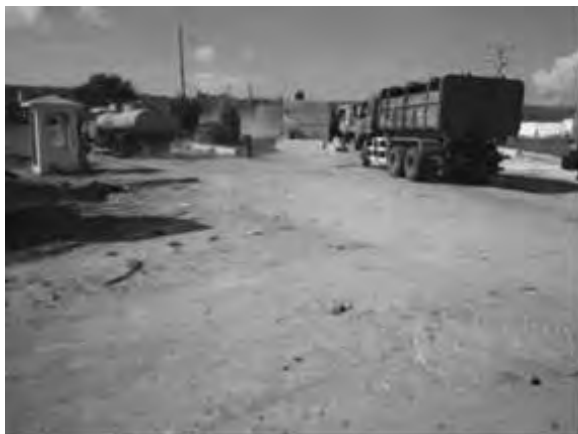
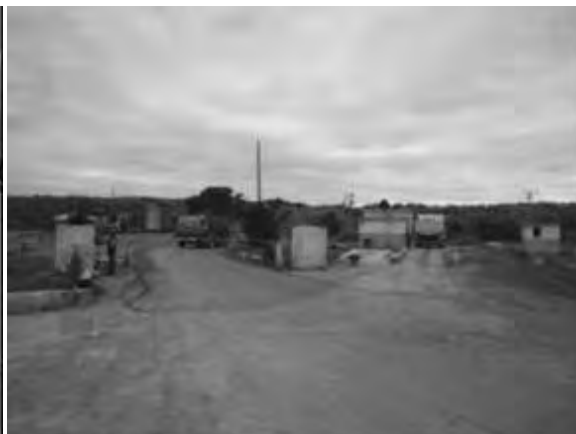
The emergency access road and the exit road were paved so that the vehicles could pass swiftly.

Through these improvements, the traffic line around the entrance became clear.

June 10, 2010

December 2, 2010

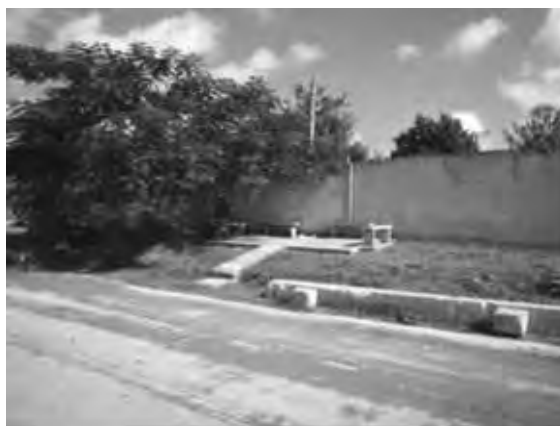
Photo 3-5: Rest area for waste collectors

The drivers had to wait for the collectors to finish collecting the raw materials at the dumping site, which contributed to the prolongation of the waste collection vehicle roundtrip time in the landfill. UPPH determined to prohibit the waste collectors from entering the landfill, preparing a rest area near the landfill entrance so that they could wait there for their vehicles to come back to pick them up.

As a result, the roundtrip time inside of the landfill was considerably reduced.

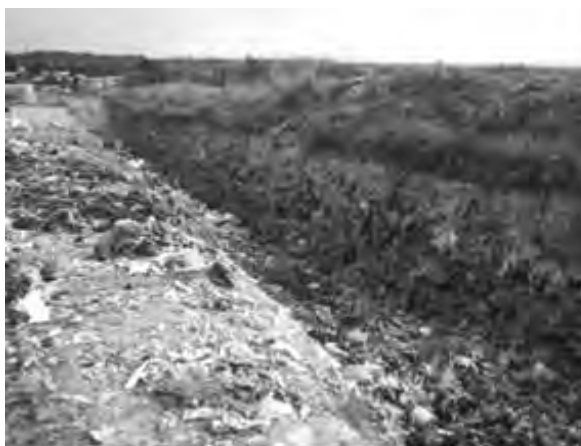
Photo 3-6: Trench at Calle100

The method has been also applied in the oldest landfill zone or ZONA I, where the organic waste has been converted into the soil. It can be used for covering. As a lot of plastic materials of low decomposability are found mixed in such soil, UPPH has a plan to sieve the soil using the trommel in the compost yard in future.

Although the trench method requires excavation with backhoe, leveling and compaction can be effectively carried out with one heavy machine, resulting in the prolongation of the landfill life.

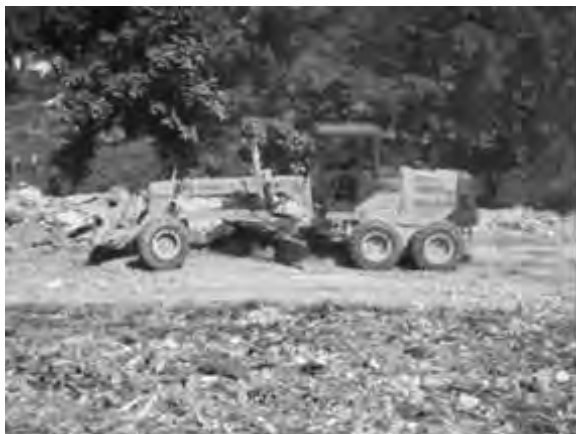
Photo 3-8: Access road widening (8 vías)

The repair of the access road not only improves the driving conditions for waste collection vehicle but also serves to prevent the drivers from dumping the waste onto the margins of the road in the nighttime. The construction work to widen and level out the access road has started in 8 vías landfill with the installation of a truck scale.

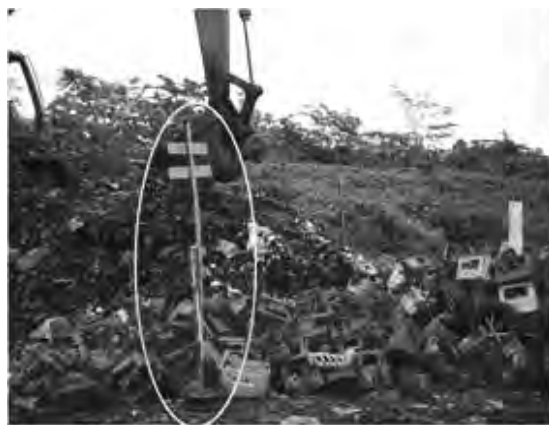
Photo 3-12: Height control with a wooden post

The experts explained that the landfill height could be controlled easily, using water hose or wooden post in form of dragonfly.

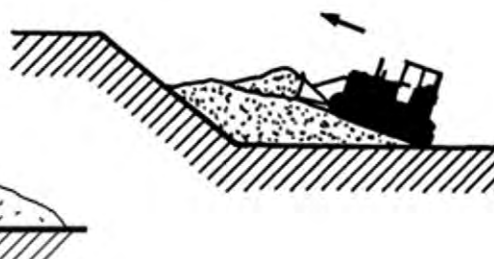
Figure 3-5: Method of pushing the waste upwards

There are two alternative ways for leveling and compaction of dumped waste, using bulldozer(s); method of dropping the waste towards the bottom of the slope and method of pushing the waste upwards against the slope.

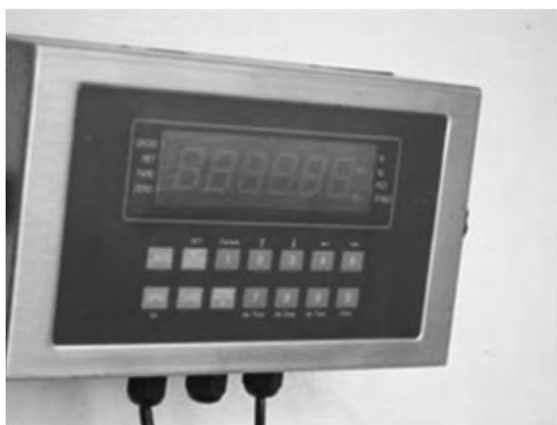
Photo 3-16: Indicator of the truck scale out of order, Calle100

The expert had heard that the truck scale installed in the Calle100 landfill had been repaired some times and even that the repair had been completed, but he could never confirmed that it was functioning during his stay.

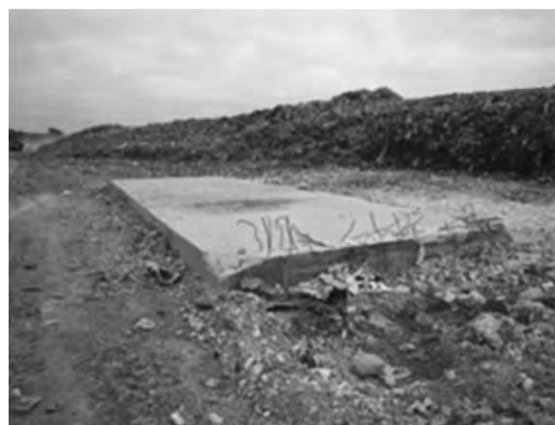
Photo 3-17: Basement for truck scale, 8 vías

A truck scale is being installed in the 8 vías final disposal landfill. The basement concrete was prepared as of 2 December 2012.

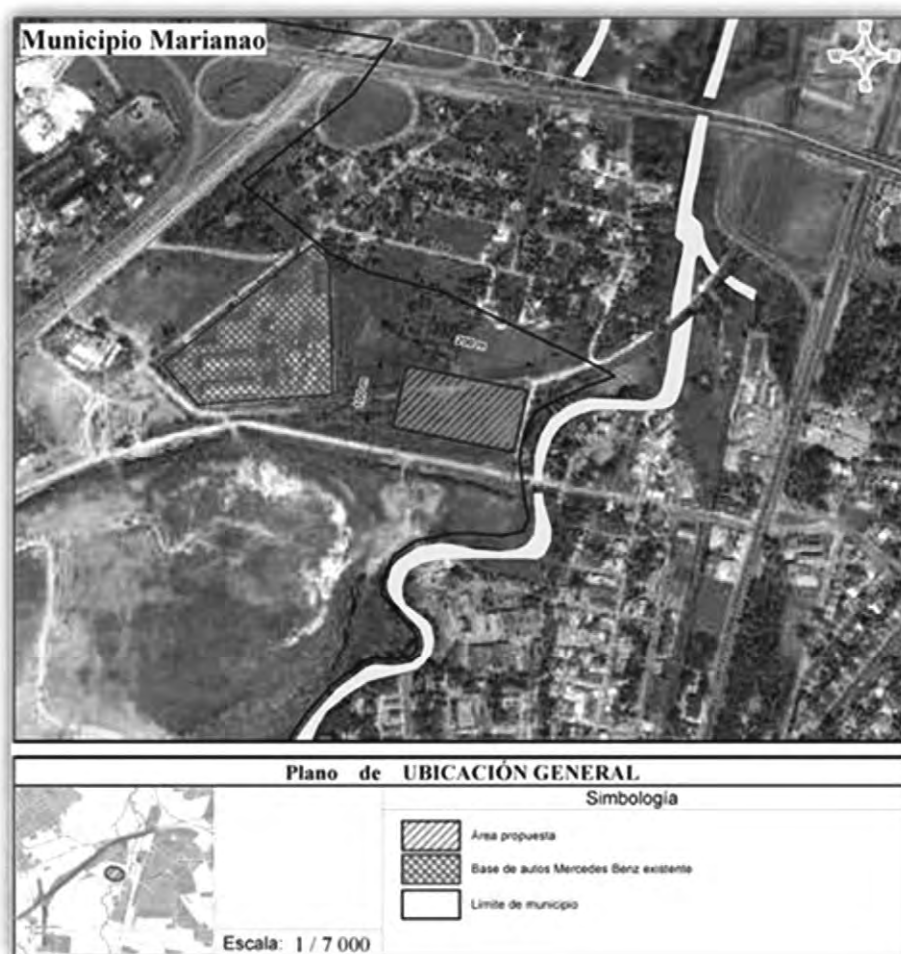
Photo 3-18: Revised construction site of lagoon in the Calle100 landfill

When visiting it again in October 2010, the expert was informed that the lagoon was to be constructed definitely at the downstream area and that the geological and land surveys had started.

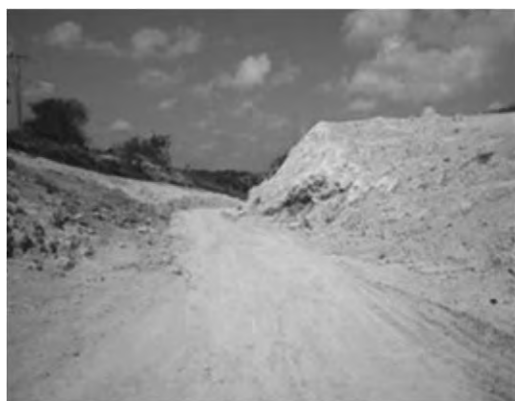
Photo 3-19: 10 May 2010

Then, the construction work was suspended and when visiting the site again in November 2010 the expert found the condition of the access road deteriorated compared with the condition observed in last February 2010 due to the erosion caused by the precipitation during these several months.

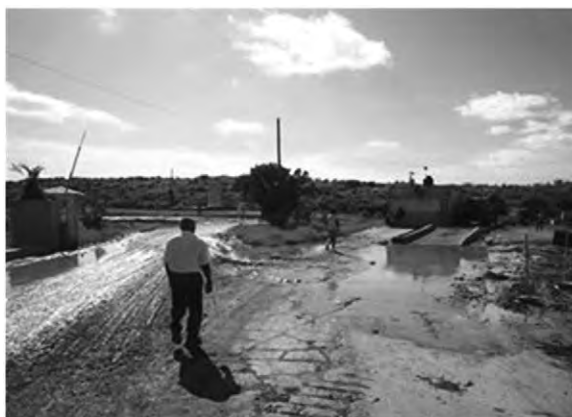
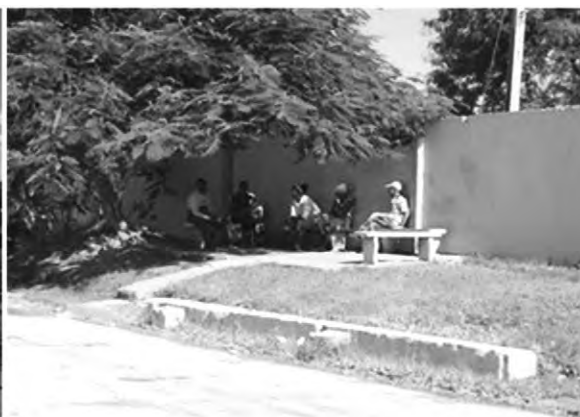
Photo 4-1: Control of entry and exit

Separation of entry and exit of collection vehicles (October, 2011)

Resting place for collectors (October, 2011)

In this landfill, the separation of entry and exit path of the collection vehicles has been firmly established after the installation of a control barrier and the expansion of the paved surface in the exit path. It is also observed that the collectors use the resting area.

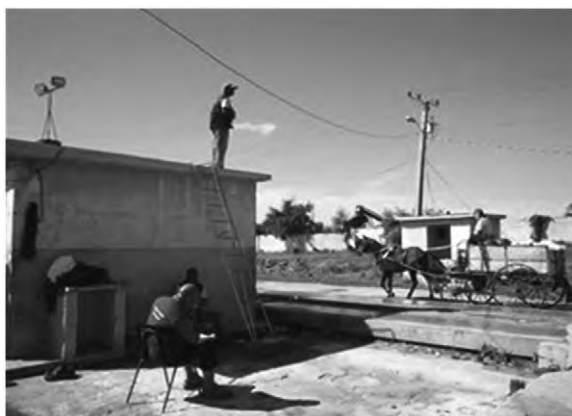
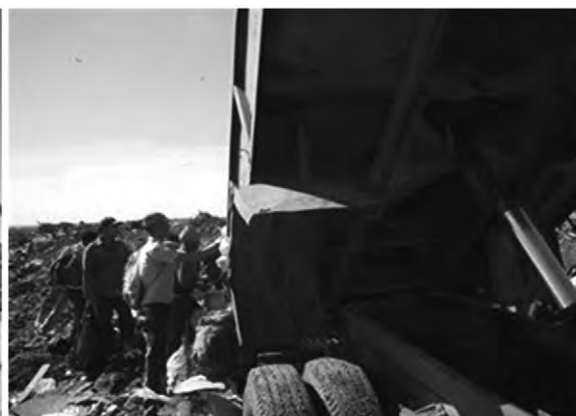
Photo 4-2: Waste Inspection

Inspectors check solid waste transported by vehicles (October 2010)

Inspection of solid waste in dumping area (October 2010)

Standing around the weighbridges, which are inoperable, the inspectors check collection vehicles and talk with their drivers to verify the type of waste transported and the same inspection is also done in the dumping area.

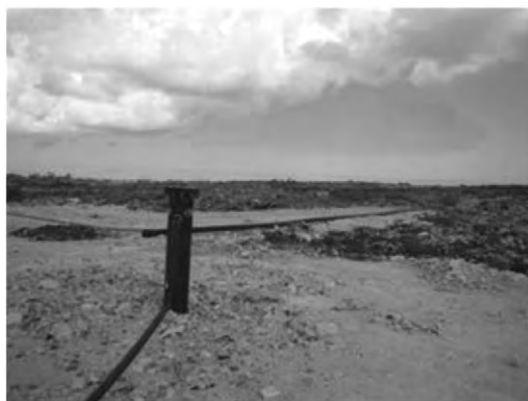
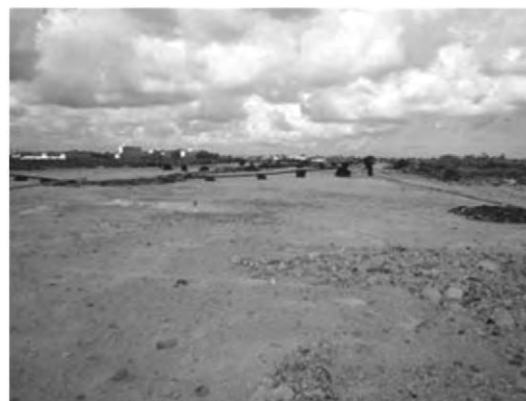
Photo 4-3 Expansion of methane gas extraction area

Soil coverage around the wells to extract methane gas in the CDM project (May, 2011)

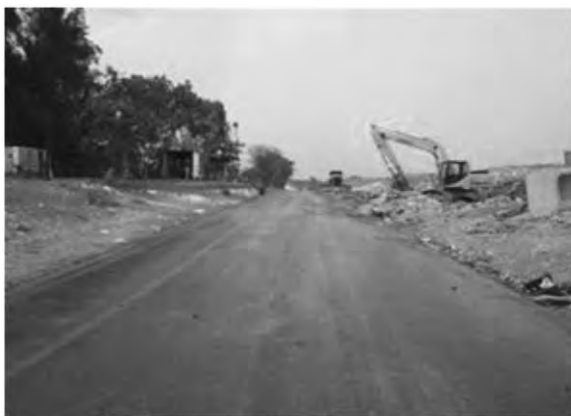
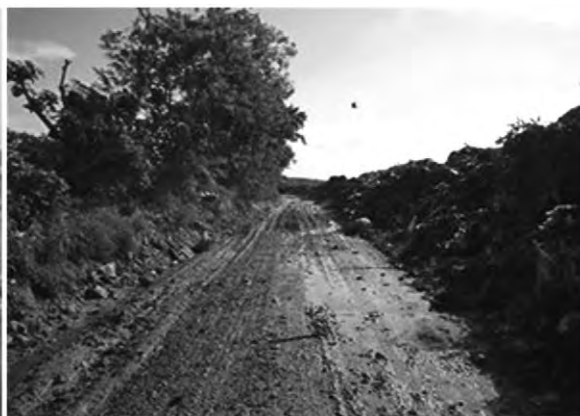
Photo 4-4 Access route to Ocho Vias

Image of access route to Ocho Vias landfill
(May, 2011)

Image of access route after raining
(October, 2011)

The access route to Ocho Vias landfill has been widened and paved, but due to constant rainfalls in October 2011, the water accumulation did not allow collection vehicles to enter into a dumping area. Consequently there were few days an entry of collection vehicles was not permitted completely. We were explained that this measure had been notified to the competent authorities, but not to the collector vehicles. Since they were not allowed to enter, neither could take the waste to other landfills, some trucks got to discharge its waste around the landfill entrance, violating the rules and the accumulation of solid waste was very high.

A fuel is provided to operate heavy machineries, but not in an enough quantity and they cannot clean the area immediately. Seeing the waste accumulated, the collection vehicles continue discharging at an access road to the landfill, letting the area remains messy, thus falling into a vicious cycle.

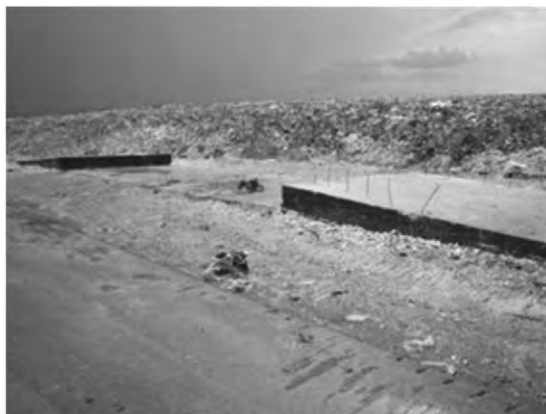
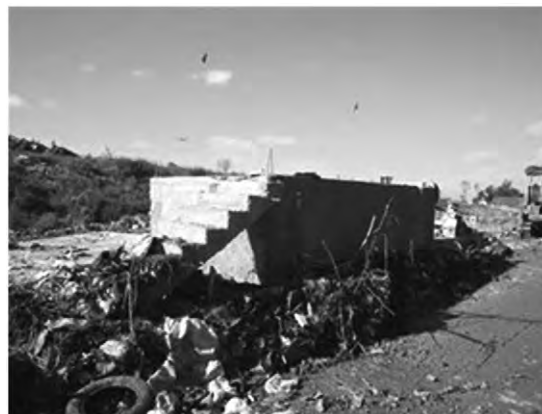
Photo 4-5 Wastes disposed of near the base for weighbridge to be constructed

Base for weighbridge (May, 2011)

Office for control of weighbridge (October, 2011)

There is waste dumped around the base of weighbridges under construction, so there is a risk that it would be damaged by cleaning with heavy equipment.

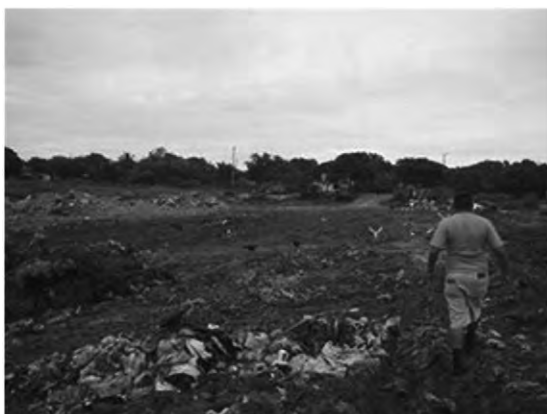
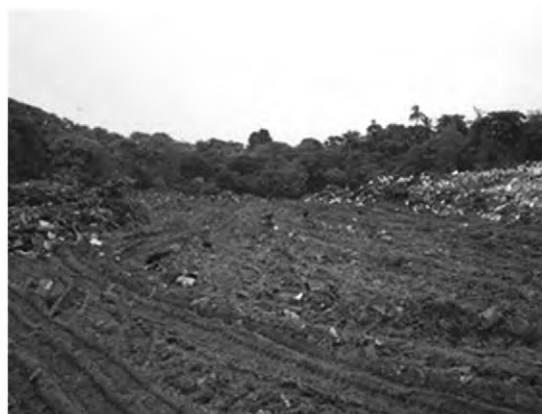
Photo 4-6 Situation of dumping area (October, 2011)

Situation of dumping area (October, 2011)

Situation of dumping area slope
(October, 2011)

After the expert pointed out the need to use heavy machineries to extinguish fires, they began to be sent periodically to the landfill. This also helped to improve the dumping area conditions, reducing its slope.

When we visited the landfill in October 2011, despite unfavorable conditions after raining constantly nearly for a week, it was observed that the dumping area has been maintained in acceptable conditions and had advanced the process of forming a gentle slope. The volume of waste disposal has increased temporarily due to the arrival of vehicles that discharge normally at Ocho Vias landfill where it had banned the reception of wastes because of bad weather. It was also observed the

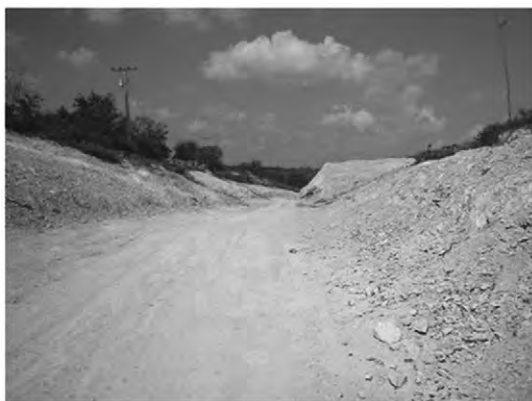
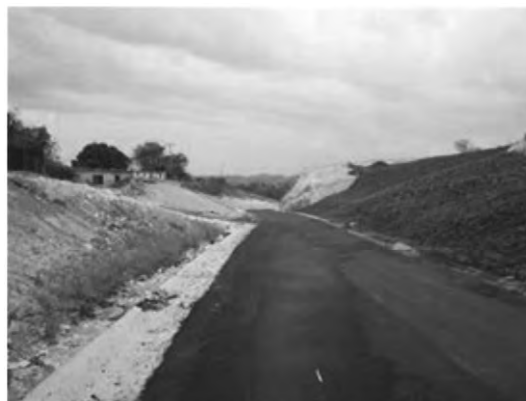
Photo 4-7 Access route to New Landfill

A construction of access road to new landfill had begun before the project started and there have been delays, but it is almost entirely completed.

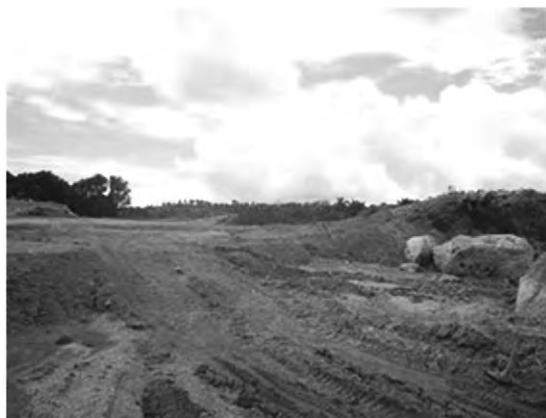
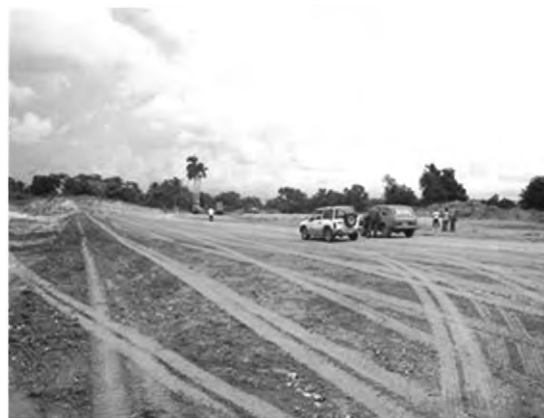
Photo 4-8 Nueva Guanabacoa works in progress

A constructor was hired to carry out a works for block No.1 and they began the works. The construction was suspended for the modification of the coordinates and the study of trees located in the zone and was re-initiated by the retaining walls foundation works.

Landfill access route works explanation
(October, 2011)

Retaining wall construction explanation
(October, 2011)

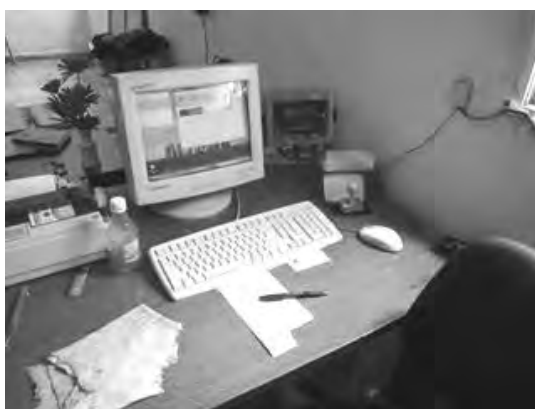
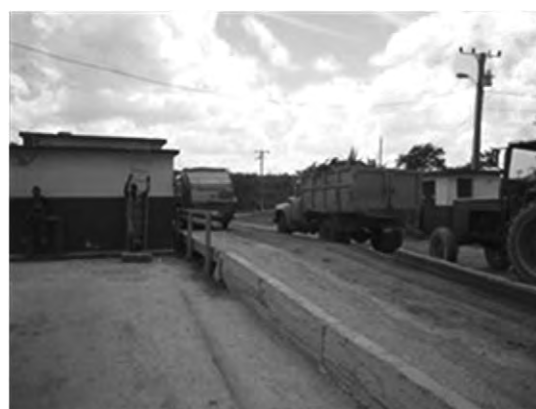
Photo 5-1: Calle 100 Weighbridge

With regard to Calle 100 landfill site, the weighbridge became operational as from November, 2012, using some of the parts previously planned to be installed at Ocho Vías landfill site, and it has remained so up to the present (April, 2013).

Compactor trucks have been identified, including license and registration. Some data such as the weight per vehicle and truck arrival and departure times have also been recorded.

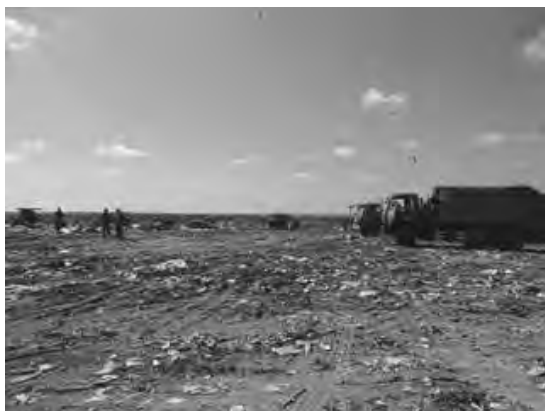
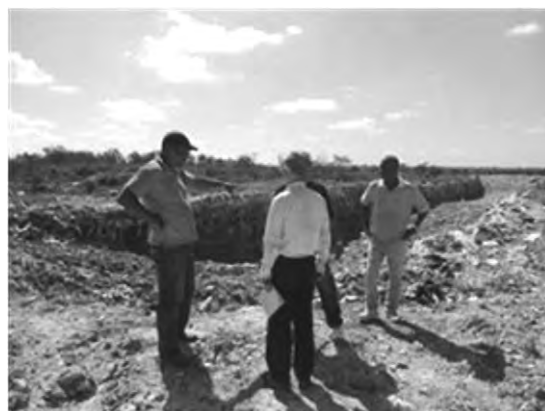
Photo 5-2: Calle 100

For methane gas extraction, filled trenches continue to be dug out. Decomposed sandy wastes are used as surrogate for soil and organic wastes are dumped into the dug trenches. It has been reported that the areas currently used for methane extraction have not increased.

Waste dumping area

Re-excavation of trenches

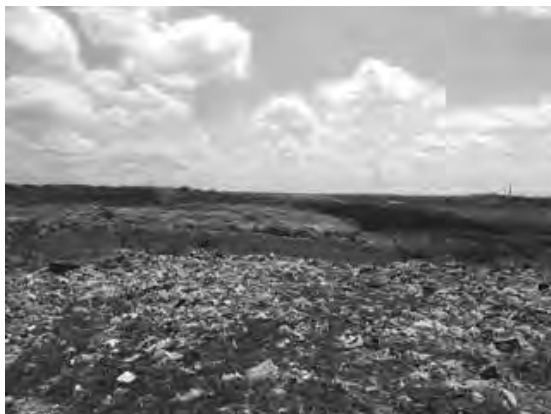
Photo 5-3: Ocho Vias

There has been some progress regarding the works required to install the weighbridge. The foundations have been already laid. However, due to the use of some of its parts for the installation of the weighbridge at Calle 100 landfill site, it is not known when the works will be resumed. The works are likely to become worthless as Ocho Vías site is expected to be closed eventually.

Uncovered wastes

A new final disposal site to be used once the site is closed down has not been secured yet. Consequently, I pointed out that the covering of currently exposed wastes, the shaping of slopes, and the compaction and covering of wastes using soil may help reduce the pollutant load.

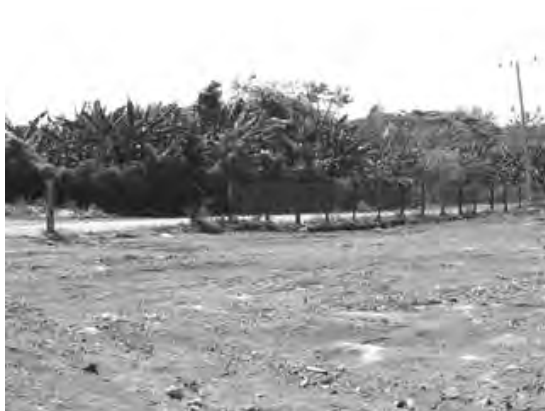
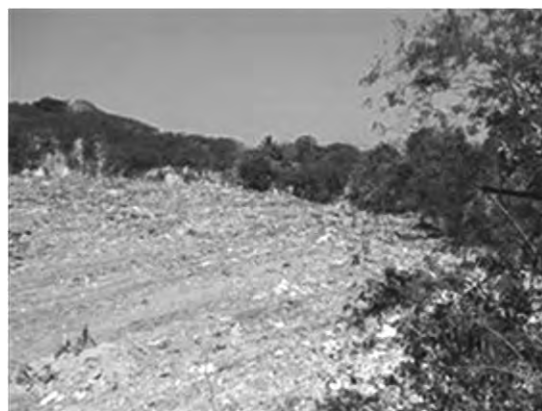
Photo 5-4: Tarara

Landfill operations extend up to the point where the land is level after the slope gradient was reduced to make it accessible for heavy equipment.

The life service of the landfill site is expected to be 2-3 years judging from the height of the access roads and the nearby houses.

Fence to prevent trespassing

Current situation

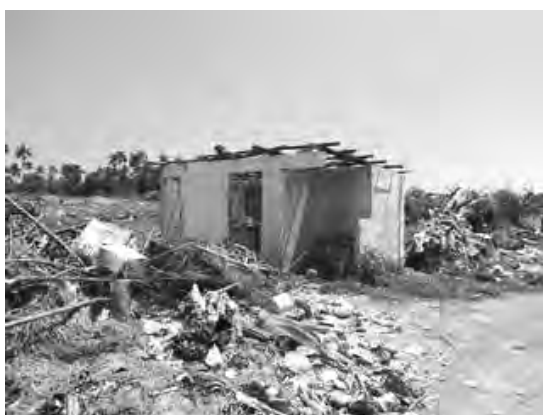
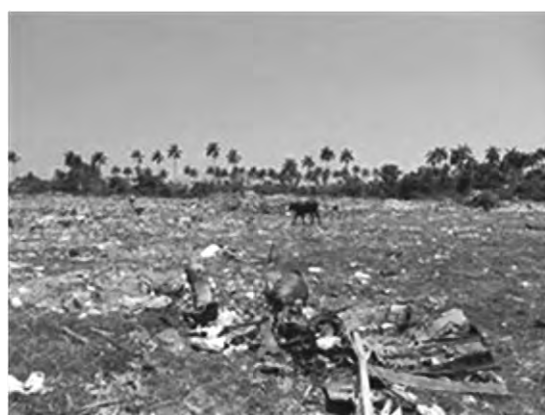
Photo 5-5: Campo Florido

The wastes piled up around the hut. It was difficult for the compactor trucks to access the site as the wastes were dumped along the access road. Waste compaction and covering with soil is carried out once a month using the heavy equipment owned by Tarará landfill site. Therefore, it is difficult to tackle any contingencies that may arise.

Most wastes are taken to the site using horse-driven carts. Waste volume has decreased. The site condition has not changed significantly since the beginning of the project.

Destroyed hut and wastes dumped near the site entrance

Current site condition

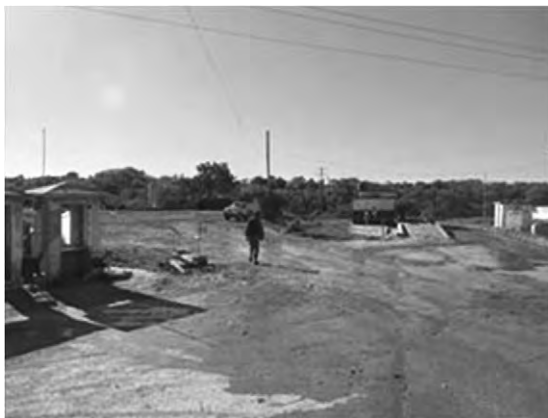
Photo 6-1: Broken Weighbridge

The weighbridge in operation during my previous stay in April 2013 has been out of service for some time now. I was told that it broke down only a few days before my arrival and it is not planned to be repaired during my assignment.

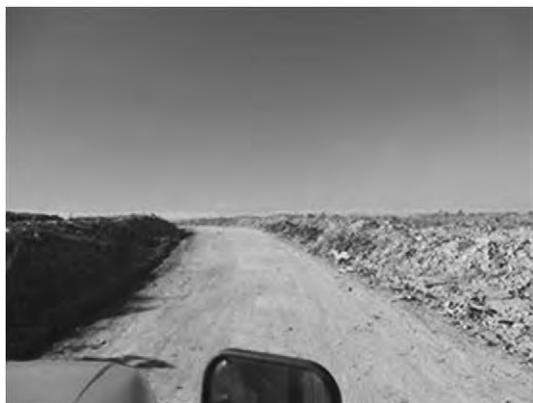
Photo 6-3: Present Condition of the Sloping Access Road to the Landfill Site

Mr. Domingo is still the landfill site manager. With regards to the inner road, the condition of the sloping access road to the site has changed. Its width has increased. It has been kept in relatively good condition. At the waste dumping area, where it is difficult for collection vehicles to pass by the recyclable material segregation place, truck circulation has improved by using a whistle, a generally uncommon way in Cuba I had previously recommended.

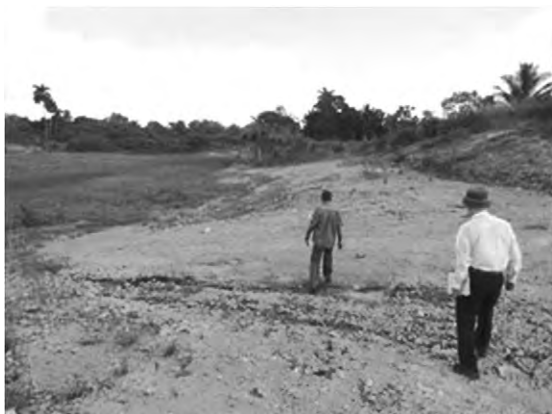
Photo 6-20: Oxidation pond slope

The slope has cracked partly due to the emergence of rocks. The pond bottom is rugged in some areas as earth moving works have not been executed accurately.

As the shape of the New Guanabacoa landfill site is planned to be complicated, I recommended that waterproofing with clay should be carefully analyzed to confirm its feasibility.

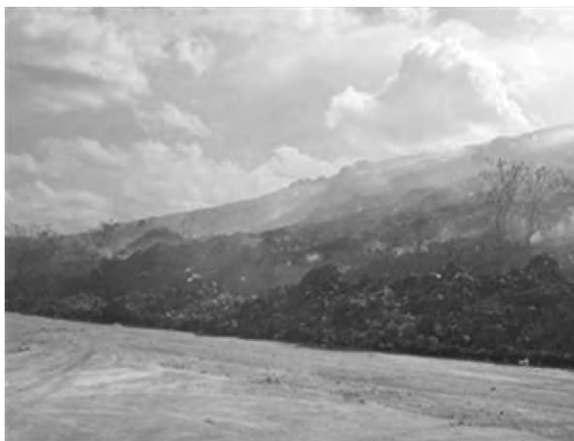
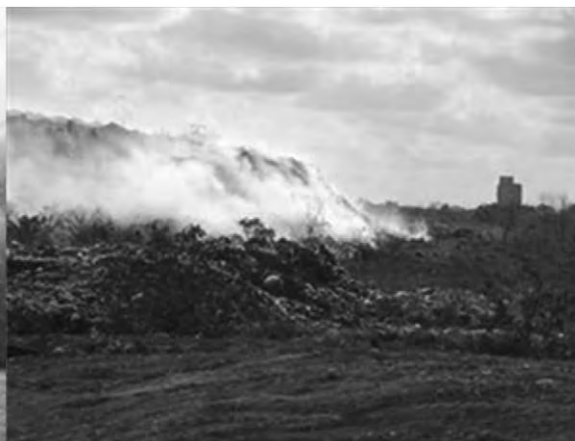
Photo 7-1: Fire at the Site

An extensive fire broke out in Calle 100 landfill site on May 12, 2014. A fire is usually put out by spreading and compacting soil using 2 bulldozers. Operators from other organizations and heavy equipment from a building site nearby to total 8 machineries had to be used this time though to extinguish the fire almost completely by May 15.

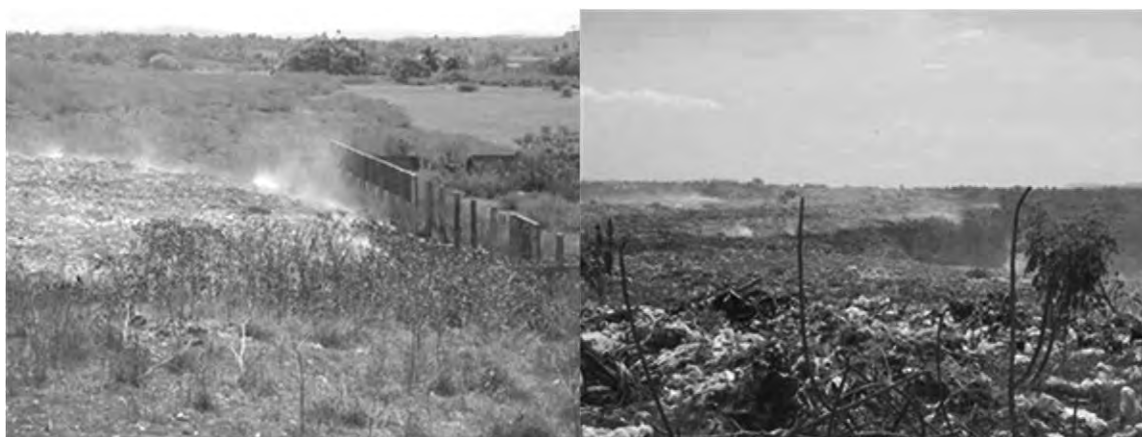
Photo 7-6: Fire Generation at Ocho Vías Landfill Site

On May 5, when we visited Ocho Vías, some smoke was being generated at the site and the situation was worse than before. Then on our way to Guanabacoa, again we inspected the condition of Ocho Vías landfill site to confirm that the fire had been reduced, but smoke was still being generated in several areas within the site.

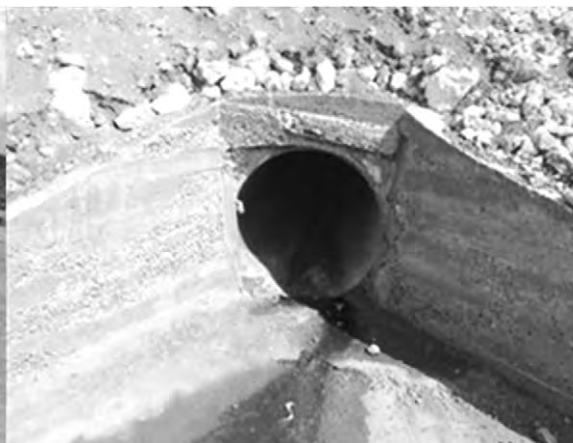
Photo 7-8: Crossing pipe construction

We have confirmed that the works for the construction of the crossing pipe at the new access road have not been neatly executed, as can be seen from the casing frames left behind at the site.
