3. PROJECT ACTIVITIES AND OUTPUT

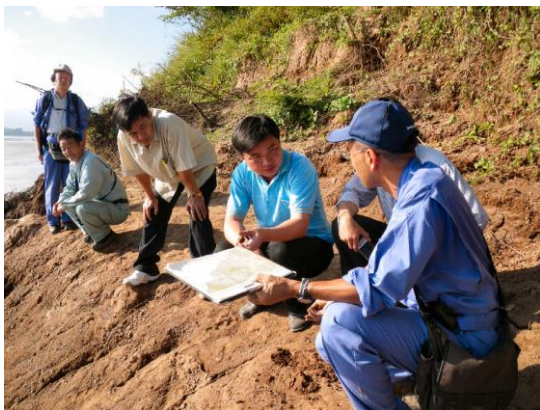
*Photo 3.3-1 On-site Training to C/P Officials
(Simplified Soil Test)*

Field survey was conducted jointly by JICA expert team and C/P officials. Hearing investigation to the related institution and local residents as appropriate was performed combining with the training on simplified soil test and sampling of riverbed materials (simplified grain size measurement).

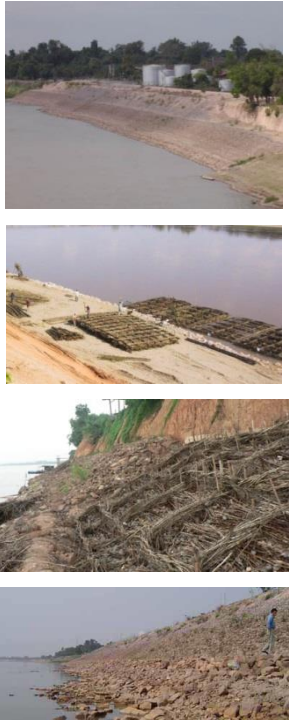
No	Work Method	Features	Photo	Construction material	Remark
1	Cobble stone with Soda Works + Soda Mattress + Rip-rap foundation	<p>This method consists of Siki-Soda on the slope of earth embankment, tie-twig hurdle work on them, made of willow branch, covered by pebble stone and sand with willow plantation on them.</p> <p>Rip-rap work is a foundation of the slopes to support the upper structure to avoid any failure of the slope. Surface riprap is to protect the foundation against river flood, and inner one is placed to avoid soil and gravel flushing out due to backpressure.</p> <p>Soda Mattress consists of Soda (facine), Rensai (bunch of facine), Siki-Soda (facine flooring), Sigara (hurdle work), and Chinseki (rubble stone).</p> <p>On the lower lattice structure of Rensai with grid</p>

Soda (Brush wood), Wooden short pile, stone	<p>Construction cost: About 810 ~1,690 US\$/m,</p> <p>Suitable for mild slope river, not for rapid flow river</p>

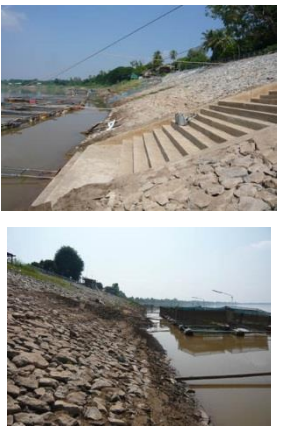
No	Work Method	Features	Photo	Construction material	Remark
2	Pitched stone in concrete frames + riprap foundation work	<p>Pitched stone is so placed as to form flat surface in concrete frame work on embanked riverbank with mild slope of about 1 : 3. Stone size of about 200 – 400 mm in diameter is used. Stone layer thickness is about 0.5 m. Concrete step and drain culvert made of concrete are built in the slope perpendicular to the river. Width of slope is about 30m. Foundation work of rip-rap stone work supports the slope protection work above.</p> <p>Shoulder work of about 1 m wide is set for sidewalk and a line of drainage culver beneath it.</p> <p>Rigid structure is strong against fast flow velocity, but once damaged easy to collapse.</p>

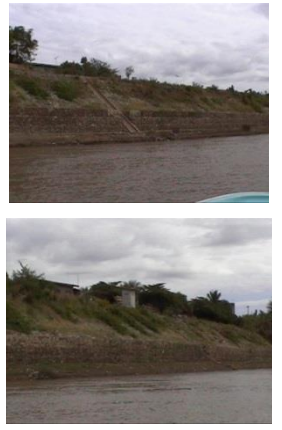
Concrete, Stone, geotextile	About 2,800 US\$/m (Thailand)
3	Reno Mattress + Gabion Mattress	<p>River bank is covered by combination of Reno Mattress and Gabion basket as shown below. Lower part at the edge is connected to natural riverbank. Iron basket could gradually deteriorate in long years.</p>

Reno Mattress, Gabion basket, stone, geo-textile	About 1,920 US\$/m as of 1995-1996 (Wattay and Tha Wat Muangwa)

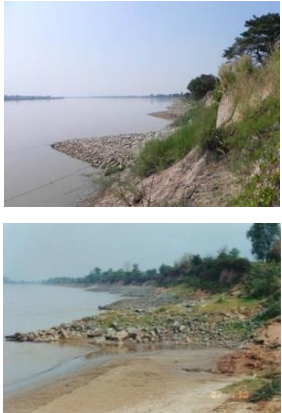
No	Work Method	Features	Photo	Construction material	Remark
4	Rip-rap Groyne	<p>Groyne work is to protect riverbanks from the direct attack of the river flow by reducing the flow velocity and changing the flow direction. Function of the groyne is;</p> <p>1) Reducing the flow velocity by increasing resistance to the flow (flow velocity reduction action), 2) Blocking the flowing water to change its direction so that it does not impact the location that should be protected.</p>

Stone, crushed stone	<p>About 600~1,800 US\$/m</p> <p>Riverbank between groyne could be vulnerable in high water period.</p> <p>Tip of groyne might be weak against fast river current.</p>

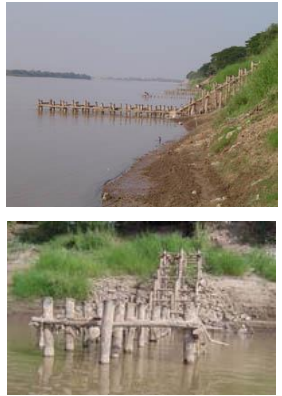
5.	Wooden Pile Dike Groyne	<p>Typical permeable dyke groyne made of wooden piles spaced in every 1.0~1.2m each other and arranged in more than two rows. Piles are tightened by wooden board laterally and longitudinally or diagonally to connect each pile. This work is usually applied in mild slope river. For steep slope river also protected, where piles can be driven into the riverbed with sufficient depth of embedment. Although less construction cost, necessary attention to the conservation of forest with respect to environmental aspect should be paid. Sometimes Soda mattress is placed around the groyne against possible erosion.</p>

Wood	<p>About 200 US\$/m</p> <p>Suitable for river with sandy riverbed, not suitable for gravel/stone riverbed.</p>

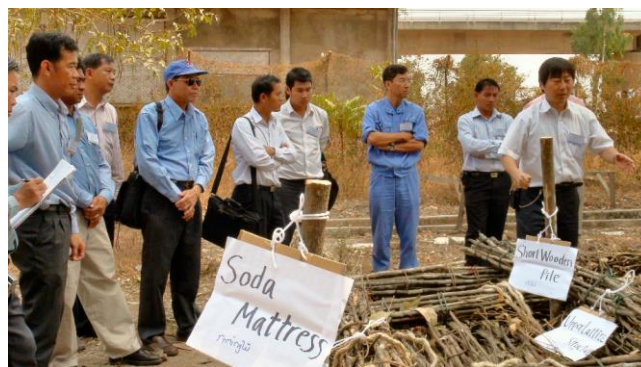
Photo 3.3-3 Explaining the Fabrication Process of Soda Mattress

The seminar was held as a part of training to improve ability of C/P officials from the target group. Therefore lecture programs on “Survey and Planning of Riverbank Protection Works” were presented by C/P officials as instructor under the guidance of JICA experts. On the other hand, lecture programs on “River Engineering and River Management” related to 3.6.1 were presented by JICA experts as instructor. In addition, JICA expert in Traditional Riverbank Protection/ Construction Advice demonstrated fabrication of Soda Mattress (fascine mattress), one of the Japanese traditional riverbank protection works.

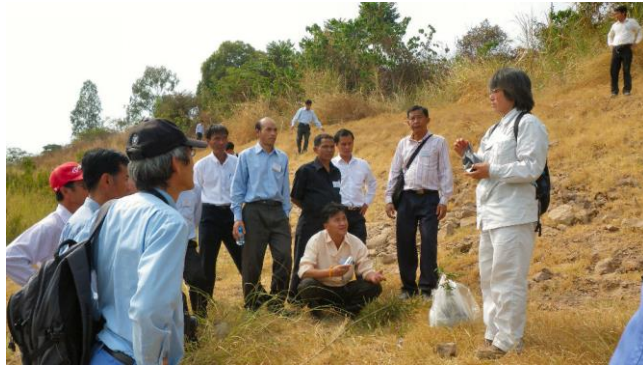
Photo 3.3-5 *Explaining the Vegetation Establishment Technique by JICA Expert*

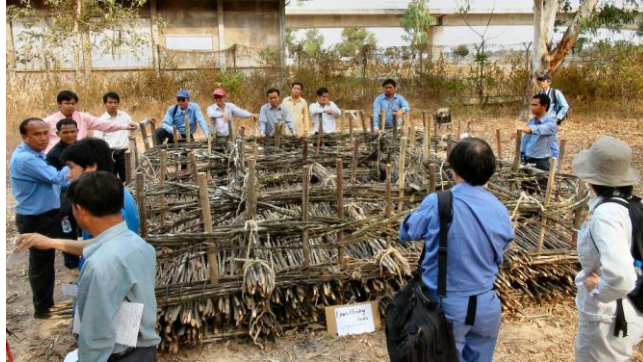
Photo 3.3-6 *Completed 4m × 4m Soda Mattress (Minimum Size)*

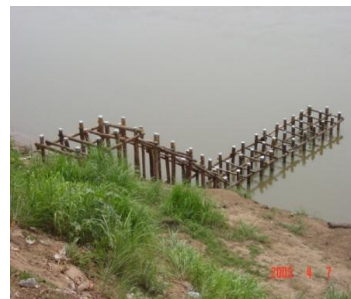
Fig. 3.3-6 Wooden Pile Dike Groyne Work as a Candidate Riverbank Protection Works at Navanhnoy Site in Oudomxay Province (Adopted for Wat Chom Cheng Site in Vientiane Capital)

Finally Navanhnoy site and Wooden Pile Dike Groyne Work (reinforced by Soda Mattress) method were recommended for prioritized site and candidate riverbank protection works for future, respectively, and approved by Director General of DPWT Oudomxay Province.

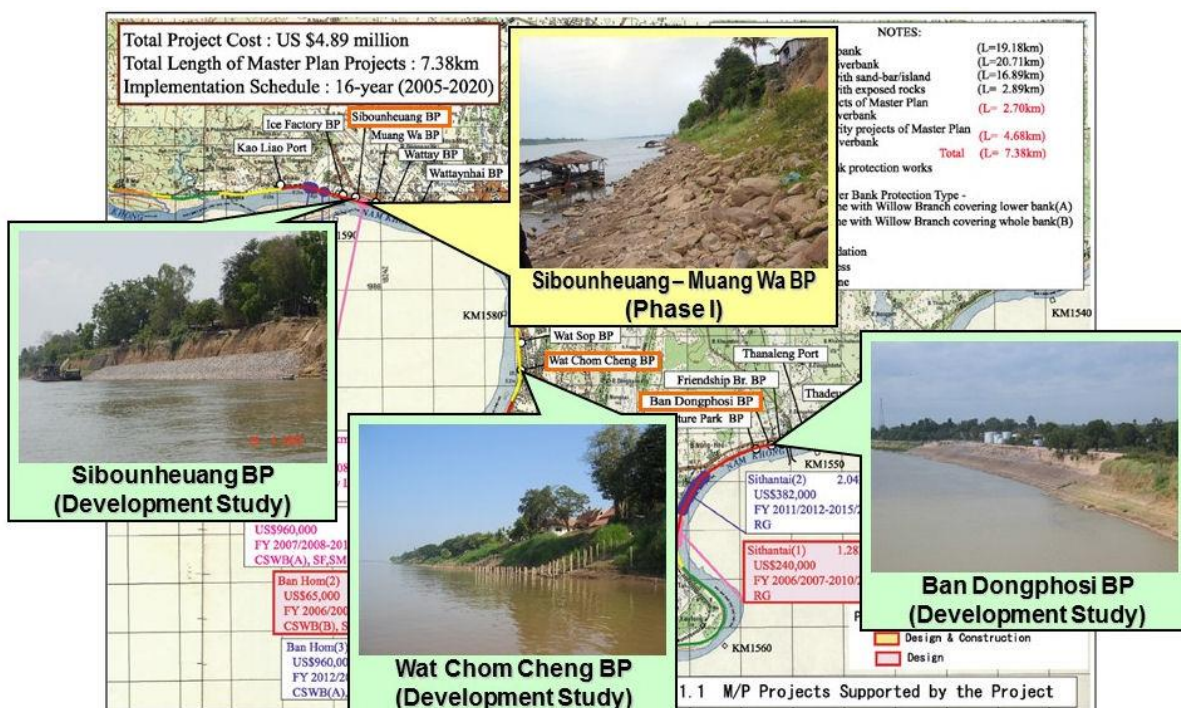
Fig. 3.4-1 Riverbank Protection Works Conducted in Development Study and Phase I in Vientiane Capital

- Riverbank protection works installed at four (4) sites were in good condition and well functioning. Even though small deformation and/or local damage had been occasionally occurred to the structure which has experienced the first rainy (flood) season after completion, necessity of maintenance was almost nothing.

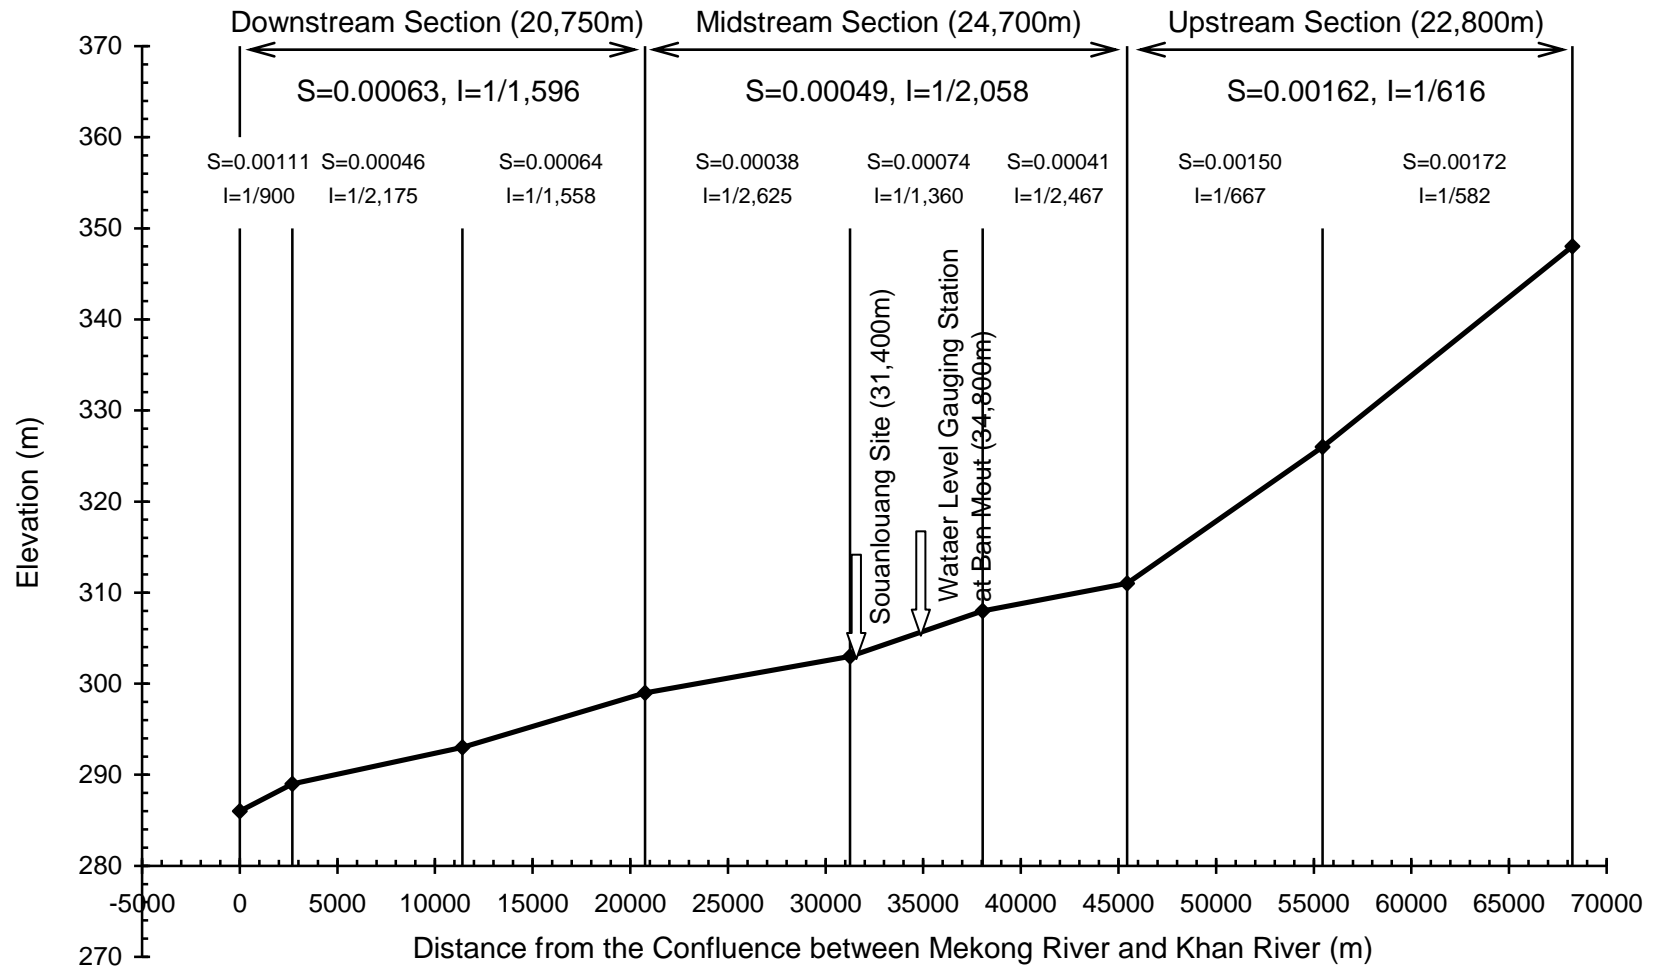
Fig. 3.4-3 Longitudinal Profile of Khan River by GPS Survey

Cross section survey of the Khan River was conducted as well as topographic survey along Souanlouang (Nasa) site for around the same period. Two (2) cross section lines at 0+098.012 (IP1) and 0+0288.218 (IP-END) were surveyed. Also bathymetric survey at 0+098.012 (IP1) during high water season was conducted by C/P official in August 2013.

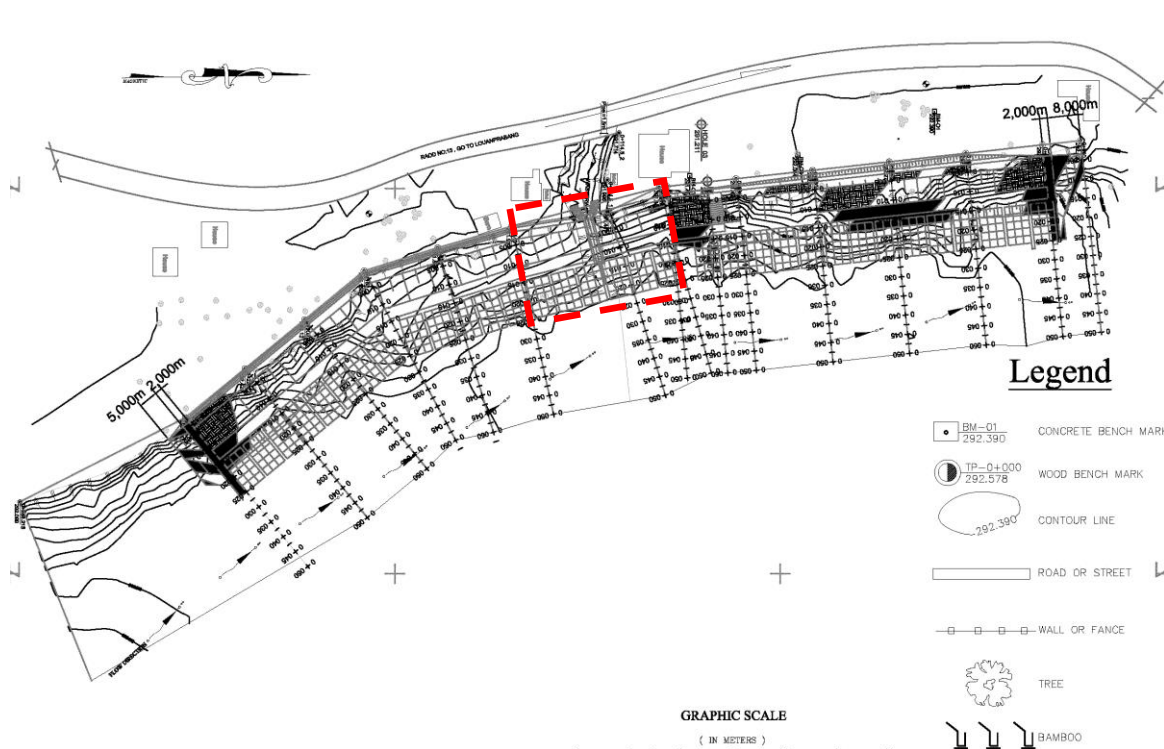
Fig. 3.4-7 *Layout of Riverbank Protection Works at Souanlouang (Nasa) Site*
(Additional Works Including Confluence Between Small Stream and Khan River, Total Length: 40m)

Furthermore, additional riverbank protection works for total length of 40m (from CS 0+100m to CS 0+140m) including confluence between small stream and Khan River (refer to Fig. 3.4-7) was also conducted by Lao side with their own budget.

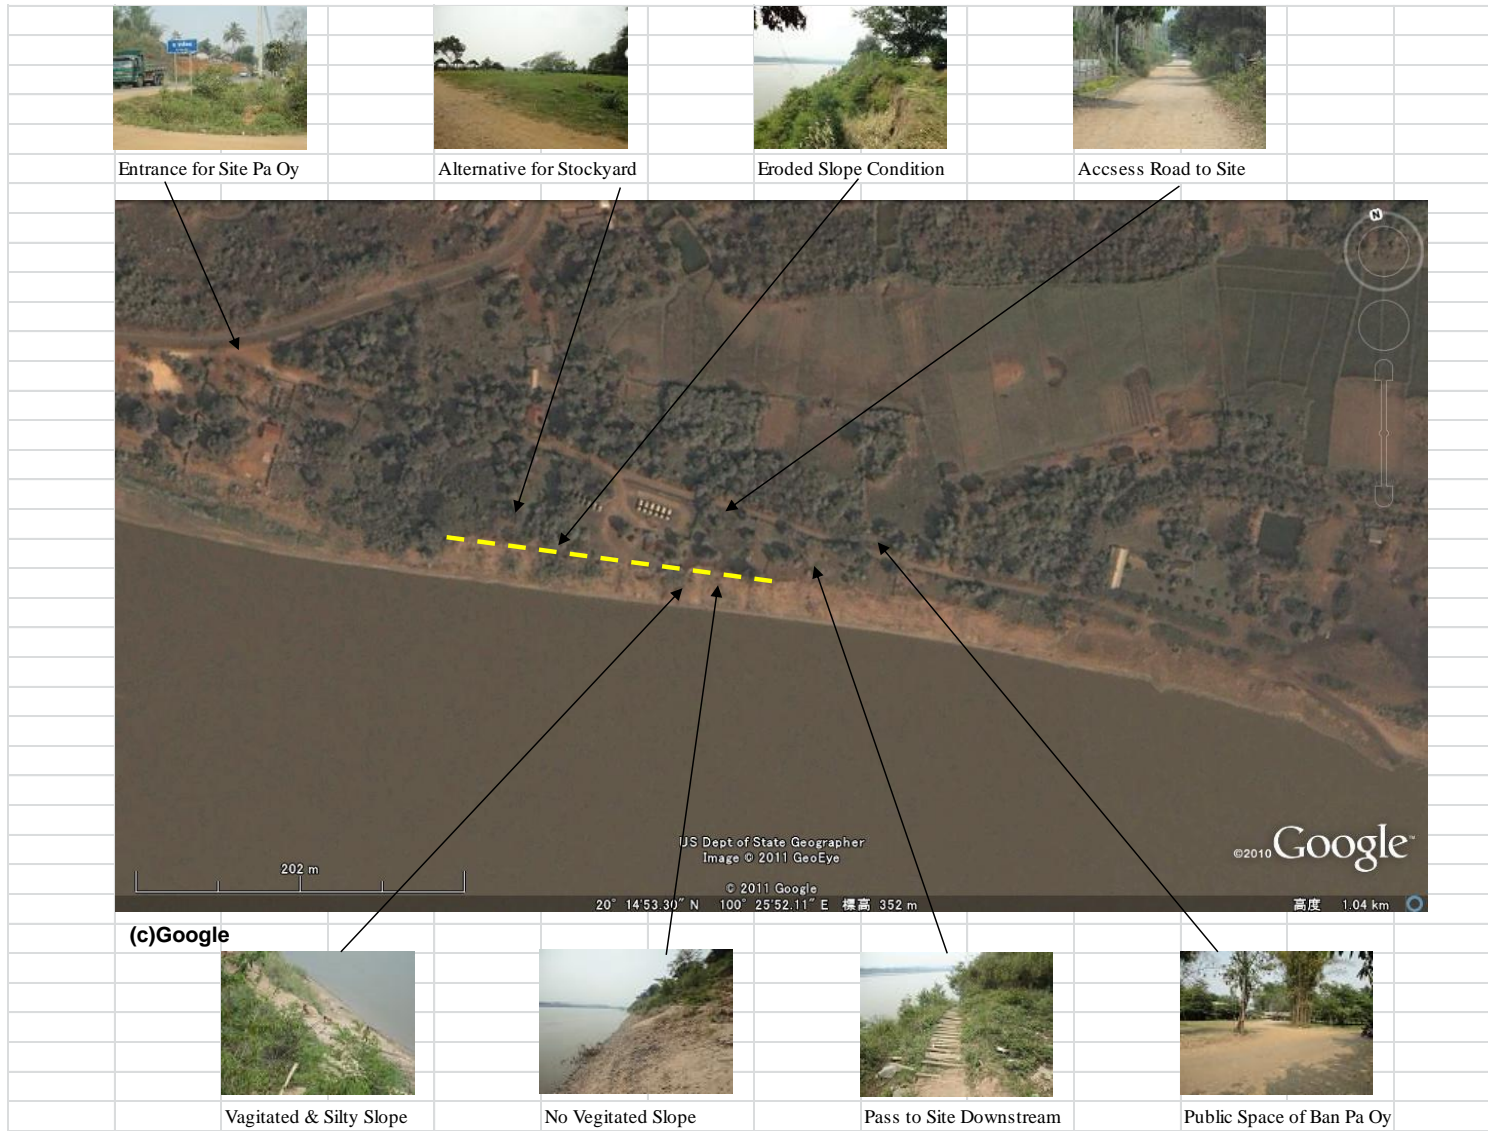
Fig. 3.4-8 Location and Site Pictures of Paoy Site in Bokeo Province

- Access road from Houayxay town has enough capacity for transportation of labor, construction material and machine.
- Temporary stock yard is available in local private business and Paoy village at the site.
- Critical place is not recognized for the temporary construction road in land use condition.
- Temporary facilities of electricity and water supply are available in the construction site.
- Environmental problem is not critical as to ambient noise, dust control and traffic control,

The location and site picture of the existing condition at construction site is as shown in Fig. 3.4-8.

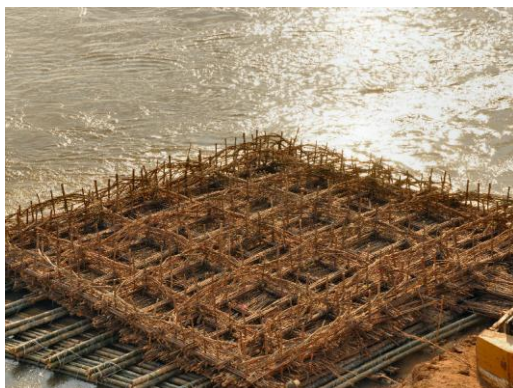
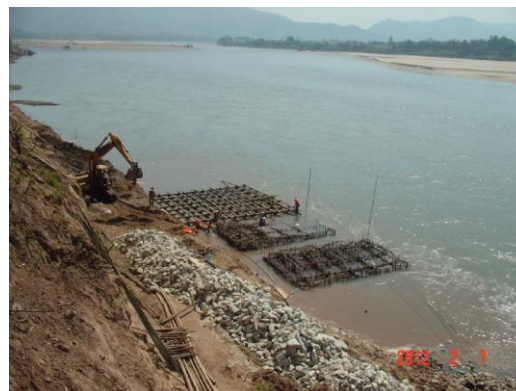
Photo 3.4-4 Progress Situation of Pilot Construction Work as of February 2012

Riverbank protection work selected in Bokeo Province consists of i) Cobble Stone with Soda Work as slope protection work, ii) Rip-rap foundation work and iii) Soda Mattress as foot protection work, considering the design condition at Paoy site, situation of riverbank protection works done in the previous stage of riverbank protection work in Lao and progress in capability of construction work by Lao contractor. Especially the Soda Mattress of 10m × 10m size was

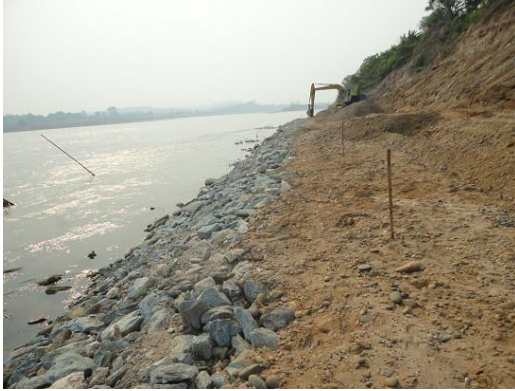
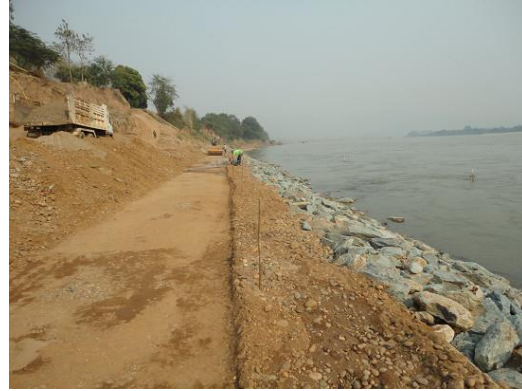
Photo 3.4-5 *Progress Situation of Pilot Construction Work as of March 2012*

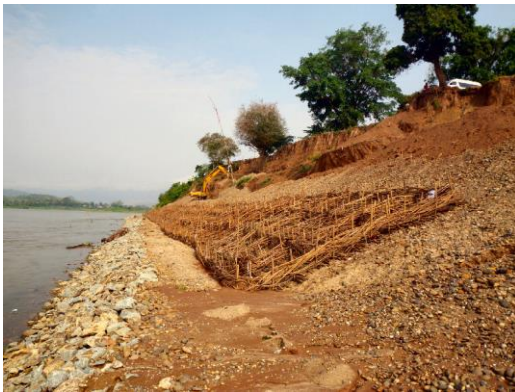
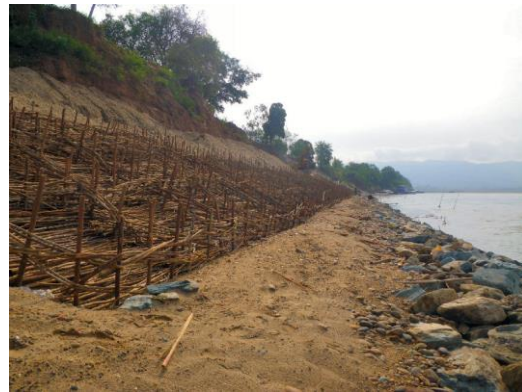
Photo 3.4-6 *Progress Situation of Pilot Construction Work as of April 2012*

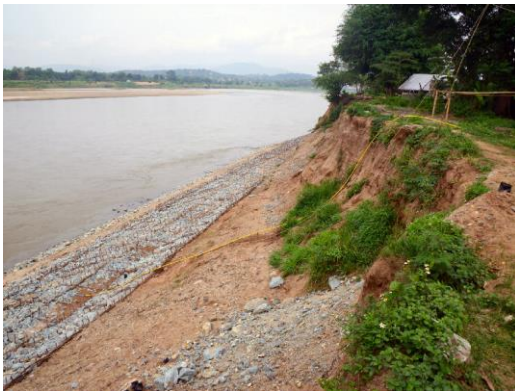
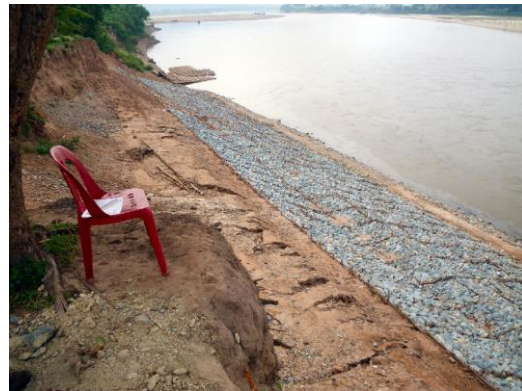
Photo 3.4-7 *Progress Situation of Pilot Construction Work as of May 2012*

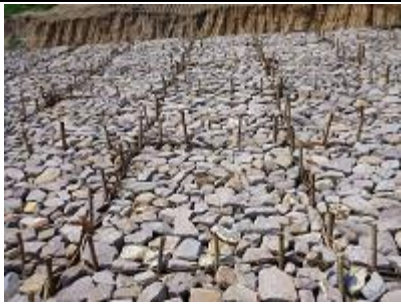
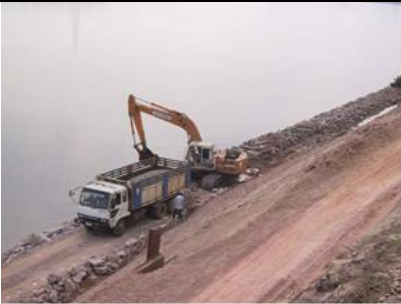
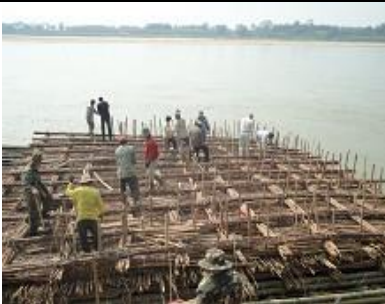
[Slope Protection] Cobble Stone with Soda Work Slope Area: 4,290 m ² Rock Size: φ 150 – 250 mm	[Foundation] Riprap Foundation Work Volume: 4,500 m ³ Maximum Rock Size: φ 450 mm	[Foot Protection] Soda Mattress Work Assembling on Bamboo Raft Unit: 5 (Size: 6m×10m×0.9m)

Riverbank protection works for Pakthoay site consists of i) Cobble Stone with Soda Work as slope protection work, ii) Riprap Foundation Work and iii) Soda Mattress Work as foot protection work (refer to Fig. 3.4-10).

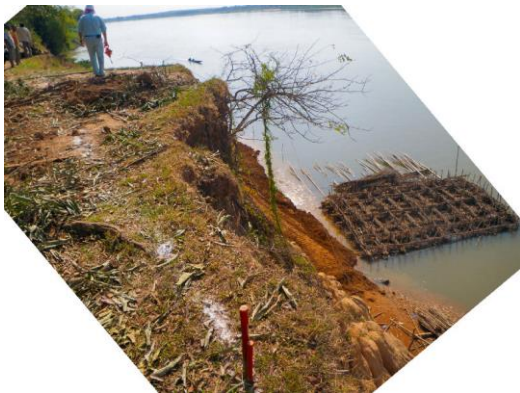
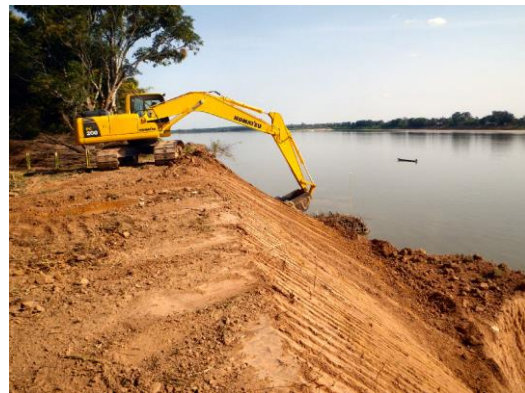
Photo 3.4-10 Progress Situation of Pilot Construction Works as of February 2013

Riverbank protection works selected for Pakthoay site consists of i) Cobble stone with Soda work as slope protection work, ii) Rip-rap foundation work and iii) Soda mattress as foot protection work; however, Soda mattress should be installed only water colliding front section because of difficulty in installation due to topographic condition at Pakthoay site.

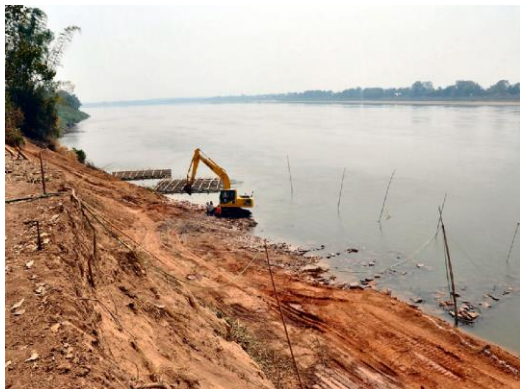
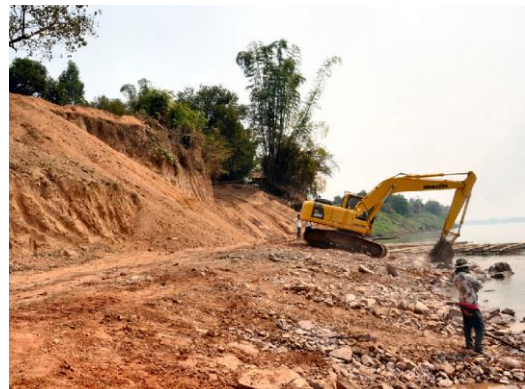
Photo 3.4-11 Progress Situation of Pilot Construction Works as of March 2013

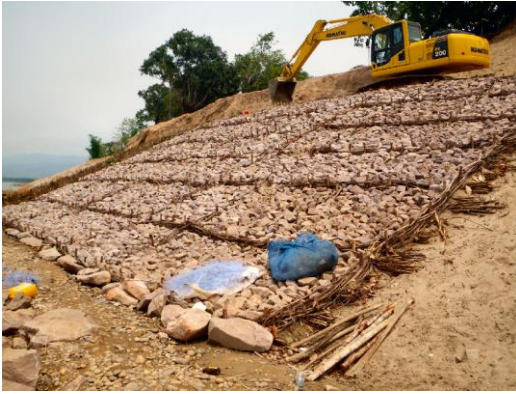
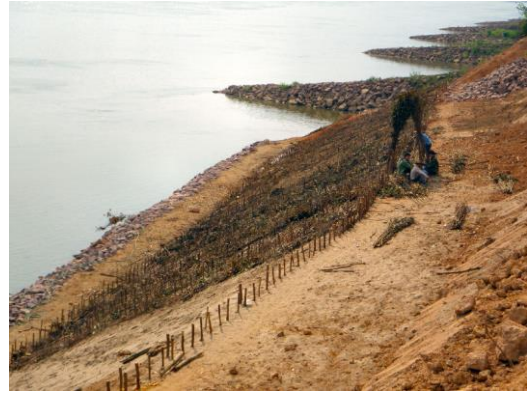
Photo 3.4-12 Progress Situation of Pilot Construction Works as of April 2013

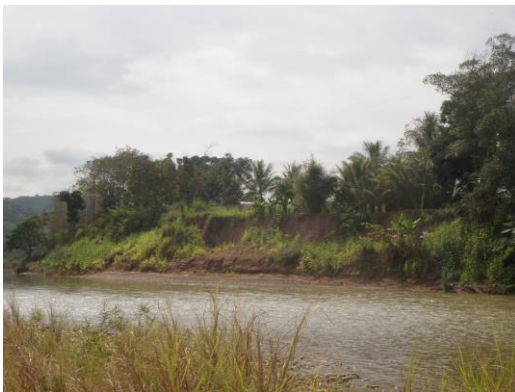
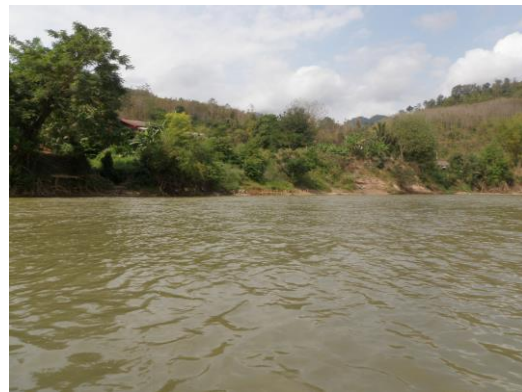
Photo 3.4-16 Situation of Riverbank Erosion at Souanlouang (Nasa) Site as of January 2013

Souanlouang (Nasa) Village of Xiang Ngeun District is located along National Road No. 13. Linear distance between the center of Luangprabang City and Souanlouang (Nasa) Village is approximately 12 km south-southeastward (refer to Fig. 3.4-11). Although previous two (2) pilot construction were implemented at the riverbank along the Mekong River, last pilot construction site was selected at the riverbank along the Khan River, which is typical tributary of the Mekong River, to disseminate traditional riverbank protection works at not only main stream but also tributaries of the Mekong River. Situation of riverbank erosion at Souanlouang (Nasa) site as of January 2013 is as shown in Photo 3.4-16.

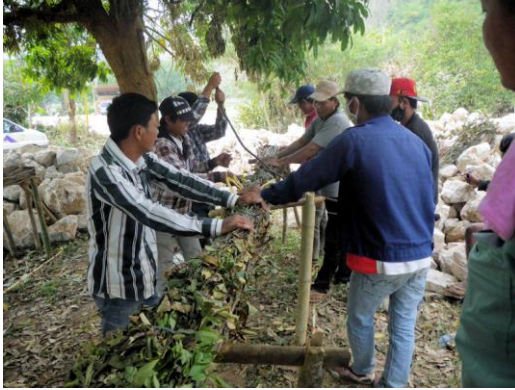
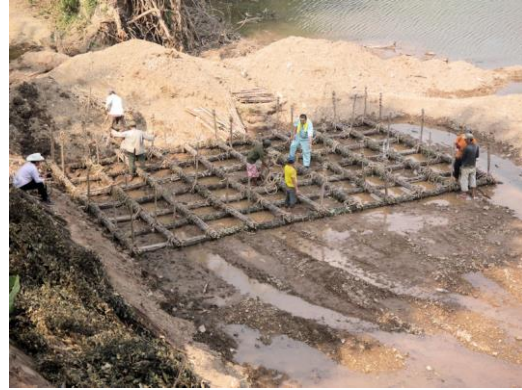
Photo 3.4-17 *On-site Training to C/P Officials, Contractor and Local Labors by JICA Experts*

It is particularly worth noting for construction procedure that Soda Mattress was assembled on the dried-up riverbed directly by the diversion of riverflow (refer to Photo 3.4-17). As riverbed of the Mekong River is not dried up even in dry season, installation of Soda Mattress along the Mekong River was implemented by the crane, which is generally applied in Japan, or its assembly on the water by using bamboo raft which has been introduced to Lao P. D. R. in Phase I and also used to be applied in Japan before construction modernization (refer to Photo

3.4-18). Meanwhile water level of the Khan River in February 2014 was lower than that of February 2013. In addition, it was easy to install the coffer dam at upstream of the left bank due to the existence of holm (island) at Souanlouang (Nasa) site. Therefore river flow could be diverted easily and it was possible to assemble Soda Mattress on the dried-up riverbed.

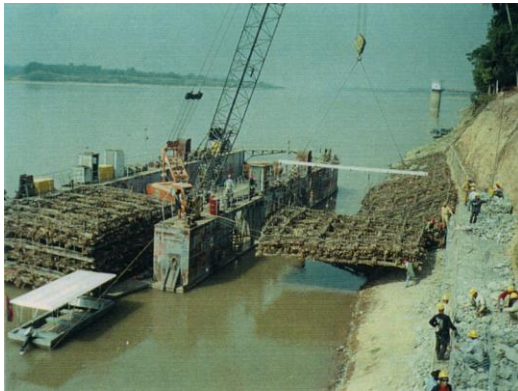
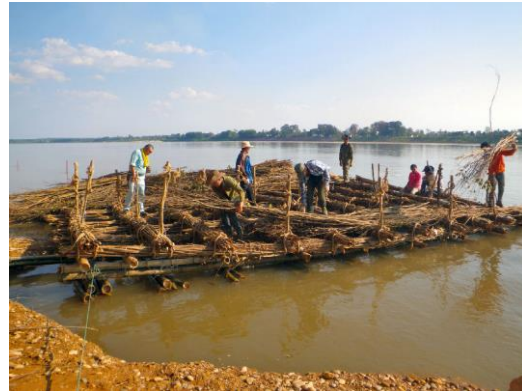
Photo 3.4-18 *Installation Method of Soda Mattress in Previous Pilot Construction (Left: IDI Pilot Construction (2001) and Right: Pakthoay Site in Bolikhamxay Province (2013))*

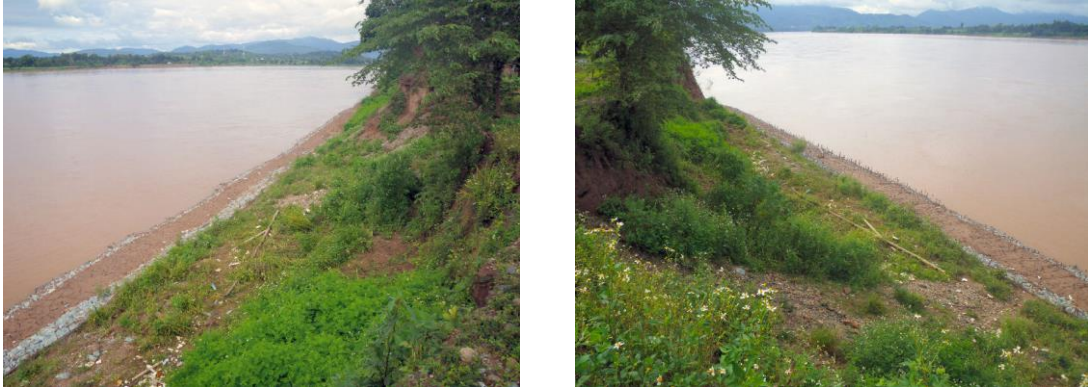
Photo 3.5-1 Situation of Pilot Construction Site in Ban Paoy as of August 2012

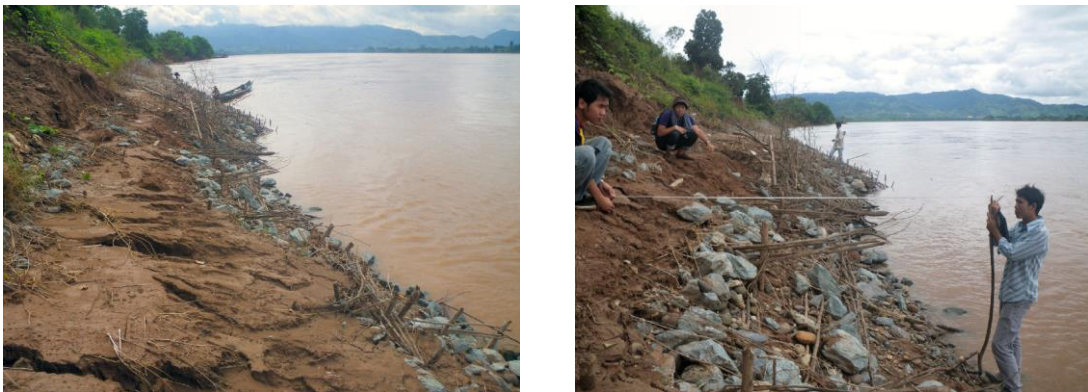
Photo 3.5-2 Deformation of Slope Protection Work and Monitoring Activity by C/P Officials

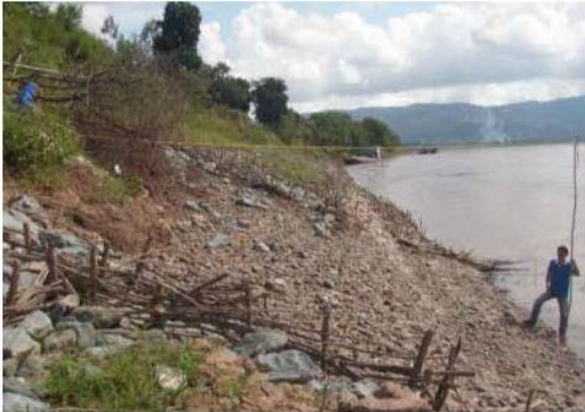
Fig. 3.5-1 Monitoring Result at Damaged Section (0+240m) at Paoy Site as of December 2012

Site Name	Pa-oy	Date of Inspection	12/12/12	Inspector	Dethoud om										
Condition/Photograph,

<table><tr> <td>Station</td> <td>0+240</td> </tr><tr> <td>Damage Records</td> <td>layer Upper and middle</td> </tr></table>

Station	0+240	Damage Records	layer Upper and middle	Length(m)	20 m	Responses	<input type="checkbox"/> Urgent <input type="checkbox"/> Not urgent	Possible Counter Measure	Possible stone work, Rensai tence work and plant willow
Station	0+240														
Damage Records	layer Upper and middle														
Length(m)	20 m														
Responses	<input type="checkbox"/> Urgent <input type="checkbox"/> Not urgent														
Possible Counter Measure	Possible stone work, Rensai tence work and plant willow														
Damage point after rainy session

Detailed information of monitoring result by C/P officials as of December 2012 and March 2013 on damaged portion of slope protection work at around section 0+240m are as shown in Fig. 3.5-1 and Fig. 3.5-2, respectively. Based on the detailed information, maintenance operation was planned in collaboration with C/P officials and JICA experts. After that maintenance operation was carried out by the Contractor. Gabion Mattress Work was adopted as repair work based on the agreement between Technical Cooperation Project Team and the Contractor. Detailed information of monitoring result by C/P officials as of May 2013 on damaged portion of slope protection work at around section 0+240m just after completion of repair work is as shown in Fig. 3.5-3.

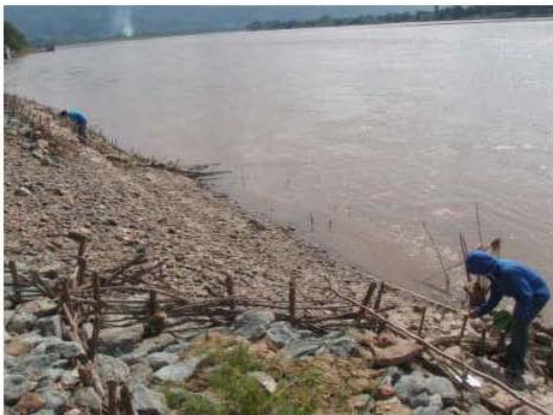
Fig. 3.5-2 Monitoring Result at Damaged Section (0+240m) at Paoy Site as of March 2013

Site Name	pa-oy	Date of Inspection	18/03/13	Inspector											
Condition/Photograph, sketch

<table><tr> <td>Station</td> <td>0+240</td> </tr><tr> <td>Damage Records</td> <td>layer Upper and middle</td> </tr></table>

Station	0+240	Damage Records	layer Upper and middle	Length(m)	20 m	Responses	<input type="checkbox"/> Urgent <input checked="" type="checkbox"/> Not urgent	Possible Counter Measure	Possible stone work, Rensai tence work and plant willow
Station	0+240														
Damage Records	layer Upper and middle														
Length(m)	20 m														
Responses	<input type="checkbox"/> Urgent <input checked="" type="checkbox"/> Not urgent														
Possible Counter Measure	Possible stone work, Rensai tence work and plant willow														
Check more detail to repairer the damage point

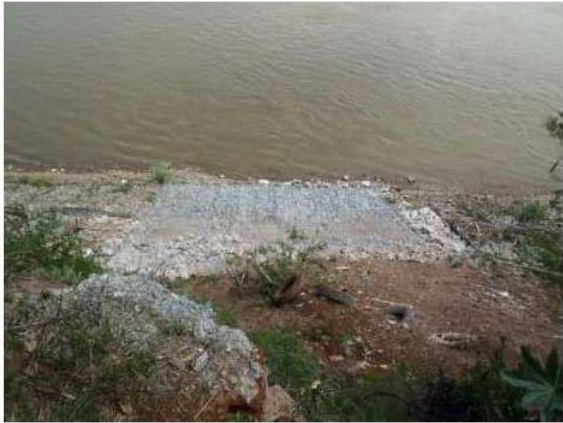
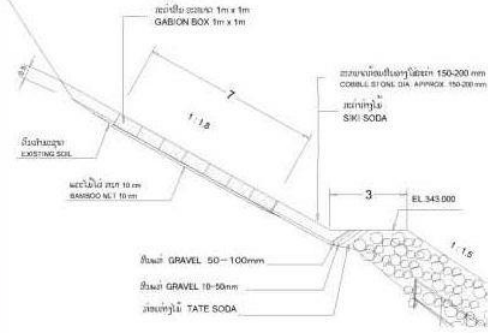
Remark: Completed repair work by Gabion Box		Damage Records		Station	0+240
				layer	Upper and middle
				Length(m)	20 m
		Responses		<input type="checkbox"/> Urgent <input type="checkbox"/> Not urgent	
		Possible Measure		Counter	Possible stone work

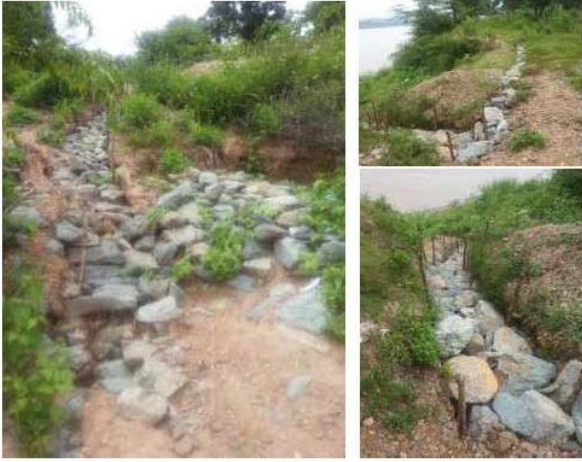
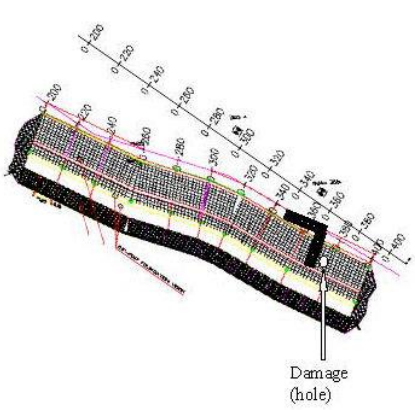
Remark: Completed repair work by Soda Drainage Work		Damage Records		Station	0+360
				layer	Upper and middle
				Length(m)	40 m
		Responses		<input type="checkbox"/> Urgent <input type="checkbox"/> Not urgent	
		Possible Measure		Counter	Possible stone work, Rensai tence

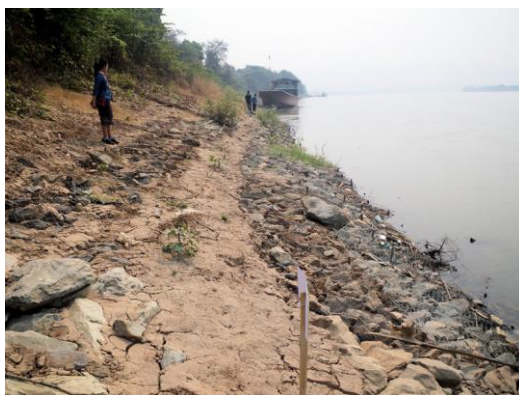
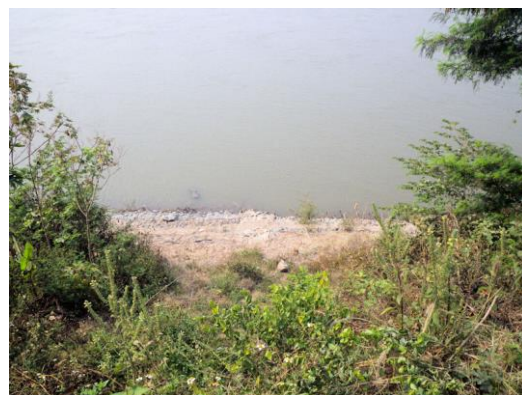
Photo 3.5-3 Monitoring Result at Damaged Section (0+240m) at Paoy Site as of March 2014

In the fourth year, situation at around section 0+240m as of March 2014 is as shown in Photo 3.5-3. As Paoy site has experienced rainy season twice after completion of the construction, riverbank was tended to be stable and there was no additional damage at around section 0+240m. In addition, vegetation as represented by Mekong Willow has been favorably progressed (refer to Photo 3.5-4, 3.5-5) and riverbank at Paoy site was assessed to be kept in good condition.

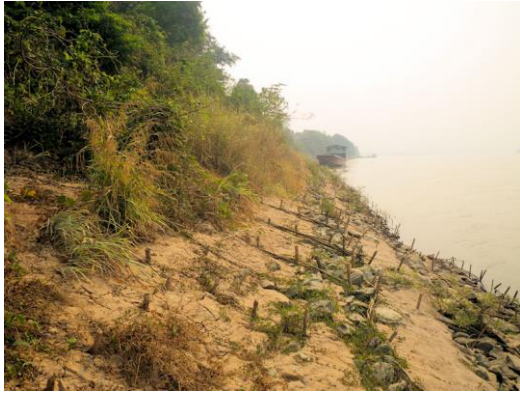
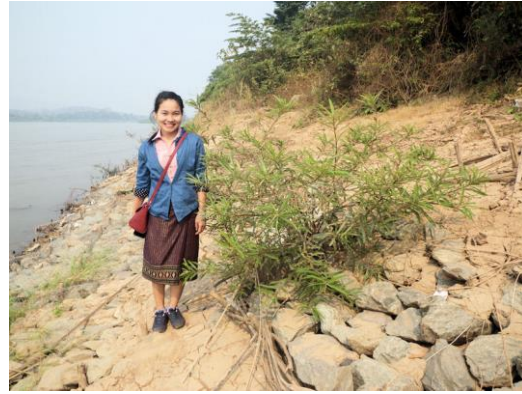
Photo 3.5-4 Progress of Vegetation at the Slope at Paoy Site as of March 2014

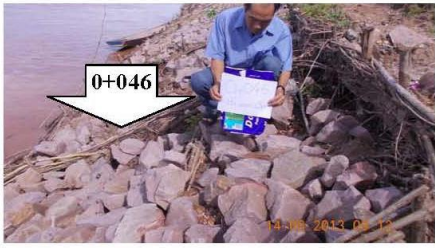
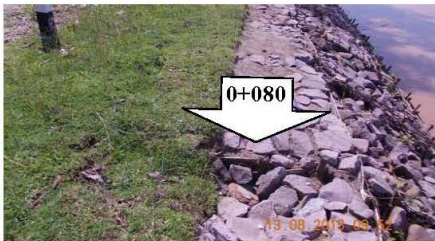
Fig. 3.5-6 Monitoring Result at Damaged Section (0+046m, 0+080m) at Pakthoay Site as of August 2013

ຊື່ສະຖານທີ່	ປາກທວາຍ	ວັນທີ ສ້າງ	14 / 08 / 2013	ຜູ້ສ້າງ	ຄຳແສນ ພະຍາໄຊ
ປະເພດໂຄງສ້າງ	ກະຕ່າໄຊດາ, ລຽນທຶນປ້ອງກັນຄວາມເນີນ ແລະ ວາງທຶນລ່ອກຕຶນ ແລະ	ເຈົ້າຂອງໂຄງການ	ກິມ ຍທນ	ກໍ່ສ້າງສຳເລັດໃນປີ	ພຶດສະພາ 2013

ໝາຍເຫດ: ເກີດມີ ນ້ຳລອດພື້ນ ຢູ່ຈຸດ 0+046 ແລະ 0+080		ຈຸດທີ່ເກີດຄວາມເສຍຫາຍ / ການສ້ອມແປງ	0+046 ແລະ 0+080		
		ລາຄາການກໍ່ສ້າງ			
		No.

Final inspection on riverbank protection works at Pakthoay Village, Thaphabath District in Bolikhamxay Province was conducted in June 2013. After that some portions of slope protection work were damaged due to rise of water in the Mekong River and heavy rain in the beginning of August 2013. Detailed information of monitoring result by C/P officials as of August 2013 on damaged portions of slope protection work are as shown in Fig. 3.5-6 and Fig. 3.5-7.

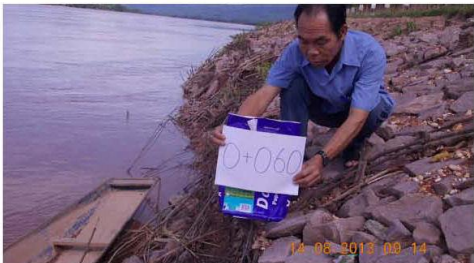
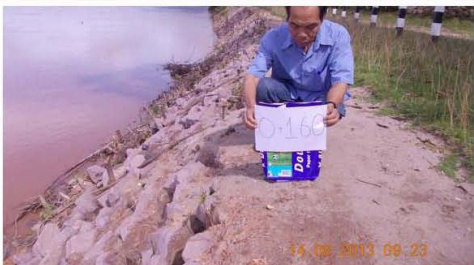
Fig. 3.5-7 Monitoring Result at Damaged Section (0+060 to 0+160m) at Pakthoay Site as of August 2013

ຊື່ສະຖານທີ່	ປາກທວາຍ	ວັນທີ ສ້າງ	14 / 08 / 2013	ຜູ້ສ້າງ	ຄຳແສນ ພະຍາໄຊ
ປະເພດໂຄງສ້າງ	ກະຕ່າໄຊດາ, ລຽນທຶນປ້ອງກັນຄວາມເນີນ ແລະ ວາງທຶນລ່ອກຕຶນ ແລະ	ເຈົ້າຂອງໂຄງການ	ກິມ ຍທນ	ກໍ່ສ້າງສຳເລັດໃນປີ	ພຶດສະພາ 2013

ໝາຍເຫດ: ກະຕ່າໄຊດາ ເກີດຄວາມເສຍຫາຍຢູ່ຫຼາຍຈຸດ		ຈຸດທີ່ເກີດຄວາມເສຍຫາຍ / ການສ້ອມແປງ	ຈຸດກະຕ່າຂາດ		
		ລາຄາການກໍ່ສ້າງ			
		No.

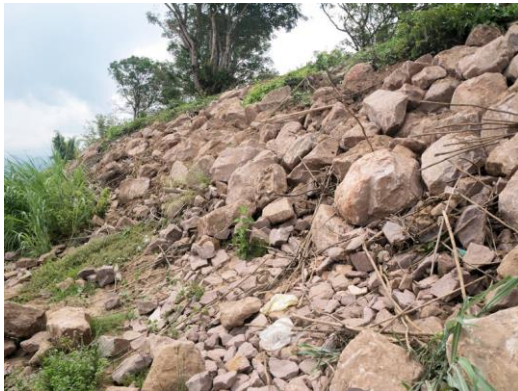
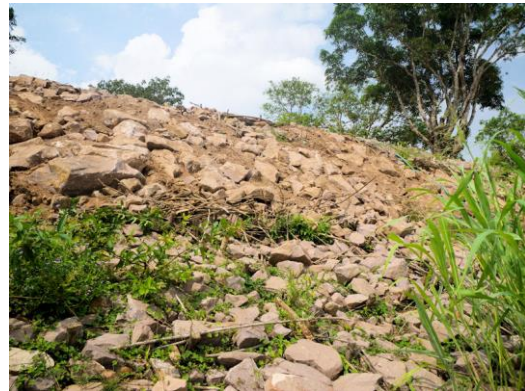
Photo 3.5-7 Monitoring Result at Damaged Section at Pakthoay Site as of May 2014

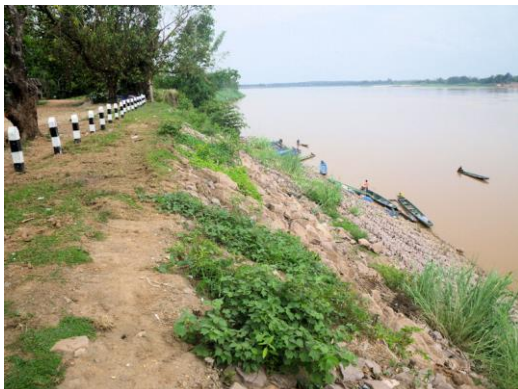
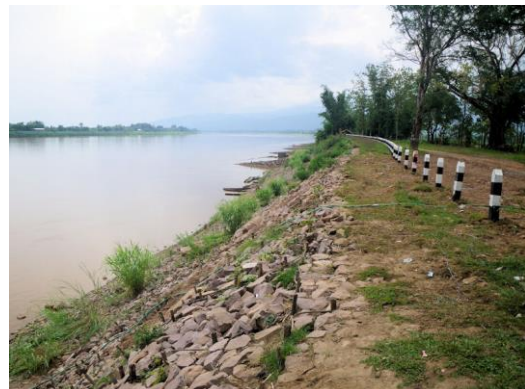
Photo 3.5-8 Progress of Vegetation at the Slope at Pakthoay Site as of May 2014

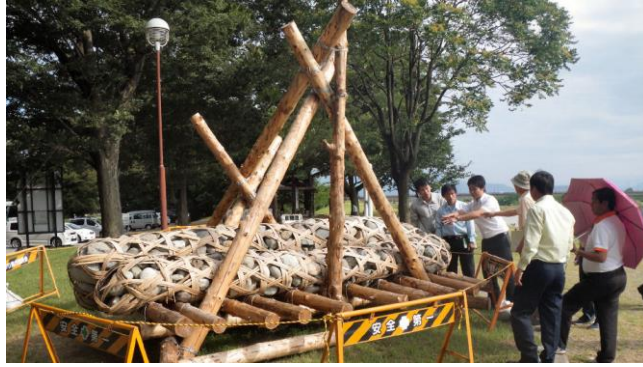
Photo 3.6-5 Trainees received on-site orientation on “Seigyū” (Skeleton Work) [1st Batch]

Note: Skeleton work called “Seigyū” in Japanese is a traditional river work in Japan. Skeleton work is a kind of permeable groyne which has the origin in Fuji River and used for many rapid streams in Japan.

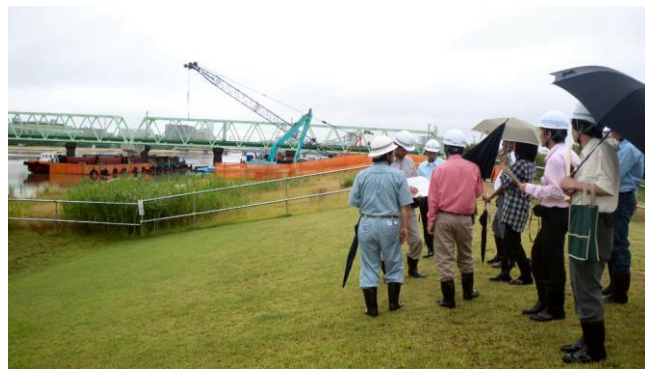
Photo 3.6-9 *Trainees received on-site orientation on “Yasuragi Levee” (levee with very mild slope as a water amenity facility) in the downstream of Shinano River [1st Batch]*

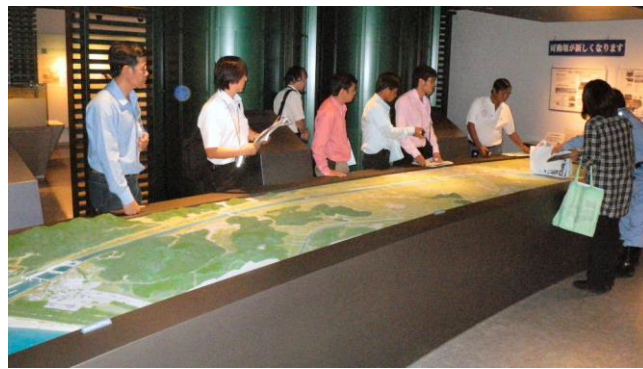
Photo 3.6-12 *Trainees received an orientation on Ohkouzu Diversion Channel at Shinano River Ohkouzu Museum [1st Batch]*

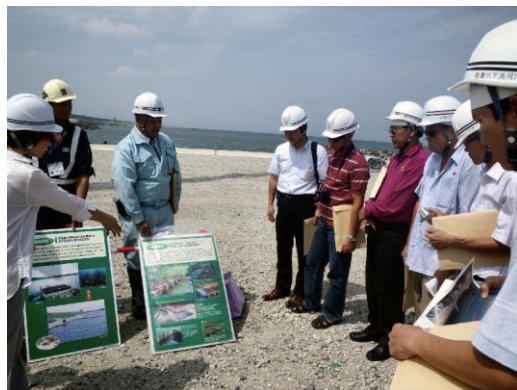
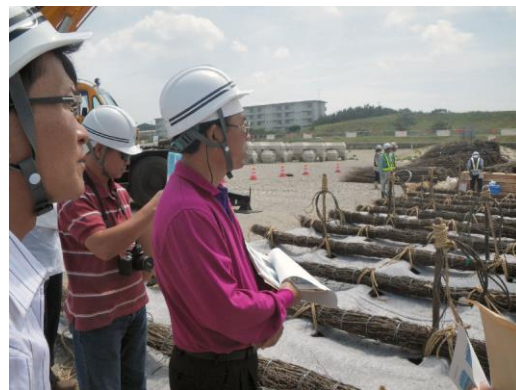
Photo 3.6-13 *Trainees Visited Assembly Yard of Soda Mattresses which are Installed as a Basement of Offshore Dike in Niigata Coast [2nd Batch]*

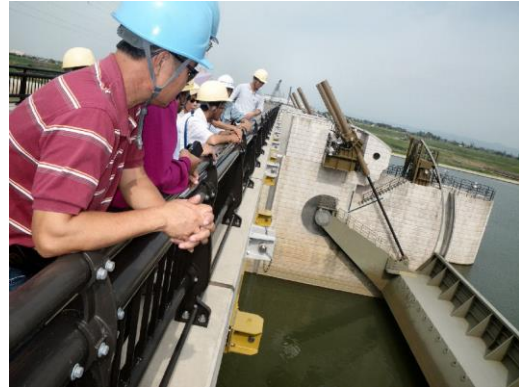
Photo 3.6-14 Trainees Received On-site Orientation on Movable Weir (Left: Old, Right: New) at Ohkouzu Diversion Channel of Shinano River [2nd Batch]
