Lumi 川流域洪水管理計画案

ケニア共和国
洪水に脆弱な地域における効果的な
洪水管理のための能力開発プロジェクト

Lumi 川流域
洪水管理計画（案）

2013 年 7 月

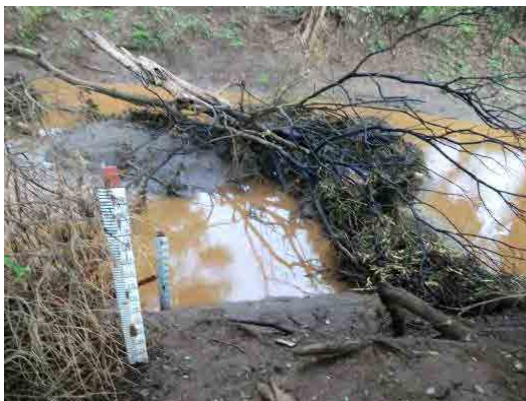
水位観測所番号:3J15
Lumi 川の水位を測定

各水位観測所とも、自動観測は実施されておらず、朝と夕方の 1 日 2 回の目視による水位観測を実施している。そのため、水位データから流量データへの変換が行われているが、洪水時の流量を適切に捉えているとはいえない。

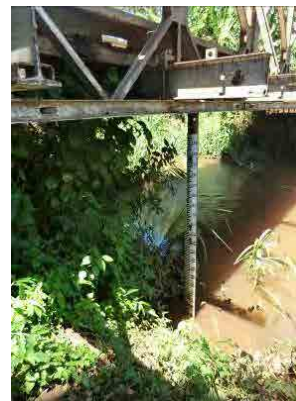
水位観測所番号:3J16
Lumi 川の水位を測定。橋梁の下に設置

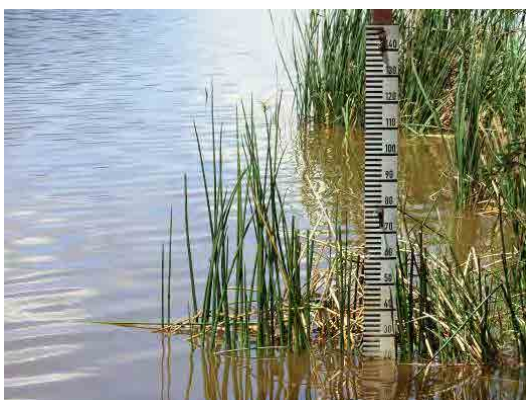
水位観測所番号:3J2
JIPE 湖の水位を観測するために、サファリキャンプ内に設置された水位観測地点

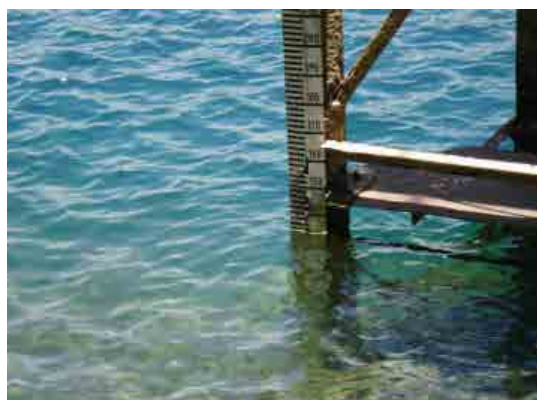
水位観測所番号:3J12
Challa 湖の水位を測定

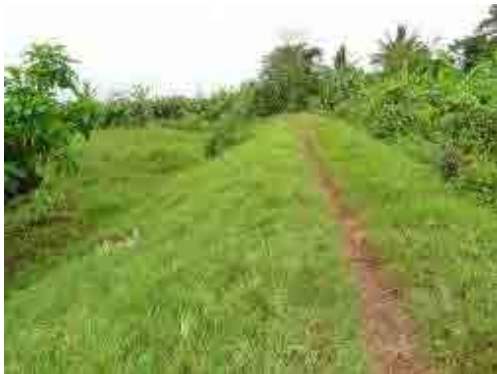
写真 3.1.1 Canal-C の堤防

現時点においても、Canal-C の一部区間（約 700m）の堤防が破堤しているため、Lumi 川下流の氾濫水は Canal-C に沿って流下せず、Canal-B や Canal-A まで拡散している状況である。これらの水路システムが本来の機能を十分発揮できていないことが、Lumi 川下流域の西側の低平地で洪水被害が多発するようになった一因と推察される。

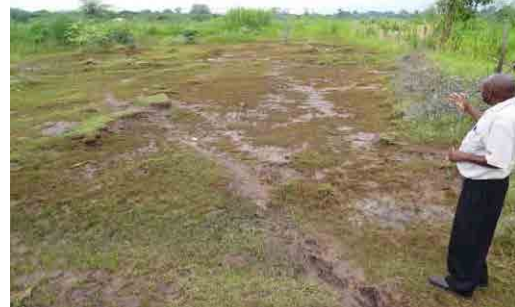
写真 3.1.2 Canal-C の堤防が決壊した箇所

既存の排水路は主要なものとして、Canal A、Canal B、Canal C の3本がある。これら Canal A、Canal B、Canal C それぞれを浚渫し、改修を行ってその流下能力を高めることで、被害は大きく軽減されるものと考えられる。特に Canal C は現在は破堤しているが堤防部分があり、それを再構築するのも一つの方法である。

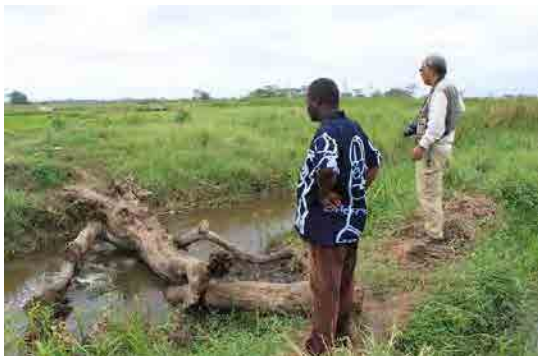
写真 3.1.3 Kimorigo village 周辺の Canal-A

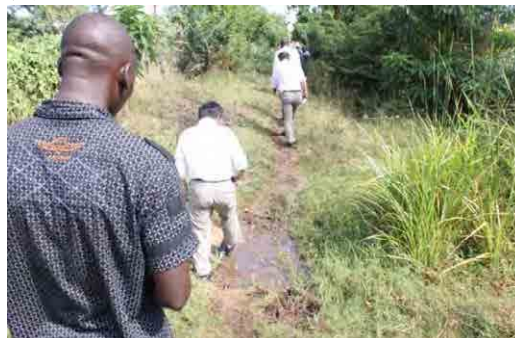
写真 3.1.4 Canal-C の堤防が人為的に破壊された地点

- ・ 居住地が集中している地区の長期湛水のため、住民の居住不能状態、農地の浸水被害、飲料用の泉の汚染、インフラ被害（道路の寸断と通学不能、病院の水没）および家畜の死亡という被害が発生している。
- ・ 灌漑用水の取得を目的とした農民の故意による堤防の破壊によって、堤防の一部区間が機能していない。

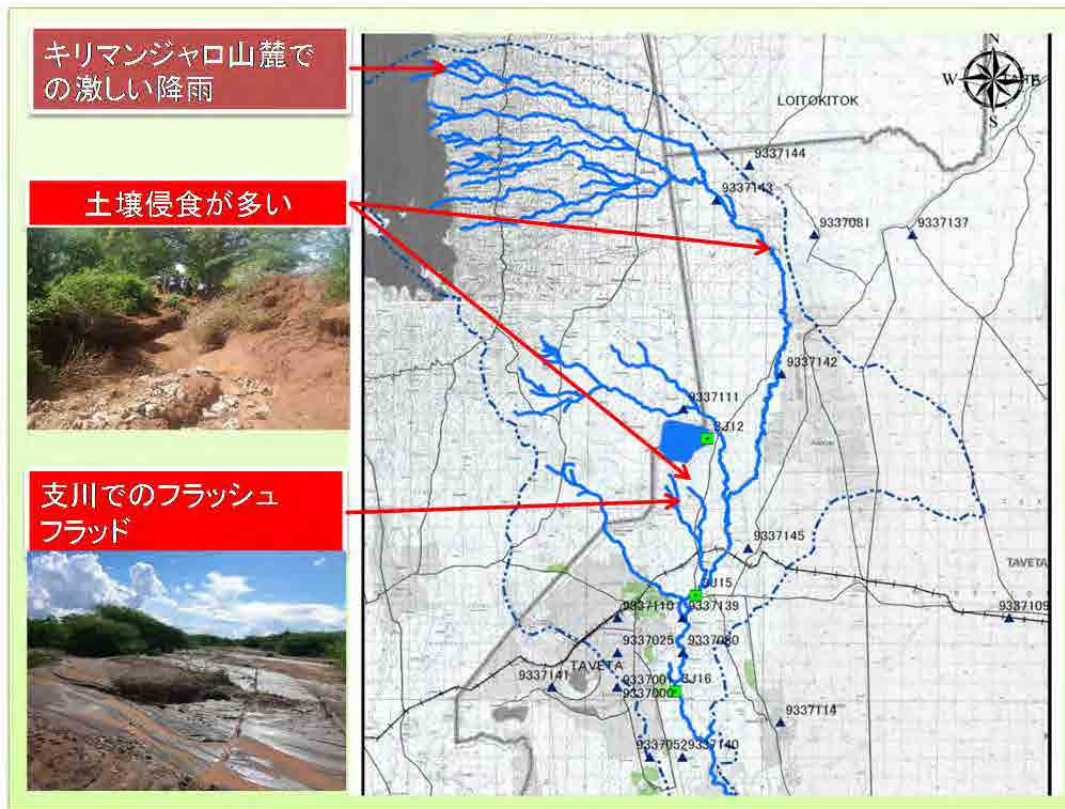
図 3.2.3 Lumi 川中上流域での洪水特性

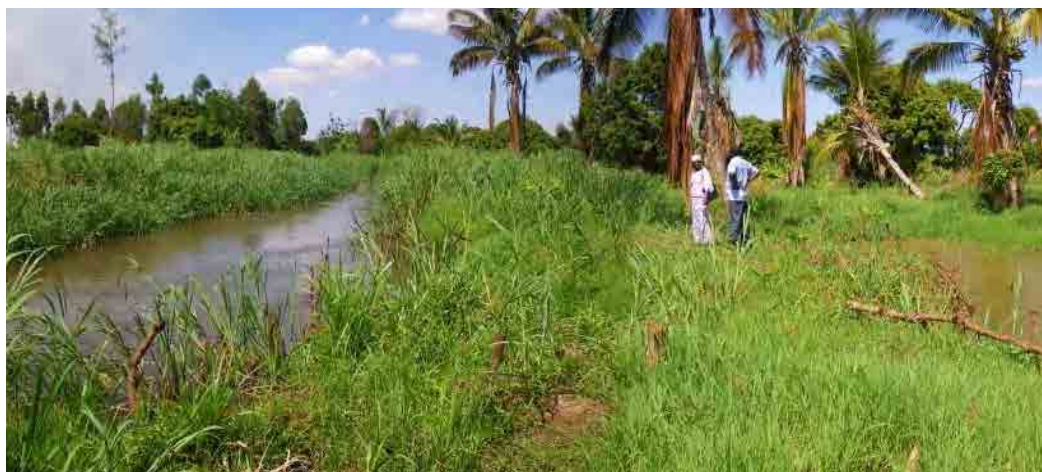
- Lumi 下流本川低平地では、Lumi 本川の流下能力不足に伴う Lumi 本川の溢水や破堤により低平地が浸水する
- Lumi 本川の流下能力不足の原因は、川幅が狭く、上流からの土砂供給により川床が上昇し天井川となっているため、河道面積が不足していることに加えて、地形勾配が 1/1000 から 1/500 となだらかになっているため、流速が小さいことに起因する（下記の Lumi 川河口付近の写真を参照）

写真 3.2.1 Lumi 川河口付近(川幅が狭く、天井川となっている)

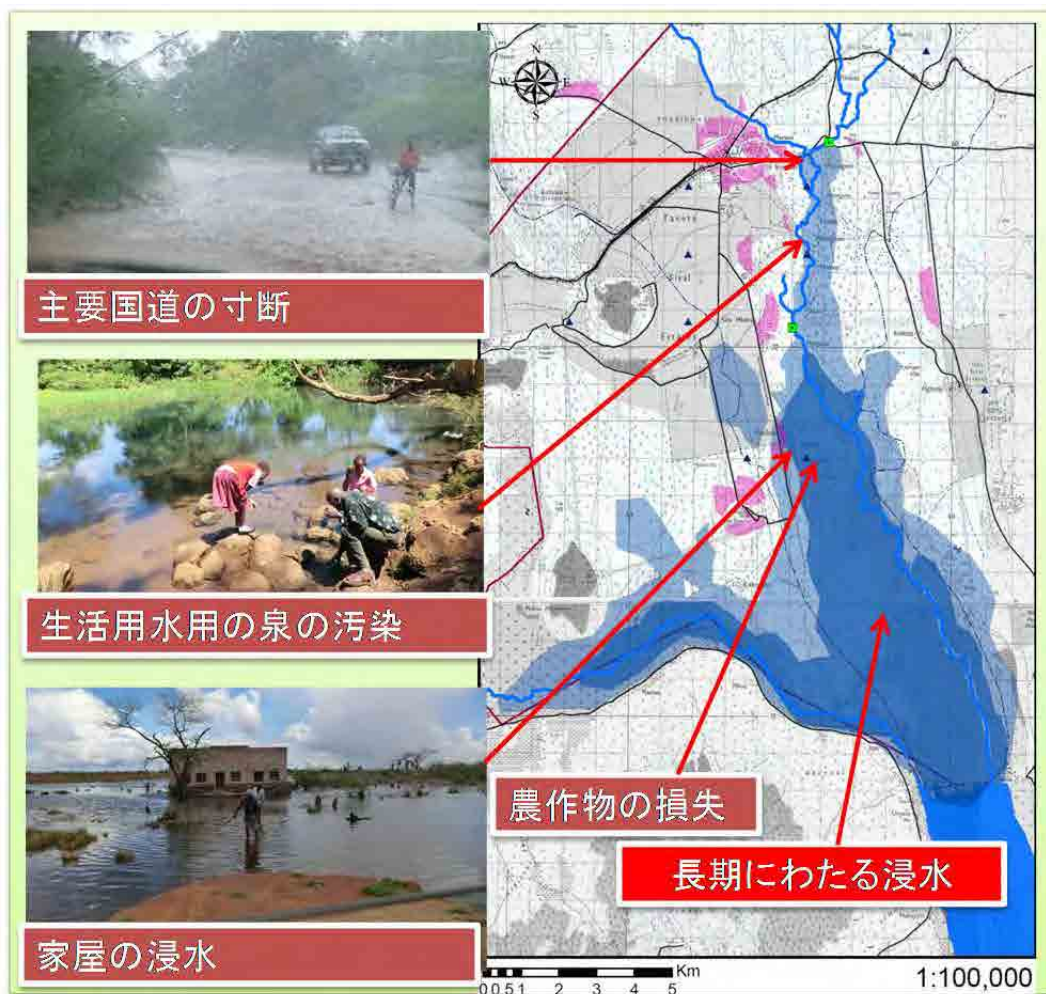
図 3.2.4 Lumi 川下流本川の低平地での洪水特性

天井川となっている Lumi 川下流の本川から溢水・破堤することにより、洪水が低平地に拡散し、地形的に平坦であるため、排水されにくいことによって湛水が長期化している。湛水することにより土壁の家屋の損壊や、農作物の損失、生活用水用の泉の汚染、未舗装道路の軟弱化、病院等の社会インフラの水没、家畜・家禽類の死亡、さらには、地域全体が水没して家屋も居住不能となることにより長期的避難をせざるを得ないといった被害が生じている。

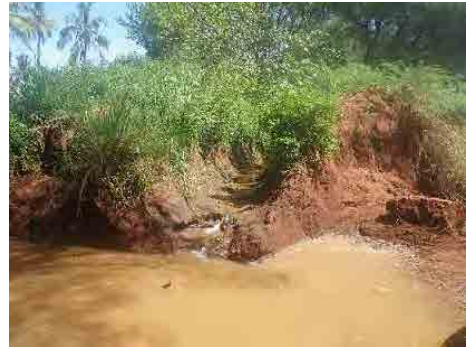
側面からのフラッシュフラッドによって
破壊された用水路

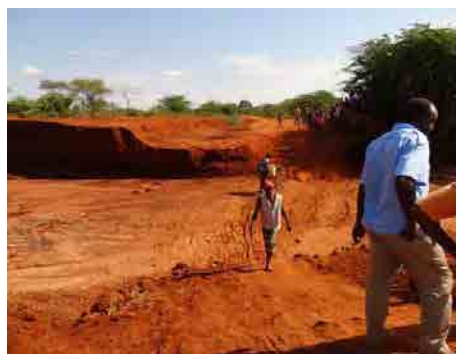
道路橋が流失した様子

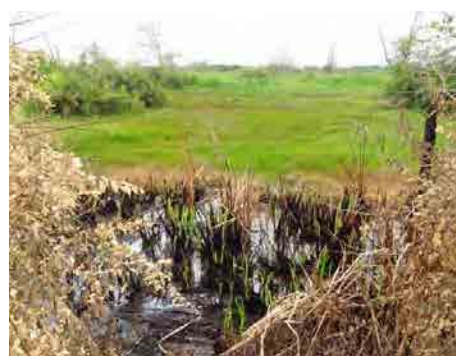
Canal-C の堤防が決壊した箇所周辺の湿地

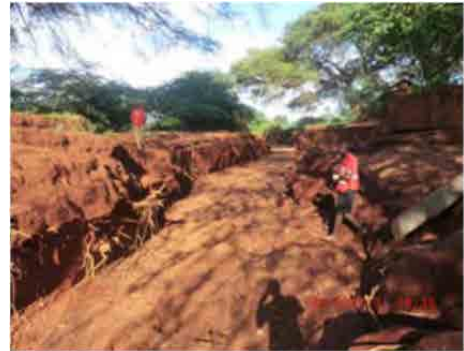
季節河川によって河岸が浸食され
土地が流失

Lumi 川下流域の支川や Jipe 湖へ直接流入する小河川では、フラッシュフラッドによって河岸が浸食され、農地や家屋用地が流失するといった被害が生じている。これは、普段は水のない枯れ川（季節河川）は河道の大きさが小さいにもかかわらず、上流で降雨が発生すると、一気に増水し、河岸を浸食しながら流下することが原因であると考えられる。また、かつては樹林に覆われていたが、薪炭材として樹木が伐採され、今では樹木はまばらに生えているだけとなっている。そのため、激しい雨が降ると、表土に降雨が直接当たり、土壌が流出してしまうことも問題とされている。

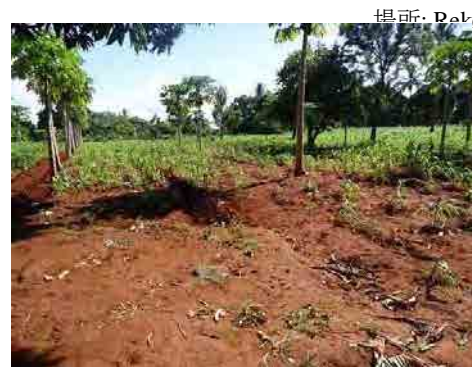
場所：Kimala Irrigation Scheme

洪水によって表土が流出した農地

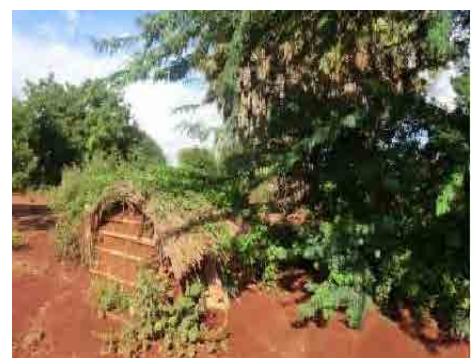
衛生面に関しては、トイレに関する被害が多く聞かれる。この地域のトイレは地面に穴を掘って、上に簡便な壁と屋根を付けただけの形式が主流である。こうしたトイレは、洪水時に水没し、中の汚物が流出することにより、衛生状態を悪化させ、コレラなどの各種水因性の疾患の原因となっている。

堆積土砂で埋まり、放置されたトイレ

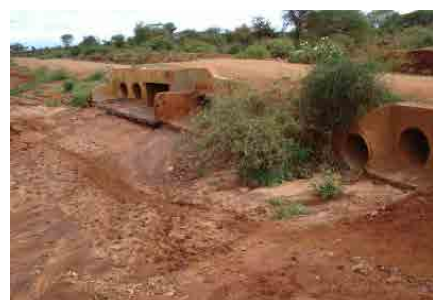
家屋・インフラの損害に関しては、洪水を考慮していない構造が問題であると考えられる。右の写真で示すコンクリート製の橋梁は、枯れ川を横断しており、パイプカルバートにより水を流下させるような構造となっているが、パイプの大きさや数は、洪水時の流量に対して小さすぎるものと考えられる。ケニアでは、洪水時の流量を推定する手法が確立されていないため、特に道路に付帯する橋梁の開口部は、洪水流を安全に流下させるだけの断面を確保していないことが多い。こうした被害に対する対策は、この地域における洪水

道路を横断する枯れ川に設置された
パイプカルバート付きの橋梁

流量の算定手法を確立し、道路の設置者に対して、その手法を採用するように呼びかけることである。また、道路の路面の高さも、洪水による浸水位よりも低く設定されていることが多いため、適切な大きさと配置のカルバートの設置とともに、道路路面を高く嵩上げすることが必要と考えられる。

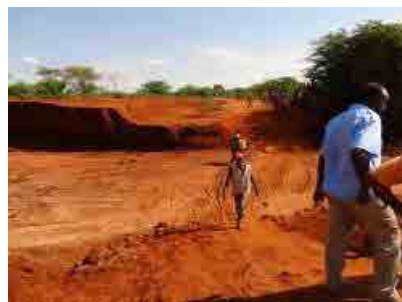
場所：Rengesa

上記と同じ構造のコンクリートの橋梁がフラッシュフラッドにより流失

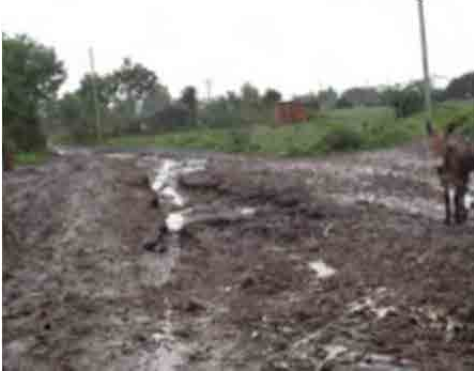
No.		11		
対象		Lumi 川下流・長期浸水エリア		
対策		コミュニティ道路の整備		
概要		道路の嵩上げやカルバートの設置などで道路が使用不能になることを防ぐ		
イメージ

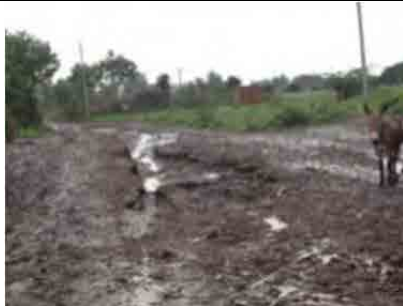
No.		19		
対象		Lumi 下流支川エリア		
対策		コミュニティ道路の整備		
概要		道路の嵩上げやカルバートの設置などで道路が使用不能になることを防ぐ		
イメージ

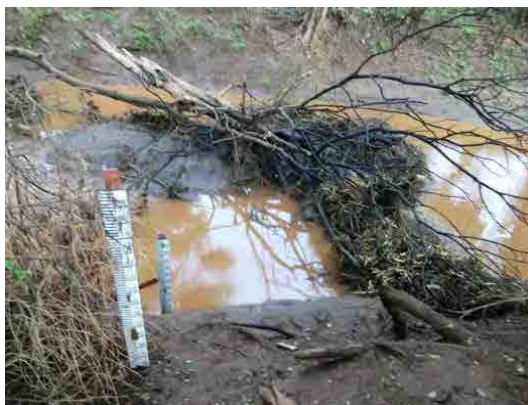
Water Level Gauging Station No.: 3J15
Measure water level of Lumi River.

Automatic measurement is not done at each water level gauging station, but the visual observation is carried out twice a day, i.e. in the morning and in the evening. Therefore, the river discharge at the time of flood is said to be inaccurate although the conversion is done from water level data to river discharge data.

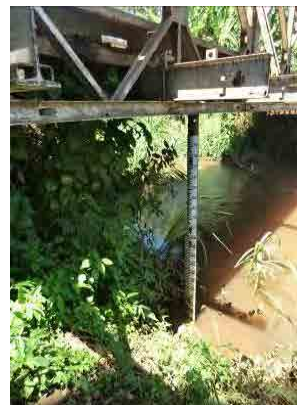
Water Level Gauging Station No.: 3J16
Measure water level of Lumi River. Install device under the pier.

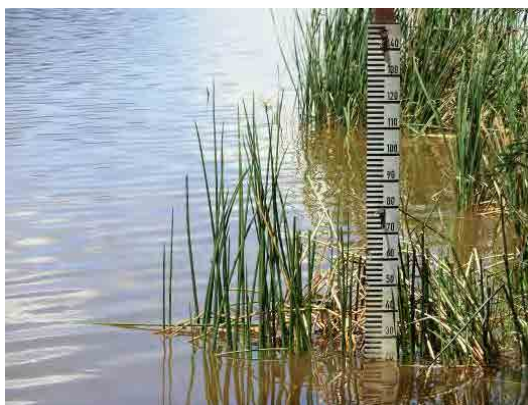
Water Level Gauging Station No.: 3J2
Water level gauging station inside Safari Camp for measurement of water level of Lake Jipe

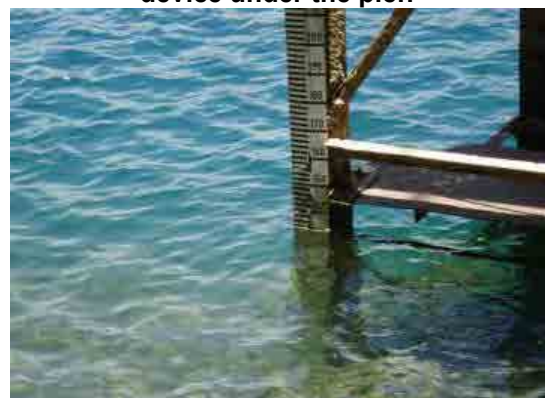
Water Level Gauging Station No.: 3J12
Measure water level of Lake Challa.

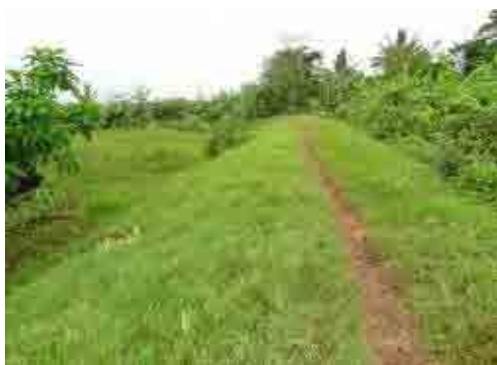
Photo 3.1.1 Embankment of the Canal-C

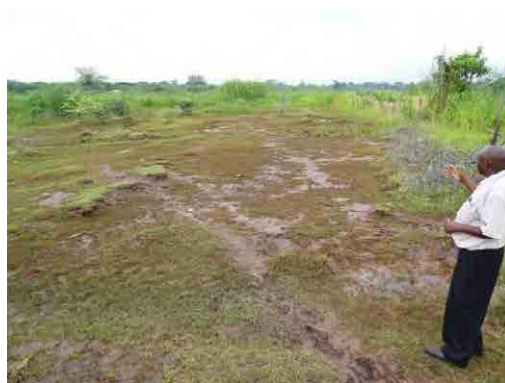
Photo 3.1.2 Broken point of the embankment Canal-C

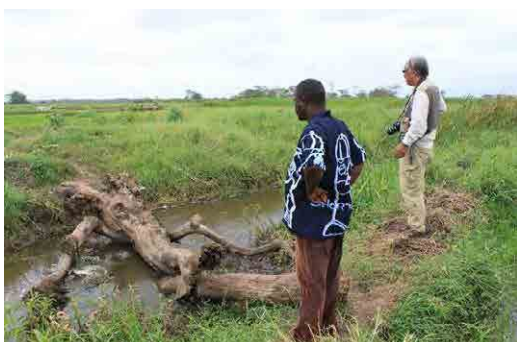
Photo 3.1.3 Canal-A around Kimorigo village

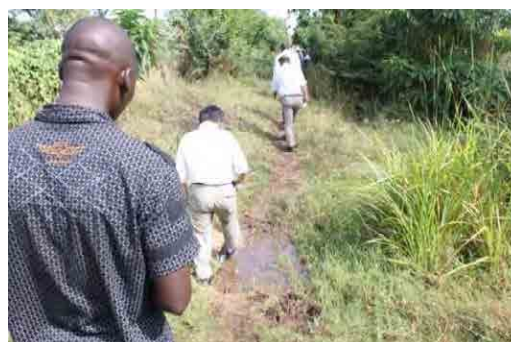
Photo 3.1.4 A point of artificially-destroyed embankment

(take agricultural water from Lumi R. of the left side on the photo and supply to the right side)

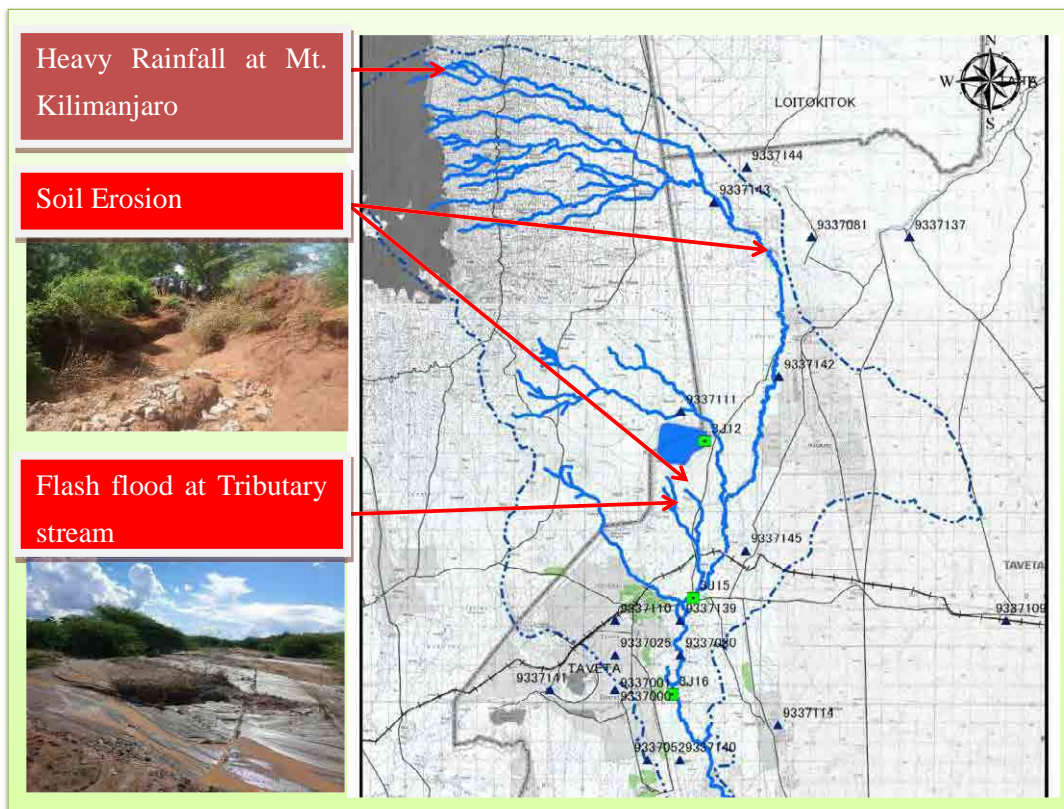
Figure 3.2.3 Flood Characteristics in upstream and middle stream

Around upstream to middle stream, sediment outflow has occurred with farmland erosion caused by furious rainfall and high velocity sheet flow. However, in this area, raising livestock is also prosperous, and then the impact from sediment outflow is not so severe.

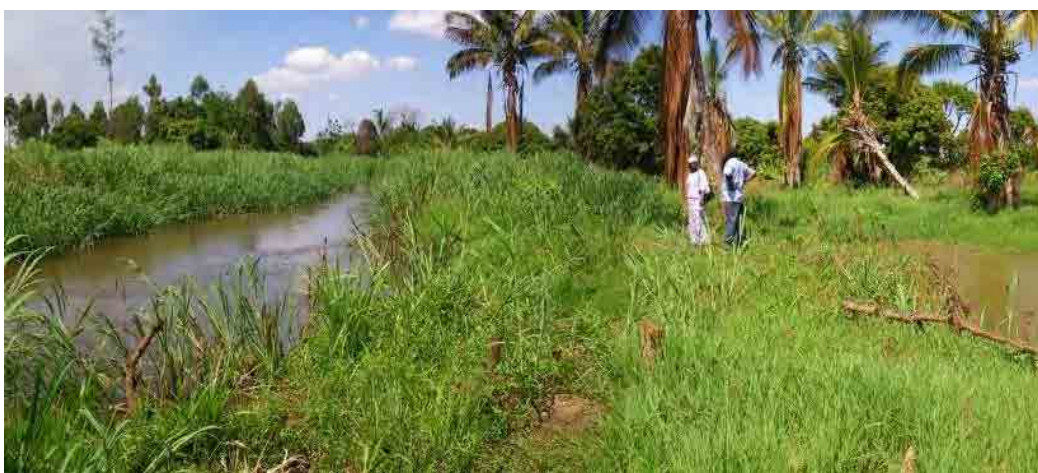
- Low-lying area is inundated by flood water of over flow and dyke break from the Lumi River due to lack of flow capacity.
- The lack of flow capacity is caused by narrowness, high bedded and gentle slope of the Lumi River. Aggradation of river bed levels is generated by discharged sediment. Moreover gentle slope (1/1000 - 1/500) of river profile is causing low flow velocity. (Reference on Photo which was taken near the mouth of the Lumi River)
- Drainage canals (Canal-A, -B and -C) which are located in the inundation area don't have enough flow capacity and part of embankment along the canals is broken; hence these canals don't fulfill their function of existed facilities.
- Inundation is prolonged at the low-lying area because gradient of land features is gentle (1/1000 - 1/500).
- In addition, due to rising water level of the Lake Jipe, flooding water has nowhere to go

Photo 3.2.1 Near the mouth of the Lumi River
(the River is narrow and water level is higher than farming land)

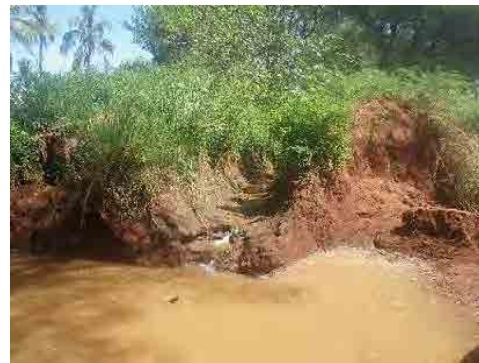
Irrigation canal broken down by flash flood from lateral face

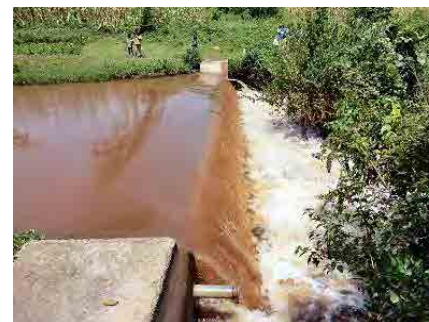
Check Dam
(Example of Nzoia River)

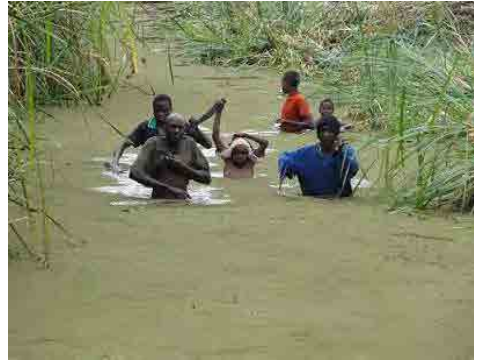
Condition at the time of flooding

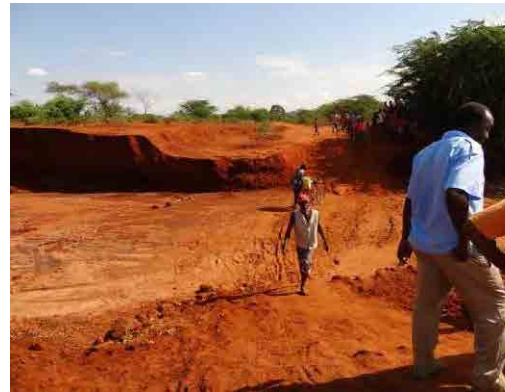
Road Bridge rushed out
 Place : Rengesa

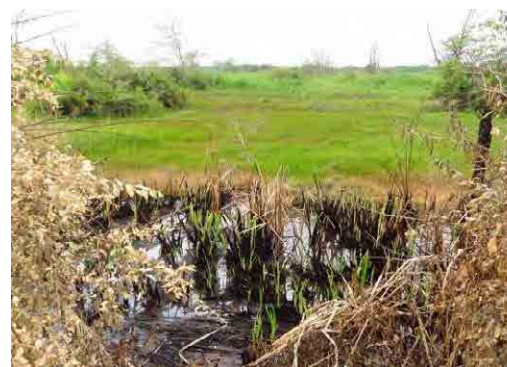
Damp ground where the bank of
 Canal-C has been washed out

Inundation in this area has various impacts such as pollution of drinking water by interfusion of flooded water to the spring, damage to houses and living of the residents. For instance, severed road by inundation will make students go to school and agricultural products to deliver to the market impossible. In addition, as the access to the hospital becomes impossible, another issue will occur where by the resident cannot have medical service. Furthermore, as the residents have little knowledge and information to reduce damages, the damages becomes larger such as to drown livestock. To reduce the flood damage, it is considered an effective mean that the residents acquire knowledge and information on disaster prevention and devise countermeasure by themselves. As countermeasures, education on disaster prevention at school, early flood warning system, etc. are considered. Further, to force an end of inundation from Lumi River, the countermeasures such as widening of and improvement by dredging, etc. of Lumi River, improvement of the existing drainage canal in low-lying area and dredging of Lake Jipe to improve the storage capacity are considered. There are three major existing drainage canals of Canal A, Canal B and Canal C. It is considered to reduce the flood damages largely by heighten the flow capacity of these Canal A, Canal B and Canal C by way of dredging and improvement. Especially, though the bank of Canal C is partly broken down at present, it is one of the options to rehabilitate the bank.

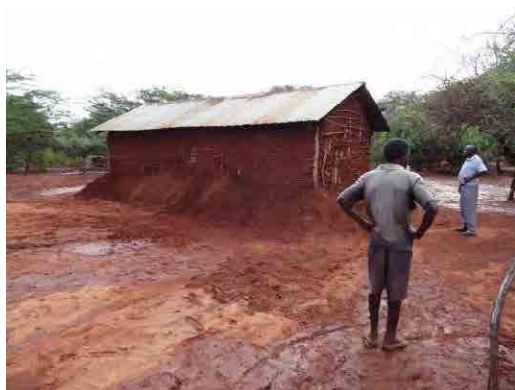
Land elevation after inundation of house
 Place : Rengesa

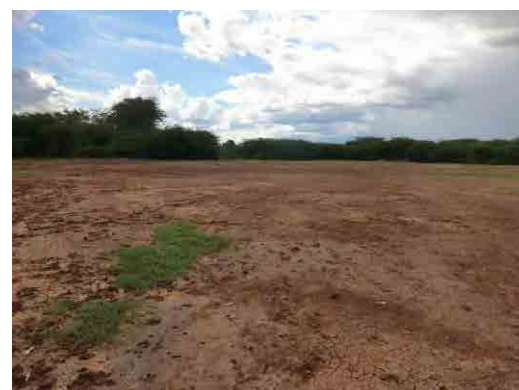
Evacuation camp site
 Place : Kimorigo

impossible to reside and the houses are washed out. Assurance of living quarter is important for victims of flood, therefore, construction of evaluation camp is considered as a countermeasure. There is an existing place being utilized as evacuation camp site, however, the facility is not well constructed. Therefore, it is considered appropriate to improve the existing evacuation camp. Countermeasure method to be considered for this area is summarized below.

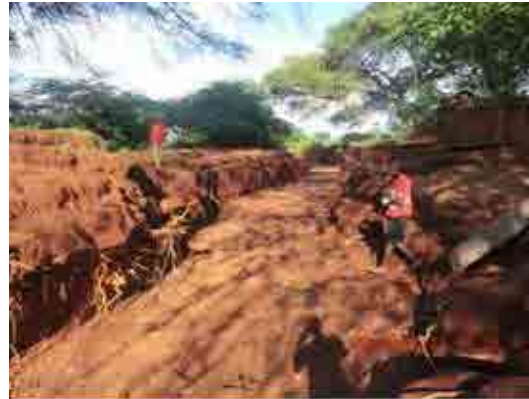
Wash out of land by bank erosion of seasonal river
Place: Rekeke

In the tributaries of the downstream of Lumi River and the small rivers directly flowing into Lake Jipe, the river bank is eroded by flash flood, and damages on agricultural land and housing lot are occurred by washout of land. It is supposed to be that the rainfall in the upstream swells the dry up river (seasonal river), where normally there is no water in the narrow river course, into flash flood with erosion of river bank. Besides, the area was covered by trees once. However, as the trees were logged as fuel wood materials, there are only scattered trees in the area at present. Therefore, if there is a heavy rain, the rainfall directly hits the surface soil, and it results in washout of soil.

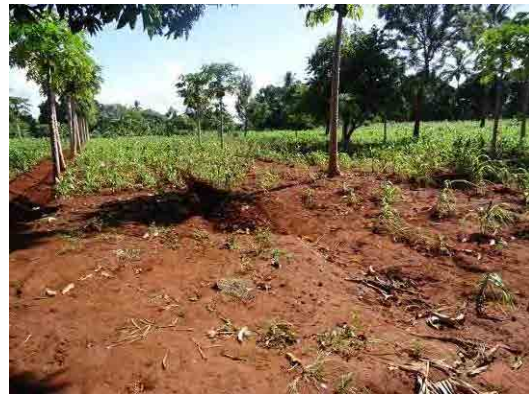
Agricultural land of which the surface soil has been washed out by flood
Place : Kimala Irrigation Scheme

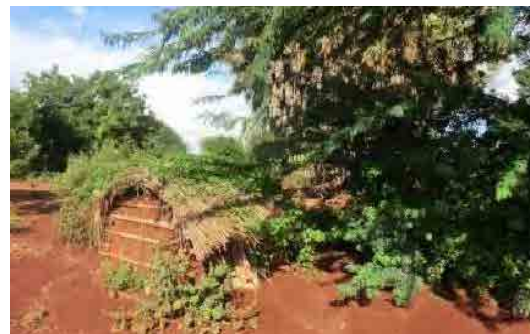
Toilet left as being buried by sedimentation by flood
Place: Rekeke

Damages on toilet often induce sanitary issues. Toilet in this area is mainly constructed by digging a hole on the ground and surrounded by wall and roof. These toilets are submerged under water at the time of flood and the human waste is flown out. Sanitary environment is deteriorated and this causes various waterborne diseases like Cholera, etc.

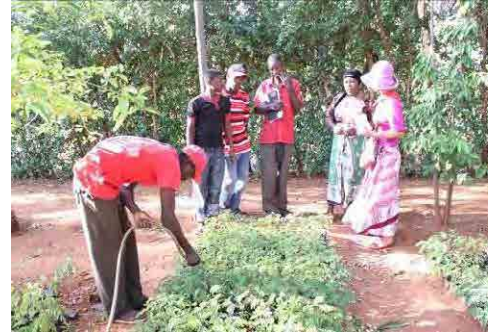
Forestation by KRCS Volunteer Group
(Planting nursery tree)
Place : Rekeke

For washout of soil, it is considered, as one of the methods, to reforest for the purpose of protection and development of forest and trees. In fact, it may not be difficult as the forestation activity is carried out in the downstream of Lumi River by the volunteer group organized by Red Cross of Kenya. Forestation requires time to heighten an effect, however, as an impact to the environment is quite small or few, it is ideal to promote as much as possible as a countermeasure to be adopted by the community level.

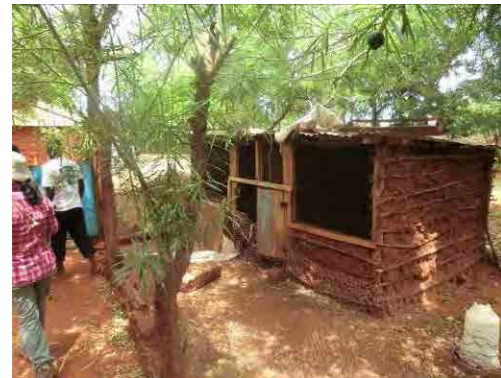
Chicken House

Regarding loss of livestock and agricultural products, lack of knowledge and information to reduce damage by resident level becomes obstacles. For instance, chicken house is constructed directly on the ground though it is submerged every year by flood. Accordingly, chickens are easily drown by the inundation caused by flood. There is a possibility to reduce damages by raising elevation of chicken house not to be submerged under water like the south east Asian countries where many floods hit every year. It is quite important that the residents shall have such a knowledge for reduction of damage, and minimizing the flood damage will largely contribute to the recovery of living after flood damage.

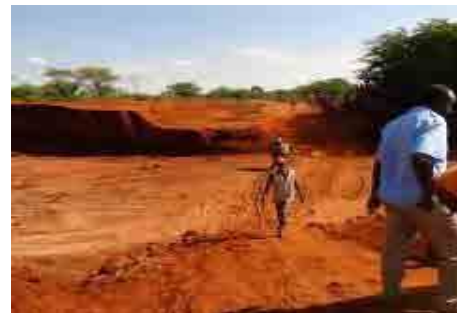
Washout of the concrete bridge of
the same structure to the above by
flash flood
Place : Rengesa

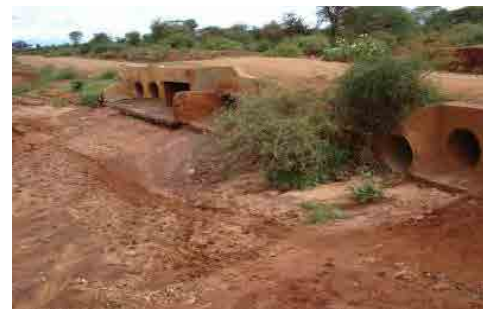
Bridge with pipe culvert installed at the
dry up river crossing the road

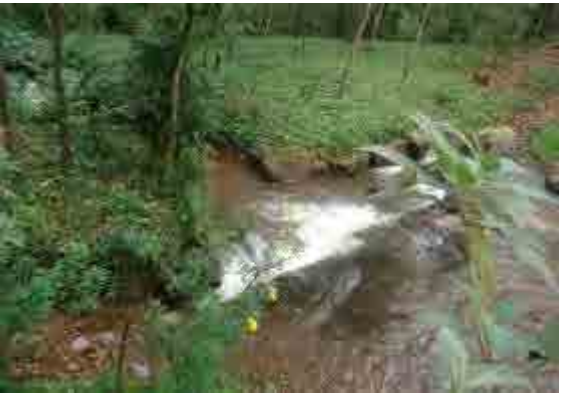
Description : Magombo in Kenyerere in Nyamira District the water in the river channel is colourless and clean with rocky riverbed	Description : Magombo in Kenyerere in Nyamira District the river structure is a culvert constructed for purposes of road transport

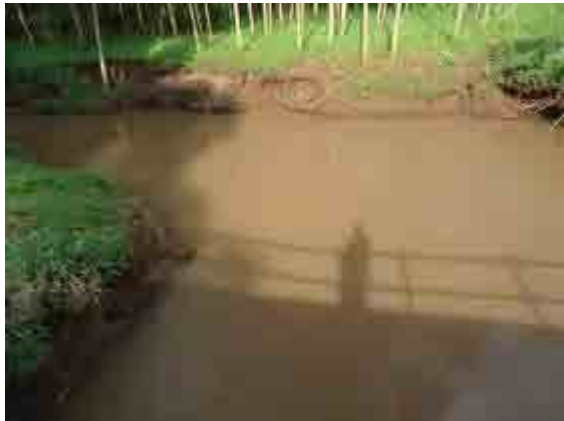
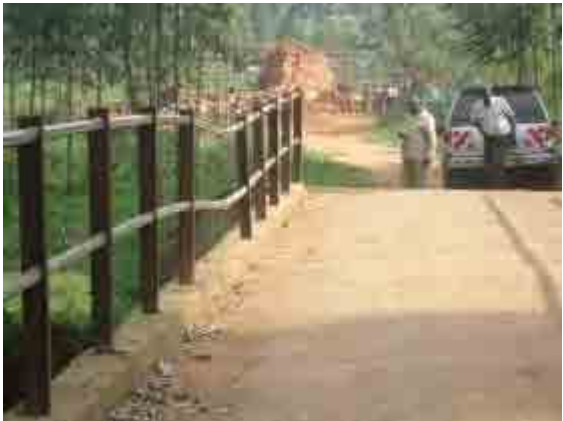
<p>Description : Confluence point at Gekano-Kanyamware boundary where R. Gekano and R. Kanyamware join and both drain into R. Gucha. Riverbed material is pebbles and soil sediments and there is riverbank erosion</p>	<p>Description : Gekano-Kanyamware boundary the river structure is a seventeen metre (17M) concrete vehicular bridge that links two sub-locations and there are brick making works by community members just 20M from the river</p>

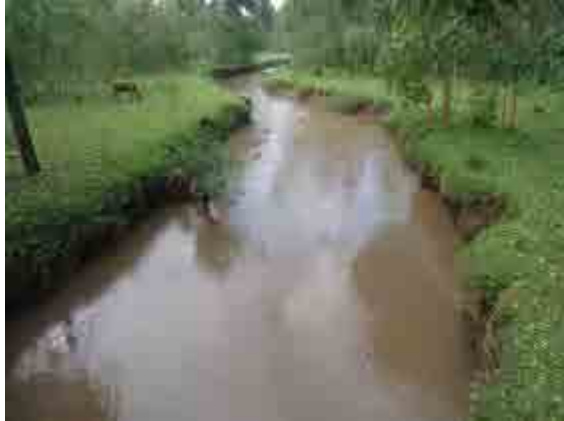
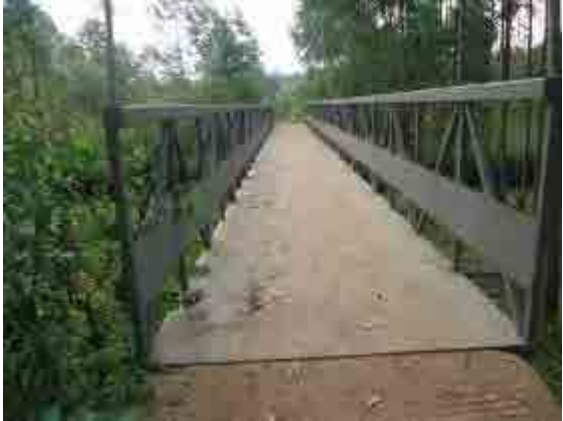
<p>Description : Kianwarimu-Gekano area where the water is light brown greyish in colour and the riverbed material is pebbles and soil sediments and there is riverbank erosion</p>	<p>Description : Kianwarimu-Gekano area here there is a twenty metre (20M) steel footbridge constructed and blue gum trees are planted in the riparian areas</p>

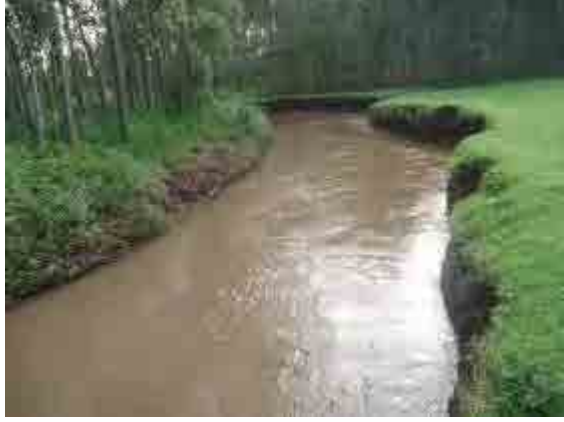
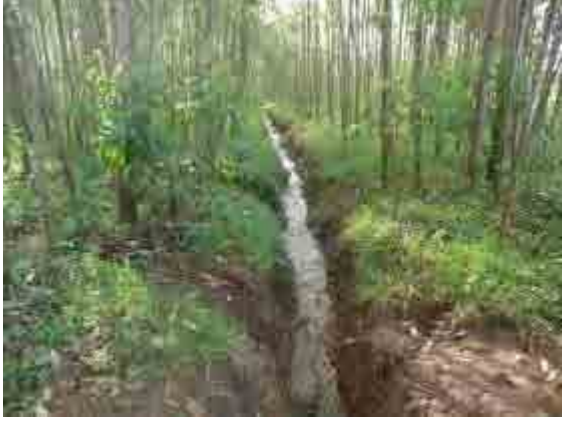
<p>Description : R. Gucha widens at Gekano area in Nyamira district as it flows downstream riverbed material is soil sediments with few traces of pebbles</p>	<p>Description : Gekano area in Nyamira district where there is a river structure a drainage canal dug by community members to channel water from their nearby hills into the river channel</p>

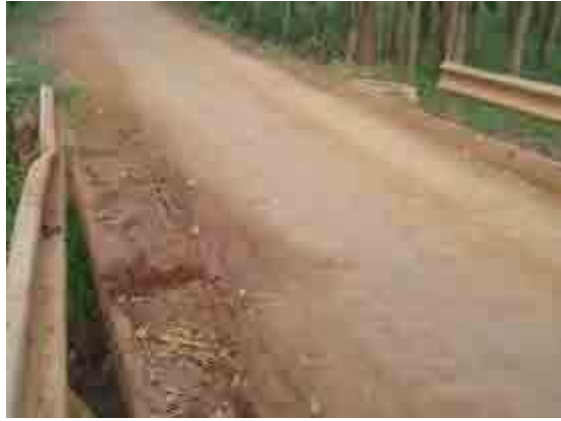
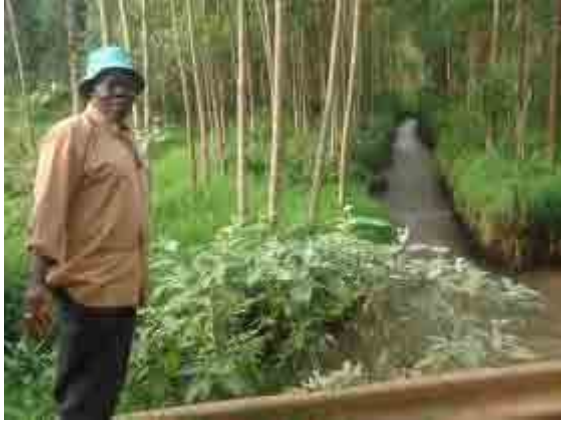
<p>Description : Esani area boundary of Manga and Boribari Districtriver structure includes a vehicular bridge constructed on the murram road that links Manga and Boribari</p>	<p>Description : Community member from Esani explains how the drainage canal was dug and now it protects the bridge from being flooded but the nearby school still get affected by floods during rainy seasons</p>

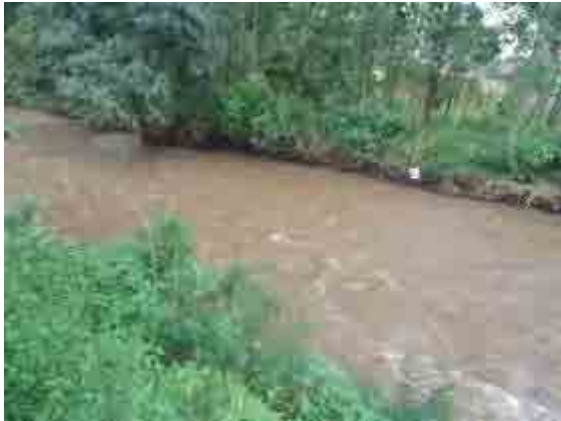
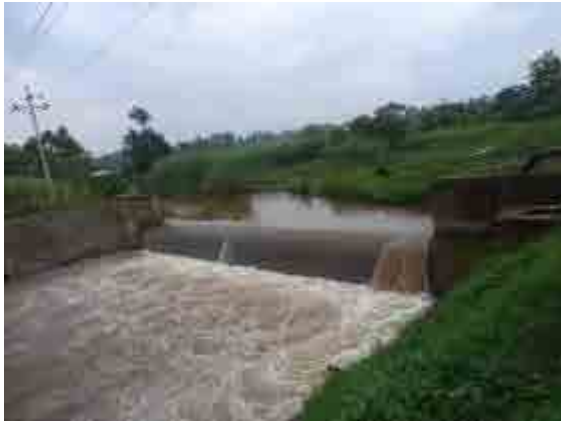
<p>Description: Kegati area in Kisii Town the river water is brown in colour and riverbed material is rocky and soil sediment there is minimal riverbank erosion</p>	<p>Description : Kegati area in Kisii Town the river structure includes water intake that supplies Kisii town</p>

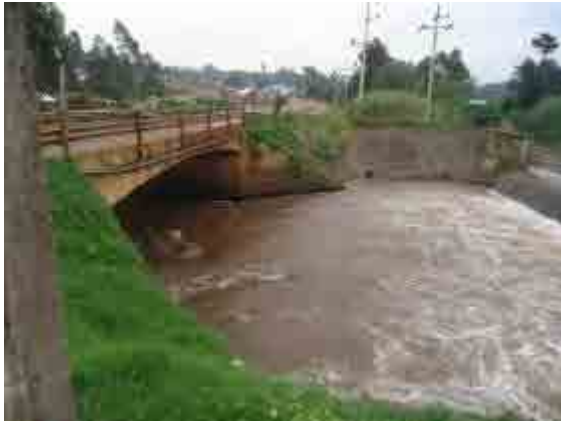
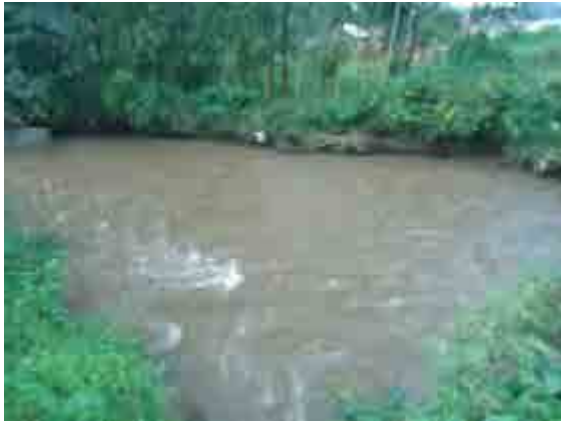
<p>Description : Kegati area in Kisii Town the river structure includes vehicular bridge that KisiiNarok road passes over the R. Gucha</p>	<p>Description : Kegati area in Kisii Town the water flows downstream and there is vegetation cover in the riparian areas</p>

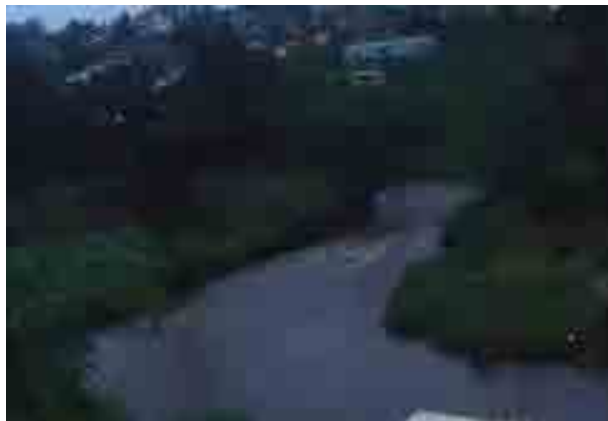
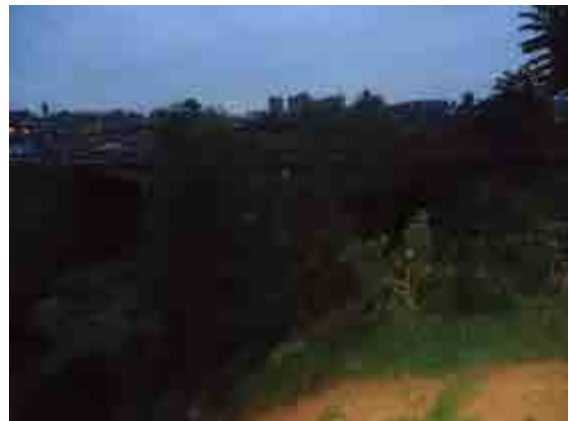
<p>Description :Ogembo town in Gucha District the river water is brown in colour and riverbed material is rocky and soil sediment there is minimal riverbank erosion</p>	<p>Description :Ogembo town in Gucha District the river structure includes vehicular bridge that KisiiKilgoris road passes over the R. Gucha</p>

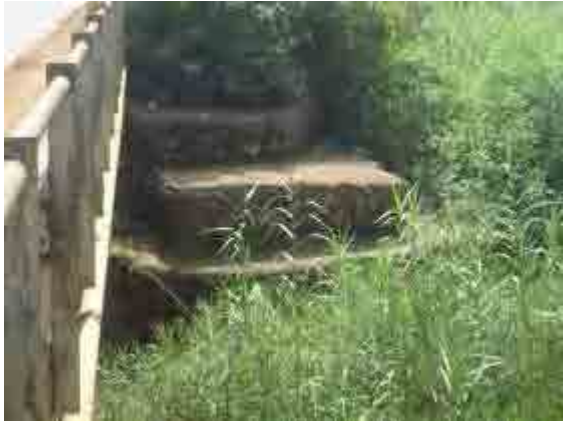
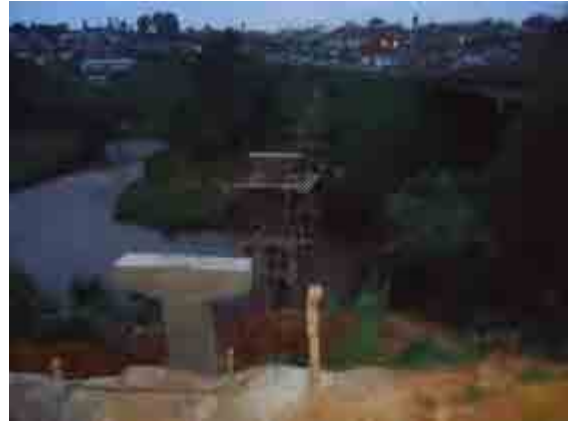
<p>Description : Ogembo town in Gucha District the river structure includes the gabion works used to reinforce the vehicular bridge that KisiiKilgoris road passes over the R. Gucha</p>	<p>Description : Ogembo town in Gucha District the river structure includes the under construction footbridge that will give pedestrian easy access to the market stalls</p>
<p>River Gucha System: Midstream</p>

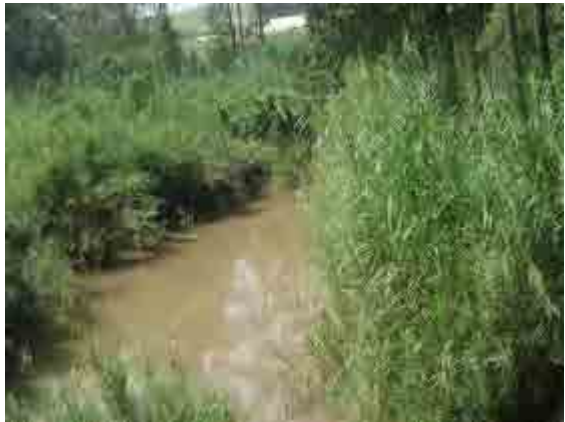
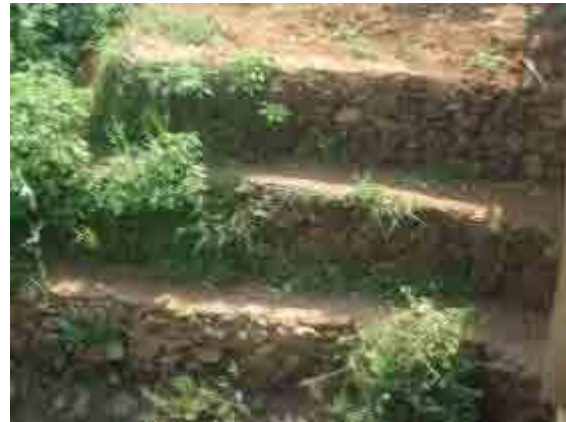
<p>Description : Sare bridge in Awendo town R. Sare a tributary of R. Gucha. The river water is brown in colour and riverbed material is rocky and sandy there is minimal riverbank erosion</p>	<p>Description :Sare bridge in Awendo town the river structure includes the gabion works used to reinforce the vehicular bridge that KisiiMigori road passes over the R. Sare</p>

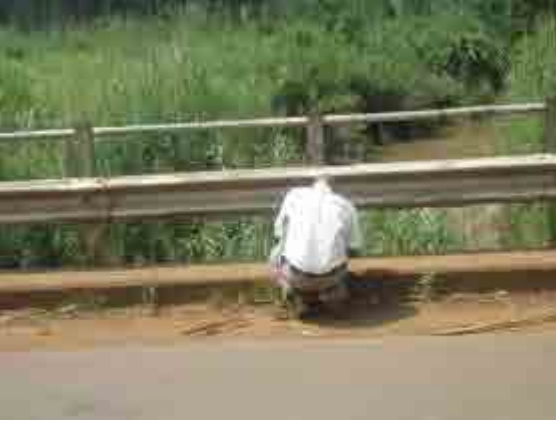
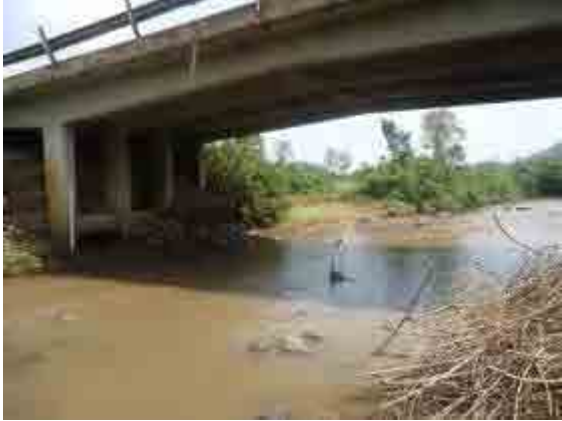
<p>Description : Oyani bridge where R. Oyani a tributary of R. Gucha passes under. The river water is brown in colour and riverbed material is rocky and sandy there is minimal riverbank erosion</p>	<p>Description : Oyani bridge near Awendo town the river structure includes the gabion works used to reinforce the vehicular bridge that KisiiMigori road passes over the R. Oyani and their debris in river channel</p>

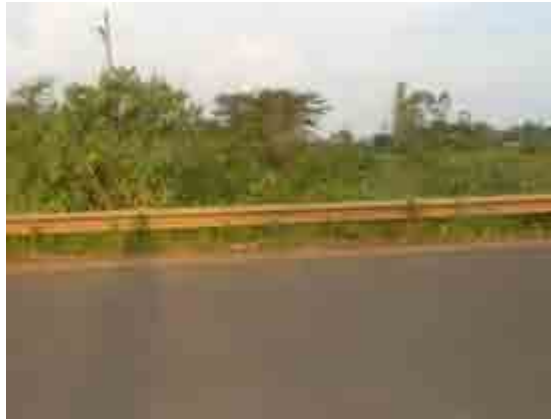
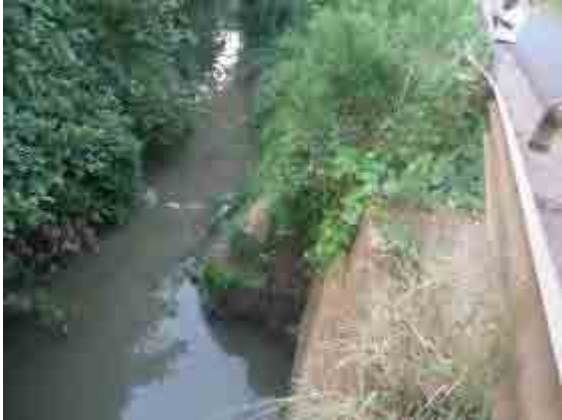
<p>Description : Onyinjo bridge where seasonal R. Onyinjo a tributary of R. Gucha passes under. There are overgrown vegetation within the river channel and the riverbed material is rocky</p>	<p>Description : Mirogi bridge the river structure includes the vehicular bridge that Sori-Rongo road passes over the R. Mirogi in which the water is greyish in colour and some point stagnant and riverbed material is rocky</p>
<p>River Gucha System: Downstream</p>

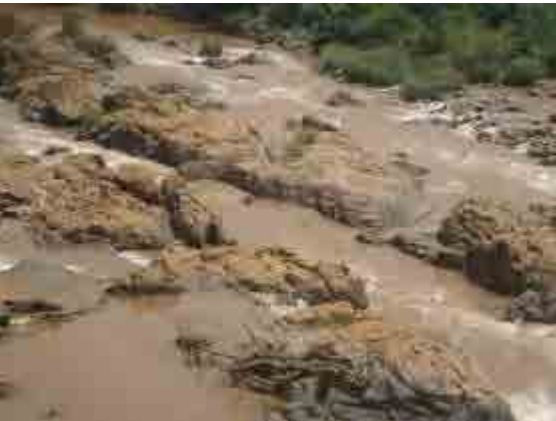
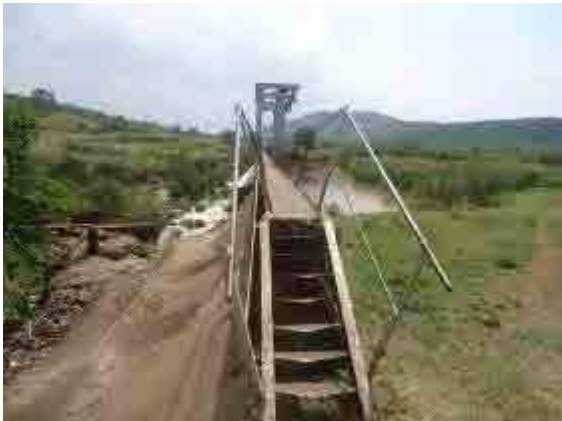
<p>Description : GogoKenGenGogoin Nyatike district R. Gucha flows downstream and the water colour is brownish and the riverbed material is rocky and soil sediments</p>	<p>Description : GogoKenGenGogo Hydroelectric plant on R. Gucha. River Structures include dam, water intake and footbridge. The dam is silted</p>

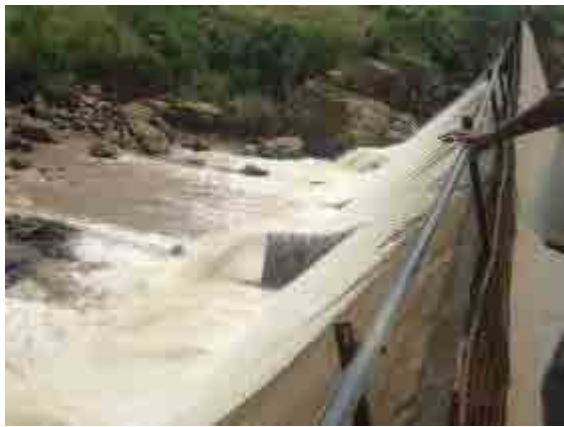
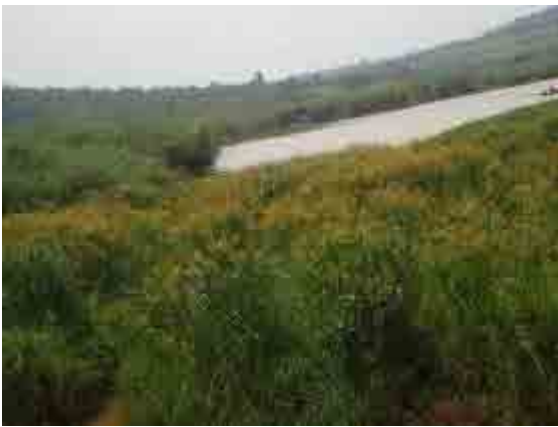
<p>Description : GogoKenGenGogo Hydroelectric plant on R. Gucha. The water flows at high velocity</p>	<p>Description : GogoKenGenGogo Hydroelectric plant on R. Gucha. The dam is silted leading to vegetation growth in some parts of the dam</p>

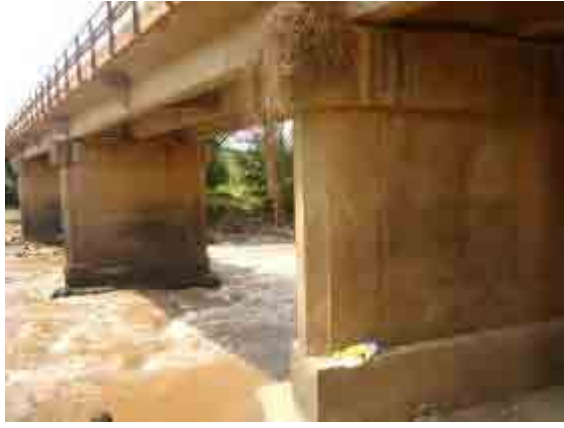
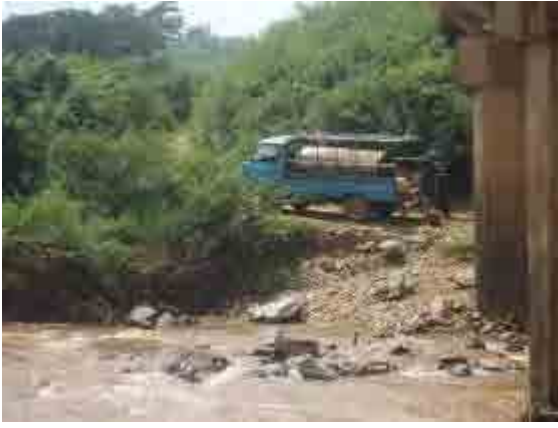
<p>Description : DarajaAego in Nyatike District, R. Gucha flows downstream and the water colour is brownish and the riverbed material is rocky and soil sediments. The river structure is the vehicular bridge on Migori-WathOnger road</p>	<p>Description : DarajaAego in Nyatike District, R. Gucha flows downstream and the water abstractors using pumps to pump into their lorry thereafter use the water to wash gold ore in the mines</p>

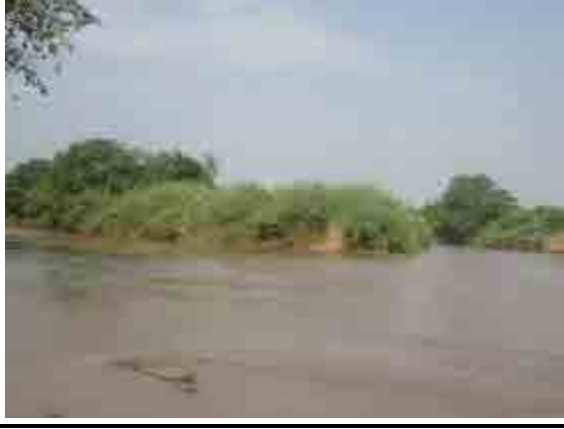
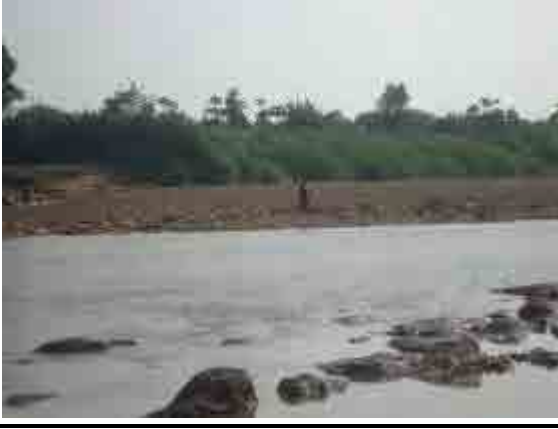
<p>Description : Sango area in Nyatike District, the confluence of R. Gucha and R. Migori the water colour is brownish and the riverbed material is rocky, sandy and soil sediments.</p>	<p>Description : Sango area in Nyatike District, the confluence of R. Gucha and R. Migori there is a huge deposit of soil sediments within the river channel which during rainy season is covered by water</p>
