Lumi 川流域洪水管理計画案

ケニア共和国
洪水に脆弱な地域における効果的な
洪水管理のための能力開発プロジェクト

Lumi 川流域
洪水管理計画（案）

2013 年 7 月

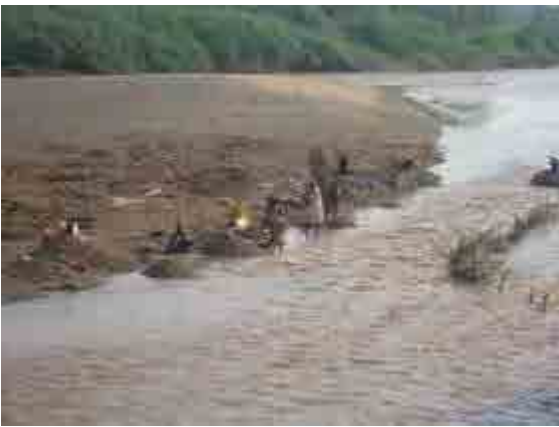
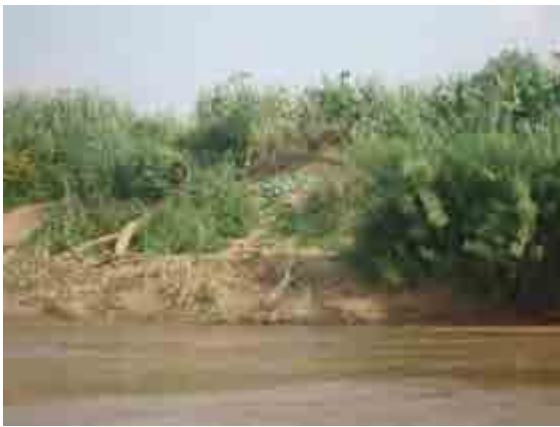
<p>Description : Sango area in Nyatike District, the confluence of R. Gucha and R. Migori the community members mine gold from the soil sediments deposited within the river channel during low rain seasons</p>	<p>Description : R. Gucha at the downstream where there is riparian encroachment with agricultural activities undertaken almost at the brick of the riverbanks</p>

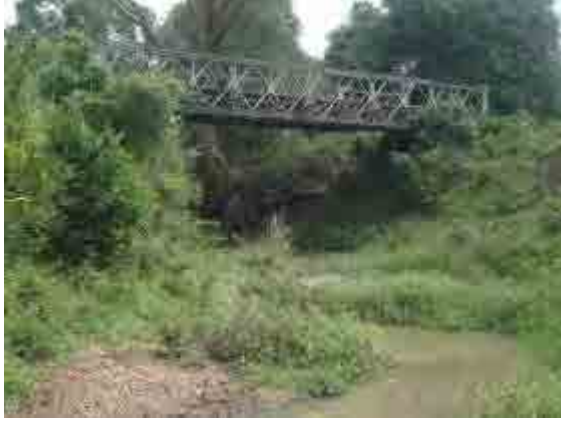
<p>Description : Magor bridge in Transmara East district R. Migori flows through. The riverbed material soil sedimentation water levels are low during dry season and very high during rainy season</p>	<p>Description : Magor bridge in Transmara East district R. Migori flows under this bridge . The river structure is a vehicular steel bridge, there vegetation noted in the river channels</p>

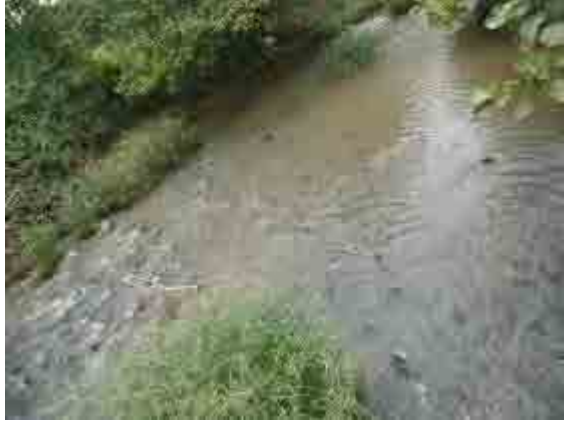
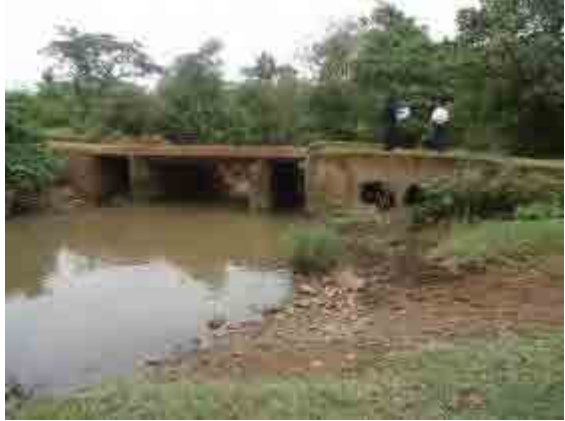
<p>Description : ASTU, Indiyano Sub-location Transmara District R. Remo that drains into R. Migori flows downstream riverbed material is rocky, pebbles and sand alluvial</p>	<p>Description : ASTU, Indiyano Sub-location Transmara District R. Remo flows through a river structure a box 3 compartment bridge for vehicular use and 2 cylindrical culvert compartments constructed as one unit</p>

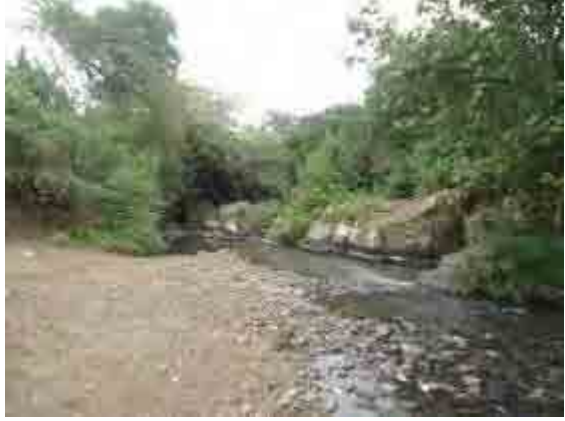
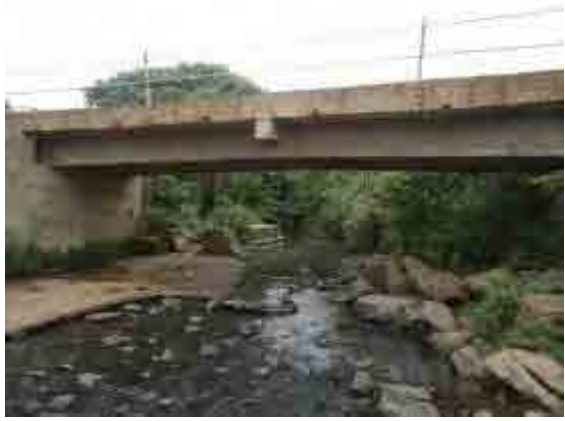
<p>Description : Ndiri area in Transmara District, R. Ndiri that drains into R. Migori flows downstream riverbed material is rocky pebbles and alluvial soil</p>	<p>Description : Ndiri area in Transmara District, river structure is a vehicular Bridge; and parts of old structures of the decommissioned bridge and also a watering point for livestock</p>
<p>River Migori System: Midstream</p>

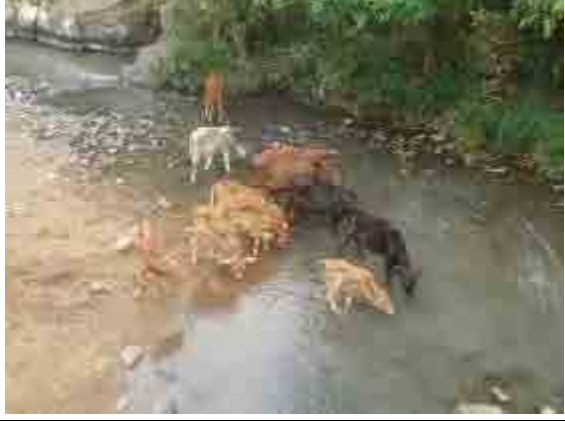
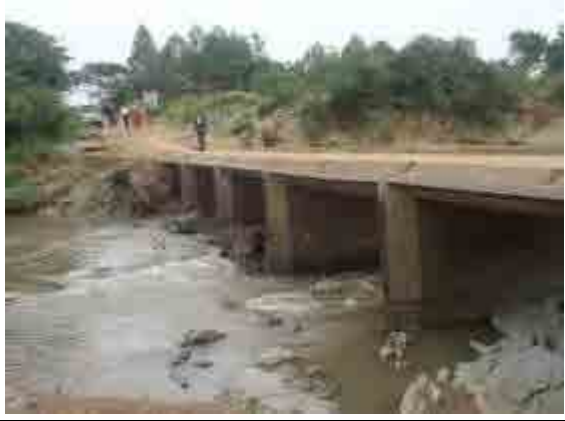
<p>Description : Transmara-Kuria boundary bridge R. Migori flows downstream riverbed material is rocky and sand alluvial and the point acts as a watering point for livestock</p>	<p>Description : Transmara-Kuria boundary bridge R. Migori flows downstream river structure 5 compartments vehicular bridge</p>

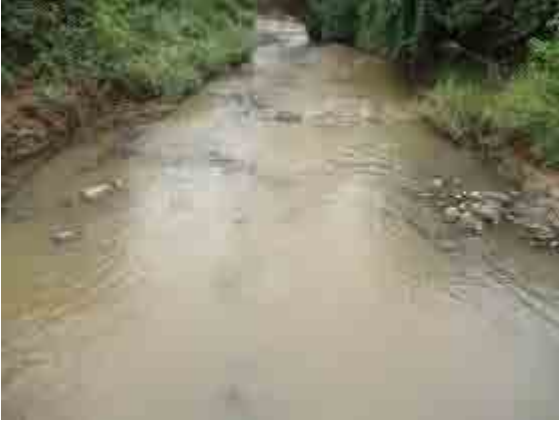
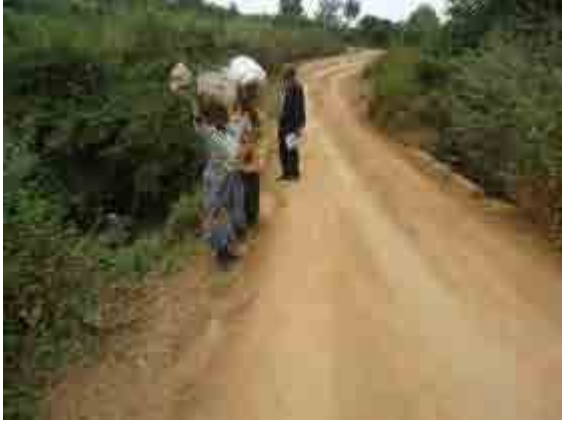
<p>Description : Nyeikute village, Komanga Sub-location in Kuria-Kihancha District R. Nyogoto a tributary of R. Migori has riverbed material of rocky and sand alluvial</p>	<p>Description : R. Nyogoto a tributary of R. Migori has river structure box culvert for vehicular use; River overflows the bridge and affects the farms nearby</p>

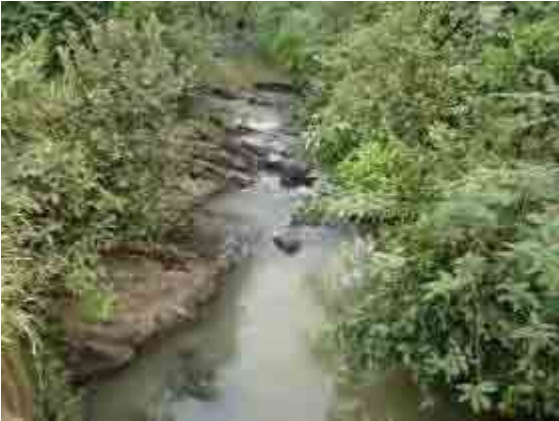
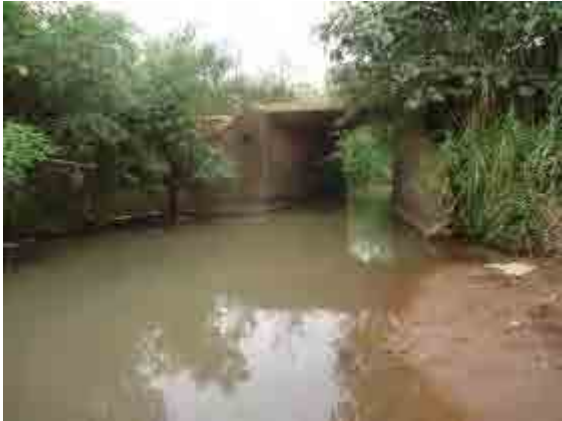
<p>Description : Daraja ya Masaba area boundary of Nthiange and Masaba sub-locations in Kuria District R. Bungenech a tributary of R. Migori has riverbed material of rocky and sand alluvial. River catchment is intact with minimal human activities observed</p>	<p>Description : R. Bungenech a tributary of R. Migori has river structure of box culvert on the road that links the two locations i.e. Nthiange and Masaba sub-locations in Kuria District</p>

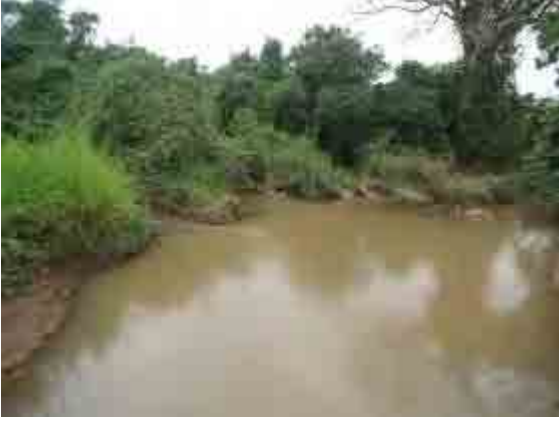
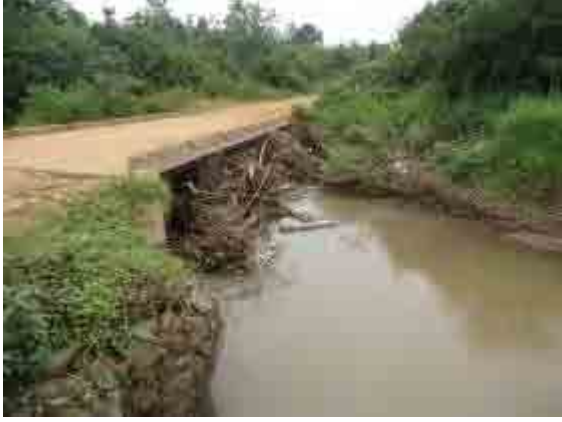
<p>Description : At the confluence of R. Bosara and R. Nyandara is where R. Hibwaa a tributary of R. Migori starts. Riverbed material are rocky, pebbles and sand Rocky, pebbles and sand alluvial</p>	<p>Description : R. Hibwaa has river structure a vehicular bridge and gabions. There are debris blockages on the bridge compartments</p>

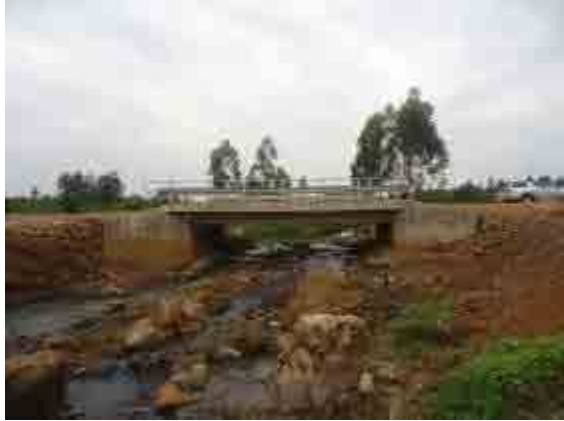
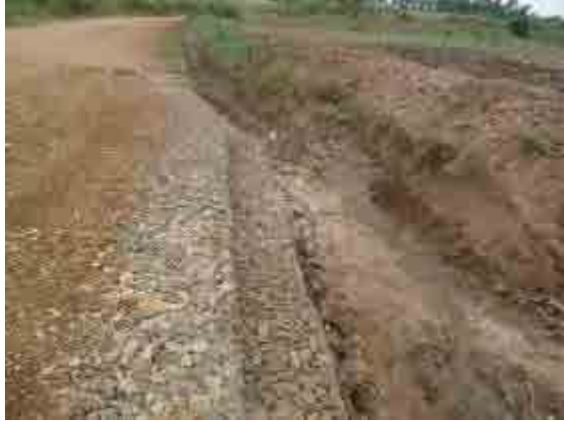
<p>Description : Ragane Area near the boundary of Kuria and Migori districts. R. Ragane a tributary of R. Migori flows and riverbed material is rocky and pebbles and one of the river structure is the vehicular bridge</p>	<p>Description : R. Ragane a tributary of R. Migori flows and the river structure includes gabion works that reinforces the bridge and drainage canal that drains run-off water into the river channel</p>

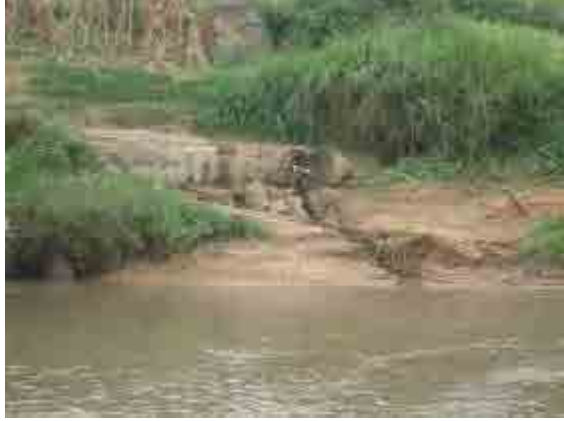
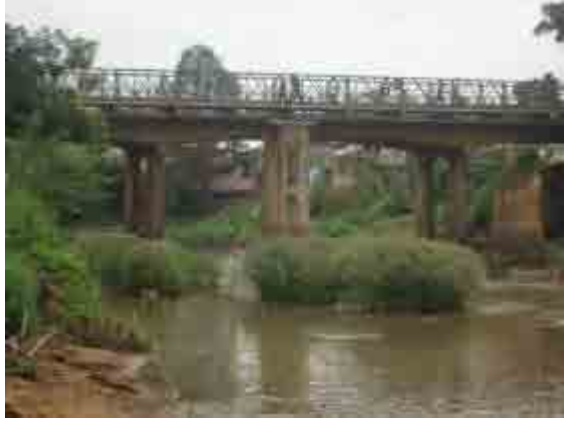
<p>Description : Migori Bridge in Migori where R. Migori flows and riverbed material is rocky and sandy</p>	<p>Description : R. Migori flows downstream and there is a river structure i.e. bridge constructed above the river channel on an A1 road</p>

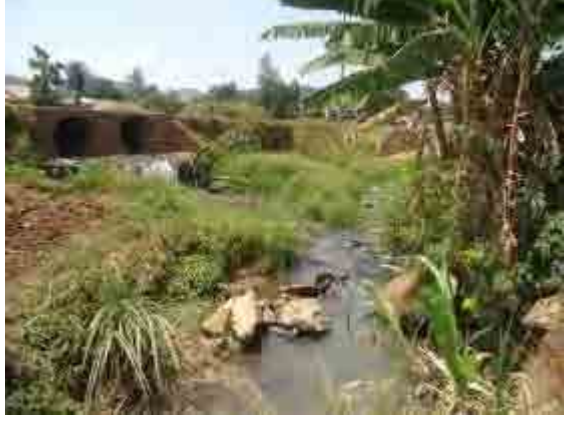
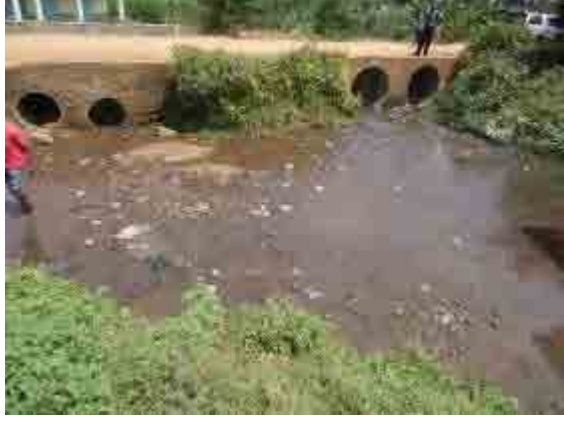
<p>Description : Nyasare estate in Migori Town: R. Nyasare a tributary of R. Migori and the riverbed material is rocky, pebbles and sandy</p>	<p>Description : R. Nyasare as it flows downstream it has river structure which is 5 compartment cylindrical culvert and a house is constructed just beside the river</p>

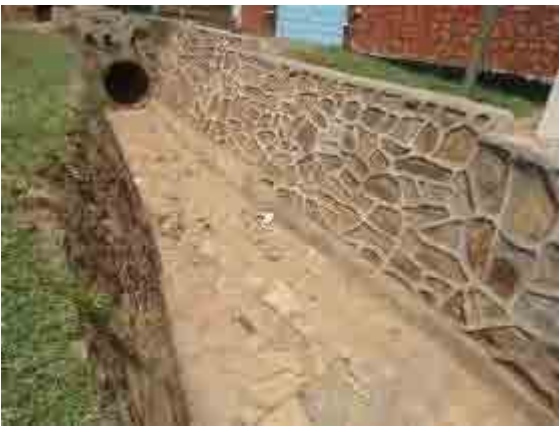
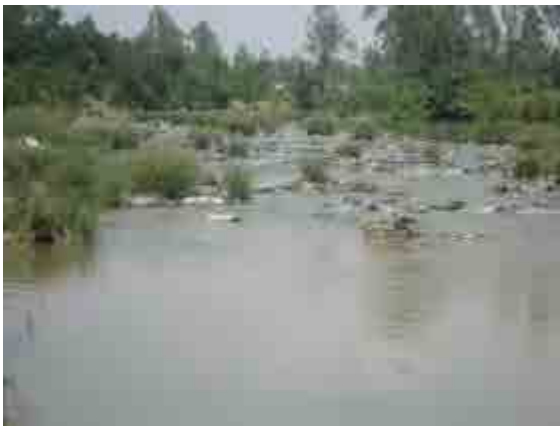
<p>Description : On R. Nyasare there is also a run-off water drainage that drains into the river channel</p>	<p>Description : R. Nyasare drains into R. Migori which is about 100 M apart at this point. There are no river structures on R. Migori at this point but there are vegetation growing in the river channel</p>

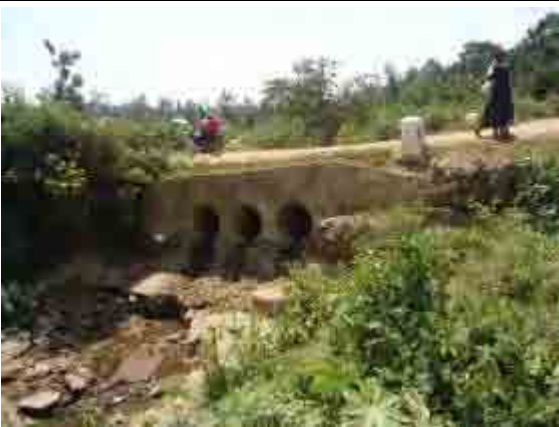
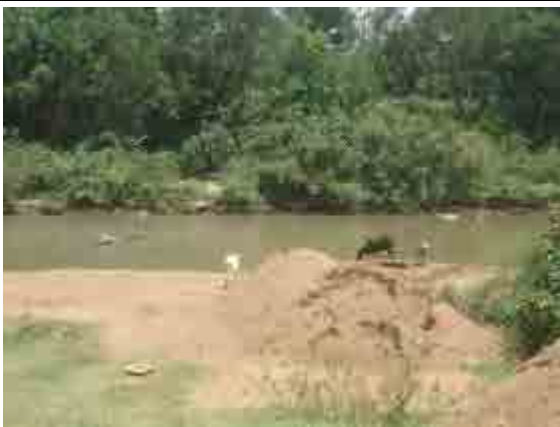
<p>Description : Nyamure in Magina area in Migori Town: R. Nyagogo also known as R. Nyamure a tributary of R. Migori and the riverbed material is rocky, pebbles and sandy has river structure a 3 compartment cylindrical culvert and gabions</p>	<p>Description : R. Nyagogo drains into R. Migori which is about 200 M apart at this point. There are no river structures on R. Migori at this point but there are sand harvesting activities and the point acts as a watering point for the livestock</p>

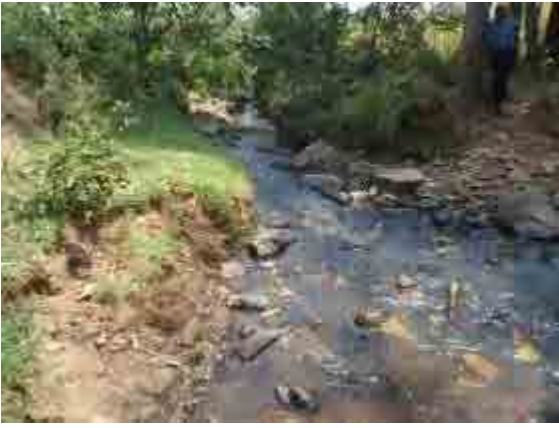
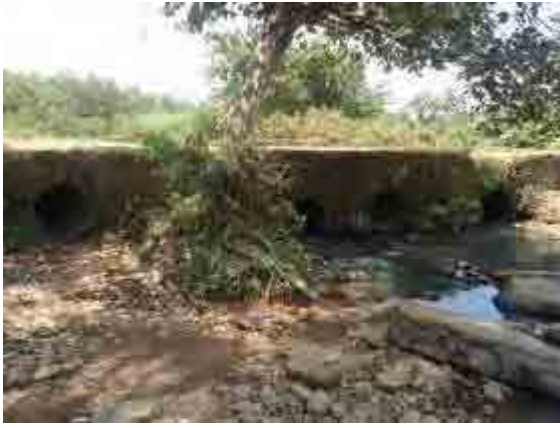
<p>Description : Kakrao area in Migori district R. Nyasarara a tributary of R. Migori and the riverbed material is soil sediments, rocky and pebbles</p>	<p>Description : R. Nyasarara that drains into R. Migori flows downstream river structure is 4 compartment cylindrical culvert of which some are blocked</p>

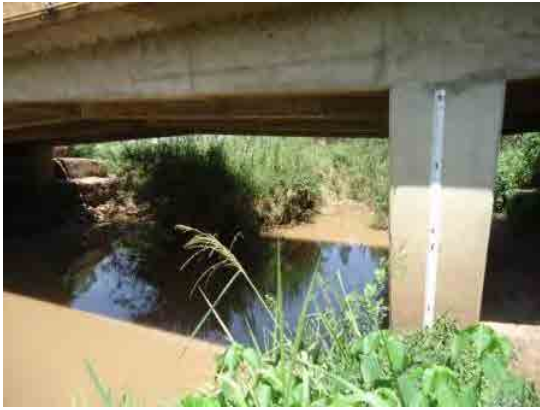
Water Level Gauging Station No.:1KB11
Observation River :Oyani River

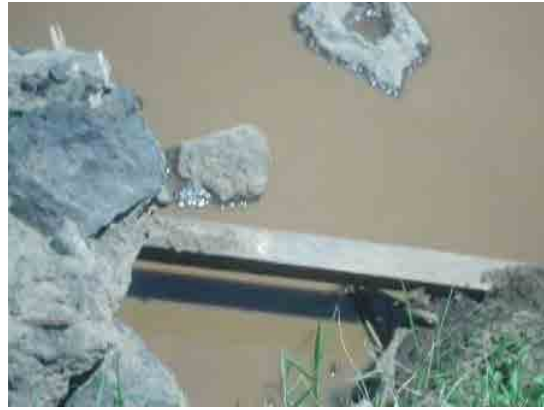
Water Level Gauging Station No.:1KC03
Observation River :Migori River
Special Note :Water level gauge is broken off and damaged.

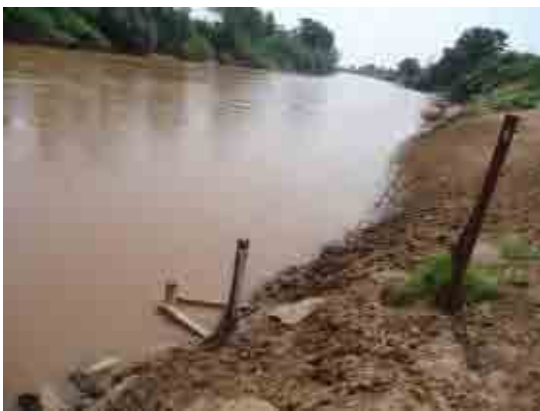
Water Level Gauging Station No.:1KB05
Observation River :Gucha Migori River

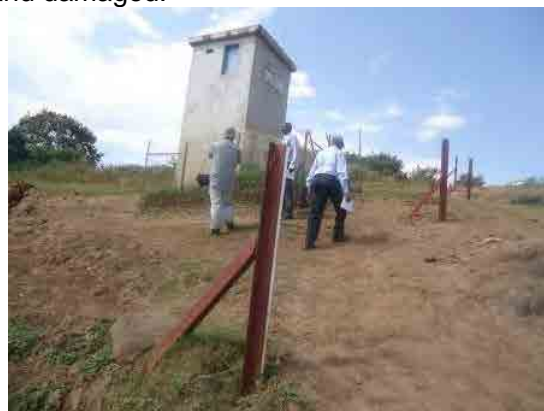
Water Level Gauging Station No.:1KB05
Observation River :Gucha Migori River
Special Note : This is an automated gauge station that transmit data to WRMA Regional Office

The secondary data collected from Lake Basin Authority “RIVER PROFILE STUDIES VOLUME IV, LOWER KUJA, IRRIGATION DEVELOPMENT ANNEX II HYDROLOGY OCT 1985” reports that: The Kuja flow record at 1KB05 provides an annual series of 15 years. Although this record is short it has the benefit of the station being reasonably calibrated up to 5.78M (534M³/S). the highest level at which flows have been gauged by current meter; with the highest observed level in 15 years being at 6.70M, under 1M higher than the maximum gauged by current meter. By contrast, records at 1KB1, 1KB1A and 1KC3 are longer but have less certain flood flow ratings. The highest gauged flow of the Kuja at 1KB1/1KB1A is only 139M³/S, although the 1KC03Migori has been gauged at 477 M³/S.⁴ (Page A2-17)

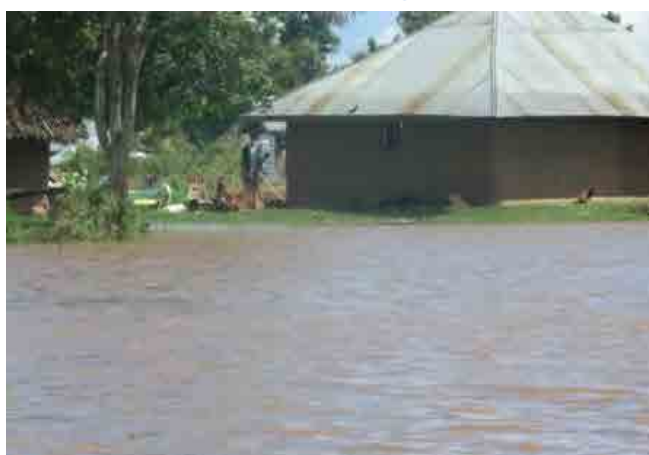
Figure 3.2.5 Flood Characteristics: Damaged riverbank after floods by R. Gucha Migori

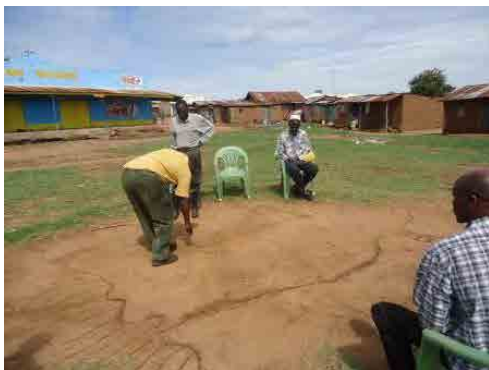
Drawing the map on the ground

Example of the community driven flood hazard map is shown in the figure 3.2.8 below.
