**DATA COLLECTION SURVEY  
ON  
ROAD CONNECTIVITY  
IN  
THE KINGDOM OF BHUTAN**

**FINAL REPORT**

**SEPTEMBER 2014**

**JAPAN INTERNATIONAL COOPERATION AGENCY**

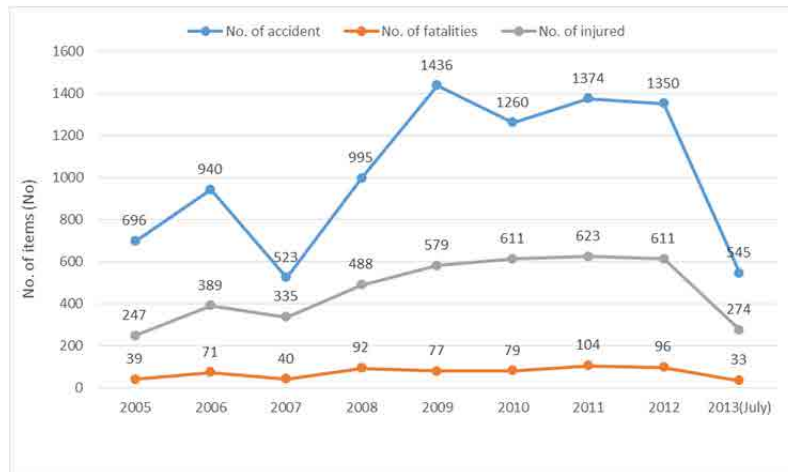
Source: Road Safety and Transport Authority, Annual Report Financial Year 2012-2013  
<Figure 2-19> Record of the number of accidents (death, injury)

A record of traffic accidents in Bhutan is shown in Figure 2-19. As shown in the figure, the traffic accidents increased rapidly from 2007 up to 2009. After 2009, the number of traffic accidents varies from 1,200 to 1,400. Traffic accident data is compiled by Road Safety and Transport Authority (RSTA) and its annual report stated that the number of fatal accidents was 14 per 10,000 vehicles in 2012. This probability is reported to be rather high in the South Asian area. Major details of accidents describe accidents caused by structural factors of roads, bad weather, poor visibility, etc.

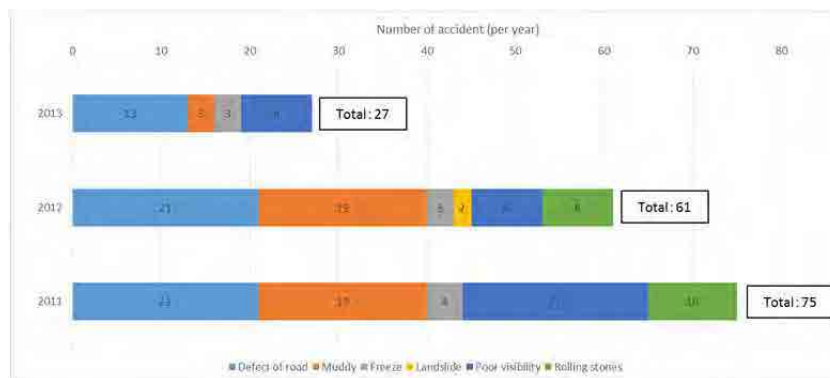
Source: Royal Bhutan Police  
<Figure 2-20> Record of number of accidents by road condition

The data regarding accidents managed by police is shown in Figure 2-20. This data does not cover all accidents that occurred on Primary National Highways, however, the relationship between the cause of accident and the condition of roads can be understood using this data. According to this, many accidents are often caused by “a defect of the road”. This includes various types of defects, however the major defect is not clear. “Mud on the road surface” and “bad visibility on the road” are raised as other causes.

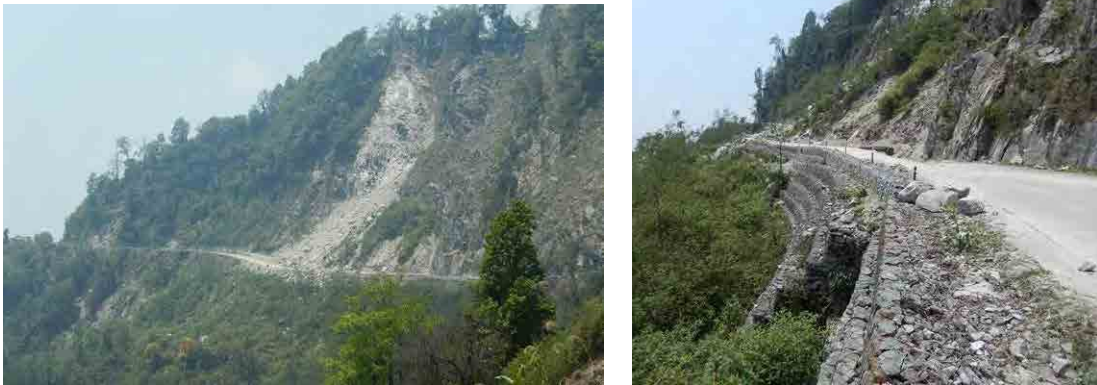
Source: Photos taken by JICA Study Team  
<Figure4-2> Jumbja landslide

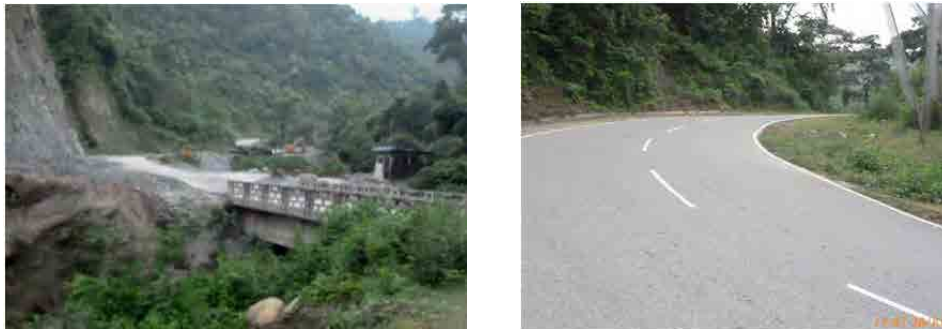
Source: Photos taken by JICA Study Team  
(Left) Section being widened, (Right) Widened section  
<Figure4-3> Condition of PNH3

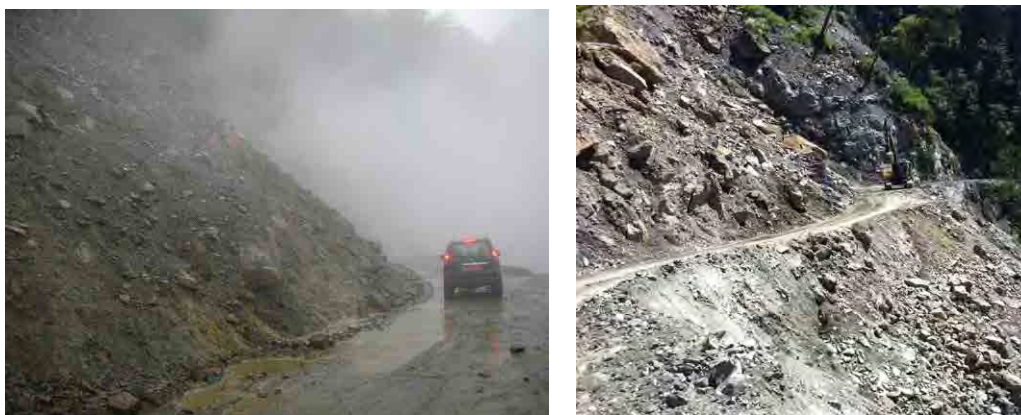
Source: Photos taken by JICA Study Team  
<Figure4-4> Slope failure condition (PNH4)

locations respectively in the Trongsa - Zhemgang section and Zhemgang - Gelephu section. The road is maintained moving new colluvial deposits occurring in the wet season from the mountain side of the road to the valley side.

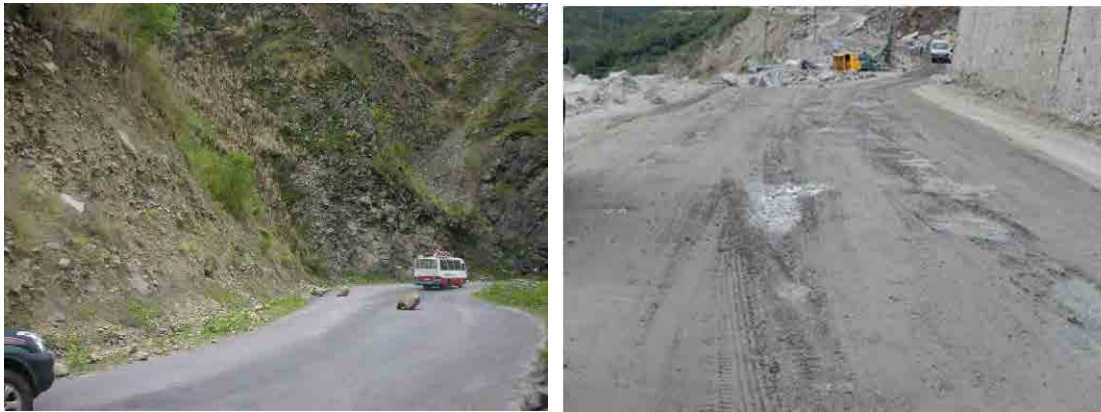
Source: JICA Study Team  
<Figure 4-5> Present condition of PNH-5

PNH-5 runs west from Gelephu to Sarpang, another city on the border, connecting to Wangdue of PNH-1. The traffic volume here is about 450 vehicles/day. At present, construction of the Phunatshangchu I/II Hydroelectric Project is in full swing. Note that this national highway is used in combination with the construction road, including many damaged and narrow sections.

There are some bridges constructed under Japan's grant aids on the route of this national highway. The bridge was washed away recently by the heavy rain of Cyclone Aila that struck Southern Asia in May, 2009. The washed-off bridge was reconstructed under the "The Project for Restoration and Improvement of Vital Infrastructure for Cyclone Disaster" in 2013, the last year. Though residents along the national highway include a relatively large proportion of the poor, this national highway is the most critical and beneficial route from the southern area to the capital and vice versa.

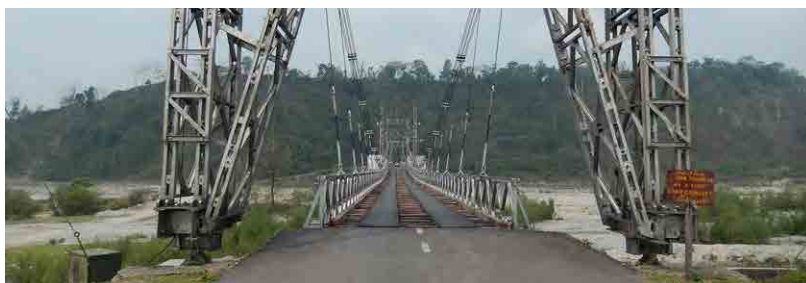
<Figure5-1> Narrow width bridge of the Southern East-West Corridor (Diana Kuenphen zam Bridge)

There are many sections of both roads and bridges in which only the carriageway width enough for one lane can be secured. Presently, the traffic volume is small in rural areas in particular, so that there are no problems such as traffic congestion, etc. However, with increasing traffic volume and the number of heavy vehicles in the future, traffic congestion and the traffic accidents during passing may possibly increase in the future.

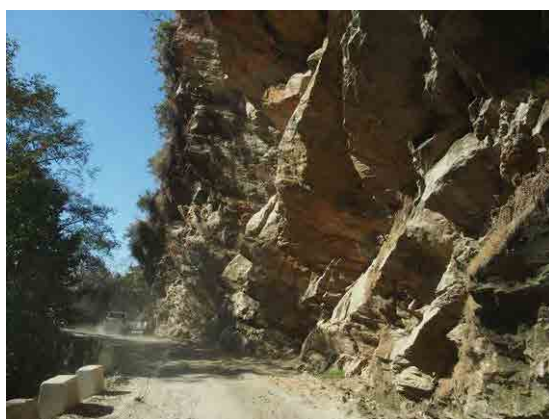
Source: JICA Study Team  
<Figure5-2> Overhanging rock slope (PNH-1)

In the site survey along PNH-1 and PNH-4, overhang terrain was observed in many slopes with exposed rocks. In such locations, the road alignment has horizontal curves with small radius to avoid the projecting rocky areas. Further, the sight distance and the vertical clearance are not secured to a satisfactory degree. The situations as above described are bottlenecks to safe and comfortable traveling because of the increase in trip time and traffic accidents (mainly head-on collisions) due to poor visibility.

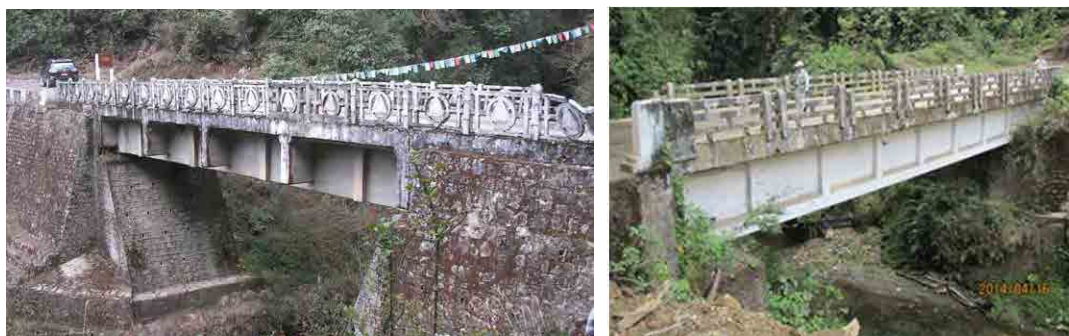
Source: JICA Study Team  
<Figure5-3> Deteriorated bridge on PNH-1 (Nagni zam Bridge) and PNH-4 (Chaplekhola zam Bridge)

There are old and damaged/broken bridges, and the increase in heavy vehicles in the future in line with the increase in the traffic volume may cause damage to or failure of the bridges. In this study, the site survey was conducted to determine the soundness of the bridges, and the results are detailed in Chapter 5-2.

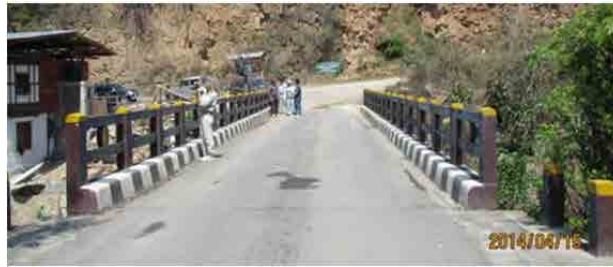
<Figure5-4> Chuzomsa zam Bridge on PNH-1 (Loading capacity=40R)

In the case of PNH-1, insufficiency of the loading capacity (40 R = about 58.5 MT) of existing bridges will become a bottleneck for smooth transport of the transformers used in the construction project of the Mangdechhu Hydroelectric Project, which is extremely important for the development of Bhutan. The transformer carrier's weight is a total of 115 MT including 80 MT of the transformer proper and 35MT for the trailer for its transportation.

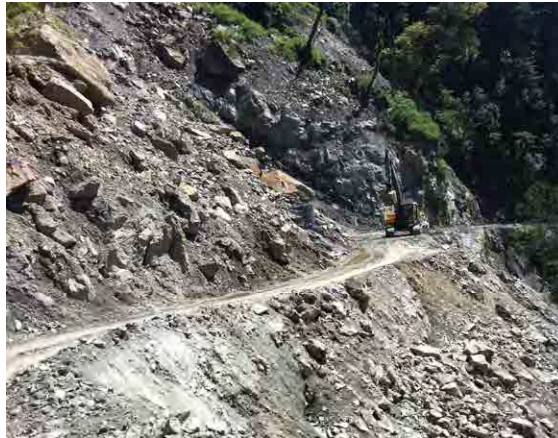
<Figure5-5> States of slope failure points along PNH-4

For all national highways in Bhutan, there exists a problem of road blockage caused by slope failure. The site survey along PNH-1 and PNH-4 confirmed loose rocks and small-scale failures in many talus slopes and the as-cut unstable slopes without any countermeasures in the cut slopes for road widening. Particularly in the rural areas, however, the traffic volume is so small that rock falling or slope failure does not interfere with the traffic enough to result in traffic accidents.

Namely, the current countermeasures are applied only to the long-term road blockages caused by large-scale failure. Once the road is blocked due to large-scale slope failure, personnel and logistics may possibly be disrupted for a long period of time.

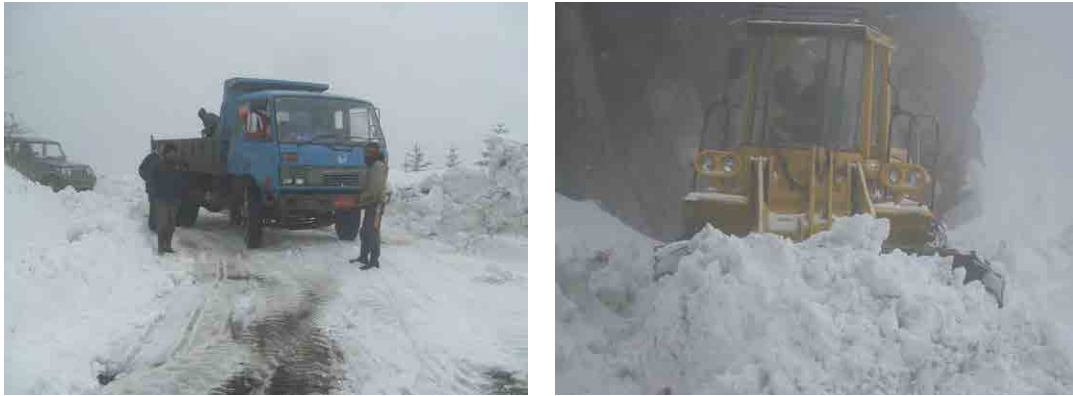
<Figure5-7> Snow cover state of the Thrumshing La and snow removal by DoR

PNH-1 has five passes with an altitude of 3,000 m or more above sea level (see Figure5-6). They are Dochu La (3,150m above sea level), Pele La (3,360m above sea level), Yotang La (3,400m above sea level), Shertang La (3,596m above sea level), and Thrumshing La (3,740m above sea level). Being located at high altitude, they have snowfall in the winter. Any snow cover on roads with steep slopes will make climbing of vehicles difficult, and vehicles have to wait in a long row till snow is removed by the regional office of DoR. These passes can be bottlenecks in the winter. The snow cover state in Thrumshing La and snow removal by DoR are shown in Figure5-7. According to a report from the DoR Lingmethang Regional Office, details of snow removal in Thrumshing La are as follows:

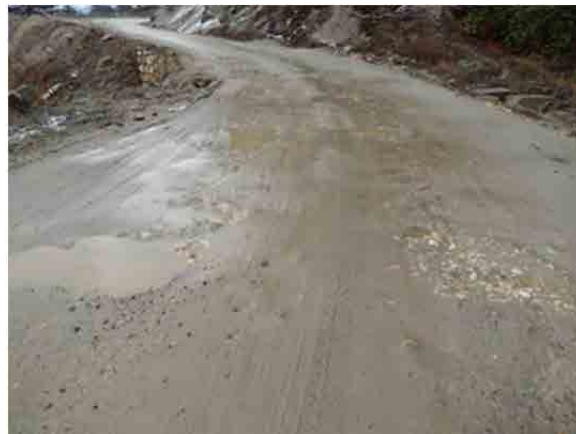
<Figure5-8> Road surface condition on northern slope of Thrumshing La Pass

Of five passes on PNH-1 as previously described, the section of about 5 km on the northern slope of Thrumshing La Pass is left neglected with the pavement surface course removed and the base course exposed because of low temperature and snow cover in winter and insufficient daylight hours for repair. For this section, repaving was attempted under assistance from ADB in 2004, but failed. Subsequently, DoR repeated re-pavement independently, with all attempts up to now resulting in failure. Poor road condition may be said to be a factor causing a traffic bottleneck because of increase in trip time or vehicle damage.

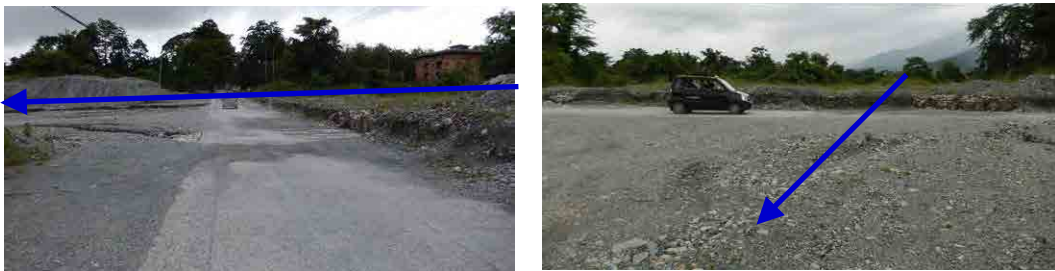
Source: JICA Study Team  
<Figure5-9> PNH-4 in Gelephu

For existing roads in the southern area, the embankment height was determined without taking into account the high water level of the river in many locations. In such locations, high water allows river water to overflow over the road surface, resulting in road flooding and disrupting vehicle traffic. According to the onsite report, heavy rainfall in rainy season causes overflow at the points indicated with arrows in Figure5-9, disrupting the road traffic, within the city of Gelephu along PNH-4.

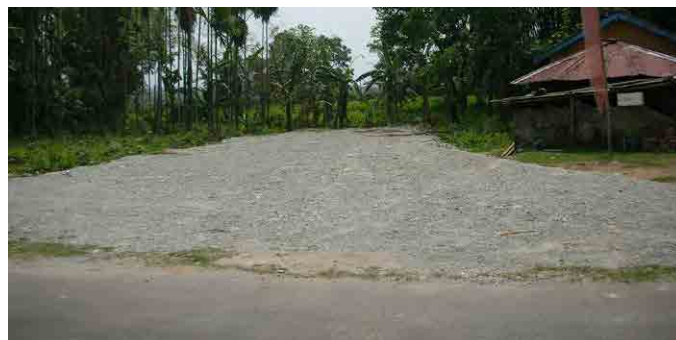
<Figure5-10> States of the unconnected section of the Southern East-West Corridor (the approach to Maukhola Bridge)

The construction work is delayed at present for the unconnected sections of the Southern East-West Corridor, which is an important alternative to PNH-1. This presents a bottleneck for securing safe and convenient material transportation route within Bhutan.

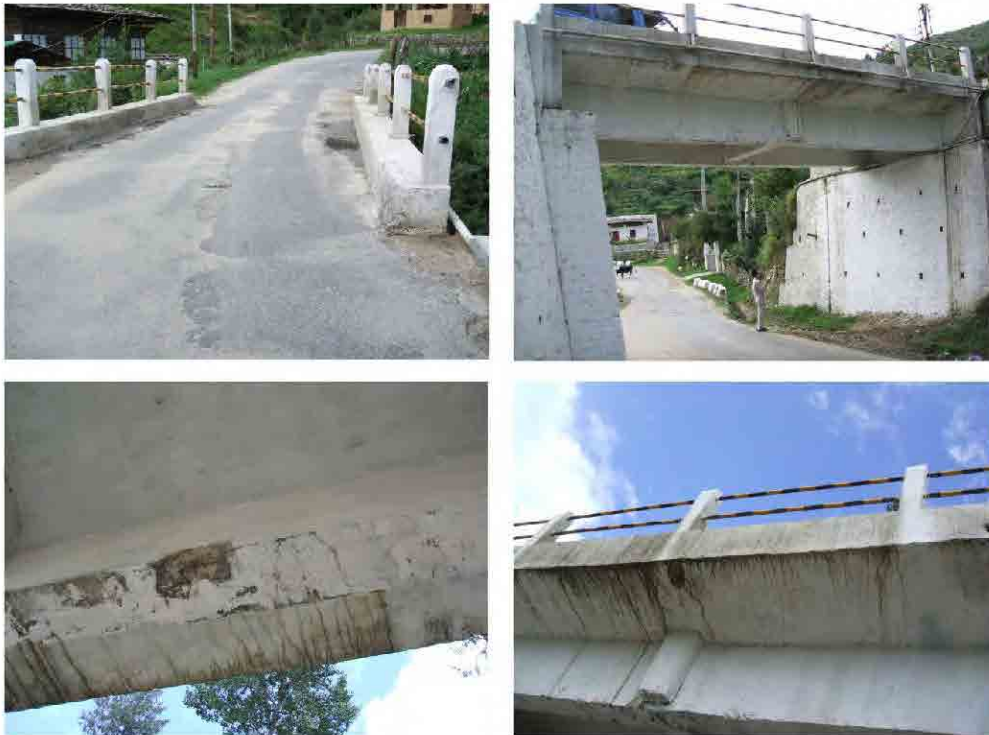
<Figure 5-13> Existing soundness survey data (2)

①	Defects on main girder is due to hiting by the over loading height of the public carrier
②	Recommended to provide H-shape steel to protect the main girder
③	Reinforcement bar revealing
④	White washing has been carried out
⑤	For details kindly refer the photographs.
⑥	-
⑦	-
⑧	-
⑨	-
⑩	-

[Bridge Condition Photos] Bridge Name: Semtokha Flyover Zam (TH-15) Date: 20th,Jul,2006

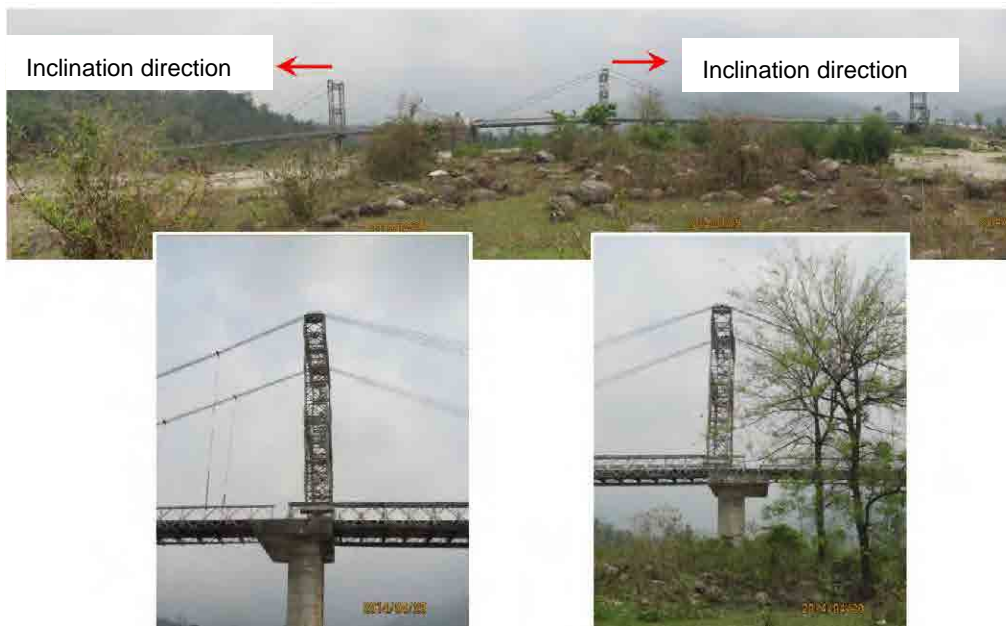
<Figure5-15> States of inclination of the main tower

- Panel points of the main tower are not rigid connections, but pin connections. Although the vertical load is predominant in the main tower, inclination caused by the unbalanced lateral load acting on the pin connections may lead to collapse because it is difficult to maintain its stability.

- The tower top is structured to allow sliding of the cable (wire). If this portion is so corroded as to make wire sliding impossible, a horizontal force occurs at the top and the resultant horizontal force may cause collapse of the tower similarly to the case above described. Specifically, such horizontal force may cause turning of the pin connections of the tower (no bending moment occurs because the connections are pin connections, but rotation may occur).

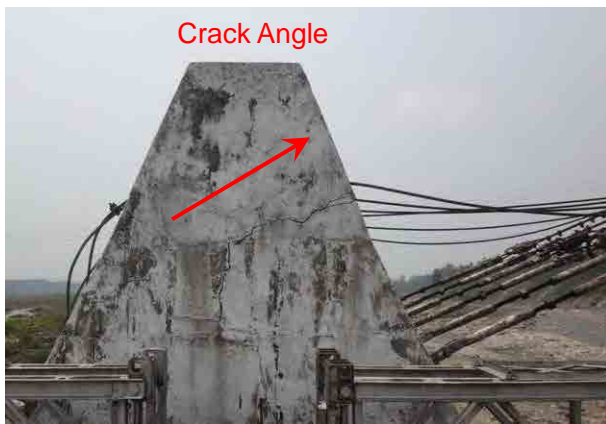
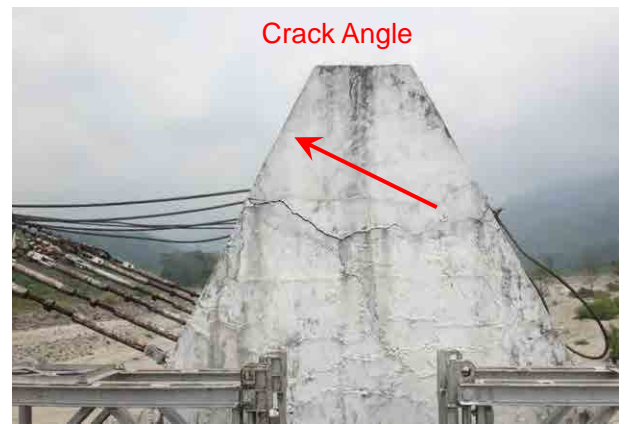
Source: JICA Study Team  
<Figure5-16> Cracks in the anchorage

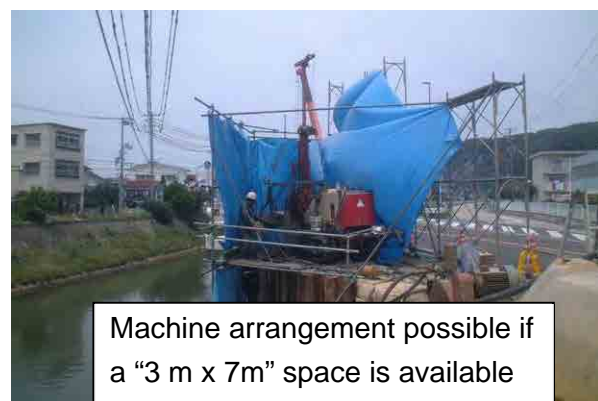
<Figure6-5>Execution

- With a highly-mobile compact machine or plant, this method proves extremely effective in a narrow place where the construction environment is severe.
- By selecting the drilling method that is appropriate for the ground conditions, piling under various geological conditions is possible.
- Environmental consciousness to minimize vibration and noise in the course of construction is important,

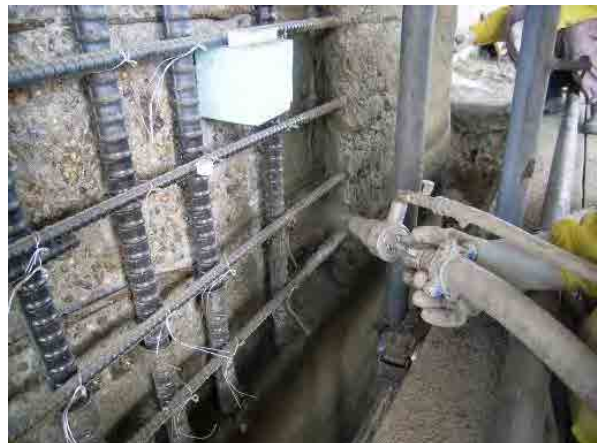
Source: NETIS  
<Figure6-6>Execution

a. The thickness of the lining can be decreased to about 1/5 of that required by other methods in the past by setting the reinforcing steel on the surface of the existing pier and spraying with a special polymer cement mortar lining material which is great in strength characteristics (compression, bending, adhesion, etc.) and durability rather than using concrete.

b. The following effects can be expected by adopting by spraying the mortar lining;

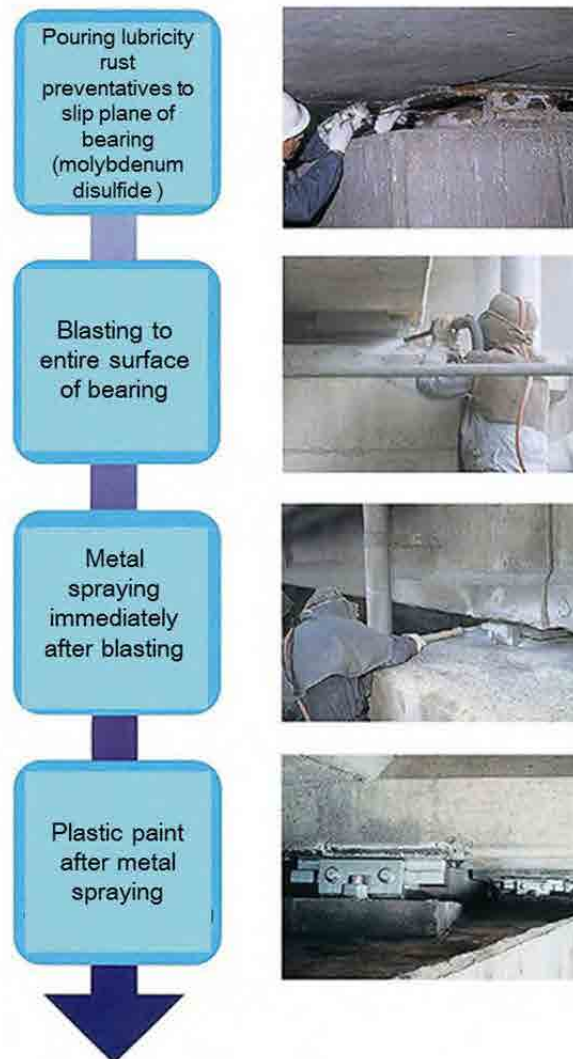
Rejuvenation of existing steel bearings is achieved by treating them with an anticorrosive rust preventative lubricant.

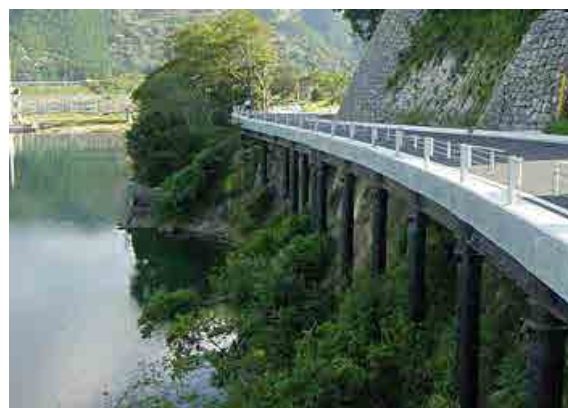
<Figure6-9>Example of the method

- a. This method requires the prefabrication of short structural sections that are easy to transport and erect. Weight of each section is approximately 2ton.
- b. The jointing method can absorb errors in pile work up to 100mm
- c. The impact of existing traffic can be minimized by implementing a launching erection method

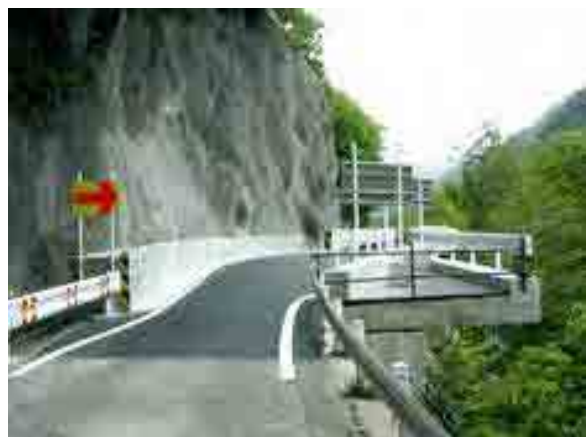
<Figure6-11>Example of the method

- a. This method maximizes the principle of leverage to ensure stability by constructing a precast retaining wall on the mountain side of floor slab and pouring cast-in place concrete behind the wall to make the slab stable.
- b. It is applicable to every geological condition and road alignment. Few impacts on the natural environment are expected since it does not violate sleep on the both side of mountainside and valley side.

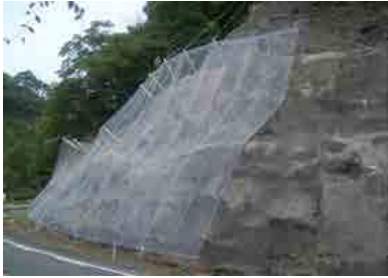
<p>Source: Hinomaru website</p>	<p>The net covers the entire surface of the slope that rock fall may occur on using lightweight materials such as wire mesh or wire rope. Quick construction is possible because it is lightweight.</p> <p>① Covering type rock fall protection net : It binds the rocks that have lost their binding force to the ground by the tension of the wire mesh and friction of the ground wire mesh. It doesn't allow falling rock to bound but lets them slide along the slope.</p> <p>② Pocket type rock fall protection net : This is composed of hanging ropes, props, wire mesh, wire rope etc. and provides an entrance for falling rock on the upper part and absorbs the energy of the falling rock by collision of the falling rocks with the wire net. It is adopted when there is small scale rock fall, exfoliation from base rock, rock fall that tends to occur frequently and rock fall from high places is expected.</p>

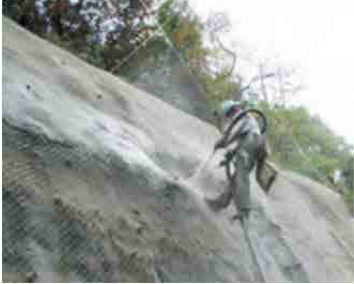
<p>Spraying method</p>

<p>Source: Amanokigyo inc. website</p>	<p>This prevents weathering of rock, collapse and erosion due to penetration of rainwater by spraying mortar and concrete on the slope. For the cliff surface degraded by weathering, etc., it is one of the methods with a high adoption record since the blocking effect on water penetration, the changes of temperature and outside air is very high and workability is excellent. It is also adopted for the cut slopes and tunnel lining. This is conducted by transportation of mortar and concrete to the prescribed position through a high pressure hose or pipe by compressed air and the cast concrete and compaction is done by spraying powered by the compressed air not using concrete forms.</p>
<p>Rock shed</p>

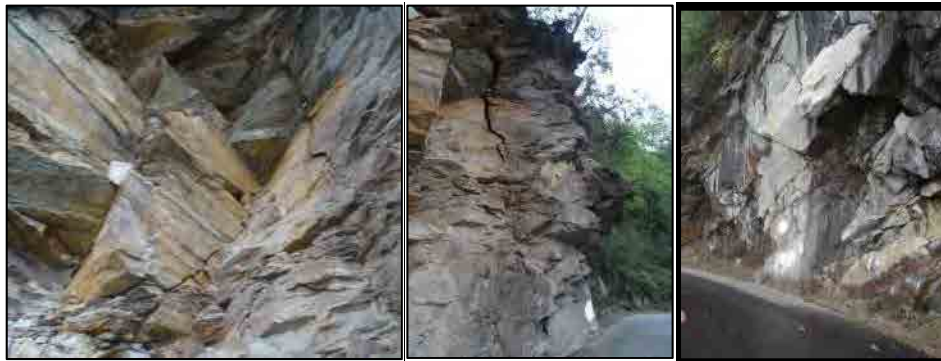
Source: JICA Study Team  
<Figure6-14>Site condition

The geological condition consists mainly of granite and amphibolite, with the rock classified in the range of B to CII classes. Here the rock is classified approximately CI class for the design. The strike and dip is predominantly N20W~25E and 60S ~ 25N for Thomang Cliff and N30E~40E and 45N~15N for Namling Cliff. Construction along the road may uncover stratum with opposite dip in many locations. However, dip slope and break-away may cause falling rocks in certain locations.

Cracks tend to be wedge-wise fall-off or block-like separation of more or less 2m, as shown above. It is essential to select a construction method that can handle these rocks.

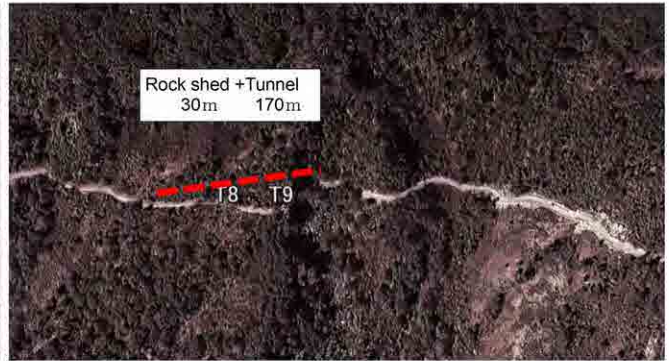
Source: JICA Study Team  
 <Figure6-16> Location of survey for Thomang Cliff

Tunneling is chosen for the mountain ridge and blocky rocks of 20 m or more for the benefit of road alignment. Rock sheds are to be applied to the slope before and after the tunnel to function as rock fall protection. For the rock fall protection net, the spraying work is to be employed along with rock bolts and applied to the slope or precipitous wall of 20 m or less. Figures 6-16 to 6-20 show the survey state and the section selected for construction.

Surveys were done at Thomang Cliff and Namling Cliff. Then, the locations where the countermeasures utilizing the technologies of Bhutan were considered difficult were extracted as shown in Figure6-16 to Figure6-20. The survey section is 955 m long for Thomang Cliff and 1320 m for Namling Cliff.

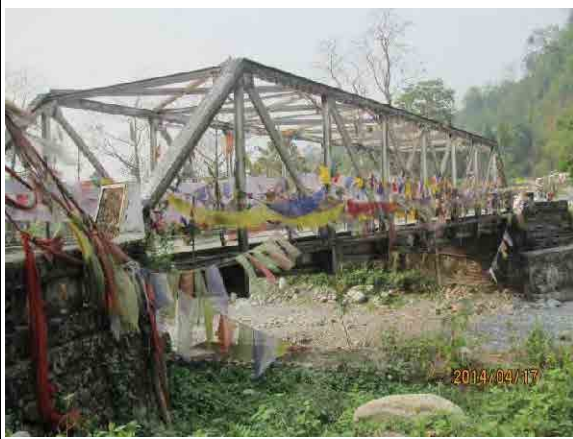
B-1. Passang zam Bridge

<ul style="list-style-type: none"> <li>The existing bridge is 40 m long. The new bridge position must be changed to the upstream or downstream side according to the road alignments. Since the bridge may possibly reduce the river width, it is essential to analyze the river conditions and to set up the proper bridge length. If the bridge length of 50 m in the reconstruction proposal is valid, a prestressed concrete bridge should be preferred (the post tensioning box-girder preferred).</li> <li>Since the river is dried up except for the wet season, erection of the superstructure with the fixed support (the representative method with the cast-in-place box girder) may be possible depending on the results of the study.</li> </ul>
B-2. Beteni zam Bridge

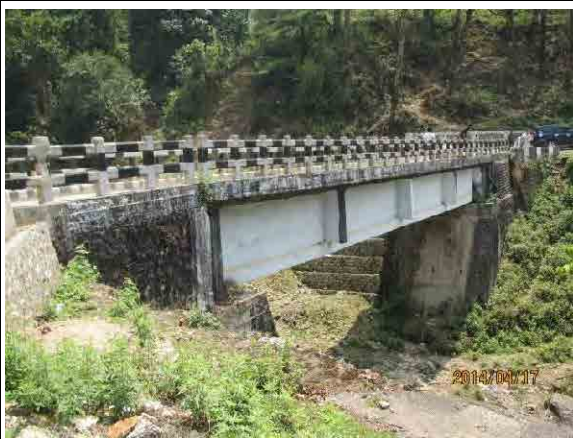
<ul style="list-style-type: none"> <li>The existing bridge is 25 m long. A new bridge may have to be repositioned to the downstream side, with the length increased slightly. If the length of 30 m shown in the table is selected, a prestressed concrete bridge should be preferred (the post tensioning T-girder considered preferred).</li> <li>Erection with erection girders is planned because the large cranes are considered difficult to carry to the site.</li> </ul>

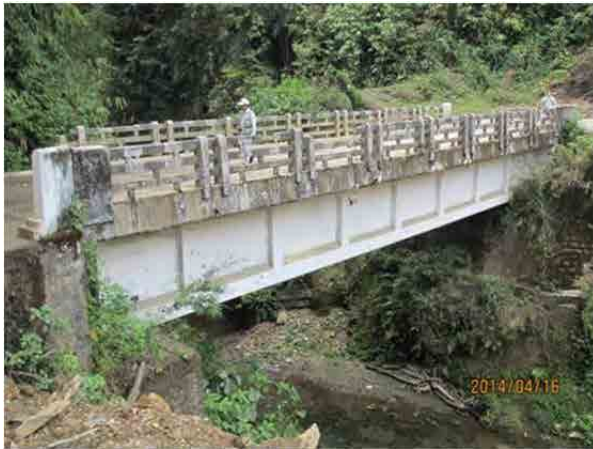
B-4.Chaplekhola Bridge

- The existing bridge is 20 m long. A new bridge may have to be repositioned to the downstream side, with the length increased slightly. The length of 25m in the table is selected.
- If the length of 25 m shown in the table is selected, a PC bridge should be preferred rather than RC bridge considering the design load of 70R. (In Japan, PCT girder is preferable if the bridge is 25m long.)  
⇒Construction cost is calculated for a PC bridge.
- Erection with an erection girder is planned because the valley is deep and construction of timbering is considered to be difficult and the large cranes are considered to be difficult to carry to the site.

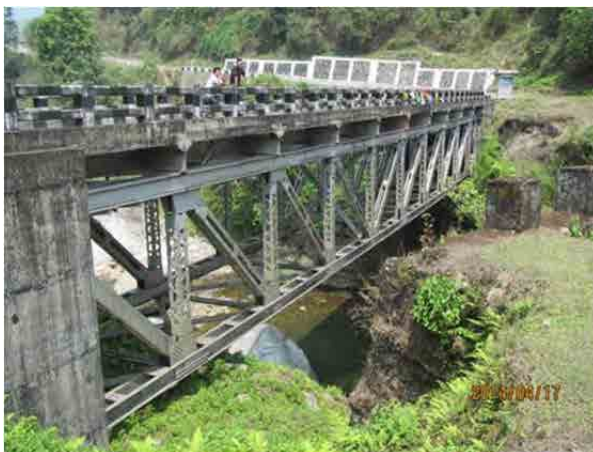
- The existing bridge is 61m long. A new bridge may have to be repositioned to the downstream side, with the length increased slightly. (The substructure of an older bridge is on the upstream side). It is proposed to be steel truss bridge of the length of 65m in this bridge plan, reexamination of bridge type considering the erection method is necessary in the detail plan stage.  
⇒Construction cost is calculated for a steel truss bridge (65m)
- Rock is exposed and a spread foundation substructure is considered to be possible.

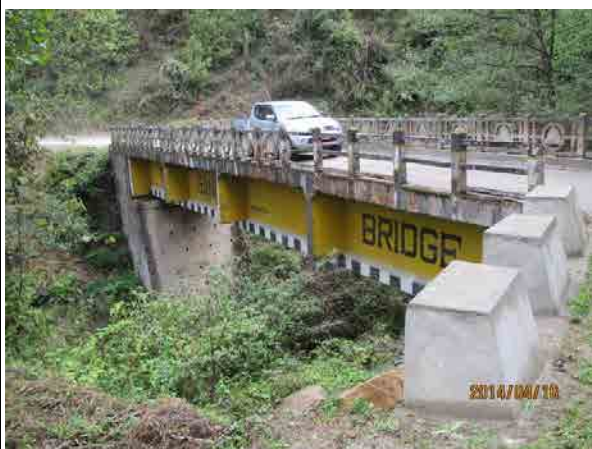
- The existing bridge is 25 m long. A new bridge may have to be repositioned to the downstream side, with the length increased slightly. A bridge length of 28 m in the table is selected.
- Considering the design load (70R), the reinforced concrete bridge of 25 m in length, if selected, may be economically unacceptable when compared with a prestressed concrete bridge. (In Japan, the prestressed concrete T girder is predominant when the bridge length is 25 m.) ⇒ **The construction cost was calculated for the prestressed concrete bridge.**
- Erection with erection girders is planned because the valley is so deep and the river level is so high that support would be difficult to construct and large cranes are considered difficult to carry to the site.

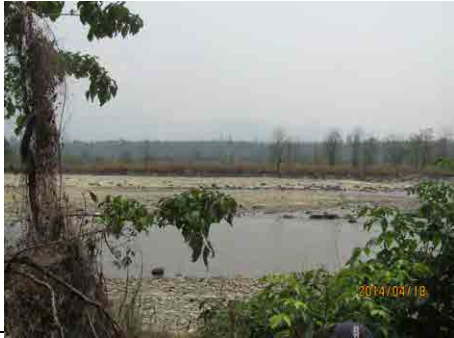
Views of Maukhola river, the opposite shore and Sandbank from the abutment position of the right bank. (Elevation difference between the log way on the right bank is small)
⑥

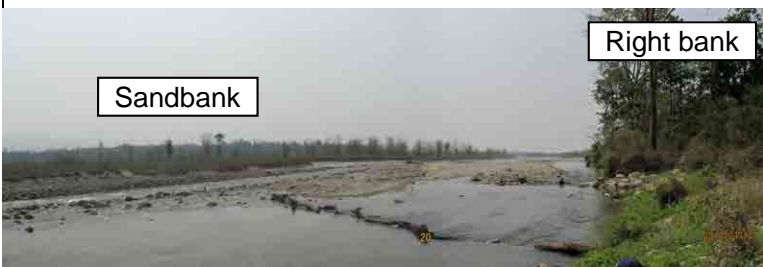
Log way on right bank side
⑦

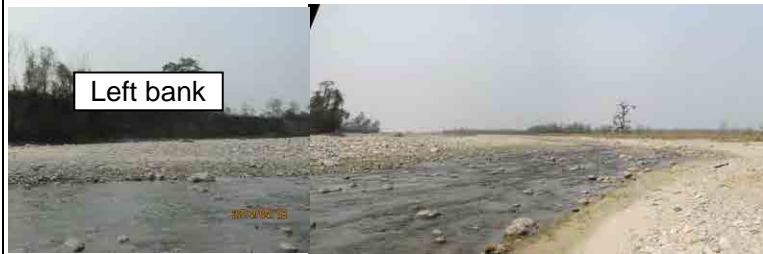
Log way on left bank side
⑨

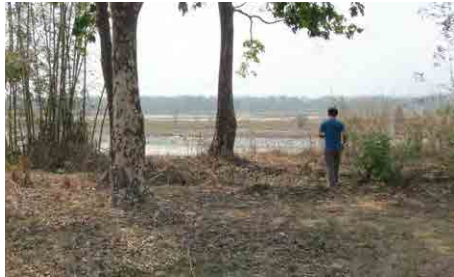
Views on Maukhola river, sandbank and opposite shore from the abutment position of the left bank. (There is an elevation difference between the log way in the left bank.)

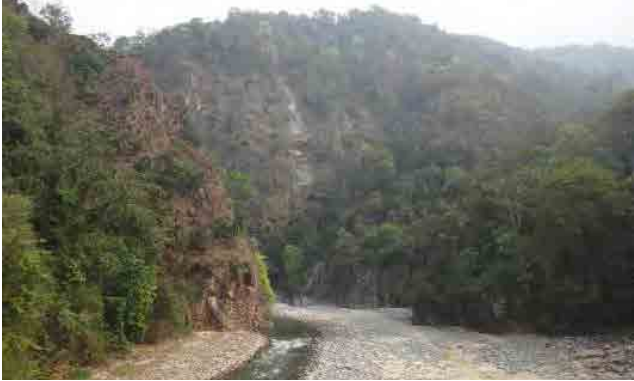
<p>Maukhola River</p> <ul style="list-style-type: none"> <li>• View upstream from Geleg (Aie) zam</li> <li>• Flow of the Maukhola river moves from the mountain area to an alluvial fan area.</li> </ul>

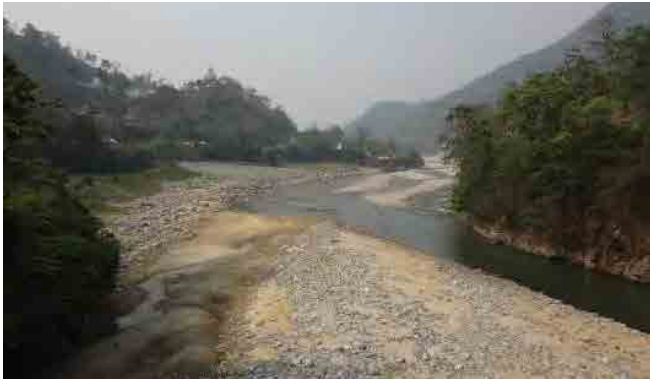
<p>Maukhola River</p> <ul style="list-style-type: none"> <li>• View downstream from Geleg (Aie) zam</li> <li>• Flow of the Maukhola river moves from the mountain area to an alluvial fan area.</li> </ul>

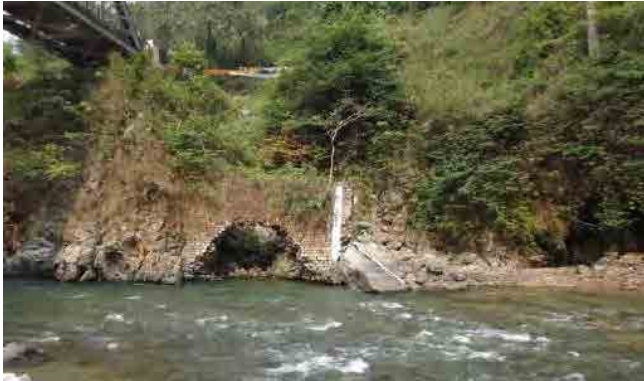
<p>Maukhola River</p> <ul style="list-style-type: none"> <li>• Gauging station upstream of Geleg of (Aie) zam.</li> </ul>

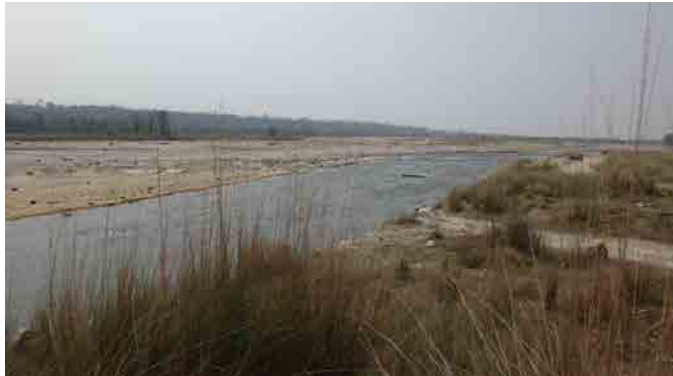
<p>Maukhola River</p> <ul style="list-style-type: none"> <li>• Water route on the right bank side</li> </ul>

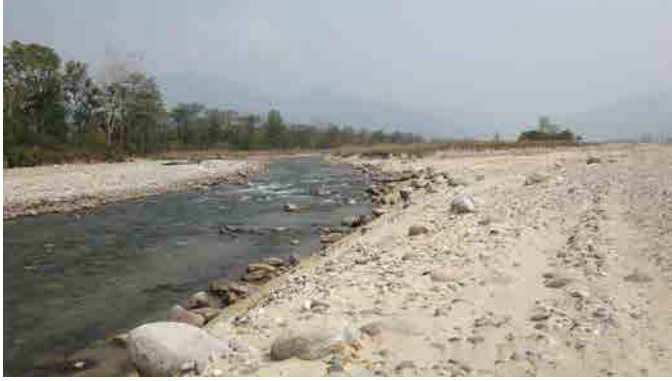
<p>Maukhola River</p> <ul style="list-style-type: none"> <li>• View upstream</li> <li>• Water route on the right bank.</li> <li>• Near Maukhola bridge construction site</li> </ul>

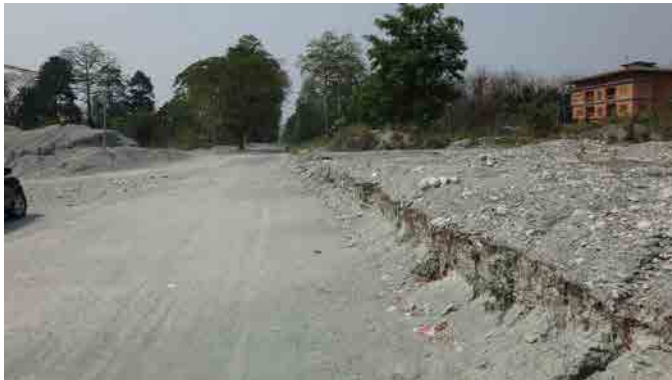
<p>Right tributary1 (Downstream side of the bifurcate)</p> <ul style="list-style-type: none"> <li>• Concrete pavement allowing overflow (River bed and road surface is at the same height. Traffic is closed during flood)</li> </ul>

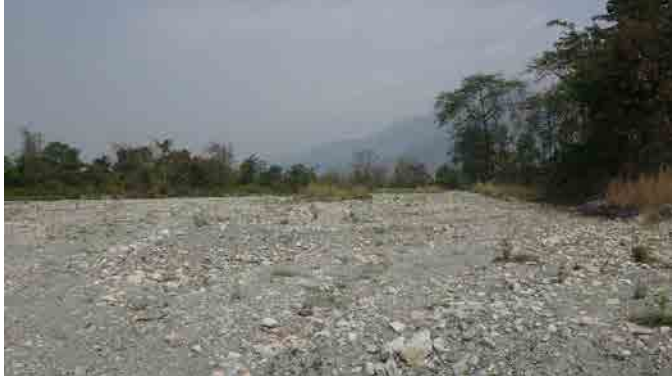
<p>Right tributary1 (Downstream side of the bifurcate)</p> <ul style="list-style-type: none"> <li>• No water in the river channel.</li> </ul>

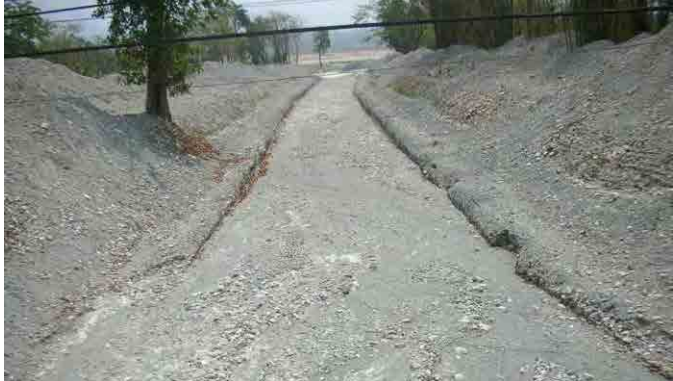
<p>Right tributary1 (Downstream side of the bifurcate)</p> <ul style="list-style-type: none"> <li>• View downstream</li> <li>• No water in the river channel.</li> <li>• Embankment on the left and right bank is the soil excavated from the river bed</li> </ul>

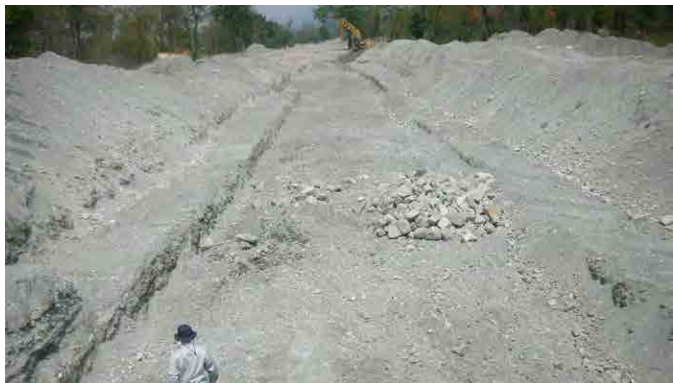
<p>Right tributary1 (Downstream side of the bifurcate)</p> <ul style="list-style-type: none"> <li>• View upstream</li> <li>• No water in the river channel.</li> <li>• Embankments on the left and right are made of the soil excavated from the river bed</li> </ul>

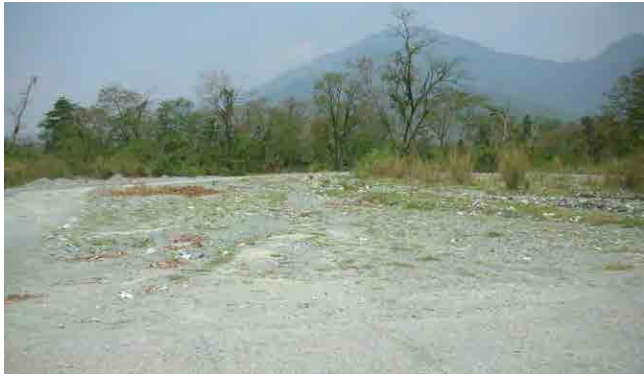
<p>Right tributary 2</p> <ul style="list-style-type: none"> <li>• View upstream</li> <li>• No water in the river channel.</li> </ul>

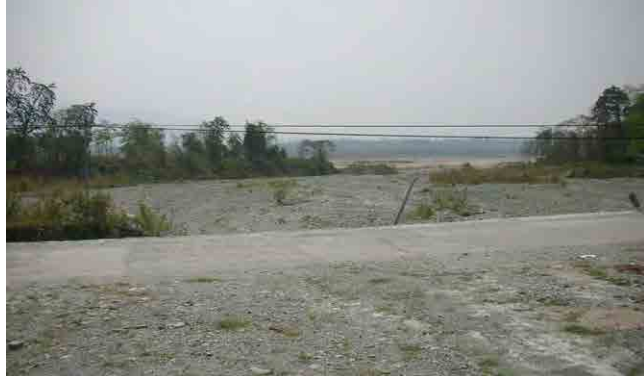
<p>Right tributary 2</p> <ul style="list-style-type: none"> <li>• View downstream</li> <li>• No water in the river channel.</li> <li>• Concrete pavement allowing overflow</li> </ul>

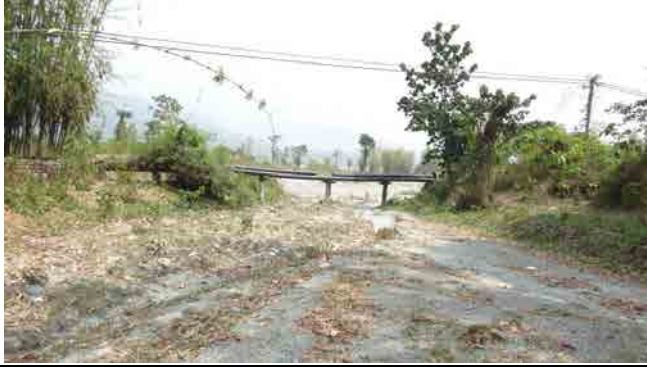
<p>Right tributary 3</p> <ul style="list-style-type: none"> <li>• View downstream</li> <li>• No water in the river channel.</li> </ul>

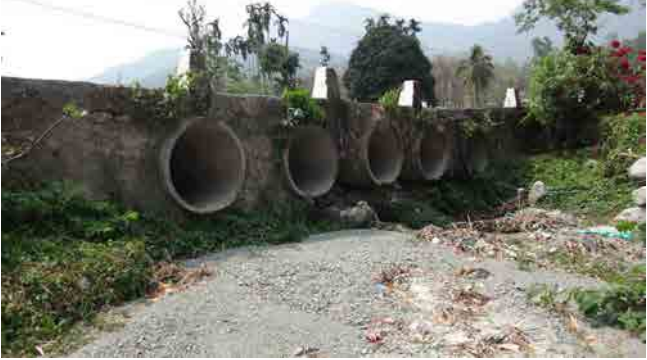
<p>Right tributary 3</p> <ul style="list-style-type: none"> <li>• View downstream</li> <li>• No water in the river channel.</li> <li>• Structure of road intersection is 5 stations storm pipe.</li> </ul>

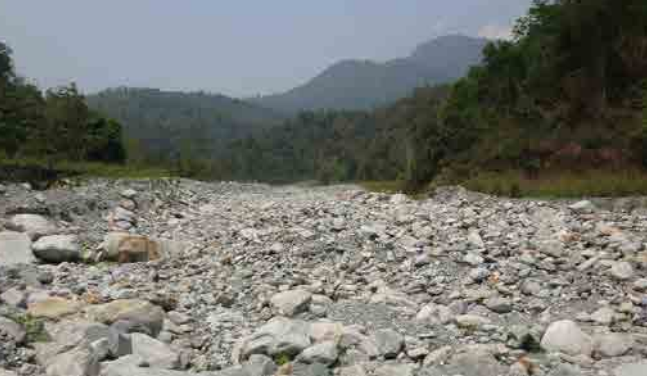
<p>Right tributary 4</p> <ul style="list-style-type: none"> <li>• View upstream</li> <li>• No water in the river channel.</li> <li>• The largest rock is about <math>\phi = 1.0\text{m}</math>.</li> <li>• Excavation of river bed is conducted before the rainy season. (interview with DoR)</li> </ul>

- Right tributary 4, right tributary 5 and left tributary 5 are steep streams and there is slope failure therefore large diameter gravel is washed into the river.

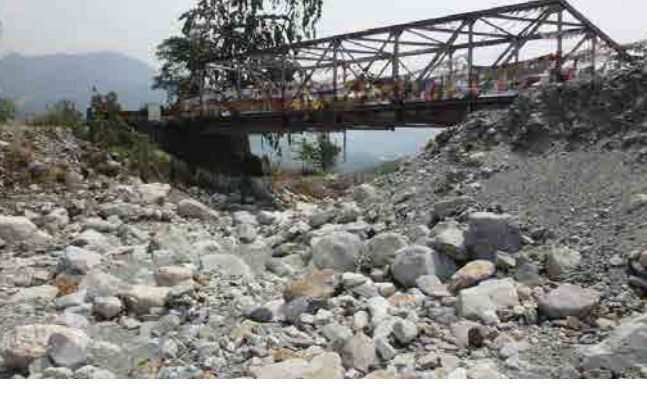
<p>Right tributary 4</p> <ul style="list-style-type: none"> <li>• View downstream</li> <li>• No water in the river channel.</li> <li>• The largest rock is about <math>\phi = 1.0\text{m}</math> • Excavation of river bed is conducted before the rainy season.(interview with DoR)</li> </ul>

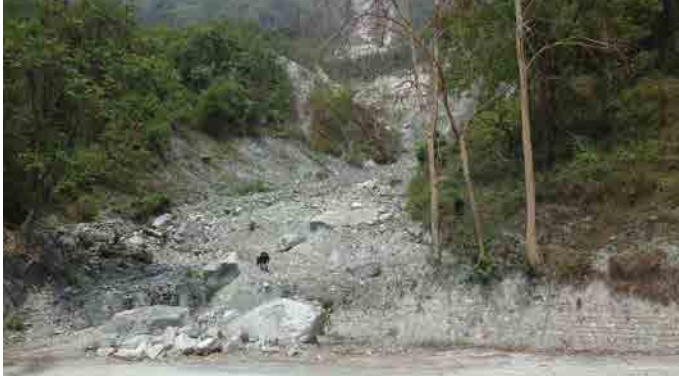
<p>Right tributary 5</p> <ul style="list-style-type: none"> <li>• View upstream</li> <li>• Soil from slope failure is washed into the river channel.</li> </ul>

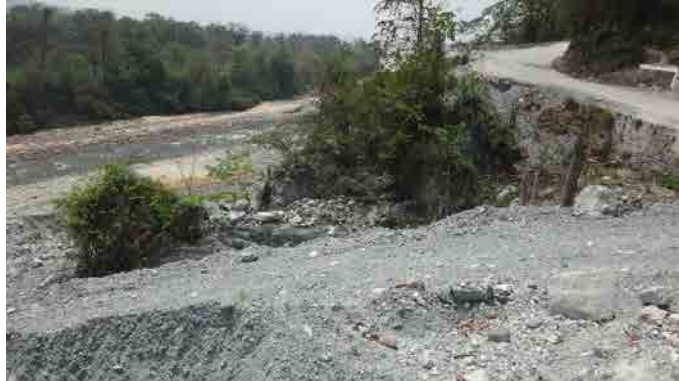
<p>Right tributary 5</p> <ul style="list-style-type: none"> <li>• View downstream</li> <li>• Soil from slope failure is washed into the river channel.</li> </ul>

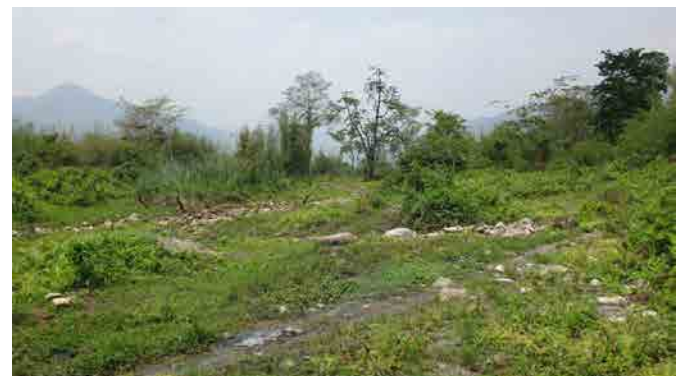
<p>Left tributary 1</p> <ul style="list-style-type: none"> <li>• View upstream</li> <li>• Water and vegetation exist.</li> </ul>

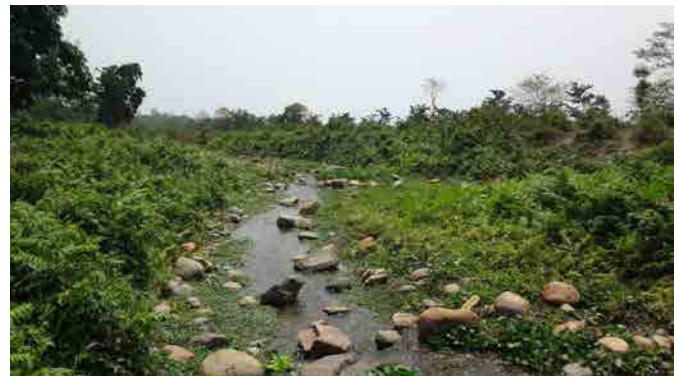
<p>Left tributary 1</p> <ul style="list-style-type: none"> <li>• View downstream</li> <li>• Water and vegetation exist.</li> </ul>

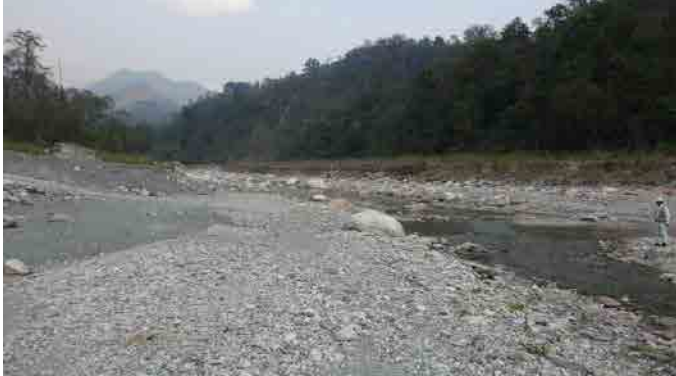
<p>Left tributary 4</p> <ul style="list-style-type: none"> <li>• View upstream</li> <li>• Water exists. Flow volume is small.</li> </ul>

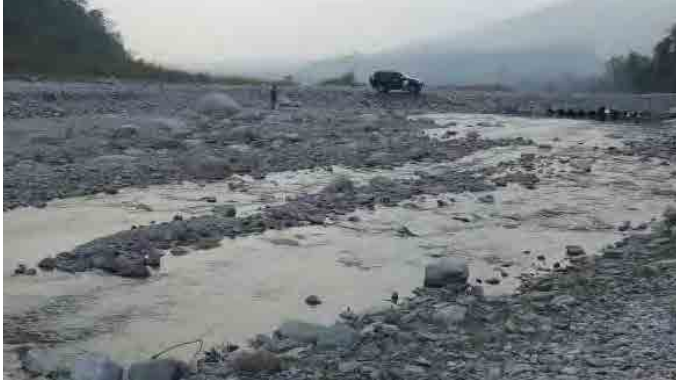
<p>Left tributary 4</p> <ul style="list-style-type: none"> <li>• View downstream</li> <li>• Water exists. Flow volume is small.</li> <li>• It is temporary structure of hume pipe and embankment in the crossing point of river channel.</li> </ul>
