**DATA COLLECTION SURVEY  
ON  
ROAD CONNECTIVITY  
IN  
THE KINGDOM OF BHUTAN**

**FINAL REPORT**

**SEPTEMBER 2014**

**JAPAN INTERNATIONAL COOPERATION AGENCY**

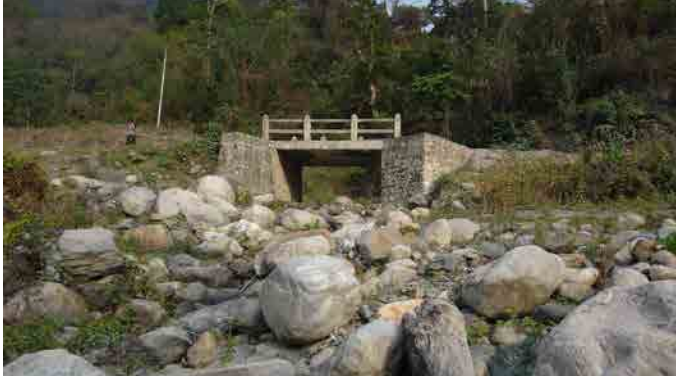
<p>Left tributary 5</p> <ul style="list-style-type: none"> <li>• View upstream</li> <li>• No water in the river channel.</li> <li>• The largest rock is about <math>\phi = 1.0\text{m}</math></li> </ul>

- Right tributary 4, right tributary 5 and left tributary 5 are steep streams and there is slope failure therefore large diameter gravel is washed into the river.

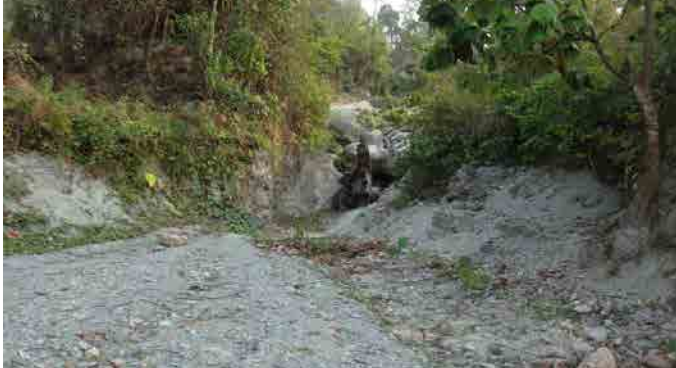
<p>Left tributary 5</p> <ul style="list-style-type: none"> <li>• View upstream from the main stream</li> <li>• No water in the river channel.</li> </ul>

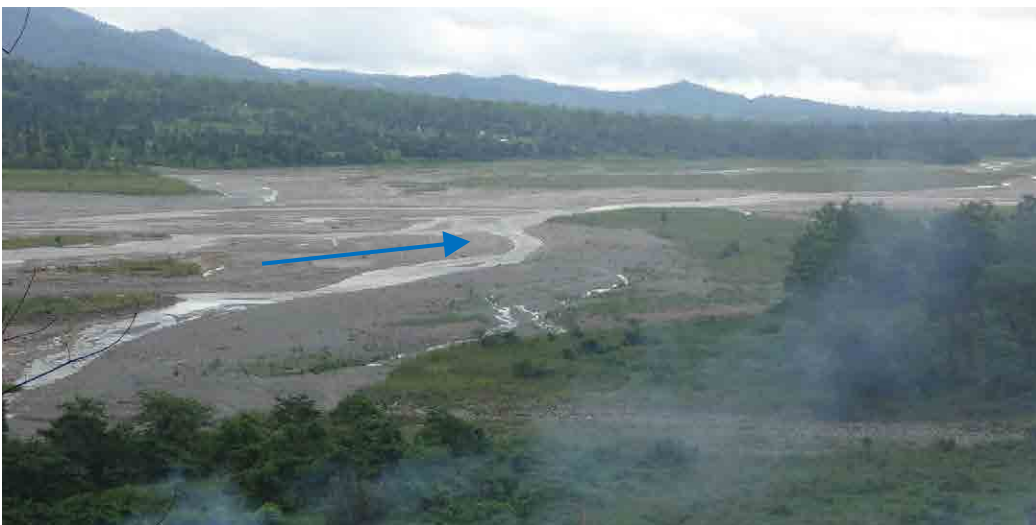
Source: JICA Study Team  
<Figure 7-15>View of Maukhola river

- The river channel does not seem to ever become more swollen than the current river channel.
- The small island with grass field remains in all seasons.
- The number of water routes has increased above those in the dry season and the volume of water has increased compared to the dry season. However, the volume is small.

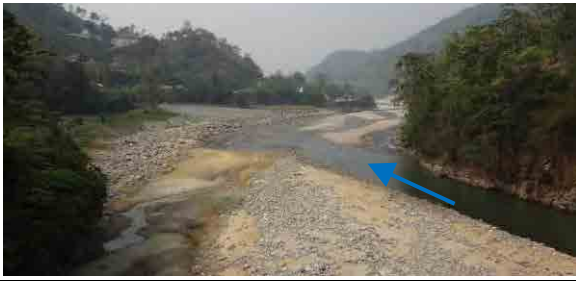
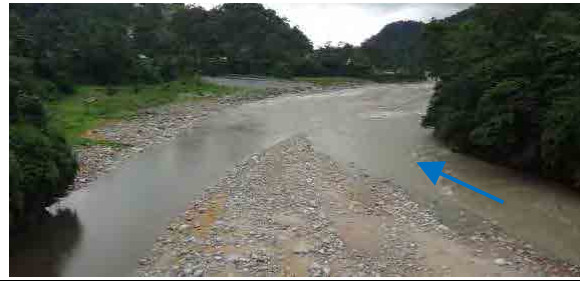
<Figure 7-16>Photo at Geleg (Aie) Bridge (taken by JICA Study Team)

<ul style="list-style-type: none"> <li>• The change in the material of the river bed is small and flood is not expected at the moment.</li> <li>• Water flow has increased.</li> </ul>

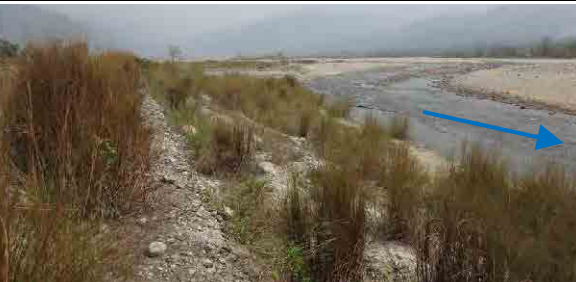
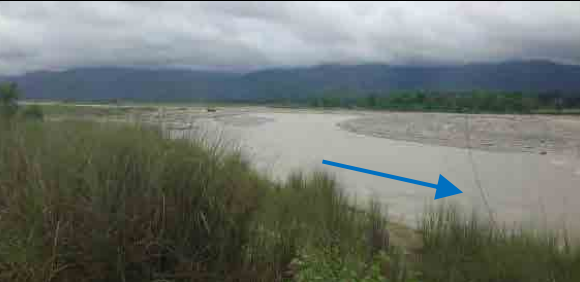
<ul style="list-style-type: none"> <li>• The increase of water volume is observed. However the quantity of vegetation has not decreased and flooding is not expected at the moment.</li> </ul>

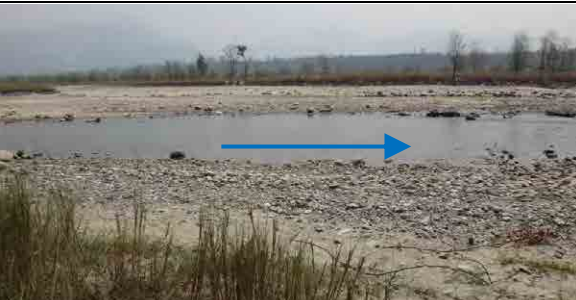
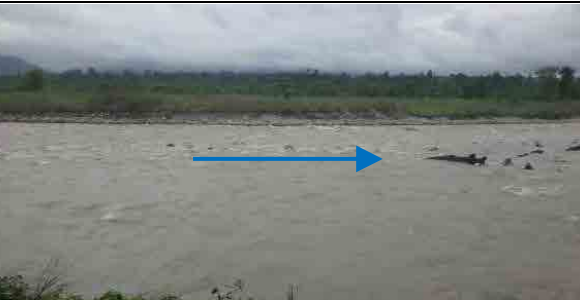
<ul style="list-style-type: none"> <li>• The increase of water volume is observed but no evidence of the flooding can be seen.</li> <li>• A small island with woodland remains visible therefore no flooding is expected at the moment.</li> <li>• The flow velocity of the center of the channel was about 4m/s at the time of the survey. (simple measurement at site)</li> </ul>

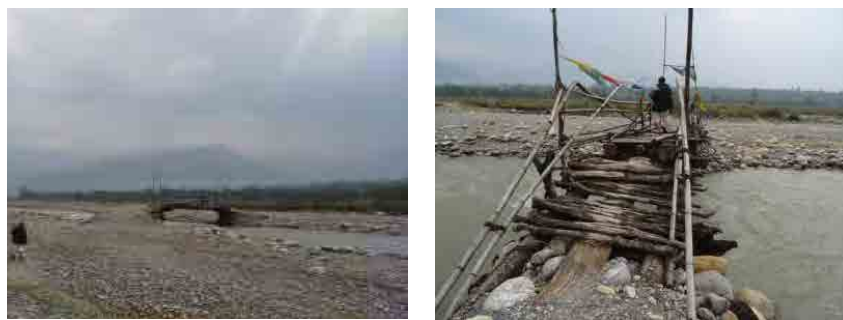
Source: JICA Study Team  
<Figure7-24>Temporary timber bridge over the Maukhola

The Maukhola River runs low during the dry season and allows people to ford it at some points. Mostly, however, it is over some temporary bridges placed over the river that people come and go between the banks. During the rainy season, these temporary bridges are washed away by flood, so people use boats to cross the river, but the river, when running high and rapid, is dangerous.

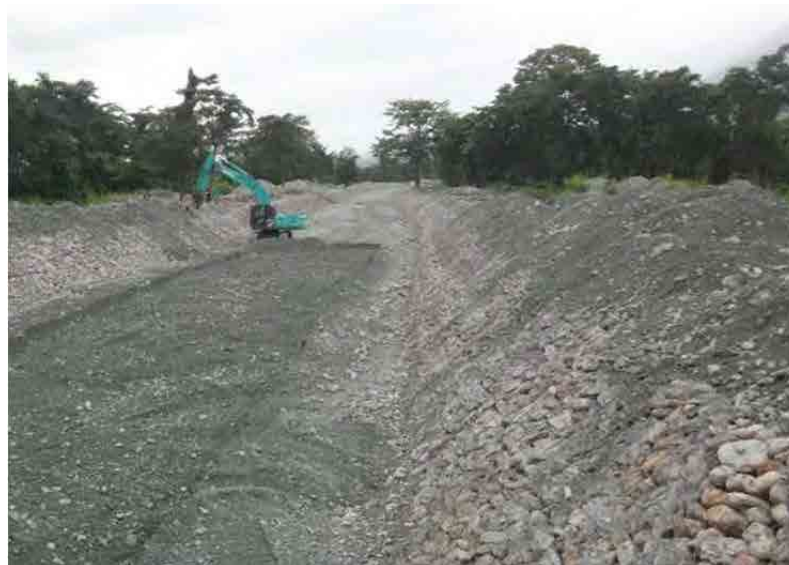
<Figure 7-25> Embankment protection works on Shetikharey river (Right tributary1)

Bank protection is under construction on the right tributary1 of the Shetikharey River in Sarpang. The current situation as of July 2014 is as below.
