## **CHAPTER 12**

### **STUDY OF TIDE OBSERVATION SYSTEM**

### **12.1 TIDE OBSERVATION SYSTEM**

#### **12.1.3 INTRODUCTION OF TIDE OBSERVATION EQUIPMENT IN YANGON PORT**

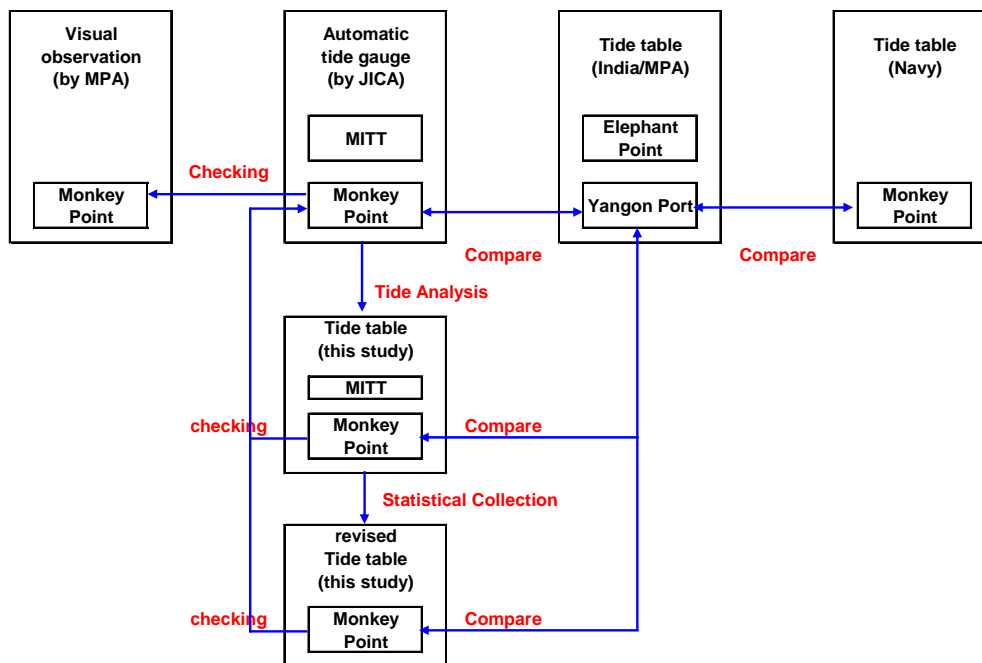
The flow of analysis using the observation data of tide levels obtained at Monkey Point and MITT is shown in Figure 12.2.1. First, the characteristics and accuracy of the MPA and Navy Tide tables were checked by comparing with the observation data. Second, the tide levels during the observation periods were predicted with the harmonic analysis of observation data, and then the accuracy of predicted tide levels were checked with the observation data. In the course of analysis, the errors considered as influence of the river were discovered. The errors were collected, and the accuracy of collected prediction of tide levels were checked with the observed data.

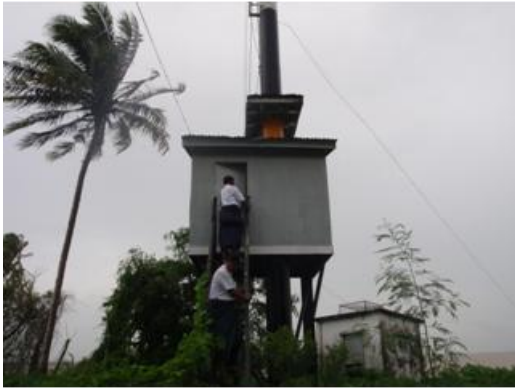
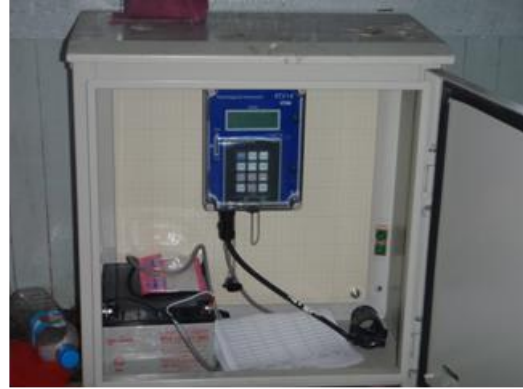
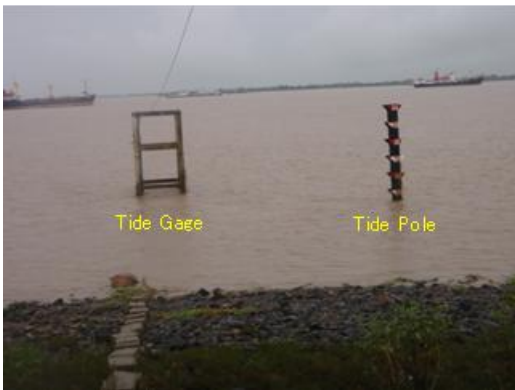
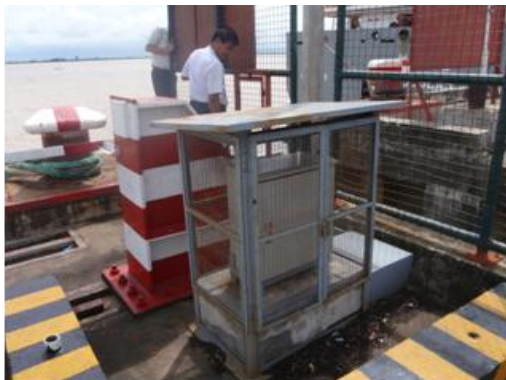
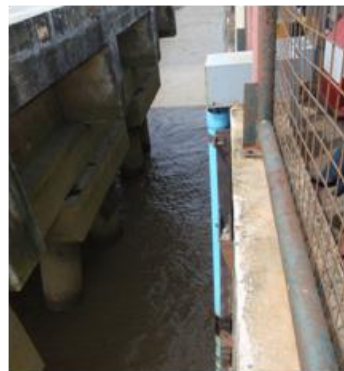
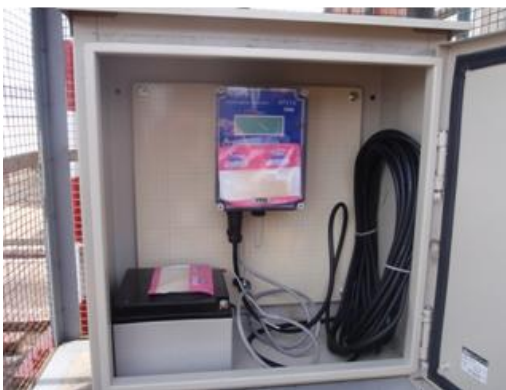
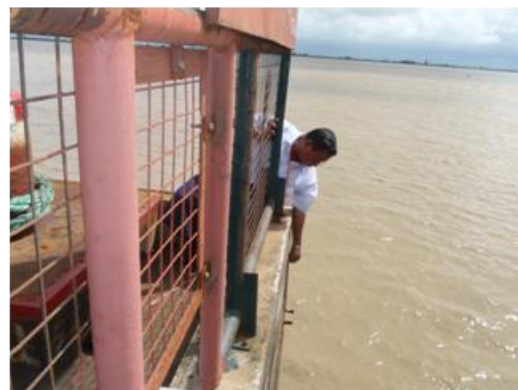
Photo 12.2.1 Tide Observation Facilities at Monkey Point and MITT

Monkey Point

MITT

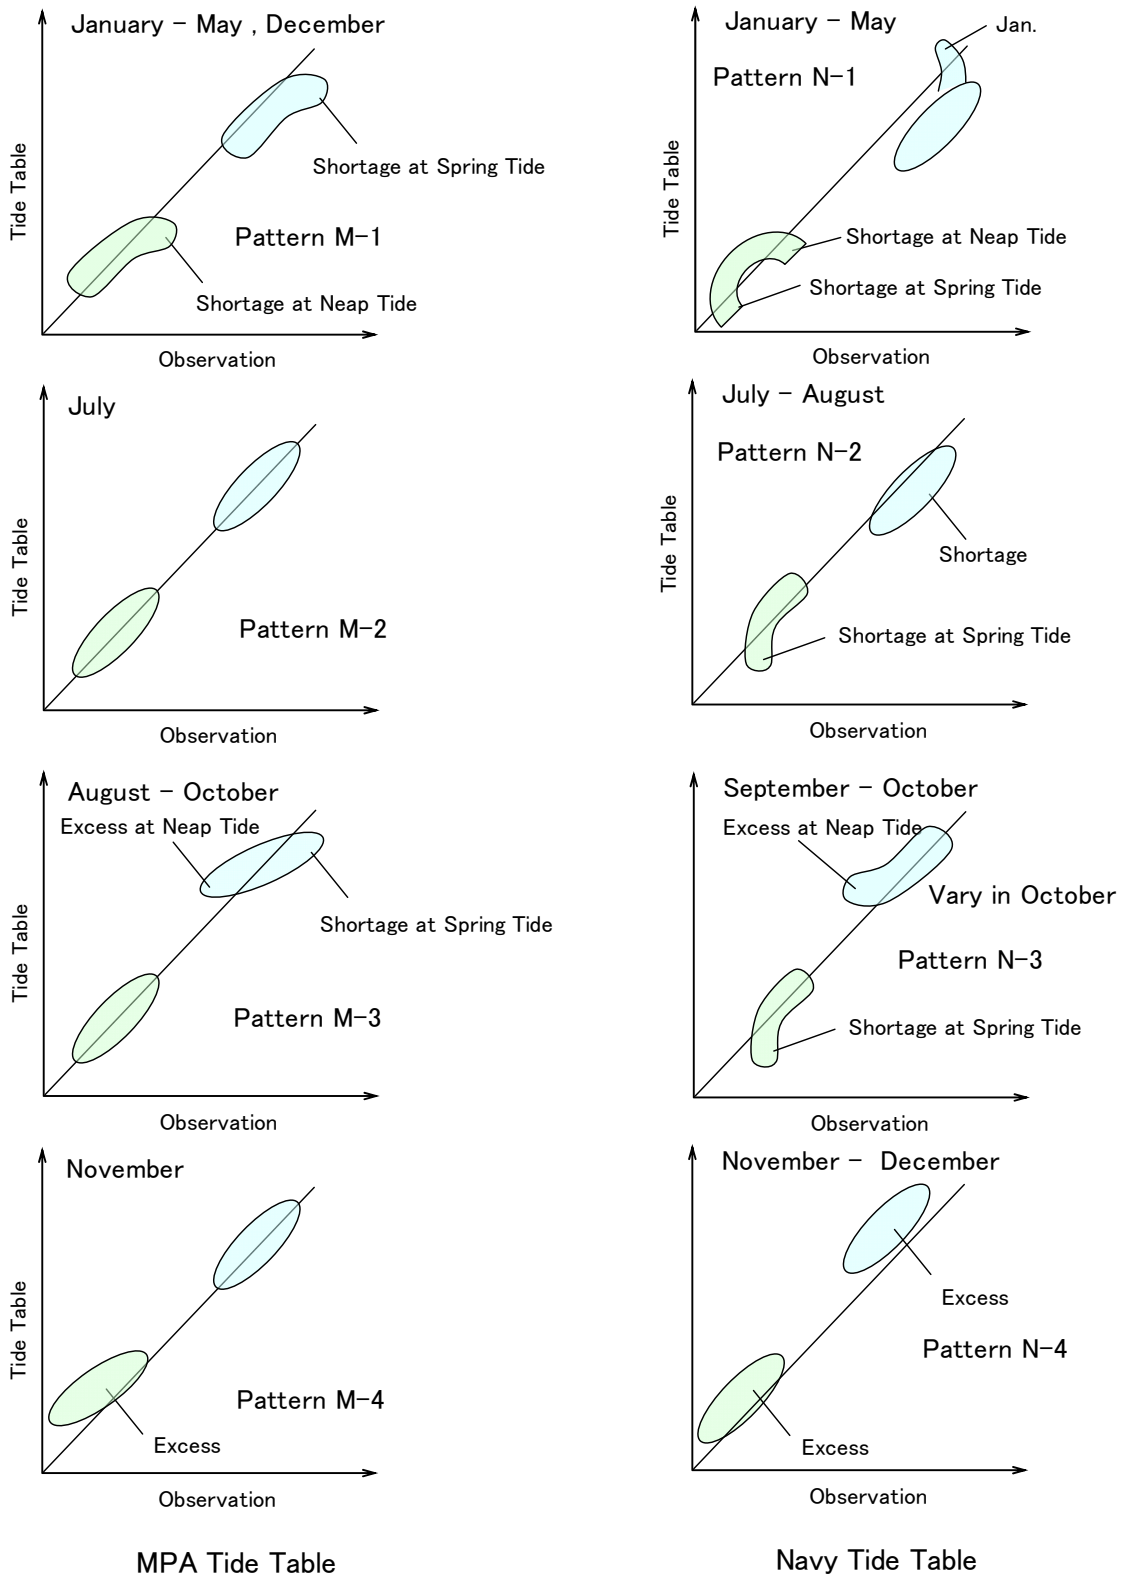
Figure 12.2.9 Relation Patterns between Observation Data and Tide Table

By organizing the above condition, there is a relation, which is illustrated in Figure 12.2.9

While amplitudes of tide become fairly small at neap tide, the tide levels in tide tables do not match the observation data. Since the amplitude did not become small at neap tide in Patterns M-2 and M-3, the gap with the observation data was still small. It was thought that the reason why the tide levels would not match at spring tide or neap tide is because amplitudes of harmonic constants used for prediction was small. Moreover, the reason why both low water levels and high water levels were constantly high was because it did not correspond to variation of mean water level at the point.

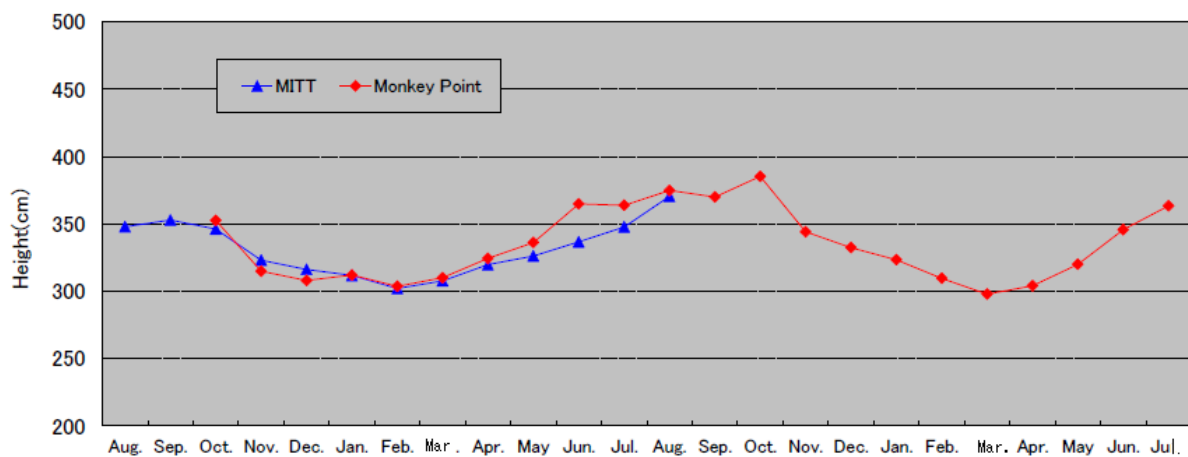
Figure 12.2.13 shows the monthly average of MSL calculated from the observation data at Monkey Point and MITT. The average of MSL was high from August to October in the rainy season and the gap with the average in February in the dry season, which was the lowest value, was 0.7-0.9 m.

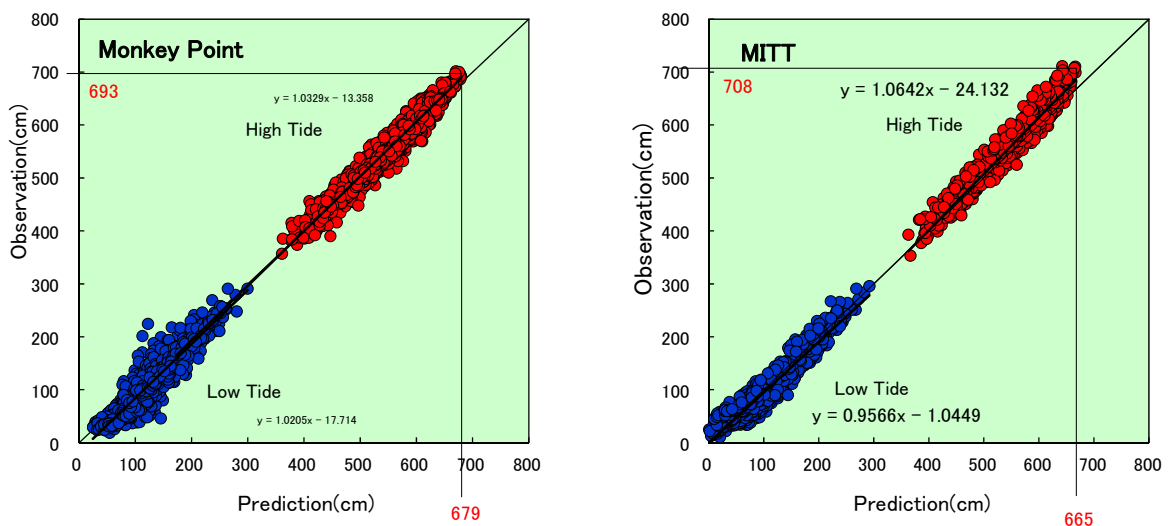
Figure 12.3.1 Comparison of Predicted and Observed Tide Levels

However, the predicted high water level at the spring tide tends to be low as it can be seen in the current tide tables. When compared around the highest tide level, the predicted tide level was 50-60 cm lower, which reached about 10% of the tidal level range. In Japan, where the tidal level range reaches 200-300 cm, it is recognized that 30 cm of deviation commonly happens. Therefore, it may be said that the gap here was within the margin of error.

As shown in Figure 12.3.1, tide level during high tide predicted by using harmonic constants described in Table 12.3.1 was slightly lower than the observation value. Although it is considered to be influenced by change of mean water level, it was difficult to find the factor due to limited observation data. Therefore, at this moment, the tide level was corrected by using the regression formula shown in Figure 12.3.1. Moreover, since there are time gaps during high tide and low tide which reached more than 30 min, the tidal time was corrected also. Figure 12.3.5 shows the relation between time gaps during high and low tides and tide level. No relation between time gaps and tide level during high tide was identified. Since the gap at MITT was 7 min and 10 min at Monkey Point, correction for these gaps was considered. On the other hand, since the relation between time gaps and tide level during low tide was clearly identified, the correction value calculated by using regression formula was deducted from the predicted value.

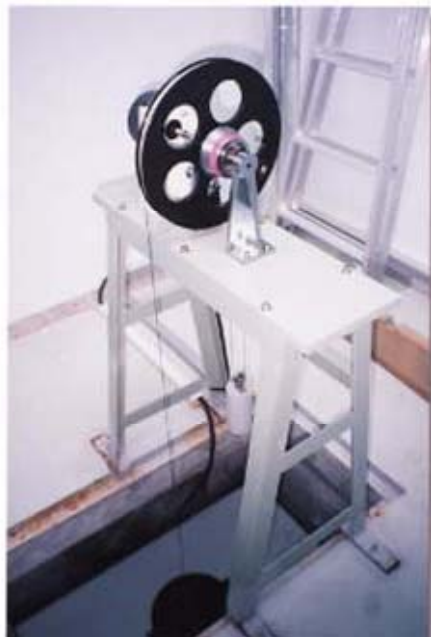
The basic equipment of the tide gauge station consists of a well, water pipe, and observation (tide gauge) room. The principle of the tidal observation is to observe seawater rise and fall which is caused by the water coming through the water pipe with a certain diameter by measuring the position of a buoy. The pipe can remove a short cycle of water surface fluctuation.

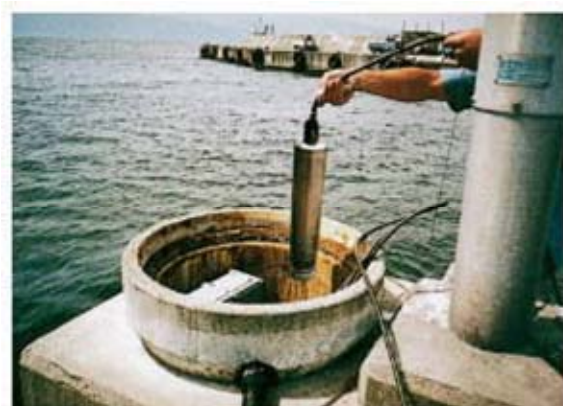
Photo 12.5.2 Tide Gauge with Float System

There is another type of tide gauge that measures the change of water pressure using a sensor sunk below the sea.

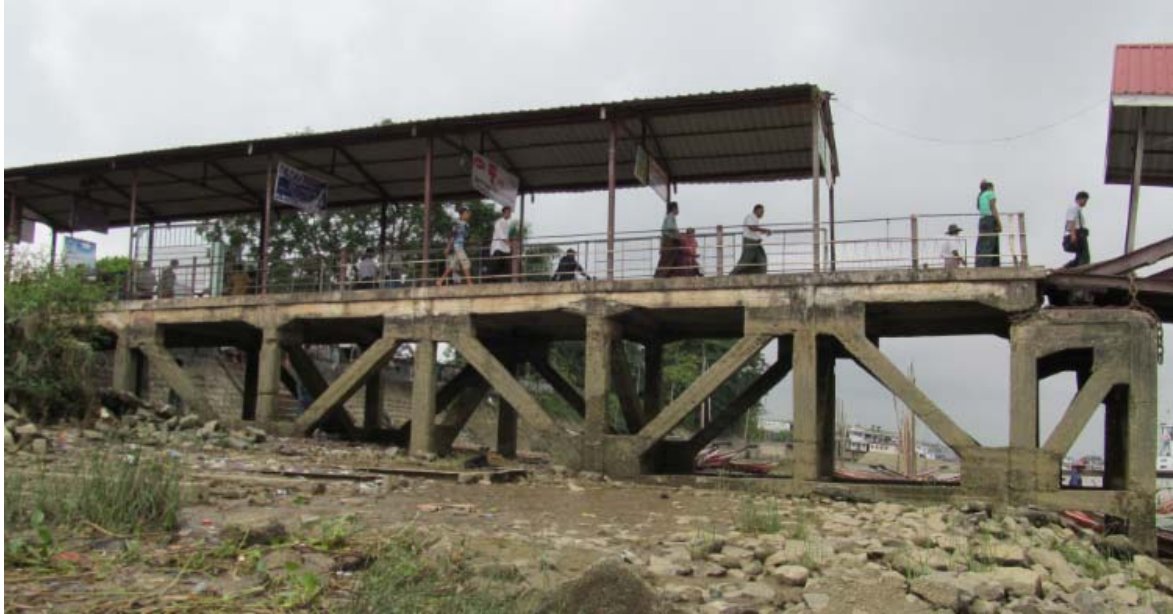
Photo 13.4.1 Whole View of Dalla Port Jetty

Check obvious settlement, leaning and deformation of concrete structure by taking a whole view of the jetty.

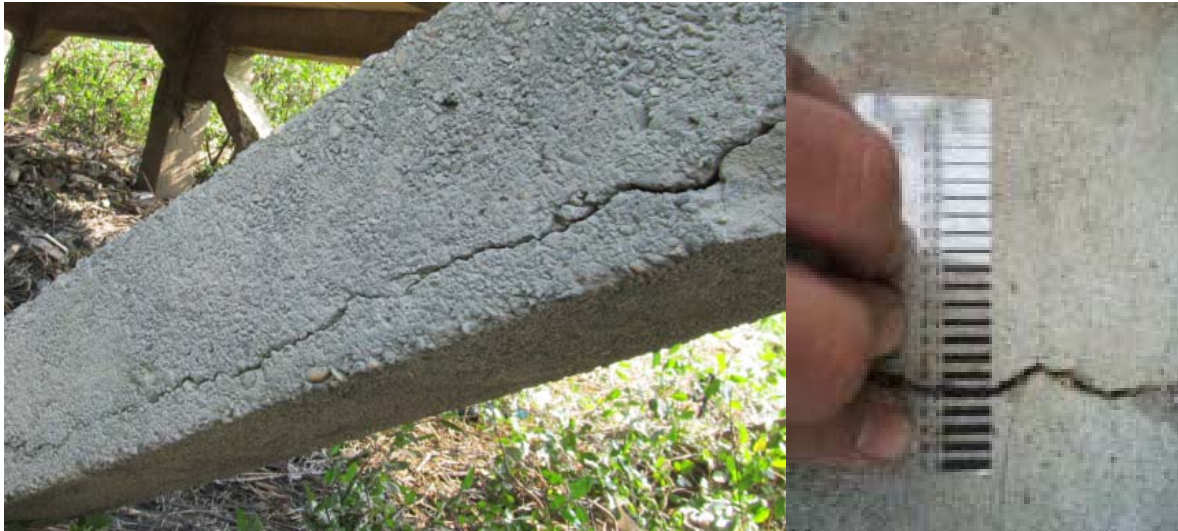
Photo 13.4.2 Cracks

- Find cracks with width over 0.3 mm.
- Check a typical crack width at the widest point.
- Measure the crack width with a crack scale or measure.

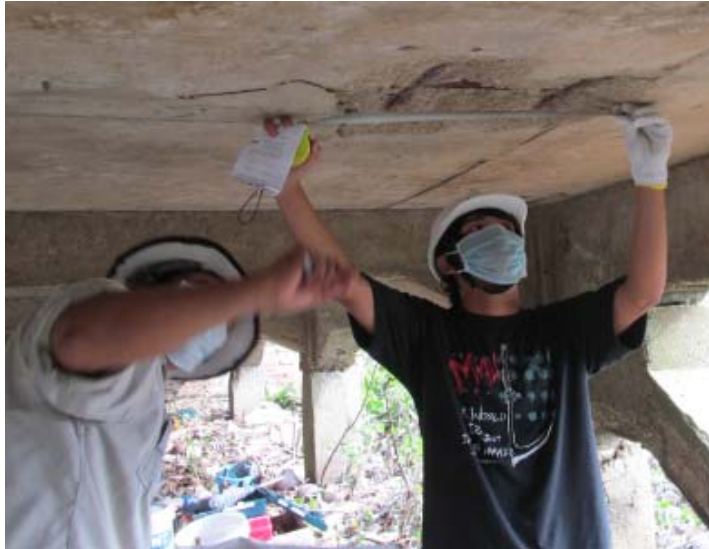
Photo 13.4.3 Spalling and Delamination of Concrete Cover

- Check for loss and concrete member with a decreasing cross section.
- Check the rebar diameter of the exposed part (measure length and width).

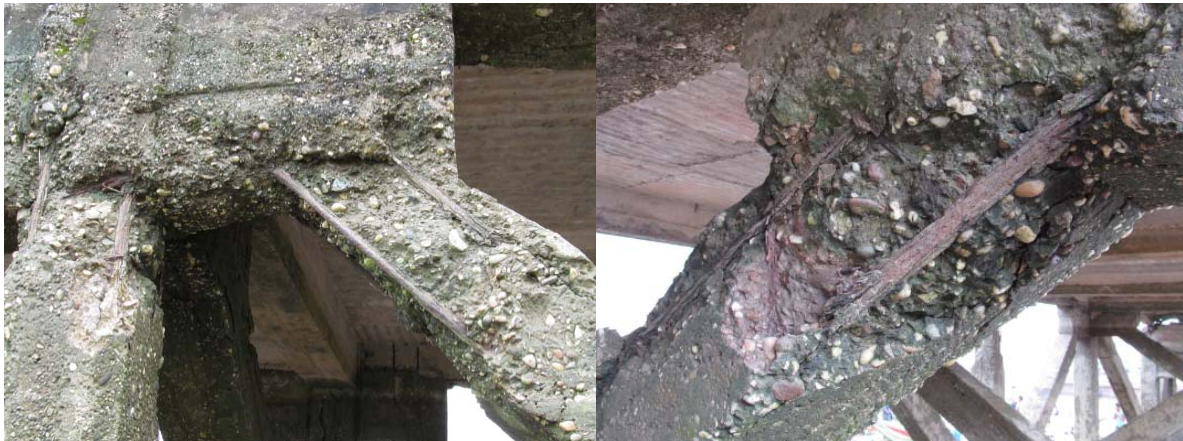
Photo 13.4.4 Spalling and Delamination of Concrete Cover

- Check exposed rebar for corrosion (condition of rust).
- Measure length, width, and rebar diameter.

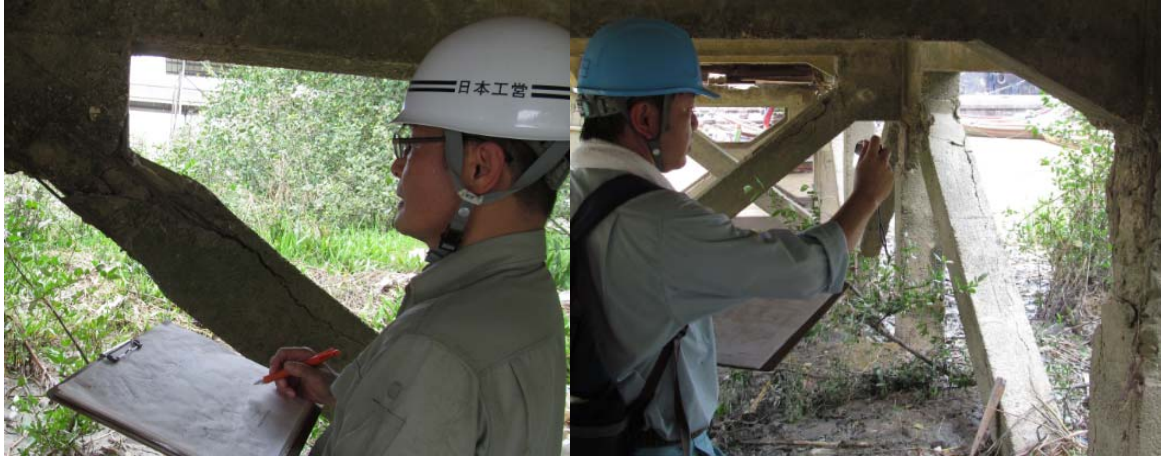
Photo 13.4.5 Freehand Drawing and Taking Photo

- Make a photo record at the measured locations and number the photos.

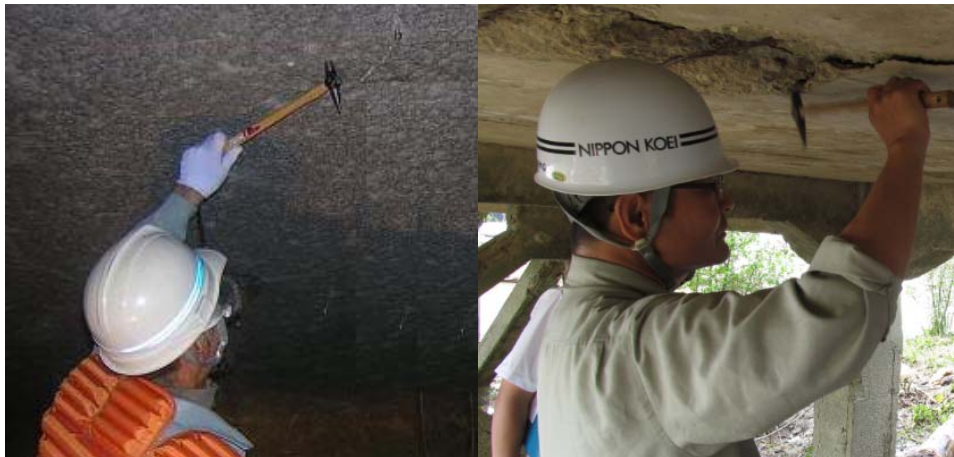
- Subsurface defects inside concrete, such as voids, can be found by hammering test.
- Sound of hammering of concrete surface would be different between good part and deteriorated part.

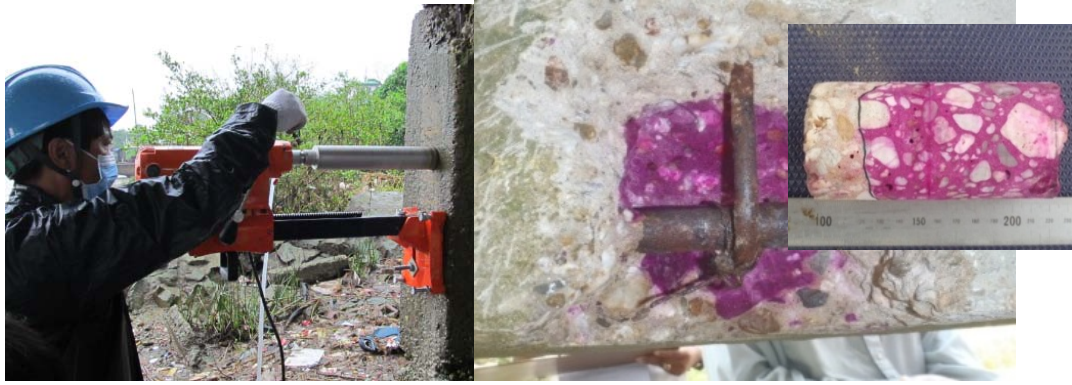
Photo 13.4.9 Core Sample and Chipping Concrete

- Carbonation depth in concrete is measured by core sampling or chipping concrete using 1% Phenolphthalein liquid solution.
- High alkaline part would change to red color; carbonated part would not change color.

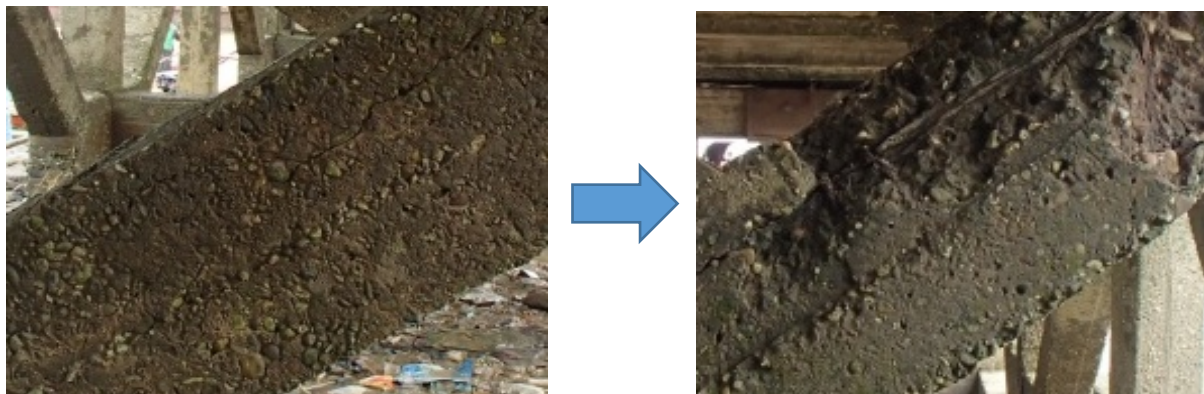
Photo 13.4.11 Chipping Concrete Cover and Exposing Rebar

- When rebar is exposed by delamination, degree of corrosion is inspected using visual test.
- Before delamination, by chipping the concrete cover out and exposing the rebar, the degree of corrosion of the rebar in the concrete can be inspected.

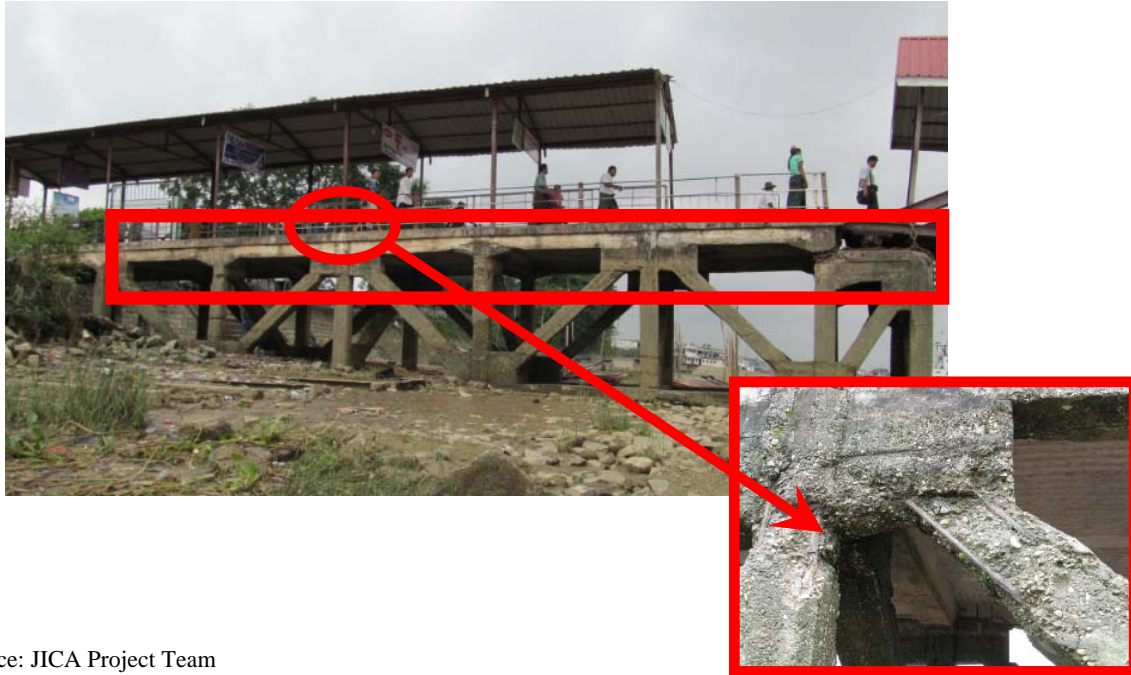
Photo 13.4.12 Area in Poor Condition (Dalla Jetty)

- Area of high water level is in poor condition.
- Because of too much salt, CO<sub>2</sub>, water and O<sub>2</sub>.

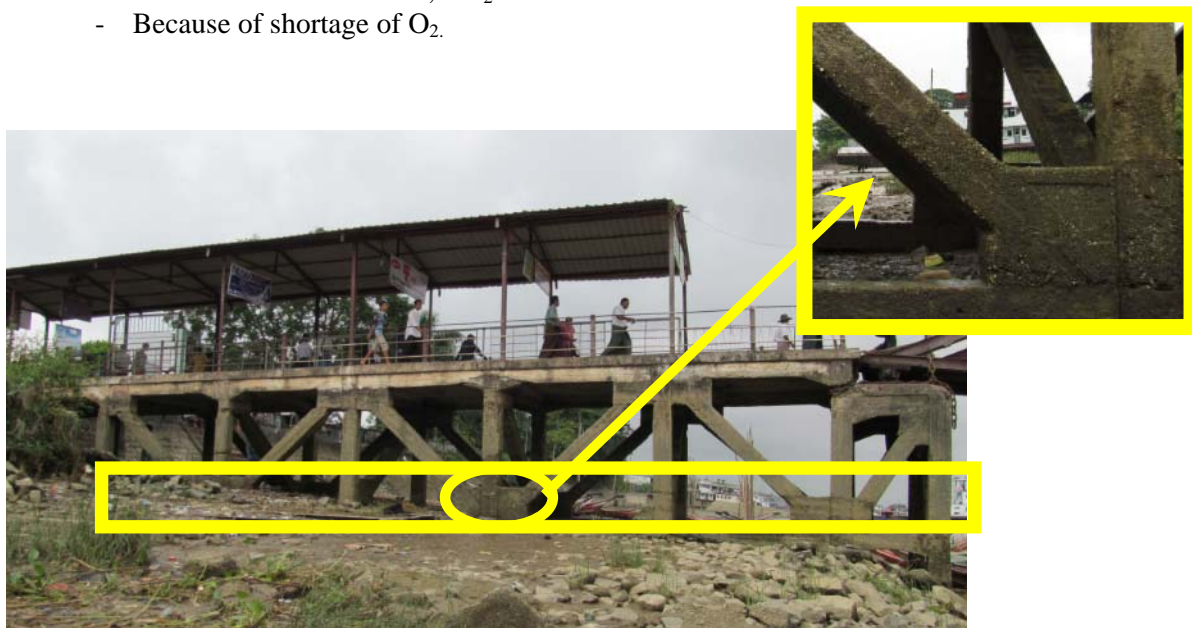
Photo 13.4.13 Area in Good Condition (Dalla Jetty)

- Area of low to high water level is in good condition.
- Because of too much salt, CO<sub>2</sub> and water.
- Because of shortage of O<sub>2</sub>.

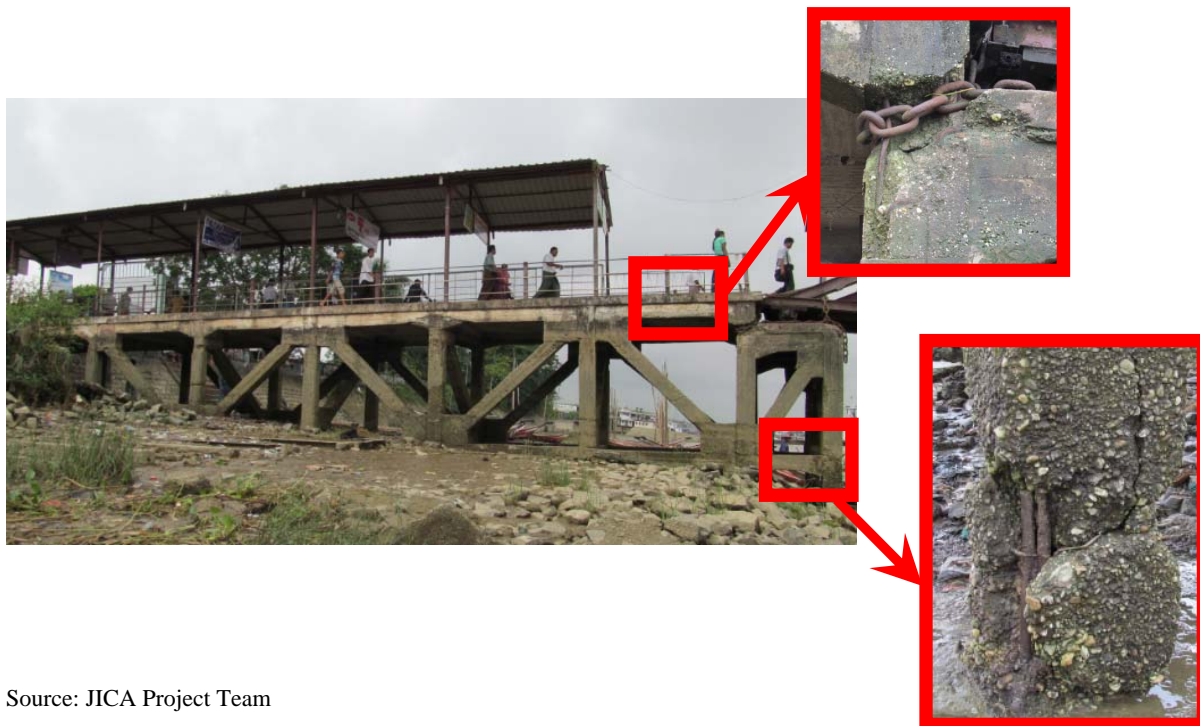
Photo 13.4.14 Area in Poor Condition (Dalla Jetty)

- Some parts are in poor condition.
- Because of shock and load.

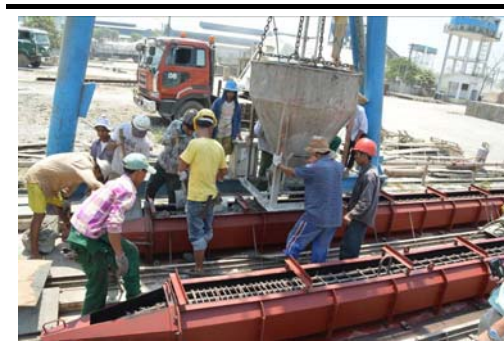
#### 1) Concrete Pile Fabrication

The concrete piles for the porter way (500 x 500 mm hexagonal) and slipway (400 x 400 mm square) were manufactured at the Hi-Tech Concrete's Shwe Pyi Thar Plant.

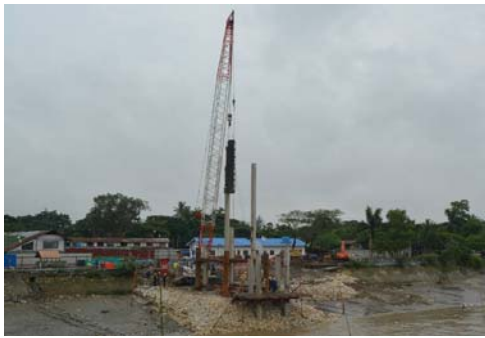
## 2) Piling Work

The picture shows the piling work at the west porter way. First, a temporary sand mount was constructed on the riverbed for accessing a pile driving crawler crane. A diesel hammer was connected to a short section of a leader guide and lifted by a crane to act as a flying hammer.

The concrete piles were set into the steel guide frame, and driven by the flying hammer to the required depth.

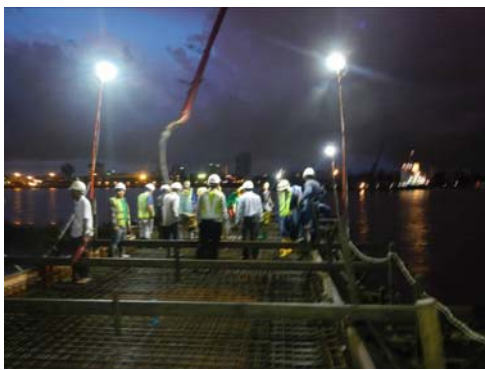
## 3) Porter Way Concreting

The contractor procured the ready-mix concrete from Hi-Tech Concrete located at the Yangon side. The contractor, in an attempt to shorten the concrete delivery time, cast the large volume concrete at night.

The picture shows the slab concrete casting at the west porter way.

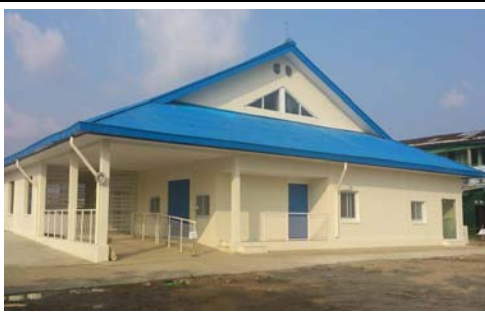
## 4) Passenger Terminal Building

The contractor manufactured the steel members at its own factory (J&M Steel Solutions) at Yangon side.

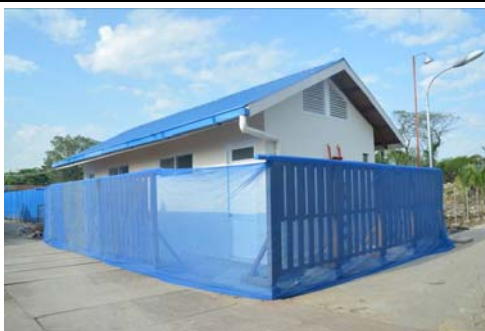
## 5) Public Toilet

The foundation type is isolated footing type with brick retaining wall. Roof is timber truss structure.

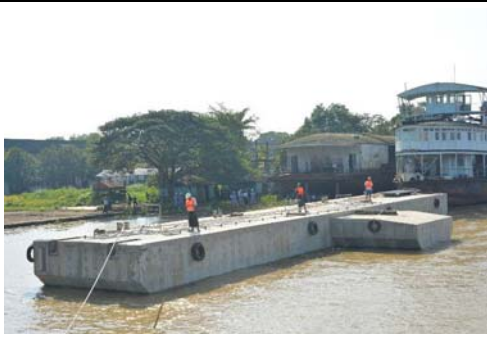
## 6) Pontoon Concrete Coating

The steel pontoons were manufactured at the IWT's Dalla Dockyard by IWT with technical assistance by JICA. The contractor then cast the 15 cm thick concrete coating on the sides and 10 cm thick on the top of the pontoons.

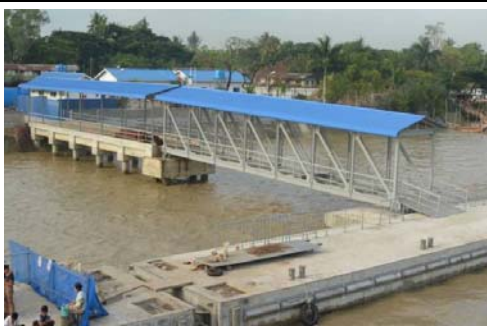
## 7) Movable Steel Bridge

The contractor manufactured the steel members at its own factory (J&M Steel Solutions) at Yangon side. Assembly of the bridge was carried out at MPA's Botahtaung Maintenance Yard.

The completed steel bridges were towed to the site on a pontoon, and positioned in between the porter way and the new pontoon during high tide, and set to position when the tide went down.

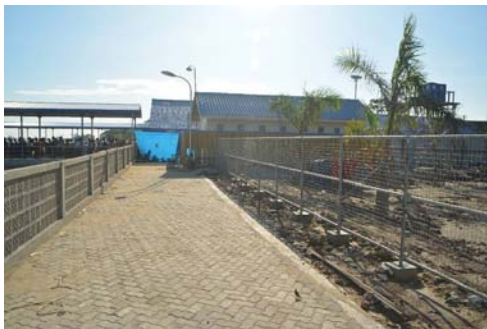
## 8) Pavement

The subbase of the pavement is crushed stone and sand, and the surface is made of interlocking concrete blocks.

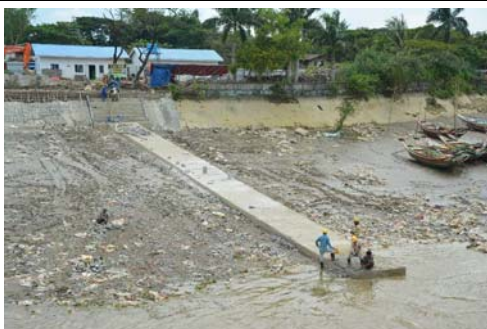
## 9) Slipway

Concrete square piles (400 x 400 mm) were used for the slipway foundation. The thickness of the slab concrete is 400 mm, and the concrete near the tip of the slipway was cast during low tide.

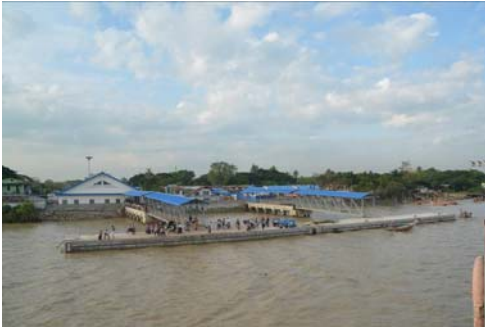
## 10) Completion Overview

Two new pontoons were connected by pins, and two steel bridges were installed. The building on the left is the new passenger terminal building. The new slipway is to the west of the west porter way (right), but is not visible because of high tide.
