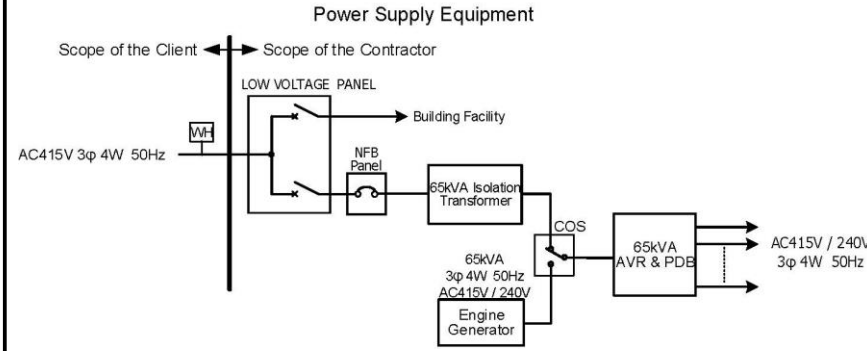
The Project for the Rehabilitation of the Medium Wave Radio in the Republic of Fiji				
Title				DWG. No.
Block Diagram of MW Transmitting System				S-01
DATE	DESIGNED	CHECKED	APPROVED	REVISION
18 Sep 2014	K. Nagatomo	T. Kobayashi	K. Tanaka	
YACHIYO ENGINEERING CO., LTD. TOKYO JAPAN

- Abbreviation**
- ATU : Antenna Tuning Unit
 - AVR : Automatic Voltage Regulator
 - COS : Change-over Switch
 - DIP : Diplexer / Combiner
 - MW : Medium Wave
 - NFB : Non Fuse Breaker
 - PDB : Primary Distribution Board
 - OB : Obstruction (Lighting)
- Symbol**
- : Molded Case Circuit Breaker
 - : VU (Audio Level) Meter
 - : Modulation Percent Meter
 - : Audio Jack

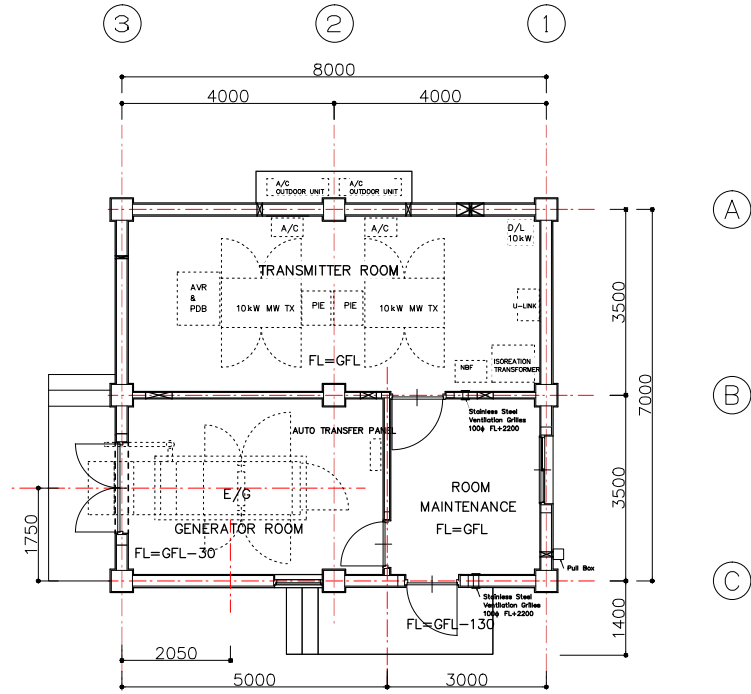
GROUND FLOOR PLAN S=1/100

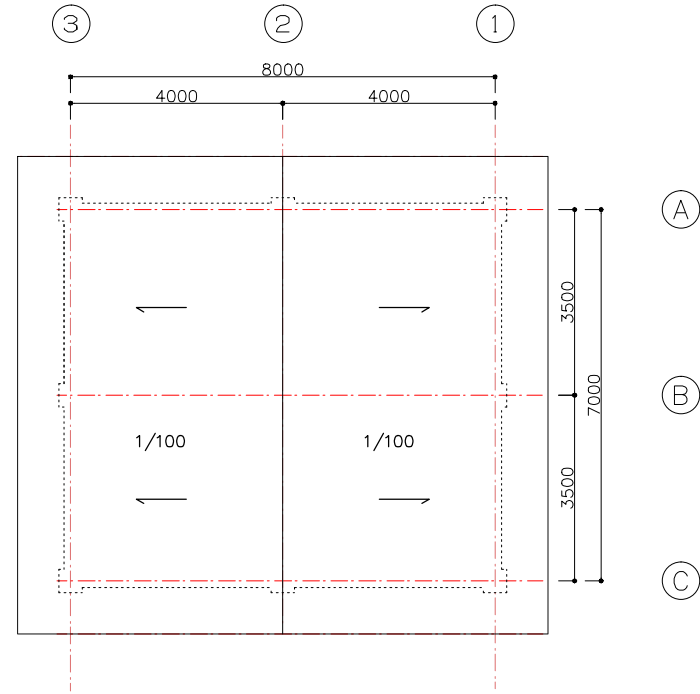
ROOF PLAN S=1/100

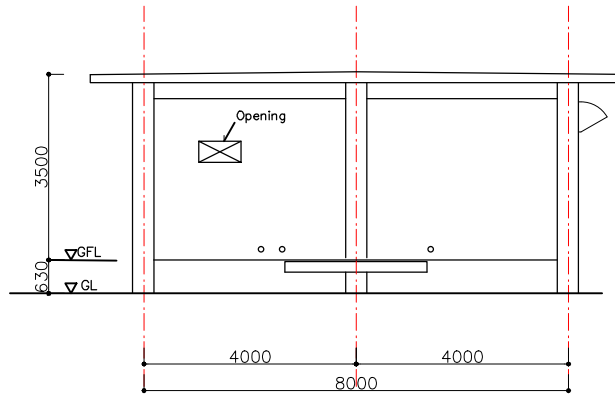
① ② ③
①-A LINE ELEVATION

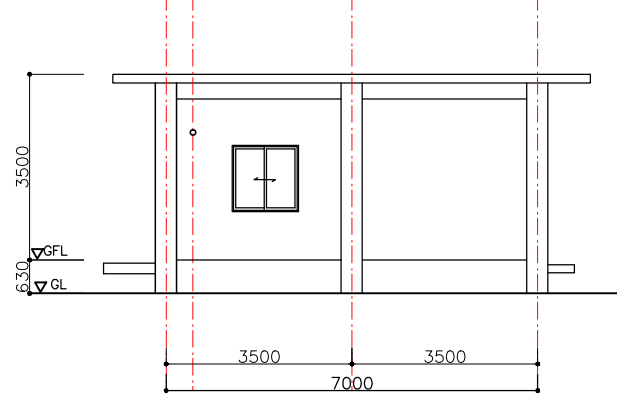
③ ② ①
①-B LINE ELEVATION

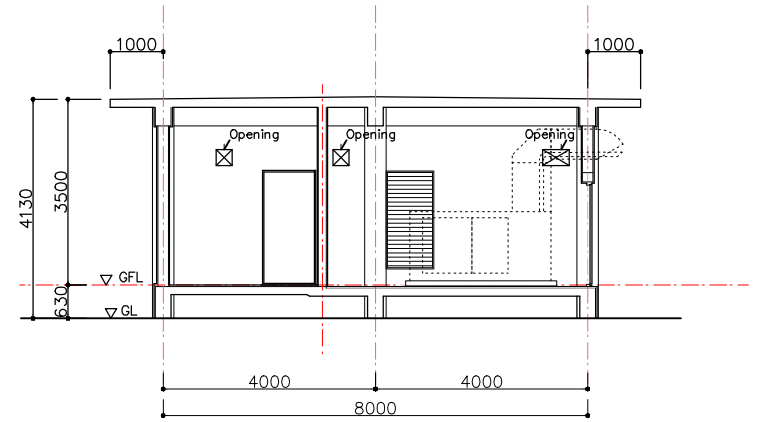
① ② ③
①-B LINE SECTION

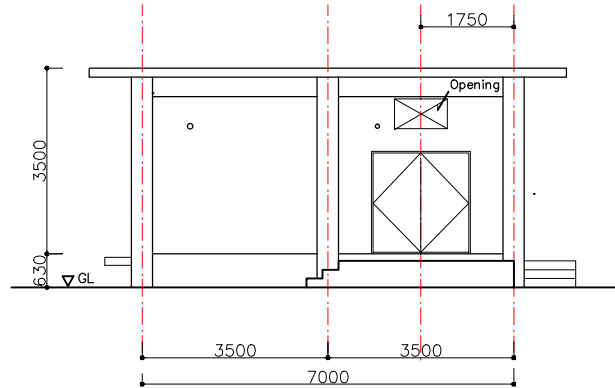
③ ② ①
①-C LINE ELEVATION

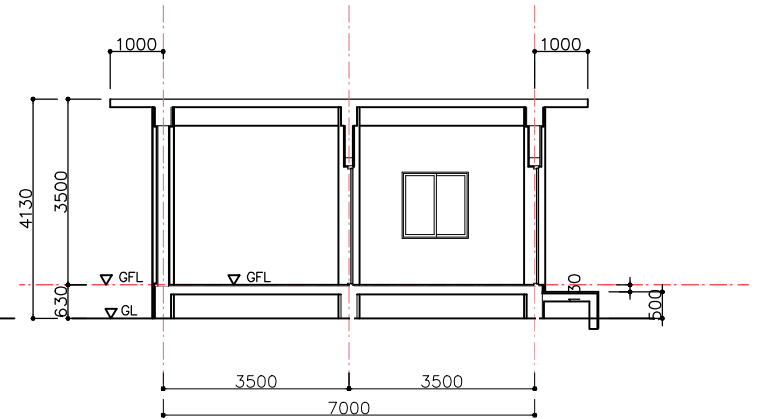
③ ② ①
①-C LINE SECTION

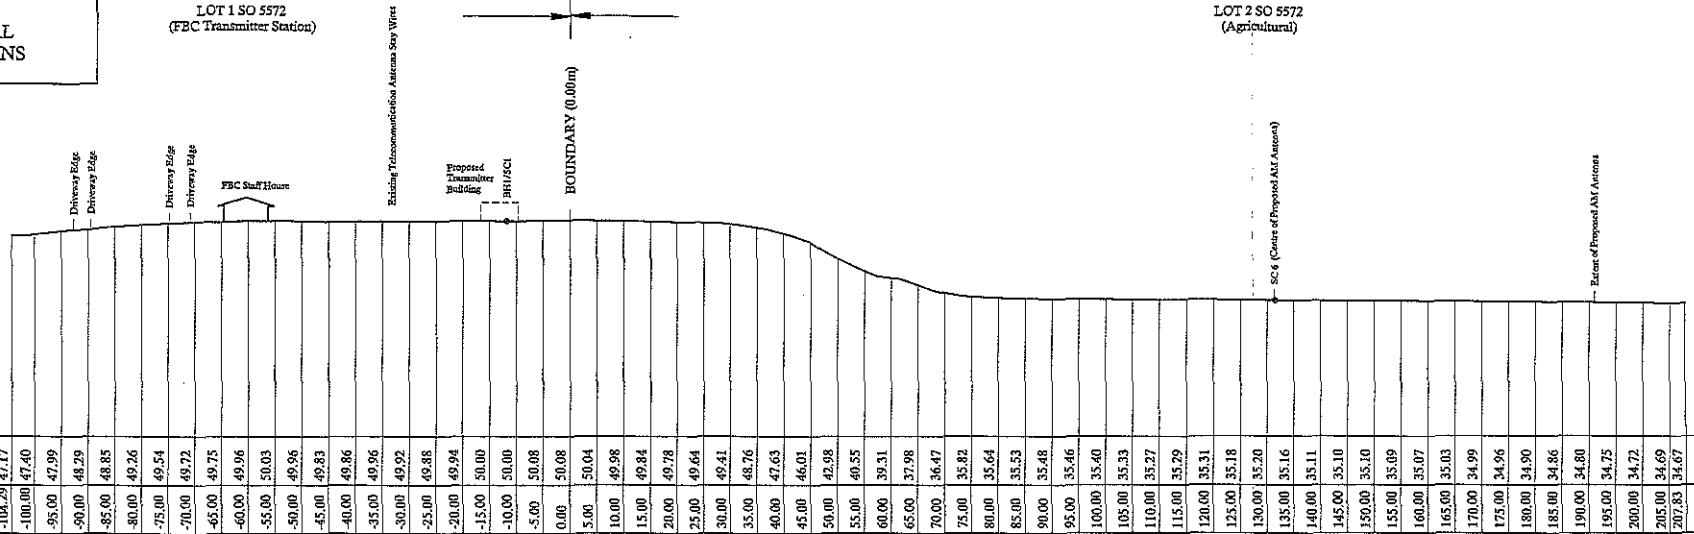
Section B - B

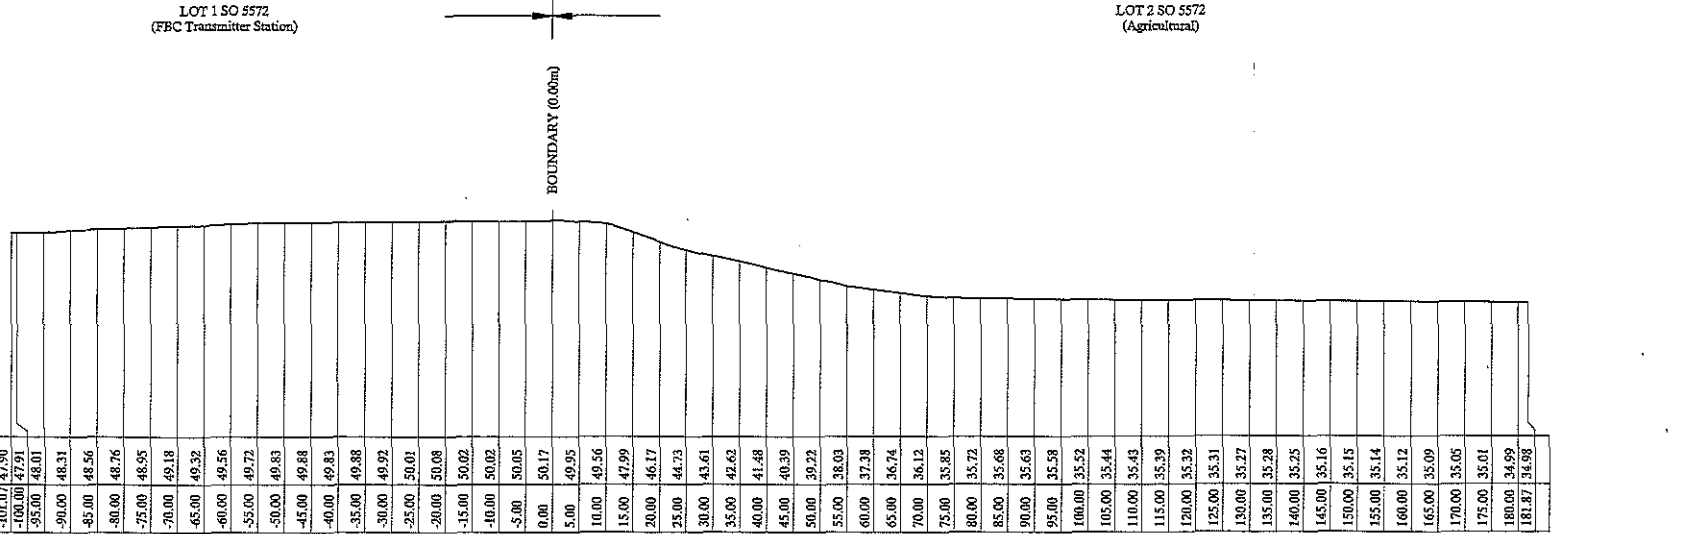
Section A - A

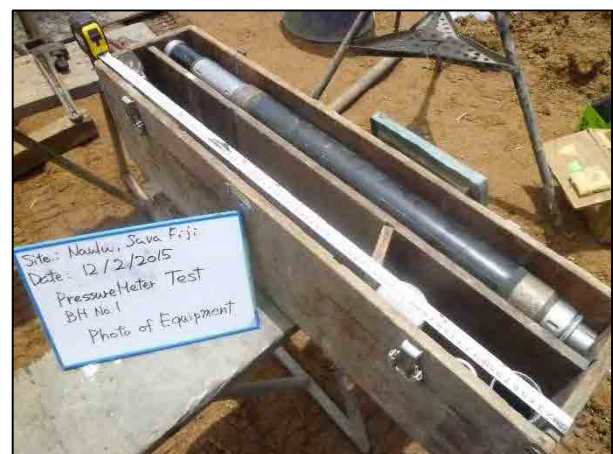
Figure 4.2: Pressuremeter

The geotechnical investigations were undertaken by Geotech Drilling International Ltd (GDI) under the supervision of T&TI. The machine drilled boreholes were performed using a tracked rig using HQT (HQ Triple Tube) wireline techniques with Standard Penetration Testing (SPT) performed at regular intervals. A photo of the equipment used is shown in Figures 4.1 and 4.2 below.

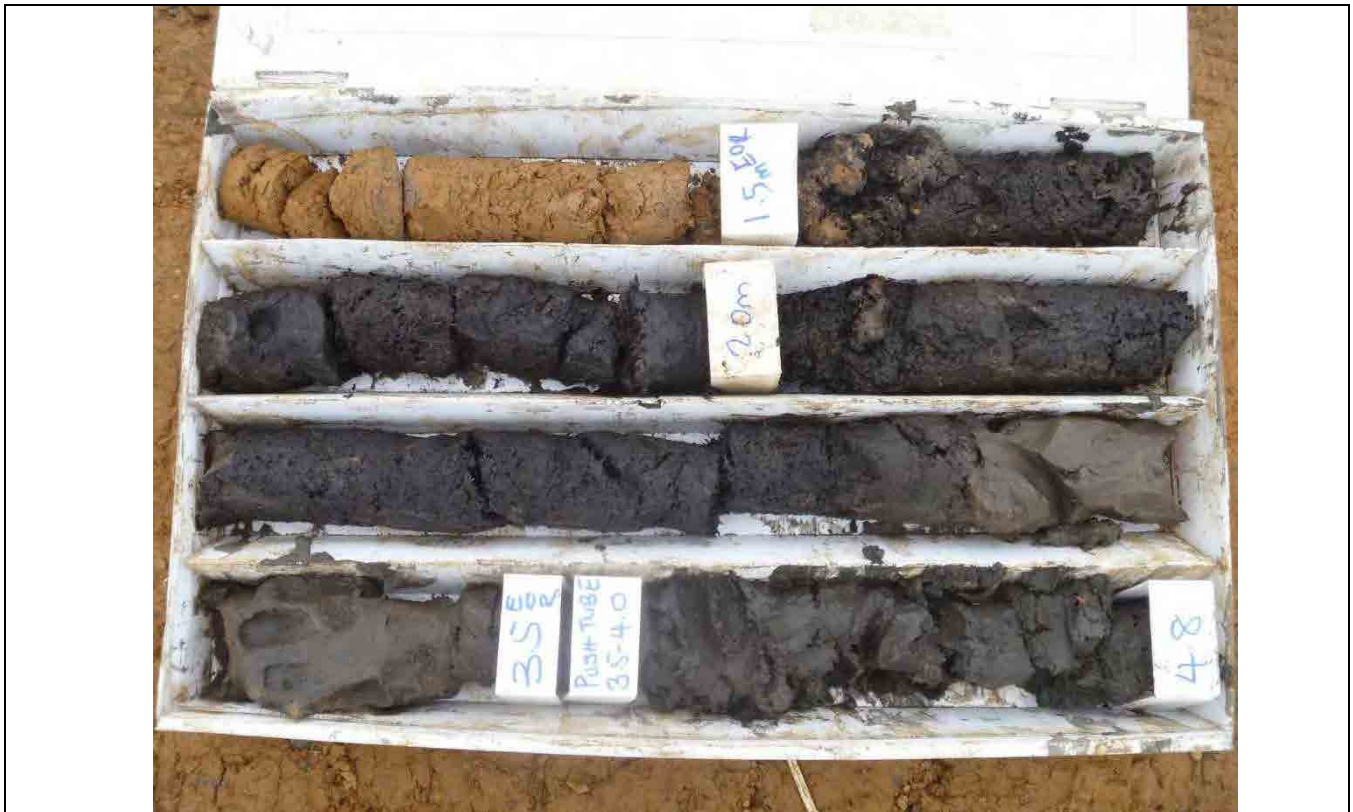
Photograph 1- BH1 0.0-4.8m

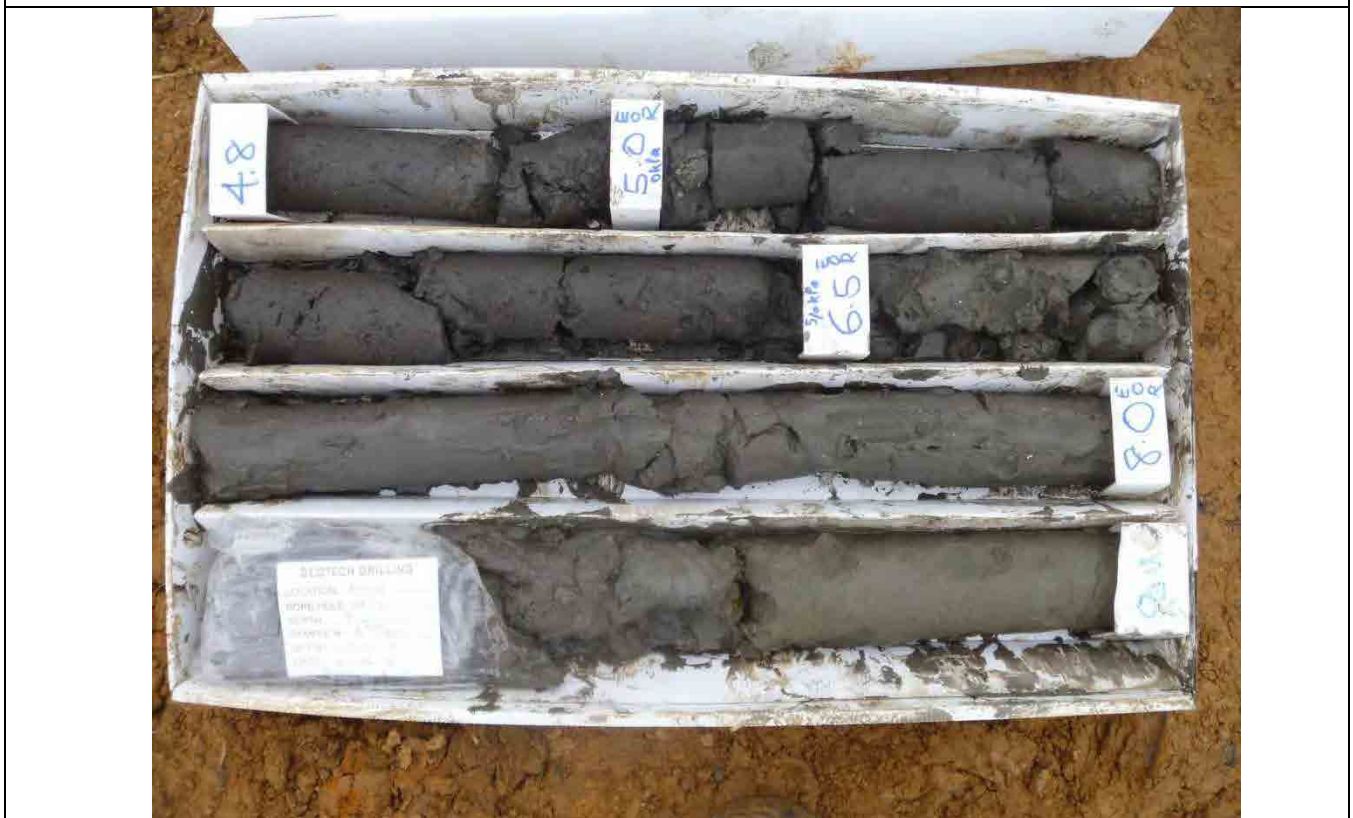
Photograph 2- BH1-4.8-8.9m

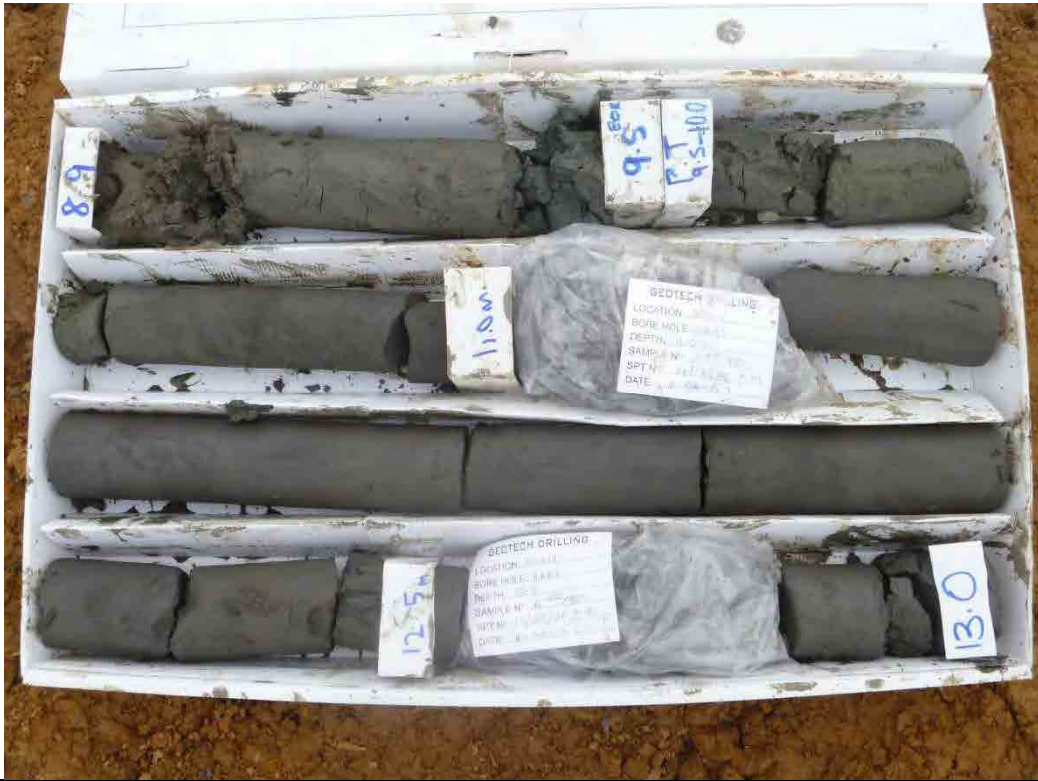
Photograph 3- BH1-8.9-13.0m

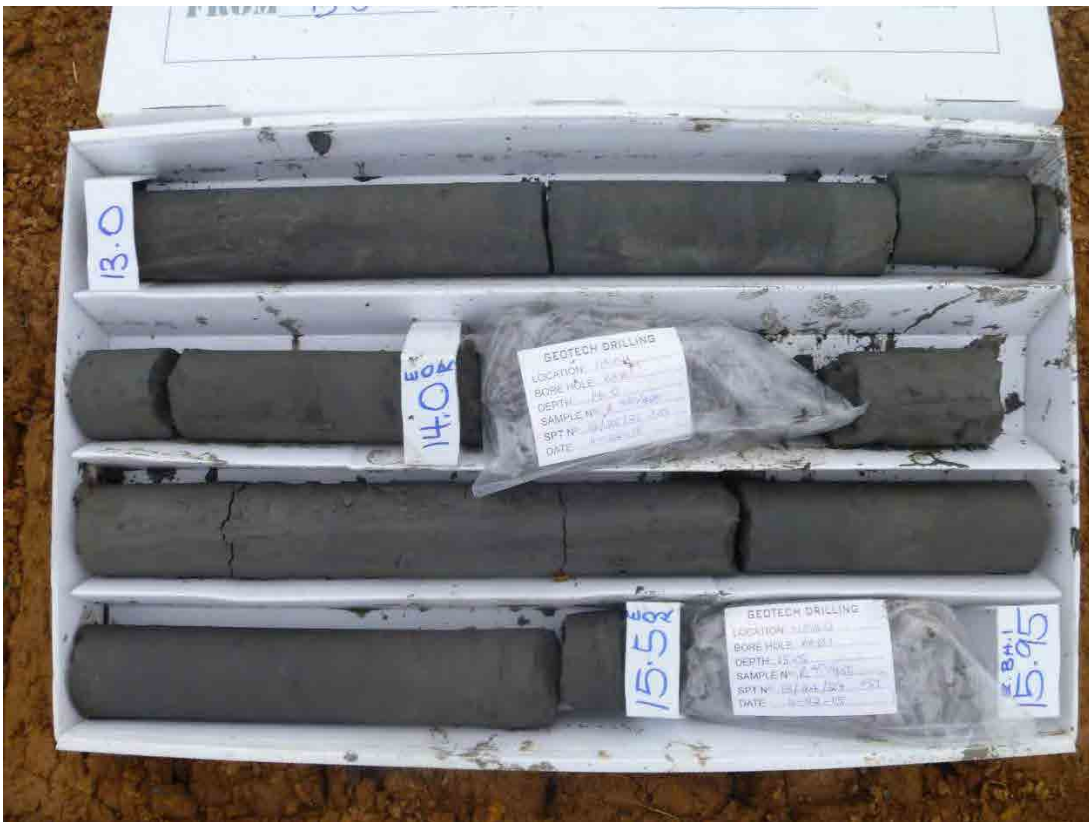
Photograph 4-BH1-13.0-15.95m

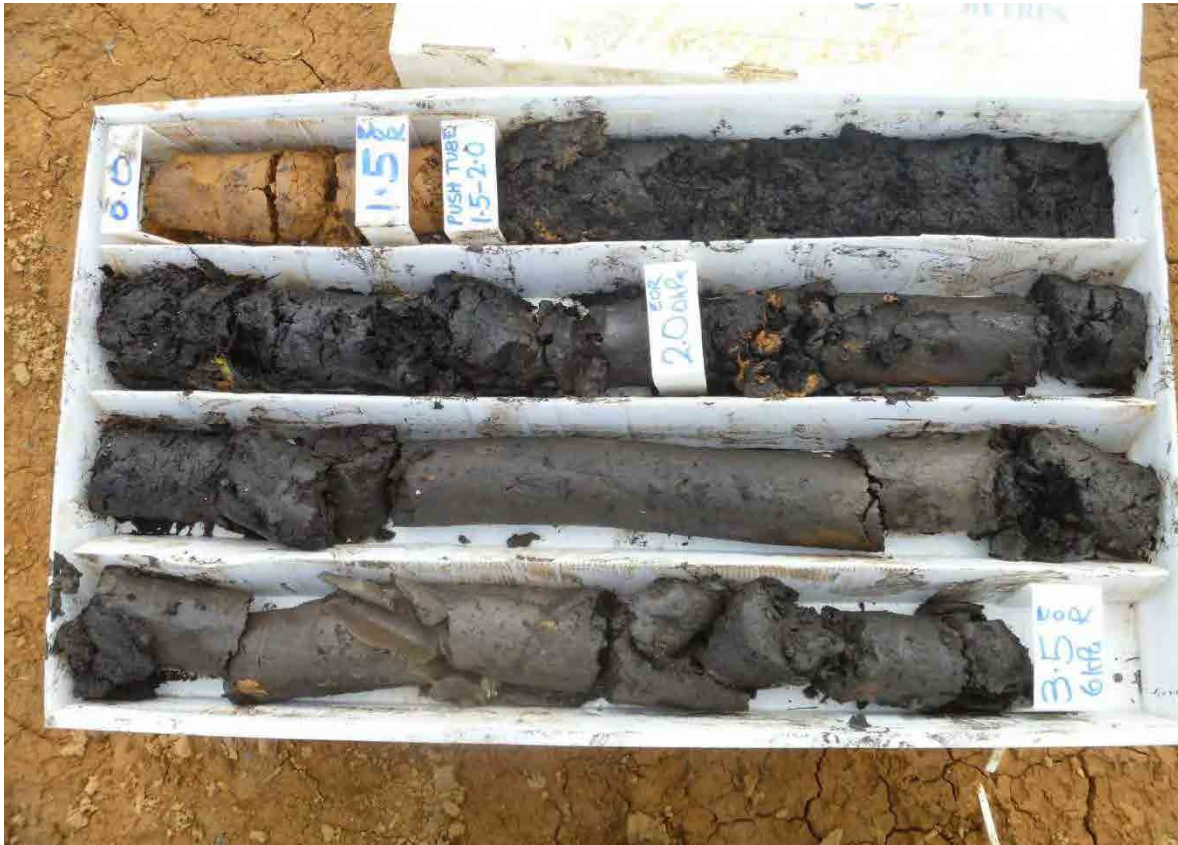
Photograph 5- BH2-0.0-3.5m

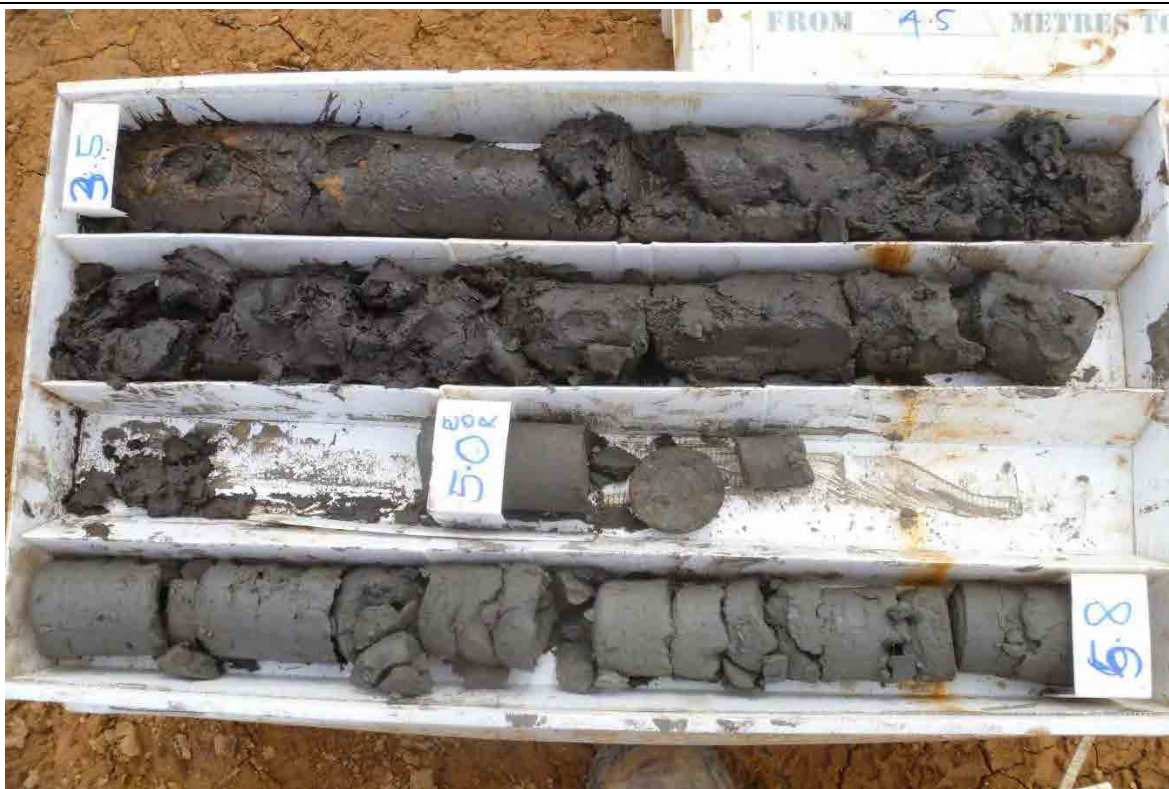
Photograph 6- BH2-3.5-5.80m

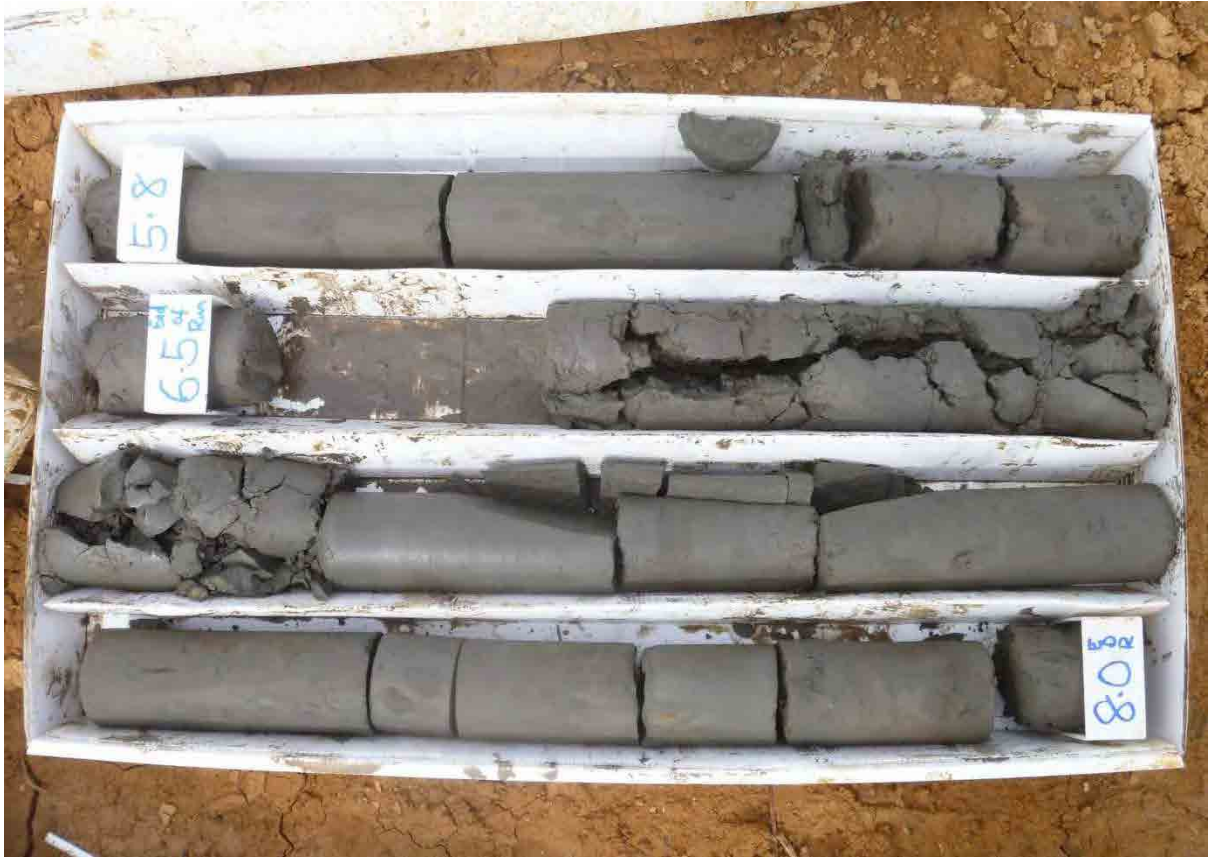
Photograph 7- BH2-5.8-8.0m

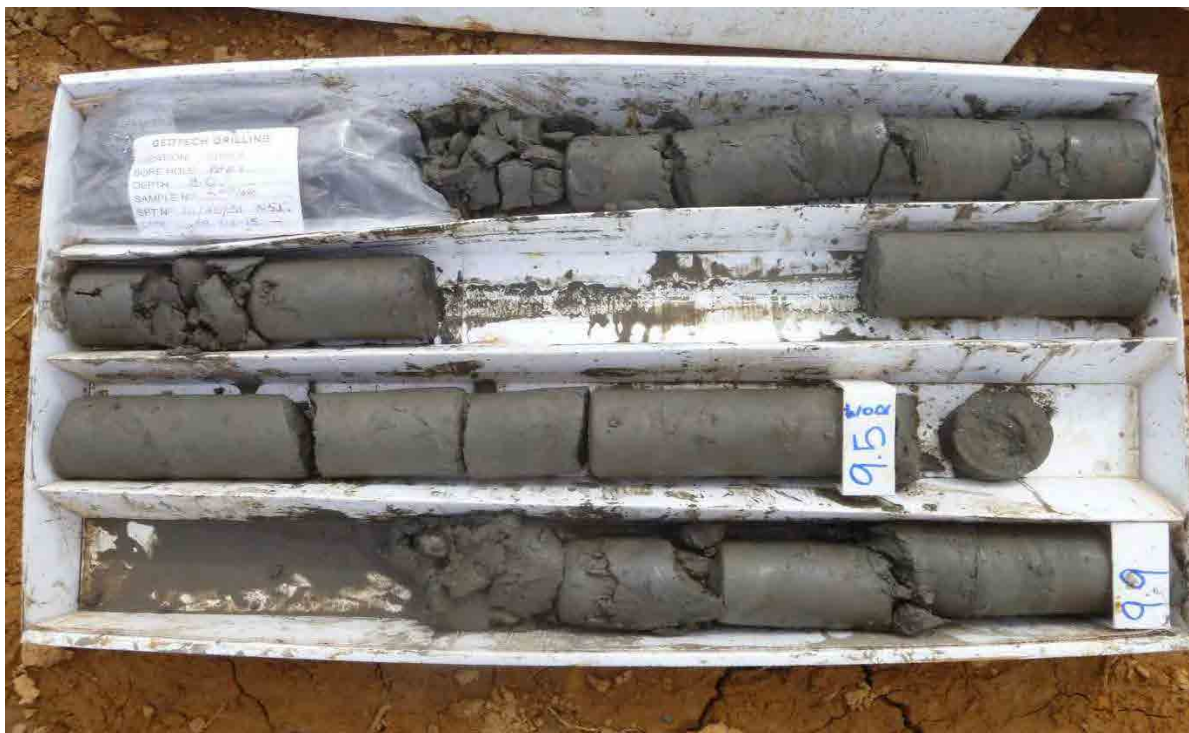
Photograph 8- BH2-8.0-9.9m

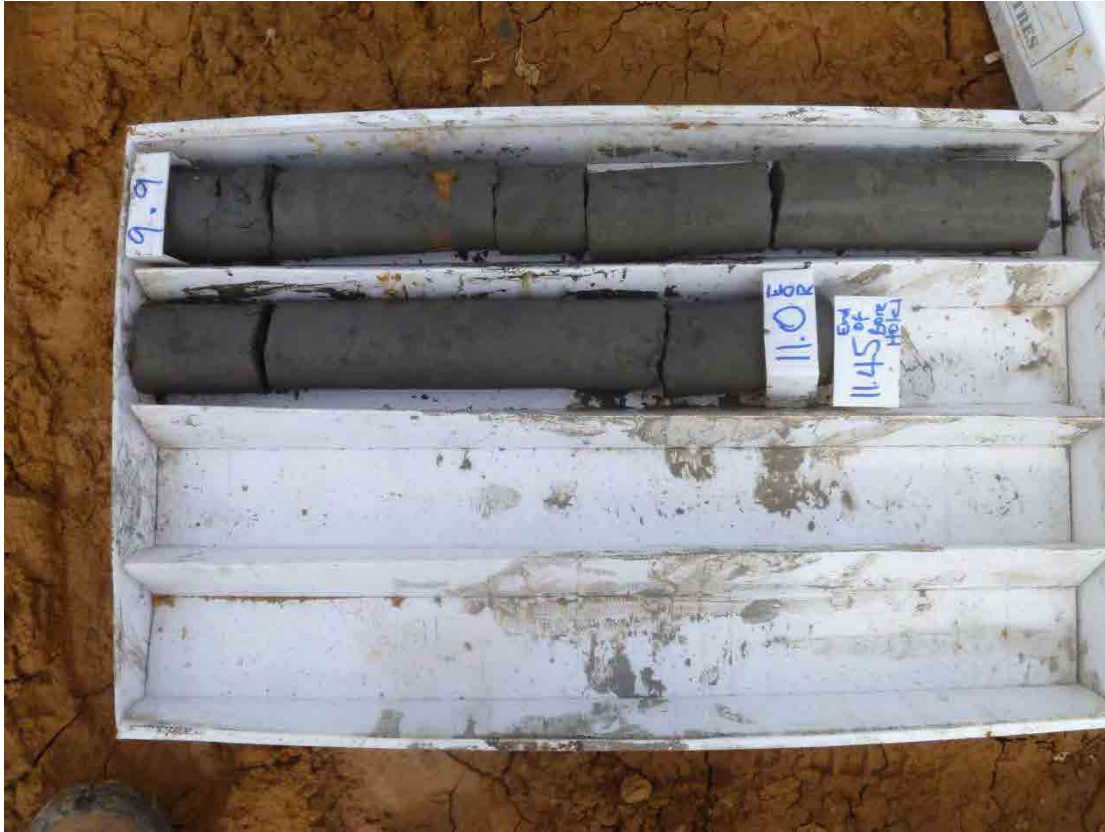
Photograph 9- BH2-9.90-11.45m

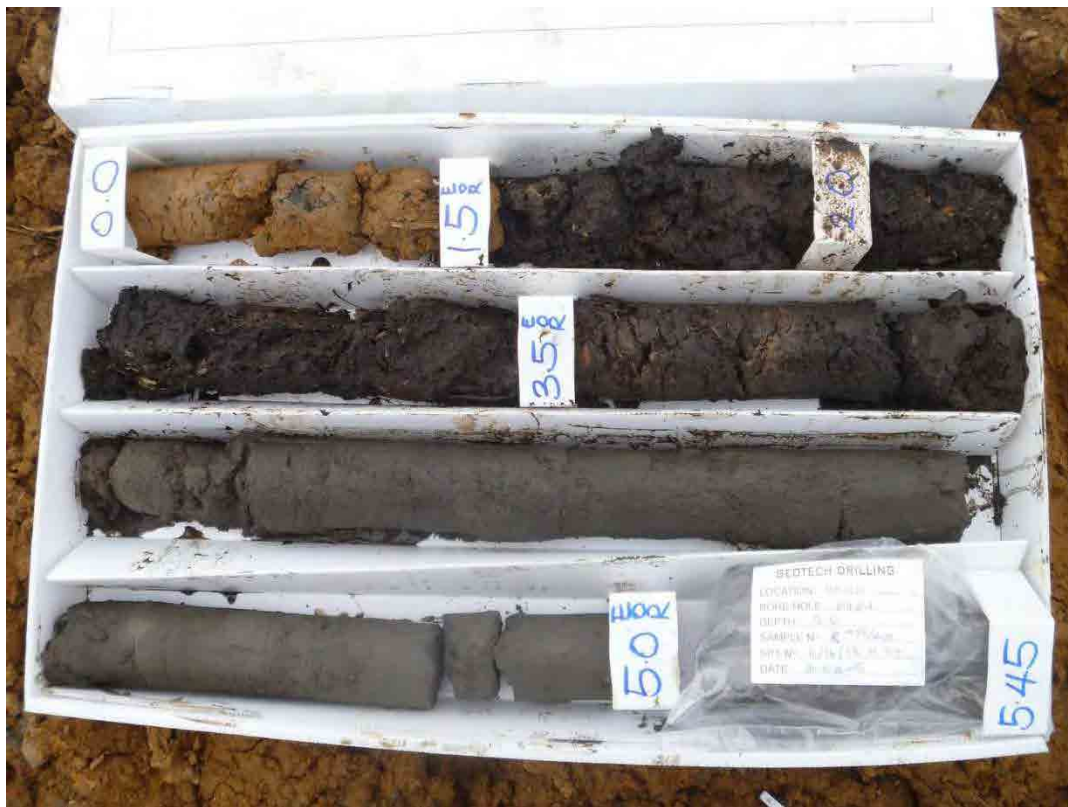
Photograph 10- BH3-0.0-5.45m

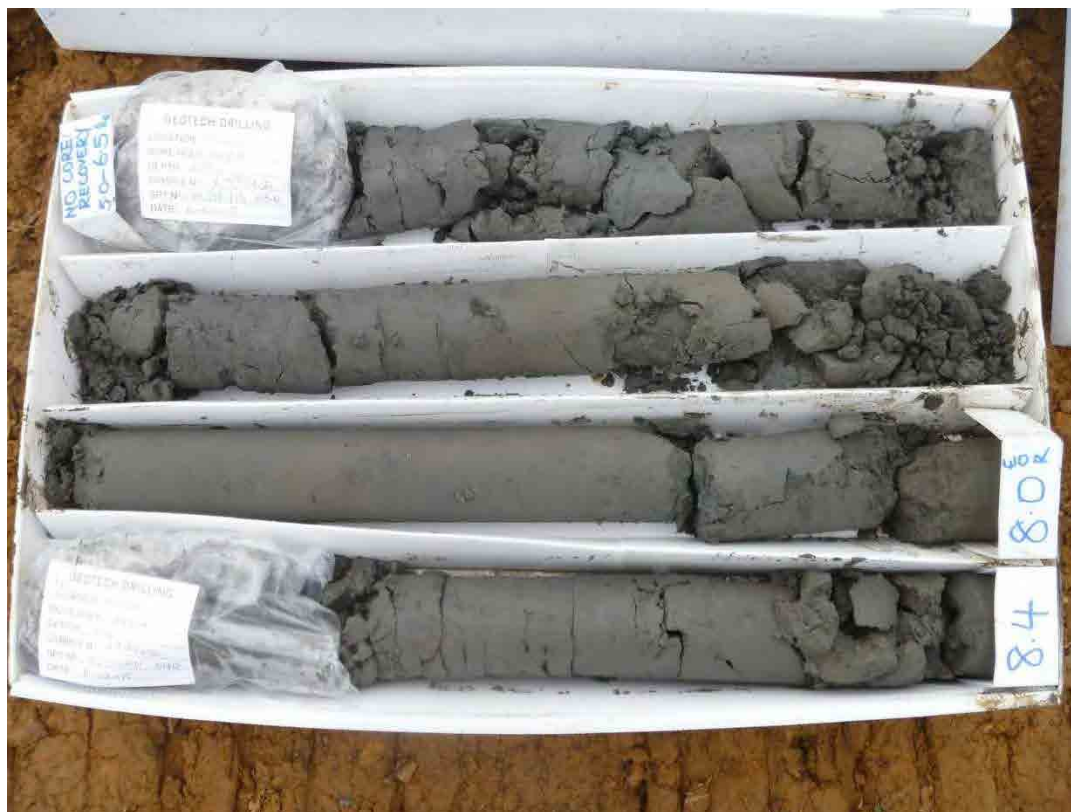
Photograph 11-BH3-5.45-8.40m

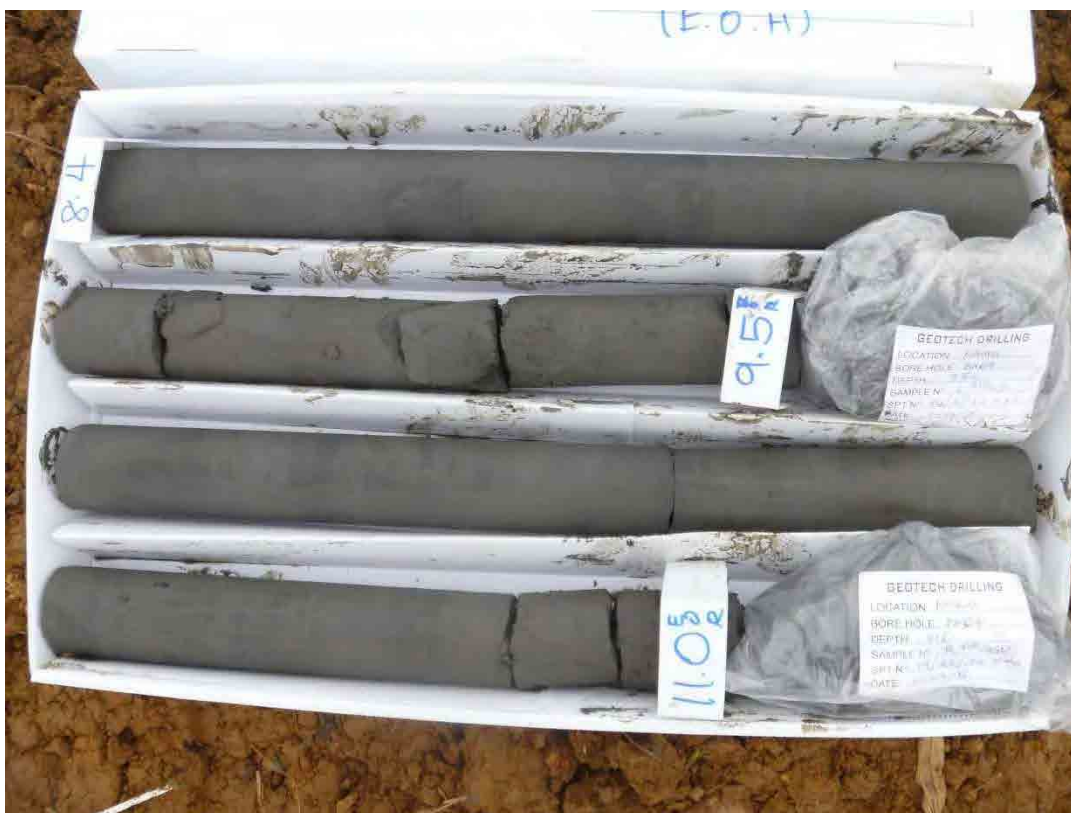
Photograph 12- BH3-8.40-11.45m

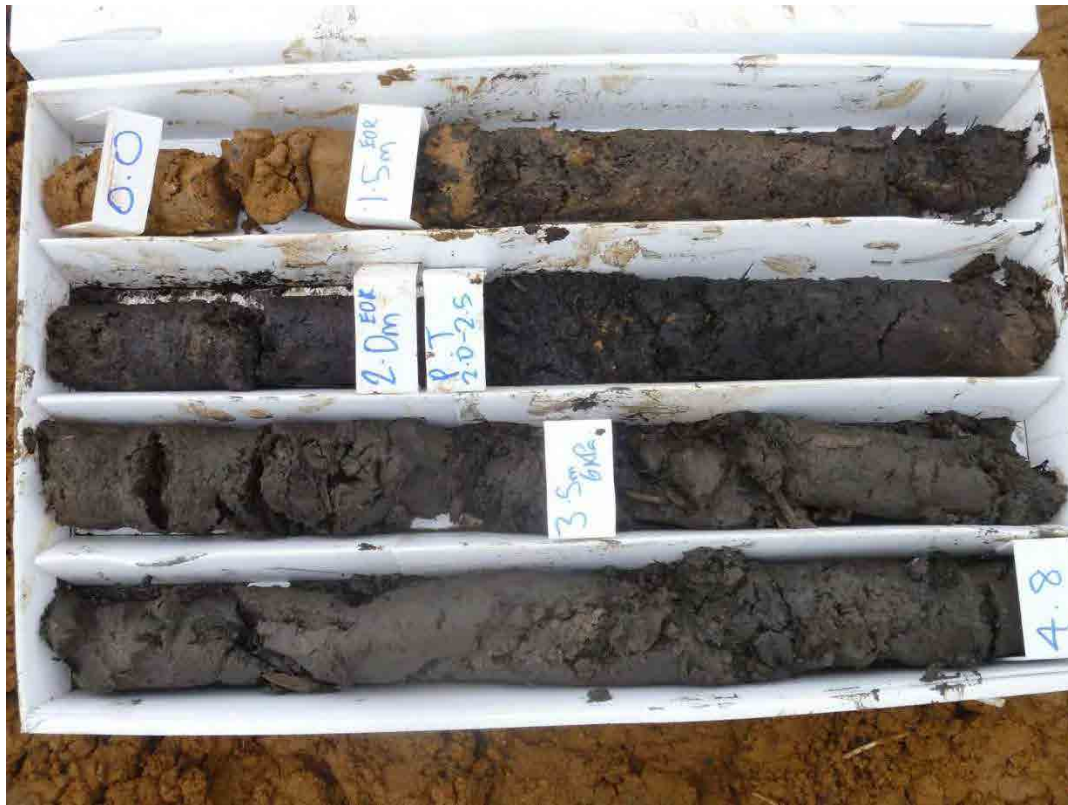
Photograph 13- BH4-0.0-4.80m

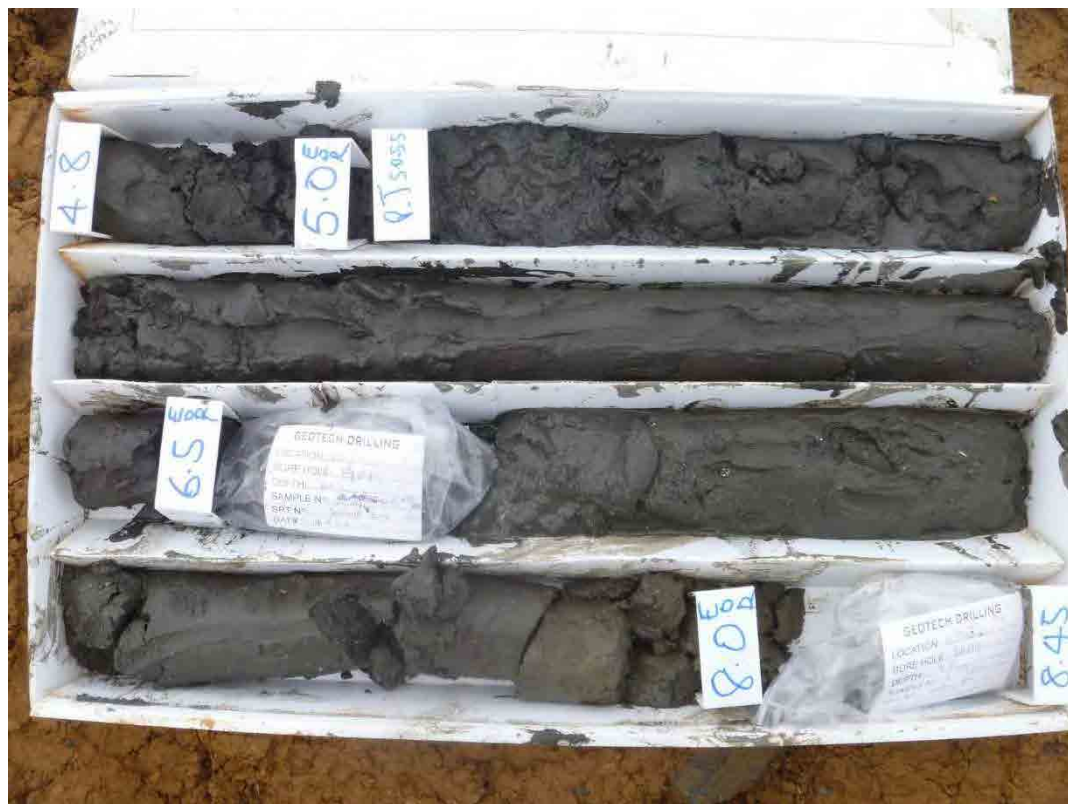
Photograph 14- BH4-4.80-8.45m

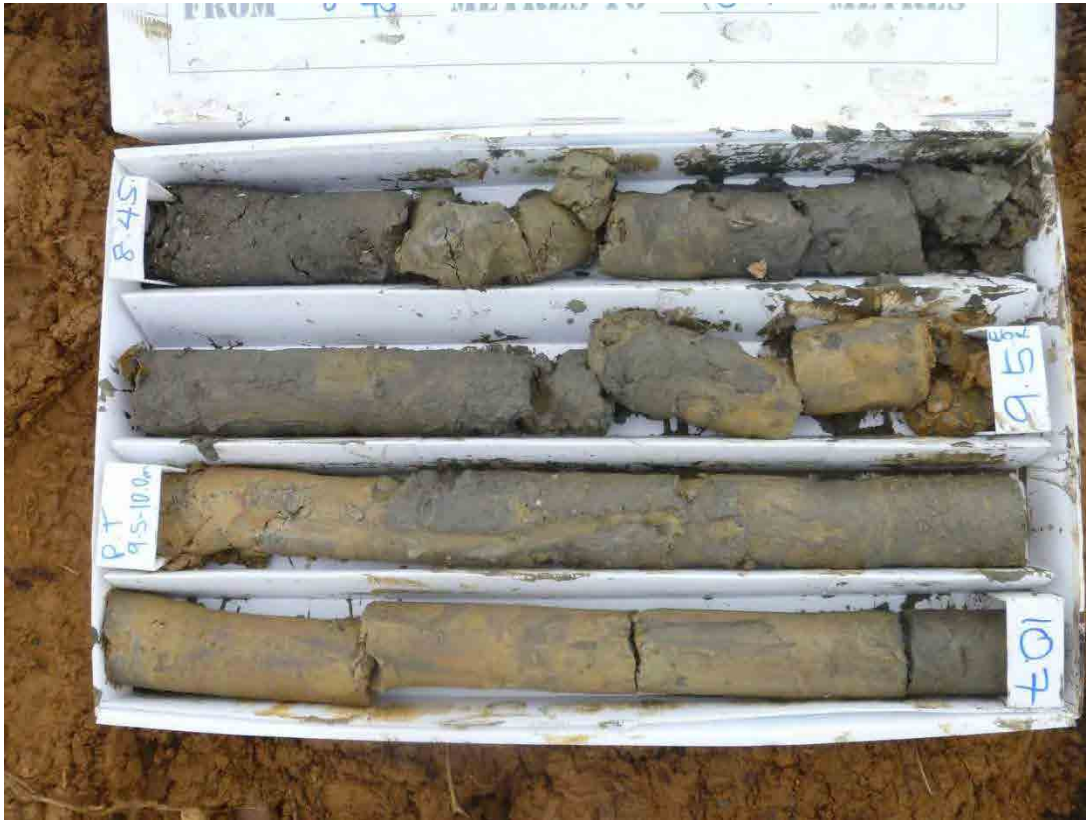
Photopgraph 15-BH4-8.45-10.70m

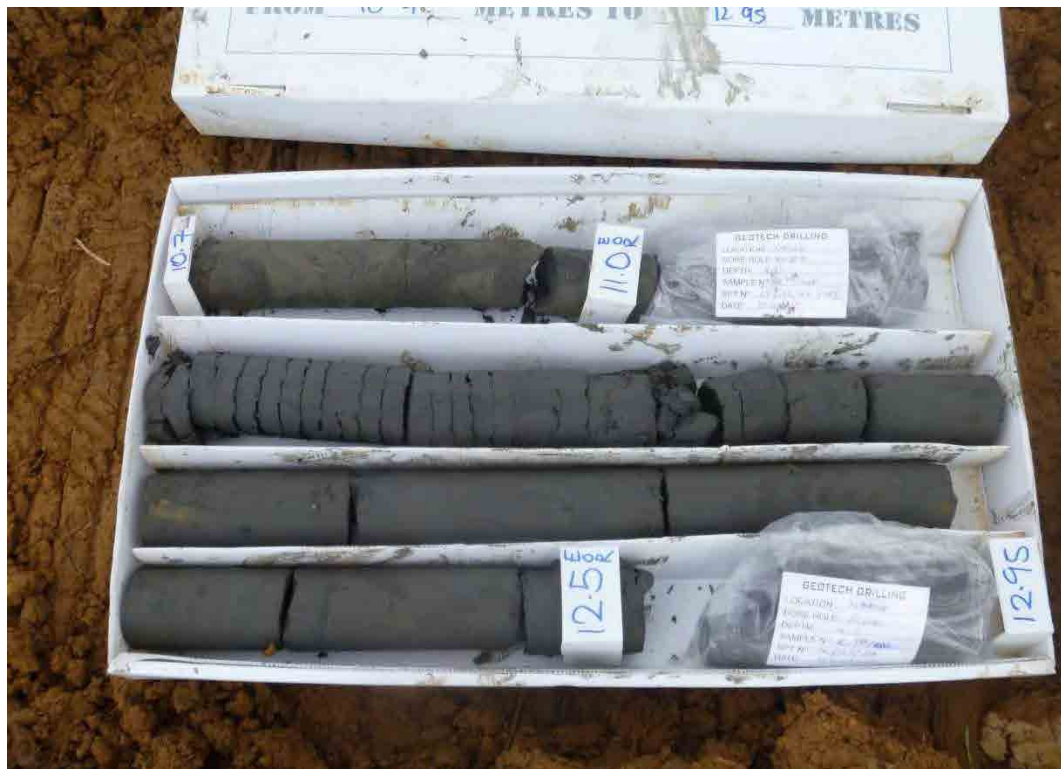
Photograph 16-BH4-10.70-12.95m

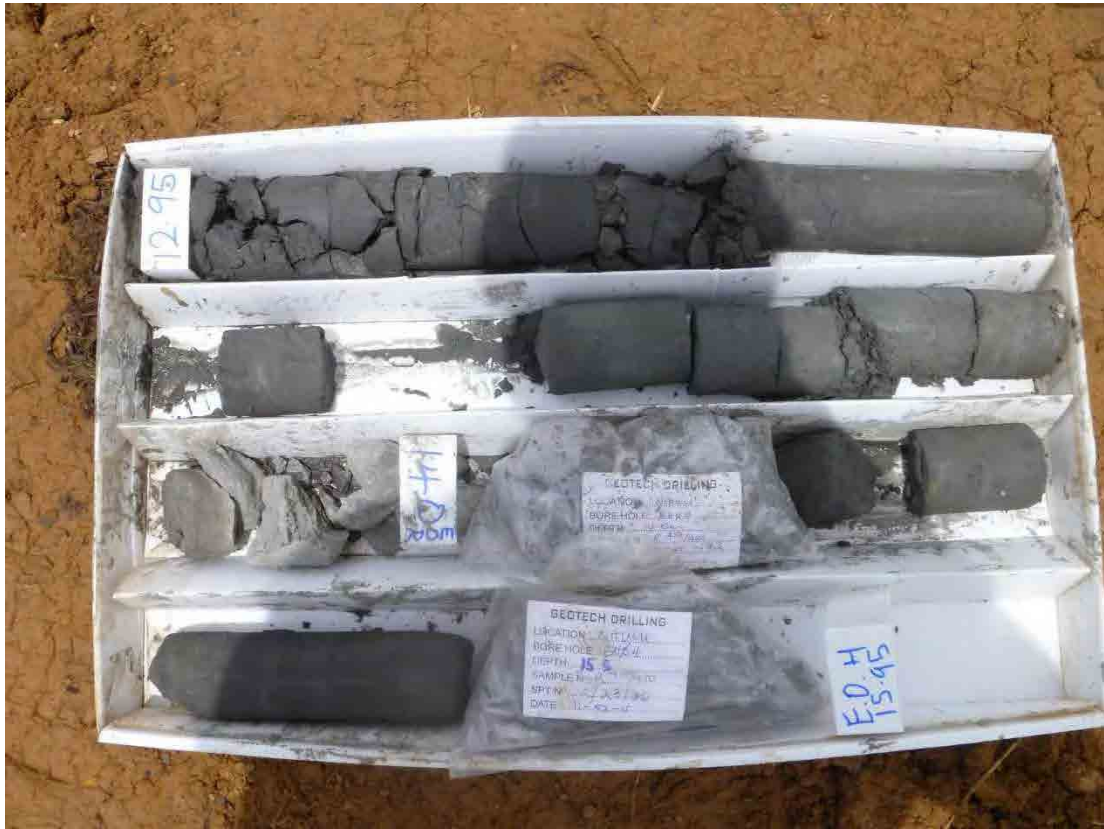
Photograph 17-BH4-12.95-15.95m

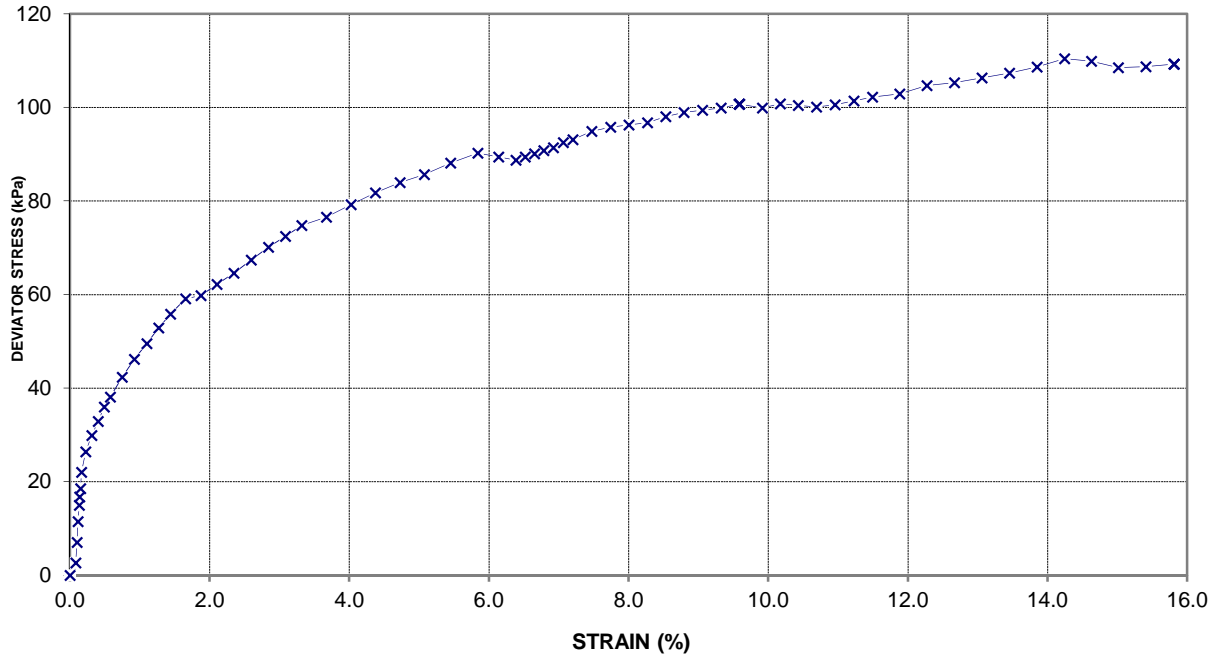
DEVIATOR STRESS VS STRAIN

Sample Height:	113.92	mm	Bulk Density:	1.73	t/m ³
Sample Diameter:	53.66	mm	Dry Density:	1.13	t/m ³
Height / Diameter:	2.12		Water Content:	53.3	%

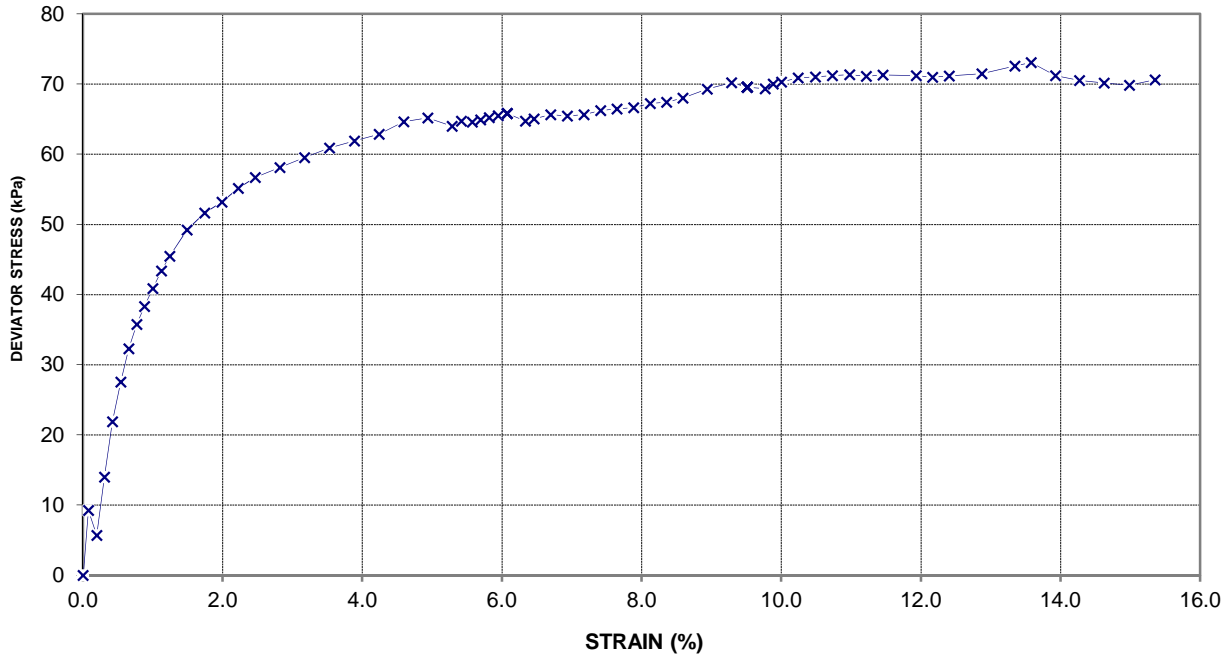
DEVIATOR STRESS VS STRAIN

Sample Height:	112.96	mm	Bulk Density:	1.73	t/m ³
Sample Diameter:	53.67	mm	Dry Density:	1.13	t/m ³
Height / Diameter:	2.10		Water Content:	52.7	%
