フィジー共和国 中波ラジオ放送復旧計画

準備調査報告書

平成 27 年 4 月
(2015 年)

独立行政法人
国際協力機構 (JICA)

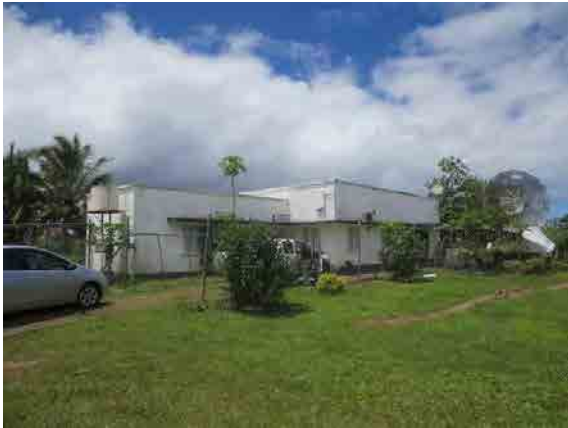
ナウル送信所送信機建屋

送信所はスバ市内より約 10 km に位置している。写真の送信機建屋は建設後 30 年を経過しており、屋根及び建具等の劣化が著しい。

FBCによると、ナウル送信所の建屋は1979年に建設されたものであり、床面積は、約190 m²、コンクリートブロック積造、屋根は木造トラスの鋼板敷き平屋建てである。屋根及び外壁の老朽化が見られ、窓及び扉等の雨仕舞が不完全なため、豪雨時には隙間部分から雨漏り被害を受けている。また、天井板も一部塞がっておらず、天井裏の埃が機材の上に落ち故障の原因になっている。既存の建屋は自然冷却式の送信機用に建設されており、空調機が設置されていない。従って、窓及び扉周辺の隙間から外部の塵及び湿気が侵入し、送信機器の劣化に繋がっている。電気配線や配管等も機器の更新毎に追加した様子が見られ、施工具合が不十分である。図 2-1-3 にナウル送信所送信機建屋の平面図及び外観写真を示す。

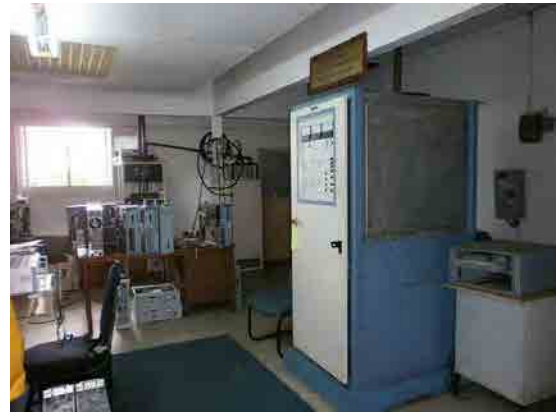
ナウル送信所中波送信機

FBC の中波ラジオ放送は、2013 年に故障により中断したが応急修理により出力が 2 kW に減力した状態で放送している。

既設の中波送信機は、2000年に設置されたカナダ製10kW、558kHzが1台稼動中でフィジー語の放送を行っている。2000年当時774kHzでヒンズー語放送に使用していた送信機は、2004年に故障し、交換部品が入手不可能で修理できないため、アンテナと共に撤去されている。現在558kHzで放送している送信機は2013年の故障後、廃棄品から中古の部品を集めて組立てたもので、一部のユニットは送信機内部に収納出来ず送信機の脇に置いて運用している状況である。定格出力は10kWであるがユニットの劣化及びアンテナとの整合が悪く、2kWの出力しか出ていない。一方、既設の中波アンテナの状況としては、経年により基礎鉄骨部分に錆びによる腐食が進行しており、このままではサイクロン等で倒壊の危険が予想される。さらにアンテナ付近のATU（整合装置）と呼ばれるアンテナと送信機の特性を調整する機材も同様の状況であり、送信出力不足の原因となっている。

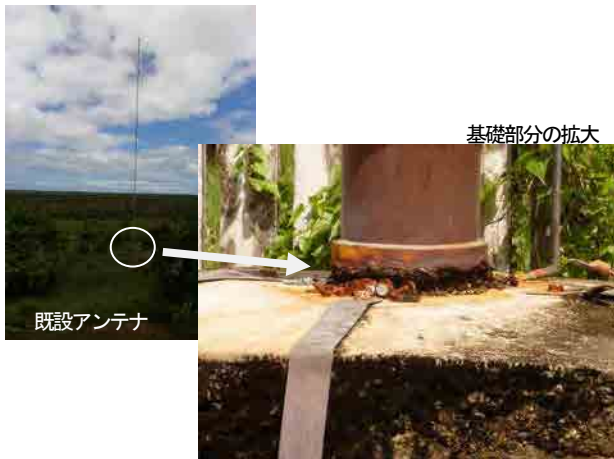
ナウル送信所既設アンテナ

既設アンテナは建設後 50 年を経過している。支線は経年により断線し、基礎部分も腐食する等、緊急に更新が必要である。

既設の 558 kHz で放送している中波送信機は各部の劣化並びにアンテナとの不整合が原因で、定格出力 10 kW のところ、現在は 2 kW の送信出力しか得られておらず、放送のカバレッジ（サービスエリア）が極端に狭くなっている。そのため、全国民に向けた放送が達成出来ていない（現在のカバレッジを図 2-1-8 に示す）。既設の中波アンテナは鉄骨基礎部分の錆びによる腐食並びに支線ワイヤー劣化のため、倒壊の危険があり、今後の継続した使用が困難な状態にある。また、774 kHz で放送していた送信機は交換部品の製造中止等の理由により

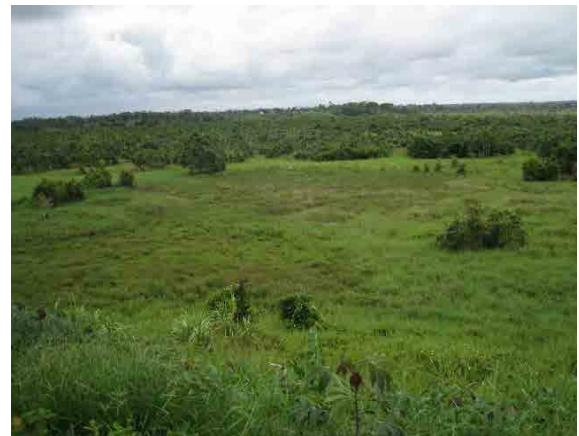
ナウル送信所新設アンテナ計画用地

既設アンテナから 300 m ほど離れた新設アンテナ計画用地の状況。

There is a possibility that the interruption period becomes less than 6 months if the suitable location for new antenna is found at about 300 meter away from the existing antenna in the FBC site, where the effect of electromagnetic wave from the existing antenna is considered relatively small. Even in this case, an interruption of the existing antenna is unavoidable but probably limited in the period of adjustment and test of broadcasting from new antenna.

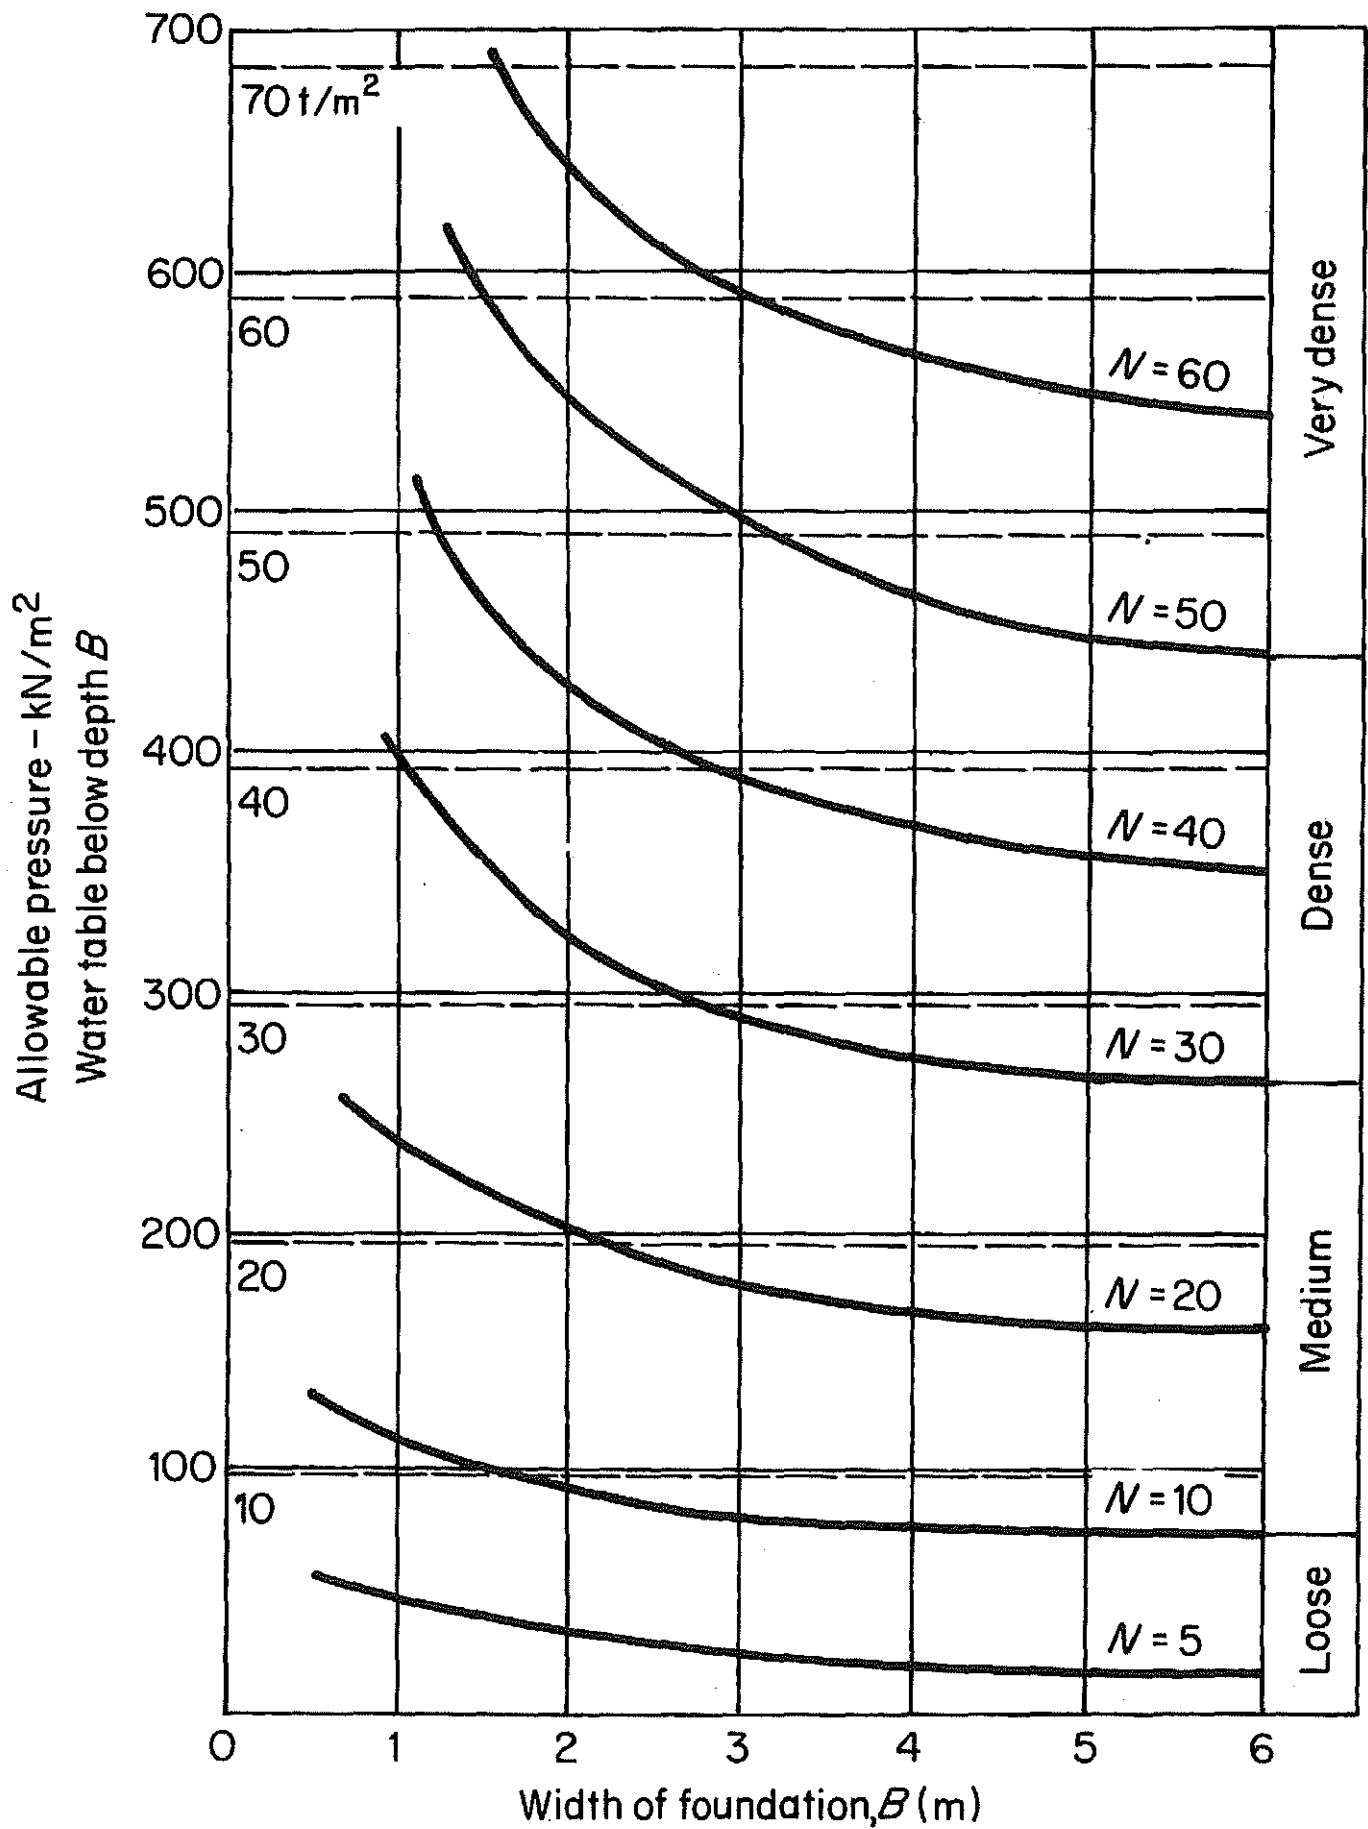
Fig. 2.19 Chart for estimating allowable bearing pressure for foundations in sand on basis of results of standard penetration test (Terzaghi and Peck^{2.8}). N values are shown in blows per 300 mm.
