**The Republic of Fiji
Ministry of Public Enterprises
Fiji Broadcasting Company**

**PREPARATORY SURVEY REPORT
ON
THE PROJECT FOR
THE REHABILITATION OF THE MEDIUM
WAVE RADIO TRANSMISSION
IN
THE REPUBLIC OF FIJI**

APRIL 2015

YACHIYO ENGINEERING CO., LTD.

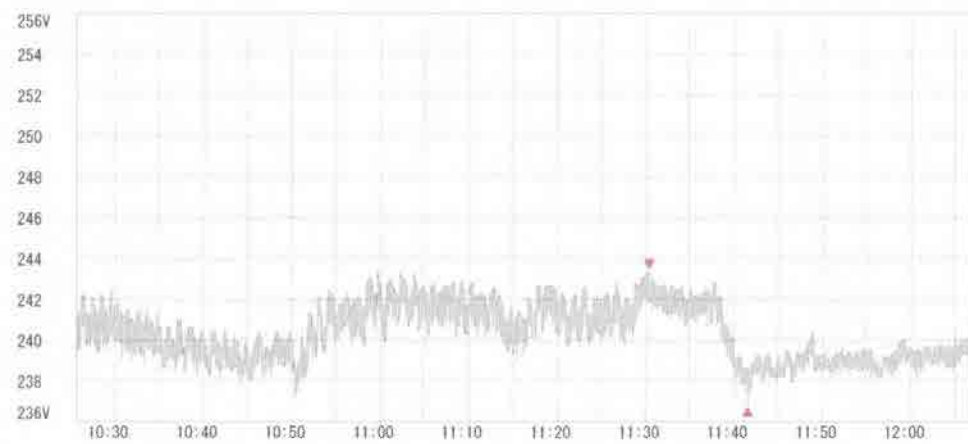
Observations: Nominal voltage in the Republic of Fiji is 240 V (single phase), and the measured voltage varies from 236.8 V to 243.4 V. Although there were no power interruptions of note, the Team saw how the voltage can vary over the short term. Such voltage fluctuations have an adverse impact on the electronic circuitry of broadcasting equipment and can lead to abnormal heating, malfunction, failure and so on. Accordingly, installing an AVR (automatic voltage regulator) possessing enough capacity to satisfy the power consumption of the equipment will be planned on the power source side of the equipment installed in the new Transmitter House.

Max.: 243.4V (October 2, 2014,11:30)

Min.: 236.8V (October 2, 2014.11:42)

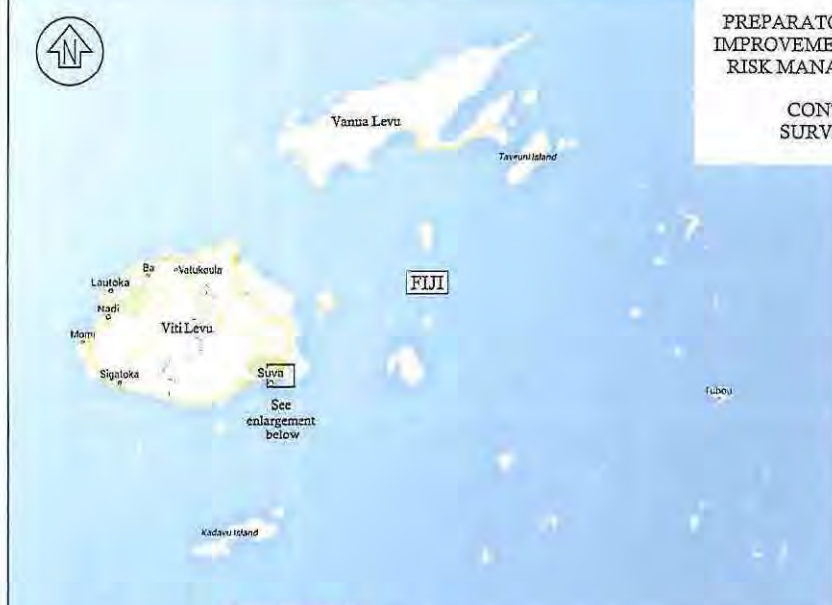
SITE PLAN

Name	Easting (m)	Northing (m)	RL (m)
BH1/SC1	1976784.80	3881776.56	30.02
BH2/SC2	1976767.18	3881771.57	49.91
BH3/SC3	1976741.38	3881833.15	42.81
BH4/SC4	1976741.42	3881896.06	35.50
BH5/SC5/SC5A	1976804.49	3881913.35	35.16
SC5	1976798.78	3881915.72	35.20

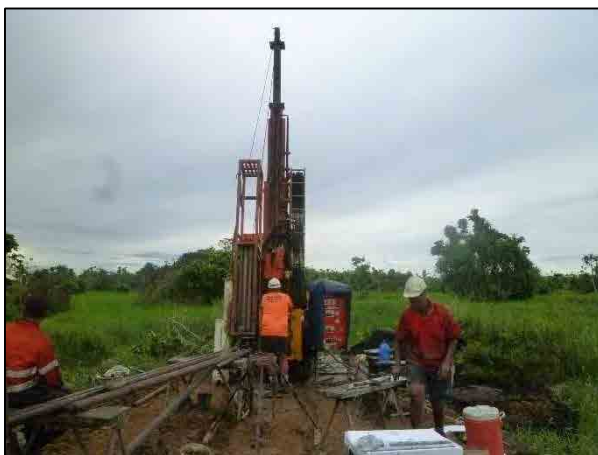
Figure 4.1: GDI drilling rig used during the investigations.

The geotechnical investigations were undertaken by Geotech Drilling International Ltd (GDI) under the supervision of T&TI. The machine drilled boreholes were performed using a tracked rig using HQT (HQ Triple Tube) wireline techniques with Standard Penetration Testing (SPT) performed at regular intervals. A photo of the equipment used is shown in Figures 4.1 and 4.2 below.

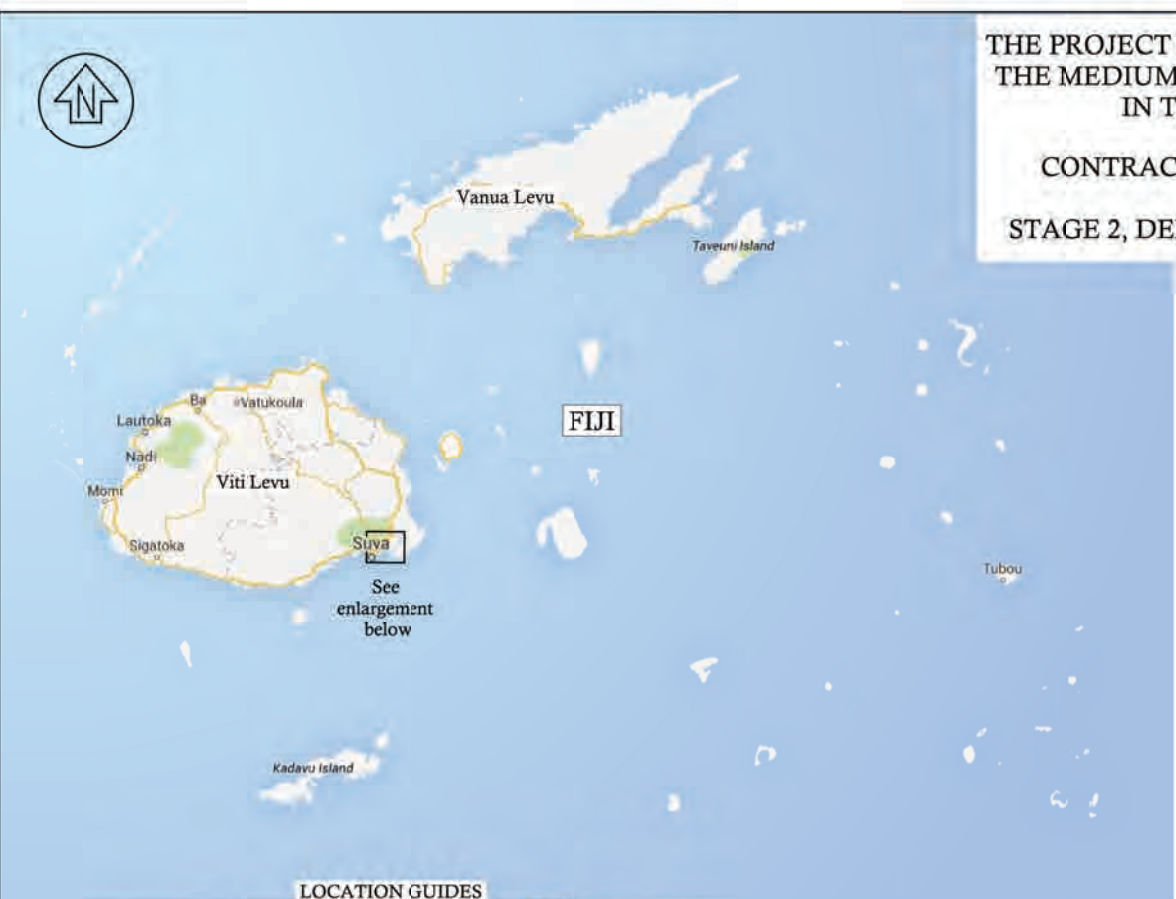
THE PROJECT FOR THE REHABILITATION OF
THE MEDIUM WAVE RADIO TRANSMISSION
IN THE REPUBLIC OF FIJI
CONTRACT OF SOILS EXPLORATIONS
STAGE 2, DEEPER SOILS INVESTIGATIONS

Name	Easting (m)	Northing (m)	RL (m)
MB1	1976825.5	3881918.5	35.1
MB2	1976837.0	3881883.7	35.1
MB3	1976789.7	3881925.9	35.2
MB4	1976849.8	3881945.8	34.8

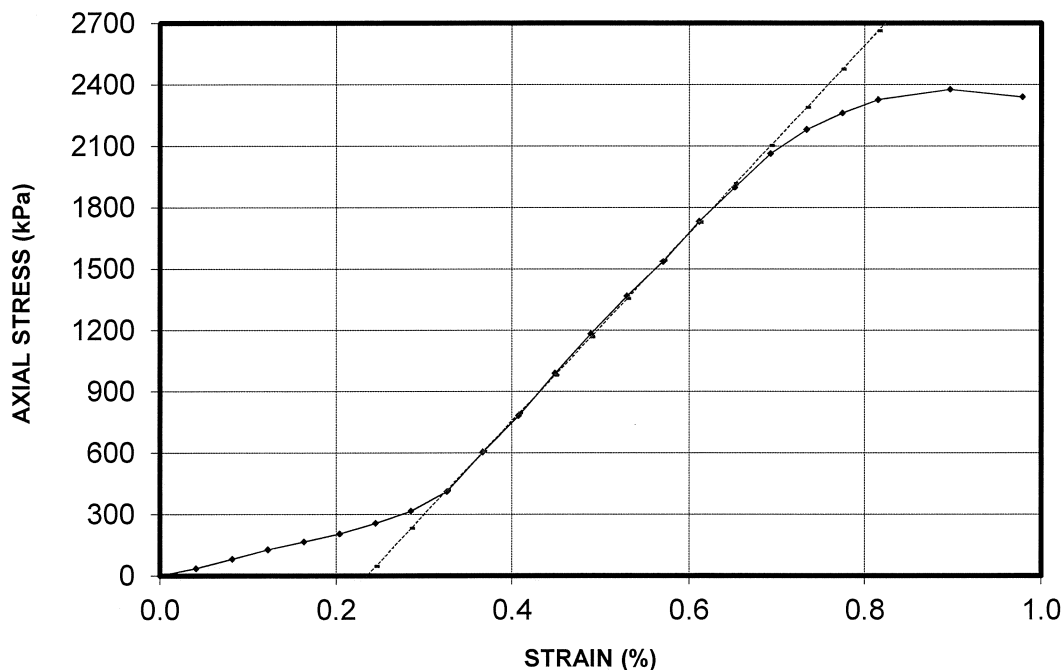
UNCONFINED COMPRESSIVE STRENGTH TEST
AXIAL STRESS VS STRAIN
