**PREPARATORY SURVEY ON THE PROJECT FOR
REINFORCEMENT OF TRANSMISSION NETWORK IN NACALA
CORRIDOR IN THE REPUBLIC OF MOZAMBIQUE**

TOPOGRAPHIC SURVEY

**GEOTECHNICAL INVESTIGATION AND TOPOGRAPHIC
SURVEY FOR PREPARATORY SURVEY OF REINFORCEMENT
PLAN FOR TRANSMISSION LINE AT NACALA CORRIDOR IN
MOZAMBIQUE**

FINAL REPORT

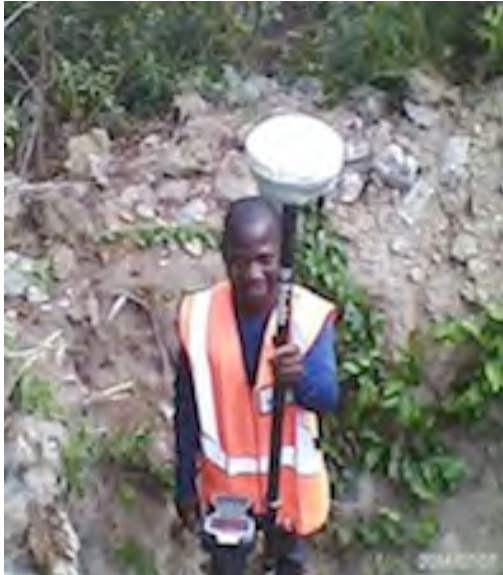
Removed beacon in Meconta

The survey was done on the WGS 84 UTM Zone 37 System. Unfortunately the closest official beacon to the site, which was reported to be located in Meconta has been destroyed as a result of vandalism action. In the absence of an official beacon the survey was conducted on the basis of self-positioning a differential GPS Trimble make, model R4. The base was set for about four hours enabling to have accurate horizontal coordinates, which are tied to the Mozambique official network. The heights used in this survey were GPS heights, which are geoid ones. No transformation was done to get levels referenced to the mean sea level; therefore heights in this survey are geoid heights.

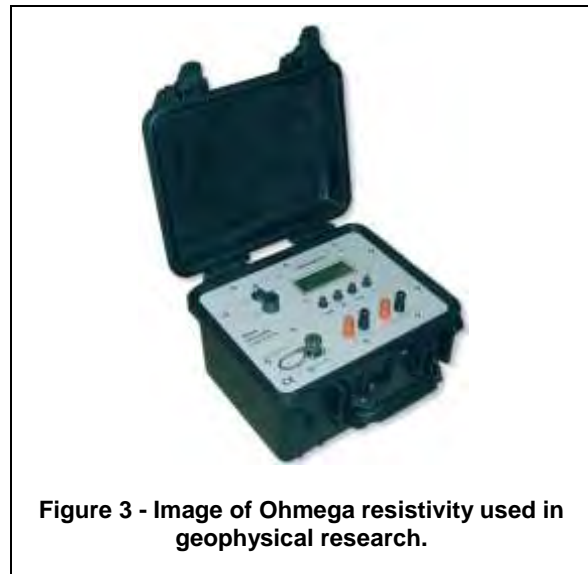
The array of the electrodes, both current and potential was Schlumberger, in this case with a constant separation between both electrodes.

Figure 3 - Image of Ohmega resistivity used in geophysical research.

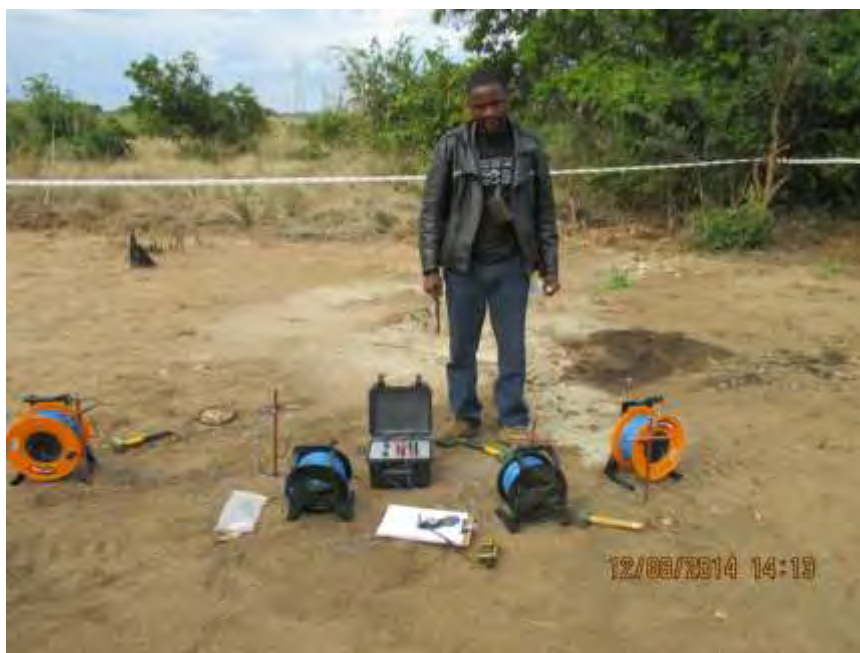
Figure 4 - SEV set-up and geophysical technician during the field works near Borehole 01

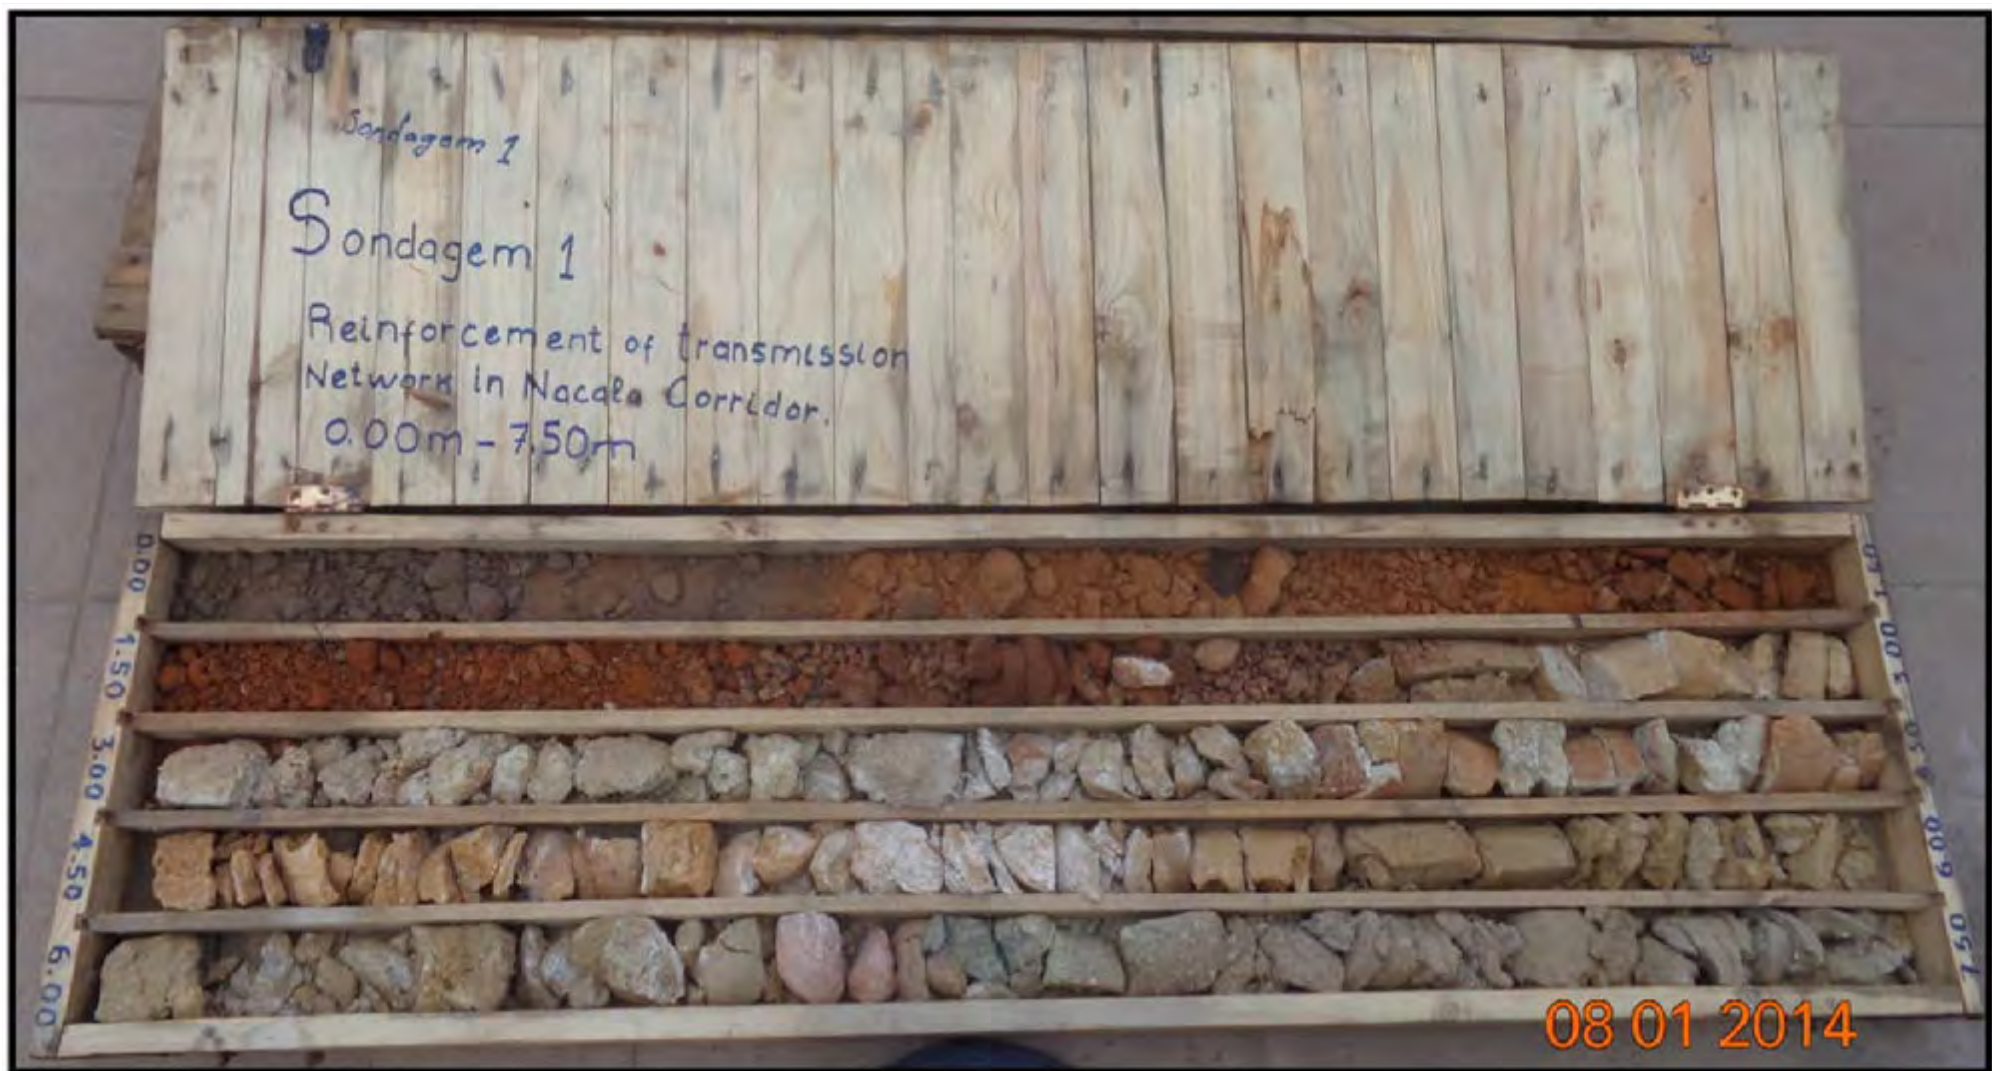
Depth (m)	Water level	Samples		Blow counts (N) 30 cm	Graphic Log	MATERIAL DESCRIPTION	Classification Symbol	Water Content (%)	Dry Unit Weight kg/m ³	REMARKS AND OTHER TESTS
0						Clayey silt, dark brown, fine grained, loose				
1		SPT disturbed	BH1-01	Refusal		Sandy silt, reddish color, fine grained, medium	SM	5.9		LL=NP PL=NP IP=NP
2		SPT disturbed	BH1-02	Refusal		Silt and conglomerate botrioidal calcite and spherical. Phenocrysts and quartz crystals, reddish and brown color, very dense				
3		SPT disturbed	BH1-03	35		Silty clay (calcite), white color and medium to fine grain size, hard	CH	32.6		LL=54 PL=27.9 IP=26.1
4				Refusal		Sandy fat clay, white and red color, with fine to medium grain size sand, hard				
5		SPT disturbed	BH1-05	Refusal		Silty sand, gray color, with fine grain size, very dense				
6		SPT disturbed	BH1-06	39		Silty clay (calcite), white color and medium to fine grain size, hard

Photo 1 - Logg 1, from 0.0m to 7.5m depth

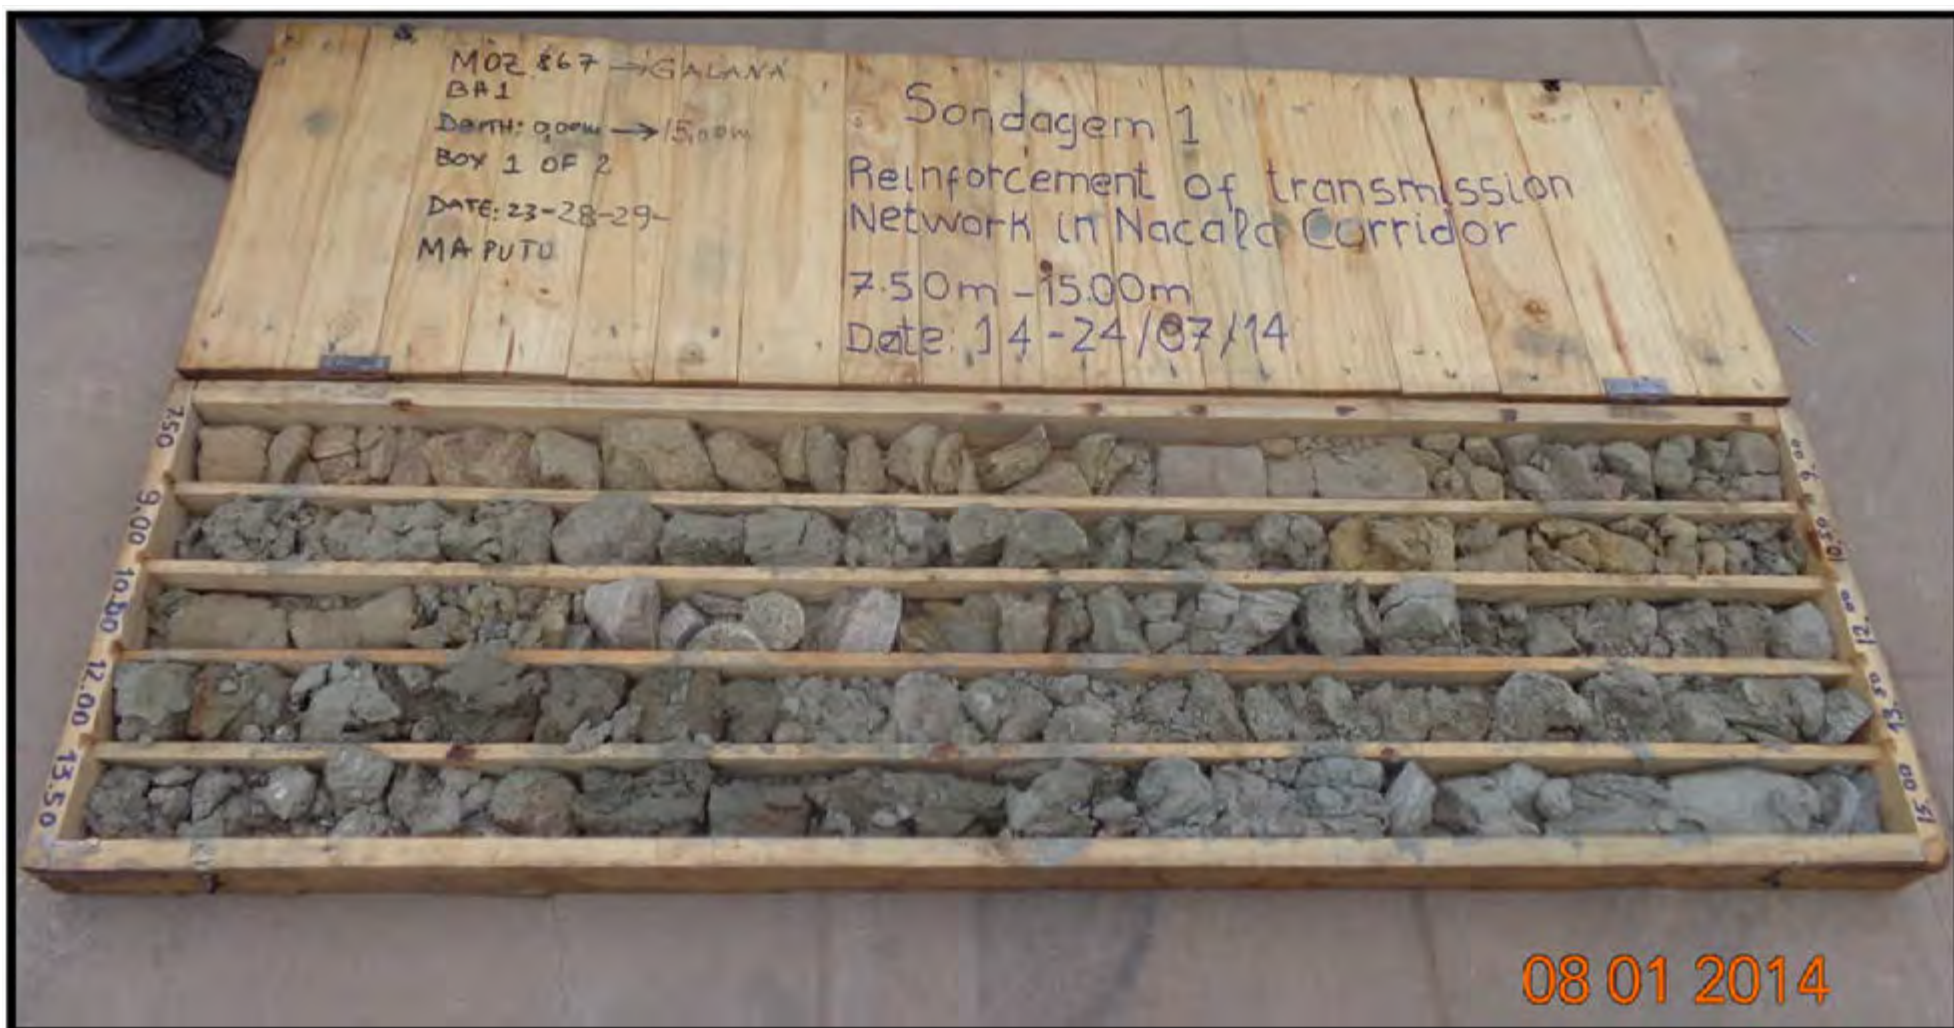
15				Refusal		Silty clayey sand, mottled with gray color, medium to fine grain size, hard				
				Refusal		Gneiss rock, gray to white color, very hard				
				Refusal		Silty clay, graycolor, medium to fine grain size, very hard				
				Refusal		Granite, very hard

Photo 2 - Logg 1, from 7.5m to 15m depth

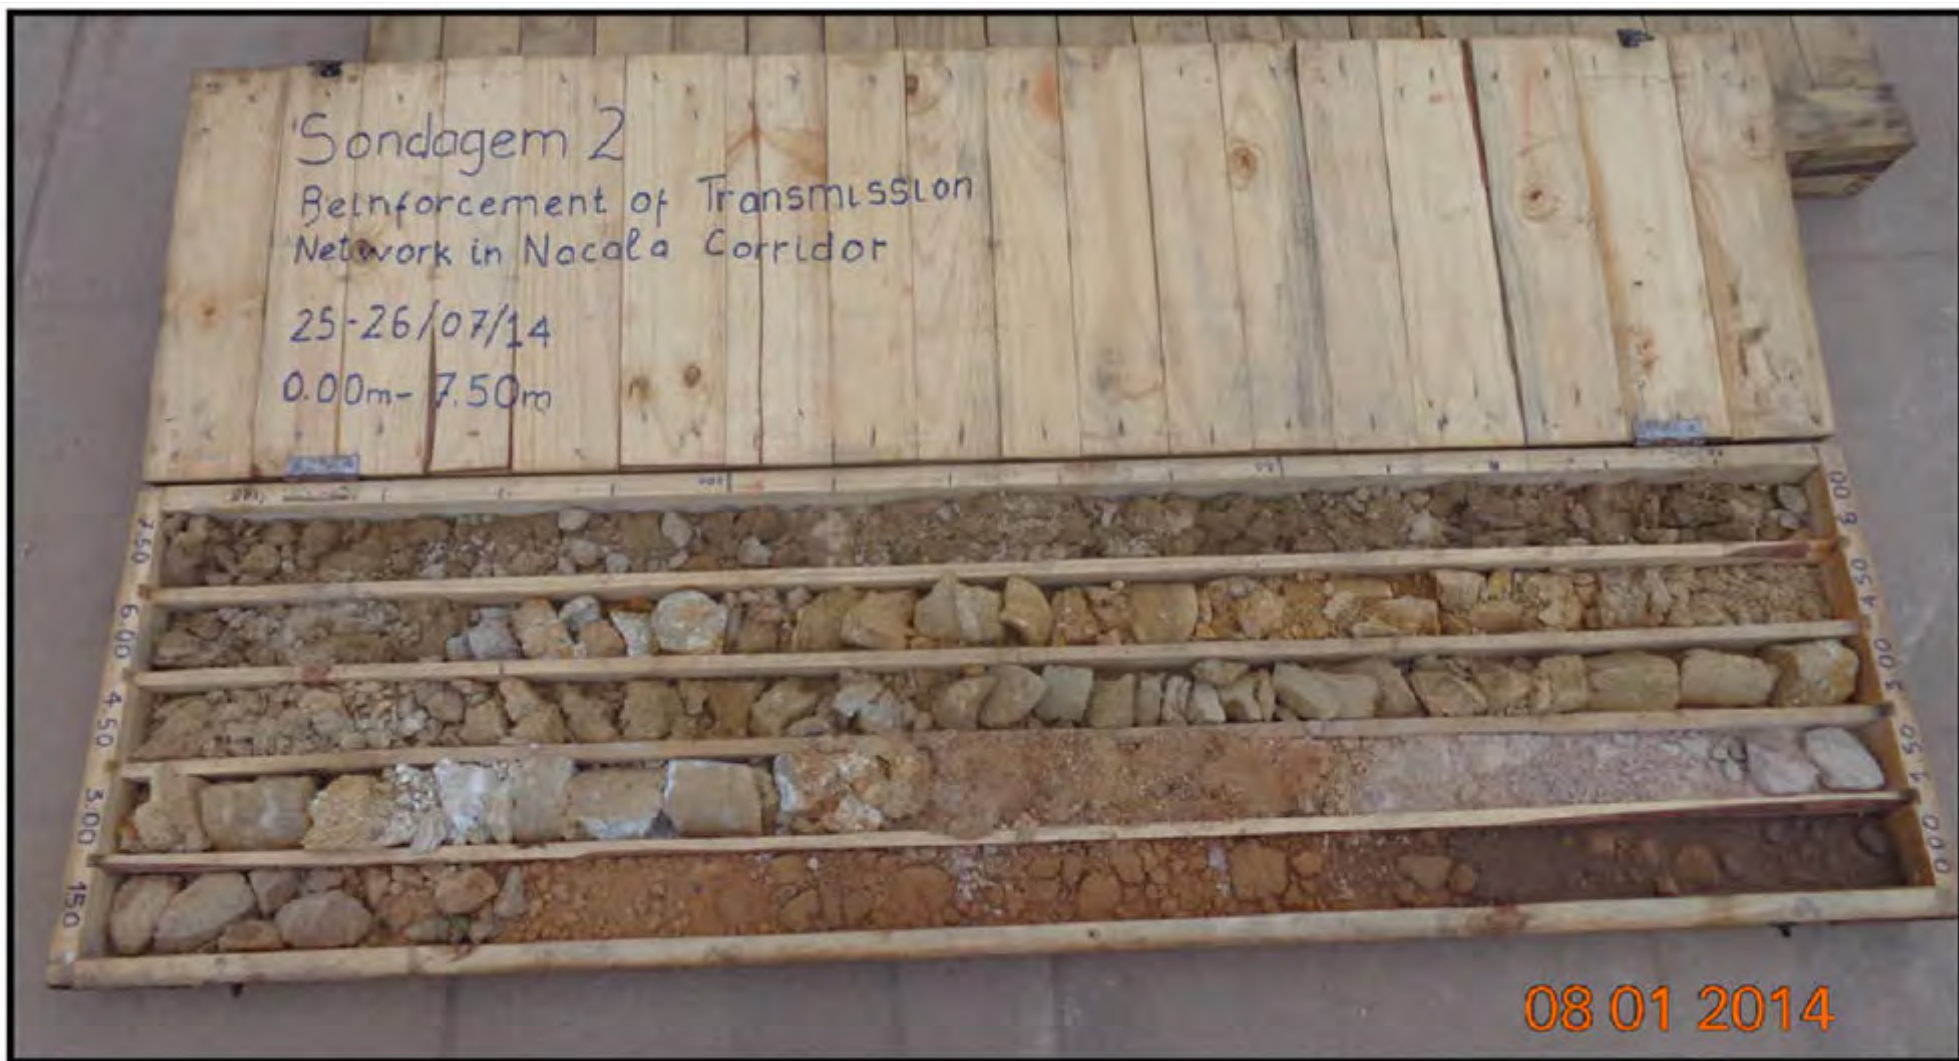
Depth (m)	Water level	Samples		Blow counts (N) 30 cm	Graphic Log	MATERIAL DESCRIPTION	Classification Symbol	Water Content (%)	Dry Unit Weight kg/m³	REMARKS AND OTHER TESTS
		Type	Number							
0						Sandy silt dark brown color, medium to fine grain size, very loose				
1		SPT disturbed	BH2-01	9		Silty Sand, reddish brown color, medium to fine grain size, very loose				
2		SPT disturbed	BH2-02	14		Micaceous silty sand, conglomerates (botrioidal calcite) and saprolite, fine grain size, medium	SM	9.9		LL=NP PL=NP IP=NP
3		SPT disturbed	BH2-03	46		Silt (calcite and siltstone), white color, medium to fine grain size, medium dense				
4		SPT disturbed	BH2-04	Refusal		Micaceous silty sand, brown color, variegated, medium to fine grain size, very dense				
5		SPT disturbed	BH2-05	54		Fragmented saprolite preserving gneiss structure, brown color, very dense				
6				Refusal		Saprolite, yellowish brown color, with medium to fine grain size, very dense

Photo 3 - Logg 2, from 0.0m to 7.5m depth

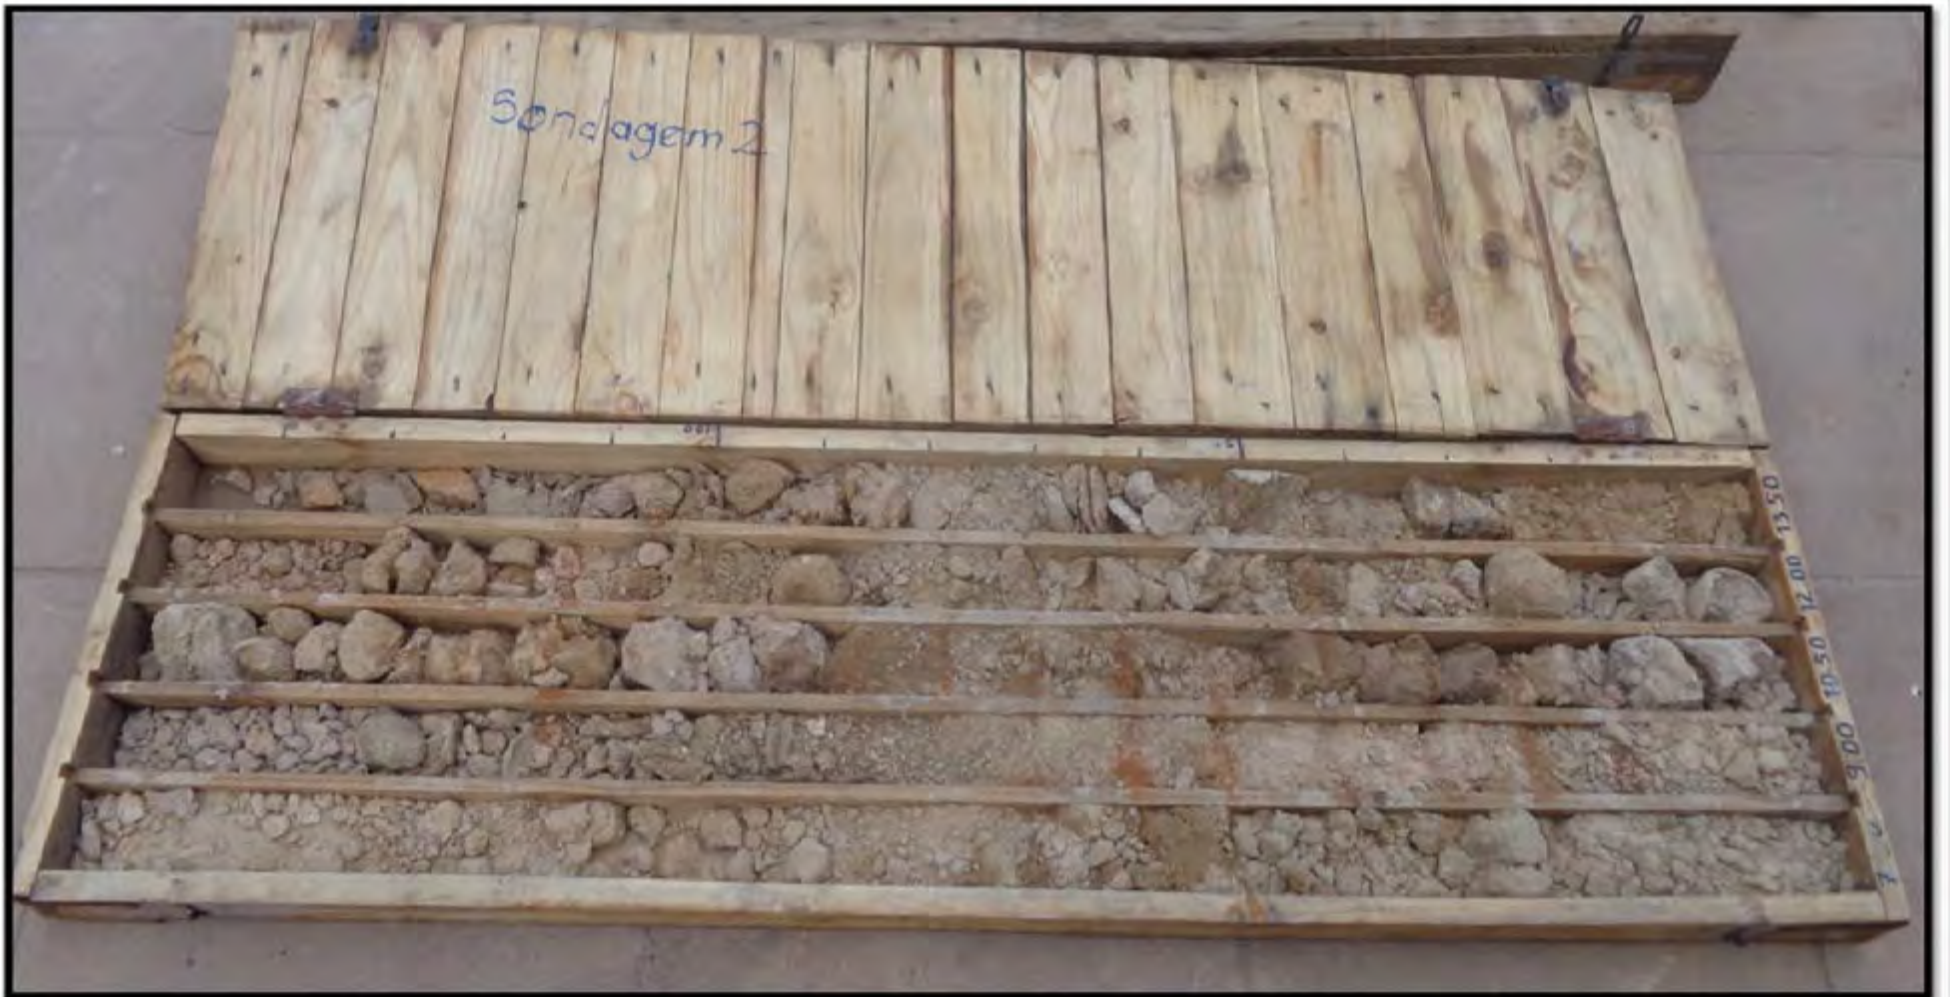
15				Refusal		Fragmented saprolite (weathered gneiss), brown color, medium to fine grain size, very dense

Photo 4 Logg 2, from 7.5m to 15.0m depth

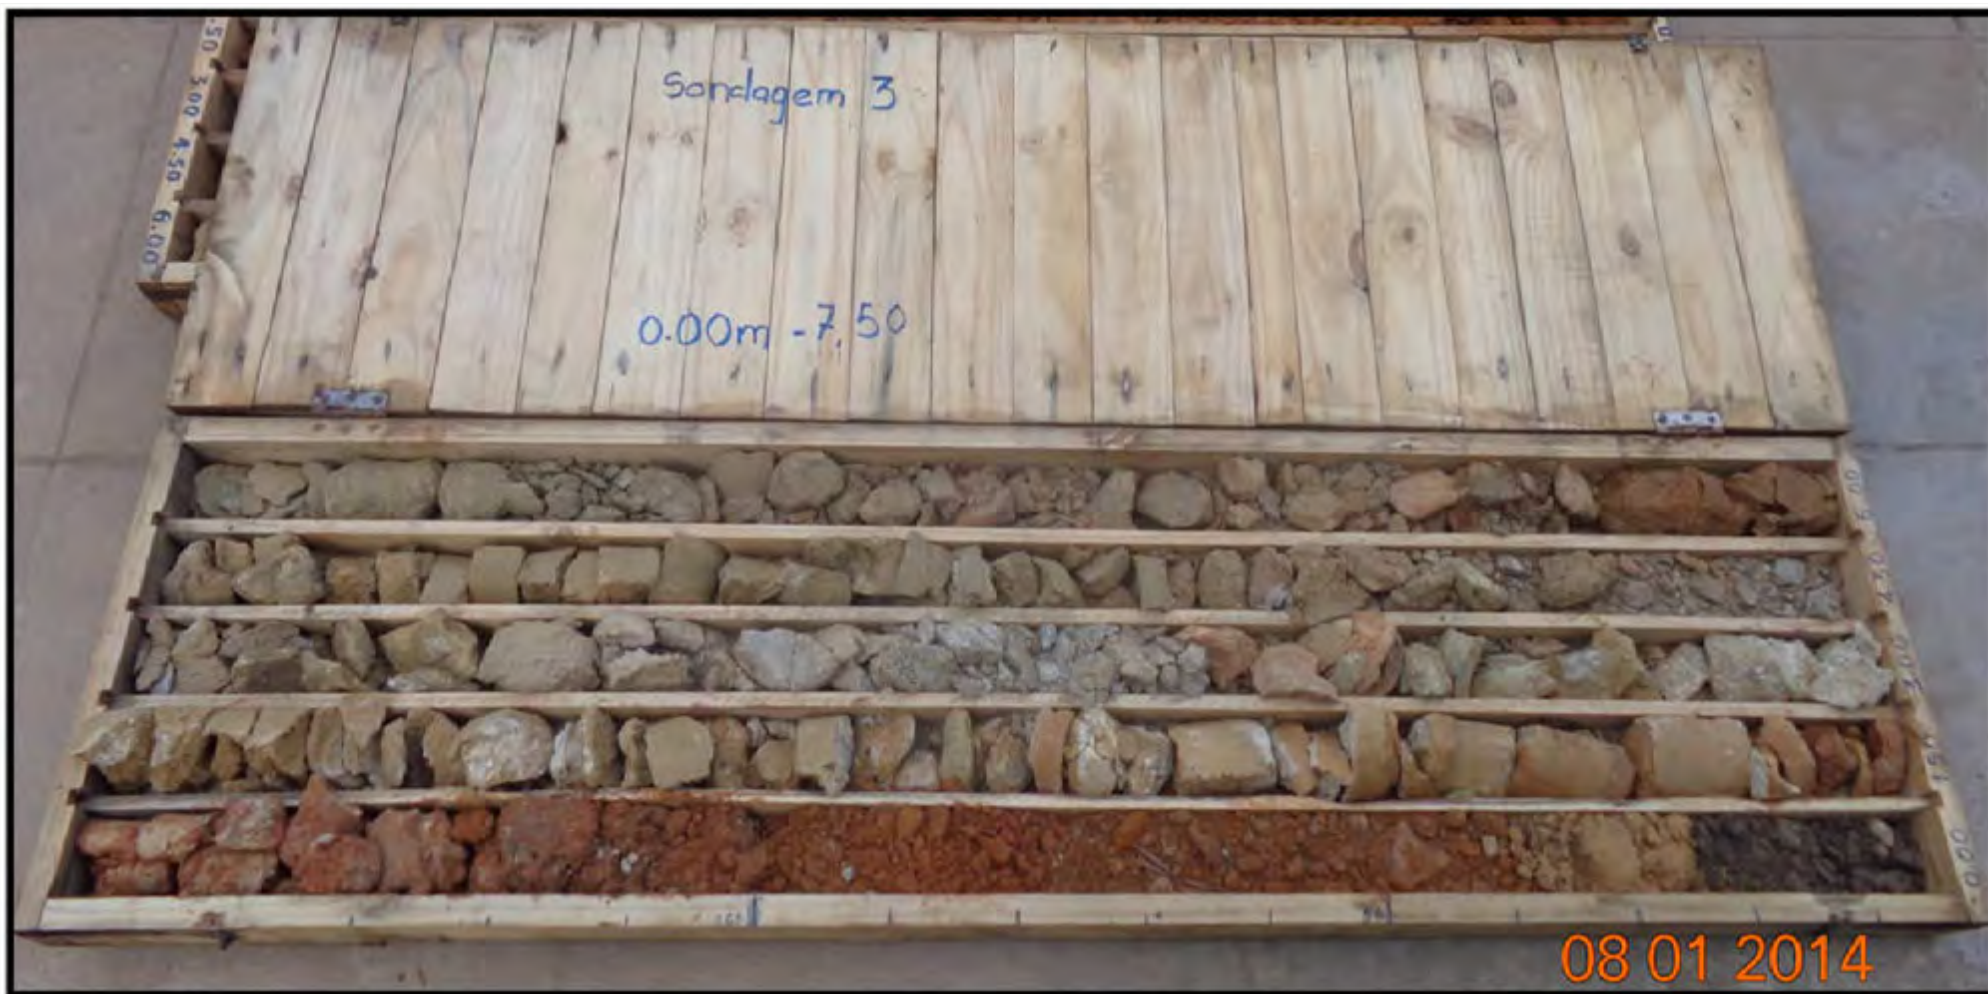
Depth (m)	Water level	Samples		Blow counts (N) 30 cm	Graphic Log	MATERIAL DESCRIPTION	Classification Symbol	Water Content (%)	Dry Unit Weight kg/m ³	REMARKS AND OTHER TESTS
		Type	Number							
0						Sandy silt (with organic material) dark brown to reddish color, medium to fine grain size, very loose				
1		SPT disturbed	BH3-01	11		Mottled silty sand, reddish brown color, fine to medium, very loose				
2		SPT disturbed	BH3-02	24		Mottled sandy clay, brown color, fine to coarse grain size medium				
3		SPT disturbed	BH3-03	46		Mottled silty sand, white and brown banded color (calcite and siltstone), fine grain size, dense	SM			LL=NP PL=NP IP=NP
4		SPT disturbed	BH3-04	79		Mottled micaceous silty sand, light gray green color, fine to medium grain size, very dense		4.36		
5		SPT disturbed	BH3-05	27		Silty clay, gray to green color, fine to medium grain size, very stiff				
6		SPT disturbed	BH3-06	Refusal		Mottled sandy clay, gray to brown color, fine grain size very dense

Photo 5 - Logg 3, from 0.0m to 7.5m depth

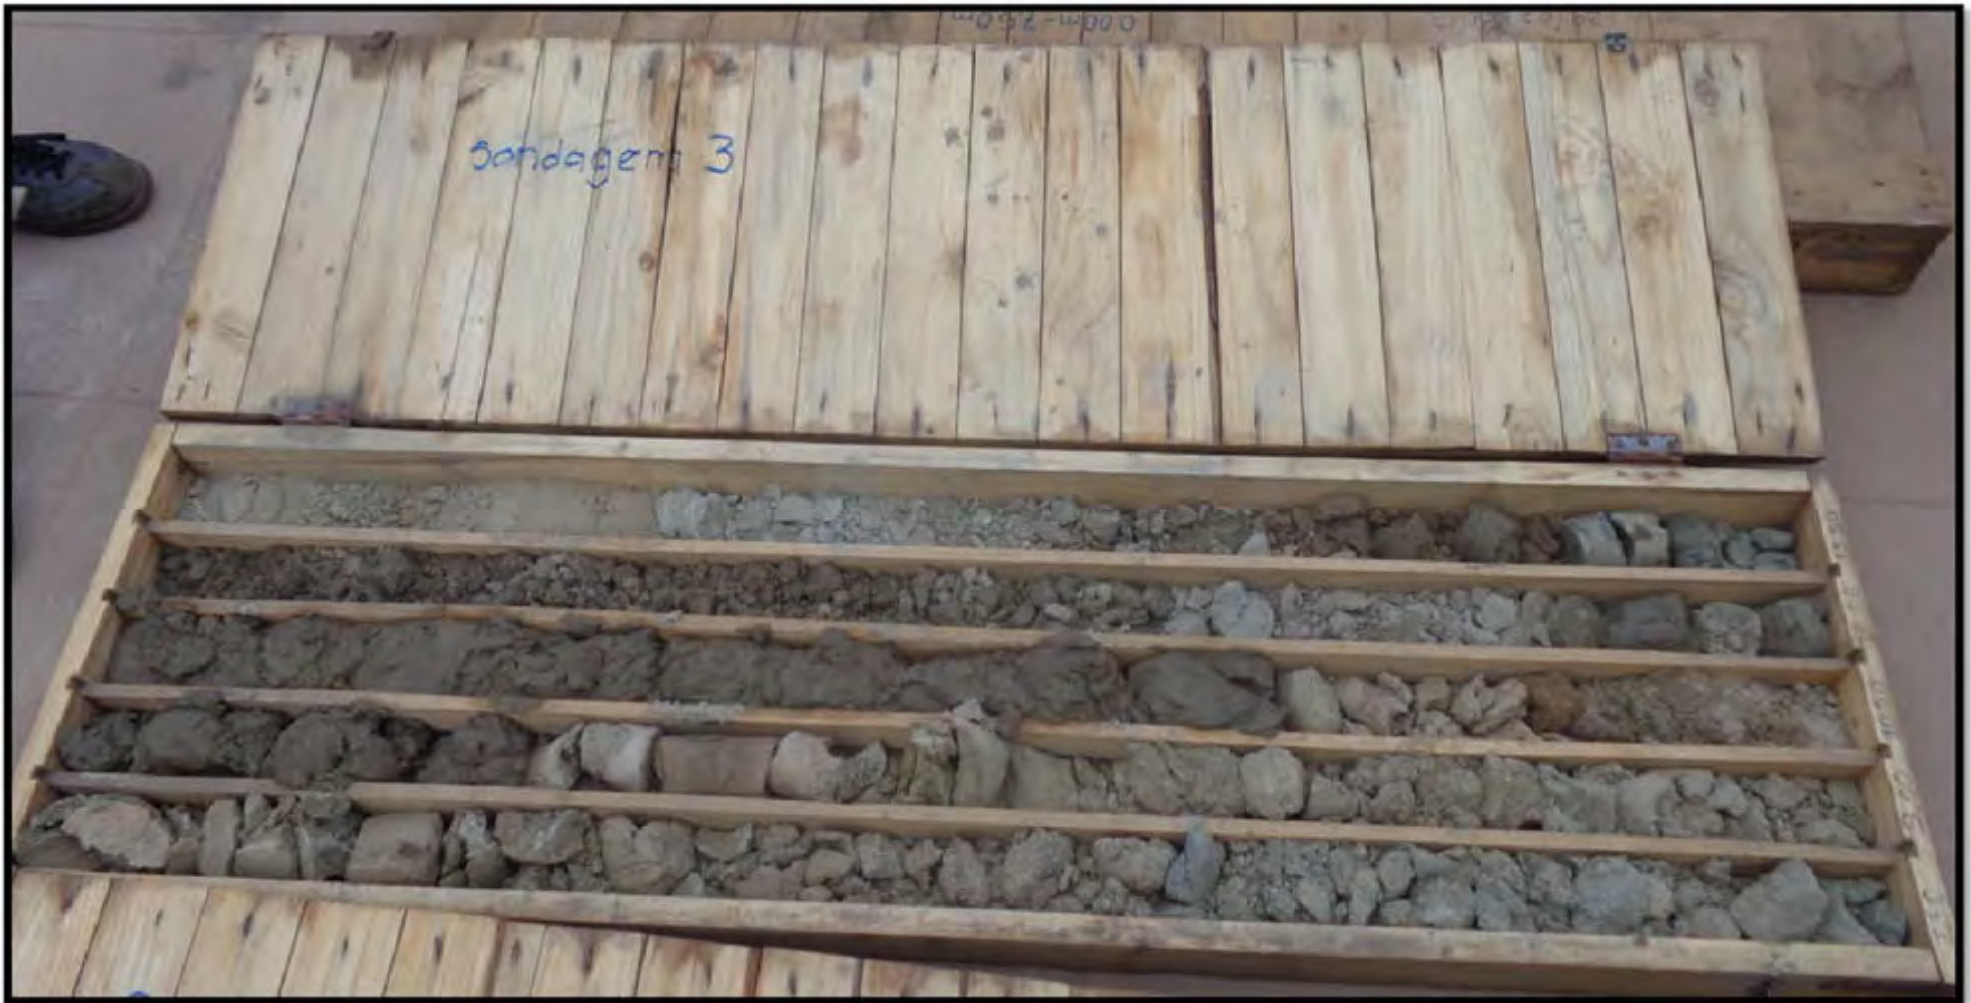
Bent silty sand, gray color, medium to fine grain size, very dense				
15						Silty clay, gray color, very fine grained, hard

Photo 6 - Logg 3, from 7.5m to 15.0m depth
