**ENVIRONMENTAL AND SOCIAL
CONSIDERATION SURVEY (ESCS)
FOR PREPARATORY SURVEY ON
THE PROJECT FOR
REINFORCEMENT OF
TRANSMISSION NETWORK IN
NACALA CORRIDOR IN THE
REPUBLIC OF MOZAMBIQUE**

**Simplified Land Use Compensation
Plan (SLUCP)**

January 2015

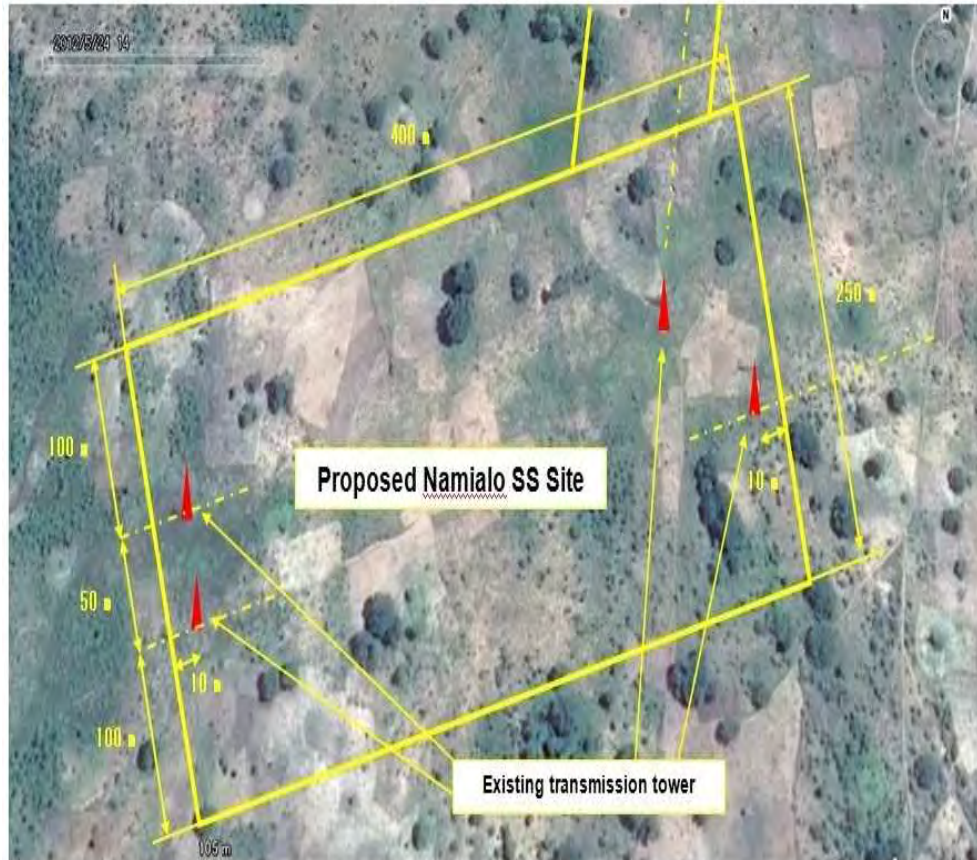
Figure 1- Map of Namialo Substation proposed Site

The project site (Figure 1) is basically located in an area that is open/vacant lands interspersed with small-scale agricultural subsistence oriented farmlands, machambas, with no human settlements. There is no housing/human settlement in the gross 100m of ROW located along the TL planned for the project facilities of access road and substation.

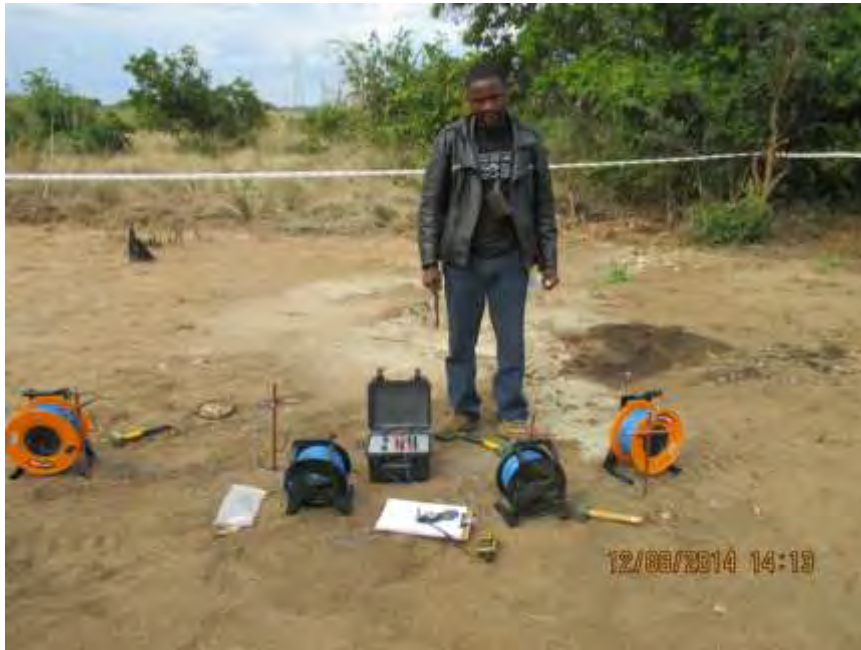
Figure 4 - SEV set-up and geophysical technician during the field works near Borehole 01

The vertical electrical soundings using the geoelectric method took place in the pre-selected sites according to the needs of the study.

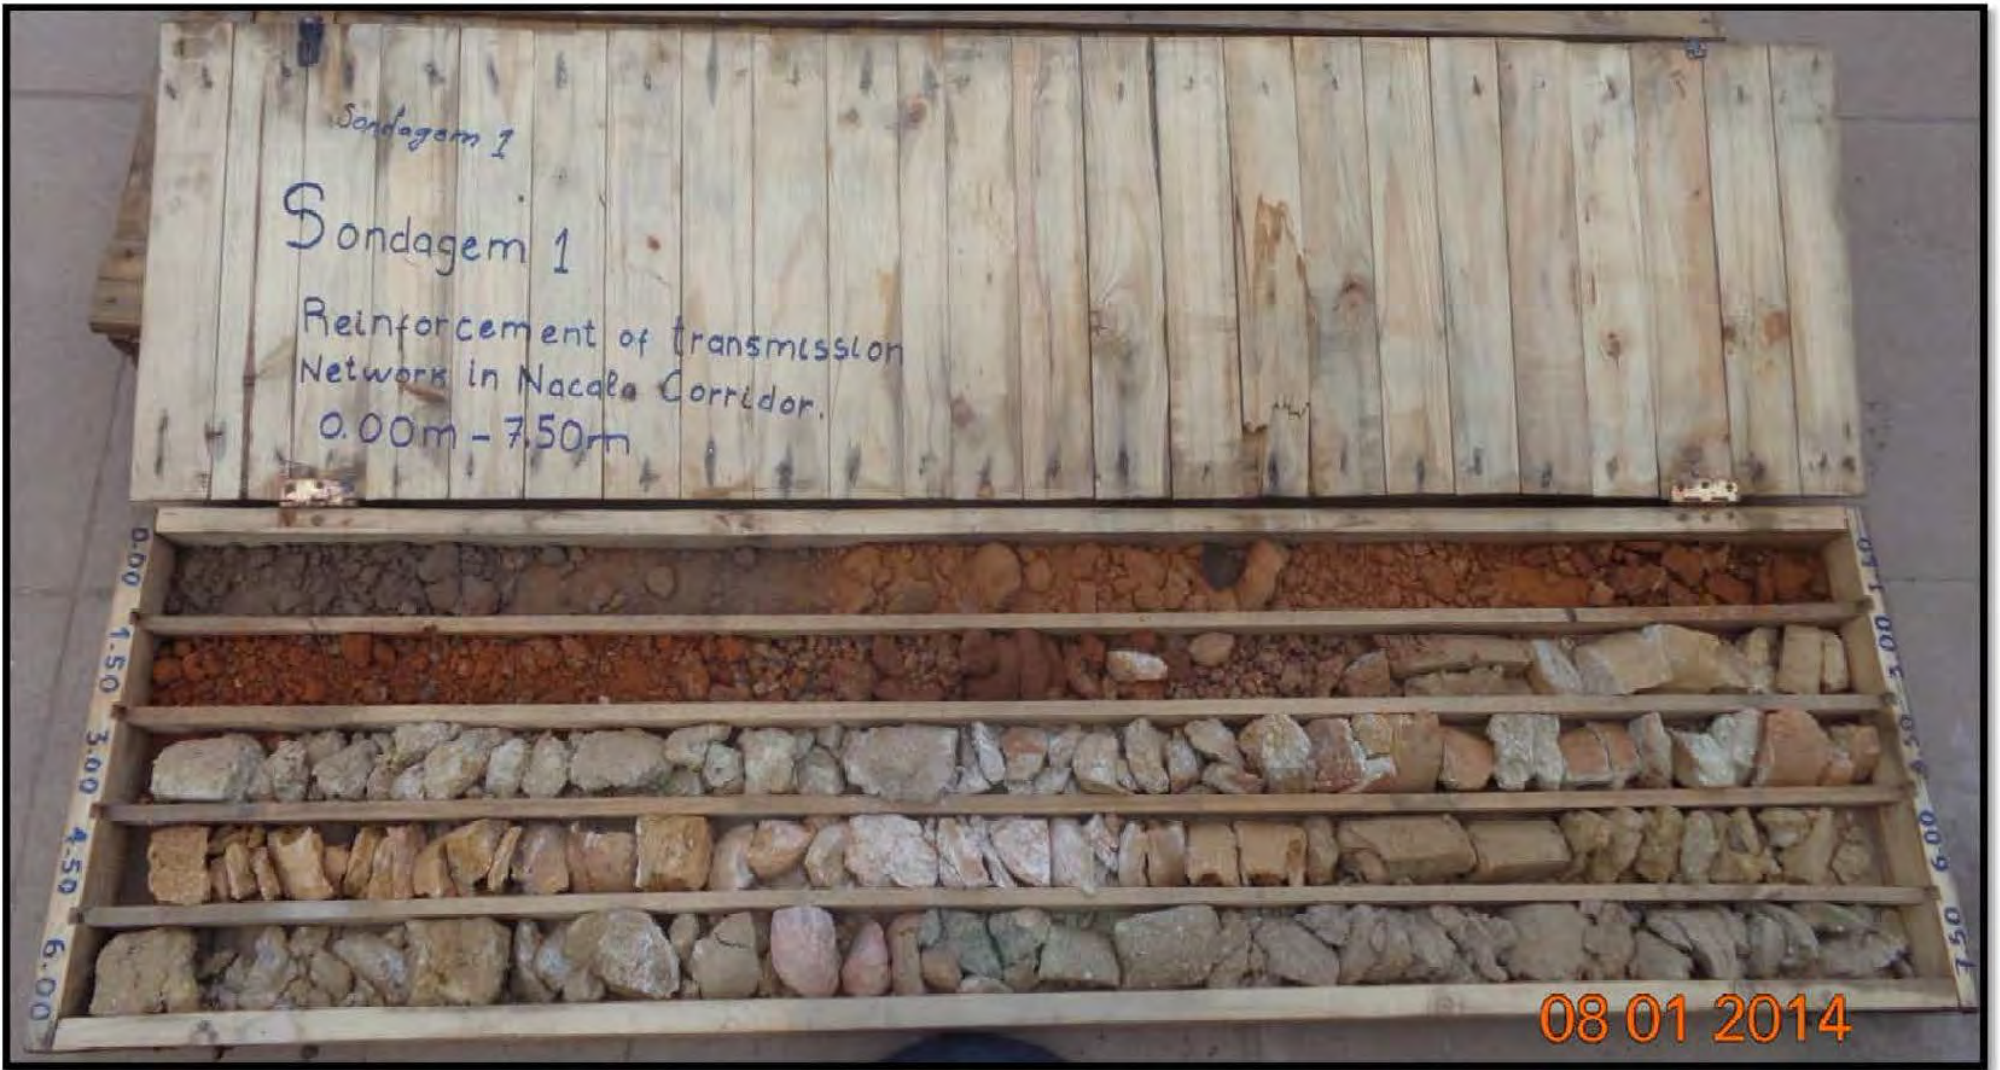
AI6-46

Photo 1 - Logg 1, from 0.0m to 7.5m depth

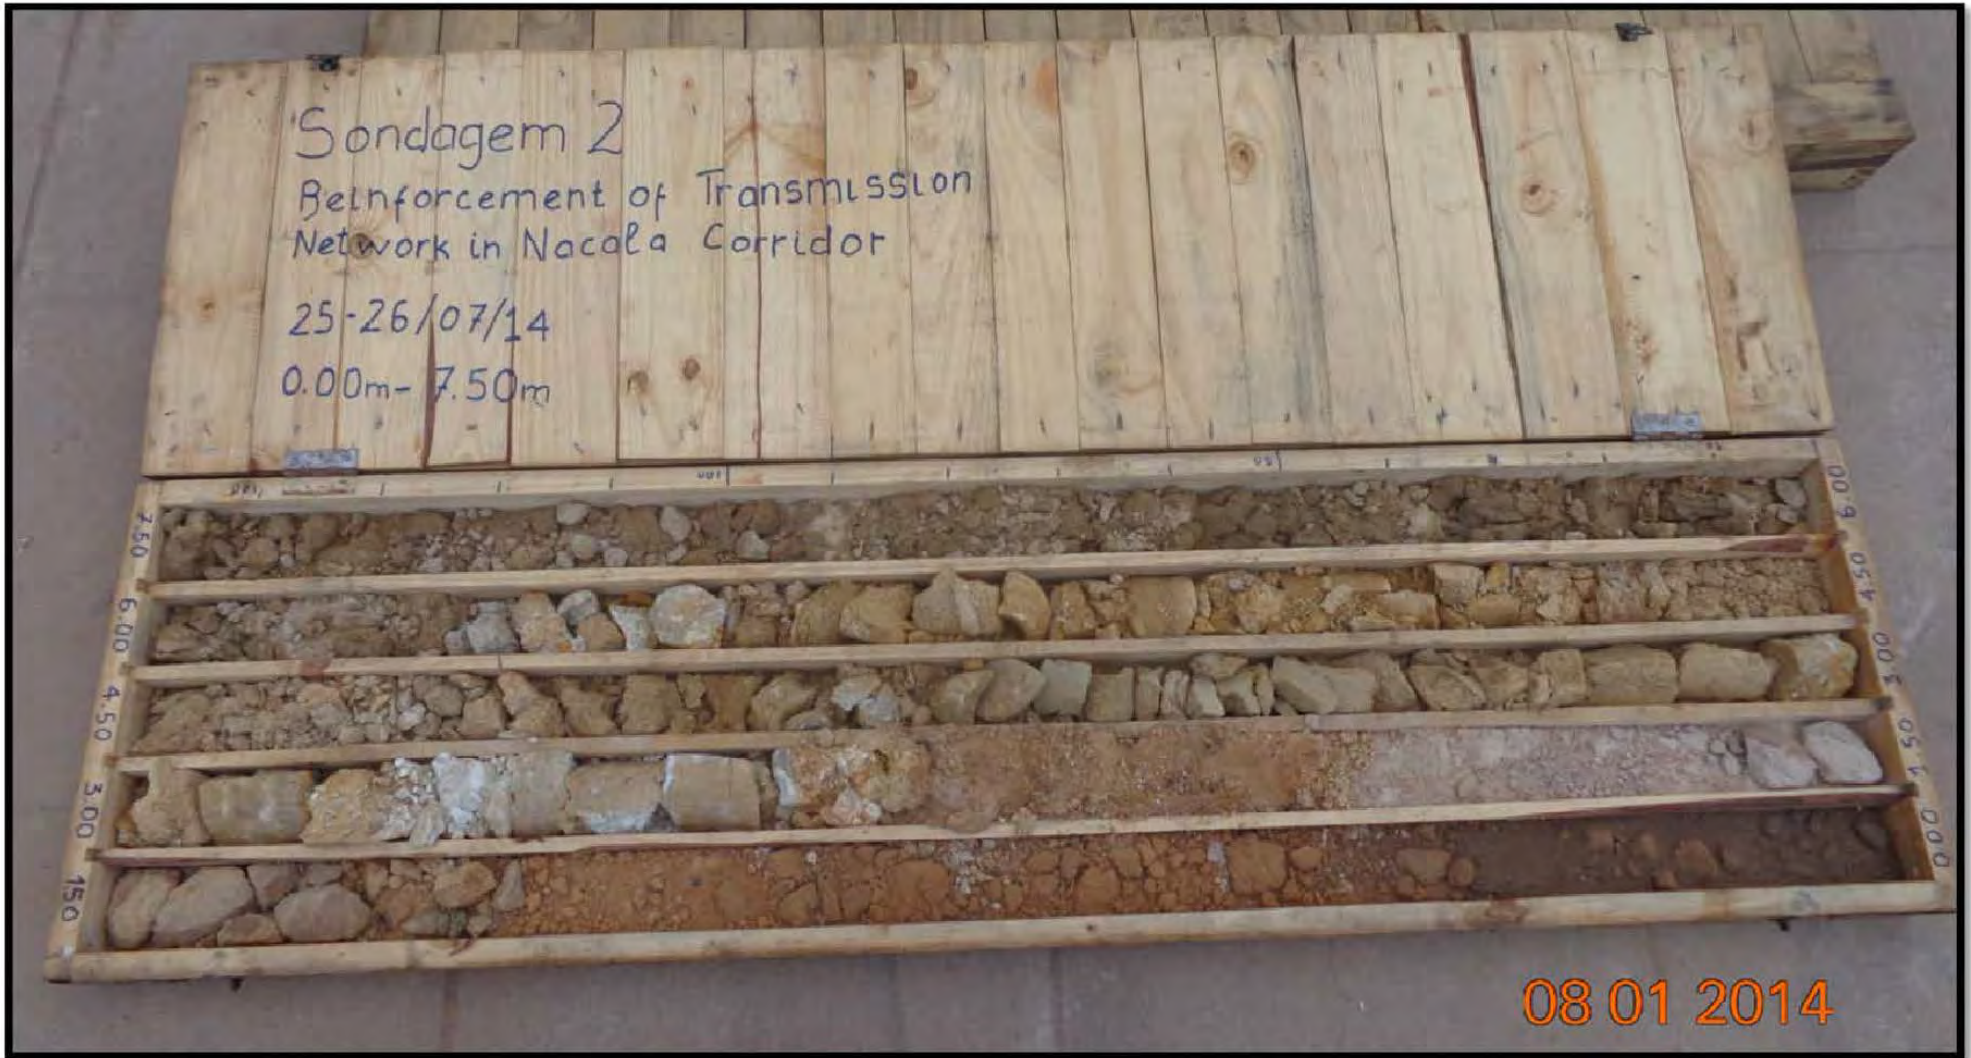
Photo 3 - Logg 2, from 0.0m to 7.5m depth

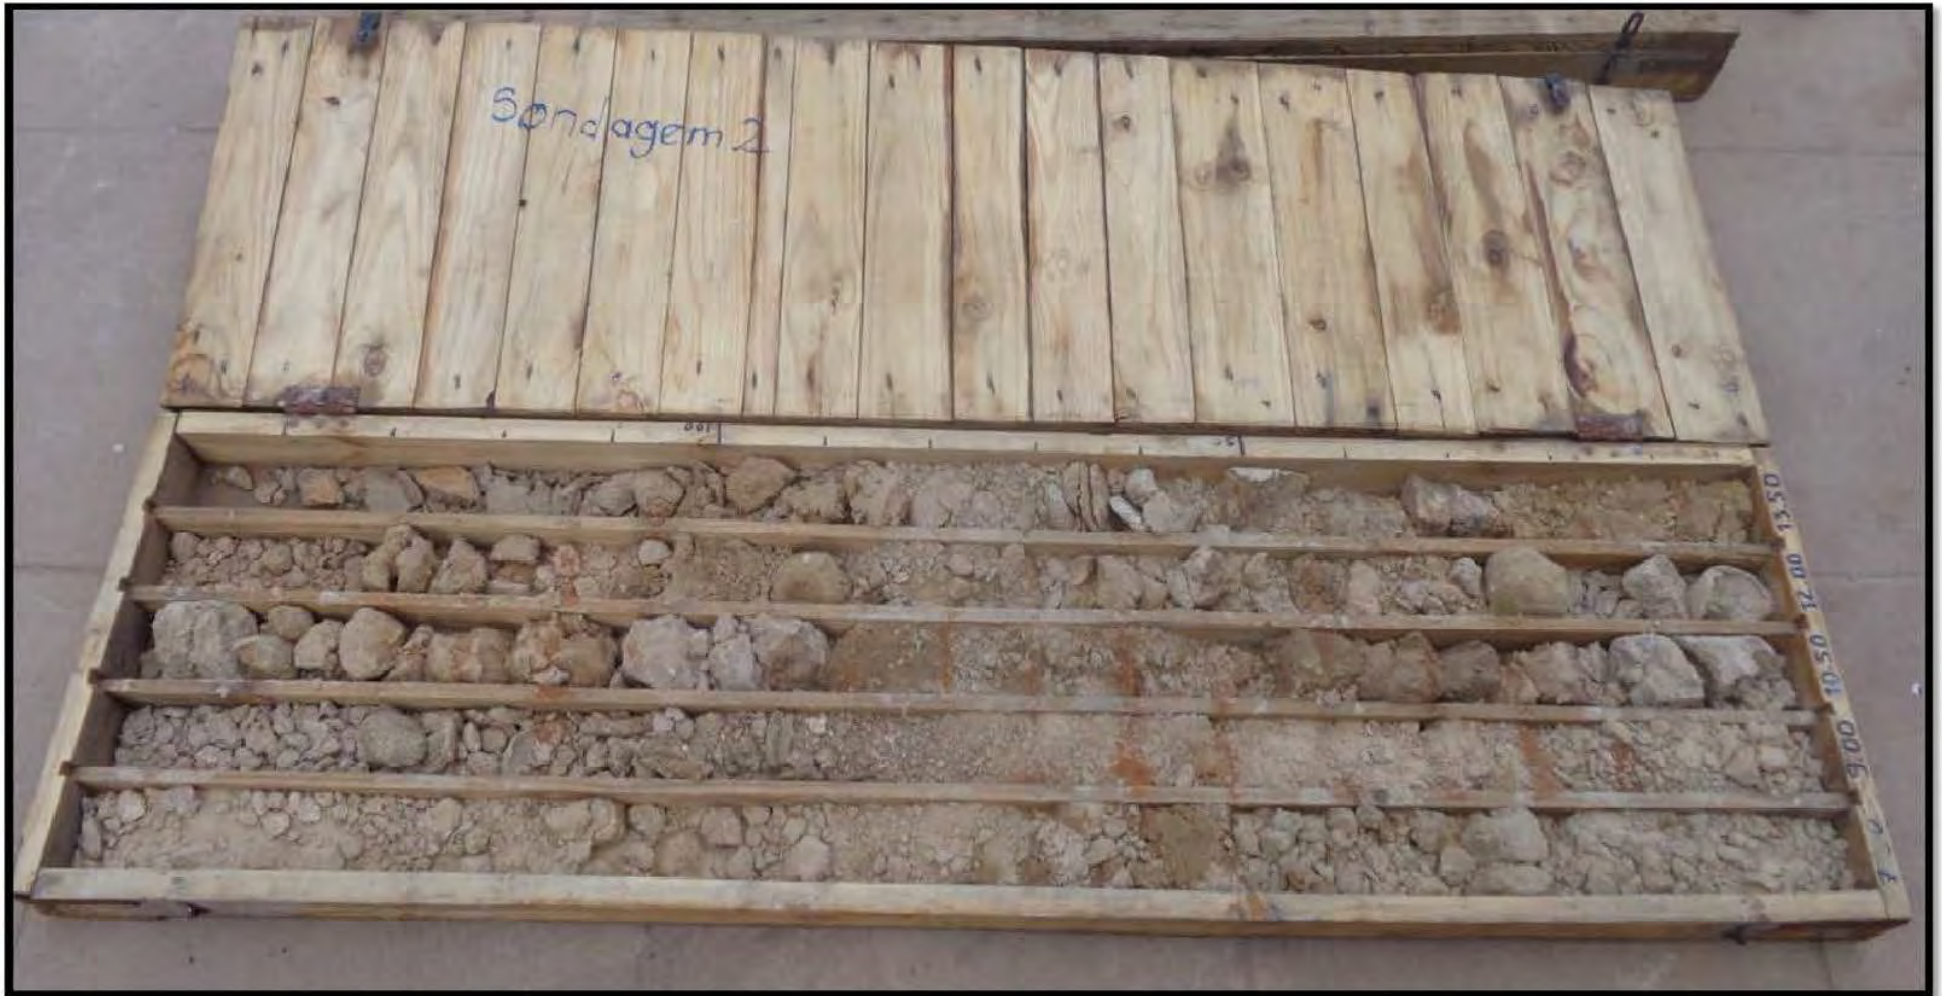
Photo 4 Logg 2, from 7.5m to 15.0m depth

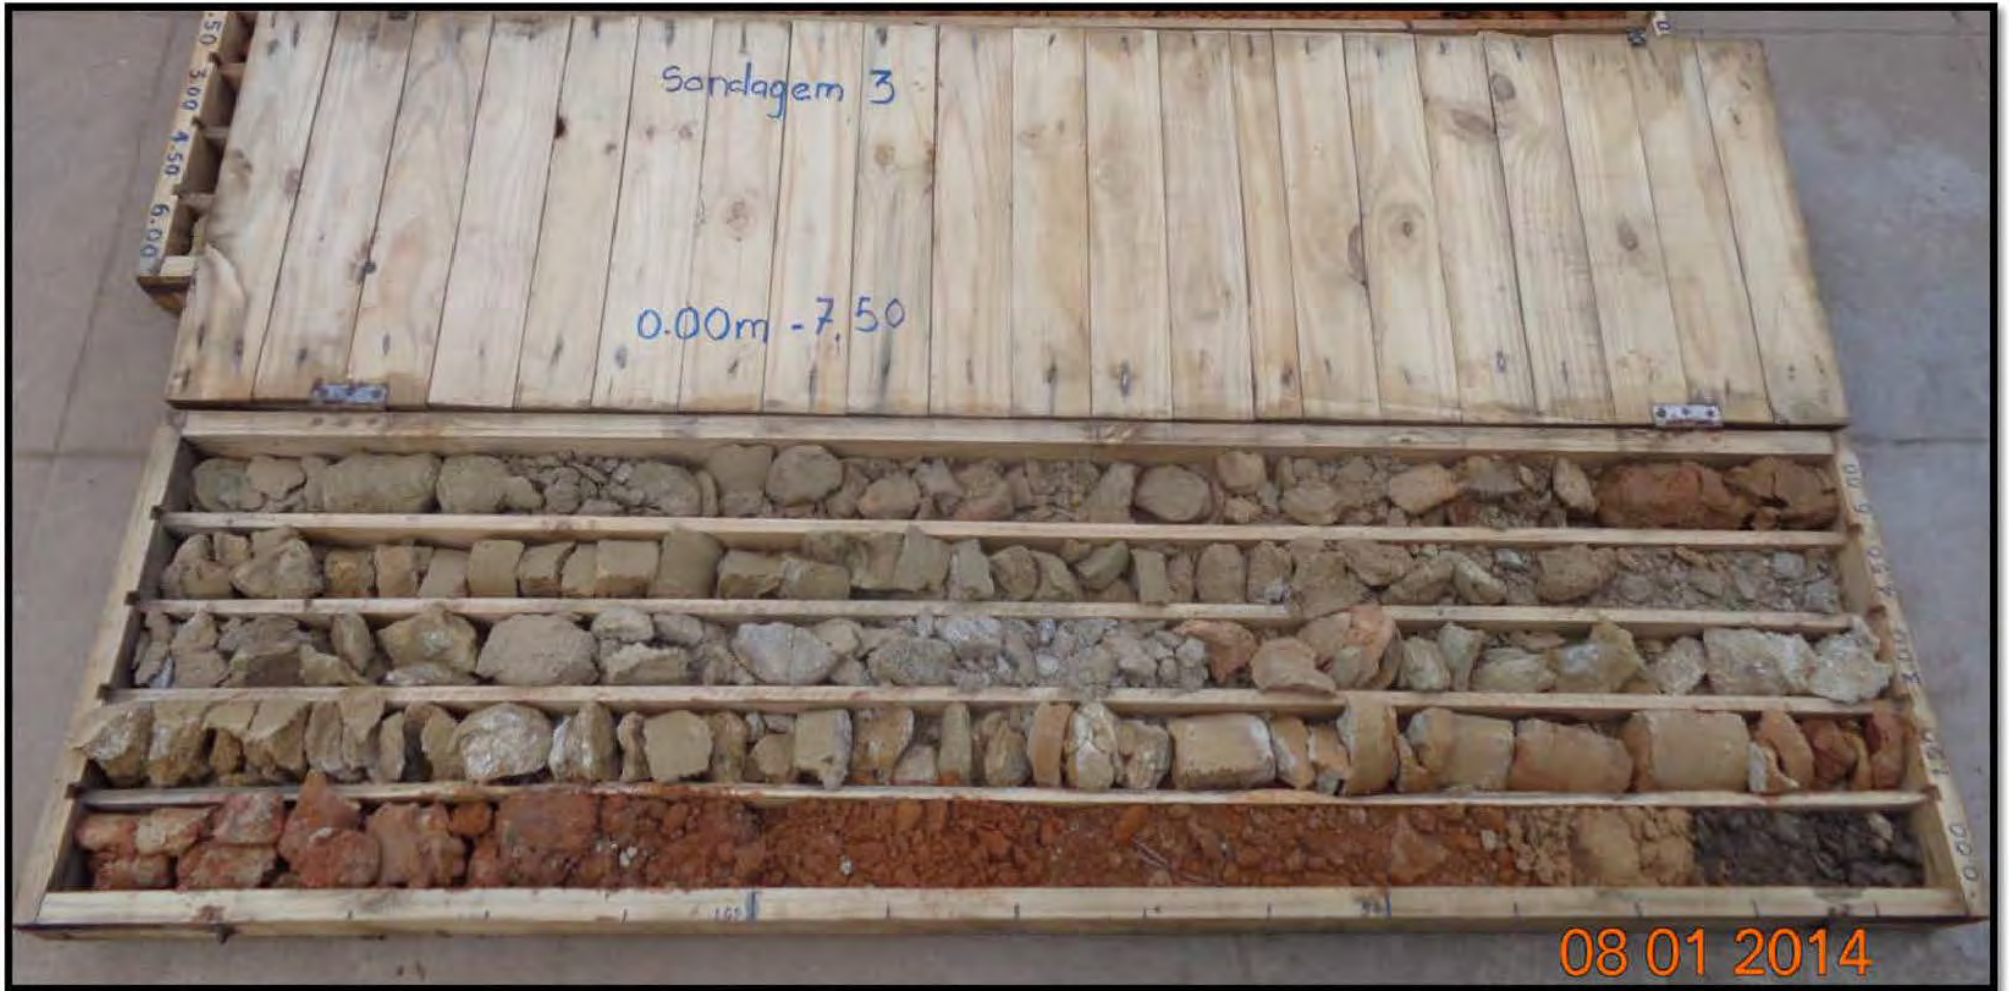
Photo 5 - Logg 3, from 0.0m to 7.5m depth

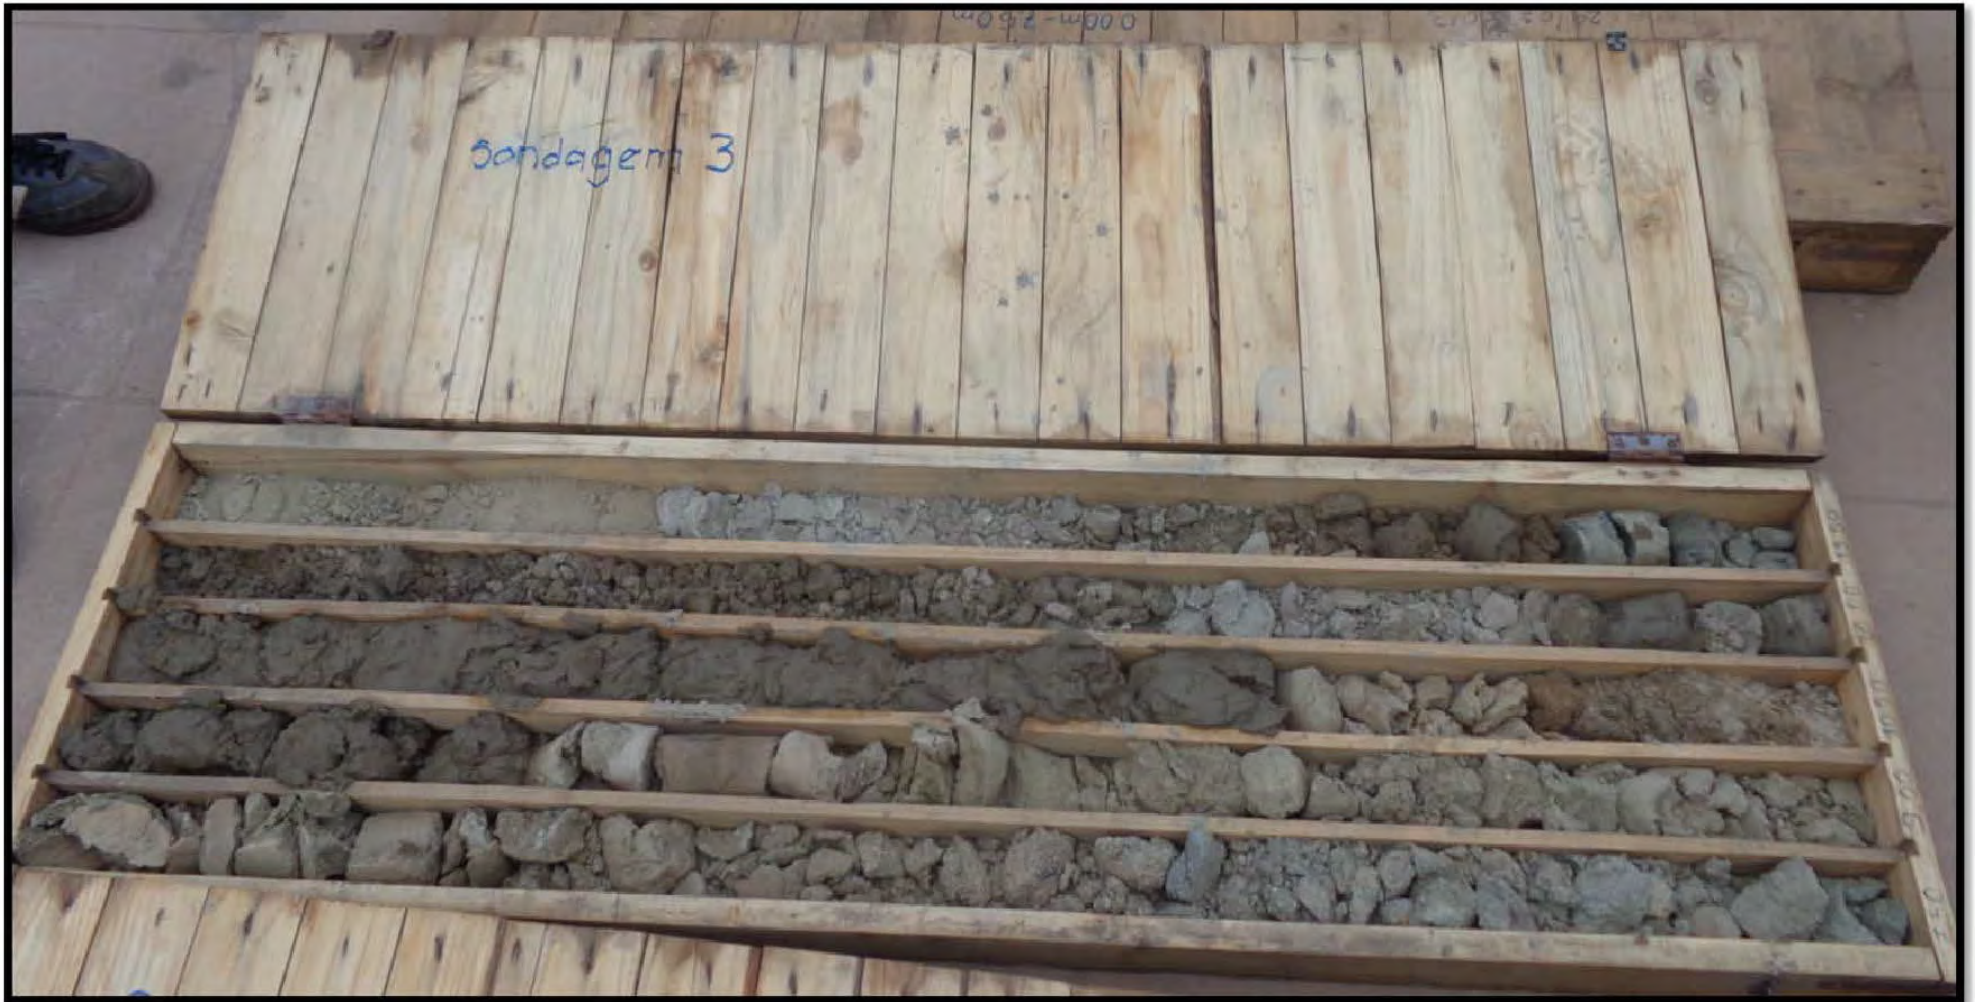
Photo 6 - Logg 3, from 7.5m to 15.0m depth

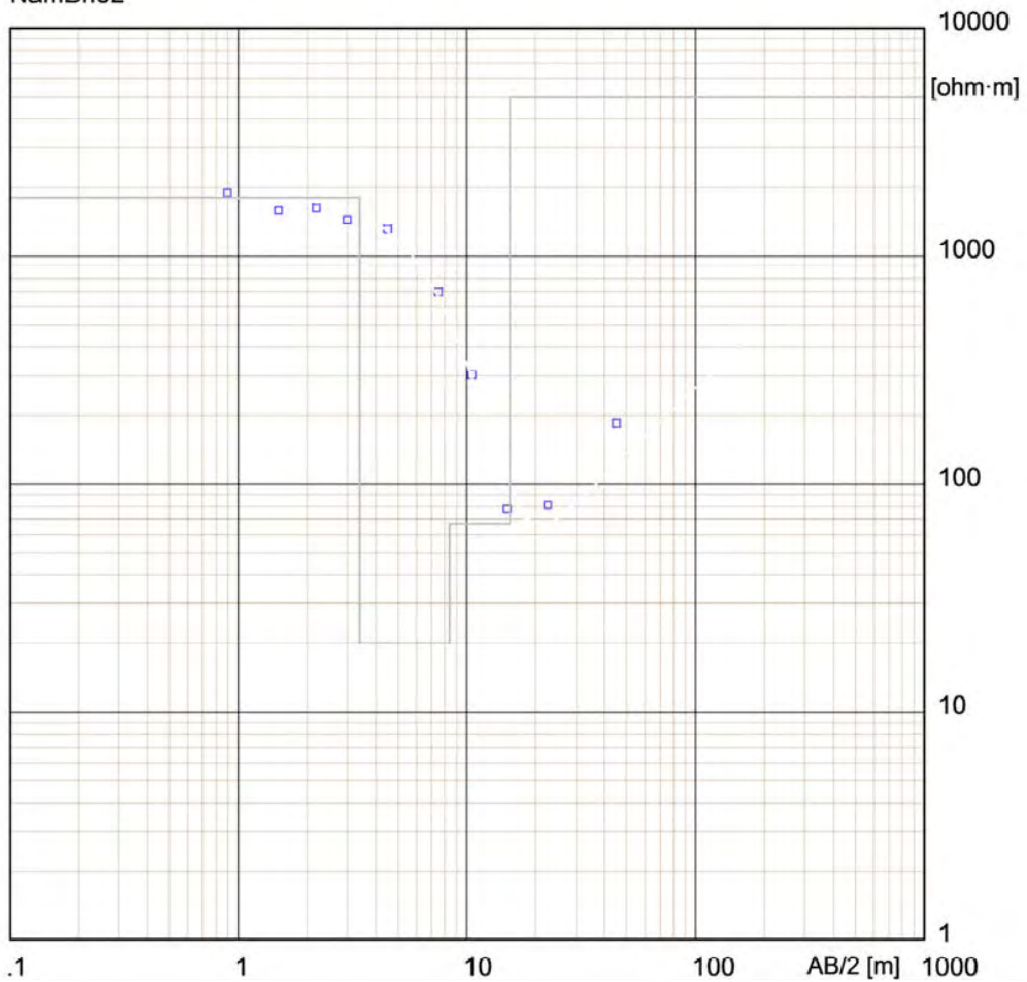
NamBh02

Location X = 39.962067 Y = -14.944467 Z = 190 Azim = 060-240

Model			
Resistivity	Thickness	Depth	Altitude
[ohm·m]	[m]	[m]	[m]
1807	3.4	3.4	190
20	5	8.4	186.6
67	7	15.4	181.6
5000		15	175
