**THE PREPARATORY SURVEY  
ON  
WATER SUPPLY SYSTEM IMPROVEMENT  
PROJECT  
IN THE REPUBLIC OF PALAU**

**Sector Development Framework**

**October 2014**

**JAPAN INTERNATIONAL COOPERATION AGENCY (JICA)**

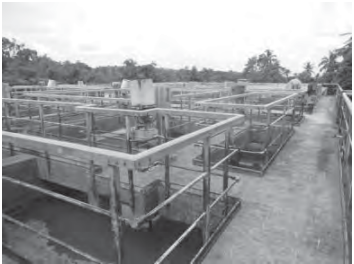
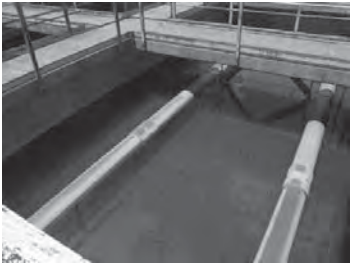
Type	Up flow sedimentation basin with tube settler
Size	15ft <sup>W</sup> x 45ft <sup>L</sup> x 3ft <sup>Dep</sup> x 3 basins (lines)
Capacity	154,800G (total of 3 basins)
Number	3 basins (1 row x 3 lines)

[left] Flocculation Basins, [right] Sedimentation Basins

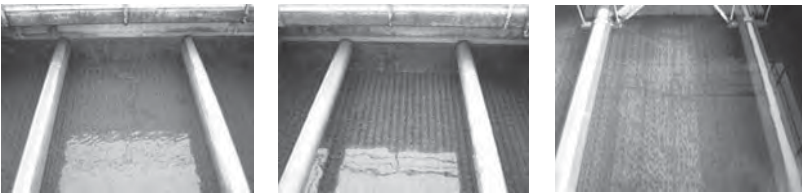
outlet pipe, periodic cleaning of clarifier is recommended.

[left] before cleaning, [center] just after cleaning, [right] 1 day after cleaning

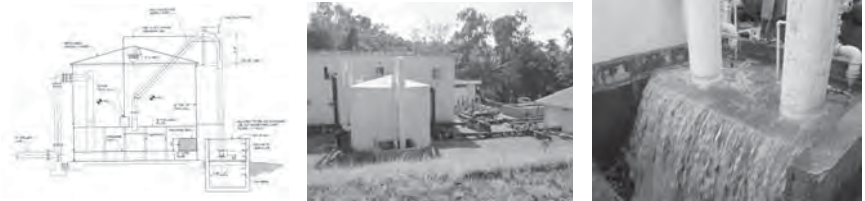
As described above, it is recommended that rapid sand filters be renewed.

[left] As built Drawing in 1990s by WWO, [center] No.3 Filter, [right] Backwashing

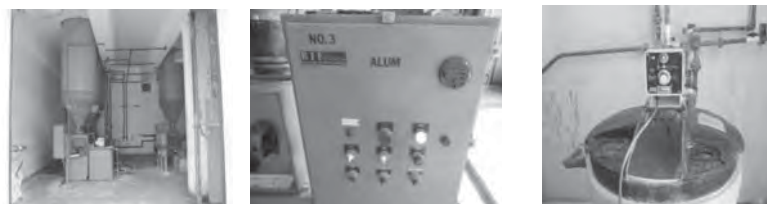
Since the chemical dosing facilities are deteriorated, renewal is recommended.

[left] Chemical Dosing Facilities, [center] Dosing Facility (Alum), [right] Dosing Facility (Calcium Hypochlorite)

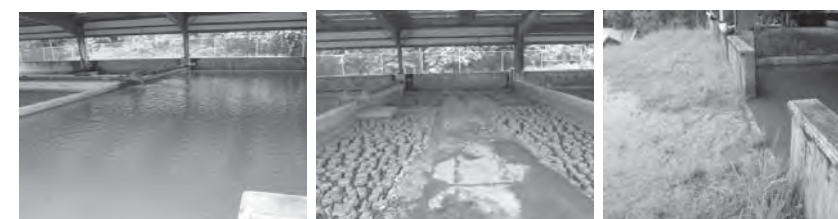
Sometimes discharged sludge from clarifier overflows from the sludge drying bed to the natural stream as shown in the following photos. It is recommended to be held appropriate operation for sludge drying bed.

[left] Just discharged, [center] Dried up, [right] Overflow of sludge

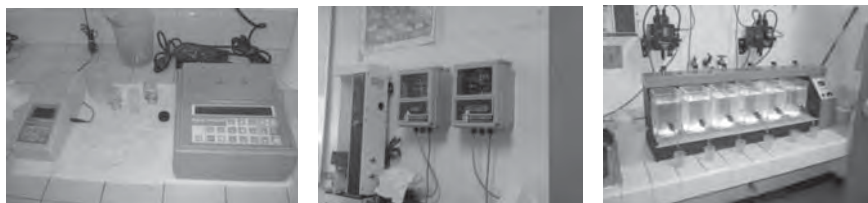
Item	Test Method	Sampling Point
<b>Physical Analysis</b>		
Turbidity	Turbidity meter	(1)Raw water, (2)Before Filter, (3)After filter, (4) Clear Water Well
<b>Chemical Analysis</b>		
Chlorine	Chlorine ion meter	(1) Clear Water Well

[left] Turbidity meter (left), Chlorine ion meter(right), [center] Automatic Turbidity meter (out of order), [right] Jar Test

It is recommended that more kinds of water quality such as pH shall be examined and new equipment be procured. And it is recommended to conduct the capacity building for the management of the water treatment system.

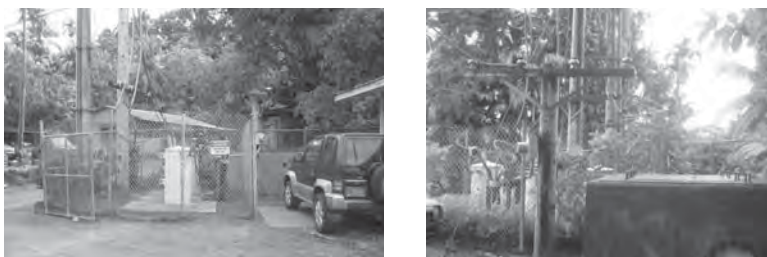
**Figure 3.1-17 Power Receiving Equipment**

It is noted that the electric pole which is wooden and old should be replaced as soon as possible.

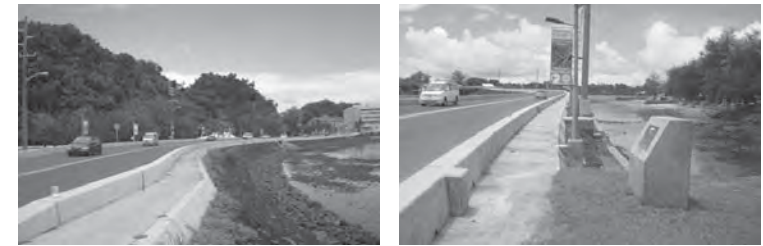
Malakal causeway (West side)

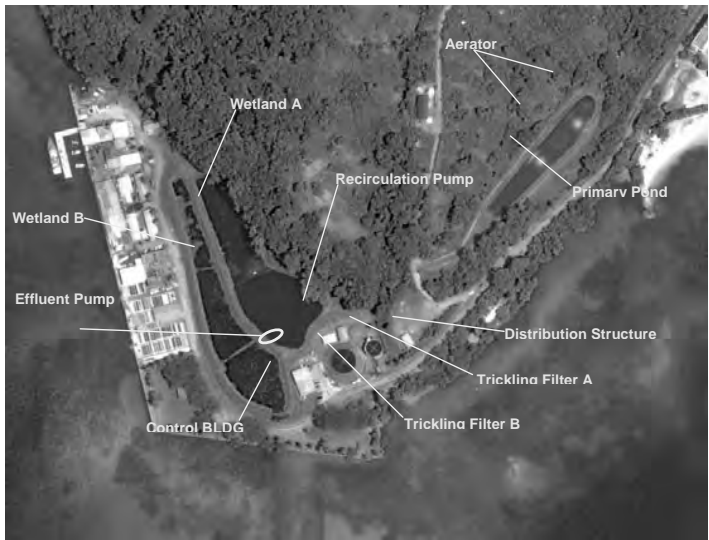
Figure 4.5-6 Layout of Malakal Sewage Treatment Plant

Name	Description
	effluent is discharged through the pump station via existing 18" pipe to an existing ocean outfall. The effluent can flow by gravity and through the ocean outfall under certain condition. However when the tide is high and flow exceeds 1MGD, the effluent pump is activated to pump the effluent Through ocean outfall.

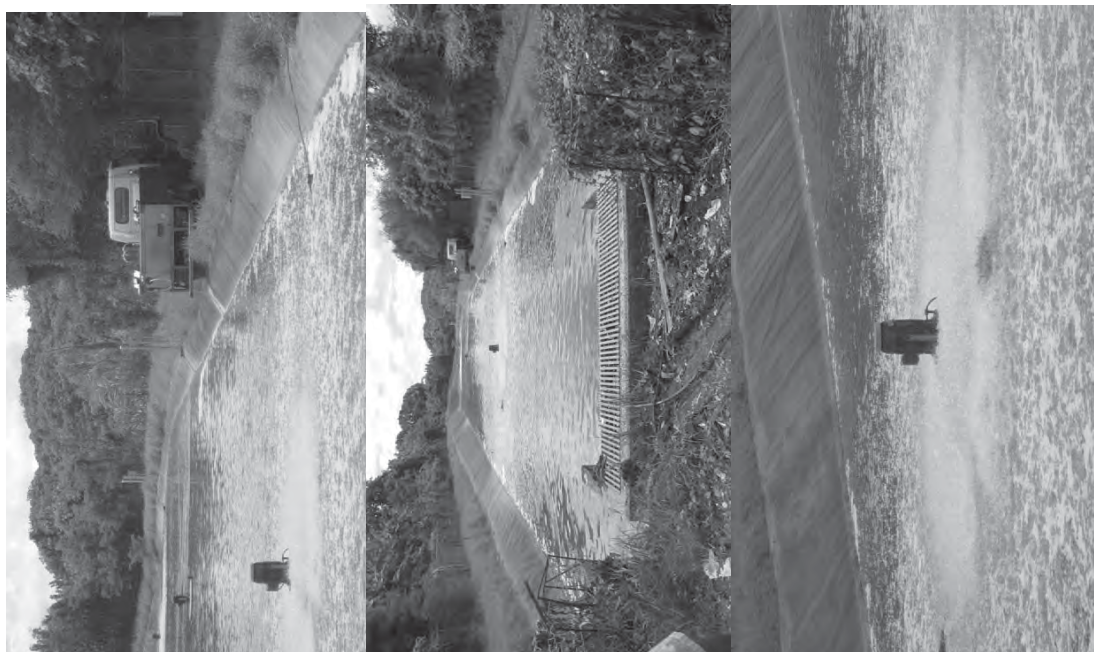
<b>Section 4.4.2, (4)</b>	The surface aerators were removed from the primary pond at least 3 years ago and have not been	No change

These pictures were taken at Malakal STP on 25<sup>th</sup> in June, 2014.

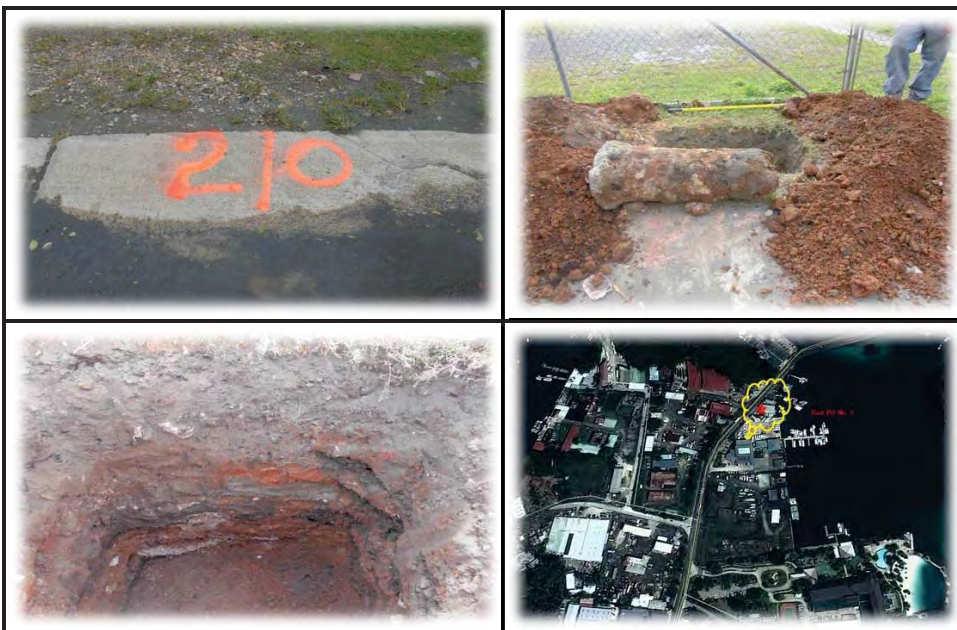
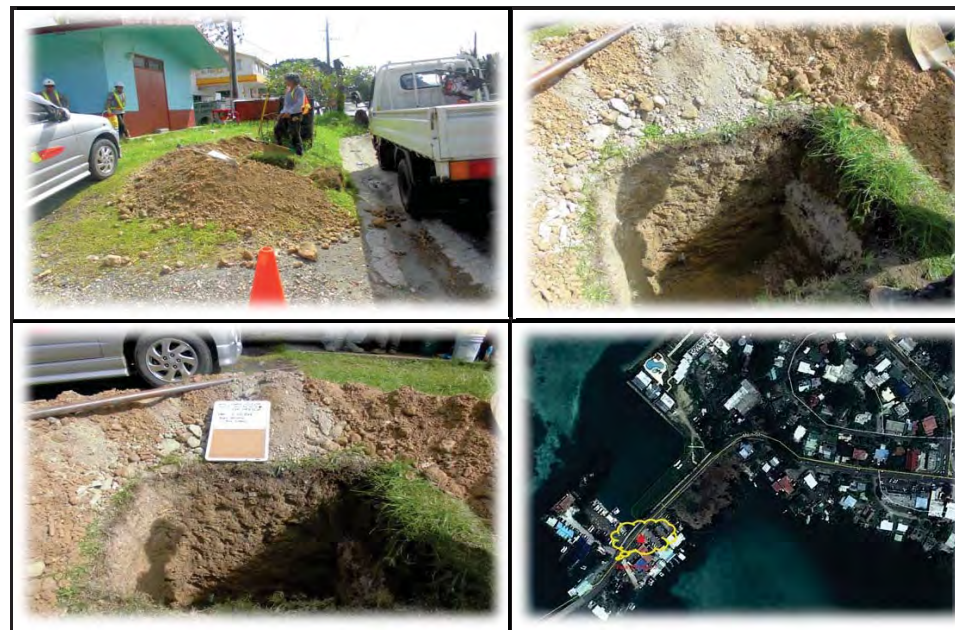
Location/ Area	Test Pit No.	Type Of Soil	Thickness / Layer	Remarks
Infront of CIP Office	3	Coral	120 cm	
Malakal, Koror

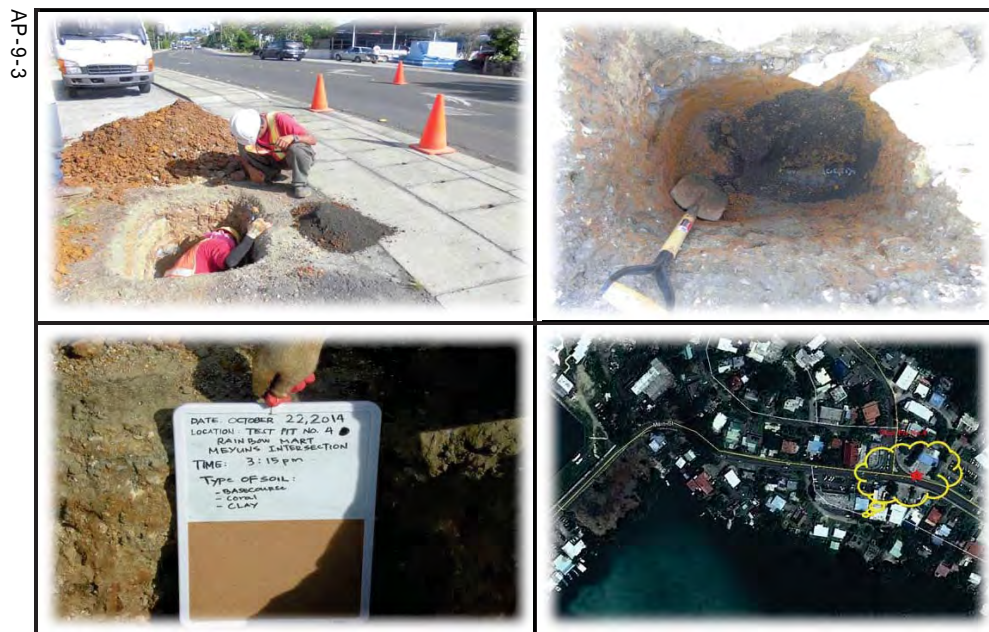
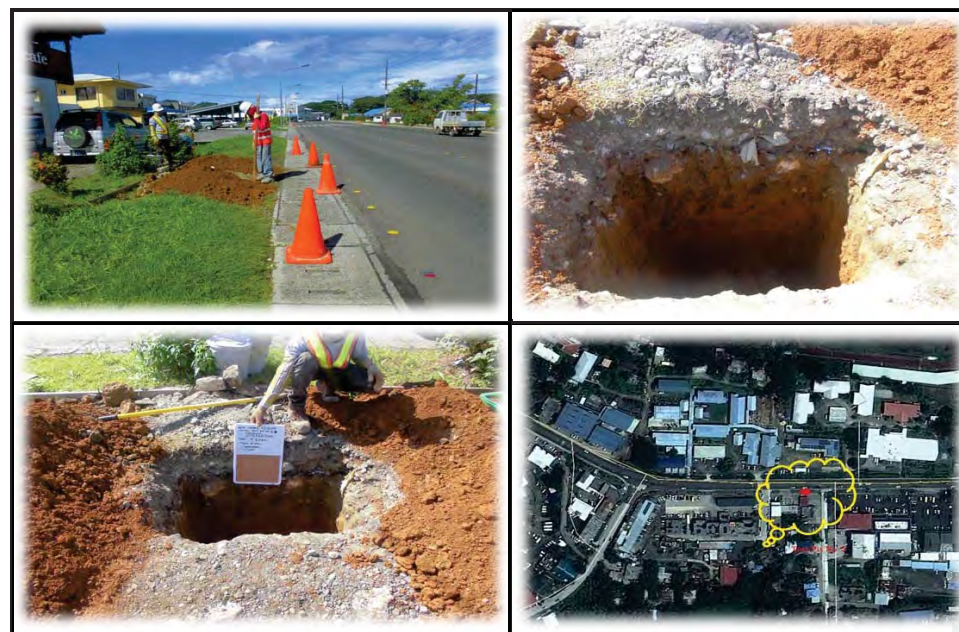
Location/ Area	Test Pit No.	Type Of Soil	Thickness / Layer	Remarks
Infront of H.E Store	5	Basecourse	40 cm	
Malakal, Koror		Clay	80 cm

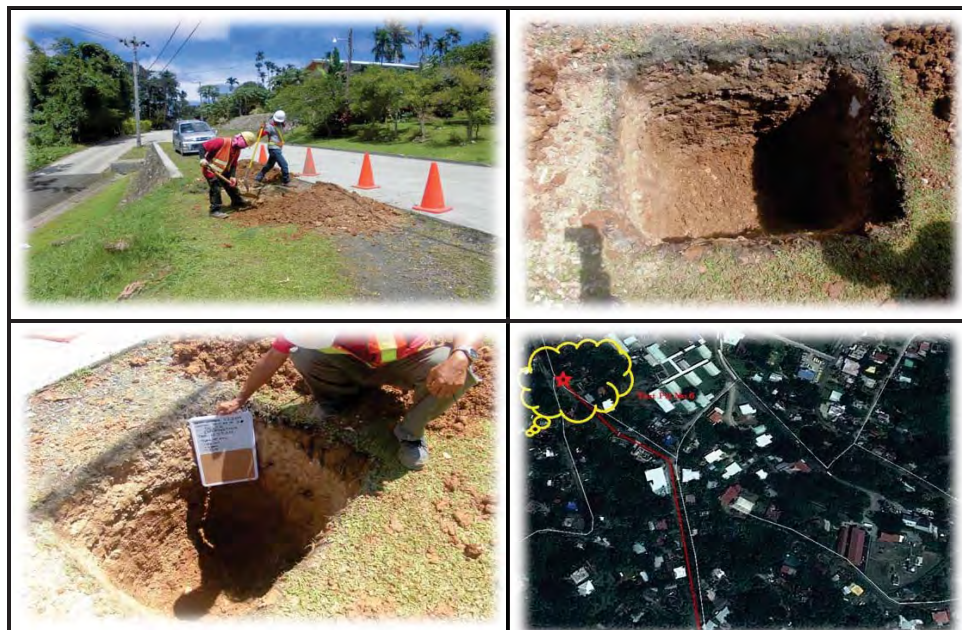
Location/ Area	Test Pit No.	Type Of Soil	Thickness / Layer	Remarks
Infront of Ochob House	6	Top soil	4 cm	
Ngerbeched, Koror		Basecourse	6 cm	
		Coral	40 cm	
		Clay	70 cm

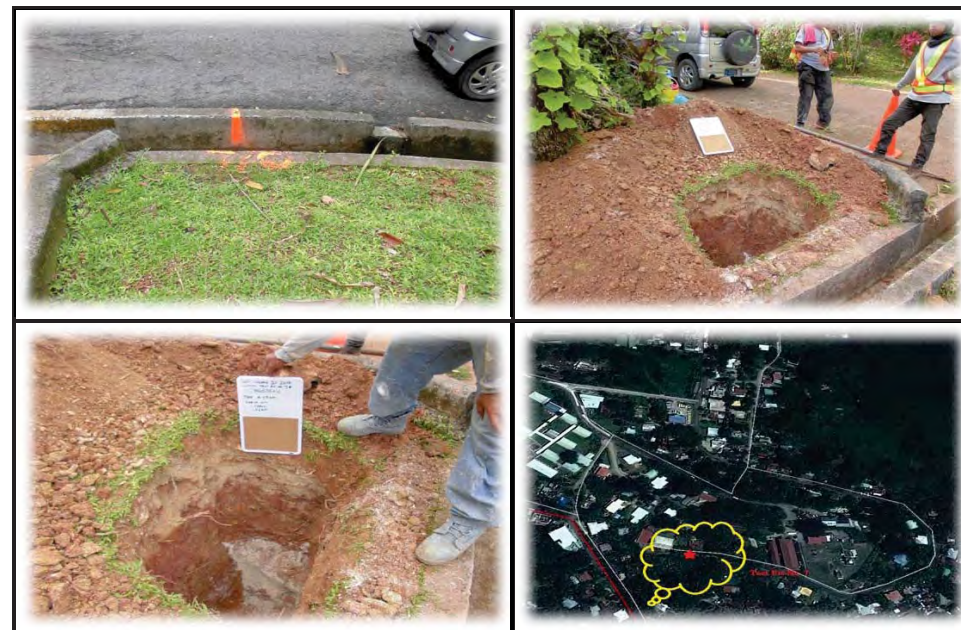
Location/ Area	Test Pit No.	Type Of Soil	Thickness / Layer	Remarks
Ngebekuu Area	7	Coral	35 cm	
Ngerbeched, Koror		Clay	95 cm

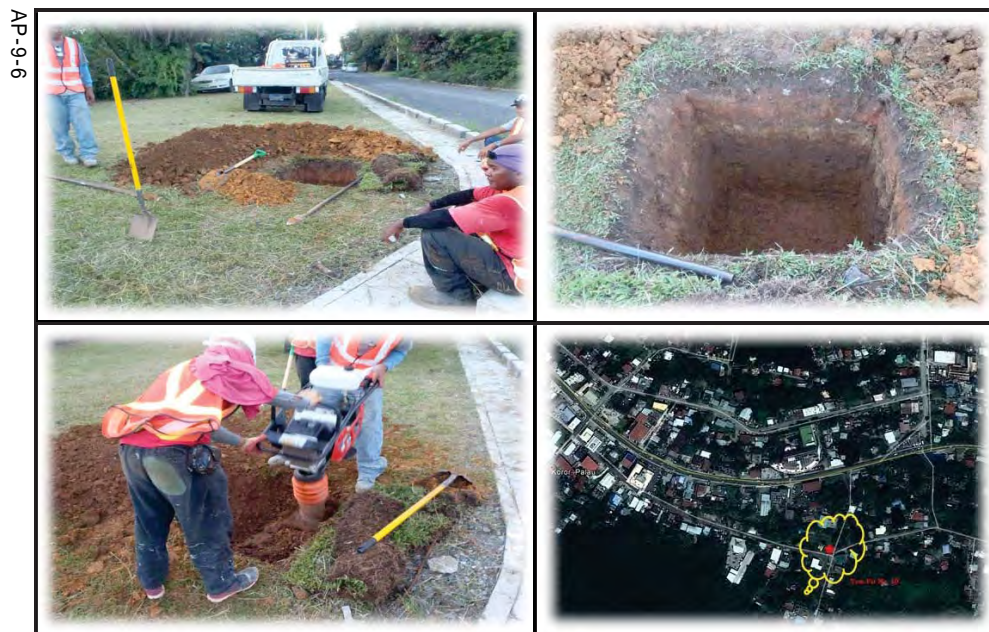
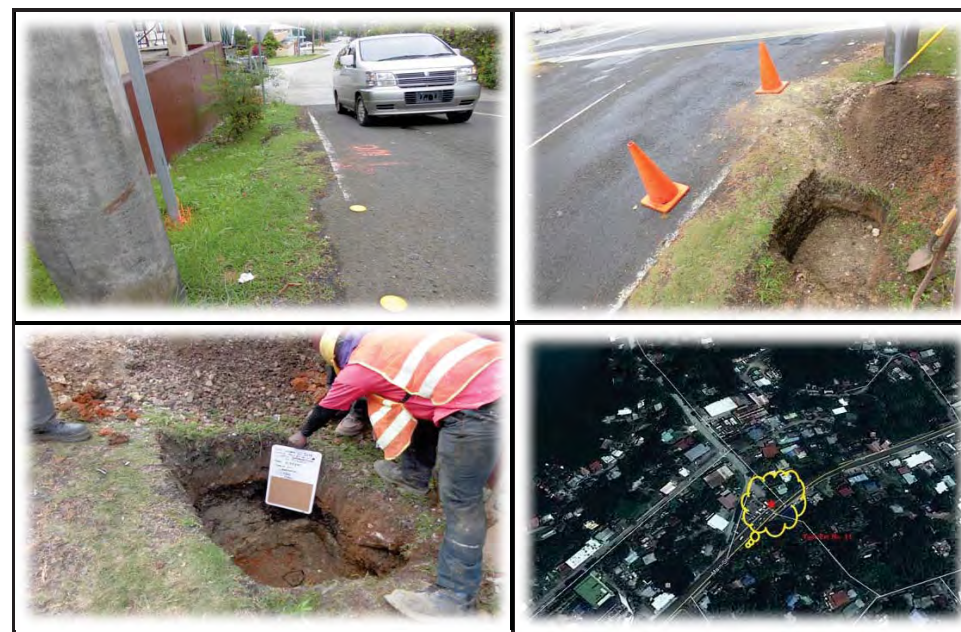
Location/ Area	Test Pit No.	Type Of Soil	Thickness / Layer	Remarks
NECO Building Ikelau, Koror	11	Basecourse Clay Coral	100 cm 10 cm 10 cm

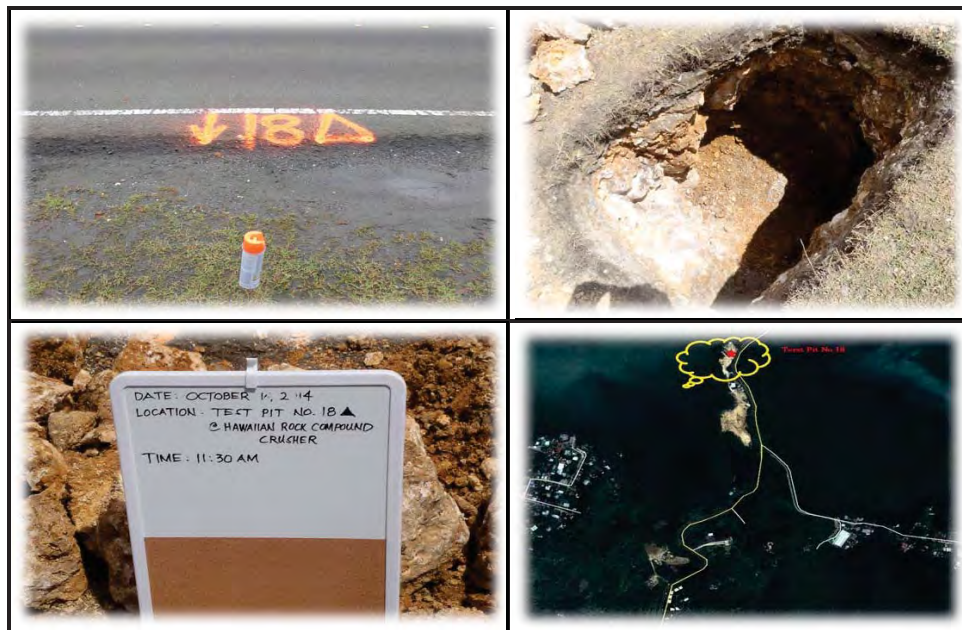
Location/ Area	Test Pit No.	Type Of Soil	Thickness / Layer	Remarks
Hawaiian Rock Quarry	18	Coral	15 cm	
Ngesaul, Koror		Rocks	105 cm

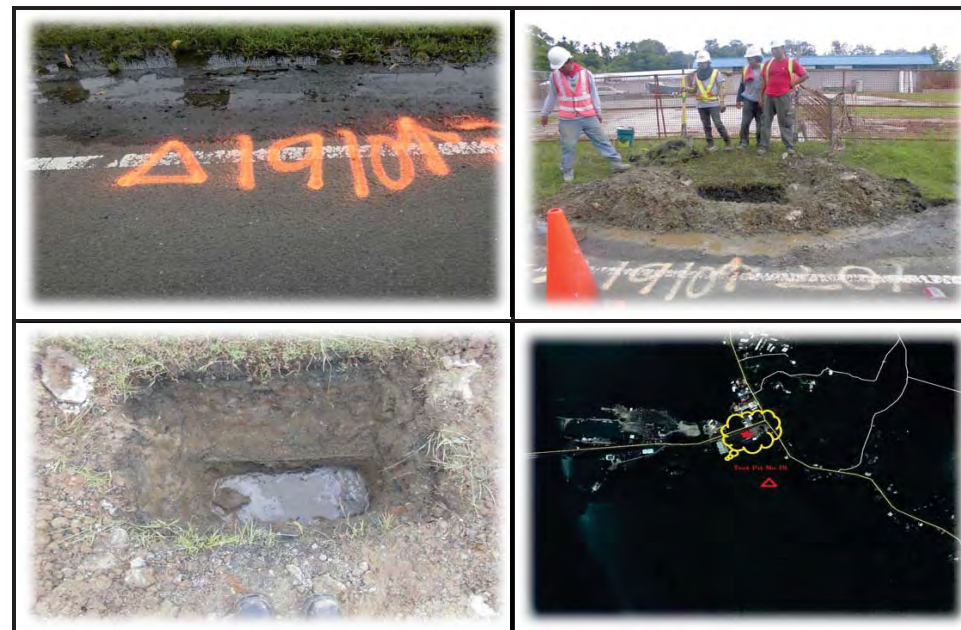
Location/ Area	Test Pit No.	Type Of Soil	Thickness / Layer	Remarks
Shell Gas Station	19	Basecourse	120 cm	
Airai

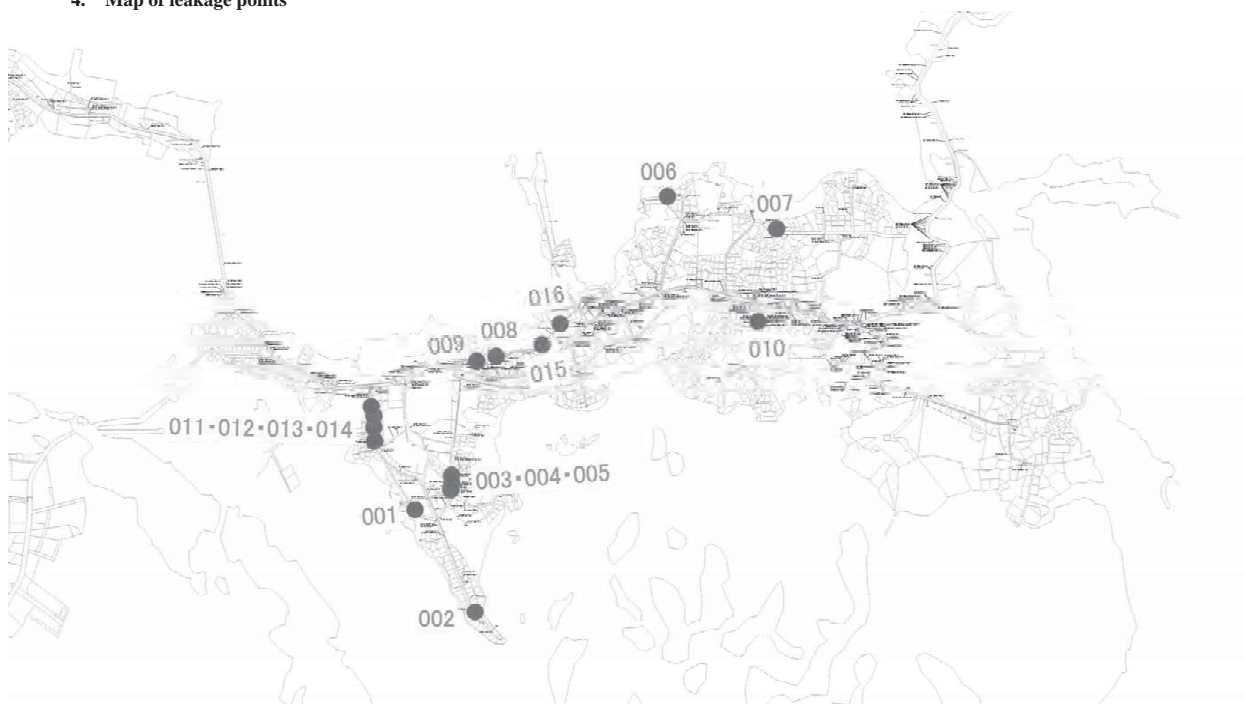
#### 4. Map of leakage points

Number of water leakage points: 16 points  
Estimated volume of water leakage: 9.78m<sup>3</sup>/h

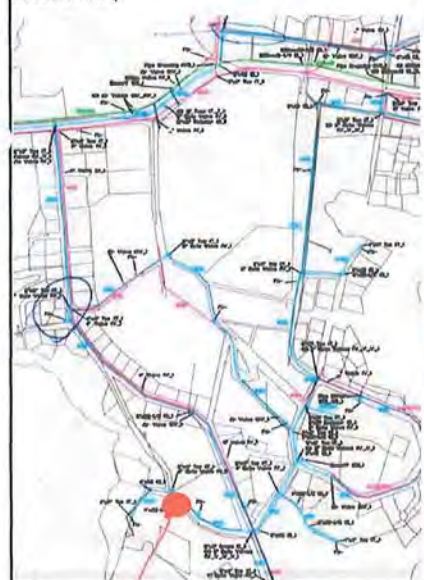
Location Map

Leakage Record Sheet				Leak. No 001	
Date of survey:	30-Sep-14		Street		
House No,			GPS	N : 07° 20' 09.7" E : 134° 28' 25.6"	
Main Pipe	1. CIP, 2. DCIP, 3. PVC, 4. ACP, 5. Others		Location	1. Pipe, 2. Joint+Socket, 3. Ferrule, 4. Valve, 5. Meter, 6. Tap, 7. Reservoir Tank, 8. Others,	
Diameter	200 mm		Condition	1. Hole, 2. Crack, 3. Packing, 4. Loose Connection, 5. Over Flow, 6. Unknown, 7. Others ( )	
Service Pipe	1. PEP, 2. PVC, 3. GP, 4. Others ( )		Cause	1. Corrosion, 2. Deterioration (Aging), 3. Traffic Load, 4. Wrong Construction, 5. Less Adhesive, 6. Pressure Fluctuation, 7. Defective Valve, 8. Destruction, 9. Other Construction, 10. Unknown, 11. Others( )	
Diameter	25 mm		Surface	1. Asphalt, 2. Concrete, 3. Gravel, 4. Grass, 5. Soil, 6. Others	
Depth	cm		Leakage Size	1. Large, 2. Middium, 3. Small, 4. Drops, Estimated volume ( 1.0 m3/h)	
			Detected Method	1. Patrol, 2. Customer Informing, 3. Acoustic, 4. Pinpoint,

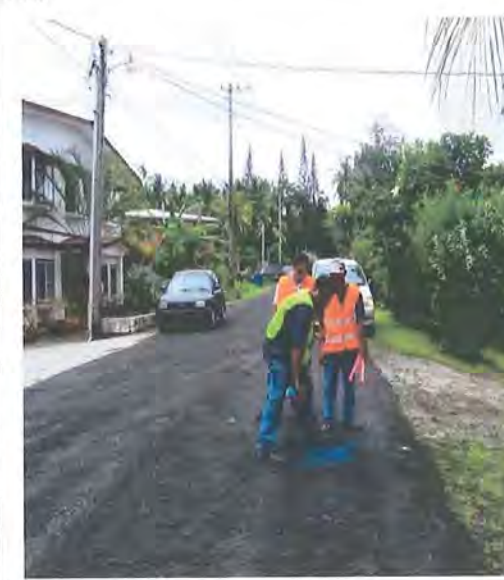
Photo

Leakage Record Sheet				Leak. No 002	
Date of survey:	30-Sep-14		Street		
House No,			GPS	N : 07° 19' 50.6" E : 134° 28' 38.6"	
Main Pipe	1. CIP, 2. DCIP, 3. PVC, 4. ACP, 5. Others		Location	1. Pipe, 2. Joint+Socket, 3. Ferrule, 4. Valve, 5. Meter, 6. Tap, 7. Reservoir Tank, 8. Others,	
Diameter	200 mm		Condition	1. Hole, 2. Crack, 3. Packing, 4. Loose Connection, 5. Over Flow, 6. Unknown, 7. Others ( )	
Service Pipe	1. PEP, 2. PVC, 3. GP, 4. Others ( )		Cause	1. Corrosion, 2. Deterioration (Aging), 3. Traffic Load, 4. Wrong Construction, 5. Less Adhesive, 6. Pressure Fluctuation, 7. Defective Valve, 8. Destruction, 9. Other Construction, 10. Unknown, 11. Others( )	
Diameter	50 mm		Surface	1. Asphalt, 2. Concrete, 3. Gravel, 4. Grass, 5. Soil, 6. Others	
Depth	cm		Leakage Size	1. Large, 2. Middium, 3. Small, 4. Drops, Estimated volume ( 0.6 m3/h)	
			Detected Method	1. Patrol, 2. Customer Informing, 3. Acoustic, 4. Pinpoint,

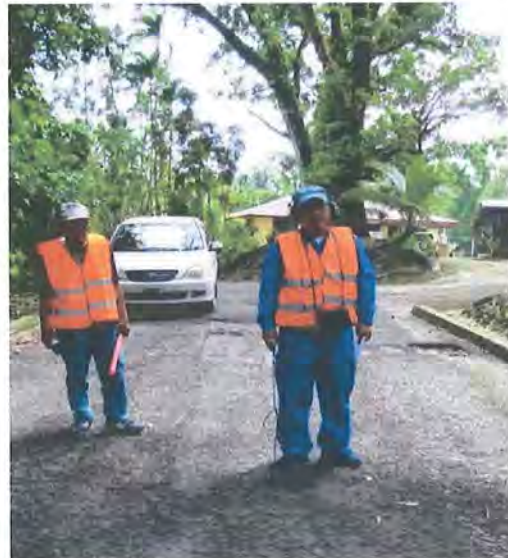
Photo

Leakage Record Sheet				Leak. No 003	
Date of survey:	1-Oct-14		Street		
House No,			GPS	N : 07° 20' 13.6" E : 134° 28' 32.9"	
Main Pipe	1. CIP, 2. DCIP, 3. PVC, 4. ACP, 5. Others		Location	1. Pipe, 2. Joint+Socket, 3. Ferrule, 4. Valve, 5. Meter, 6. Tap, 7. Reservoir Tank, 8. Others,	
Diameter	200 mm		Condition	1. Hole, 2. Crack, 3. Packing, 4. Loose Connection, 5. Over Flow, 6. Unknown, 7. Others ( )	
Service Pipe	1. PEP, 2. PVC, 3. GP, 4. Others ( )		Cause	1. Corrosion, 2. Deterioration (Aging), 3. Traffic Load, 4. Wrong Construction, 5. Less Adhesive, 6. Pressure Fluctuation, 7. Defective Valve, 8. Destruction, 9. Other Construction, 10. Unknown, 11. Others( )	
Diameter	50 mm				
Depth	cm		Surface	1. Asphalt, 2. Concrete, 3. Gravel, 4. Grass, 5. Soil, 6. Others	
Leakage Size	1. Large, 2. Middium, 3. Small, 4. Drops, Estimated volume ( 0.06 m3/h)		Detected Method	1. Patrol, 2. Customer Informing, 3. Acoustic, 4. Pinpoint,

Remarks: Please confirm the boring investigation.

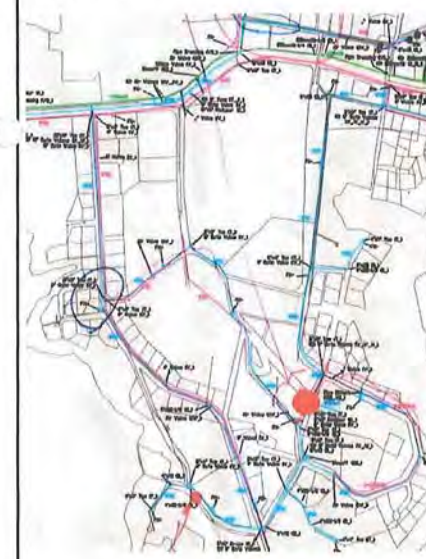
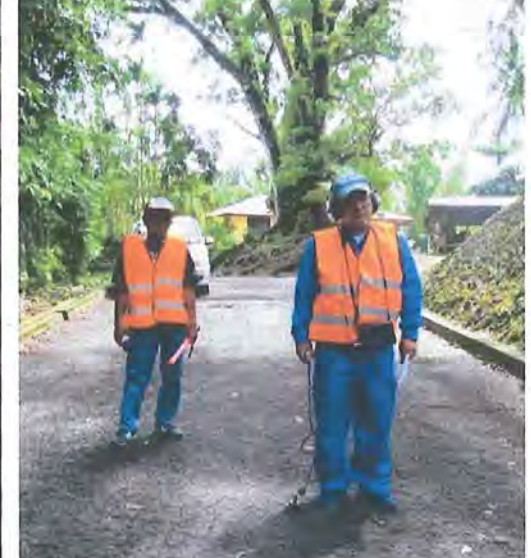
Leakage Record Sheet				Leak. No 004	
Date of survey:	1-Oct-14		Street		
House No,			GPS	N : 07° 20' 13.9" E : 134° 28' 32.9"	
Main Pipe	1. CIP, 2. DCIP, 3. PVC, 4. ACP, 5. Others		Location	1. Pipe, 2. Joint+Socket, 3. Ferrule, 4. Valve, 5. Meter, 6. Tap, 7. Reservoir Tank, 8. Others,	
Diameter	200 mm		Condition	1. Hole, 2. Crack, 3. Packing, 4. Loose Connection, 5. Over Flow, 6. Unknown, 7. Others ( )	
Service Pipe	1. PEP, 2. PVC, 3. GP, 4. Others ( )		Cause	1. Corrosion, 2. Deterioration (Aging), 3. Traffic Load, 4. Wrong Construction, 5. Less Adhesive, 6. Pressure Fluctuation, 7. Defective Valve, 8. Destruction, 9. Other Construction, 10. Unknown, 11. Others( )	
Diameter	mm				
Depth	cm		Surface	1. Asphalt, 2. Concrete, 3. Gravel, 4. Grass, 5. Soil, 6. Others	
Leakage Size	1. Large, 2. Middium, 3. Small, 4. Drops, Estimated volume ( 0.06 m3/h)		Detected Method	1. Patrol, 2. Customer Informing, 3. Acoustic, 4. Pinpoint,

Remarks: Please confirm the boring investigation.

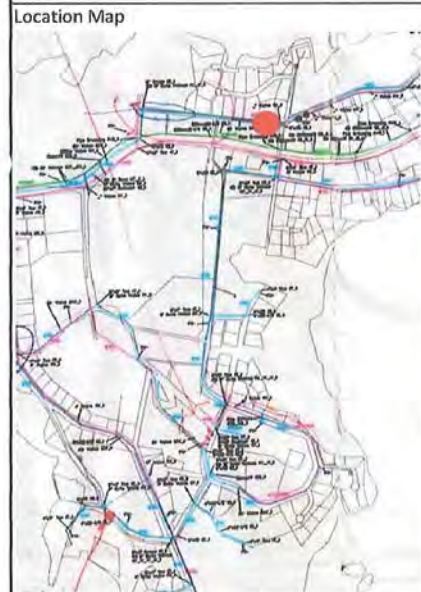
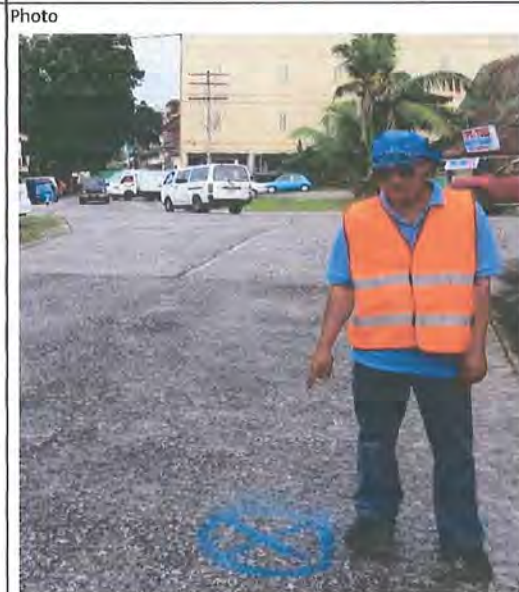
Leak. No 009

Date of survey:	6-Oct-14	Street	
House No,		GPS	N : 07° 20' 33.6" E : 134° 28' 37.6"
Main Pipe	1. CIP, 2. DCIP, 3. PVC, 4. ACP, 5. Others	Location	1. Pipe, 2. Joint+Socket, 3. Ferrule, 4. Valve, 5. Meter, 6. Tap, 7. Reservoir Tank, 8. Others,
Diameter	200 mm	Condition	1. Hole, 2. Crack, 3. Packing, 4. Loose Connection, 5. Over Flow, 6. Unknown, 7. Others ( )
Service Pipe	1. PEP, 2. PVC, 3. GP, 4. Others ( )	Cause	1. Corrosion, 2. Deterioration (Aging), 3. Traffic Load, 4. Wrong Construction, 5. Less Adhesive, 6. Pressure Fluctuation, 7. Defective Valve, 8. Destruction, 9. Other Construction, 10. Unknown, 11. Others( )
Diameter	mm		
Depth	cm	Surface	1.Asphalt, 2.Concrete, 3.Gravel, 4.Grass, 5.Soil, 6.Others
Leakage Size	1. Large, 2. Middium, 3. Small, 4. Drops, Estimated volume ( 0.1 m3/h)	Detected Method	1. Patrol, 2. Customer Informing, 3. Acoustic, 4. Pinpoint,

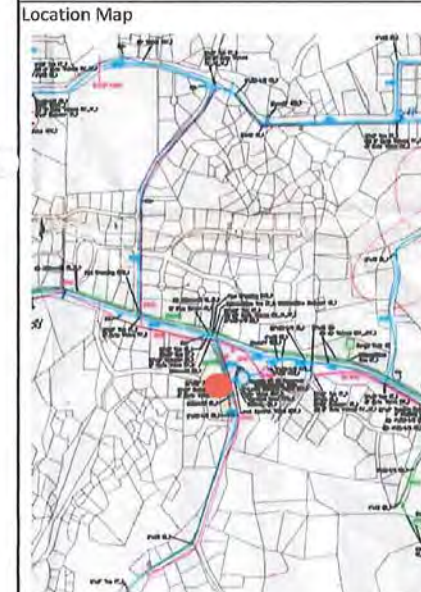
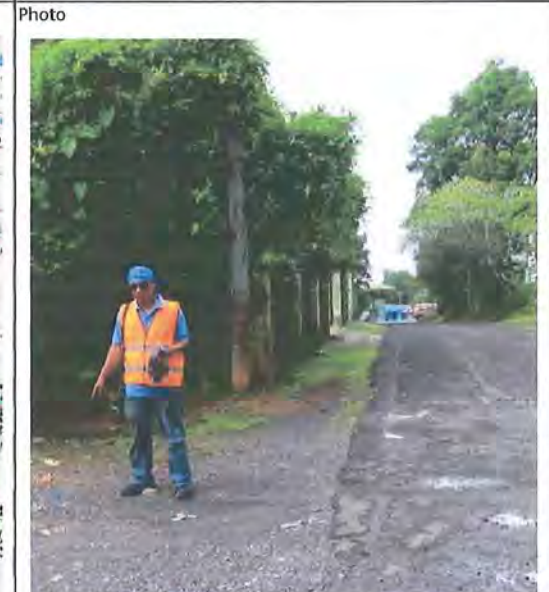
Leak. No 010

Date of survey:	6-Oct-14	Street	
House No,		GPS	N : 07° 20' 34.0" E : 134° 28' 38.0"
Main Pipe	1. CIP, 2. DCIP, 3. PVC, 4. ACP, 5. Others	Location	1. Pipe, 2. Joint+Socket, 3. Ferrule, 4. Valve, 5. Meter, 6. Tap, 7. Reservoir Tank, 8. Others,
Diameter	mm	Condition	1. Hole, 2. Crack, 3. Packing, 4. Loose Connection, 5. Over Flow, 6. Unknown, 7. Others ( )
Service Pipe	1. PEP, 2. PVC, 3. GP, 4. Others ( )	Cause	1. Corrosion, 2. Deterioration (Aging), 3. Traffic Load, 4. Wrong Construction, 5. Less Adhesive, 6. Pressure Fluctuation, 7. Defective Valve, 8. Destruction, 9. Other Construction, 10. Unknown, 11. Others( )
Diameter	13 mm		
Depth	cm	Surface	1.Asphalt, 2.Concrete, 3.Gravel, 4.Grass, 5.Soil, 6.Others
Leakage Size	1. Large, 2. Middium, 3. Small, 4. Drops, Estimated volume ( 0.1 m3/h)	Detected Method	1. Patrol, 2. Customer Informing, 3. Acoustic, 4. Pinpoint,
