CHAPTER 2 DEVELOPMENT OF PDM

Project Name : The Project for Improvement of Management Capacity of Operation and Maintenance for Water Supply Facilities in Nile Delta Area

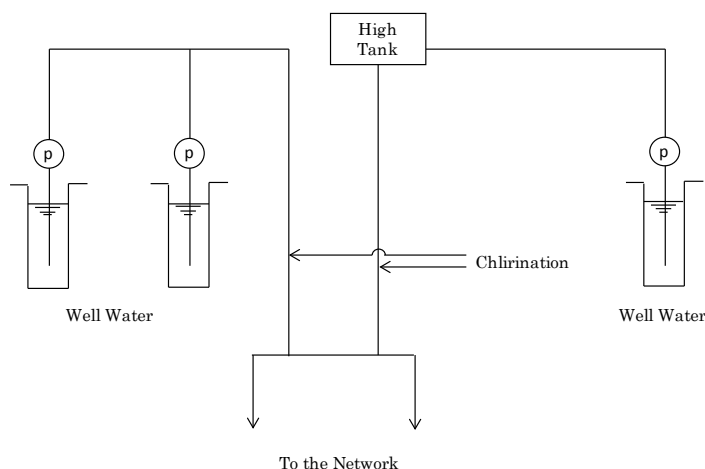
Figure 4.1-18 Schematic Water Flow and Facility Component of Ashama Well Station

- ◆ Capacity : 4,000 m³/day- Design Capacity
- ◆ Water source : Well water
- ◆ Service population : Approx. 40,000 – 50,000 people
- ◆ Establishment : Year 1952 (Expanded in year 2000, 2005 and 2009)

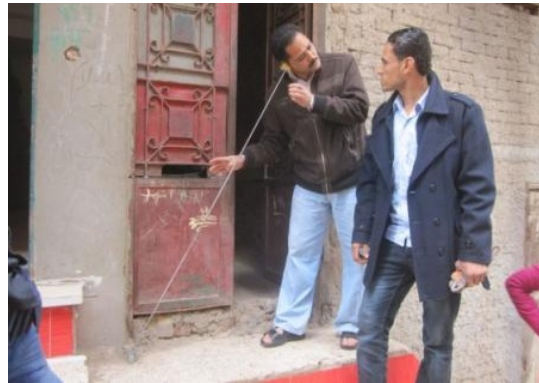
Figure 4.2-3 House Connection Survey using Acoustic Rod on GHAPWASCO

As the 1st approach to detect leak in pipe network, the Project team listens to the sound of house connection, using acoustic rod and digital sound detector. When leak occurs, the leak sound travels through the pipe. The method of house connection survey is shown on Figure 4.2-3.

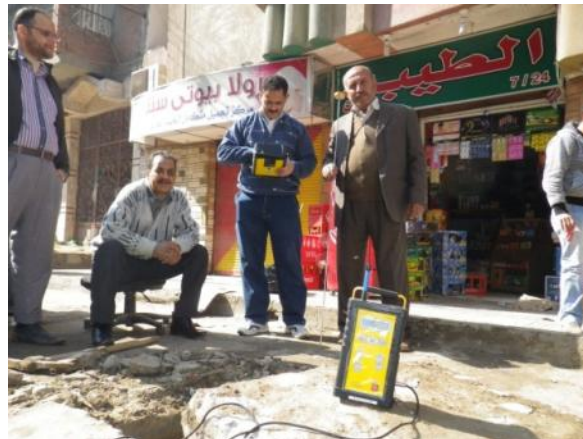
Figure 4.2-4 Leak Noise Correlator Survey on GHAPWASCO

Leak noise correlator is used when the leak sound is not detected from the ground surface even if the two (2) different house connections have suspected noise. The equipment shows the distance from the sensors to the leak point. After the leak noise correlator survey, the ground surface survey should be done again.

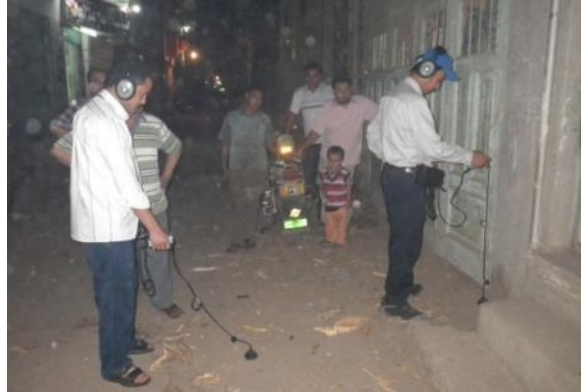
Figure 4.2-5 Ground Surface Survey using Water Leak Detector on GHAPWASCO

Water leak detector is used to detect leak sound which traveled through soil to the ground surface. The ground surface survey method using the water leak detector is shown in Figure 4.2-4. When its operation was launched, the Project team conducted the survey in the nighttime to avoid background or environmental noise. GHAPWASCO arranged security police for safety purpose, but it took cost and time. Therefore, the Project team modified to do it in daytime for the pilot area in Tanta Markaz.

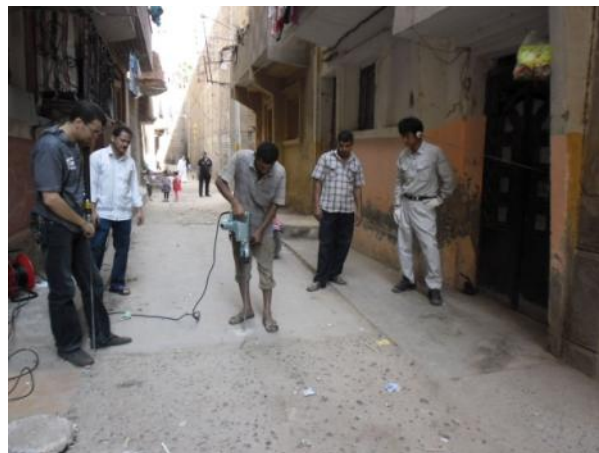
Figure 4.2-6 Drilling for Confirmation on GHAPWASCO

After the survey by water leak detector, the Project team conducts leak confirmation to know the presence of leak. Using hammer drill and Boring bar, the Project team makes some small bore holes to insert acoustic rod to check if the detected point has leak noise and/or water from pipeline. The confirmation is a key to success for accurate leak detection survey.

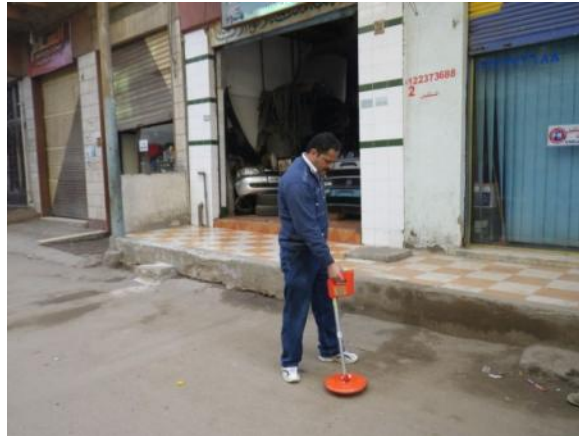
Figure 4.2-7 Training of Metal Locator for Buried Manhole Cover Location on GHAPWASCO

Metal locator is used to locate valves when the valve cover is buried underground by soil or asphalt.

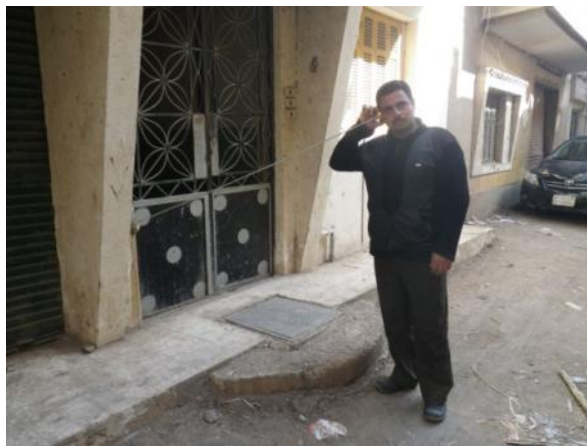
Figure 4.2-13 House Connection Survey using Acoustic Rod on MCWW

Figure 4.2-13 shows house connection survey by acoustic rod.

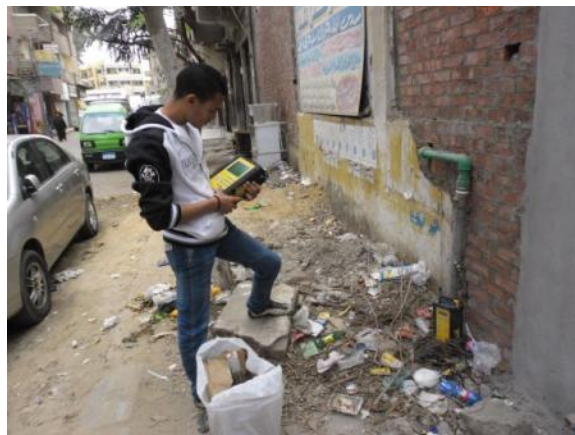
Figure 4.2-14 Leak Noise Correlator Survey on MCWW

Figure 4.2-14 shows survey using the leak noise correlator.

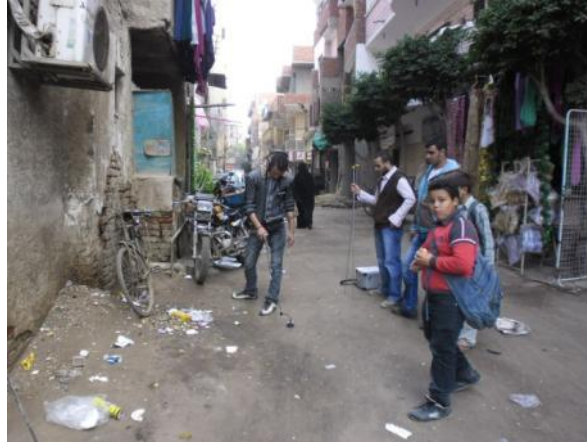
Figure 4.2-15 Ground Surface Survey using Water Leak Detector on MCWW

The ground surface survey method using the water leak detector is shown in Figure 4.2-15.

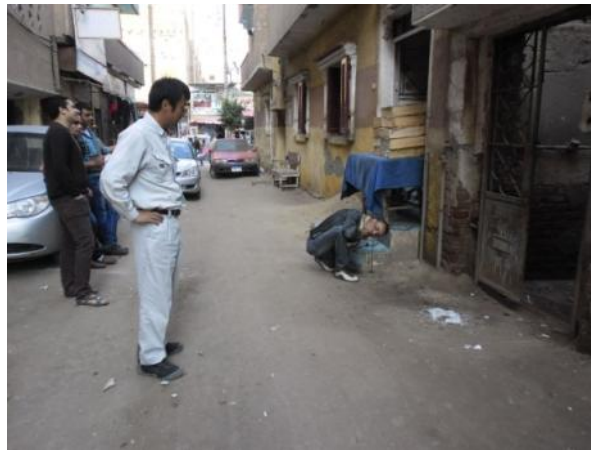
Figure 4.2-16 Noise Confirmation on MCWW

Figure 4.2-16 shows confirmation of leak place by drilling.

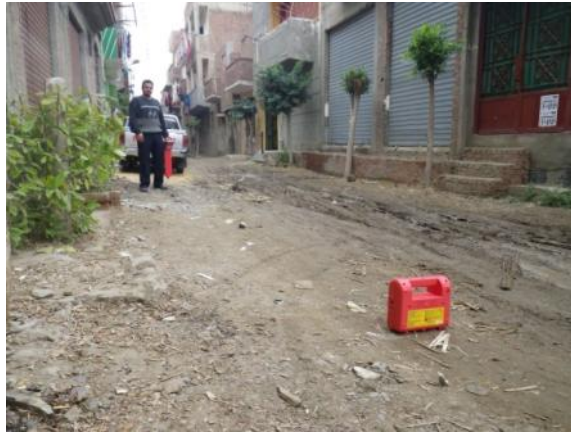
Figure 4.2-17 Training of Metal Pipe Locator on MCWW

Metal locator is used to locate valves when the valve cover is buried underground by soil or asphalt.

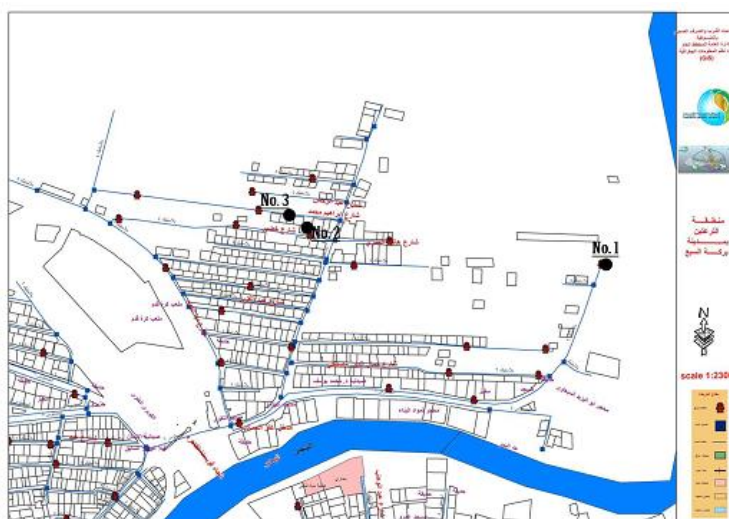
Figure 4.2-22 Location of Detected Leaks at Elterreten Area in Berket El Sab'a Markaz

As an example, locations of detected leak points in Elterreten area in Berket El Sab'a Markaz are shown in Figure 4.2-22. In the area, three (3) leaks were found and all leaks were repaired.
