**THE URGENT DEVELOPMENT STUDY ON  
THE PROJECT ON  
REHABILITATION AND RECOVERY  
FROM TYPHOON YOLANDA  
IN  
THE PHILIPPINES**

**FINAL REPORT (I)**

**VOLUME 2: GENERAL GRANT  
AID PROJECT**

**JUNE 2015**

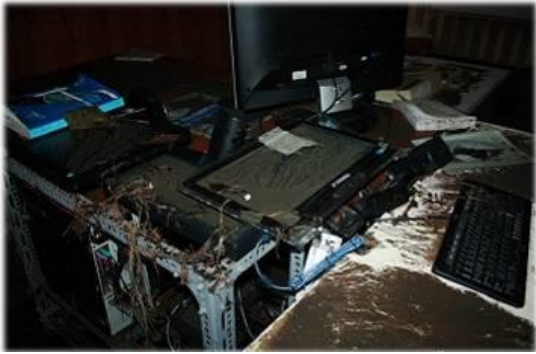
Damaged Engine Room Simulator

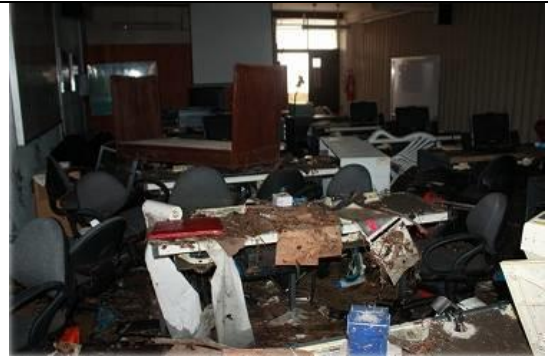
Damaged GMDSS simulator

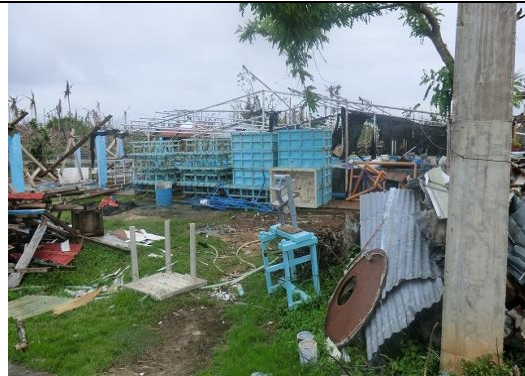
Damaged Cultivating Tank

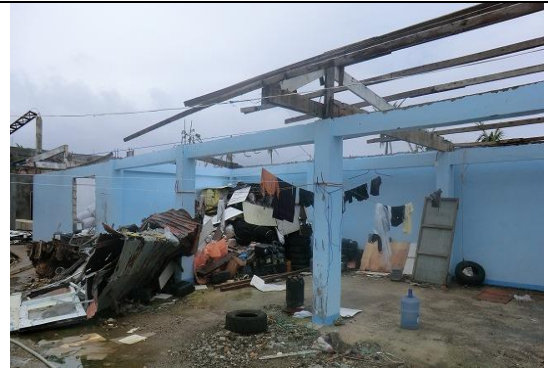
Damaged Nursery Facilities

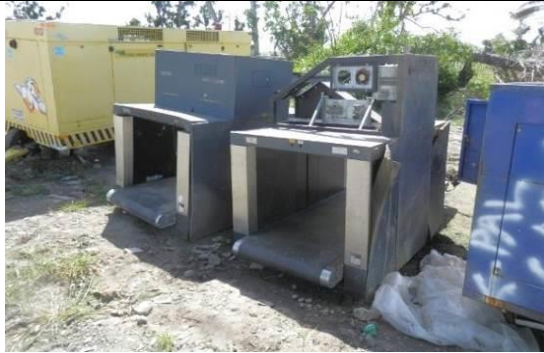
Destroyed X-ray Inspection System

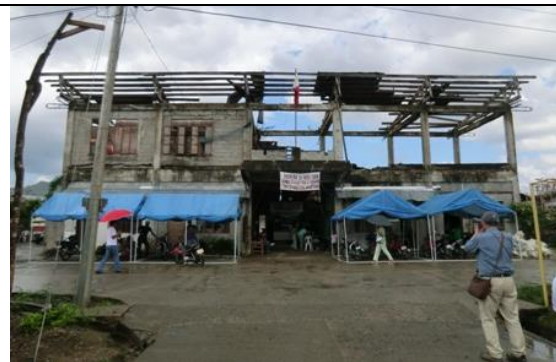
Damaged office due to aging and by typhoon (Lawaan)

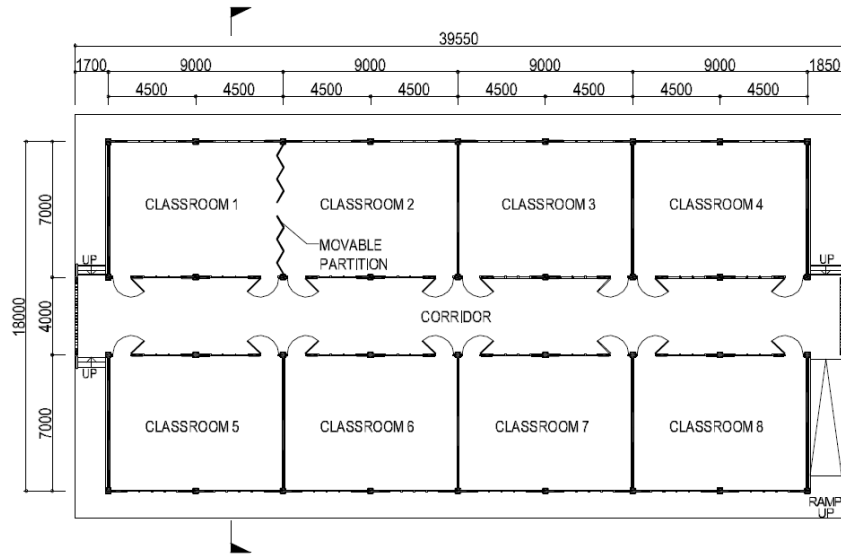
PLAN

### 8 CLASSROOM BUILDING, ONE STORY

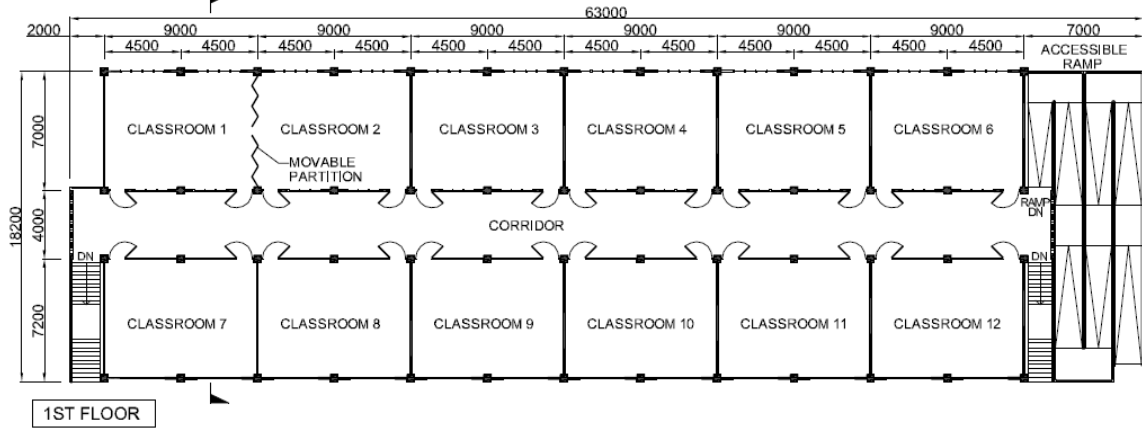
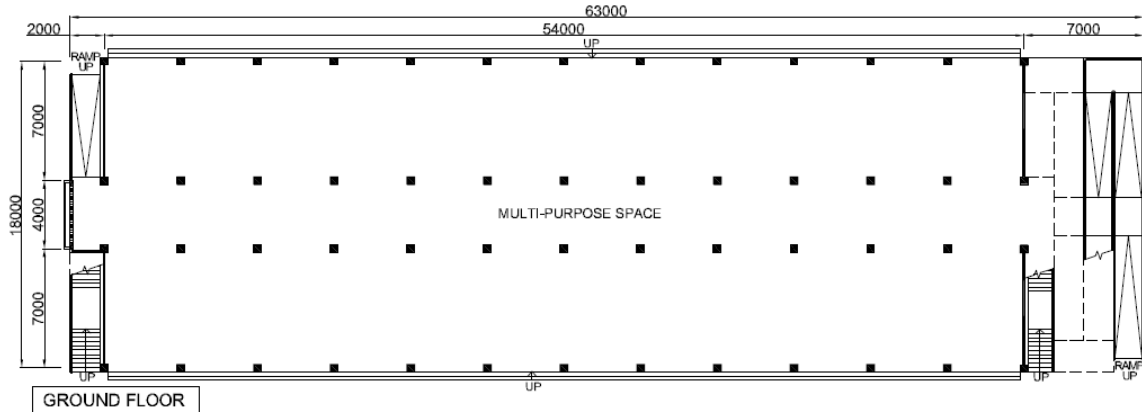
**PLAN**

**12 CLASSROOM BUILDING, TWO STORY (PILOT)**

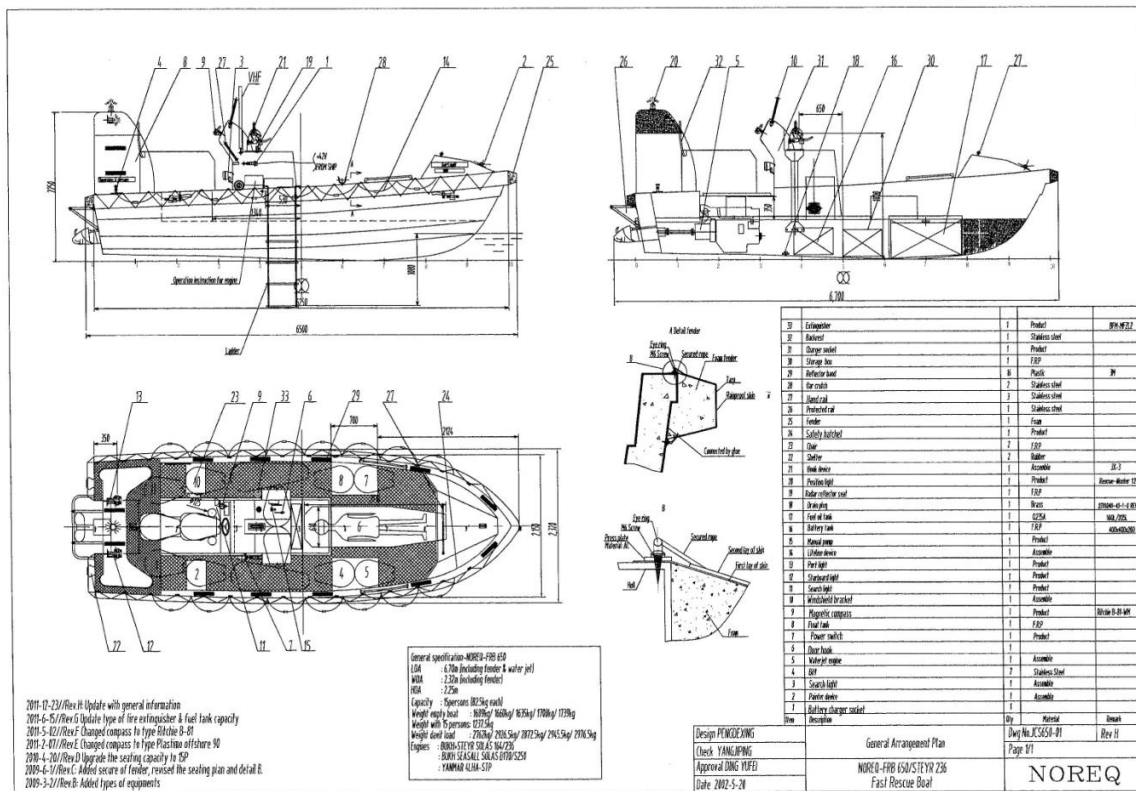
**Figure 2-2-13 Example of General View of a High-Speed Rescue Boat (NMP)**

Items	Specification
Fast rescue boat and Davits	Hull (L:6.35×B:2.3×H:2.3) Capacity 15 persons, with at least 30 knots, propulsion system (outboard motor or water jet)
	Hydraulic telescopic boom crane for ships (Including winch maximum load 30KN)
Totally Enclosed Lifeboat and Davits	Hull (L:5.25×B:2.3×d:1.) Capacity 25 persons, with at least 6 knots, propulsion system (inboard engine)
	Gravity type davits (Including winch maximum load 30KN)
Various Safety Equipment	Fireman's Outfit, Immersion Suit, Manikin, Portable resuscitator kit, Helicopter sling, Distress signal units, Multi Gas Detector
Full Mission Engine Room Simulator	Restoration and refurbishment (Engine room graphic panel, Control room control stand, Failure setting panel and bridge control stand) Add evaluation system
GMDSS (Global Maritime Distress and Safety System) simulator related equipment	MF/HF Receiver with DSC unit, VHF Radio Transmitter/Receiver with DSC, FACSIMILE (weather fax)
