THE REPUBLIC OF MAURITIUS
MINISTRY OF ENVIRONMENT, SUSTANAIBLE
DEVELOPMENT, DISASTER AND BEACH MANAGEMENT
(MOESDDBM)

**THE PROJECT FOR CAPACITY
DEVELOPMENT ON COASTAL
PROTECTION AND REHABILITATION
IN THE REPUBLIC OF MAURITIUS**

FINAL REPORT

MAIN REPORT

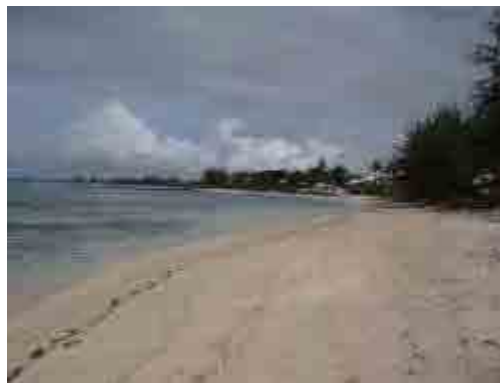
North: Pte. aux Cannoniers

sediment. The photos at north and west coast shown in Figure 2.2.2 is the coasts with such characteristics. Here, the width of the coral reef is from 100m to less than 1km. On the other hand, east coast has wide coral reef compared to north and west coasts and there are some coasts where the width of coral reef is more than 5km. The coast with such conditions is formed by silty sand, clay humus soil and gravel. South coast is mainly formed by rocky cliff except some area of southwest coast. The coast formed by gravel also exists at south area. The main source of the sedimentation coral sand is coral and coral rock which were breaking at the reef edge due to breaking wave action.

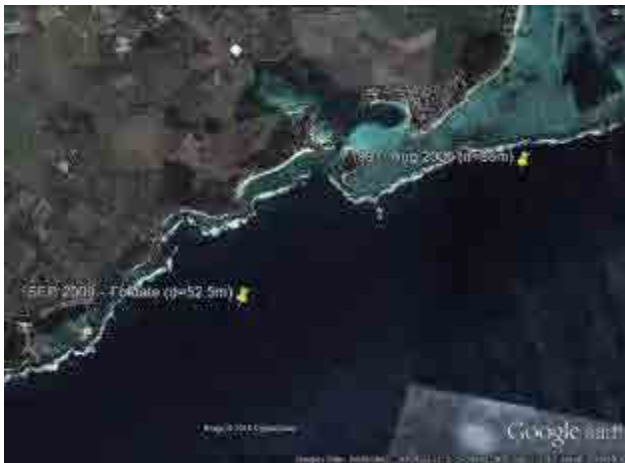
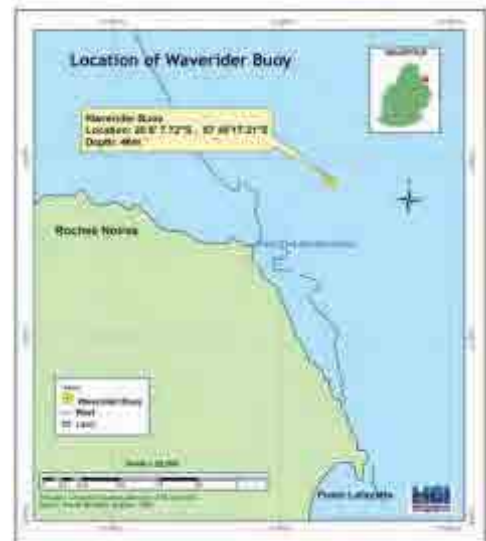
In Mauritius, the wave observations have been carried out continuously at two points, namely Blue Bay (by MMS) and Roches Noires (by MOI). Figure 2.2.18 shows the location of these points. Location of observation station in Blue Bay has been changed, while MOI has started observation since February in 2012. In this study, the seasonal characteristic of waves have been analyzed based on the wave data collected. Also, additional wave recorder and current meters have been installed in this study to continue the wave observations since February 2013. Details of data collection status is shown in the Supporting Report (9. Wave Observation Data).

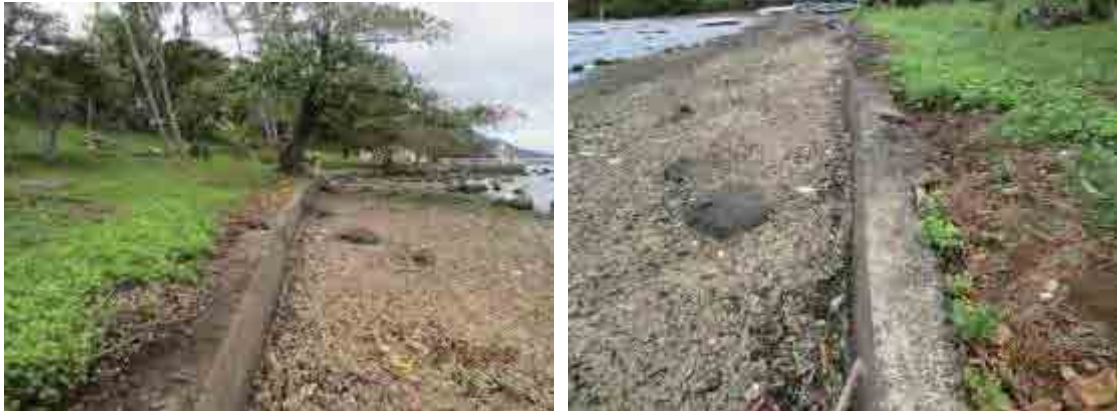
Figure 2.4.1 Revetment in Riviere des Creoles

Regarding to the situation in Riviere des Creoles, for example, progression of aging and deformation can be identified in some points of the revetment. In 2014 a flexible revetment was constructed based on the recommendations of Japanese engineers to alleviate a reported problem of crabs not being able to pass over the revetment (to lay eggs, etc.).

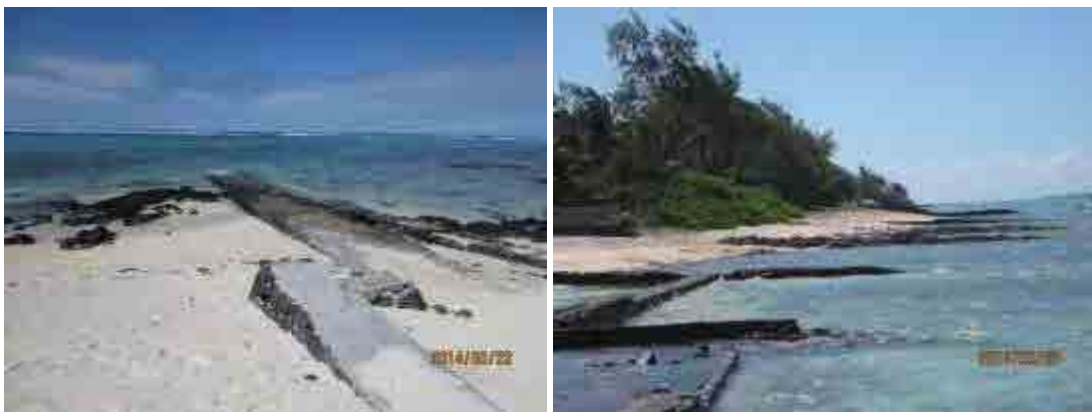
Figure 2.4.2 Groyne in Pte. d'Esny

Small-scale groynes are constructed by lessees of coastal land in Pte. d'Esny. Structure of the groyne is composed of assembled rocks held together with mortar and with a width of 1.5m on the crest. Most of the groynes have a height of less than 1.0m, however, some are 3.0m high on the beach section as they also function to demarcate the property boundary line.

There are areas of coastline in Pte. d'Esny where groynes and partial coastal erosion are hindering beach accessibility and preventing people from walking along the beach. This is an issue with regards to coastal management and public coastal use.

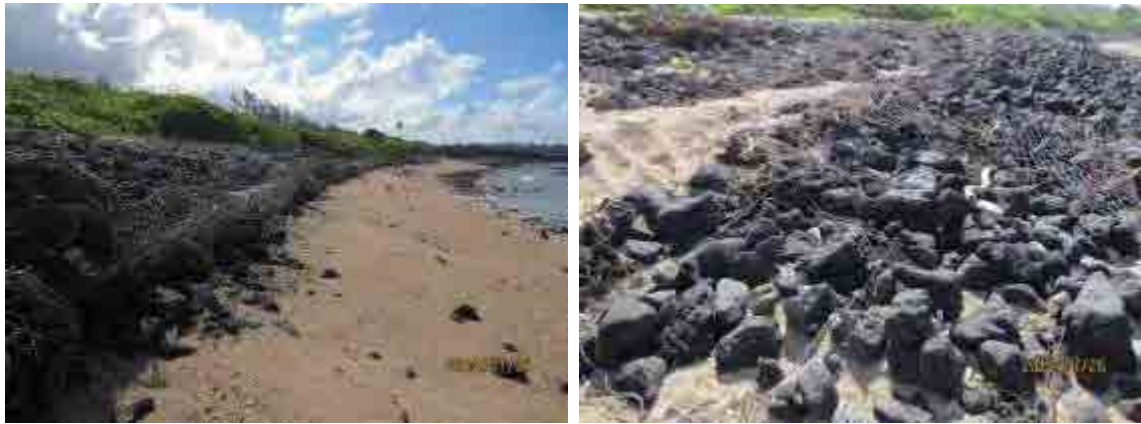
Figure 2.4.3 Gabion in Saint Felix

Regarding to the gabion in Saint Felix, it was constructed between 1995 and 1996 after the cyclone hit in 1994. The height of the gabion is approximately 5.0m at the highest part. Cut off iron wires and scattering of rocks from within the gabion on the sandy beach were identified in the field in 2012.

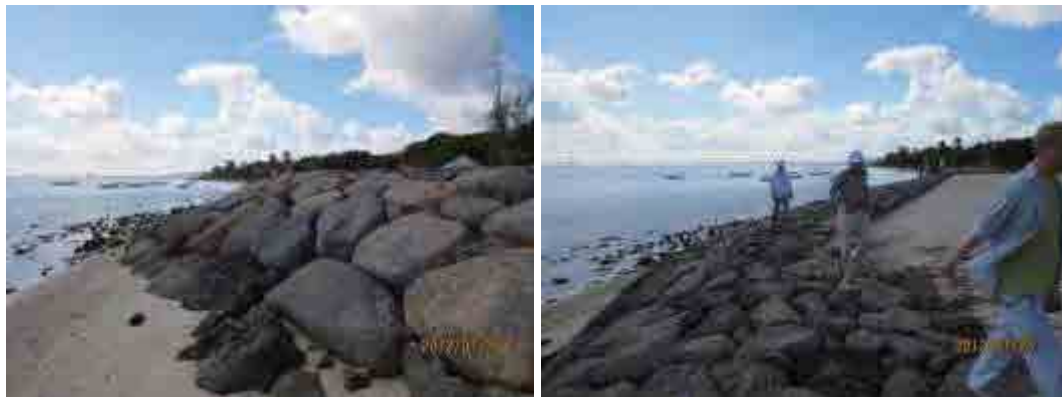
Figure 2.4.4 Rock Revetment at Pte. aux Sables

The rock revetment at Pte. aux Sables was built covering the existing beach to a height of over 2.0m. The revetment was constructed to prevent the erosion at the public beach and has proven to be effective. Furthermore, since it is a comparatively new structure and the weight of rocks is sufficient to protect them from being moved, no major problems have been identified so far. However, since the alignment of the revetment is set along the existing coastal line, it is possible it is blocking the sand movement along the shoreline (littoral drift) due to its covering the sand beach. In fact, there has been erosion on an adjacent section of coastline causing the destruction of a small-scale revetment that existed there. Accessibility to the beach from on top of the revetment is poor because the surface of the revetment crest is not comfortable to walk on as well as the width of sand beach is not wide enough.

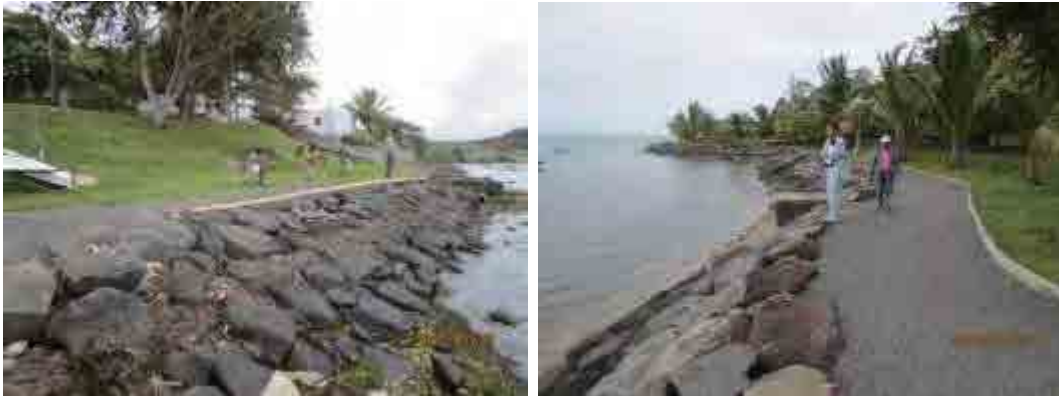
Figure 2.4.5 Rock Revetment in the South of Grand Sable

The rock revetment in the south of Grand Sable is smaller than the one at Pte. aux Sables in size and there is a pedestrian walkway along the top of it. However, base of the revetment is completely under sea water and tidal markings on the revetment slope reveal that the tide reaches half way up the revetment. It is difficult to access to the beach due to some slippery

surfaces on the slope of the revetment.

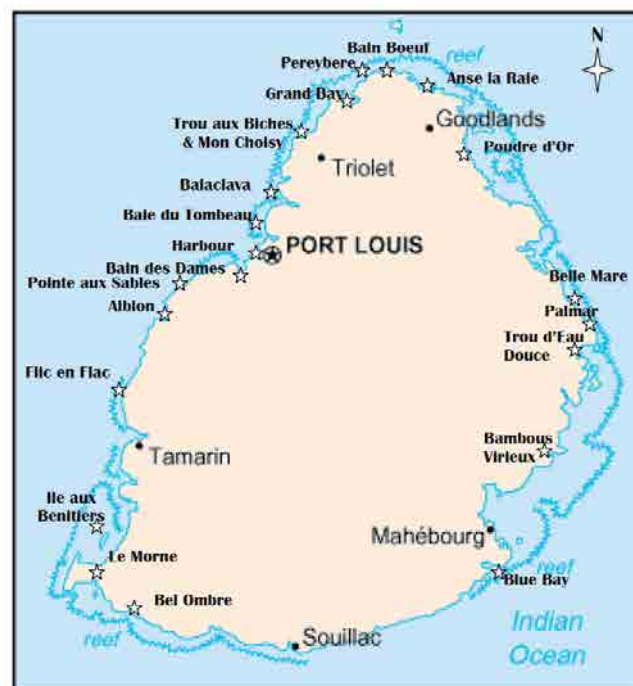
Figure 2.6.1 Locations of Water Quality monitoring in Lagoons by AFRC

The main water quality parameters in lagoons are nitrate and phosphate of nutrient salts, and chemical oxygen demand (COD), an indicator of organic contamination, together with coliform and fecal coliform. Figure 2.6.1 shows the AFRC monitoring points.

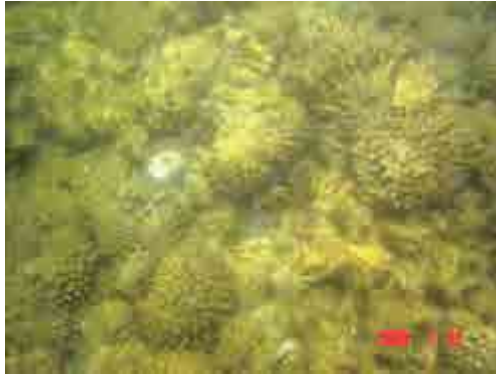
Photo 2.6.1 Algal Bloom (by AFRC)

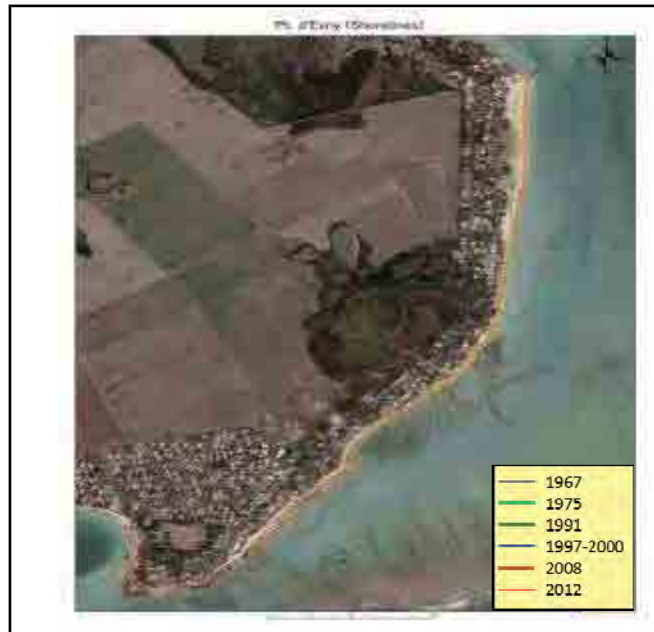
Figure 2.8.4 A Finished Product for the Shoreline Database

After geometric correction of aerial photos and six photography periods of satellite photos (1967, 1975, 1991, 1997-1999, 2008, 2011-2012) ended, shoreline was input using a digital function of ArcGIS according to each year and shoreline database was created.

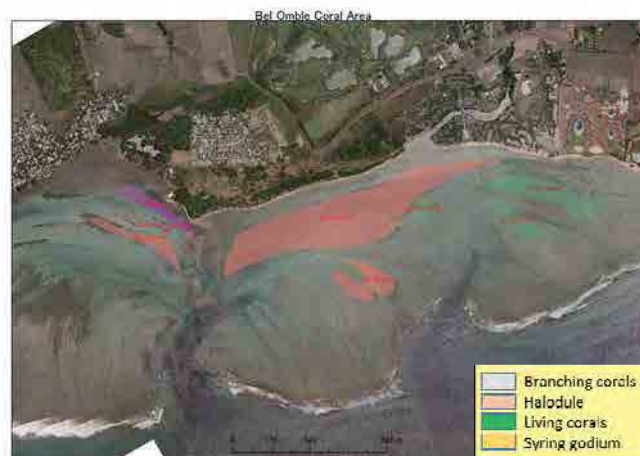
Figure 2.8.5 Interpretation of Coral and Seagrass

The distribution of coral and seagrass were interpreted by the aerial photograph and spot-check (by snorkel) survey in the project as shown in Figure 2.8.5 and Figure 2.8.6. The database was made employing the same method of shoreline database by the digitization and geometric correction.

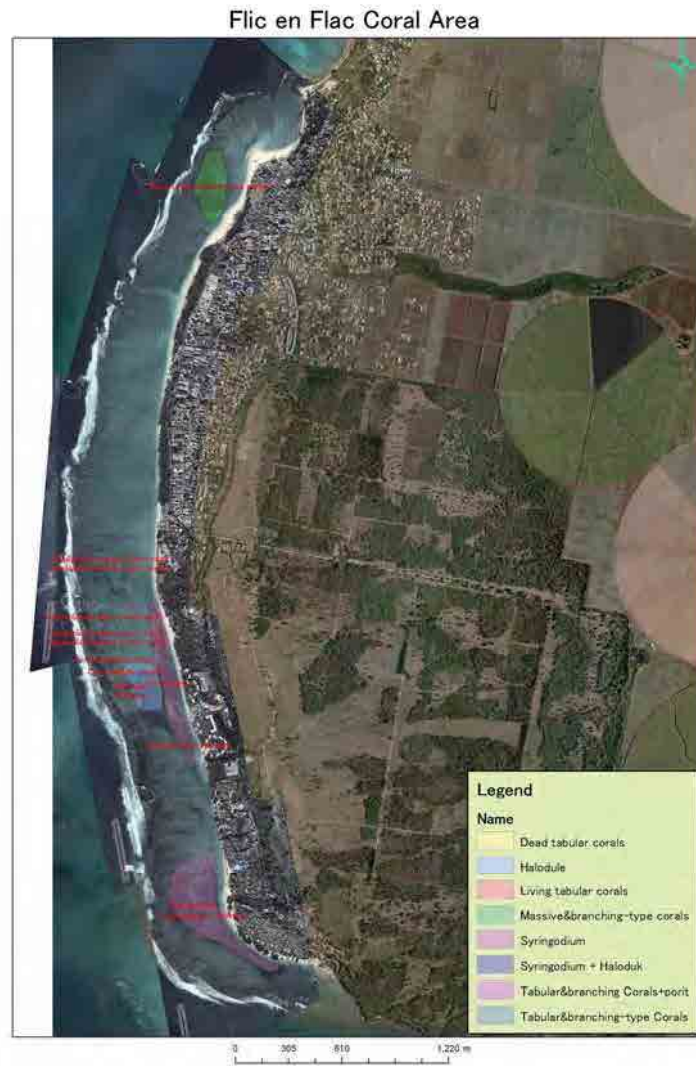
Figure 2.8.10 Results of Survey by Glass Boat in the Lagoon at Flic en Flac

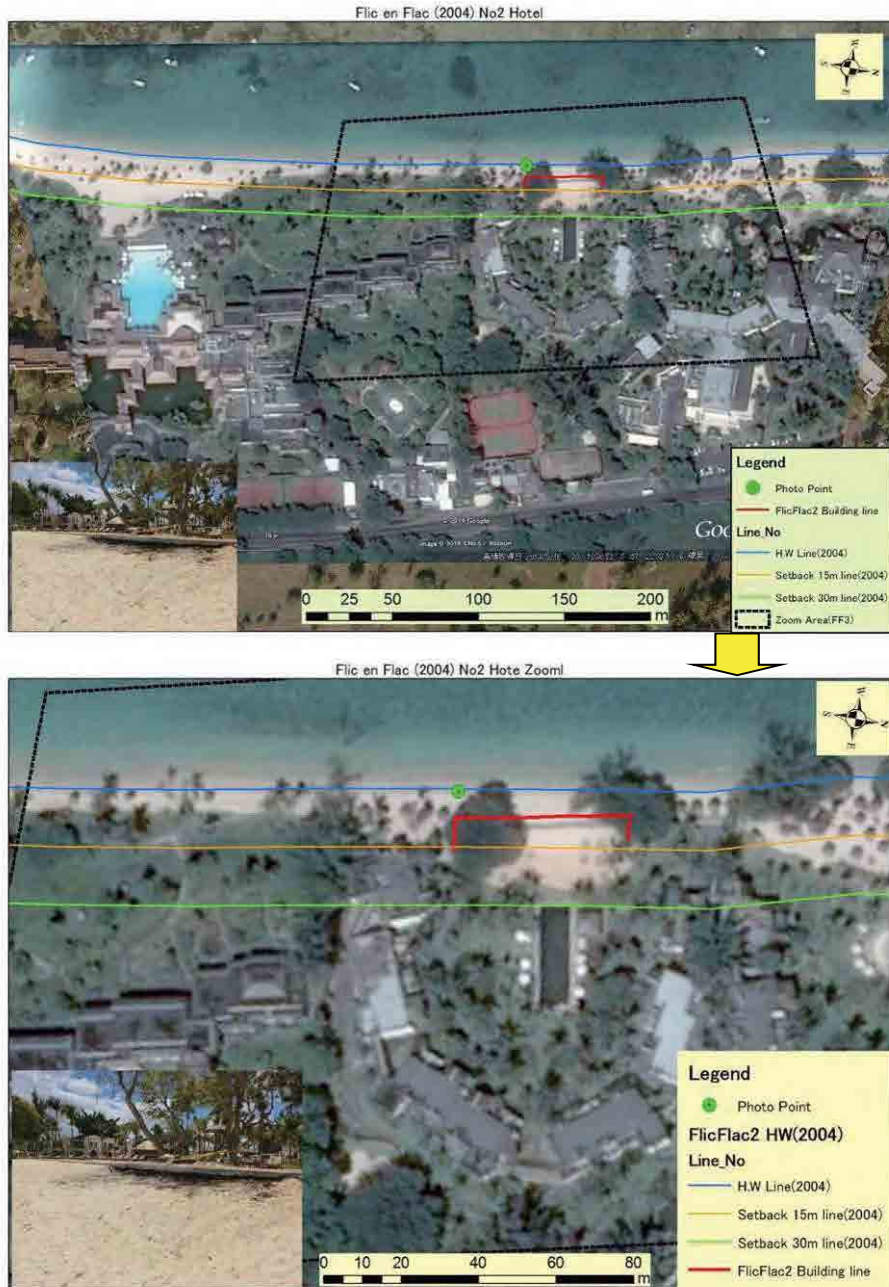
Figure 5.3.4 Verification of Positional Relation between Hotel Facilities and Setback Line (Flic en Flac-1)

A part of the walkway at the Hilton hotel exists in front of the hotel on the beach. This structure was not in aerial photographs until 2000 but it can be seen in a satellite photograph in 2004. A line for HWM was put on the satellite photograph in 2004 and then from the HWM line as a starting point, lines with 15 m and 30 m from the HWM were added on the landward side of the HWM. The result proves that this structure is located between the HWM and the 15m setback line. There is a possibility that this was constructed without observing the setback rule. It is necessary to demolish or relocate this deck through discussion between hotel management and related institutions because this structure will block continuous sediment transport in and around the hotel in the future.

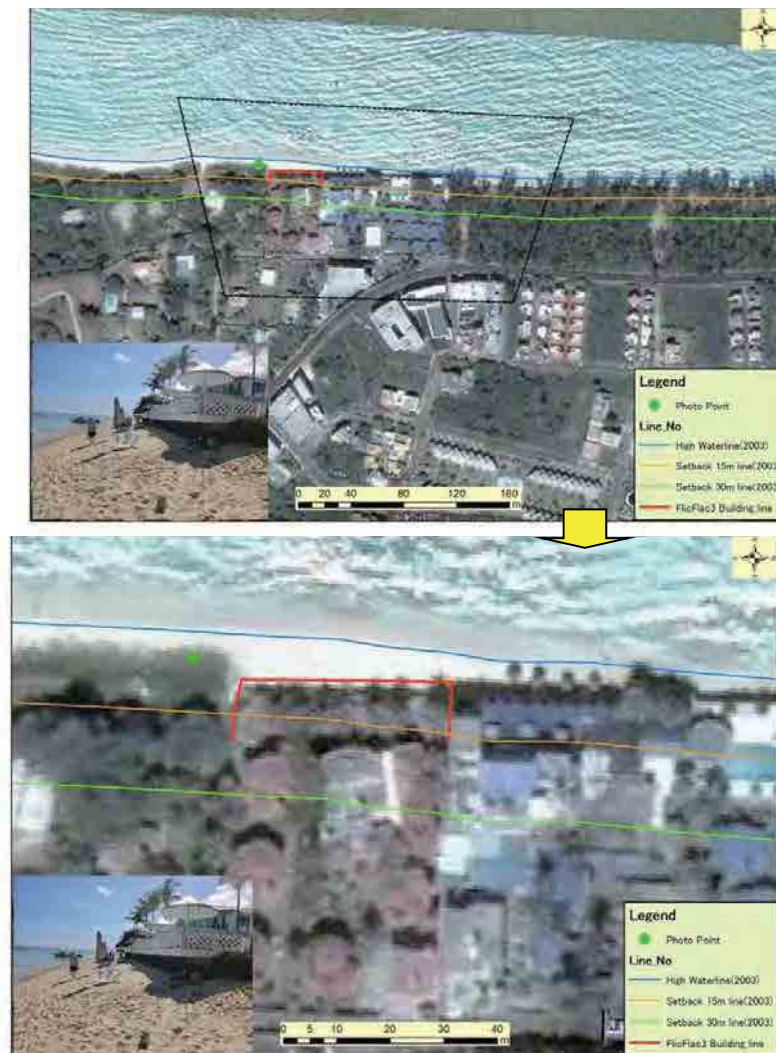
Figure 5.3.5 Verification of Positional Relation between Hotel Facilities and Setback Line (Flic en Flac-2)

A concrete deck exists in front of the Gold Beach Hotel as well as the Hilton Hotel as mentioned above. This deck was not in aerial photographs until 2000, but it can be seen in satellite photographs from 2003. An HWM line was put on the satellite photograph in 2003 and then from the HWM line as a starting point, lines with 15 m and 30 m from the HWM were added on the landward side. The result proves that this deck is located between the HWM and the 15m setback line. In addition, a part of the hotel facilities and swimming pool are also included in this area. There is a possibility that this deck was constructed without observing the setback rule. It is necessary to demolish or relocate this deck through

discussions between the hotel management and related institutions because this will block continuous sediment transport in and around the hotel in the future. Given that the site is already developed and setback cannot be enforced, it may be recommended that the impermeable retaining wall be modified into a sloping and permeable retaining wall.

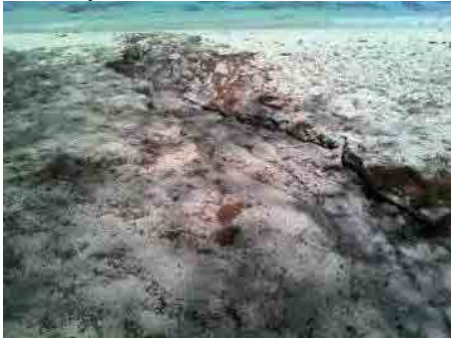
Lack of drainage system	<ul style="list-style-type: none"> ● Runoff caused by rainwater from the landside washes away sandy beaches locally.

<ul style="list-style-type: none"> ● It is necessary to prepare a drainage plan by conforming to the road rehabilitation and improvement plan behind the coastal zone, especially at areas where local scouring of sandy beaches occurs due to rain drainage. ● Soakaway drains shall be constructed in between parking areas/ roadside and public space to catch any surface runoff. The dune should be well vegetated to minimize effects of surface water runoff. Any hardened sand on the public space due to anthropogenic effects shall be loosened regularly through daily maintenance.
	<ul style="list-style-type: none"> ● Garbage accumulates in ditches close to beaches. It might flow out to the sea after it rains. 	<ul style="list-style-type: none"> ● It is necessary periodically remove and collect garbage in drains located in public beaches by the Beach Authority and in the other areas by the district council.

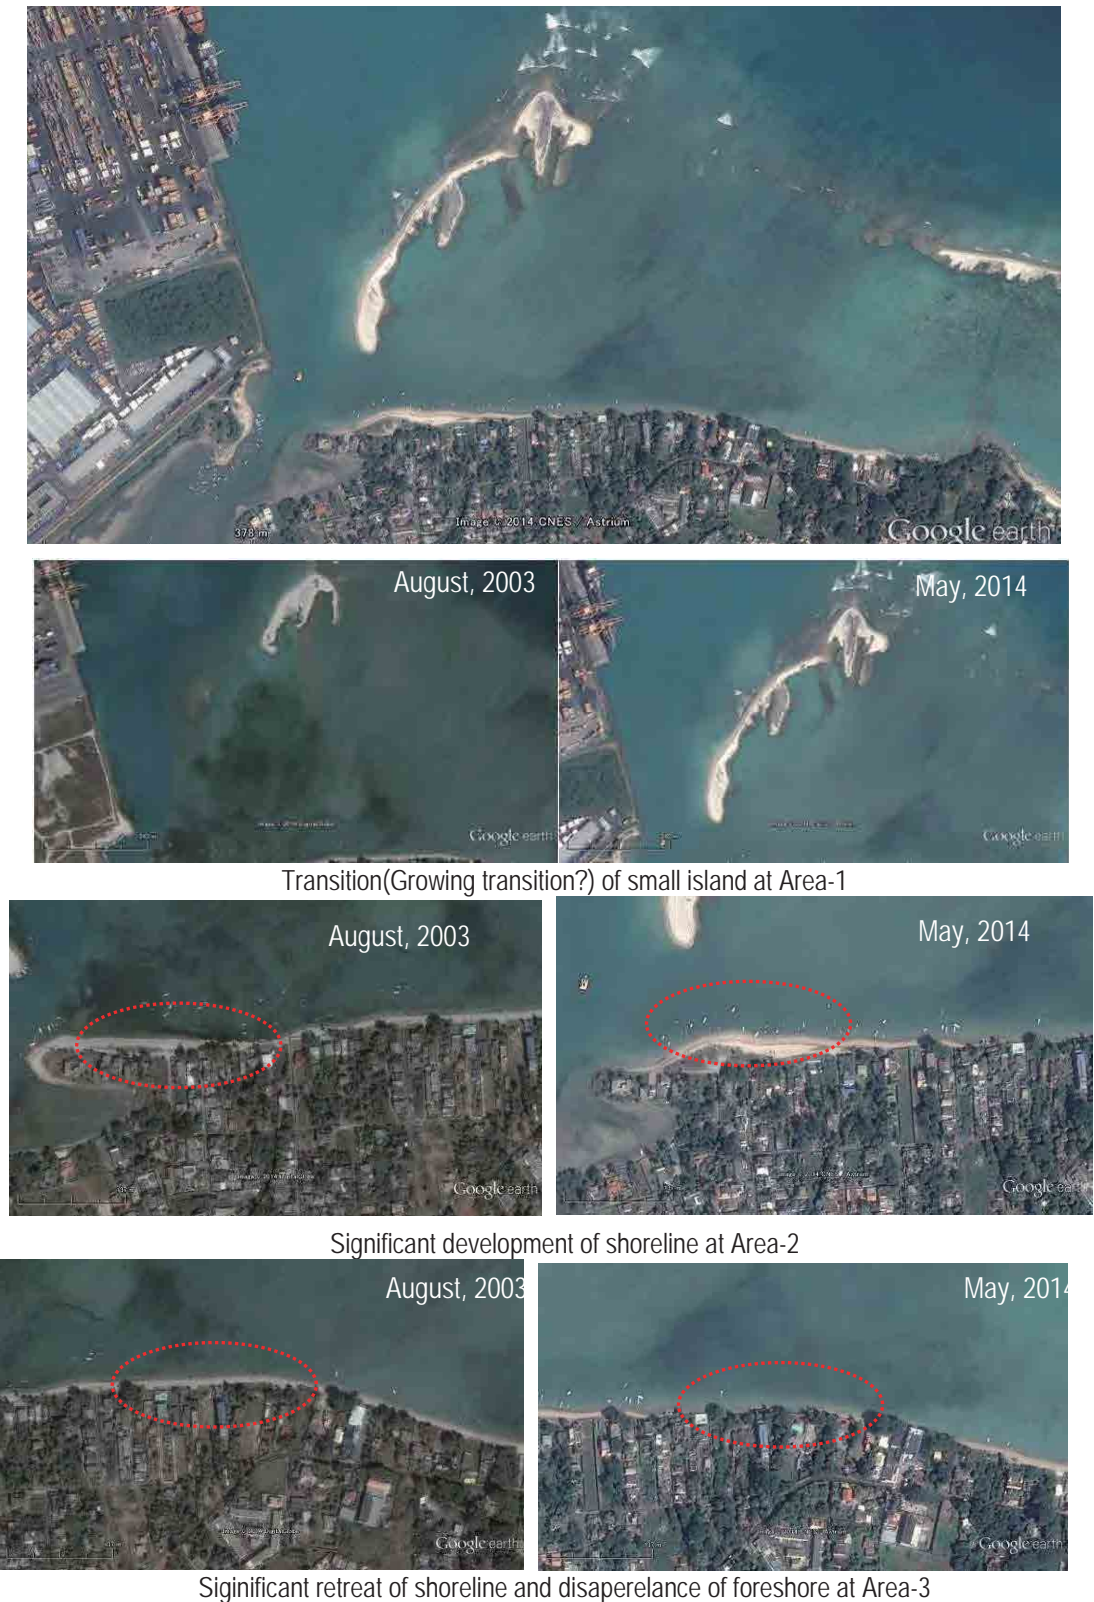
Figure 5.4.5 Transition of Sedimentation in Lagoon and Secular Change of Erosion and Sedimentation Area at Baie du Tombeau

At the moment, it is impossible to extract sand because sand extraction on the lagoon was banned in 2001. However, it is thought that the coastal condition behind the island can be stabilized if the size or shape of the island is adjusted by dredging because it is presumed that development of the island may influence the beach behind the island. The dredging sand can be used as beach nourishment material as well as maintenance for the eroded parts of this beach and other beaches that have not kept balanced sediment budget as mentioned above. It is also thought that comprehensive and flexible beach management would be favorable for Mauritius.

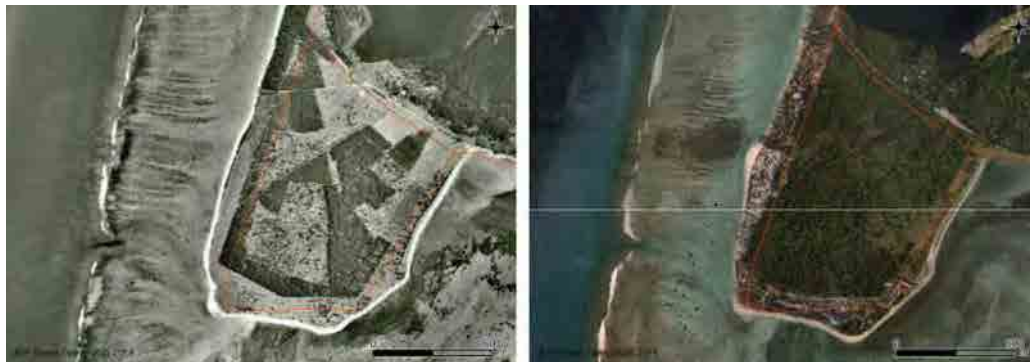
Figure 6.2.2 Change in Beach with Shallow Area Offshore:

As shown in Figure 6.2.2, there was no remarkable change in the coastline at south Le Morne in the aerial photo of 1967. A tongue-like beach deposited offshore with a width of 200m. The tongue-like beach appeared with the development of a coral community just outside this beach as shown in Figure 6.2.2. The satellite photo was taken in 2008. Current marks on the bottom at this point show that the shore current goes from offshore to the beach, then turns and is divided into two directions, i.e. north and south. There was no shallow area in 1967. Deposition of sand on the beach seemed to be advanced by the movement of sand from offshore to the beach and by the diminishing effect of the shallow area with the development of the shallow area.

Left aerial photo in 1967, Right satellite photo in 2008

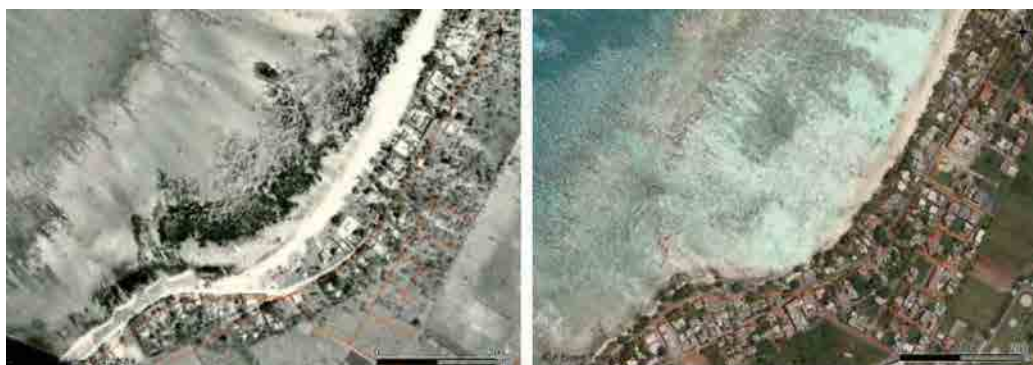
Figure 6.2.3 Changes in the Shape of Beach with the Change of Shoal at Trou aux Biches:

The beach was maintained with a long shoal off the beach in the aerial photo taken in 1967 at Trou aux Biches. But, the long shoal disappeared in the satellite photo taken in 2008 and a part of the beach was eroded back to 100 m. Dr. Bhagooli, University of Mauritius, surmised that the shaded area seemed to be seagrass beds. However, the shoal still appears in the north area of the eroded coast and the beach has been maintained with no change.

Left an aerial photo taken in 1967, Right a satellite photo taken in 2008

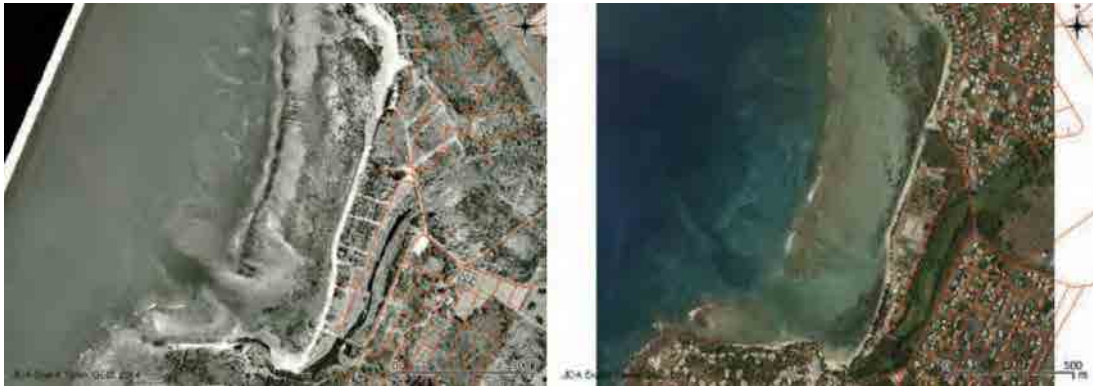
Figure 6.2.4 Changes in the Shape of Beach with the Shoal Offshore in Albion:

Left an aerial photo taken in 1967, Right a satellite photo taken in 2008

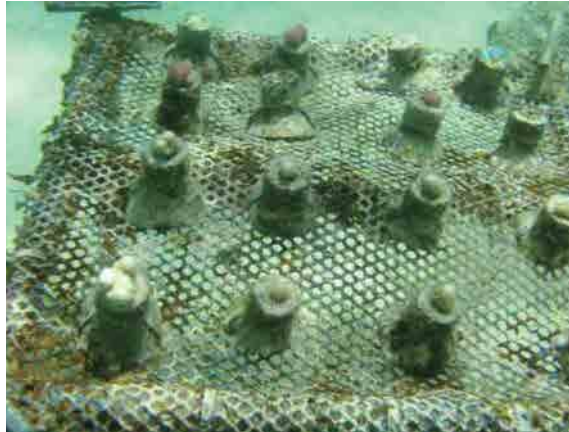
Figure 6.3.1 Coral Farming by AFRC

The Fisheries Division (AFRC) has been carrying out coral plantation at Albion, Pointe aux Sables and Trou aux Biches as a measure of coral rehabilitation since 2011. According to the AFRC report, the survival rate of planted corals was ca. 50 % after 2 years (Figure 6.3.1).MOI also carried out coral plantation at Albion, Trou aux Biches and Flic en Flac (Table 6.3.4).

Small basal tables made of PVC were set at Albion, Pointe aux Sables and Trou aux Biches in 2010. In 2013, AFRC set five large galvanised iron basal tables with 100 coral fragments at each of the following sites: Balaclava Marine Park, Trou aux Biches. Six hundred coral fragments have been placed in Blue Bay Marine Park. In future plans, the same type of large basal tables will be set at Ile aux Benitiers, Pointe aux Sables, Albion, Bel Ombre and Mon Choisy..

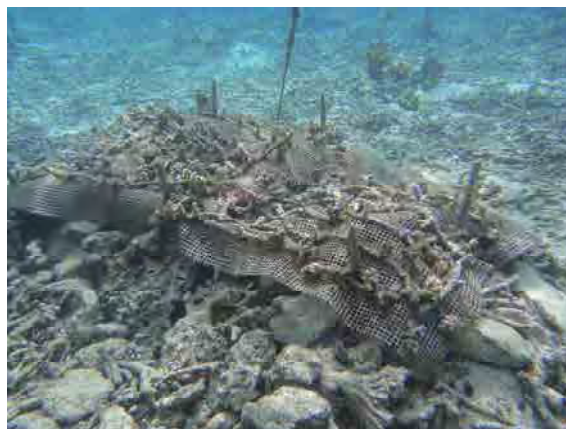
Figure 6.3.2 Coral Plantation by MOI in Flic en Flac Lagoon

MOI has completed a study on coral farming. According to the surveys carried out in 2014, the survival rates of planted corals were over 75% at Albion (3 years after plantation), over 65 % at Flic en Flac (2 years after plantation) and over 35 % at Trou aux Biches (1 year after plantation) (Figure 6.3.2). These survival rates are evaluated as good except for that at Trou aux Biches.

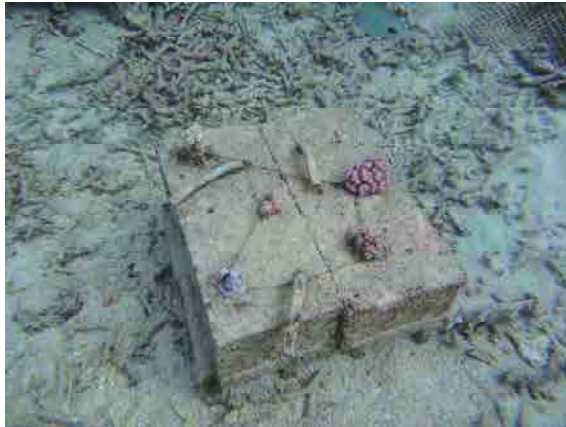
Figure 6.3.3 Reef Rehabilitation by MOESDDBM in Flic en Flac Lagoon.

The ministry responsible for the environment also started a coral reef restoration project in 2003 and continues using natural regeneration in Flic en Flac Lagoon (Figure 6.3.3) following the recommendation from Baird (2003) and confirmed the possibility of natural regeneration in some species.

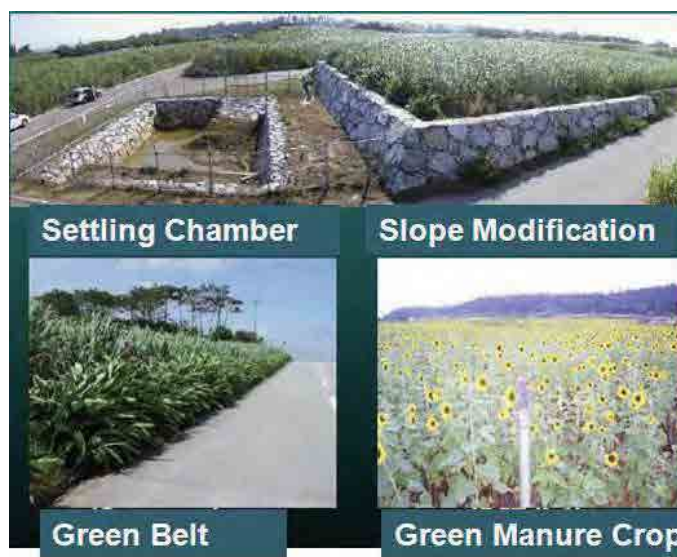
Figure 6.4.1 Examples of Measures against Red Soil Inflow

1. Countermeasures for the pollution sources on land are the basic countermeasures. (Figure 6.4.1 shows examples of countermeasures against red soil inflow which can be taken on land.)
2. Development of wetland in river mouths is an effective supplementary countermeasure.

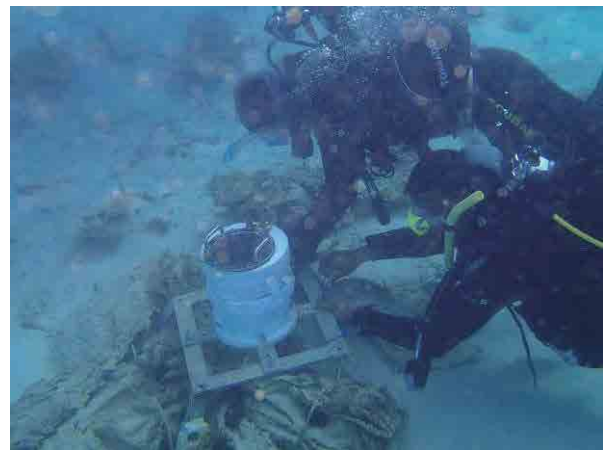
(Item 1-2) Installation of wave current meter

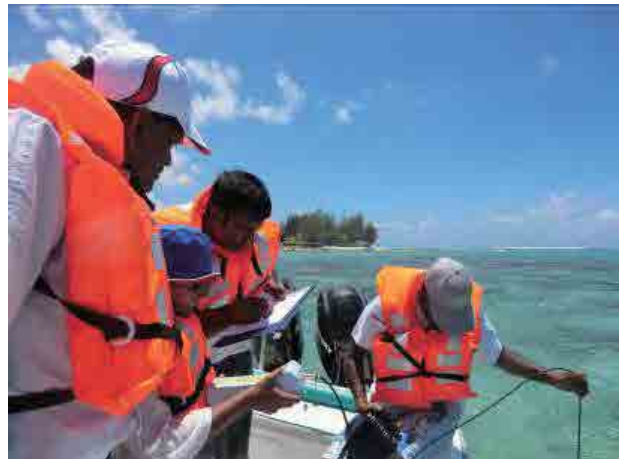
(Item 1-5) Water Quality Check by Multipurpose Water Quality Analyzer
