**THE PROJECT FOR CAPACITY
DEVELOPMENT ON COASTAL
PROTECTION AND REHABILITATION
IN THE REPUBLIC OF MAURITIUS**

**FINAL REPORT
SUPPORTING REPORT**

JAPAN INTERNATIONAL COOPERATION AGENCY

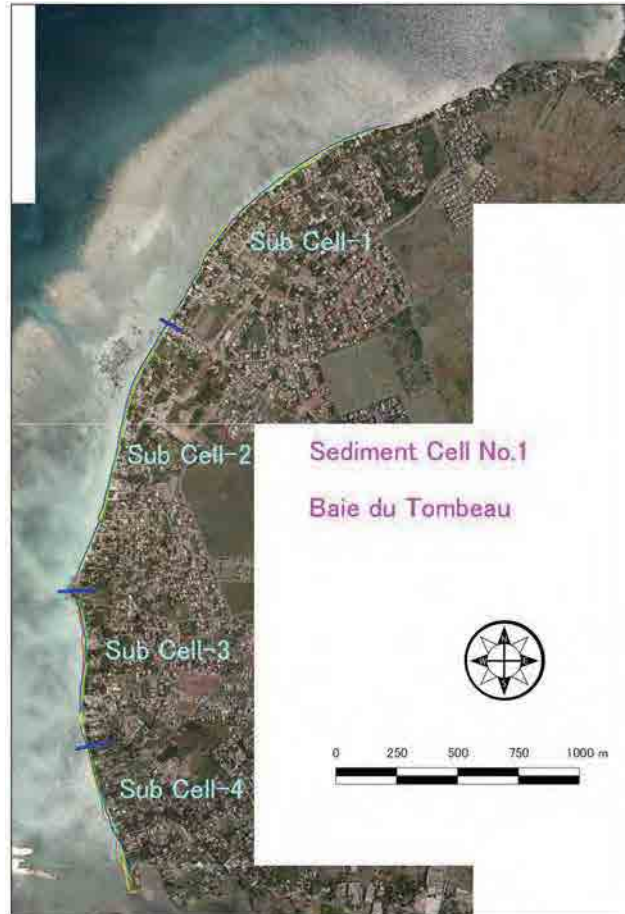
Source: This figure was processed by JICA Study Team based on Satellite image obtained from MHL.
Figure 1.1 Area of analysis (Sediment Cell No.1, Sub Cell-1-4)

Sediment Cell No.1 – No.13 included in 20 coasts for basic survey are subject to the analysis by topographic interpretation of aerial photos. And each Sediment Cell was divided into some Sub Cell with separating points of the rocky point, river mouth, jetty, and other infection points of shoreline changes. Figure 1.1 to Figure 1.23 show the Sub Cells to be analyzed in each Sediment Cell.

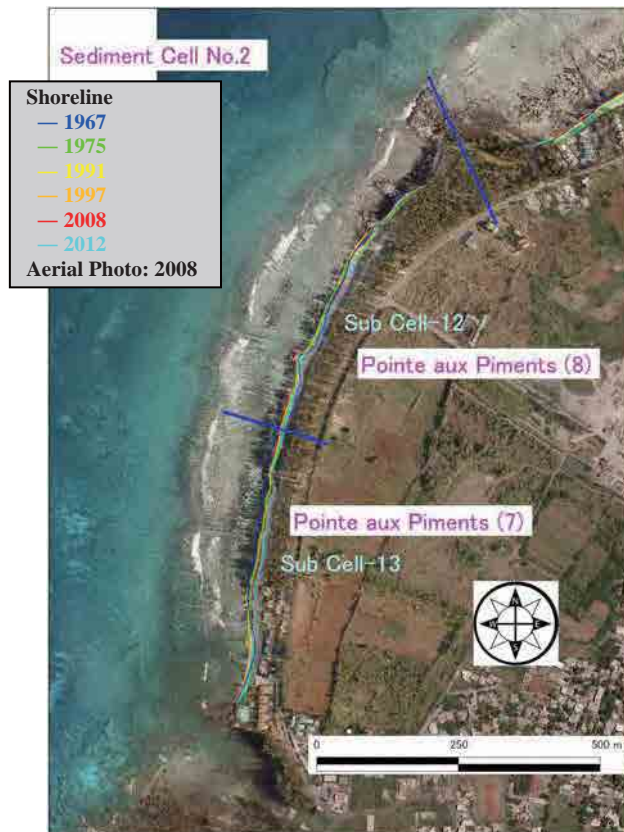
Source: This figure was processed by JICA Study Team based on Satellite image obtained from MHL.
Figure 1.5 Area of analysis (Sediment Cell No.2, Sub Cell-12-13)

For example, a series of coasts Sediment Cell No.2 locate in northwest of Mauritius Island was divided into 16 parts (Sub Cell 1-16) from north to south as shown in Figure 1.2 to Figure 1.6. The number in parentheses after location name in those figures, for example “Mon Choisy (14)”, means serial number of the declared public beaches of Mauritius. Moreover, interpreted shorelines were drawn on the satellite image in 2008 as shown in the legend.

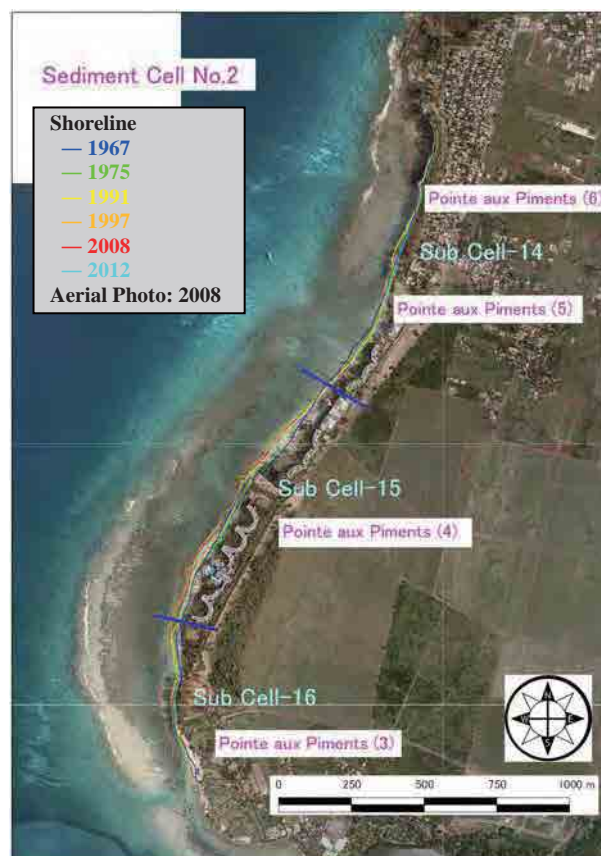
Source: This figure was processed by JICA Study Team based on Satellite image obtained from MHL.
Figure 1.6 Area of analysis (Sediment Cell No.2, Sub Cell-14-16)

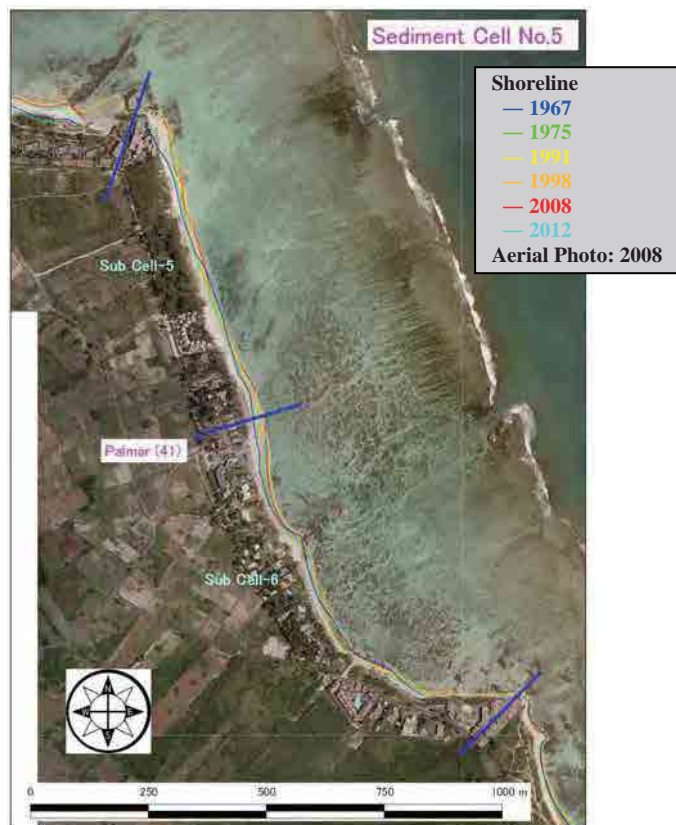
Source: This figure was processed by JICA Study Team based on Satellite image obtained from MHL.
Figure 1.10 Area of analysis (Sediment Cell No.5, Sub Cell-5-6)

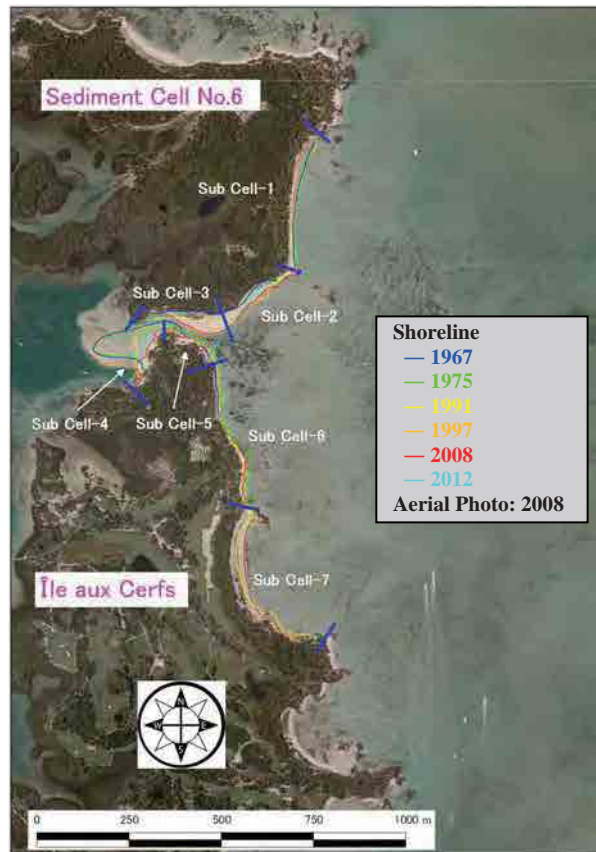
Source: This figure was processed by JICA Study Team based on Satellite image obtained from MHL.
 Figure 1.13 Area of analysis (Sediment Cell No.6, Sub Cell-1-7)

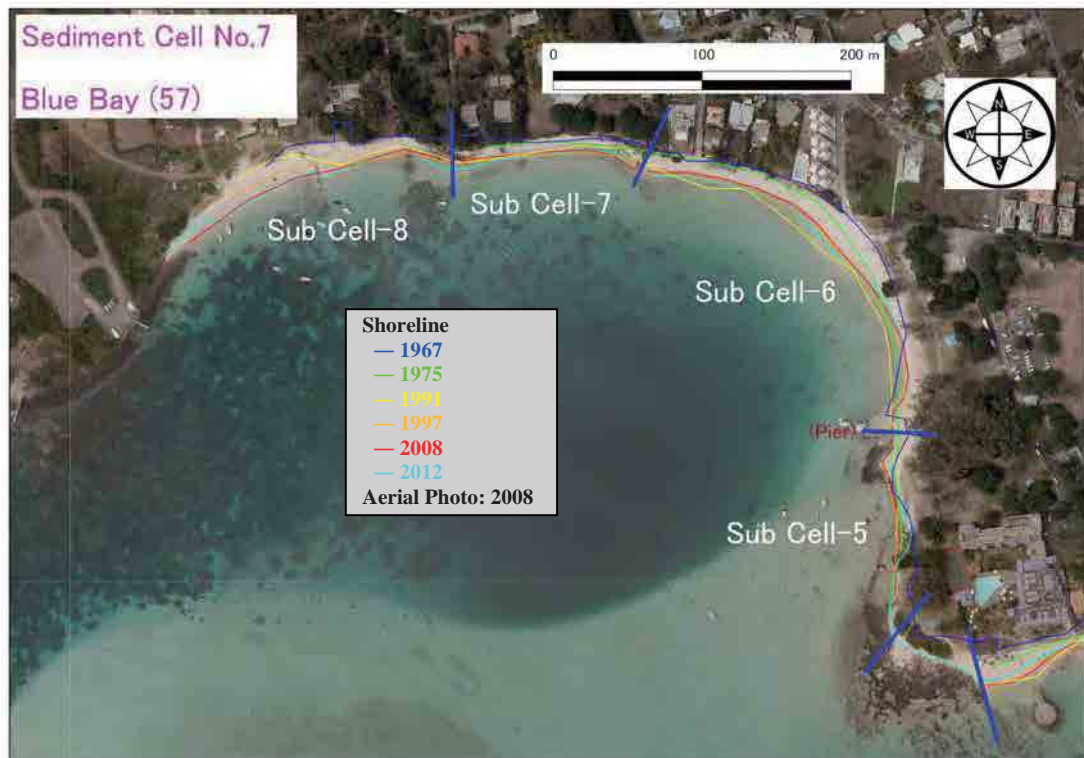
Source: This figure was processed by JICA Study Team based on Satellite image obtained from MHL.
 Figure 1.15 Area of analysis (Sediment Cell No.7, Sub Cell-5-8)

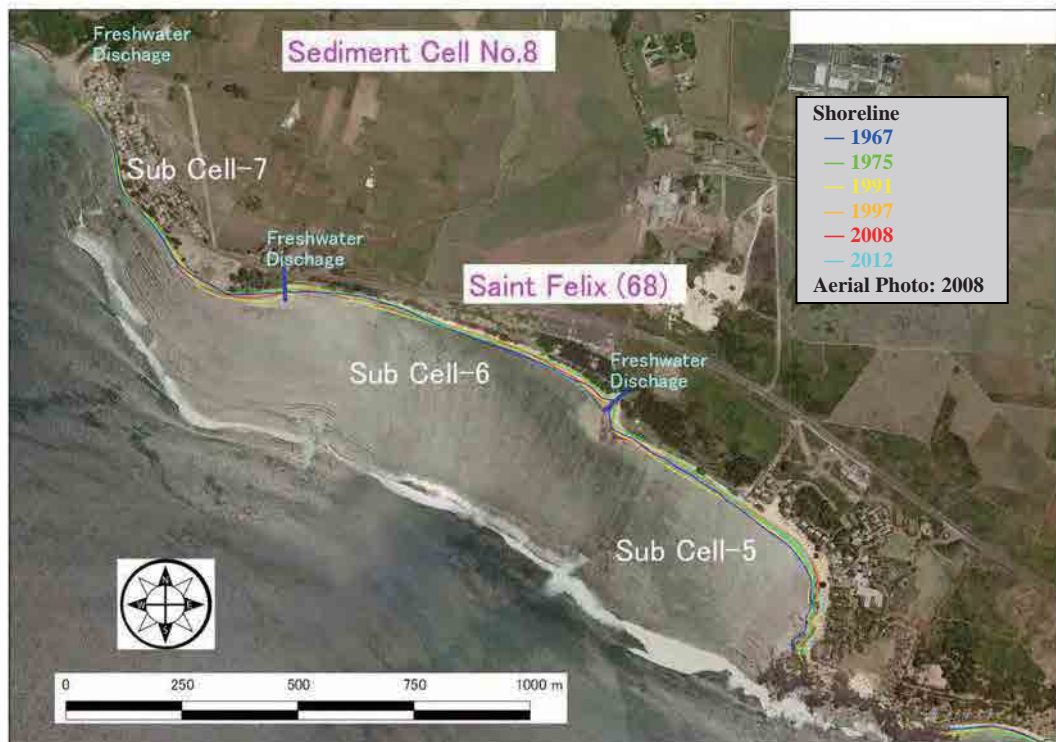
Source: This figure was processed by JICA Study Team based on Satellite image obtained from MHL.
 Figure 1.17 Area of analysis (Sediment Cell No.8, Sub Cell-5-7)

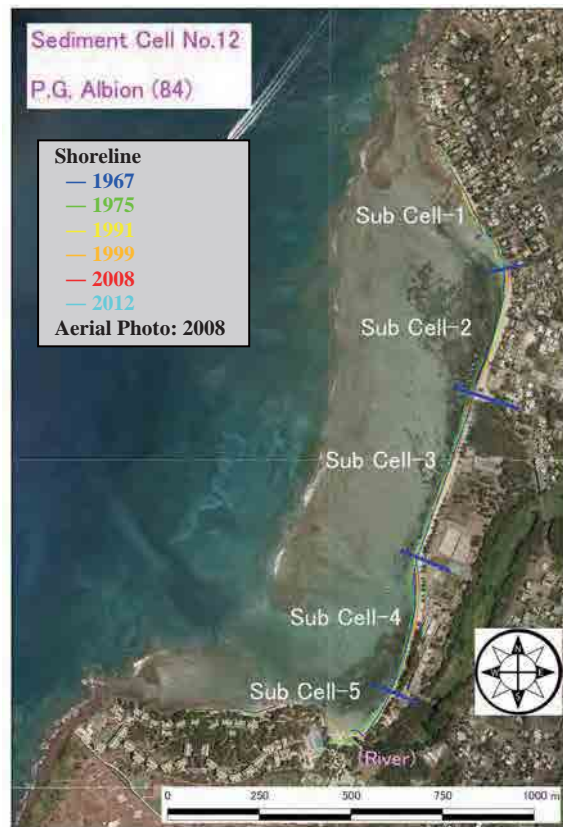
Source: This figure was processed by JICA Study Team based on Satellite image obtained from MHL.
 Figure 1.22 Area of analysis (Sediment Cell No.12, Sub Cell-1-5)

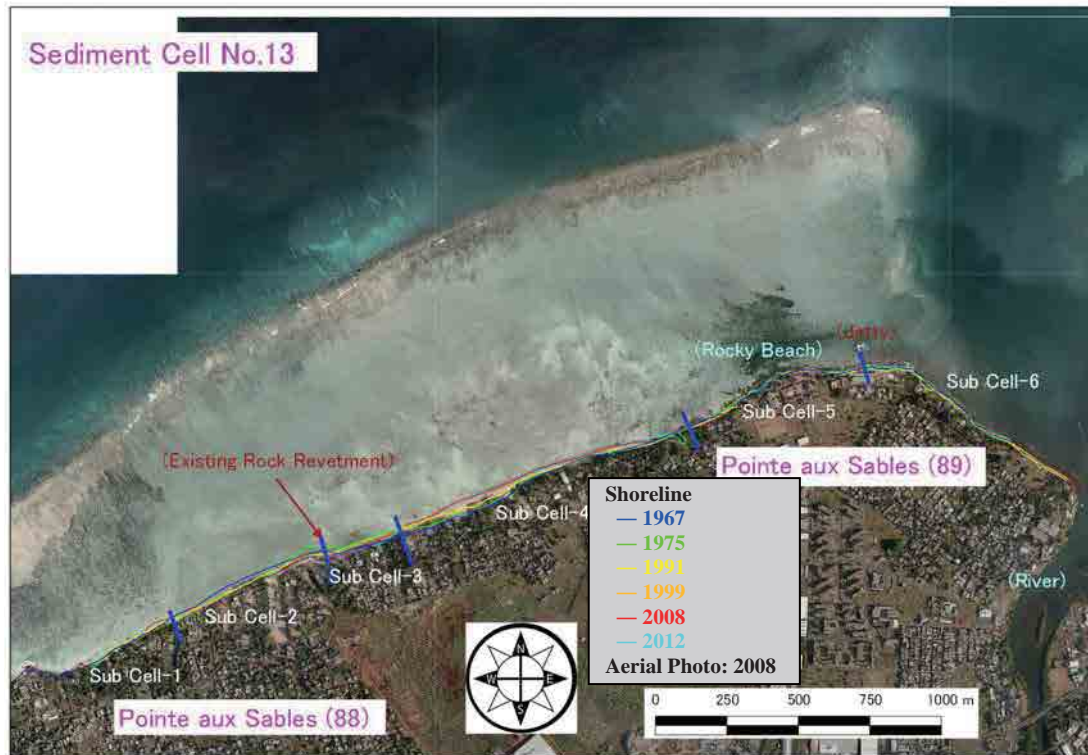
Source: This figure was processed by JICA Study Team based on Satellite image obtained from MHL.
Figure 1.1.23 Area of analysis (Sediment Cell No.13, Sub Cell-1-6)

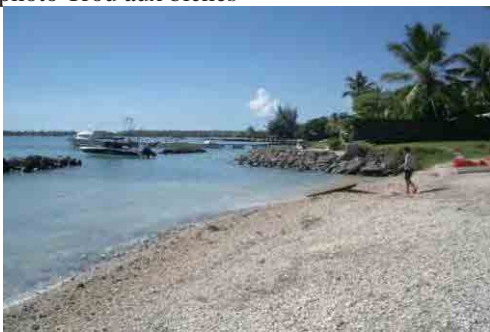
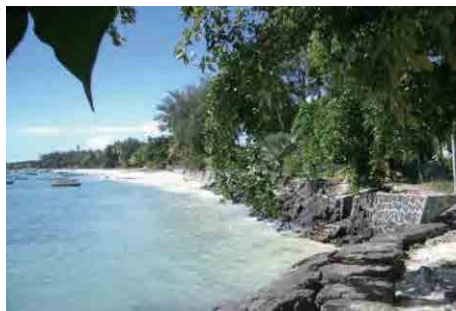
Coast photo Trou aux biches		Coast photo Trou aux biches, Partially damaged seawall

Natural and topographic characteristics	Sea state	Considerably affected by cyclonic waves	
	Topography	Though some of the west side is a rocky shore, but most of the coast is a sand beach. The width of the reef on the front is around 300 m. The slope of beach berm is within a range of 1/6 to 1/14 and a gentle slope is formed at Mon Choisy. The grain size of sea bed material with 0.2 mm of medium diameter is fine relative to the other beaches.	
Environmental characteristics	Coral reef	Coral reef coverage behind reef edge is a range of 10 to 60%. According to the results of coral reef monitoring by AFRC, coral reef coverage around the reef edge at Trou aux Biches is on a declining trend from 2000 to 2010.

General assessment		A protection program should be developed for Mon Choisy where coastal erosion is progressing and the beach nourishment conducted as the coastal protection works caused little effect. The investigation and planning of countermeasures into the cause of poor coral reef coverage. AFB artificial reef construction plan in Mon Choisy is considered inappropriate because of its possible negative impact on the local sediment transport mechanism and environmental conditions.

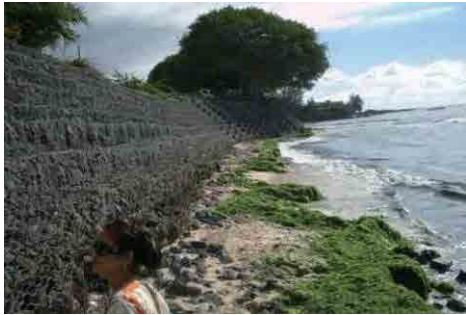
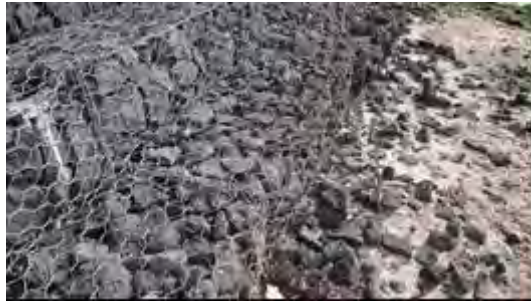
Coast photo ①	Coast photo Damaged gabions ②

Natural and topographic characteristics	Sea state	Considerably affected by cyclonic waves	
	Topography	Coast with a narrow width of sand beach, having a cliff on the back and reef on the front	
Environmental characteristics	Coral reef	Coral reef coverage is around 50%. According to the results of coral reef monitoring at Anse La Raie by AFRC, it gathers that coral reef coverage is on a declining trend from 2000 to 2010.	
	Water quality	Transparency is 2m and siltation is high. According to the results of water quality monitoring at Anse La Raie by AFRC, it gathers that water quality is relatively good.	
Coastal transformation characteristics	Disaster and structures	Gabions were constructed for prevention against overtopping waves to the hinterland as well as erosion.

Coastal transformation	Prior to the construction of the gabions, erosion was observed in the cliff area. The current erosion state is unknown.	
Coastal utilization characteristics	Beach utilization	Utilized as PB (public beach). The frequency of beach utilization is middle. The hinterland is a cemetery.	
General assessment		The previously eroded scarp has been improved with constructions. The hinterland is a cemetery. Beach user is limited. In light of these facts, the necessity of creating a protection program is considered low.

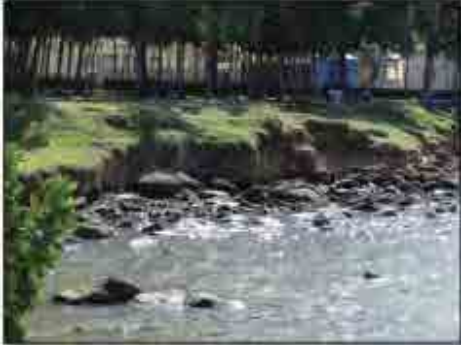
Natural and topographic characteristics	Sea state	Considerably affected by cyclonic waves The reef existing on the east side greatly contributes to attenuation of incoming waves.		
	Topography	Sand beach and gravel beach, with around 600m-wide reef existing on the east side		
Environmental characteristics	Coral reef	Coral reef coverage is 0%. According to the results of coral reef monitoring by AFRC, coral reef coverage behind the reef edge was about 60% in 2000 and have been 0% from 2009.		
	Water quality	Transparency is 1m or less, and siltation is very high. Algal coverage is 50% or more. According to the results of water quality monitoring by AFRC, contamination of water quality from textile factories had been observed until about 2003. Water quality has been being improved since then, though PO ₄ , which causes eutrophication, still remains relatively high.

Coastal transformation characteristics	Disaster and structures	-		
	Coastal transformation	The aerial photograph showed no remarkable indication of erosion. However, local erosion has caused scarps.		
Coastal utilization characteristics	Beach utilization	Utilized as PB (public beach). The frequency of beach utilization is not high. The houses are scattered at hinterland.		
General assessment		A problem is that water quality rather than coral reef is deteriorated. From the viewpoint of coastal protection, however, the necessity of creating a protection program is considered low and partial or local protection seems to be a sufficient countermeasure.

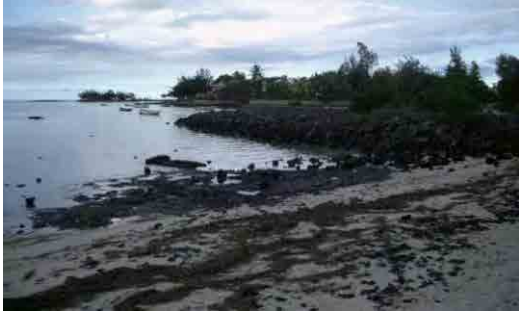
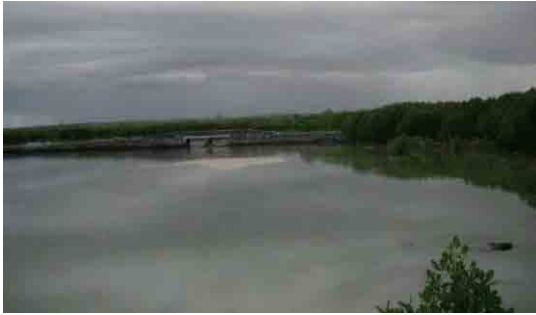
Coast photo		Damaged seawall ①	Coast photo Barachos fish farm ②

Natural and topographic characteristics	Sea state	Considerably affected by cyclonic waves The reef widely existing on the northeast side contributes to attenuation of waves.		
	Topography	Gravel beach and sand beach with around 600m-wide reef on the northeast side		
Environmental characteristics	Coral reef	Shore side is affected by fresh water, where is unsuitable for coral habitat.		
	Water quality	The hinterland is a mangrove forest and affected by fresh water. Water quality is relatively good because the houses and hotels are little and the polluting effect from hinterland is low.		
Coastal transformation characteristics	Disaster and structures	Von Molke PB: Damages (holes) are observed on the seawall. There is Barachos fish farm here.

Coastal transformation	According to the results of topographic interpretation by aerial photos, an eroding velocity of up to 23cm/year was measured at partial shoreline. As a whole, no remarkable indication of erosion was found.		
Coastal utilization characteristics	Beach utilization	Utilized as PB (public beach). The frequency of beach utilization is not high. There are residents' houses behind.		
General assessment		Though this coast is affected by cyclones, its eroding rate is relatively small due to wide reef. Damage is limited to some facilities and no facility fell down. Countermeasures and protection intended for individual facility rather than the whole coast seem sufficient. In light of these, the necessity of creating a protection program is considered low.

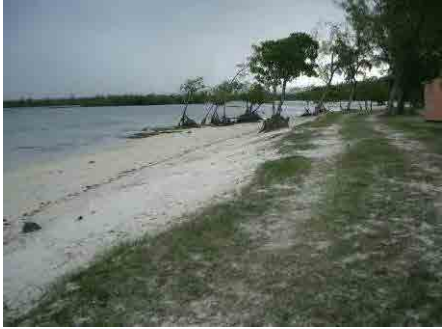
Coast photo	<p>Eroded area</p> <p>①</p>

Coastal transformation	According to the results of topographic interpretation by aerial photos, the erosion with maximum rate of 31cm/year and the sedimentation with maximum rate of 68 cm year were observed at partial shoreline. The moving forward (sedimentation) of shoreline arise from not only the alongshore sediment transport but also cross-shore sediment transport.	
Coastal utilization characteristics	Beach utilization	Utilized as PB (public beach). The frequency of beach utilization is not high. There is a coastal forest behind.	
General assessment		Although the elucidation of sedimentation mechanism is important due to the relatively-large erosion and sedimentation, there is no damage problem because the number of structures is limited. The necessity of creating a protection program is considered low. Although the coral reef is underdeveloped at the back of bay, the problem of water quality is not.

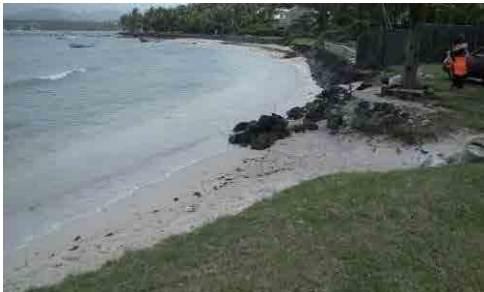
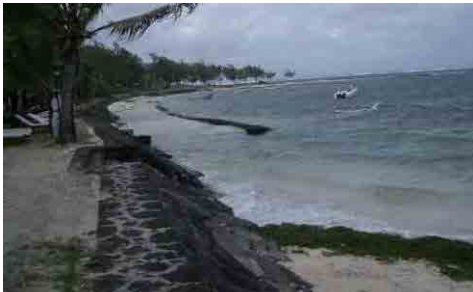
Coast photo	T.d'Eau Douce Erosion in front of the hotel	T.d'Eau Douce Short groin and wave-dissipating works

Coastal transformation characteristics	Disaster and structures	Beach shaping was implemented (in 2006, 1km) Installation of gabions and groins was implemented in La Tropical.	
	Coastal transformation	According to the results of topographic interpretation by aerial photos, the beach at Belle Mare is relatively stable. At Palmar and T.d'Eau Douce, large-scaled alongshore sediment transport has generated the remarkable eroded area (21cm/year) and sedimentation area (64cm/year).	
Coastal utilization characteristics	Beach utilization	Utilized as PB (public beach). There are hotels and residents' houses behind. The frequency of beach utilization by local residents and tourists is high.	
General assessment		Judging from the fact that some structures for controlling sediment transport such as groins have been provided, wide-scaled alongshore sediment transport has generated the remarkable eroded area and sedimentation area. The hinterland has been considerably utilized such as hotels, and the existence of the scarp can be trouble. In light of these facts, it is required to study the current situation and devise a coastal protection program as well as countermeasures based on the study results.

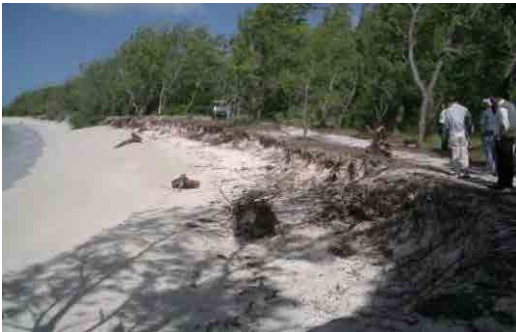
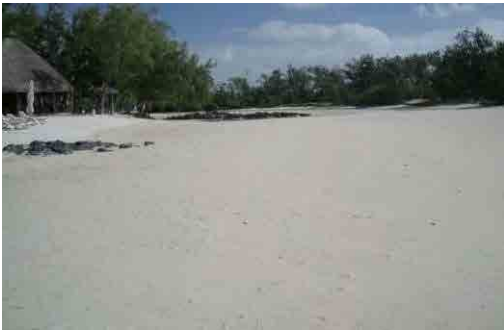
Coast photo		Alongshore eroded area	Coast photo

Natural and topographic characteristics	Sea state	Affected by waves from the east		
	Topography	Sand beach with around 1,600m-wide reef on the front. There is a waterway between the islands.		
Environmental characteristics	Coral reef	Coral reef coverage offshore waterway between the islands varies widely depending on point, in a range of 0 to 5%. Coral reef coverage around the reef edge is 50% or more and coral reef is relatively good.		
	Water quality	Offshore waterway between the islands, transparency is 3m and siltation is middle. According to the results of water quality survey by this study, turbidity and PO4-P are high in a water area between small islands (Ile aux Cerfs) and capital island lets. Offshore, water quality is relatively good.

Coastal transformation characteristics	Disaster and structures	The problems are the closed waterway between the islands and erosion along the seashore.		
	Coastal transformation	According to the results of topographic interpretation by aerial photos, only near waterway sedimentation (68 cm/year) is observed. At other coastal areas, erosion (maximum 23cm/year) is observed.		
Coastal utilization characteristics	Beach utilization	Utilized as a popular tourist spot. There are hotels and camp sites behind.		
General assessment		The closed waterway between the islands prevents tidal movement of materials, which will possibly result in some problems including deterioration of water quality. Since this coast is a popular tourist spot, coastal protection is important. Based on EIA evaluation, and monitoring, and study of the current situation, a long-term coastal protection program should be proposed.

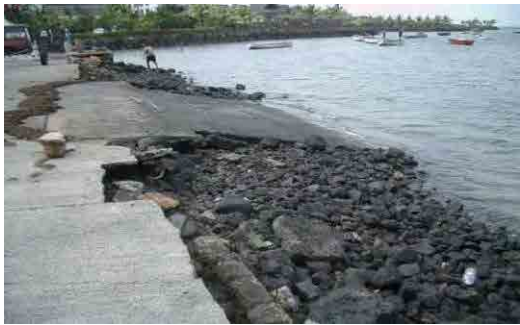
Natural and topographic characteristics	Sea state	Waves due to the trade wind are arriving from the southeast, but attenuated by reefs.					
	Topography	Gravel beach with wide reef expanding on the east front side					
Environmental characteristics	Coral reef	This coast is be subject to effects of GRSE River, where is unsuitable for coral habitat. Coral reef coverage near beach is 0%.					
	Water quality	Transparency is around 2m, and siltation is high. According to the results of water quality survey by this study, salinity is low due to effects by fresh water of GRSE River and turbidity and chlorophyll a.					
Coastal transformation characteristics	Disaster and structures	The inclined wharf was provided, but damaged.					
	Coastal transformation	The aerial photograph showed no remarkable indication of erosion.

Coastal utilization characteristics	Beach utilization	Utilized mainly as inclined wharf					
General assessment		Since there are a few topographic data, numerical data on coastal transformation is not available. This coast is utilized as inclined wharf rather than beach, and the importance and potential for development of the hinterland are found low. In light of these facts, the necessity of creating a coastal protection program is considered low.

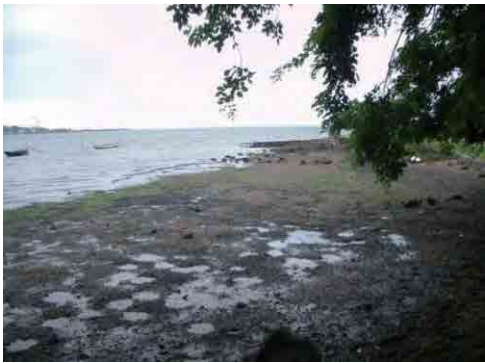
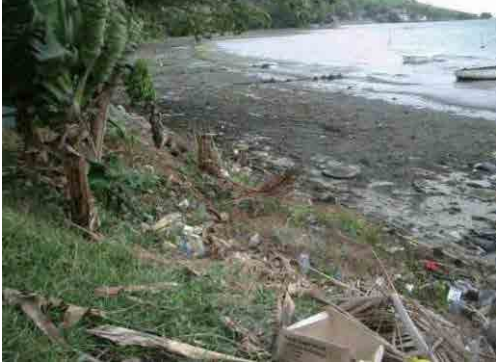
Coast photo Coast situation				Coast photo Coast situation

Natural and topographic characteristics	Sea state	Waves due to monsoon are arriving from the south, but attenuated by wide reef (around 2km-wide).					
	Topography	Reef attenuates waves in a wide area with 5km-wide, leading to silt sedimentation. Especially in the wide reef in the southeast area, there are native mangroves. There are some gravel beaches. The medium diameter of sea bed material (under water) is within a range of 0.5 mm to 0.7 mm. The medium diameter from beach berm is around 8 mm partially.					
Environmental characteristics	Coral reef	The back of the bay is affected by river (fresh water), where is unsuitable for coral habitat and seaweeds flourish. Coral reef coverage near beach is 0%.					
	Water quality	Transparency is 1m or less, and siltation is very high. The hinterland (beach berm) is a mangrove forest. Water quality at the back of the bay is affected by fresh water and is polluted due to the domestic wastewater.

Coastal transformation characteristics	Disaster and structures	Since waves are attenuated, no damaged structure is observed. The impact to hinterland by storm surge is concerned.					
	Coastal transformation	The results of the analysis through the aerial photograph and field work show this coast is stable.					
Coastal utilization characteristics	Beach utilization	A coast road was built and has been fully utilized as a community road. The importance of this coast seems high.					
General assessment		Since the widely used road was built at a low altitude, countermeasures against overtopping waves are required. A protection program such as bank raising of road and construction of seawall (revetment) should be considered.

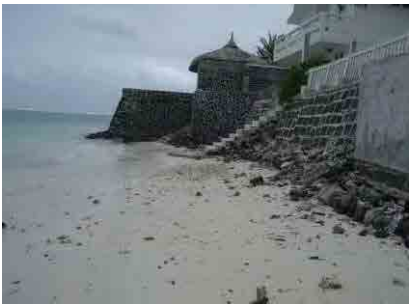
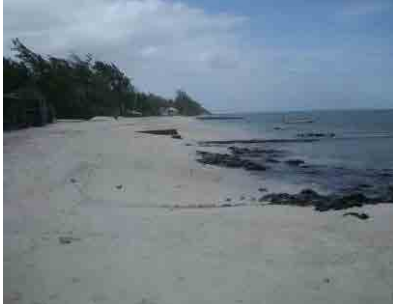
Coast photo Seawall in the eroded area		Coast photo Groins and rocky shore

Natural and topographic characteristics	Sea state	Overtopping waves are arriving from the south Alongshore current to the north caused by reef	
	Topography	The width of reef at the north side is within a range of 0.5km to 2km, wide compared to the south side. Littoral drift sand to the north is predominant due to the topographic characteristics. The slope of beach berm is within a range of 1/8 to 1/10. The height of beach berm is around 2m. The grain size of sea bed material with 0.3 mm of medium diameter is fine relative to the other beaches.	
Environmental characteristics	Coral reef	Coral reef coverage near the beach is around 1%. Coral reef coverage near the reef edge is around 70% and coral reef is relatively good.

Water quality	Transparency is 10 to 15m, and siltation is little. Water quality is relatively good due to little pollution load from river, compared to Blue Bay	
Coastal transformation characteristics	Disaster and structures	Several groins have been installed. There are damages on the seawall and groins. At a high tide time, overtopping waves caused damages in the cottage area. Some groins were removed (in 2008).	
	Coastal transformation	Erosion due to alongshore sediment transport is observed. According to the results of the analysis through the aerial photograph, the sedimentation area at north side is 40cm/year (shoreline advance) and the erosion area at south side is 31cm/year (shoreline recession).	
Coastal utilization characteristics	Beach utilization	The hinterland has been utilized as a cottage area for a long time. Besides, the beach is actively utilized as a bathing beach or mooring spot, for example.

General assessment		The convex shape causes alongshore current over the reef to the north as well as coastal transformation. Though a groin removal plan is under consideration, it is important to reach mutual agreement on the personal right of cottage owners and stability of the entire coast. Further study should be carried out and the coastal protection program should be devised because of difficult mechanism for sediment transport.

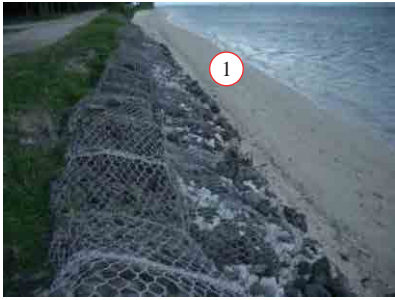
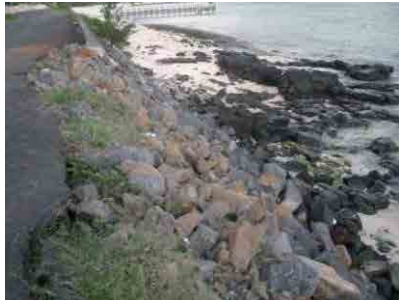
Coast photo	Partially damaged Riambel gabion	Coast photo	Partially damaged seawall

Coastal transformation characteristics	Disaster and structures	Riviere des Galets: The seawall has been often restored with gabions. (A 800m-wide seawall was built in 1995 with its 215m-wide part restored in 2003 and 104m-wide part restored in 2011)	
	Coastal transformation	According to the results of topographic interpretation by aerial photos, an eroding velocity of up to 23cm/year was measured at partial shoreline. As a whole, no remarkable indication of erosion was found.	
Coastal utilization characteristics	Beach utilization	Utilized as PB (public beach). The frequency of beach utilization is not high. There are a coast road and houses behind.	
General assessment		Though gabions are damaged, the damage is limited to the expected degree. There is no important facility in the hinterland, and erosion degree is very small with an eroding velocity of 8cm/year. In light of these facts, the necessity of creating a protection program is considered low.

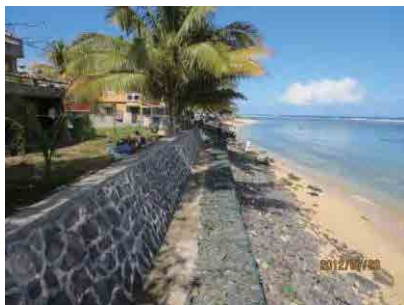
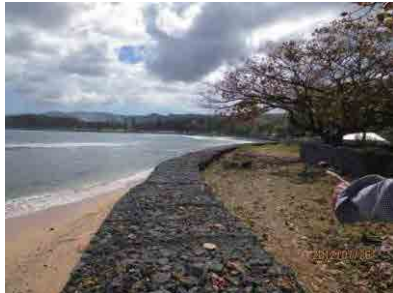
Natural and topographic characteristics	Sea state	Located on the south side of the island, and affected by waves from the south and southwest.		
	Topography	Sand beach with around 500m-wide reef on the south side.		
Environmental characteristics	Coral reef	Near beach, seaweeds flourish and coral reef coverage is 0%. Coral reef coverage behind reef edge is 20%. According to the results of coral reef monitoring by AFRC, coral reef coverage varies widely depending on year and does not show the distinct decline trend from 2000 to 2010.		
	Water quality	Near beach, transparency is 5m and siltation is low. According to the results of water quality monitoring by this study, water quality parameters above the environmental standards (standards for type A1 sea areas) in Mauritius was observed and water quality is relatively good.

Coastal transformation characteristics	Disaster and structures	The seawall has been continuously constructed while groins, detached breakwaters (or similarly shaped structures) and piers are observed in some places.		
	Coastal transformation	According to the results of topographic interpretation by aerial photos, coastal erosion with (14cm/year) has been observed at west side.		
Coastal utilization characteristics	Beach utilization	Utilized for the hotel. The frequency of beach utilization is relatively high.		
General assessment		Coral reef is on the verge of a crisis and still expanding erosion is observed. In front of hotel, the seawall and jetty have been constructed by the hotel. The broad-based protection program should be devised for this coast, because some structure has a potential to foster the coastal erosion and the projection of hotel facility might be implemented.

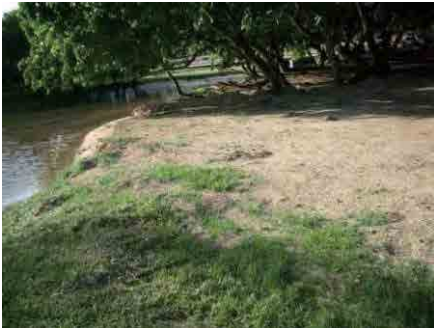
Natural and topographic characteristics	Sea state	Low-altitude beach located on the south side of the island, and affected by waves from the south and southwest		
	Topography	A narrow sand beach with reef at the front south side, of which width is unknown because of unclear edges		
Environmental characteristics	Coral reef	Coral reef coverage near beach is 30 to 50% and coral reef is relatively good.		
	Water quality	Transparency near beach is 10 to 15m and siltation is low. Though three rivers including Baie du Cap River inflow, water quality is relatively good due to small river flow.		
Coastal transformation characteristics	Disaster and structures	Though a seawall was constructed, it is small and no damage has been observed. However, the partial beach has a problem with inundation in the coastal lower area due to insufficient drainage.

Coastal transformation	According to the aerial photograph and the result of field work, though slight erosion was observed on the Village coast road, no erosion was observed as a whole.		
Coastal utilization characteristics	Beach utilization	Utilized as PB (public beach) and for a coast road, but the frequency of beach utilization is not high.		
General assessment		As for this beach, the good conditions keep into place. As a whole, the necessity of devising a protection program is considered low because significant erosion has not been observed and important facility at hinterland is little.

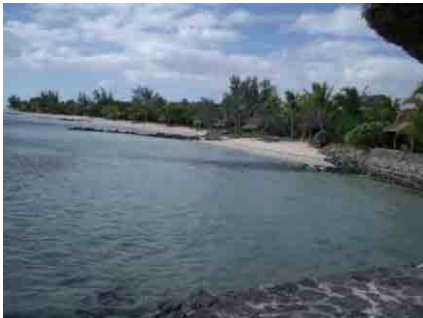
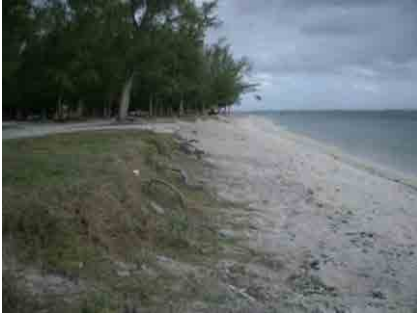
Coast photo		Erosion near the groin for the hotel	Coast photo

Natural and topographic characteristics	Sea state	Located at the edge of the southwest and affected by waves from the southwest		
	Topography	Sand beach with around 650 to 900m-wide reef on the front Convex sand beach. The slope of beach berm is around 1/8. The medium diameter of sea bed material within coral reef is around 0.6 mm and that near the coral reef edge is coarse slightly. .		
Environmental characteristics	Coral reef	Behind reef edge, coral reef coverage is 0% and algal coverage is 20%. According to the results of coral reef monitoring at Ile aux Benitiers by AFRC, it gathers that coral reef coverage near reef edge is on a declining trend from 2000 to 2010.		
	Water quality	Transparency is 15m and siltation is little. Seawater exchange with open sea is active due to the strong wave and wind and water quality is relatively good.

Coastal transformation characteristics	Disaster and structures	Damaged by Cyclone Caro (in 1960) Even now, scarps are observed. .		
	Coastal transformation	According to the results of topographic interpretation by aerial photos, a lot of places are on a sedimentation trend and this beach is regarded as stable. At the north side of a groin near Paradis Hotel, coastal erosion with erosion rate of 25 cm/year occurs. Further, the results of the field work show scarps are observed in PB and Le Morne Village.		
Coastal utilization characteristics	Beach utilization	Utilized as PB (public beach), where the hotel and guest house are available. Also this coast is famous for kite surfing and a good coast road is provided.		
General assessment		As a whole, though this beach is on a stable trend, erosion occurs in some place due to the construction of training wall. The protection program by the non-physical measures including maintenance management plan should be considered. Further special attention should be considered because of active utilization of the beach as well as the hinterland.

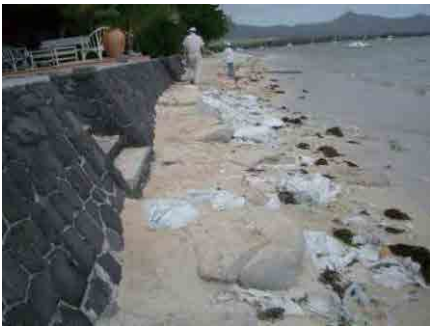
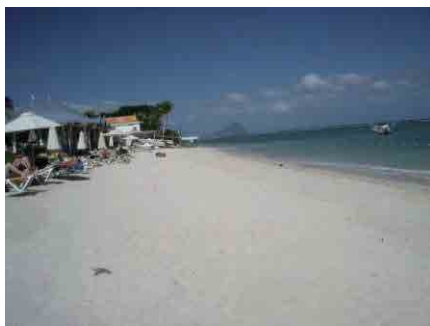
Coast photo		Condition of Preneuse seawall		Coast photo

Natural and topographic characteristics	Sea state	Located at the west side of the island and affected by waves from the west as well as cyclones		
	Topography	Convex sand beach with around 500m-wide reef on the front. The slope of beach berm is within a range of 1/8 to 1/10 and the grain size of sea bed material with 0.3 mm of medium diameter is fine relative to the other beaches.		
Environmental characteristics	Coral reef	Coral reef coverage ranges from 1 to 30%. The coverage tends to become lower near the river-mouth (Black River, Grand River Noire).		
	Water quality	Transparency is 2.5 to 8m. Siltation is high at Preneuse and low at Tamarin and Flic en Flac. According to the results of water quality monitoring by AFRC, water quality at Tamarin and Flic en Flac is relatively good. Meanwhile, water quality at Preneuse is affected by Black River and is polluted.

Coastal transformation characteristics	Disaster and structures	Gabions (in 1995, a total length of 700m), groins (in 1995, 10 units), removal of the seawall (in 2007), implementation of sand bypass (in 2008), and removal of the gabions (in 2008)		
	Coastal transformation	According to the results of topographic interpretation by aerial photos, the south side of the Pearle Beach is stable. But the north side is erosion area with erosion rate of 12cm/year and scarps are observed in Manisa PB. In the area extending from Manisa to Villas Caroline, sand spit at the north end is on a sedimentation trend with a rate of 48 cm//year is. It seems that scarps easily occur on this coast. In the case of the cyclone in January 2013, a scarp of around 1.5m occurred.		
Coastal utilization characteristics	Beach utilization	Utilized as PB (public beach) as well as hotel's private beach. Most of the hinterland is a tourist spot where restaurants and shops are located. At its inland side, there are houses.

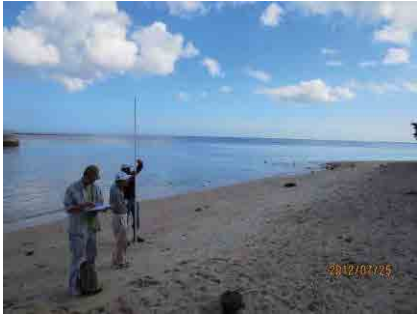
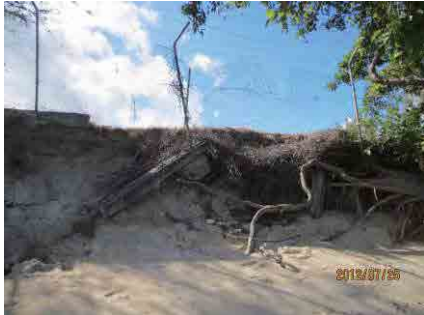
Coast photo		Albion sand beach		Coast photo

Natural and topographic characteristics	Sea state	Located at the west side of the island, and affected by waves from the west as well as cyclones		
	Topography	Pocket beach with around 400m-wide reef on the front. Reef width is narrow compared with Le Morne, Flic en Flac and Pointe D' Esny. The medium diameters is around 1 mm and coarse relative to the other beaches		
Environmental characteristics	Coral reef	Coral reef coverage ranges from 2 to 33%, and it tends to become lower near the coast line. According to the results of coral reef monitoring by AFRC, coral reef coverage around the reef edge from 2000 to 2010 has been decline from 60% to 0%.		
	Water quality	Transparency is 3m, and siltation is low. Though water quality has been relatively good, PO4-P and fecal coliform bacteria above the environmental standards in Mauritius is detected, and water pollution is advancing. This coast is subject to coral bleaching because of the increased water temperature in the lagoon which is very shallow.

Coastal transformation characteristics	Disaster and structures	Small retaining walls and fences have been installed, but some of which were damaged by scarps.		
	Coastal transformation	As a whole, this coast is an eroded area with a rate of 31 to 49cm/year. Though PB (public beach) is stable, erosion at the front side of AFRC and scarps (1 to 2m) were observed between 2007 and 2008.		
Coastal utilization characteristics	Beach utilization	Utilized as PB (public beach), where Albion Laboratory (AFRC) is located. A hotel was built at the south end (in 2008).		
General assessment		Since this coast is an eroded area as a whole, there is a fear that coral reef will be deteriorated. In light of the existence of scarps on the front of the laboratory and damaged fences, a protection program should be devised.

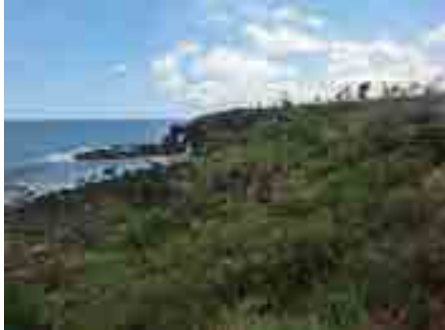
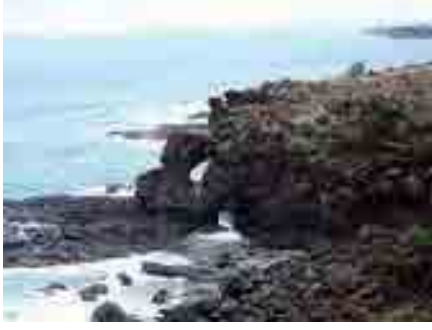
Coast photo		Coast photo Condition of the cliff coast

Natural and topographic characteristics	Sea state	Located at the west side of the island, and affected by waves from the west as well as cyclones		
	Topography	A coast consisting of rocky shore and beach rocks There are sand beaches, but a few, at the north side.		
Environmental characteristics	Coral reef	It is assumed that the coral reef is in a relatively good condition, but the actual condition has not been investigated.		
	Water quality	Coral reef is inexistent offshore. Coastal water is affected strongly by open sea, and water quality is relatively good.		
Coastal transformation characteristics	Disaster and structures	Unknown		
	Coastal transformation	This coast consists of rocky shore and beach rocks, without any remarkable transformation observed. Slope failure occurs partially.

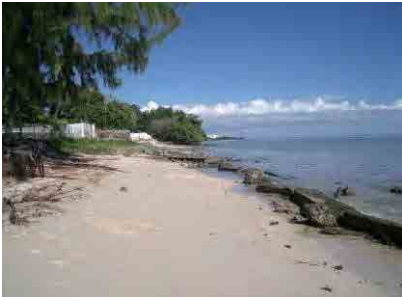
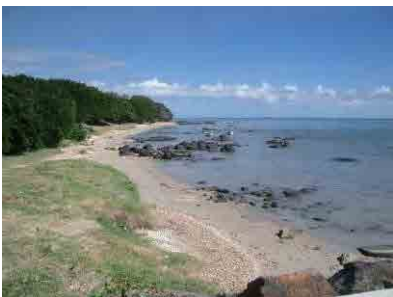
Coast photo Erosion condition at the west side				Coast photo Sedimentation condition at the east side

Natural and topographic characteristics	Sea state		Located at the west side of the island Slightly facing to the north, and affected by cyclones				
	Topography		Sand beach with rocky shore in some places Around 800m-wide reef at the north side				
Environmental characteristics	Coral reef		Coral reef coverage is 7% around fore reef and 1% within reef. According to the results of coral reef monitoring by AFRC, coral reef coverage around the reef edge from 2000 to 2010 has been decline from 60% to 0%.				
	Water quality		Transparency is 3m, and siltation is high. Water quality is affected by Grand North West River. According to the results of water quality monitoring by this study, turbidity and chlorophyll a are very high and water pollution is advancing due to domestic pollution load.

Coastal transformation characteristics	Disaster and structures		A masonry seawall was installed (in 2010, 241m). The seawall normal at the front side of the leased premises is irregular.				
	Coastal transformation		Remarkable alongshore sediment transport is observed at the east side. A sand beach width is narrow at the west side and wide at the east side. According to the results of topographic interpretation by aerial photos, sedimentation with a rate of up to 62cm/year is observed at the east side. At the west side, alongshore sediment transport has caused erosion with a velocity of 32cm/year.				
Coastal utilization characteristics	Beach utilization		Utilized as a beach, where some pleasure boats are found.				
General assessment			The downstream side of the seawall constructed by Mauritian government is on an erosion trend. It is necessary to formulate a protection program taking into account the impact of upstream side at the seawall and the impact of itself. As for the formulation of protection program, the priority for urgency and necessity is high due to land outflow and expanding of erosion area at downstream side. Coral reef and water quality are on a declining trend.

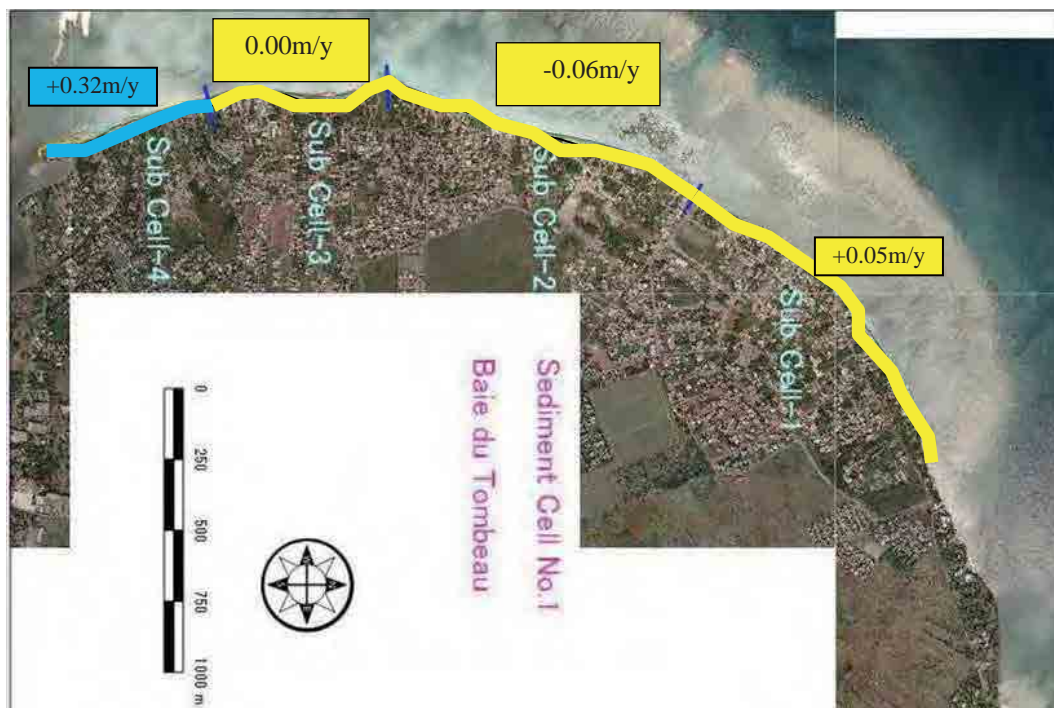
Figure 3.1.2 Regulation map of land-use (Plan) (Baie du Tombeau)

According to Volume 1 Section 5.3.2_C, three area such as erosion area, potential risk area of erosion and accumulation area are set up and classified considering beach erosion rate in past. Figure 3.1.2 shows regulation map of land use for this beach. Erosion and accumulation area are intermixed in this beach. This beach consists of potential risk area (-0.06 m/y - +0.01 m/y at Sub-cell- 2 and Sub-cell-3) and accumulation area at other areas. The accumulation is remarkable at Suc-cell-4 of south part of the beach. It is necessary to carry out continuous monitoring and to understand tendency of erosion at potential risk area. In addition, it is necessary to carry out periodic monitoring at the whole area of the beach because there is some possibility of reuse of sand from Sub-cell-4 at accumulated area to eroded area.

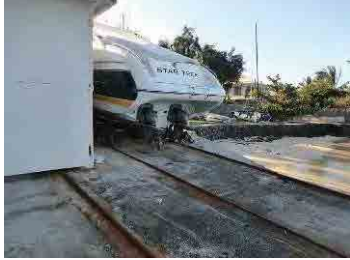
<p>Slipway for private leisure boat on the beach(2)</p>

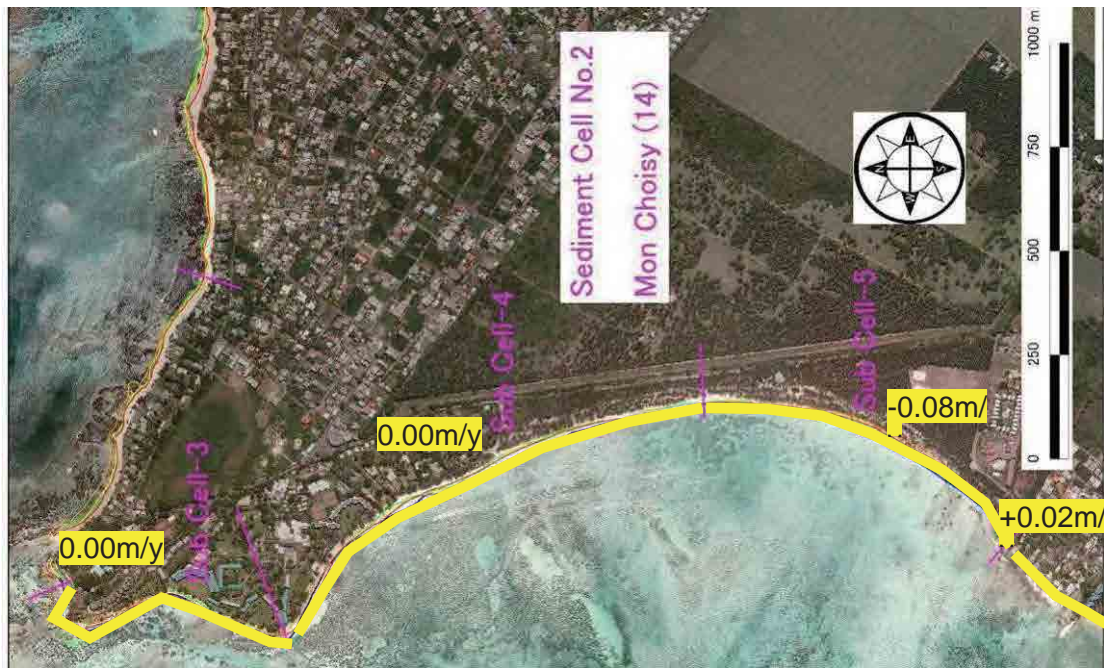
Figure 3.3.1 Regulation map of land-use (Plan)(Mon Choisy)

According to Volume 1 Section 5.3.2_C, three area such as erosion area, potential risk area of erosion and accumulation area are set up and classified considering beach erosion rate in past. Figure 3.3.1 shows regulation map of land use for this beach. This beach belong to potential risk area because erosion speed is between -0.08 and $+0.02$ m/year at whole area. It is necessary to carry out continuous monitoring and to understand a mid-and long-term tendency of erosion. The review of setback line is also required at leased areas during a renewal of contract.

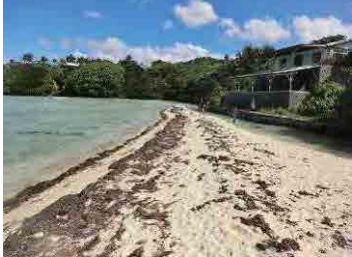
<p data-bbox="284 1697 646 1798">The sand spit at the west end of this beach. The sand accumulates on the west of sand spit and the shallow area exists.</p>

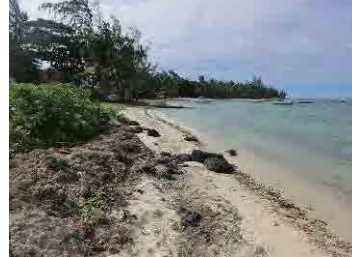
<p data-bbox="1038 1697 1401 1798">Large volume of sea grass and rubbish accumulate on the beach. Cleaning may not be done for a long time.</p>

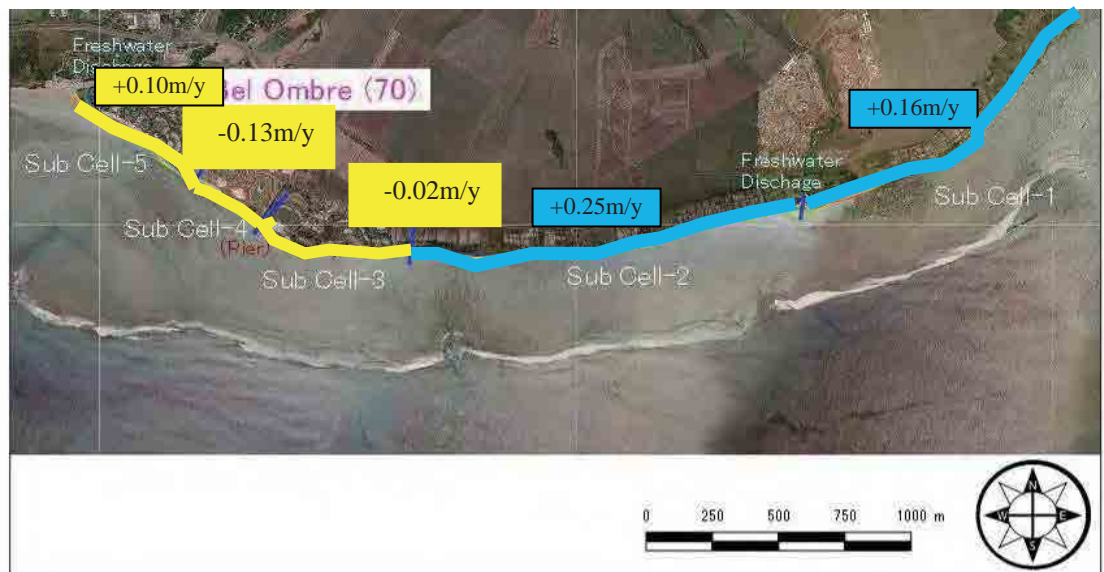
Figure 3.8.1 Regulation map of land-use (Plan) (Bel Ombre)

According to Volume 1 Section 5.3.2_C, three area such as erosion area, potential risk area of erosion and accumulation area are set up and classified considering beach erosion rate in past. Figure 3.8.1 shows regulation map of land use for this beach. The beach shows tendency of accumulation on erosion on the east side. The erosion rate is -0.02 to $+0.10$ m/y on the west side as potential risk area. It is necessary to carry out continuous monitoring and to understand tendency of erosion at potential risk area.

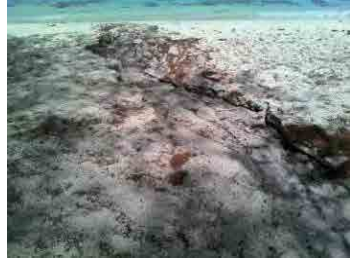
<p>⑧ Scouring at public beach due to rainwater discharging</p>

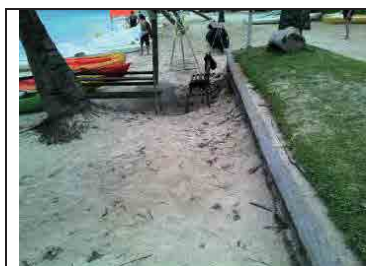
Trees and flower bed on foreshore and backshore
