**THE PROJECT FOR CAPACITY
DEVELOPMENT ON COASTAL
PROTECTION AND REHABILITATION
IN THE REPUBLIC OF MAURITIUS**

**FINAL REPORT
SUPPORTING REPORT**

JAPAN INTERNATIONAL COOPERATION AGENCY

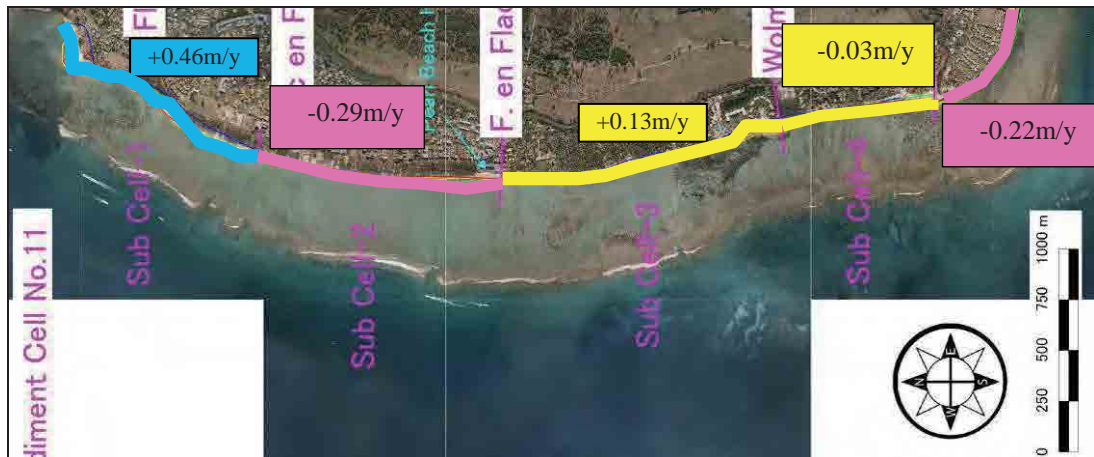
Figure 3.10.1 Regulation map of land-use (Plan) (Flic en Flac)

According to Volume 1 Section 5.3.2_C, three area such as erosion area, potential risk area of erosion and accumulation area are set up and classified considering beach erosion rate in past. Figure 3.10.1 shows regulation map of land-use for this beach. Erosion area and accumulation area are intermixed in this beach. The beach consists of potential risk area (-0.03 and +0.13 m/y) at Sub-cell-3 and 4 and erosion area (-0.22 and +0.29 m/s) at Sub-cell-2 and 5. It is necessary to carry out continuous monitoring and to understand tendency of erosion at potential risk area and to implement the short-term and mid-and- long term conservation measures at erosion area.

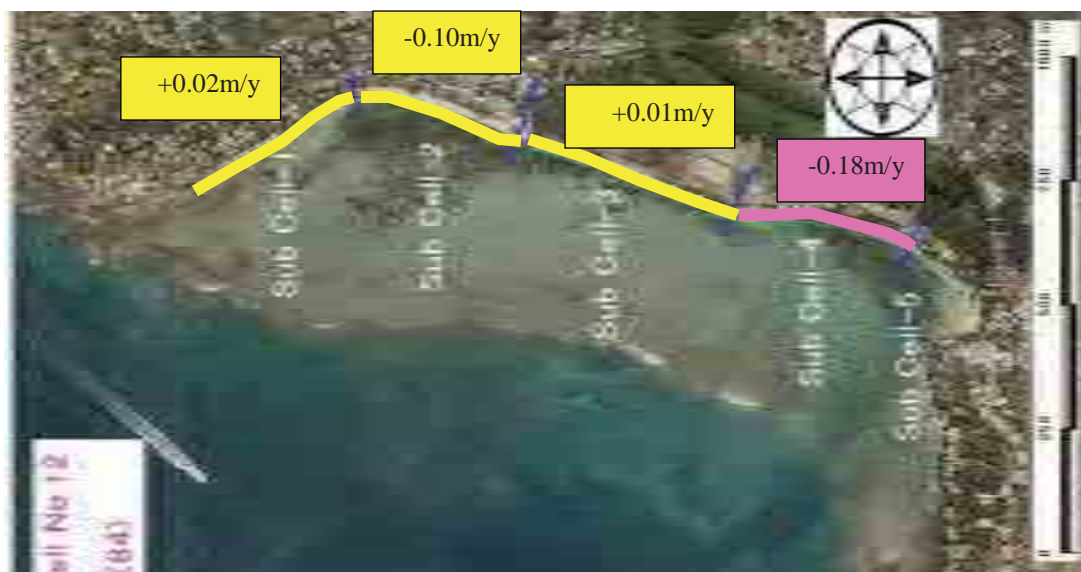
Figure 3.11.1 Regulation map of land-use (Plan) (Albion)

According to Volume 1 Section 5.3.2_C, three area such as erosion area, potential risk area of erosion and accumulation area are set up and classified considering beach erosion rate in past. Figure 3.11.1 shows regulation map of land-use for this beach. The beach shows tendency of erosion over almost the whole area. This beach consists of potential risk area (between -0.10 to +0.02 m/y at Sub-cell-1 to 3 and erosion area (-0.18m/y at Sub-cell-4). It is necessary to carry out continuous monitoring and to understand tendency of erosion at potential risk area and to implement short-term, and mid- and long- term beach conservation measures at erosion area.

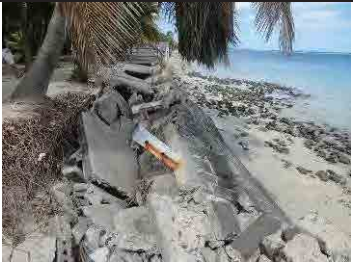
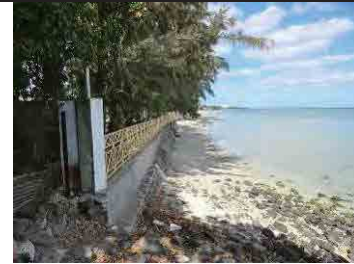
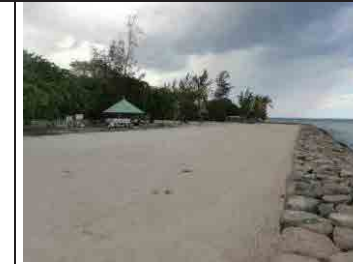
<p>Collapse of vertical revetment at eroded area on the west side of the beach</p>	<p>Vertical revetment at eroded area on the west side of the beach</p>	<p>Revetment was constructed at approx. 30 m offshore from the existing beach and sand was backfilled between them in the public beach</p>

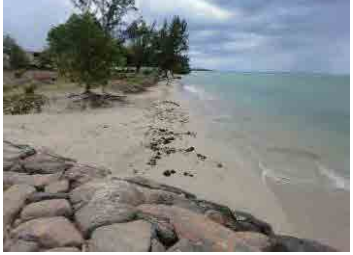
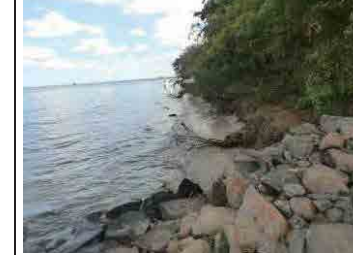
<p>The beach on the west side of public beach shows tendency of accumulation</p>	<p>Masonry revetment was constructed on the east side of public beach due to erosion</p>	<p>The erosion is going on at the down-drift of the guest house.</p>

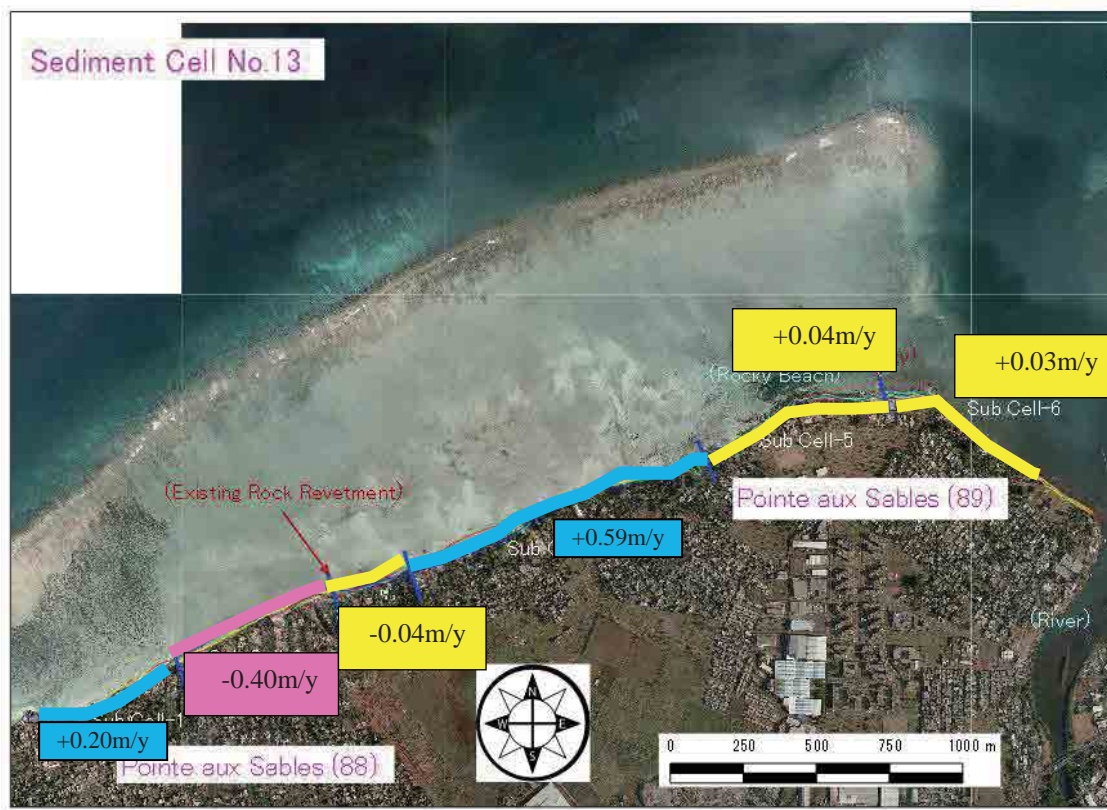
Figure 3.12.1 Regulation map of land-use (Plan) (Pte. aux Sables)

According to Volume 1 Section 5.3.2_C, three area such as erosion area, potential risk area of erosion and accumulation area are set up and classified considering beach erosion rate in past. Figure 3.12.1 shows regulation map of land use for this beach. Erosion area and accumulation area are (inter)mixed in this beach. This beach consists of potential risk area (between -0.04 and +0.04 m/y at Sub-cell-3, 5 and 6) and erosion area (-0.40m/y at Sub-cell-2). It is necessary to carry out continuous monitoring and to understand tendency of erosion at potential risk area and to implement the short-term, and mid- and long- term beach conservation measures at erosion area. In addition, it is necessary to carry out periodic monitoring at the whole sea area because there is a possibility that sand of Sub-cell-4(accumulated area) will be reused in the eroded area.

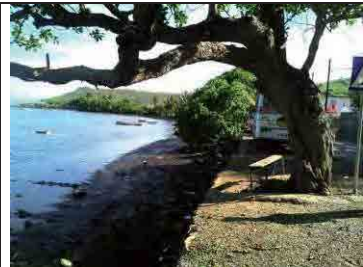
<p>Present condition of the candidate site</p>	<p>A lot of wastes and seaweeds are deposited on the beach</p>	<p>A lot of wastes and tires are deposited on the beach. They are given off a bad smell.</p>

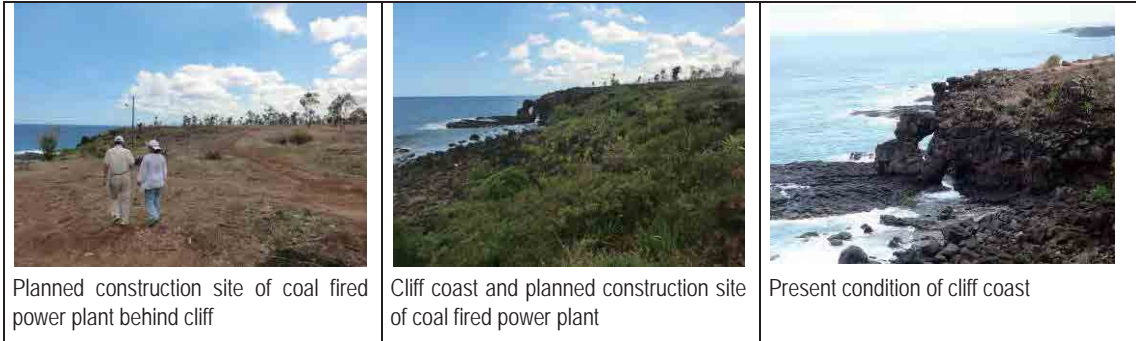
It is necessary to set up setback line for important facilities such as public facilities, power generation facility, etc, in consideration of long-term cliff coast erosion and slope failure. The minimum setback line is set up at line of 45 degree as angle of rupture from slope area as shown in the schematic diagram above.

Minimum Setback line = Slope area + Horizontal area (Considering 45 degree as angle of rupture) + 5m

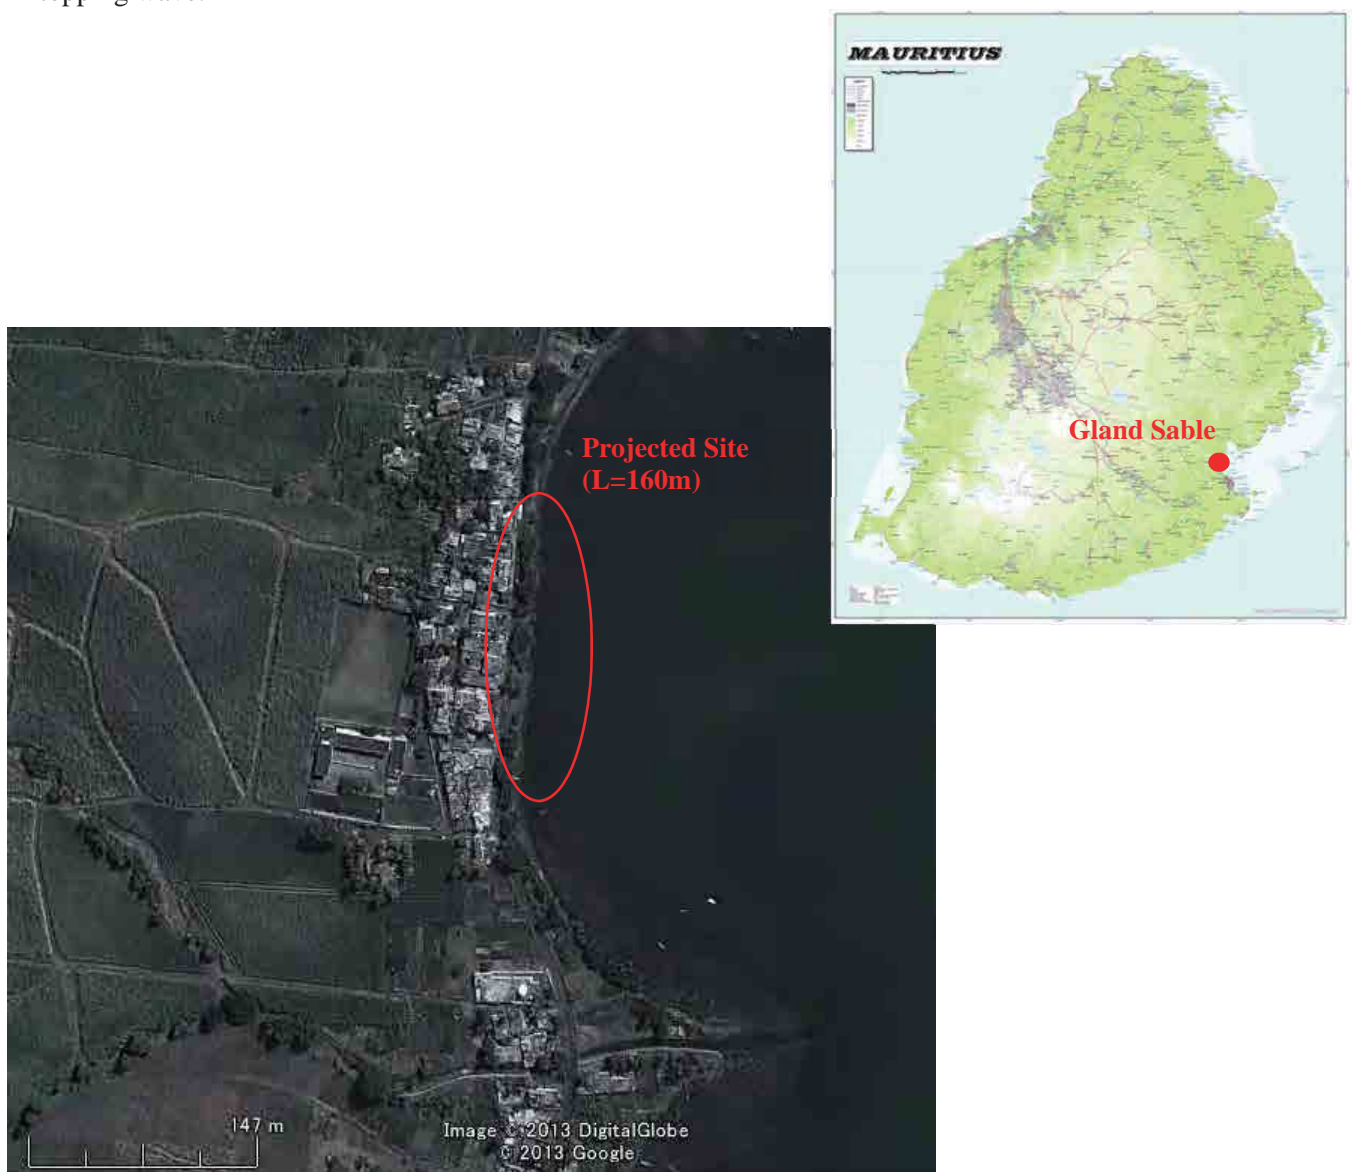
Figure 3-1 Location of the Projected Site

The site is located on Grand Sable as a part of the whole coastal area. Since the construction of the revetment is in the coast, no private properties will be involved with the settlement, whereas construction activity may temporarily affect surrounding areas of the construction site. Limitation of the construction area on the land side would be defined as the boarder of the road adjacent to the projected coast, while the offshore side can be identified the end edge of the slope planned as approximately 30m from the top of the revetment.

Based on the current coastal condition having comparatively gentle slope on the beach, length of the revetment is designed as 150m, where the area having high risk of natural disaster including over topping wave.

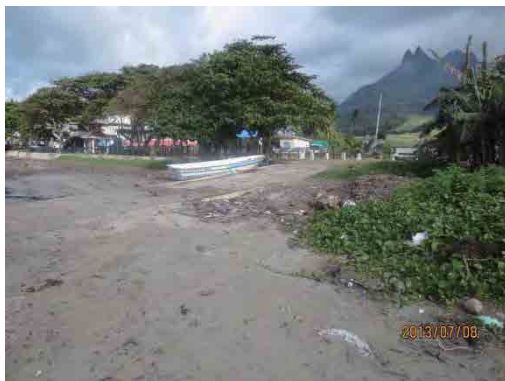
Figure-4.1 public coastal park, a wharf

- At the site, there is a public beach, slipway for a fishing boat, and 8 drainage channels in the future development area.
- Fishermen routinely use the beach to collect clams and other shellfish.
- Coastal erosion has occurred between the road and the seashore, and the seawall has been repaired with old tires.
- Existing bus stop and vehicles stopping lane are protruded into the coast so that the existing seawall is not straightly aligned.
- Elevation of the area behind the existing seawall is between 2.5 m and 1.5 m.

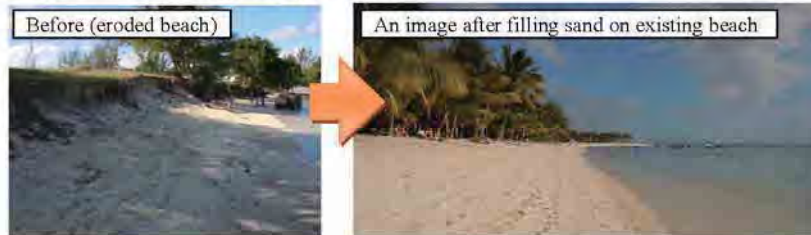
1. Beach nourishment (sand / gravel filling)

Advantage : Natural beach conditions in environment and utilization are maintained.

Disadvantage : Periodic maintenance would be needed if the filled materials are unstable.

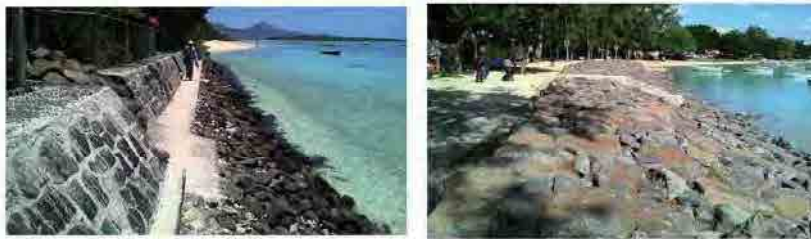
2. Seawalls, Revetments (concrete or rocks): Prevention of beach erosion and wave overtopping

Advantage : More stable against coastal disaster.

Disadvantage : It could waste the natural environment of beach and be obstacles for beach use.
