The Project for Improvement of Road Technology in Disaster Affected Area in Myanmar

Completion Report on Pilot Project (Phase II -2) Behavior Observation Work for High Embankment at Kywe Chan Ye Kyaw Bridge Approach Road

**Japan International Cooperation Agency
(JICA)**

**Pegasus Engineering Corporation
Oriental Consultants Global Co., Ltd.**

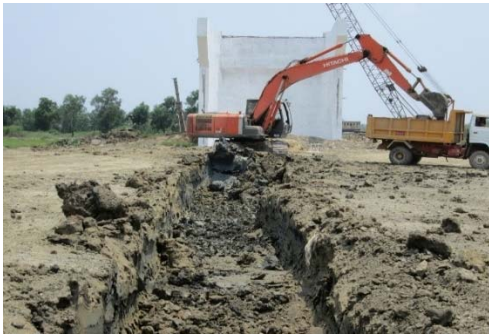
Photo 5 Excavation of Existing road

- a) Removal of original road embankment with around 1.5 meter height and 5 meter width
- b) Removal of bottom sludge in the side canal

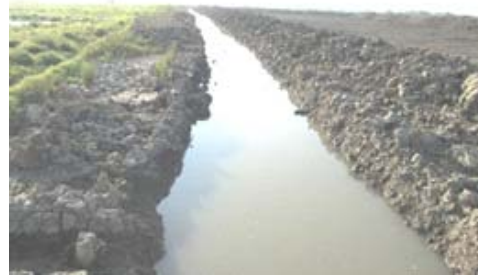
Photo 6 Existed canal along road

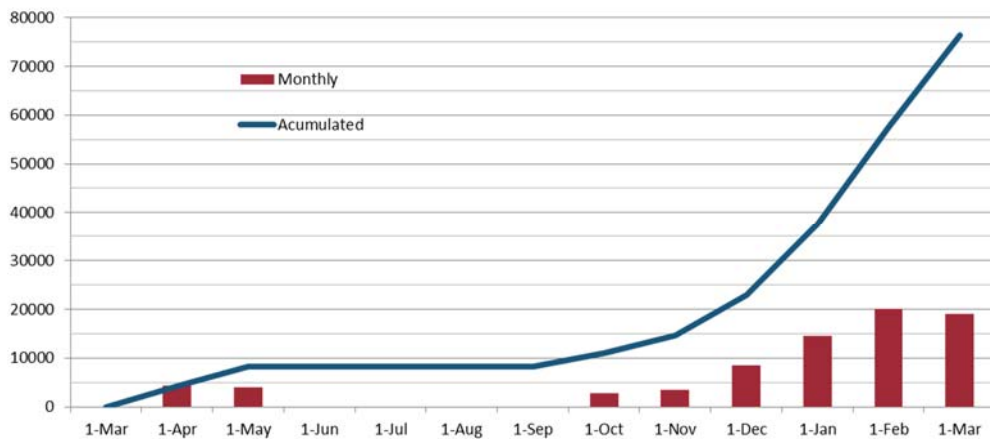
Embankment work was started from March 2014 and suspended at the height of 0.9 meters during the rainy season between June 2014 and December 2014. The work re-started from January 2015 and completed in end of April 2015.

Fig 8 Construction Schedule (Earth work) As of March 2014

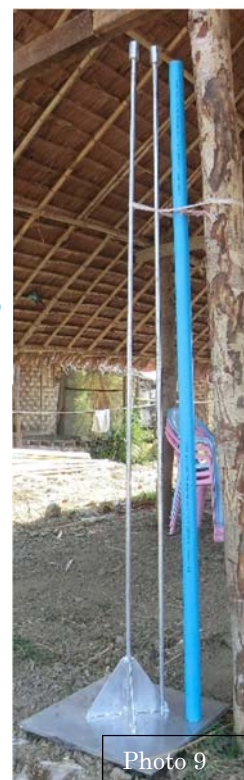
6 settlement-boards were set on the location of road shoulders with the interval of 50 meters. On the processing of embankment work, the center steel rods and cover PVC pipes were extended.

bending of the center rods by the horizontal pressure due to the embankment heavy equipment.

Measurement of level height of the rod top was done by survey equipment.

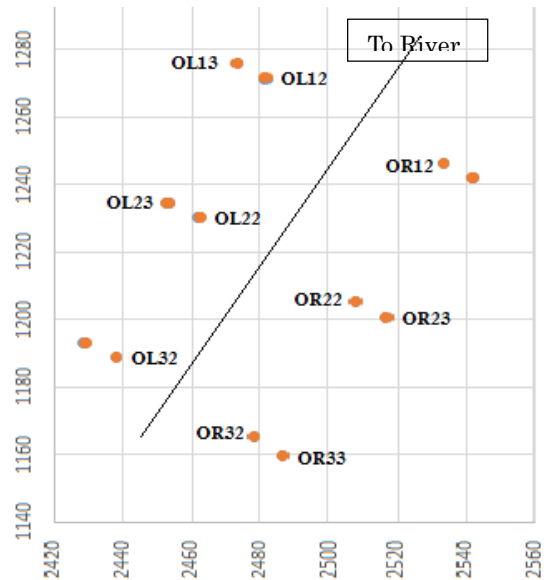
Fig 10 Arrangement of Survey Pegs

Considering the rotting during the survey period, 12 Plastic pegs were installed at the both side of embankment. Half of them were in toe positions of embankment and half were 10 m from the toe line.

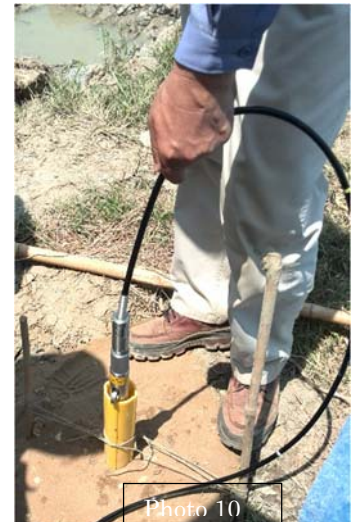
4-inclinometer guide pipes were installed at the toe position of embankment. Inclinator will show the horizontal movement of the ground on the assumption that the bottom of the guide pipe is placed on the stable soil stratum and it should be a fixed point. The lateral movement will be calculated by measuring the inclination of each depth. Measurement was done at 0.5 meter interval during inserting and extracting the inclinometer. The data will be collected in data logger.

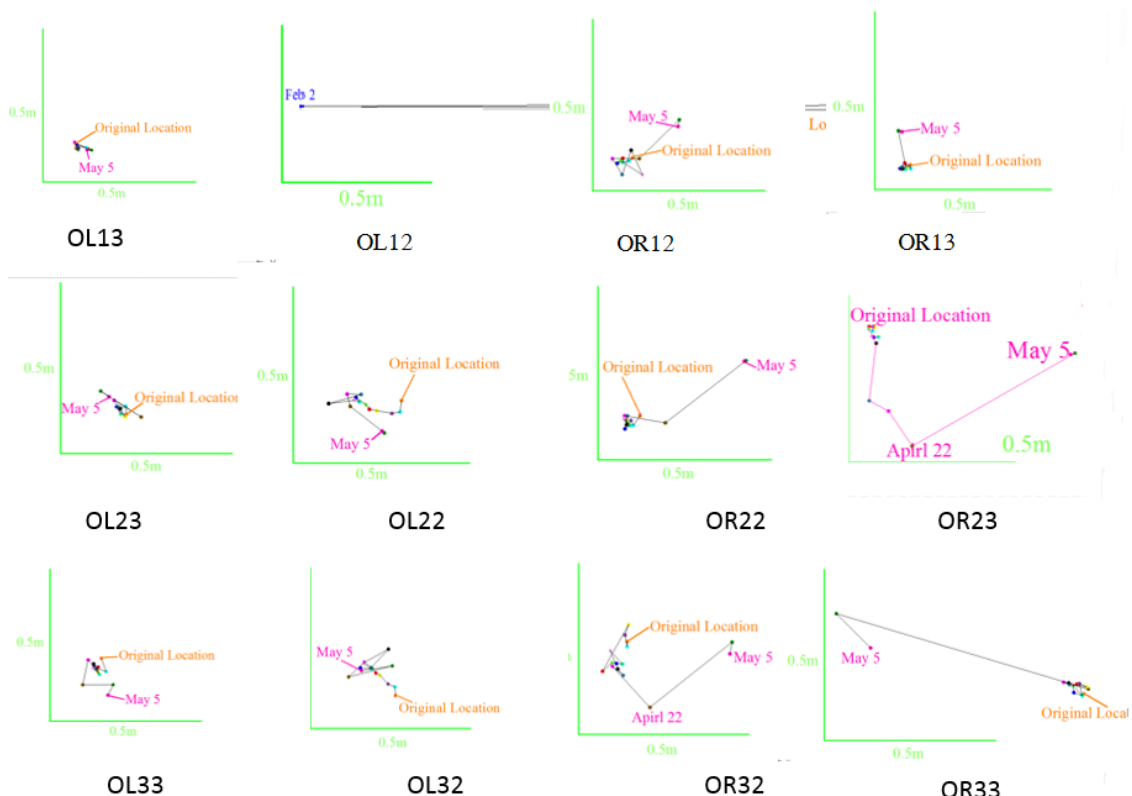
Fig 13 Horizontal Movement of survey Peg

The maximum distance of the movement is around 0.6 m at Peg R23 during latest 2 weeks between April and May. It is after the completion of embankment. There is no dangerous phenomenon in spite of such big movement results. Some of the movement distance and the speed was not seem to a reasonable value since the embankment itself is in stable conditions.

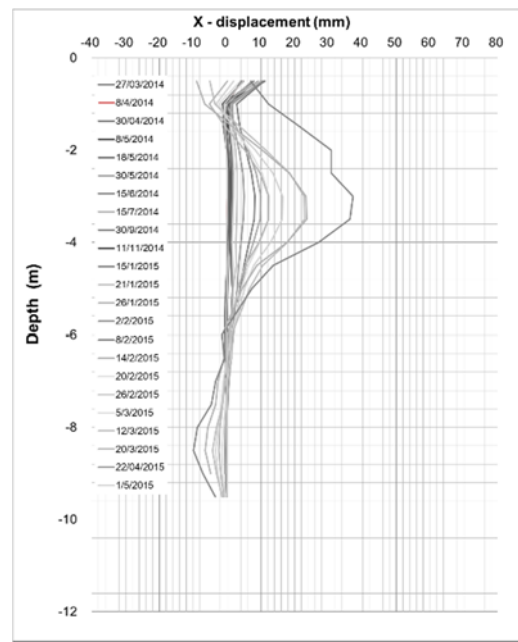
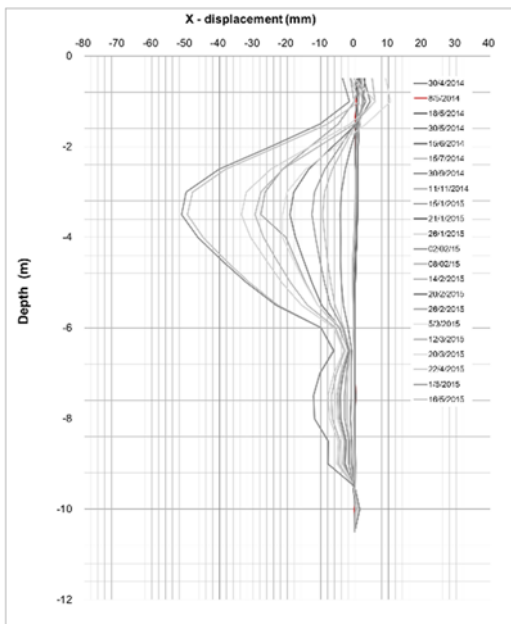
Fig 15 Lateral Movement of underground

The data shows the maximum movement (around 5 cm) occurred in the depth of 3-3.5 meters. However, the movement of the ground surface is just a few mm. It is different from the data by Three-D survey results.

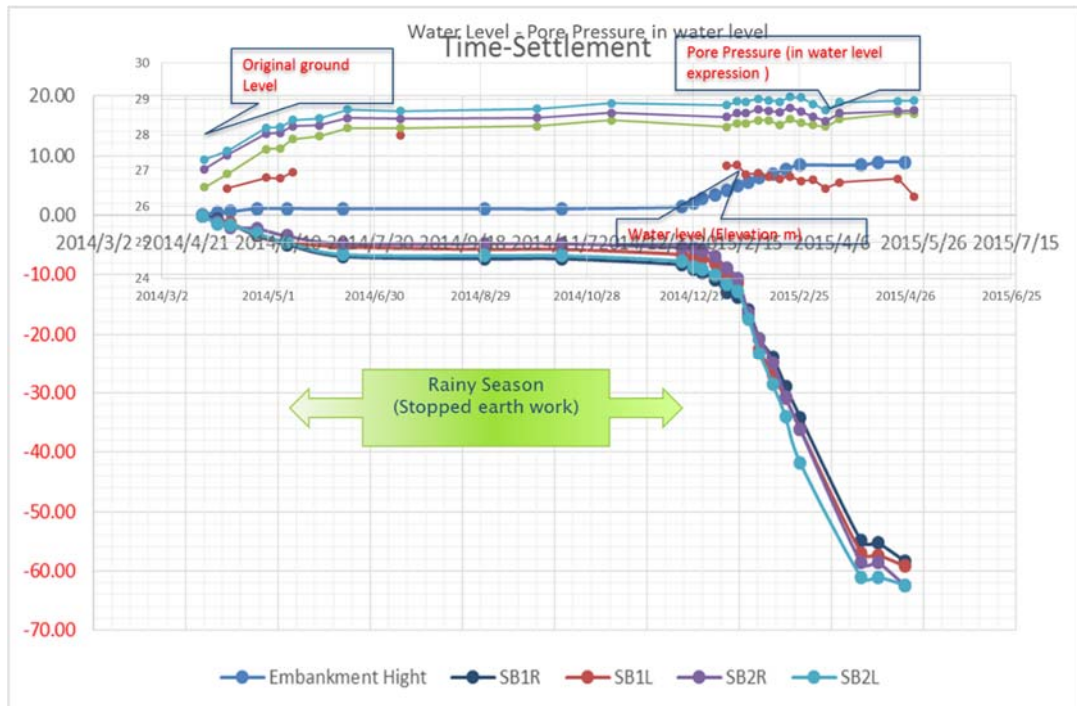
Settlement-board data and the heights of embankment with pore pressure (in water level expression) and underground water level data results are shown in below:

Fig 17 Relationship between Embankment Height (m) & underground water level (m)

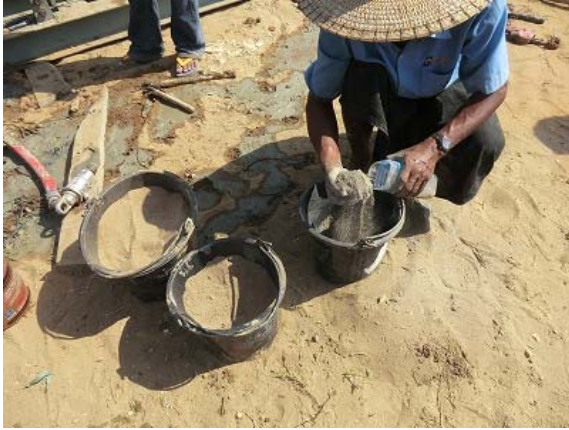
Preparation of Filling materials for bored hole for pore-pressure gauge

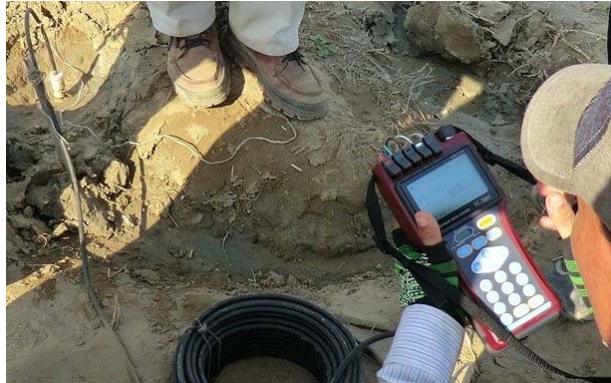
Measuring of Pore Pressure by Data logger

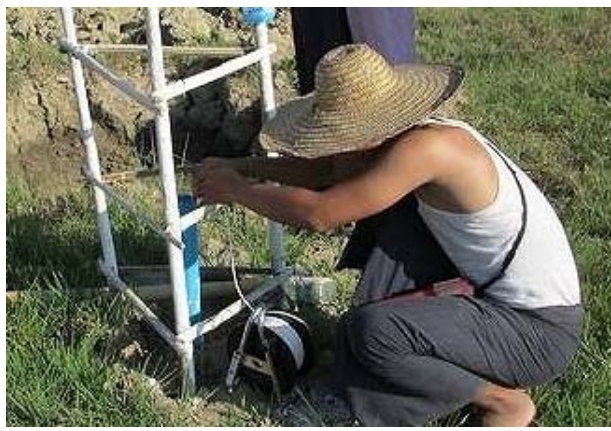
Measuring of Underground water level by electric detector

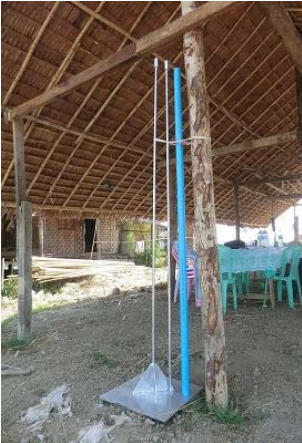
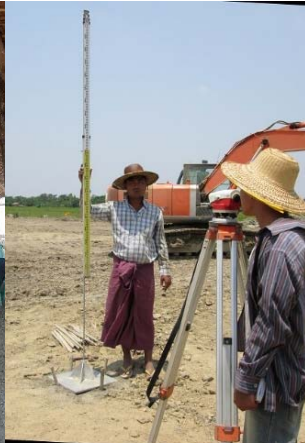
Settlement Board & Training of measurement

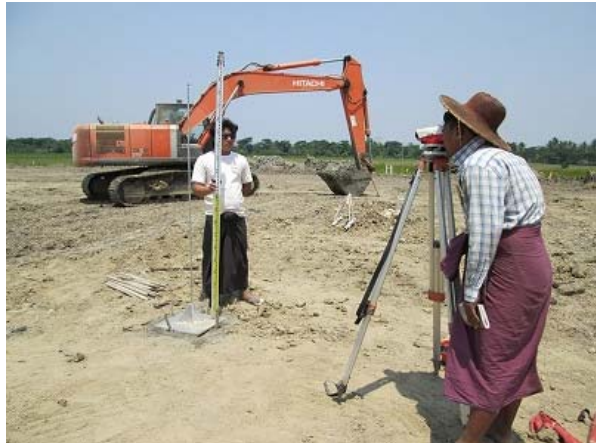
Initial measurement of settlement board after setting at site
