**Appendix-5: Minutes of the Public Consultation Meeting**

## **Minutes of the Public Consultation Meeting of the Project for Upgrade of Wharf for Domestic Transport**

**Environmental Impact Assessment Report**

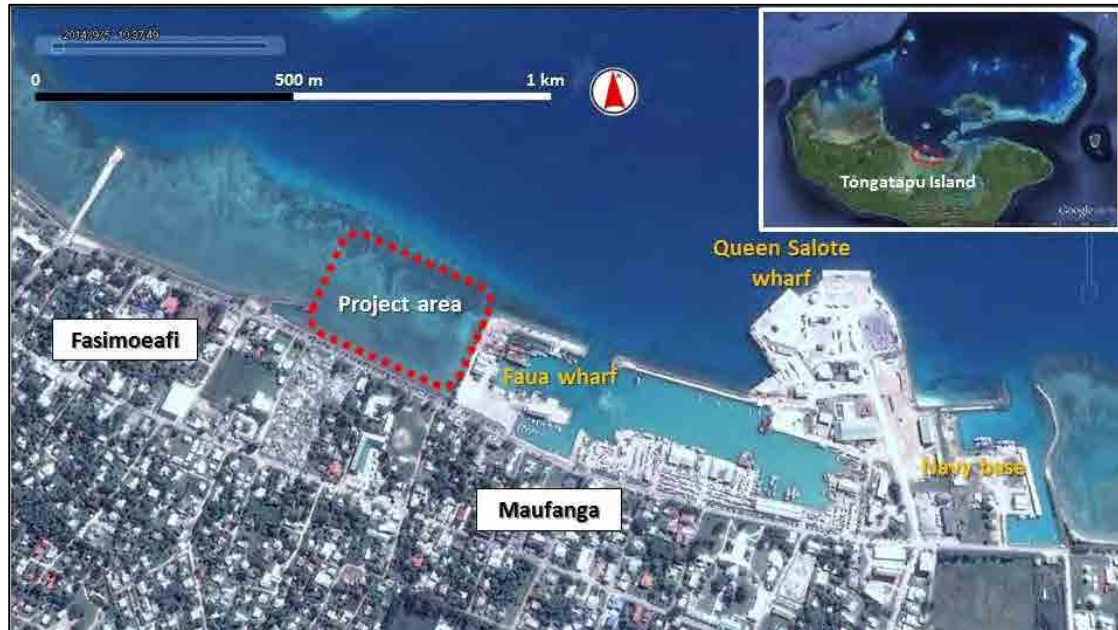
**Figure 3-1 Location of the new domestic wharf (red-dotted line)**

The new domestic wharf is located in Tongatapu Island, Nukualofa, the capital of Tonga. It is in front of Maufanga, one of the coastal villages in Nukualofa. Figure 3-1 shows the location of the new domestic wharf.

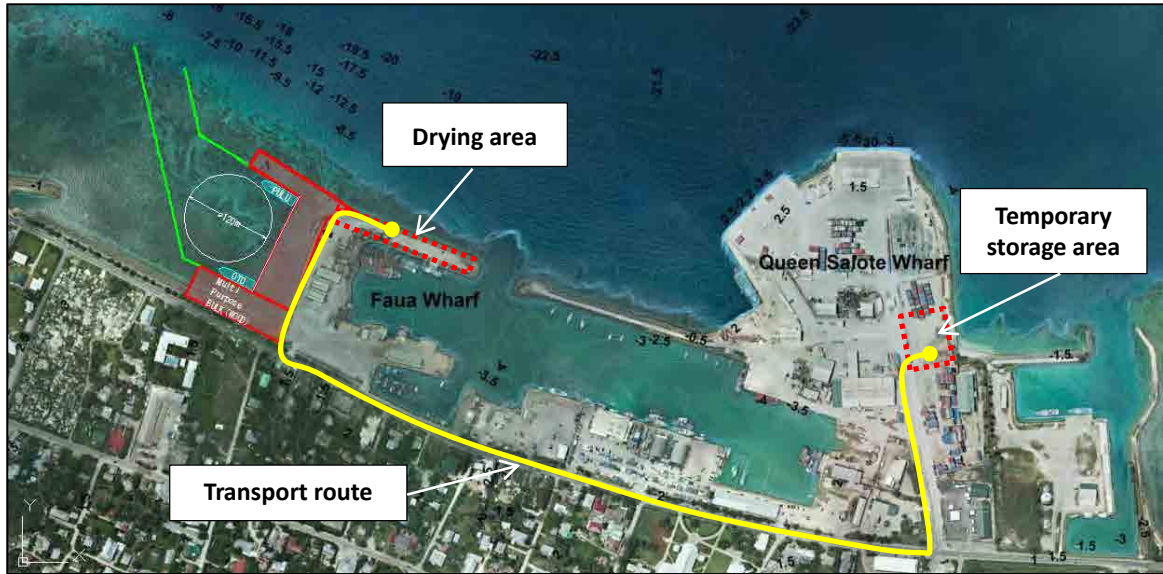
**Figure 3-5 Handling process of the excessive dredged material**

The access channel and turning basin will be dredged with an excavator placed on a barge. The dredged material will be used for reclaiming the wharf. Around 30,000 m<sup>3</sup> of excessive dredged material will be generated, which will be temporary stored in the empty space available south of Queen Salote wharf for later beneficial use. The excessive dredged material will be transported to the storage area with dump trucks after drying them at north side of Faua wharf. Figure 3-5 shows the handling process of the excessive dredged material.

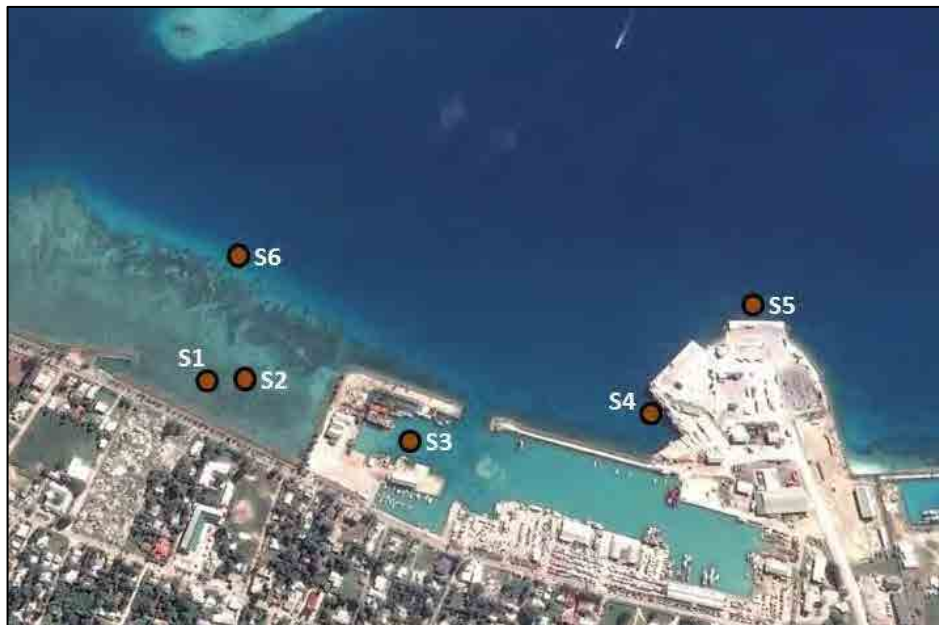
**Figure 4-3 Location of the sediment quality survey sites**

Sediment quality survey was conducted on September 3<sup>rd</sup>, 2014 to understand the sediment quality status of the planned dredging area and around Nukualofa port. Table 4-4 shows the survey parameters and analysis method. All chemical parameters were analyzed in New Zealand at Hill Laboratories Ltd., which is a laboratory accredited by International Accreditation NZ. Particle size analysis was conducted at Geotechnics Ltd., laboratory. Figure 4-3 shows the location of the survey sites. Sediment samples were collected by a diver from the surface layer only.

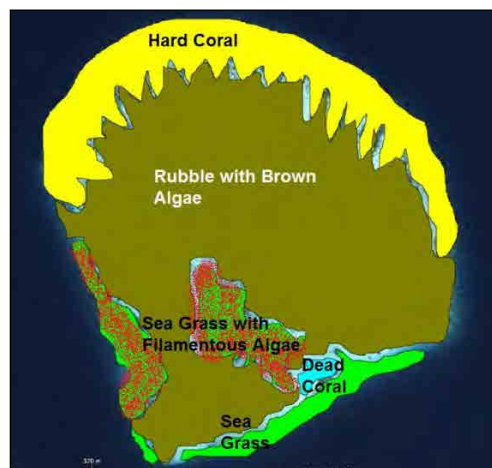
**Figure 4-8** Coral and seagrass distribution at the offshore reef

Figure 4-8 shows the coral and seagrass distribution at the offshore reef. Corals were mainly distributed in the outer reef flat and reef slope of the north side of the reef. Seagrass were mainly distributed in the west and east side of the reef.

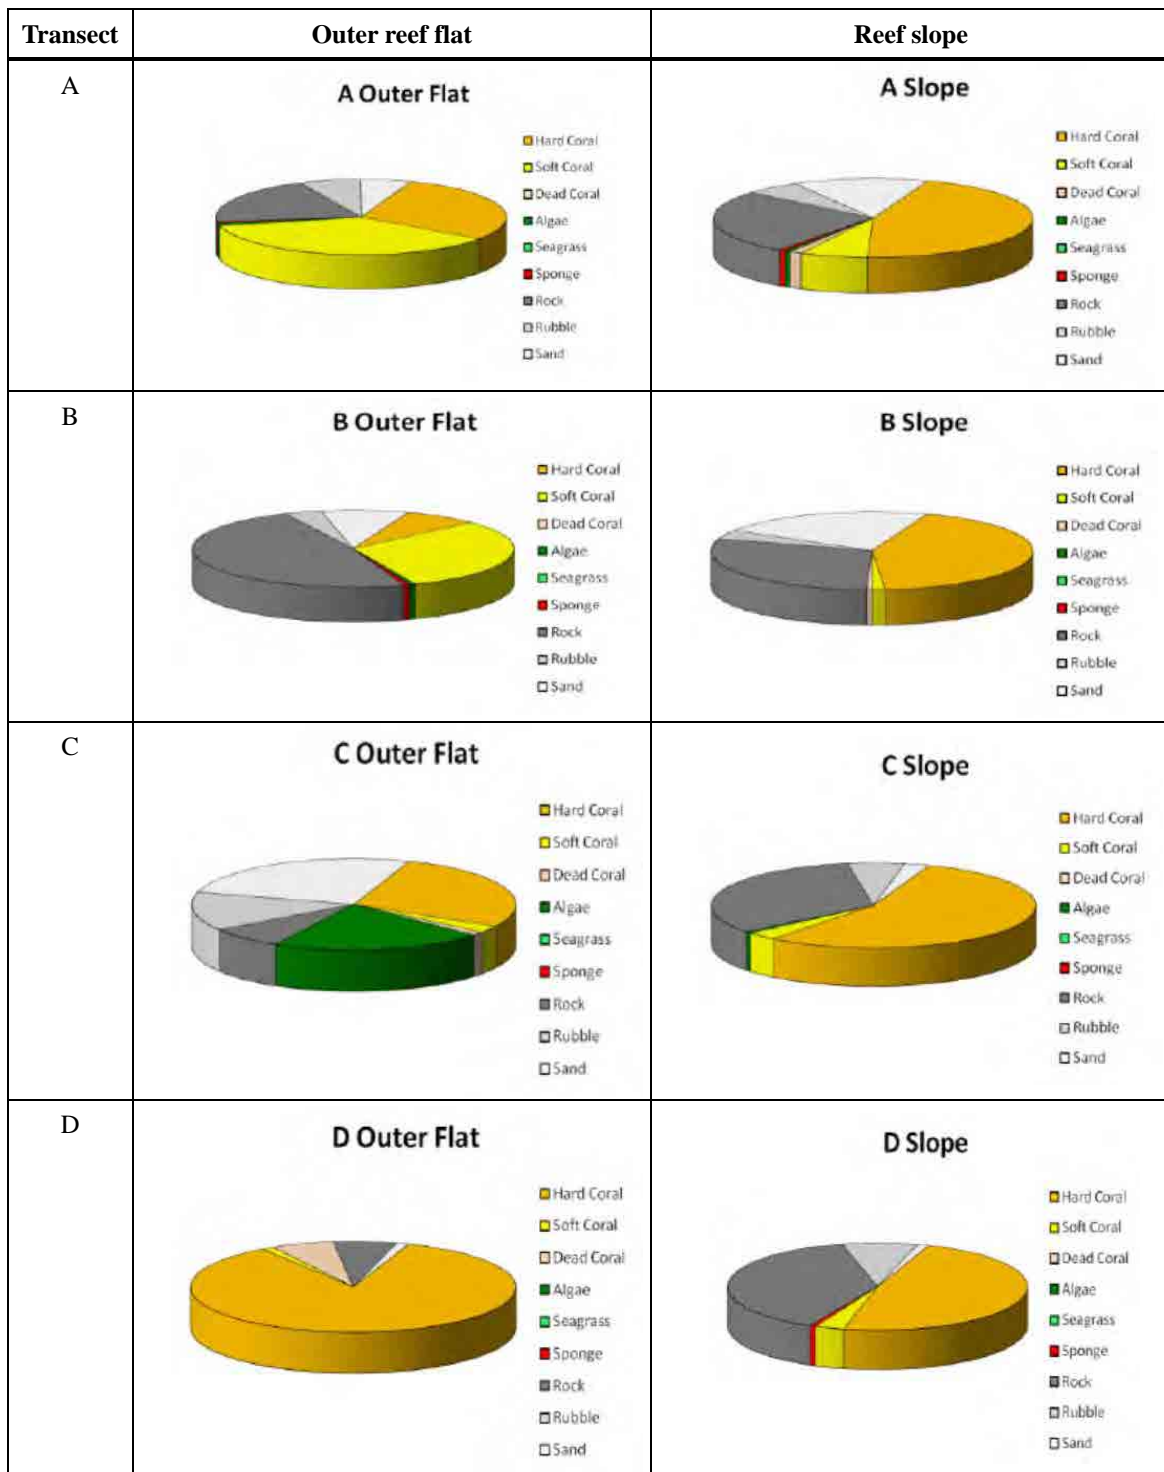
**Figure 4-9 Percent substrate type in the coral reef around the project site**

In the reef slope, hard coral coverage was more or less uniform between transects, ranging between around 40-50%. Soft coral coverage was less than 10% at all transects.

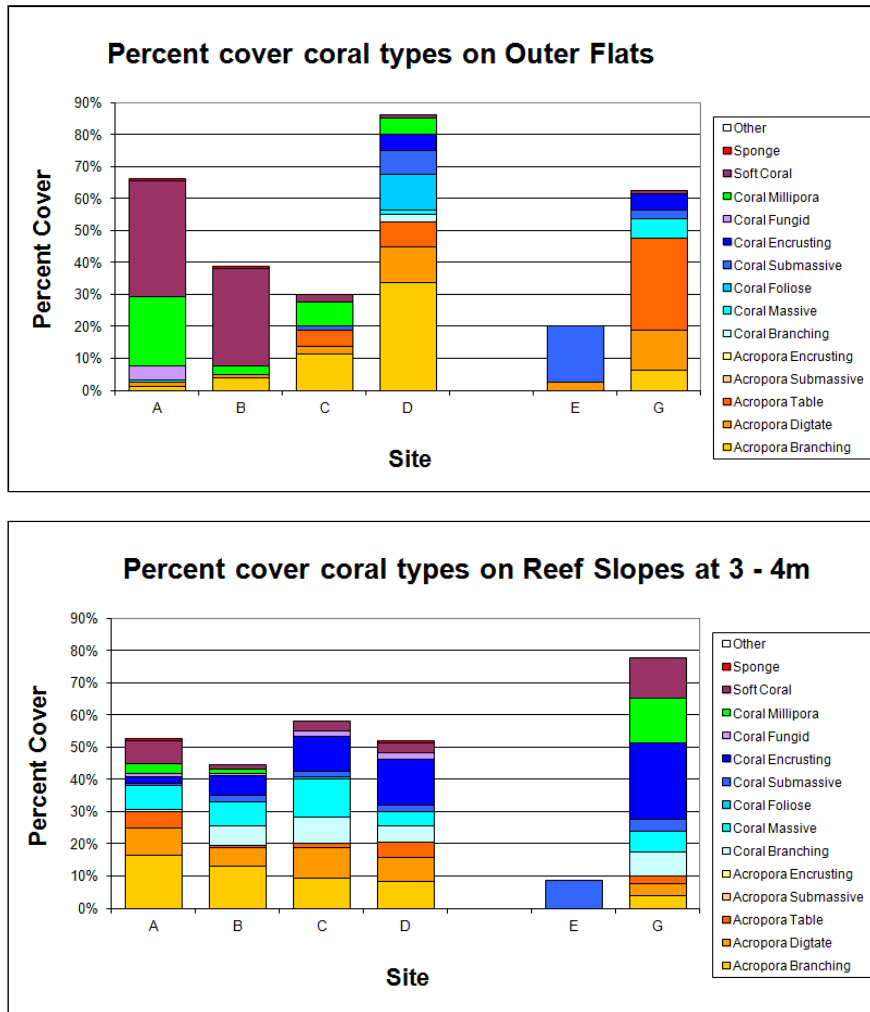
Figure 4-11 Lifeform diversity of hard corals in the project area and offshore reef

In the reef slope, lifeform diversity of hard corals were more or less uniform between transects. In addition to *Acropora* corals, there were diverse ranges of non-*Acropora* corals, most notably encrusting and massive corals (bluish bars).

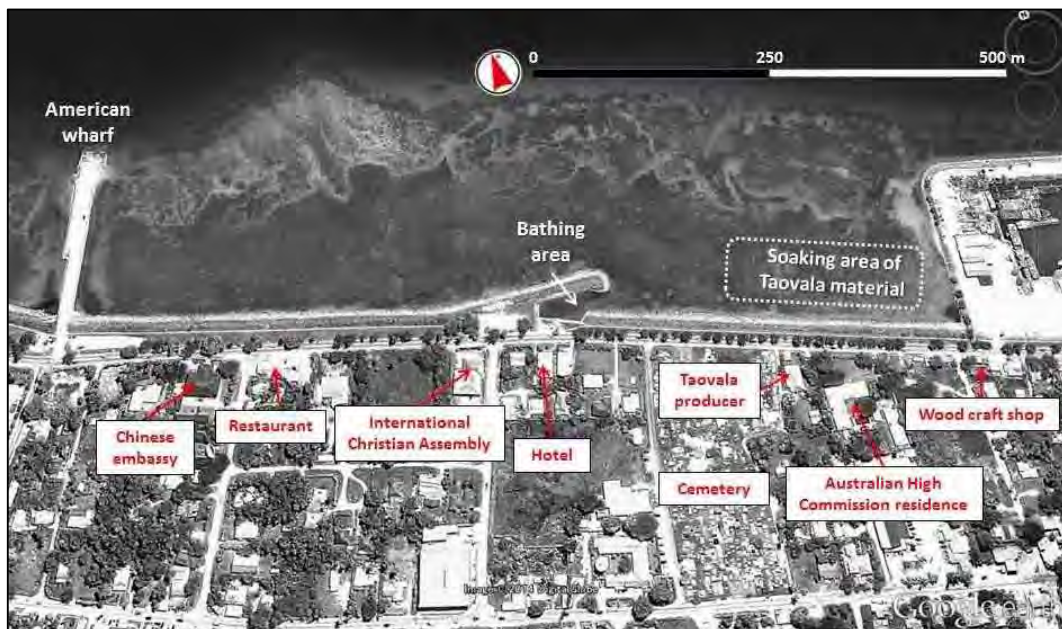
Figure 4-13 Main land and water uses around the project site

Children often bathe inside the jetty built between the port and American wharf. The offshore reef lying northwest of the project site is used as a diving spot by local tour operators.

Figure 4-13 shows the main land and water uses adjacent to the project site.

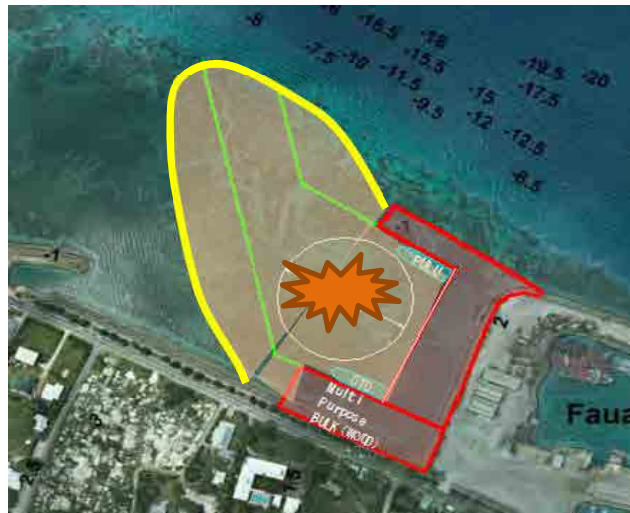
**Figure 6-2 Image of silt curtain installation**

Dredging works will degrade the water quality, as it will suspend/disperse significant amount of seabed sediments into the surrounding waters. Such dispersion of sediments may affect the surrounding ecosystem through increasing water turbidity. To minimize sediment dispersion, silt curtain will be installed around the construction site, which will block the sediments to a certain extent. Figure 6-2 shows an image of how silt curtain will be installed.

Note: The yellow line is the silt curtain

In addition, turbidity levels will be monitored in the adjacent waters as sediments can leak out through the silt curtain. Additional measures will be implemented if turbidity levels exceed the set threshold value (see Section 7.2.3 for details).
