## 2.8 Saint Lucia

## 3) Field Inspection and Confirmation of Site Condition

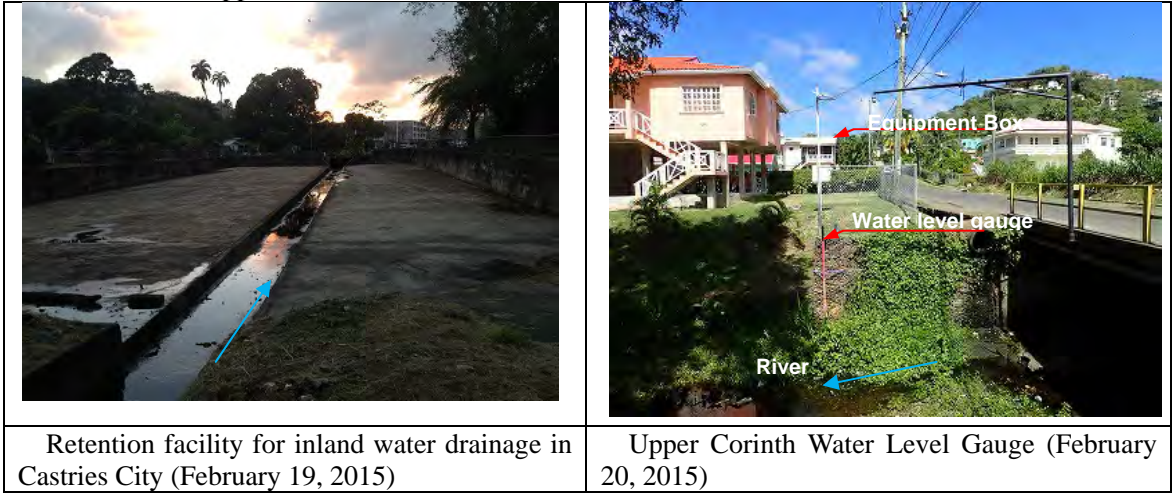
Currently, the observation and recording units are functioning but warning dissemination cannot be made due to communication equipment (modem) troubles at the three stations; these equipment have not been repaired due to the lack of manual and spare parts. Figure 2.8.5 (right side) shows a present situation of the Upper Corinth automatic waterlevel gauge.

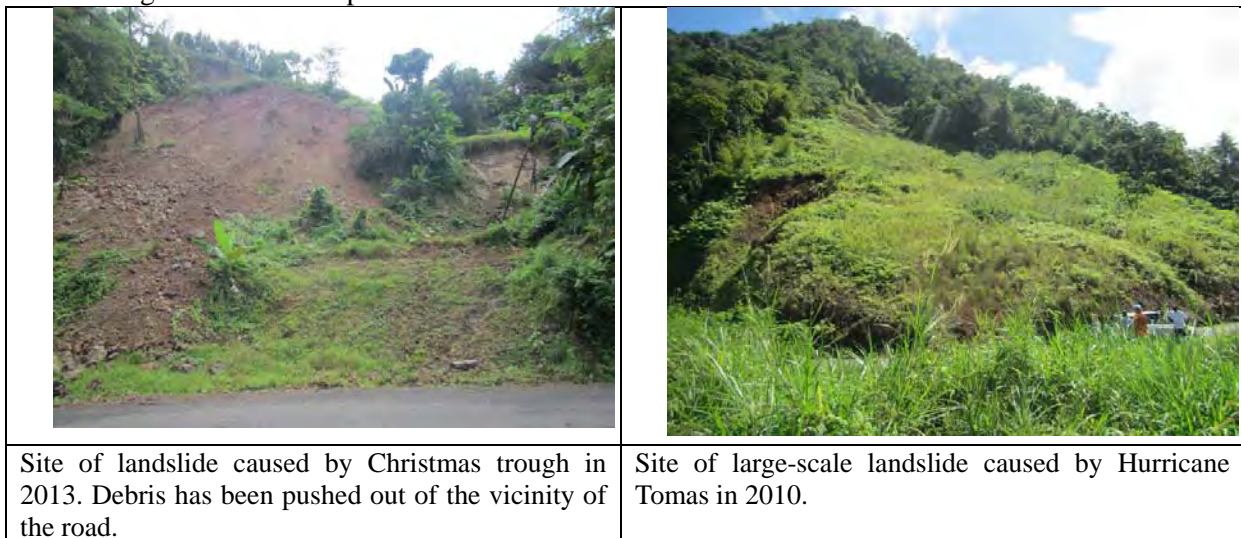
Fundamental countermeasures such as slope stabilization are not implemented yet but temporary countermeasures such as temporary road closure, sediment removal, and road reopening after sediment removal are repeatedly undertaken when sediment disasters occur. Field inspection was conducted around the Anse La Verdure area where landslides occur frequently and traces of the past disaster still remain. Figure 2.8.7 shows present situation of the Anse La Verdure Area.

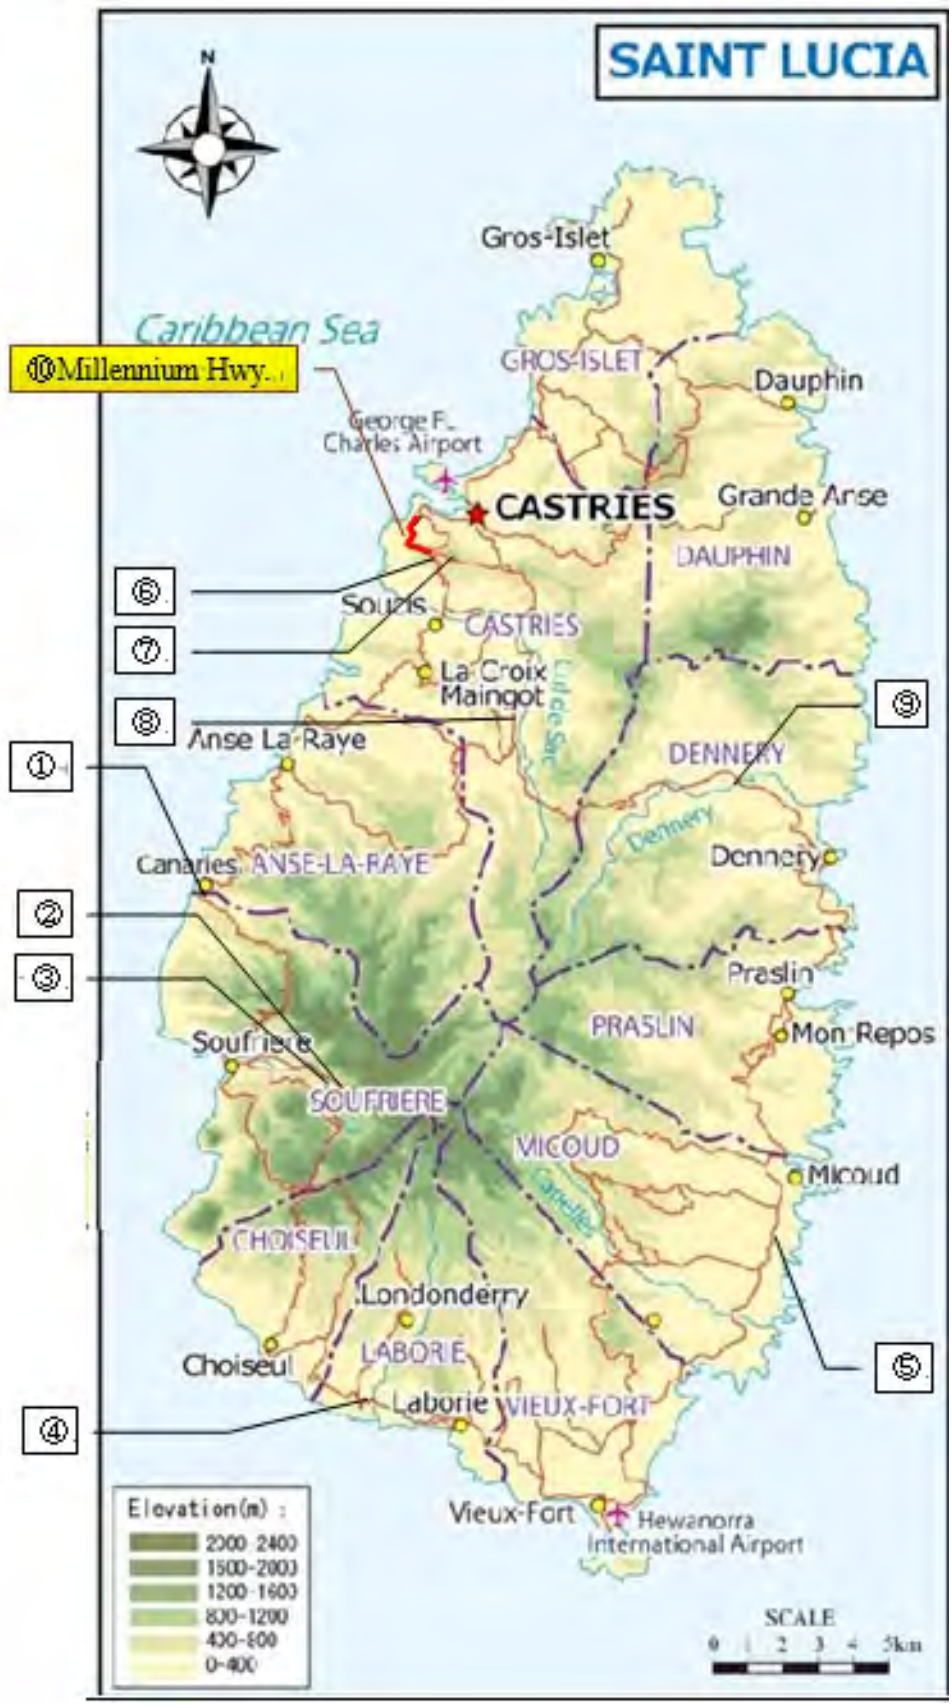
**Figure 2.8.9 Locations of Field Inspection (Bridge)**

No	Name	Road	Damage Situation	Present Situation
①	Canaries Bridge	WCR	Broken	Rebuilt with Bailey Bridge
②	Ravine Claire Bridge		Flowed down	Re-erected with Bailey Bridge
③	Mocha Bridge		Broken	Newly built
④	Piaye Valley Bridge	WCR	Broken	Newly built
⑤	Wannier,- Micoud Culvert	ECR	Culvert and road flushed away	Newly constructed with larger section box culvert
⑥	Cul de Sac Bridge	ECR	Overflowed	Used in a critical condition
⑦	Ferrands Bridge	ECR	Overflowed	Used in a critical condition
⑧	Ravine Poisson Bridge	ECR	Overflowed	Used in a critical condition
⑨	Alba Bridge	ECR	Broken	Newly built
⑩	Millennium Highway		Pavement deteriorated	Used as normally

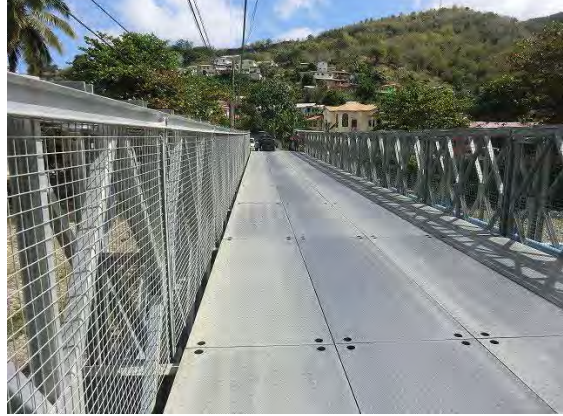
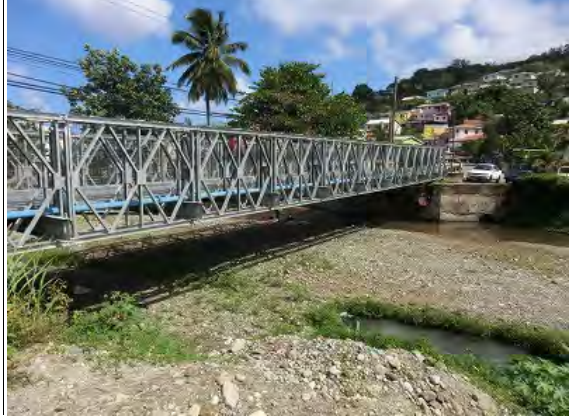
The old Bailey bridge was washed away during the Christmas flood and was reconstructed with a new Bailey truss with length of 33 m and width of 4.2 m as seen in Figure 2.8.10. It is probable that similar damage might be caused in case of a similar scale flood because the position and clearance of the new bridge seem same as the old one.

<p>Date : February 21, 2015          Site : Right bank near the Canaries River mouth          Outline : Bailey bridge with new steel floor slab.</p>	<p>Date : February 21, 2015          Site : View from downstream left bank          Outline : Restored in the same manner as the previous bridge in terms of location as well as height</p>

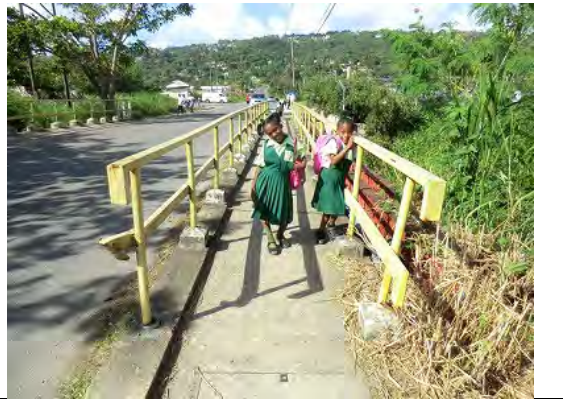
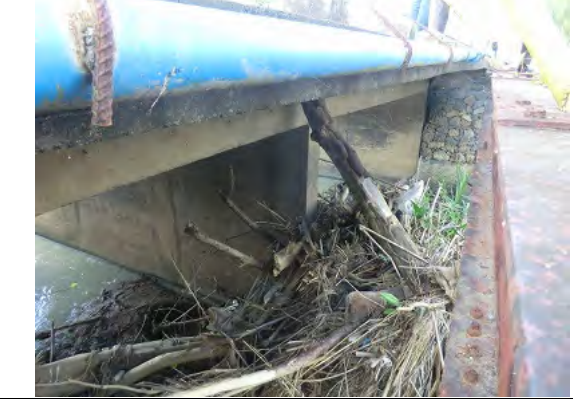
The present Cul de Sac Bridge is a two-lane box culvert type. Many driftwoods, dead branches, and dry grasses are caught under the bridge in the upstream side even during the the dry season. Such driftwoods and others prevent the smooth flow of river water, which raises the water level and causes inundation in the upstream reaches. Therefore, it is required to modify the bridge design into a single span bridge (with no pier) in view of disaster mitigation.

<p>Date : February 19, 2015          Site : From right bank towards left and downstream to right side. 21 m long and 5.5 m wide</p>	<p>Date : February 19, 2015          Site : Central partition wall</p>

Furthermore, some considerations shall be taken regarding countermeasures such as settlement consolidation at the abutment structure and approach road area in the design of a new bridge in another place because the proposed construction area is on the flood plain of the Cul de Sac River. Present situation of the Cul de Sac Bridge is seen in Figure 2.8.11.

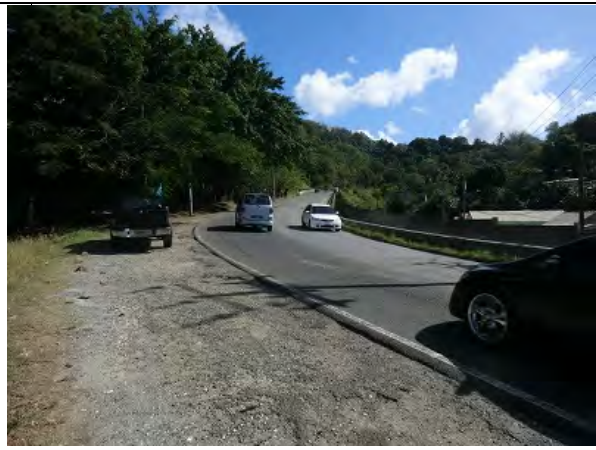
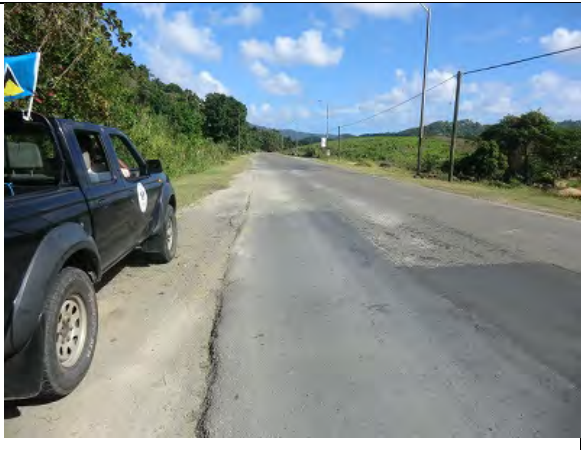
It is generally observed that the pavement of the highway does not need urgent repair although there were locally deteriorated parts. Notwithstanding, the improvement of the pavement is one of the government’s requirement for the rehabilitation. Present situation of the Millenium Highway is seen in Figure 2.8.14

<p>Date : February 19, 2015          Site : Millennium Highway, about 300 m from the starting point          Outline : Much traffic and road surface looks in good condition</p>	<p>Date : February 19, 2015          Site : Millennium Highway          Outline : Deteriorated portion; no other section where pavement condition is particularly bad</p>

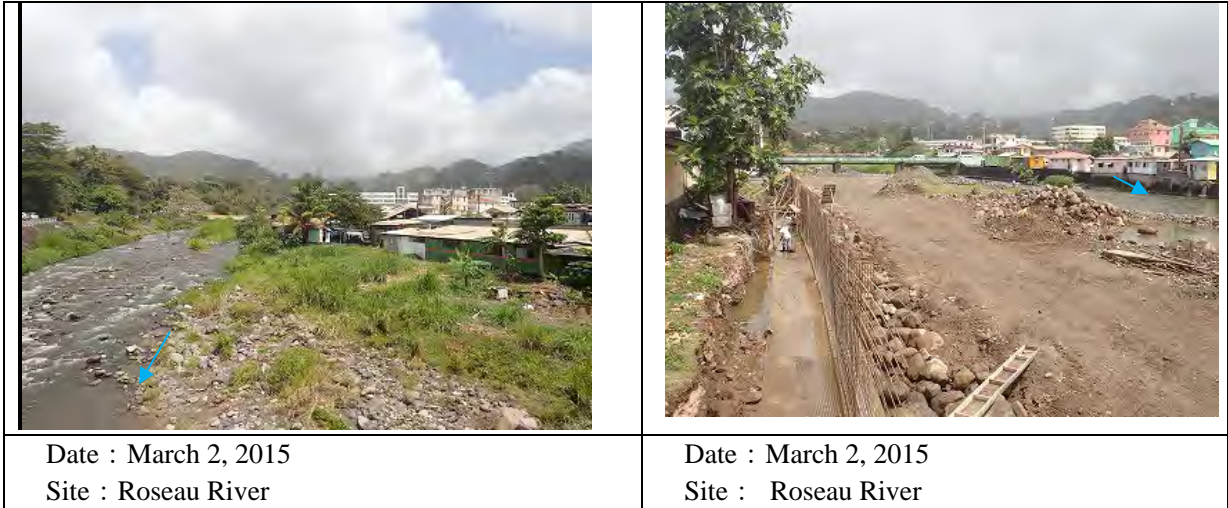
**Figure 2.9.5 Situation of Affected Area along the Roseau River**

The Roseau River flows through the Roseau City area, which is like a mountain stream with rather high flow velocity. In the upper reaches of the urban area where there is no dyke system, flood

disasters frequently occur due to flash floods by heavy rainfall every year. In the downstream reach in the urban area, no severe flood damage has occurred since river improvement with bank protection works have been well undertaken through steel sheet pile revetment, concrete wall, and gabion piling. Currently, river protection works with concrete walls are in progress at the downstream right bank using the national budget. Furthermore, sediment runoff is so remarkable that periodical dredging works are carried out at the river mouth area and downstream reaches. On the other hand, risky situation in the river course is identified by some squatters in the sandbar, which disturbs flood flow in the river. Figure 2.9.5 shows present situation of the affected area along the Roseau River downstream reach.

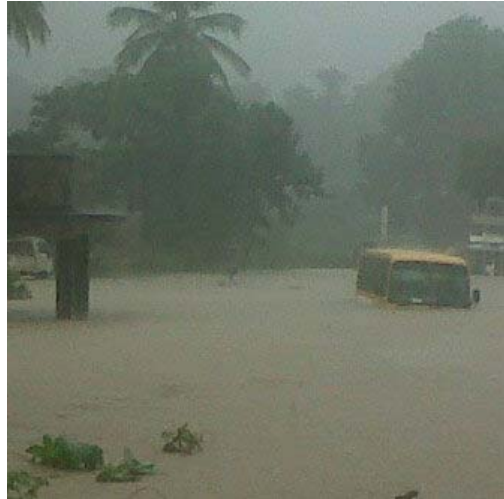
**Figure 2.9.6 River Mouth Area of the Layou River**

In the 2011 flood, villages at the right side of the river mouth were inundated due to flooding around the bridge on the trunk road, while no inundation occurred in the 2013 flood. During the flooding in 2011, lots of sediment were deposited in the downstream reaches where dredging works are ongoing.

<p>Date : September 28, 2011  Site : Layou River mouth  Outline : A bus stuck in flood waters in Layou  Source: News Article  <a href="http://dominicanewsonline.com/news/homepage/news/accidents-tragedy/kelver-darroux-say-situation-in-layou-is-terrible/">http://dominicanewsonline.com/news/homepage/news/accidents-tragedy/kelver-darroux-say-situation-in-layou-is-terrible/</a></p>	<p>Date : February 28, 2015  Site : Bridge at the Layou River mouth  Source : JICA Study Team</p>

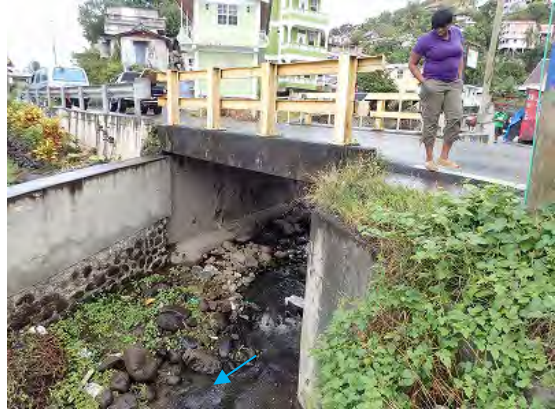
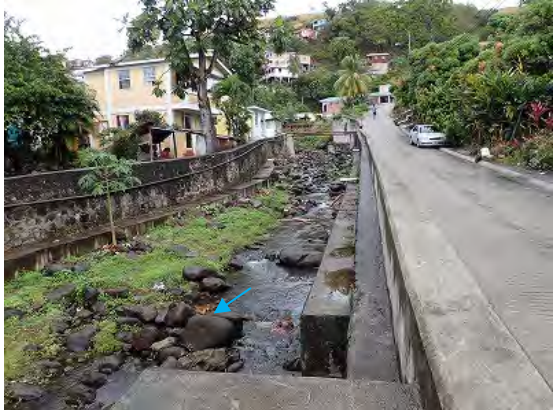
Both the Massacre River and the Mahault River are small-scale rivers with a width of 6 m which the west coastal road with the most traffic in Dominica crosses. The structures of the said rivers were damaged by the flood in 2010 and the retaining wall has been constructed as part of the rehabilitation works in the downstream reach to the river mouth section. Bridges on the river create a bottleneck in the river course which cause backwater effect and inundation in the upper reach area. Present condition around Massacre River mouth area is shown in Figure 2.9.7.

<p>Date : February 28, 2015  Site : Bridge near the Massacre River mouth</p>	<p>Date : February 28, 2015  Site : Revetment wall near the Massacre River mouth  Outline : After the flood in 2011, masonry revetment was constructed, which is 3 m high and 1 m from the riverbed. There is dike road at the left side.</p>

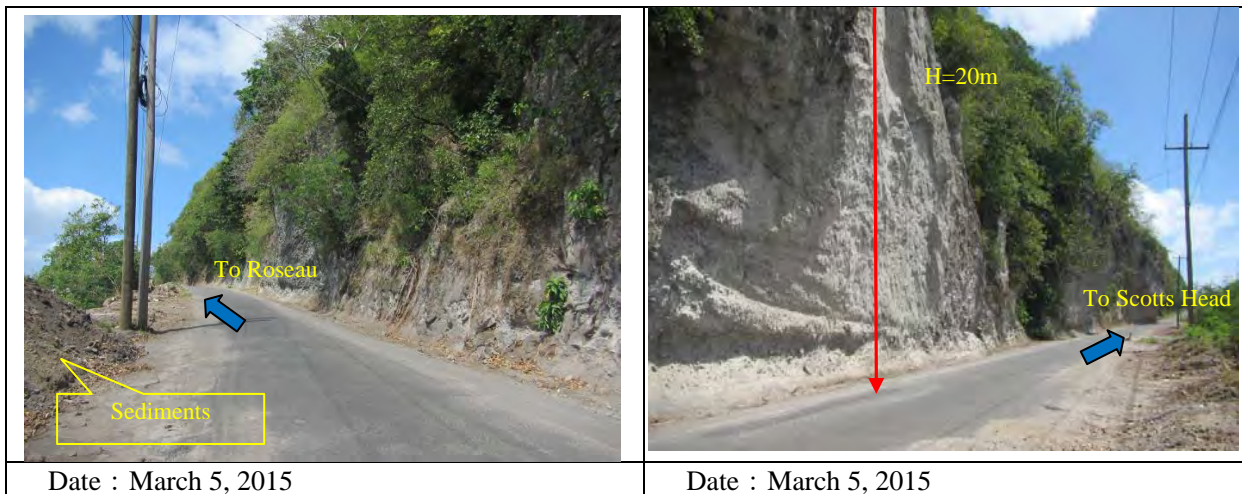
**Figure 2.9.9 Step Cut Slope between Pointe Michel and Soufriere**

In particular, slope failures and rockfalls are frequent at the section between Soufrière and Pointe Michel.

Field inspection was conducted around the Anse La Verdu area where landslides occur frequently and traces of the past disaster still remain.

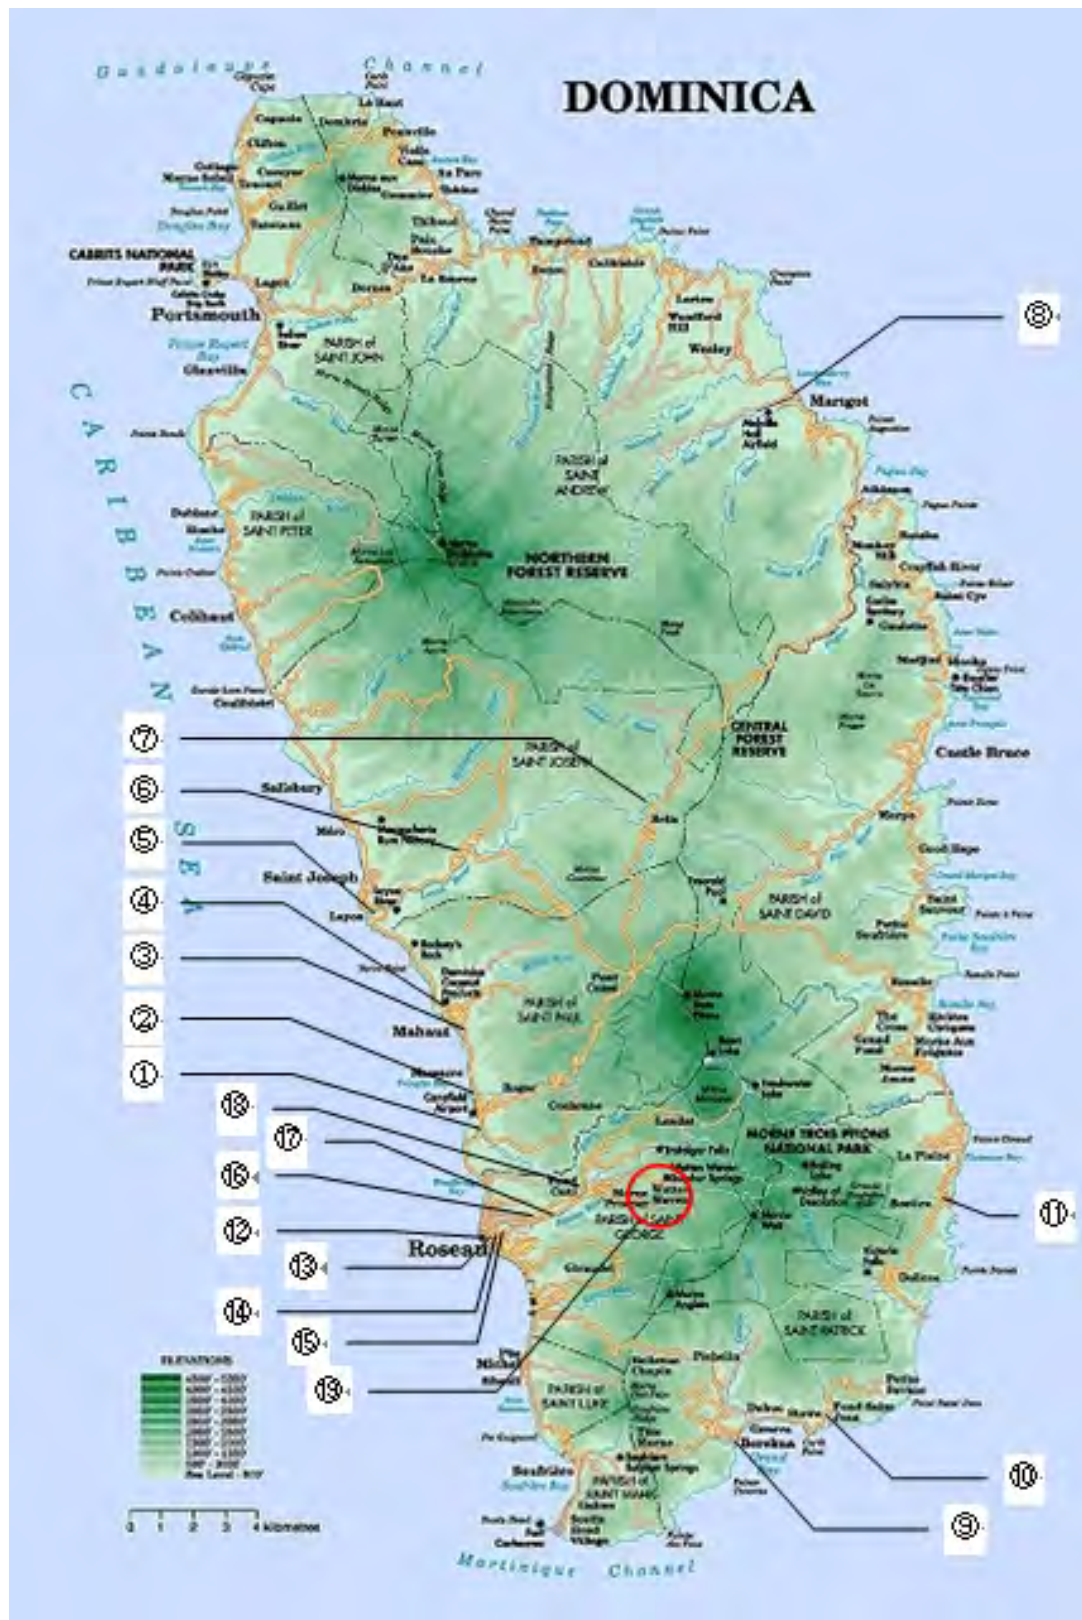
Figure 2.9.11 Locations of Field Inspection (Bridges)

The present situation of the bridges that have been inspected is shown in Table 2.9.9. Among these bridges, most of the bridges in the southern area were damaged by the Christmas flood in 2013, while bridges in the western coastal area suffered damages from Tropical Depression Ophelia.

No	Bridge Name	Road	Damage Situation	Present Situation
1.	Checkhall River Bridge	WCR	Overflowed	Used as before
2.	Massacre River Bridge	WCR	Overflowed	Concrete wall was built and used as before

6.	Layou River, Midstream Bridge		Overflowed and one span broken	Repaired and used as before
7.	Layou River, Upper branch stream Bridge	EOLH	Overflowed and broken	Refurbished

8.	Channel River Bridge		Overflowed	Used as before
9.	Geneva River	DFSJ	Overflowed	Used as before
10.	White River	FJPS	Overflowed, Deteriorated by sea breeze	Plan of renovation through EU Fund

11.	Tabarie River	DMR	Overflowed	Used as before
12.	China Friendship Bridge	HS	No damage	
13.	Roseau Bridge	GGs	Overflowed	Used as before
14.	West Bridge	IndPS	Overflowed	Used as before

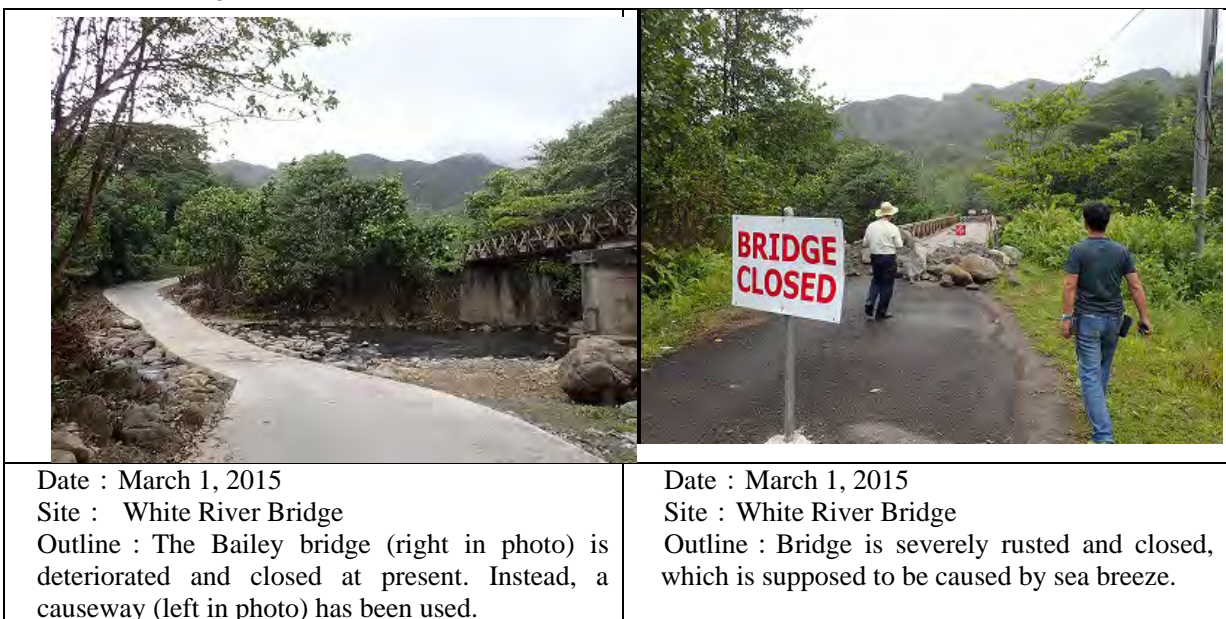
The old Bailey truss type bridge with length of 36 m and width of 3.6 m shown in Figure 2.9.13 is located on the Fond St Jean-Petite Savanne Main Road crossing the White River around its river mouth. This bridge is not in use.

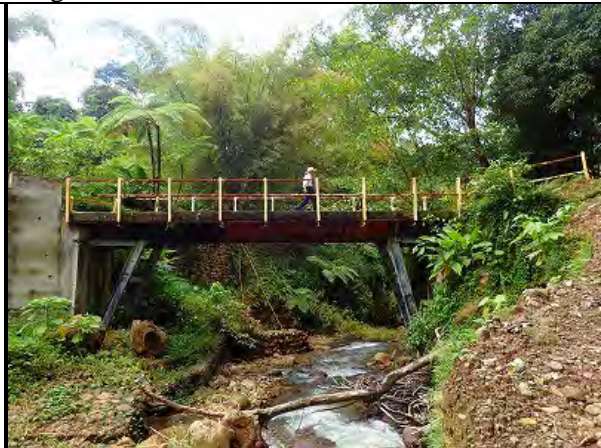
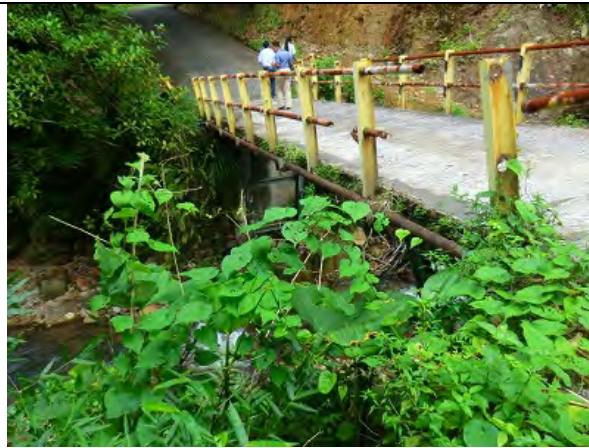
This is a 12 m long and 3 m wide bridge made of steel girder with concrete slab crossing a tributary of the Roseau River as seen in Figure 2.9.15. There is a spout of Hot Sulfur Spring at about 30 m upstream of the bridge wherein the sulfide seems to affect the steel of the bridge. Handrail of the bridge has been severely damaged. The said Hot Sulfur Spring is an important sightseeing spot and this bridge is a part of the road connecting to Roseau; therefore, it is strongly desired to replace the bridge.

<p>Date : March 3, 2015                  Site : A bridge on the Geneva River                  Outline : This bridge is a portion of the Link Road between Hot Sulfur Spring and Roseau</p>	<p>Date : March 4, 2015                  Site : View from downstream left bank                  Outline : Steel-made handrails have fallen out due to heavy rust.</p>

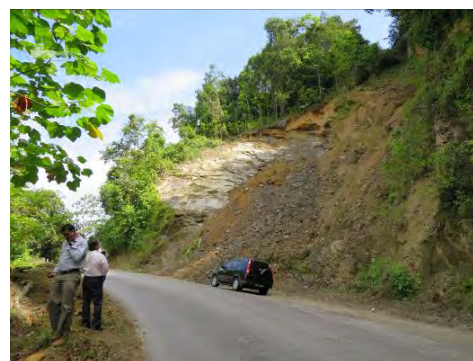
**Figure 2.10.7 Slope Collapse in North Coast Road in the Trinidad Island**

Roads located in the north of the capital of Port of Spain including Diego Martin Road, Morne Coco Road, and North Coast Road run through steep slope areas with weak weathered metamorphic rocks, so that they suffer

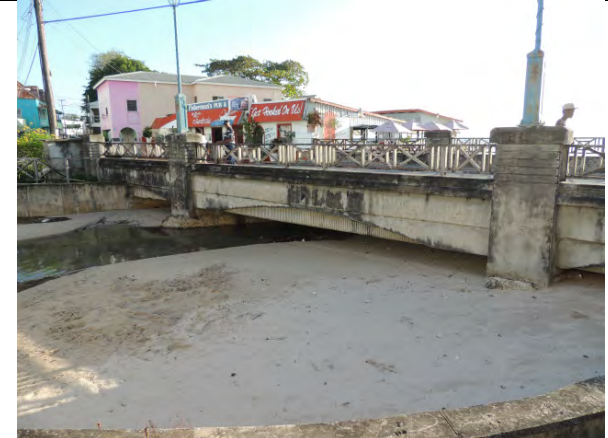
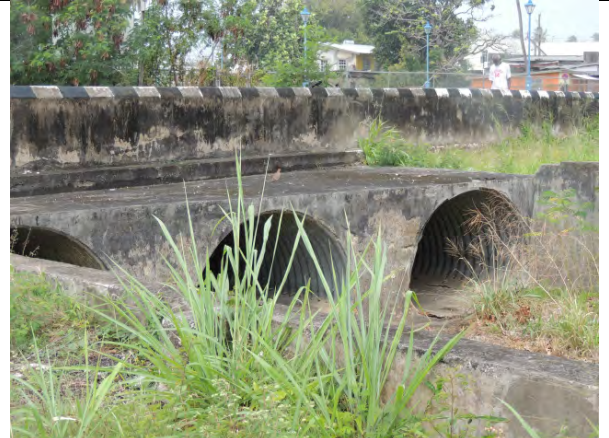
<p>River mouth in Speightstown, where sand is deposited and river flow is almost blocked. It was explained that the sand was removed before the rainy season.</p>	<p>Drainage culverts beneath the highway in Speightstown, which have insufficient flow capacity resulting in floods in the upstream area. It was explained that improvement works would be carried out for the upstream section of the river.</p>

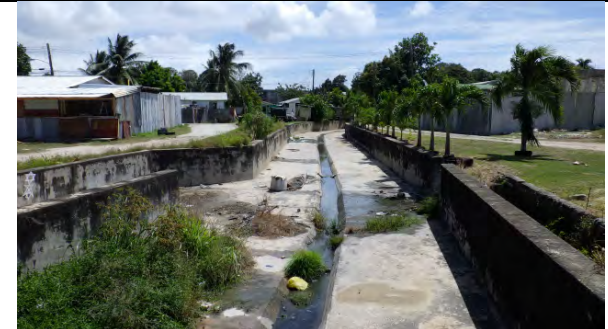
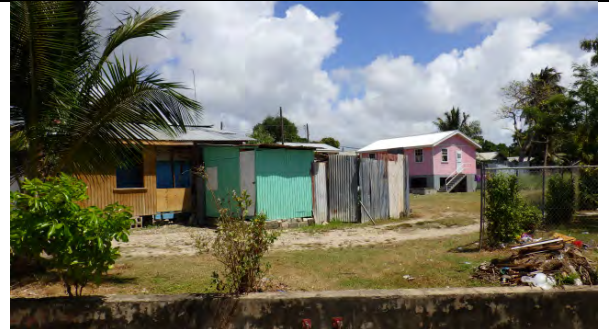
<p>Garden Land in Bridgetown, in which the trunk drainage canal runs. The drainage canal located upstream of the trunk canal has less flow capacity, causing floods.</p>	<p>Houses located near the connection point of the trunk drainage canal and upstream canal. The houses in the low elevation area are inundated due to insufficient flow capacity of the upstream canal.</p>

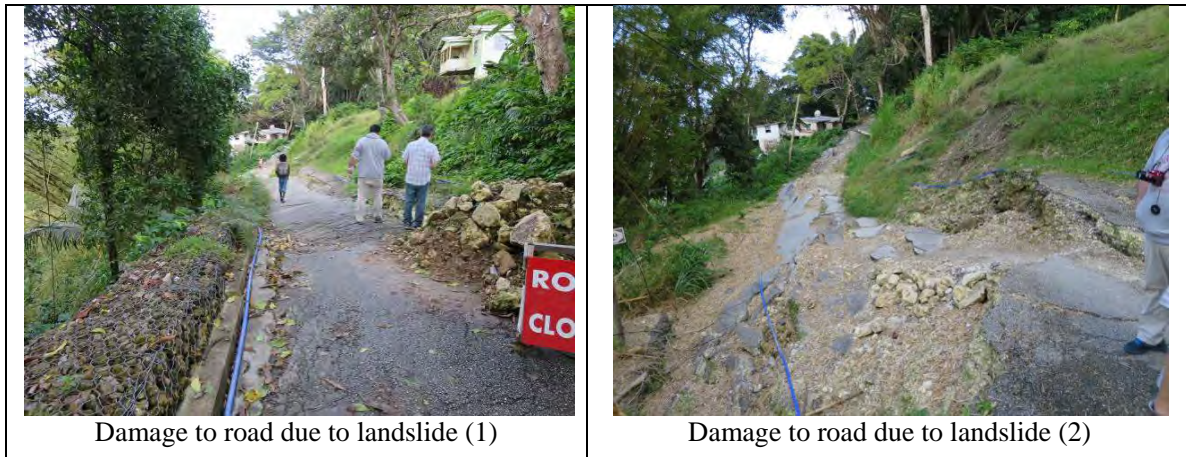
**Figure 2.11.8 Damages to Roads due to Landslide in November 2014 (White Hill Area)**

The White Hill Area is covered by the Jose Riverbed composed of mudstone, between layers of which sandstone is intercalated. The area is one of those prone to sediment disasters in Barbados. The road section damaged by landslide due to heavy rainfall on November 23, 2014 was inspected by the JICA Study Team as shown in Figure 2.11.8. It was observed during the inspection that the width of the landslide was about 80 m. The Ministry of Transport and Works is responsible for the restoration of the damaged section of the road; however, the section was not restored as of February 2015.

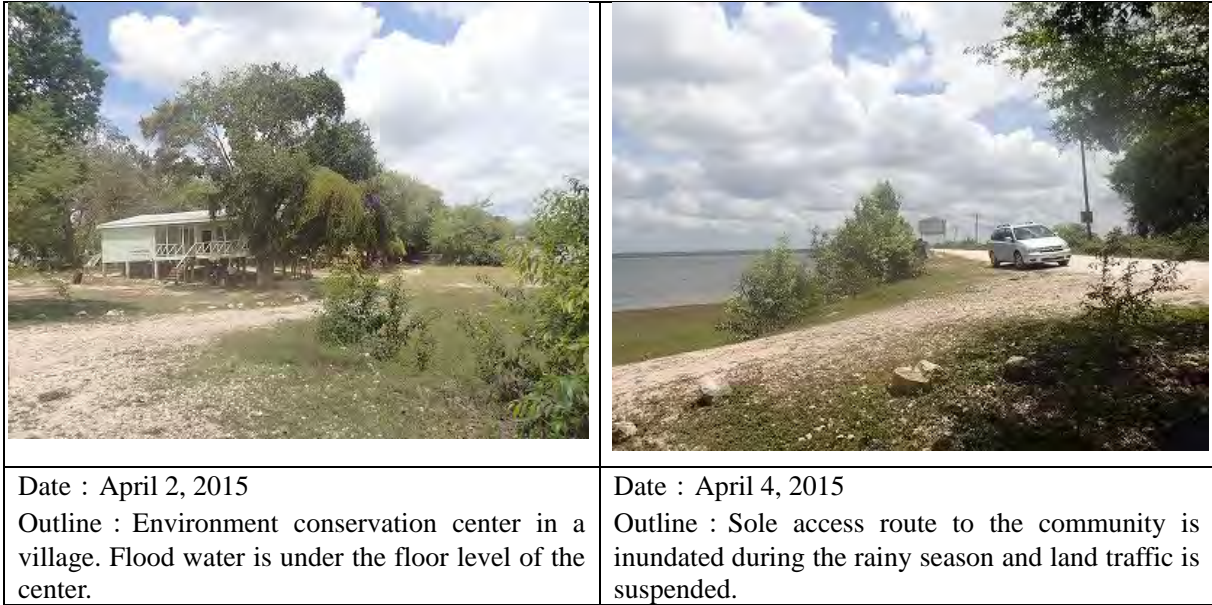
**Figure 2.12.5 Flood-affected Area near Crooked Tree Point**

The Crooked Tree Village was one of the target communities for community disaster management in the Caribbean Disaster Management Project, Phase II (CADM2 from January 2009 to June 2012), which is located at the downstream lagoon of the Belize River with a population of about 1,000. Inundation occurs in this community every year when the water level of the lagoon rises; in 2014, the situation where there is no other access than using boat lasted for about three to four months. Present condition of the Crooked Tree Village is shown in Figure 2.12.5.

The water level gauges installed under CADM2 in the lagoon have been used for community flood disaster mitigation activities under the management of the National Emergency Management Organization (NEMO).

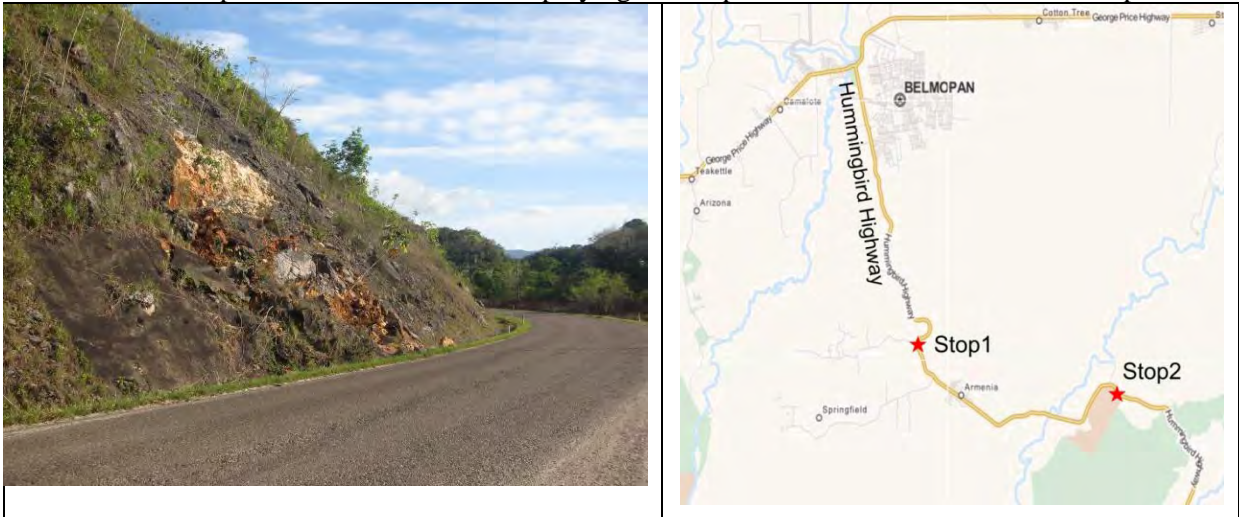
Date: April 6, 2015  
 Location: Stop 1 – Slope Failure Site  
 Description: Small slope failure site on Hummingbird Highway. Source : JICA Study Team

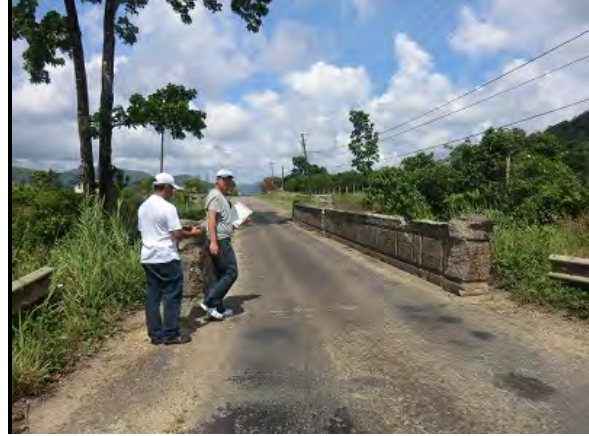
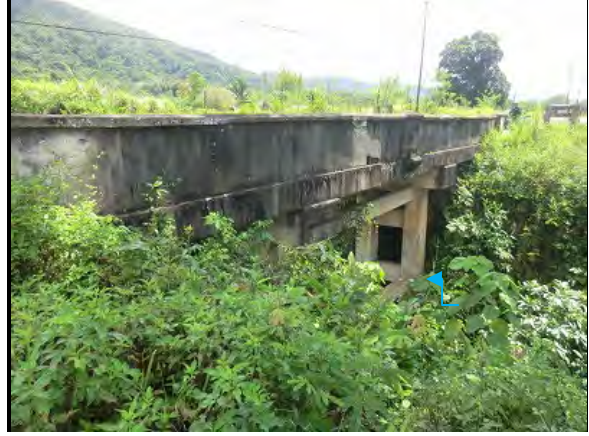
Concrete girder bridge with a width of one lane that disturbs smooth traffic along the trunk road and has a risk against safe traffic. It was constructed as a railway bridge in the 1950s and then modified to the road bridge. It is getting decrepit.

Date : April 4, 2015 10:09 AM  
 Site : Valley Community Bridge 1  
 Outline : Three-span 20 m long bridge with concrete girders, which is less secure against transportation due to one lane availability.

Date : March 29, 2015  
 Site : Valley Community Bridge 1 (side view)  
 Outline : Pier is composed of four concrete pillars joined by concrete girders.

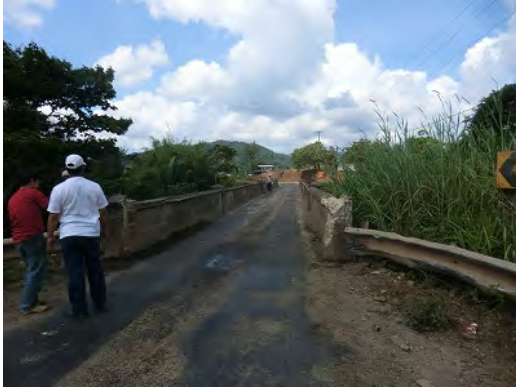
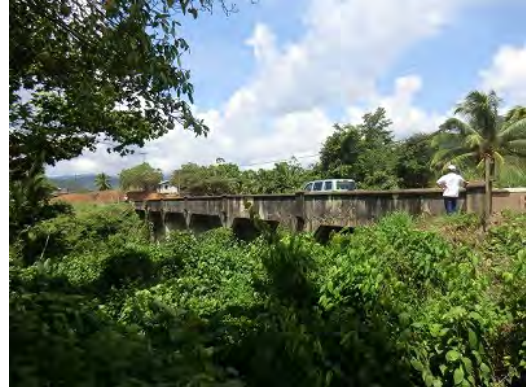
**Figure 2.12.9 Bridges in and around Hummingbird Highway (1/2)**

Date : April 4, 2015 10:14 AM  
 Site : Valley Community Bridge 2  
 Outline : Six-span 40 m long bridge with concrete girders; constructed in the 1950s

Date : April 4, 2015  
 Site : Valley Community Bridge 2  
 Outline : River valley was so deep and covered by thickly grown trees that riverbed was not clearly seen.

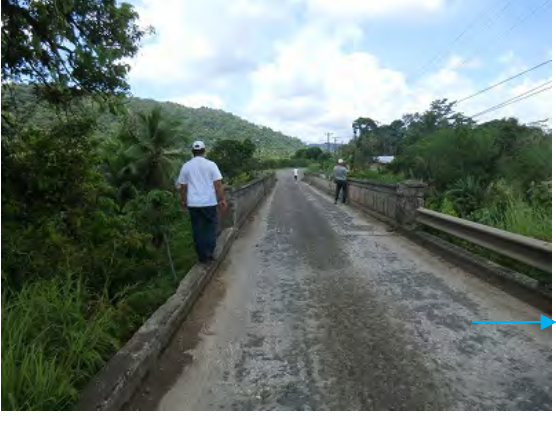
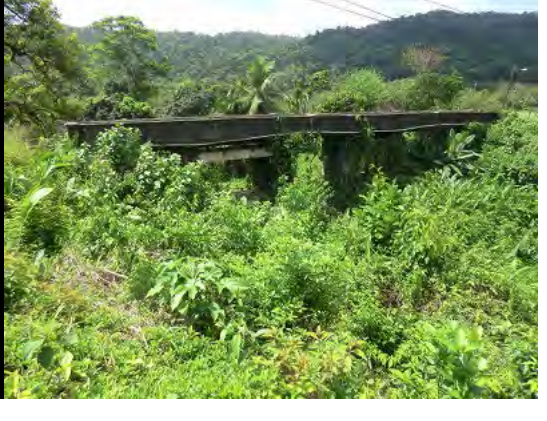
<p>Date : April 4, 2015 10:20 AM  Site : Valley Community Bridge 3  Outline : A 30 m long bridge with concrete girders; Traffic of trucks and trailers are frequent because of a huge juice factory along the road.</p>	<p>Date : April 4, 2015  Site : Valley Community Bridge 3  Outline : Piers are composed of rectangular pillars connected with girders and individual gatepost type.</p>

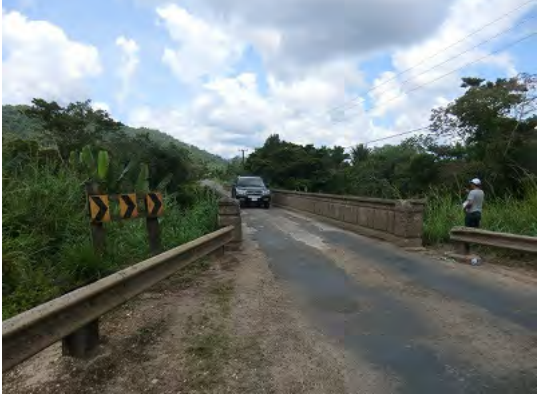
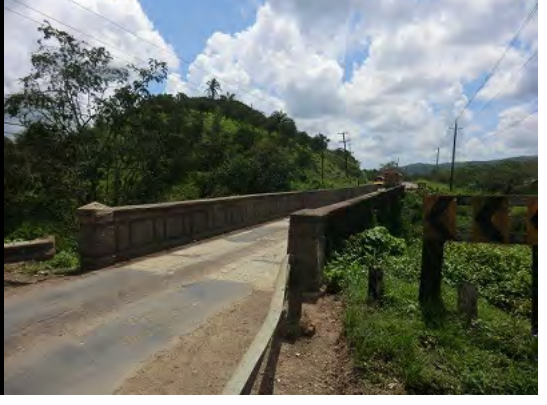
**Figure 2.12.9 Bridges in and around Hummingbird Highway (2/2)**

<p>Date : April 4, 2015 10:34 AM  Site : Valley Community Bridge 4  Outline : Concrete girder bridge, which is 75 m long. Two-lane road becomes narrow at the bridge with one lane.</p>	<p>Date : April 4, 2015 11:35 AM  Site : Valley Community Bridge 5  Outline : Concrete girder bridge, which is 55 m long.</p>
<p>Source: JICA Study Team</p>

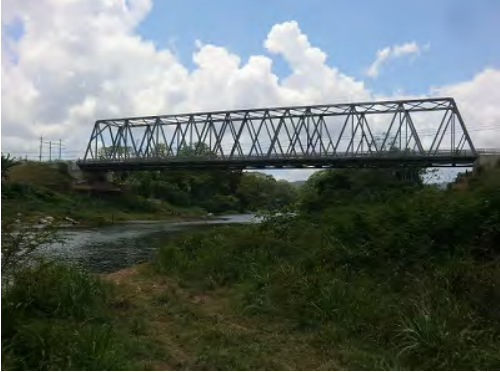
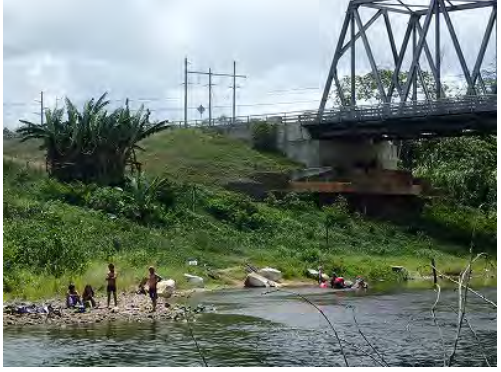
It is a steel girder bridge across the Sittee River which was constructed with the support of CDB and completed in November 2014 as shown in Figure 2.12.10. The old bridge constructed in 1975 was washed away during flood due to Tropical Storm Arthur in 2008. Taking this into consideration, the new bridge was raised by 3 m higher than the old bridge. The new bridge is 90 m long, and has 8 m wide vehicle lane and 1.3 m wide sidewalk.

<p>Date : April 4, 2015 12:18 PM  Outline : Steel truss bridge completed in November 2004 with CDB's support. The old bridge was washed away during Tropical Storm Arthur in 2008.</p>	<p>Date : April 04, 2015  Outline : Old bridge's abutment is left in front of the abutment of the new bridge protected by steel sheet piles and gabions. New bridge is raised by 3 m from the old one.</p>

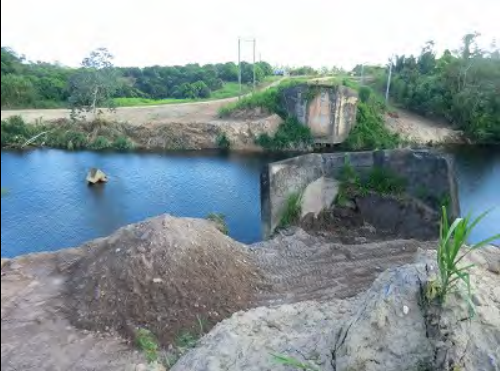
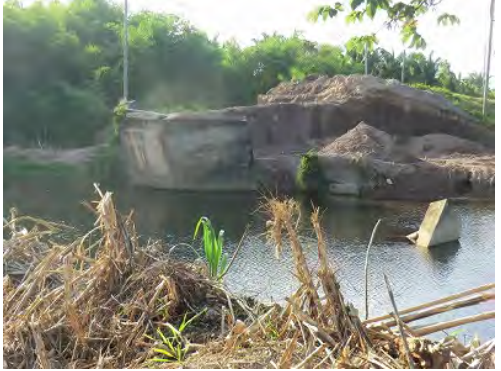
<p>Date : April 10, 2015  Outline : Most of the bridge structures were washed away except the abutment in the foreground of the photo. The bridge was broken during Tropical Storm Arthur in June 2008.</p>	<p>Date : April 10, 2015  Outline : Previous bridge with five piers was damaged due to many driftwoods caught in the piers.</p>

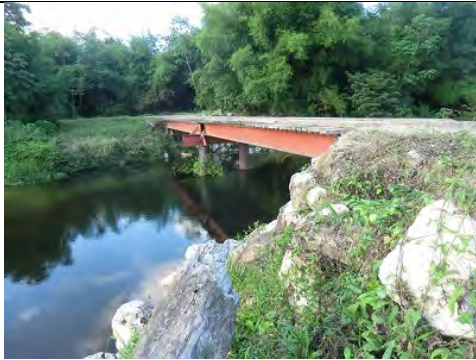
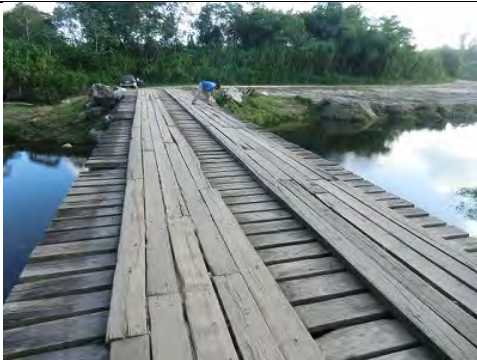
<p>Date : April 10, 2015  Site : Temporary bridge as detour of the original Mullin River Bridge  Outline : Temporary bridge which is about 21 m long and 3.5 m wide situated at the downstream side of the broken bridge.</p>	<p>Date : April 4, 2015  Site : Temporary bridge which is about 21 m long at the downstream side of the Rio Mullin River.</p>

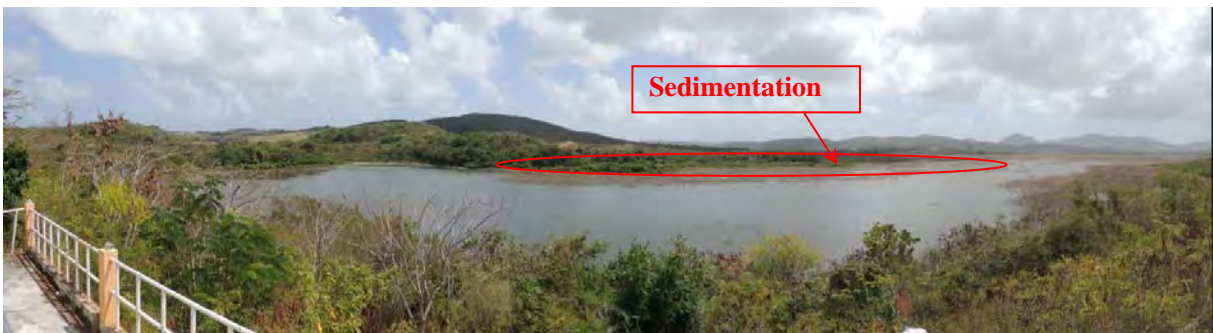
**Figure 3.1.1 Potwork Dam Reservoir**

There are several dams constructed in Antigua and Barbuda but not for flood control. The largest dam in the country is the Potwork Dam in Antigua Island. With 47 years had passed after its construction, the sedimentation problem becomes evident. The reservoir capacity is 4.5 million m<sup>3</sup> and dam operator is the Antigua Public Utility Authority (APUA). This serious sedimentation is supposed to be the reason for the shallow reservoir since about 50 years has already passed since its construction. Present situation of the Potworks Dam Reservoir is shown in Figure 3.1.1.

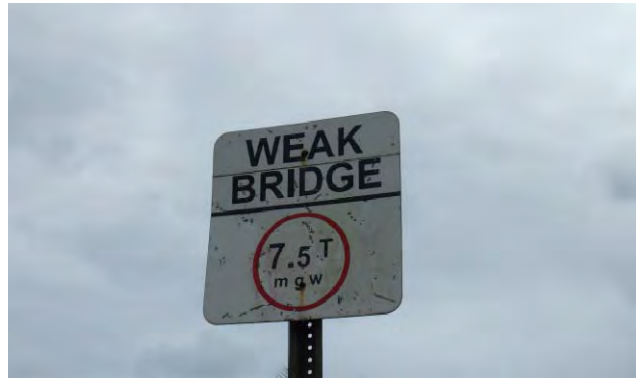
**Figure 3.1.3 Road Sign at the Banderz Bridge**

Another Banderz Bridge is located on the road, utilized as a detour to the main road, and to control the entry of heavy vehicles, a road sign is erected, as shown in Figure 3.1.3. According to the observation of the JICA Survey Team, frequent traffic was found during inspection, even though specific traffic volume was unknown, including trucks.

Considering the condition mentioned above, the Banderz Bridge, which is in use requires to be rehabilitated or reinforced.

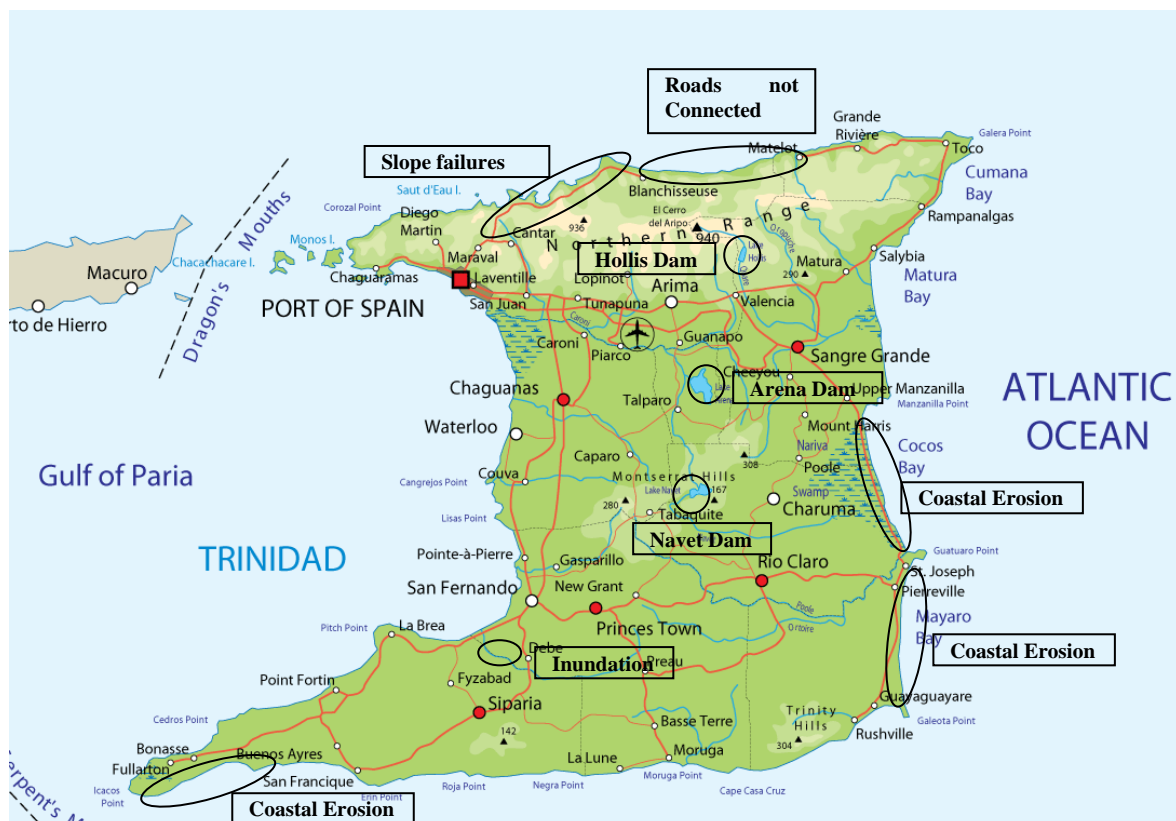
**Figure 3.10.1 Disaster Vulnerable Area in Trinidad and Tobago**

The present situation along the north coastal line is that the roads between Port of Spain and Blanchisseuse as well as between Toco and Matelot are separately available but no link road between Blanchisseuse and Matelot. Previously, Matelot was isolated due to interruptions on the road going to Matelot.
