## 2.8 Saint Lucia

## 3) Field Inspection and Confirmation of Site Condition

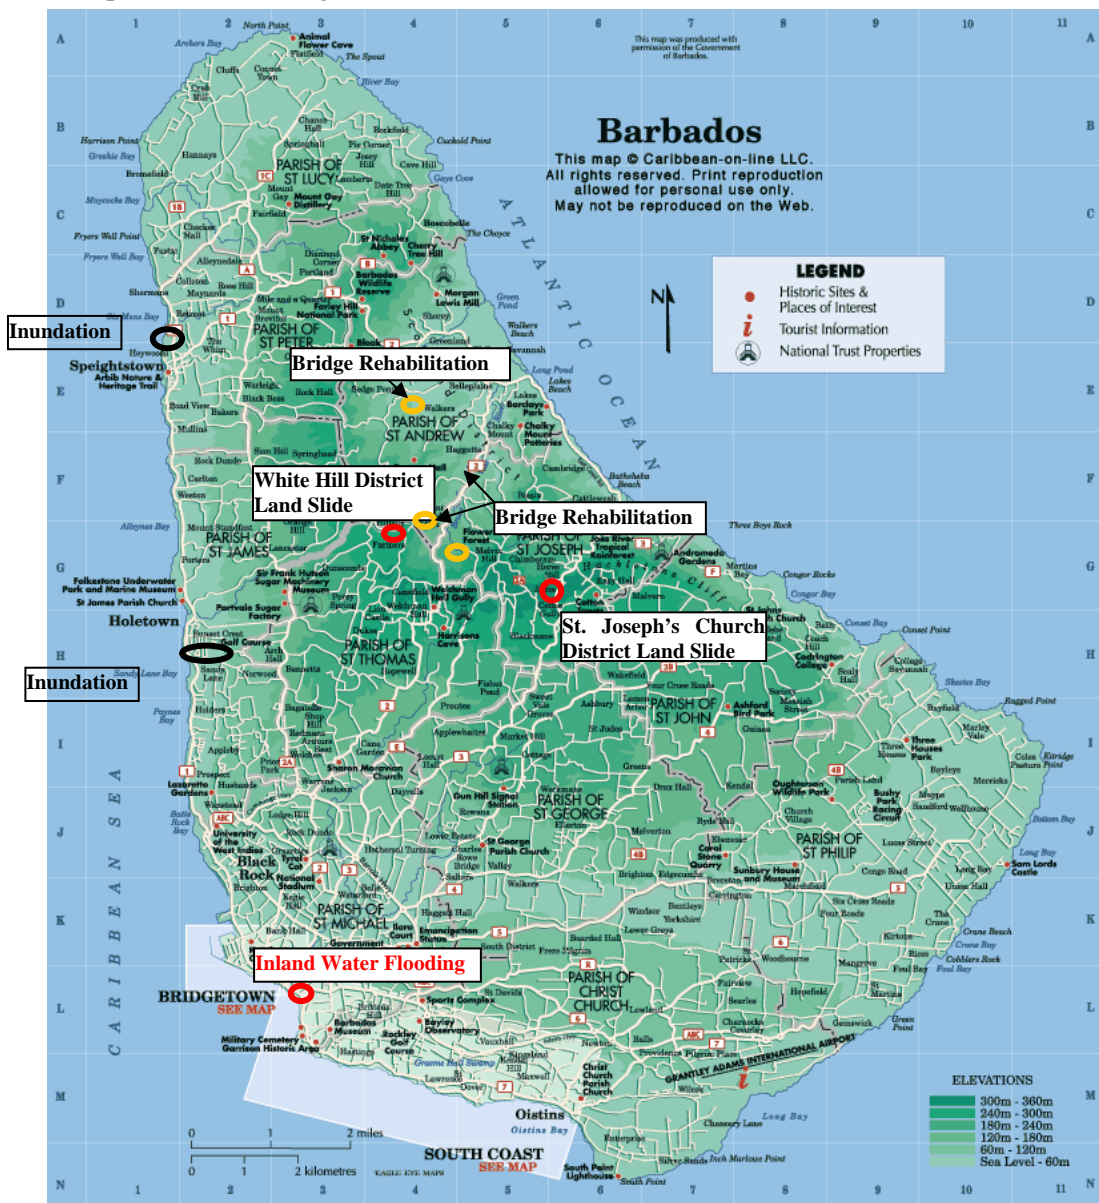
**Figure 3.11.1 Disaster Vulnerable Area in Barbados**

Damages are found in the abutments of two bridges on the trunk road No.2 in Scotland. It was temporarily reinforced by the H-beams but there is no plan for a bridge replacement. The trunk road No.8 is used as the land transportation route for the sand, for which there is a diversion route even though it is long detour.

There is damage in the Bawden's Bridge on the road, which is not a main one but used for a bus route. Traffic is suspended at the bridge site and another detour road is used for the bus route.
