## 7. 自然条件調査

### 7.1. 自然条件一般

## 7.1.2. 海象条件

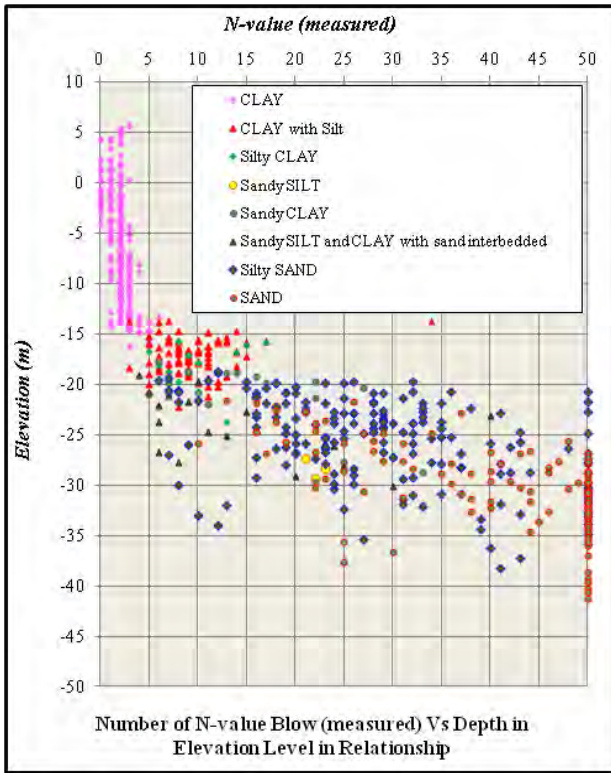
図 7.2-50 岸壁エリアの標準試験結果

各エリアの標準貫入試験結果について深度分布図を、図 7.2-50～図 7.2-53 に示す。

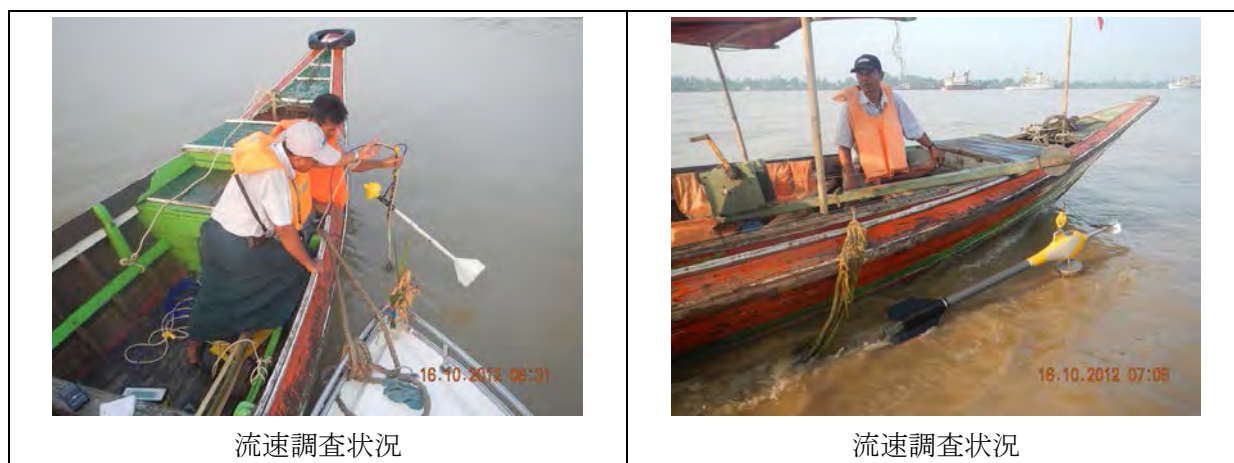
図 7.4-2 流速調査状況

- 潮位方向は、ほぼ南北に流れており、HWLを境に方向が180度変わる。

- 流速は、Down Stream で最大で 1.3m/s であった。
- 平均流速は、上中層で約 0.7m/s、下層で約 0.6m/s と少し遅い。
- 水温は、最高 29.20 度、最低 28.43 度と、ほとんど変わらない。

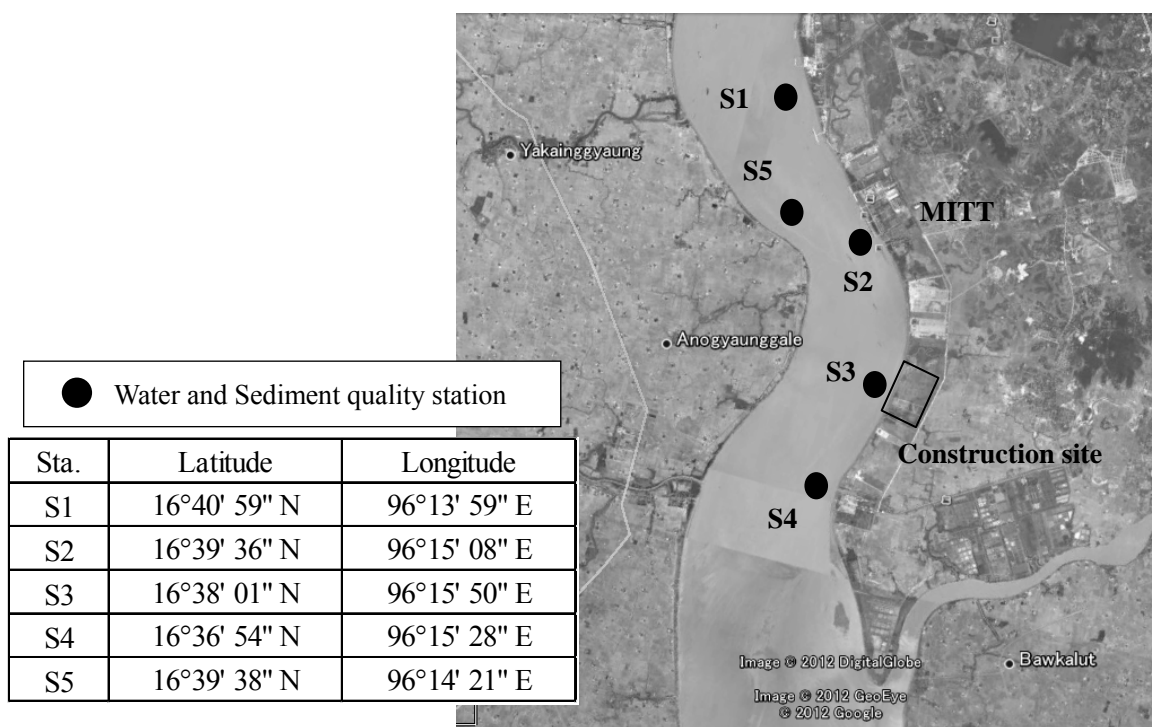
図 7.5-1 水質・底質調査地点

ティラワ地区港周辺の水質の状況を把握するために図 7.5-1 に示す地点において水質調査を実施した。水質調査は、2012年8月13日～15日にかけて干潮時に行った。測定項目は表 7.5-1 に示す通りであり、表層、底層（海底面上1m）の2層より採水後、分析を行った。分析方法は、水温は棒状温度計、塩分はセキスイデジタル塩分計 SS-31A（日本製）、pH はハンディ pH 計 pH6011（台湾製）、溶存酸素濃度（DO）はテストキット Aqua D.O.（タイ製）を用いて、採水後直ちに分析した。その他の項目はサンプルを分析機関に持ち込み、分析を行った。

測定地点の配置は、S1 は上流のバックグラウンド地点、S2 はティラワ地区港で稼働している MITT の前面、S3 は対象事業区域前面、S4 は下流のバックグラウンド地点、S5 は浚渫土砂の土捨て場として位置付けた。
