7. Natural Condition Survey

7.1. Outline of Myanmar's Natural Condition

Soil Investigation is carried out to obtain the necessary data and information used for the planning and design of Jetty, Yard, Channel and Offshore Pilot Station for the project. The work was performed by a local subcontractor. This report summarized the soil conditions based on the soil investigation results. The detailed result is described in the report submitted by a local subcontractor.

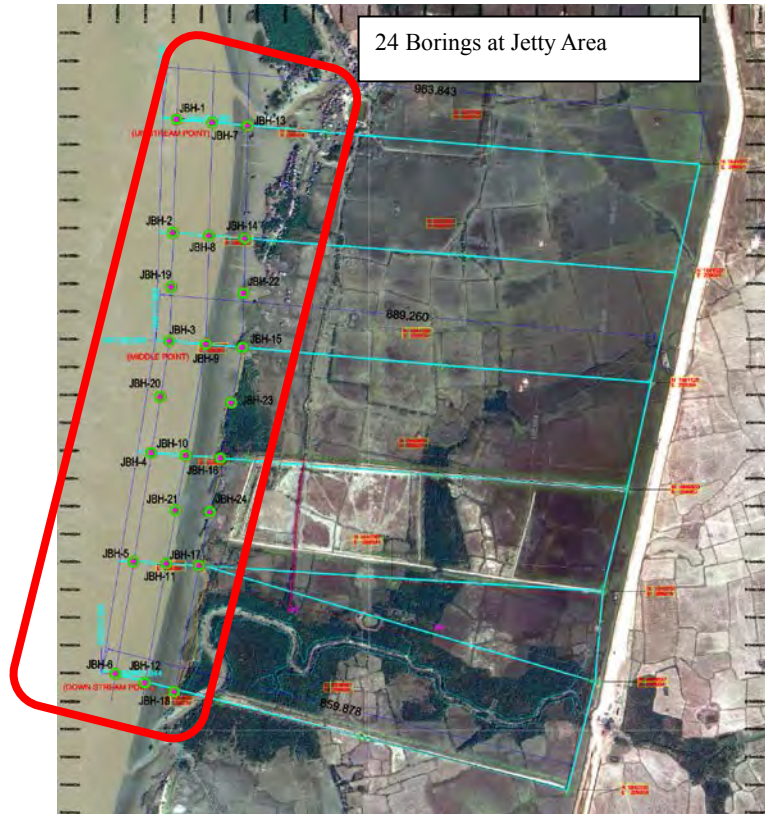
Figure 7.2-1 Location Map of Jetty Area

The location of the soil investigation is mainly divided in three (4) areas, Jetty area (Figure7.2-1), Yard area (Figure7.2-2), Channel and Offshore Pilot Station area (Figure7.2-3). For the work of Jetty area, SEP (Self Elevated Platform) is used for 18 points in water work, and land platform is used for remaining 6 points. For the work of Yard area, land platform is used for all points. For the work of Channel and Offshore Pilot Station area, SEP is used for all points.

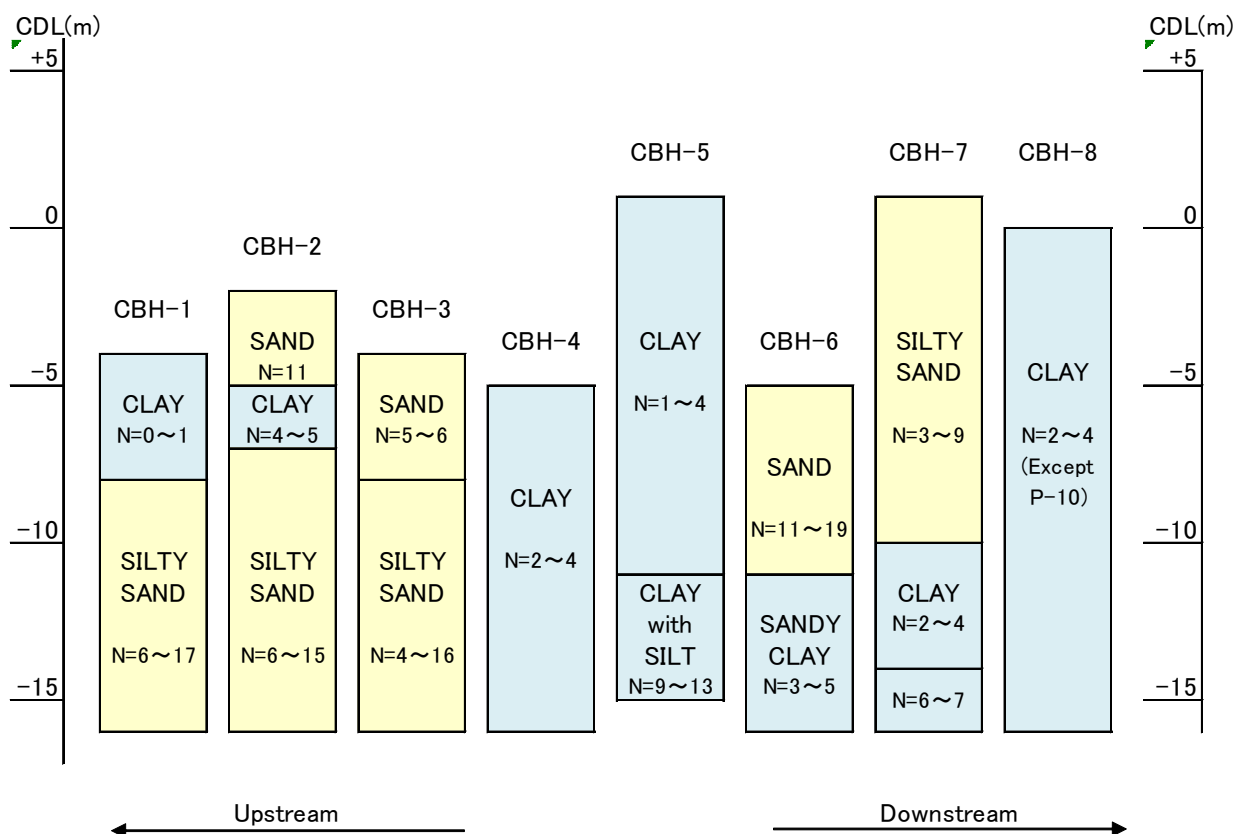
Figure 7.2-8 Schematic view of soil condition for Channel area

As shown in Figure7.2-8, the difference of ground height between the survey points is up to around 5m and soil composition of each point is also not uniformed. For a tendency, sand is deposited mainly at upstream side and clay is mainly deposited at downstream side.

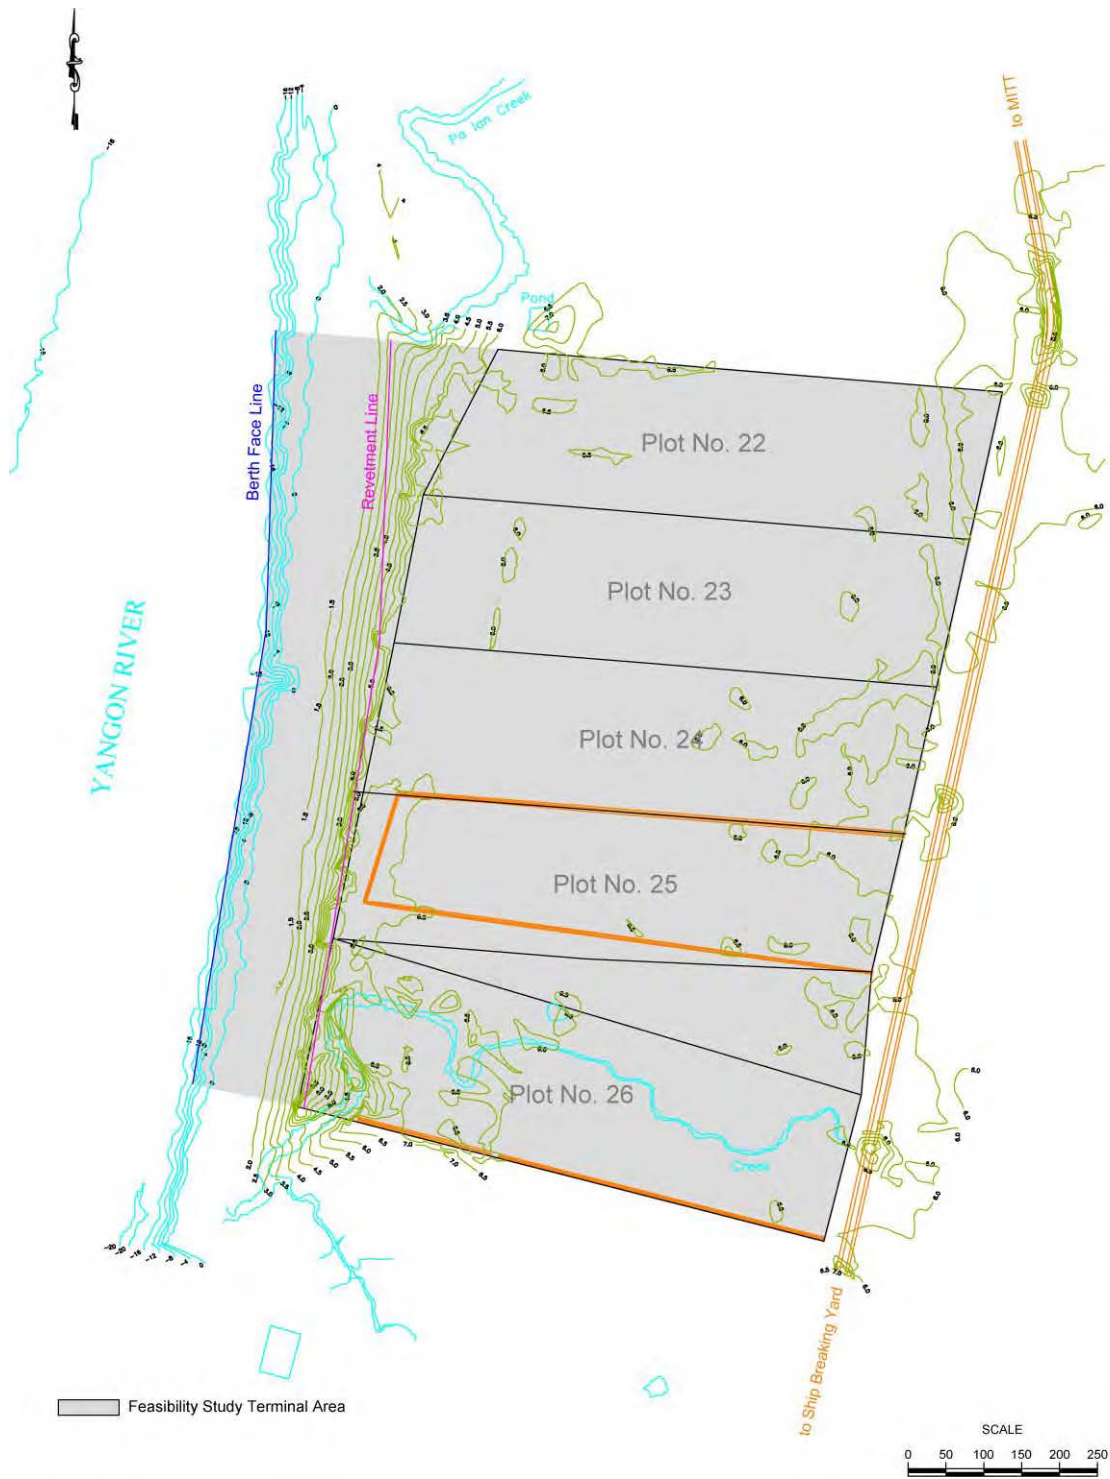
Figure 7.3-4 Topographic Map at Proposed Terminal Area

Line length parallel to the berth line from Plot No.22 to No.26 is around 1000m, line length perpendicular to the berth line from the river bank to existing road is around 1000m too. The total area is around 1.0km² (100 hectare = 250acres). The survey results are used for the confirmation of existing topographic conditions, study for earth filling, revetment design and others.

The average elevation at the Plot No.22 to 26 is around +6.0m CDL. It is around 2 meters lower than the backside road. Differential of the elevations in the area is not so much. Because of the poor drainage, the area is muddy marsh in the rainy season. Presently, there is a village of 600 residents at Plot No.20 to 23. (Details of the village are found in Chapter 5.4.) A creek flows at the Plot No. 21 and flows out from Plot No.22. There are rice paddies at the Plot No. 22 to 24. There are traces of land reclamation in 2011 at the Plot No.25. At the Plot No.26, another creek flows and the creek bank is surrounded by natural vegetation (refer to Figure 7.3-3, 7.3-4 and 7.3-7).
