***ANTHROPOLOGICAL SPECIAL STUDY
FOR RELATION BETWEEN PASTORALIST
COMMUNITIES AND THE PROJECT***

THE PROJECT FOR ENHANCING COMMUNITY RESILIENCE AGAINST DROUGHT IN NORTHERN KENYA

ANNEX C ANTHROPOLOGICAL SPECIAL STUDY FOR EXAMINING RELATION BETWEEN PASTORALIST COMMUNITIES AND THE PROJECT

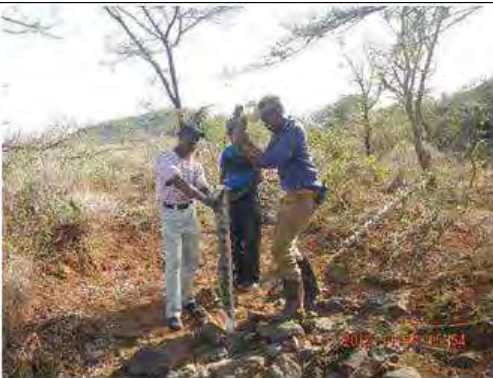
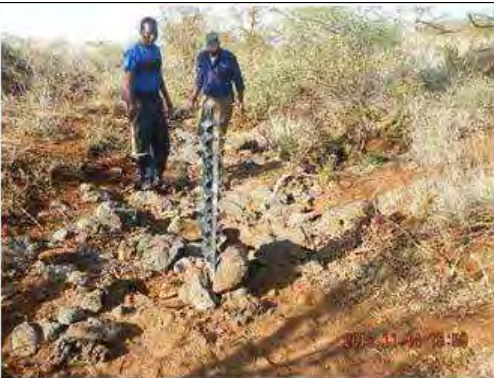
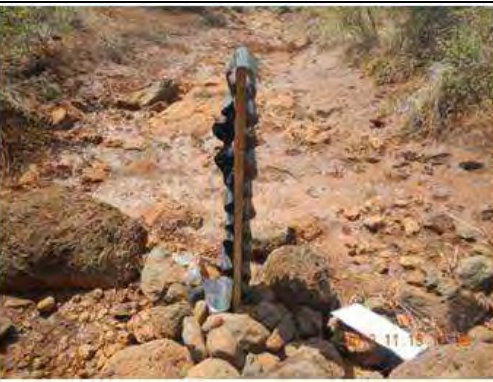
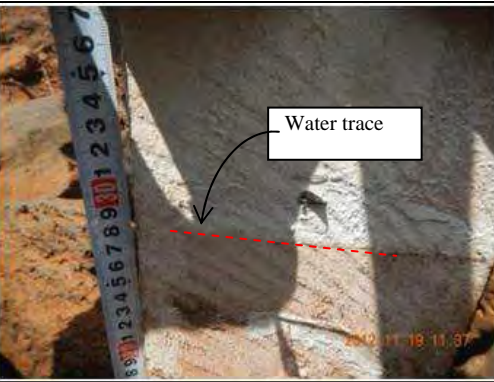
<p>Installation of water flow marking plate at proposed intake points of seasonal river :</p>	<p>Water flow marking plate installed :</p>

<p>Water mark investigation after installation : Five days after installation, water mark was confirmed</p>	<p>Water mark investigation after installation : From the mark, water depth in this runoff is 28 cm and discharge was estimated at 1.5m³/sec at maximum in that day with assumptions of .river width and gradient</p>

In addition to information from pastoralists who know the site conditions about pastures and water availability in the area, water flow condition was surveyed by installing water flow marking plates (wooden timber with white water-based paint and plastic cover) for selection of proposed sites of water pans

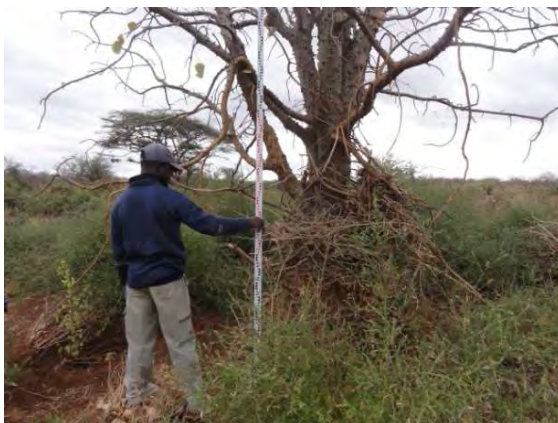
Figure AD2.4.1 Trace of Flood: Measuring Height of Flood Water

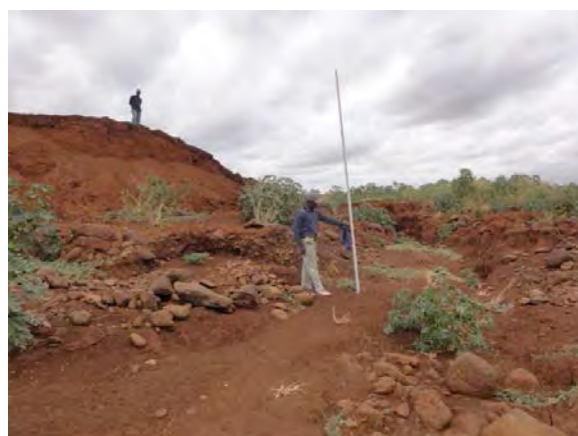
During the last rainy season, 2 water pans at Dololo Dokatu and Dadach Manchure had serious damages by scouring embankment and sedimentation in the water pans. Taking of the huge magnitude with 1/50-60 probability into consideration, such damages made by the flood were classified as force majeure.

The damages of pans occurred because 1) the flood was a huge magnitude with 1/50-60 probability, 2) it occurred during construction and some protecting facilities such as spillway, outlet channel, bank and so on were under construction.

Figure AD2.4.2 Damages by Scouring Dololo Dokatu Water Pan

The damages made by the flood were classified as force majeure in this case. And hence the additional works to repair and the original design was reviewed and modified to avoid future damage. The additional works included desilting of soil deposit in water pan and silt trap and an additional embankment and shaping. The design modification included

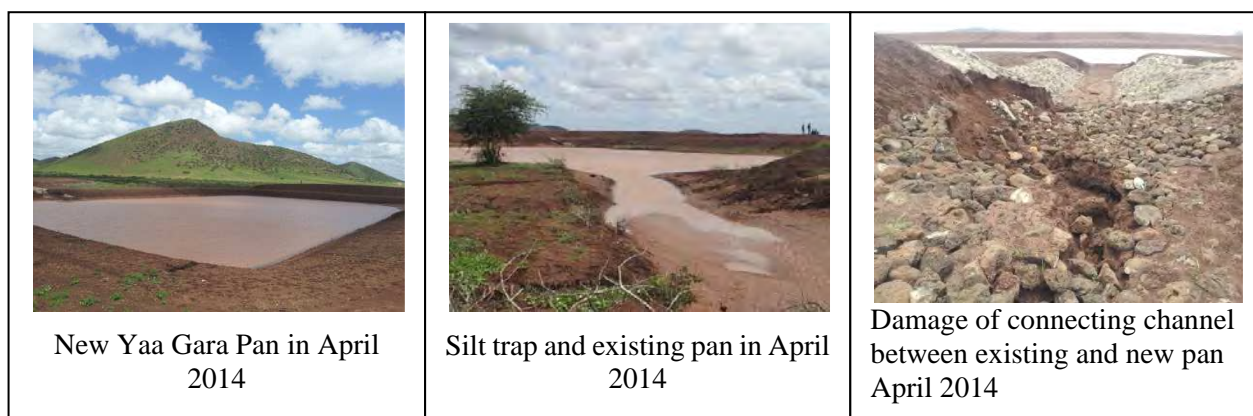
In the short rainy season in 2013, the Yaa Gara Water Pan did not hold water for livestock use, because large parts of Marsabit North Sub-county including Hurri Hills Location did not benefit from the short rains in November 2013. The newly constructed pan was however, half full in mid April, 2014 during the long rains. It was the only pan in Hurri Hills that collected good amounts of surface runoff. Further works was carried out at Yaa Gara pan in July 2014 to repair the inlet channel rip rap which had been destroyed by inflowing water

Figure AD2.5.2 Yaa Gara Water Pan during the Monitoring Period

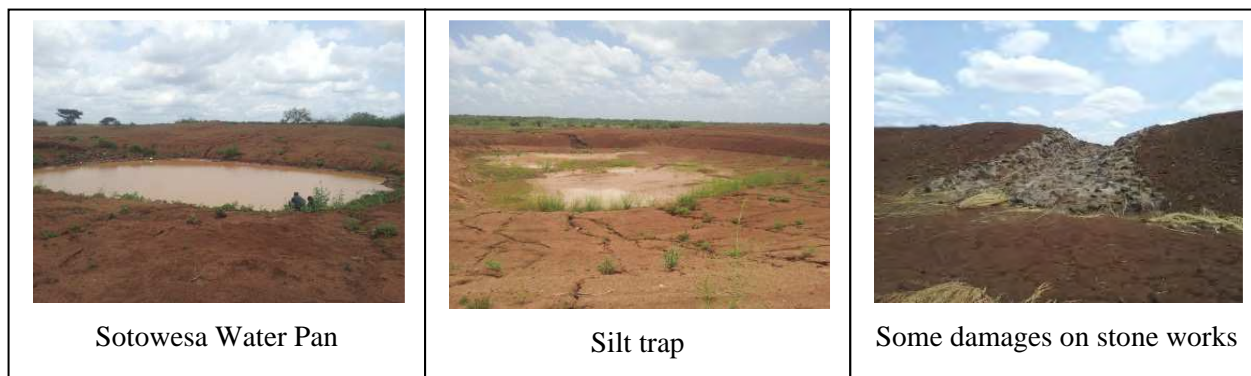
Construction Works of Sotowesa Water Pan was completed in February 2014 after suspension of the works by the long rains in 2013. The defects of the construction works such as damages to the stone

masonry rip rap in the inlet channel during the long rains in 2014 were repaired by the contractor in July 2014. During the short rains in 2014, the pan collected only limited runoff water due to the little rainfall in this area.

Figure AD2.5.3 Sotowesa Water Pan during the Monitoring Period

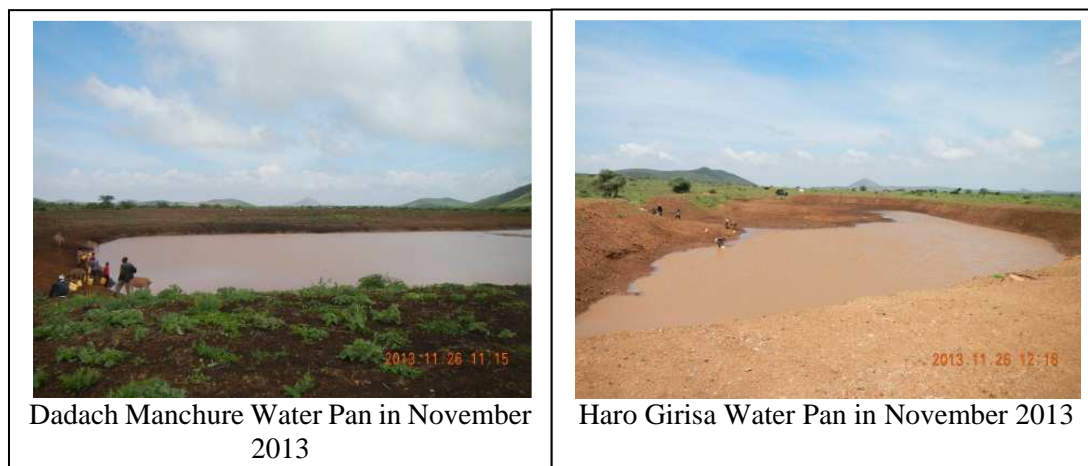
Dadach Manchure Water Pan has been satisfactory operated since the short rains in mid-November 2013. The pan received a little water during the rains in February and March 2014. During short rains in 2014, the community people reported that there was siltation on the connection channel from the silt trap and the main pan or any defects on correlation between the spillway level and bed elevation of connection channel, causing spilling out of the collected water.

Figure AD2.5.4 Dadach Manchure and Haro Girisa Water Pans during the Monitoring Period

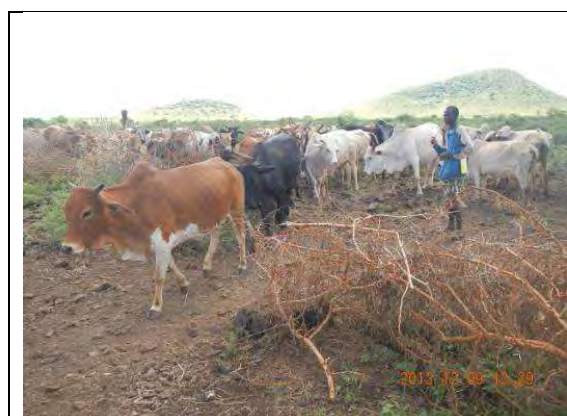
Figure AD2.7.4 Dadach Manchure Pan with Cattle: Cattle leave the pan after watering through a gate constructed with twigs. The twigs act as a deterrent to restrict access to the pan. It also allows for pan access from a single point.

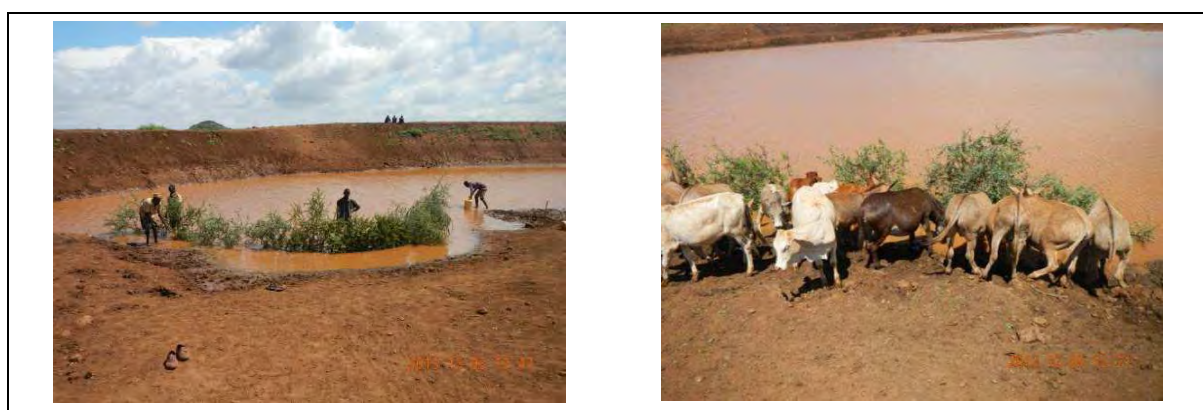
Figure AD2.7.5 Traditional Measures for Pan Management: Livestock drinking water from pan at the designated point cut off using ‘meer’, twigs to form a barrier to control livestock during watering.

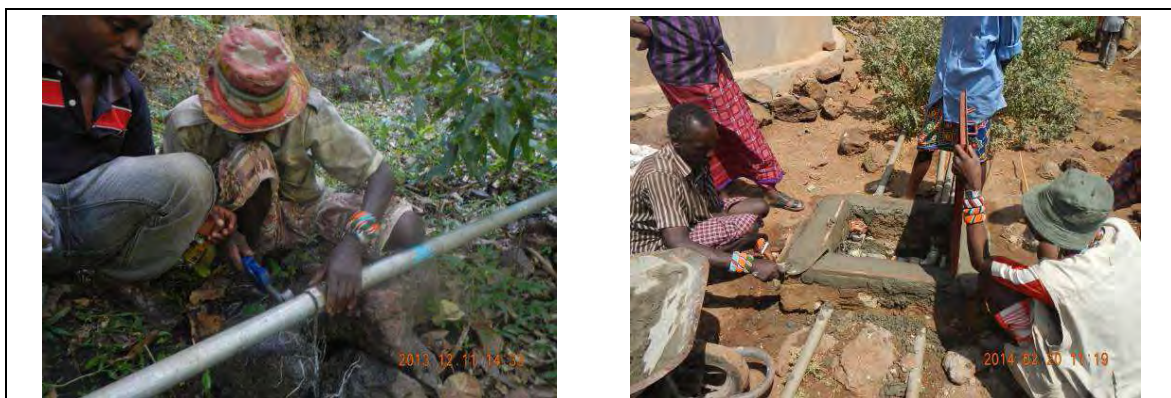
In spite of the less amount of fee collection, the committee has kept collecting from those who agreed and the collected fees, and has been utilised for general repairs of pipes that quite frequently occur. The fund has been mainly used for purchasing spare parts such as gate valves, air valves and some fitting like union joints, which were used to repair the parts especially where constantly vandalised by wild animals. Maintenance works were carried out by the Community with trained volunteer community member. Repairing work of fixing a leaking pipe was arranged with spare parts (unions) bought from their repair fund, and repairing of a manhole cover was also taken care with material (cement) bought with money from the community repair fund.

Figure AD3.5.2 *Maintenance Work by the Community*

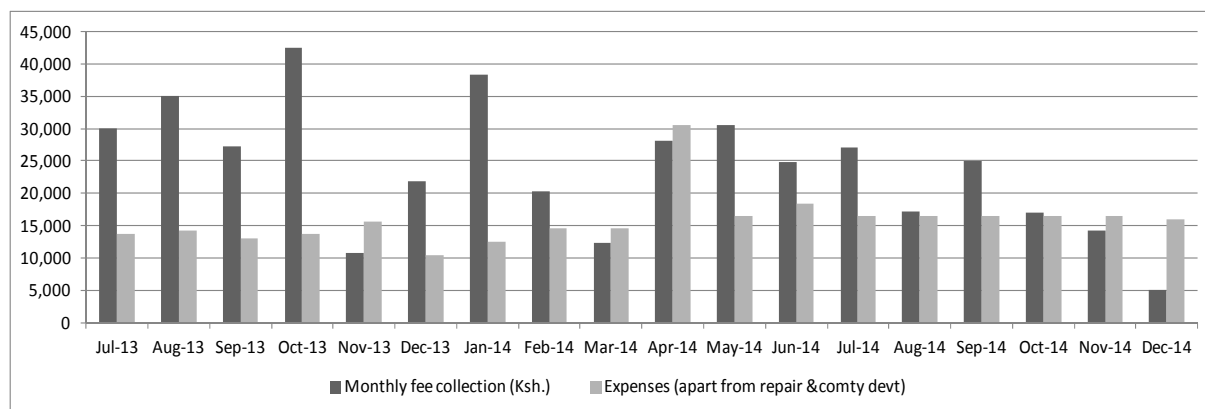
The following figure indicates the trend of income and expense of Gobore borehole. In order to assess the potential of savings as well as soundness of their operation, the expense of the following graph does not include maintenance and community development activity costs.

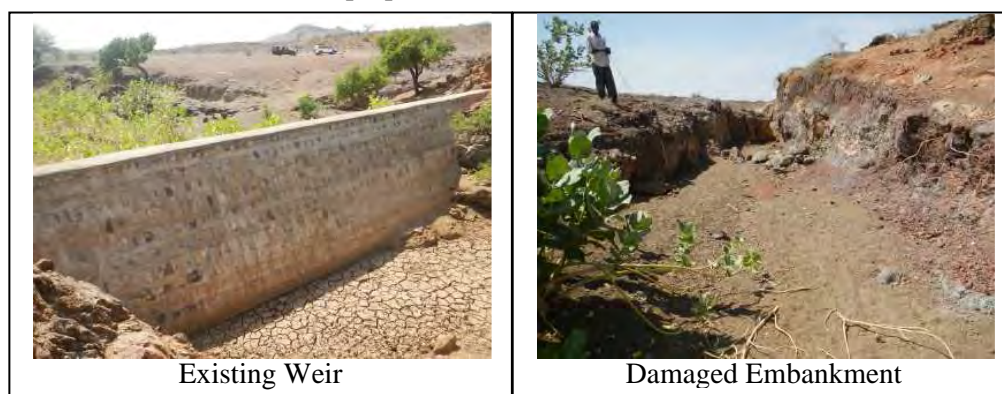
The sub-project aimed to improve the water supply conditions in Kangakipur area both for livestock and domestic water through rehabilitation of existing Nakipi Sand Dam that was constructed in year 2007 by the Lokitang Catholic Mission. The sand dam then was not functional as designed especially on the upper dam side due to heavy damages by flood overflow on the left bank. In Kangakipur Community, community managed disaster risk reduction (CMDRR) was conducted, and community action plans (CAPs) have been formulated. CAPs proposed rehabilitation of this sand dam.

Figure A8.1.1 Present Conditions of Nakipi Sand Dam

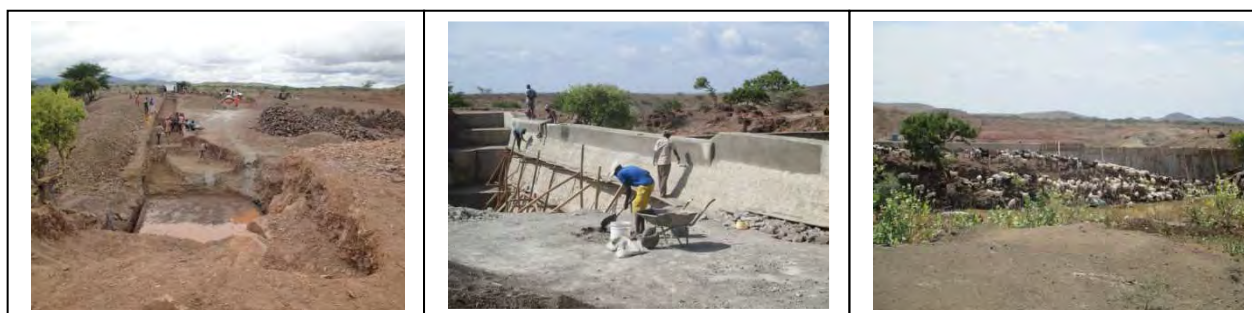
The works were commenced in August 2014. The sub-contract works of Nakipi Sand Dam were substantially completed and final inspection was also conducted by the project team to clarify outstanding works and minor defects to be rectified during the defects liability period in accordance with the conditions of sub-contract.

Figure AD8.3.1 Construction Photos of Nakipi Sand Dam
