5.3.1 現地簡易水質測定結果

5.3.2 現地水質測定状況

(1) ザガイン地域

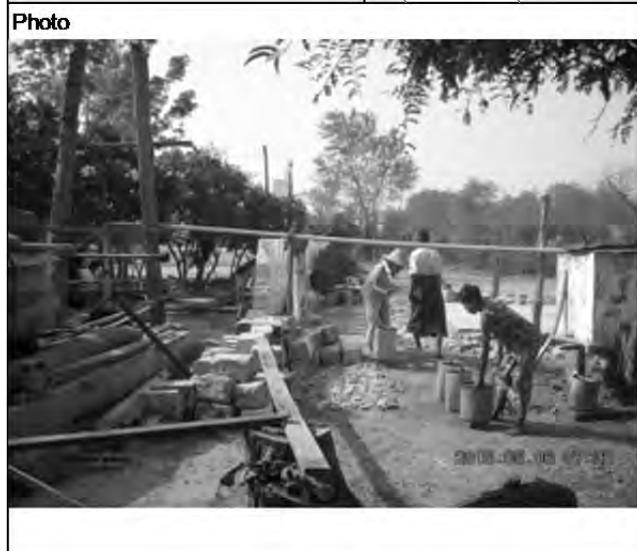
Information of Existing Water Sauce - 1				
Type	○ Deep Well		X	721184
	Shallow Well		Y	2468685
	Storage reservoir			
	Others			
Hydrogeological Information	Drilled Depth (m)	160	Sample ID	SA2-1-1
	Diameter (in)	6	Temperature (°C)	30.2
	S.W.L (m)	40	pH	7.95
	D.W.L (m)		EC (µs/cm)	1,230
	Yield (m³/hour)	5.5	Smell	Non
	No.of users (person/day)		Color	Non
	Supply facilities	Submergible pump	Mn (mg/l)	<0.02
	Remarks (Lithology , etc.)		Fe (mg/l)	<0.2
At the beginning of the operation Mono pump was used. However, submergible pump has installed now. Flat alluvial plane.		F (mg/l)	1.5	
		NO3- (mg/l)	20.0	
		NO2- (mg/l)	<0.02	
		Coliforms

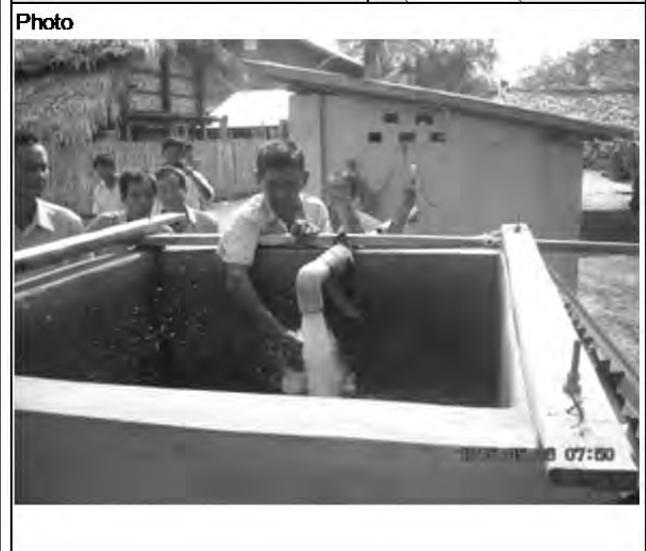
Information of Existing Water Sauce - 2				
Type	○ Deep Well		X	721013
	Shallow Well		Y	2468509
	Storage reservoir			
	Others			
Hydrogeological Information	Drilled Depth (m)	122	Sample ID	SA2-1-2
	Diameter (in)	2	Temperature (°C)	31.2
	S.W.L (m)	30	pH	8.13
	D.W.L (m)		EC (µs/cm)	1,425
	Yield (m³/hour)	3.6	Smell	Non
	No.of users (person/day)		Color	Non
	Supply facilities	Airlift	Mn (mg/l)	<0.02
	Remarks (Lithology , etc.)		Fe (mg/l)	<0.2
Constructed at 2007. Air lift pipe length 90m		F (mg/l)	0.2	
		NO3- (mg/l)	<1	
		NO2- (mg/l)	<0.02	
		Coliforms

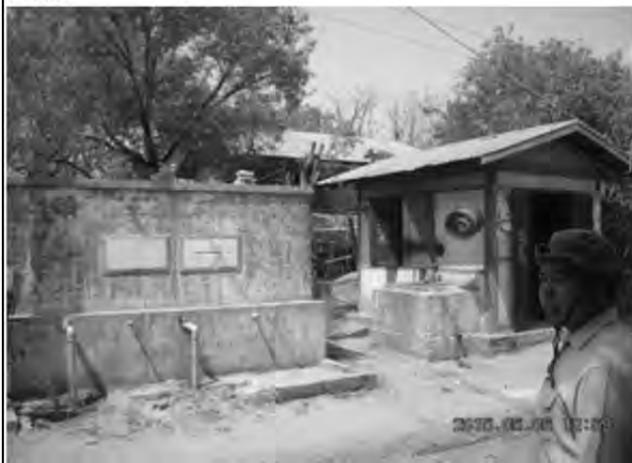
Photo

Information of Existing Water Sauce - 1				
Type	○ Deep Well		X	720877
	Shallow Well		Y	2486641
	Storage reservoir		/	
	Others			
Hydrogeological Information	Drilled Depth (m)	82	Sample ID	SA2-2-1
	Diameter (in)	2	Temperature (°C)	31.5
	S.W.L (m)	37	pH	7.84
	D.W.L (m)		EC (µs/cm)	1,475
	Yield (m ³ /hour)	3.6	Smell	Non
	No. of users (person/day)		Color	Non
	Supply facilities	Air lift	Mn (mg/l)	<0.02
	Remarks (Lithology, etc.)		Fe (mg/l)	<0.2
		F (mg/l)	0.4	
		NO3- (mg/l)	15.0	
		NO2- (mg/l)	<0.02	
		Coliforms

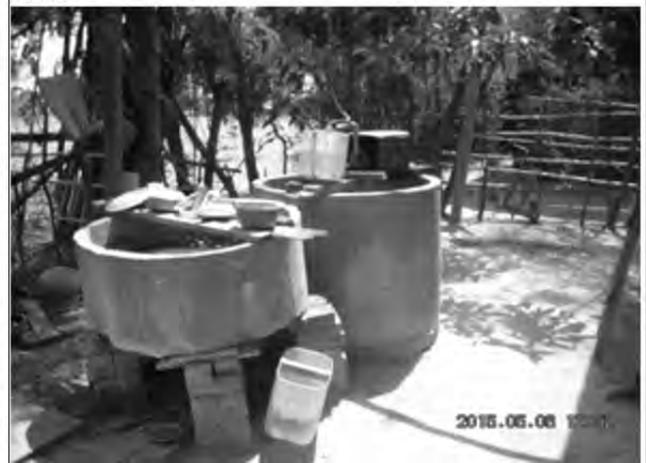
Photo

Information of Existing Water Sauce - 2				
Type	Deep Well		X	721015
	Shallow Well		Y	2486402
	Storage reservoir		/	
	○ Others Dug Well			
Hydrogeological Information	Drilled Depth (m)	6.0	Sample ID	SA2-2-2
	Diameter (in)	1.0m	Temperature (°C)	29.2
	S.W.L (m)	5.7	pH	7.58
	D.W.L (m)		EC (µs/cm)	2,470
	Yield (m ³ /hour)		Smell	Non
	No. of users (person/day)		Color	Non
	Supply facilities		Mn (mg/l)	<0.02
	Remarks (Lithology, etc.)		Fe (mg/l)	<0.2
SWL in rainy season is 2.7m Target : 7200885/2486381		F (mg/l)	0.4	
		NO3- (mg/l)	45.0	
		NO2- (mg/l)	0.1	
		Coliforms	Too much

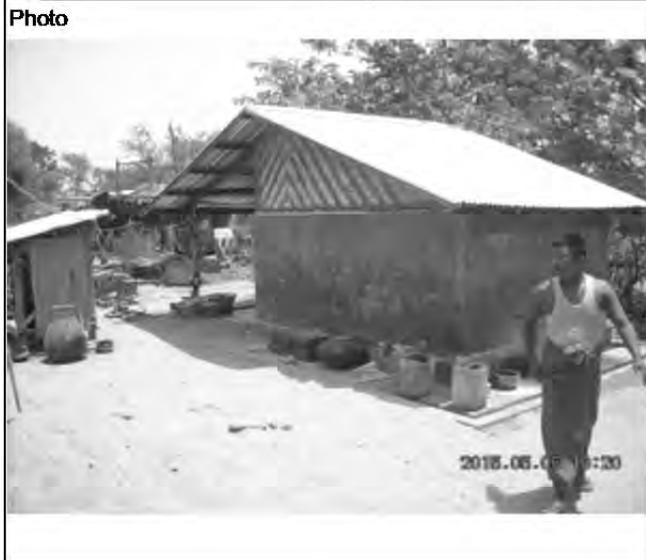
Information of Existing Water Source - 1					
Type	○ Deep Well	Coordinate	X	712929	
	Shallow Well		Y	2487787	
	Storage reservoir				
	Others				
Hydrogeological Information	Drilled Depth (m)	73	Sample ID	SA2-3-1	
	Diameter (in)	2	Temperature (°C)	30.0	
	S.W.L (m)	>30	pH	8.36	
	D.W.L (m)		EC (µs/cm)	2,610	
	Yield (m ³ /hour)	9.1	Smell	Non	
	No.of users (person/day)		Color	Non	
	Supply facilities	Airlift	Mn (mg/l)	<0.02	
	Remarks (Lithology , etc.)			Fe (mg/l)	<0.2
Irawagi Formation			F (mg/l)	0.8	
Private Well			NO3- (mg/l)	45<	
280 TW exist 5-6 hour one well			NO2- (mg/l)	<0.02	
				Coliforms	2.0

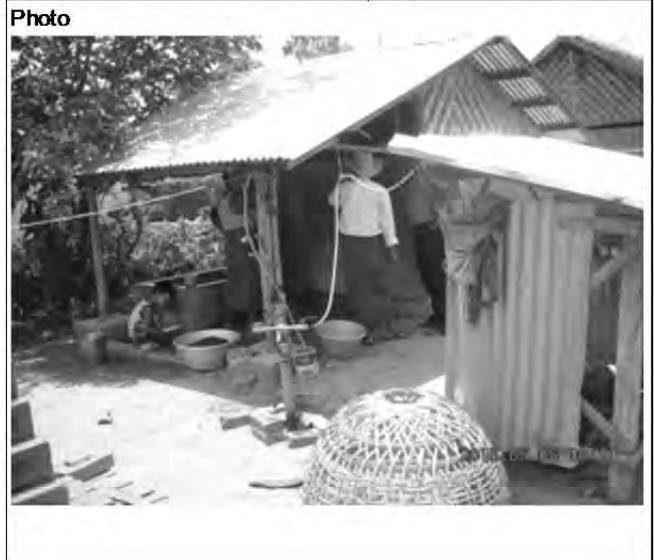
Information of Existing Water Source - 2					
Type	○ Deep Well	Coordinate	X	712889	
	Shallow Well		Y	2488508	
	Storage reservoir				
	Others				
Hydrogeological Information	Drilled Depth (m)	122	Sample ID	SA2-3-2	
	Diameter (in)	2	Temperature (°C)	30.3	
	S.W.L (m)	37	pH	7.95	
	D.W.L (m)		EC (µs/cm)	620	
	Yield (m ³ /hour)	3.6	Smell	Non	
	No.of users (person/day)		Color	Non	
	Supply facilities	Airlift	Mn (mg/l)	<0.02	
	Remarks (Lithology , etc.)			Fe (mg/l)	<0.2
No electricity when we visited, therefore we could not get fresh water. The sample got from resouivre tank.			F (mg/l)	0.2	
				NO3- (mg/l)	<1
				NO2- (mg/l)	<0.02
				Coliforms

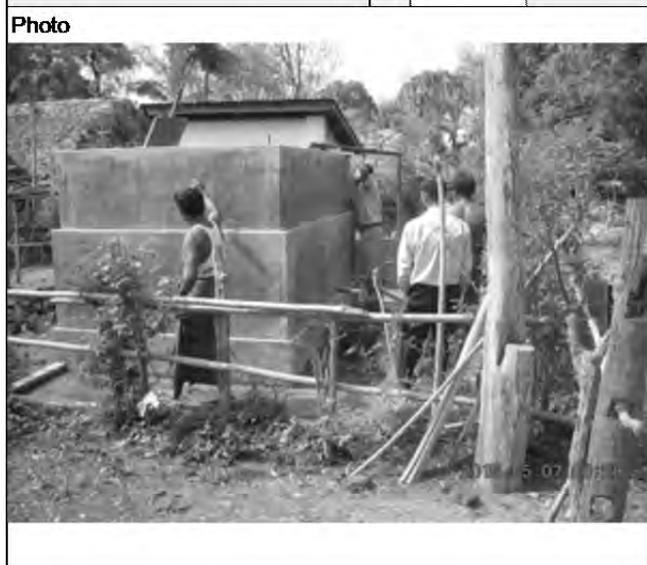
Information of Existing Water Source - 1				
Type	○ Deep Well	Coordinate	X	704411
	Shallow Well		Y	2487667
	Storage reservoir			
	Others			
Hydrogeological Information	Drilled Depth (m)	122	Sample ID	SA2-4-1
	Diameter (in)	2	Temperature (°C)	29.8
	S.W.L (m)	39	pH	8.14
	D.W.L (m)		EC (µs/cm)	534
	Yield (m ³ /hour)	5.5	Smell	Non
	No.of users (person/day)		Color	Non
	Supply facilities	Air lift	Mn (mg/l)	<0.02
	Remarks (Lithology , etc.)	Results of Simplified Water Quality Test		
Constructed in 2005 Public well	Fe (mg/l) <0.2			
	F (mg/l) 0.2			
	NO3- (mg/l) <1			
	NO2- (mg/l) <0.02			
	Coliforms

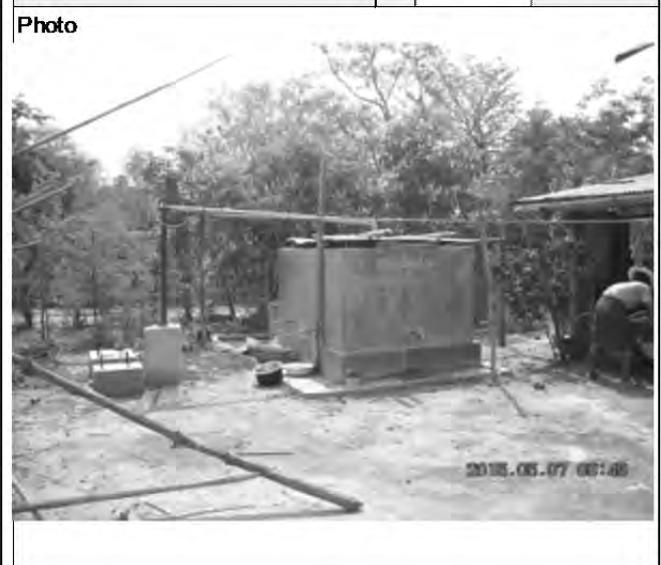
Information of Existing Water Source - 2				
Type	○ Deep Well	Coordinate	X	704202
	Shallow Well		Y	2487722
	Storage reservoir			
	Others			
Hydrogeological Information	Drilled Depth (m)	62.0	Sample ID	SA2-4-2
	Diameter (in)	2	Temperature (°C)	30.4
	S.W.L (m)	32	pH	8.12
	D.W.L (m)		EC (µs/cm)	663
	Yield (m ³ /hour)	3.6	Smell	Non
	No.of users (person/day)		Color	Non
	Supply facilities		Mn (mg/l)	<0.02
	Remarks (Lithology , etc.)	Results of Simplified Water Quality Test		
Constructed in 2013 Enough for drinking water, however total amount is not enough. 10 private TW(61 m ave)	Fe (mg/l) <0.2			
	F (mg/l) 0.6			
	NO3- (mg/l) 5.0			
	NO2- (mg/l) <0.02			
	Coliforms

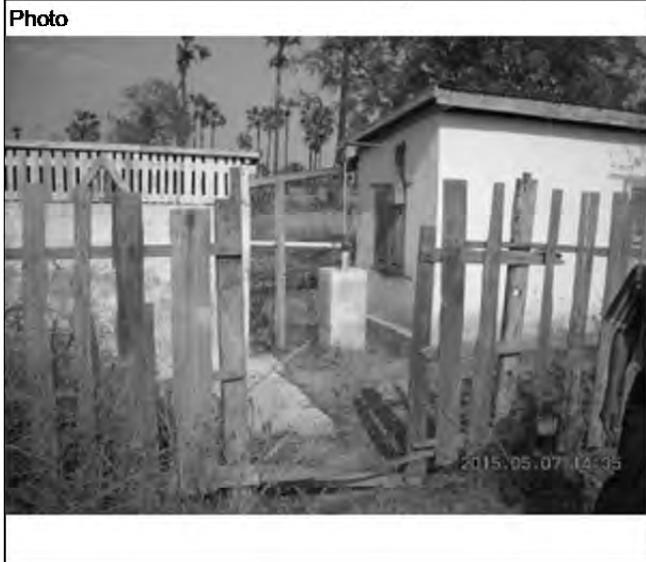
Information of Existing Water Source - 1				
Type	○ Deep Well		X	729667
	Shallow Well		Y	2470736
	Storage reservoir			
	Others			
Hydrogeological Information	Drilled Depth (m)	118	Sample ID	SA2-5-1
	Diameter (in)	4	Temperature (°C)	31.7
	S.W.L (m)	34	pH	7.91
	D.W.L (m)		EC (µs/cm)	628
	Yield (m ³ /hour)		Smell	Sulfur smell
	No.of users (person/day)		Color	Non
	Supply facilities		Mn (mg/l)	<0.02
	Remarks (Lithology , etc.)		Fe (mg/l)	<0.2
They could not drink. Target : 729874/2471014		F (mg/l)	0.6	
		NO3- (mg/l)	<1	
		NO2- (mg/l)	<0.02	
		Coliforms		
		Results of Simplified Water Quality Test

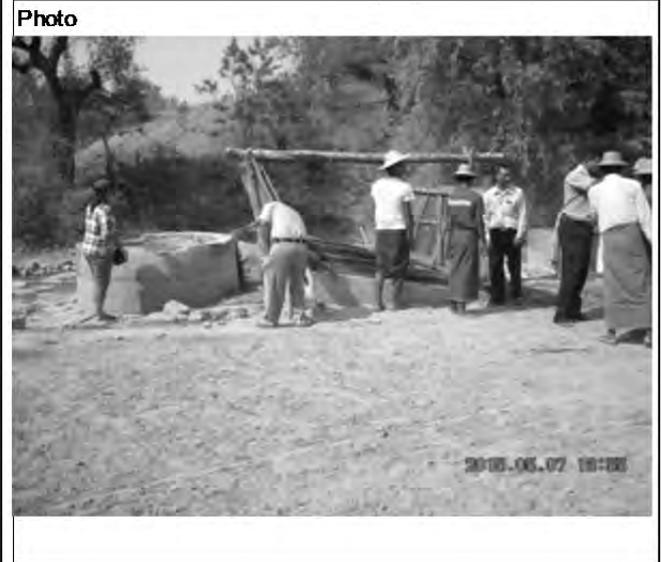
Information of Existing Water Source - 2				
Type	Deep Well		X	729835
	Shallow Well		Y	2471196
	Storage reservoir			
	○ Others <i>Dug Well</i>			
Hydrogeological Information	Drilled Depth (m)	12.5	Sample ID	SA2-5-2
	Diameter (in)	1.7m	Temperature (°C)	30.6
	S.W.L (m)	8.1	pH	7.34
	D.W.L (m)		EC (µs/cm)	1,136
	Yield (m ³ /hour)		Smell	Non
	No.of users (person/day)		Color	Non
	Supply facilities		Mn (mg/l)	<0.02
	Remarks (Lithology , etc.)		Fe (mg/l)	<0.2
		F (mg/l)	0.6	
		NO3- (mg/l)	5.0	
		NO2- (mg/l)	<0.02	
		Coliforms	0	
		Results of Simplified Water Quality Test

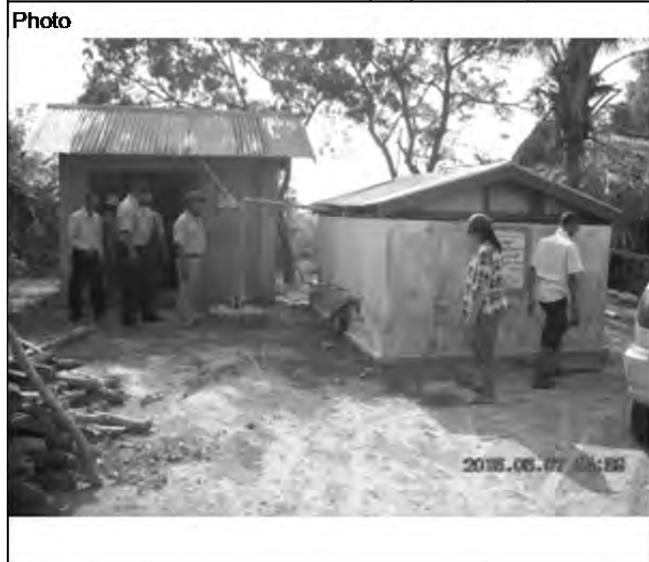
Information of Existing Water Source - 1					
Type	<input type="radio"/> Deep Well	Coordinate	X	729847	
	<input type="radio"/> Shallow Well		Y	2470770	
	<input type="radio"/> Storage reservoir				
	<input type="radio"/> Others				
Hydrogeological Information	Drilled Depth (m)	146	Results of Simplified Water Quality Test	Sample ID	SA2-5-3
	Diameter (in)	2		Temperature (°C)	
	S.W.L (m)	36		pH	
	D.W.L (m)			EC (µs/cm)	
	Yield (m³/hour)	4.1		Smell	
	No.of users (person/day)			Color	
	Supply facilities			Mn (mg/l)	
	Remarks (Lithology , etc.)	DRD constructed. More salty Cannot operate now.		Fe (mg/l)	
			F (mg/l)		
			NO3- (mg/l)		
			NO2- (mg/l)		
			Coliforms

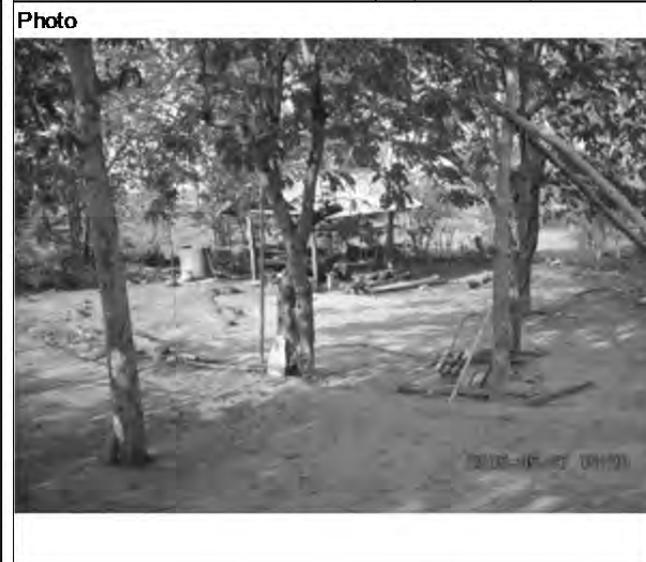
Information of Existing Water Source - 2					
Type	<input type="radio"/> Deep Well	Coordinate	X	732022	
	<input type="radio"/> Shallow Well		Y	2470662	
	<input type="radio"/> Storage reservoir				
	<input type="radio"/> Others				
Hydrogeological Information	Drilled Depth (m)	115	Results of Simplified Water Quality Test	Sample ID	SA2-5-4
	Diameter (in)	4		Temperature (°C)	31.1
	S.W.L (m)	28		pH	7.53
	D.W.L (m)			EC (µs/cm)	1,700
	Yield (m³/hour)			Smell	Non
	No.of users (person/day)			Color	Non
	Supply facilities	Airlift		Mn (mg/l)	<0.02
	Remarks (Lithology , etc.)	Twegi village's well. Almost top of the hill. In the monestry compound.		Fe (mg/l)	<0.2
			F (mg/l)	0.6	
			NO3- (mg/l)	<1	
			NO2- (mg/l)	<0.02	
			Coliforms

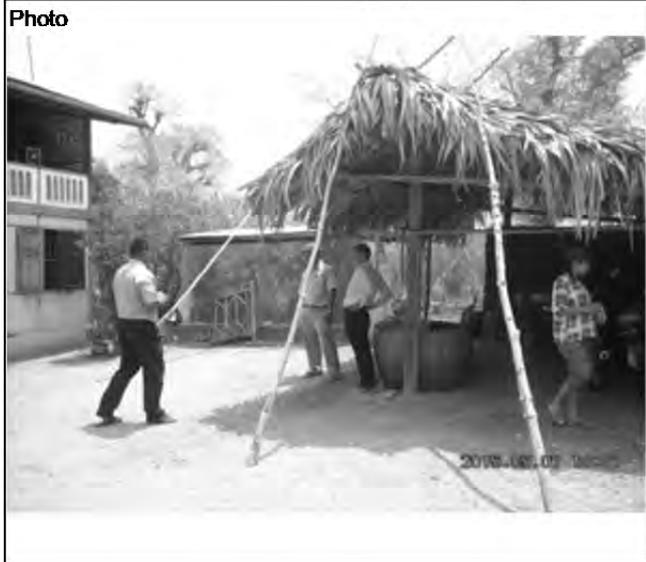
Information of Existing Water Source - 1					
Type	○ Deep Well		X	700719	
	Shallow Well		Y	2482574	
	Storage reservoir				
	Others				
Hydrogeological Information	Drilled Depth (m)	70	Sample ID	SA2-6-1	
	Diameter (in)	2	Temperature (°C)	30.3	
	S.W.L (m)	32	pH	7.94	
	D.W.L (m)		EC (µs/cm)	949	
	Yield (m ³ /hour)	4.5	Smell	Non	
	No.of users (person/day)		Color	Non	
	Supply facilities		Mn (mg/l)	<0.02	
	Remarks (Lithology, etc.)			Fe (mg/l)	<0.2
Private well 20 Airlift well (private) in this 3 years				F (mg/l)	0.8
				NO3- (mg/l)	30.0
				NO2- (mg/l)	<0.02
				Coliforms

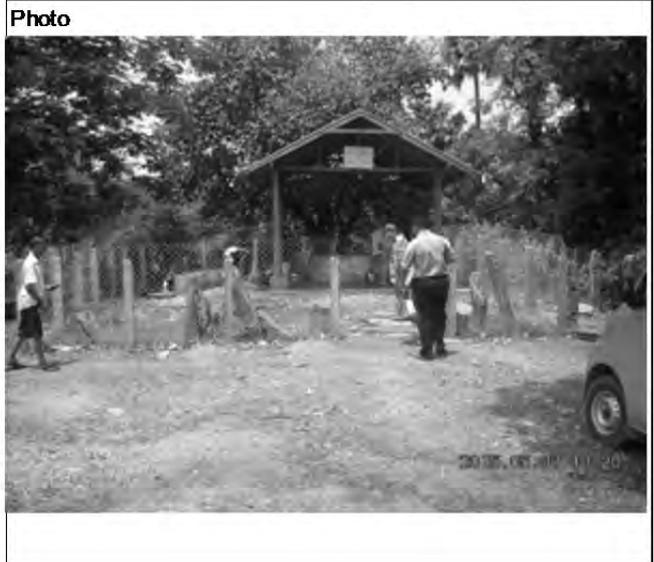
Information of Existing Water Source - 2					
Type	Deep Well		X	700290	
	Shallow Well		Y	2482117	
	Storage reservoir				
	○ Others <i>Dug Well</i>				
Hydrogeological Information	Drilled Depth (m)	9.1	Sample ID	SA2-6-2	
	Diameter (in)	1.4m	Temperature (°C)	28.6	
	S.W.L (m)	8.7	pH	7.04	
	D.W.L (m)		EC (µs/cm)	663	
	Yield (m ³ /hour)		Smell	Non	
	No.of users (person/day)		Color	Non	
	Supply facilities		Mn (mg/l)	<0.02	
	Remarks (Lithology, etc.)			Fe (mg/l)	<0.2
Use for drinking.				F (mg/l)	0.4
				NO3- (mg/l)	4.0
				NO2- (mg/l)	<0.02
				Coliforms	Too much

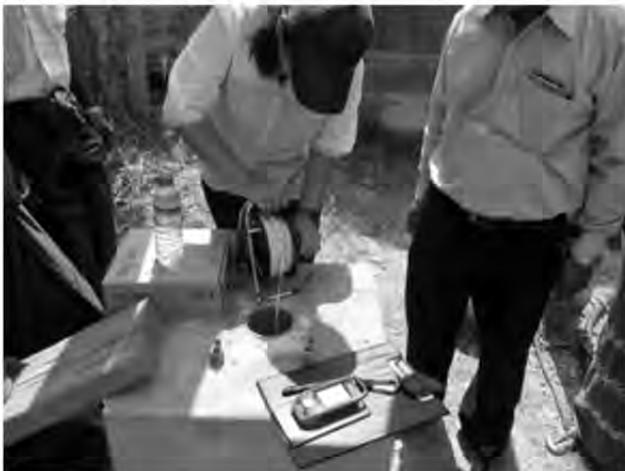
Photo

Information of Existing Water Sauce - 1				
Type	<input type="radio"/> Deep Well	Coordinate	X	742454
	<input type="radio"/> Shallow Well		Y	2430600
	<input type="radio"/> Storage reservoir			
	<input type="radio"/> Others			
Hydrogeological Information	Drilled Depth (m)	192	Sample ID	SA2-07-1
	Diameter (in)	4	Temperature (°C)	30.6
	S.W.L (m)	72.2	pH	8.68
	D.W.L (m)		EC (µs/cm)	1,224
	Yield (m³/hour)		Smell	Non
	No.of users (person/day)		Color	Non
	Supply facilities		Mn (mg/l)	<0.02
	Remarks (Lithology , etc.)		Fe (mg/l)	<0.2
			F (mg/l)	0.8
			NO3- (mg/l)	10.0
			NO2- (mg/l)	< 0.02
			Coliforms

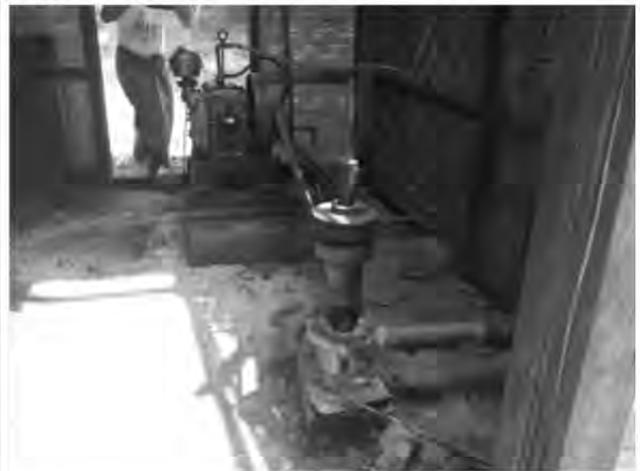
Photo

Information of Existing Water Sauce - 2				
Type	<input type="radio"/> Deep Well	Coordinate	X	742361
	<input type="radio"/> Shallow Well		Y	2430401
	<input type="radio"/> Storage reservoir			
	<input type="radio"/> Others			
Hydrogeological Information	Drilled Depth (m)	152	Sample ID	SA2-07-2
	Diameter (in)	6	Temperature (°C)	36.7
	S.W.L (m)	70	pH	7.52
	D.W.L (m)		EC (µs/cm)	1,245
	Yield (m³/hour)	11.4	Smell	Non
	No.of users (person/day)		Color	Non
	Supply facilities		Mn (mg/l)	<0.02
	Remarks (Lithology , etc.)		Fe (mg/l)	<0.2
			F (mg/l)	0.8
			NO3- (mg/l)	10.0
			NO2- (mg/l)	<0.02
			Coliforms

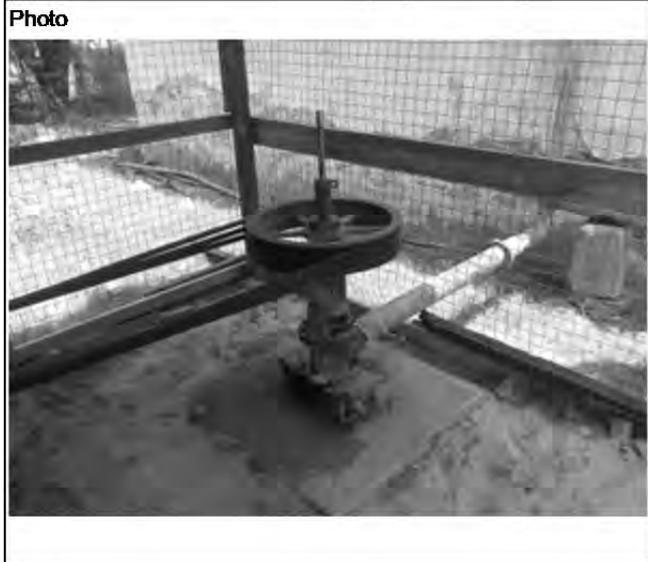
Information of Existing Water Source - 1						
Type	○ Deep Well		Coordinate	X	743872	
	Shallow Well			Y	2426840	
	Storage reservoir					
	Others					
Hydrogeological Information	Drilled Depth (m)	173	Results of Simplified Water Quality Test	Sample ID	SA2-08-1	
	Diameter (in)	6		Temperature (°C)	37.9	
	S.W.L (m)	61		pH	7.81	
	D.W.L (m)			EC (µs/cm)	2,820	
	Yield (m ³ /hour)	9.1		Smell	Non	
	No.of users (person/day)			Color	Non	
	Supply facilities			Mn (mg/l)	<0.02	
	Remarks (Lithology , etc.)			Fe (mg/l)	<0.2	
- Mono Pump system - They have another well. Unfortunately,solar pump system(80W x 30 panels) which is using Grundfos SQL pump has broken for a week. However, water amount is still no problem. -116m TW donated UNICEF in 2012, cannot operate cause of moter pump trouble		F (mg/l)	0.8			
		NO3- (mg/l)	<1			
		NO2- (mg/l)	< 0.02			
		Colifoms

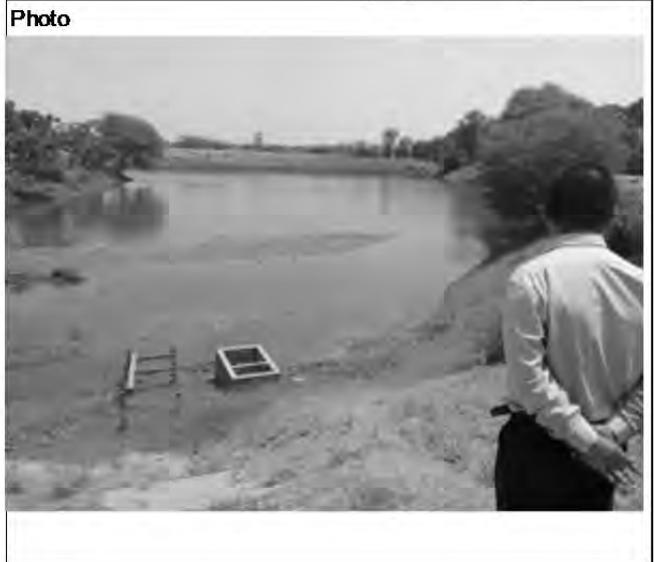
Information of Existing Water Source - 2						
Type	Deep Well		Coordinate	X	743809	
	Shallow Well			Y	2426699	
	○ Storage reservoir					
	Others					
Hydrogeological Information	Drilled Depth (m)		Results of Simplified Water Quality Test	Sample ID	SA2-08-2	
	Diameter (in)			Temperature (°C)	36.5	
	S.W.L (m)			pH	8.80	
	D.W.L (m)			EC (µs/cm)	311	
	Yield (m ³ /hour)			Smell	Non	
	No.of users (person/day)			Color	Shallow Yellow	
	Supply facilities			Mn (mg/l)	<0.02	
	Remarks (Lithology , etc.)			Fe (mg/l)	0.2	
Water taste is better than well, therefore many people use pond water for drinking. Target : 743821- 2426594		F (mg/l)	0.2			
		NO3- (mg/l)	<1			
		NO2- (mg/l)	<0.02			
		Colifoms	60<

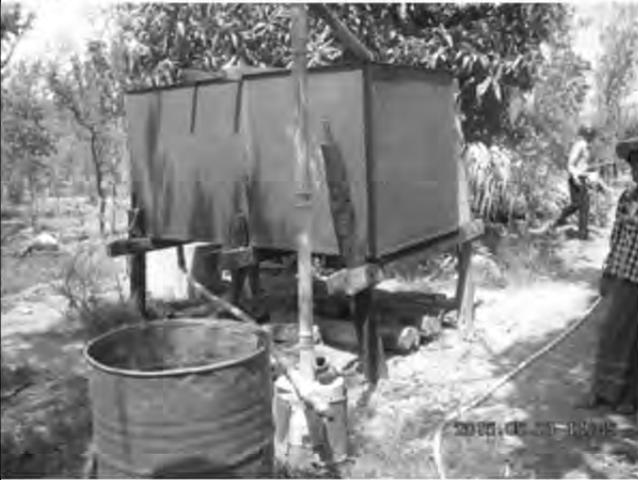
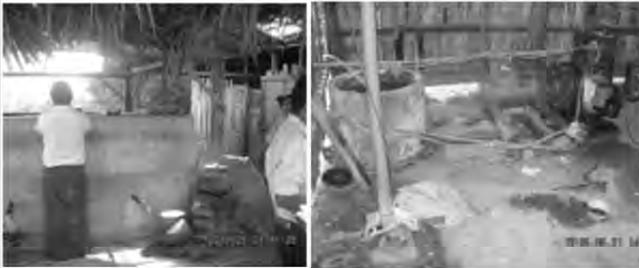
Information of Existing Water Source - 1					Information of Existing Water Source - 2						
Type	○ Deep Well		Coordinate	X	742923	Type	○ Deep Well		Coordinate	X	742829
	Shallow Well			Y	2472596		Shallow Well			Y	2472777
	Storage reservoir						Storage reservoir				
	Others						Others				
Hydrogeological Information	Drilled Depth (m)	97	Results of Simplified Water Quality Test	Sample ID	SA2-9-1	Hydrogeological Information	Drilled Depth (m)	102	Results of Simplified Water Quality Test	Sample ID	SA2-9-2
	Diameter (in)	4		Temperature (°C)	30.7		Diameter (in)	2		Temperature (°C)	31.8
	S.W.L (m)	42		pH	7.66		S.W.L (m)			pH	7.83
	D.W.L (m)			EC (µs/cm)	1,302		D.W.L (m)			EC (µs/cm)	648
	Yield (m³/hour)	4.5		Smell	Non		Yield (m³/hour)	4.5		Smell	Non
	No. of users (person/day)			Color	Non		No. of users (person/day)			Color	Non
	Supply facilities	Submersible pump		Mn (mg/l)	<0.02		Supply facilities	Air lift		Mn (mg/l)	<0.02

Remarks (Lithology, etc.)	Public well. 34 years ago it was constructed.		Fe (mg/l)	<0.2		Remarks (Lithology, etc.)	Target : 742840 / 2472680 Private Well (picture) Monastery well (96m)		Fe (mg/l)	<0.2
		F (mg/l)	0.6			F (mg/l)	0.2				
		NO3- (mg/l)	2.0			NO3- (mg/l)	1.0				
		NO2- (mg/l)	<0.02			NO2- (mg/l)	<0.02				
		Coliforms				Coliforms					
Photo					Photo

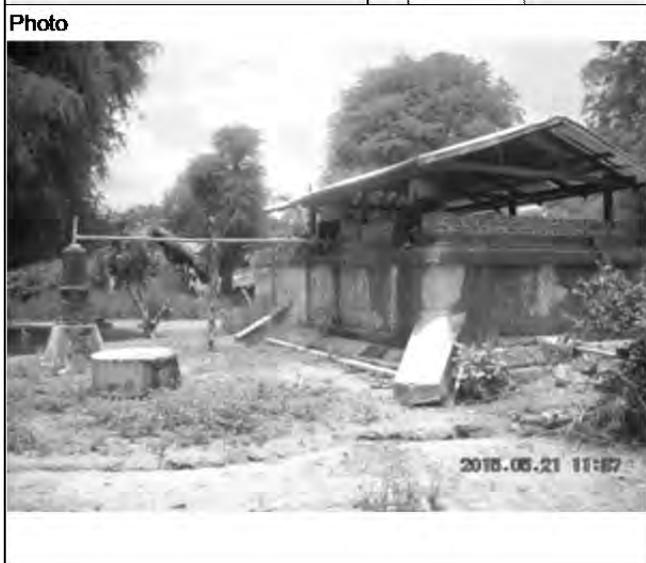
Information of Existing Water Source - 1				
Type	○ Deep Well	Coordinate	X	747982
	Shallow Well		Y	2482474
	Storage reservoir			
	Others			
Hydrogeological Information	Drilled Depth (m)	224	Sample ID	SA2-10-1
	Diameter (in)	2	Temperature (°C)	31.3
	S.W.L (m)	+3m	pH	7.05
	D.W.L (m)		EC (µs/cm)	861.0
	Yield (m ³ /hour)	350g/h	Smell	Non
	No.of users (person/day)		Color	Non
	Supply facilities	Artesian	Mn (mg/l)	<0.02
	Remarks (Lithology , etc.)		Results of Simplified Water Quality Test	
Water supplied to 100HH from this surface tank. 2 public well - 224m 2 private well - 91m (2015 constructed)s		Fe (mg/l)	<0.2	
		F (mg/l)	0.0	
		NO3- (mg/l)	<1	
		NO2- (mg/l)	<0.02	
		Coliforms

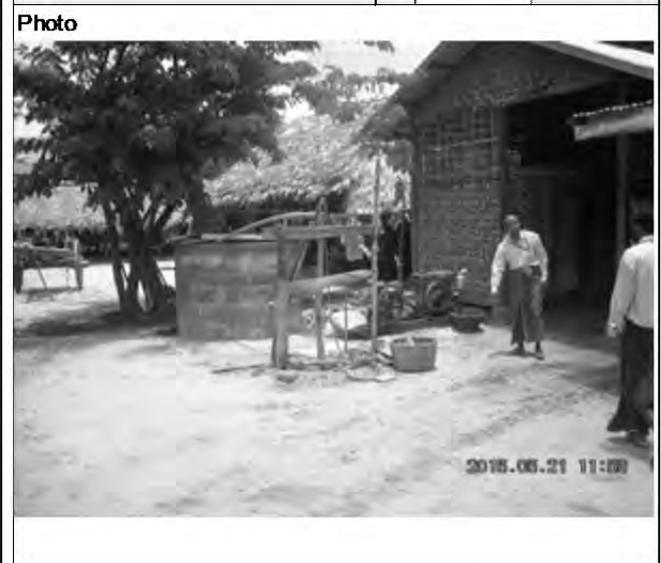
Information of Existing Water Source - 2				
Type	○ Deep Well	Coordinate	X	748057
	Shallow Well		Y	2482660
	Storage reservoir			
	Others			
Hydrogeological Information	Drilled Depth (m)	91	Sample ID	SA2-10-2
	Diameter (in)	2	Temperature (°C)	29.9
	S.W.L (m)	21	pH	8.13
	D.W.L (m)		EC (µs/cm)	1014.0
	Yield (m ³ /hour)	1200g/h	Smell	Non
	No.of users (person/day)		Color	Non
	Supply facilities	Air lift	Mn (mg/l)	<0.02
	Remarks (Lithology , etc.)		Results of Simplified Water Quality Test	
Target : 747838 / 2482552 0-61 m Fine sand 61m ~ Brown fine sand.		Fe (mg/l)	<0.2	
		F (mg/l)	0.2	
		NO3- (mg/l)	5.0	
		NO2- (mg/l)	<0.02	
		Coliforms

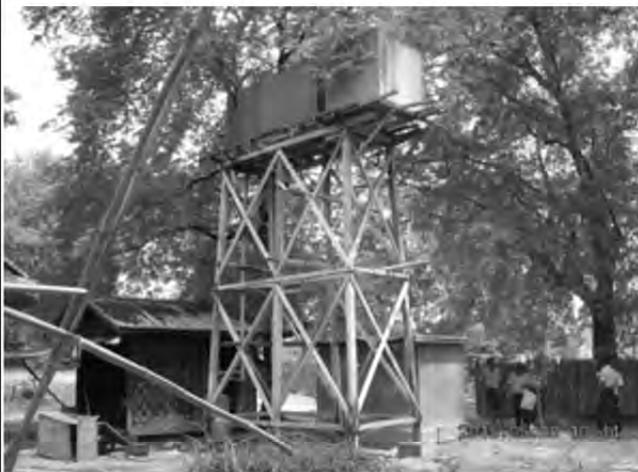
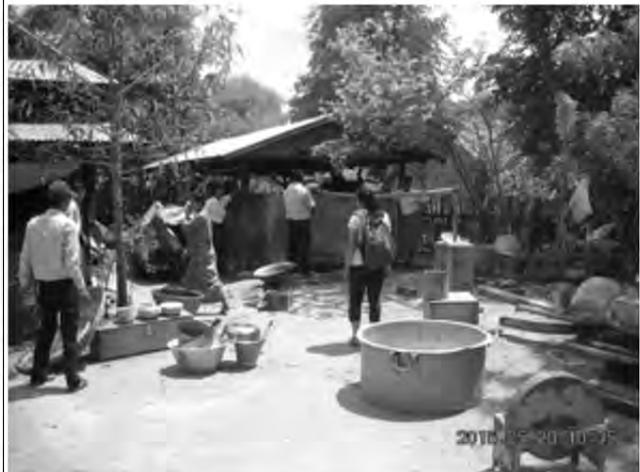
Information of Existing Water Source - 1				Information of Existing Water Source - 2					
Type	○ Deep Well		X	748212	Type	○ Deep Well		X	748297
	Shallow Well		Y	2458178		Shallow Well		Y	2458027
	Storage reservoir					Storage reservoir			
	Others								
Hydrogeological Information	Drilled Depth (m)	244	Sample ID	SA2-11-1	Hydrogeological Information	Drilled Depth (m)	61	Sample ID	SA2-11-2
	Diameter (in)	2	Temperature (°C)	30.6		Diameter (in)	2	Temperature (°C)	29.0
	S.W.L (m)	55	pH	7.64		S.W.L (m)	22	pH	7.67
	D.W.L (m)		EC (µs/cm)	920		D.W.L (m)		EC (µs/cm)	721
	Yield (m ³ /hour)	4.5	Smell	Non		Yield (m ³ /hour)	3.4	Smell	Non
	No.of users (person/day)		Color	Non		No.of users (person/day)		Color	Non
	Supply facilities	Air lift	Mn (mg/l)	<0.02		Supply facilities	Air lift	Mn (mg/l)	<0.02
	Remarks (Lithology , etc.)		Fe (mg/l)	<0.2		Remarks (Lithology , etc.)		Fe (mg/l)	<0.2
Donated by NGA MONO pump TW(1980) had broken		F (mg/l)	0.0	Private well Target : 748283/2458130		F (mg/l)	0.0

NO3- (mg/l)	5.0			NO3- (mg/l)	1.0		
		NO2- (mg/l)	<0.02			NO2- (mg/l)	<0.02		
		Coliforms				Coliforms

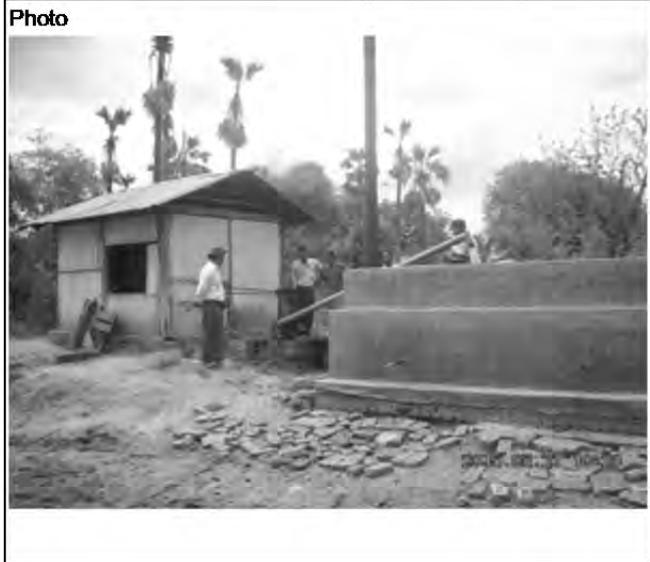
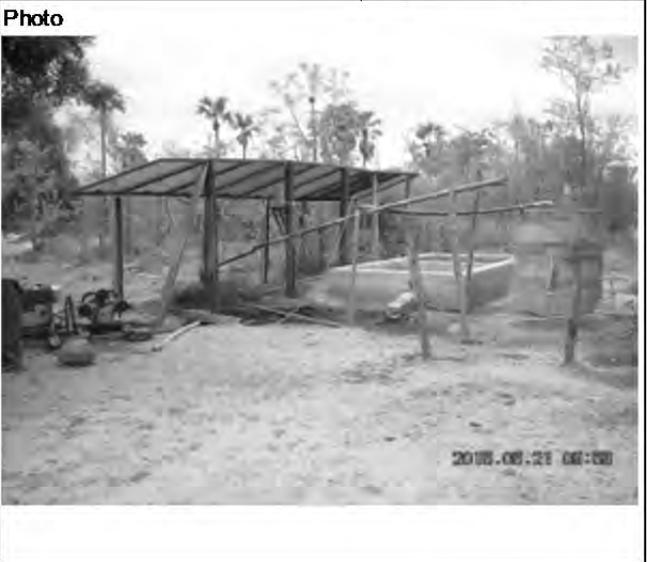
Information of Existing Water Source - 1					Information of Existing Water Source - 2						
Type	○ Deep Well		Coordinate	X	751008	Type	○ Deep Well		Coordinate	X	750726
	Shallow Well			Y	2470107		Shallow Well			Y	2470091
	Storage reservoir						Storage reservoir				
	Others						Others				
Hydrogeological Information	Drilled Depth (m)	97	Results of Simplified Water Quality Test	Sample ID	SA2-12-1	Hydrogeological Information	Drilled Depth (m)	305	Results of Simplified Water Quality Test	Sample ID	SA2-12-2
	Diameter (in)	6		Temperature (°C)	30.5		Diameter (in)	2		Temperature (°C)	30.9
	S.W.L (m)			pH	7.25		S.W.L (m)			pH	8.61
	D.W.L (m)			EC (µs/cm)	912		D.W.L (m)			EC (µs/cm)	1,155
	Yield (m³/hour)	31.8		Smell	Non		Yield (m³/hour)			Smell	Non
	No.of users (person/day)			Color	Non		No.of users (person/day)			Color	Non
	Supply facilities	Mono Pump		Mn (mg/l)	<0.02		Supply facilities	Air lift		Mn (mg/l)	<0.02

Remarks (Lithology , etc.)	Irrawaddi formation. 1 Mono pump well 97m 3 Airlift Well -305m : public - 97m :Monastery -97m : Private		Fe (mg/l)	<0.2		Remarks (Lithology , etc.)	Constructed in 2003. They hoped to get artesian well, however couldn't reach. Target : 750823 / 2470044		Fe (mg/l)	<0.2
			F (mg/l)	0.0				F (mg/l)	1.0		
			NO3- (mg/l)	<1				NO3- (mg/l)	<1		
			NO2- (mg/l)	<0.02				NO2- (mg/l)	<0.02		
			Coliforms					Coliforms

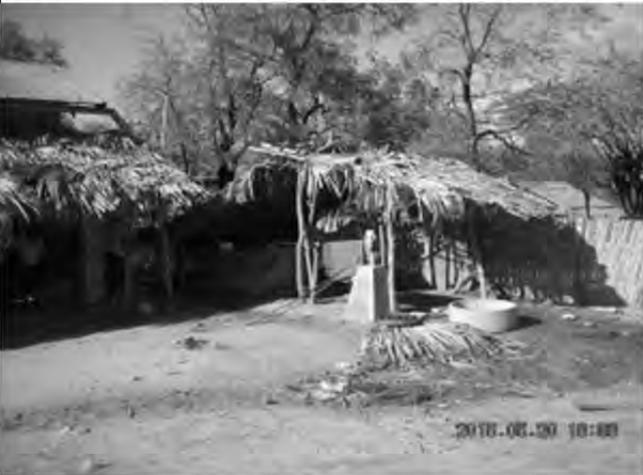
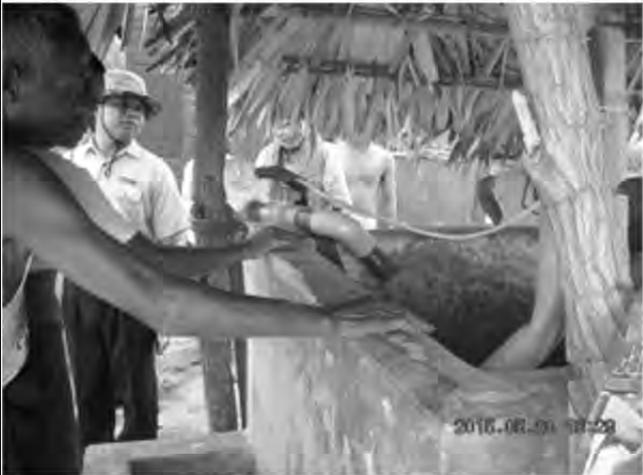
Information of Existing Water Source - 1					Information of Existing Water Source - 2						
Type	○ Deep Well		Coordinate	X	766191	Type	○ Deep Well		Coordinate	X	766062
	Shallow Well			Y	2449689		Shallow Well			Y	2449698
	Storage reservoir						Storage reservoir				
	Others						Others				
Hydrogeological Information	Drilled Depth (m)	182	Results of Simplified Water Quality Test	Sample ID	SA2-13-1	Hydrogeological Information	Drilled Depth (m)	61	Results of Simplified Water Quality Test	Sample ID	SA2-13-2
	Diameter (in)	2		Temperature (°C)	31.7		Diameter (in)	2		Temperature (°C)	31.7
	S.W.L (m)			pH	7.92		S.W.L (m)			pH	8.48
	D.W.L (m)			EC (µs/cm)	4,470		D.W.L (m)			EC (µs/cm)	1,253
	Yield (m³/hour)	5.5		Smell	Non		Yield (m³/hour)	2.7		Smell	Non
	No.of users (person/day)			Color	Non		No.of users (person/day)			Color	Non
	Supply facilities	Air lift		Mn (mg/l)	<0.02		Supply facilities	Air lift		Mn (mg/l)	<0.02

Remarks (Lithology , etc.)			Fe (mg/l)	<0.2		Remarks (Lithology , etc.)			Fe (mg/l)	<0.2
Q2 area. 107m TW (PDA)Cannot drink 60m~182mPrivate TW (total 28TWs) Shallow well's water quality is better than deep one.		F (mg/l)	0.8	Private Well Target- 766166/2449638		F (mg/l)	0.6				
		NO3- (mg/l)	<1			NO3- (mg/l)	2.0				
		NO2- (mg/l)	<0.02			NO2- (mg/l)	<0.02				
		Coliforms				Coliforms					
Photo					Photo

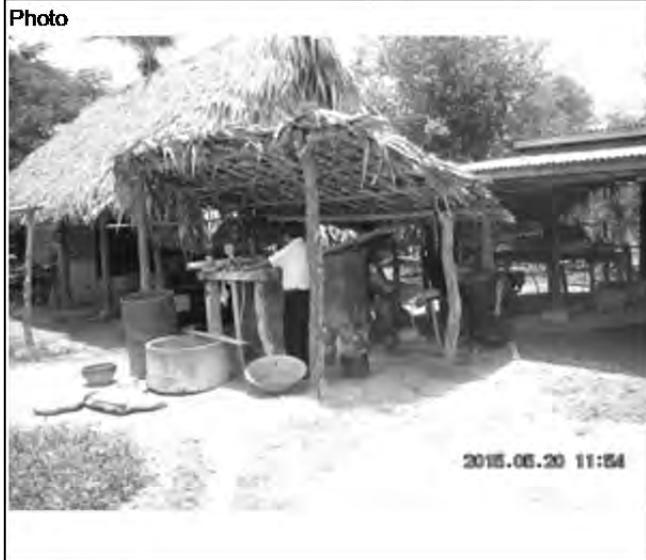
Information of Existing Water Source - 1				
Type	○ Deep Well	Coordinate	X	751681
	Shallow Well		Y	2457462
	Storage reservoir			
	Others			
Hydrogeological Information	Drilled Depth (m)	115	Sample ID	SA2-14-1
	Diameter (in)	2	Temperature (°C)	29.6
	S.W.L (m)		pH	7.50
	D.W.L (m)		EC (µs/cm)	731
	Yield (m ³ /hour)	>4.5	Smell	Non
	No.of users (person/day)		Color	Non
	Supply facilities	Air lift	Mn (mg/l)	<0.02
	Remarks (Lithology , etc.)	Irrawaddi formation. Mostly sandy soil. Private 6 TW (107-137m) Shallow 28 well (All private)		Fe (mg/l)
			F (mg/l)	0.0
			NO3- (mg/l)	<1
			NO2- (mg/l)	<0.02
			Coliforms

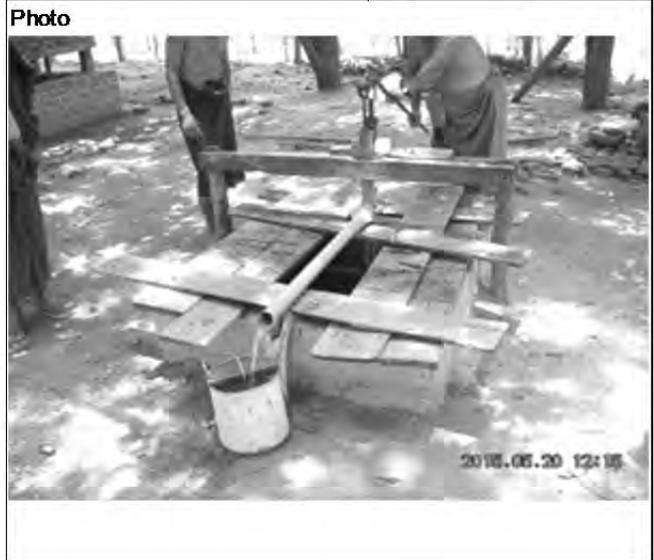
Information of Existing Water Source - 2				
Type	Deep Well	Coordinate	X	751521
	○ Shallow Well		Y	2457542
	Storage reservoir			
	Others			
Hydrogeological Information	Drilled Depth (m)	30	Sample ID	SA2-14-2
	Diameter (in)		Temperature (°C)	28.7
	S.W.L (m)	7.6m<	pH	7.04
	D.W.L (m)		EC (µs/cm)	954
	Yield (m ³ /hour)		Smell	Non
	No.of users (person/day)		Color	Non
	Supply facilities	Suction pump	Mn (mg/l)	<0.02
	Remarks (Lithology , etc.)	Coner of the school area Target : 751516/ 2457534		Fe (mg/l)
			F (mg/l)	0.2
			NO3- (mg/l)	5.0
			NO2- (mg/l)	<0.02
			Coliforms	Too much

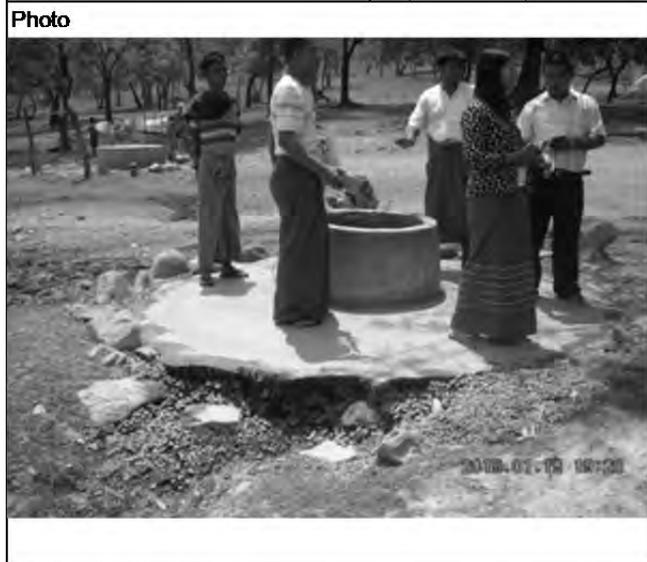
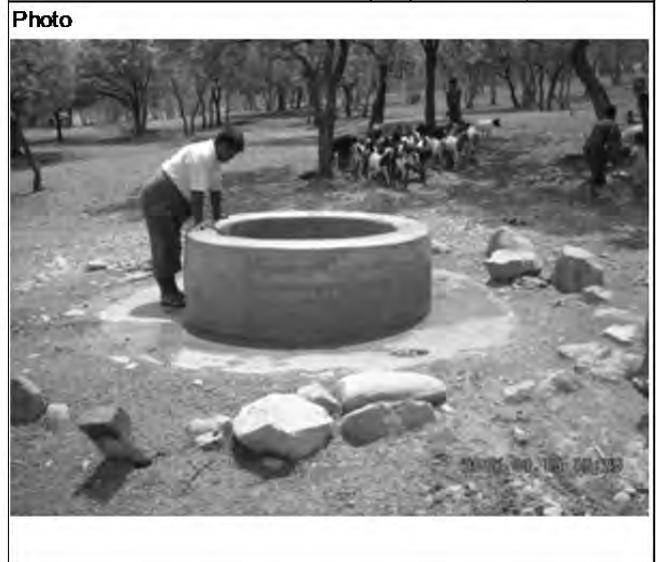
Region	SAGAING		Date	2015/5/5	
Township	Sarlingyi		Reported by	YORITATE Toru	
Village / ID	Minntaw	SA2-16	Coordinate (WGS84 UTM)	Zone X	46Q Y

Information of Existing Water Source - 1						
Type	Deep Well	Coordinate	X	9506514		
	Shallow Well		Y	2194759		
	Storage reservoir					
	○ Others(Dug well)					
Hydrogeological Information	Drilled Depth (m)	3	Results of Simplified Water Quality Test	Sample ID	SA2-16-1	
	Diameter (in)	0.8		Temperature (°C)	32.0	
	S.W.L (m)	2.3		pH	7.35	
	D.W.L (m)			EC (µs/cm)	935	
	Yield (m³/hour)			Smell	Non	
	No.of users (person/day)			Color	Non	
	Supply facilities			Mn (mg/l)	<0.02	
	Remarks (Lithology , etc.)	In the morning, water level is back to the ground level.		Fe (mg/l)	<0.2	
	F (mg/l)			1.5		
	NO3-(mg/l)			30.0		
	NO2-(mg/l)			<0.07		
	Coliforms

Information of Existing Water Source - 2						
Type	Deep Well	Coordinate	X	9506526		
	Shallow Well		Y	2194751		
	Storage reservoir					
	○ Others(Dug well)					
Hydrogeological Information	Drilled Depth (m)	3.8	Results of Simplified Water Quality Test	Sample ID		
	Diameter (in)	1.45		Temperature (°C)		
	S.W.L (m)	3.8		pH		
	D.W.L (m)	0.6		EC (µs/cm)		
	Yield (m³/hour)			Smell		
	No.of users (person/day)			Color		
	Supply facilities			Mn (mg/l)		
	Remarks (Lithology , etc.)			Fe (mg/l)		
	F (mg/l)					
	NO3-(mg/l)					
	NO2-(mg/l)					
	Coliforms

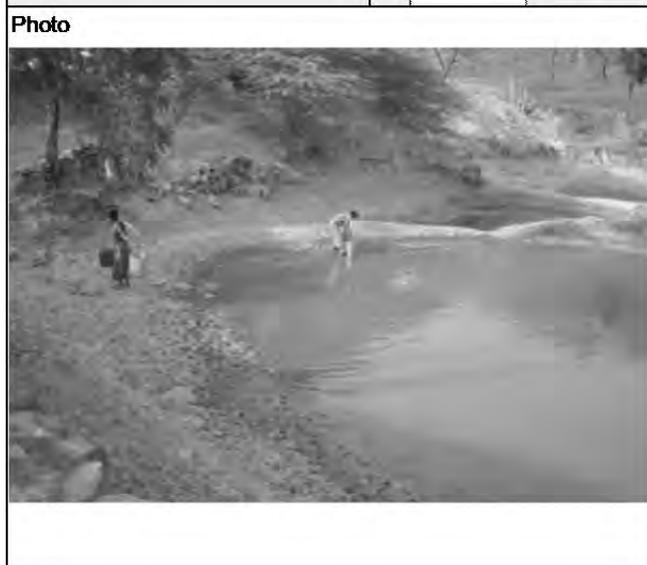
Region	SAGAING		Date	2015/5/5	
Township	Sarlingyi		Reported by	YORITATE Toru	
Village / ID	Kine	SA2-17	Coordinate (WGS84 UTM)	Zone X	711531
				46Q Y	2437798

Information of Existing Water Source - 1								
Type	Deep Well	Coordinate	X	711613				
	Shallow Well		Y	2437746				
	○ Storage reservoir							
	Others							
Hydrogeological Information	Drilled Depth (m)	91	Sample ID	SA2-17-1				
	Diameter (in)	4	Temperature (°C)	33.9				
	S.W.L (m)	19	pH	8.82				
	D.W.L (m)		EC (µs/cm)	640				
	Yield (m ³ /hour)	4.5	Smell	Non				
	No.of users (person/day)	305	Color	Shallow Yellow				
	Supply facilities		Mn (mg/l)	<0.02				
	Remarks (Lithology , etc.)	Results of Simplified Water Quality Test						
Pond is only one source of water. Lower Peg formation. Edge of pond crop up sand and silt stone alternation. Hardly weathered.								
	Fe (mg/l)						<0.2	
	F (mg/l)						1.5	
	NO3- (mg/l)						2.0	
	NO2- (mg/l)						0.1	
	Coliforms	2

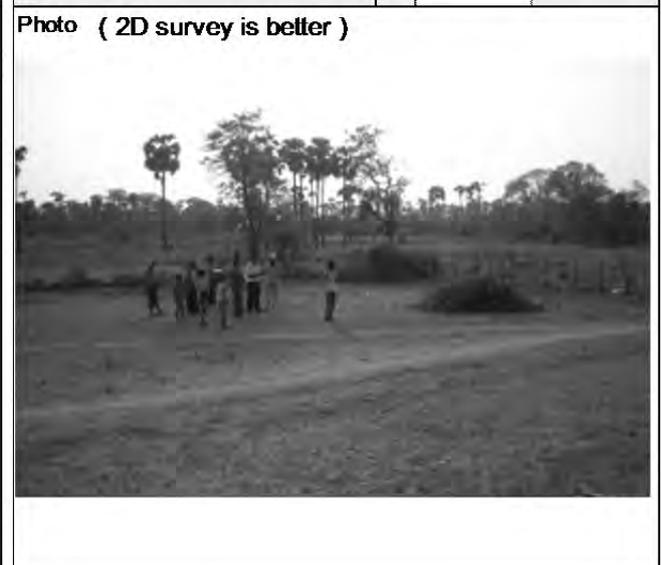
Information of Existing Water Source - 2								
Type	Deep Well	Coordinate	X					
	Shallow Well		Y					
	Storage reservoir							
	Others							
Hydrogeological Information	Drilled Depth (m)		Sample ID					
	Diameter (in)		Temperature (°C)					
	S.W.L (m)		pH					
	D.W.L (m)		EC (µs/cm)					
	Yield (m ³ /hour)		Smell					
	No.of users (person/day)		Color					
	Supply facilities		Mn (mg/l)					
	Remarks (Lithology , etc.)	Results of Simplified Water Quality Test						
Target: 711640 / 2437561								
	Fe (mg/l)							
	F (mg/l)							
	NO3- (mg/l)							
	NO2- (mg/l)							
	Coliforms

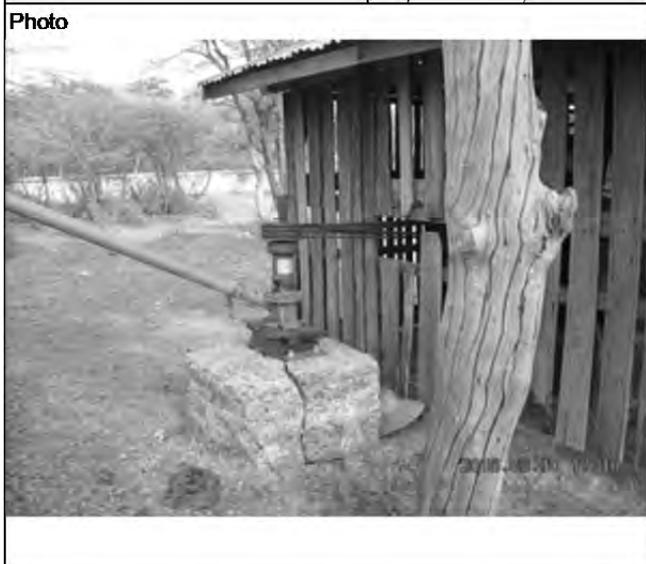
Information of Existing Water Source - 1						
Type	Deep Well	Coordinate	X	749919		
	Shallow Well		Y	2422162		
	Storage reservoir					
	Others					
Hydrogeological Information	Drilled Depth (m)	55	Results of Simplified Water Quality Test	Sample ID	SA2-18-1	
	Diameter (in)	4		Temperature (°C)		
	S.W.L (m)	21		pH		
	D.W.L (m)			EC (µs/cm)		
	Yield (m³/hour)			Smell		
	No.of users (person/day)			Color		
	Supply facilities	Mono		Mn (mg/l)		
	Remarks (Lithology , etc.)			Fe (mg/l)		
Irrawaddi formation area. Drive shaft has broken. Well also too old, can not reuse. Constructed by RUD			F (mg/l)			
			NO3- (mg/l)			
			NO2- (mg/l)			
			Coliforms

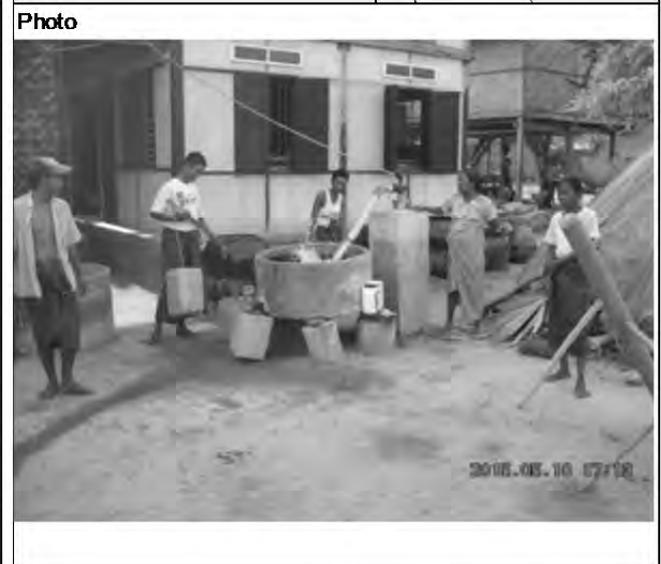
Information of Existing Water Source - 2						
Type	Deep Well	Coordinate	X	749919		
	Shallow Well		Y	2422594		
	Storage reservoir					
	Others					
Hydrogeological Information	Drilled Depth (m)	167	Results of Simplified Water Quality Test	Sample ID	SA2-18-2	
	Diameter (in)	4		Temperature (°C)	32.2	
	S.W.L (m)	36		pH	8.24	
	D.W.L (m)			EC (µs/cm)	3,600	
	Yield (m³/hour)			Smell	Non	
	No.of users (person/day)			Color	Non	
	Supply facilities	Air lift		Mn (mg/l)	<0.02	
	Remarks (Lithology , etc.)			Fe (mg/l)	<0.2	
Target : 749957/2422670			F (mg/l)	1.5		
			NO3- (mg/l)	<1		
			NO2- (mg/l)	<0.02		
			Coliforms

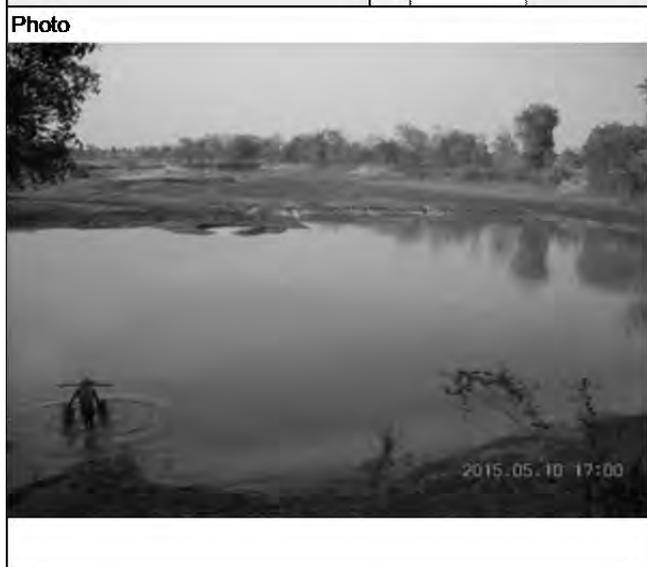
Information of Existing Water Source - 1						
Type	Deep Well	Coordinate	X	750050		
	Shallow Well		Y	2422676		
	○ Storage reservoir					
	Others					
Hydrogeological Information	Drilled Depth (m)	Results of Simplified Water Quality Test	Sample ID	SA2-18-3		
	Diameter (in)		Temperature (°C)	37.9		
	S.W.L (m)		pH	9.13		
	D.W.L (m)		EC (µs/cm)	244		
	Yield (m ³ /hour)		Smell	Non		
	No.of users (person/day)		Color	Non		
	Supply facilities		Mn (mg/l)	<0.02		
	Remarks (Lithology , etc.)		Fe (mg/l)	<0.2		
Retention pond.	F (mg/l)	0.2				
	NO3-(mg/l)	<1				
	NO2-(mg/l)	<0.02				
	Coliforms

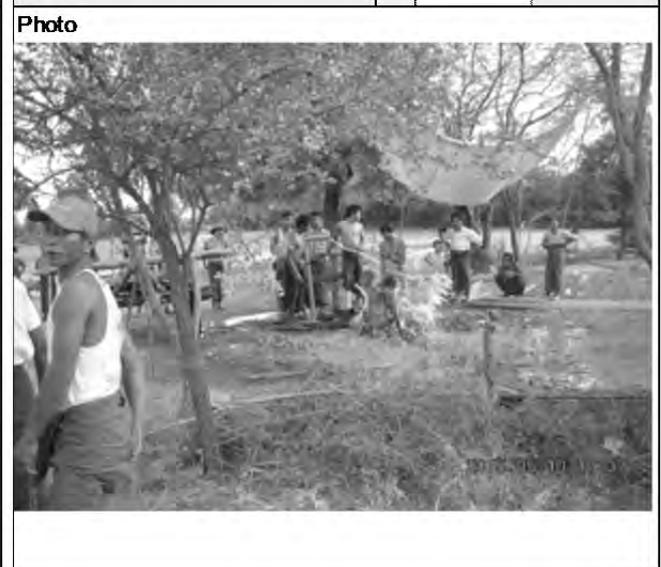
Information of Existing Water Source - 2						
Type	Deep Well	Coordinate	X	750132		
	○ Shallow Well		Y	2421633		
	Storage reservoir					
	Others					
Hydrogeological Information	Drilled Depth (m)	Results of Simplified Water Quality Test	Sample ID	SA2-18-4		
	Diameter (in)		Temperature (°C)	31.3		
	S.W.L (m)		pH	7.98		
	D.W.L (m)		EC (µs/cm)	2190		
	Yield (m ³ /hour)		Smell	Non		
	No.of users (person/day)		Color	Non		
	Supply facilities		Mn (mg/l)	<0.02		
	Remarks (Lithology , etc.)		Fe (mg/l)	<0.2		
	F (mg/l)	0.8				
	NO3-(mg/l)	5.0				
	NO2-(mg/l)	0.05				
Coliforms

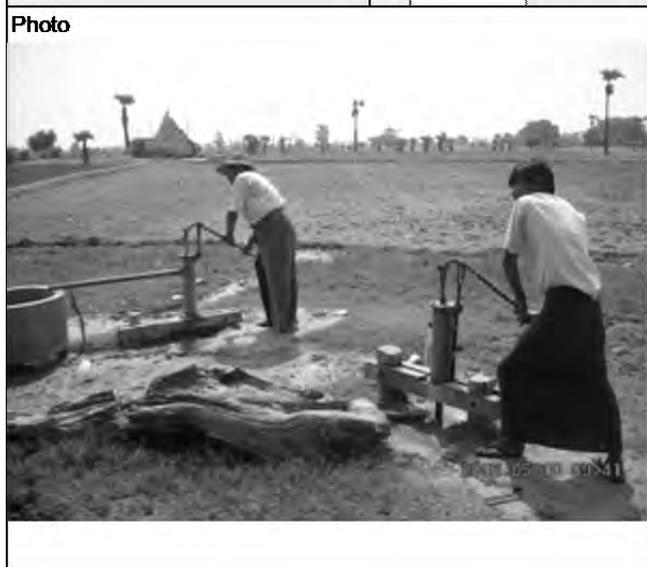
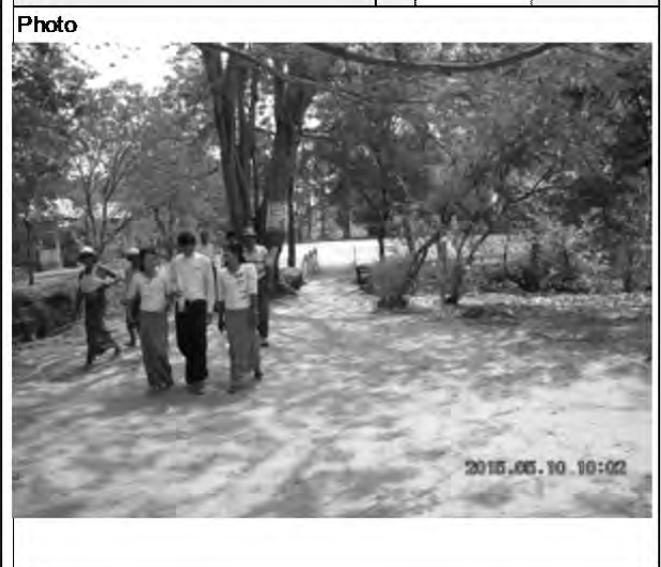
Region	SAGAING 3		Date	2015/5/10
Township	Myinmu		Reported by	YORITATE Toru
Village / ID	Hlayookan	SA2-19	Coordinate (WGS84 UTM)	X Y

Information of Existing Water Source - 1					
Type	Deep Well	Coordinate	X	758776	
	Shallow Well		Y	2438782	
	Storage reservoir				
	Others				
Hydrogeological Information	Drilled Depth (m)	Results of Simplified Water Quality Test	Sample ID	SA2-19-3	
	Diameter (in)		Temperature (°C)	29.7	
	S.W.L (m)		pH	7.3	
	D.W.L (m)		EC (µs/cm)	1084	
	Yield (m ³ /hour)		Smell	Non	
	No.of users (person/day)		Color	Non	
	Supply facilities		Handpump	Mn (mg/l)	<0.02
	Remarks (Lithology , etc.)		Fe (mg/l)	<0.2	
	F (mg/l)	0.4			
	NO3- (mg/l)	5.0			
	NO2- (mg/l)	<0.02			
	Coliforms

Information of Existing Water Source - 2				
Type	Deep Well	Coordinate	X	
	Shallow Well		Y	
	Storage reservoir			
	Others			
Hydrogeological Information	Drilled Depth (m)	Results of Simplified Water Quality Test	Sample ID	SA2-19
	Diameter (in)		Temperature (°C)	
	S.W.L (m)		pH	
	D.W.L (m)		EC (µs/cm)	
	Yield (m ³ /hour)		Smell	
	No.of users (person/day)		Color	
	Supply facilities		Mn (mg/l)	
	Remarks (Lithology , etc.)		Fe (mg/l)	
	F (mg/l)			
	NO3- (mg/l)			
	NO2- (mg/l)			
	Coliforms

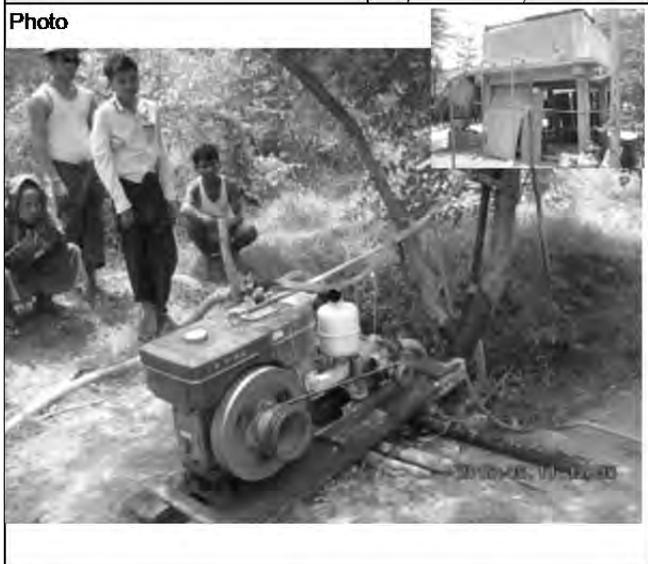
Information of Existing Water Source - 1				
Type	Deep Well	Coordinate	X	773591
	○ Shallow Well		Y	2437376
	Storage reservoir			
	Others (River)			
Hydrogeological Information	Drilled Depth (m)	24	Sample ID	SA2-20-1
	Diameter (in)		Temperature (°C)	31.6
	S.W.L (m)		pH	7.31
	D.W.L (m)		EC (µs/cm)	676
	Yield (m ³ /hour)	13.6	Smell	Non
	No.of users (person/day)		Color	Non
	Supply facilities		Mn (mg/l)	<0.02
	Remarks (Lithology , etc.)			Fe (mg/l)
Q2. 2 shallow wels combine with suction pump system. Water is sent to the over head tank and distributed to each house. This system constructed last year and water amount is enough. 105 houses are connect this system and pay 300 kyats/m3.		Results of Simplified Water Quality Test	F (mg/l)	0.0
			NO3- (mg/l)	<1
			NO2- (mg/l)	<0.02
			Coliforms

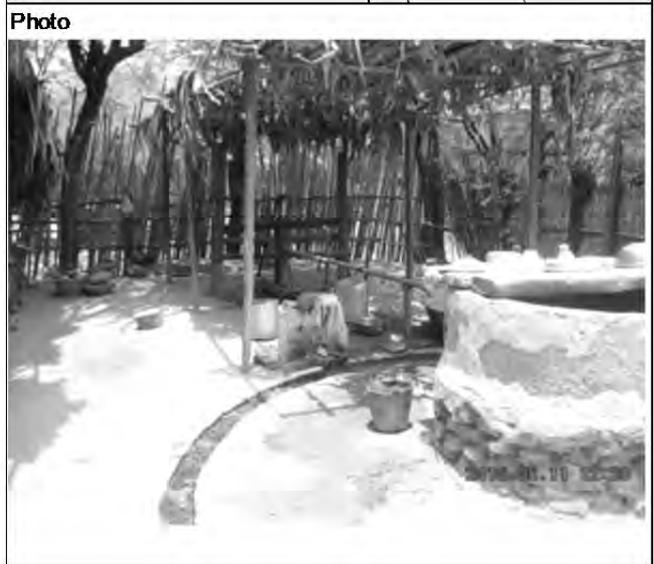
Information of Existing Water Source - 2				
Type	Deep Well	Coordinate	X	773839
	○ Shallow Well		Y	2437211
	Storage reservoir			
	Others			
Hydrogeological Information	Drilled Depth (m)	24	Sample ID	SA2-20-2
	Diameter (in)		Temperature (°C)	30.4
	S.W.L (m)	10	pH	6.86
	D.W.L (m)		EC (µs/cm)	3,800
	Yield (m ³ /hour)		Smell	Non
	No.of users (person/day)		Color	Non
	Supply facilities	Hand Pump	Mn (mg/l)	<0.02
	Remarks (Lithology , etc.)			Fe (mg/l)
More than 100 household have like this shallow well. However every shallow well can not use for drinking cause of salty water.		Results of Simplified Water Quality Test	F (mg/l)	0.0
			NO3- (mg/l)	45<
			NO2- (mg/l)	0.1
			Coliforms
