5.3.1 現地簡易水質測定結果

5.3.2 現地水質測定状況

(1) ザガイン地域

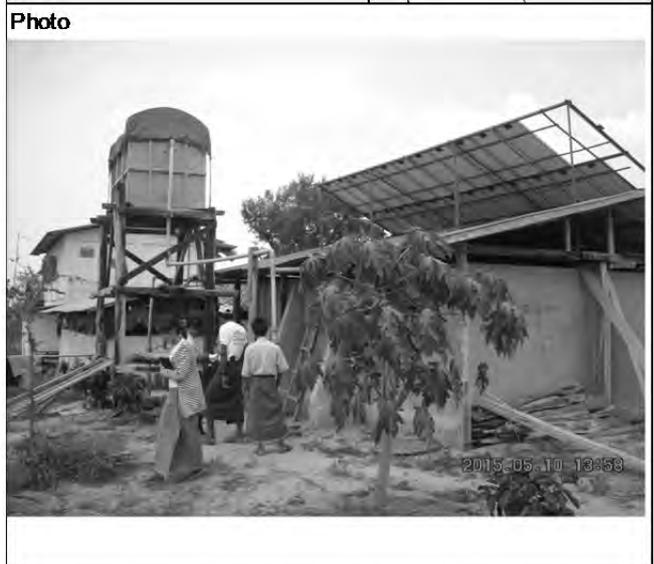
Information of Existing Water Source - 2				
Type	o Deep Well	Coordinate	X	745617
	Shallow Well		Y	2447824
	Storage reservoir			
	Others			
Hydrogeological Information	Drilled Depth (m)	167	Sample ID	SA2-21-2
	Diameter (in)	4	Temperature (°C)	31.7
	S.W.L (m)	36	pH	7.39
	D.W.L (m)		EC (µs/cm)	2,310
	Yield (m ³ /hour)		Smell	Non
	No.of users (person/day)		Color	Non
	Supply facilities	Submergible pump	Mn (mg/l)	<0.02
	Remarks (Lithology , etc.)	Results of Simplified Water Quality Test		
AC pump Target : 745592/ 2447

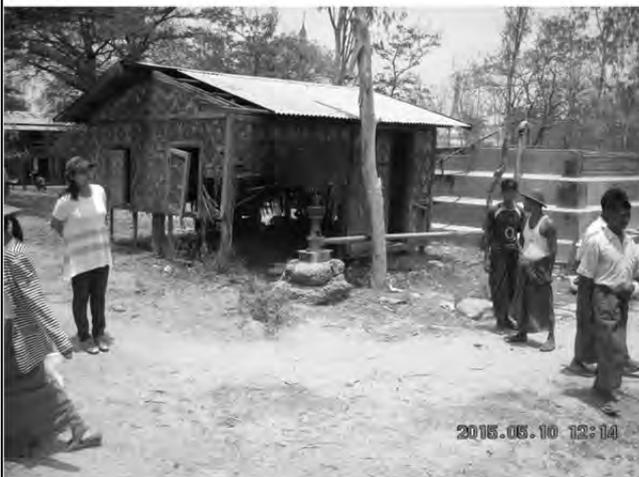
Photo

Information of Existing Water Source - 1					
Type	○ Deep Well		Coordinate	X	747989
	Shallow Well			Y	2446283
	Storage reservoir				
	Others				
Hydrogeological Information	Drilled Depth (m)	161	Results of Simplified Water Quality Test	Sample ID	SA2-22-1
	Diameter (in)	2		Temperature (°C)	
	S.W.L (m)	55		pH	
	D.W.L (m)			EC (µs/cm)	
	Yield (m³/hour)	13.6		Smell	
	No.of users (person/day)			Color	
	Supply facilities	Mono		Mn (mg/l)	
	Remarks (Lithology , etc.)	Constructed in 1986. Pump trable. Can not operate.		Fe (mg/l)	
			F (mg/l)		
			NO3- (mg/l)		
			NO2- (mg/l)		
			Coliforms

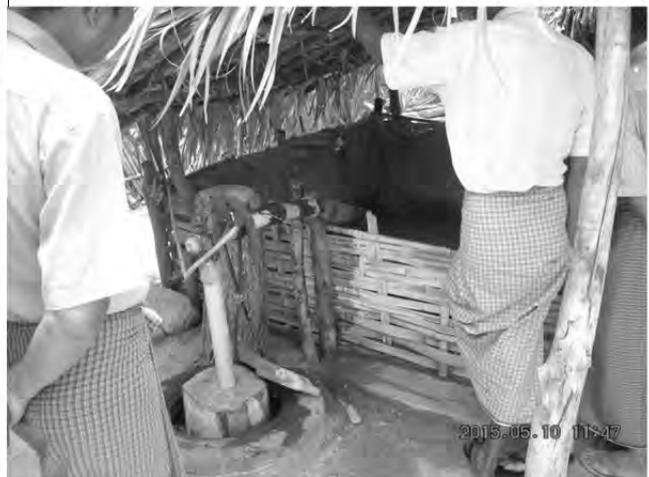
Photo

Information of Existing Water Source - 2					
Type	○ Deep Well		Coordinate	X	747929
	Shallow Well			Y	2446231
	Storage reservoir				
	Others				
Hydrogeological Information	Drilled Depth (m)	152	Results of Simplified Water Quality Test	Sample ID	SA2-22-2
	Diameter (in)	2		Temperature (°C)	32.6
	S.W.L (m)	55		pH	8.02
	D.W.L (m)			EC (µs/cm)	1,663
	Yield (m³/hour)	3.4		Smell	Non
	No.of users (person/day)			Color	Non
	Supply facilities	Handpump		Mn (mg/l)	<0.02
	Remarks (Lithology , etc.)	0-30 sand and clay 30-90 mad 90 ~ Hard stone		Fe (mg/l)	<0.2
			F (mg/l)	0.2	
			NO3- (mg/l)	5.0	
			NO2- (mg/l)	<0.02	
			Coliforms

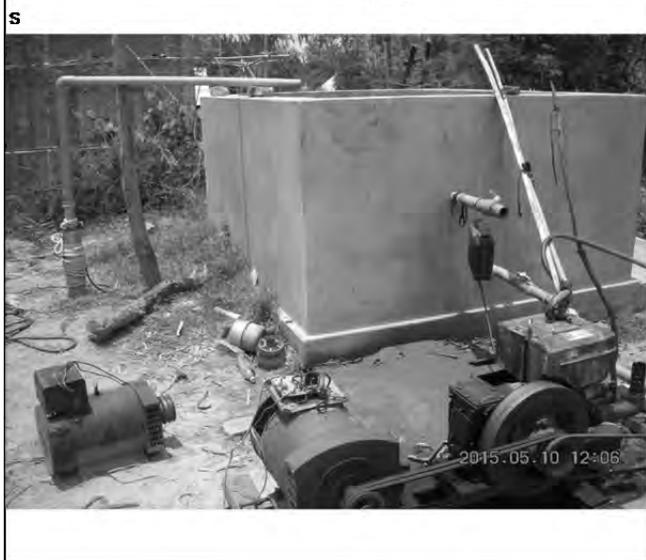
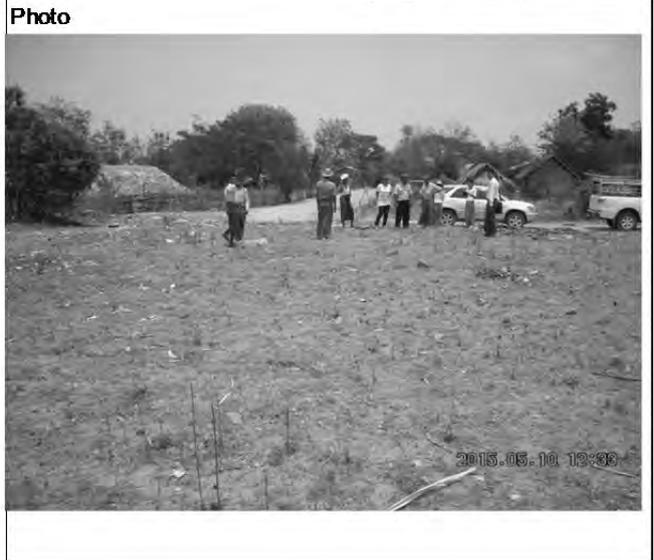
Information of Existing Water Source - 1						
Type	○ Deep Well		Coordinate	X	747853	
	Shallow Well			Y	2446360	
	Storage reservoir					
	Others					
Hydrogeological Information	Drilled Depth (m)	113	Results of Simplified Water Quality Test	Sample ID	SA2-22-3	
	Diameter (in)	4		Temperature (°C)	32.1	
	S.W.L (m)			pH	7.26	
	D.W.L (m)			EC (µs/cm)	1,582	
	Yield (m³/hour)	9.1		Smell	Non	
	No.of users (person/day)			Color	Non	
	Supply facilities	Submergible		Mn (mg/l)	<0.02	
	Remarks (Lithology , etc.)	Pump installed in 48m. Static Water Level is estimated around 30m.		Fe (mg/l)	<0.2	
			F (mg/l)	0.2		
			NO3- (mg/l)	10.0		
			NO2- (mg/l)	<0.02		
			Coliforms

Information of Existing Water Source - 2						
Type	Deep Well		Coordinate	X	747673	
	Shallow Well			Y	2446221	
	Storage reservoir					
	Others					
Hydrogeological Information	Drilled Depth (m)		Results of Simplified Water Quality Test	Sample ID		
	Diameter (in)			Temperature (°C)		
	S.W.L (m)			pH		
	D.W.L (m)			EC (µs/cm)		
	Yield (m³/hour)			Smell		
	No.of users (person/day)			Color		
	Supply facilities			Mn (mg/l)		
	Remarks (Lithology , etc.)	Target X=747673, Y=2446441		Fe (mg/l)		
			F (mg/l)			
			NO3- (mg/l)			
			NO2- (mg/l)			
			Coliforms

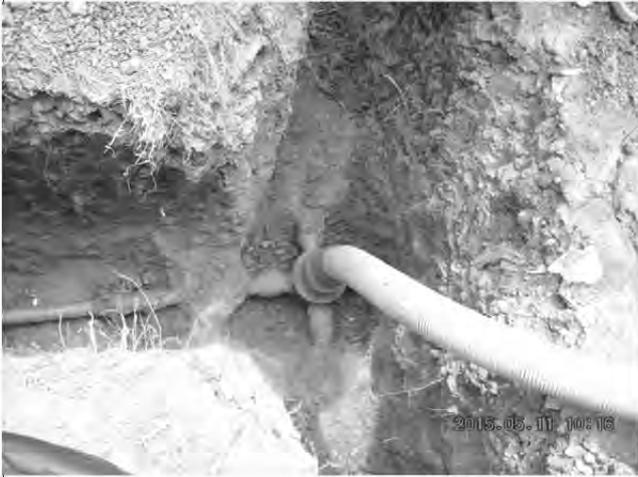
Information of Existing Water Source - 1						Information of Existing Water Source - 2					
Type	Deep Well		Coordinate	X	774423	Type	Deep Well		Coordinate	X	774560
	○ Shallow Well			Y	2444502		○ Shallow Well			Y	2444437
	Storage reservoir						Storage reservoir				
	Others						Others				
Hydrogeological Information	Drilled Depth (m)	15	Results of Simplified Water Quality Test	Sample ID	SA2-23-1	Hydrogeological Information	Drilled Depth (m)	24	Results of Simplified Water Quality Test	Sample ID	SA2-23-2
	Diameter (in)			Temperature (°C)	29.8		Diameter (in)	4		Temperature (°C)	31.9
	S.W.L (m)			pH	7.60		S.W.L (m)	3		pH	7.58
	D.W.L (m)			EC (µs/cm)	1,601		D.W.L (m)			EC (µs/cm)	1,838
	Yield (m³/hour)			Smell	Non		Yield (m³/hour)			Smell	Muddy smell
	No.of users (person/day)			Color	Non		No.of users (person/day)			Color	Shallow Yellow
	Supply facilities	Hand Pump		Mn (mg/l)	<0.02		Supply facilities	Suction		Mn (mg/l)	<0.02

Fe (mg/l)	<0.2					Fe (mg/l)	<0.2
Remarks (Lithology , etc.)			F (mg/l)	0.8	Remarks (Lithology , etc.)			F (mg/l)	0.4	NO3- (mg/l)	1.5
Q2 area. Many house have such as shallow well. However they can not use for drinking cause of high salinity.			NO3- (mg/l)	20.0	5 well convine system. 10 system are operating in this area. It is mainly use for agriculture. 0-6m : silty clay 6m : Sand private well for agriculture			NO3- (mg/l)	1.5	NO2- (mg/l)	0.1
			NO2- (mg/l)	0.2				NO2- (mg/l)	0.1	Coliforms	
			Coliforms					Coliforms			
Photo

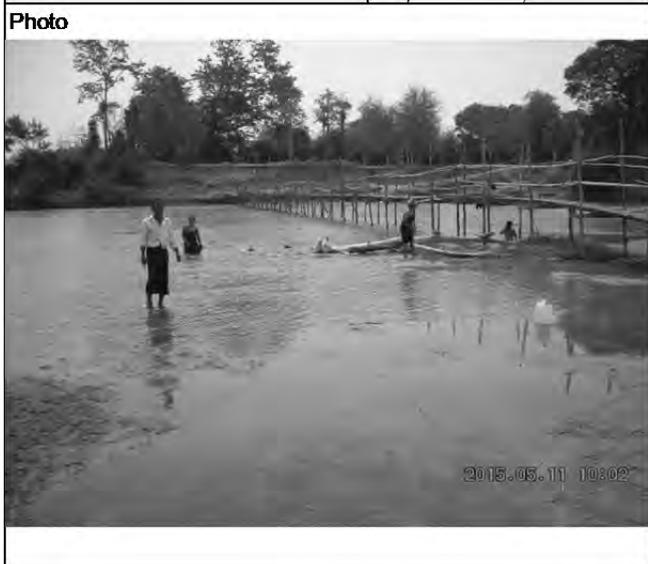
Information of Existing Water Source - 1						
Type	Deep Well	Coordinate	X	774727		
	Shallow Well		Y	2444435		
	Storage reservoir					
	○ Others (River)					
Hydrogeological Information	Drilled Depth (m)	Results of Simplified Water Quality Test	Sample ID	SA2-23-3		
	Diameter (in)		Temperature (°C)	32.1		
	S.W.L (m)		pH	8.66		
	D.W.L (m)		EC (µs/cm)	474		
	Yield (m ³ /hour)		Smell	Non		
	No.of users (person/day)		Color	Non		
	Supply facilities		Mn (mg/l)			
	Remarks (Lithology , etc.)		Fe (mg/l)	< 0.2		
Muu River water. Use it for drinking.	F (mg/l)	0.2				
	NO3- (mg/l)	<1				
	NO2- (mg/l)	<0.02				
	Coliforms

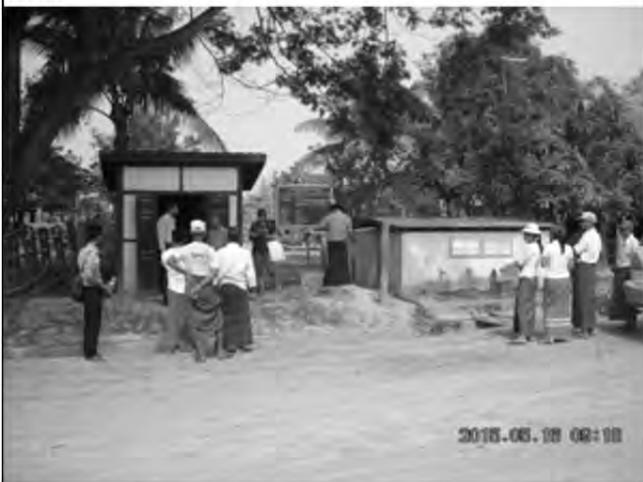
Photo

Information of Existing Water Source - 1					Information of Existing Water Source - 2						
Type	○ Deep Well		Coordinate	X	773446	Type	○ Deep Well		Coordinate	X	773526
	Shallow Well			Y	2612929		Shallow Well			Y	2612915
	Storage reservoir						Storage reservoir				
	Others						Others				
Hydrogeological Information	Drilled Depth (m)	82	Results of Simplified Water Quality Test	Sample ID	SA2-24-1	Hydrogeological Information	Drilled Depth (m)	116	Results of Simplified Water Quality Test	Sample ID	SA2-24-2
	Diameter (in)	2		Temperature (°C)	27.3		Diameter (in)	2		Temperature (°C)	27.1
	S.W.L (m)			pH	7.84		S.W.L (m)			pH	6.77
	D.W.L (m)			EC (µs/cm)	1,053		D.W.L (m)			EC (µs/cm)	34,800
	Yield (m ³ /hour)	3.2		Smell	Non		Yield (m ³ /hour)			Smell	Salty smell
	No.of users (person/day)			Color	Non		No.of users (person/day)			Color	Non
	Supply facilities			Mn (mg/l)	<0.02		Supply facilities			Mn (mg/l)	0.02

Remarks (Lithology , etc.)			Fe (mg/l)	<0.2		Remarks (Lithology , etc.)			Fe (mg/l)	<0.2
Constructed in 2005.		F (mg/l)	0.2			F (mg/l)	0.2				
		NO3- (mg/l)	<1			NO3- (mg/l)	<1				
		NO2- (mg/l)	<0.02			NO2- (mg/l)	<0.02				
		Coliforms				Coliforms

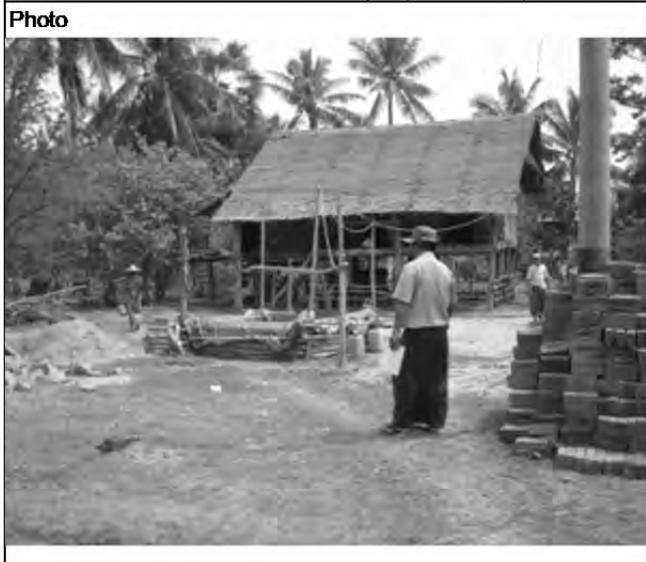
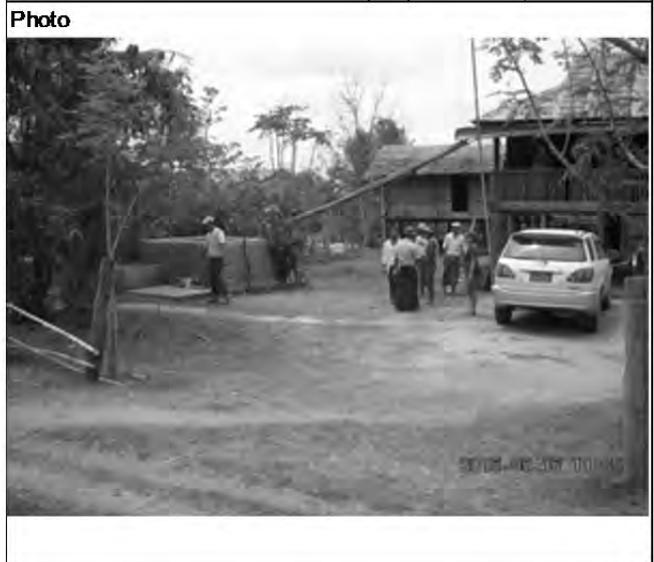
Information of Existing Water Source - 1					
Type	○ Deep Well	Coordinate	X	772025	
	Shallow Well		Y	2612947	
	Storage reservoir				
	Others				
Hydrogeological Information	Drilled Depth (m)	152	Results of Simplified Water Quality Test	Sample ID	SA2-25-1
	Diameter (in)	2		Temperature (°C)	28.1
	S.W.L (m)	30		pH	8.08
	D.W.L (m)			EC (µs/cm)	665
	Yield (m³/hour)	2.3		Smell	Non
	No.of users (person/day)			Color	Non
	Supply facilities			Mn (mg/l)	<0.02
	Remarks (Lithology , etc.)	Botton of 12m in Screen. 7 Dug wells and 7 Shallow wells 6 Tube Wells(3 public and 3 privatel)		Fe (mg/l)	<0.2
			F (mg/l)	0.2	
			NO3-(mg/l)	<1	
			NO2-(mg/l)	<0.02	
			Coliforms	0

Information of Existing Water Source - 2					
Type	Deep Well	Coordinate	X	772013	
	Shallow Well		Y	2612839	
	Storage reservoir				
	Others				
Hydrogeological Information	Drilled Depth (m)		Results of Simplified Water Quality Test	Sample ID	SA2-25
	Diameter (in)			Temperature (°C)	
	S.W.L (m)			pH	
	D.W.L (m)			EC (µs/cm)	
	Yield (m³/hour)			Smell	
	No.of users (person/day)			Color	
	Supply facilities			Mn (mg/l)	
	Remarks (Lithology , etc.)	Target : 772013 / 2612839		Fe (mg/l)	
			F (mg/l)		
			NO3-(mg/l)		
			NO2-(mg/l)		
			Coliforms

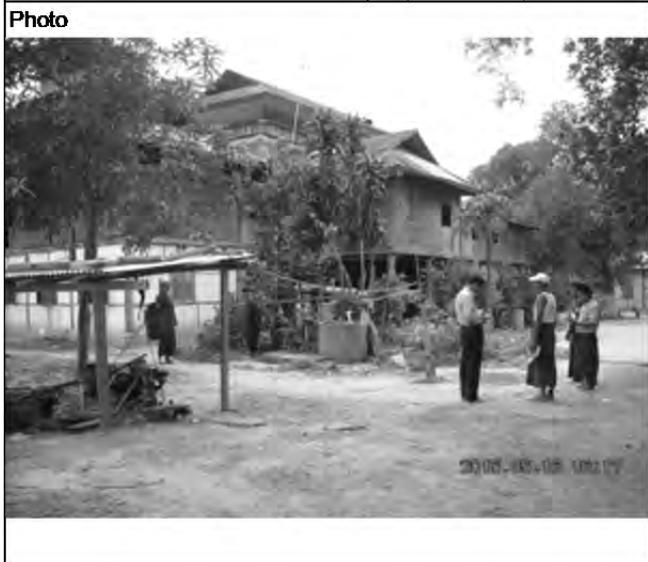
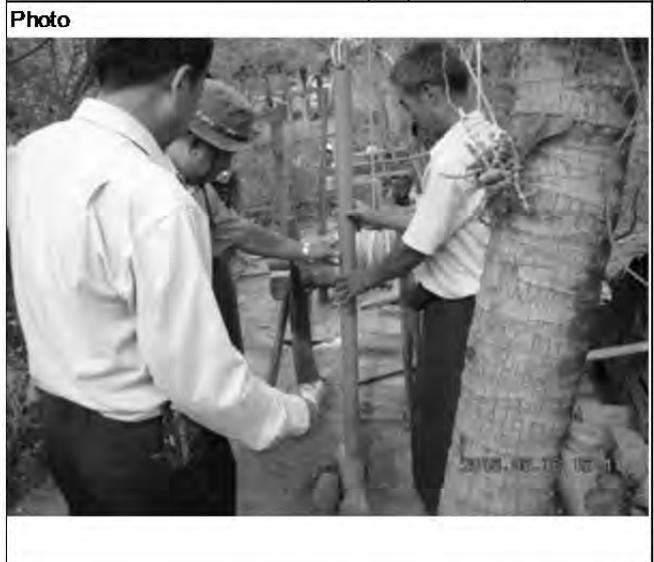
Region	SAGAING		Date	2015/5/16
Township	Kanbalu		Reported by	YORITATE Toru
Village / ID	Inngoteto	SA2-27	Coordinate (WGS84 UTM)	X Y

Information of Existing Water Source - 1				
Type	○ Deep Well	Coordinate	X	768435
	Shallow Well		Y	2598073
	Storage reservoir			
	Others			
Hydrogeological Information	Drilled Depth (m)	61	Sample ID	SA2-27-1
	Diameter (in)	2	Temperature (°C)	27.7
	S.W.L (m)		pH	7.31
	D.W.L (m)		EC (µs/cm)	796
	Yield (m ³ /hour)	1.1	Smell	Non
	No.of users (person/day)		Color	Non
	Supply facilities	Air lift	Mn (mg/l)	<0.02
	Remarks (Lithology , etc.)	Results of Simplified Water Quality Test		
Very low yield in Monastery 2 Tube wells (1 damaged, 1 monastery) 16 Shallow wells	Fe (mg/l) 0.2			
	F (mg/l) 0.2			
	NO3- (mg/l) 45<			
	NO2- (mg/l) <0.02			
	Coliforms

Information of Existing Water Source - 2				
Type	Deep Well	Coordinate	X	768370
	○ Shallow Well		Y	2598171
	Storage reservoir			
	Others			
Hydrogeological Information	Drilled Depth (m)	21	Sample ID	SA2-27-2
	Diameter (in)	3	Temperature (°C)	28.6
	S.W.L (m)	17.8	pH	7.37
	D.W.L (m)		EC (µs/cm)	1,487
	Yield (m ³ /hour)		Smell	Non
	No.of users (person/day)		Color	Shallow white
	Supply facilities		Mn (mg/l)	<0.02
	Remarks (Lithology , etc.)	Results of Simplified Water Quality Test		
Private well Target : 768388 / 2598038 (Monastery)	Fe (mg/l) <0.2			
	F (mg/l) 3.0			
	NO3- (mg/l) <1			
	NO2- (mg/l) <0.02			
	Coliforms

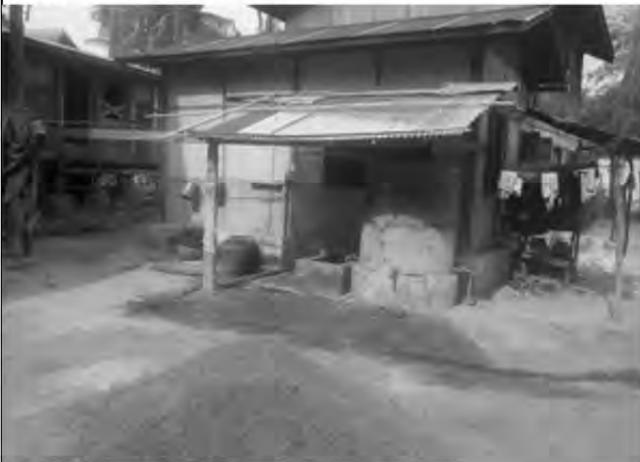
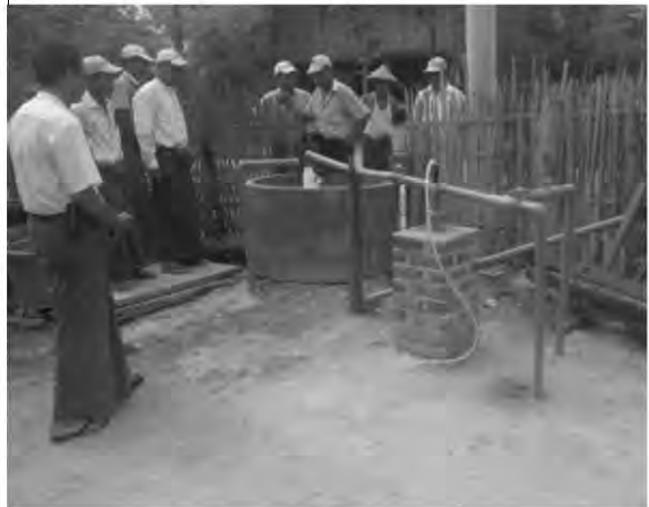
Region	SAGAING		Date	2015/5/15
Township	Kanbalu		Reported by	YORITATE Toru
Village / ID	Myayhtoo	SA2-28	Coordinate (WGS84 UTM)	X
			Y

Information of Existing Water Source - 1					Information of Existing Water Source - 2						
Type	○ Deep Well		Coordinate	X	745074	Type	○ Deep Well		Coordinate	X	745102
	Shallow Well			Y	2565109		Shallow Well			Y	2565190
	Storage reservoir						Storage reservoir				
	Others						Others				
Hydrogeological Information	Drilled Depth (m)	82	Results of Simplified Water Quality Test	Sample ID	SA2-28-1	Hydrogeological Information	Drilled Depth (m)	76	Results of Simplified Water Quality Test	Sample ID	SA2-28-2
	Diameter (in)	2		Temperature (°C)	29.0		Diameter (in)	2		Temperature (°C)	28.8
	S.W.L (m)	67		pH	7.05		S.W.L (m)	61		pH	7.19
	D.W.L (m)			EC (µs/cm)	681		D.W.L (m)			EC (µs/cm)	858
	Yield (m³/hour)			Smell	Slightly certain smell		Yield (m³/hour)			Smell	Non
	No. of users (person/day)			Color	Shallow yellow		No. of users (person/day)			Color	Shallow white
	Supply facilities	Air lift		Mn (mg/l)	<0.02		Supply facilities	Air lift		Mn (mg/l)	<0.02

Remarks (Lithology , etc.)	Operating by power, however target area does not have water. 17 Air lift TW (70m) Below 91 m can get good water.		Fe (mg/l)	0.2		Remarks (Lithology , etc.)	Sands came up with water.		Fe (mg/l)	<0.2
			F (mg/l)	0.0				F (mg/l)	0.0		
			NO3- (mg/l)	<1				NO3- (mg/l)	<1		
			NO2- (mg/l)	<0.02				NO2- (mg/l)	<0.02		
			Coliforms					Coliforms

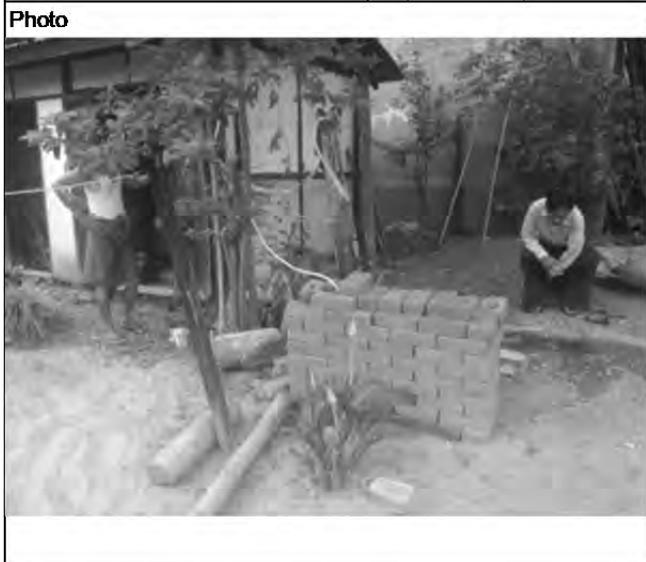
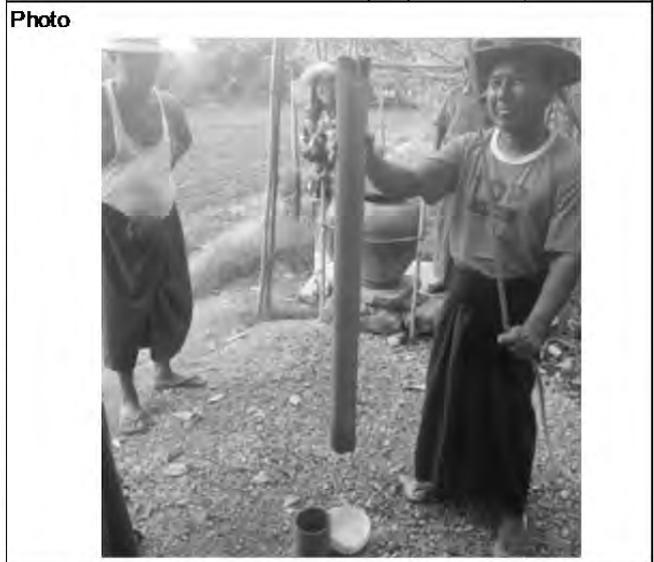
Region	SAGAING		Date	2015/5/15
Township	Kanbalu		Reported by	YORITATE Toru
Village / ID	Myayhtoo	SA2-28	Coordinate (WGS84 UTM)	X
			Y

Information of Existing Water Source - 1				
Type	○ Deep Well	Coordinate	X	744822
	Shallow Well		Y	2565124
	Storage reservoir			
	Others			
Hydrogeological Information	Drilled Depth (m)	171	Sample ID	SA2-28-3
	Diameter (in)	2	Temperature (°C)	28.9
	S.W.L (m)	146.3	pH	7.24
	D.W.L (m)		EC (µs/cm)	981
	Yield (m ³ /hour)		Smell	Non
	No.of users (person/day)		Color	Shallow yellow
	Supply facilities	Air lift	Mn (mg/l)	<0.02
	Remarks (Lithology , etc.)		Results of Simplified Water Quality Test	
		Fe (mg/l)	<0.2	
		F (mg/l)	0.0	
		NO3- (mg/l)	1.0	
		NO2- (mg/l)	<0.02	
		Coliforms

Information of Existing Water Source - 2				
Type	Deep Well	Coordinate	X	748784
	○ Shallow Well		Y	2565102
	Storage reservoir			
	Others			
Hydrogeological Information	Drilled Depth (m)	16	Sample ID	SA2-28-4
	Diameter (in)	3	Temperature (°C)	
	S.W.L (m)	8	pH	
	D.W.L (m)		EC (µs/cm)	
	Yield (m ³ /hour)		Smell	
	No.of users (person/day)		Color	
	Supply facilities		Mn (mg/l)	
	Remarks (Lithology , etc.)		Results of Simplified Water Quality Test	
		Fe (mg/l)		
		F (mg/l)		
		NO3- (mg/l)		
		NO2- (mg/l)		
		Coliforms

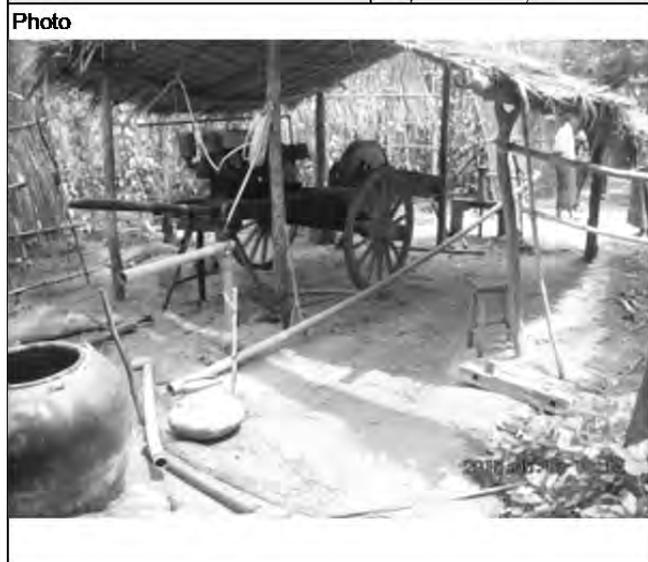
Region	SAGAING		Date	2015/5/17
Township	Kanbalu		Reported by	YORITATE Toru
Village / ID	Khaowntar	SA2-29	Coordinate (WGS84 UTM)	X Y

Information of Existing Water Source - 1				
Type	<input type="radio"/> Deep Well	Coordinate	X	776703
	<input type="radio"/> Shallow Well		Y	2551428
	<input type="radio"/> Storage reservoir			
	<input type="radio"/> Others			
Hydrogeological Information	Drilled Depth (m)	116	Sample ID	SA2-29-1
	Diameter (in)	2	Temperature (°C)	28.7
	S.W.L (m)	30	pH	7.26
	D.W.L (m)		EC (µs/cm)	947
	Yield (m ³ /hour)		Smell	Non
	No.of users (person/day)		Color	Non
	Supply facilities		Mn (mg/l)	<0.02
	Remarks (Lithology , etc.)		Fe (mg/l)	<0.2
Private tubewell 30 Tube wells(29 privates) Half of them can drink.		Results of Simplified Water Quality Test	F (mg/l)	0.8
			NO3-(mg/l)	<1
			NO2-(mg/l)	<0.02
			Coliforms

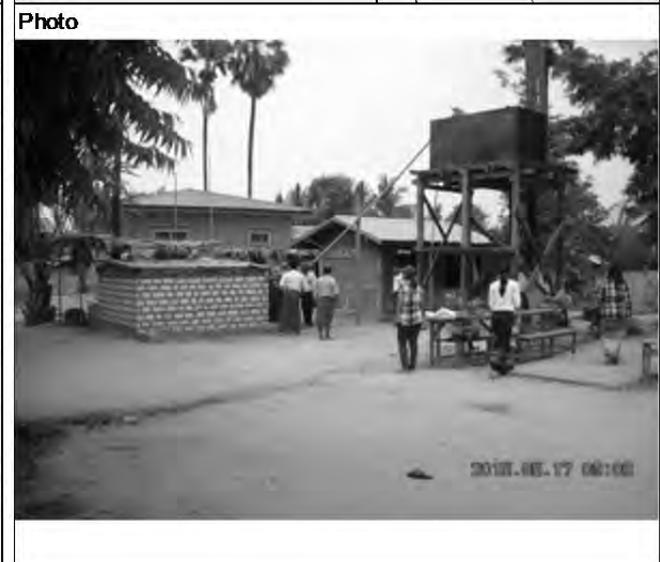
Information of Existing Water Source - 2				
Type	<input type="radio"/> Deep Well	Coordinate	X	776612
	<input type="radio"/> Shallow Well		Y	2551398
	<input type="radio"/> Storage reservoir			
	<input type="radio"/> Others			
Hydrogeological Information	Drilled Depth (m)	110	Sample ID	SA2-29-2
	Diameter (in)	2	Temperature (°C)	29.1
	S.W.L (m)		pH	7.74
	D.W.L (m)		EC (µs/cm)	1,423
	Yield (m ³ /hour)	4.5	Smell	Non
	No.of users (person/day)		Color	Non
	Supply facilities		Mn (mg/l)	<0.02
	Remarks (Lithology , etc.)		Fe (mg/l)	<0.2
Target : 776585 / 2551429 (In the monastery). Corner of the monastery.		Results of Simplified Water Quality Test	F (mg/l)	0.0
			NO3-(mg/l)	<1
			NO2-(mg/l)	<0.02
			Coliforms

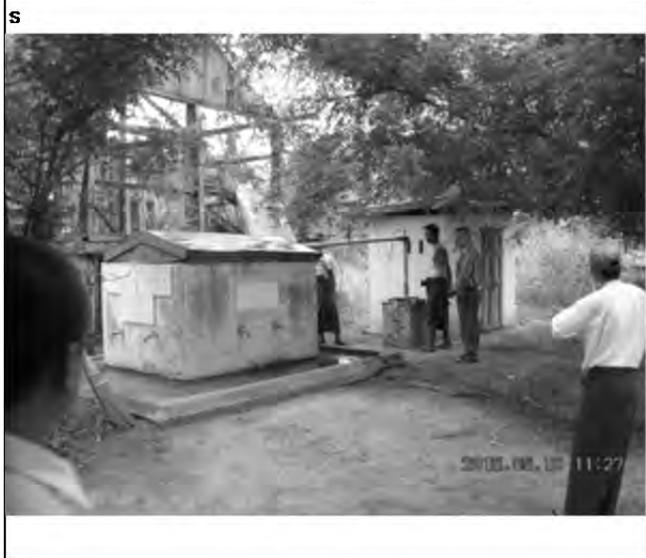
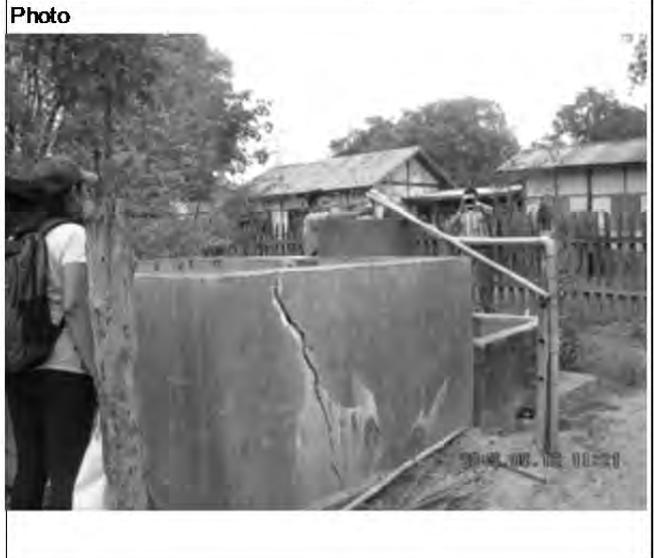
Region	SAGAING		Date	2015/5/18
Township	Kanbalu		Reported by	YORITATE Toru
Village / ID	Nyaungkanthar	SA2-30	Coordinate (WGS84 UTM)	X
			Y

Information of Existing Water Source - 1				
Type	○ Deep Well	Coordinate	X	770617
	Shallow Well		Y	2587691
	Storage reservoir			
	Others			
Hydrogeological Information	Drilled Depth (m)	122	Sample ID	SA2-30-1
	Diameter (in)	2	Temperature (°C)	27.6
	S.W.L (m)		pH	7.53
	D.W.L (m)		EC (µs/cm)	1,905
	Yield (m ³ /hour)	75g/day	Smell	Non
	No.of users (person/day)		Color	Non
	Supply facilities	Air lift	Mn (mg/l)	<0.02
	Remarks (Lithology , etc.)		Results of Simplified Water Quality Test	
Public tube well. 3 tube well - can use for drinking. 2 public : 122m 1 private : 45m Very small yield , almost unsuccessful well		Fe (mg/l)	<0.2	
		F (mg/l)	0.0	
		NO3- (mg/l)	45.0	
		NO2- (mg/l)	<0.02	
		Coliforms

Information of Existing Water Source - 2				
Type	Deep Well	Coordinate	X	770701
	○ Shallow Well		Y	2597767
	Storage reservoir			
	Others			
Hydrogeological Information	Drilled Depth (m)	45	Sample ID	SA2-30-2
	Diameter (in)	2	Temperature (°C)	28.1
	S.W.L (m)		pH	8.19
	D.W.L (m)		EC (µs/cm)	691
	Yield (m ³ /hour)	28g/day	Smell	Non
	No.of users (person/day)		Color	Non
	Supply facilities	Air lift	Mn (mg/l)	<0.02
	Remarks (Lithology , etc.)		Results of Simplified Water Quality Test	
Private Well. Target : 779771 / 2597741		Fe (mg/l)	<0.2	
		F (mg/l)	0.0	
		NO3- (mg/l)	<1	
		NO2- (mg/l)	<0.02	
		Coliforms	0

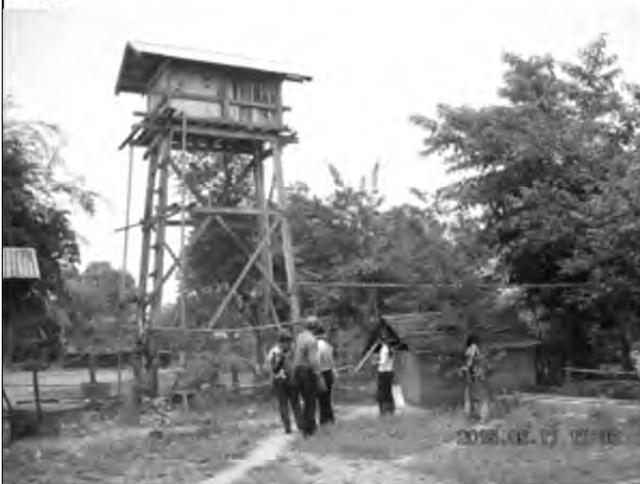
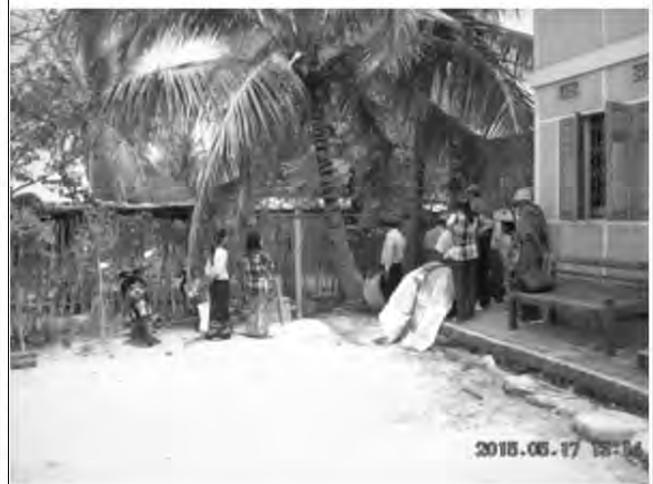
Region	SAGAING		Date	2015/5/17
Township	Kanbalu		Reported by	YORITATE Toru
Village / ID	Myaymon	SA2-31	Coordinate (WGS84 UTM)	X Y

Information of Existing Water Source - 1					Information of Existing Water Source - 2						
Type	○ Deep Well		Coordinate	X	785078	Type	○ Deep Well		Coordinate	X	784990
	Shallow Well			Y	2543981		Shallow Well			Y	2544342
	Storage reservoir						Storage reservoir				
	Others						Others				
Hydrogeological Information	Drilled Depth (m)	98	Results of Simplified Water Quality Test	Sample ID	SA2-31-1	Hydrogeological Information	Drilled Depth (m)	73	Results of Simplified Water Quality Test	Sample ID	SA2-31-2
	Diameter (in)	2		Temperature (°C)	29.3		Diameter (in)	2		Temperature (°C)	29.1
	S.W.L (m)			pH	8.16		S.W.L (m)			pH	8.14
	D.W.L (m)			EC (µs/cm)	1,210		D.W.L (m)			EC (µs/cm)	3,210
	Yield (m³/hour)	4.5		Smell	Non		Yield (m³/hour)	1.4		Smell	Non
	No.of users (person/day)			Color	Non		No.of users (person/day)			Color	Non
	Supply facilities			Mn (mg/l)	<0.02		Supply facilities			Mn (mg/l)	<0.02
	Remarks (Lithology , etc.) South part of village. Overhead is already too old , cannot use. 44 Tube well - 1 is public in school.			Fe (mg/l)	<0.2		Remarks (Lithology , etc.) North part of village. Target 2 785110 / 2544263 Water quality is south part is better than north part. North wells are salt.			Fe (mg/l)	<0.2

F (mg/l)			0.2	F (mg/l)	1.5						
NO3- (mg/l)			1.0	NO3- (mg/l)	45<						
NO2- (mg/l)			<0.02	NO2- (mg/l)	<0.02						
Coliforms				Coliforms

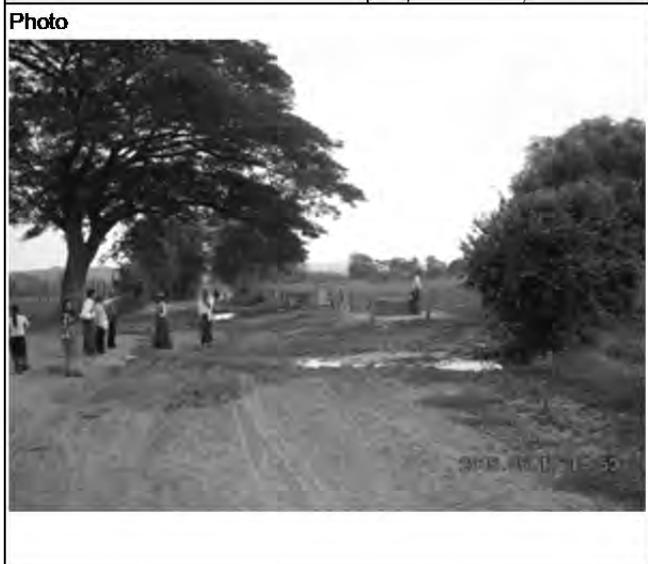
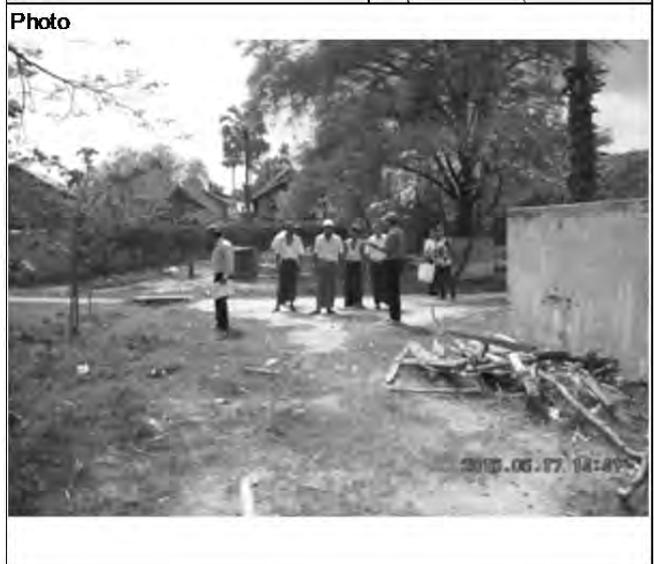
Region	SAGAING		Date	2015/5/17
Township	kanbalu		Reported by	YORITATE Toru
Village / ID	Layytwinzin	SA2-32	Coordinate (WGS84 UTM)	X
				Y

Information of Existing Water Source - 1				
Type	Deep Well	Coordinate	X	800278
	Shallow Well		Y	2549565
	Storage reservoir			
	○ Others <i>Dug Well</i>			
Hydrogeological Information	Drilled Depth (m)	2.4	Sample ID	SA2-32-1
	Diameter (in)	1.5m	Temperature (°C)	28.5
	S.W.L (m)	1.5	pH	7.40
	D.W.L (m)		EC (µs/cm)	880
	Yield (m ³ /hour)		Smell	Non
	No.of users (person/day)		Color	Shallow yellow
	Supply facilities		Mn (mg/l)	<0.02
	Remarks (Lithology , etc.)	Results of Simplified Water Quality Test		
Dug well constructed low area. This area will be below flow water in the rainy season. Therefore every year after rainy season they have to clean up the well to remove sand.	Fe (mg/l) <0.2			
	F (mg/l) 0.0			
	NO3- (mg/l) 1.0			
	NO2- (mg/l) <0.08			
	Coliforms Too much

Information of Existing Water Source - 2				
Type	Deep Well	Coordinate	X	
	Shallow Well		Y	
	Storage reservoir			
	○ Others			
Hydrogeological Information	Drilled Depth (m)		Sample ID	
	Diameter (in)		Temperature (°C)	
	S.W.L (m)		pH	
	D.W.L (m)		EC (µs/cm)	
	Yield (m ³ /hour)		Smell	
	No.of users (person/day)		Color	
	Supply facilities		Mn (mg/l)	
	Remarks (Lithology , etc.)	Results of Simplified Water Quality Test		
Target : 800148 / 2549708	Fe (mg/l)			
They have two test experience.	F (mg/l)			
1. 116m (Dry well) (Target point)	NO3- (mg/l)			
2. 146m (small water 50g/h)	NO2- (mg/l)			
	Coliforms

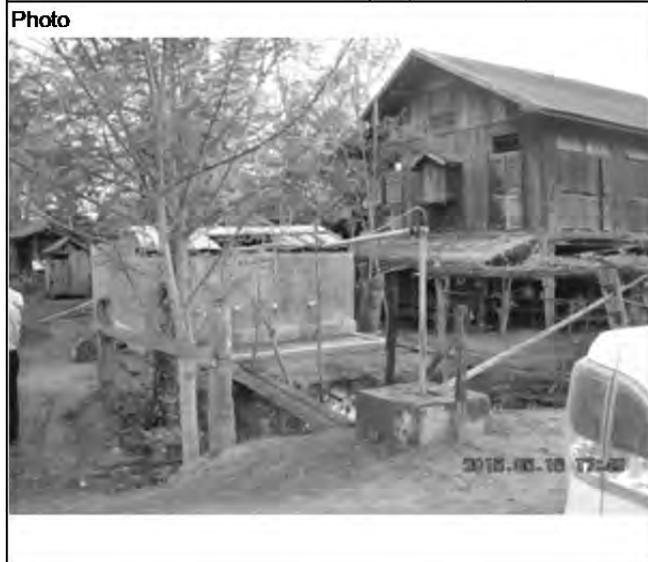
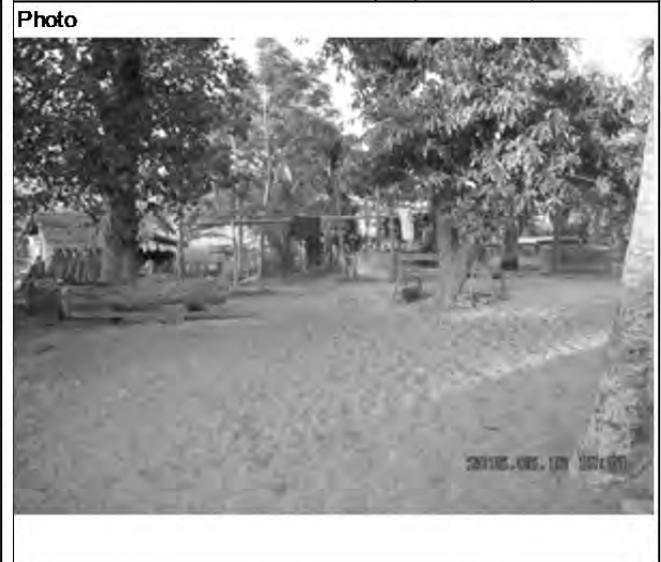
Region	SAGAING		Date	2015/5/16
Township	Kanbalu		Reported by	YORITATE Toru
Village / ID	Chaungchar	SA2-33	Coordinate (WGS84 UTM)	X
			Y

Information of Existing Water Source - 1				
Type	Deep Well	Coordinate	X	762364
	○ Shallow Well		Y	2587378
	Storage reservoir			
	Others			
Hydrogeological Information	Drilled Depth (m)	38	Sample ID	SA2-33-1
	Diameter (in)	2	Temperature (°C)	29.4
	S.W.L (m)		pH	7.87
	D.W.L (m)		EC (µs/cm)	657
	Yield (m ³ /hour)	1.6	Smell	Non
	No.of users (person/day)		Color	Non
	Supply facilities	Air lift	Mn (mg/l)	<0.02
	Remarks (Lithology , etc.)		Results of Simplified Water Quality Test	
2 Tube wells -1 public, 1 monastery 27 Shallow wells with hand pump.		Fe (mg/l)	<0.2	
		F (mg/l)	0.0	
		NO3- (mg/l)	<1	
		NO2- (mg/l)	<0.02	
		Coliforms	0

Information of Existing Water Source - 2				
Type	Deep Well	Coordinate	X	762527
	○ Shallow Well		Y	2587375
	Storage reservoir			
	Others			
Hydrogeological Information	Drilled Depth (m)	49	Sample ID	SA2-33-2
	Diameter (in)	2	Temperature (°C)	27.4
	S.W.L (m)	9	pH	8.03
	D.W.L (m)		EC (µs/cm)	621
	Yield (m ³ /hour)	2.5	Smell	Non
	No.of users (person/day)		Color	Non
	Supply facilities		Mn (mg/l)	<0.02
	Remarks (Lithology , etc.)		Results of Simplified Water Quality Test	
Monastery Operation cost : 1000 kyats -fuel/hour		Fe (mg/l)	<0.2	
		F (mg/l)	0.2	
		NO3- (mg/l)	<1	
		NO2- (mg/l)	<0.02	
		Coliforms	0

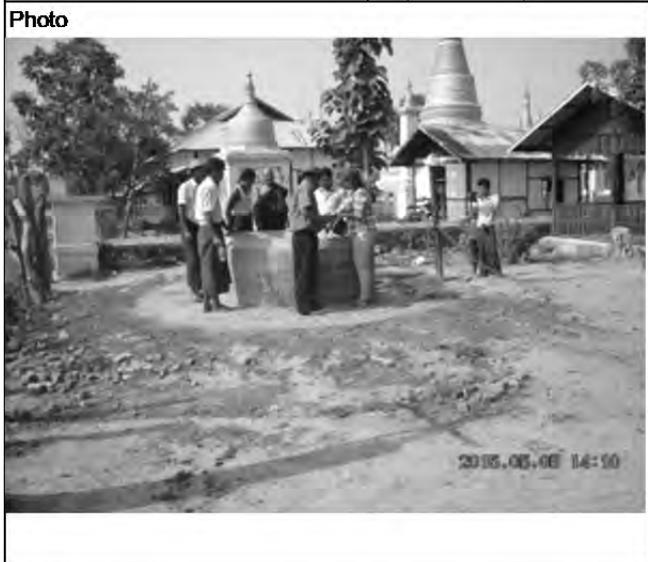
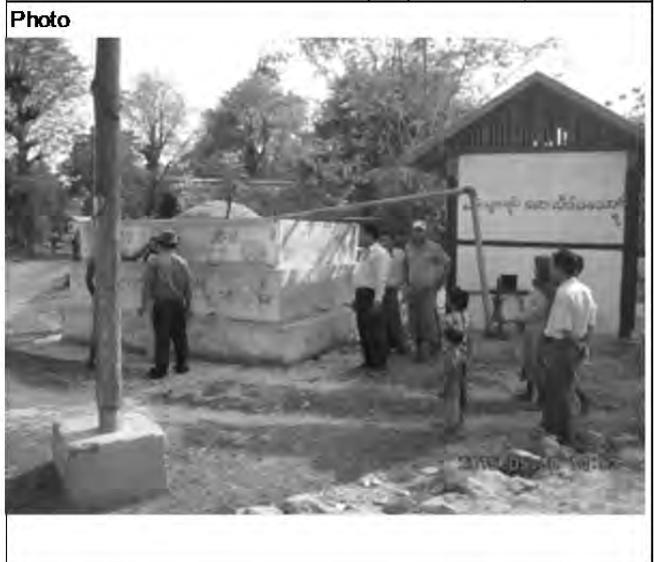
Region	SAGAING		Date	2015/5/9
Township	Dabayin		Reported by	YORITATE Toru
Village / ID	Minyogone	SA2-34	Coordinate (WGS84 UTM)	X
			Y

Information of Existing Water Source - 1					
Type	Deep Well	Coordinate	X	732024	
	Shallow Well		Y	2513022	
	Storage reservoir				
	○ Others <i>Dug Well</i>				
Hydrogeological Information	Drilled Depth (m)	8.9	Results of Simplified Water Quality Test	Sample ID	SA2-34-1
	Diameter (in)	1.6 m		Temperature (°C)	29.7
	S.W.L (m)	4.3		pH	6.95
	D.W.L (m)			EC (µs/cm)	477
	Yield (m³/hour)			Smell	Non
	No.of users (person/day)			Color	Non
	Supply facilities			Mn (mg/l)	<0.02
	Remarks (Lithology , etc.)	Only one dug well is water source in this village. Target : 731866/ 2513234 (Next to the abandoned dug well)		Fe (mg/l)	<0.2
			F (mg/l)	0.2	
			NO3- (mg/l)	<1	
			NO2- (mg/l)	<0.02	
			Coliforms	Too much

Information of Existing Water Source - 2					
Type	○ Deep Well	Coordinate	X	732713	
	Shallow Well		Y	2512110	
	Storage reservoir				
	Others				
Hydrogeological Information	Drilled Depth (m)	103	Results of Simplified Water Quality Test	Sample ID	SA2-34-2
	Diameter (in)	4		Temperature (°C)	30.1
	S.W.L (m)	3.2		pH	7.9
	D.W.L (m)			EC (µs/cm)	1,224
	Yield (m³/hour)	6.8		Smell	Non
	No.of users (person/day)			Color	Non
	Supply facilities			Mn (mg/l)	<0.02
	Remarks (Lithology , etc.)	Next village 1 km from Minyogone village constructed in 1982.		Fe (mg/l)	0.3
			F (mg/l)	0.2	
			NO3- (mg/l)	<1	
			NO2- (mg/l)	<0.02	
			Coliforms

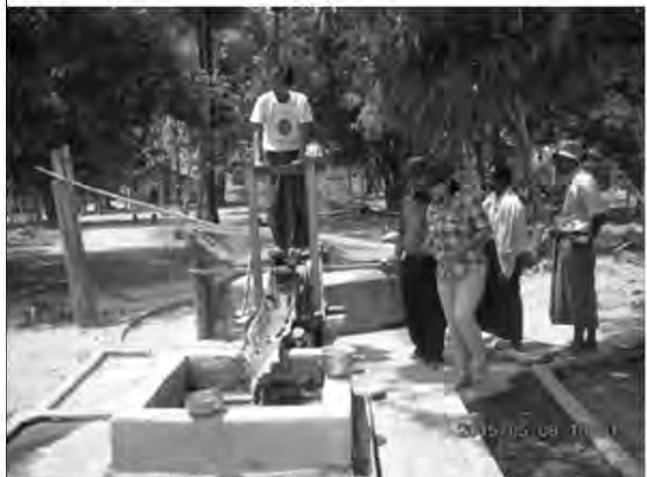
Region	SAGAING		Date	2015/5/9
Township	Dabayin		Reported by	YORITATE Toru
Village / ID	Shandaw	SA2-35	Coordinate (WGS84 UTM)	X
			Y

Information of Existing Water Source - 1				
Type	Deep Well	Coordinate	X	725732
	Shallow Well		Y	2501505
	Storage reservoir			
	Others (dug in canal)			
Hydrogeological Information	Drilled Depth (m)	Results of Simplified Water Quality Test	Sample ID	SA2-35-1
	Diameter (in)		Temperature (°C)	23.8
	S.W.L (m)		pH	7.09
	D.W.L (m)		EC (µs/cm)	438
	Yield (m ³ /hour)		Smell	muddy smell
	No.of users (person/day)		Color	Shallow milk yellow
	Supply facilities		Mn (mg/l)	<0.02
	Remarks (Lithology , etc.)		Fe (mg/l)	<0.2
People digging bottom of the canal and get the water for all useage. 2 tube wells 1.Constructed in 2005, 82m .Water amount reduced and stopped using in 2009. 2.Constructed in 1975 already useless. In the next village 247m artesian well exit.	F (mg/l)	0.2		
	NO3- (mg/l)	1.0		
	NO2- (mg/l)	<0.02		
	Coliforms	Too much		
	Photo

Information of Existing Water Source - 2				
Type	Deep Well	Coordinate	X	725913
	Shallow Well		Y	2500405
	Storage reservoir			
	Others			
Hydrogeological Information	Drilled Depth (m)	Results of Simplified Water Quality Test	Sample ID	SA2-35-2
	Diameter (in)		Temperature (°C)	28.4
	S.W.L (m)		pH	7.55
	D.W.L (m)		EC (µs/cm)	748
	Yield (m ³ /hour)		Smell	Non
	No.of users (person/day)		Color	Non
	Supply facilities		Mn (mg/l)	<0.02
	Remarks (Lithology , etc.)		Fe (mg/l)	<0.2
Dug well with foot pump. Monestry between neighbor village.	F (mg/l)	0.8		
	NO3- (mg/l)	<1		
	NO2- (mg/l)	<0.02		
	Coliforms	Too much		
	Photo

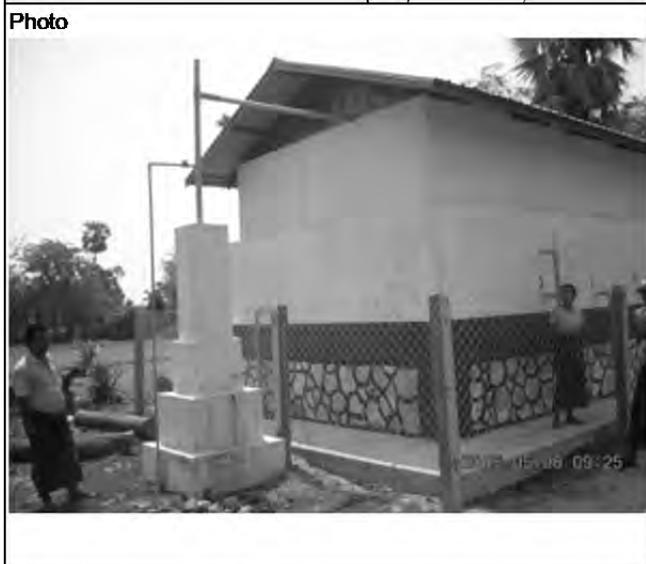
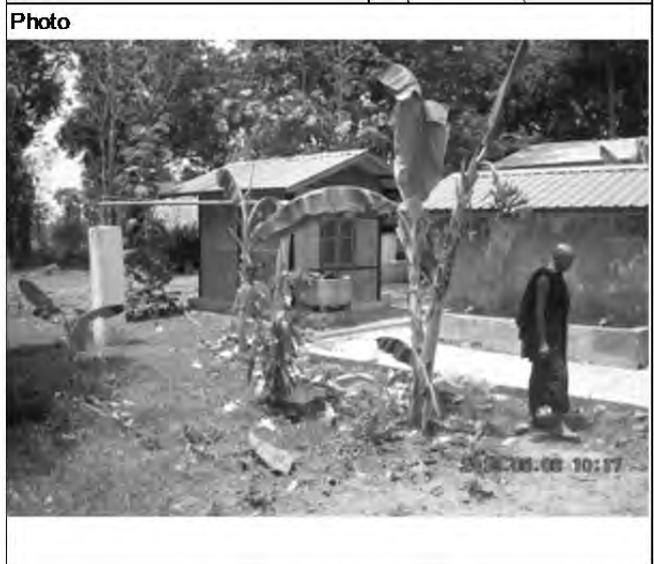
Region	SAGAING		Date	2015/5/9
Township	Dabayin		Reported by	YORITATE Toru
Village / ID	Shandaw	SA2-35	Coordinate (WGS84 UTM)	X Y

Information of Existing Water Source - 1				
Type	<input type="radio"/> Deep Well	Coordinate	X	728341
	<input type="radio"/> Shallow Well		Y	2501689
	<input type="radio"/> Storage reservoir			
	<input type="radio"/> Others			
Hydrogeological Information	Drilled Depth (m)	247	Sample ID	SA2-35-3
	Diameter (in)	2	Temperature (°C)	30.4
	S.W.L (m)		pH	7.87
	D.W.L (m)		EC (µs/cm)	1,564
	Yield (m ³ /hour)	9.1	Smell	Non
	No.of users (person/day)		Color	Non
	Supply facilities	Artesian	Mn (mg/l)	<0.02
	Remarks (Lithology , etc.)	Results of Simplified Water Quality Test		
Artesian well.		Fe (mg/l)	<0.2	
		F (mg/l)	0.2	
		NO3- (mg/l)	<1	
		NO2- (mg/l)	<0.02	
		Coliforms

Information of Existing Water Source - 2				
Type	<input type="radio"/> Deep Well	Coordinate	X	725889
	<input type="radio"/> Shallow Well		Y	2500389
	<input type="radio"/> Storage reservoir			
	<input type="radio"/> Others			
Hydrogeological Information	Drilled Depth (m)		Sample ID	SA2-35-4
	Diameter (in)	2	Temperature (°C)	27.7
	S.W.L (m)		pH	8.38
	D.W.L (m)		EC (µs/cm)	1,004
	Yield (m ³ /hour)	5.5	Smell	Non
	No.of users (person/day)		Color	Non
	Supply facilities	Airlift	Mn (mg/l)	<0.02
	Remarks (Lithology , etc.)	Results of Simplified Water Quality Test		
Same monetry with SA2-35-2. Donated in 2013.		Fe (mg/l)	<0.2	
		F (mg/l)	0.2	
		NO3- (mg/l)	<1	
		NO2- (mg/l)	<0.02	
		Coliforms

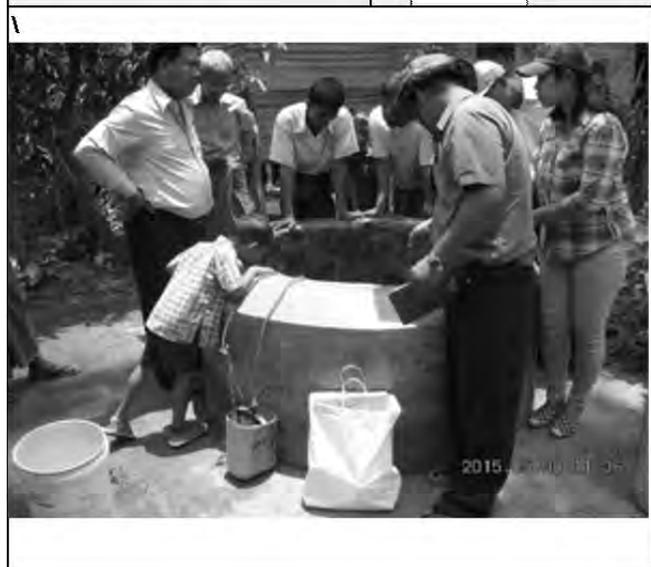
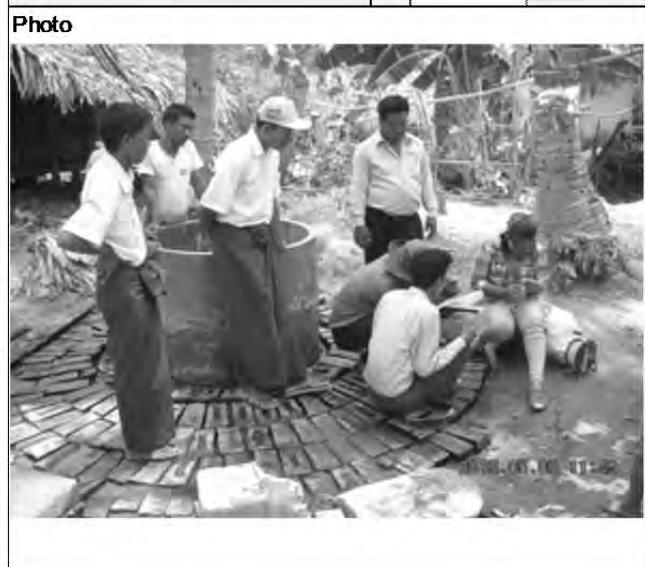
Region	SAGAING		Date	2015/5/9
Township	Dabayin		Reported by	YORITATE Toru
Village / ID	Kyuntaw (S)	SA2-36	Coordinate (WGS84 UTM)	X
				Y

Information of Existing Water Source - 1				
Type	Deep Well	Coordinate	X	728635
	Shallow Well		Y	2505308
	Storage reservoir			
	○ Others <i>Dug Well</i>			
Hydrogeological Information	Drilled Depth (m)	4.8	Sample ID	SA2-36-1
	Diameter (in)	1.1m	Temperature (°C)	27.6
	S.W.L (m)	3.6	pH	6.94
	D.W.L (m)		EC (µs/cm)	896
	Yield (m ³ /hour)		Smell	Non
	No.of users (person/day)		Color	Non
	Supply facilities		Mn (mg/l)	0.02
	Remarks (Lithology , etc.)	Results of Simplified Water Quality Test		
MONO pump tube well -100m damaged in 1995 (728646/2505196) Test well -61m does not have water.	Fe (mg/l) <0.2			
	F (mg/l) 0.2			
	NO3- (mg/l) <1			
	NO2- (mg/l) <0.02			
	Coliforms

Information of Existing Water Source - 2				
Type	Deep Well	Coordinate	X	728715
	Shallow Well		Y	2505233
	Storage reservoir			
	○ Others <i>Dug Well</i>			
Hydrogeological Information	Drilled Depth (m)	4.3	Sample ID	SA2-36-2
	Diameter (in)	1.0m	Temperature (°C)	27.9
	S.W.L (m)	2.3	pH	7.30
	D.W.L (m)		EC (µs/cm)	2,230
	Yield (m ³ /hour)		Smell	Non
	No.of users (person/day)		Color	Non
	Supply facilities		Mn (mg/l)	<0.02
	Remarks (Lithology , etc.)	Results of Simplified Water Quality Test		
Targey: 728632 / 2505189	Fe (mg/l) <0.02			
	F (mg/l) 0.1			
	NO3- (mg/l) 10.0			
	NO2- (mg/l) 0.7			
	Coliforms

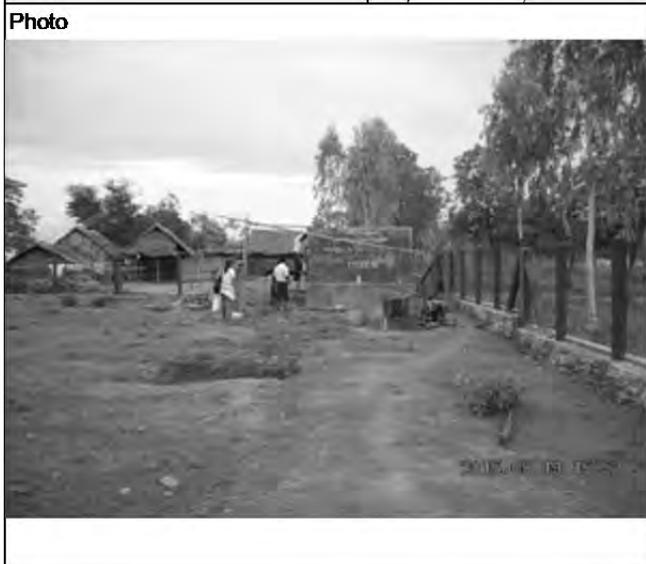
Region	SAGAING		Date	2015/5/19
Township	Wetlet		Reported by	YORITATE Toru
Village / ID	Palae Thwe(Ywarhit)	SA2-37	Coordinate (WGS84 UTM)	X
				Y

Information of Existing Water Source - 1				
Type	○ Deep Well	Coordinate	X	798855
	Shallow Well		Y	2492654
	Storage reservoir			
	Others			
Hydrogeological Information	Drilled Depth (m)	109	Sample ID	SA2-37-1
	Diameter (in)		Temperature (°C)	31.4
	S.W.L (m)		pH	8.06
	D.W.L (m)		EC (µs/cm)	924
	Yield (m ³ /hour)	3.4	Smell	Non
	No.of users (person/day)		Color	Non
	Supply facilities		Mn (mg/l)	<0.02
	Remarks (Lithology , etc.)	Results of Simplified Water Quality Test		Fe (mg/l)
F (mg/l)				0.0
NO3-(mg/l)				<1
NO2-(mg/l)				<0.02
Coliforms				0

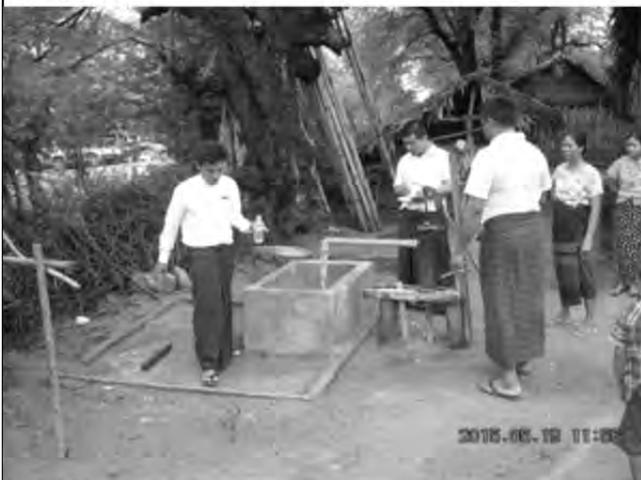
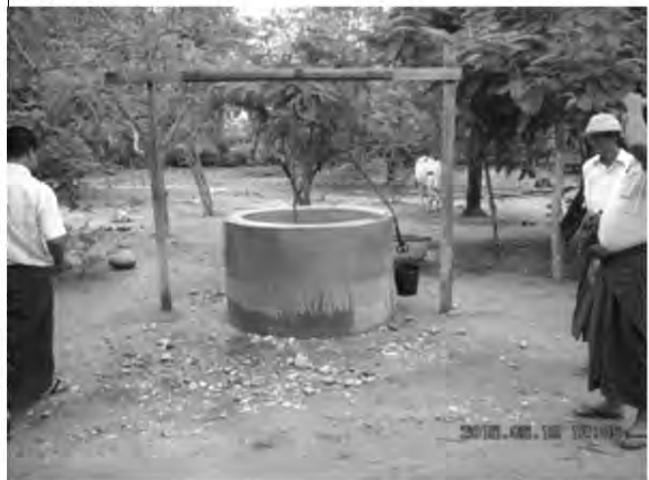
NO3- (mg/l)	2.0			NO3- (mg/l)	20.0		
		NO2- (mg/l)	<0.02			NO2- (mg/l)	<0.02		
		Coliforms	0			Coliforms	uncounted

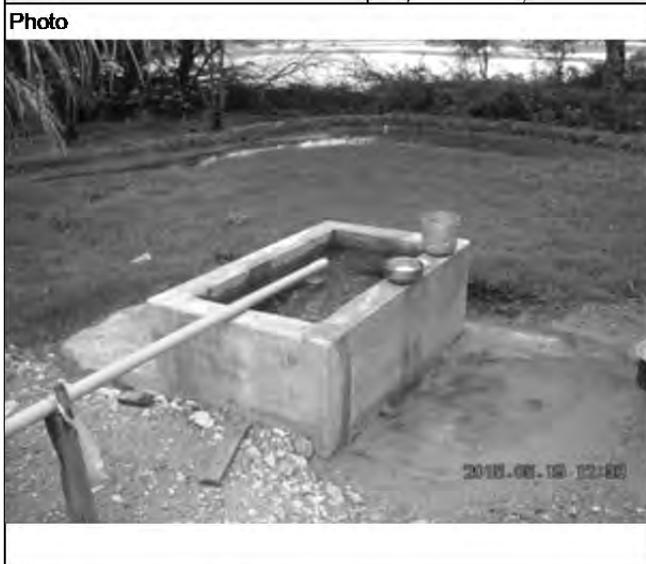
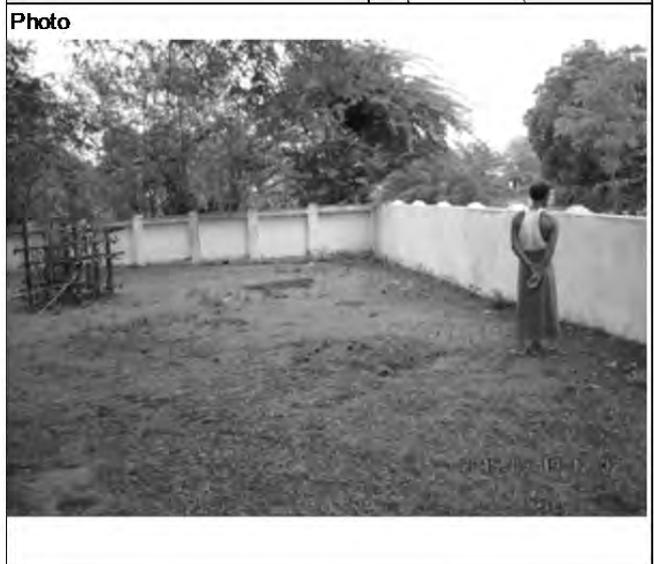
Region	SAGAING		Date	2015/5/19
Township	Wetlet		Reported by	YORITATE Toru
Village / ID	Poukkan	SA2-38	Coordinate (WGS84 UTM)	X
			Y

Information of Existing Water Source - 1				
Type	Deep Well	Coordinate	X	797690
	○ Shallow Well		Y	2462872
	Storage reservoir			
	Others			
Hydrogeological Information	Drilled Depth (m)	38	Sample ID	SA2-38-3
	Diameter (in)	2	Temperature (°C)	30.0
	S.W.L (m)		pH	7.9
	D.W.L (m)		EC (µs/cm)	1,500
	Yield (m ³ /hour)	1.4	Smell	Non
	No.of users (person/day)		Color	Non
	Supply facilities	Artesian	Mn (mg/l)	<0.02
	Remarks (Lithology , etc.)		Fe (mg/l)	<0.2
F (mg/l)			2.0	
NO3- (mg/l)			5.0	
NO2- (mg/l)			<0.02	
Coliforms			0

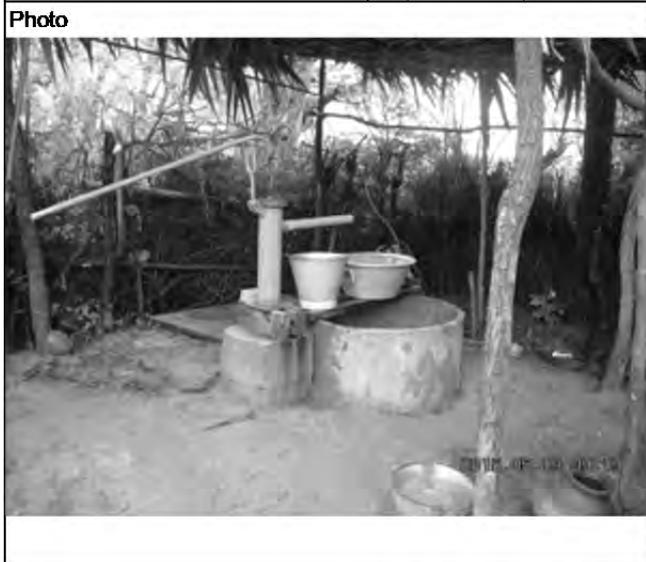
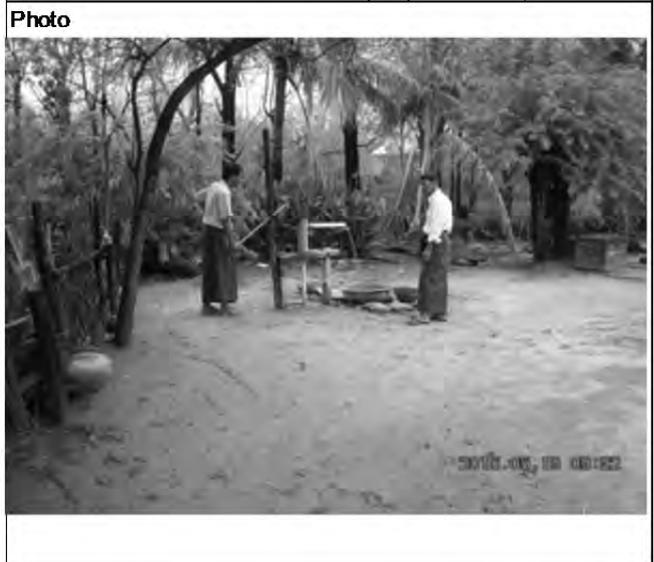
Region	SAGAING		Date	2015/5/19
Township	Wetlet		Reported by	YORITATE Toru
Village / ID	Sabeidaw	SA2-40	Coordinate (WGS84 UTM)	X Y

Information of Existing Water Source - 1				
Type	Deep Well	Coordinate	X	786790
	○ Shallow Well		Y	2472040
	Storage reservoir			
	Others			
Hydrogeological Information	Drilled Depth (m)	10.6	Sample ID	SA2-40-1
	Diameter (in)		Temperature (°C)	27.4
	S.W.L (m)	1.5	pH	7.84
	D.W.L (m)		EC (µs/cm)	764
	Yield (m ³ /hour)		Smell	Non
	No.of users (person/day)		Color	Non
	Supply facilities		Mn (mg/l)	<0.02
	Remarks (Lithology , etc.)		Fe (mg/l)	<0.2
Results of Simplified Water Quality Test			F (mg/l)	0.6
			NO3- (mg/l)	10.0
			NO2- (mg/l)	<0.02
			Coliforms	0

Information of Existing Water Source - 2				
Type	Deep Well	Coordinate	X	786486
	○ Shallow Well		Y	2472202
	Storage reservoir			
	Others			
Hydrogeological Information	Drilled Depth (m)	10.6	Sample ID	SA2-40-2
	Diameter (in)		Temperature (°C)	28.3
	S.W.L (m)		pH	8.03
	D.W.L (m)		EC (µs/cm)	2,130
	Yield (m ³ /hour)		Smell	Non
	No.of users (person/day)		Color	Non
	Supply facilities		Mn (mg/l)	<0.02
	Remarks (Lithology , etc.)		Fe (mg/l)	<0.2
Results of Simplified Water Quality Test			F (mg/l)	3.0
			NO3- (mg/l)	5.0
			NO2- (mg/l)	<0.02
			Coliforms	Too much

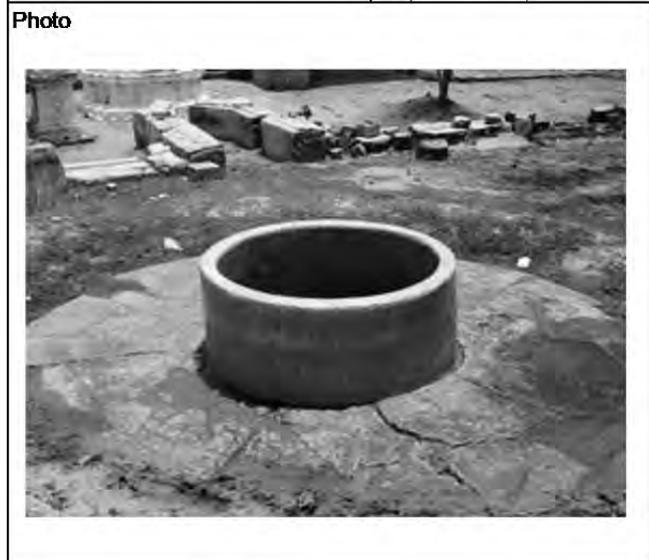
Region	Mandalay		Date	2015.5.24	
Township	Mahlaing		Reported by	Sasaki	
Village / ID	Htantawgyi	MA2-01	Coordinate (WGS84 UTM)	X	766932
			Y	2339178

Information of Existing Water Sauce - 1						
Type	Deep Well	Coordinate	X	767026		
	Shallow Well		Y	2338930		
	Storage reservoir					
	○ Others <i>Dug Well</i>					
Hydrogeological Information	Drilled Depth (m)	15	Sample ID	MA2-01-1		
	Diameter (in)	1.5m	Temperature (°C)	30.3		
	S.W.L (m)	no data	pH	7.43		
	D.W.L (m)		EC (µs/cm)	2,310		
	Yield (m³/hour)		Smell	Non		
	No.of users (person/day)	480	Color	Non		
	Supply facilities		Mn (mg/l)	<0.02		
	Remarks (Lithology , etc.)	There are 4 shallow well in the village. But 3 of shallow well be come salty and villager can use only 1 well for drinking. That well is located near the irrigation channel. SWL is around GL-10m. And this village have another tube well (180 feet) to use some village event.		Fe (mg/l)	<0.2	
Results of Simplified Water Quality Test	F (mg/l)			0.4		
	NO3- (mg/l)			10		
	NO2- (mg/l)			<0.02		
	Coliforms			Too much
