5.3.1 現地簡易水質測定結果

5.3.2 現地水質測定状況

(1) ザガイン地域

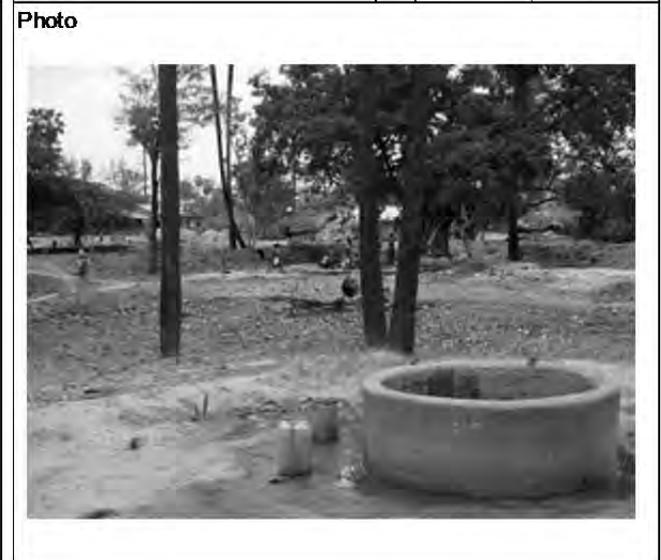
Information of Existing Water Sauce - 2						
Type	Deep Well	Coordinate	X	767009		
	Shallow Well		Y	2339022		
	Storage reservoir					
	○ Others <i>Dug Well</i>					
Hydrogeological Information	Drilled Depth (m)	15	Sample ID	MA2-01-2		
	Diameter (in)	1.5m	Temperature (°C)	30.8		
	S.W.L (m)		pH	7.82		
	D.W.L (m)		EC (µs/cm)	3,560		
	Yield (m³/hour)		Smell	Non		
	No.of users (person/day)		Color	Non		
	Supply facilities		Mn (mg/l)			
	Remarks (Lithology , etc.)	Salty well. They don't use for drinking water. To use for laundry and bathing.		Fe (mg/l)		
Results of Simplified Water Quality Test	F (mg/l)					
	NO3- (mg/l)					
	NO2- (mg/l)					
	Coliforms

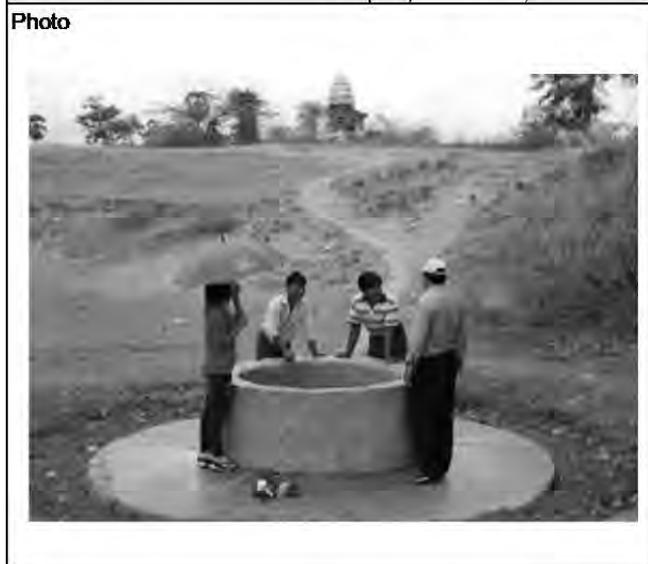
Region	Mandalay		Date	2015.5.19	
Township	Mahlaing		Reported by	Yamasaki	
Village / ID	Asone	MA2-02	Coordinate (WGS84 UTM)	X	769179
				Y	2329028

Information of Existing Water Source - 1						
Type	Deep Well	Coordinate	X	768727		
	Shallow Well		Y	2328337		
	Storage reservoir					
	○ Others <i>Dug Well</i>					
Hydrogeological Information	Drilled Depth (m)	6.1	Results of Simplified Water Quality Test	Sample ID	MA2-02-1	
	Diameter (in)	1.5m		Temperature (°C)	27.5	
	S.W.L (m)	1.8		pH	7.48	
	D.W.L (m)			EC (µs/cm)	1,472	
	Yield (m ³ /hour)			Smell	Non	
	No.of users (person/day)	650		Color	Non	
	Supply facilities			Mn (mg/l)	<0.02	
	Remarks (Lithology , etc.)	Electrical pole have already installed. But only some house can use electricity. This well is located around 1km from center of village. This village has some dug well. when they boil rice use these water, rice will become yellow. There are no deep well near this village.				
	Fe (mg/l)					<0.02
	F (mg/l)					0
	NO3- (mg/l)					<1
	NO2- (mg/l)					<0.02
	Coliforms					Too much

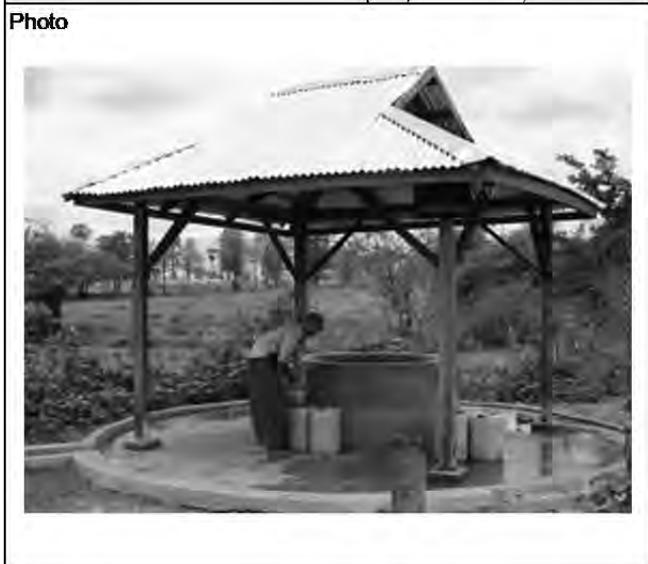
Region	Mandalay		Date	2015.5.19	
Township	Mahlaing		Reported by	Yamasaki	
Village / ID	Khinthar(S)	MA2-03	Coordinate (WGS84 UTM)	X	782188
				Y	2317148

Information of Existing Water Source - 1								
Type	Deep Well	Coordinate	X	781754				
	Shallow Well		Y	2317206				
	Storage reservoir							
	○ Others <i>Dug Well</i>							
Hydrogeological Information	Drilled Depth (m)	6.1	Sample ID	MA2-03-1				
	Diameter (in)		Temperature (°C)	27.6				
	S.W.L (m)	3.1	pH	7.41				
	D.W.L (m)		EC (µs/cm)	781				
	Yield (m ³ /hour)		Smell	Non				
	No.of users (person/day)	480	Color	Non				
	Supply facilities		Mn (mg/l)	<0.02				
	Remarks (Lithology , etc.)	This village is shared pond water with neighbor village in rainy season.						
	Fe (mg/l)						<0.2	
	F (mg/l)						0	
	NO3- (mg/l)						<1	
	NO2- (mg/l)						<0.02	
	Coliforms						7

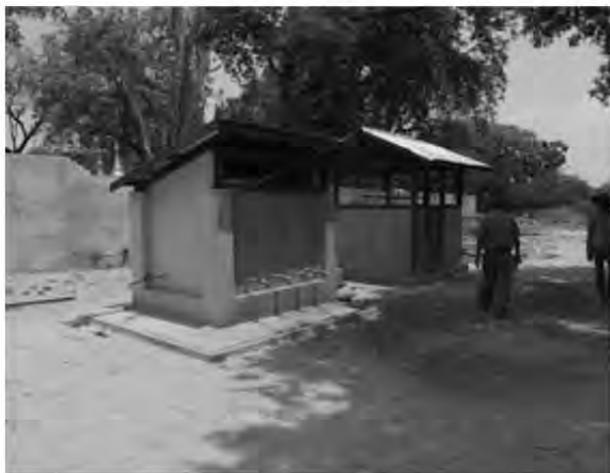
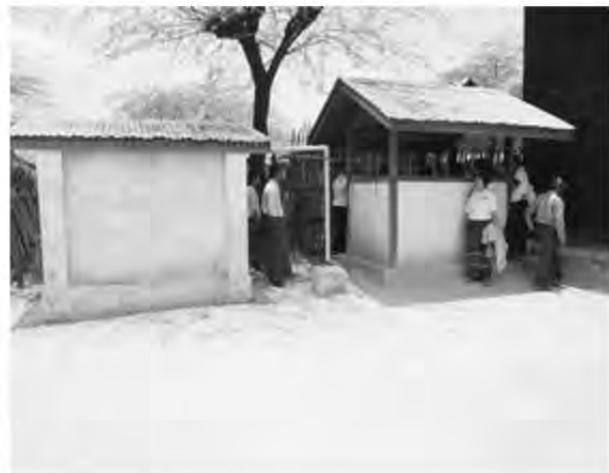
Region	Mandalay		Date	2015/5/24
Township	Myingyan		Reported by	Maruo
Village / ID	Chaysay	MA2-04	Coordinate (WGS84 UTM)	X
			Y

Information of Existing Water Source - 1					Information of Existing Water Source - 2						
Type	○ Deep Well		Coordinate	X	753208	Type	Deep Well		Coordinate	X	753114
	Shallow Well			Y	2369050		○ Shallow Well			Y	2369048
	Storage reservoir						Storage reservoir				
	Others						Others				
Hydrogeological Information	Drilled Depth (m)	91.4	Results of Simplified Water Quality Test	Sample ID	MA2-4-1	Hydrogeological Information	Drilled Depth (m)	59.4	Results of Simplified Water Quality Test	Sample ID	MA2-4-2
	Diameter (in)	1		Temperature (°C)	31.1		Diameter (in)	3		Temperature (°C)	31.0
	S.W.L (m)	30.4		pH	8.06		S.W.L (m)	19.2		pH	8.11
	D.W.L (m)			EC (µs/cm)	2,880		D.W.L (m)			EC (µs/cm)	2,580
	Yield (m³/hour)			Smell	Non		Yield (m³/hour)			Smell	Non
	No.of users (person/day)			Color	Non		No.of users (person/day)			Color	Non
	Supply facilities	Compressor		Mn (mg/l)	<1		Supply facilities	Compressor		Mn (mg/l)	<1

Remarks (Lithology , etc.)	DDA well 2013- inside the school compound.		Fe (mg/l)	0.2		Remarks (Lithology , etc.)	Another tube well in the clinic , drilled by DDA in 2000 X 2369051.62mN Y 753117.55mE		Fe (mg/l)	<0.2
			F (mg/l)	0				F (mg/l)	0		
			NO3- (mg/l)	<1				NO3- (mg/l)	<1		
			NO2- (mg/l)	<0.02				NO2- (mg/l)	<0.02		
			Coliforms					Coliforms

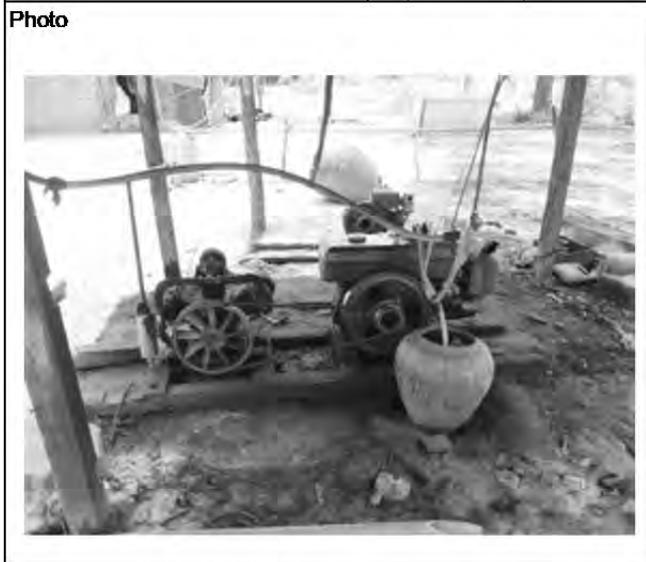
Region	Mandalay		Date	2015/5/25
Township	Myingyan		Reported by	Maruo
Village / ID	Talgyi	MA2-05	Coordinate (WGS84 UTM)	X
			Y

Information of Existing Water Source - 1					
Type	○ Deep Well	Coordinate	X	758959	
	Shallow Well		Y	2405065	
	Storage reservoir				
	Others				
Hydrogeological Information	Drilled Depth (m)	71.6	Results of Simplified Water Quality Test	Sample ID	MA2-5-1
	Diameter (in)	2		Temperature (°C)	30.9
	S.W.L (m)			pH	8.27
	D.W.L (m)			EC (µs/cm)	1,303
	Yield (m ³ /hour)			Smell	Non
	No.of users (person/day)			Color	Turbidity
	Supply facilities	compressor		Mn (mg/l)	<1
	Remarks (Lithology , etc.)			Fe (mg/l)	<0.2
Monastery well - water contain sand, Ayarwaddy river.		F (mg/l)	0.7		
		NO3- (mg/l)	1		
		NO2- (mg/l)	<0.02		
		Coliforms

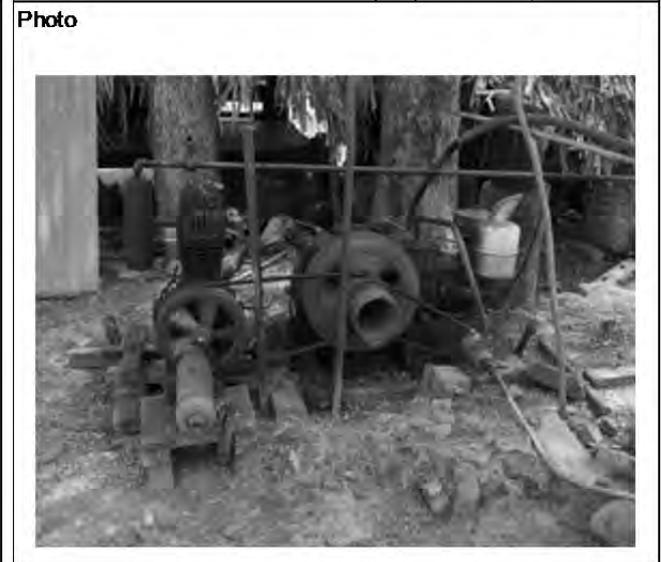
Information of Existing Water Source - 2					
Type	Deep Well	Coordinate	X	758815	
	○ Shallow Well		Y	2404938	
	Storage reservoir				
	Others				
Hydrogeological Information	Drilled Depth (m)	45.7	Results of Simplified Water Quality Test	Sample ID	MA2-5-2
	Diameter (in)	3		Temperature (°C)	30.5
	S.W.L (m)	8.2		pH	8.44
	D.W.L (m)			EC (µs/cm)	1,783
	Yield (m ³ /hour)			Smell	Non
	No.of users (person/day)			Color	Non
	Supply facilities	Compressor		Mn (mg/l)	<1
	Remarks (Lithology , etc.)			Fe (mg/l)	<0.2
Private tube well in the village. This house has a tractor and telephone. Family use the water for drilling.		F (mg/l)	1		
		NO3- (mg/l)	4		
		NO2- (mg/l)	<0.02		
		Coliforms

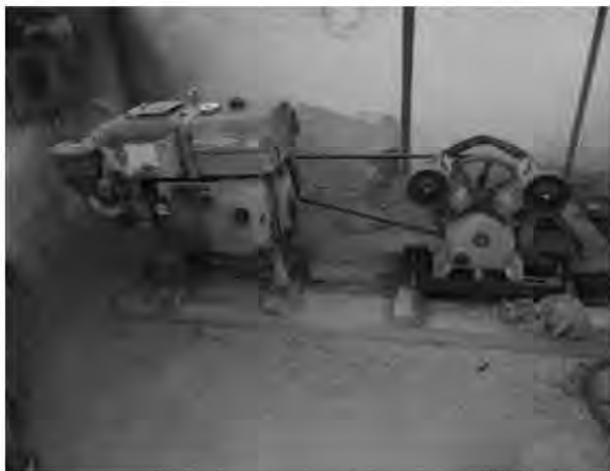
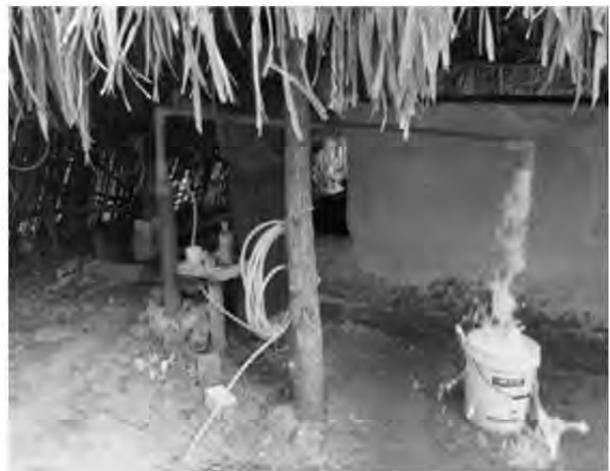
Region	Mandalay		Date	2015/5/24
Township	Myingyan		Reported by	Maruo
Village / ID	Kuywar	MA2-06	Coordinate (WGS84 UTM)	X
			Y

Information of Existing Water Source - 1					Information of Existing Water Source - 2						
Type	Deep Well		Coordinate	X	749780	Type	○ Deep Well		Coordinate	X	749809
	○ Shallow Well			Y	2369023		Shallow Well			Y	2369054
	Storage reservoir						Storage reservoir				
	Others						Others				
Hydrogeological Information	Drilled Depth (m)	59	Results of Simplified Water Quality Test	Sample ID	MA2-6-1	Hydrogeological Information	Drilled Depth (m)	79	Results of Simplified Water Quality Test	Sample ID	MA2-6-2
	Diameter (in)	3		Temperature (°C)	31.2		Diameter (in)	3		Temperature (°C)	31.8
	S.W.L (m)	16.7		pH	7.88		S.W.L (m)	19.2		pH	8.69
	D.W.L (m)			EC (µs/cm)	274		D.W.L (m)			EC (µs/cm)	2,450
	Yield (m³/hour)			Smell	Non		Yield (m³/hour)			Smell	Non
	No.of users (person/day)			Color	Turbidity		No.of users (person/day)			Color	Non
	Supply facilities	Compressor		Mn (mg/l)	0		Supply facilities	Compressor		Mn (mg/l)	<1

Remarks (Lithology , etc.)	Private well - near DDA well, very salty . Possibly deeper could be better quality, 2008 drilled. X : 2369023.86mN Y : 749780.33mE		Fe (mg/l)	0.5		Remarks (Lithology , etc.)	300m from frist private well. Drill deeper quality may be better. Drilled in 2015- private well. X : 2369053.90mN Y : 749809.86mE		Fe (mg/l)	<0.2
			F (mg/l)	4				F (mg/l)	2		
			NO3- (mg/l)	1				NO3- (mg/l)	1.5		
			NO2- (mg/l)	<0.02				NO2- (mg/l)	0.1		
			Coliforms					Coliforms

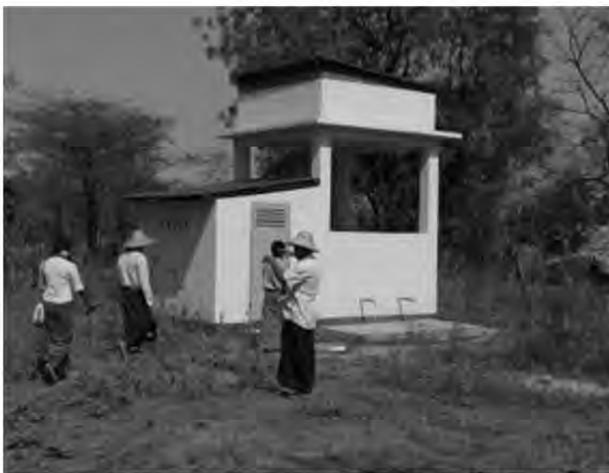
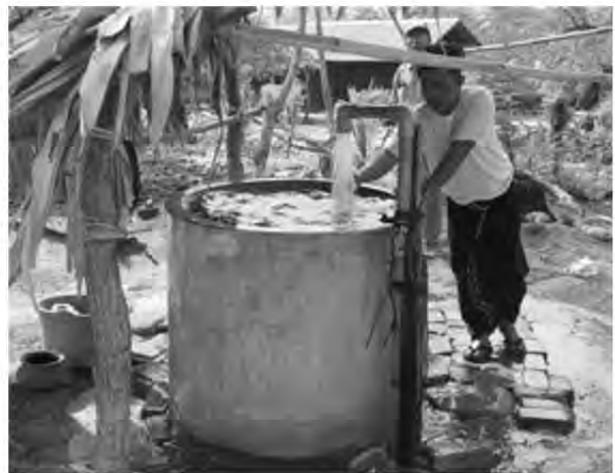
Region	Mandalay		Date	5/24/2015
Township	Myingyan		Reported by	Maruo
Village / ID	Yonehto	MA2-07	Coordinate (WGS84 UTM)	X
			Y

Information of Existing Water Source - 1						
Type	○ Deep Well	Coordinate	X	762463		
	Shallow Well		Y	2384138		
	Storage reservoir					
	Others					
Hydrogeological Information	Drilled Depth (m)	98	Sample ID	MA2-7-1		
	Diameter (in)	3	Temperature (°C)	31.0		
	S.W.L (m)	46	pH	7.73		
	D.W.L (m)		EC (µs/cm)	7,960		
	Yield (m ³ /hour)		Smell	Non		
	No.of users (person/day)		Color	Non		
	Supply facilities	Compressor	Mn (mg/l)	<1		
	Remarks (Lithology , etc.)	Results of Simplified Water Quality Test				
Inside clinic compound behind monastery, drilled in 2014 by Gov Health Organization.						
	Fe (mg/l)					<0.2
	F (mg/l)					0
	NO3- (mg/l)					45
	NO2- (mg/l)					0
	Coliforms

Information of Existing Water Source - 2						
Type	○ Deep Well	Coordinate	X	762698		
	Shallow Well		Y	2384434		
	Storage reservoir					
	Others					
Hydrogeological Information	Drilled Depth (m)	98	Sample ID	MA2-7-2		
	Diameter (in)	4	Temperature (°C)	30.9		
	S.W.L (m)		pH	7.58		
	D.W.L (m)		EC (µs/cm)	7,340		
	Yield (m ³ /hour)		Smell	Non		
	No.of users (person/day)		Color	Non		
	Supply facilities	Compressor	Mn (mg/l)	<1		
	Remarks (Lithology , etc.)	Results of Simplified Water Quality Test				
Private tube well Taste Slightly salty X : 2384434.60mN Y : 762698.30mE						
	Fe (mg/l)					<0.2
	F (mg/l)					0
	NO3- (mg/l)					20
	NO2- (mg/l)					0.02
	Coliforms

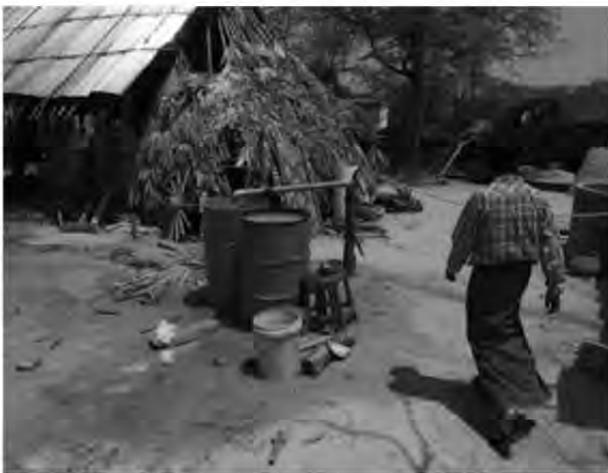
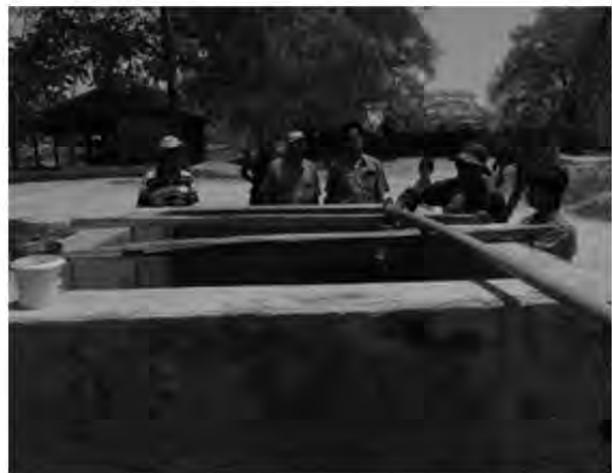
Region	Mandalay		Date	2015/5/25
Township	Myingyan		Reported by	Maruo
Village / ID	Phatpin-I	MA2-08	Coordinate (WGS84 UTM)	X Y

Information of Existing Water Source - 1					Information of Existing Water Source - 2						
Type	○ Deep Well		Coordinate	X	766089	Type	○ Deep Well		Coordinate	X	766347
	Shallow Well			Y	2399238		Shallow Well			Y	2399645
	Storage reservoir						Storage reservoir				
	Others						Others				
Hydrogeological Information	Drilled Depth (m)	61	Results of Simplified Water Quality Test	Sample ID	MA2-8-1	Hydrogeological Information	Drilled Depth (m)	107	Results of Simplified Water Quality Test	Sample ID	MA2-8-2
	Diameter (in)	2		Temperature (°C)	30.3		Diameter (in)	3		Temperature (°C)	30.6
	S.W.L (m)			pH	8.24		S.W.L (m)			pH	8.46
	D.W.L (m)			EC (µs/cm)	6,160		D.W.L (m)			EC (µs/cm)	1,930
	Yield (m ³ /hour)			Smell	Non		Yield (m ³ /hour)	500g/h		Smell	Slightly certain smell
	No.of users (person/day)			Color	High turbidity		No.of users (person/day)			Color	Slightly muddy
	Supply facilities	Compressor		Mn (mg/l)	<1		Supply facilities			Mn (mg/l)	<1

Remarks (Lithology , etc.)			Fe (mg/l)	<0.2		Remarks (Lithology , etc.)			Fe (mg/l)	<0.2
Private well. Water certain yellow sand and silt. Taste is salty and they use this water for animals. X : 2399238.43mN Y : 766089.93mE Nyaungwin village is next to the target village.		F (mg/l)	0	Monastery well - slightly salty X : 2399645.31mN Y : 766347.70mE		F (mg/l)	0.2				
		NO3- (mg/l)	<1			NO3- (mg/l)	<1				
		NO2- (mg/l)	<0.02			NO2- (mg/l)	<0.02				
		Coliforms				Coliforms

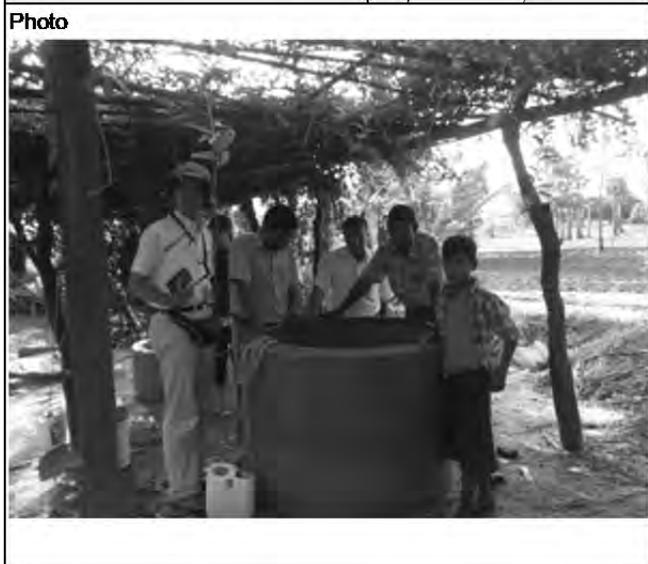
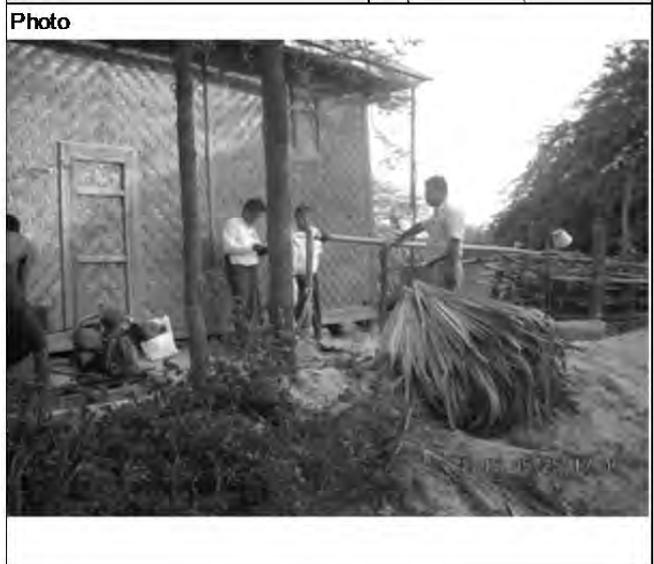
Region	MANDALAY		Date	2015/5/25
Township	Ngazon		Reported by	YORITATE Toru
Village / ID	Konelel	MA2-9	Coordinate (WGS84 UTM)	X Y

Information of Existing Water Source - 1					
Type	Deep Well	Coordinate	X	758753	
	Shallow Well		Y	2410571	
	Storage reservoir				
	○ Others <i>Dug Well</i>				
Hydrogeological Information	Drilled Depth (m)	11	Sample ID	MA2-9 -1	
	Diameter (in)	1.0m	Temperature (°C)	29.1	
	S.W.L (m)	9.4	pH	8.33	
	D.W.L (m)		EC (µs/cm)	6,020	
	Yield (m ³ /hour)		Smell	Non	
	No.of users (person/day)		Color	Non	
	Supply facilities		Mn (mg/l)	<0.02	
	Remarks (Lithology , etc.)	Results of Simplified Water Quality Test			
Dug well. Can not drink water. Other 11 dugwells are also high salinity water can not drink. Monestry TW (189m) and DDA drilled TW (128m) are also high salinity therefore, nnow not uder the operation. Pego Formation area.					
	Fe (mg/l)				<0.2
	F (mg/l)				5.0
	NO3- (mg/l)				8.0
	NO2- (mg/l)				<0.02
	Coliforms

Information of Existing Water Source - 2					
Type	○ Deep Well	Coordinate	X	758200	
	Shallow Well		Y	2410349	
	Storage reservoir				
	Others				
Hydrogeological Information	Drilled Depth (m)	61	Sample ID	MA2-9 -2	
	Diameter (in)	2	Temperature (°C)	30.8	
	S.W.L (m)		pH	7.93	
	D.W.L (m)		EC (µs/cm)	6,360	
	Yield (m ³ /hour)	4.1	Smell	Non	
	No.of users (person/day)		Color	Non	
	Supply facilities		Mn (mg/l)	<0.02	
	Remarks (Lithology , etc.)	Results of Simplified Water Quality Test			
Private well. Can not drink water. Target : 758855 / 2410492					
	Fe (mg/l)				<0.2
	F (mg/l)				0.0
	NO3- (mg/l)				45<
	NO2- (mg/l)				0.2
	Coliforms

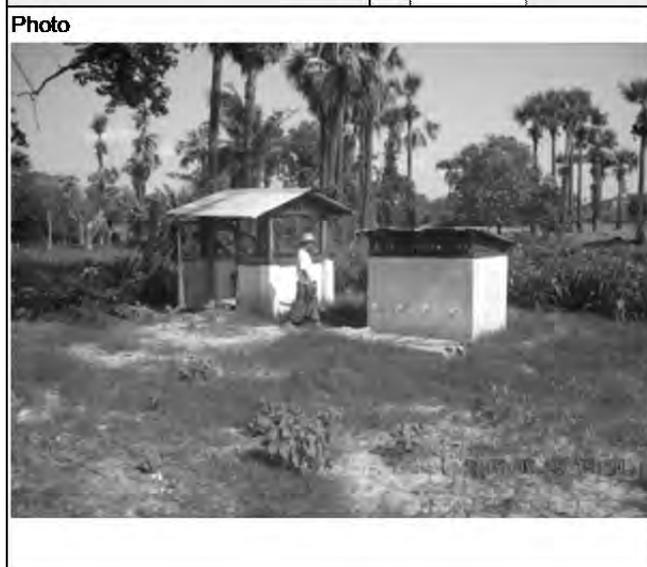
Region	MANDALAY		Date	2015/5/25
Township	Ngazon		Reported by	YORITATE Toru
Village / ID	Phaungkadaw	MA2-10	Coordinate (WGS84 UTM)	X Y

Information of Existing Water Source - 1				
Type	Deep Well	Coordinate	X	766115
	Shallow Well		Y	2416389
	Storage reservoir			
	○ Others <i>Dug Well</i>			
Hydrogeological Information	Drilled Depth (m)	18m×3	Sample ID	MA2-10-1
	Diameter (in)	2	Temperature (°C)	29.8
	S.W.L (m)	2.0	pH	7.12
	D.W.L (m)		EC (µs/cm)	6,470
	Yield (m ³ /hour)		Smell	Non
	No.of users (person/day)		Color	Non
	Supply facilities	Suction Pump	Mn (mg/l)	0.02
	Remarks (Lithology , etc.)	Upper Pego Formation.N45W,60S 3 shallow well (18m×3) combination system for suction pump. While pumping, close (10m distance) dug well's water also draw down.		
		Results of Simplified Water Quality Test	Fe (mg/l)	<0.2
			F (mg/l)	0.0
			NO3- (mg/l)	8.0
			NO2- (mg/l)	<0.02
			Coliforms

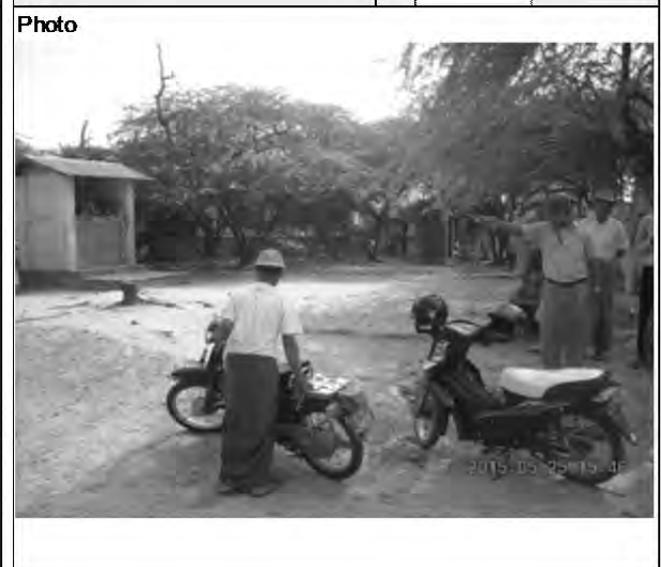
Region	MANDALAY		Date	2015/5/25
Township	Ngazon		Reported by	YORITATE Toru
Village / ID	Kaungzin	MA2-11	Coordinate (WGS84 UTM)	X
			Y

Information of Existing Water Source - 1				
Type	○ Deep Well	Coordinate	X	765457
	Shallow Well		Y	2403617
	Storage reservoir			
	Others <i>Dug Well</i>			
Hydrogeological Information	Drilled Depth (m)	152	Sample ID	MA2-11 -1
	Diameter (in)	2	Temperature (°C)	30.4
	S.W.L (m)	unknown	pH	7.86
	D.W.L (m)		EC (µs/cm)	2,340
	Yield (m ³ /hour)	3.2	Smell	Non
	No.of users (person/day)		Color	Non
	Supply facilities	Airlift	Mn (mg/l)	<0.02
	Remarks (Lithology , etc.)	Private well belong to the Monestry. Upper Peg formation Sand Silt rock alternation. N10E, 60 ~ 90N		
		Results of Simplified Water Quality Test	Fe (mg/l)	<0.2
			F (mg/l)	0.6
			NO3- (mg/l)	8.0
			NO2- (mg/l)	<0.02
			Coliforms

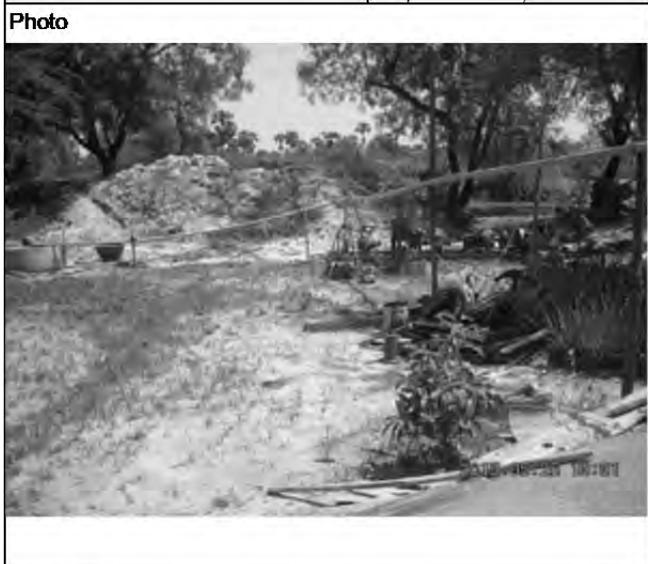
Information of Existing Water Source - 2				
Type	Deep Well	Coordinate	X	768899
	○ Shallow Well		Y	2402581
	Storage reservoir			
	Others			
Hydrogeological Information	Drilled Depth (m)	10	Sample ID	MA2-11 -2
	Diameter (in)	2	Temperature (°C)	pump broken can not get water
	S.W.L (m)		pH	
	D.W.L (m)		EC (µs/cm)	
	Yield (m ³ /hour)		Smell	
	No.of users (person/day)		Color	
	Supply facilities		Mn (mg/l)	
	Remarks (Lithology , etc.)	Private well.(3 well conivation) but now pump does not work. Can not get water anyway, water can not drink. Target : 764970 / 2403461 Now stopin sxc		
		Results of Simplified Water Quality Test	Fe (mg/l)	
			F (mg/l)	
			NO3- (mg/l)	
			NO2- (mg/l)	
			Coliforms

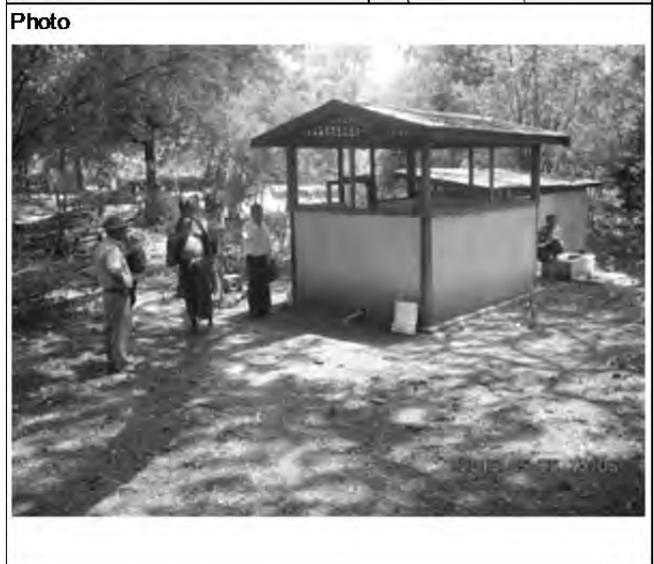
Region	MANDALAY		Date	2015/5/25
Township	Ngazon		Reported by	YORITATE Toru
Village / ID	Ywarsite	MA2-12	Coordinate (WGS84 UTM)	X
			Y

Information of Existing Water Source - 1				
Type	<input type="radio"/> Deep Well	Coordinate	X	768195
	Shallow Well		Y	2402362
	Storage reservoir			
	Others <i>Dug Well</i>			
Hydrogeological Information	Drilled Depth (m)	213	Sample ID	MA2-12-1
	Diameter (in)	2	Temperature (°C)	31.7
	S.W.L (m)		pH	7.91
	D.W.L (m)		EC (µs/cm)	11,680
	Yield (m ³ /hour)	3.2	Smell	Non
	No.of users (person/day)		Color	Non
	Supply facilities	Airlift	Mn (mg/l)	<0.02
	Remarks (Lithology , etc.)		Fe (mg/l)	<0.2
Private well. Upper Peg formation Sand Silt rock alternation. N10E, 60 ~ 90N		F (mg/l)	5.0	
		NO3- (mg/l)	8.0	
		NO2- (mg/l)	1<	
		Coliforms

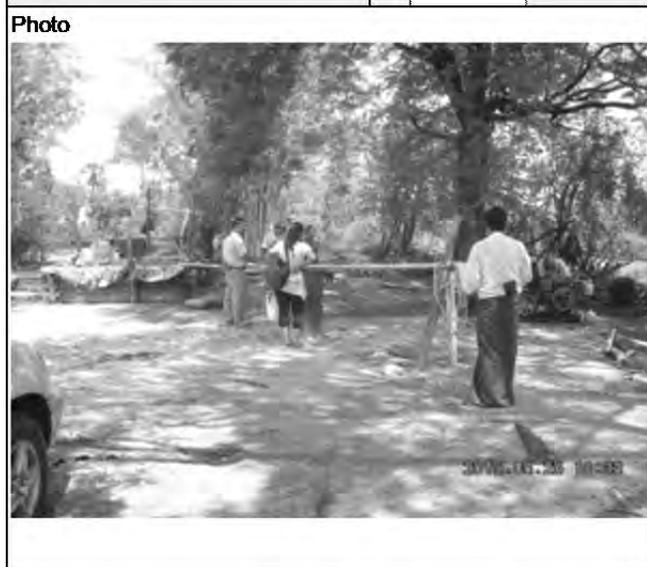
Information of Existing Water Source - 2				
Type	<input type="radio"/> Deep Well	Coordinate	X	768899
	Shallow Well		Y	2402581
	Storage reservoir			
	Others <i>Dug Well</i>			
Hydrogeological Information	Drilled Depth (m)	6	Sample ID	MA2-12-2
	Diameter (in)	1.4 m	Temperature (°C)	27.8
	S.W.L (m)	3.1	pH	7.28
	D.W.L (m)		EC (µs/cm)	3,340
	Yield (m ³ /hour)		Smell	Non
	No.of users (person/day)		Color	Non
	Supply facilities		Mn (mg/l)	0.05
	Remarks (Lithology , etc.)		Fe (mg/l)	<0.2
Public dug well Target : 768301 / 2402220		F (mg/l)	0.4	
		NO3- (mg/l)	<1	
		NO2- (mg/l)	<0.02	
		Coliforms

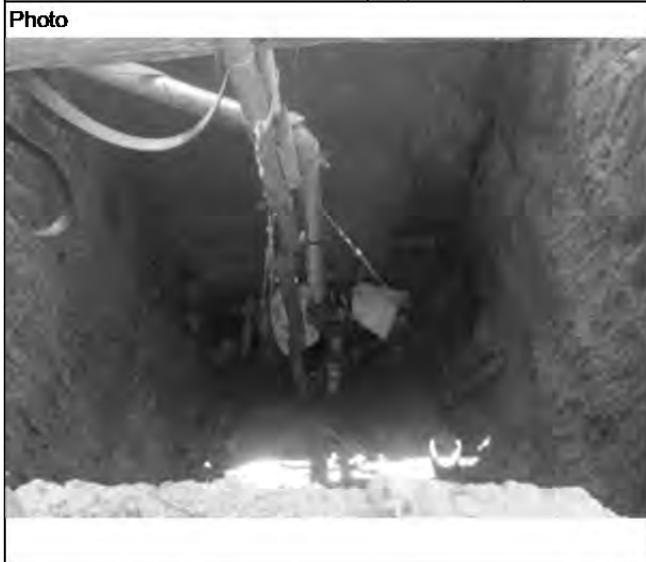
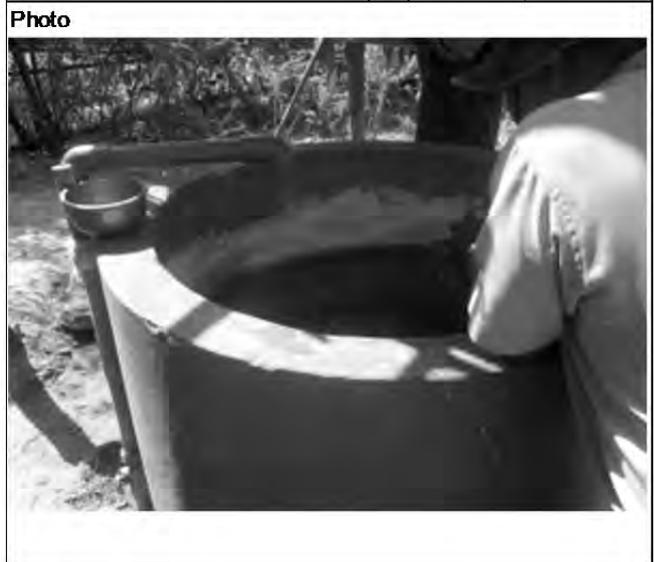
Region	MANDALAY		Date	2015/5/24
Township	Natogyi		Reported by	YORITATE Toru
Village / ID	Kyaungnan	MA2-13	Coordinate (WGS84 UTM)	X
			Y

Information of Existing Water Source - 1				
Type	Deep Well	Coordinate	X	767771
	Shallow Well		Y	2376174
	Storage reservoir			
	Others			
Hydrogeological Information	Drilled Depth (m)	18m×4	Sample ID	MA2-13-1
	Diameter (in)	2	Temperature (°C)	32.8
	S.W.L (m)	7	pH	7.51
	D.W.L (m)		EC (µs/cm)	1,342
	Yield (m ³ /hour)		Smell	Slightly certain smell
	No.of users (person/day)		Color	Shallow Yellow
	Supply facilities		Mn (mg/l)	<0.02
	Remarks (Lithology , etc.)	UNICEF Donation. This system will covered several villages.		
		Results of Simplified Water Quality Test	Fe (mg/l)	<0.2
			F (mg/l)	0.4
			NO3- (mg/l)	<1
			NO2- (mg/l)	<0.02
			Coliforms

Information of Existing Water Source - 2				
Type	Deep Well	Coordinate	X	767555
	Shallow Well		Y	2375350
	Storage reservoir			
	Others			
Hydrogeological Information	Drilled Depth (m)	78	Sample ID	MA2-13-2
	Diameter (in)	2	Temperature (°C)	30.8
	S.W.L (m)	21	pH	7.8
	D.W.L (m)		EC (µs/cm)	11,800
	Yield (m ³ /hour)		Smell	Non
	No.of users (person/day)		Color	Turbidity
	Supply facilities	Airlift	Mn (mg/l)	<0.02
	Remarks (Lithology , etc.)	Target: 767494 / 2375884		
		Results of Simplified Water Quality Test	Fe (mg/l)	<0.2
			F (mg/l)	2.0
			NO3- (mg/l)	3.0
			NO2- (mg/l)	<0.02
			Coliforms

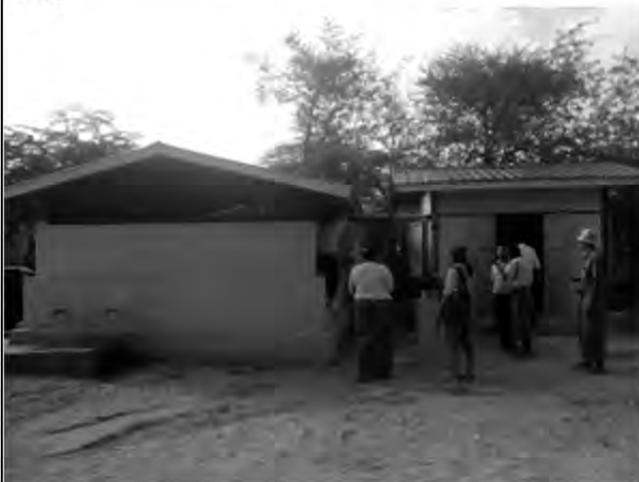
Photo

Information of Existing Water Sauce - 1						Information of Existing Water Sauce - 2					
Type	○ Deep Well		Coordinate	X	757384	Type	○ Deep Well		Coordinate	X	757248
	Shallow Well			Y	2368882		Shallow Well			Y	2368842
	Storage reservoir						Storage reservoir				
	Others						Others				
Hydrogeological Information	Drilled Depth (m)	234	Results of Simplified Water Quality Test	Sample ID	MA2-14-1	Hydrogeological Information	Drilled Depth (m)	127	Results of Simplified Water Quality Test	Sample ID	MA2-14-2
	Diameter (in)	4		Temperature (°C)	31.2		Diameter (in)	2		Temperature (°C)	30.8
	S.W.L (m)			pH	7.58		S.W.L (m)			pH	7.86
	D.W.L (m)			EC (µs/cm)	6,540		D.W.L (m)			EC (µs/cm)	2,120
	Yield (m³/hour)	8.2		Smell	Non		Yield (m³/hour)	1.4		Smell	Non
	No.of users (person/day)			Color	Shallow White		No.of users (person/day)			Color	Non
	Supply facilities			Mn (mg/l)	<0.02		Supply facilities			Mn (mg/l)	<0.02

Remarks (Lithology , etc.)						Fe (mg/l)	<0.2		Remarks (Lithology , etc.)	
Constructed by DRD in 2015.2				F (mg/l)	0.8	Private well Target : 757400 / 2368579				F (mg/l)	0.4
				NO3- (mg/l)	1.0					NO3- (mg/l)	<1
				NO2- (mg/l)	<0.01					NO2- (mg/l)	<0.02
				Coliforms						Coliforms

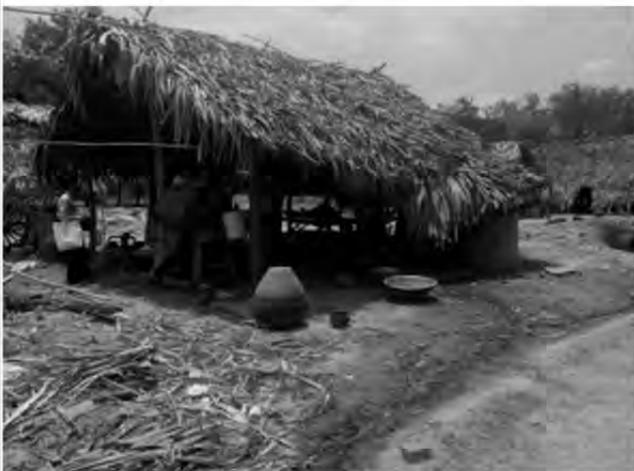
Photo

Information of Existing Water Source - 1				
Type	o Deep Well	Coordinate	X	772147
	Shallow Well		Y	2368696
	Storage reservoir			
	Others			
Hydrogeological Information	Drilled Depth (m)	91	Sample ID	MA2-15-1
	Diameter (in)	2	Temperature (°C)	34.4
	S.W.L (m)	30	pH	8.48
	D.W.L (m)		EC (µs/cm)	2,800
	Yield (m ³ /hour)	3.4	Smell	Non
	No.of users (person/day)		Color	Non
	Supply facilities	Airlift	Mn (mg/l)	<0.02
	Remarks (Lithology , etc.)	Private Well.		
		Results of Simplified Water Quality Test	Fe (mg/l)	<0.2
			F (mg/l)	1.5
			NO3- (mg/l)	1.0
			NO2- (mg/l)	<0.02
			Coliforms

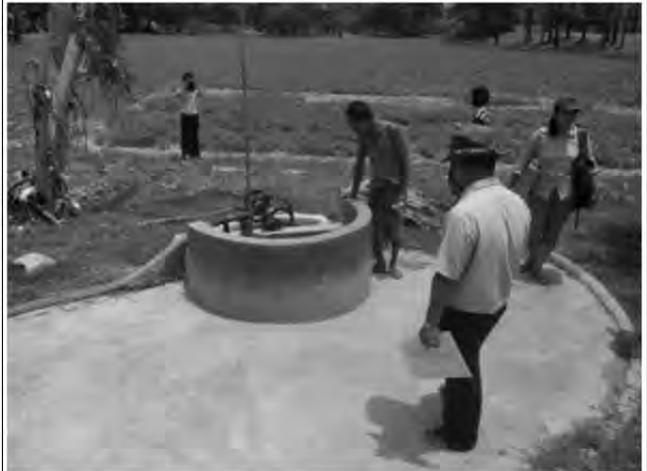
Photo

Information of Existing Water Source - 2				
Type	o Deep Well	Coordinate	X	772036
	Shallow Well		Y	2368666
	Storage reservoir			
	Others			
Hydrogeological Information	Drilled Depth (m)	61	Sample ID	MA2-15-2
	Diameter (in)	2	Temperature (°C)	30.6
	S.W.L (m)		pH	7.86
	D.W.L (m)		EC (µs/cm)	1,192
	Yield (m ³ /hour)		Smell	Non
	No.of users (person/day)		Color	Shallow Yellow
	Supply facilities		Mn (mg/l)	<0.02
	Remarks (Lithology , etc.)	Drilled in dugwell to use suction pump. *Target : 772248 / 2368667		
		Results of Simplified Water Quality Test	Fe (mg/l)	<0.2
			F (mg/l)	0.6
			NO3- (mg/l)	<1
			NO2- (mg/l)	<0.02
			Coliforms

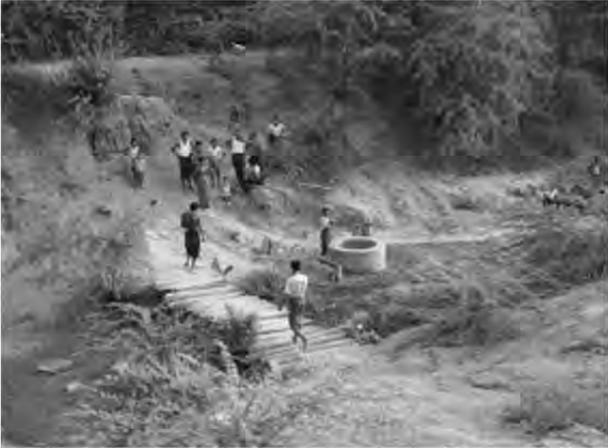
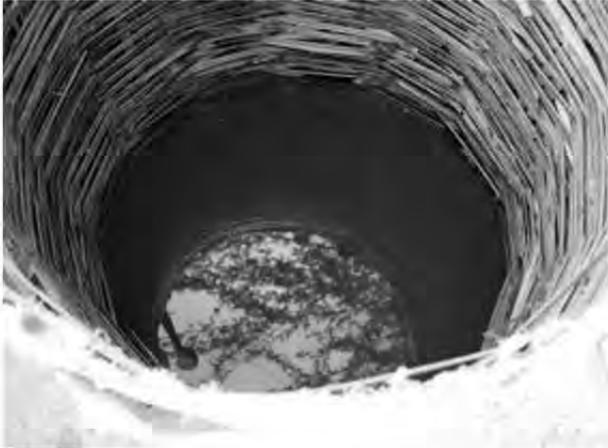
Region	Mandalay		Date	2015.5.24	
Township	Taungthar		Reported by	Sasaki	
Village / ID	Chaungnar	MA2-16	Coordinate (WGS84 UTM)	X	751816
				Y	2357948

Information of Existing Water Source - 1						Information of Existing Water Source - 2					
Type	Deep Well		Coordinate	X	751878	Type	Deep Well		Coordinate	X	751799
	Shallow Well			Y	2358123		Shallow Well			Y	2357810
	Storage reservoir						Storage reservoir				
	○ Others <i>Dug Well</i>						○ Others <i>Dug Well</i>				
Hydrogeological Information	Drilled Depth (m)	15	Results of Simplified Water Quality Test	Sample ID	MA2-16-1	Hydrogeological Information	Drilled Depth (m)	5	Results of Simplified Water Quality Test	Sample ID	MA2-16-2
	Diameter (in)	1.5 m		Temperature (°C)	30.0		Diameter (in)	1.0 m		Temperature (°C)	29.4
	S.W.L (m)	5		pH	8.16		S.W.L (m)			pH	7.38
	D.W.L (m)			EC (µs/cm)	2,030		D.W.L (m)			EC (µs/cm)	3,450
	Yield (m³/hour)			Smell	Slightly sour		Yield (m³/hour)			Smell	Non
	No.of users (person/day)	450		Color	slightly brown		No.of users (person/day)			Color	Slightly turbidity
	Supply facilities			Mn (mg/l)	<0.02		Supply facilities			Mn (mg/l)	<0.02

Remarks (Lithology , etc.) This well is located near small stream. The stream water and is almost dry up, so that villagers wait long time for recharge. Almost villagers use only this well for drinking.			Fe (mg/l)	<0.2		Remarks (Lithology , etc.) This well is located near small stream. Water is salty, they don't use for drinking.			Fe (mg/l)	<0.2
F (mg/l)			3~8	F (mg/l)	0.2						
NO3- (mg/l)			5~10	NO3- (mg/l)	<1						
NO2- (mg/l)			<0.02	NO2- (mg/l)	<0.02						
Coliforms			Too much	Coliforms	5						
Photo						Photo

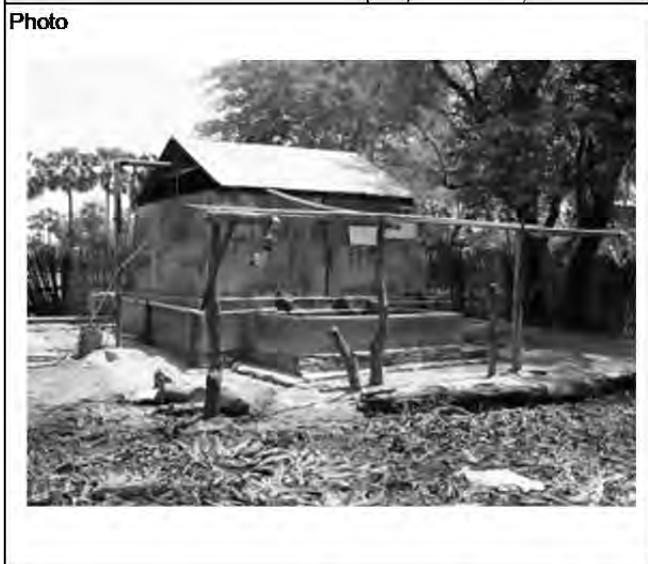
Region	Mandalay		Date	2015.5.25	
Township	Taungthar		Reported by	Sasaki	
Village / ID	Chaungstone (La)	MA2-17	Coordinate (WGS84 UTM)	X	735423
			Y	2354667

Information of Existing Water Source - 1						
Type	○ Deep Well		Coordinate	X	735397	
	Shallow Well			Y	2354670	
	Storage reservoir					
	Others					
Hydrogeological Information	Drilled Depth (m)	137	Results of Simplified Water Quality Test	Sample ID	MA2-17-1	
	Diameter (in)	4		Temperature (°C)	34.7	
	S.W.L (m)	98		pH	7.33	
	D.W.L (m)			EC (µs/cm)	1483	
	Yield (m ³ /hour)	16.4		Smell	Non	
	No.of users (person/day)	800		Color	Non	
	Supply facilities	monopump		Mn (mg/l)	<0.02	
	Remarks (Lithology , etc.)			Fe (mg/l)	<0.2	
Located in monastery. This well was drilled at 35 years ago. And Villagers repaired clogging by themselves at 2 years ago. Pumping up is 3 times per day.			F (mg/l)	0.2		
			NO3- (mg/l)	<1		
			NO2- (mg/l)	<0.02		
			Coliforms

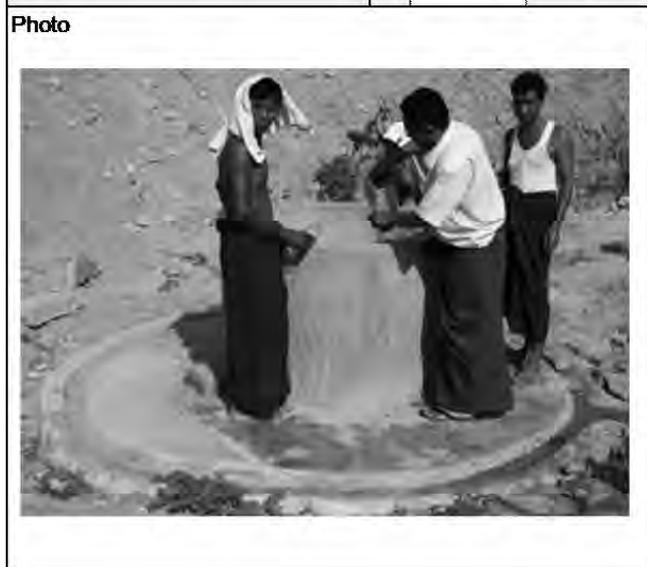
Region	Mandalay		Date	2015.5.24	
Township	Taungthar		Reported by	Sasaki	
Village / ID	Kyaukkartaungkone	MA2-18	Coordinate (WGS84 UTM)	X	748923
				Y	2341631

Information of Existing Water Source - 1								
Type	Deep Well	Coordinate	X	748843				
	Shallow Well		Y	2341588				
	Storage reservoir							
	○ Others <i>Dug Well</i>							
Hydrogeological Information	Drilled Depth (m)	5	Sample ID	MA2-18-1				
	Diameter (in)	1.0 m	Temperature (°C)	31.0				
	S.W.L (m)		pH	8.02				
	D.W.L (m)		EC (µs/cm)	794				
	Yield (m ³ /hour)		Smell	Non				
	No.of users (person/day)		Color	Non				
	Supply facilities		Mn (mg/l)	<0.02				
	Remarks (Lithology , etc.)	Villagers wait long time for recharge and villagers use only this well for drinking. In dry season, sometime region will supply the drinking water. but that is not regullary.This village has electric line and alomost house can use it. this village is located in Pegu area, so it is difficult to drill the deep well.						
	Fe (mg/l)						<0.2	
	F (mg/l)						0.2	
	NO3- (mg/l)						5~10	
	NO2- (mg/l)						<0.02	
	Coliforms						14

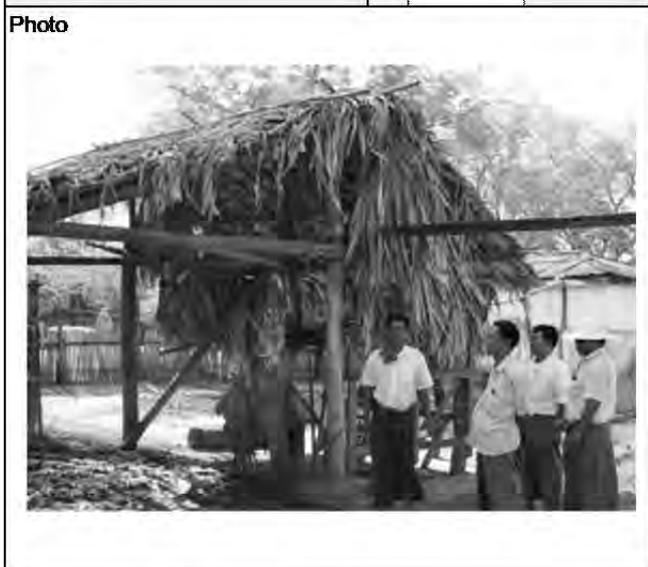
Region	Mandalay		Date	2015.5.25	
Township	Taungthar		Reported by	Sasaki	
Village / ID	Tharzi	MA2-19	Coordinate (WGS84 UTM)	X	740022
				Y	2346931

Information of Existing Water Source - 1					
Type	○ Deep Well		Coordinate	X	740016
	Shallow Well			Y	2346893
	Storage reservoir				
	Others				
Hydrogeological Information	Drilled Depth (m)	259	Results of Simplified Water Quality Test	Sample ID	MA2-19-1
	Diameter (in)	4		Temperature (°C)	38.0
	S.W.L (m)	153		pH	7.38
	D.W.L (m)			EC (µs/cm)	1,609
	Yield (m ³ /hour)	3.6		Smell	Slightly sour
	No.of users (person/day)	950		Color	Non
	Supply facilities	monopump		Mn (mg/l)	<0.02
	Remarks (Lithology , etc.)			Fe (mg/l)	<0.2
Drilled in around 1980. BAJ maintained in 2010. Water is not enough in dry season. Neighbor vilage also has same depth well.		F (mg/l)	<0		
		NO3- (mg/l)	<1		
		NO2- (mg/l)	<0.02		
		Coliforms

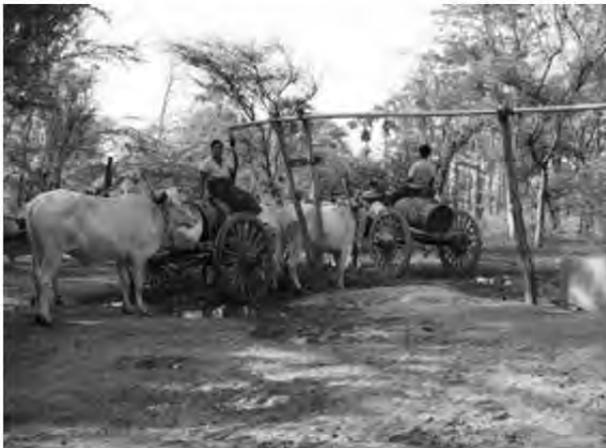
Photo

Information of Existing Water Source - 1						Information of Existing Water Source - 2					
Type	○ Deep Well		Coordinate	X	740499	Type	Deep Well		Coordinate	X	
	Shallow Well			Y	2349023		Shallow Well			Y	
	Storage reservoir						Storage reservoir				
	Others						Others				
Hydrogeological Information	Drilled Depth (m)	244	Results of Simplified Water Quality Test	Sample ID	MA2-20-1	Hydrogeological Information	Drilled Depth (m)		Results of Simplified Water Quality Test	Sample ID	
	Diameter (in)	4		Temperature (°C)	34.5		Diameter (in)			Temperature (°C)	
	S.W.L (m)	105		pH	7.33		S.W.L (m)			pH	
	D.W.L (m)			EC (µs/cm)	1,516		D.W.L (m)			EC (µs/cm)	
	Yield (m³/hour)	3.2		Smell	Non		Yield (m³/hour)			Smell	
	No.of users (person/day)	1150		Color	Non		No.of users (person/day)			Color	
	Supply facilities	monopump		Mn (mg/l)	<0.02		Supply facilities			Mn (mg/l)	
	Remarks (Lithology , etc.)			Fe (mg/l)	<0.2		Remarks (Lithology , etc.)			Fe (mg/l)

Drilled in 1981. Village repaired by own budget when pump and generator was broken. Tharzi village (MA2-19) is very near. Using same aquifer?		F (mg/l)	0			F (mg/l)					
		NO3- (mg/l)	<1			NO3- (mg/l)					
		NO2- (mg/l)	<0.02			NO2- (mg/l)					
		Coliforms	19			Coliforms

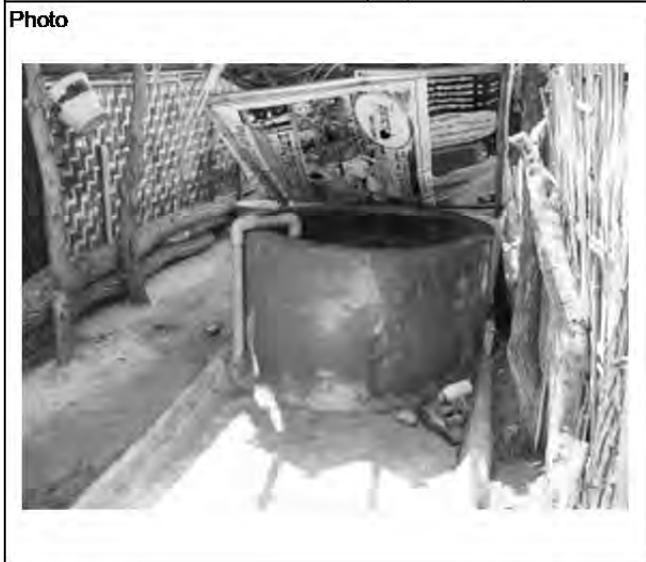
Region	Mandalay		Date	2015.5.25	
Township	Taungthar		Reported by	Sasaki	
Village / ID	ThayarMyaing	MA2-21	Coordinate (WGS84 UTM)	X	745680
				Y	2342452

Information of Existing Water Source - 1						
Type	Deep Well	Coordinate	X	745668		
	○ Shallow Well		Y	2342355		
	Storage reservoir					
	Others					
Hydrogeological Information	Drilled Depth (m)	36	Results of Simplified Water Quality Test	Sample ID	MA2-21-1	
	Diameter (in)	2		Temperature (°C)	29.8	
	S.W.L (m)			pH	8.41	
	D.W.L (m)			EC (µs/cm)	4,440	
	Yield (m ³ /hour)	3.6		Smell	Non	
	No.of users (person/day)			Color	Non	
	Supply facilities	motor pump		Mn (mg/l)	<0.02	
	Remarks (Lithology , etc.)			Fe (mg/l)	<0.2	
Village has 12 shallow well and all of well depth is around 36 - 54m. They used to share with neighboring house. some house can use electricity and pump up by motor. But sometime electricity can't use during several hours by brack out.			F (mg/l)	1.5~3		
			NO3- (mg/l)	45<		
			NO2- (mg/l)	0.5~1		
			Coliforms	7

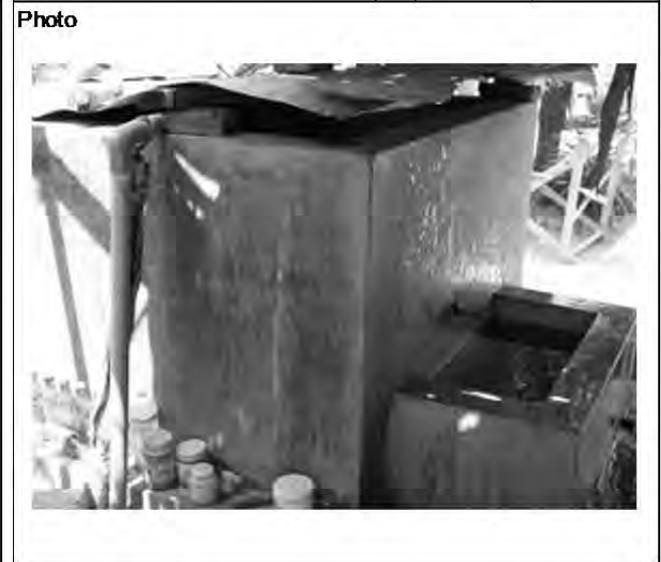
Information of Existing Water Source - 2						
Type	Deep Well	Coordinate	X	745625		
	○ Shallow Well		Y	2342444		
	Storage reservoir					
	Others					
Hydrogeological Information	Drilled Depth (m)	54	Results of Simplified Water Quality Test	Sample ID	MA2-21-2	
	Diameter (in)	2		Temperature (°C)	29.1	
	S.W.L (m)			pH	8.15	
	D.W.L (m)			EC (µs/cm)	3,460	
	Yield (m ³ /hour)	3.6		Smell	Non	
	No.of users (person/day)			Color	Non	
	Supply facilities	motor pump		Mn (mg/l)	<0.02	
	Remarks (Lithology , etc.)			Fe (mg/l)	<0.2	
all of well have small tank. They request big tank. In 1980, 100m depth well was drilled. but that well became salty aroud 4 - 5 years. they already stoped to use now. Simple water quality test is carried out 6 well. all of them have high flouride.			F (mg/l)	1.5		
			NO3- (mg/l)	45<		
			NO2- (mg/l)	<0.2		
			Coliforms	Too much

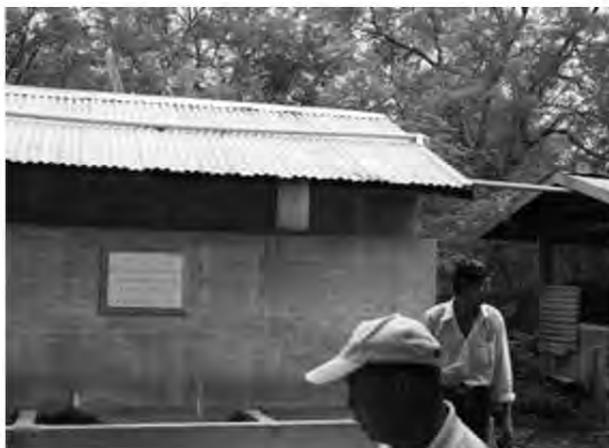
Photo

Information of Existing Water Source - 1						Information of Existing Water Source - 2					
Type	○ Deep Well		Coordinate	X	826855	Type	○ Deep Well		Coordinate	X	826620
	Shallow Well			Y	2270738		Shallow Well			Y	2271085
	Storage reservoir						Storage reservoir				
	Others						Others				
Hydrogeological Information	Drilled Depth (m)	235	Results of Simplified Water Quality Test	Sample ID	MA2-22-1	Hydrogeological Information	Drilled Depth (m)	82	Results of Simplified Water Quality Test	Sample ID	MA2-22-2
	Diameter (in)	2		Temperature (°C)	35.1		Diameter (in)	2		Temperature (°C)	28.7
	S.W.L (m)			pH	8.18		S.W.L (m)			pH	8.20
	D.W.L (m)			EC (µs/cm)	635		D.W.L (m)			EC (µs/cm)	919
	Yield (m³/hour)	4.5		Smell	Non		Yield (m³/hour)			Smell	Non
	No.of users (person/day)			Color	Non		No.of users (person/day)			Color	Non
	Supply facilities	compressor		Mn (mg/l)	<0.02		Supply facilities	compressor		Mn (mg/l)	<0.02

Remarks (Lithology , etc.)	There is residents suffering from kidney stones after 5 years start to drinking. Under repairing due to the engine trouble.		Fe (mg/l)	<0.2		Remarks (Lithology , etc.)	Located in monastery.		Fe (mg/l)	<0.2
			F (mg/l)	0.2				F (mg/l)	0.2		
			NO3- (mg/l)	<1				NO3- (mg/l)	<1		
			NO2- (mg/l)	<0.02				NO2- (mg/l)	<0.02		
			Coliforms					Coliforms

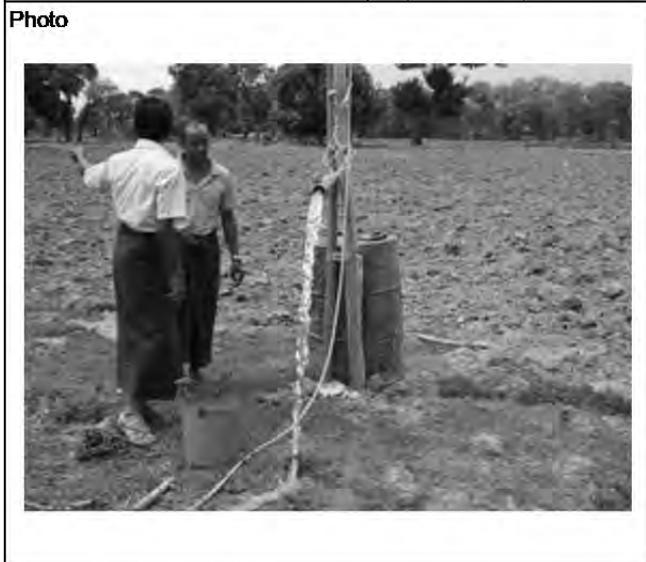
Region	Mandalay		Date	2015.5.18	
Township	Yamethin		Reported by	Yamasaki	
Village / ID	Kangyi	MA2-23	Coordinate (WGS84 UTM)	X	828701
				Y	2246082

Information of Existing Water Source - 1						
Type	Deep Well		Coordinate	X	828635	
	Shallow Well			Y	2246064	
	Storage reservoir					
	Others					
Hydrogeological Information	Drilled Depth (m)	55	Results of Simplified Water Quality Test	Sample ID	MA2-23-1	
	Diameter (in)	2		Temperature (°C)	30.0	
	S.W.L (m)			pH	8.09	
	D.W.L (m)			EC (µs/cm)	2,020	
	Yield (m ³ /hour)	2.2		Smell	Non	
	No.of users (person/day)	20HH		Color	Slightly muddy	
	Supply facilities	compresser		Mn (mg/l)	<0.02	
	Remarks (Lithology , etc.)			Fe (mg/l)	<0.2	
a bit salty and included sand. But this water can use to drinking. Pump displacement is not so much, and also the number of using households is not much.			F (mg/l)	0.8		
			NO3- (mg/l)	<1		
			NO2- (mg/l)	<0.02		
			Coliforms	5

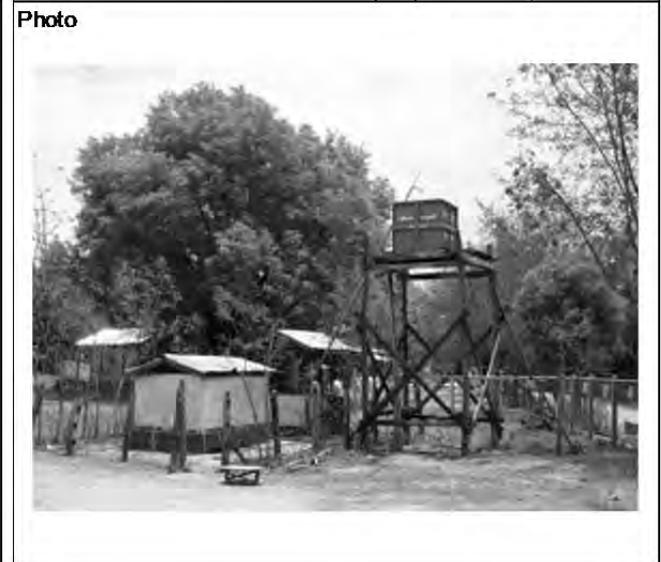
Information of Existing Water Source - 2						
Type	Deep Well		Coordinate	X	829123	
	Shallow Well			Y	2246062	
	Storage reservoir					
	Others					
Hydrogeological Information	Drilled Depth (m)	220	Results of Simplified Water Quality Test	Sample ID	MA2-23-2	
	Diameter (in)	2		Temperature (°C)	31.3	
	S.W.L (m)	200		pH	8.51	
	D.W.L (m)			EC (µs/cm)	1,983	
	Yield (m ³ /hour)	3.6		Smell	Non	
	No.of users (person/day)	50HH		Color	Non	
	Supply facilities	compresser		Mn (mg/l)	<0.02	
	Remarks (Lithology , etc.)			Fe (mg/l)	<0.2	
this village has 2 deep well. Another one is not used much due to the pumping cost. Some house can use this water by distributed pipe.			F (mg/l)	1.5		
			NO3- (mg/l)	<1		
			NO2- (mg/l)	<0.02		
			Coliforms

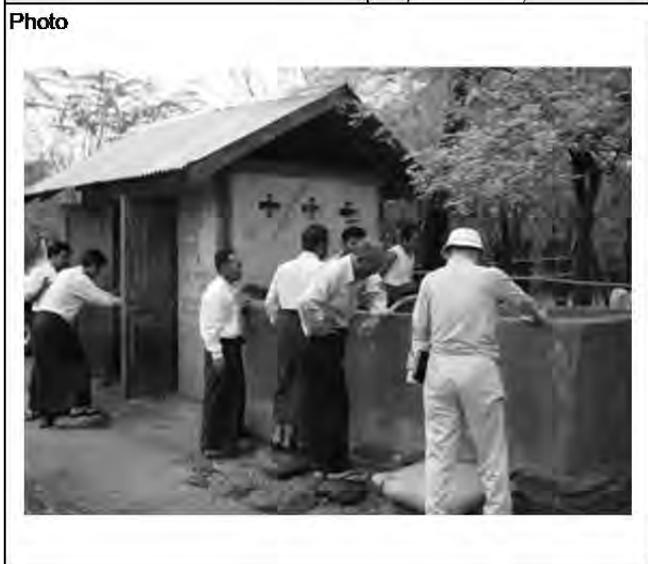
Region	Mandalay		Date	2015.5.18	
Township	Pyawbwe		Reported by	Yamasaki	
Village / ID	Wayronesu	MA2-25	Coordinate (WGS84 UTM)	X	804877
				Y	2275454

Information of Existing Water Source - 1						
Type	○ Deep Well		Coordinate	X	804775	
	Shallow Well			Y	2275467	
	Storage reservoir					
	Others					
Hydrogeological Information	Drilled Depth (m)	116	Results of Simplified Water Quality Test	Sample ID	MA2-25-1	
	Diameter (in)	2		Temperature (°C)	30.0	
	S.W.L (m)	11		pH	8.40	
	D.W.L (m)			EC (µs/cm)	1,986	
	Yield (m ³ /hour)	1.4		Smell	Non	
	No.of users (person/day)	100		Color	Non	
	Supply facilities	compressor		Mn (mg/l)	<0.02	
	Remarks (Lithology , etc.)			Fe (mg/l)	<0.2	
Concrete tank(W=2.5m,L=1m,H=1m) water is supplied by hose.		F (mg/l)	0			
		NO3- (mg/l)	<1			
		NO2- (mg/l)	<0.02			
		Coliforms

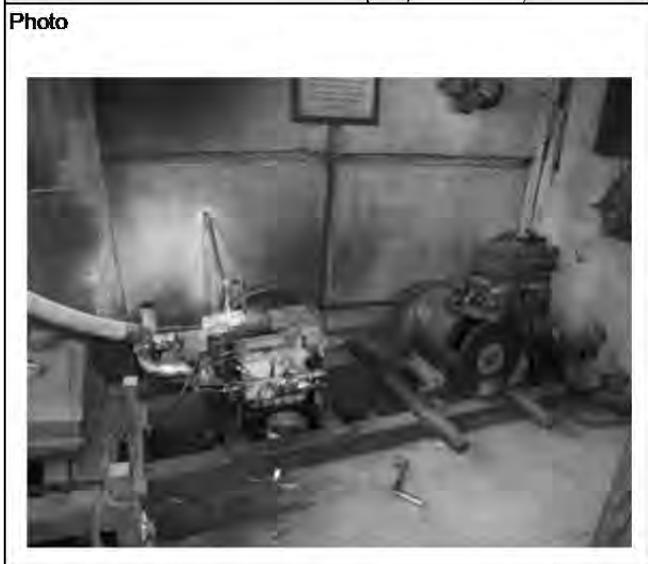
Region	Mandalay		Date	2015/5/7
Township	Nyaungoo		Reported by	Maruo
Village / ID	Kanzauk	MA2-29	Coordinate (WGS84 UTM)	X
			Y

Information of Existing Water Source - 1					
Type	<input type="radio"/> Deep Well	Coordinate	X	709762	
	<input type="radio"/> Shallow Well		Y	2328729	
	<input type="radio"/> Storage reservoir				
	<input type="radio"/> Others				
Hydrogeological Information	Drilled Depth (m)	200	Results of Simplified Water Quality Test	Sample ID	MA2-29-1
	Diameter (in)	6		Temperature (°C)	35.7
	S.W.L (m)			pH	7.06
	D.W.L (m)			EC (µs/cm)	1,036
	Yield (m³/hour)	5.9		Smell	Non
	No.of users (person/day)			Color	Non
	Supply facilities	Submersible pump		Mn (mg/l)	<0.02
	Remarks (Lithology , etc.)	Drilled by BAJ in 2003		Fe (mg/l)	<0.2
			F (mg/l)	0.1	
			NO3-(mg/l)		
			NO2-(mg/l)	<0.02	
			Coliforms

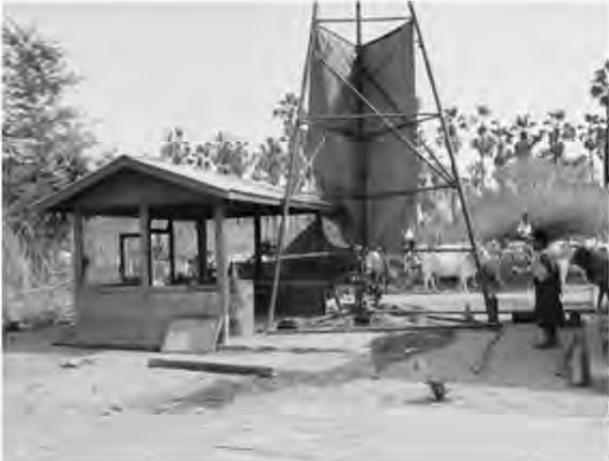
Region	Mandalay		Date	2015/5/7
Township	Nyaungoo		Reported by	Maruo
Village / ID	Talbindel	MA2-30	Coordinate (WGS84 UTM)	X
			Y

Information of Existing Water Source - 1					Information of Existing Water Source - 2						
Type	○ Deep Well		Coordinate	X	719325	Type	Deep Well		Coordinate	X	
	Shallow Well			Y	2332051		Shallow Well			Y	
	Storage reservoir						Storage reservoir				
	Others						Others				
Hydrogeological Information	Drilled Depth (m)	280	Results of Simplified Water Quality Test	Sample ID	MA2-30-1	Hydrogeological Information	Drilled Depth (m)		Results of Simplified Water Quality Test	Sample ID	
	Diameter (in)	4		Temperature (°C)	36.3		Diameter (in)			Temperature (°C)	
	S.W.L (m)	219		pH	6.77		S.W.L (m)			pH	
	D.W.L (m)			EC (µs/cm)	1,239		D.W.L (m)			EC (µs/cm)	
	Yield (m³/hour)	3.6		Smell	Iron smell		Yield (m³/hour)			Smell	
	No.of users (person/day)			Color	Shallow whie		No.of users (person/day)			Color	
	Supply facilities			Mn (mg/l)	<0.02		Supply facilities			Mn (mg/l)	
	Remarks (Lithology , etc.)				Fe (mg/l)		1	Remarks (Lithology , etc.)			Fe (mg/l)

Pump position 830ft, BAJ just rehabilitated cleaned element.			F (mg/l)	0.5				F (mg/l)			
			NO3- (mg/l)				NO3- (mg/l)				
			NO2- (mg/l)	<0.02			NO2- (mg/l)				
			Coliforms				Coliforms				
Photo					Photo
