5.3.1 現地簡易水質測定結果

5.3.2 現地水質測定状況

(1) ザガイン地域

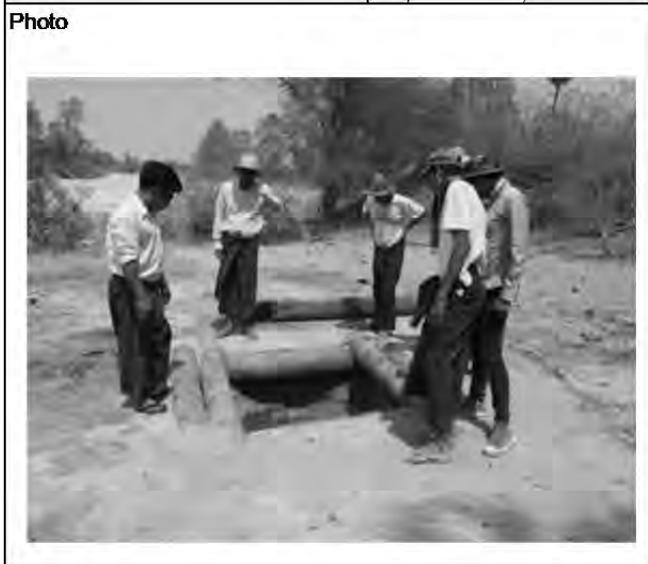
Region	Mandalay		Date	2015/5/6
Township	Nyaungoo		Reported by	Maruo
Village / ID	Mongywettaw	MA2-31	Coordinate (WGS84 UTM)	X
			Y

Information of Existing Water Source - 1				
Type	Deep Well	Coordinate	X	724266
	Shallow Well		Y	2337196
	Storage reservoir			
	○ Others(Dug Well)			
Hydrogeological Information	Drilled Depth (m)	Results of Simplified Water Quality Test	Sample ID	MA2-31-1
	Diameter (in)		Temperature (°C)	27.5
	S.W.L (m)		pH	8.05
	D.W.L (m)		EC (µs/cm)	500
	Yield (m ³ /hour)		Smell	Non
	No.of users (person/day)		Color	Non
	Supply facilities		Mn (mg/l)	<0.02
	Remarks (Lithology , etc.)		Fe (mg/l)	<0.02
Dug well in the pond. Oyintaungyartan is next to the target village.	F (mg/l)	0		
	NO3-(mg/l)			
	NO2-(mg/l)	<0.02		
	Coliforms

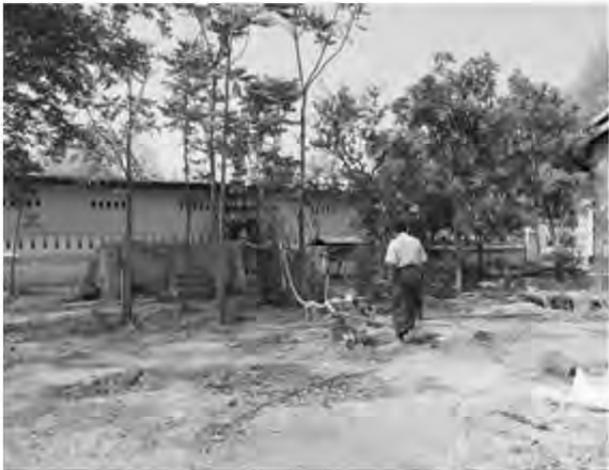
Region	Mandalay		Date	2015/5/7
Township	Nyaungoo		Reported by	Maruo
Village / ID	Phoenekan	MA2-32	Coordinate (WGS84 UTM)	X
			Y

Information of Existing Water Source - 1					Information of Existing Water Source - 2						
Type	○ Deep Well		Coordinate	X	703729	Type	Deep Well		Coordinate	X	
	Shallow Well			Y	2334750		Shallow Well			Y	
	Storage reservoir						Storage reservoir				
	Others						Others				
Hydrogeological Information	Drilled Depth (m)	152	Results of Simplified Water Quality Test	Sample ID	MA2-32-1	Hydrogeological Information	Drilled Depth (m)		Results of Simplified Water Quality Test	Sample ID	
	Diameter (in)			Temperature (°C)	31.6		Diameter (in)			Temperature (°C)	
	S.W.L (m)	37		pH	7.33		S.W.L (m)			pH	
	D.W.L (m)	Big		EC (µs/cm)	1,043		D.W.L (m)			EC (µs/cm)	
	Yield (m³/hour)			Smell	Non		Yield (m³/hour)			Smell	
	No.of users (person/day)			Color	Non		No.of users (person/day)			Color	
	Supply facilities	Submarsible pump		Mn (mg/l)	<0.02		Supply facilities			Mn (mg/l)	
	Remarks (Lithology , etc.)			Fe (mg/l)	<0.2		Remarks (Lithology , etc.)			Fe (mg/l)

Pump position - 440 ft About 1.5 miles from Phonenekan village. Taungpon village is next to the target village.			F (mg/l)	0.7				F (mg/l)			
			NO3- (mg/l)					NO3- (mg/l)			
			NO2- (mg/l)	<0.02				NO2- (mg/l)			
			Coliforms					Coliforms			
Photo					Photo

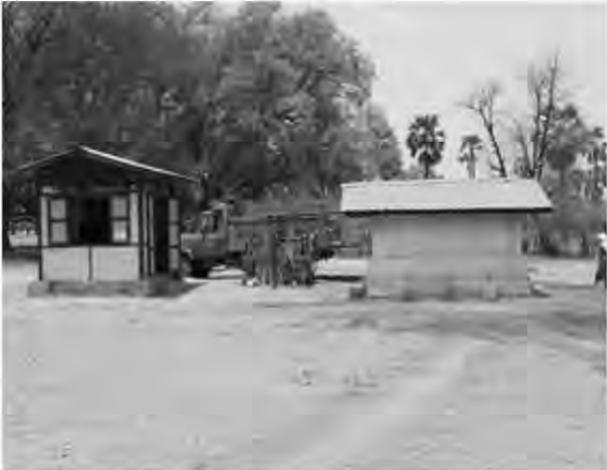
Region	Mandalay		Date	2015/5/6
Township	Nyaungoo		Reported by	Maruo
Village / ID	Saingkan(Tetide)	MA2-34	Coordinate (WGS84 UTM)	X
				Y

Information of Existing Water Source - 1					Information of Existing Water Source - 2						
Type	○ Deep Well		Coordinate	X	725695	Type	Deep Well		Coordinate	X	
	Shallow Well			Y	2329987		Shallow Well			Y	
	Storage reservoir						Storage reservoir				
	Others						Others				
Hydrogeological Information	Drilled Depth (m)	365	Results of Simplified Water Quality Test	Sample ID	MA2-34-1	Hydrogeological Information	Drilled Depth (m)		Results of Simplified Water Quality Test	Sample ID	
	Diameter (in)			Temperature (°C)	34.6		Diameter (in)			Temperature (°C)	
	S.W.L (m)			pH	7.37		S.W.L (m)			pH	
	D.W.L (m)			EC (µs/cm)	814		D.W.L (m)			EC (µs/cm)	
	Yield (m³/hour)			Smell	Iron smell		Yield (m³/hour)			Smell	
	No.of users (person/day)			Color	Non		No.of users (person/day)			Color	
	Supply facilities	Pump		Mn (mg/l)	<0.02		Supply facilities			Mn (mg/l)	
				Fe (mg/l)	0.6					Fe (mg/l)	
Remarks (Lithology , etc.) JICA well. Kudaw village is next to the target village.		F (mg/l)	0.2	Remarks (Lithology , etc.)		F (mg/l)

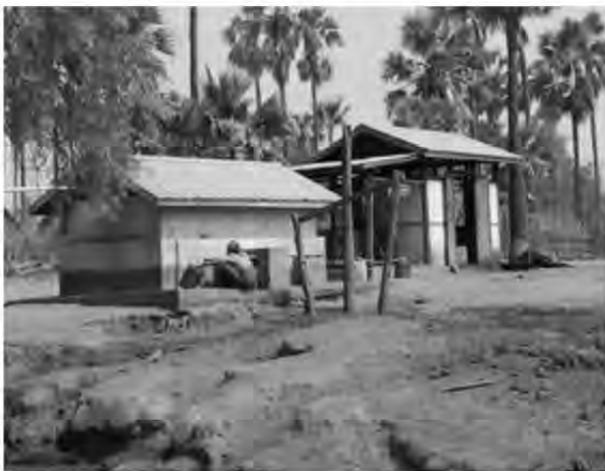
Region	Mandalay		Date	2015/5/6
Township	Nyaungoo		Reported by	Maruo
Village / ID	Byugyi	MA2-35	Coordinate (WGS84 UTM)	X
			Y

Information of Existing Water Source - 1					
Type	○ Deep Well	Coordinate	X	724027	
	Shallow Well		Y	2324767	
	Storage reservoir				
	Others				
Hydrogeological Information	Drilled Depth (m)	309	Results of Simplified Water Quality Test	Sample ID	MA2-35-1
	Diameter (in)	6		Temperature (°C)	
	S.W.L (m)	236		pH	7.61
	D.W.L (m)	239		EC (µs/cm)	908
	Yield (m³/hour)	8.2		Smell	Non
	No.of users (person/day)			Color	Non
	Supply facilities	Mono pump		Mn (mg/l)	<0.02
	Remarks (Lithology , etc.)			Fe (mg/l)	<0.2
		F (mg/l)	0.1		
		NO3- (mg/l)			
		NO2- (mg/l)	<0.02		
		Coliforms

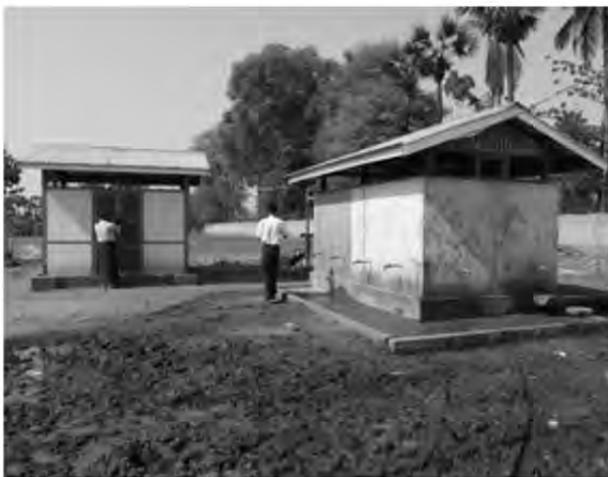
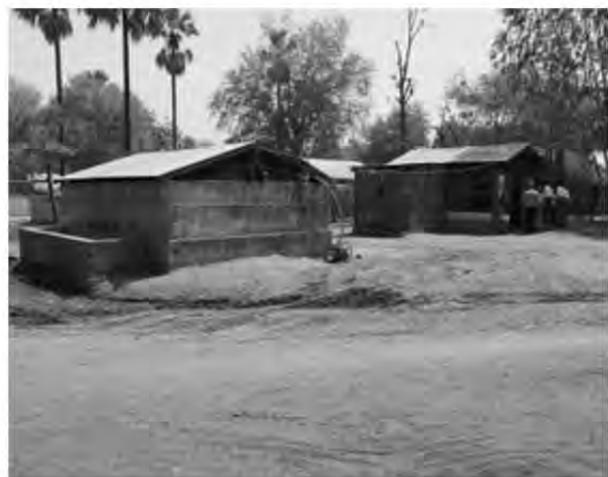
Region	Mandalay		Date	2015/5/5
Township	Kyaukpadaung		Reported by	Maruo
Village / ID	Aleywar-2	MA2-36	Coordinate (WGS84 UTM)	X Y

Information of Existing Water Sauce - 1				Information of Existing Water Sauce - 2					
Type	○ Deep Well		X	718697	Type	○ Deep Well		X	718334
	Shallow Well		Y	2309611		Shallow Well		Y	2309805
	Storage reservoir					Storage reservoir			
	Others					Others			
Hydrogeological Information	Drilled Depth (m)	270	Sample ID	MA2-36-1	Hydrogeological Information	Drilled Depth (m)	270	Sample ID	MA2-36-2
	Diameter (in)		Temperature (°C)	32.8		Diameter (in)	4	Temperature (°C)	34.7
	S.W.L (m)		pH	6.20		S.W.L (m)	150	pH	6.00
	D.W.L (m)		EC (µs/cm)	1,907		D.W.L (m)		EC (µs/cm)	1,343
	Yield (m ³ /hour)		Smell	Iron smell		Yield (m ³ /hour)	6.8	Smell	Slightly iron
	No.of users (person/day)		Color	Non		No.of users (person/day)		Color	Non
	Supply facilities		Mn (mg/l)	3		Supply facilities		Mn (mg/l)	1
	Remarks (Lithology , etc.) Iron contents is very high and a little sour.		Results of Simplified Water Quality Test			Fe (mg/l)	>10	Remarks (Lithology , etc.) Dagagayi is northern part of Aleyawa 2 and 2 km far . Drilled 33 years ago. This tube well is slightly deeper than other well 4-6 deeper.

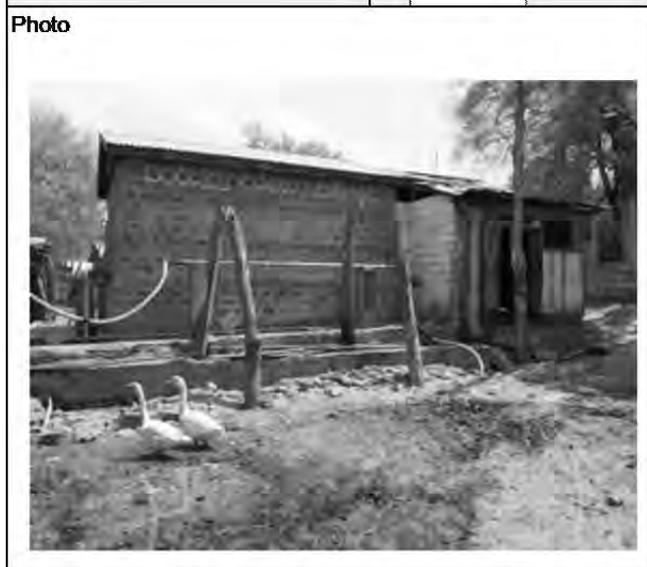
Region	Mandalay		Date	2015/5/5
Township	Kyautpadaung		Reported by	Maruo
Village / ID	Lelgyi(Ma)	MA2-38	Coordinate (WGS84 UTM)	X
			Y

Information of Existing Water Source - 1					
Type	○ Deep Well	Coordinate	X	734592	
	Shallow Well		Y	2325518	
	Storage reservoir				
	Others				
Hydrogeological Information	Drilled Depth (m)	300	Results of Simplified Water Quality Test	Sample ID	MA2-38-1
	Diameter (in)	4		Temperature (°C)	31.5
	S.W.L (m)	52		pH	7.48
	D.W.L (m)			EC (µs/cm)	1,203
	Yield (m³/hour)	10.2		Smell	Sulfur smell
	No.of users (person/day)			Color	Slightly muddy
	Supply facilities			Mn (mg/l)	<0.02
	Remarks (Lithology , etc.)	7 years ago (2009) developed by air lifting by JICA project and a year ago		Fe (mg/l)	5
			F (mg/l)	0.6	
			NO3- (mg/l)		
			NO2- (mg/l)	<0.02	
			Coliforms

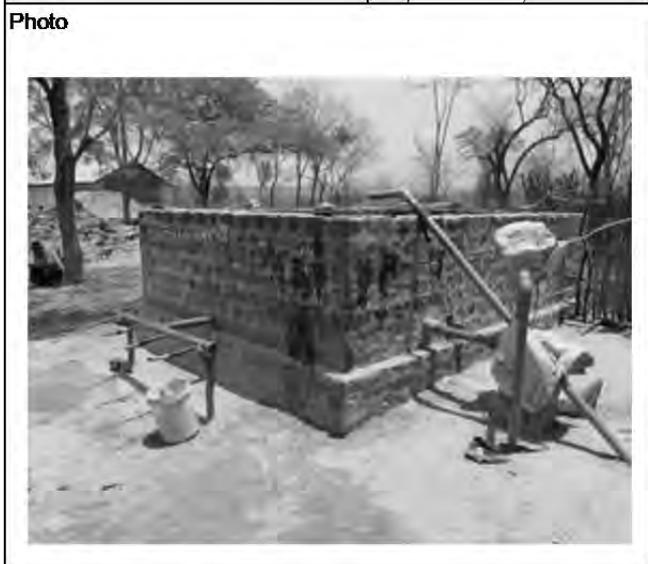
Region	Mandalay		Date	2015/5/5
Township	Kyaukpadaung		Reported by	Maruo
Village / ID	Thayattaw	MA2-39	Coordinate (WGS84 UTM)	X
			Y

Information of Existing Water Source - 1				
Type	○ Deep Well		X	729384
	Shallow Well		Y	2325075
	Storage reservoir			
	Others			
Hydrogeological Information	Drilled Depth (m)	300	Sample ID	MA2-39-1
	Diameter (in)	4	Temperature (°C)	32.8
	S.W.L (m)	226	pH	7.11
	D.W.L (m)		EC (µs/cm)	947
	Yield (m ³ /hour)	2.7	Smell	Non
	No.of users (person/day)		Color	Non
	Supply facilities		Mn (mg/l)	<1
	Remarks (Lithology , etc.)		Fe (mg/l)	<0.2
		Results of Simplified Water Quality Test		
		F (mg/l)	<0.1	
		NO3- (mg/l)		
		NO2- (mg/l)	<0.02	
		Coliforms

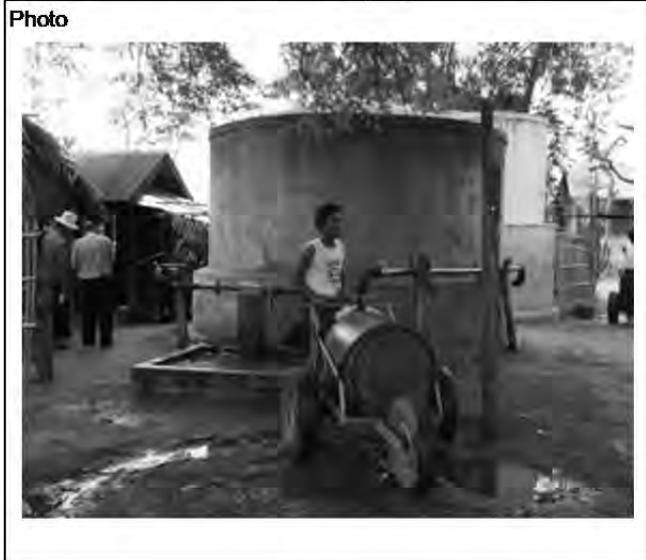
Region	Magway		Date	2015/5/13
Township	Magway		Reported by	Maruo
Village / ID	Natkan	MG2-01	Coordinate (WGS84 UTM)	X
			Y

Information of Existing Water Sauce - 1					
Type	○ Deep Well	Coordinate	X	706494	
	Shallow Well		Y	2234069	
	Storage reservoir				
	Others				
Hydrogeological Information	Drilled Depth (m)	174	Results of Simplified Water Quality Test	Sample ID	MG2-1-1
	Diameter (in)	4		Temperature (°C)	31.4
	S.W.L (m)	73		pH	7.16
	D.W.L (m)			EC (µs/cm)	988
	Yield (m³/hour)	5.0		Smell	Non
	No.of users (person/day)			Color	Non
	Supply facilities	Pump		Mn (mg/l)	0
	Remarks (Lithology , etc.)	Drilled by DDA in 2014		Fe (mg/l)	0.4
			F (mg/l)	0.4	
			NO3-(mg/l)		
			NO2-(mg/l)	<0.02	
			Coliforms

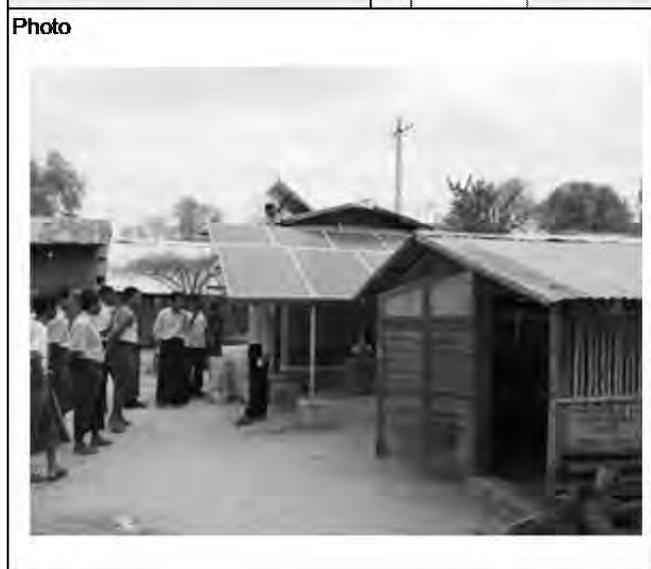
Region	Magway		Date	2015/5/19
Township	Magway		Reported by	Maruo
Village / ID	Thanbo(Ywarthit)	MG2-02	Coordinate (WGS84 UTM)	X
				Y

Information of Existing Water Source - 1				
Type	○ Deep Well	Coordinate	X	776115
	Shallow Well		Y	2216165
	Storage reservoir			
	Others			
Hydrogeological Information	Drilled Depth (m)	120.3	Sample ID	MG2-2-1
	Diameter (in)	4	Temperature (°C)	32.0
	S.W.L (m)	84	pH	7.16
	D.W.L (m)		EC (µs/cm)	1,494
	Yield (m ³ /hour)		Smell	Non
	No.of users (person/day)		Color	Non
	Supply facilities	Pump	Mn (mg/l)	<1
	Remarks (Lithology , etc.)		Results of Simplified Water Quality Test	
Slightly salty Borehole drilled in 1999 by SPDC.		Fe (mg/l)	<0.2	
		F (mg/l)	0.6	
		NO3- (mg/l)	3.0	
		NO2- (mg/l)	0.1	
		Coliforms

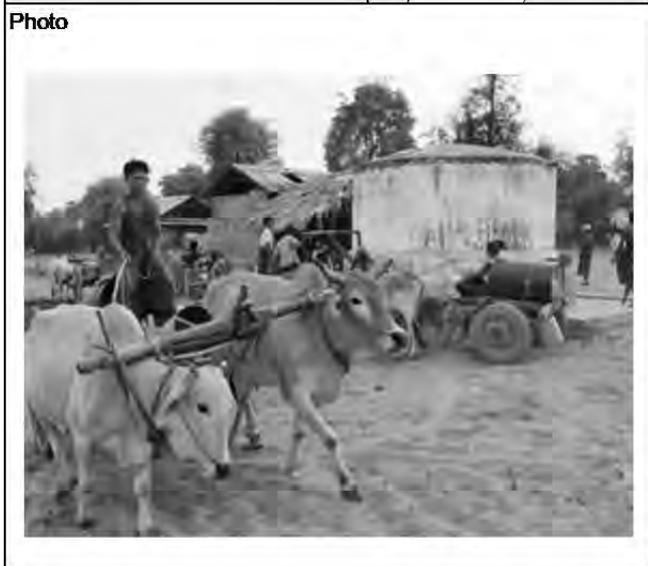
Region	Magway		Date	2015/5/12
Township	Magway		Reported by	Maruo
Village / ID	Nyaungbinthar	MG2-03	Coordinate (WGS84 UTM)	X
			Y

Information of Existing Water Source - 1				
Type	○ Deep Well	Coordinate	X	736944
	Shallow Well		Y	2243982
	Storage reservoir			
	Others			
Hydrogeological Information	Drilled Depth (m)	120	Sample ID	MG2-3-1
	Diameter (in)	4	Temperature (°C)	32.6
	S.W.L (m)	154	pH	7.30
	D.W.L (m)		EC (µs/cm)	1,067
	Yield (m ³ /hour)	6.4	Smell	Non
	No.of users (person/day)		Color	Non
	Supply facilities		Mn (mg/l)	<1
	Remarks (Lithology , etc.)		Fe (mg/l)	<0.02
		F (mg/l)	0.1	
		NO3- (mg/l)		
		NO2- (mg/l)	<0.02	
		Coliforms

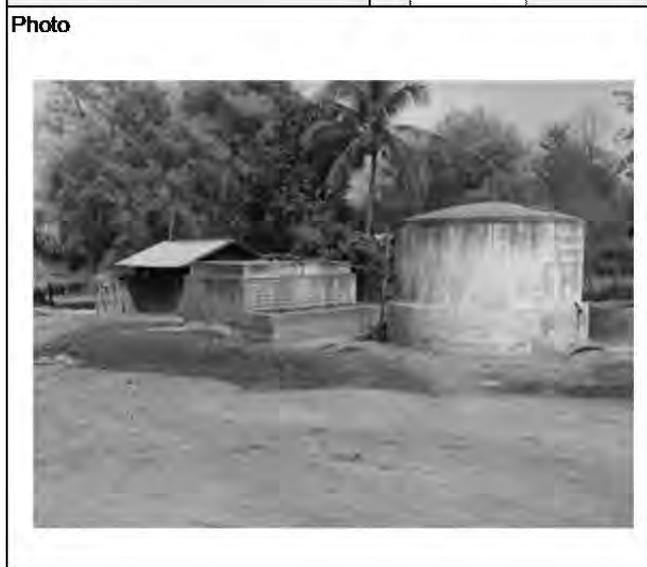
Information of Existing Water Source - 1				
Type	○ Deep Well	Coordinate	X	718611
	Shallow Well		Y	2237657
	Storage reservoir			
	Others			
Hydrogeological Information	Drilled Depth (m)	220	Sample ID	MG2-4-1
	Diameter (in)	6	Temperature (°C)	33.0
	S.W.L (m)	134	pH	7.11
	D.W.L (m)		EC (µs/cm)	1,010
	Yield (m ³ /hour)	9.1	Smell	Slightly iron
	No.of users (person/day)		Color	Non
	Supply facilities	Mono pump	Mn (mg/l)	<1
	Remarks (Lithology , etc.) Drilled originally in 1978 Repaired in 2004. Again in 2014 by BAJ.		Fe (mg/l)	0.3
F (mg/l)			0.3	
NO3- (mg/l)			<1	
NO2- (mg/l)			<0.02	
Coliforms

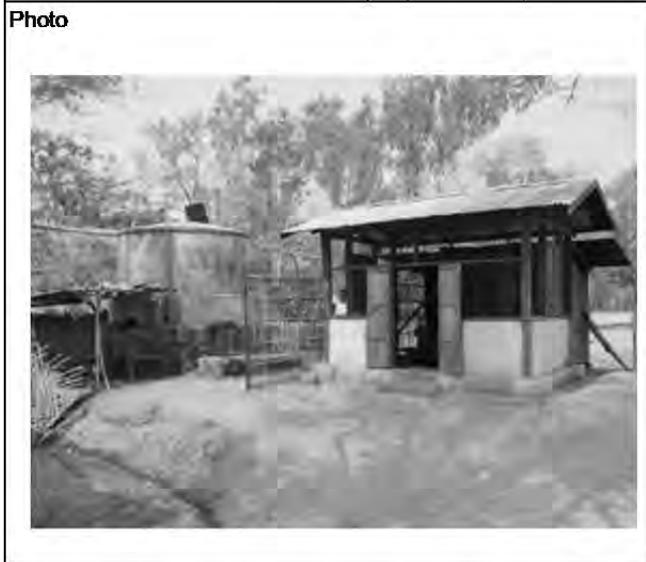
Information of Existing Water Source - 1				
Type	<input type="radio"/> Deep Well	Coordinate	X	725131
	<input type="radio"/> Shallow Well		Y	2213520
	<input type="radio"/> Storage reservoir			
	<input type="radio"/> Others			
Hydrogeological Information	Drilled Depth (m)	200	Sample ID	MG2-5-1
	Diameter (in)	4	Temperature (°C)	33.4
	S.W.L (m)	153	pH	7.23
	D.W.L (m)		EC (µs/cm)	1,460
	Yield (m ³ /hour)	5.5	Smell	Slightly iron
	No.of users (person/day)		Color	Non
	Supply facilities		Mn (mg/l)	<1
	Remarks (Lithology , etc.)		Results of Simplified Water Quality Test	
BAJ replaced Mono pump Bore hole drilled in 1985 by WRUD.		Fe (mg/l)	0.7	
		F (mg/l)	0.3	
		NO3- (mg/l)	<1	
		NO2- (mg/l)	<0.02	
		Coliforms

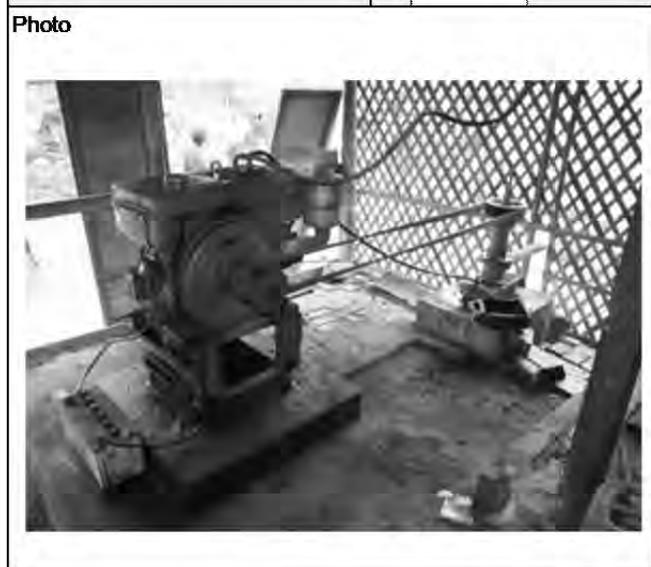
Region	Magway		Date	2015/5/15
Township	Magway		Reported by	Maruo
Village / ID	Thapyaysan(N)	MG2-06	Coordinate (WGS84 UTM)	X
			Y

Information of Existing Water Source - 1				
Type	○ Deep Well	Coordinate	X	712184
	Shallow Well		Y	2227130
	Storage reservoir			
	Others			
Hydrogeological Information	Drilled Depth (m)	189	Sample ID	MG2-6-1
	Diameter (in)	6	Temperature (°C)	35.5
	S.W.L (m)	97	pH	7.32
	D.W.L (m)		EC (µs/cm)	1,108
	Yield (m ³ /hour)	9.1	Smell	Slightly iron
	No.of users (person/day)		Color	Non
	Supply facilities		Mn (mg/l)	<1
	Remarks (Lithology , etc.)	Results of Simplified Water Quality Test		Fe (mg/l)
Chinese generator with MONO 640-A- Pump	F (mg/l)			0.5
	NO3- (mg/l)			2.0
	NO2- (mg/l)			<0.02
	Coliforms

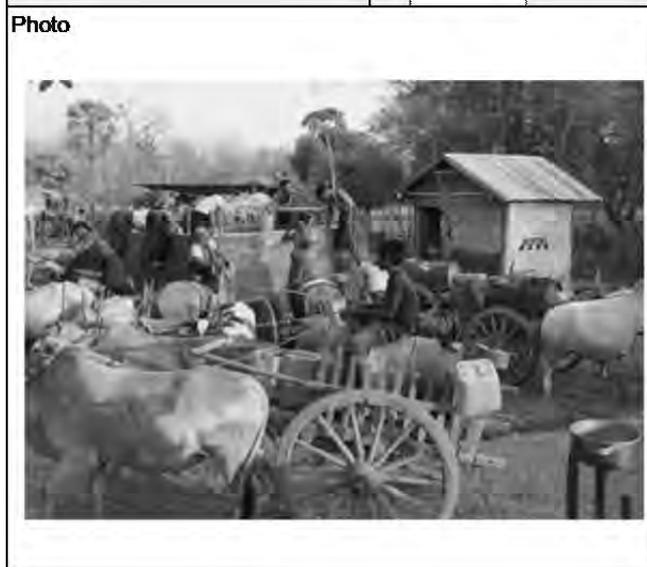
Region	Magway		Date	2015/5/12
Township	Magway		Reported by	Maruo
Village / ID	Leikkan	MG2-08	Coordinate (WGS84 UTM)	X
			Y

Information of Existing Water Source - 1					
Type	<input type="radio"/> Deep Well	Coordinate	X	726925	
	<input type="radio"/> Shallow Well		Y	2239707	
	<input type="radio"/> Storage reservoir				
	<input type="radio"/> Others				
Hydrogeological Information	Drilled Depth (m)	114	Results of Simplified Water Quality Test	Sample ID	MG2-8-1
	Diameter (in)	6		Temperature (°C)	31.8
	S.W.L (m)			pH	7.0
	D.W.L (m)			EC (µs/cm)	872
	Yield (m³/hour)	5.9		Smell	Slightly iron
	No.of users (person/day)			Color	Non
	Supply facilities	Pump		Mn (mg/l)	<1
	Remarks (Lithology , etc.)			Fe (mg/l)	0.3
Drilled by WRUD in 1981 BAJ cleaned element of MONO pump Villagers replaced generator 2014		F (mg/l)	0.2		
		NO3- (mg/l)			
		NO2- (mg/l)	<0.02		
		Coliforms

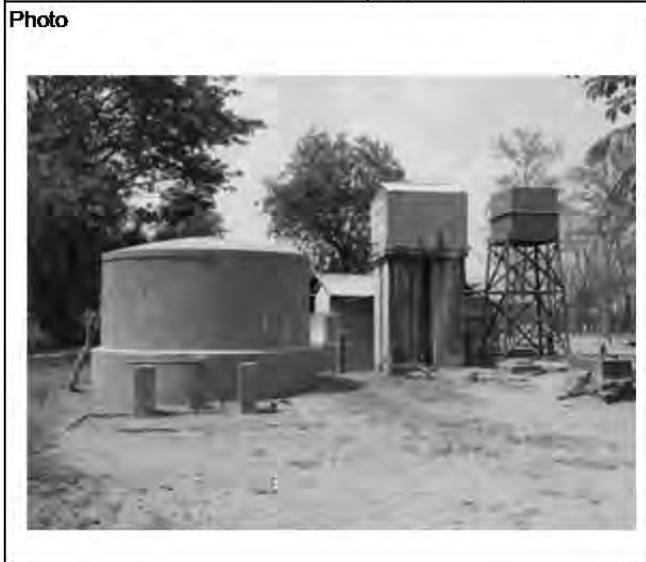
Region	Magway		Date	2015/5/15
Township	Magway		Reported by	Maruo
Village / ID	Ywarthitgyi	MG2-09	Coordinate (WGS84 UTM)	X
			Y

Information of Existing Water Source - 1					
Type	○ Deep Well	Coordinate	X	722084	
	Shallow Well		Y	2237682	
	Storage reservoir				
	Others				
Hydrogeological Information	Drilled Depth (m)	177	Results of Simplified Water Quality Test	Sample ID	MG2-9-1
	Diameter (in)			Temperature (°C)	32.2
	S.W.L (m)	104		pH	7.04
	D.W.L (m)			EC (µs/cm)	805
	Yield (m³/hour)	6.8		Smell	Non
	No.of users (person/day)			Color	Non
	Supply facilities			Mn (mg/l)	<1
	Remarks (Lithology , etc.)			Fe (mg/l)	<0.2
Drilled in 2010 by SPDC. Chinese engine with Mono pump SPDC : State peace and Development Council.			F (mg/l)	0.1	
			NO3- (mg/l)	<1	
			NO2- (mg/l)	<0.02	
			Coliforms

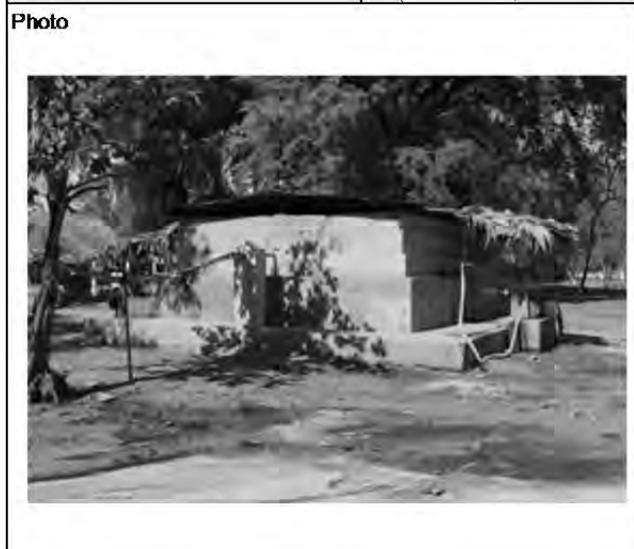
Information of Existing Water Sauce - 1				
Type	○ Deep Well	Coordinate	X	702708
	Shallow Well		Y	2281908
	Storage reservoir			
	Others			
Hydrogeological Information	Drilled Depth (m)	327	Sample ID	MG2-10-1
	Diameter (in)	4		
	S.W.L (m)	210		
	D.W.L (m)			
	Yield (m³/hour)	4.1		
	No.of users (person/day)			
	Supply facilities			
	Remarks (Lithology , etc.)	Originally drilled by WRUD in 1981. BAJ replaced elements of MONO pump in 2007.		
Results of Simplified Water Quality Test		Temperature (°C)	29.4	
		pH	7.37	
		EC (µs/cm)	1,013	
		Smell	Iron smell	
		Color	Non	
		Mn (mg/l)	<1	
		Fe (mg/l)	2	
		F (mg/l)	0.8	
Results of Simplified Water Quality Test		NO3- (mg/l)	<1	
		NO2- (mg/l)	<0.02	
		Coliforms

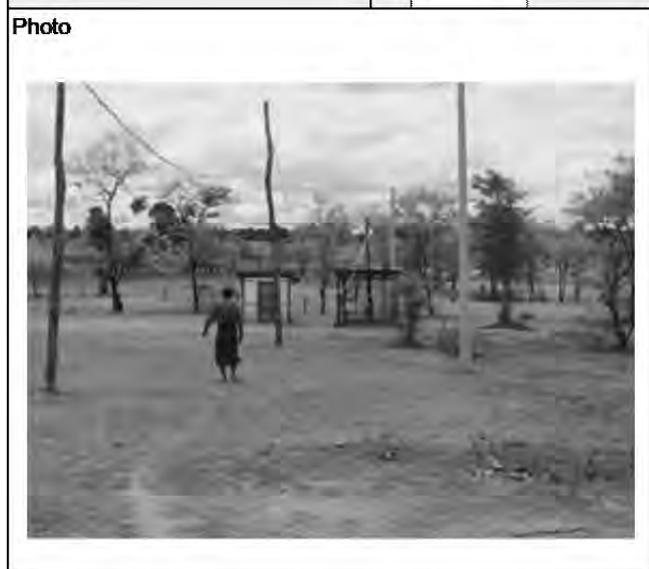
Region	Magway		Date	2015/5/20
Township	Chauk		Reported by	Maruo
Village / ID	Zeebwar	MG2-12	Coordinate (WGS84 UTM)	X
			Y

Information of Existing Water Source - 1				
Type	○ Deep Well	Coordinate	X	711611
	Shallow Well		Y	2298972
	Storage reservoir			
	Others			
Hydrogeological Information	Drilled Depth (m)	152	Sample ID	MG2-12-1
	Diameter (in)	4	Temperature (°C)	28.2
	S.W.L (m)		pH	7.86
	D.W.L (m)		EC (µs/cm)	1,409
	Yield (m ³ /hour)	7.3	Smell	Non
	No.of users (person/day)		Color	Non
	Supply facilities		Mn (mg/l)	<1
	Remarks (Lithology , etc.)	Results of Simplified Water Quality Test		Fe (mg/l)
Existing well owned by a Monastery	F (mg/l)			2
High fluoride	NO3- (mg/l)			1
Electrified submersible pump.	NO2- (mg/l)			<0.02
	Coliforms

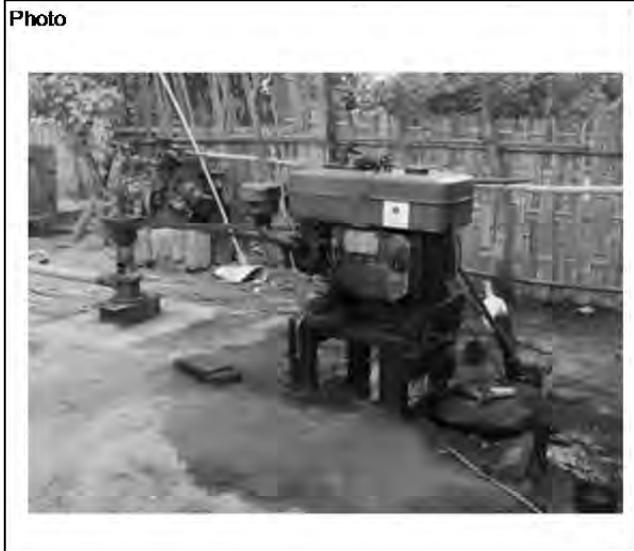
Region	Magway		Date	2015/5/21
Township	Chauk		Reported by	Maruo
Village / ID	Yarpyay	MG2-13	Coordinate (WGS84 UTM)	X
			Y

Information of Existing Water Sauce - 1					
Type	○ Deep Well		Coordinate	X	690042
	Shallow Well			Y	2301200
	Storage reservoir				
	Others				
Hydrogeological Information	Drilled Depth (m)	148	Results of Simplified Water Quality Test	Sample ID	MG2-13-1
	Diameter (in)	6		Temperature (°C)	31.8
	S.W.L (m)			pH	7.42
	D.W.L (m)			EC (µs/cm)	2,150
	Yield (m³/hour)	4.5		Smell	Iron smell
	No.of users (person/day)			Color	Non
	Supply facilities			Mn (mg/l)	<1
	Remarks (Lithology , etc.)			Fe (mg/l) 0.5	
Htaukshaykan village is next to the target village. Drilled in 1985 by WRUD.		F (mg/l) 0.1			
		NO3- (mg/l) <1			
		NO2- (mg/l) <0.02			
		Coliforms

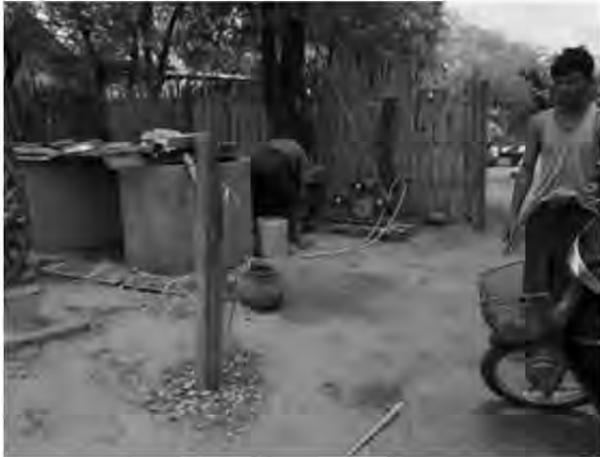
Region	Magway		Date	2015/5/21
Township	Chauk		Reported by	Maruo
Village / ID	Kyatesu(N)	MG2-14	Coordinate (WGS84 UTM)	X
				Y

Information of Existing Water Source - 1					Information of Existing Water Source - 2						
Type	○ Deep Well		Coordinate	X	665497	Type	Deep Well		Coordinate	X	
	Shallow Well			Y	2292703		Shallow Well			Y	
	Storage reservoir						Storage reservoir				
	Others						Others				
Hydrogeological Information	Drilled Depth (m)	67	Results of Simplified Water Quality Test	Sample ID	MG2-14-1	Hydrogeological Information	Drilled Depth (m)		Results of Simplified Water Quality Test	Sample ID	
	Diameter (in)	2		Temperature (°C)	37.8		Diameter (in)			Temperature (°C)	
	S.W.L (m)			pH	8.15		S.W.L (m)			pH	
	D.W.L (m)			EC (µs/cm)	3,090		D.W.L (m)			EC (µs/cm)	
	Yield (m³/hour)	3.4		Smell	Non		Yield (m³/hour)			Smell	
	No.of users (person/day)			Color	Non		No.of users (person/day)			Color	
	Supply facilities			Mn (mg/l)	<1		Supply facilities			Mn (mg/l)	
	Remarks (Lithology , etc.)			Fe (mg/l)	<0.2		Remarks (Lithology , etc.)			Fe (mg/l)

Private tube well - salty water Compressor well - water is always hot.		F (mg/l)	0			F (mg/l)					
		NO3- (mg/l)	1			NO3- (mg/l)					
		NO2- (mg/l)	<0.02			NO2- (mg/l)					
		Coliforms				Coliforms					
Photo					Photo

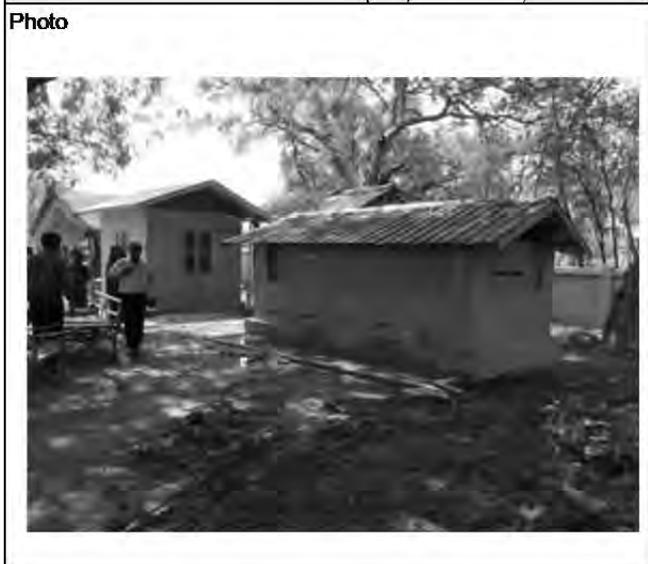
Region	Magway		Date	2015/5/21
Township	Chauk		Reported by	Maruo
Village / ID	Winkabar	MG2-15	Coordinate (WGS84 UTM)	X
			Y

Information of Existing Water Source - 1				
Type	○ Deep Well	Coordinate	X	684440
	Shallow Well		Y	2287209
	Storage reservoir			
	Others			
Hydrogeological Information	Drilled Depth (m)	110	Sample ID	MG2-15-1
	Diameter (in)	4	Temperature (°C)	30.5
	S.W.L (m)	30	pH	8.37
	D.W.L (m)		EC (µs/cm)	703
	Yield (m ³ /hour)	4.1	Smell	Non
	No.of users (person/day)		Color	Non
	Supply facilities	Compressor	Mn (mg/l)	<1
	Remarks (Lithology , etc.)	Compressor well drilled in 2015 by regional government.		
		Results of Simplified Water Quality Test	Fe (mg/l)	<0.2
			F (mg/l)	0.2
			NO3- (mg/l)	1.5
			NO2- (mg/l)	0.1
			Coliforms

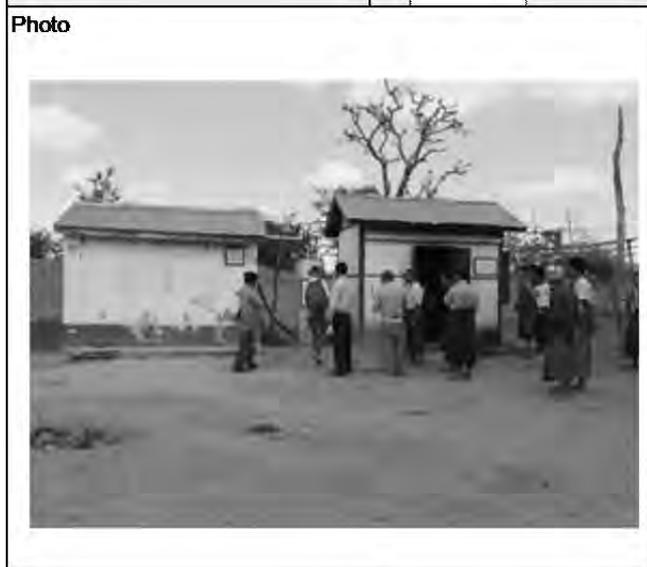
Region	Magway		Date	2015/5/21
Township	Chauk		Reported by	Maruo
Village / ID	Kyatkan	MG2-16	Coordinate (WGS84 UTM)	X
			Y

Information of Existing Water Source - 1				
Type	○ Deep Well	Coordinate	X	690394
	Shallow Well		Y	2296166
	Storage reservoir			
	Others			
Hydrogeological Information	Drilled Depth (m)	171	Sample ID	MG2-16-1
	Diameter (in)		Temperature (°C)	40.2
	S.W.L (m)		pH	8.50
	D.W.L (m)		EC (µs/cm)	1,571
	Yield (m ³ /hour)	1.4	Smell	Oilly smell
	No.of users (person/day)		Color	Non
	Supply facilities		Mn (mg/l)	<1
	Remarks (Lithology , etc.) Existing well just by a pond at the edge of the village.	Results of Simplified Water Quality Test		Fe (mg/l)
F (mg/l)				0.3
NO3- (mg/l)				<1
NO2- (mg/l)				<0.02
Coliforms

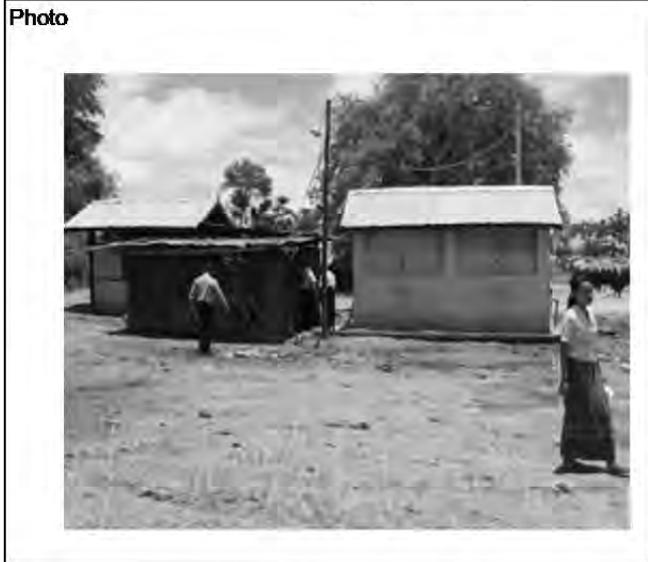
Region	Magway		Date	2015/5/20
Township	Chauk		Reported by	Maruo
Village / ID	Sudat	MG2-17	Coordinate (WGS84 UTM)	X
			Y

Information of Existing Water Source - 1						
Type	○ Deep Well	Coordinate	X	707065		
	Shallow Well		Y	2285476		
	Storage reservoir					
	Others					
Hydrogeological Information	Drilled Depth (m)	365	Sample ID	MG2-17-1		
	Diameter (in)	4	Temperature (°C)	29.5		
	S.W.L (m)	262	pH	7.32		
	D.W.L (m)		EC (µs/cm)	1,089		
	Yield (m ³ /hour)	6.8	Smell	Non		
	No.of users (person/day)		Color	Non		
	Supply facilities		Mn (mg/l)	<1		
	Remarks (Lithology , etc.)	Results of Simplified Water Quality Test				
Mono pump - Electricity powered. Gwaypin(DRD-001) is next to the target Village.						
	Fe (mg/l)					<0.2
	F (mg/l)					0.2
	NO3- (mg/l)					1
	NO2- (mg/l)					0.05
	Coliforms

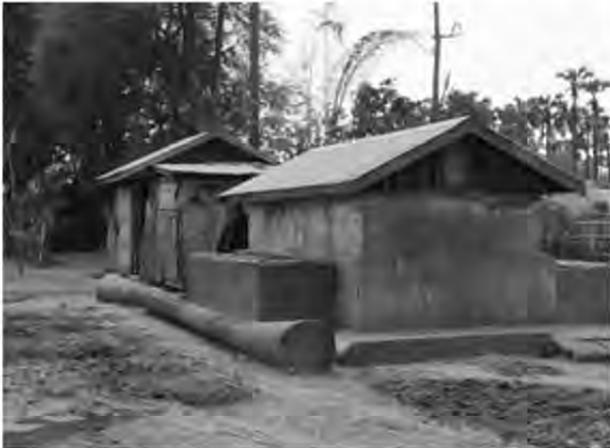
Region	Magway		Date	2015/5/19
Township	Yenangyaung		Reported by	Maruo
Village / ID	Lelgyinyoe	MG2-19	Coordinate (WGS84 UTM)	X
			Y

Information of Existing Water Sauce - 1					Information of Existing Water Sauce - 2						
Type	○ Deep Well		Coordinate	X	724077	Type	Deep Well		Coordinate	X	
	Shallow Well			Y	2266805		Shallow Well			Y	
	Storage reservoir						Storage reservoir				
	Others						Others				
Hydrogeological Information	Drilled Depth (m)	278	Results of Simplified Water Quality Test	Sample ID	MG2-19-1	Hydrogeological Information	Drilled Depth (m)		Results of Simplified Water Quality Test	Sample ID	
	Diameter (in)	4		Temperature (°C)	30.9		Diameter (in)			Temperature (°C)	
	S.W.L (m)	134		pH	6.82		S.W.L (m)			pH	
	D.W.L (m)			EC (µs/cm)	1,410		D.W.L (m)			EC (µs/cm)	
	Yield (m ³ /hour)	6.5		Smell	Non		Yield (m ³ /hour)			Smell	
	No.of users (person/day)			Color	Non		No.of users (person/day)			Color	
	Supply facilities			Mn (mg/l)	<1		Supply facilities			Mn (mg/l)	
	Remarks (Lithology , etc.)			Fe (mg/l)	<0.2		Remarks (Lithology , etc.)			Fe (mg/l)

Water with sand Slightly salty Existing well drilled in 1981 by WRUD.		F (mg/l)	0.3			F (mg/l)					
		NO3- (mg/l)	1.5			NO3- (mg/l)					
		NO2- (mg/l)	<0.02			NO2- (mg/l)					
		Coliforms				Coliforms					
Photo					Photo

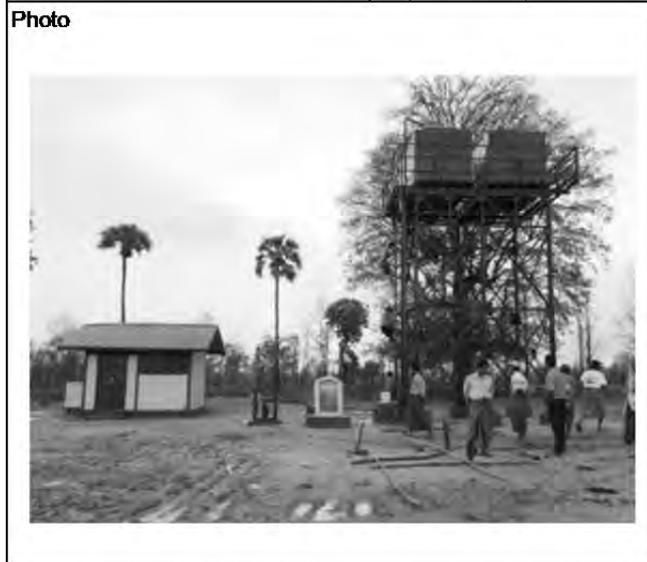
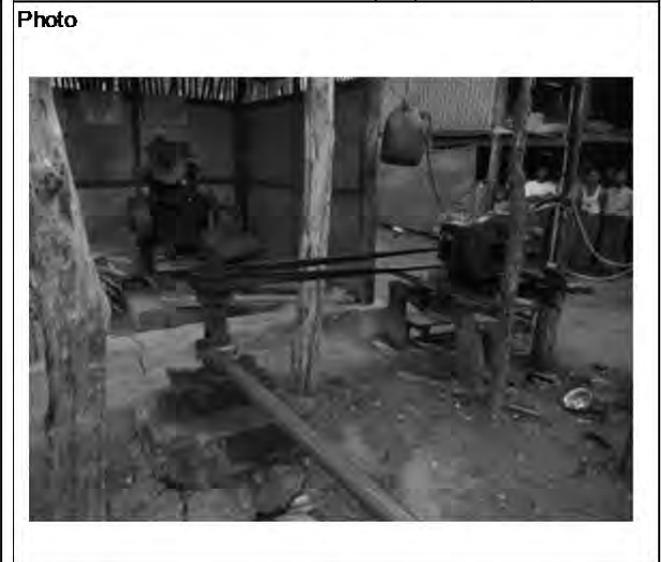
Region	Magway		Date	2015/5/19
Township	Yenangyaung		Reported by	Maruo
Village / ID	Teipyinsakan	MG2-19	Coordinate (WGS84 UTM)	X
				Y

Information of Existing Water Source - 1						
Type	○ Deep Well	Coordinate	X	724896		
	Shallow Well		Y	2268094		
	Storage reservoir					
	Others					
Hydrogeological Information	Drilled Depth (m)	248	Sample ID	MG2-19-2		
	Diameter (in)	6	Temperature (°C)	31.1		
	S.W.L (m)	142	pH	6.50		
	D.W.L (m)	148	EC (µs/cm)	2,370		
	Yield (m ³ /hour)	10.2	Smell	Iron smell		
	No.of users (person/day)		Color	Non		
	Supply facilities		Mn (mg/l)	<1		
	Remarks (Lithology , etc.)	Results of Simplified Water Quality Test				
Next to Lelgyinyoe village . BAJ well - 2014						
	Fe (mg/l)					1.5
	F (mg/l)					1.0
	NO3- (mg/l)					<1
	NO2- (mg/l)					<0.02
	Coliforms

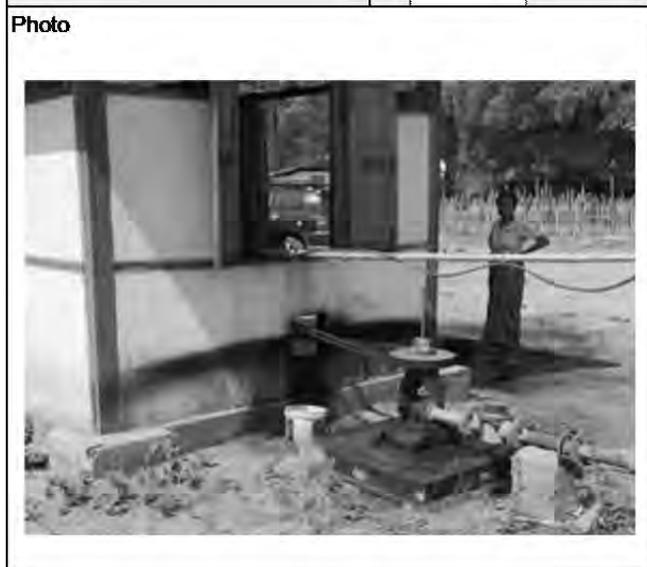
Region	Magway		Date	2015/5/10
Township	Myothit		Reported by	Maruo
Village / ID	Tharmyar	MG2-21	Coordinate (WGS84 UTM)	X
			Y

Information of Existing Water Source - 1				
Type	○ Deep Well	Coordinate	X	736194
	Shallow Well		Y	2241244
	Storage reservoir			
	Others			
Hydrogeological Information	Drilled Depth (m)	198	Sample ID	MG2-21-1
	Diameter (in)		Temperature (°C)	32.1
	S.W.L (m)	119	pH	6.91
	D.W.L (m)		EC (µs/cm)	666
	Yield (m ³ /hour)	245.5	Smell	Non
	No.of users (person/day)		Color	Non
	Supply facilities	Pump	Mn (mg/l)	<0.02
	Remarks (Lithology , etc.)		Results of Simplified Water Quality Test	
Drilled in 2002 by JICA- working well.		Fe (mg/l)	<0.2	
		F (mg/l)	0.1	
		NO3- (mg/l)		
		NO2- (mg/l)	<0.02	
		Coliforms

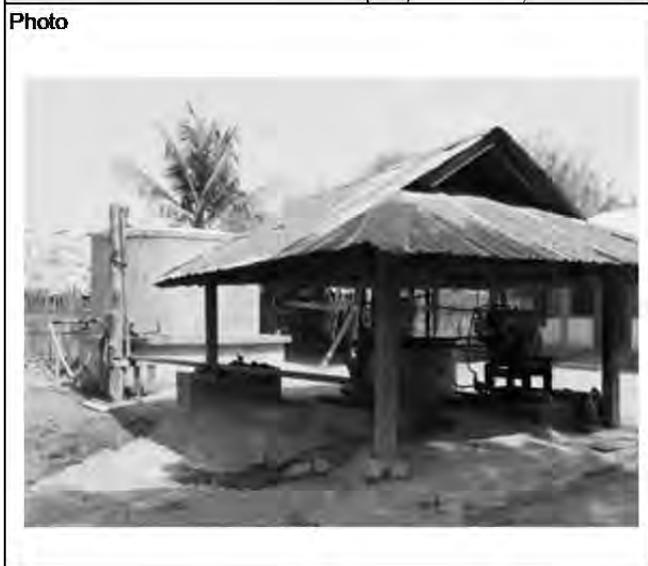
Region	Magway		Date	2015/5/8
Township	Myothit		Reported by	Maruo
Village / ID	Aungmyinthar	MG2-22	Coordinate (WGS84 UTM)	X
				Y

Information of Existing Water Source - 1					
Type	○ Deep Well		Coordinate	X	733075
	Shallow Well			Y	2231654
	Storage reservoir				
	Others				
Hydrogeological Information	Drilled Depth (m)	104	Results of Simplified Water Quality Test	Sample ID	MG2-22-1
	Diameter (in)	4		Temperature (°C)	36.6
	S.W.L (m)	55		pH	7.87
	D.W.L (m)			EC (µs/cm)	993
	Yield (m³/hour)	3.2		Smell	Non
	No.of users (person/day)			Color	Non
	Supply facilities			Mn (mg/l)	<0.02
	Remarks (Lithology , etc.) Drilled by WRUD in 1981 210 - House hold, 1150 - Populations.			Fe (mg/l)	<0.2
F (mg/l)			0.3		
NO3- (mg/l)					
NO2- (mg/l)			<0.02		
Coliforms

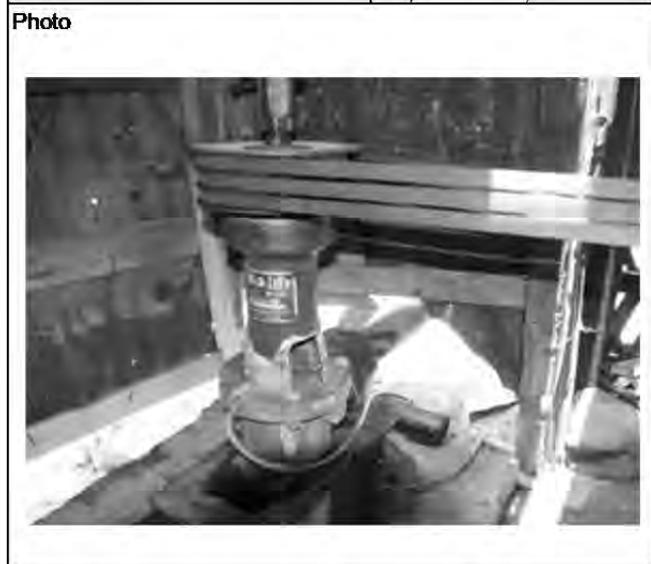
Information of Existing Water Source - 1					
Type	○ Deep Well	Coordinate	X	738864	
	Shallow Well		Y	2222537	
	Storage reservoir				
	Others				
Hydrogeological Information	Drilled Depth (m)	116	Sample ID	MG2-23-1	
	Diameter (in)	4	Temperature (°C)	38.5	
	S.W.L (m)	52	pH	7.51	
	D.W.L (m)		EC (µs/cm)	863	
	Yield (m ³ /hour)	6.8	Smell	Non	
	No.of users (person/day)		Color	Non	
	Supply facilities		Mn (mg/l)	<0.02	
	Remarks (Lithology , etc.)	Results of Simplified Water Quality Test			
Drilled by WRUD in 1980. There is a new well at the edge of the village . Pump was broken and has been repaired.					
	Fe (mg/l)				<0.2
	F (mg/l)				0.3
	NO3- (mg/l)				
	NO2- (mg/l)	<0.02			
	Coliforms

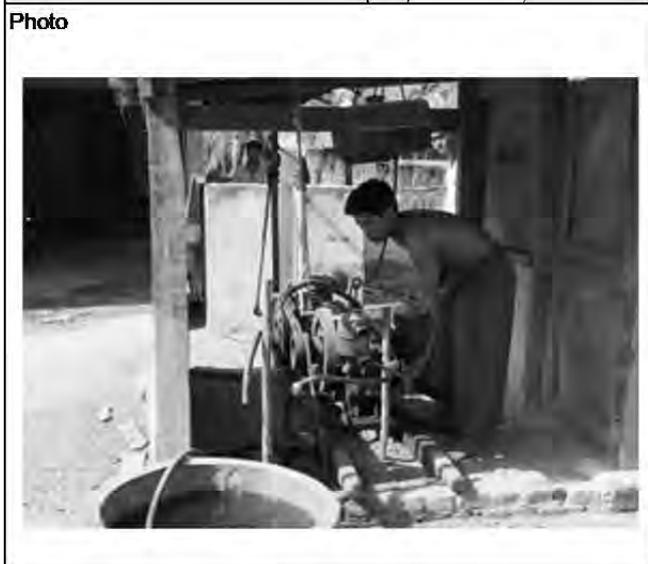
Region	Magway		Date	2015/5/9
Township	Myothit		Reported by	Maruo
Village / ID	Indaw(N)	MG2-24	Coordinate (WGS84 UTM)	X
			Y

Information of Existing Water Source - 1				
Type	○ Deep Well	Coordinate	X	742446
	Shallow Well		Y	2229548
	Storage reservoir			
	Others			
Hydrogeological Information	Drilled Depth (m)	110	Sample ID	MG2-24-1
	Diameter (in)	2	Temperature (°C)	41.5
	S.W.L (m)		pH	8.13
	D.W.L (m)		EC (µs/cm)	928
	Yield (m ³ /hour)	3.6	Smell	Non
	No.of users (person/day)		Color	High turbidity
	Supply facilities		Mn (mg/l)	<0.02
	Remarks (Lithology , etc.) Air lifting well. Only one well in this village. Drilled by DDA in 2011.		Results of Simplified Water Quality Test	Fe (mg/l)
F (mg/l)				0.1
NO3- (mg/l)				
NO2- (mg/l)				<0.02
Coliforms

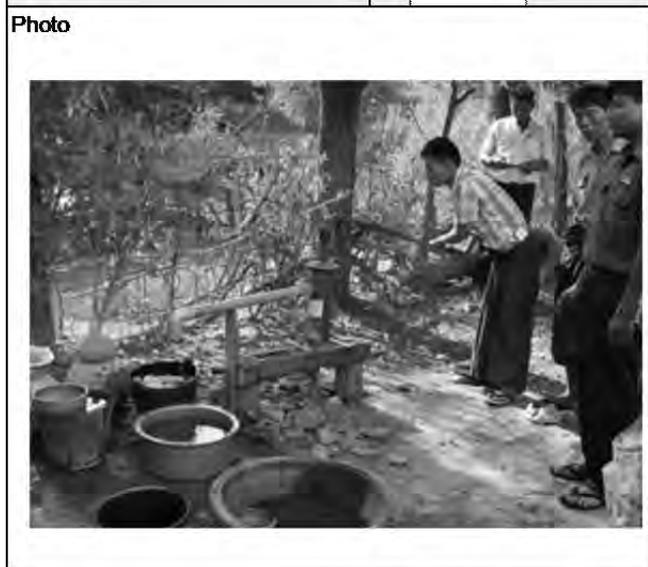
Region	Magway		Date	2015/5/9
Township	Myothit		Reported by	Maruo
Village / ID	Htanaungkwin	MG2-25	Coordinate (WGS84 UTM)	X
				Y

Information of Existing Water Source - 1				
Type	Deep Well	Coordinate	X	770840
	○ Shallow Well		Y	2225170
	Storage reservoir			
	Others			
Hydrogeological Information	Drilled Depth (m)	11	Sample ID	MG2-25-1
	Diameter (in)	2	Temperature (°C)	29.4
	S.W.L (m)	10	pH	7.34
	D.W.L (m)		EC (µs/cm)	1,085
	Yield (m ³ /hour)		Smell	Non
	No.of users (person/day)		Color	Non
	Supply facilities		Mn (mg/l)	<0.02
	Remarks (Lithology , etc.)	Results of Simplified Water Quality Test		Fe (mg/l)
Hand pump well near the Dam.	F (mg/l)			0.1
	NO3- (mg/l)			
	NO2- (mg/l)			<0.02
	Coliforms

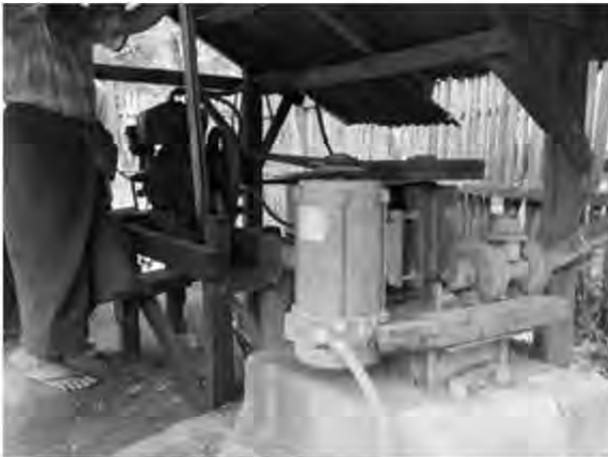
Region	Magway		Date	2015/5/9
Township	Myothit		Reported by	Maruo
Village / ID	Manawtgone	MG2-26	Coordinate (WGS84 UTM)	X
			Y

Information of Existing Water Source - 1				
Type	○ Deep Well	Coordinate	X	732002
	Shallow Well		Y	2222325
	Storage reservoir			
	Others			
Hydrogeological Information	Drilled Depth (m)	128	Sample ID	MG2-26-1
	Diameter (in)	6	Temperature (°C)	32.0
	S.W.L (m)	24	pH	8.31
	D.W.L (m)		EC (µs/cm)	662
	Yield (m ³ /hour)	10.5	Smell	Non
	No.of users (person/day)		Color	Non
	Supply facilities		Mn (mg/l)	<0.02
	Remarks (Lithology , etc.)			Fe (mg/l)
F (mg/l)				0.1
NO3- (mg/l)				
NO2- (mg/l)				<0.02
Coliforms				
Results of Simplified Water Quality Test

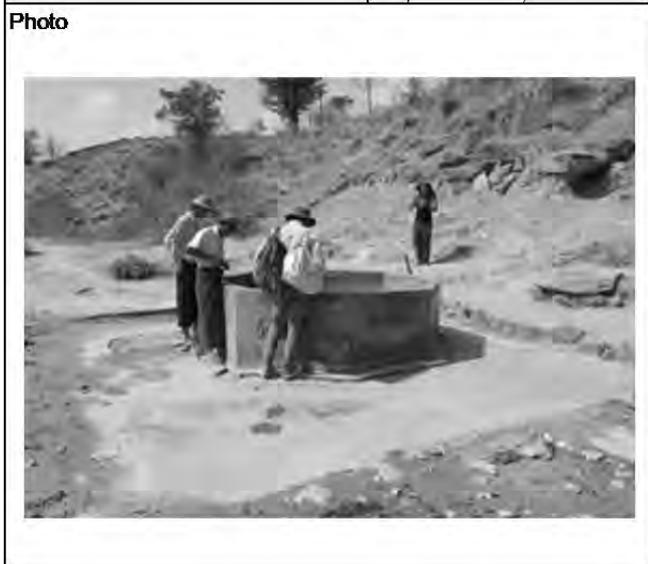
Region	Magway		Date	2015/5/11
Township	Natmauk		Reported by	Maruo
Village / ID	Htonepoutchine	MG2-28	Coordinate (WGS84 UTM)	X
			Y

Information of Existing Water Source - 1					
Type	Deep Well	Coordinate	X	730959	
	Shallow Well		Y	2255652	
	Storage reservoir				
	○ Others(Dug Well)				
Hydrogeological Information	Drilled Depth (m)	Results of Simplified Water Quality Test	Sample ID	MG2-28-1	
	Diameter (in)		Temperature (°C)	31.3	
	S.W.L (m)		pH	7.58	
	D.W.L (m)		EC (µs/cm)	868	
	Yield (m ³ /hour)		Smell	Non	
	No.of users (person/day)		Color		
	Supply facilities		Pump	Mn (mg/l)	<0.02
	Remarks (Lithology , etc.)		Fe (mg/l)	<0.2	
	F (mg/l)	0.6			
	NO3- (mg/l)				
	NO2- (mg/l)	0.05			
	Coliforms	35

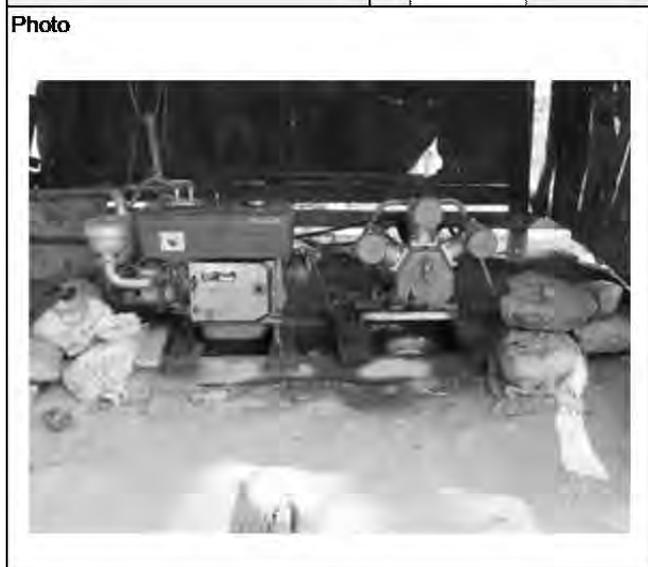
Region	Magway		Date	2015/5/11
Township	Natmauk		Reported by	Maruo
Village / ID	Satkyattaung (Monastery)	MG2-28	Coordinate (WGS84 UTM)	X
				Y

Information of Existing Water Source - 1				
Type	○ Deep Well		X	731705
	Shallow Well		Y	2255329
	Storage reservoir			
	Others			
Hydrogeological Information	Drilled Depth (m)	106.6	Sample ID	MG2-28-2
	Diameter (in)	2	Temperature (°C)	33.3
	S.W.L (m)		pH	8.21
	D.W.L (m)		EC (µs/cm)	701
	Yield (m ³ /hour)		Smell	Non
	No.of users (person/day)		Color	Non
	Supply facilities	Compressor	Mn (mg/l)	<0.02
	Remarks (Lithology , etc.) It drill more than 500ft, water became salty. This village is next to the target village.		Results of Simplified Water Quality Test	
Fe (mg/l)			0.7	
F (mg/l)			0	
NO3- (mg/l)				
NO2- (mg/l)			<0.02	
		Coliforms

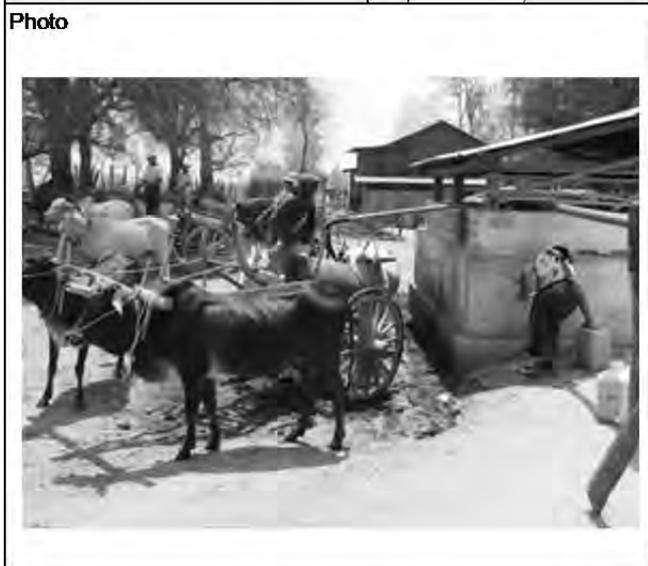
Region	Magway		Date	2015/5/10
Township	Natmak		Reported by	Maruo
Village / ID	Padaukgote(Ywargyi)	MG2-29	Coordinate (WGS84 UTM)	X Y

Information of Existing Water Source - 1				
Type	○ Deep Well		X	737425
	Shallow Well		Y	2248858
	Storage reservoir			
	Others			
Hydrogeological Information	Drilled Depth (m)	219	Sample ID	MG2-29-1
	Diameter (in)		Temperature (°C)	35.2
	S.W.L (m)		pH	6.93
	D.W.L (m)		EC (µs/cm)	2,950
	Yield (m ³ /hour)	3.6	Smell	Iron smell
	No.of users (person/day)		Color	Non
	Supply facilities	Pump	Mn (mg/l)	<0.02
	Remarks (Lithology , etc.) EC very high		Fe (mg/l)	3
F (mg/l)			0.8	
NO3- (mg/l)				
NO2- (mg/l)			<0.02	
Coliforms

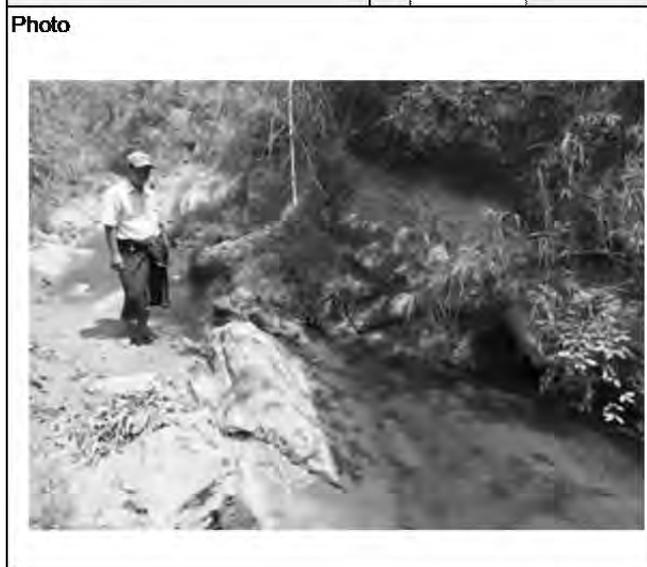
Region	Magway		Date	2015/5/12
Township	Natmauk		Reported by	Maruo
Village / ID	Sellel	MG2-30	Coordinate (WGS84 UTM)	X
			Y

Information of Existing Water Source - 1					
Type	○ Deep Well	Coordinate	X	783632	
	Shallow Well		Y	2259197	
	Storage reservoir				
	Others				
Hydrogeological Information	Drilled Depth (m)	Results of Simplified Water Quality Test	Sample ID	MG2-30-1	
	Diameter (in)		Temperature (°C)	33.9	
	S.W.L (m)		pH	8.68	
	D.W.L (m)		EC (µs/cm)	935	
	Yield (m ³ /hour)		Smell	Non	
	No.of users (person/day)		Color	Non	
	Supply facilities		Pump	Mn (mg/l)	<1
				Fe (mg/l)	0.2
Remarks (Lithology , etc.)			F (mg/l)	0.2	
WP 220- Hand pump			NO3- (mg/l)		
			NO2- (mg/l)	<0.02	
			Coliforms

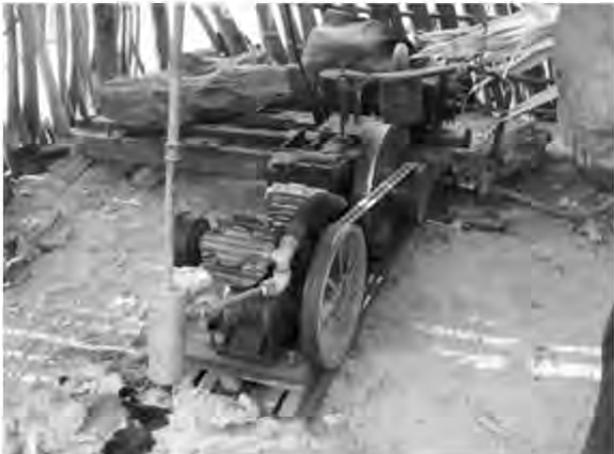
Region	Magway		Date	2015/5/10
Township	Natmauk		Reported by	Maruo
Village / ID	Ywartharlay	MG2-32	Coordinate (WGS84 UTM)	X
				Y

Information of Existing Water Source - 1					Information of Existing Water Source - 2						
Type	○ Deep Well		Coordinate	X	731373	Type	Deep Well		Coordinate	X	
	Shallow Well			Y	2275351		Shallow Well			Y	
	Storage reservoir						Shallow Well				
	Others						Others				
Hydrogeological Information	Drilled Depth (m)	177	Results of Simplified Water Quality Test	Sample ID	MG2-32-1	Hydrogeological Information	Drilled Depth (m)		Results of Simplified Water Quality Test	Sample ID	
	Diameter (in)	2		Temperature (°C)	33.5		Diameter (in)			Temperature (°C)	
	S.W.L (m)	67		pH	7.29		S.W.L (m)			pH	
	D.W.L (m)			EC (µs/cm)	3,840		D.W.L (m)			EC (µs/cm)	
	Yield (m³/hour)	3.4		Smell	Iron smell		Yield (m³/hour)			Smell	
	No.of users (person/day)			Color	Non		No.of users (person/day)			Color	
	Supply facilities	Airlift compressor		Mn (mg/l)	2		Supply facilities			Mn (mg/l)	
	Remarks (Lithology , etc.)			Fe (mg/l)	1		Remarks (Lithology , etc.)			Fe (mg/l)

Now discharge only 500 g/d ,drilled in 2006. Natmauk Municipality funded the cost 2275000 kyats. There have DRD well 200 m far from the the target village by WRUD in Phankharsen village.(168m depth and SWL 85 m)		F (mg/l)	0.2			F (mg/l)					
		NO3- (mg/l)				NO3- (mg/l)					
		NO2- (mg/l)	0.0			NO2- (mg/l)					
		Coliforms				Coliforms					
Photo					Photo

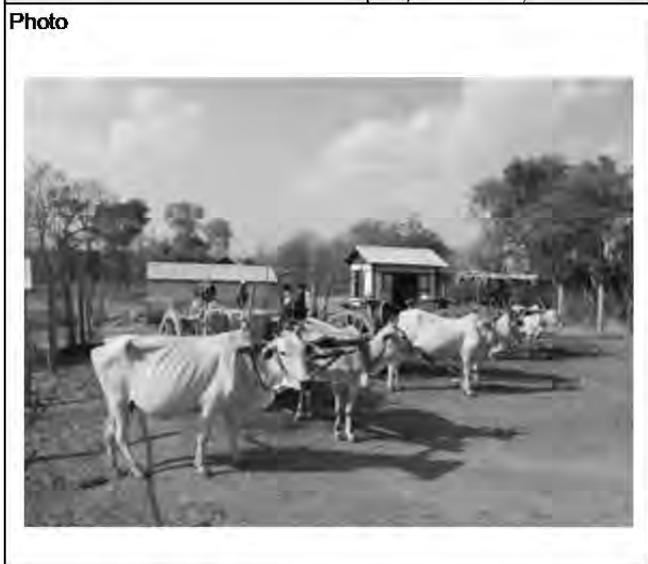
Region	Magway		Date	
Township	Natmak		Reported by	Maruo
Village / ID	Wayonegone	MG2-33	Coordinate (WGS84 UTM)	X
				Y

Information of Existing Water Source - 1				
Type	○ Deep Well	Coordinate	X	736518
	storage reservoir		Y	2267323
	Storage reservoir			
	Others			
Hydrogeological Information	Drilled Depth (m)	Results of Simplified Water Quality Test	Sample ID	MG2-33-1
	Diameter (in)		Temperature (°C)	34
	S.W.L (m)		pH	7.35
	D.W.L (m)		EC (µs/cm)	5,330
	Yield (m³/hour)		Smell	Slightly iron
	No.of users (person/day)		Color	Non
	Supply facilities		Mn (mg/l)	<0.02
			Fe (mg/l)	8
Remarks (Lithology , etc.) JICA well - drilled in 2014 by JICA Grant. Oakpho village is next to the target village.			F (mg/l)	0.8
			NO3- (mg/l)	
			NO2- (mg/l)	<0.02
			Coliforms

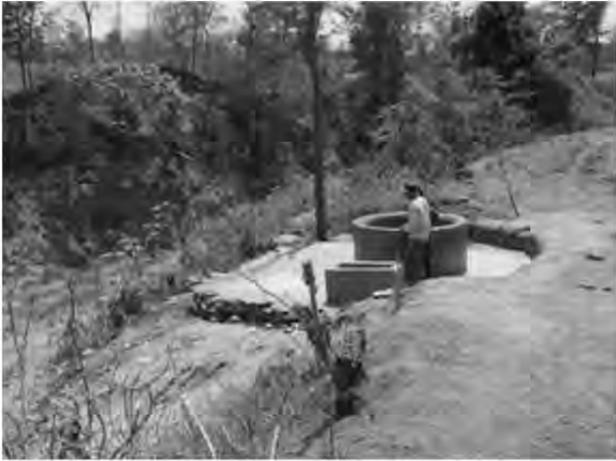
Region	Magway		Date	2015/5/11
Township	Natmauk		Reported by	Maruo
Village / ID	Nyaunggone	MG2-34	Coordinate (WGS84 UTM)	X
			Y

Information of Existing Water Source - 1					Information of Existing Water Source - 2				
Type	○ Deep Well	Coordinate	X	732682	Type	Deep Well	Coordinate	X	
	Shallow Well		Y	2256117		Shallow Well		Y	
	Storage reservoir					Storage reservoir			
	Others					Others			
Hydrogeological Information	Drilled Depth (m)	Results of Simplified Water Quality Test	Sample ID	MG2-34-1	Hydrogeological Information	Drilled Depth (m)	Results of Simplified Water Quality Test	Sample ID	
	Diameter (in)		Temperature (°C)	29.6		Diameter (in)		Temperature (°C)	
	S.W.L (m)		pH	7.88		S.W.L (m)		pH	
	D.W.L (m)		EC (µs/cm)	1,280		D.W.L (m)		EC (µs/cm)	
	Yield (m³/hour)		Smell	Non		Yield (m³/hour)		Smell	
	No.of users (person/day)		Color	Non		No.of users (person/day)		Color	
	Supply facilities		Mn (mg/l)	<0.02		Supply facilities		Mn (mg/l)	
	Remarks (Lithology , etc.) Dug well by a river. People say a bit salty and not salty, high fluoride.		Fe (mg/l)	<0.2		Remarks (Lithology , etc.)		Fe (mg/l)

F (mg/l)		1.3	F (mg/l)						
NO3- (mg/l)			NO3- (mg/l)						
NO2- (mg/l)		<0.02	NO2- (mg/l)						
Coliforms			Coliforms						
Photo					Photo
