5.3.1 現地簡易水質測定結果

5.3.2 現地水質測定状況

(1) ザガイン地域

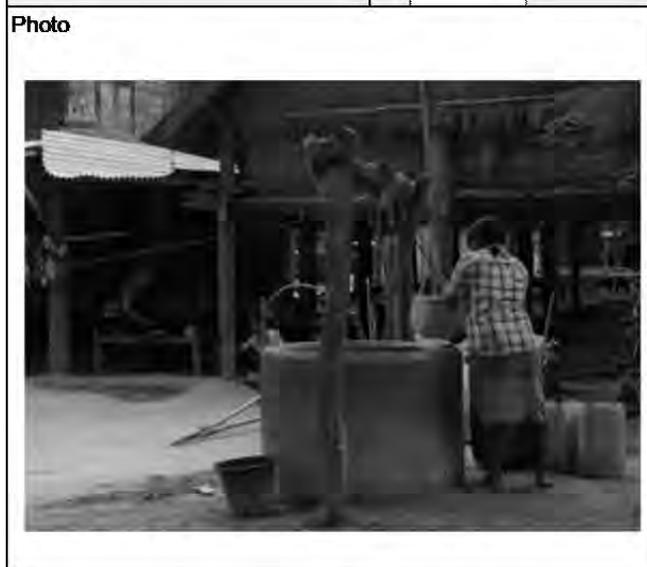
Region	Magway		Date	2015/5/18
Township	Taungdwingyi		Reported by	Maruo
Village / ID	Kokkohla	MG2-36	Coordinate (WGS84 UTM)	X
			Y

Information of Existing Water Source - 1				
Type	Deep Well	Coordinate	X	765957
	Shallow Well		Y	2218608
	Storage reservoir			
	○ Others(Dug Well)			
Hydrogeological Information	Drilled Depth (m)	Results of Simplified Water Quality Test	Sample ID	MG2-36-1
	Diameter (in)		Temperature (°C)	28.9
	S.W.L (m)		pH	7.04
	D.W.L (m)		EC (µs/cm)	1,335
	Yield (m ³ /hour)		Smell	Non
	No.of users (person/day)		Color	Non
	Supply facilities		Mn (mg/l)	<1
	Remarks (Lithology , etc.)		Fe (mg/l)	<0.2
Dug well - 15m deep	F (mg/l)	0.3		
	NO3-(mg/l)	20		
	NO2-(mg/l)	0.1		
	Coliforms

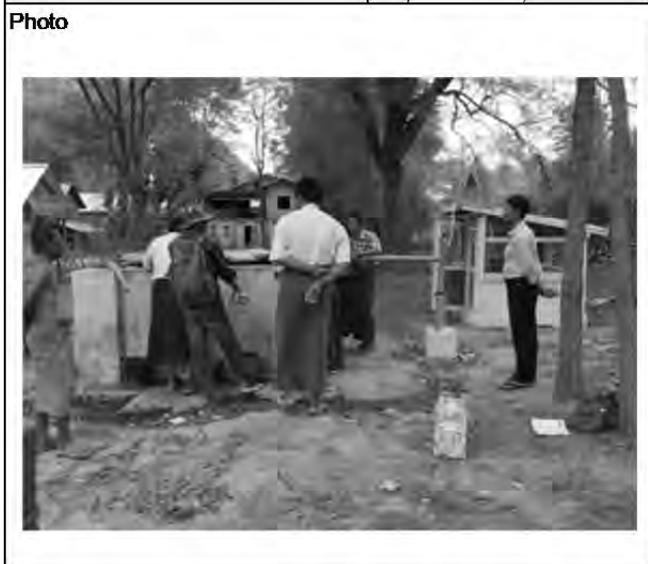
Region	Magway		Date	2015/5/18
Township	Taungdwingyi		Reported by	Maruo
Village / ID	Kokkohla	MG2-36	Coordinate (WGS84 UTM)	X
			Y

Information of Existing Water Source - 1				
Type	○ Deep Well	Coordinate	X	766919
	Shallow Well		Y	2218218
	Storage reservoir			
	Others			
Hydrogeological Information	Drilled Depth (m)	116	Sample ID	MG2-36-2
	Diameter (in)	4	Temperature (°C)	29.7
	S.W.L (m)	18	pH	8.67
	D.W.L (m)		EC (µs/cm)	1,587
	Yield (m ³ /hour)	3.2	Smell	Muddy smell
	No.of users (person/day)		Color	Shallow yellow
	Supply facilities	Compressor	Mn (mg/l)	<1
	Remarks (Lithology , etc.)		Results of Simplified Water Quality Test	
Pantwinlay village is next to target village. WRUD well drilled in 2014.		Fe (mg/l)	<0.2	
		F (mg/l)	2.0	
		NO3- (mg/l)	<1	
		NO2- (mg/l)	<0.02	
		Coliforms

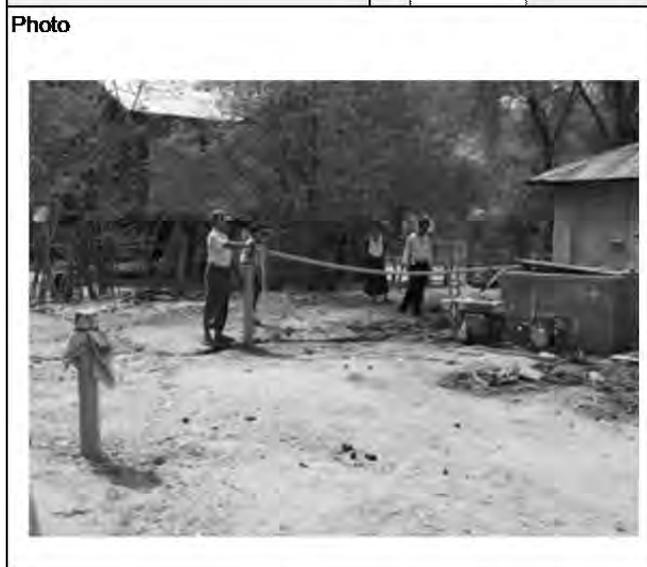
Region	Magway		Date	2015/5/17
Township	Taungdwingyi		Reported by	Maruo
Village / ID	Kangyigone	MG2-37	Coordinate (WGS84 UTM)	X
			Y

Information of Existing Water Source - 1					
Type	○ Deep Well	Coordinate	X	762556	
	Shallow Well		Y	2192933	
	Storage reservoir				
	Others				
Hydrogeological Information	Drilled Depth (m)	183	Results of Simplified Water Quality Test	Sample ID	MG2-37-1
	Diameter (in)			Temperature (°C)	29.3
	S.W.L (m)	165		pH	8.82
	D.W.L (m)			EC (µs/cm)	4,520
	Yield (m³/hour)	0.2		Smell	Non
	No.of users (person/day)			Color	HighTurbidity
	Supply facilities	Compressor		Mn (mg/l)	<1
	Remarks (Lithology , etc.)	High fluoride		Fe (mg/l)	<0.2
			F (mg/l)	3.0	
			NO3-(mg/l)	<1	
			NO2-(mg/l)	<0.02	
			Coliforms

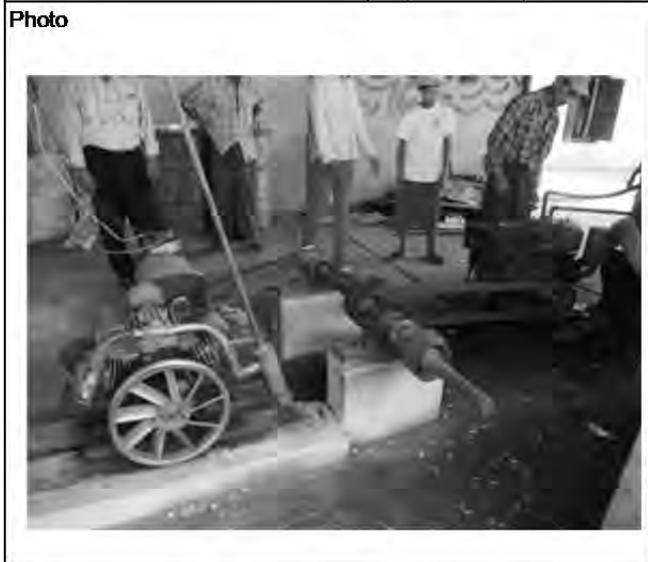
Region	Magway		Date	2015/5/17
Township	Taungdwingyi		Reported by	Maruo
Village / ID	Kangyigone	MG2-37	Coordinate (WGS84 UTM)	X
			Y

Information of Existing Water Source - 1					
Type	○ Deep Well	Coordinate	X	757586	
	Shallow Well		Y	2193879	
	Storage reservoir				
	Others				
Hydrogeological Information	Drilled Depth (m)	183	Results of Simplified Water Quality Test	Sample ID	MG2-37-2
	Diameter (in)	2		Temperature (°C)	30.1
	S.W.L (m)	2		pH	8.77
	D.W.L (m)			EC (µs/cm)	722
	Yield (m ³ /hour)			Smell	Non
	No.of users (person/day)			Color	Non
	Supply facilities	Compressor		Mn (mg/l)	<1
	Remarks (Lithology , etc.)			Fe (mg/l)	<0.2
Payatkyal village is next to the target village along the main road.		F (mg/l)	0.2		
		NO3- (mg/l)	<1		
		NO2- (mg/l)	<0.02		
		Coliforms

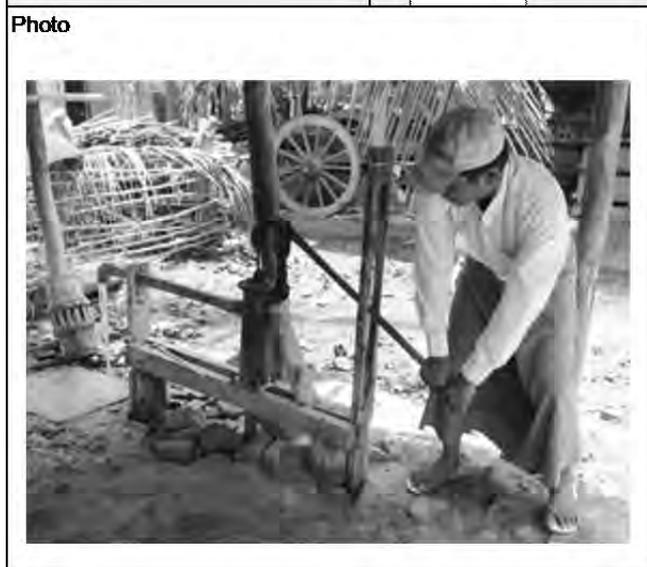
Region	Magway		Date	2015/5/18
Township	Taungdwingyi		Reported by	Maruo
Village / ID	Htaukkyantgwin	MG2-38	Coordinate (WGS84 UTM)	X
			Y

Information of Existing Water Source - 1				
Type	Deep Well	Coordinate	X	772150
	○ Shallow Well		Y	2184875
	Storage reservoir			
	Others			
Hydrogeological Information	Drilled Depth (m)	15	Sample ID	MG2-38-1
	Diameter (in)		Temperature (°C)	28.7
	S.W.L (m)		pH	7.48
	D.W.L (m)		EC (µs/cm)	1,615
	Yield (m ³ /hour)		Smell	Non
	No.of users (person/day)		Color	Non
	Supply facilities		Mn (mg/l)	<1
	Remarks (Lithology , etc.)	Results of Simplified Water Quality Test		Fe (mg/l)
Hand pump	F (mg/l)			0.6
	NO3- (mg/l)			3
	NO2- (mg/l)			<0.02
	Coliforms

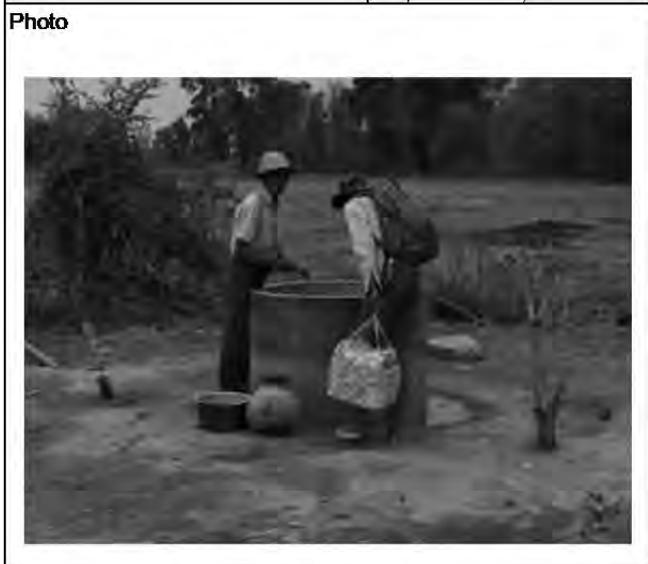
Region	Magway		Date	2015/5/17
Township	Taungdwingyi		Reported by	Maruo
Village / ID	Hlebwegyi	MG2-39	Coordinate (WGS84 UTM)	X
			Y

Information of Existing Water Source - 1				
Type	Deep Well	Coordinate	X	747939
	Shallow Well		Y	2200787
	Storage reservoir			
	○ Others(Dug Well)			
Hydrogeological Information	Drilled Depth (m)	5	Sample ID	MG2-39-1
	Diameter (in)		Temperature (°C)	30.5
	S.W.L (m)		pH	8.00
	D.W.L (m)		EC (µs/cm)	845
	Yield (m ³ /hour)		Smell	Non
	No.of users (person/day)		Color	Slightly turbidity
	Supply facilities		Mn (mg/l)	<1
	Remarks (Lithology , etc.) Dug well- 5m deep.		Results of Simplified Water Quality Test	Fe (mg/l)
F (mg/l)				0.1
NO3-(mg/l)				4
NO2-(mg/l)				<0.02
Coliforms

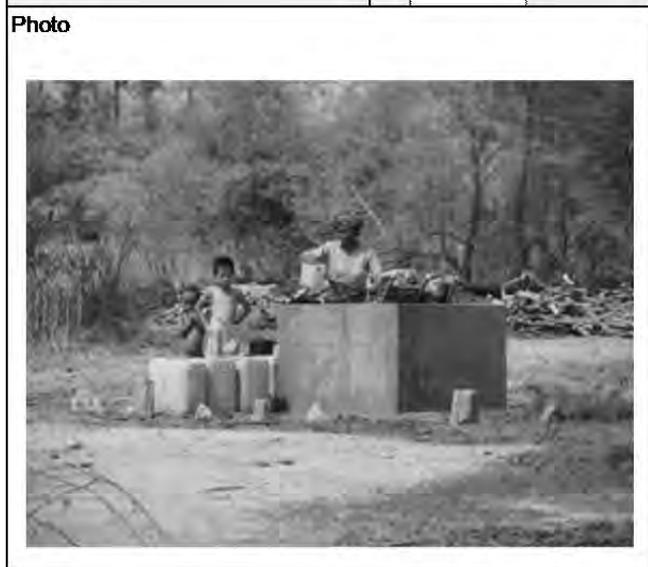
Region	Magway		Date	2015/5/17
Township	Taungdwingyi		Reported by	Maruo
Village / ID	YayHtwetgyi	MG2-40	Coordinate (WGS84 UTM)	X
			Y

Information of Existing Water Source - 1				
Type	Deep Well	Coordinate	X	743090
	Shallow Well		Y	2197425
	Storage reservoir			
	○ Others(Dug Well)			
Hydrogeological Information	Drilled Depth (m)	Results of Simplified Water Quality Test	Sample ID	MG2-40-1
	Diameter (in)		Temperature (°C)	29.5
	S.W.L (m)		pH	7.93
	D.W.L (m)		EC (µs/cm)	678
	Yield (m ³ /hour)		Smell	Non
	No.of users (person/day)		Color	Turbidity
	Supply facilities		Mn (mg/l)	<1
	Remarks (Lithology , etc.)		Fe (mg/l)	<0.2
Dug well,one of thee in one place.	F (mg/l)	0.2		
	NO3-(mg/l)	1		
	NO2-(mg/l)	<0.02		
	Coliforms
