Appendix 5.3.1 Result of Field Water Quality Measurement

Result of Field Water Quality Measurement (Sagaing Region-1)

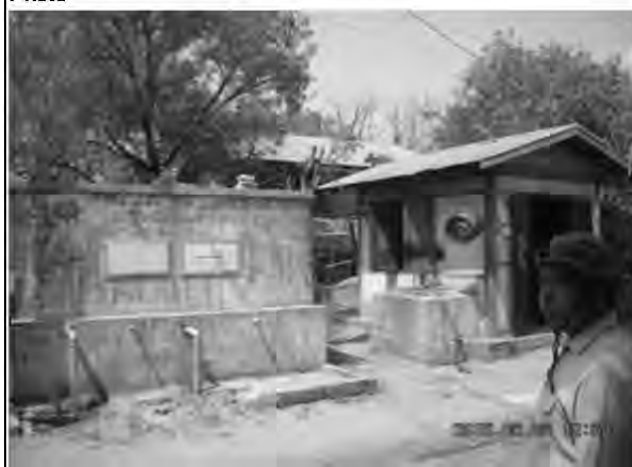
Photo

Information of Existing Water Source - 1				
Type	○ Deep Well	Coordinate	X	720877
	Shallow Well		Y	2486641
	Storage reservoir			
	Others			
Hydrogeological Information	Drilled Depth (m)	82	Sample ID	SA2-2-1
	Diameter (in)	2	Temperature (°C)	31.5
	S.W.L (m)	37	pH	7.84
	D.W.L (m)		EC (µs/cm)	1,475
	Yield (m ³ /hour)	3.6	Smell	Non
	No. of users (person/day)		Color	Non
	Supply facilities	Air lift	Mn (mg/l)	<0.02
	Remarks (Lithology, etc.)		Fe (mg/l)	<0.2
		F (mg/l)	0.4	
		NO ₃ - (mg/l)	15.0	
		NO ₂ - (mg/l)	<0.02	
		Coliforms

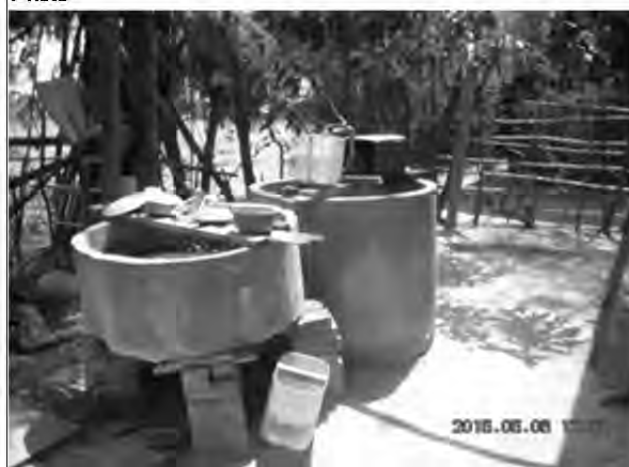
Photo

Information of Existing Water Source - 2				
Type	Deep Well	Coordinate	X	721015
	Shallow Well		Y	2486402
	Storage reservoir			
	○ Others Dug Well			
Hydrogeological Information	Drilled Depth (m)	6.0	Sample ID	SA2-2-2
	Diameter (in)	1.0m	Temperature (°C)	29.2
	S.W.L (m)	5.7	pH	7.58
	D.W.L (m)		EC (µs/cm)	2,470
	Yield (m ³ /hour)		Smell	Non
	No. of users (person/day)		Color	Non
	Supply facilities		Mn (mg/l)	<0.02
	Remarks (Lithology, etc.)		Fe (mg/l)	<0.2
SWL in rainy season is 2.7m Target : 7200885/2486381		F (mg/l)	0.4	
		NO ₃ - (mg/l)	45.0	
		NO ₂ - (mg/l)	0.1	
		Coliforms	Too much

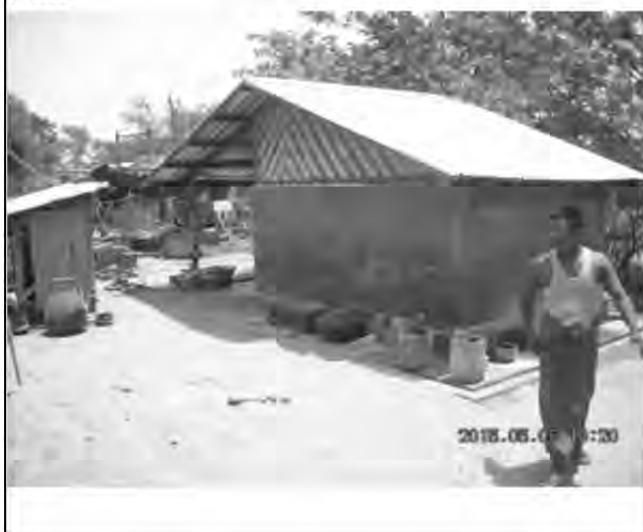
Photo

Information of Existing Water Source - 1				
Type	o Deep Well	Coordinate	X	712929
	Shallow Well		Y	2487787
	Storage reservoir			
	Others			
Hydrogeological Information	Drilled Depth (m)	73	Sample ID	SA2-3-1
	Diameter (in)	2	Temperature (°C)	30.0
	S.W.L (m)	>30	pH	8.36
	D.W.L (m)		EC (µs/cm)	2,610
	Yield (m ³ /hour)	9.1	Smell	Non
	No.of users (person/day)		Color	Non
	Supply facilities	Airlift	Mn (mg/l)	<0.02
	Remarks (Lithology , etc.)	Results of Simplified Water Quality Test		Fe (mg/l)
Irawagi Formation	F (mg/l)			0.8
Private Well	NO3- (mg/l)			45<
280 TW exist 5-6 hour one well	NO2- (mg/l)			<0.02
	Coliforms			2.0

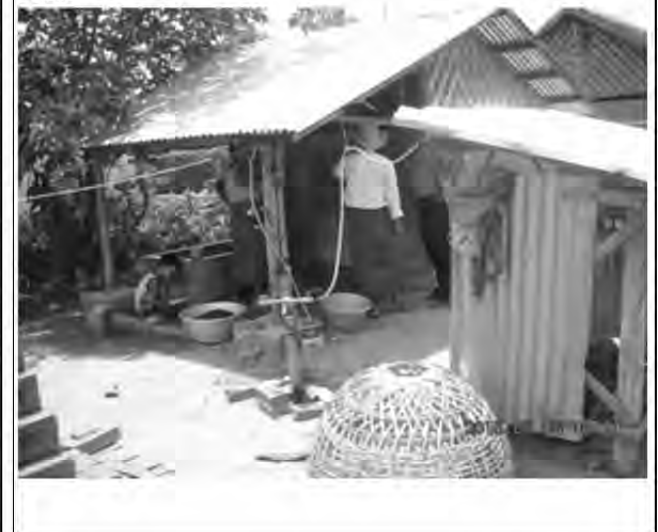
Photo

Information of Existing Water Source - 2				
Type	o Deep Well	Coordinate	X	712889
	Shallow Well		Y	2488508
	Storage reservoir			
	Others			
Hydrogeological Information	Drilled Depth (m)	122	Sample ID	SA2-3-2
	Diameter (in)	2	Temperature (°C)	30.3
	S.W.L (m)	37	pH	7.95
	D.W.L (m)		EC (µs/cm)	620
	Yield (m ³ /hour)	3.6	Smell	Non
	No.of users (person/day)		Color	Non
	Supply facilities	Airlift	Mn (mg/l)	<0.02
	Remarks (Lithology , etc.)	Results of Simplified Water Quality Test		Fe (mg/l)
No electricity when we visited, therefore we could not get fresh water. The sample got from resouivre tank.	F (mg/l)			0.2
	NO3- (mg/l)			<1
	NO2- (mg/l)			<0.02
	Coliforms

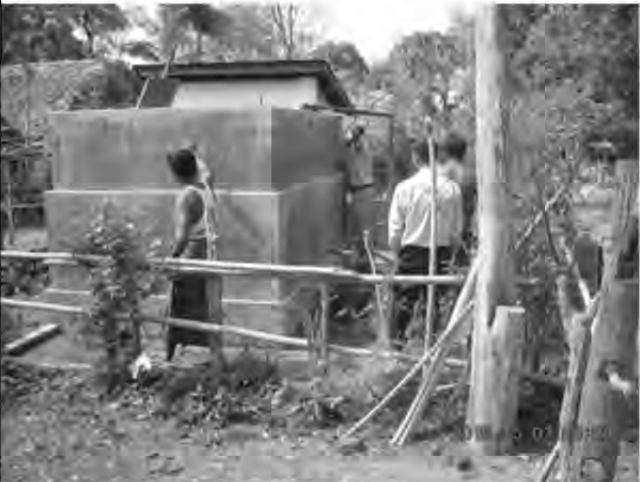
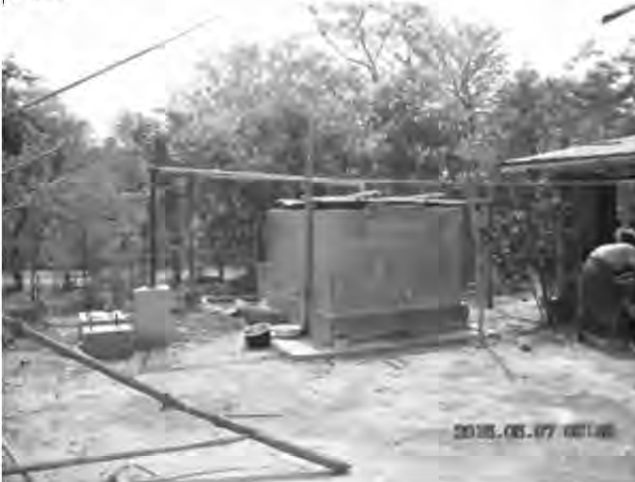
Information of Existing Water Source - 1					Information of Existing Water Source - 2						
Type	○ Deep Well		Coordinate	X	704411	Type	○ Deep Well		Coordinate	X	704202
	Shallow Well			Y	2487667		Shallow Well			Y	2487722
	Storage reservoir						Storage reservoir				
	Others						Others				
Hydrogeological Information	Drilled Depth (m)	122	Results of Simplified Water Quality Test	Sample ID	SA2-4-1	Hydrogeological Information	Drilled Depth (m)	62.0	Results of Simplified Water Quality Test	Sample ID	SA2-4-2
	Diameter (in)	2		Temperature (°C)	29.8		Diameter (in)	2		Temperature (°C)	30.4
	S.W.L (m)	39		pH	8.14		S.W.L (m)	32		pH	8.12
	D.W.L (m)			EC (µs/cm)	534		D.W.L (m)			EC (µs/cm)	663
	Yield (m³/hour)	5.5		Smell	Non		Yield (m³/hour)	3.6		Smell	Non
	No. of users (person/day)			Color	Non		No. of users (person/day)			Color	Non
	Supply facilities	Air lift		Mn (mg/l)	<0.02		Supply facilities			Mn (mg/l)	<0.02

Remarks (Lithology, etc.)			Fe (mg/l)	<0.2		Remarks (Lithology, etc.)			Fe (mg/l)	<0.2
Constructed in 2005 Public well		F (mg/l)	0.2	Constructed in 2013 Enough for drinking water, however total amount is not enough. 10 private TW(61 m ave)		F (mg/l)	0.6				
		NO3- (mg/l)	<1			NO3- (mg/l)	5.0				
		NO2- (mg/l)	<0.02			NO2- (mg/l)	<0.02				
		Coliforms				Coliforms					
Photo					Photo

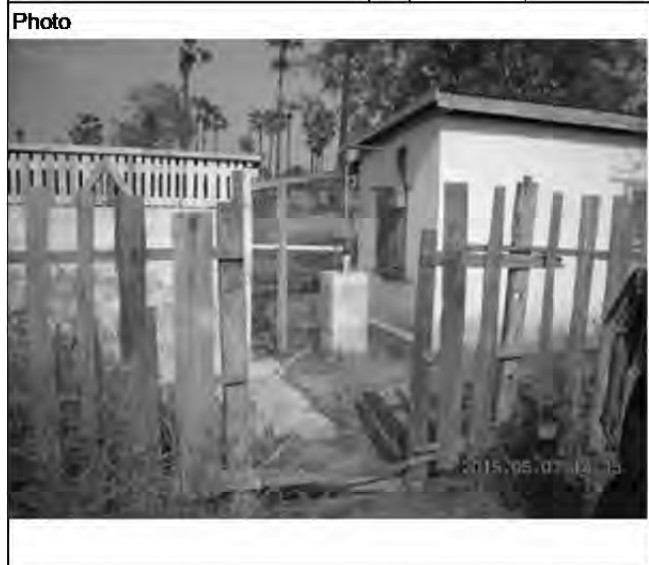
Information of Existing Water Source - 1				
Type	○ Deep Well		X	729667
	Shallow Well		Y	2470736
	Storage reservoir			
	Others			
Hydrogeological Information	Drilled Depth (m)	118	Sample ID	SA2-5-1
	Diameter (in)	4	Temperature (°C)	31.7
	S.W.L (m)	34	pH	7.91
	D.W.L (m)		EC (µs/cm)	628
	Yield (m ³ /hour)		Smell	Sulfur smell
	No.of users (person/day)		Color	Non
	Supply facilities		Mn (mg/l)	<0.02
	Remarks (Lithology , etc.)		Fe (mg/l)	<0.2
They could not drink. Target : 729874/2471014		F (mg/l)	0.6	
		NO3- (mg/l)	<1	
		NO2- (mg/l)	<0.02	
		Coliforms

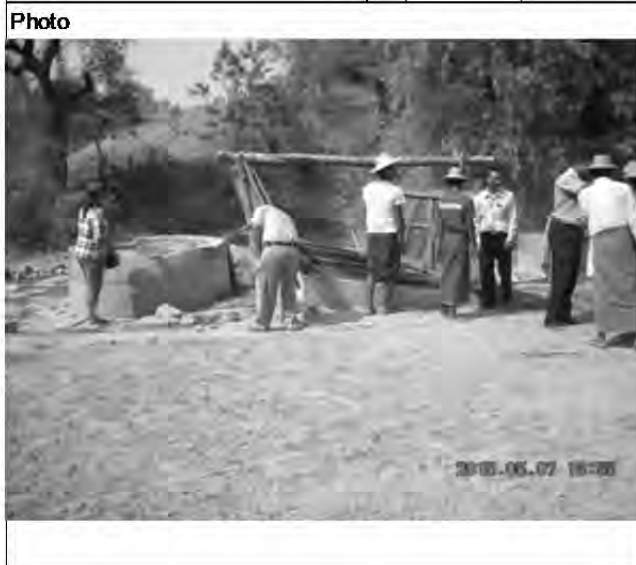
Information of Existing Water Source - 2				
Type	Deep Well		X	729835
	Shallow Well		Y	2471196
	Storage reservoir			
	○ Others <i>Dug Well</i>			
Hydrogeological Information	Drilled Depth (m)	12.5	Sample ID	SA2-5-2
	Diameter (in)	1.7m	Temperature (°C)	30.6
	S.W.L (m)	8.1	pH	7.34
	D.W.L (m)		EC (µs/cm)	1,136
	Yield (m ³ /hour)		Smell	Non
	No.of users (person/day)		Color	Non
	Supply facilities		Mn (mg/l)	<0.02
	Remarks (Lithology , etc.)		Fe (mg/l)	<0.2
		F (mg/l)	0.6	
		NO3- (mg/l)	5.0	
		NO2- (mg/l)	<0.02	
		Coliforms	0

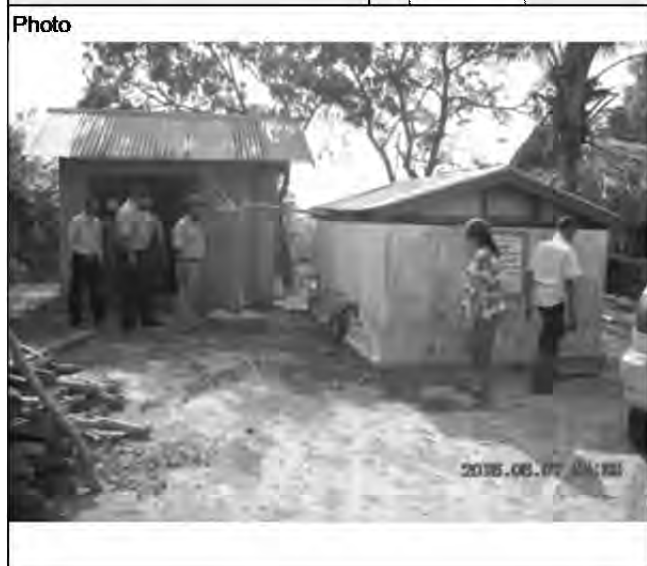
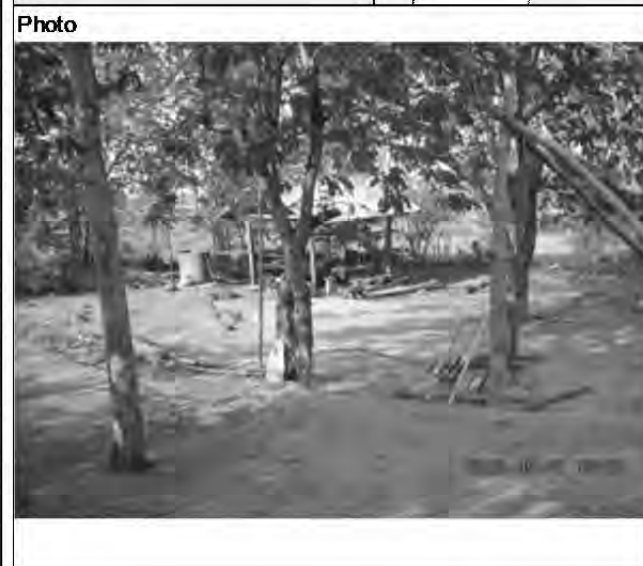
Information of Existing Water Source - 1					
Type	<input type="radio"/> Deep Well	Coordinate	X	729847	
	<input type="radio"/> Shallow Well		Y	2470770	
	<input type="radio"/> Storage reservoir				
	<input type="radio"/> Others				
Hydrogeological Information	Drilled Depth (m)	146	Results of Simplified Water Quality Test	Sample ID	SA2-5-3
	Diameter (in)	2		Temperature (°C)	
	S.W.L (m)	36		pH	
	D.W.L (m)			EC (µs/cm)	
	Yield (m³/hour)	4.1		Smell	
	No.of users (person/day)			Color	
	Supply facilities			Mn (mg/l)	
	Remarks (Lithology , etc.)	DRD constructed. More salty Cannot operate now.		Fe (mg/l)	
			F (mg/l)		
			NO3- (mg/l)		
			NO2- (mg/l)		
			Coliforms

Information of Existing Water Source - 2					
Type	<input type="radio"/> Deep Well	Coordinate	X	732022	
	<input type="radio"/> Shallow Well		Y	2470662	
	<input type="radio"/> Storage reservoir				
	<input type="radio"/> Others				
Hydrogeological Information	Drilled Depth (m)	115	Results of Simplified Water Quality Test	Sample ID	SA2-5-4
	Diameter (in)	4		Temperature (°C)	31.1
	S.W.L (m)	28		pH	7.53
	D.W.L (m)			EC (µs/cm)	1,700
	Yield (m³/hour)			Smell	Non
	No.of users (person/day)			Color	Non
	Supply facilities	Airlift		Mn (mg/l)	<0.02
	Remarks (Lithology , etc.)	Twegi village's well. Almost top of the hill. In the monestry compound.		Fe (mg/l)	<0.2
			F (mg/l)	0.6	
			NO3- (mg/l)	<1	
			NO2- (mg/l)	<0.02	
			Coliforms

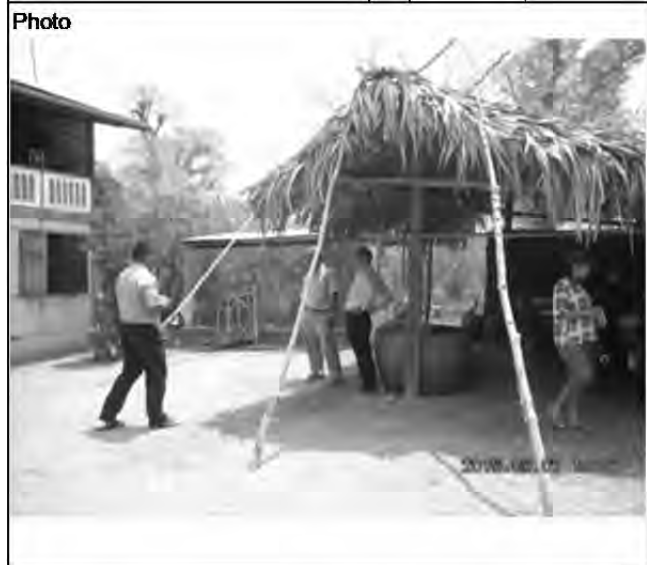
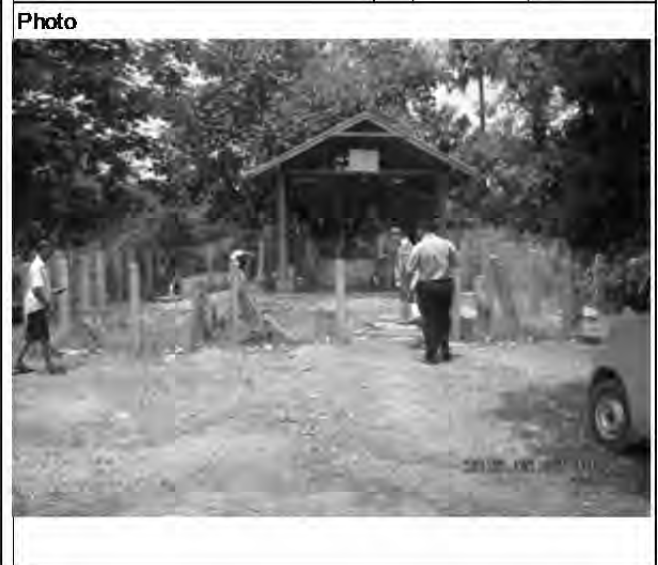
Information of Existing Water Source - 1				
Type	○ Deep Well		X	700719
	Shallow Well		Y	2482574
	Storage reservoir			
	Others			
Hydrogeological Information	Drilled Depth (m)	70	Sample ID	SA2-6-1
	Diameter (in)	2	Temperature (°C)	30.3
	S.W.L (m)	32	pH	7.94
	D.W.L (m)		EC (µs/cm)	949
	Yield (m³/hour)	4.5	Smell	Non
	No. of users (person/day)		Color	Non
	Supply facilities		Mn (mg/l)	<0.02
	Remarks (Lithology, etc.)		Fe (mg/l)	<0.2
Private well 20 Airlift well (private) in this 3 years		F (mg/l)	0.8	
		NO3- (mg/l)	30.0	
		NO2- (mg/l)	<0.02	
		Coliforms		
		Results of Simplified Water Quality Test

Information of Existing Water Source - 2				
Type	Deep Well		X	700290
	Shallow Well		Y	2482117
	Storage reservoir			
	○ Others <i>Dug Well</i>			
Hydrogeological Information	Drilled Depth (m)	9.1	Sample ID	SA2-6-2
	Diameter (in)	1.4m	Temperature (°C)	28.6
	S.W.L (m)	8.7	pH	7.04
	D.W.L (m)		EC (µs/cm)	663
	Yield (m³/hour)		Smell	Non
	No. of users (person/day)		Color	Non
	Supply facilities		Mn (mg/l)	<0.02
	Remarks (Lithology, etc.)		Fe (mg/l)	<0.2
Use for drinking.		F (mg/l)	0.4	
		NO3- (mg/l)	4.0	
		NO2- (mg/l)	<0.02	
		Coliforms	Too much	
		Results of Simplified Water Quality Test

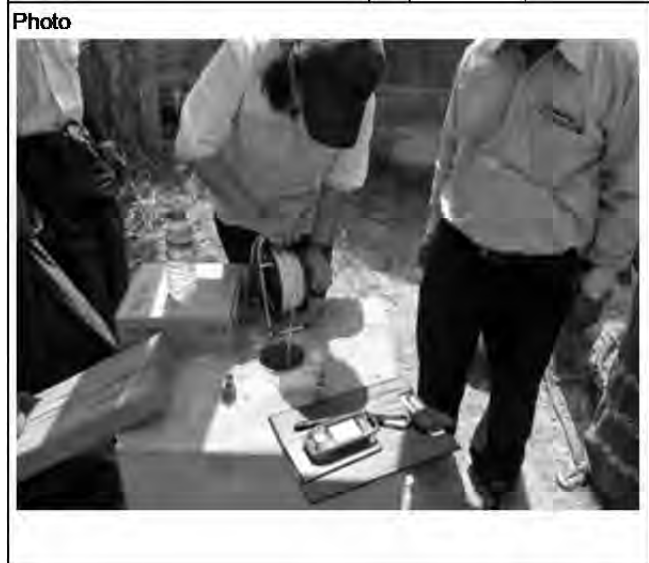
Information of Existing Water Source - 1					
Type	<input type="radio"/> Deep Well	Coordinate	X	742454	
	<input type="radio"/> Shallow Well		Y	2430600	
	<input type="radio"/> Storage reservoir				
	<input type="radio"/> Others				
Hydrogeological Information	Drilled Depth (m)	192	Results of Simplified Water Quality Test	Sample ID	SA2-07-1
	Diameter (in)	4		Temperature (°C)	30.6
	S.W.L (m)	72.2		pH	8.68
	D.W.L (m)			EC (µs/cm)	1,224
	Yield (m³/hour)			Smell	Non
	No.of users (person/day)			Color	Non
	Supply facilities			Mn (mg/l)	<0.02
				Fe (mg/l)	<0.2
Remarks (Lithology , etc.)				F (mg/l)	0.8
<ul style="list-style-type: none"> - Solar pump system (80W x 30 panels) - Grundfos SQL pump - Pmpup has broken for a week. Water was taken from remaining water in the tank. - It was constructed in 1979. -Water get from water tank. 				NO3- (mg/l)	10.0
				NO2- (mg/l)	< 0.02
				Coliforms

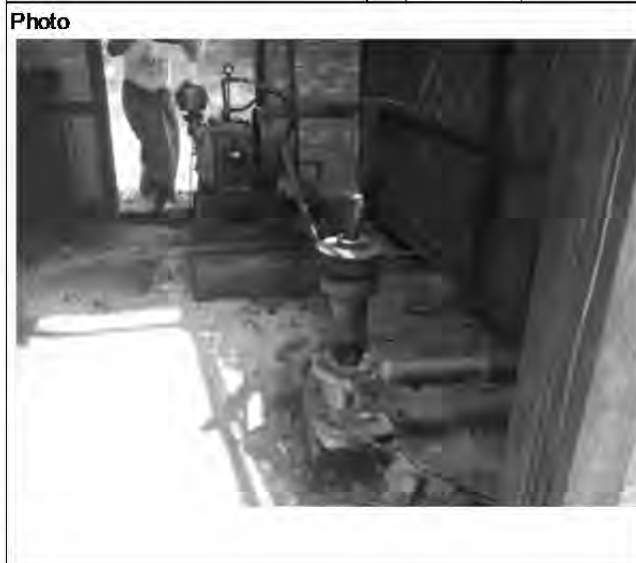
Information of Existing Water Source - 2					
Type	<input type="radio"/> Deep Well	Coordinate	X	742361	
	<input type="radio"/> Shallow Well		Y	2430401	
	<input type="radio"/> Storage reservoir				
	<input type="radio"/> Others				
Hydrogeological Information	Drilled Depth (m)	152	Results of Simplified Water Quality Test	Sample ID	SA2-07-2
	Diameter (in)	6		Temperature (°C)	36.7
	S.W.L (m)	70		pH	7.52
	D.W.L (m)			EC (µs/cm)	1,245
	Yield (m³/hour)	11.4		Smell	Non
	No.of users (person/day)			Color	Non
	Supply facilities			Mn (mg/l)	<0.02
				Fe (mg/l)	<0.2
Remarks (Lithology , etc.)				F (mg/l)	0.8
<ul style="list-style-type: none"> - 9 hours opelation. - Mono pump system. - Constructed in 1979. - Water is sufficient now however, they need repair Grundfos pump ASAP. -Meter system for each hour (0-54m : Yellow sand and clay,ss 54-91m: Sand stone / 91m- Blue stone.) 				NO3- (mg/l)	10.0
				NO2- (mg/l)	<0.02

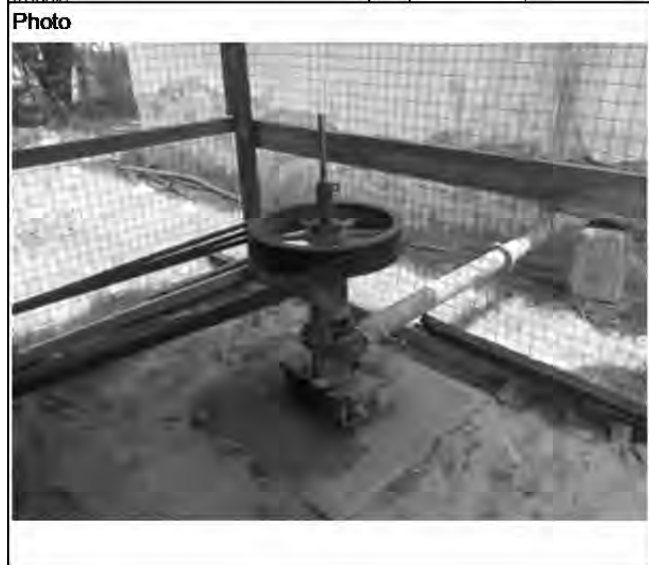
Information of Existing Water Source - 1						
Type	○ Deep Well		Coordinate	X	743872	
	Shallow Well			Y	2426840	
	Storage reservoir					
	Others					
Hydrogeological Information	Drilled Depth (m)	173	Results of Simplified Water Quality Test	Sample ID	SA2-08-1	
	Diameter (in)	6		Temperature (°C)	37.9	
	S.W.L (m)	61		pH	7.81	
	D.W.L (m)			EC (µs/cm)	2,820	
	Yield (m³/hour)	9.1		Smell	Non	
	No.of users (person/day)			Color	Non	
	Supply facilities			Mn (mg/l)	<0.02	
	Remarks (Lithology , etc.)			Fe (mg/l)	<0.2	
- Mono Pump system - They have another well. Unfortunately,solar pump system (80W x 30 panels) which is using Grundfos SQL pump has broken for a week. However, water amount is still no problem. -116m TW donated UNICEF in 2012, cannot operate cause of moter pump trouble			F (mg/l)	0.8		
			NO3- (mg/l)	<1		
			NO2- (mg/l)	< 0.02		
			Coliforms

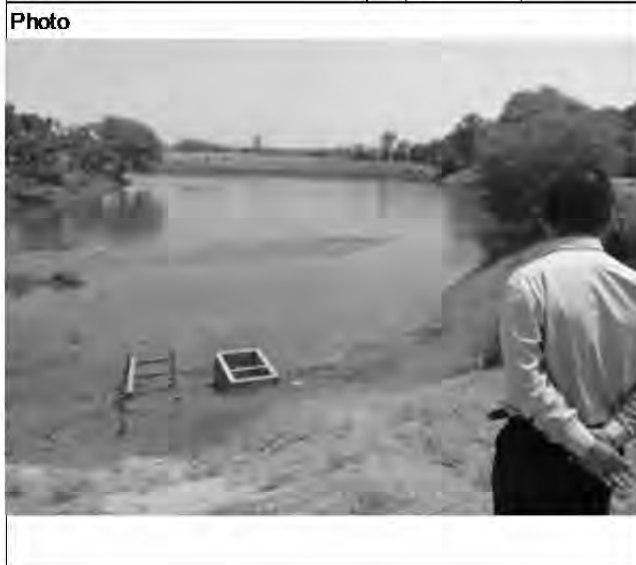
Information of Existing Water Source - 2						
Type	Deep Well		Coordinate	X	743809	
	Shallow Well			Y	2426699	
	○ Storage reservoir					
	Others					
Hydrogeological Information	Drilled Depth (m)		Results of Simplified Water Quality Test	Sample ID	SA2-08-2	
	Diameter (in)			Temperature (°C)	36.5	
	S.W.L (m)			pH	8.80	
	D.W.L (m)			EC (µs/cm)	311	
	Yield (m³/hour)			Smell	Non	
	No.of users (person/day)			Color	Shallow Yellow	
	Supply facilities			Mn (mg/l)	<0.02	
	Remarks (Lithology , etc.)			Fe (mg/l)	0.2	
Water taste is better than well, therefore many people use pond water for drinking. Target : 743821- 2426594			F (mg/l)	0.2		
			NO3- (mg/l)	<1		
			NO2- (mg/l)	<0.02		
			Coliforms	60<

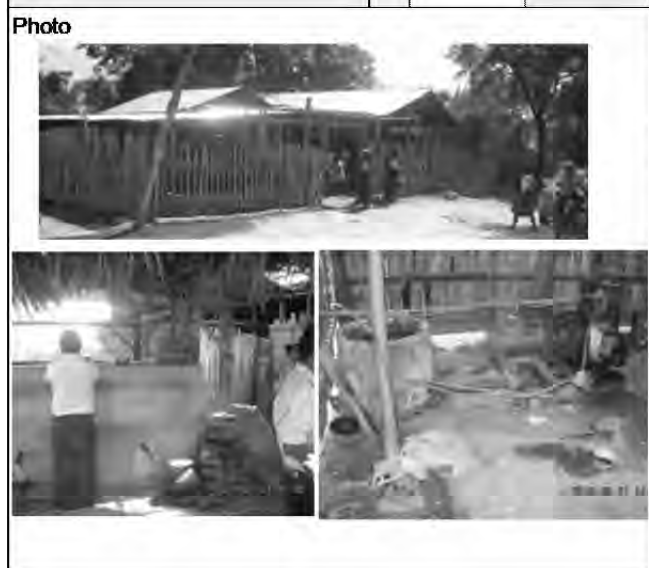
Information of Existing Water Source - 1				
Type	o Deep Well	Coordinate	X	742923
	Shallow Well		Y	2472596
	Storage reservoir			
	Others			
Hydrogeological Information	Drilled Depth (m)	97	Sample ID	SA2-9-1
	Diameter (in)	4	Temperature (°C)	30.7
	S.W.L (m)	42	pH	7.66
	D.W.L (m)		EC (µs/cm)	1,302
	Yield (m ³ /hour)	4.5	Smell	Non
	No.of users (person/day)		Color	Non
	Supply facilities	Submersible pump	Mn (mg/l)	<0.02
	Remarks (Lithology , etc.)		Fe (mg/l)	<0.2
Public well. 34 years ago it was constructed.		F (mg/l)	0.6	
		NO3- (mg/l)	2.0	
		NO2- (mg/l)	<0.02	
		Coliforms

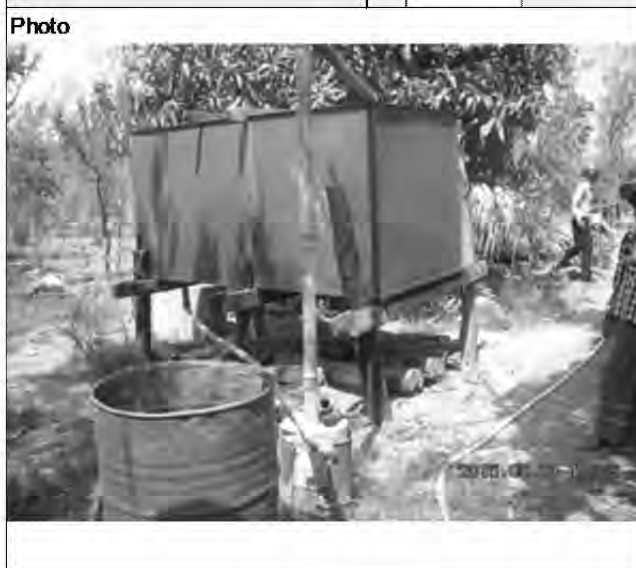
Information of Existing Water Source - 2				
Type	o Deep Well	Coordinate	X	742829
	Shallow Well		Y	2472777
	Storage reservoir			
	Others			
Hydrogeological Information	Drilled Depth (m)	102	Sample ID	SA2-9-2
	Diameter (in)	2	Temperature (°C)	31.8
	S.W.L (m)		pH	7.83
	D.W.L (m)		EC (µs/cm)	648
	Yield (m ³ /hour)	4.5	Smell	Non
	No.of users (person/day)		Color	Non
	Supply facilities	Air lift	Mn (mg/l)	<0.02
	Remarks (Lithology , etc.)		Fe (mg/l)	<0.2
Target : 742840 / 2472680 Private Well (picture) Monastery well (96m)		F (mg/l)	0.2	
		NO3- (mg/l)	1.0	
		NO2- (mg/l)	<0.02	
		Coliforms

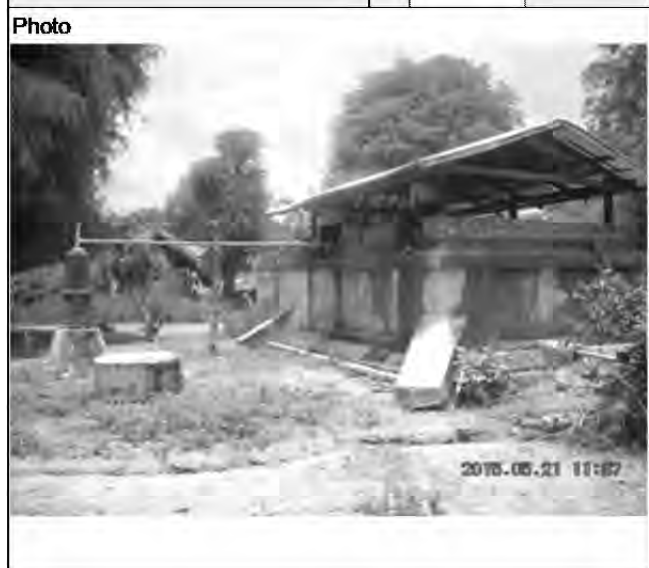
Information of Existing Water Source - 1				
Type	o Deep Well	Coordinate	X	747982
	Shallow Well		Y	2482474
	Storage reservoir			
	Others			
Hydrogeological Information	Drilled Depth (m)	224	Sample ID	SA2-10-1
	Diameter (in)	2	Temperature (°C)	31.3
	S.W.L (m)	+3m	pH	7.05
	D.W.L (m)		EC (µs/cm)	861.0
	Yield (m ³ /hour)	350g/h	Smell	Non
	No.of users (person/day)		Color	Non
	Supply facilities	Artesian	Mn (mg/l)	<0.02
	Remarks (Lithology , etc.)		Results of Simplified Water Quality Test	
Water supplied to 100HH from this surface tank. 2 public well - 224m 2 private well - 91m (2015 constructed)s		Fe (mg/l)	<0.2	
		F (mg/l)	0.0	
		NO3- (mg/l)	<1	
		NO2- (mg/l)	<0.02	
		Coliforms

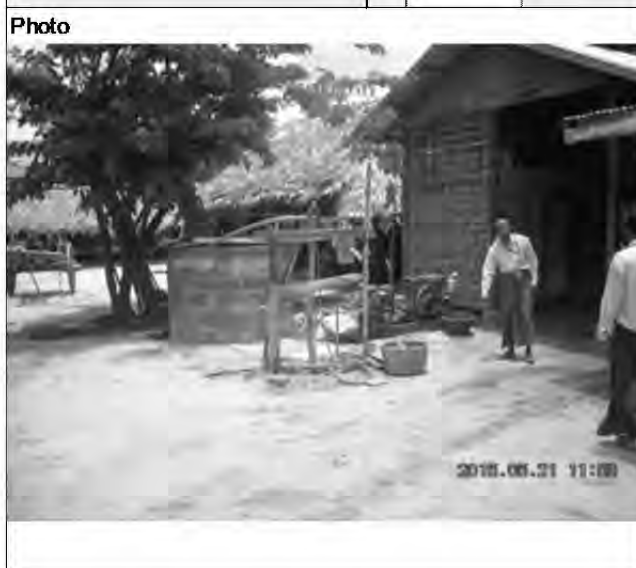
Information of Existing Water Source - 2				
Type	o Deep Well	Coordinate	X	748057
	Shallow Well		Y	2482660
	Storage reservoir			
	Others			
Hydrogeological Information	Drilled Depth (m)	91	Sample ID	SA2-10-2
	Diameter (in)	2	Temperature (°C)	29.9
	S.W.L (m)	21	pH	8.13
	D.W.L (m)		EC (µs/cm)	1014.0
	Yield (m ³ /hour)	1200g/h	Smell	Non
	No.of users (person/day)		Color	Non
	Supply facilities	Air lift	Mn (mg/l)	<0.02
	Remarks (Lithology , etc.)		Results of Simplified Water Quality Test	
Target : 747838 / 2482552 0-61 m Fine sand 61m ~ Brown fine sand.		Fe (mg/l)	<0.2	
		F (mg/l)	0.2	
		NO3- (mg/l)	5.0	
		NO2- (mg/l)	<0.02	
		Coliforms

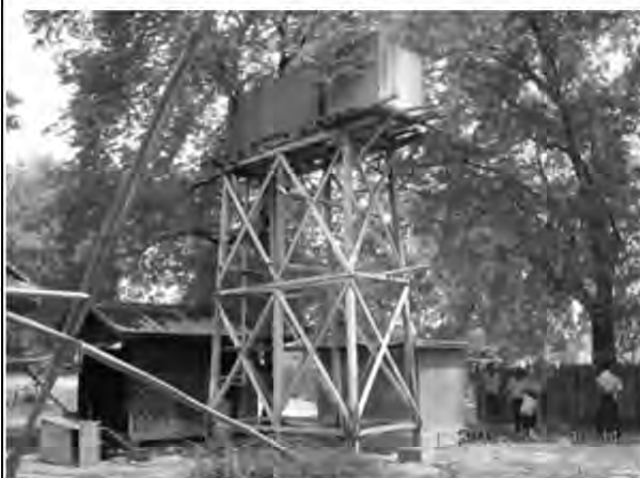
Photo

Information of Existing Water Source - 1					Information of Existing Water Source - 2						
Type	○ Deep Well		Coordinate	X	748212	Type	○ Deep Well		Coordinate	X	748297
	Shallow Well			Y	2458178		Shallow Well			Y	2458027
	Storage reservoir						Storage reservoir				
	Others						Others				
Hydrogeological Information	Drilled Depth (m)	244	Results of Simplified Water Quality Test	Sample ID	SA2-11-1	Hydrogeological Information	Drilled Depth (m)	61	Results of Simplified Water Quality Test	Sample ID	SA2-11-2
	Diameter (in)	2		Temperature (°C)	30.6		Diameter (in)	2		Temperature (°C)	29.0
	S.W.L (m)	55		pH	7.64		S.W.L (m)	22		pH	7.67
	D.W.L (m)			EC (µs/cm)	920		D.W.L (m)			EC (µs/cm)	721
	Yield (m ³ /hour)	4.5		Smell	Non		Yield (m ³ /hour)	3.4		Smell	Non
	No.of users (person/day)			Color	Non		No.of users (person/day)			Color	Non
	Supply facilities	Air lift		Mn (mg/l)	<0.02		Supply facilities	Air lift		Mn (mg/l)	<0.02

Remarks (Lithology , etc.)			Fe (mg/l)	<0.2		Remarks (Lithology , etc.)			Fe (mg/l)	<0.2
Donated by NGA		F (mg/l)	0.0	Private well		F (mg/l)	0.0				
MONO pump TW(1980) had broken		NO3- (mg/l)	5.0	Target : 748283/2458130		NO3- (mg/l)	1.0				
		NO2- (mg/l)	<0.02			NO2- (mg/l)	<0.02				
		Coliforms				Coliforms

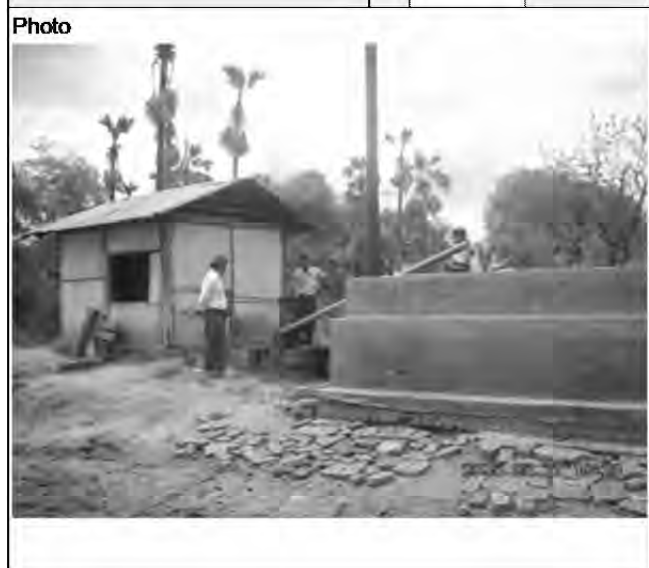
Information of Existing Water Source - 1				
Type	o Deep Well	Coordinate	X	751008
	Shallow Well		Y	2470107
	Storage reservoir			
	Others			
Hydrogeological Information	Drilled Depth (m)	97	Sample ID	SA2-12-1
	Diameter (in)	6	Temperature (°C)	30.5
	S.W.L (m)		pH	7.25
	D.W.L (m)		EC (µs/cm)	912
	Yield (m ³ /hour)	31.8	Smell	Non
	No.of users (person/day)		Color	Non
	Supply facilities	Mono Pump	Mn (mg/l)	<0.02
	Remarks (Lithology , etc.)		Results of Simplified Water Quality Test	
Irrawaddi formation. 1 Mono pump well 97m 3 Airlift Well -305m : public - 97m :Monastery -97m : Private		Fe (mg/l)	<0.2	
		F (mg/l)	0.0	
		NO3- (mg/l)	<1	
		NO2- (mg/l)	<0.02	
		Coliforms

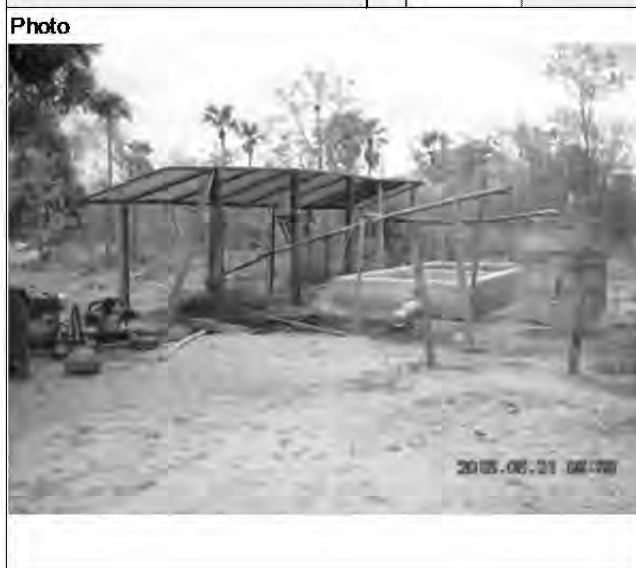
Information of Existing Water Source - 2				
Type	o Deep Well	Coordinate	X	750726
	Shallow Well		Y	2470091
	Storage reservoir			
	Others			
Hydrogeological Information	Drilled Depth (m)	305	Sample ID	SA2-12-2
	Diameter (in)	2	Temperature (°C)	30.9
	S.W.L (m)		pH	8.61
	D.W.L (m)		EC (µs/cm)	1,155
	Yield (m ³ /hour)		Smell	Non
	No.of users (person/day)		Color	Non
	Supply facilities	Air lift	Mn (mg/l)	<0.02
	Remarks (Lithology , etc.)		Results of Simplified Water Quality Test	
Constructed in 2003. They hoped to get artesian well, however couldn't reach. Target : 750823 / 2470044		Fe (mg/l)	<0.2	
		F (mg/l)	1.0	
		NO3- (mg/l)	<1	
		NO2- (mg/l)	<0.02	
		Coliforms

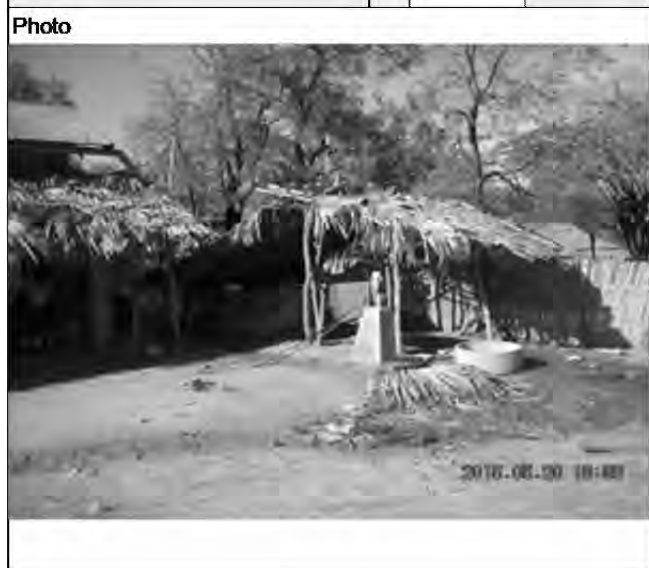
Information of Existing Water Source - 1				
Type	<input type="radio"/> Deep Well	Coordinate	X	766191
	<input type="radio"/> Shallow Well		Y	2449689
	<input type="radio"/> Storage reservoir			
	<input type="radio"/> Others			
Hydrogeological Information	Drilled Depth (m)	182	Sample ID	SA2-13-1
	Diameter (in)	2	Temperature (°C)	31.7
	S.W.L (m)		pH	7.92
	D.W.L (m)		EC (µs/cm)	4,470
	Yield (m ³ /hour)	5.5	Smell	Non
	No.of users (person/day)		Color	Non
	Supply facilities	Air lift	Mn (mg/l)	<0.02
	Remarks (Lithology , etc.)		Fe (mg/l)	<0.2
Q2 area. 107m TW (PDA)Cannot drink 60m-182m Private TW (total 28TWs) Shallow well's water quality is better than deep one.		F (mg/l)	0.8	
		NO3- (mg/l)	<1	
		NO2- (mg/l)	<0.02	
		Coliforms		
		Results of Simplified Water Quality Test

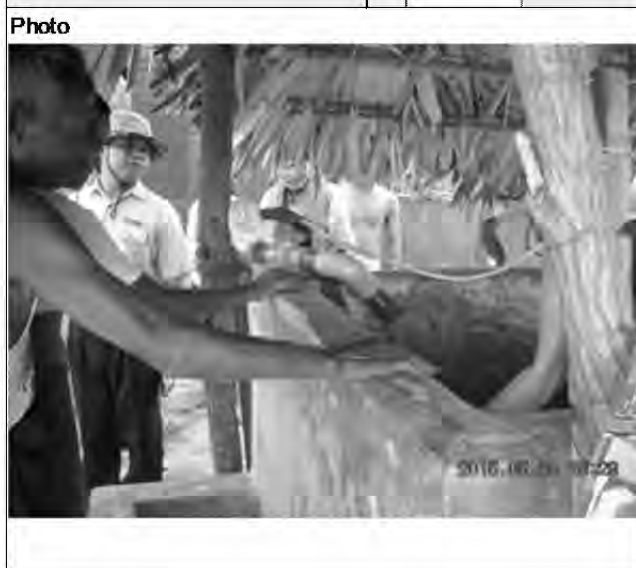
Information of Existing Water Source - 2				
Type	<input type="radio"/> Deep Well	Coordinate	X	766062
	<input type="radio"/> Shallow Well		Y	2449698
	<input type="radio"/> Storage reservoir			
	<input type="radio"/> Others			
Hydrogeological Information	Drilled Depth (m)	61	Sample ID	SA2-13-2
	Diameter (in)	2	Temperature (°C)	31.7
	S.W.L (m)		pH	8.48
	D.W.L (m)		EC (µs/cm)	1,253
	Yield (m ³ /hour)	2.7	Smell	Non
	No.of users (person/day)		Color	Non
	Supply facilities	Air lift	Mn (mg/l)	<0.02
	Remarks (Lithology , etc.)		Fe (mg/l)	<0.2
Private Well Target- 766166/2449638		F (mg/l)	0.6	
		NO3- (mg/l)	2.0	
		NO2- (mg/l)	<0.02	
		Coliforms		
		Results of Simplified Water Quality Test

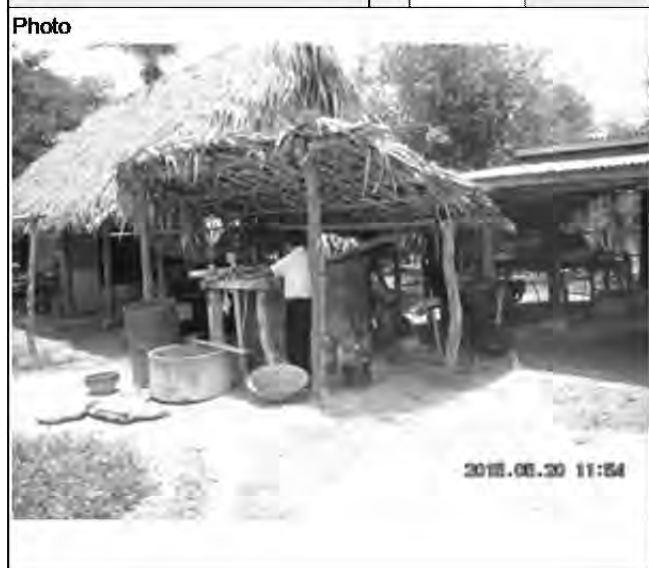
Information of Existing Water Source - 1				
Type	o Deep Well	Coordinate	X	751681
	Shallow Well		Y	2457462
	Storage reservoir			
	Others			
Hydrogeological Information	Drilled Depth (m)	115	Sample ID	SA2-14-1
	Diameter (in)	2	Temperature (°C)	29.6
	S.W.L (m)		pH	7.50
	D.W.L (m)		EC (µs/cm)	731
	Yield (m ³ /hour)	>4.5	Smell	Non
	No.of users (person/day)		Color	Non
	Supply facilities	Air lift	Mn (mg/l)	<0.02
	Remarks (Lithology , etc.)		Results of Simplified Water Quality Test	
Irrawaddi formation. Mostly sandy soil. Private 6 TW (107-137m) Shallow 28 well (All private)		Fe (mg/l)	<0.2	
		F (mg/l)	0.0	
		NO3- (mg/l)	<1	
		NO2- (mg/l)	<0.02	
		Coliforms

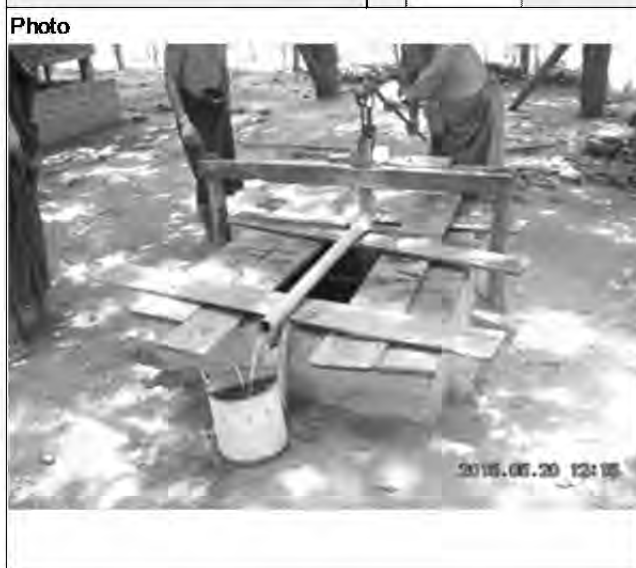
Information of Existing Water Source - 2				
Type	Deep Well	Coordinate	X	751521
	o Shallow Well		Y	2457542
	Storage reservoir			
	Others			
Hydrogeological Information	Drilled Depth (m)	30	Sample ID	SA2-14-2
	Diameter (in)		Temperature (°C)	28.7
	S.W.L (m)	7.6m<	pH	7.04
	D.W.L (m)		EC (µs/cm)	954
	Yield (m ³ /hour)		Smell	Non
	No.of users (person/day)		Color	Non
	Supply facilities	Suction pump	Mn (mg/l)	<0.02
	Remarks (Lithology , etc.)		Results of Simplified Water Quality Test	
Coner of the school area Target : 751516/ 2457534		Fe (mg/l)	<0.2	
		F (mg/l)	0.2	
		NO3- (mg/l)	5.0	
		NO2- (mg/l)	<0.02	
		Coliforms	Too much

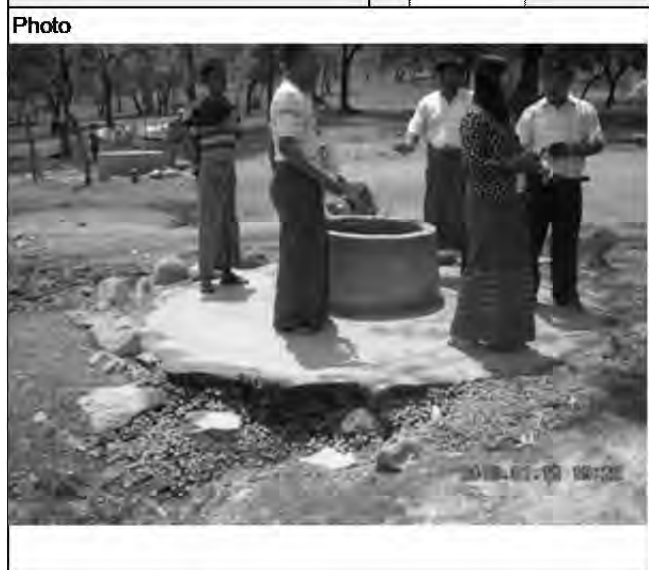
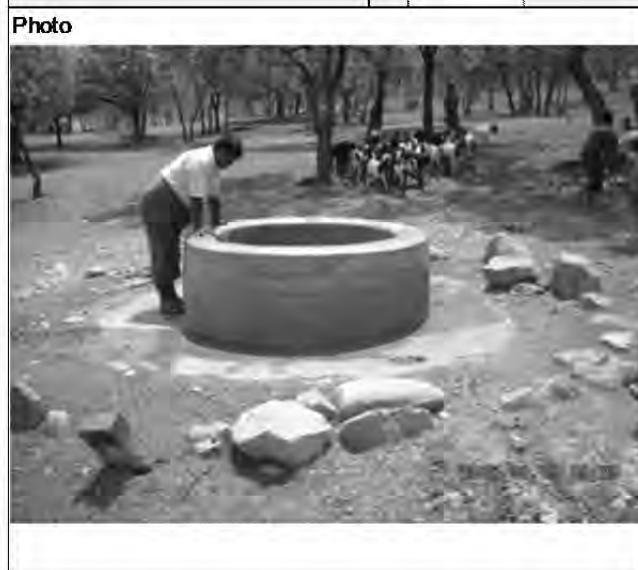
Information of Existing Water Source - 1						
Type	Deep Well	Coordinate	X	9506514		
	Shallow Well		Y	2194759		
	Storage reservoir					
	○ Others(Dug well)					
Hydrogeological Information	Drilled Depth (m)	3	Sample ID	SA2-16-1		
	Diameter (in)	0.8	Temperature (°C)	32.0		
	S.W.L (m)	2.3	pH	7.35		
	D.W.L (m)		EC (µs/cm)	935		
	Yield (m ³ /hour)		Smell	Non		
	No.of users (person/day)		Color	Non		
	Supply facilities		Mn (mg/l)	<0.02		
	Remarks (Lithology , etc.)	Results of Simplified Water Quality Test		Fe (mg/l)	<0.2	
In the morning, water level is back to the ground level.	F (mg/l)			1.5		
	NO3- (mg/l)			30.0		
	NO2- (mg/l)			<0.07		
	Coliforms

Information of Existing Water Source - 2						
Type	Deep Well	Coordinate	X	9506526		
	Shallow Well		Y	2194751		
	Storage reservoir					
	○ Others(Dug well)					
Hydrogeological Information	Drilled Depth (m)	3.8	Sample ID			
	Diameter (in)	1.45	Temperature (°C)			
	S.W.L (m)	3.8	pH			
	D.W.L (m)	0.6	EC (µs/cm)			
	Yield (m ³ /hour)		Smell			
	No.of users (person/day)		Color			
	Supply facilities		Mn (mg/l)			
	Remarks (Lithology , etc.)	Results of Simplified Water Quality Test		Fe (mg/l)		
	F (mg/l)					
	NO3- (mg/l)					
	NO2- (mg/l)					
	Coliforms

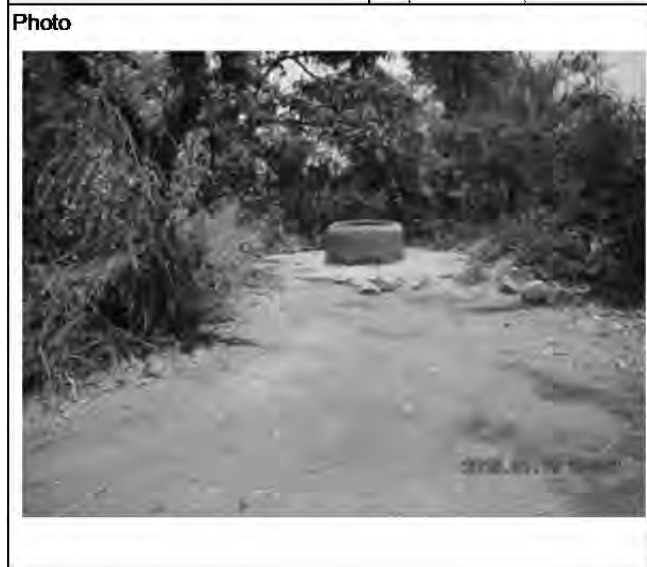
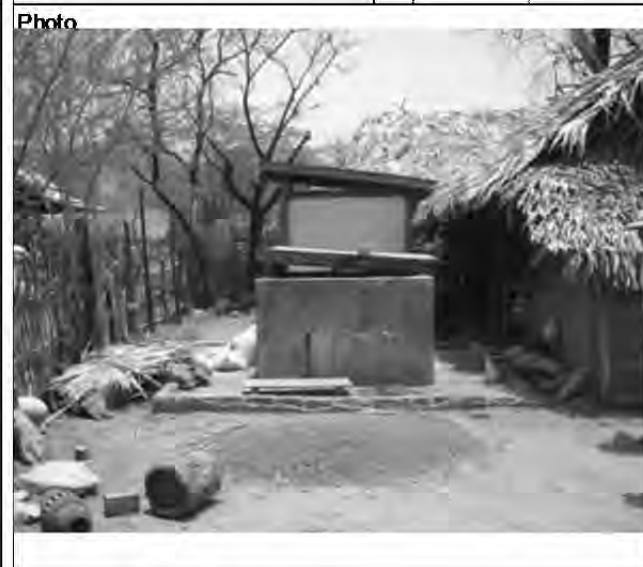
Information of Existing Water Source - 3						
Type	Deep Well	Coordinate	X	712670		
	Shallow Well		Y	2428751		
	Storage reservoir					
	Others					
Hydrogeological Information	Drilled Depth (m)	8	Sample ID	SA2-16-2		
	Diameter (in)	1.1	Temperature (°C)	31.6		
	S.W.L (m)	5.9	pH	7.56		
	D.W.L (m)		EC (µs/cm)	1,337		
	Yield (m ³ /hour)		Smell			
	No. of users (person/day)		Color			
	Supply facilities		Mn (mg/l)	<0.02		
			Fe (mg/l)	0.2		
Remarks (Lithology, etc.) - 2" riser pipe, Air lift. Small water. - High salinity. Can not drink.			F (mg/l)	1.5		
			NO3- (mg/l)	3.0		
			NO2- (mg/l)	<0.02		
			Coliforms	0		
			Results of Simplified Water Quality Test

Information of Existing Water Source -						
Type	Deep Well	Coordinate	X	9505791		
	Shallow Well		Y	2105791		
	Storage reservoir					
	Others					
Hydrogeological Information	Drilled Depth (m)	121	Sample ID	SA2-16-3		
	Diameter (in)	2	Temperature (°C)	32.2		
	S.W.L (m)		pH	7.42		
	D.W.L (m)		EC (µs/cm)	4,830		
	Yield (m ³ /hour)		Smell	No		
	No. of users (person/day)		Color	No		
	Supply facilities		Mn (mg/l)	<0.02		
			Fe (mg/l)	1.5		
Remarks (Lithology, etc.) 2"riser pipe, Air lift. Small water. High salinity. Can not drink.			F (mg/l)	<0.2		
			NO3- (mg/l)	1.0		
			NO2- (mg/l)	<0.02		
			Coliforms			
			Results of Simplified Water Quality Test

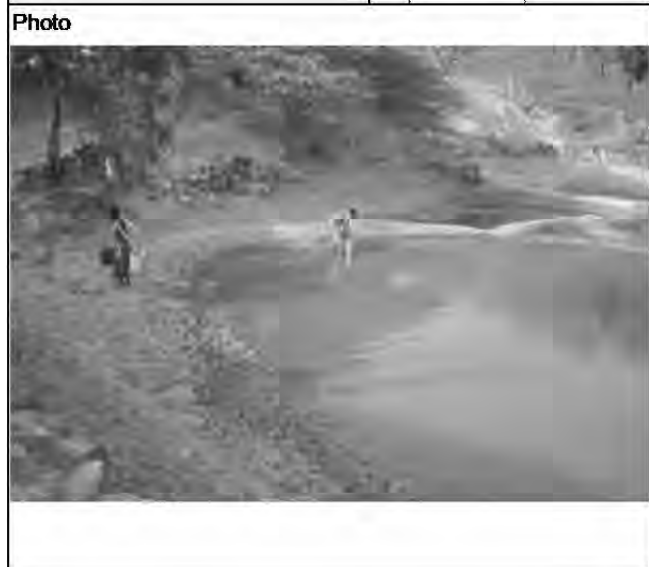
Information of Existing Water Source - 1								
Type	Deep Well	Coordinate	X	711613				
	Shallow Well		Y	2437746				
	○ Storage reservoir							
	Others							
Hydrogeological Information	Drilled Depth (m)	91	Sample ID	SA2-17-1				
	Diameter (in)	4	Temperature (°C)	33.9				
	S.W.L (m)	19	pH	8.82				
	D.W.L (m)		EC (µs/cm)	640				
	Yield (m ³ /hour)	4.5	Smell	Non				
	No.of users (person/day)	305	Color	Shallow Yellow				
	Supply facilities		Mn (mg/l)	<0.02				
	Remarks (Lithology , etc.)	Results of Simplified Water Quality Test						
Pond is only one source of water. Lower Peg formation. Edge of pond crop up sand and silt stone alternation. Hardly weathered.								
	Fe (mg/l)						<0.2	
	F (mg/l)						1.5	
	NO3-(mg/l)						2.0	
	NO2-(mg/l)						0.1	
	Coliforms	2

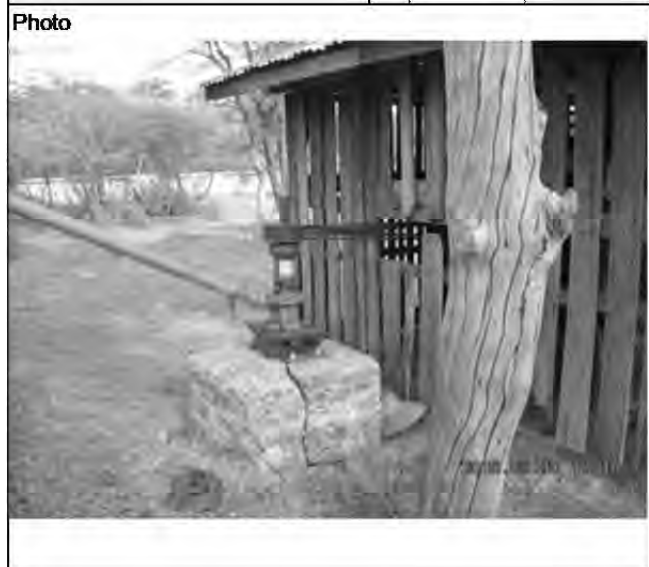
Information of Existing Water Source - 2						
Type	Deep Well	Coordinate	X	749919		
	Shallow Well		Y	2422594		
	Storage reservoir					
	Others					
Hydrogeological Information	Drilled Depth (m)	167	Sample ID	SA2-18-2		
	Diameter (in)	4	Temperature (°C)	32.2		
	S.W.L (m)	36	pH	8.24		
	D.W.L (m)		EC (µs/cm)	3,600		
	Yield (m ³ /hour)		Smell	Non		
	No. of users (person/day)		Color	Non		
	Supply facilities	Air lift		Mn (mg/l)	<0.02	
	Remarks (Lithology, etc.) Target : 749957/2422670			Fe (mg/l)	<0.2	
F (mg/l)				1.5		
NO3- (mg/l)				<1		
NO2- (mg/l)				<0.02		
Coliforms						
Results of Simplified Water Quality Test

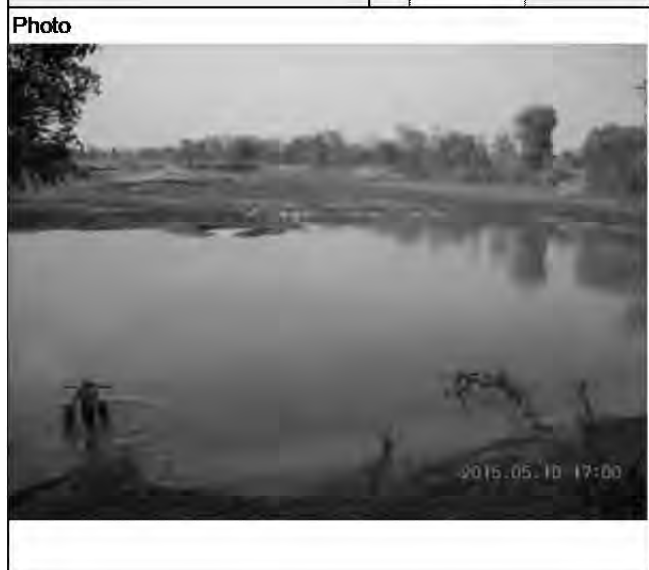
Information of Existing Water Source - 2						
Type	Deep Well	Coordinate	X	750132		
	○ Shallow Well		Y	2421633		
	Storage reservoir					
	Others					
Hydrogeological Information	Drilled Depth (m)	Results of Simplified Water Quality Test	Sample ID	SA2-18-4		
	Diameter (in)		Temperature (°C)	31.3		
	S.W.L (m)		pH	7.98		
	D.W.L (m)		EC (µs/cm)	2190		
	Yield (m ³ /hour)		Smell	Non		
	No.of users (person/day)		Color	Non		
	Supply facilities		Mn (mg/l)	<0.02		
	Remarks (Lithology , etc.)		Fe (mg/l)	<0.2		
	F (mg/l)	0.8				
	NO3- (mg/l)	5.0				
	NO2- (mg/l)	0.05				
Coliforms

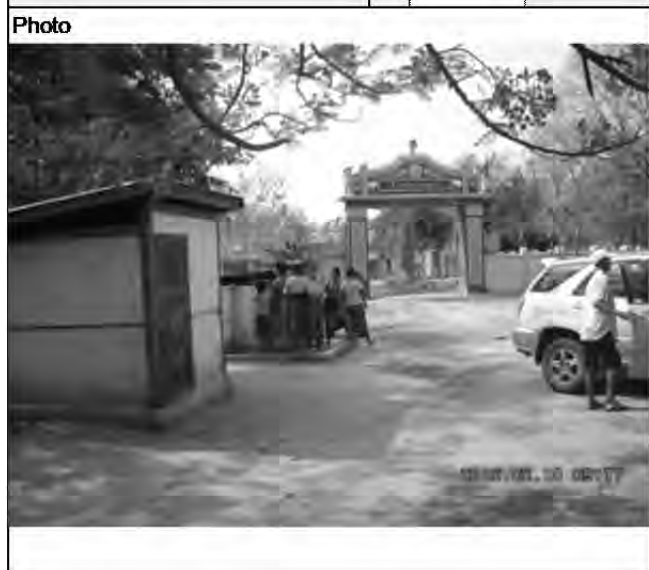
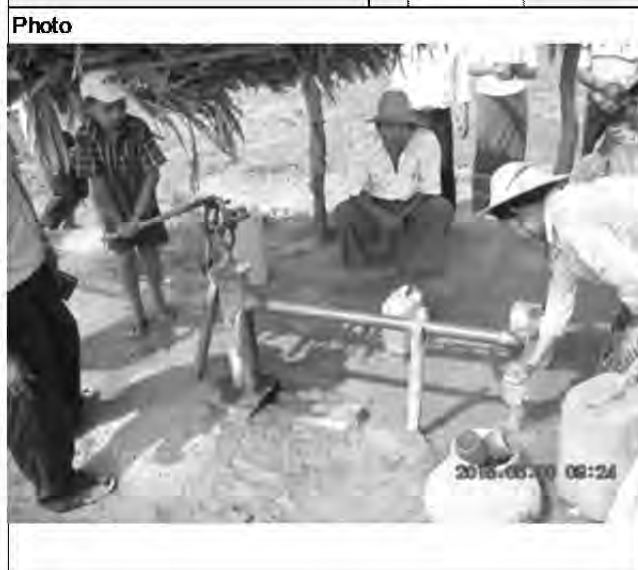
Information of Existing Water Source - 1				
Type	○ Deep Well	Coordinate	X	758105
	Shallow Well		Y	2439332
	Storage reservoir			
	Others			
Hydrogeological Information	Drilled Depth (m)	152	Sample ID	SA2-19-1
	Diameter (in)	2	Temperature (°C)	30.9
	S.W.L (m)	115	pH	8.2
	D.W.L (m)		EC (µs/cm)	1,050
	Yield (m ³ /hour)	2.0	Smell	Non
	No.of users (person/day)	580	Color	Non
	Supply facilities	Air lift	Mn (mg/l)	<0.02
	Remarks (Lithology , etc.)		Fe (mg/l)	<0.2
Alluvial plane Target place is X=758109, Y=2439343 0.47m : Clay sand 49-55m : Sticky clay (yellow) 55-61m : Clay sand 61-152m : Blue sand -Irawadi formation 67-69, 98-101 : Hard rock		F (mg/l)	1.5	
		NO3- (mg/l)	1.0	
		NO2- (mg/l)	0.02	
		Coliforms		
		Results of Simplified Water Quality Test

Information of Existing Water Source - 2				
Type	Deep Well	Coordinate	X	757753
	○ Shallow Well		Y	2489582
	Storage reservoir			
	Others			
Hydrogeological Information	Drilled Depth (m)	7	Sample ID	SA2-19-2
	Diameter (in)		Temperature (°C)	29.7
	S.W.L (m)	3	pH	7.35
	D.W.L (m)		EC (µs/cm)	1,178
	Yield (m ³ /hour)		Smell	Non
	No.of users (person/day)		Color	Non
	Supply facilities	Handpump	Mn (mg/l)	<0.02
	Remarks (Lithology , etc.)		Fe (mg/l)	<0.2
		F (mg/l)	0.6	
		NO3- (mg/l)	20.0	
		NO2- (mg/l)	<0.02	
		Coliforms		
		Results of Simplified Water Quality Test

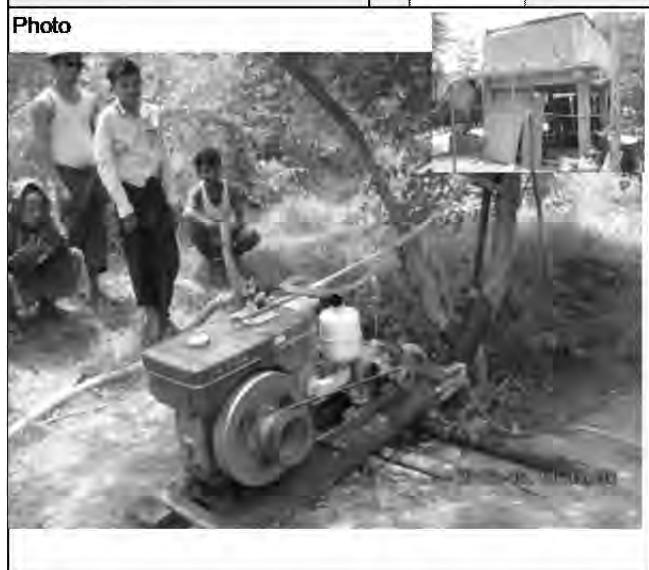
Information of Existing Water Source - 2						
Type	Deep Well	Coordinate	X	773839		
	○ Shallow Well		Y	2437211		
	Storage reservoir					
	Others					
Hydrogeological Information	Drilled Depth (m)	24	Sample ID	SA2-20-2		
	Diameter (in)		Temperature (°C)	30.4		
	S.W.L (m)	10	pH	6.86		
	D.W.L (m)		EC (µs/cm)	3,800		
	Yield (m ³ /hour)		Smell	Non		
	No.of users (person/day)		Color	Non		
	Supply facilities	Hand Pump	Mn (mg/l)	<0.02		
	Remarks (Lithology , etc.)	Results of Simplified Water Quality Test				
More than 100 household have like this shallow well. However every shallow well can not use for drinking cause of salty water.						
	Fe (mg/l)					<0.2
	F (mg/l)					0.0
	NO3- (mg/l)					45<
	NO2- (mg/l)					0.1
	Coliforms

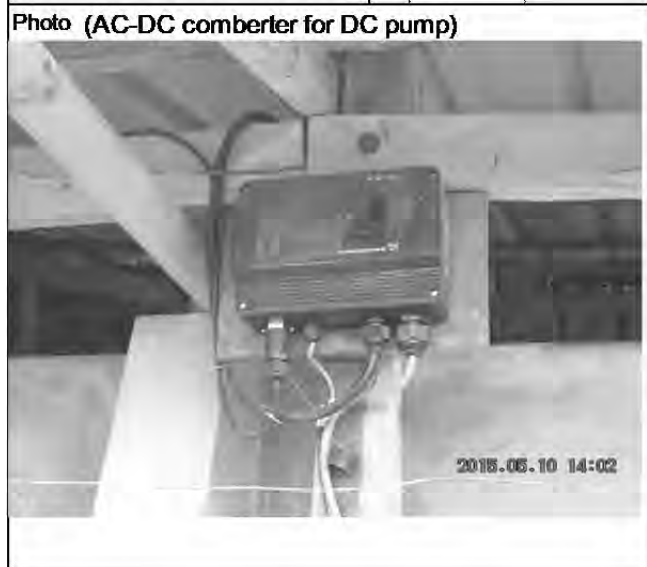
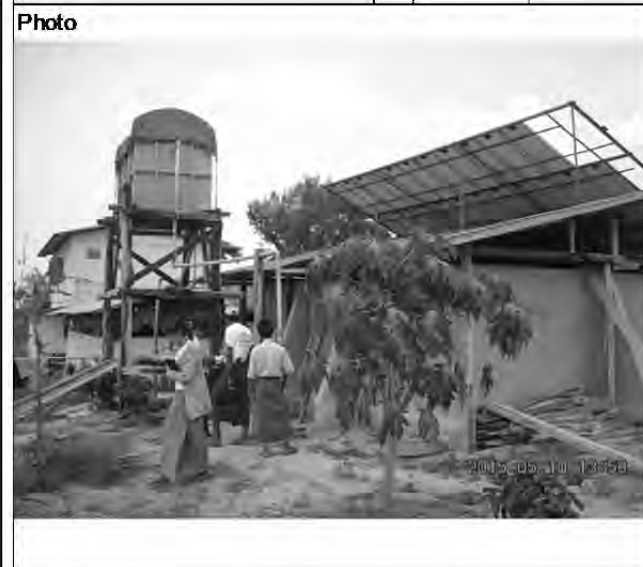
Information of Existing Water Source - 1				
Type	o Deep Well	Coordinate	X	745604
	Shallow Well		Y	2447822
	Storage reservoir			
	Others			
Hydrogeological Information	Drilled Depth (m)	167	Sample ID	SA2-21-1
	Diameter (in)	4	Temperature (°C)	
	S.W.L (m)	36	pH	
	D.W.L (m)		EC (µs/cm)	
	Yield (m ³ /hour)		Smell	
	No.of users (person/day)		Color	
	Supply facilities	Submergible	Mn (mg/l)	
	Remarks (Lithology , etc.)		Results of Simplified Water Quality Test	
Water supply system 2 wells - SA2-21-1 and 2 used for the system. (Solar+Generator, Hiblid and Grundfos DC pump) 800m ³ / month suppling. 300 kyats/m ³ .		Fe (mg/l)		
		F (mg/l)		
		NO3- (mg/l)		
		NO2- (mg/l)		
		Coliforms

Information of Existing Water Source - 2				
Type	o Deep Well	Coordinate	X	745617
	Shallow Well		Y	2447824
	Storage reservoir			
	Others			
Hydrogeological Information	Drilled Depth (m)	167	Sample ID	SA2-21-2
	Diameter (in)	4	Temperature (°C)	31.7
	S.W.L (m)	36	pH	7.39
	D.W.L (m)		EC (µs/cm)	2,310
	Yield (m ³ /hour)		Smell	Non
	No.of users (person/day)		Color	Non
	Supply facilities	Submergible pump	Mn (mg/l)	<0.02
	Remarks (Lithology , etc.)		Results of Simplified Water Quality Test	
AC pump Target : 745592/ 2447		Fe (mg/l)	<0.2	
		F (mg/l)	0.6	
		NO3- (mg/l)	<1	
		NO2- (mg/l)	<0.02	
		Coliforms

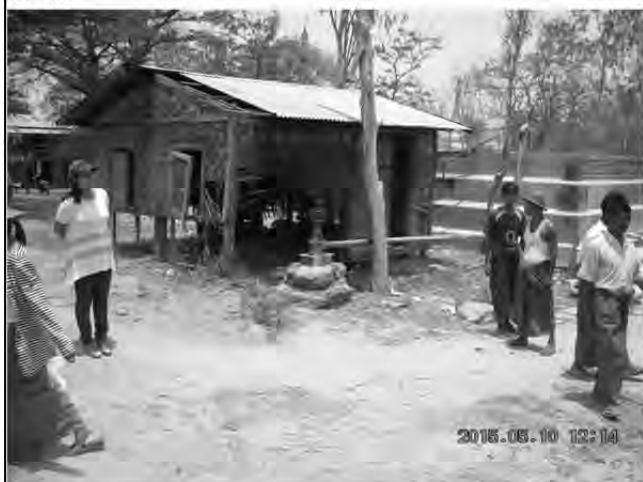
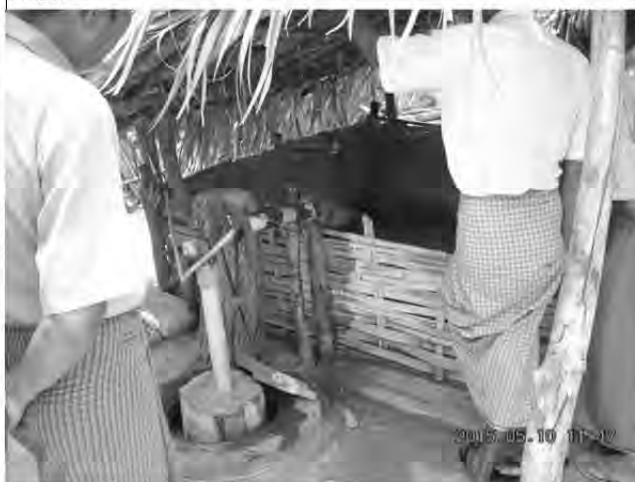
Photo

Information of Existing Water Source - 1				Information of Existing Water Source - 2							
Type	<input type="radio"/> Deep Well	Coordinate	X	747989	Type	<input type="radio"/> Deep Well	Coordinate	X	747929		
	<input type="radio"/> Shallow Well		Y	2446283		<input type="radio"/> Shallow Well		Y	2446231		
	<input type="radio"/> Storage reservoir					<input type="radio"/> Storage reservoir					
	<input type="radio"/> Others					<input type="radio"/> Others					
Hydrogeological Information	Drilled Depth (m)	161	Results of Simplified Water Quality Test	Sample ID	SA2-22-1	Hydrogeological Information	Drilled Depth (m)	152	Results of Simplified Water Quality Test	Sample ID	SA2-22-2
	Diameter (in)	2		Temperature (°C)			Diameter (in)	2		Temperature (°C)	32.6
	S.W.L (m)	55		pH			S.W.L (m)	55		pH	8.02
	D.W.L (m)			EC (µs/cm)			D.W.L (m)			EC (µs/cm)	1,663
	Yield (m³/hour)	13.6		Smell			Yield (m³/hour)	3.4		Smell	Non

No.of users (person/day)			Color			No.of users (person/day)			Color	Non
	Supply facilities	Mono		Mn (mg/l)			Supply facilities	Handpump		Mn (mg/l)	<0.02
	Remarks (Lithology , etc.)	Constructed in 1986. Pump trable. Can not operate.		Fe (mg/l)			Remarks (Lithology , etc.)	0-30 sand and clay 30-90 mad 90 ~ Hard stone		Fe (mg/l)	<0.2
			F (mg/l)				F (mg/l)	0.2			
			NO3- (mg/l)				NO3- (mg/l)	5.0			
			NO2- (mg/l)				NO2- (mg/l)	<0.02			
			Coliforms				Coliforms
