Appendix 5.3.1 Result of Field Water Quality Measurement

Result of Field Water Quality Measurement (Sagaing Region-1)

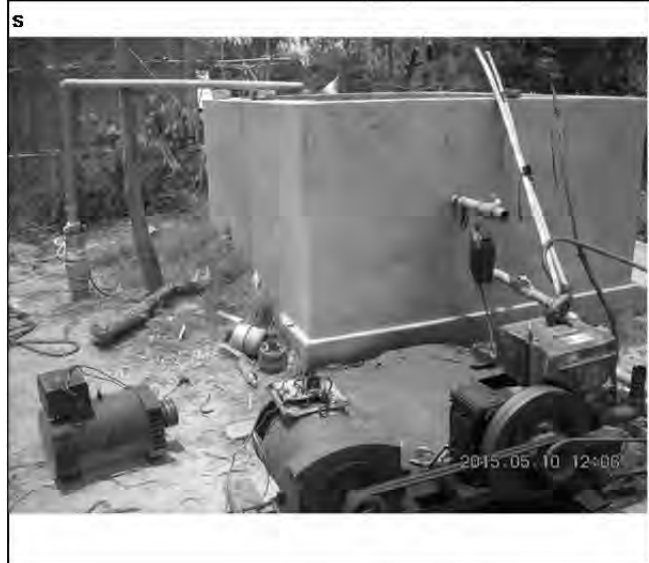
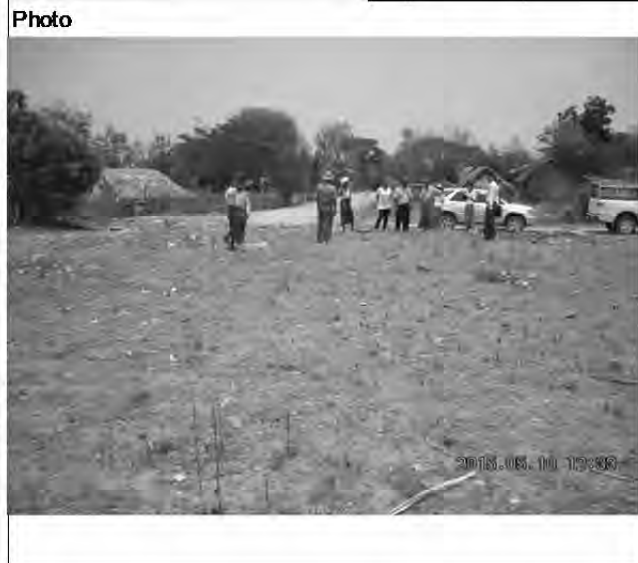
Information of Existing Water Source - 1					
Type	o Deep Well		Coordinate	X	747853
	Shallow Well			Y	2446360
	Storage reservoir				
	Others				
Hydrogeological Information	Drilled Depth (m)	113	Results of Simplified Water Quality Test	Sample ID	SA2-22-3
	Diameter (in)	4		Temperature (°C)	32.1
	S.W.L (m)			pH	7.26
	D.W.L (m)			EC (µs/cm)	1,582
	Yield (m³/hour)	9.1		Smell	Non
	No.of users (person/day)			Color	Non
	Supply facilities	Submergible		Mn (mg/l)	<0.02
	Remarks (Lithology , etc.)	Pump installed in 48m. Static Water Level is estimated around 30m.		Fe (mg/l)	<0.2
			F (mg/l)	0.2	
			NO3- (mg/l)	10.0	
			NO2- (mg/l)	<0.02	
			Coliforms

Information of Existing Water Source - 2					
Type	Deep Well		Coordinate	X	747673
	Shallow Well			Y	2446221
	Storage reservoir				
	Others				
Hydrogeological Information	Drilled Depth (m)		Results of Simplified Water Quality Test	Sample ID	
	Diameter (in)			Temperature (°C)	
	S.W.L (m)			pH	
	D.W.L (m)			EC (µs/cm)	
	Yield (m³/hour)			Smell	
	No.of users (person/day)			Color	
	Supply facilities			Mn (mg/l)	
	Remarks (Lithology , etc.)	Target X=747673, Y=2446441		Fe (mg/l)	
			F (mg/l)		
			NO3- (mg/l)		
			NO2- (mg/l)		
			Coliforms

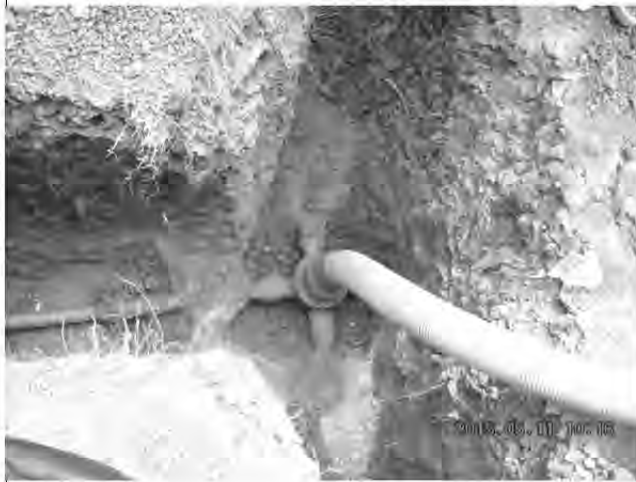
Fe (mg/l)	<0.2					Fe (mg/l)	<0.2
Remarks (Lithology , etc.) Q2 area. Many house have such as shallow well. However they can not use for drinking cause of high salinity.			F (mg/l)	0.8	Remarks (Lithology , etc.) 5 well convine system. 10 system are operating in this area. It is mainly use for agriculture. 0-6m : silty clay 6m : Sand private well for agriculture			F (mg/l)	0.4		
			NO3- (mg/l)	20.0				NO3- (mg/l)	1.5		
			NO2- (mg/l)	0.2				NO2- (mg/l)	0.1		
			Coliforms					Coliforms			
Photo

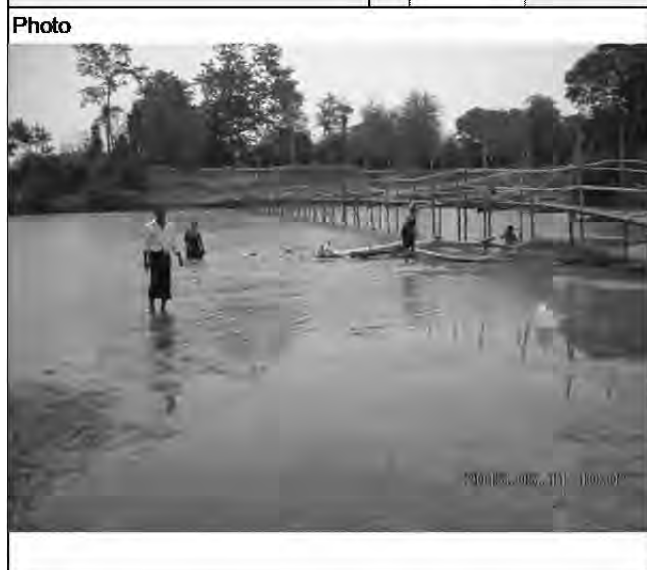
Region	SAGAING		Date	2015/5/11	
Township	Myinmu		Reported by	YORITATE Toru	
Village / ID	Magyidaw	SA2-23	Coordinate (WGS84 UTM)	X	774428
			Y	2444493

Information of Existing Water Source - 1						
Type	Deep Well	Coordinate	X	774727		
	Shallow Well		Y	2444435		
	Storage reservoir					
	○ Others (River)					
Hydrogeological Information	Drilled Depth (m)	Results of Simplified Water Quality Test	Sample ID	SA2-23-3		
	Diameter (in)		Temperature (°C)	32.1		
	S.W.L (m)		pH	8.66		
	D.W.L (m)		EC (µs/cm)	474		
	Yield (m³/hour)		Smell	Non		
	No.of users (person/day)		Color	Non		
	Supply facilities		Mn (mg/l)			
	Remarks (Lithology , etc.)		Fe (mg/l)	< 0.2		
Muu River water. Use it for drinking.	F (mg/l)	0.2				
	NO3- (mg/l)	<1				
	NO2- (mg/l)	<0.02				
	Coliforms

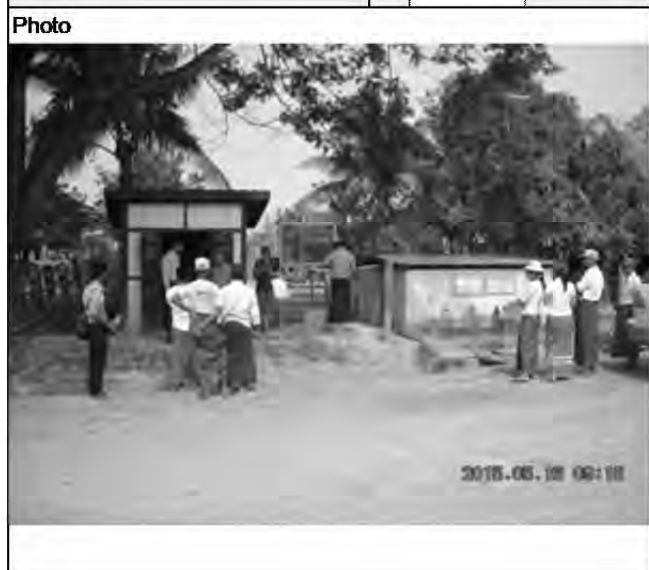
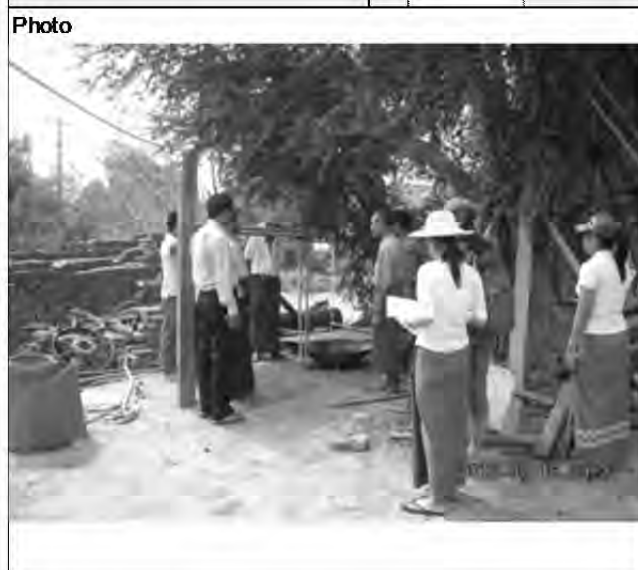
Region	SAGAING		Date	2015/5/16
Township	Kanbalu		Reported by	YORITATE Toru
Village / ID	Thindaw	SA2-24	Coordinate (WGS84 UTM)	X
			Y

Information of Existing Water Source - 1					
Type	<input type="radio"/> Deep Well	Coordinate	X	773446	
	<input type="radio"/> Shallow Well		Y	2612929	
	<input type="radio"/> Storage reservoir				
	<input type="radio"/> Others				
Hydrogeological Information	Drilled Depth (m)	82	Results of Simplified Water Quality Test	Sample ID	SA2-24-1
	Diameter (in)	2		Temperature (°C)	27.3
	S.W.L (m)			pH	7.84
	D.W.L (m)			EC (µs/cm)	1,053
	Yield (m³/hour)	3.2		Smell	Non
	No.of users (person/day)			Color	Non
	Supply facilities			Mn (mg/l)	<0.02
	Remarks (Lithology , etc.)	Constructed in 2005.		Fe (mg/l)	<0.2
			F (mg/l)	0.2	
			NO3-(mg/l)	<1	
			NO2-(mg/l)	<0.02	
			Coliforms

Information of Existing Water Source - 2					
Type	<input type="radio"/> Deep Well	Coordinate	X	773526	
	<input type="radio"/> Shallow Well		Y	2612915	
	<input type="radio"/> Storage reservoir				
	<input type="radio"/> Others				
Hydrogeological Information	Drilled Depth (m)	116	Results of Simplified Water Quality Test	Sample ID	SA2-24-2
	Diameter (in)	2		Temperature (°C)	27.1
	S.W.L (m)			pH	6.77
	D.W.L (m)			EC (µs/cm)	34,800
	Yield (m³/hour)			Smell	Salty smell
	No.of users (person/day)			Color	Non
	Supply facilities			Mn (mg/l)	0.02
	Remarks (Lithology , etc.)			Fe (mg/l)	<0.2
			F (mg/l)	0.2	
			NO3-(mg/l)	<1	
			NO2-(mg/l)	<0.02	
			Coliforms

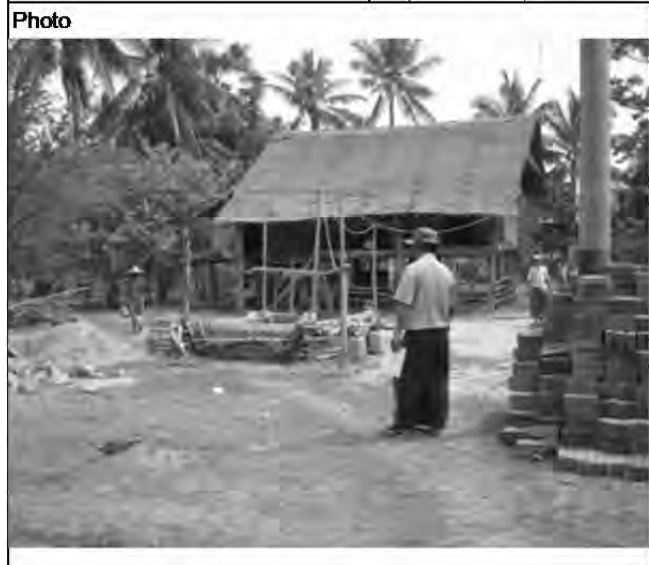
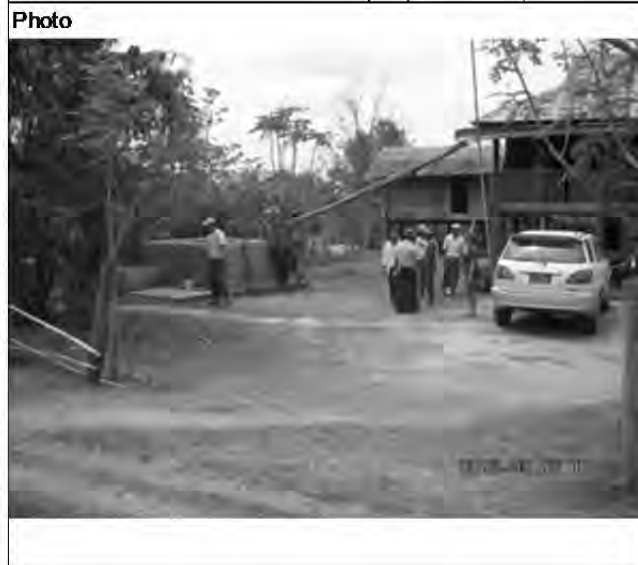
Region	SAGAING		Date	2015/5/16
Township	Kanbalu		Reported by	YORITATE Toru
Village / ID	Lwingyi	SA2-25	Coordinate (WGS84 UTM)	X
			Y

Information of Existing Water Source - 1					
Type	o Deep Well	Coordinate	X	772025	
	Shallow Well		Y	2612947	
	Storage reservoir				
	Others				
Hydrogeological Information	Drilled Depth (m)	152	Results of Simplified Water Quality Test	Sample ID	SA2-25-1
	Diameter (in)	2		Temperature (°C)	28.1
	S.W.L (m)	30		pH	8.08
	D.W.L (m)			EC (µs/cm)	665
	Yield (m³/hour)	2.3		Smell	Non
	No.of users (person/day)			Color	Non
	Supply facilities			Mn (mg/l)	<0.02
	Remarks (Lithology , etc.)	Botton of 12m in Screen. 7 Dug wells and 7 Shallow wells 6 Tube Wells(3 public and 3 private)		Fe (mg/l)	<0.2
			F (mg/l)	0.2	
			NO3-(mg/l)	<1	
			NO2-(mg/l)	<0.02	
			Coliforms	0

Information of Existing Water Source - 2					
Type	Deep Well	Coordinate	X	772013	
	Shallow Well		Y	2612839	
	Storage reservoir				
	Others				
Hydrogeological Information	Drilled Depth (m)		Results of Simplified Water Quality Test	Sample ID	SA2-25
	Diameter (in)			Temperature (°C)	
	S.W.L (m)			pH	
	D.W.L (m)			EC (µs/cm)	
	Yield (m³/hour)			Smell	
	No.of users (person/day)			Color	
	Supply facilities			Mn (mg/l)	
	Remarks (Lithology , etc.)	Target : 772013 / 2612839		Fe (mg/l)	
			F (mg/l)		
			NO3-(mg/l)		
			NO2-(mg/l)		
			Coliforms

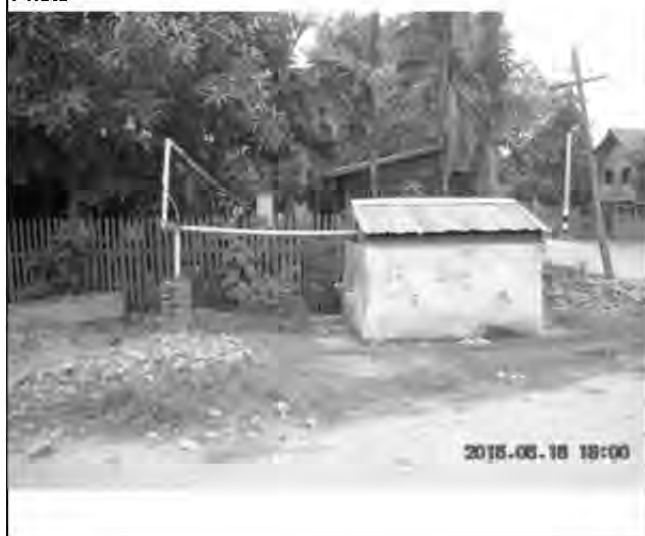
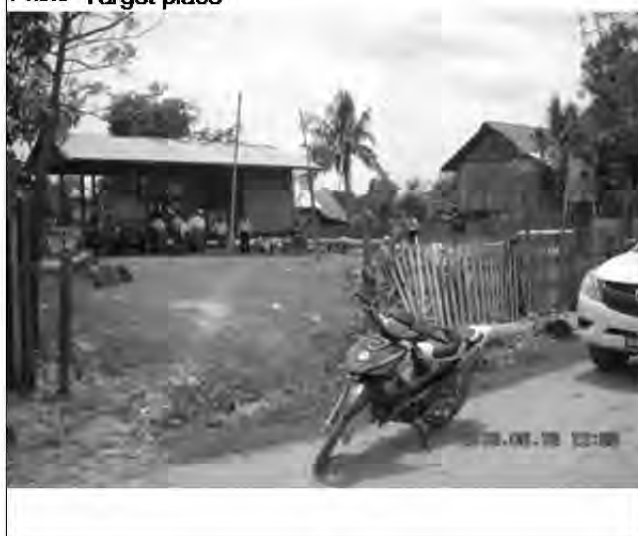
Region	SAGAING		Date	2015/5/16
Township	Kanbalu		Reported by	YORITATE Toru
Village / ID	Koetaungboh(Kyunkone)	SA2-26	Coordinate (WGS84 UTM)	X Y

Information of Existing Water Source - 1				Information of Existing Water Source - 2					
Type	o Deep Well		X	773469	Type	o Deep Well		X	773675
	Shallow Well		Y	2620861		Shallow Well		Y	2620875
	Storage reservoir					Storage reservoir			
	Others								
Hydrogeological Information	Drilled Depth (m)	152	Sample ID	SA2-26-1	Hydrogeological Information	Drilled Depth (m)	85	Sample ID	SA2-26-2
	Diameter (in)	2	Temperature (°C)	27.0		Diameter (in)	2	Temperature (°C)	27.1
	S.W.L (m)		pH	7.60		S.W.L (m)		pH	7.27
	D.W.L (m)		EC (µs/cm)	1,113		D.W.L (m)		EC (µs/cm)	1,450
	Yield (m ³ /hour)	1.8	Smell	Sulfer smell		Yield (m ³ /hour)	3.0	Smell	Non
	No.of users (person/day)		Color	Shallow yellow		No.of users (person/day)		Color	Non
	Supply facilities	Air lift	Mn (mg/l)	0.01		Supply facilities	Air lift	Mn (mg/l)	<0.02
	Remarks (Lithology , etc.)		Fe (mg/l)	<0.2		Remarks (Lithology , etc.)		Fe (mg/l)	<0.2
73 Shallow wells with rope 20 Tubewells(1 public, 19 private) They don't like tube well water. They use pond water for drinking. Bottom of 18m in screen.		F (mg/l)	0.2	Target 2 : 773590 / 2620729 Target 1 is low priority. Bottom of 10m in screen.		F (mg/l)	0.0

NO3- (mg/l)	<1			NO3- (mg/l)	45.0		
		NO2- (mg/l)	<0.02			NO2- (mg/l)	<0.02		
		Coliforms				Coliforms			
		Results of Simplified Water Quality Test	Results of Simplified Water Quality Test

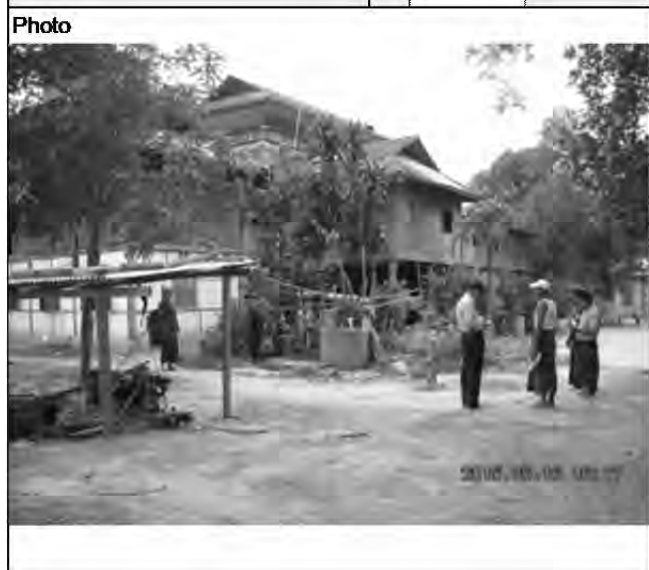
Information of Existing Water Source - 2				
Type	Deep Well	Coordinate	X	768370
	o Shallow Well		Y	2598171
	Storage reservoir			
	Others			
Hydrogeological Information	Drilled Depth (m)	21	Sample ID	SA2-27-2
	Diameter (in)	3	Temperature (°C)	28.6
	S.W.L (m)	17.8	pH	7.37
	D.W.L (m)		EC (µs/cm)	1,487
	Yield (m ³ /hour)		Smell	Non
	No.of users (person/day)		Color	Shallow white
	Supply facilities		Mn (mg/l)	<0.02
	Remarks (Lithology , etc.)	Results of Simplified Water Quality Test		Fe (mg/l)
Private well	F (mg/l)			3.0
Target : 768388 / 2598038 (Monestry)	NO3- (mg/l)			<1
	NO2- (mg/l)			<0.02
	Coliforms

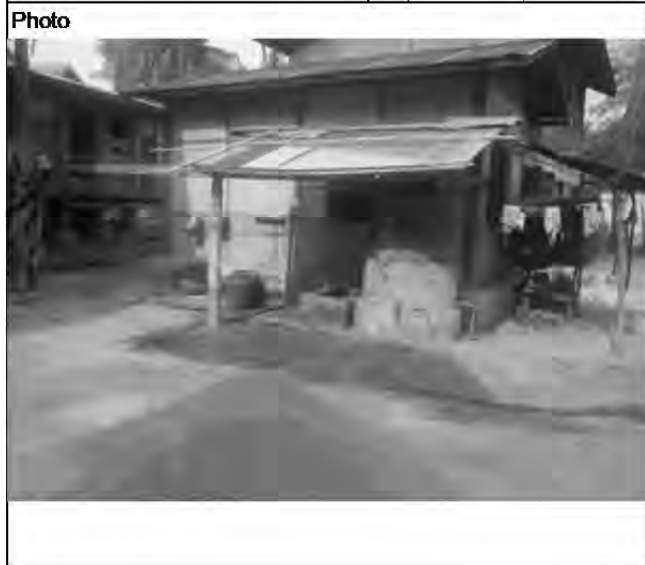
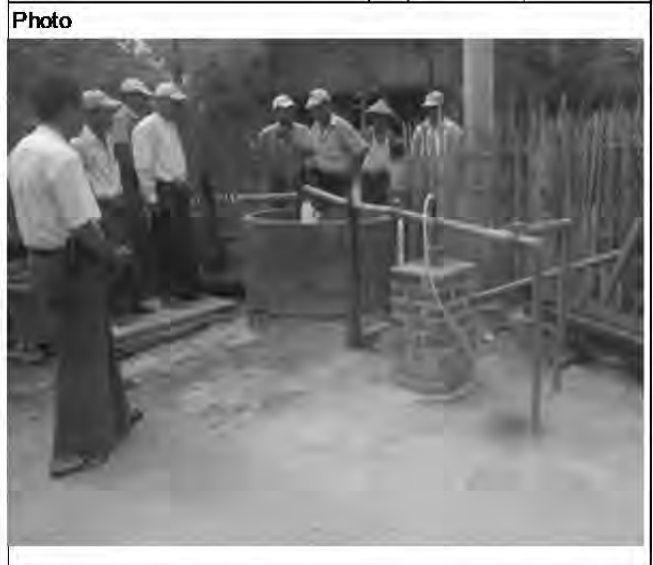
Region	SAGAING		Date	2015/5/15
Township	Kanbalu		Reported by	YORITATE Toru
Village / ID	Myayhtoo	SA2-28	Coordinate (WGS84 UTM)	X
			Y

Information of Existing Water Source - 1				
Type	<input type="radio"/> Deep Well	Coordinate	X	745074
	<input type="radio"/> Shallow Well		Y	2565109
	<input type="radio"/> Storage reservoir			
	<input type="radio"/> Others			
Hydrogeological Information	Drilled Depth (m)	82	Sample ID	SA2-28-1
	Diameter (in)	2	Temperature (°C)	29.0
	S.W.L (m)	67	pH	7.05
	D.W.L (m)		EC (µs/cm)	681
	Yield (m³/hour)		Smell	Slightly certain smell
	No.of users (person/day)		Color	Shallow yellow
	Supply facilities	Air lift	Mn (mg/l)	<0.02
	Remarks (Lithology , etc.) Operating by power, however target area does not have water. 17 Air lift TW (70m) Below 91 m can get good water.		Fe (mg/l)	0.2
F (mg/l)			0.0	
NO3- (mg/l)			<1	
NO2- (mg/l)			<0.02	
Coliforms

Information of Existing Water Source - 2				
Type	<input type="radio"/> Deep Well	Coordinate	X	745102
	<input type="radio"/> Shallow Well		Y	2565190
	<input type="radio"/> Storage reservoir			
	<input type="radio"/> Others			
Hydrogeological Information	Drilled Depth (m)	76	Sample ID	SA2-28-2
	Diameter (in)	2	Temperature (°C)	28.8
	S.W.L (m)	61	pH	7.19
	D.W.L (m)		EC (µs/cm)	858
	Yield (m³/hour)		Smell	Non
	No.of users (person/day)		Color	Shallow white
	Supply facilities	Air lift	Mn (mg/l)	<0.02
	Remarks (Lithology , etc.) Sands came up with water.		Fe (mg/l)	<0.2
F (mg/l)			0.0	
NO3- (mg/l)			<1	
NO2- (mg/l)			<0.02	
Coliforms

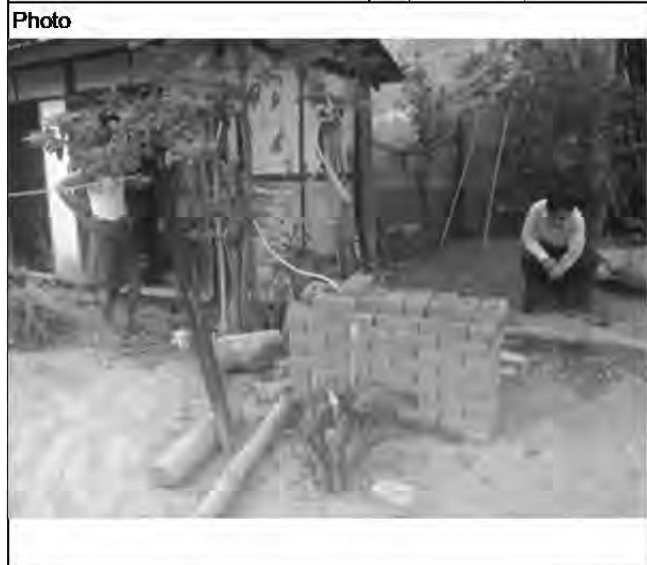
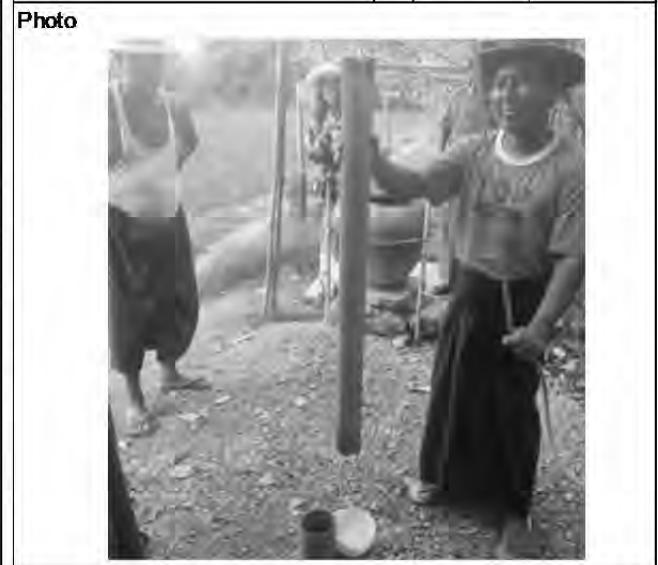
Region	SAGAING		Date	2015/5/15
Township	Kanbalu		Reported by	YORITATE Toru
Village / ID	Myayhtoo	SA2-28	Coordinate (WGS84 UTM)	X
			Y

Information of Existing Water Source - 1				
Type	o Deep Well	Coordinate	X	744822
	Shallow Well		Y	2565124
	Storage reservoir			
	Others			
Hydrogeological Information	Drilled Depth (m)	171	Sample ID	SA2-28-3
	Diameter (in)	2	Temperature (°C)	28.9
	S.W.L (m)	146.3	pH	7.24
	D.W.L (m)		EC (µs/cm)	981
	Yield (m ³ /hour)		Smell	Non
	No. of users (person/day)		Color	Shallow yellow
	Supply facilities	Air lift	Mn (mg/l)	<0.02
	Remarks (Lithology, etc.)		Results of Simplified Water Quality Test	
		Fe (mg/l)	<0.2	
		F (mg/l)	0.0	
		NO3- (mg/l)	1.0	
		NO2- (mg/l)	<0.02	
		Coliforms

Information of Existing Water Source - 2				
Type	o Deep Well	Coordinate	X	748784
	Shallow Well		Y	2565102
	Storage reservoir			
	Others			
Hydrogeological Information	Drilled Depth (m)	16	Sample ID	SA2-28-4
	Diameter (in)	3	Temperature (°C)	
	S.W.L (m)	8	pH	
	D.W.L (m)		EC (µs/cm)	
	Yield (m ³ /hour)		Smell	
	No. of users (person/day)		Color	
	Supply facilities		Mn (mg/l)	
	Remarks (Lithology, etc.)		Results of Simplified Water Quality Test	
Target : 745839/ 2565464		Fe (mg/l)		
		F (mg/l)		
		NO3- (mg/l)		
		NO2- (mg/l)		
		Coliforms

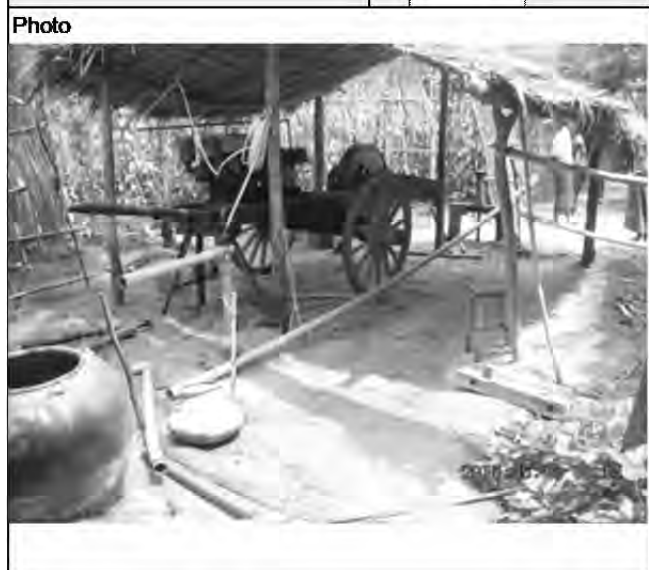
Information of Existing Water Source - 2				
Type	o Deep Well	Coordinate	X	776612
	Shallow Well		Y	2551398
	Storage reservoir			
	Others			
Hydrogeological Information	Drilled Depth (m)	110	Sample ID	SA2-29-2
	Diameter (in)	2	Temperature (°C)	29.1
	S.W.L (m)		pH	7.74
	D.W.L (m)		EC (µs/cm)	1,423
	Yield (m ³ /hour)	4.5	Smell	Non
	No.of users (person/day)		Color	Non
	Supply facilities		Mn (mg/l)	<0.02
	Remarks (Lithology , etc.)		Fe (mg/l)	<0.2
Target : 776585 / 2551429 (In the monastery). Corner of the monastery.		Results of Simplified Water Quality Test		
		F (mg/l)	0.0	
		NO3-(mg/l)	<1	
		NO2-(mg/l)	<0.02	
		Coliforms

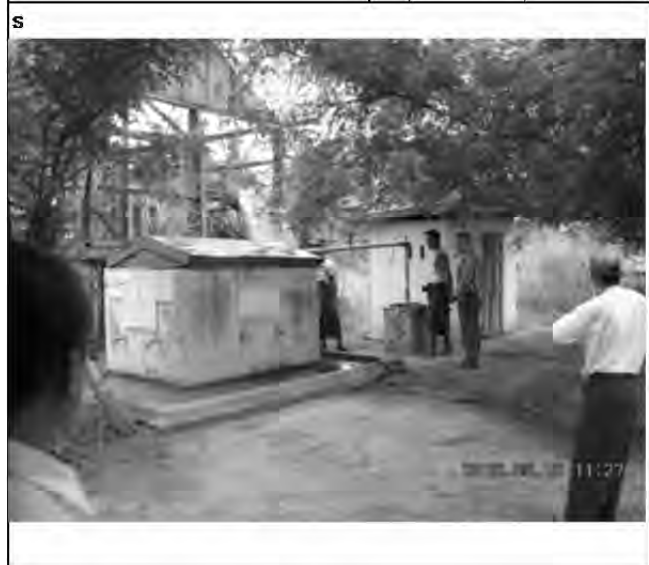
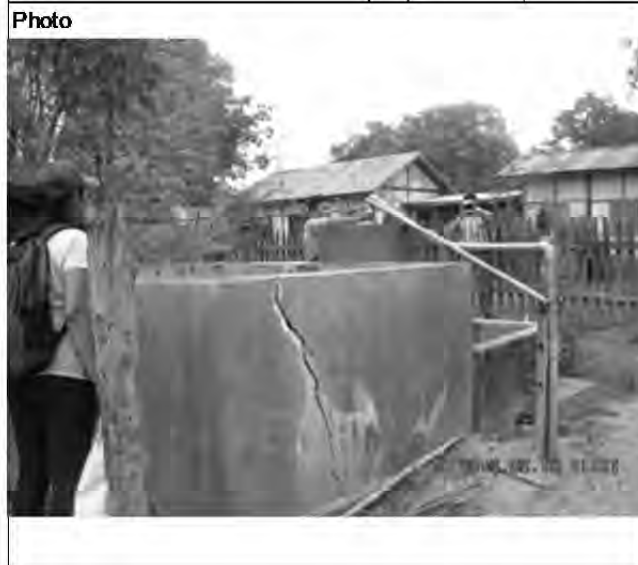
Region	SAGAING		Date	2015/5/18
Township	Kanbalu		Reported by	YORITATE Toru
Village / ID	Nyaungkanthar	SA2-30	Coordinate (WGS84 UTM)	X
				Y

Information of Existing Water Source - 1				
Type	o Deep Well	Coordinate	X	770617
	Shallow Well		Y	2587691
	Storage reservoir			
	Others			
Hydrogeological Information	Drilled Depth (m)	122	Sample ID	SA2-30-1
	Diameter (in)	2	Temperature (°C)	27.6
	S.W.L (m)		pH	7.53
	D.W.L (m)		EC (µs/cm)	1,905
	Yield (m ³ /hour)	75g/day	Smell	Non
	No.of users (person/day)		Color	Non
	Supply facilities	Air lift	Mn (mg/l)	<0.02
	Remarks (Lithology , etc.)		Results of Simplified Water Quality Test	
Public tube well. 3 tube well - can use for drinking. 2 public : 122m 1 private : 45m Very small yield , almost unsuccessful well		Fe (mg/l)	<0.2	
		F (mg/l)	0.0	
		NO3- (mg/l)	45.0	
		NO2- (mg/l)	<0.02	
		Coliforms

Information of Existing Water Source - 2				
Type	Deep Well	Coordinate	X	770701
	o Shallow Well		Y	2597767
	Storage reservoir			
	Others			
Hydrogeological Information	Drilled Depth (m)	45	Sample ID	SA2-30-2
	Diameter (in)	2	Temperature (°C)	28.1
	S.W.L (m)		pH	8.19
	D.W.L (m)		EC (µs/cm)	691
	Yield (m ³ /hour)	28g/day	Smell	Non
	No.of users (person/day)		Color	Non
	Supply facilities	Air lift	Mn (mg/l)	<0.02
	Remarks (Lithology , etc.)		Results of Simplified Water Quality Test	
Private Well. Target : 779771 / 2597741		Fe (mg/l)	<0.2	
		F (mg/l)	0.0	
		NO3- (mg/l)	<1	
		NO2- (mg/l)	<0.02	
		Coliforms	0

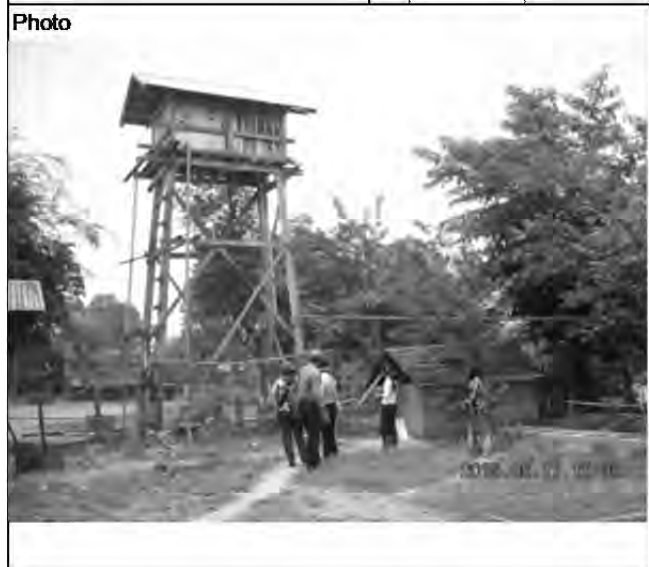
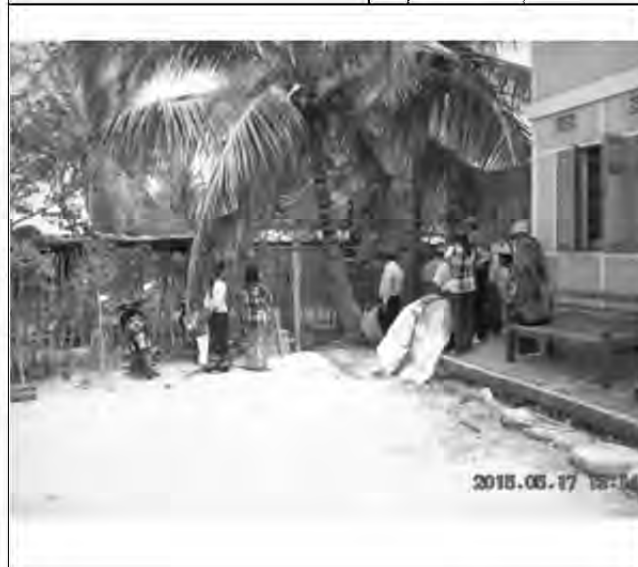
Region	SAGAING		Date	2015/5/17
Township	Kanbalu		Reported by	YORITATE Toru
Village / ID	Myaymon	SA2-31	Coordinate (WGS84 UTM)	X
				Y

Information of Existing Water Source - 1					
Type	<input type="radio"/> Deep Well	Coordinate	X	785078	
	<input type="radio"/> Shallow Well		Y	2543981	
	<input type="radio"/> Storage reservoir				
	<input type="radio"/> Others				
Hydrogeological Information	Drilled Depth (m)	98	Results of Simplified Water Quality Test	Sample ID	SA2-31-1
	Diameter (in)	2		Temperature (°C)	29.3
	S.W.L (m)			pH	8.16
	D.W.L (m)			EC (µs/cm)	1,210
	Yield (m³/hour)	4.5		Smell	Non
	No.of users (person/day)			Color	Non
	Supply facilities			Mn (mg/l)	<0.02
	Remarks (Lithology , etc.)	South part of village. Overhead is already too old , cannot use. 44 Tube well - 1 is public in school.		Fe (mg/l)	<0.2
		F (mg/l)	0.2		
		NO3- (mg/l)	1.0		
		NO2- (mg/l)	<0.02		
		Coliforms

Information of Existing Water Source - 2					
Type	<input type="radio"/> Deep Well	Coordinate	X	784990	
	<input type="radio"/> Shallow Well		Y	2544342	
	<input type="radio"/> Storage reservoir				
	<input type="radio"/> Others				
Hydrogeological Information	Drilled Depth (m)	73	Results of Simplified Water Quality Test	Sample ID	SA2-31-2
	Diameter (in)	2		Temperature (°C)	29.1
	S.W.L (m)			pH	8.14
	D.W.L (m)			EC (µs/cm)	3,210
	Yield (m³/hour)	1.4		Smell	Non
	No.of users (person/day)			Color	Non
	Supply facilities			Mn (mg/l)	<0.02
	Remarks (Lithology , etc.)	North part of village. Target 2 785110 / 2544263 Water quality is south part is better than north part. North wells are salt.		Fe (mg/l)	<0.2
		F (mg/l)	1.5		
		NO3- (mg/l)	45<		
		NO2- (mg/l)	<0.02		
		Coliforms

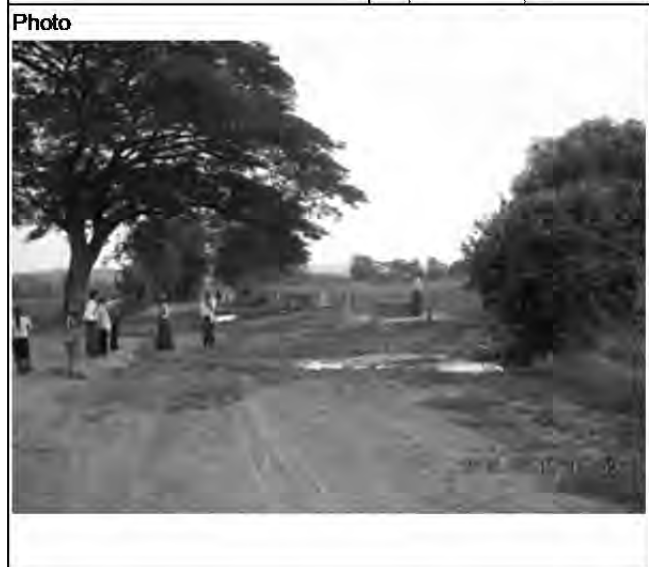
Region	SAGAING		Date	2015/5/17
Township	kanbalu		Reported by	YORITATE Toru
Village / ID	Layytwinzin	SA2-32	Coordinate (WGS84 UTM)	X
			Y

Information of Existing Water Source - 1				
Type	Deep Well	Coordinate	X	800278
	Shallow Well		Y	2549565
	Storage reservoir			
	○ Others <i>Dug Well</i>			
Hydrogeological Information	Drilled Depth (m)	2.4	Sample ID	SA2-32-1
	Diameter (in)	1.5m	Temperature (°C)	28.5
	S.W.L (m)	1.5	pH	7.40
	D.W.L (m)		EC (µs/cm)	880
	Yield (m ³ /hour)		Smell	Non
	No.of users (person/day)		Color	Shallow yellow
	Supply facilities		Mn (mg/l)	<0.02
	Remarks (Lithology , etc.)	Results of Simplified Water Quality Test		
Dug well constructed low area. This area will be below flow water in the rainy season. Therefore every year after rainy season they have to clean up the well to remove sand.		Fe (mg/l)	<0.2	
		F (mg/l)	0.0	
		NO3- (mg/l)	1.0	
		NO2- (mg/l)	<0.08	
		Coliforms	Too much

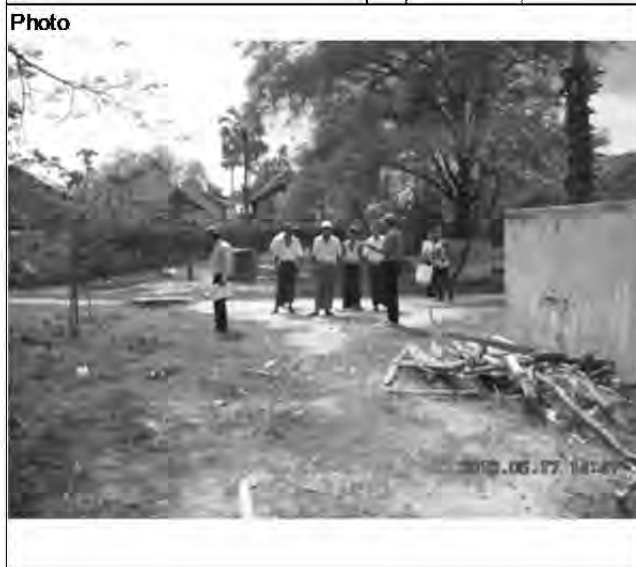
Information of Existing Water Source - 2				
Type	Deep Well	Coordinate	X	
	Shallow Well		Y	
	Storage reservoir			
	○ Others			
Hydrogeological Information	Drilled Depth (m)		Sample ID	
	Diameter (in)		Temperature (°C)	
	S.W.L (m)		pH	
	D.W.L (m)		EC (µs/cm)	
	Yield (m ³ /hour)		Smell	
	No.of users (person/day)		Color	
	Supply facilities		Mn (mg/l)	
	Remarks (Lithology , etc.)	Results of Simplified Water Quality Test		
Target : 800148 / 2549708 They have two test experience. 1. 116m (Dry well) (Target point) 2. 146m (small water 50g/h)		Fe (mg/l)		
		F (mg/l)		
		NO3- (mg/l)		
		NO2- (mg/l)		
		Coliforms

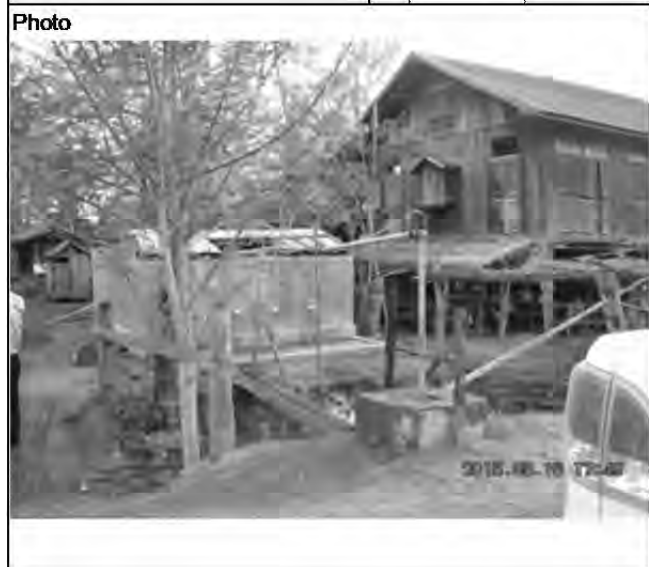
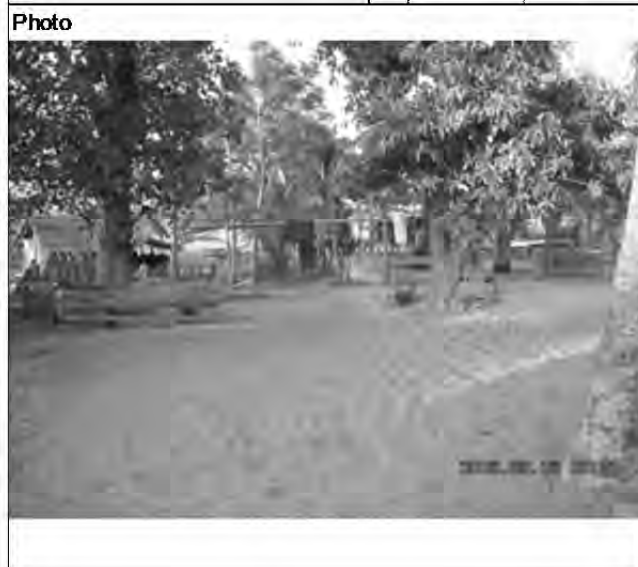
Region	SAGAING		Date	2015/5/16
Township	Kanbalu		Reported by	YORITATE Toru
Village / ID	Chaungchar	SA2-33	Coordinate (WGS84 UTM)	X
			Y

Information of Existing Water Source - 1				
Type	Deep Well	Coordinate	X	762364
	○ Shallow Well		Y	2587378
	Storage reservoir			
	Others			
Hydrogeological Information	Drilled Depth (m)	38	Sample ID	SA2-33-1
	Diameter (in)	2	Temperature (°C)	29.4
	S.W.L (m)		pH	7.87
	D.W.L (m)		EC (µs/cm)	657
	Yield (m ³ /hour)	1.6	Smell	Non
	No.of users (person/day)		Color	Non
	Supply facilities	Air lift	Mn (mg/l)	<0.02
	Remarks (Lithology , etc.)		Results of Simplified Water Quality Test	
2 Tube wells -1 public, 1 monastery 27 Shallow wells with hand pump.		Fe (mg/l)	<0.2	
		F (mg/l)	0.0	
		NO3- (mg/l)	<1	
		NO2- (mg/l)	<0.02	
		Coliforms	0

Information of Existing Water Source - 2				
Type	Deep Well	Coordinate	X	762527
	○ Shallow Well		Y	2587375
	Storage reservoir			
	Others			
Hydrogeological Information	Drilled Depth (m)	49	Sample ID	SA2-33-2
	Diameter (in)	2	Temperature (°C)	27.4
	S.W.L (m)	9	pH	8.03
	D.W.L (m)		EC (µs/cm)	621
	Yield (m ³ /hour)	2.5	Smell	Non
	No.of users (person/day)		Color	Non
	Supply facilities		Mn (mg/l)	<0.02
	Remarks (Lithology , etc.)		Results of Simplified Water Quality Test	
Monastery Operation cost : 1000 kyats -fuel/hour		Fe (mg/l)	<0.2	
		F (mg/l)	0.2	
		NO3- (mg/l)	<1	
		NO2- (mg/l)	<0.02	
		Coliforms	0

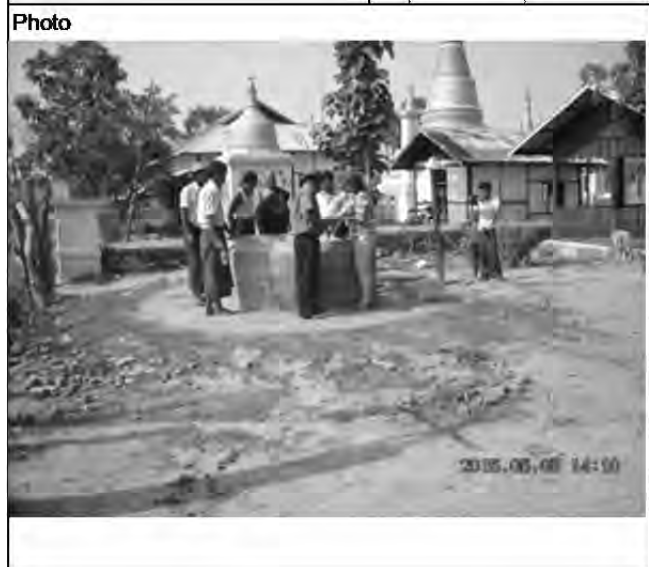
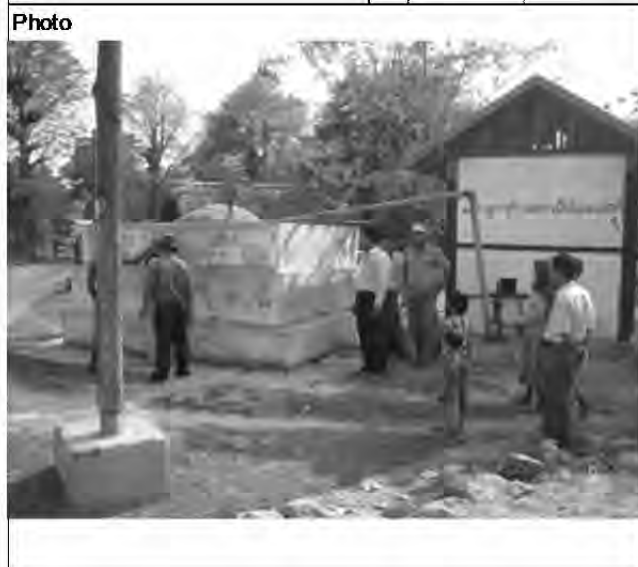
Region	SAGAING		Date	2015/5/9
Township	Dabayin		Reported by	YORITATE Toru
Village / ID	Minyogone	SA2-34	Coordinate (WGS84 UTM)	X
			Y

Information of Existing Water Source - 1					
Type	Deep Well	Coordinate	X	732024	
	Shallow Well		Y	2513022	
	Storage reservoir				
	○ Others <i>Dug Well</i>				
Hydrogeological Information	Drilled Depth (m)	8.9	Results of Simplified Water Quality Test	Sample ID	SA2-34-1
	Diameter (in)	1.6 m		Temperature (°C)	29.7
	S.W.L (m)	4.3		pH	6.95
	D.W.L (m)			EC (µs/cm)	477
	Yield (m³/hour)			Smell	Non
	No.of users (person/day)			Color	Non
	Supply facilities			Mn (mg/l)	<0.02
	Remarks (Lithology , etc.)	Only one dug well is water source in this village. Target : 731866/ 2513234 (Next to the abandoned dug well)		Fe (mg/l)	<0.2
		F (mg/l)	0.2		
		NO3- (mg/l)	<1		
		NO2- (mg/l)	<0.02		
		Coliforms	Too much

Information of Existing Water Source - 2					
Type	○ Deep Well	Coordinate	X	732713	
	Shallow Well		Y	2512110	
	Storage reservoir				
	Others				
Hydrogeological Information	Drilled Depth (m)	103	Results of Simplified Water Quality Test	Sample ID	SA2-34-2
	Diameter (in)	4		Temperature (°C)	30.1
	S.W.L (m)	3.2		pH	7.9
	D.W.L (m)			EC (µs/cm)	1,224
	Yield (m³/hour)	6.8		Smell	Non
	No.of users (person/day)			Color	Non
	Supply facilities			Mn (mg/l)	<0.02
	Remarks (Lithology , etc.)	Next village 1 km from Minyogone village constructed in 1982.		Fe (mg/l)	0.3
		F (mg/l)	0.2		
		NO3- (mg/l)	<1		
		NO2- (mg/l)	<0.02		
		Coliforms

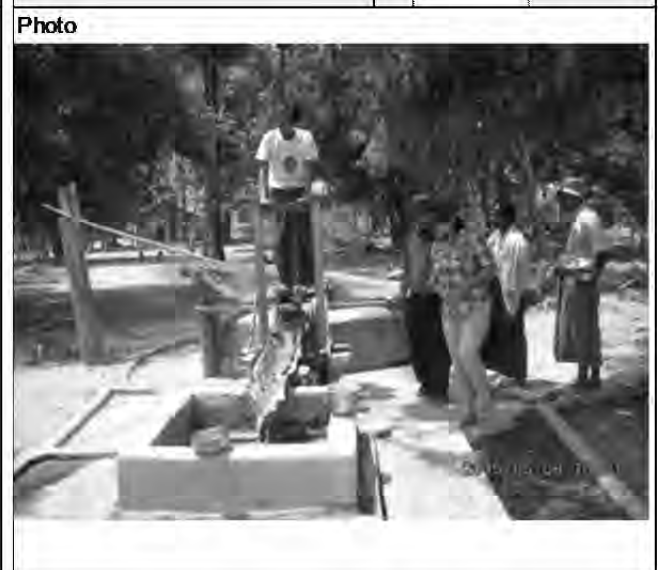
Information of Existing Water Source - 2				
Type	Deep Well	Coordinate	X	725913
	Shallow Well		Y	2500405
	Storage reservoir			
	Others			
Hydrogeological Information	Drilled Depth (m)	Results of Simplified Water Quality Test	Sample ID	SA2-35-2
	Diameter (in)		Temperature (°C)	28.4
	S.W.L (m)		pH	7.55
	D.W.L (m)		EC (µs/cm)	748
	Yield (m³/hour)		Smell	Non
	No.of users (person/day)		Color	Non
	Supply facilities		Mn (mg/l)	<0.02
	Remarks (Lithology , etc.)		Fe (mg/l)	<0.2
Dug well with foot pump. Monestry between neighbor village.	F (mg/l)	0.8		
	NO3- (mg/l)	<1		
	NO2- (mg/l)	<0.02		
	Coliforms	Too much

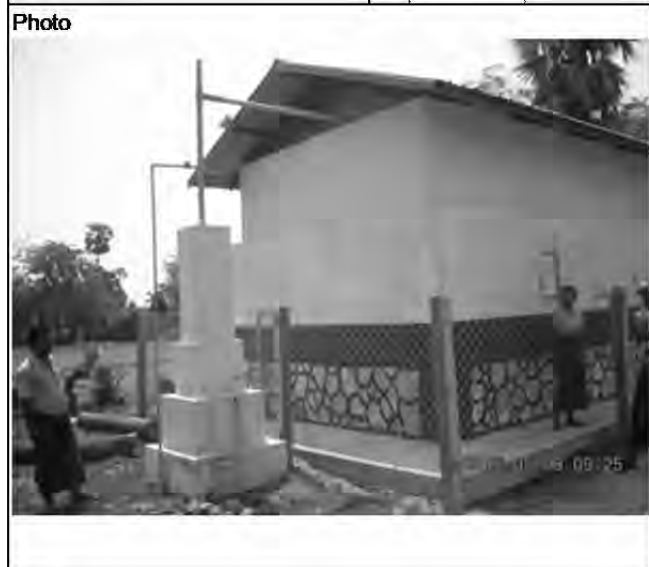
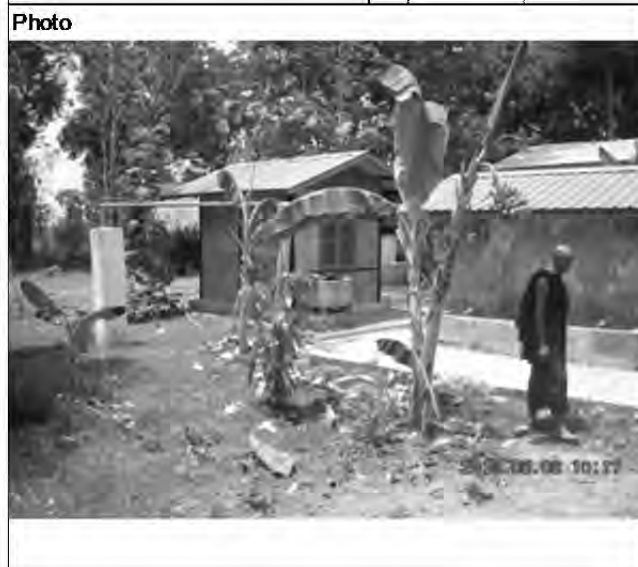
Region	SAGAING		Date	2015/5/9
Township	Dabayin		Reported by	YORITATE Toru
Village / ID	Shandaw	SA2-35	Coordinate (WGS84 UTM)	X Y

Information of Existing Water Source - 1				
Type	<input type="radio"/> Deep Well	Coordinate	X	728341
	<input type="radio"/> Shallow Well		Y	2501689
	<input type="radio"/> Storage reservoir			
	<input type="radio"/> Others			
Hydrogeological Information	Drilled Depth (m)	247	Sample ID	SA2-35-3
	Diameter (in)	2	Temperature (°C)	30.4
	S.W.L (m)		pH	7.87
	D.W.L (m)		EC (µs/cm)	1,564
	Yield (m ³ /hour)	9.1	Smell	Non
	No.of users (person/day)		Color	Non
	Supply facilities	Artesian	Mn (mg/l)	<0.02
	Remarks (Lithology , etc.)		Results of Simplified Water Quality Test	
Artesian well.		Fe (mg/l)	<0.2	
		F (mg/l)	0.2	
		NO3- (mg/l)	<1	
		NO2- (mg/l)	<0.02	
		Coliforms

Information of Existing Water Source - 2				
Type	<input type="radio"/> Deep Well	Coordinate	X	725889
	<input type="radio"/> Shallow Well		Y	2500389
	<input type="radio"/> Storage reservoir			
	<input type="radio"/> Others			
Hydrogeological Information	Drilled Depth (m)		Sample ID	SA2-35-4
	Diameter (in)	2	Temperature (°C)	27.7
	S.W.L (m)		pH	8.38
	D.W.L (m)		EC (µs/cm)	1,004
	Yield (m ³ /hour)	5.5	Smell	Non
	No.of users (person/day)		Color	Non
	Supply facilities	Airlift	Mn (mg/l)	<0.02
	Remarks (Lithology , etc.)		Results of Simplified Water Quality Test	
Same monetry with SA2-35-2. Donated in 2013.		Fe (mg/l)	<0.2	
		F (mg/l)	0.2	
		NO3- (mg/l)	<1	
		NO2- (mg/l)	<0.02	
		Coliforms

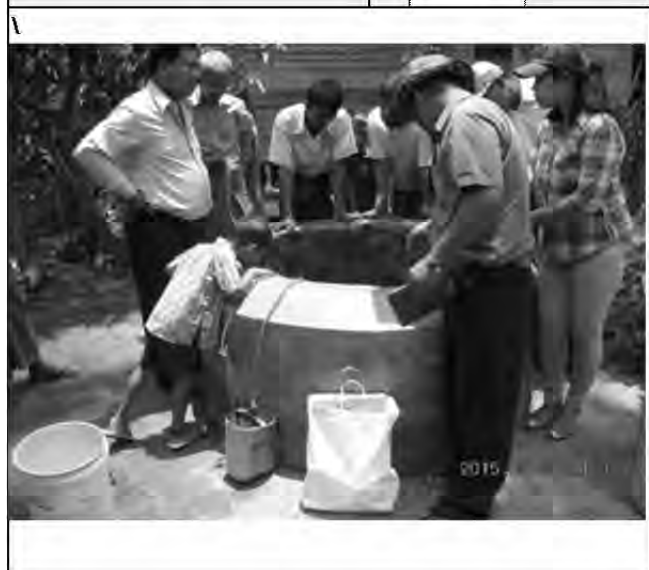
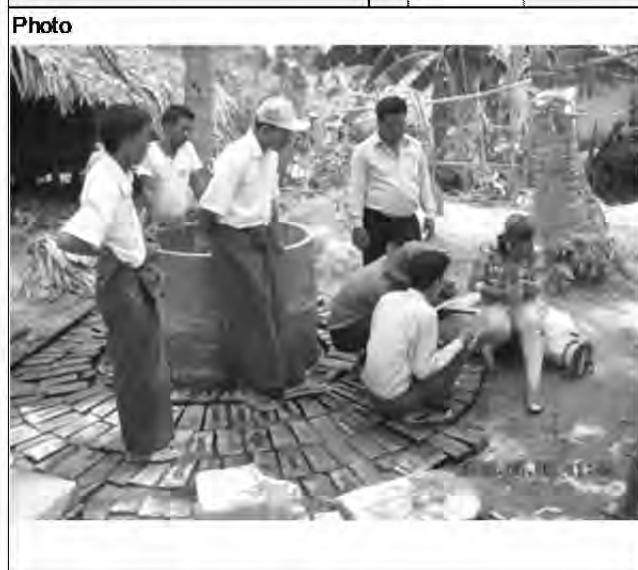
Region	SAGAING		Date	2015/5/9
Township	Dabayin		Reported by	YORITATE Toru
Village / ID	Kyuntaw (S)	SA2-36	Coordinate (WGS84 UTM)	X Y

Information of Existing Water Source - 1				
Type	Deep Well	Coordinate	X	728635
	Shallow Well		Y	2505308
	Storage reservoir			
	○ Others <i>Dug Well</i>			
Hydrogeological Information	Drilled Depth (m)	4.8	Sample ID	SA2-36-1
	Diameter (in)	1.1m	Temperature (°C)	27.6
	S.W.L (m)	3.6	pH	6.94
	D.W.L (m)		EC (µs/cm)	896
	Yield (m ³ /hour)		Smell	Non
	No.of users (person/day)		Color	Non
	Supply facilities		Mn (mg/l)	0.02
	Remarks (Lithology , etc.)	MONO pump tube well -100m damaged in 1995 (728646/2505196) Test well -61m does not have water.		
Results of Simplified Water Quality Test		Fe (mg/l)	<0.2	
		F (mg/l)	0.2	
		NO3- (mg/l)	<1	
		NO2- (mg/l)	<0.02	
		Coliforms

Information of Existing Water Source - 2				
Type	Deep Well	Coordinate	X	728715
	Shallow Well		Y	2505233
	Storage reservoir			
	○ Others <i>Dug Well</i>			
Hydrogeological Information	Drilled Depth (m)	4.3	Sample ID	SA2-36-2
	Diameter (in)	1.0m	Temperature (°C)	27.9
	S.W.L (m)	2.3	pH	7.30
	D.W.L (m)		EC (µs/cm)	2,230
	Yield (m ³ /hour)		Smell	Non
	No.of users (person/day)		Color	Non
	Supply facilities		Mn (mg/l)	<0.02
	Remarks (Lithology , etc.)	Targey: 728632 / 2505189		
Results of Simplified Water Quality Test		Fe (mg/l)	<0.02	
		F (mg/l)	0.1	
		NO3- (mg/l)	10.0	
		NO2- (mg/l)	0.7	
		Coliforms

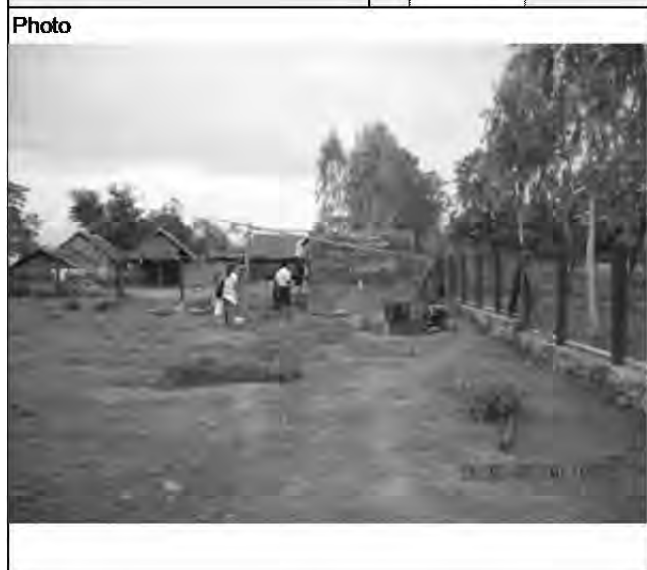
Region	SAGAING		Date	2015/5/19
Township	Wetlet		Reported by	YORITATE Toru
Village / ID	Palae Thwe(Ywarhit)	SA2-37	Coordinate (WGS84 UTM)	X Y

Information of Existing Water Source - 1				
Type	o Deep Well	Coordinate	X	798855
	Shallow Well		Y	2492654
	Storage reservoir			
	Others			
Hydrogeological Information	Drilled Depth (m)	109	Sample ID	SA2-37-1
	Diameter (in)		Temperature (°C)	31.4
	S.W.L (m)		pH	8.06
	D.W.L (m)		EC (µs/cm)	924
	Yield (m ³ /hour)	3.4	Smell	Non
	No.of users (person/day)		Color	Non
	Supply facilities		Mn (mg/l)	<0.02
	Remarks (Lithology , etc.)	Results of Simplified Water Quality Test		Fe (mg/l)
F (mg/l)				0.0
NO3- (mg/l)				<1
NO2- (mg/l)				<0.02
Coliforms				0

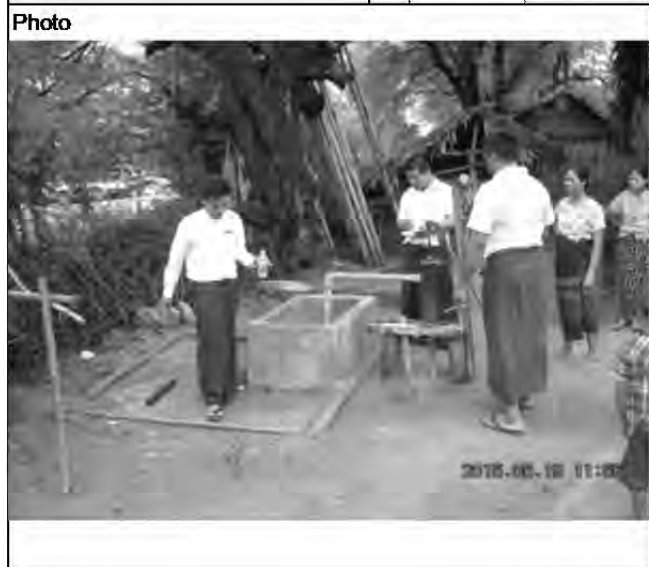
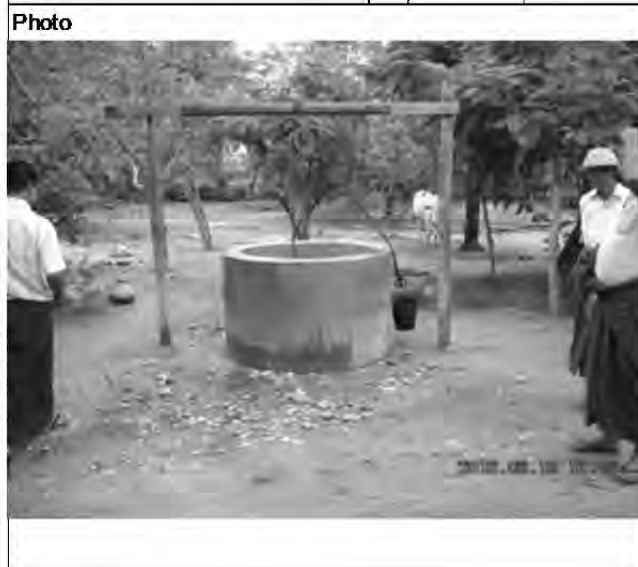
Region	SAGAING		Date	2015/5/
Township	Wetlet		Reported by	YORITATE Toru
Village / ID	Poukkan	SA2-38	Coordinate (WGS84 UTM)	X
				Y

Information of Existing Water Source - 1				
Type	Deep Well	Coordinate	X	796340
	○ Shallow Well		Y	2461884
	Storage reservoir			
	Others			
Hydrogeological Information	Drilled Depth (m)	41	Sample ID	SA2-38-1
	Diameter (in)		Temperature (°C)	29.2
	S.W.L (m)		pH	7.5
	D.W.L (m)		EC (µs/cm)	1388.0
	Yield (m ³ /hour)		Smell	Non
	No. of users (person/day)		Color	Non
	Supply facilities	Hand pump	Mn (mg/l)	<0.02
	Remarks (Lithology, etc.)		Results of Simplified Water Quality Test	
Alluvial plane. People get drinking water from dugwell.		Fe (mg/l)	<0.2	
		F (mg/l)	1.5	
		NO3- (mg/l)	2.0	
		NO2- (mg/l)	<0.02	
		Coliforms	0

Information of Existing Water Source - 2				
Type	Deep Well	Coordinate	X	796371
	○ Shallow Well		Y	2461780
	Storage reservoir			
	○ Others (Dug well)			
Hydrogeological Information	Drilled Depth (m)	13.4	Sample ID	SA2-38-2
	Diameter (in)	1.1	Temperature (°C)	28.2
	S.W.L (m)	2.3	pH	7.5
	D.W.L (m)		EC (µs/cm)	595.0
	Yield (m ³ /hour)		Smell	Non
	No. of users (person/day)		Color	Non
	Supply facilities		Mn (mg/l)	<0.02
	Remarks (Lithology, etc.)		Results of Simplified Water Quality Test	
Constructed in 1994. Artesian well locating 2 to 3 km far from the village.		Fe (mg/l)	<0.2	
		F (mg/l)	0.8	
		NO3- (mg/l)	20.0	
		NO2- (mg/l)	<0.02	
		Coliforms	uncounted

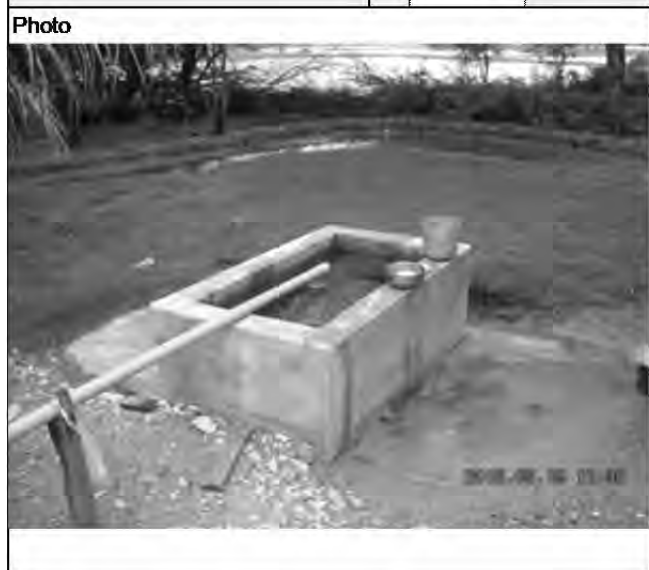
Region	SAGAING		Date	2015/5/19
Township	Wetlet		Reported by	YORITATE Toru
Village / ID	Poukkan	SA2-38	Coordinate (WGS84 UTM)	X
			Y

Information of Existing Water Source - 1				
Type	Deep Well	Coordinate	X	797690
	Shallow Well		Y	2462872
	Storage reservoir			
	Others			
Hydrogeological Information	Drilled Depth (m)	38	Sample ID	SA2-38-3
	Diameter (in)	2	Temperature (°C)	30.0
	S.W.L (m)		pH	7.9
	D.W.L (m)		EC (µs/cm)	1,500
	Yield (m ³ /hour)	1.4	Smell	Non
	No.of users (person/day)		Color	Non
	Supply facilities	Artesian	Mn (mg/l)	<0.02
	Remarks (Lithology , etc.)		Fe (mg/l)	<0.2
F (mg/l)			2.0	
NO3- (mg/l)			5.0	
NO2- (mg/l)			<0.02	
Coliforms			0

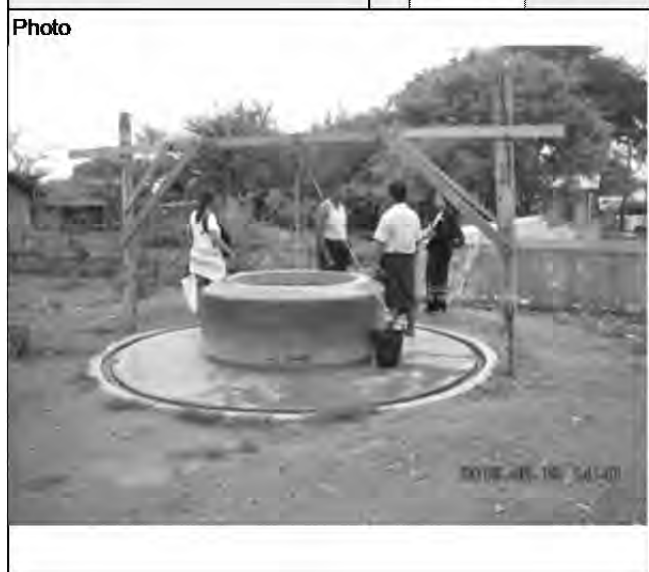
Region	SAGAING		Date	2015/5/19
Township	Wetlet		Reported by	YORITATE Toru
Village / ID	Shwenyaunglaw	SA2-39	Coordinate (WGS84 UTM)	X
			Y

Information of Existing Water Source - 1				
Type	Deep Well	Coordinate	X	803376
	Shallow Well		Y	2470865
	Storage reservoir			
	○ Others <i>Dug Well</i>			
Hydrogeological Information	Drilled Depth (m)	11.5	Sample ID	SA2-39-1
	Diameter (in)	1.2m	Temperature (°C)	29.0
	S.W.L (m)	5.10 - 0.70	pH	7.91
	D.W.L (m)		EC (µs/cm)	809
	Yield (m ³ /hour)		Smell	Non
	No.of users (person/day)		Color	Non
	Supply facilities		Mn (mg/l)	<0.02
	Remarks (Lithology , etc.)		Fe (mg/l)	<0.2
		Results of Simplified Water Quality Test	F (mg/l)	0.8
			NO3- (mg/l)	30.0
			NO2- (mg/l)	<0.02
			Coliforms	Too much

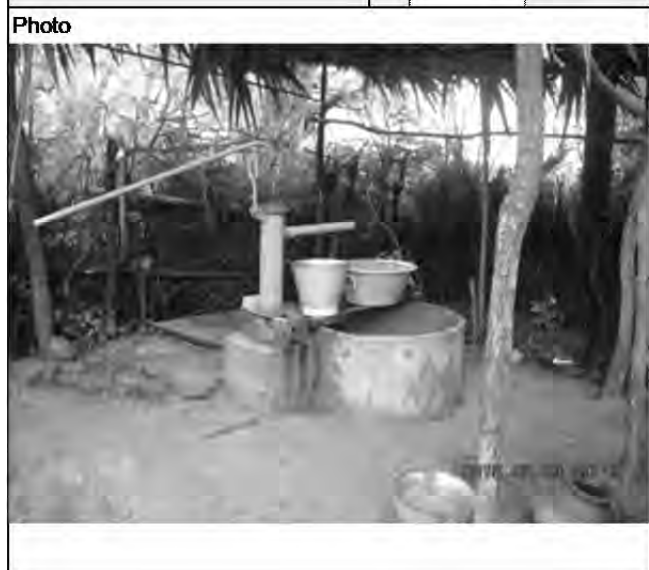
Region	SAGAING		Date	2015/5/19
Township	Wetlet		Reported by	YORITATE Toru
Village / ID	Sabeidaw	SA2-40	Coordinate (WGS84 UTM)	X Y

Information of Existing Water Source - 1				
Type	Deep Well	Coordinate	X	786790
	Shallow Well		Y	2472040
	Storage reservoir			
	Others			
Hydrogeological Information	Drilled Depth (m)	10.6	Sample ID	SA2-40-1
	Diameter (in)		Temperature (°C)	27.4
	S.W.L (m)	1.5	pH	7.84
	D.W.L (m)		EC (µs/cm)	764
	Yield (m ³ /hour)		Smell	Non
	No. of users (person/day)		Color	Non
	Supply facilities		Mn (mg/l)	<0.02
	Remarks (Lithology, etc.)		Fe (mg/l)	<0.2
Results of Simplified Water Quality Test			F (mg/l)	0.6
			NO3- (mg/l)	10.0
			NO2- (mg/l)	<0.02
			Coliforms	0

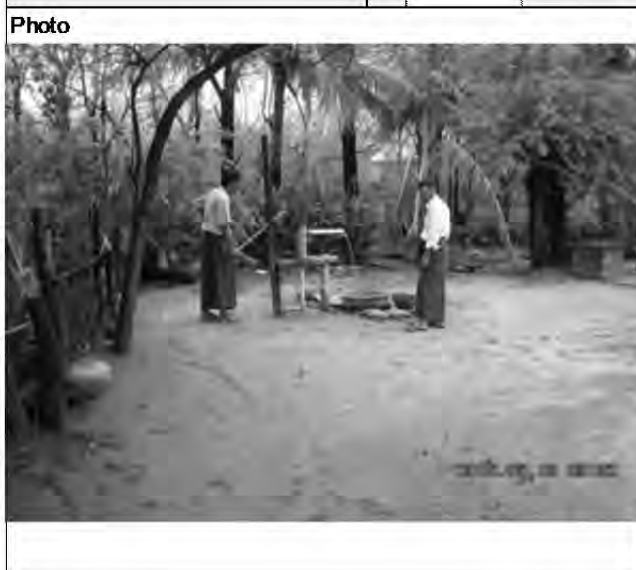
Information of Existing Water Source - 2				
Type	Deep Well	Coordinate	X	786486
	Shallow Well		Y	2472202
	Storage reservoir			
	Others			
Hydrogeological Information	Drilled Depth (m)	10.6	Sample ID	SA2-40-2
	Diameter (in)		Temperature (°C)	28.3
	S.W.L (m)		pH	8.03
	D.W.L (m)		EC (µs/cm)	2,130
	Yield (m ³ /hour)		Smell	Non
	No. of users (person/day)		Color	Non
	Supply facilities		Mn (mg/l)	<0.02
	Remarks (Lithology, etc.)		Fe (mg/l)	<0.2
Results of Simplified Water Quality Test			F (mg/l)	3.0
			NO3- (mg/l)	5.0
			NO2- (mg/l)	<0.02
			Coliforms	Too much

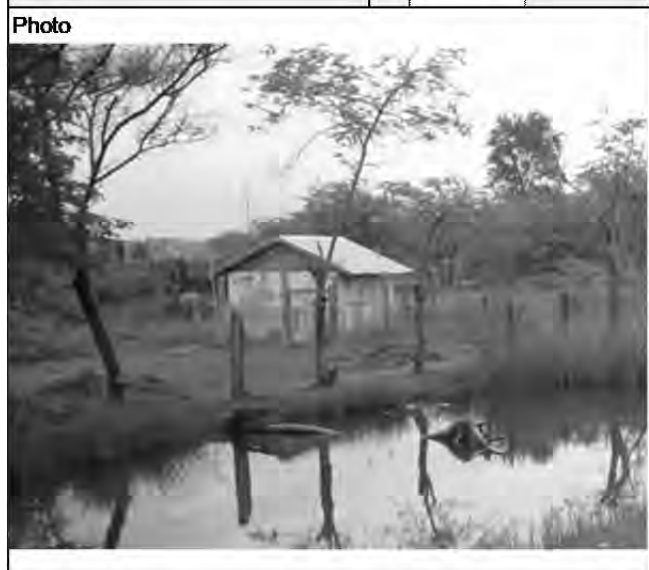
Region	SAGAING		Date	2015/5/19
Township	Wetlet		Reported by	YORITATE Toru
Village / ID	Sabeidaw	SA2-40	Coordinate (WGS84 UTM)	X Y

Information of Existing Water Source - 1				
Type	o Deep Well	Coordinate	X	786311
	Shallow Well		Y	2474369
	Storage reservoir			
	Others			
Hydrogeological Information	Drilled Depth (m)	122	Sample ID	SA2-40-3
	Diameter (in)	4	Temperature (°C)	29.0
	S.W.L (m)	1.5	pH	8.14
	D.W.L (m)		EC (µs/cm)	1,204
	Yield (m ³ /hour)	6.8	Smell	Non
	No.of users (person/day)		Color	Non
	Supply facilities	Artesian	Mn (mg/l)	<0.02
	Remarks (Lithology , etc.)		Results of Simplified Water Quality Test	
Locating 2km out side of the village.		Fe (mg/l)	<0.2	
		F (mg/l)	3.0	
		NO3- (mg/l)	<1	
		NO2- (mg/l)	<0.02	
		Coliforms

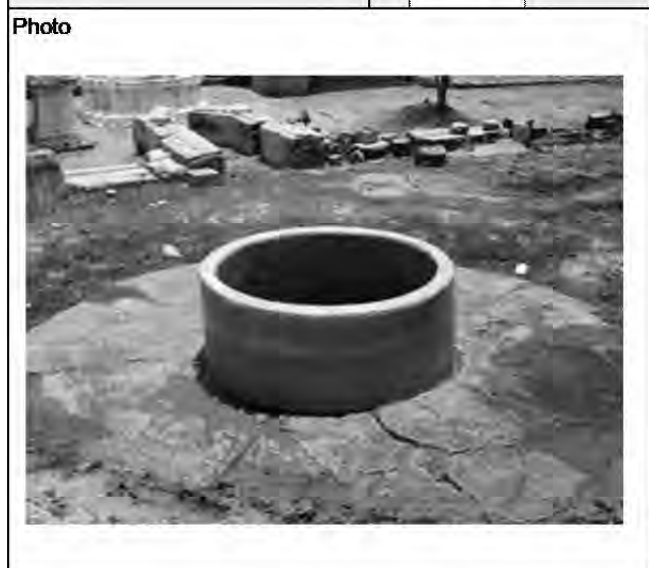
Region	Mandalay		Date	2015.5.24	
Township	Mahlaing		Reported by	Sasaki	
Village / ID	Htantawgyi	MA2-01	Coordinate (WGS84 UTM)	X	766932
			Y	2339178

Information of Existing Water Sauce - 1						
Type	Deep Well	Coordinate	X	767026		
	Shallow Well		Y	2338930		
	Storage reservoir					
	○ Others <i>Dug Well</i>					
Hydrogeological Information	Drilled Depth (m)	15	Sample ID	MA2-01-1		
	Diameter (in)	1.5m	Temperature (°C)	30.3		
	S.W.L (m)	no data	pH	7.43		
	D.W.L (m)		EC (µs/cm)	2,310		
	Yield (m ³ /hour)		Smell	Non		
	No.of users (person/day)	480	Color	Non		
	Supply facilities		Mn (mg/l)	<0.02		
	Remarks (Lithology , etc.)	Results of Simplified Water Quality Test		Fe (mg/l)	<0.2	
There are 4 shallow well in the village. But 3 of shallow well be come salty and villager can use only 1 well for drinking. That well is located near the irrigation channel. SWL is around GL-10m. And this village have another tube well (180 feet) to use some village event.	F (mg/l)			0.4		
	NO3- (mg/l)			10		
	NO2- (mg/l)			<0.02		
	Coliforms			Too much
