Appendix 5.3.1 Result of Field Water Quality Measurement

Result of Field Water Quality Measurement (Sagaing Region-1)

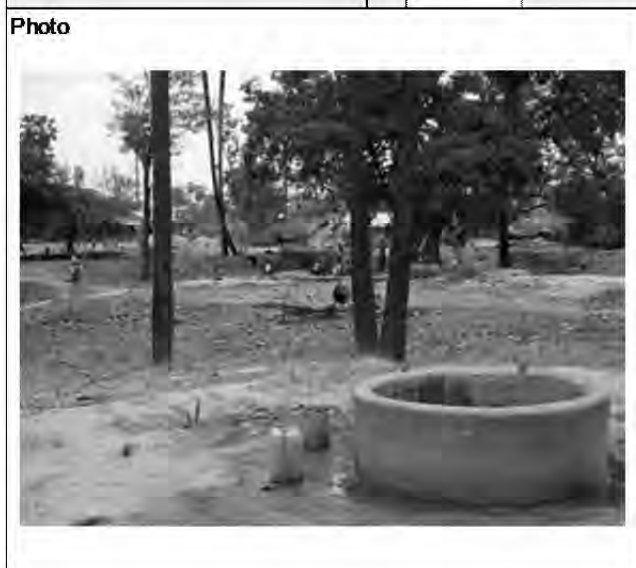
Information of Existing Water Sauce - 2						
Type	Deep Well	Coordinate	X	767009		
	Shallow Well		Y	2339022		
	Storage reservoir					
	○ Others <i>Dug Well</i>					
Hydrogeological Information	Drilled Depth (m)	15	Sample ID	MA2-01-2		
	Diameter (in)	1.5m	Temperature (°C)	30.8		
	S.W.L (m)		pH	7.82		
	D.W.L (m)		EC (µs/cm)	3,560		
	Yield (m ³ /hour)		Smell	Non		
	No.of users (person/day)		Color	Non		
	Supply facilities		Mn (mg/l)			
	Remarks (Lithology , etc.)	Results of Simplified Water Quality Test		Fe (mg/l)		
Salty well. They don't use for drinking water. To use for laundry and bathing.	F (mg/l)					
	NO3- (mg/l)					
	NO2- (mg/l)					
	Coliforms

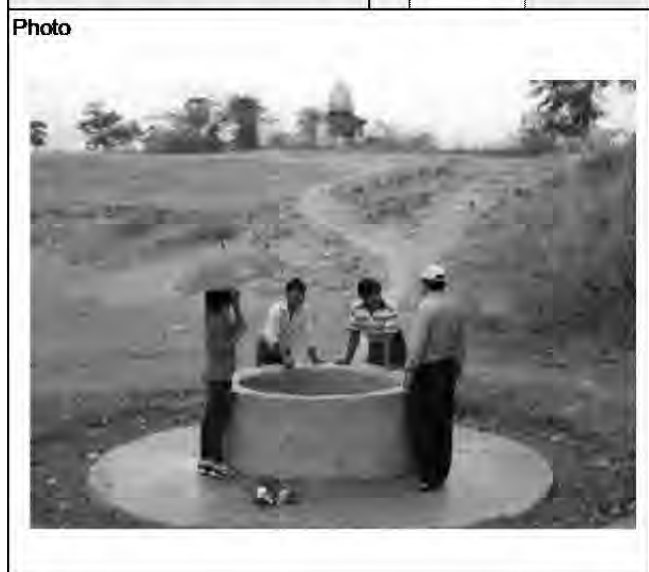
Region	Mandalay		Date	2015.5.19	
Township	Mahlaing		Reported by	Yamasaki	
Village / ID	Asone	MA2-02	Coordinate (WGS84 UTM)	X	769179
				Y	2329028

Information of Existing Water Source - 1						
Type	Deep Well	Coordinate	X	768727		
	Shallow Well		Y	2328337		
	Storage reservoir					
	○ Others <i>Dug Well</i>					
Hydrogeological Information	Drilled Depth (m)	6.1	Results of Simplified Water Quality Test	Sample ID	MA2-02-1	
	Diameter (in)	1.5m		Temperature (°C)	27.5	
	S.W.L (m)	1.8		pH	7.48	
	D.W.L (m)			EC (µs/cm)	1,472	
	Yield (m ³ /hour)			Smell	Non	
	No.of users (person/day)	650		Color	Non	
	Supply facilities			Mn (mg/l)	<0.02	
				Fe (mg/l)	<0.02	
Remarks (Lithology , etc.) Electrical pole have already installed. But only some house can use electricity. This well is located around 1km from center of village. This village has some dug well. when they boil rice use these water, rice will become yellow. There are no deep well near this village.			F (mg/l)	0		
			NO3- (mg/l)	<1		
			NO2- (mg/l)	<0.02		
			Coliforms	Too much

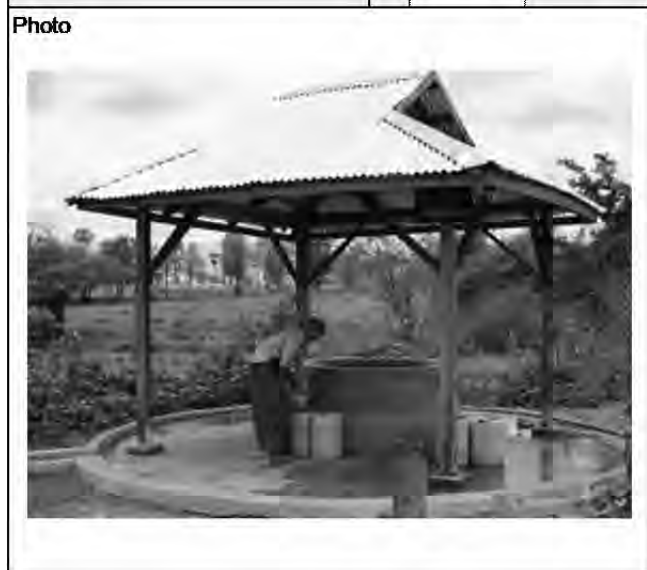
Region	Mandalay		Date	2015.5.19	
Township	Mahlaing		Reported by	Yamasaki	
Village / ID	Khinthar(S)	MA2-03	Coordinate (WGS84 UTM)	X	782188
			Y	2317148

Information of Existing Water Source - 1								
Type	Deep Well	Coordinate	X	781754				
	Shallow Well		Y	2317206				
	Storage reservoir							
	○ Others <i>Dug Well</i>							
Hydrogeological Information	Drilled Depth (m)	6.1	Sample ID	MA2-03-1				
	Diameter (in)		Temperature (°C)	27.6				
	S.W.L (m)	3.1	pH	7.41				
	D.W.L (m)		EC (µs/cm)	781				
	Yield (m ³ /hour)		Smell	Non				
	No. of users (person/day)	480	Color	Non				
	Supply facilities		Mn (mg/l)	<0.02				
	Remarks (Lithology , etc.)	This village is shared pond water with neighbor village in rainy season.						
	Fe (mg/l)						<0.2	
	F (mg/l)						0	
	NO3- (mg/l)						<1	
	NO2- (mg/l)						<0.02	
	Coliforms						7

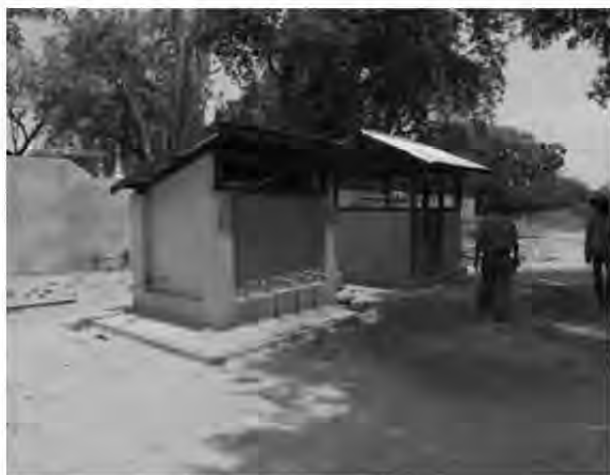
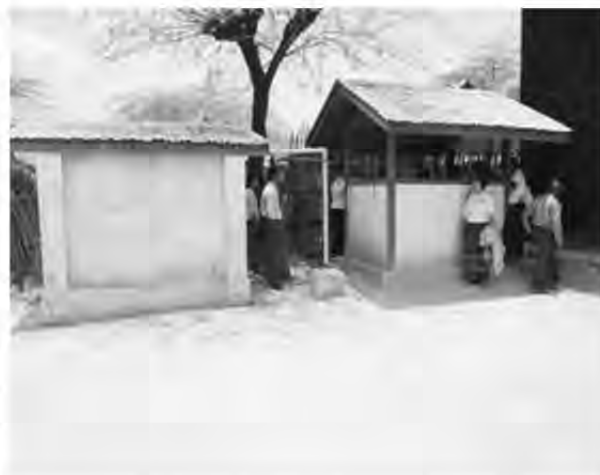
Remarks (Lithology, etc.)	DDA well 2013- inside the school compound.		Fe (mg/l)	0.2		Remarks (Lithology, etc.)	Another tube well in the clinic, drilled by DDA in 2000 X 2369051.62mN Y 753117.55mE		Fe (mg/l)	<0.2
			F (mg/l)	0				F (mg/l)	0		
			NO3- (mg/l)	<1				NO3- (mg/l)	<1		
			NO2- (mg/l)	<0.02				NO2- (mg/l)	<0.02		
			Coliforms					Coliforms

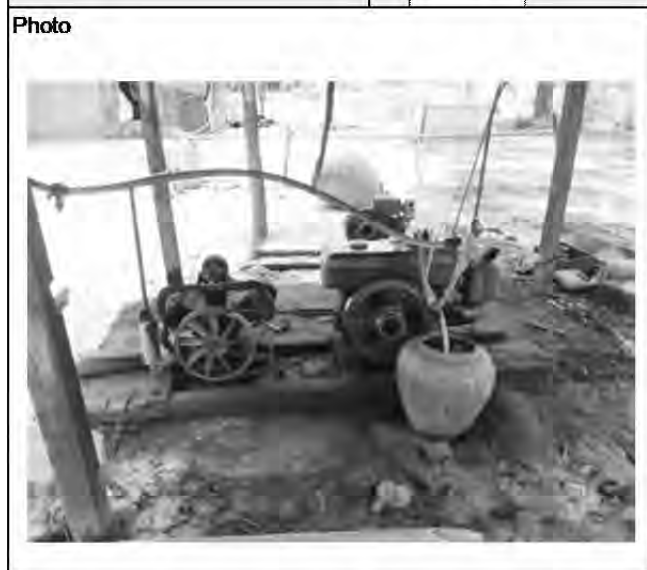
Region	Mandalay		Date	2015/5/25
Township	Myingyan		Reported by	Maruo
Village / ID	Talgyi	MA2-05	Coordinate (WGS84 UTM)	X
			Y

Information of Existing Water Source - 1					
Type	<input type="radio"/> Deep Well	Coordinate	X	758959	
	<input type="radio"/> Shallow Well		Y	2405065	
	<input type="radio"/> Storage reservoir				
	<input type="radio"/> Others				
Hydrogeological Information	Drilled Depth (m)	71.6	Results of Simplified Water Quality Test	Sample ID	MA2-5-1
	Diameter (in)	2		Temperature (°C)	30.9
	S.W.L (m)			pH	8.27
	D.W.L (m)			EC (µs/cm)	1,303
	Yield (m³/hour)			Smell	Non
	No.of users (person/day)			Color	Turbidity
	Supply facilities	compressor		Mn (mg/l)	<1
	Remarks (Lithology , etc.)	Monastery well - water contain sand, Ayarwaddy river.		Fe (mg/l)	<0.2
			F (mg/l)	0.7	
			NO3- (mg/l)	1	
			NO2- (mg/l)	<0.02	
			Coliforms

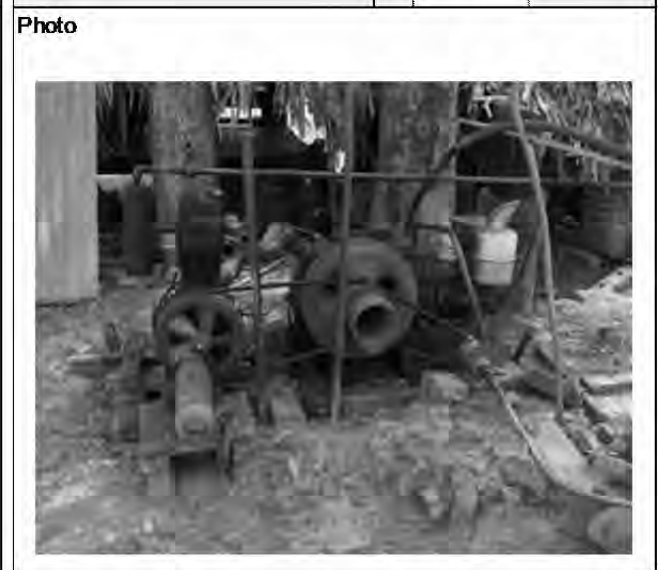
Information of Existing Water Source - 2					
Type	<input type="radio"/> Deep Well	Coordinate	X	758815	
	<input type="radio"/> Shallow Well		Y	2404938	
	<input type="radio"/> Storage reservoir				
	<input type="radio"/> Others				
Hydrogeological Information	Drilled Depth (m)	45.7	Results of Simplified Water Quality Test	Sample ID	MA2-5-2
	Diameter (in)	3		Temperature (°C)	30.5
	S.W.L (m)	8.2		pH	8.44
	D.W.L (m)			EC (µs/cm)	1,783
	Yield (m³/hour)			Smell	Non
	No.of users (person/day)			Color	Non
	Supply facilities	Compressor		Mn (mg/l)	<1
	Remarks (Lithology , etc.)	Private tube well in the village. This house has a tractor and telephone. Family use the water for drilling.		Fe (mg/l)	<0.2
			F (mg/l)	1	
			NO3- (mg/l)	4	
			NO2- (mg/l)	<0.02	
			Coliforms

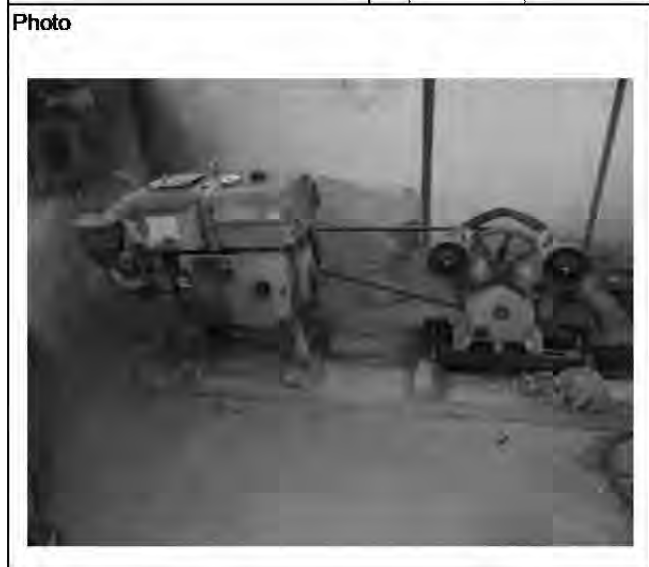
Region	Mandalay		Date	2015/5/24
Township	Myingyan		Reported by	Maruo
Village / ID	Kuywar	MA2-06	Coordinate (WGS84 UTM)	X
			Y

Information of Existing Water Source - 1					
Type	Deep Well	Coordinate	X	749780	
	Shallow Well		Y	2369023	
	Storage reservoir				
	Others				
Hydrogeological Information	Drilled Depth (m)	59	Results of Simplified Water Quality Test	Sample ID	MA2-6-1
	Diameter (in)	3		Temperature (°C)	31.2
	S.W.L (m)	16.7		pH	7.88
	D.W.L (m)			EC (µs/cm)	274
	Yield (m³/hour)			Smell	Non
	No. of users (person/day)			Color	Turbidity
	Supply facilities	Compressor		Mn (mg/l)	0
	Remarks (Lithology , etc.)	Private well - near DDA well, very salty . Possibly deeper could be better quality, 2008 drilled. X : 2369023.86mN Y : 749780.33mE		Fe (mg/l)	0.5
		F (mg/l)	4		
		NO3- (mg/l)	1		
		NO2- (mg/l)	<0.02		
		Coliforms

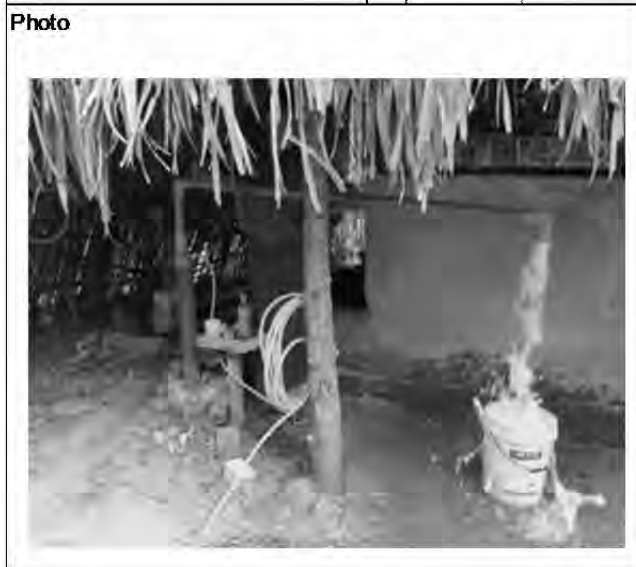
Information of Existing Water Source - 1					
Type	<input type="radio"/> Deep Well	Coordinate	X	762463	
	<input type="radio"/> Shallow Well		Y	2384138	
	<input type="radio"/> Storage reservoir				
	<input type="radio"/> Others				
Hydrogeological Information	Drilled Depth (m)	98	Results of Simplified Water Quality Test	Sample ID	MA2-7-1
	Diameter (in)	3		Temperature (°C)	31.0
	S.W.L (m)	46		pH	7.73
	D.W.L (m)			EC (µs/cm)	7,960
	Yield (m³/hour)			Smell	Non
	No.of users (person/day)			Color	Non
	Supply facilities	Compressor		Mn (mg/l)	<1
	Remarks (Lithology , etc.)	Inside clinic compound behind monastery, drilled in 2014 by Gov Health Organization.		Fe (mg/l)	<0.2
		F (mg/l)	0		
		NO3- (mg/l)	45		
		NO2- (mg/l)	0		
		Coliforms

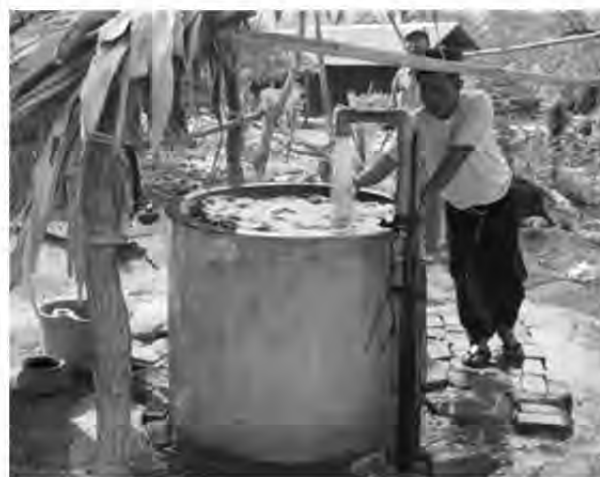
Photo

Information of Existing Water Source - 2					
Type	<input type="radio"/> Deep Well	Coordinate	X	762698	
	<input type="radio"/> Shallow Well		Y	2384434	
	<input type="radio"/> Storage reservoir				
	<input type="radio"/> Others				
Hydrogeological Information	Drilled Depth (m)	98	Results of Simplified Water Quality Test	Sample ID	MA2-7-2
	Diameter (in)	4		Temperature (°C)	30.9
	S.W.L (m)			pH	7.58
	D.W.L (m)			EC (µs/cm)	7,340
	Yield (m³/hour)			Smell	Non
	No.of users (person/day)			Color	Non
	Supply facilities	Compressor		Mn (mg/l)	<1
	Remarks (Lithology , etc.)	Private tube well Taste Slightly salty X : 2384434.60mN Y : 762698.30mE		Fe (mg/l)	<0.2
		F (mg/l)	0		
		NO3- (mg/l)	20		
		NO2- (mg/l)	0.02		
		Coliforms

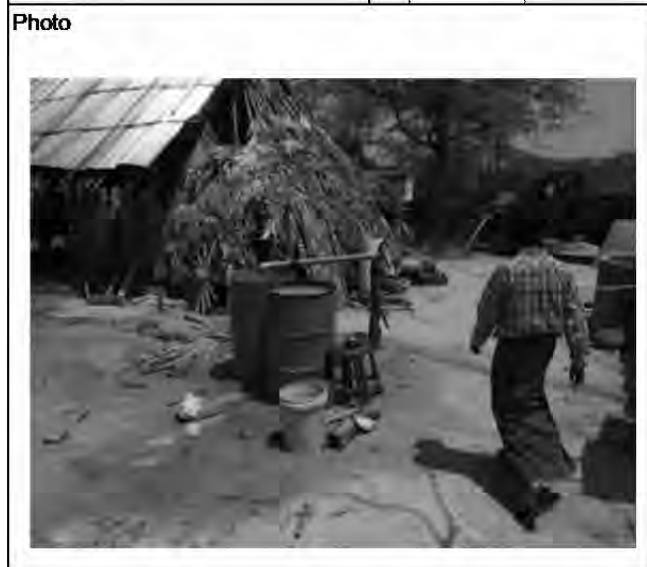
Information of Existing Water Source - 1														
Type	<input type="radio"/> Deep Well	Coordinate	X	766089										
	<input type="radio"/> Shallow Well		Y	2399238										
	<input type="radio"/> Storage reservoir													
	<input type="radio"/> Others													
Hydrogeological Information	Drilled Depth (m)	61	Sample ID	MA2-8-1										
	Diameter (in)	2	Temperature (°C)	30.3										
	S.W.L (m)		pH	8.24										
	D.W.L (m)		EC (µs/cm)	6,160										
	Yield (m³/hour)		Smell	Non										
	No.of users (person/day)		Color	High turbidity										
	Supply facilities	Compressor	Mn (mg/l)	<1										
	Remarks (Lithology , etc.)		Results of Simplified Water Quality Test											
Private well. Water certain yellow sand and silt. Taste is salty and they use this water for animals. X : 2399238.43mN Y : 766089.93mE Nyaungwin village is next to the target village.

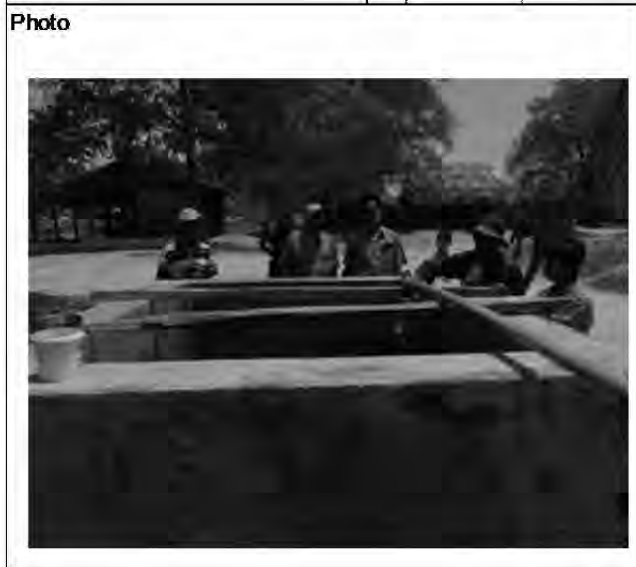
Information of Existing Water Source - 2														
Type	<input type="radio"/> Deep Well	Coordinate	X	766347										
	<input type="radio"/> Shallow Well		Y	2399645										
	<input type="radio"/> Storage reservoir													
	<input type="radio"/> Others													
Hydrogeological Information	Drilled Depth (m)	107	Sample ID	MA2-8-2										
	Diameter (in)	3	Temperature (°C)	30.6										
	S.W.L (m)		pH	8.46										
	D.W.L (m)		EC (µs/cm)	1,930										
	Yield (m³/hour)	500g/h	Smell	Slightly certain smell										
	No.of users (person/day)		Color	Slightly muddy										
	Supply facilities		Mn (mg/l)	<1										
	Remarks (Lithology , etc.)		Results of Simplified Water Quality Test											
Monastery well - slightly salty X : 2399645.31mN Y : 766347.70mE

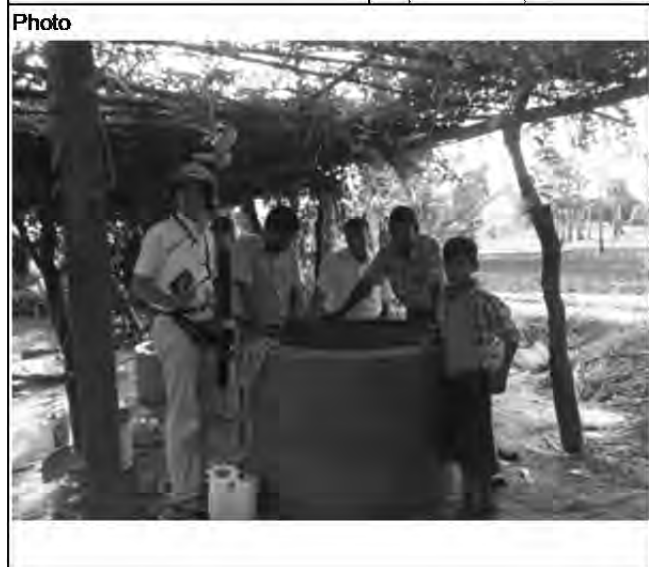
Information of Existing Water Source - 1					
Type	Deep Well	Coordinate	X	758753	
	Shallow Well		Y	2410571	
	Storage reservoir				
	○ Others <i>Dug Well</i>				
Hydrogeological Information	Drilled Depth (m)	11	Results of Simplified Water Quality Test	Sample ID	MA2-9 -1
	Diameter (in)	1.0m		Temperature (°C)	29.1
	S.W.L (m)	9.4		pH	8.33
	D.W.L (m)			EC (µs/cm)	6,020
	Yield (m³/hour)			Smell	Non
	No.of users (person/day)			Color	Non
	Supply facilities			Mn (mg/l)	<0.02
	Remarks (Lithology , etc.)	Dug well. Can not drink water. Other 11 dugwells are also high salinity water can not drink. Monestry TW (189m) and DDA drilled TW (128m) are also high salinity therefore, now not under the operation. Pego Formation area.		Fe (mg/l)	<0.2
		F (mg/l)	5.0		
		NO3- (mg/l)	8.0		
		NO2- (mg/l)	<0.02		
		Coliforms

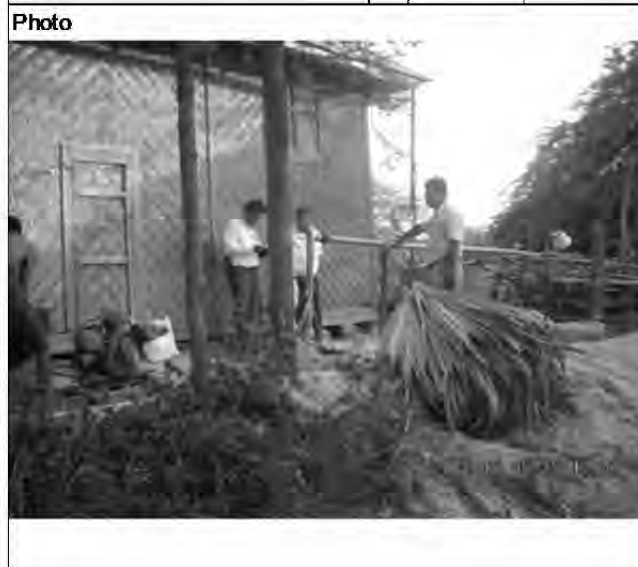
Information of Existing Water Source - 2					
Type	○ Deep Well	Coordinate	X	758200	
	Shallow Well		Y	2410349	
	Storage reservoir				
	Others				
Hydrogeological Information	Drilled Depth (m)	61	Results of Simplified Water Quality Test	Sample ID	MA2-9 -2
	Diameter (in)	2		Temperature (°C)	30.8
	S.W.L (m)			pH	7.93
	D.W.L (m)			EC (µs/cm)	6,360
	Yield (m³/hour)	4.1		Smell	Non
	No.of users (person/day)			Color	Non
	Supply facilities			Mn (mg/l)	<0.02
	Remarks (Lithology , etc.)	Private well. Can not drink water. Target : 758855 / 2410492		Fe (mg/l)	<0.2
		F (mg/l)	0.0		
		NO3- (mg/l)	45<		
		NO2- (mg/l)	0.2		
		Coliforms

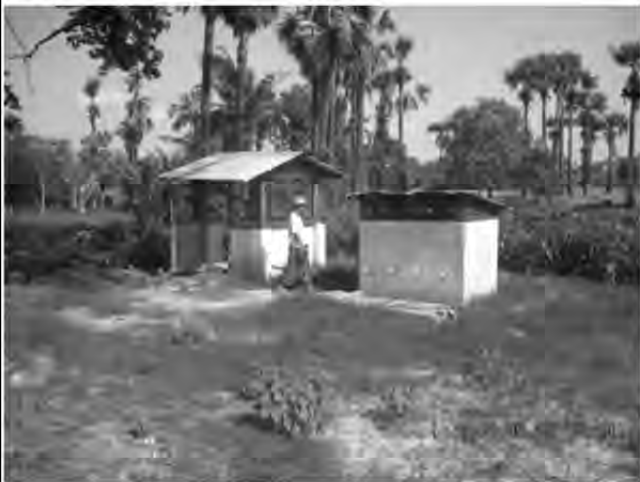
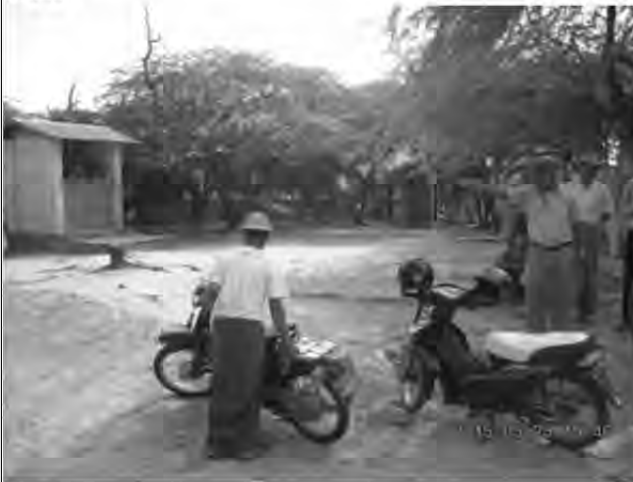
Information of Existing Water Source - 1					Information of Existing Water Source - 2						
Type	Deep Well		Coordinate	X	766115	Type	Deep Well		Coordinate	X	
	Shallow Well			Y	2416389		Shallow Well			Y	
	Storage reservoir						Storage reservoir				
	○ Others <i>Dug Well</i>						Others				
Hydrogeological Information	Drilled Depth (m)	18m×3	Results of Simplified Water Quality Test	Sample ID	MA2-10-1	Hydrogeological Information	Drilled Depth (m)		Results of Simplified Water Quality Test	Sample ID	MA2-10-2
	Diameter (in)	2		Temperature (°C)	29.8		Diameter (in)			Temperature (°C)	
	S.W.L (m)	2.0		pH	7.12		S.W.L (m)			pH	
	D.W.L (m)			EC (µs/cm)	6,470		D.W.L (m)			EC (µs/cm)	
	Yield (m³/hour)			Smell	Non		Yield (m³/hour)			Smell	
	No.of users (person/day)			Color	Non		No.of users (person/day)			Color	
	Supply facilities	Suction Pump		Mn (mg/l)	0.02		Supply facilities			Mn (mg/l)	
	Remarks (Lithology , etc.)	Upper Pego Formation.N45W,60S 3 shallow well (18m×3) combination system for suction pump. While pumping, close (10m distance) dug well's water also draw down.		Fe (mg/l)	<0.2		Remarks (Lithology , etc.)	Target : 766378 / 2416431 Pond water is using for drinking.		Fe (mg/l)

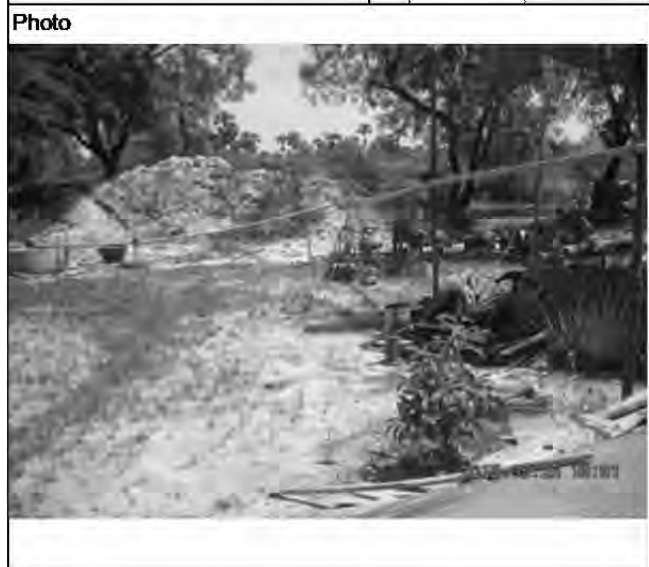
Information of Existing Water Source - 1				
Type	o Deep Well	Coordinate	X	765457
	Shallow Well		Y	2403617
	Storage reservoir			
	Others <i>Dug Well</i>			
Hydrogeological Information	Drilled Depth (m)	152	Sample ID	MA2-11 -1
	Diameter (in)	2	Temperature (°C)	30.4
	S.W.L (m)	unknown	pH	7.86
	D.W.L (m)		EC (µs/cm)	2,340
	Yield (m ³ /hour)	3.2	Smell	Non
	No.of users (person/day)		Color	Non
	Supply facilities	Airlift	Mn (mg/l)	<0.02
	Remarks (Lithology , etc.)		Fe (mg/l)	<0.2
Private well belong to the Monestry. Upper Peg formation Sand Silt rock alternation. N10E, 60 ~ 90N		F (mg/l)	0.6	
		NO3- (mg/l)	8.0	
		NO2- (mg/l)	<0.02	
		Coliforms

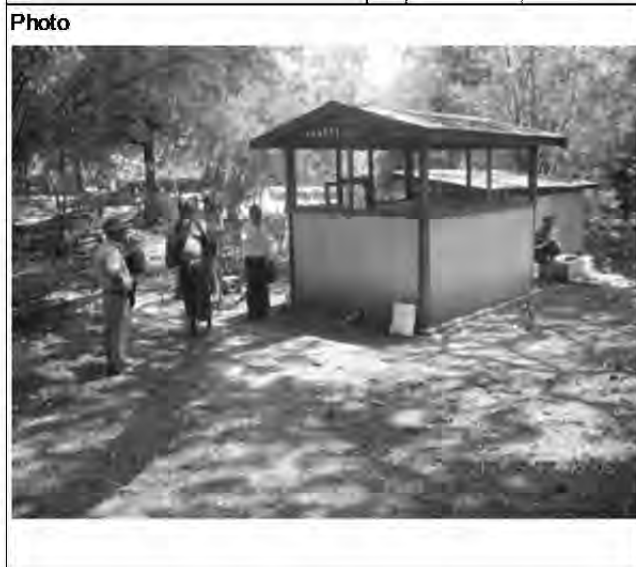
Information of Existing Water Source - 2				
Type	Deep Well	Coordinate	X	768899
	o Shallow Well		Y	2402581
	Storage reservoir			
	Others			
Hydrogeological Information	Drilled Depth (m)	10	Sample ID	MA2-11 -2
	Diameter (in)	2	Temperature (°C)	pump broken
	S.W.L (m)		pH	can not get water
	D.W.L (m)		EC (µs/cm)	
	Yield (m ³ /hour)		Smell	
	No.of users (person/day)		Color	
	Supply facilities		Mn (mg/l)	
	Remarks (Lithology , etc.)		Fe (mg/l)	
Private well.(3 well conivation) but now pump does not work. Can not get water anyway. water can not drink. Target : 764970 / 2403461 Now stopin sxc		F (mg/l)		
		NO3- (mg/l)		
		NO2- (mg/l)		
		Coliforms

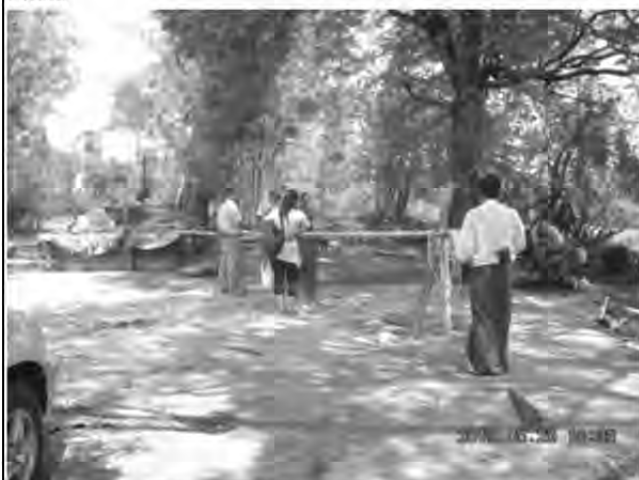
Photo

Information of Existing Water Source - 1			
Type	<input type="radio"/> Deep Well	Coordinate	X 768195
	<input type="checkbox"/> Shallow Well		Y 2402362
	<input type="checkbox"/> Storage reservoir		
	<input type="checkbox"/> Others Dug Well		
Hydrogeological Information	Drilled Depth (m)	213	Results of Simplified Water Quality Test
	Diameter (in)	2	
	S.W.L (m)		
	D.W.L (m)		
	Yield (m³/hour)	3.2	
	No.of users (person/day)		
	Supply facilities	Airlift	
	Sample ID	MA2-12-1	
Remarks (Lithology , etc.)			
Private well. Upper Peg formation Sand Silt rock alternation. N10E, 60 ~ 90N			
		Temperature (°C)	31.7
		pH	7.91
		EC (µs/cm)	11,680
		Smell	Non
		Color	Non
		Mn (mg/l)	<0.02
		Fe (mg/l)	<0.2
		F (mg/l)	5.0
		NO3- (mg/l)	8.0
		NO2- (mg/l)	1<
		Coliforms

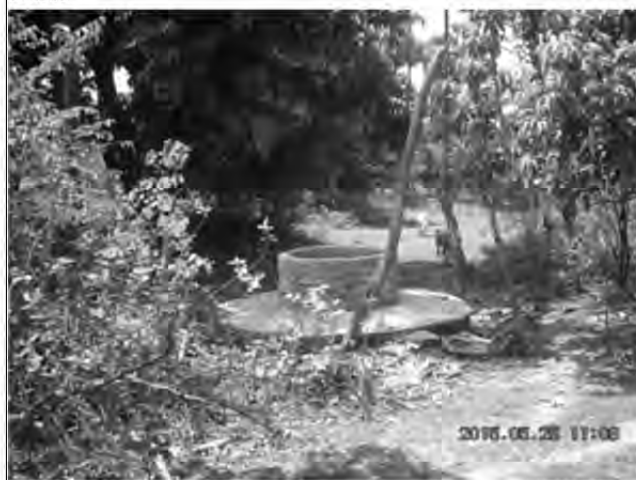
Photo

Information of Existing Water Source - 2			
Type	<input type="radio"/> Deep Well	Coordinate	X 768899
	<input type="checkbox"/> Shallow Well		Y 2402581
	<input type="checkbox"/> Storage reservoir		
	<input type="checkbox"/> Others Dug Well		
Hydrogeological Information	Drilled Depth (m)	6	Results of Simplified Water Quality Test
	Diameter (in)	1.4 m	
	S.W.L (m)	3.1	
	D.W.L (m)		
	Yield (m³/hour)		
	No.of users (person/day)		
	Supply facilities		
	Sample ID	MA2-12-2	
Remarks (Lithology , etc.)			
Public dug well Target : 768301 / 2402220			
		Temperature (°C)	27.8
		pH	7.28
		EC (µs/cm)	3,340
		Smell	Non
		Color	Non
		Mn (mg/l)	0.05
		Fe (mg/l)	<0.2
		F (mg/l)	0.4
		NO3- (mg/l)	<1
		NO2- (mg/l)	<0.02
		Coliforms

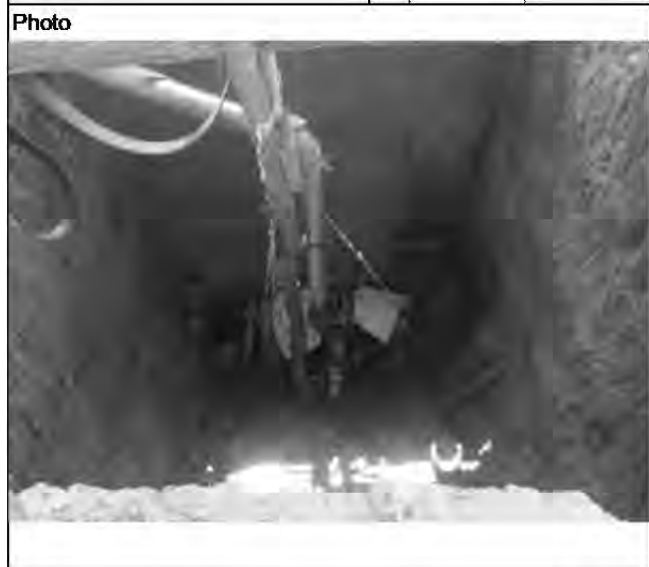
Information of Existing Water Source - 1				
Type	Deep Well	Coordinate	X	767771
	Shallow Well		Y	2376174
	Storage reservoir			
	Others			
Hydrogeological Information	Drilled Depth (m)	18m x 4	Sample ID	MA2-13-1
	Diameter (in)	2	Temperature (°C)	32.8
	S.W.L (m)	7	pH	7.51
	D.W.L (m)		EC (µs/cm)	1,342
	Yield (m ³ /hour)		Smell	Slightly certain smell
	No. of users (person/day)		Color	Shallow Yellow
	Supply facilities		Mn (mg/l)	<0.02
	Remarks (Lithology, etc.)	UNICEF Donation. This system will covered several villages.		
Results of Simplified Water Quality Test		Fe (mg/l)	<0.2	
		F (mg/l)	0.4	
		NO3- (mg/l)	<1	
		NO2- (mg/l)	<0.02	
		Coliforms

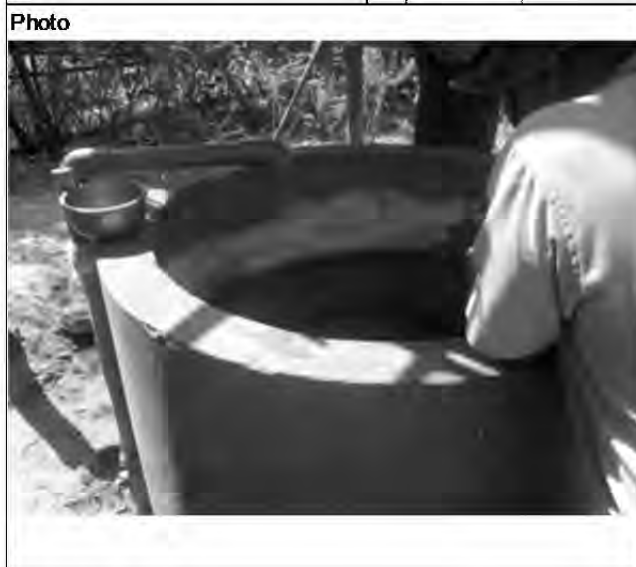
Information of Existing Water Source - 2				
Type	Deep Well	Coordinate	X	767555
	Shallow Well		Y	2375350
	Storage reservoir			
	Others			
Hydrogeological Information	Drilled Depth (m)	78	Sample ID	MA2-13-2
	Diameter (in)	2	Temperature (°C)	30.8
	S.W.L (m)	21	pH	7.8
	D.W.L (m)		EC (µs/cm)	11,800
	Yield (m ³ /hour)		Smell	Non
	No. of users (person/day)		Color	Turbidity
	Supply facilities	Airlift	Mn (mg/l)	<0.02
	Remarks (Lithology, etc.)	Target: 767494 / 2375884		
Results of Simplified Water Quality Test		Fe (mg/l)	<0.2	
		F (mg/l)	2.0	
		NO3- (mg/l)	3.0	
		NO2- (mg/l)	<0.02	
		Coliforms

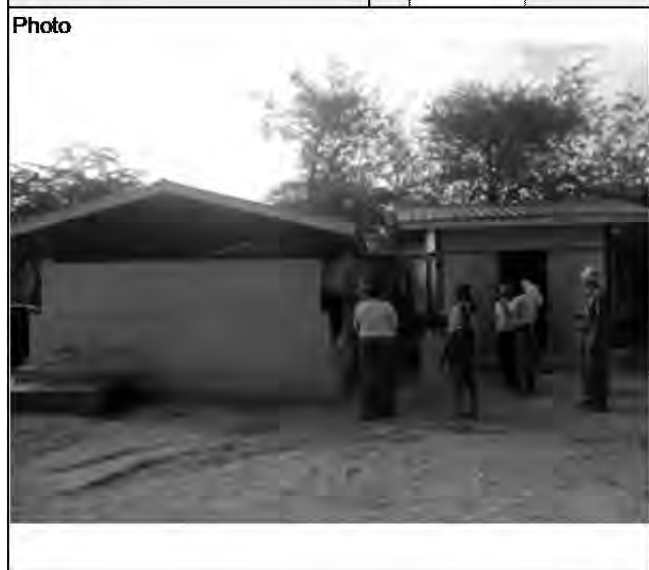
Information of Existing Water Source - 1						
Type	o Deep Well		Coordinate	X	757384	
	Shallow Well			Y	2368882	
	Storage reservoir					
	Others					
Hydrogeological Information	Drilled Depth (m)	234	Results of Simplified Water Quality Test	Sample ID	MA2-14-1	
	Diameter (in)	4		Temperature (°C)	31.2	
	S.W.L (m)			pH	7.58	
	D.W.L (m)			EC (µs/cm)	6,540	
	Yield (m³/hour)	8.2		Smell	Non	
	No.of users (person/day)			Color	Shallow White	
	Supply facilities			Mn (mg/l)	<0.02	
	Remarks (Lithology , etc.)	Constructed by DRD in 2015.2		Fe (mg/l)	<0.2	
			F (mg/l)	0.8		
			NO3- (mg/l)	1.0		
			NO2- (mg/l)	<0.01		
			Coliforms

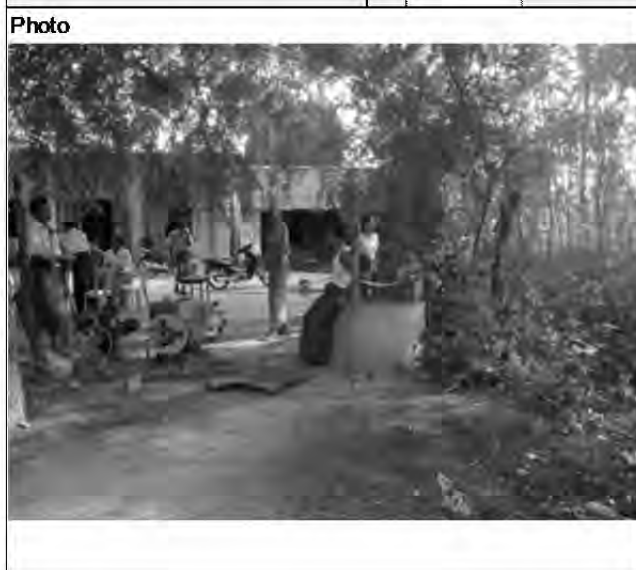
Information of Existing Water Source - 2						
Type	o Deep Well		Coordinate	X	757248	
	Shallow Well			Y	2368842	
	Storage reservoir					
	Others					
Hydrogeological Information	Drilled Depth (m)	127	Results of Simplified Water Quality Test	Sample ID	MA2-14-2	
	Diameter (in)	2		Temperature (°C)	30.8	
	S.W.L (m)			pH	7.86	
	D.W.L (m)			EC (µs/cm)	2,120	
	Yield (m³/hour)	1.4		Smell	Non	
	No.of users (person/day)			Color	Non	
	Supply facilities			Mn (mg/l)	<0.02	
	Remarks (Lithology , etc.)	Private well Target : 757400 / 2368579		Fe (mg/l)	<0.2	
			F (mg/l)	0.4		
			NO3- (mg/l)	<1		
			NO2- (mg/l)	<0.02		
			Coliforms

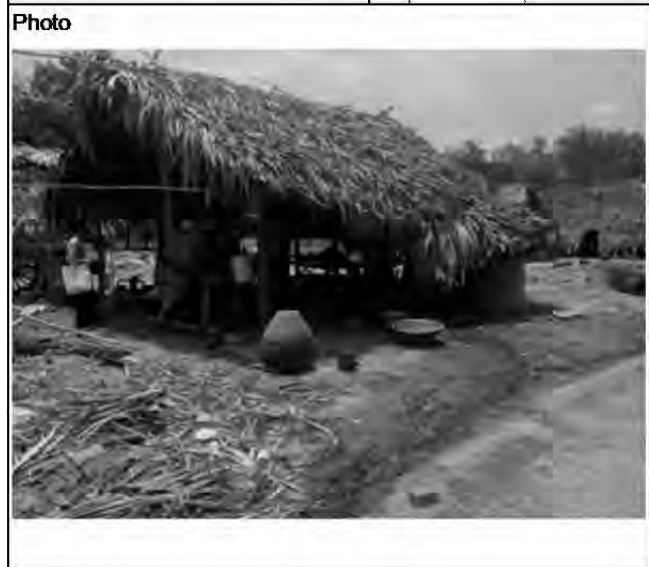
Information of Existing Water Source - 1					
Type	<input type="radio"/> Deep Well	Coordinate	X	772147	
	<input type="radio"/> Shallow Well		Y	2368696	
	<input type="radio"/> Storage reservoir				
	<input type="radio"/> Others				
Hydrogeological Information	Drilled Depth (m)	91	Results of Simplified Water Quality Test	Sample ID	MA2-15-1
	Diameter (in)	2		Temperature (°C)	34.4
	S.W.L (m)	30		pH	8.48
	D.W.L (m)			EC (µs/cm)	2,800
	Yield (m³/hour)	3.4		Smell	Non
	No.of users (person/day)			Color	Non
	Supply facilities	Airlift		Mn (mg/l)	<0.02
	Remarks (Lithology , etc.)	Private Well.		Fe (mg/l)	<0.2
		F (mg/l)	1.5		
		NO3- (mg/l)	1.0		
		NO2- (mg/l)	<0.02		
		Coliforms

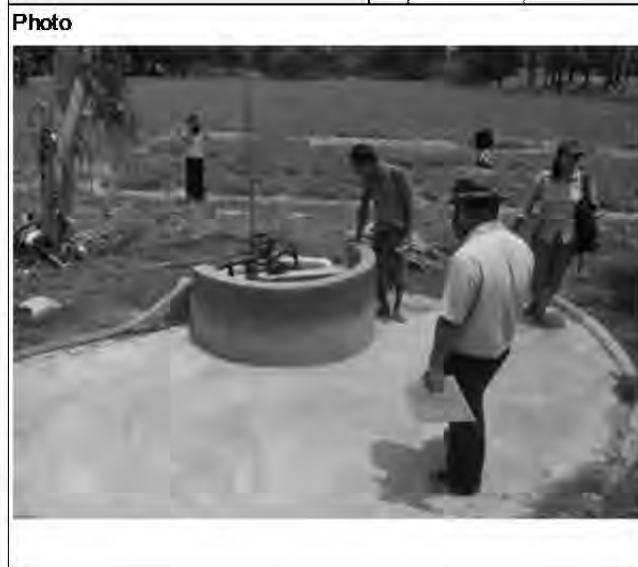
Information of Existing Water Source - 2					
Type	<input type="radio"/> Deep Well	Coordinate	X	772036	
	<input type="radio"/> Shallow Well		Y	2368666	
	<input type="radio"/> Storage reservoir				
	<input type="radio"/> Others				
Hydrogeological Information	Drilled Depth (m)	61	Results of Simplified Water Quality Test	Sample ID	MA2-15-2
	Diameter (in)	2		Temperature (°C)	30.6
	S.W.L (m)			pH	7.86
	D.W.L (m)			EC (µs/cm)	1,192
	Yield (m³/hour)			Smell	Non
	No.of users (person/day)			Color	Shallow Yellow
	Supply facilities			Mn (mg/l)	<0.02
	Remarks (Lithology , etc.)	Drilled in dugwell to use suction pump. *Target : 772248 / 2368667		Fe (mg/l)	<0.2
		F (mg/l)	0.6		
		NO3- (mg/l)	<1		
		NO2- (mg/l)	<0.02		
		Coliforms

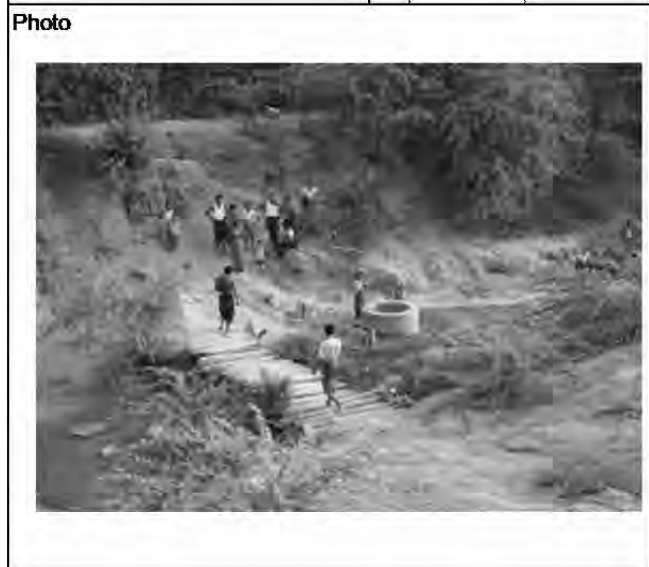
Information of Existing Water Source - 1								
Type	Deep Well	Coordinate	X	751878				
	Shallow Well		Y	2358123				
	Storage reservoir							
	○ Others <i>Dug Well</i>							
Hydrogeological Information	Drilled Depth (m)	15	Sample ID	MA2-16-1				
	Diameter (in)	1.5 m	Temperature (°C)	30.0				
	S.W.L (m)	5	pH	8.16				
	D.W.L (m)		EC (µs/cm)	2,030				
	Yield (m ³ /hour)		Smell	Slightly sour				
	No.of users (person/day)	450	Color	slightly brown				
	Supply facilities		Mn (mg/l)	<0.02				
	Remarks (Lithology , etc.)	This well is located near small stream. The stream water and is almost dry up, so that villagers wait long time for recharge. Almost villagers use only this well for drinking.						
	Fe (mg/l)						<0.2	
	F (mg/l)						3~8	
	NO3- (mg/l)						5~10	
	NO2- (mg/l)						<0.02	
	Coliforms						Too much

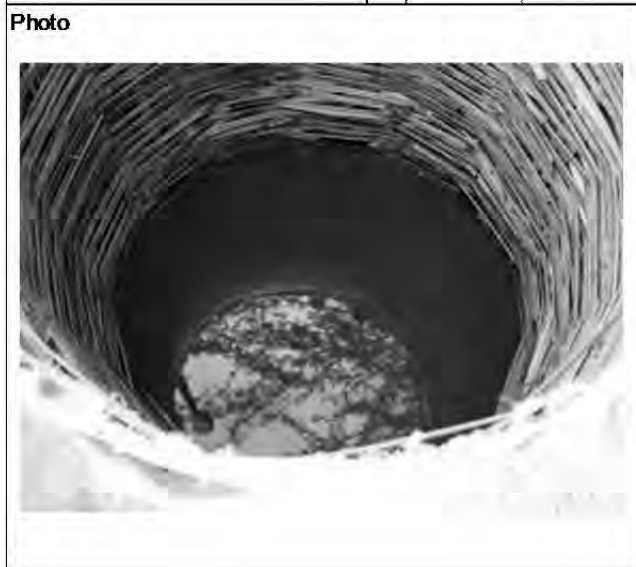
Information of Existing Water Source - 2								
Type	Deep Well	Coordinate	X	751799				
	Shallow Well		Y	2357810				
	Storage reservoir							
	○ Others <i>Dug Well</i>							
Hydrogeological Information	Drilled Depth (m)	5	Sample ID	MA2-16-2				
	Diameter (in)	1.0 m	Temperature (°C)	29.4				
	S.W.L (m)		pH	7.38				
	D.W.L (m)		EC (µs/cm)	3,450				
	Yield (m ³ /hour)		Smell	Non				
	No.of users (person/day)		Color	Slightly turbidity				
	Supply facilities		Mn (mg/l)	<0.02				
	Remarks (Lithology , etc.)	This well is located near small stream. Water is salty, they don't use for drinking.						
	Fe (mg/l)						<0.2	
	F (mg/l)						0.2	
	NO3- (mg/l)						<1	
	NO2- (mg/l)						<0.02	
	Coliforms						5

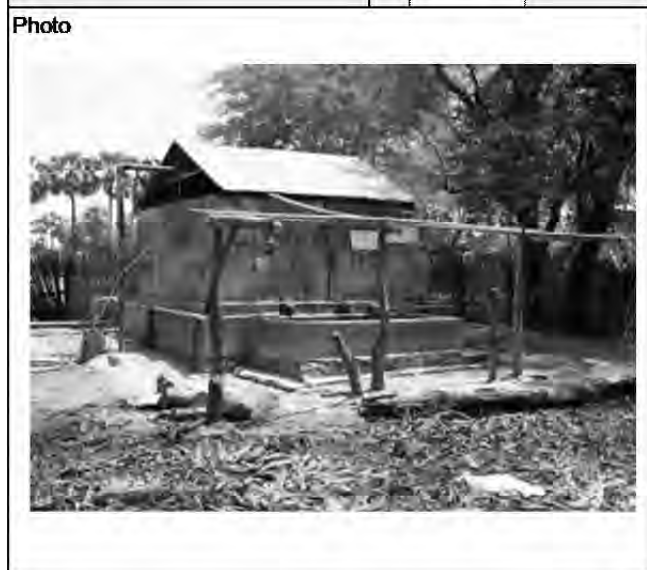
Information of Existing Water Source - 1						
Type	o Deep Well		Coordinate	X	735397	
	Shallow Well			Y	2354670	
	Storage reservoir					
	Others					
Hydrogeological Information	Drilled Depth (m)	137	Results of Simplified Water Quality Test	Sample ID	MA2-17-1	
	Diameter (in)	4		Temperature (°C)	34.7	
	S.W.L (m)	98		pH	7.33	
	D.W.L (m)			EC (µs/cm)	1483	
	Yield (m ³ /hour)	16.4		Smell	Non	
	No.of users (person/day)	800		Color	Non	
	Supply facilities	monopump		Mn (mg/l)	<0.02	
	Remarks (Lithology , etc.)			Fe (mg/l)	<0.2	
Located in monastery. This well was drilled at 35 years ago. And Villagers repaired clogging by themselves at 2 years ago. Pumping up is 3 times per day.		F (mg/l)	0.2			
		NO3- (mg/l)	<1			
		NO2- (mg/l)	<0.02			
		Coliforms

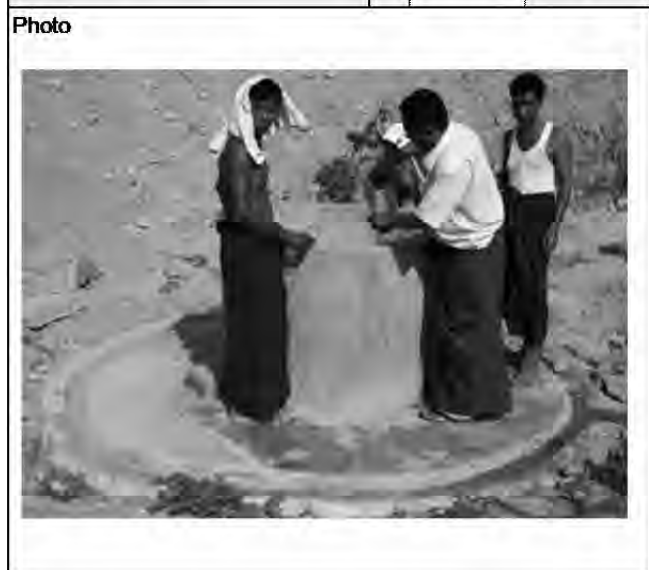
Information of Existing Water Source - 1						
Type	Deep Well	Coordinate	X	748843		
	Shallow Well		Y	2341588		
	Storage reservoir					
	○ Others <i>Dug Well</i>					
Hydrogeological Information	Drilled Depth (m)	5	Sample ID	MA2-18-1		
	Diameter (in)	1.0 m	Temperature (°C)	31.0		
	S.W.L (m)		pH	8.02		
	D.W.L (m)		EC (µs/cm)	794		
	Yield (m ³ /hour)		Smell	Non		
	No.of users (person/day)		Color	Non		
	Supply facilities		Mn (mg/l)	<0.02		
	Remarks (Lithology , etc.)	Villagers wait long time for recharge and villagers use only this well for drinking. In dry season, sometime region will supply the drinking water. but that is not regullary.This village has electric line and alomost house can use it. this village is located in Pegu area, so it is difficult to drill the deep well.		Fe (mg/l)	<0.2	
Results of Simplified Water Quality Test	F (mg/l)			0.2		
	NO3- (mg/l)			5~10		
	NO2- (mg/l)			<0.02		
	Coliforms			14

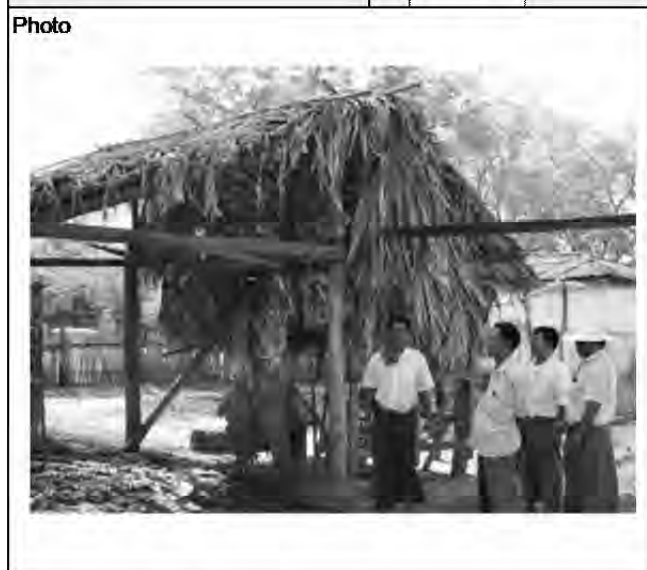
Information of Existing Water Source - 1						
Type	o Deep Well		Coordinate	X	740016	
	Shallow Well			Y	2346893	
	Storage reservoir					
	Others					
Hydrogeological Information	Drilled Depth (m)	259	Results of Simplified Water Quality Test	Sample ID	MA2-19-1	
	Diameter (in)	4		Temperature (°C)	38.0	
	S.W.L (m)	153		pH	7.38	
	D.W.L (m)			EC (µs/cm)	1,609	
	Yield (m ³ /hour)	3.6		Smell	Slightly sour	
	No.of users (person/day)	950		Color	Non	
	Supply facilities	monopump		Mn (mg/l)	<0.02	
	Remarks (Lithology , etc.)			Fe (mg/l)	<0.2	
Drilled in around 1980. BAJ maintained in 2010. Water is not enough in dry season. Neighbor vilage also has same depth well.		F (mg/l)	<0			
		NO3- (mg/l)	<1			
		NO2- (mg/l)	<0.02			
		Coliforms

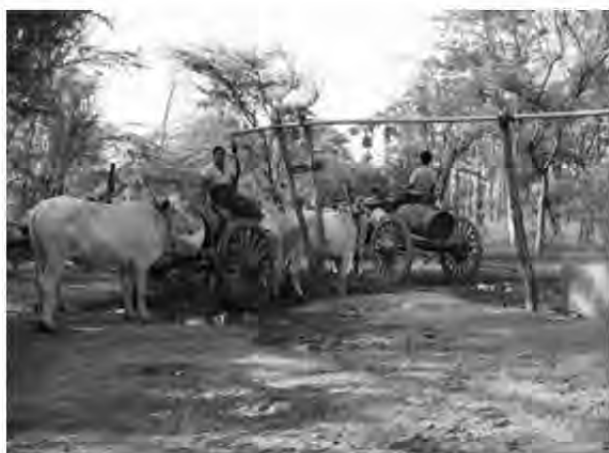
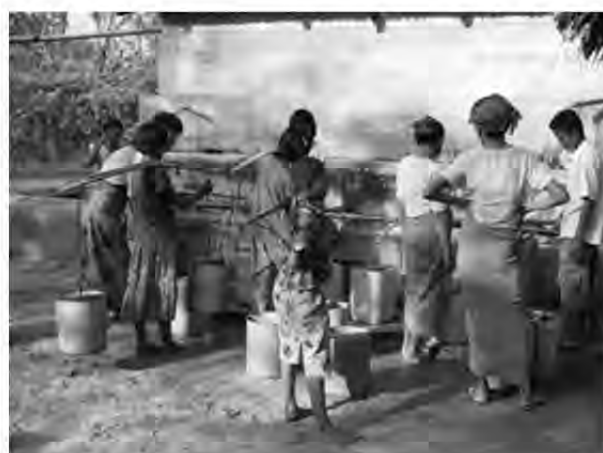
Drilled in 1981. Village repaired by own budget when pump and generator was broken. Tharzi village (MA2-19) is very near. Using same aquifer?		F (mg/l)	0			F (mg/l)					
		NO3- (mg/l)	<1			NO3- (mg/l)					
		NO2- (mg/l)	<0.02			NO2- (mg/l)					
		Coliforms	19			Coliforms

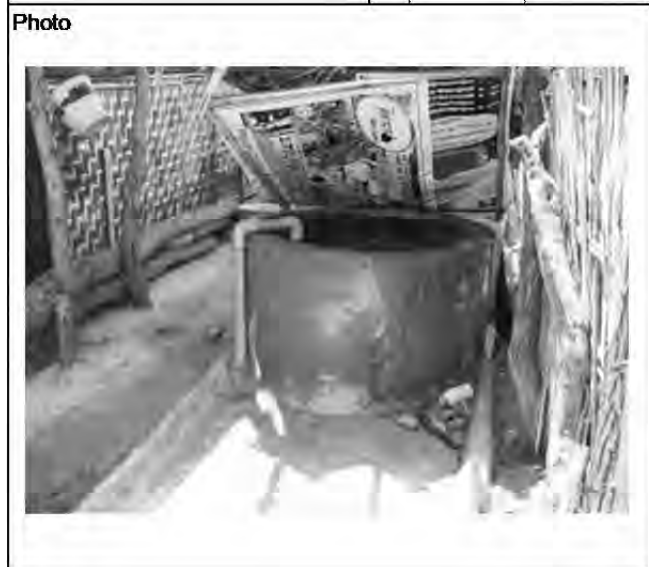
Information of Existing Water Source - 1						
Type	Deep Well	Coordinate	X	745668		
	Shallow Well		Y	2342355		
	Storage reservoir					
	Others					
Hydrogeological Information	Drilled Depth (m)	36	Results of Simplified Water Quality Test	Sample ID	MA2-21-1	
	Diameter (in)	2		Temperature (°C)	29.8	
	S.W.L (m)			pH	8.41	
	D.W.L (m)			EC (µs/cm)	4,440	
	Yield (m ³ /hour)	3.6		Smell	Non	
	No.of users (person/day)			Color	Non	
	Supply facilities	motor pump		Mn (mg/l)	<0.02	
	Remarks (Lithology , etc.)			Fe (mg/l)	<0.2	
Village has 12 shallow well and all of well depth is around 36 - 54m. They used to share with neighboring house. some house can use electricity and pump up by motor. But sometime electricity can't use during several hours by brack out.			F (mg/l)	1.5~3		
			NO3- (mg/l)	45<		
			NO2- (mg/l)	0.5~1		
			Coliforms	7

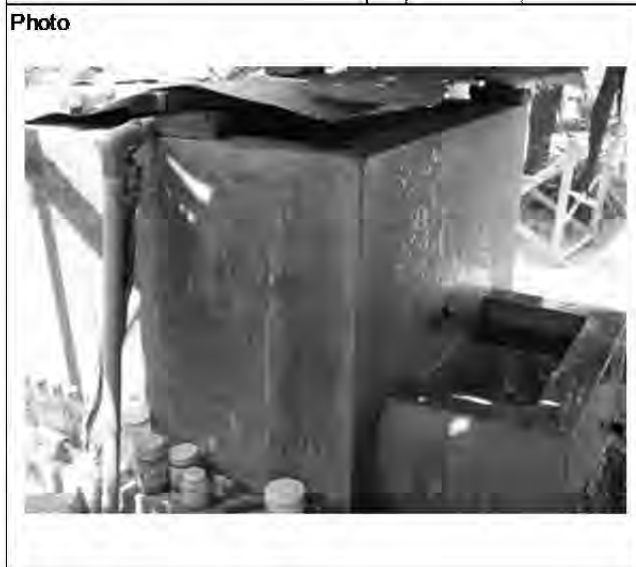
Information of Existing Water Source - 2						
Type	Deep Well	Coordinate	X	745625		
	Shallow Well		Y	2342444		
	Storage reservoir					
	Others					
Hydrogeological Information	Drilled Depth (m)	54	Results of Simplified Water Quality Test	Sample ID	MA2-21-2	
	Diameter (in)	2		Temperature (°C)	29.1	
	S.W.L (m)			pH	8.15	
	D.W.L (m)			EC (µs/cm)	3,460	
	Yield (m ³ /hour)	3.6		Smell	Non	
	No.of users (person/day)			Color	Non	
	Supply facilities	motor pump		Mn (mg/l)	<0.02	
	Remarks (Lithology , etc.)			Fe (mg/l)	<0.2	
all of well have small tank. They request big tank. In 1980, 100m depth well was drilled. but that well became salty aroud 4 - 5 years. they already stoped to use now. Simple water quality test is carried out 6 well. all of them have high flouride.			F (mg/l)	1.5		
			NO3- (mg/l)	45<		
			NO2- (mg/l)	<0.2		
			Coliforms	Too much

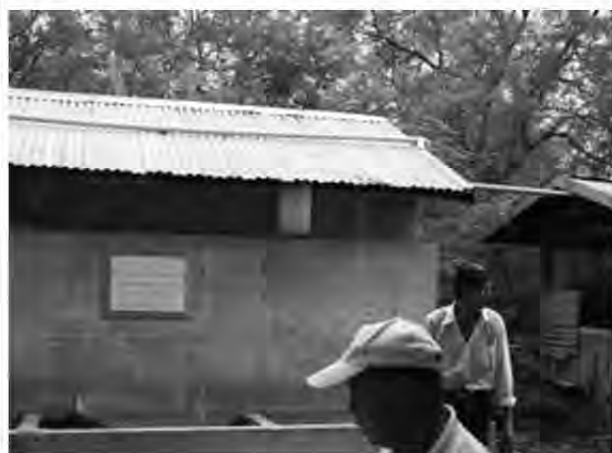
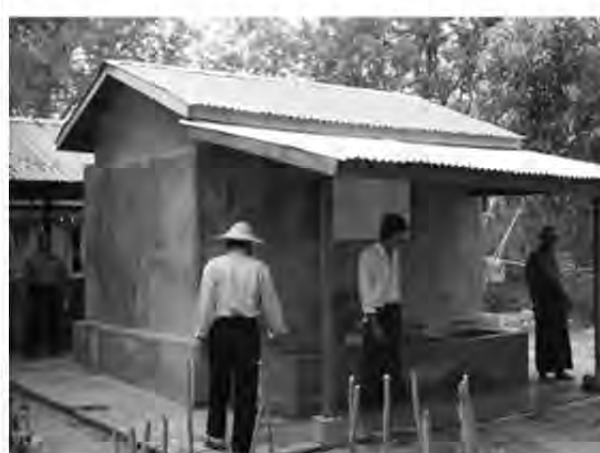
Information of Existing Water Source - 1				Information of Existing Water Source - 2							
Type	○ Deep Well		Coordinate	X	826855	Type	○ Deep Well		Coordinate	X	826620
	Shallow Well			Y	2270738		Shallow Well			Y	2271085
	Storage reservoir						Storage reservoir				
	Others						Others				
Hydrogeological Information	Drilled Depth (m)	235	Results of Simplified Water Quality Test	Sample ID	MA2-22-1	Hydrogeological Information	Drilled Depth (m)	82	Results of Simplified Water Quality Test	Sample ID	MA2-22-2
	Diameter (in)	2		Temperature (°C)	35.1		Diameter (in)	2		Temperature (°C)	28.7
	S.W.L (m)			pH	8.18		S.W.L (m)			pH	8.20
	D.W.L (m)			EC (µs/cm)	635		D.W.L (m)			EC (µs/cm)	919
	Yield (m³/hour)	4.5		Smell	Non		Yield (m³/hour)			Smell	Non
	No.of users (person/day)			Color	Non		No.of users (person/day)			Color	Non
	Supply facilities	compressor		Mn (mg/l)	<0.02		Supply facilities	compressor		Mn (mg/l)	<0.02

Remarks (Lithology , etc.)			Fe (mg/l)	<0.2		Remarks (Lithology , etc.)			Fe (mg/l)	<0.2
There is residents suffering from kidney stones after 5 years start to drinking. Under repairing due to the engine trouble.			F (mg/l)	0.2	Located in monastery.			F (mg/l)	0.2		
			NO3- (mg/l)	<1				NO3- (mg/l)	<1		
			NO2- (mg/l)	<0.02				NO2- (mg/l)	<0.02		
			Coliforms					Coliforms

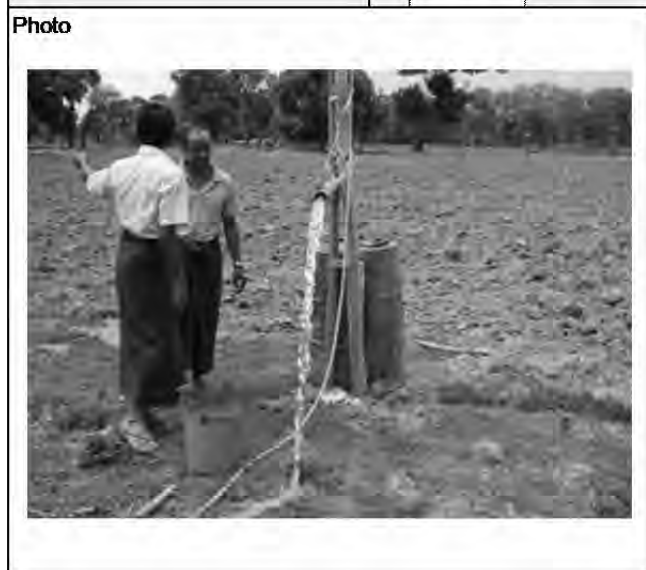
Information of Existing Water Source - 1						
Type	Deep Well	Coordinate	X	828635		
	Shallow Well		Y	2246064		
	Storage reservoir					
	Others					
Hydrogeological Information	Drilled Depth (m)	55	Sample ID	MA2-23-1		
	Diameter (in)	2	Temperature (°C)	30.0		
	S.W.L (m)		pH	8.09		
	D.W.L (m)		EC (µs/cm)	2,020		
	Yield (m ³ /hour)	2.2	Smell	Non		
	No.of users (person/day)	20HH	Color	Slightly muddy		
	Supply facilities	compresser	Mn (mg/l)	<0.02		
	Remarks (Lithology , etc.) a bit salty and included sand. But this water can use to drinking. Pump displacement is not so much, and also the number of using households is not much.			Fe (mg/l)	<0.2	
F (mg/l)				0.8		
NO3- (mg/l)				<1		
NO2- (mg/l)				<0.02		
Coliforms				5

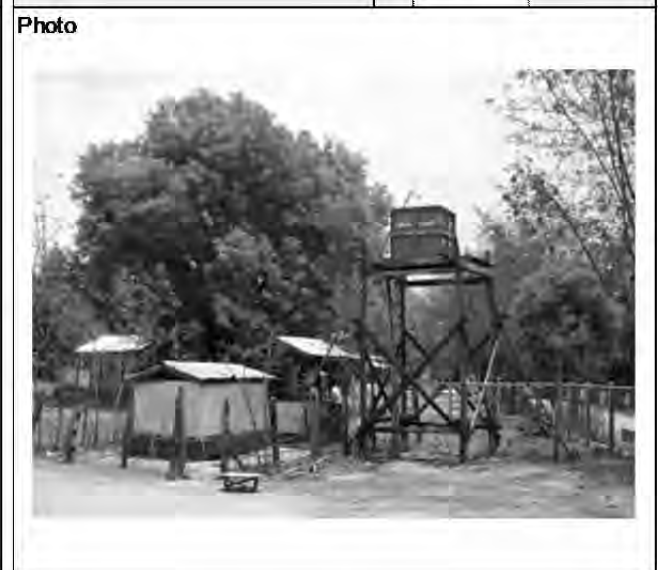
Information of Existing Water Source - 2						
Type	Deep Well	Coordinate	X	829123		
	Shallow Well		Y	2246062		
	Storage reservoir					
	Others					
Hydrogeological Information	Drilled Depth (m)	220	Sample ID	MA2-23-2		
	Diameter (in)	2	Temperature (°C)	31.3		
	S.W.L (m)	200	pH	8.51		
	D.W.L (m)		EC (µs/cm)	1,983		
	Yield (m ³ /hour)	3.6	Smell	Non		
	No.of users (person/day)	50HH	Color	Non		
	Supply facilities	compresser	Mn (mg/l)	<0.02		
	Remarks (Lithology , etc.) this village has 2 deep well. Another one is not used much due to the pumping cost. Some house can use this water by distributed pipe.			Fe (mg/l)	<0.2	
F (mg/l)				1.5		
NO3- (mg/l)				<1		
NO2- (mg/l)				<0.02		
Coliforms

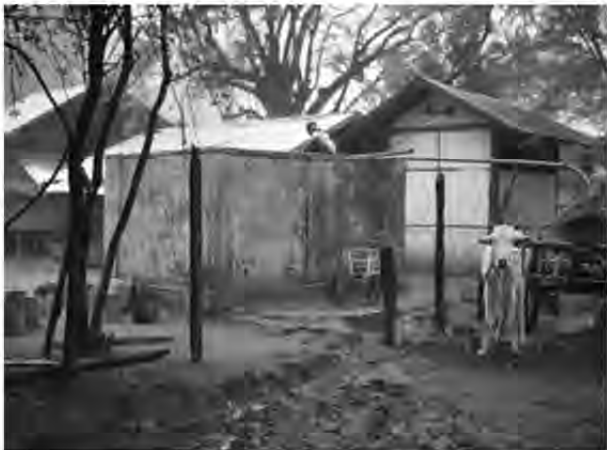
Information of Existing Water Source - 1						Information of Existing Water Source - 2					
Type	○ Deep Well		Coordinate	X	804392	Type	Deep Well		Coordinate	X	
	Shallow Well			Y	2275367		Shallow Well			Y	
	Storage reservoir						Storage reservoir				
	Others						Others				
Hydrogeological Information	Drilled Depth (m)		Results of Simplified Water Quality Test	Sample ID	MA2-24-1	Hydrogeological Information	Drilled Depth (m)		Results of Simplified Water Quality Test	Sample ID	
	Diameter (in)			Temperature (°C)	30.1		Diameter (in)			Temperature (°C)	
	S.W.L (m)			pH	8.36		S.W.L (m)			pH	
	D.W.L (m)			EC (µs/cm)	4,140		D.W.L (m)			EC (µs/cm)	
	Yield (m ³ /hour)			Smell	Non		Yield (m ³ /hour)			Smell	
	No.of users (person/day)			Color	Non		No.of users (person/day)			Color	
	Supply facilities			Mn (mg/l)	<0.02		Supply facilities			Mn (mg/l)	
	Remarks (Lithology , etc.)						Fe (mg/l)	<0.2		Remarks (Lithology , etc.)

This village can get drinking water from only this well. If water is not enough, residents go to Waryonesu (MA2-25).				F (mg/l)	0					F (mg/l)	
				NO3- (mg/l)	<1			NO3- (mg/l)			
				NO2- (mg/l)	<0.02			NO2- (mg/l)			
				Coliforms				Coliforms			
Photo						Photo

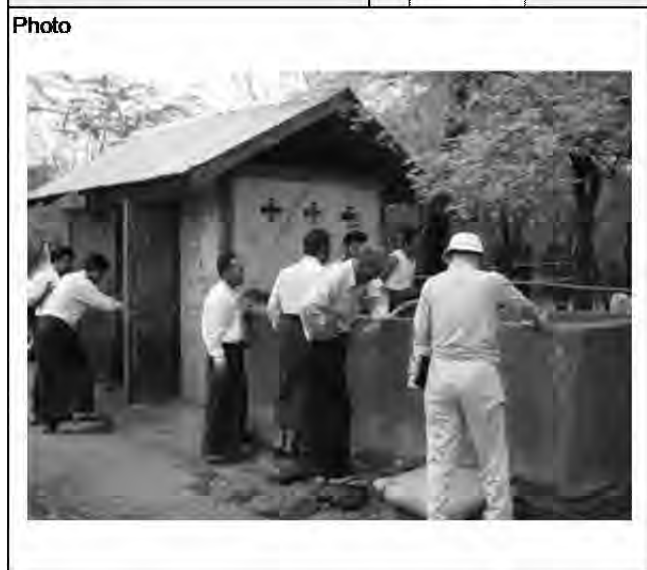
Information of Existing Water Source - 1						
Type	○ Deep Well		Coordinate	X	804775	
	Shallow Well			Y	2275467	
	Storage reservoir					
	Others					
Hydrogeological Information	Drilled Depth (m)	116	Results of Simplified Water Quality Test	Sample ID	MA2-25-1	
	Diameter (in)	2		Temperature (°C)	30.0	
	S.W.L (m)	11		pH	8.40	
	D.W.L (m)			EC (µs/cm)	1,986	
	Yield (m ³ /hour)	1.4		Smell	Non	
	No.of users (person/day)	100		Color	Non	
	Supply facilities	compressor		Mn (mg/l)	<0.02	
	Remarks (Lithology , etc.)			Fe (mg/l)	<0.2	
Concrete tank(W=2.5m,L=1m,H=1m) water is supplied by hose.			F (mg/l)	0		
			NO3- (mg/l)	<1		
			NO2- (mg/l)	<0.02		
			Coliforms
