Appendix 5.3.1 Result of Field Water Quality Measurement

Result of Field Water Quality Measurement (Sagaing Region-1)

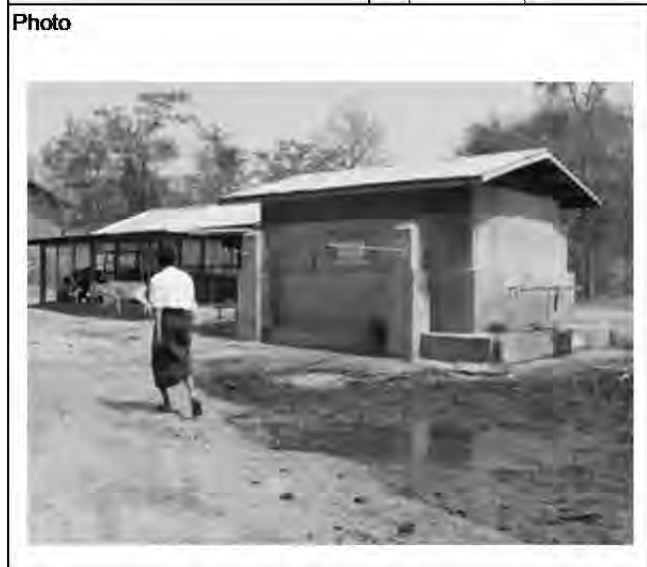
Information of Existing Water Source - 1				
Type	Deep Well	Coordinate	X	
	Shallow Well		Y	
	Storage reservoir			
	Others			
Hydrogeological Information	Drilled Depth (m)	Results of Simplified Water Quality Test	Sample ID	MA2-28
	Diameter (in)		Temperature (°C)	
	S.W.L (m)		pH	
	D.W.L (m)		EC (µs/cm)	
	Yield (m³/hour)		Smell	
	No.of users (person/day)		Color	
	Supply facilities		Mn (mg/l)	
	Remarks (Lithology , etc.)		Fe (mg/l)	
Existing tube well but low yield, another tube well drilled by BAJ(900 gph).	F (mg/l)			
	NO3- (mg/l)			
	NO2- (mg/l)			
	Coliforms

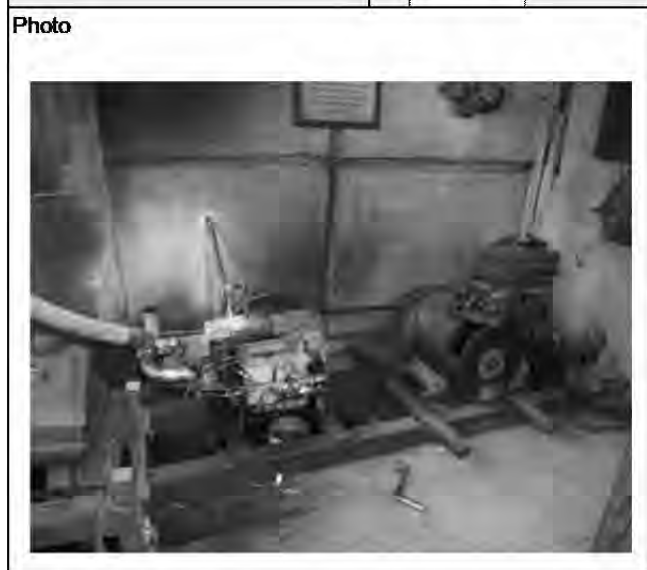
Information of Existing Water Source - 1					
Type	<input type="radio"/> Deep Well	Coordinate	X	709762	
	<input type="radio"/> Shallow Well		Y	2328729	
	<input type="radio"/> Storage reservoir				
	<input type="radio"/> Others				
Hydrogeological Information	Drilled Depth (m)	200	Results of Simplified Water Quality Test	Sample ID	MA2-29-1
	Diameter (in)	6		Temperature (°C)	35.7
	S.W.L (m)			pH	7.06
	D.W.L (m)			EC (µs/cm)	1,036
	Yield (m³/hour)	5.9		Smell	Non
	No.of users (person/day)			Color	Non
	Supply facilities	Submersible pump		Mn (mg/l)	<0.02
	Remarks (Lithology , etc.)	Drilled by BAJ in 2003		Fe (mg/l)	<0.2
			F (mg/l)	0.1	
			NO3-(mg/l)		
			NO2-(mg/l)	<0.02	
			Coliforms

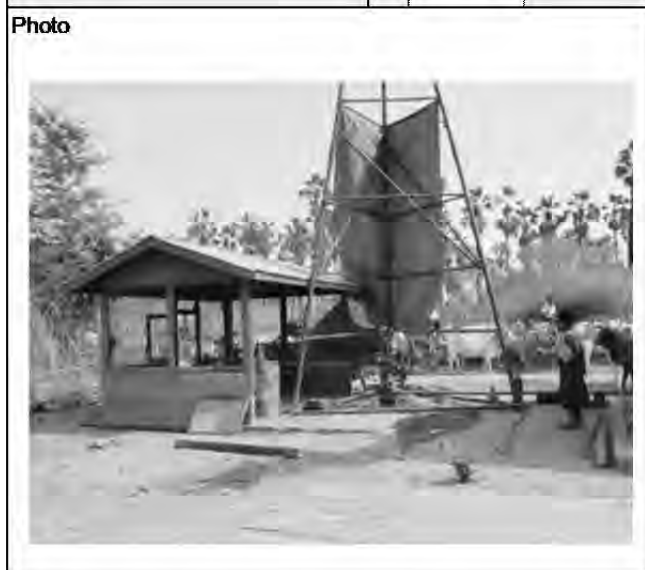
Information of Existing Water Source - 1					
Type	○ Deep Well		Coordinate	X	719325
	Shallow Well			Y	2332051
	Storage reservoir				
	Others				
Hydrogeological Information	Drilled Depth (m)	280	Results of Simplified Water Quality Test	Sample ID	MA2-30-1
	Diameter (in)	4		Temperature (°C)	36.3
	S.W.L (m)	219		pH	6.77
	D.W.L (m)			EC (µs/cm)	1,239
	Yield (m³/hour)	3.6		Smell	Iron smell
	No.of users (person/day)			Color	Shallow whie
	Supply facilities			Mn (mg/l)	<0.02
	Remarks (Lithology , etc.)	Pump position 830ft, BAJ just rehabilitated cleaned element.		Fe (mg/l)	1
			F (mg/l)	0.5	
			NO3- (mg/l)		
			NO2- (mg/l)	<0.02	
			Coliforms

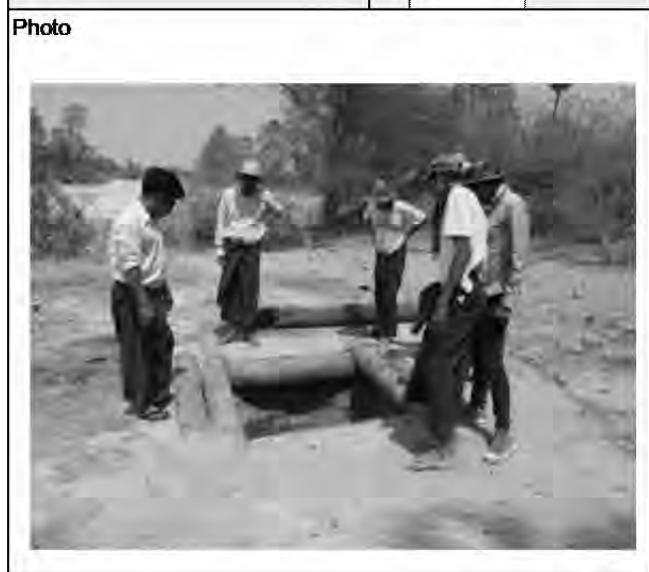
Information of Existing Water Source - 1				
Type	Deep Well	Coordinate	X	724266
	Shallow Well		Y	2337196
	Storage reservoir			
	○ Others(Dug Well)			
Hydrogeological Information	Drilled Depth (m)	Results of Simplified Water Quality Test	Sample ID	MA2-31-1
	Diameter (in)		Temperature (°C)	27.5
	S.W.L (m)		pH	8.05
	D.W.L (m)		EC (µs/cm)	500
	Yield (m ³ /hour)		Smell	Non
	No.of users (person/day)		Color	Non
	Supply facilities		Mn (mg/l)	<0.02
	Remarks (Lithology , etc.)		Fe (mg/l)	<0.02
Dug well in the pond. Oyintaungyartan is next to the target village.	F (mg/l)	0		
	NO3-(mg/l)			
	NO2-(mg/l)	<0.02		
	Coliforms

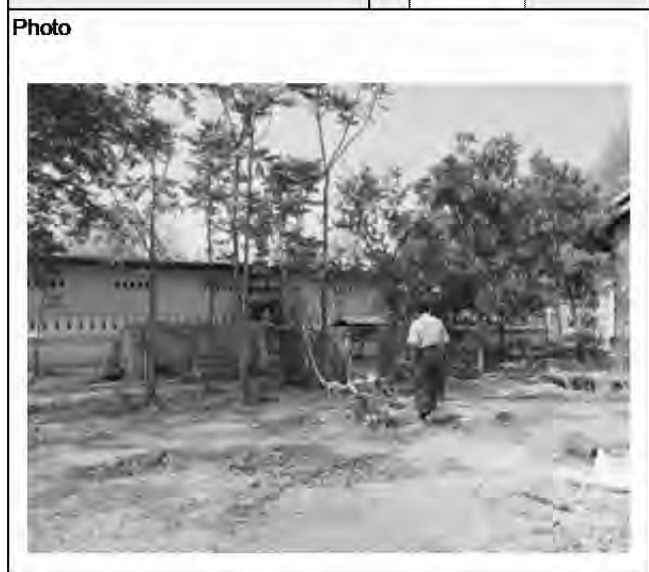
Information of Existing Water Source - 1				
Type	<input type="radio"/> Deep Well	Coordinate	X	703729
	<input type="checkbox"/> Shallow Well		Y	2334750
	<input type="checkbox"/> Storage reservoir			
	<input type="checkbox"/> Others			
Hydrogeological Information	Drilled Depth (m)	152	Sample ID	MA2-32-1
	Diameter (in)		Temperature (°C)	31.6
	S.W.L (m)	37	pH	7.33
	D.W.L (m)	Big	EC (µs/cm)	1,043
	Yield (m³/hour)		Smell	Non
	No. of users (person/day)		Color	Non
	Supply facilities	Submersible pump	Mn (mg/l)	<0.02
	Remarks (Lithology, etc.)		Fe (mg/l)	<0.2
Pump position - 440 ft About 1.5 miles from Phonenekan village. Taungpon village is next to the target village.		F (mg/l)	0.7	
		NO3- (mg/l)		
		NO2- (mg/l)	<0.02	
		Coliforms

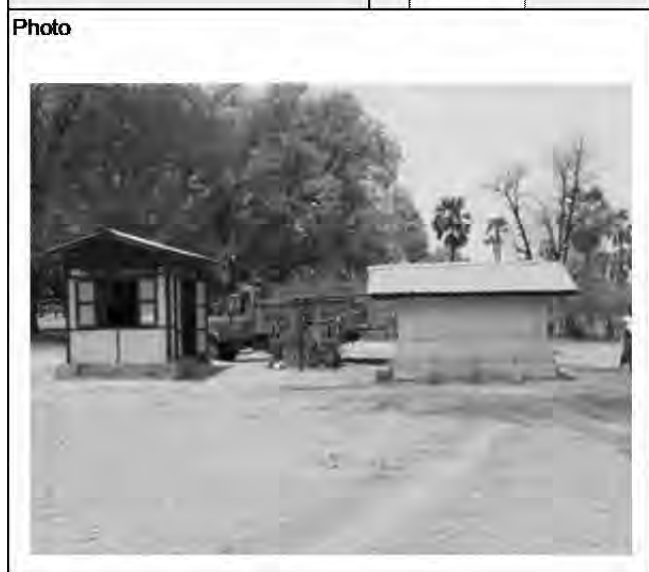
Information of Existing Water Source - 1				
Type	<input type="radio"/> Deep Well	Coordinate	X	725695
	<input type="radio"/> Shallow Well		Y	2329987
	<input type="radio"/> Storage reservoir			
	<input type="radio"/> Others			
Hydrogeological Information	Drilled Depth (m)	365	Sample ID	MA2-34-1
	Diameter (in)		Temperature (°C)	34.6
	S.W.L (m)		pH	7.37
	D.W.L (m)		EC (µs/cm)	814
	Yield (m³/hour)		Smell	Iron smell
	No.of users (person/day)		Color	Non
	Supply facilities	Pump	Mn (mg/l)	<0.02
	Remarks (Lithology , etc.) JICA well. Kudaw village is next to the target village.		Results of Simplified Water Quality Test	
Fe (mg/l)			0.6	
F (mg/l)			0.2	
NO3-(mg/l)				
NO2-(mg/l)			<0.02	
		Coliforms

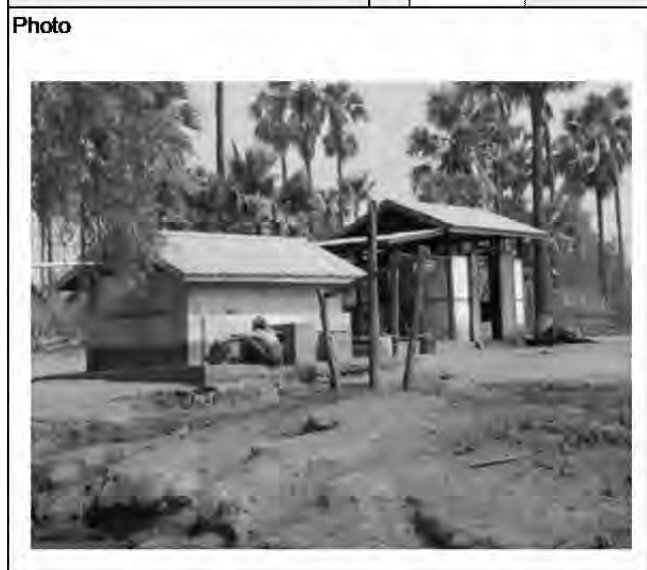
Information of Existing Water Source - 1					
Type	○ Deep Well	Coordinate	X	724027	
	Shallow Well		Y	2324767	
	Storage reservoir				
	Others				
Hydrogeological Information	Drilled Depth (m)	309	Results of Simplified Water Quality Test	Sample ID	MA2-35-1
	Diameter (in)	6		Temperature (°C)	
	S.W.L (m)	236		pH	7.61
	D.W.L (m)	239		EC (µs/cm)	908
	Yield (m³/hour)	8.2		Smell	Non
	No. of users (person/day)			Color	Non
	Supply facilities	Mono pump		Mn (mg/l)	<0.02
	Remarks (Lithology , etc.)			Fe (mg/l)	<0.2
		F (mg/l)	0.1		
		NO3- (mg/l)			
		NO2- (mg/l)	<0.02		
		Coliforms

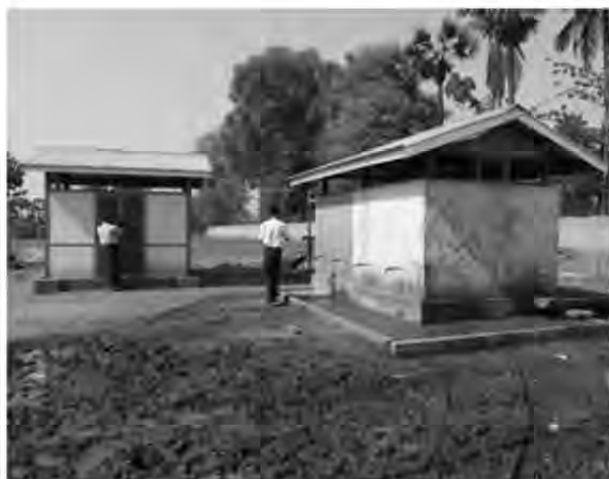
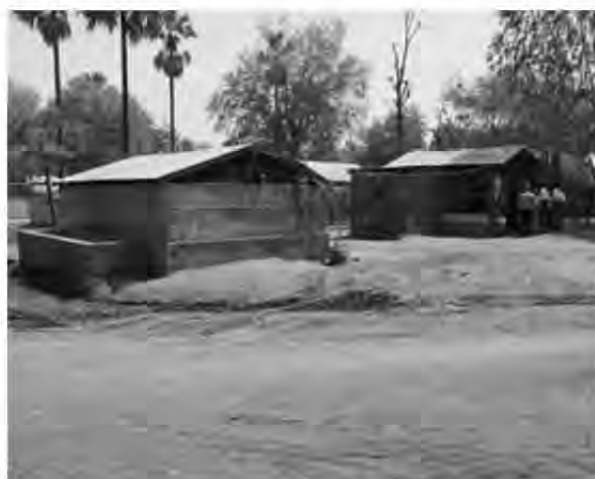
Supply facilities		Mn (mg/l)	3		Supply facilities		Mn (mg/l)	1
	Remarks (Lithology , etc.)		Results of Simplified Water Quality Test			Remarks (Lithology , etc.)		Results of Simplified Water Quality Test	
Iron contents is very high and a little sour.		Fe (mg/l)	>10	Dagagayi is northern part of Aleyawa 2 and 2 km far . Drilled 33 years ago. This tube well is slightly deeper than other well 4-6 deeper.		Fe (mg/l)	3		
		F (mg/l)	0.6			F (mg/l)	0.2		
		NO3- (mg/l)				NO3- (mg/l)	<1		
		NO2- (mg/l)	<0.02			NO2- (mg/l)	<0.02		
		Coliforms				Coliforms

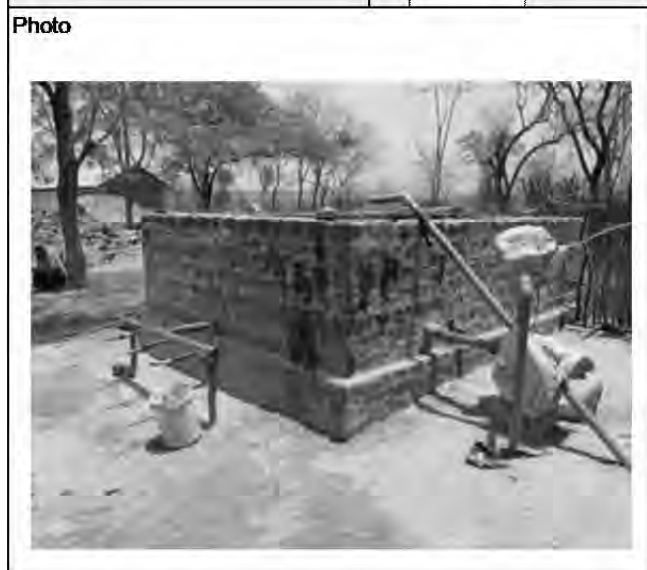
Information of Existing Water Source - 1				
Type	o Deep Well	Coordinate	X	729384
	Shallow Well		Y	2325075
	Storage reservoir			
	Others			
Hydrogeological Information	Drilled Depth (m)	300	Sample ID	MA2-39-1
	Diameter (in)	4	Temperature (°C)	32.8
	S.W.L (m)	226	pH	7.11
	D.W.L (m)		EC (µs/cm)	947
	Yield (m ³ /hour)	2.7	Smell	Non
	No.of users (person/day)		Color	Non
	Supply facilities		Mn (mg/l)	<1
	Remarks (Lithology , etc.)		Fe (mg/l)	<0.2
		F (mg/l)	<0.1	
		NO3- (mg/l)		
		NO2- (mg/l)	<0.02	
		Coliforms

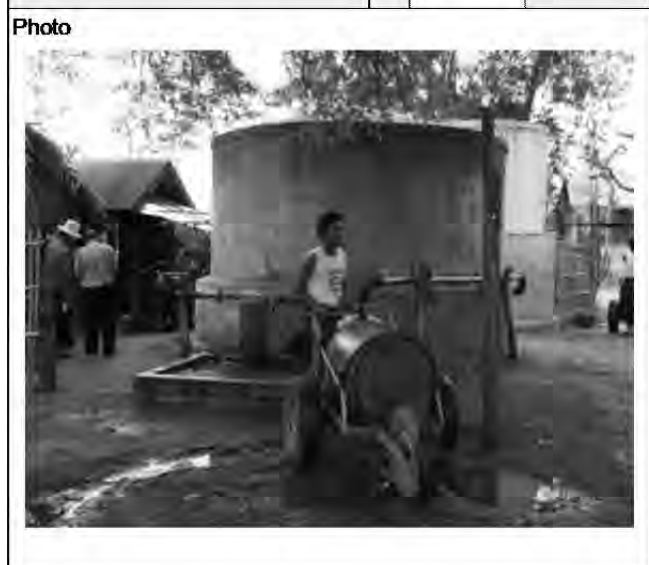
Region	Magway		Date	2015/5/13
Township	Magway		Reported by	Maruo
Village / ID	Natkan	MG2-01	Coordinate (WGS84 UTM)	X
			Y

Information of Existing Water Source - 1						
Type	○ Deep Well	Coordinate	X	706494		
	Shallow Well		Y	2234069		
	Storage reservoir		/			
	Others					
Hydrogeological Information	Drilled Depth (m)	174	Sample ID	MG2-1-1		
	Diameter (in)	4	Temperature (°C)	31.4		
	S.W.L (m)	73	pH	7.16		
	D.W.L (m)		EC (µs/cm)	988		
	Yield (m³/hour)	5.0	Smell	Non		
	No. of users (person/day)		Color	Non		
	Supply facilities	Pump	Mn (mg/l)	0		
	Remarks (Lithology, etc.)	Results of Simplified Water Quality Test				
Drilled by DDA in 2014						
	Fe (mg/l)					0.4
	F (mg/l)					0.4
	NO3- (mg/l)					
	NO2- (mg/l)	<0.02				
	Coliforms

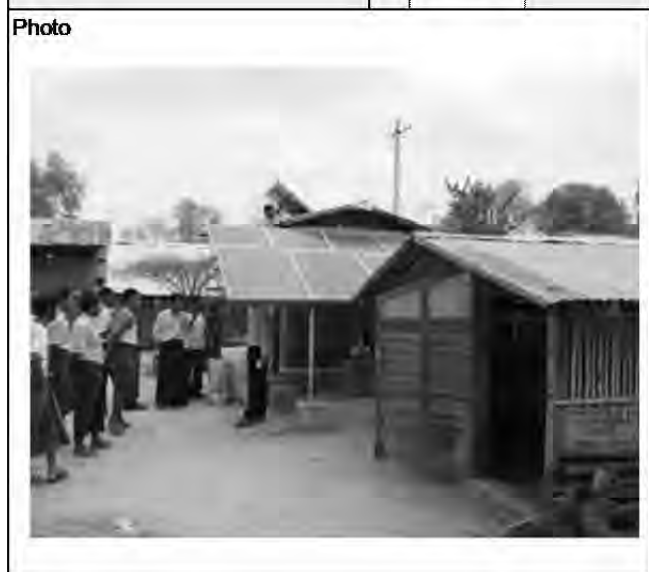
Region	Magway		Date	2015/5/19
Township	Magway		Reported by	Maruo
Village / ID	Thanbo(Ywarthit)	MG2-02	Coordinate (WGS84 UTM)	X
			Y

Information of Existing Water Source - 1					
Type	○ Deep Well	Coordinate	X	776115	
	Shallow Well		Y	2216165	
	Storage reservoir				
	Others				
Hydrogeological Information	Drilled Depth (m)	120.3	Results of Simplified Water Quality Test	Sample ID	MG2-2-1
	Diameter (in)	4		Temperature (°C)	32.0
	S.W.L (m)	84		pH	7.16
	D.W.L (m)			EC (µs/cm)	1,494
	Yield (m³/hour)			Smell	Non
	No.of users (person/day)			Color	Non
	Supply facilities	Pump		Mn (mg/l)	<1
	Remarks (Lithology , etc.)	Slightly salty Borehole drilled in 1999 by SPDC.		Fe (mg/l)	<0.2
			F (mg/l)	0.6	
			NO3-(mg/l)	3.0	
			NO2-(mg/l)	0.1	
			Coliforms

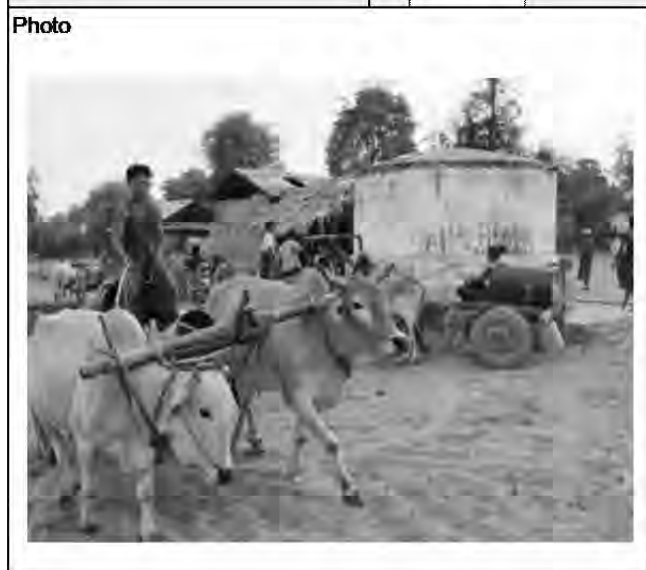
Region	Magway		Date	2015/5/12
Township	Magway		Reported by	Maruo
Village / ID	Nyaungbinthar	MG2-03	Coordinate (WGS84 UTM)	X
			Y

Information of Existing Water Source - 1					
Type	o Deep Well	Coordinate	X	736944	
	Shallow Well		Y	2243982	
	Storage reservoir				
	Others				
Hydrogeological Information	Drilled Depth (m)	120	Results of Simplified Water Quality Test	Sample ID	MG2-3-1
	Diameter (in)	4		Temperature (°C)	32.6
	S.W.L (m)	154		pH	7.30
	D.W.L (m)			EC (µs/cm)	1,067
	Yield (m³/hour)	6.4		Smell	Non
	No.of users (person/day)			Color	Non
	Supply facilities			Mn (mg/l)	<1
	Remarks (Lithology , etc.)			Fe (mg/l)	<0.02
		F (mg/l)	0.1		
		NO3- (mg/l)			
		NO2- (mg/l)	<0.02		
		Coliforms

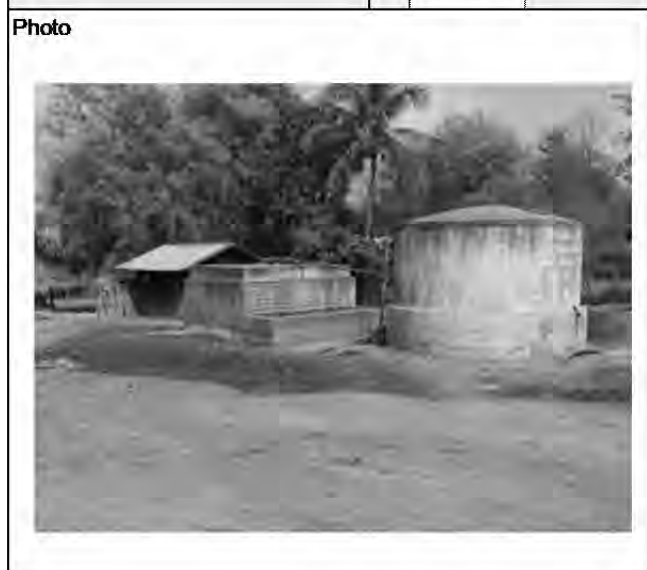
Region	Magway		Date	2015/5/15
Township	Magway		Reported by	Maruo
Village / ID	Konegyi	MG2-04	Coordinate (WGS84 UTM)	X
			Y

Information of Existing Water Source - 1					
Type	○ Deep Well	Coordinate	X	718611	
	Shallow Well		Y	2237657	
	Storage reservoir				
	Others				
Hydrogeological Information	Drilled Depth (m)	220	Results of Simplified Water Quality Test	Sample ID	MG2-4-1
	Diameter (in)	6		Temperature (°C)	33.0
	S.W.L (m)	134		pH	7.11
	D.W.L (m)			EC (µs/cm)	1,010
	Yield (m³/hour)	9.1		Smell	Slightly iron
	No.of users (person/day)			Color	Non
	Supply facilities	Mono pump		Mn (mg/l)	<1
	Remarks (Lithology , etc.)	Drilled originally in 1978 Repaired in 2004. Again in 2014 by BAJ.		Fe (mg/l)	0.3
			F (mg/l)	0.3	
			NO3- (mg/l)	<1	
			NO2- (mg/l)	<0.02	
			Coliforms

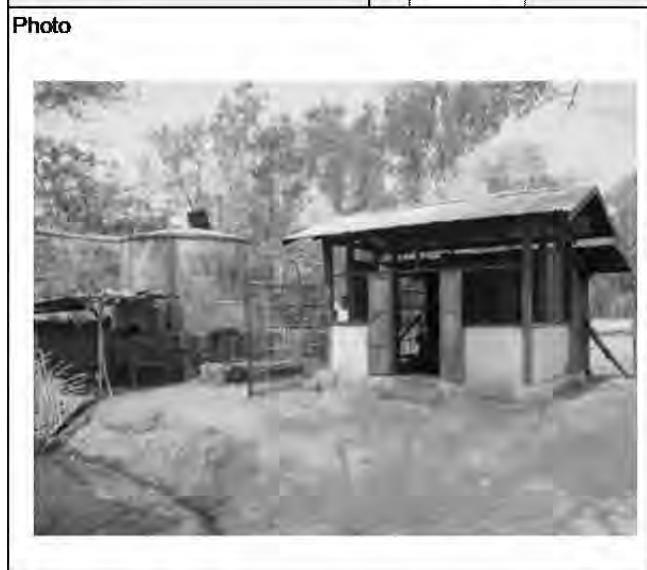
Region	Magway		Date	2015/5/16
Township	Magway		Reported by	Maruo
Village / ID	Sainggya	MG2-05	Coordinate (WGS84 UTM)	X
			Y

Information of Existing Water Source - 1					
Type	<input type="radio"/> Deep Well	Coordinate	X	725131	
	<input type="radio"/> Shallow Well		Y	2213520	
	<input type="radio"/> Storage reservoir				
	<input type="radio"/> Others				
Hydrogeological Information	Drilled Depth (m)	200	Sample ID	MG2-5-1	
	Diameter (in)	4	Temperature (°C)	33.4	
	S.W.L (m)	153	pH	7.23	
	D.W.L (m)		EC (µs/cm)	1,460	
	Yield (m ³ /hour)	5.5	Smell	Slightly iron	
	No.of users (person/day)		Color	Non	
	Supply facilities		Mn (mg/l)	<1	
	Remarks (Lithology , etc.)	Results of Simplified Water Quality Test			
BAJ replaced Mono pump Bore hole drilled in 1985 by WRUD.					
	Fe (mg/l)				0.7
	F (mg/l)				0.3
	NO3- (mg/l)				<1
	NO2- (mg/l)	<0.02			
	Coliforms

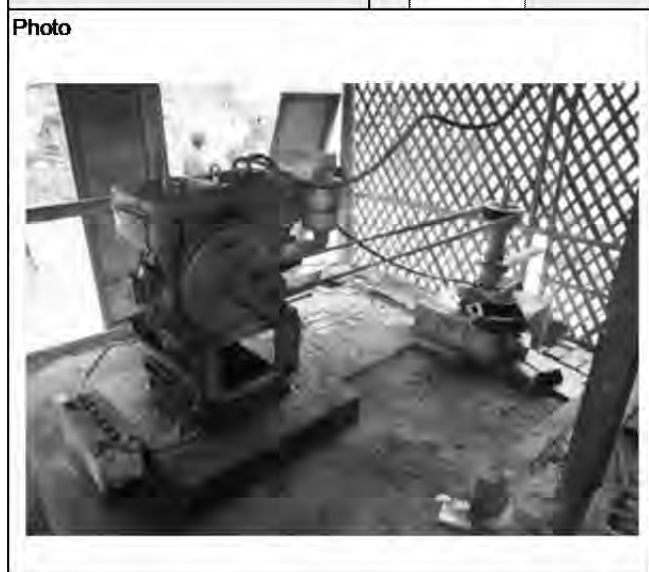
Region	Magway		Date	2015/5/15
Township	Magway		Reported by	Maruo
Village / ID	Thapyaysan(N)	MG2-06	Coordinate (WGS84 UTM)	X
			Y

Information of Existing Water Source - 1				
Type	o Deep Well	Coordinate	X	712184
	Shallow Well		Y	2227130
	Storage reservoir			
	Others			
Hydrogeological Information	Drilled Depth (m)	189	Sample ID	MG2-6-1
	Diameter (in)	6	Temperature (°C)	35.5
	S.W.L (m)	97	pH	7.32
	D.W.L (m)		EC (µs/cm)	1,108
	Yield (m ³ /hour)	9.1	Smell	Slightly iron
	No.of users (person/day)		Color	Non
	Supply facilities		Mn (mg/l)	<1
	Remarks (Lithology , etc.)	Results of Simplified Water Quality Test		
Chinese generator with MONO 640-A- Pump		Fe (mg/l)	0.2	
		F (mg/l)	0.5	
		NO3- (mg/l)	2.0	
		NO2- (mg/l)	<0.02	
		Coliforms

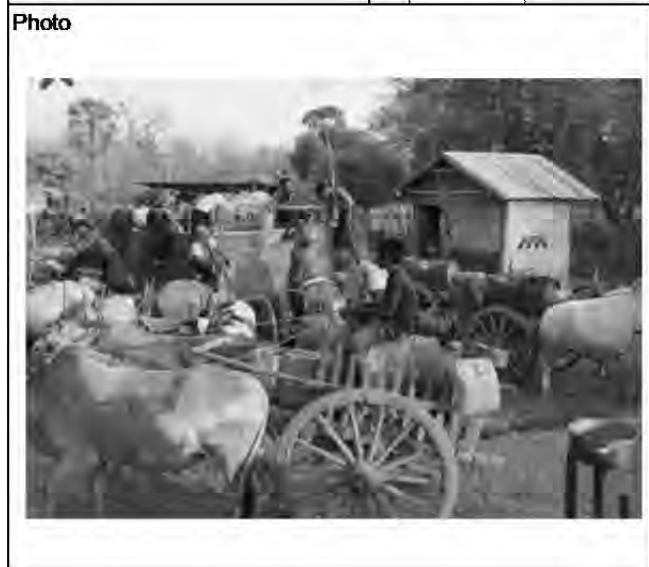
Region	Magway		Date	2015/5/12
Township	Magway		Reported by	Maruo
Village / ID	Leikkan	MG2-08	Coordinate (WGS84 UTM)	X
			Y

Information of Existing Water Source - 1			
Type	<input type="radio"/> Deep Well	Coordinate	X 726925
	<input type="radio"/> Shallow Well		Y 2239707
	<input type="radio"/> Storage reservoir		
	<input type="radio"/> Others		
Hydrogeological Information	Drilled Depth (m)	114	Results of Simplified Water Quality Test
	Diameter (in)	6	
	S.W.L (m)		
	D.W.L (m)		
	Yield (m³/hour)	5.9	
	No.of users (person/day)		
	Supply facilities	Pump	
	Sample ID	MG2-8-1	
	Temperature (°C)	31.8	
	pH	7.0	
	EC (µs/cm)	872	
	Smell	Slightly iron	
	Color	Non	
	Mn (mg/l)	<1	
	Fe (mg/l)	0.3	
	F (mg/l)	0.2	
	NO3- (mg/l)		
	NO2- (mg/l)	<0.02	
	Coliforms		
Remarks (Lithology , etc.)			
Drilled by WRUD in 1981 BAJ cleaned element of MONO pump Villagers replaced generator 2014

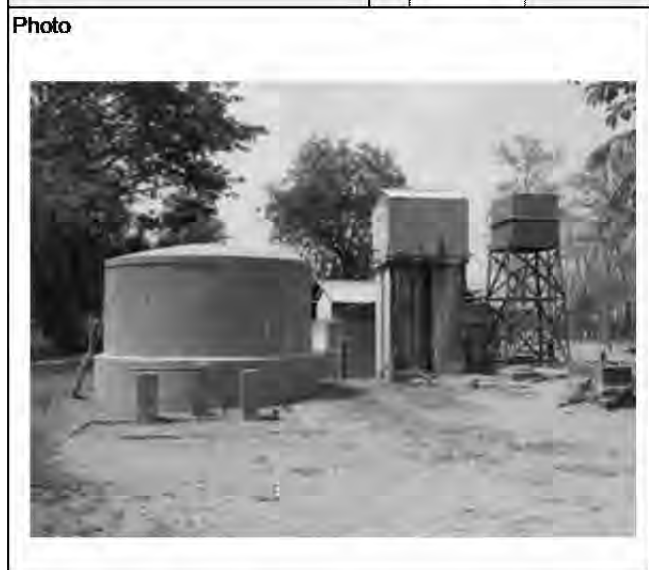
Region	Magway		Date	2015/5/15
Township	Magway		Reported by	Maruo
Village / ID	Ywarthitgyi	MG2-09	Coordinate (WGS84 UTM)	X
			Y

Information of Existing Water Source - 1				
Type	o Deep Well	Coordinate	X	722084
	Shallow Well		Y	2237682
	Storage reservoir			
	Others			
Hydrogeological Information	Drilled Depth (m)	177	Sample ID	MG2-9-1
	Diameter (in)		Temperature (°C)	32.2
	S.W.L (m)	104	pH	7.04
	D.W.L (m)		EC (µs/cm)	805
	Yield (m ³ /hour)	6.8	Smell	Non
	No.of users (person/day)		Color	Non
	Supply facilities		Mn (mg/l)	<1
	Remarks (Lithology , etc.)	Results of Simplified Water Quality Test		Fe (mg/l)
Drilled in 2010 by SPDC. Chinese engine with Mono pump SPDC : State peace and Development Council.	F (mg/l)			0.1
	NO3- (mg/l)			<1
	NO2- (mg/l)			<0.02
	Coliforms

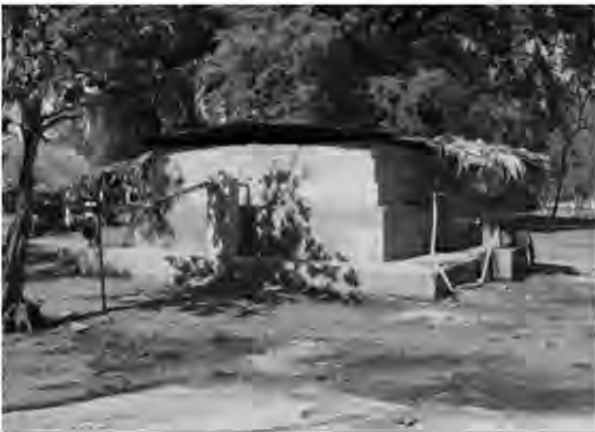
Information of Existing Water Sauce - 1					Information of Existing Water Sauce - 2						
Type	○ Deep Well		Coordinate	X	702708	Type	Deep Well		Coordinate	X	
	Shallow Well			Y	2281908		Shallow Well			Y	
	Storage reservoir						Storage reservoir				
	Others						Others				
Hydrogeological Information	Drilled Depth (m)	327	Results of Simplified Water Quality Test	Sample ID	MG2-10-1	Hydrogeological Information	Drilled Depth (m)		Results of Simplified Water Quality Test	Sample ID	
	Diameter (in)	4		Temperature (°C)	29.4		Diameter (in)			Temperature (°C)	
	S.W.L (m)	210		pH	7.37		S.W.L (m)			pH	
	D.W.L (m)			EC (µs/cm)	1,013		D.W.L (m)			EC (µs/cm)	
	Yield (m³/hour)	4.1		Smell	Iron smell		Yield (m³/hour)			Smell	
	No.of users (person/day)			Color	Non		No.of users (person/day)			Color	
	Supply facilities			Mn (mg/l)	<1		Supply facilities			Mn (mg/l)	
	Remarks (Lithology , etc.)			Fe (mg/l)	2		Remarks (Lithology , etc.)			Fe (mg/l)

Originally drilled by WRUD in 1981. BAJ replaced elements of MONO pump in 2007.		F (mg/l)	0.8			F (mg/l)					
		NO3- (mg/l)	<1			NO3- (mg/l)					
		NO2- (mg/l)	<0.02			NO2- (mg/l)					
		Coliforms				Coliforms					
Photo		Photo		Photo		Photo

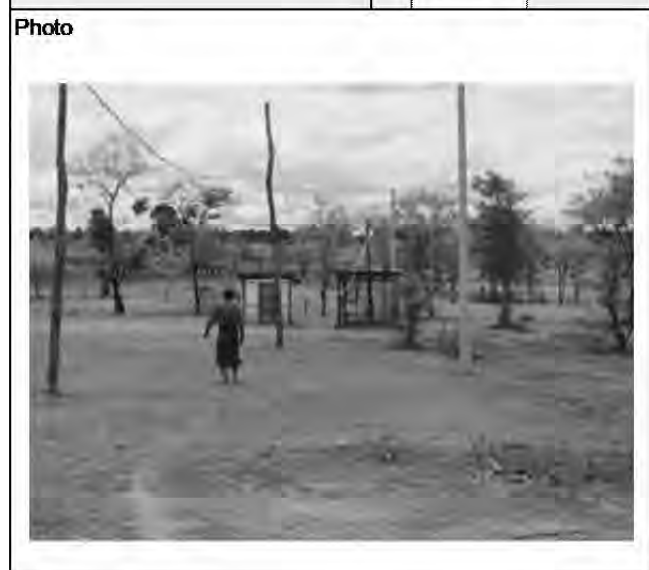
Region	Magway		Date	2015/5/20
Township	Chauk		Reported by	Maruo
Village / ID	Zeebwar	MG2-12	Coordinate (WGS84 UTM)	X
			Y

Information of Existing Water Source - 1				
Type	<input type="radio"/> Deep Well	Coordinate	X	711611
	<input type="radio"/> Shallow Well		Y	2298972
	<input type="radio"/> Storage reservoir			
	<input type="radio"/> Others			
Hydrogeological Information	Drilled Depth (m)	152	Sample ID	MG2-12-1
	Diameter (in)	4	Temperature (°C)	28.2
	S.W.L (m)		pH	7.86
	D.W.L (m)		EC (µs/cm)	1,409
	Yield (m³/hour)	7.3	Smell	Non
	No.of users (person/day)		Color	Non
	Supply facilities		Mn (mg/l)	<1
	Remarks (Lithology , etc.)	Existing well owned by a Monastery High fluoride Electrified submersible pump.		Fe (mg/l)
	F (mg/l)			2
	NO3- (mg/l)			1
	NO2- (mg/l)			<0.02
	Coliforms

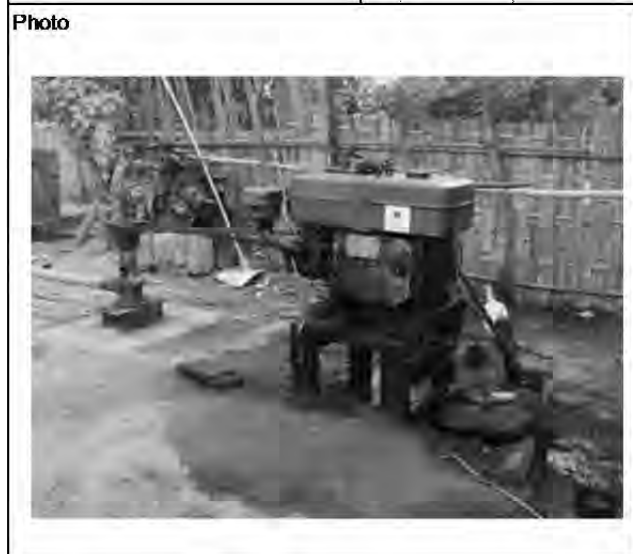
Region	Magway		Date	2015/5/21
Township	Chauk		Reported by	Maruo
Village / ID	Yarpyay	MG2-13	Coordinate (WGS84 UTM)	X
			Y

Information of Existing Water Sauce - 1					
Type	○ Deep Well		Coordinate	X	690042
	Shallow Well			Y	2301200
	Storage reservoir				
	Others				
Hydrogeological Information	Drilled Depth (m)	148	Results of Simplified Water Quality Test	Sample ID	MG2-13-1
	Diameter (in)	6		Temperature (°C)	31.8
	S.W.L (m)			pH	7.42
	D.W.L (m)			EC (µs/cm)	2,150
	Yield (m³/hour)	4.5		Smell	Iron smell
	No.of users (person/day)			Color	Non
	Supply facilities			Mn (mg/l)	<1
	Remarks (Lithology , etc.)	Htaukshaykan village is next to the target village. Drilled in 1985 by WRUD.		Fe (mg/l)	0.5
			F (mg/l)	0.1	
			NO3- (mg/l)	<1	
			NO2- (mg/l)	<0.02	
			Coliforms

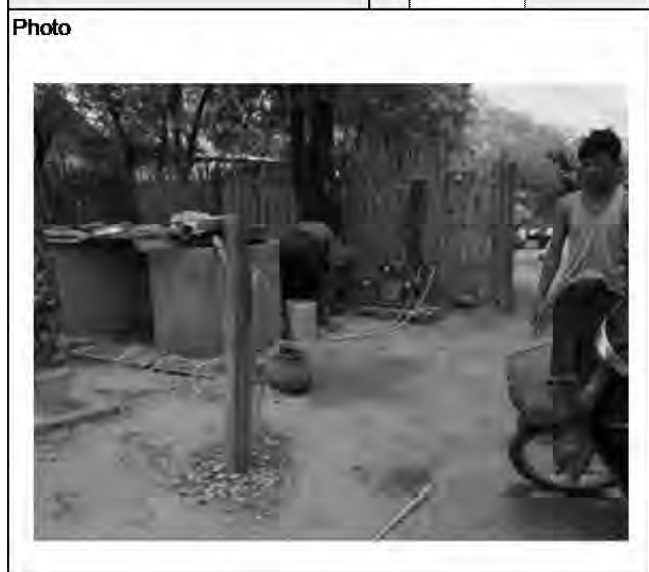
Region	Magway		Date	2015/5/21
Township	Chauk		Reported by	Maruo
Village / ID	Kyatesu(N)	MG2-14	Coordinate (WGS84 UTM)	X
			Y

Information of Existing Water Source - 1					
Type	<input type="radio"/> Deep Well	Coordinate	X	665497	
	<input type="radio"/> Shallow Well		Y	2292703	
	<input type="radio"/> Storage reservoir				
	<input type="radio"/> Others				
Hydrogeological Information	Drilled Depth (m)	67	Results of Simplified Water Quality Test	Sample ID	MG2-14-1
	Diameter (in)	2		Temperature (°C)	37.8
	S.W.L (m)			pH	8.15
	D.W.L (m)			EC (µs/cm)	3,090
	Yield (m³/hour)	3.4		Smell	Non
	No.of users (person/day)			Color	Non
	Supply facilities			Mn (mg/l)	<1
	Remarks (Lithology , etc.)	Private tube well - salty water Compressor well - water is always hot.		Fe (mg/l)	<0.2
			F (mg/l)	0	
			NO3-(mg/l)	1	
			NO2-(mg/l)	<0.02	
			Coliforms

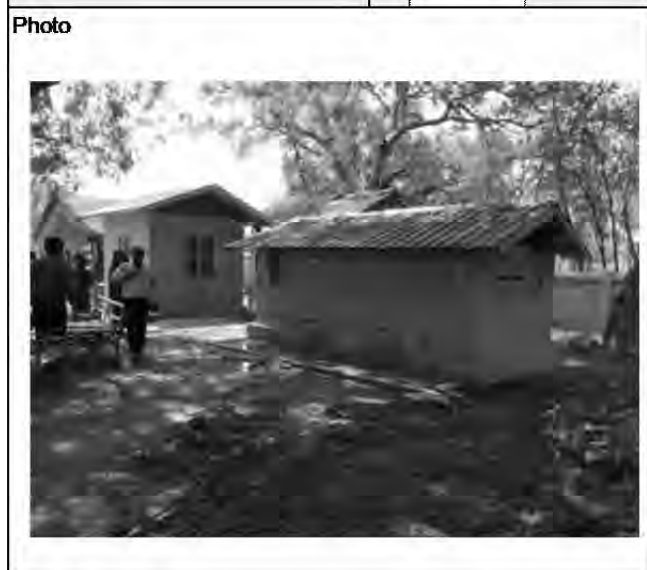
Region	Magway		Date	2015/5/21
Township	Chauk		Reported by	Maruo
Village / ID	Winkabar	MG2-15	Coordinate (WGS84 UTM)	X
			Y

Information of Existing Water Source - 1					
Type	<input type="radio"/> Deep Well	Coordinate	X	684440	
	<input type="radio"/> Shallow Well		Y	2287209	
	<input type="radio"/> Storage reservoir				
	<input type="radio"/> Others				
Hydrogeological Information	Drilled Depth (m)	110	Results of Simplified Water Quality Test	Sample ID	MG2-15-1
	Diameter (in)	4		Temperature (°C)	30.5
	S.W.L (m)	30		pH	8.37
	D.W.L (m)			EC (µs/cm)	703
	Yield (m³/hour)	4.1		Smell	Non
	No.of users (person/day)			Color	Non
	Supply facilities	Compressor		Mn (mg/l)	<1
	Remarks (Lithology , etc.)	Compressor well drilled in 2015 by regional government.		Fe (mg/l)	<0.2
			F (mg/l)	0.2	
			NO3-(mg/l)	1.5	
			NO2-(mg/l)	0.1	
			Coliforms

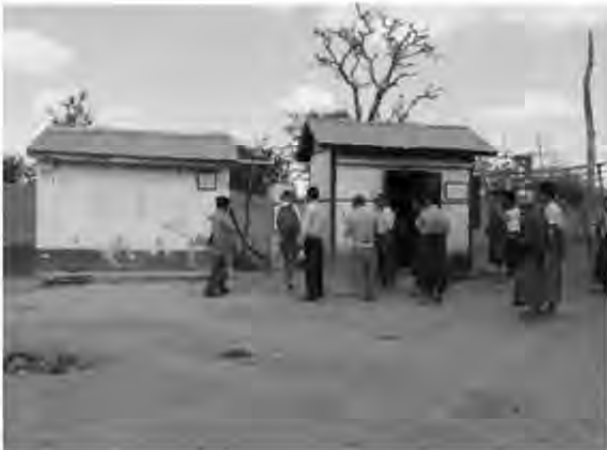
Information of Existing Water Source - 1					Information of Existing Water Source - 2						
Type	○ Deep Well		Coordinate	X	690394	Type	Deep Well		Coordinate	X	
	Shallow Well			Y	2296166		Shallow Well			Y	
	Storage reservoir						Storage reservoir				
	Others						Others				
Hydrogeological Information	Drilled Depth (m)	171	Results of Simplified Water Quality Test	Sample ID	MG2-16-1	Hydrogeological Information	Drilled Depth (m)		Results of Simplified Water Quality Test	Sample ID	
	Diameter (in)			Temperature (°C)	40.2		Diameter (in)			Temperature (°C)	
	S.W.L (m)			pH	8.50		S.W.L (m)			pH	
	D.W.L (m)			EC (µs/cm)	1,571		D.W.L (m)			EC (µs/cm)	
	Yield (m³/hour)	1.4		Smell	Oilly smell		Yield (m³/hour)			Smell	
	No.of users (person/day)			Color	Non		No.of users (person/day)			Color	
	Supply facilities			Mn (mg/l)	<1		Supply facilities			Mn (mg/l)	
	Remarks (Lithology , etc.)						Fe (mg/l)	<0.2		Remarks (Lithology , etc.)

Existing well just by a pond at the edge of the village.				F (mg/l)	0.3					F (mg/l)	
				NO3- (mg/l)	<1					NO3- (mg/l)	
				NO2- (mg/l)	<0.02					NO2- (mg/l)	
				Coliforms						Coliforms	
Photo					Photo

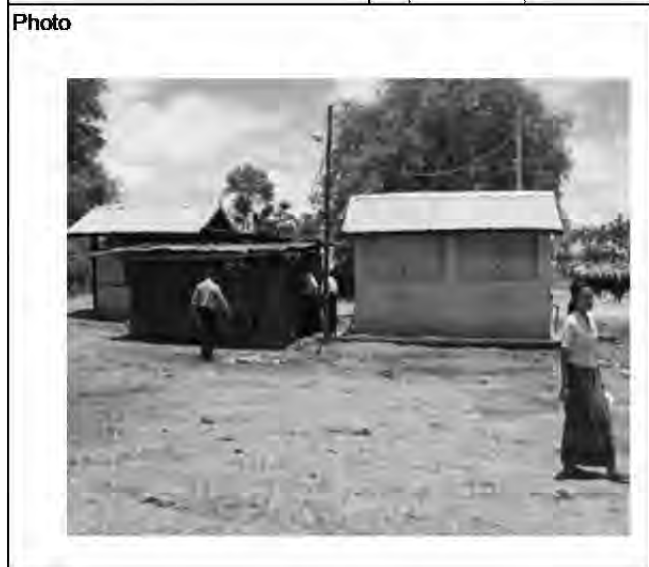
Region	Magway		Date	2015/5/20
Township	Chauk		Reported by	Maruo
Village / ID	Sudat	MG2-17	Coordinate (WGS84 UTM)	X
			Y

Information of Existing Water Source - 1					
Type	○ Deep Well	Coordinate	X	707065	
	Shallow Well		Y	2285476	
	Storage reservoir				
	Others				
Hydrogeological Information	Drilled Depth (m)	365	Results of Simplified Water Quality Test	Sample ID	MG2-17-1
	Diameter (in)	4		Temperature (°C)	29.5
	S.W.L (m)	262		pH	7.32
	D.W.L (m)			EC (µs/cm)	1,089
	Yield (m³/hour)	6.8		Smell	Non
	No.of users (person/day)			Color	Non
	Supply facilities			Mn (mg/l)	<1
	Remarks (Lithology , etc.)	Mono pump - Electricity powered. Gwaypin(DRD-001) is next to the target Village.		Fe (mg/l)	<0.2
			F (mg/l)	0.2	
			NO3-(mg/l)	1	
			NO2-(mg/l)	0.05	
			Coliforms

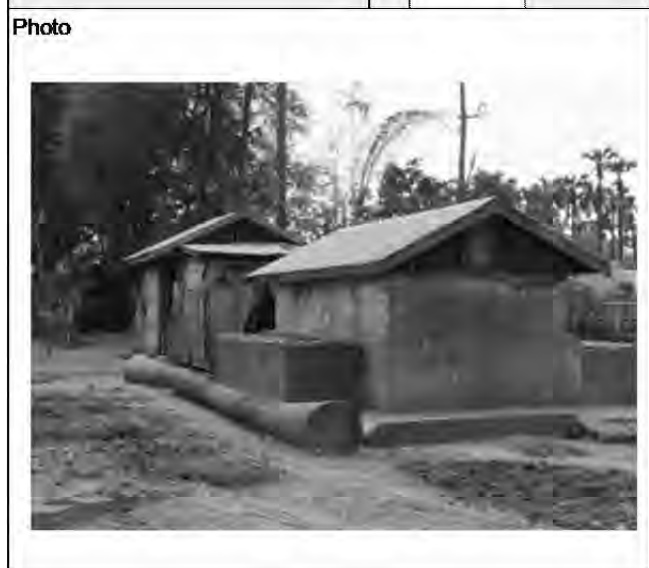
Region	Magway		Date	2015/5/19
Township	Yenangyaung		Reported by	Maruo
Village / ID	Lelgyinyoe	MG2-19	Coordinate (WGS84 UTM)	X
			Y

Information of Existing Water Source - 1				
Type	o Deep Well	Coordinate	X	724077
	Shallow Well		Y	2266805
	Storage reservoir			
	Others			
Hydrogeological Information	Drilled Depth (m)	278	Sample ID	MG2-19-1
	Diameter (in)	4	Temperature (°C)	30.9
	S.W.L (m)	134	pH	6.82
	D.W.L (m)		EC (µs/cm)	1,410
	Yield (m ³ /hour)	6.5	Smell	Non
	No.of users (person/day)		Color	Non
	Supply facilities		Mn (mg/l)	<1
	Remarks (Lithology , etc.)	Results of Simplified Water Quality Test		Fe (mg/l)
Water with sand	F (mg/l)			0.3
Slightly salty	NO3- (mg/l)			1.5
Existing well drilled in 1981 by WRUD.	NO2- (mg/l)			<0.02
	Coliforms

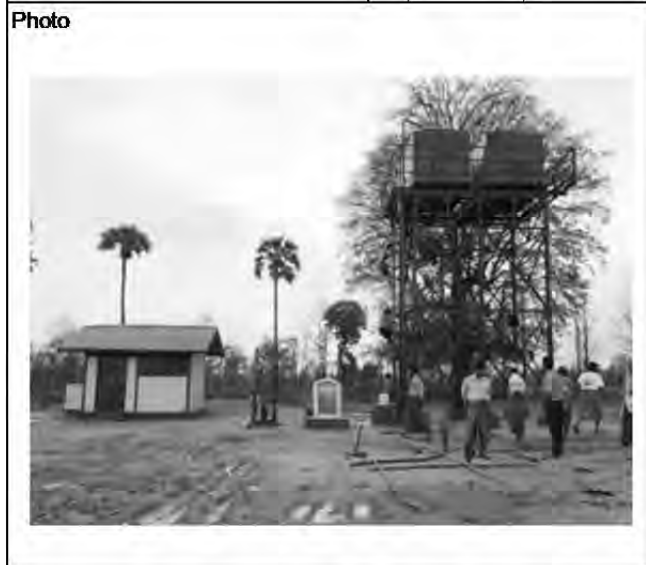
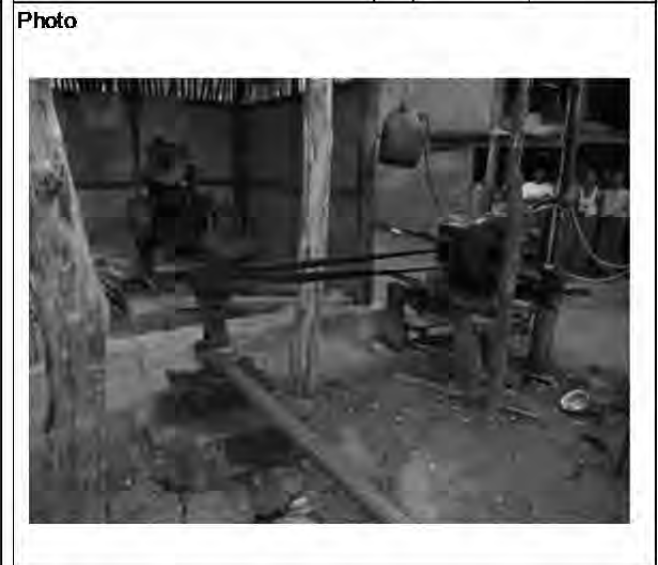
Information of Existing Water Source - 1				
Type	○ Deep Well	Coordinate	X	724896
	Shallow Well		Y	2268094
	Storage reservoir			
	Others			
Hydrogeological Information	Drilled Depth (m)	248	Sample ID	MG2-19-2
	Diameter (in)	6	Temperature (°C)	31.1
	S.W.L (m)	142	pH	6.50
	D.W.L (m)	148	EC (µs/cm)	2,370
	Yield (m ³ /hour)	10.2	Smell	Iron smell
	No.of users (person/day)		Color	Non
	Supply facilities		Mn (mg/l)	<1
	Remarks (Lithology , etc.)	Results of Simplified Water Quality Test		Fe (mg/l)
Next to Lelgyinyoe village . BAJ well - 2014	F (mg/l)			1.0
	NO3- (mg/l)			<1
	NO2- (mg/l)			<0.02
	Coliforms

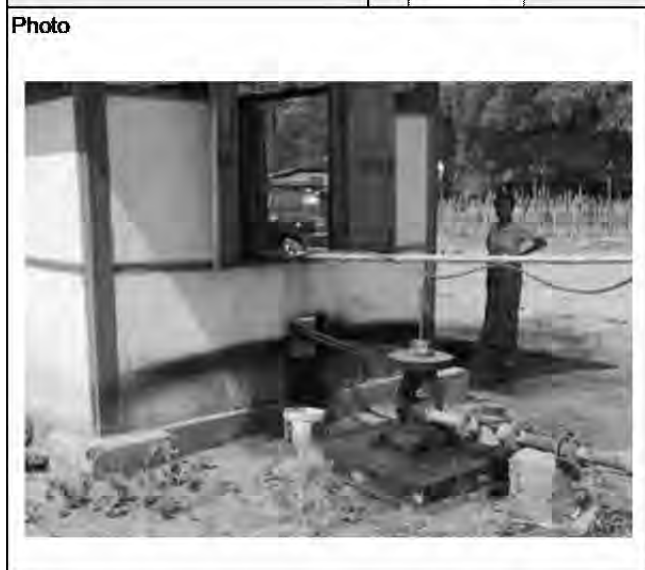
Region	Magway		Date	2015/5/10
Township	Myothit		Reported by	Maruo
Village / ID	Tharmyar	MG2-21	Coordinate (WGS84 UTM)	X
			Y

Information of Existing Water Source - 1									
Type	<input type="radio"/> Deep Well	Coordinate	X 736194						
	<input type="checkbox"/> Shallow Well		Y 2241244						
	<input type="checkbox"/> Storage reservoir								
	<input type="checkbox"/> Others								
Hydrogeological Information	Drilled Depth (m)	198	Sample ID MG2-21-1						
	Diameter (in)			Temperature (°C) 32.1					
	S.W.L (m)	119			pH 6.91				
	D.W.L (m)					EC (µs/cm) 666			
	Yield (m³/hour)	245.5					Smell Non		
	No.of users (person/day)							Color Non	
	Supply facilities	Pump							Mn (mg/l) <0.02
		F (mg/l) 0.1							
			NO3- (mg/l)						
				NO2- (mg/l) <0.02					
					Coliforms				
Remarks (Lithology , etc.)									
Drilled in 2002 by JICA- working well.

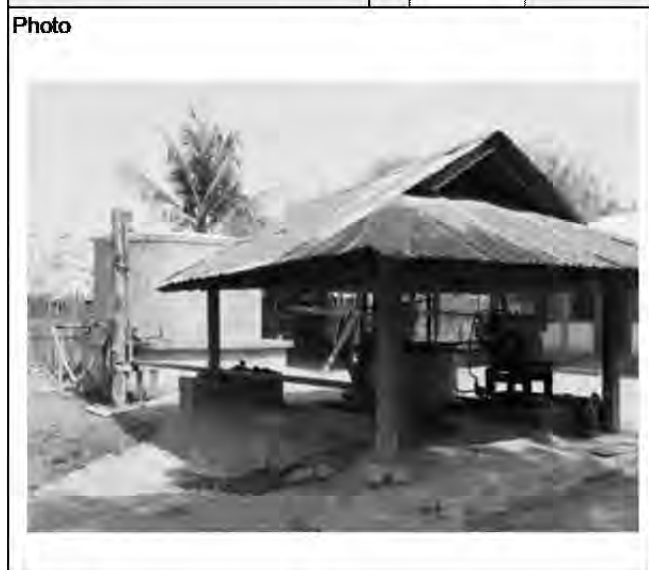
Region	Magway		Date	2015/5/8
Township	Myothit		Reported by	Maruo
Village / ID	Aungmyinthar	MG2-22	Coordinate (WGS84 UTM)	X
			Y

Information of Existing Water Source - 1				
Type	o Deep Well		X	733075
	Shallow Well		Y	2231654
	Storage reservoir			
	Others			
Hydrogeological Information	Drilled Depth (m)	104	Sample ID	MG2-22-1
	Diameter (in)	4	Temperature (°C)	36.6
	S.W.L (m)	55	pH	7.87
	D.W.L (m)		EC (µs/cm)	993
	Yield (m ³ /hour)	3.2	Smell	Non
	No.of users (person/day)		Color	Non
	Supply facilities		Mn (mg/l)	<0.02
	Remarks (Lithology , etc.)	Results of Simplified Water Quality Test		Fe (mg/l)
Drilled by WRUD in 1981	F (mg/l)			0.3
210 - House hold, 1150 - Populations.	NO3- (mg/l)			
	NO2- (mg/l)			<0.02
	Coliforms

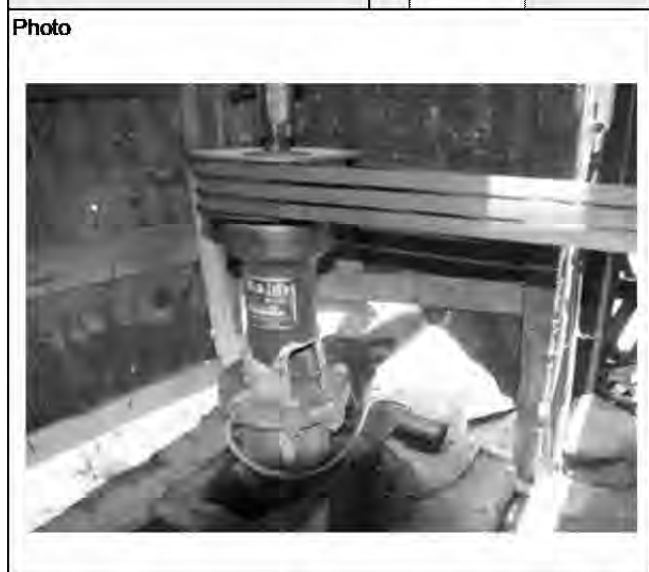
Region	Magway		Date	2015/5/9
Township	Myothit		Reported by	Maruo
Village / ID	Ngwelay	MG2-23	Coordinate (WGS84 UTM)	X
			Y

Information of Existing Water Source - 1					
Type	o Deep Well	Coordinate	X	738864	
	Shallow Well		Y	2222537	
	Storage reservoir				
	Others				
Hydrogeological Information	Drilled Depth (m)	116	Results of Simplified Water Quality Test	Sample ID	MG2-23-1
	Diameter (in)	4		Temperature (°C)	38.5
	S.W.L (m)	52		pH	7.51
	D.W.L (m)			EC (µs/cm)	863
	Yield (m³/hour)	6.8		Smell	Non
	No.of users (person/day)			Color	Non
	Supply facilities			Mn (mg/l)	<0.02
	Remarks (Lithology , etc.)	Drilled by WRUD in 1980. There is a new well at the edge of the village . Pump was broken and has been repaired.		Fe (mg/l)	<0.2
			F (mg/l)	0.3	
			NO3- (mg/l)		
			NO2- (mg/l)	<0.02	
			Coliforms

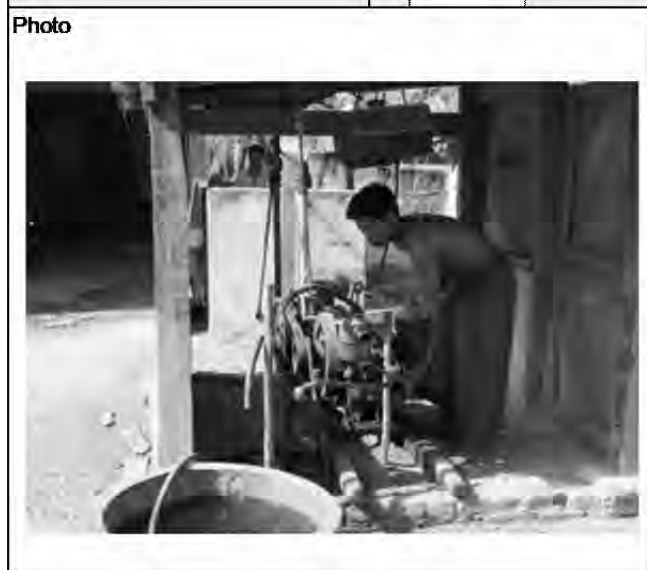
Region	Magway		Date	2015/5/9
Township	Myothit		Reported by	Maruo
Village / ID	Indaw(N)	MG2-24	Coordinate (WGS84 UTM)	X
			Y

Information of Existing Water Source - 1					
Type	<input type="radio"/> Deep Well	Coordinate	X	742446	
	<input type="radio"/> Shallow Well		Y	2229548	
	<input type="radio"/> Storage reservoir				
	<input type="radio"/> Others				
Hydrogeological Information	Drilled Depth (m)	110	Results of Simplified Water Quality Test	Sample ID	MG2-24-1
	Diameter (in)	2		Temperature (°C)	41.5
	S.W.L (m)			pH	8.13
	D.W.L (m)			EC (µs/cm)	928
	Yield (m³/hour)	3.6		Smell	Non
	No.of users (person/day)			Color	High turbidity
	Supply facilities			Mn (mg/l)	<0.02
	Remarks (Lithology , etc.)	Air lifting well. Only one well in this village. Drilled by DDA in 2011.		Fe (mg/l)	<0.2
			F (mg/l)	0.1	
			NO3-(mg/l)		
			NO2-(mg/l)	<0.02	
			Coliforms

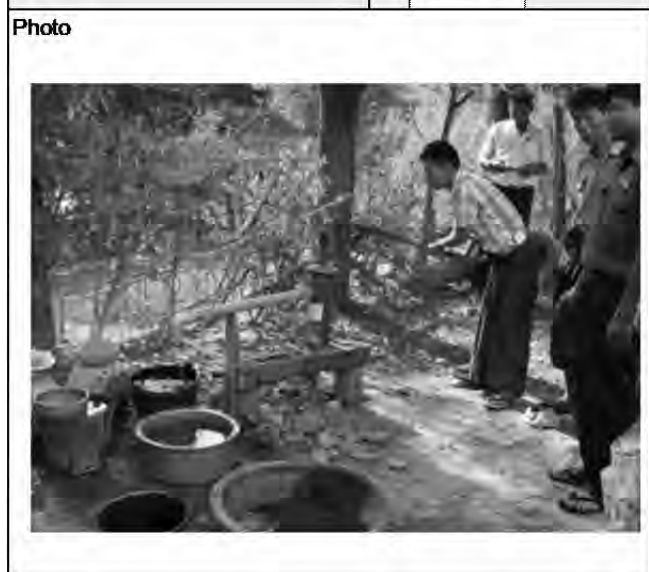
Region	Magway		Date	2015/5/9
Township	Myothit		Reported by	Maruo
Village / ID	Htanaungkwin	MG2-25	Coordinate (WGS84 UTM)	X
			Y

Information of Existing Water Source - 1				
Type	Deep Well	Coordinate	X	770840
	○ Shallow Well		Y	2225170
	Storage reservoir			
	Others			
Hydrogeological Information	Drilled Depth (m)	11	Sample ID	MG2-25-1
	Diameter (in)	2	Temperature (°C)	29.4
	S.W.L (m)	10	pH	7.34
	D.W.L (m)		EC (µs/cm)	1,085
	Yield (m ³ /hour)		Smell	Non
	No.of users (person/day)		Color	Non
	Supply facilities		Mn (mg/l)	<0.02
	Remarks (Lithology , etc.)	Results of Simplified Water Quality Test		Fe (mg/l)
Hand pump well near the Dam.	F (mg/l)			0.1
	NO3- (mg/l)			
	NO2- (mg/l)			<0.02
	Coliforms

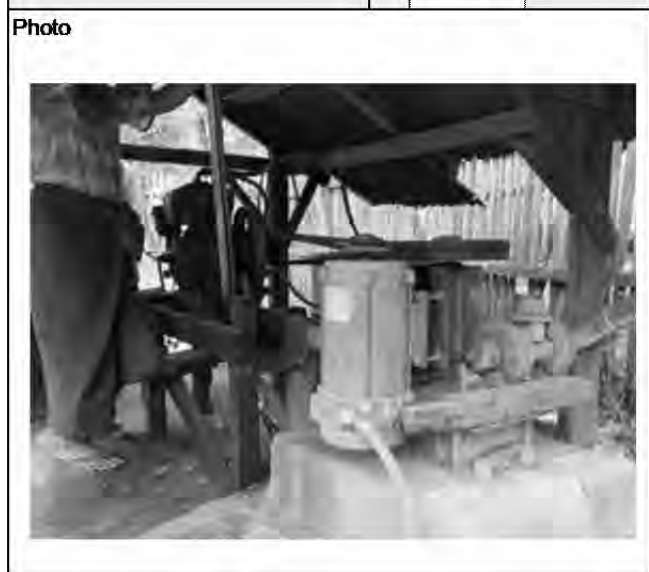
Region	Magway		Date	2015/5/9
Township	Myothit		Reported by	Maruo
Village / ID	Manawtgone	MG2-26	Coordinate (WGS84 UTM)	X
			Y

Information of Existing Water Source - 1					
Type	o Deep Well	Coordinate	X	732002	
	Shallow Well		Y	2222325	
	Storage reservoir				
	Others				
Hydrogeological Information	Drilled Depth (m)	128	Results of Simplified Water Quality Test	Sample ID	MG2-26-1
	Diameter (in)	6		Temperature (°C)	32.0
	S.W.L (m)	24		pH	8.31
	D.W.L (m)			EC (µs/cm)	662
	Yield (m³/hour)	10.5		Smell	Non
	No.of users (person/day)			Color	Non
	Supply facilities			Mn (mg/l)	<0.02
	Remarks (Lithology , etc.)			Fe (mg/l)	<0.2
		F (mg/l)	0.1		
		NO3- (mg/l)			
		NO2- (mg/l)	<0.02		
		Coliforms

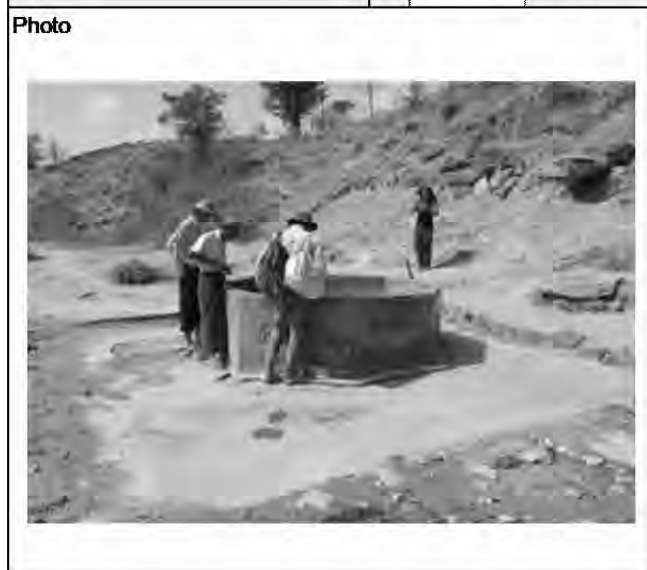
Region	Magway		Date	2015/5/11
Township	Natmauk		Reported by	Maruo
Village / ID	Htonepoutchine	MG2-28	Coordinate (WGS84 UTM)	X
				Y

Information of Existing Water Source - 1					
Type	Deep Well	Coordinate	X	730959	
	Shallow Well		Y	2255652	
	Storage reservoir				
	○ Others(Dug Well)				
Hydrogeological Information	Drilled Depth (m)	Results of Simplified Water Quality Test	Sample ID	MG2-28-1	
	Diameter (in)		Temperature (°C)	31.3	
	S.W.L (m)		pH	7.58	
	D.W.L (m)		EC (µs/cm)	868	
	Yield (m ³ /hour)		Smell	Non	
	No.of users (person/day)		Color		
	Supply facilities		Pump	Mn (mg/l)	<0.02
	Remarks (Lithology , etc.)		Fe (mg/l)	<0.2	
	F (mg/l)	0.6			
	NO3-(mg/l)				
	NO2-(mg/l)	0.05			
	Coliforms	35

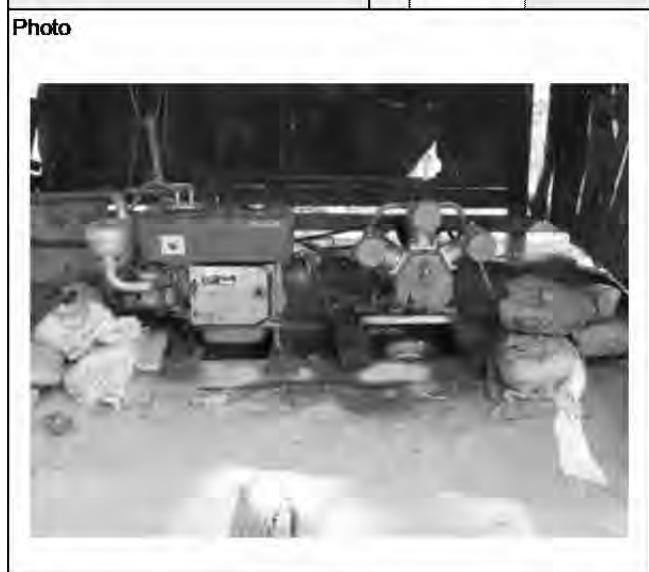
Region	Magway		Date	2015/5/11
Township	Natmauk		Reported by	Maruo
Village / ID	Satkyattaung (Monastery)	MG2-28	Coordinate (WGS84 UTM)	X
				Y

Information of Existing Water Source - 1				
Type	o Deep Well	Coordinate	X	731705
	Shallow Well		Y	2255329
	Storage reservoir			
	Others			
Hydrogeological Information	Drilled Depth (m)	106.6	Sample ID	MG2-28-2
	Diameter (in)	2	Temperature (°C)	33.3
	S.W.L (m)		pH	8.21
	D.W.L (m)		EC (µs/cm)	701
	Yield (m ³ /hour)		Smell	Non
	No.of users (person/day)		Color	Non
	Supply facilities	Compressor	Mn (mg/l)	<0.02
	Remarks (Lithology , etc.) It drill more than 500ft, water became salty. This village is next to the target village.		Results of Simplified Water Quality Test	
Fe (mg/l)			0.7	
F (mg/l)			0	
NO3- (mg/l)				
NO2- (mg/l)			<0.02	
		Coliforms

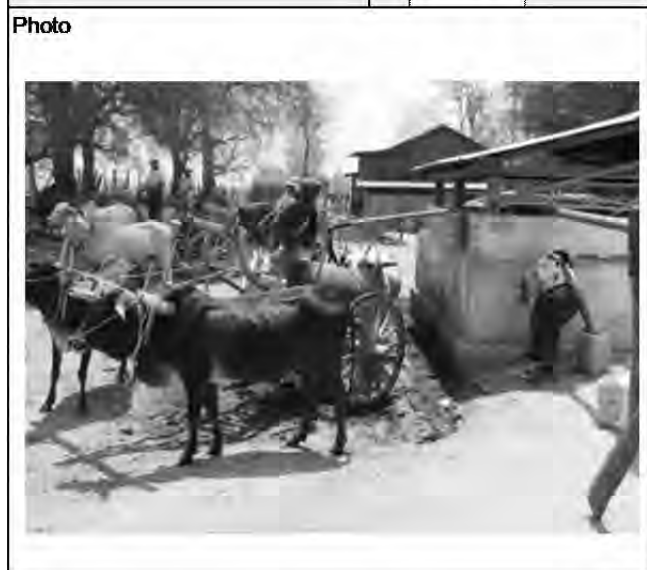
Region	Magway		Date	2015/5/10
Township	Natmak		Reported by	Maruo
Village / ID	Padaukgote(Ywargyi)	MG2-29	Coordinate (WGS84 UTM)	X Y

Information of Existing Water Source - 1				
Type	o Deep Well	Coordinate	X	737425
	Shallow Well		Y	2248858
	Storage reservoir			
	Others			
Hydrogeological Information	Drilled Depth (m)	219	Sample ID	MG2-29-1
	Diameter (in)		Temperature (°C)	35.2
	S.W.L (m)		pH	6.93
	D.W.L (m)		EC (µs/cm)	2,950
	Yield (m ³ /hour)	3.6	Smell	Iron smell
	No.of users (person/day)		Color	Non
	Supply facilities	Pump	Mn (mg/l)	<0.02
	Remarks (Lithology , etc.) EC very high		Results of Simplified Water Quality Test	
Fe (mg/l)			3	
F (mg/l)			0.8	
NO3- (mg/l)				
NO2- (mg/l)			<0.02	
		Coliforms

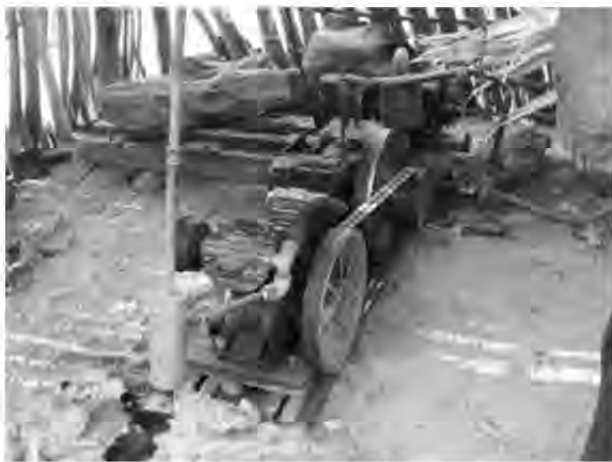
Information of Existing Water Source - 1				Information of Existing Water Source - 2							
Type	○ Deep Well		Coordinate	X	731373	Type	Deep Well	Coordinate	X		
	Shallow Well			Y	2275351		Shallow Well		Y		
	Storage reservoir						Shallow Well				
	Others										
Hydrogeological Information	Drilled Depth (m)	177	Results of Simplified Water Quality Test	Sample ID	MG2-32-1	Hydrogeological Information	Drilled Depth (m)		Results of Simplified Water Quality Test	Sample ID	
	Diameter (in)	2		Temperature (°C)	33.5		Diameter (in)			Temperature (°C)	
	S.W.L (m)	67		pH	7.29		S.W.L (m)			pH	
	D.W.L (m)			EC (µs/cm)	3,840		D.W.L (m)			EC (µs/cm)	
	Yield (m³/hour)	3.4		Smell	Iron smell		Yield (m³/hour)			Smell	
	No.of users (person/day)			Color	Non		No.of users (person/day)			Color	
	Supply facilities	Airlift compressor		Mn (mg/l)	2		Supply facilities			Mn (mg/l)	
	Remarks (Lithology , etc.)			Fe (mg/l)	1		Remarks (Lithology , etc.)			Fe (mg/l)

Now discharge only 500 g/d ,drilled in 2006. Natmauk Municipality funded the cost 2275000 kyats. There have DRD well 200 m far from the the target village by WRUD in Phankharsen village.(168m depth and SWL 85 m)		F (mg/l)	0.2			F (mg/l)					
		NO3- (mg/l)				NO3- (mg/l)					
		NO2- (mg/l)	0.0			NO2- (mg/l)					
		Coliforms				Coliforms					
Photo		Photo

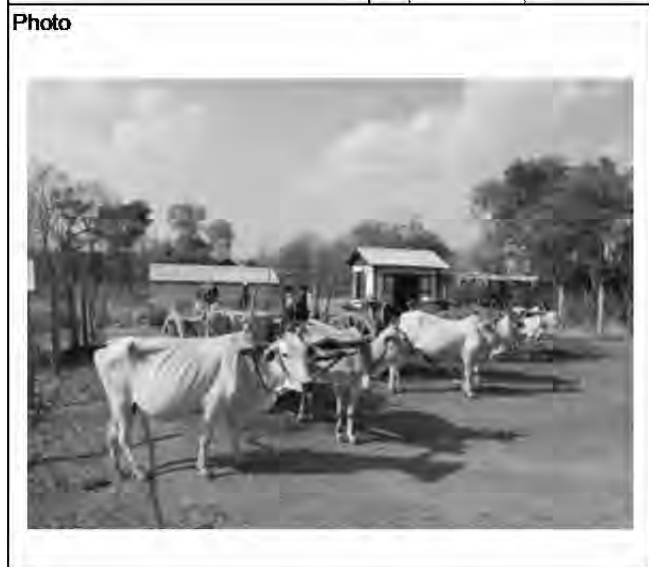
Region	Magway		Date	
Township	Natmak		Reported by	Maruo
Village / ID	Wayonegone	MG2-33	Coordinate (WGS84 UTM)	X
			Y

Information of Existing Water Source - 1					
Type	o Deep Well	Coordinate	X	736518	
	storage reservoir		Y	2267323	
	Storage reservoir				
	Others				
Hydrogeological Information	Drilled Depth (m)	Results of Simplified Water Quality Test	Sample ID	MG2-33-1	
	Diameter (in)		Temperature (°C)	34	
	S.W.L (m)		pH	7.35	
	D.W.L (m)		EC (µs/cm)	5,330	
	Yield (m ³ /hour)		Smell	Slightly iron	
	No.of users (person/day)		Color	Non	
	Supply facilities		Pump	Mn (mg/l)	<0.02
	Remarks (Lithology , etc.)		JICA well - drilled in 2014 by JICA Grant. Oakpho village is next to the target village.	Fe (mg/l)	8
		F (mg/l)	0.8		
		NO3- (mg/l)			
		NO2- (mg/l)	<0.02		
		Coliforms

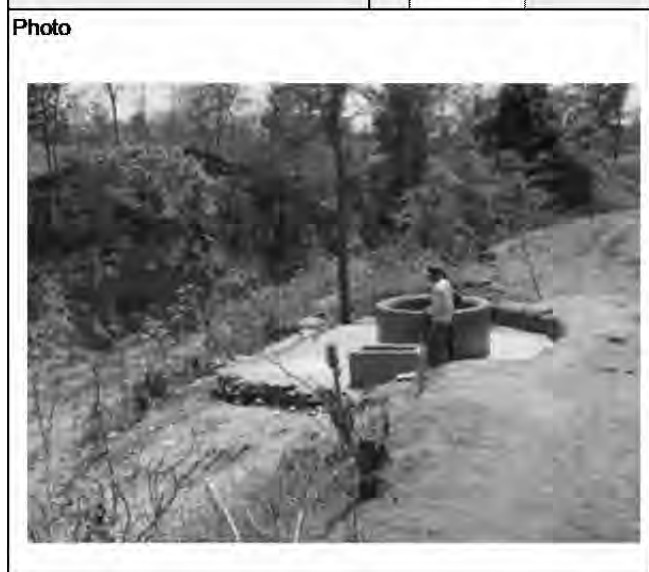
Region	Magway		Date	2015/5/11
Township	Natmauk		Reported by	Maruo
Village / ID	Nyaunggone	MG2-34	Coordinate (WGS84 UTM)	X
			Y

Information of Existing Water Source - 1				
Type	o Deep Well	Coordinate	X	732682
	Shallow Well		Y	2256117
	Storage reservoir			
	Others			
Hydrogeological Information	Drilled Depth (m)	Results of Simplified Water Quality Test	Sample ID	MG2-34-1
	Diameter (in)		Temperature (°C)	29.6
	S.W.L (m)		pH	7.88
	D.W.L (m)		EC (µs/cm)	1,280
	Yield (m ³ /hour)		Smell	Non
	No.of users (person/day)		Color	Non
	Supply facilities		Mn (mg/l)	<0.02
	Remarks (Lithology , etc.)		Fe (mg/l)	<0.2
Dug well by a river. People say a bit salty and not salty, high fluoride.	F (mg/l)	1.3		
	NO3- (mg/l)			
	NO2- (mg/l)	<0.02		
	Coliforms
