Appendix 5.3.1 Result of Field Water Quality Measurement

Result of Field Water Quality Measurement (Sagaing Region-1)

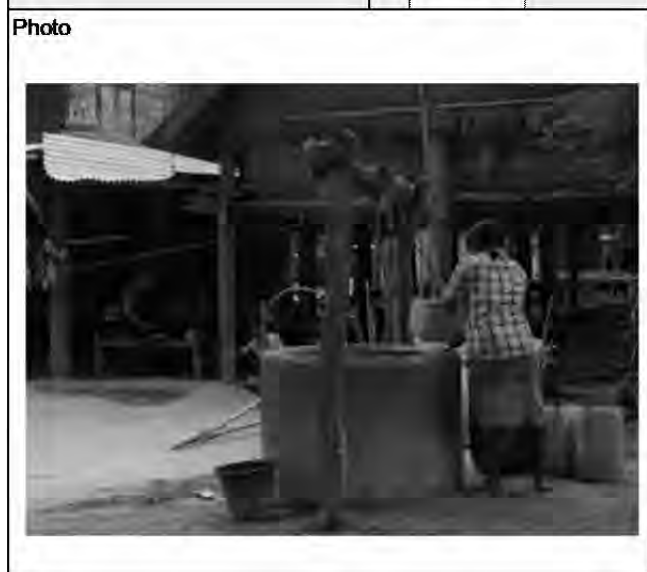
Region	Magway		Date	2015/5/18
Township	Taungdwingyi		Reported by	Maruo
Village / ID	Kokkohla	MG2-36	Coordinate (WGS84 UTM)	X
			Y

Information of Existing Water Source - 1				
Type	Deep Well	Coordinate	X	765957
	Shallow Well		Y	2218608
	Storage reservoir			
	○ Others(Dug Well)			
Hydrogeological Information	Drilled Depth (m)	Results of Simplified Water Quality Test	Sample ID	MG2-36-1
	Diameter (in)		Temperature (°C)	28.9
	S.W.L (m)		pH	7.04
	D.W.L (m)		EC (µs/cm)	1,335
	Yield (m³/hour)		Smell	Non
	No.of users (person/day)		Color	Non
	Supply facilities		Mn (mg/l)	<1
	Remarks (Lithology , etc.)		Fe (mg/l)	<0.2
Dug well - 15m deep	F (mg/l)	0.3		
	NO3-(mg/l)	20		
	NO2-(mg/l)	0.1		
	Coliforms

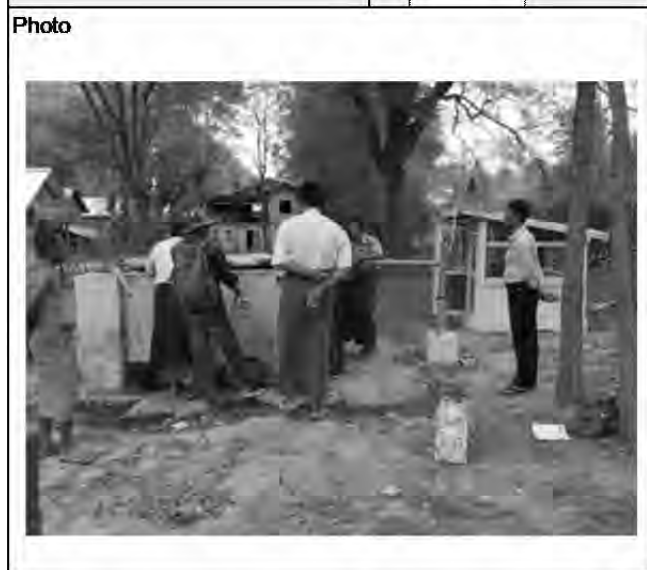
Region	Magway		Date	2015/5/18
Township	Taungdwingyi		Reported by	Maruo
Village / ID	Kokkohla	MG2-36	Coordinate (WGS84 UTM)	X
			Y

Information of Existing Water Source - 1				
Type	o Deep Well	Coordinate	X	766919
	Shallow Well		Y	2218218
	Storage reservoir			
	Others			
Hydrogeological Information	Drilled Depth (m)	116	Sample ID	MG2-36-2
	Diameter (in)	4	Temperature (°C)	29.7
	S.W.L (m)	18	pH	8.67
	D.W.L (m)		EC (µs/cm)	1,587
	Yield (m ³ /hour)	3.2	Smell	Muddy smell
	No.of users (person/day)		Color	Shallow yellow
	Supply facilities	Compressor	Mn (mg/l)	<1
	Remarks (Lithology , etc.)		Results of Simplified Water Quality Test	
Pantwinlay village is next to target village. WRUD well drilled in 2014.		Fe (mg/l)	<0.2	
		F (mg/l)	2.0	
		NO3- (mg/l)	<1	
		NO2- (mg/l)	<0.02	
		Coliforms

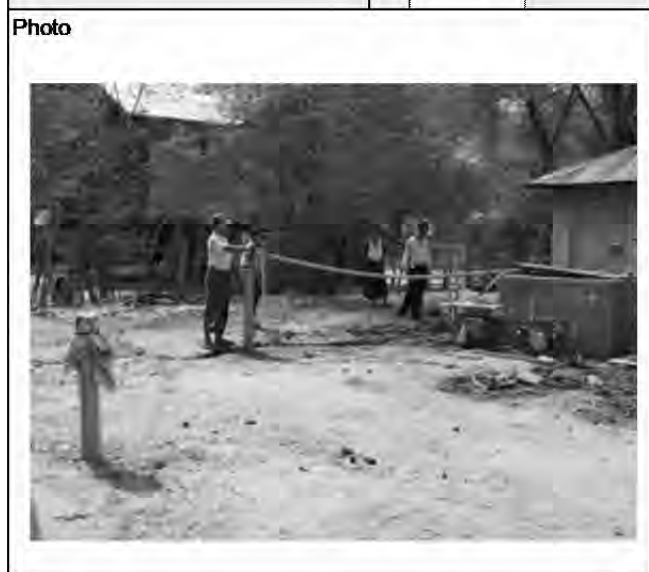
Region	Magway		Date	2015/5/17
Township	Taungdwingyi		Reported by	Maruo
Village / ID	Kangyigone	MG2-37	Coordinate (WGS84 UTM)	X
			Y

Information of Existing Water Source - 1				
Type	o Deep Well	Coordinate	X	762556
	Shallow Well		Y	2192933
	Storage reservoir			
	Others			
Hydrogeological Information	Drilled Depth (m)	183	Sample ID	MG2-37-1
	Diameter (in)		Temperature (°C)	29.3
	S.W.L (m)	165	pH	8.82
	D.W.L (m)		EC (µs/cm)	4,520
	Yield (m ³ /hour)	0.2	Smell	Non
	No.of users (person/day)		Color	HighTurbidity
	Supply facilities	Compressor	Mn (mg/l)	<1
	Remarks (Lithology , etc.)		Results of Simplified Water Quality Test	
High fluoride		Fe (mg/l)	<0.2	
		F (mg/l)	3.0	
		NO3- (mg/l)	<1	
		NO2- (mg/l)	<0.02	
		Coliforms

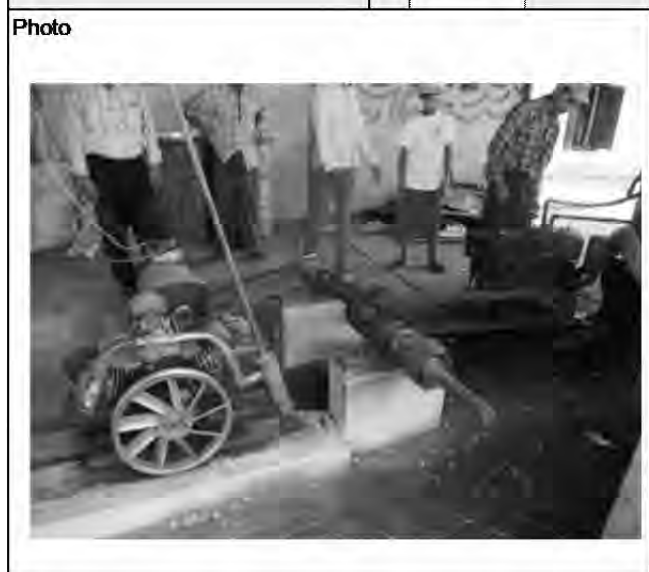
Region	Magway		Date	2015/5/17
Township	Taungdwingyi		Reported by	Maruo
Village / ID	Kangyigone	MG2-37	Coordinate (WGS84 UTM)	X
			Y

Information of Existing Water Source - 1						
Type	o Deep Well	Coordinate	X	757586		
	Shallow Well		Y	2193879		
	Storage reservoir					
	Others					
Hydrogeological Information	Drilled Depth (m)	183	Sample ID	MG2-37-2		
	Diameter (in)	2	Temperature (°C)	30.1		
	S.W.L (m)	2	pH	8.77		
	D.W.L (m)		EC (µs/cm)	722		
	Yield (m ³ /hour)		Smell	Non		
	No.of users (person/day)		Color	Non		
	Supply facilities	Compressor	Mn (mg/l)	<1		
	Remarks (Lithology , etc.)	Results of Simplified Water Quality Test				
Payatkyl village is next to the target village along the main road.						
	Fe (mg/l)					<0.2
	F (mg/l)					0.2
	NO3- (mg/l)					<1
	NO2- (mg/l)					<0.02
	Coliforms

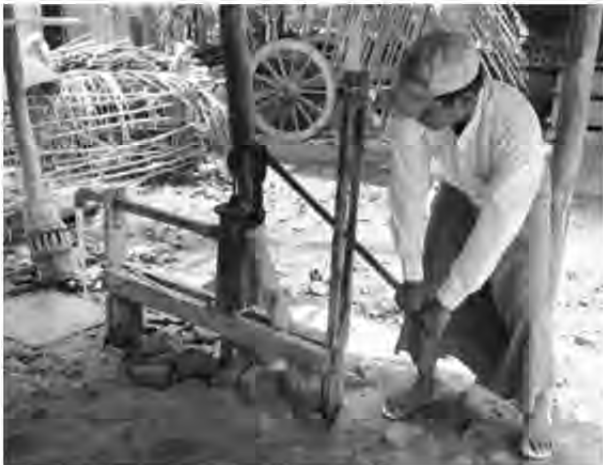
Information of Existing Water Source - 1					Information of Existing Water Source - 2																												
Type	Deep Well	Coordinate	X	772150	Type	Deep Well	Coordinate	X																									
	Shallow Well		Y	2184875		Shallow Well		Y																									
	Storage reservoir					Storage reservoir																											
	Others					Others																											
Hydrogeological Information	Drilled Depth (m)	15	Sample ID	MG2-38-1	Hydrogeological Information	Drilled Depth (m)		Sample ID																									
	Diameter (in)		Temperature (°C)	28.7		Diameter (in)		Temperature (°C)																									
	S.W.L (m)		pH	7.48		S.W.L (m)		pH																									
	D.W.L (m)		EC (µs/cm)	1,615		D.W.L (m)		EC (µs/cm)																									
	Yield (m ³ /hour)		Smell	Non		Yield (m ³ /hour)		Smell																									
	No.of users (person/day)		Color	Non		No.of users (person/day)		Color

Supply facilities		Mn (mg/l)	<1		Supply facilities		Mn (mg/l)																									
	Remarks (Lithology , etc.) Hand pump		Results of Simplified Water Quality Test			Fe (mg/l)	<0.2	Remarks (Lithology , etc.)		Results of Simplified Water Quality Test																							
F (mg/l)					0.6	Fe (mg/l)																											
NO3- (mg/l)					3	F (mg/l)																											
NO2- (mg/l)					<0.02	NO3- (mg/l)																											
Coliforms						NO2- (mg/l)																											
Photo

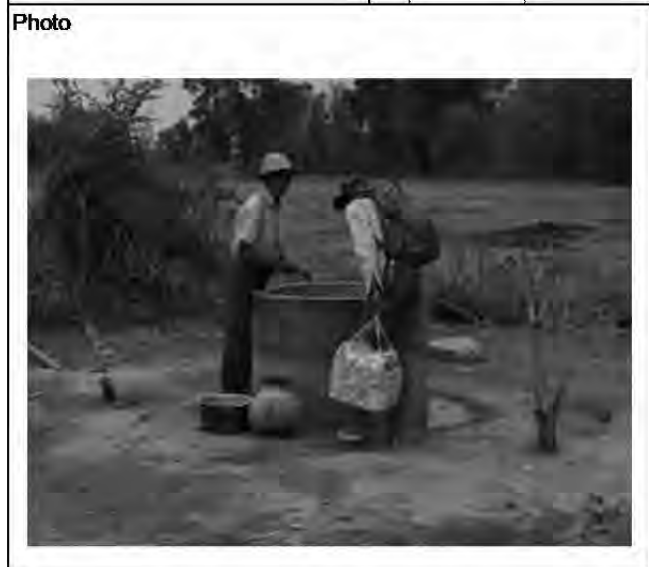
Region	Magway		Date	2015/5/17
Township	Taungdwingyi		Reported by	Maruo
Village / ID	Hlebwegyi	MG2-39	Coordinate (WGS84 UTM)	X
			Y

Information of Existing Water Source - 1				
Type	Deep Well	Coordinate	X	747939
	Shallow Well		Y	2200787
	Storage reservoir			
	○ Others(Dug Well)			
Hydrogeological Information	Drilled Depth (m)	5	Sample ID	MG2-39-1
	Diameter (in)		Temperature (°C)	30.5
	S.W.L (m)		pH	8.00
	D.W.L (m)		EC (µs/cm)	845
	Yield (m³/hour)		Smell	Non
	No.of users (person/day)		Color	Slightly turbidity
	Supply facilities		Mn (mg/l)	<1
	Remarks (Lithology , etc.) Dug well- 5m deep.		Results of Simplified Water Quality Test	Fe (mg/l)
F (mg/l)				0.1
NO3-(mg/l)				4
NO2-(mg/l)				<0.02
Coliforms

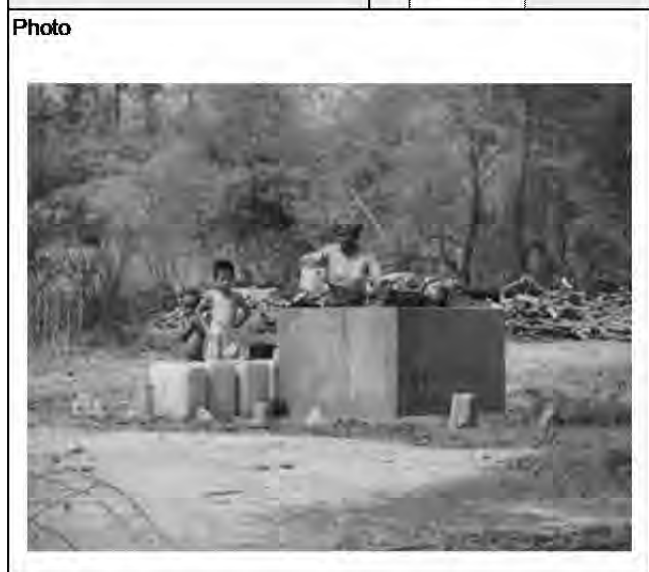
Region	Magway		Date	2015/5/17
Township	Taungdwingyi		Reported by	Maruo
Village / ID	YayHtwetgyi	MG2-40	Coordinate (WGS84 UTM)	X
			Y

Information of Existing Water Source - 1				
Type	Deep Well	Coordinate	X	743090
	Shallow Well		Y	2197425
	Storage reservoir			
	○ Others(Dug Well)			
Hydrogeological Information	Drilled Depth (m)	Results of Simplified Water Quality Test	Sample ID	MG2-40-1
	Diameter (in)		Temperature (°C)	29.5
	S.W.L (m)		pH	7.93
	D.W.L (m)		EC (µs/cm)	678
	Yield (m ³ /hour)		Smell	Non
	No.of users (person/day)		Color	Turbidity
	Supply facilities		Mn (mg/l)	<1
	Remarks (Lithology , etc.)		Fe (mg/l)	<0.2
Dug well,one of thee in one place.	F (mg/l)	0.2		
	NO3-(mg/l)	1		
	NO2-(mg/l)	<0.02		
	Coliforms
