Chapter 9

9 Basic Survey for Water Supply Planning of Small Towns

9.1 Introduction

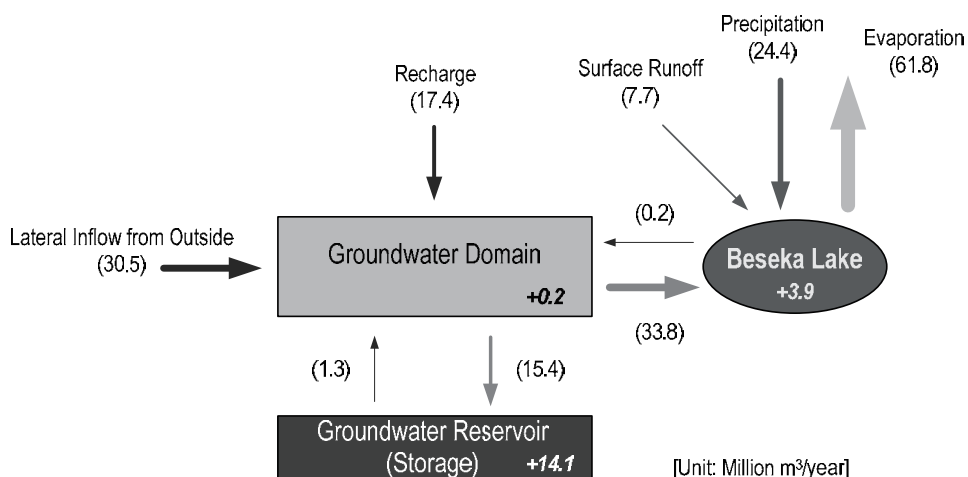
The water balance of Lake Beseka and its watershed has been analyzed by the above studies. The following figure shows the annual water balance analyzed by Ayalew (2009). The figure suggests the inflow from outside watershed of 30.5 million m³ annually.

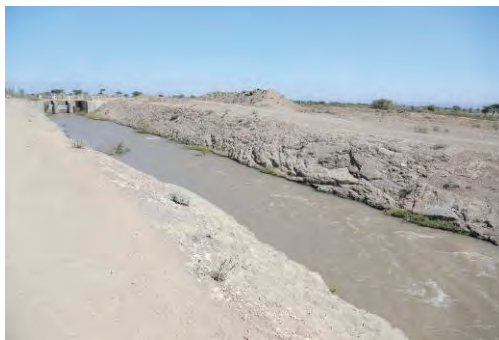
Dino ignimbrite exposed along the irrigation channel at the north of Nura Hira farm. L-BA11

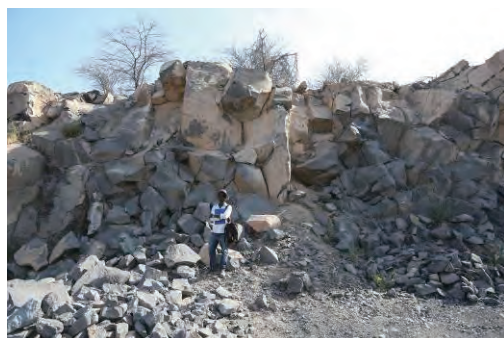
Olivine-pyroxene basalt exposed on the fault escarpment west of Lake Beseka (a-type). L-BA15

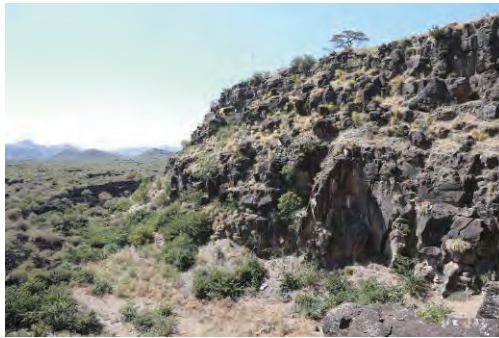
The Kone ignimbrite exposed on the west wall of Korke caldera. L-BA17

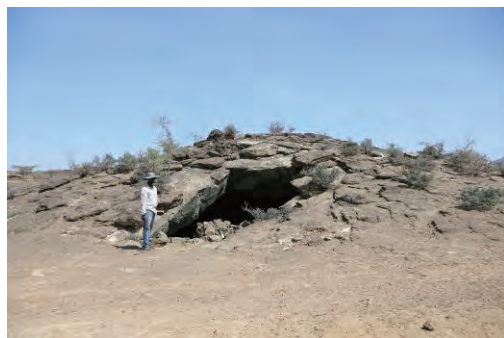
A blister with its original cavity remaining without collapsing (southern foot of Mt. Fentale). L-BA25

be cooled rapidly so that it cannot be welded strongly. Generally pyroclastic flow contains a large volume of volatiles and degassing structures are observed in the unwelded deposits. Probably the volatiles included in the original pyroclastic flow deposits of the Fentale ignimbrite lost a way out for degassing due to welding of the deposits, and then they gathered and combined at certain places increasing the volume. At last, the shape of present blisters was formed.

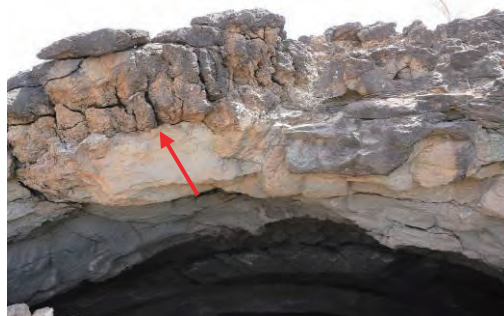
Cracks observed on the surface do not reach the inside (southern foot of Mt. Fentale)

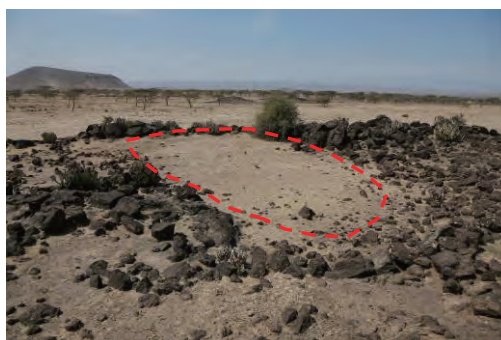
Remnant of a collapsed blister (a diameter of about 20m) (southern foot of Mt. Fentale)

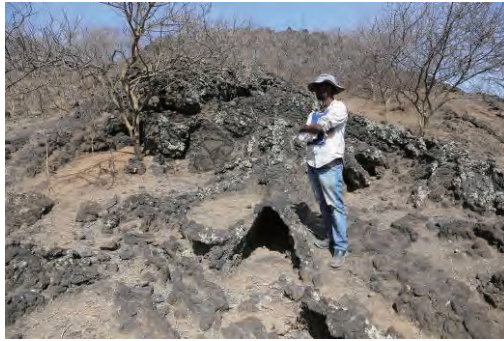
Lava tunnel observed near the eruption center of the recent basalt lava (Dinbiba). L-BA26

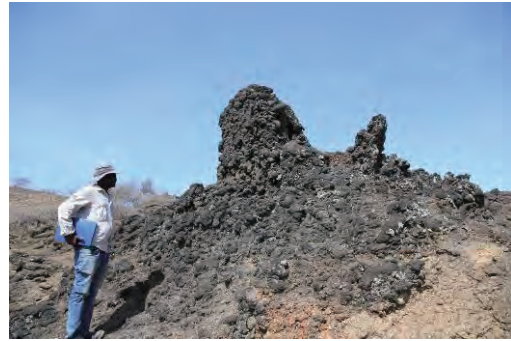
Spatter cone developed at the spout of the recent basalt lava (Dinbiba). L-BA26

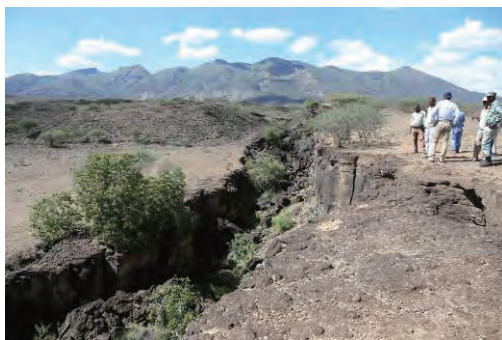
Open crack with a width of more than 10 m at 2 km north of Lake Beseka. L-BA30

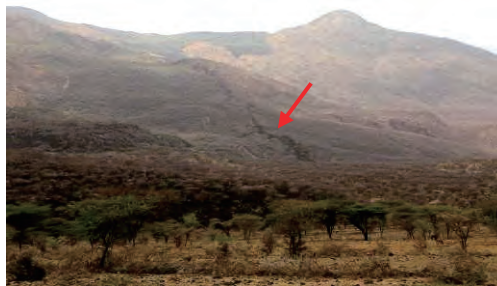
A normal fault extending from Lake Beseka towards Mt. Fentale
