8-3. 試験施工

Retrofitting Test Works by CNCRP

THE PROJECT FOR CAPACITY DEVELOPEMENT
ON
NATURAL DISASTER-RESISTANT TECHNIQUES
OF
CONSTRUCTION AND RETROFITTING FOR PUBLIC BUILDINGS
IN
THE PEOPLE'S REPUBLIC OF BANGLADESH

DRAWINGS FOR TEST WORKS

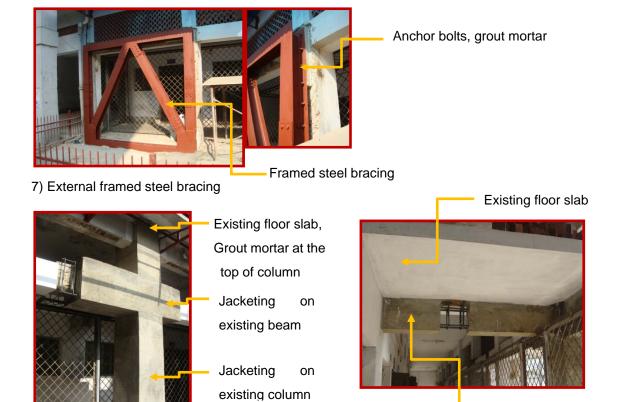
Figure Construction methods of Test Work

- 8) Concrete jacketing on existing column
- 9) Concrete jacketing on existing beam

10) New beam under floor slab

New beam, grout mortar at the top

(Construction sequence is shown by exposing each steps of construction such as anchoring, re-bar work, concreting, and mortar grouting etc.)

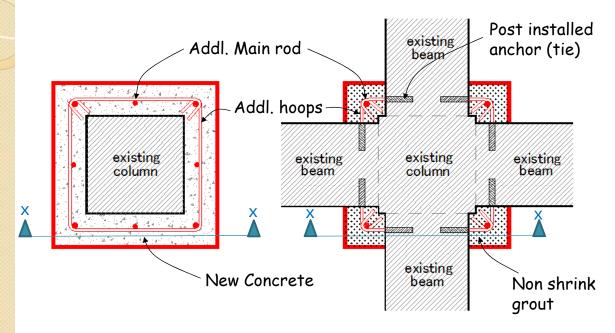
Section of column at mid span

Section of column at beam-col joint

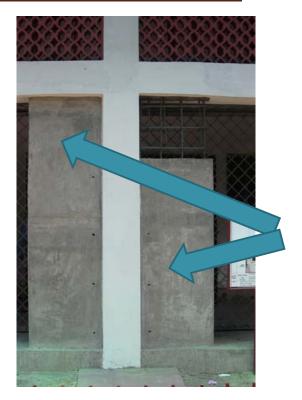
RC Wing Wall Provided at an existing column

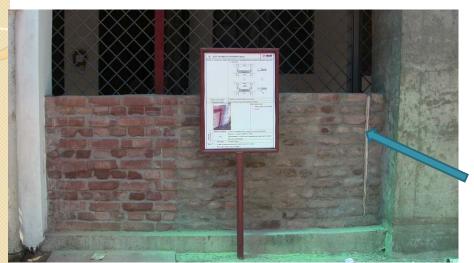
Seismic Slit is provided at a brick wall

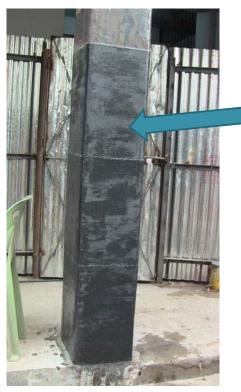
Figure 4.9-1 Flow of standard construction procedure

Repair of cross section (if necessary) Base material treatment (including round forming of corners) Applying primer Smoothing base material surface Wrapping continuous fiber sheets Curing Finishing

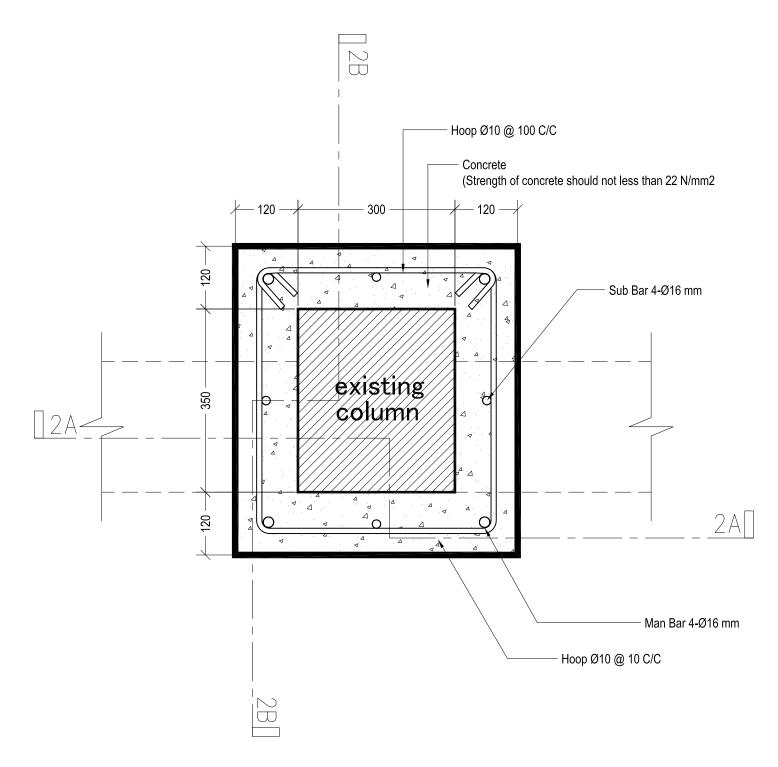
DETAILS OF COLUMN JACKETING

(PLAN SECTION AT MID HIEGHT OF COL)

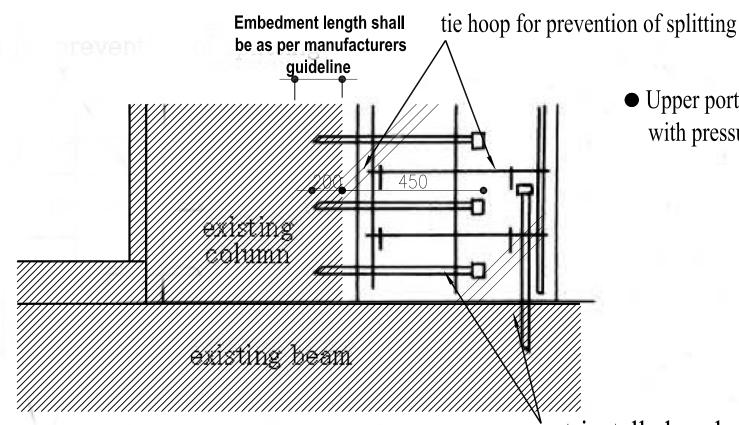
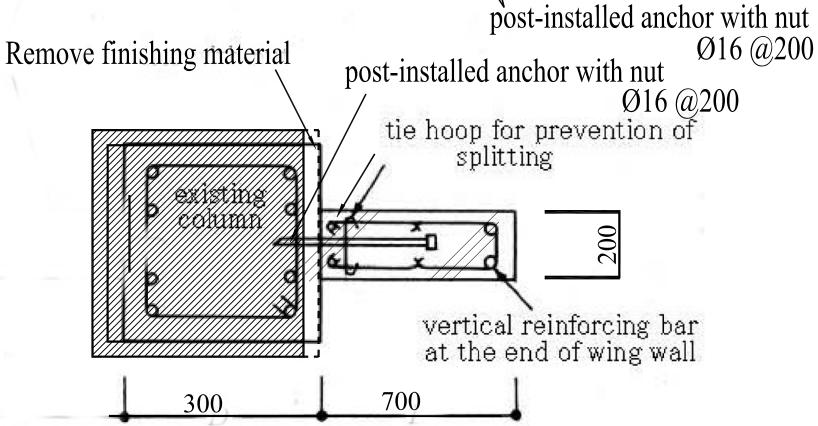
• Upper portion of RC wing wall should be grouted mortar with pressure as well as concrete jacketing and RC shear wall.
