8-4. 構造実験

CNCRP プロジェクトの一環として、第2年次（2012年）に既存 RC 造を想定した計7体、第3年次（2013年）に耐震補強試験体2体を含む計6体の縮小模型を用いた静的繰返し水平加力実験を行った。

Part 2: Experiment of year 2013

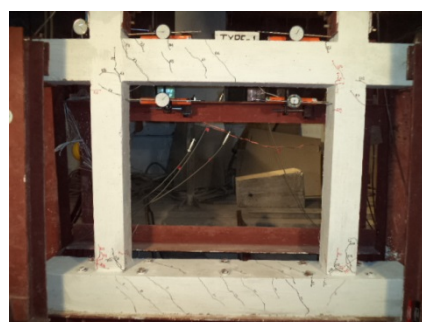
R<1/100 ($\delta < 11.75\text{mm}$), 5th and 6th cycle

Max. load: positive 5th, 4.5ton. 6th, 4.3 ton, negative 5st, 4.0ton, 6th 3.5 ton

Flexural cracks occurred at top and bottom of columns.

Vertical cracks also occurred at bottom of columns.

Diagonal crack occurred at top of right column.

R<1/100 ($\delta < 11.75\text{mm}$), max. load was positive 4.5ton and negative 4.0ton. Flexural cracks occurred at top and bottom of columns. Vertical cracks also occurred at bottom of columns. Diagonal crack occurred at the top of column. Diagonal crack at left column occurred at R < 1/200 ($\delta < 5.88\text{mm}$).

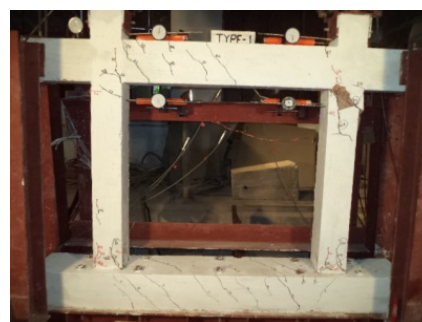
R<1/50 ($\delta < 23.5\text{mm}$), 7th cycle

Max. load: 7th positive, 4.2ton to 3.5ton.

7th positive, 3.5 ton at 23.5mm, shear failure at the top of right column occurred. Horizontal load reduced from 3.5 ton to 2.0 ton at 25.7mm, and 1.7 ton at 26.0mm. Vertical

load reduced from 16 ton to 3 ton only. The column cannot support vertical load at $R=1/50$. The load was released.

R<1/50 ($\delta < 23.5\text{mm}$), shear failure at the top of right column occurred at positive 3.5 at (25.7mm), and the vertical load dropped.

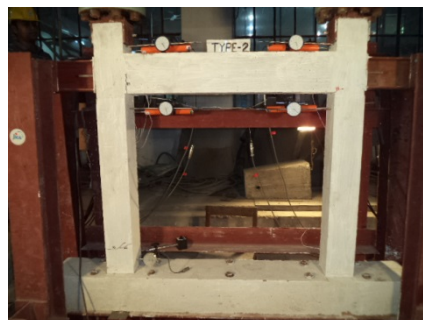
R<1/100 ($\delta < 11.75\text{mm}$), 5th and 6th cycle
 Max. load: positive 5th, 3.9ton. 6th, 3.5 ton, negative 5st, 5.0ton, 6th 4.0 ton
 Vertical crack extended at both panel zone, and strength dropped from 3.5 ton (7.8mm) to 3.0 ton (12.4mm).

R<1/100 ($\delta < 11.75\text{mm}$), max. load was observed positive 3.9ton and negative 5.0ton. Diagonal crack extended at both side of beam column panel zone, and strength dropped from 3.5 ton (at 7.8mm) to 3.0 ton (12.4mm). Flexural cracks occurred at bottom of columns.

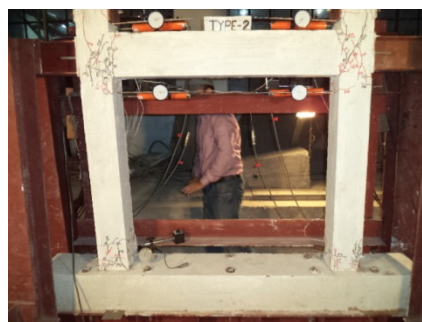
Vertical and diagonal crack extended at both panel zone.
Cover concrete at bottom of column (especially rear side) was detached.

R<1/50 ($\delta < 23.5\text{mm}$), Diagonal crack extended at both panel zone. Cover concrete at bottom of column (especially rear side) was detached.

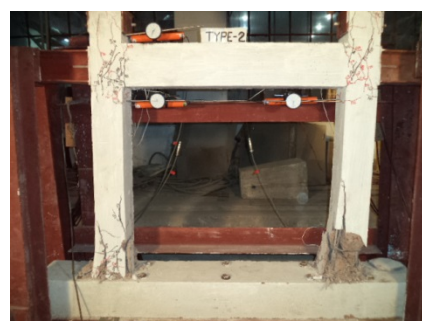
R<1/25 ($\delta < 47.0\text{mm}$), 9th cycle

Max.load; positive 3.5 ton (at -6.5mm), was reduced to 3.0ton (at +10mm), to 1.7 ton (at 20.1mm).

Vertical load was reduced from 16 to 8 ton at 30mm, and dropped to 4 ton further at 35mm. Bottom of column was failed.

Cracks of panel zone were extended.

R<1/25 ($\delta < 47.0\text{mm}$), Bottom of column was failed. Cracks of panel zone were extended. Vertical load was reduced at (30mm).

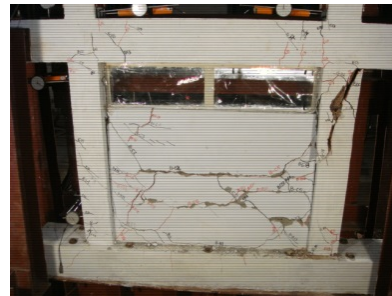
R<1/50 ($\delta < 23.5\text{mm}$), 7th cycle

Max. load: 7th positive, 7.0ton and dropped to 5.8 ton at R=1/50. Glass was broken. 7th negative, 8 ton and shear failure of right column occurred at 8.7mm, dropped to 2.7 ton at 17.1mm, and load was released.

Glass was broken with the decrease of strength of 1.2ton.

Shear failure of right column occurred at negative loading.

Right column couldn't support vertical load and vertical load was released.

Shear failure of right column

R<1/50 ($\delta < 23.5\text{mm}$), Positive load 7.0ton and dropped to 5.8 ton due to the Glass broken. Shear failure of right column occurred at (- 17.1mm) of negative loading, and vertical load was also dropped.

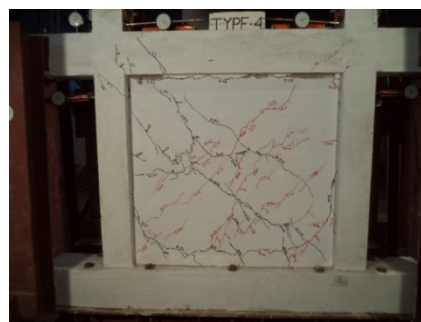
R<1/200 ($\delta < 5.88$ mm), 3rd and 4th cycle,

Max. load: positive 3rd, 11.0ton. 4th, 9.5ton, negative 3rd, 10.0 ton, 4th 9.75ton

Diagonal crack occurred at top of left column at 3rd cycle.

Cracks extended on brick wall.

R<1/200 ($\delta < 5.88\text{mm}$), max. load at positive was 11.0ton, and negative was 10.0 ton. Diagonal crack occurred at top of left column. Cracks extended on brick wall.

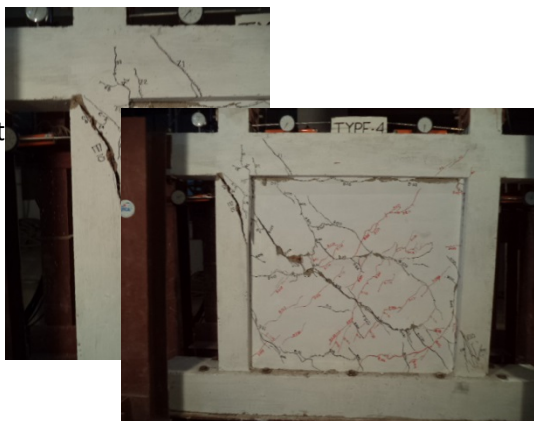
R<1/100 ($\delta < 11.75$ mm), 5th cycle,

Shear failure occurred at left column at R=1/118 (10mm/1175mm) of positive loading.

Horizontal load dropped suddenly from 10ton at R=1/118 to 6.5 ton at R=79 (14.8mm/1175mm), however maintained the vertical load.

R<1/100 ($\delta < 11.75\text{mm}$), Shear failure occurred at left column at (10mm) of positive loading. Big diagonal crack extended on brick wall and bottom of right column. At negative loading, horizontal stiffness decreased and could not support the vertical load.

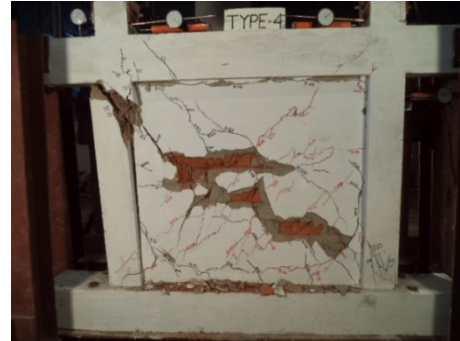
Big diagonal crack extended on brick wall.

At negative loading, horizontal stiffness decreased from the point of -7.5ton/1.2mm and maximum load was -8 ton at -2.7mm/1175, and could not support vertical load. Vertical load dropped from -16 ton to -8 ton from the point of - 7.0ton/-7.5mm to 1.5ton/-12.5mm.

Shear failure of right column (front and rear side)

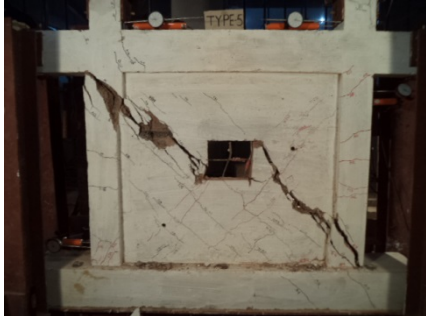
Shear failure at deflection 22.5mm

Failure n at deflectio 38.5mm

R<1/200 ($\delta < 5.88\text{mm}$), max. load was positive 23.3ton(limit of jack, at 4.3mm) and negative was 21.2ton. Horizontal crack observed at left column, diagonal crack developed at wall. Small square hole was provided on the wall at the lab. to reduce the strength, and loaded again. Shear failure occurred at positive loading 19.6 ton at 5.0mm. Axial load started the drop at around 8mm.

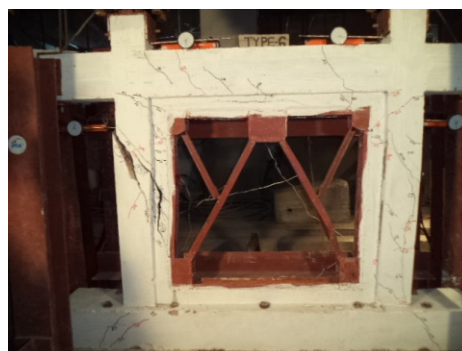
$R < 1/100$ ($\delta < 11.75\text{mm}$), 5th cycle, positive 20 ton at 9.0mm reduced to 14 ton at 20.9mm.

Shear failure occurred at left column that developed diagonal crack observed at 3rd cycle, and penetrated grout mortar portion.

Failure with diagonal and vertical crack occurred at left column.

Axial load of 16 ton was maintained, and reduced to 14 ton for left column and right column maintained 16ton. Buckling of left frame observed, which acted as a column.

Horizontal strength of 12ton was observed at 26mm, and vertical load dropped to 10to for left column.

Out of plain direction buckling was observed at right steel bracing.

Failure at deflection 20.9mm

R<1/200 ($\delta < 5.88\text{mm}$), max. load was positive 22.0ton at (5.2mm), and negative load was 22.0ton at (6.2mm). New diagonal crack occurred at middle of left column at 3rd positive cycle. Slight Buckling of out of plain direction of left bracing was observed.

R < 1/100 ($\delta < 11.75\text{mm}$), Shear failure occurred at left column at positive 20 ton at (9.0mm).

Buckling of left vertical steel frame was observed. Yield of left side brace and out of plain direction buckling at right side steel bracing was observed. Horizontal crack beneath the beam at grout mortar was observed. Vertical load drop started at 20.9mm.

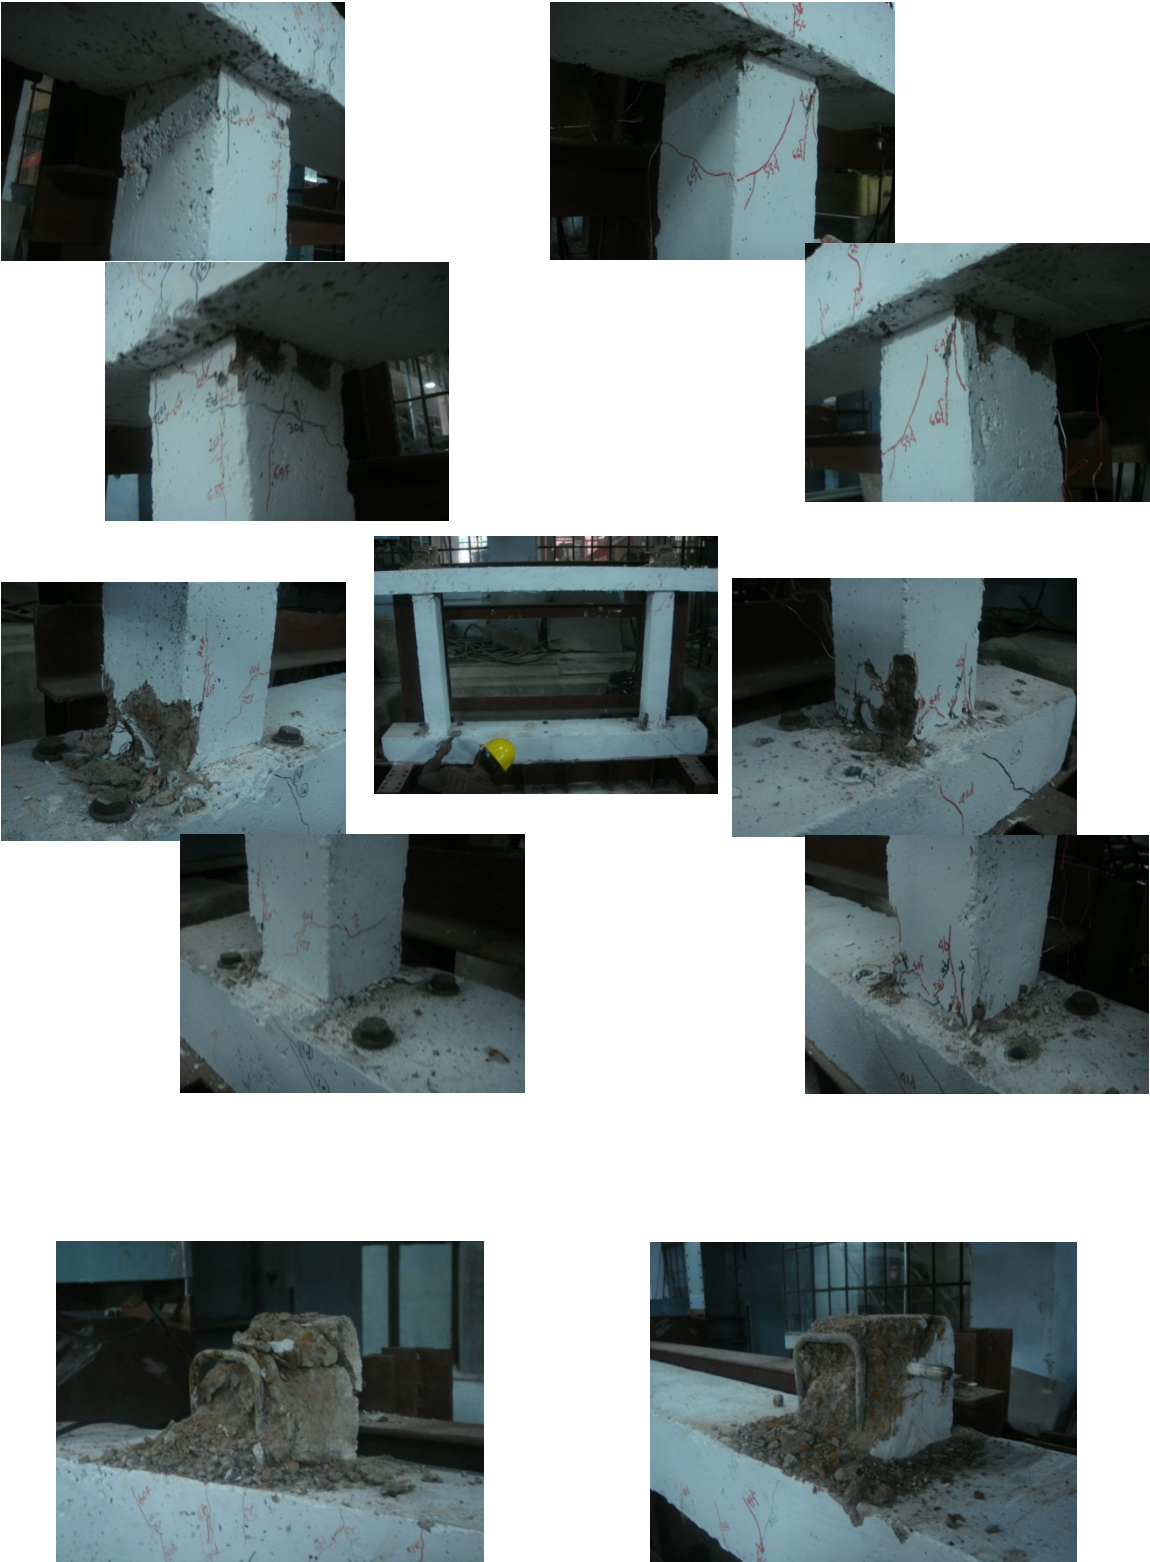
Collapse of column top caused by axial force was observed (after the test). Possible reason is that concrete was weak with honeycomb. This limited the size of vertical loading.
