Report of

Structural Experiments on 2012 and 2013 by CNCRP

March 2014

CNCRP (PWD and JICA)

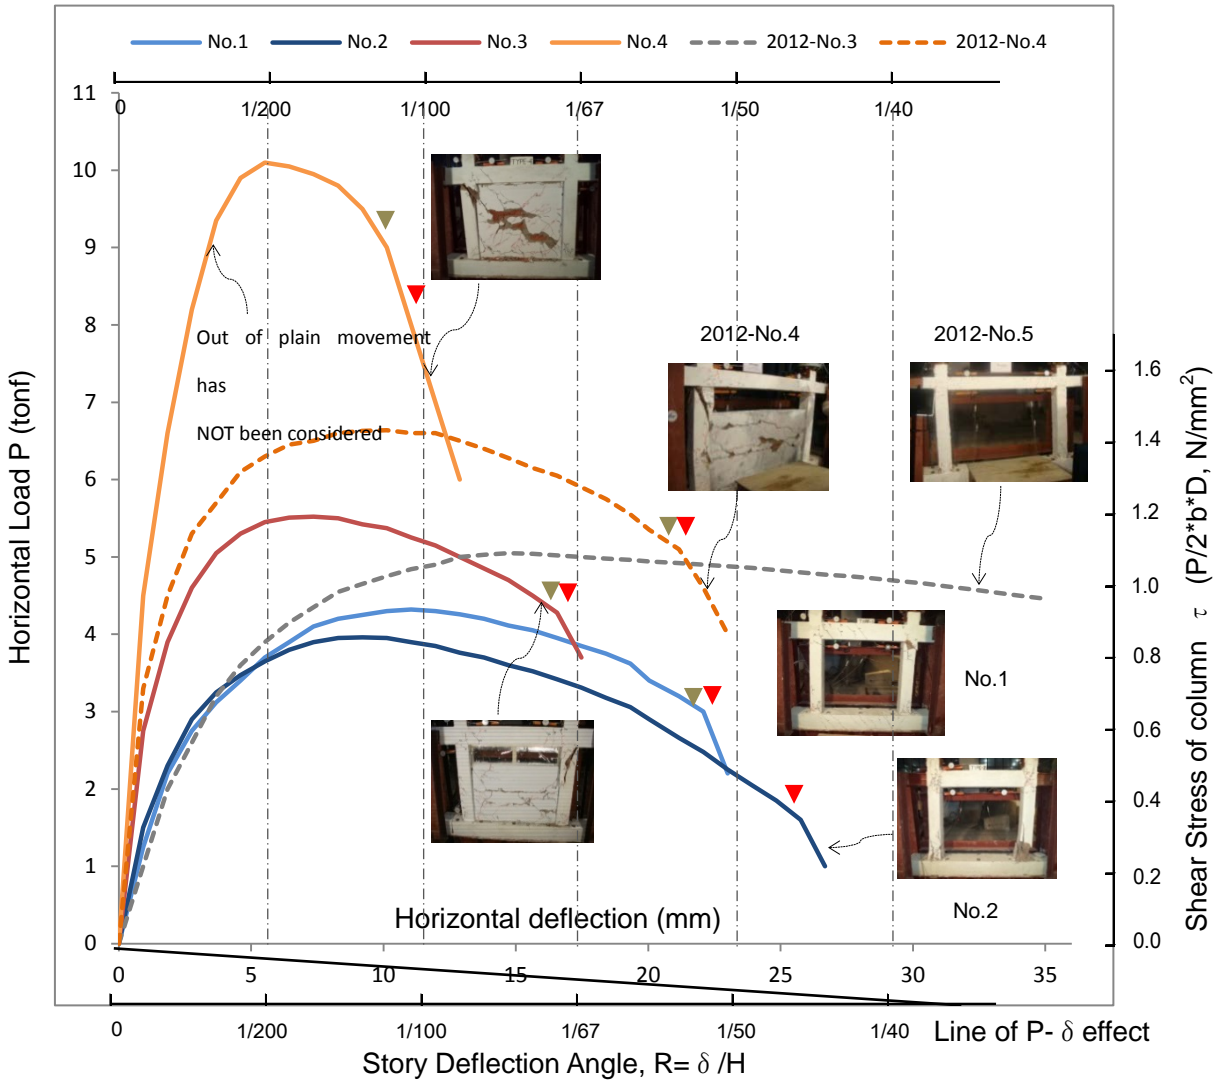
Axial force ratio: Specimen No.1 ~ No.4, $N / (b \cdot D \cdot F_c) = 0.68$ ($F_c = 10.6 \text{ N/mm}^2$, $N = 163 \text{ kN}$)

Specimen 2012-No.4, 5, $N / (b \cdot D \cdot F_c) = 0.44$ ($F_c = 16.5 \text{ N/mm}^2$, $N = 163 \text{ kN}$)

Note: Marking: ▼ denotes a point of “Drop in vertical strength”.

▼ denotes a point of “Shear failure” by the visual observation.

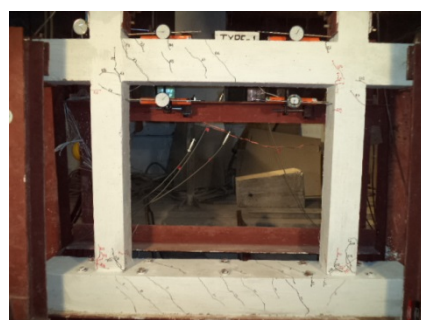
R<1/100 ($\delta < 11.75\text{mm}$), 5th and 6th cycle

Max. load: positive 5th, 4.5ton. 6th, 4.3 ton, negative 5th, 4.0ton, 6th 3.5 ton

Flexural cracks occurred at top and bottom of columns.

Vertical cracks also occurred at bottom of columns.

Diagonal crack occurred at top of right column.

R<1/100 ($\delta < 11.75\text{m}$), max. load was positive 4.5ton and negative 4.0ton. Flexural cracks occurred at top and bottom of columns. Vertical cracks also occurred at bottom of columns. Diagonal crack occurred at the top of column. Diagonal crack at left column occurred at R < 1/200 ($\delta < 5.88\text{mm}$).

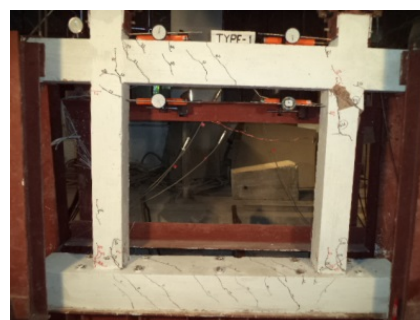
R<1/50 ($\delta < 23.5\text{mm}$), 7th cycle

Max. load: 7th positive, 4.2ton to 3.5ton.

7th positive, 3.5 ton at 23.5mm, shear failure at the top of right column occurred. Horizontal load reduced from 3.5 ton to 2.0 ton at 25.7mm, and 1.7 ton at 26.0mm. Vertical

load reduced from 16 ton to 3 ton only. The column cannot support vertical load at $R=1/50$. The load was released.

R<1/50 ($\delta < 23.5\text{mm}$), shear failure at the top of right column occurred at positive 3.5 at (25.7mm), and the vertical load dropped.

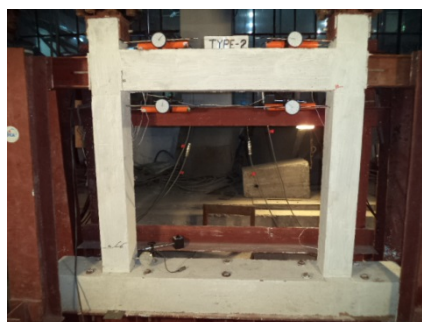
R<1/400 ($\delta < 2.94\text{mm}$), 1st and 2nd Cycle,
 Initial stiffness was 1.85t/mm (= 1ton/0.55m).
 Max. load: positive 1st, 2.0 ton. 2nd, 2.5ton, negative 1st, 3.0 ton, 2nd 3.0ton
 Slip with 1.2mm was caused at 2.0 ton, 1st cycle positive loading.
 Crack was observed at front side of bottom of left column.

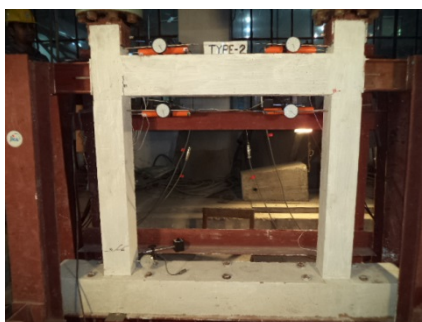
R<1/200 ($\delta < 5.88\text{mm}$), 3rd and 4th cycle,
 Max. load: positive 3rd, 3.3ton. 4th, 3.2ton, negative 3rd, 4.0ton, 4th 3.8ton
 No clear change was observed.

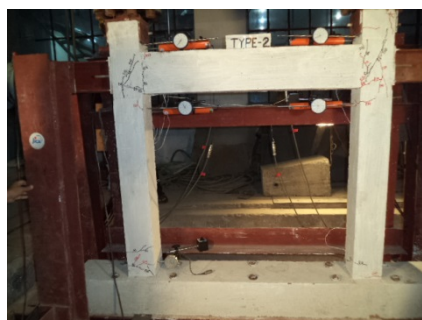
R<1/100 ($\delta < 11.75\text{m}$), 5th and 6th cycle
 Max. load: positive 5th, 3.9ton. 6th, 3.5 ton, negative 5st, 5.0ton, 6th 4.0 ton
 Vertical crack extended at both panel zone, and strength dropped from 3.5 ton (7.8mm) to 3.0 ton (12.4mm).

R<1/100 ($\delta < 11.75\text{m}$), max. load was observed positive 3.9ton and negative 5.0ton. Diagonal crack extended at both side of beam column panel zone, and strength dropped from 3.5 ton (at 7.8mm) to 3.0 ton (12.4mm). Flexural cracks occurred at bottom of columns.

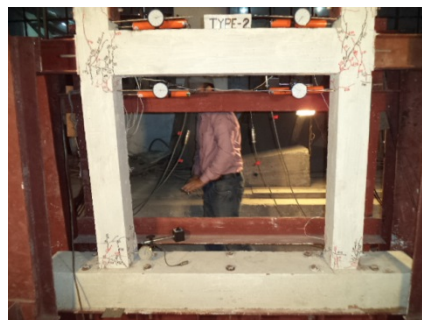
Flexural cracks occurred at bottom of columns.

Max. load: positive 7th, 4.0ton. 8th, 3.5 ton, negative 7th, 3.7 ton, 8th 3.0 ton

Vertical and diagonal crack extended at both panel zone.
Cover concrete at bottom of column (especially rear side) was detached.

R<1/50 ($\delta < 23.5\text{mm}$), Diagonal crack extended at both panel zone. Cover concrete at bottom of column (especially rear side) was detached.

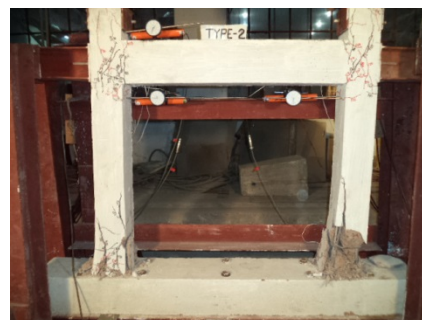
R<1/25 ($\delta < 47.0\text{mm}$), 9th cycle

Max.load; positive 3.5 ton (at -6.5mm), was reduced to 3.0ton (at +10mm), to 1.7 ton (at 20.1mm).

Vertical load was reduced from 16 to 8 ton at 30mm, and dropped to 4 ton further at 35mm. Bottom of column was failed.

Cracks of panel zone were extended.

R<1/25 ($\delta < 47.0\text{mm}$), Bottom of column was failed. Cracks of panel zone were extended. Vertical load was reduced at (30mm).

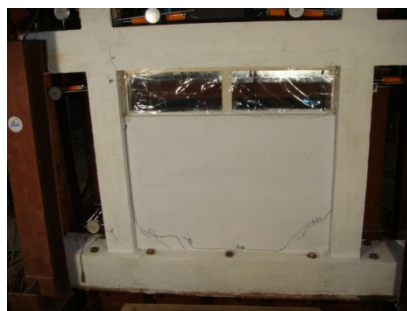
Flexural crack occurred at bottom of left and right column.

Cracks occurred for brick wall.

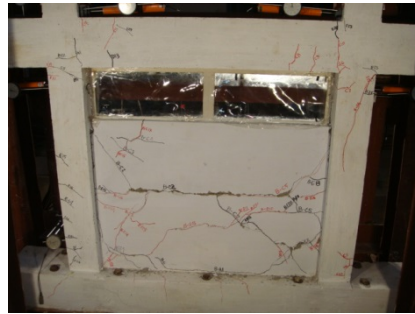
R<1/100 ($\delta < 11.75\text{mm}$), 5th and 6th cycle

Diagonal and vertical crack extended on right column, crack occurred at 5th cycle.

Many flexural cracks occurred at left column.

R<1/100 ($\delta < 11.75\text{m}$), Diagonal and vertical crack extended on right column. Many flexural cracks at left column observed.

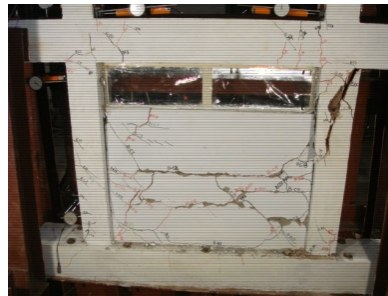
R<1/50 ($\delta < 23.5\text{mm}$), 7th cycle

Max. load: 7th positive, 7.0ton and dropped to 5.8 ton at R=1/50. Glass was broken. 7th negative, 8 ton and shear failure of right column occurred at 8.7mm, dropped to 2.7 ton at 17.1mm, and load was released.

Glass was broken with the decrease of strength of 1.2ton.

Shear failure of right column occurred at negative loading.

Right column couldn't support vertical load and vertical load was released.

Shear failure of right column

R<1/50 ($\delta < 23.5\text{mm}$), Positive load 7.0ton and dropped to 5.8 ton due to the Glass broken. Shear failure of right column occurred at (- 17.1mm) of negative loading, and vertical load was also dropped.

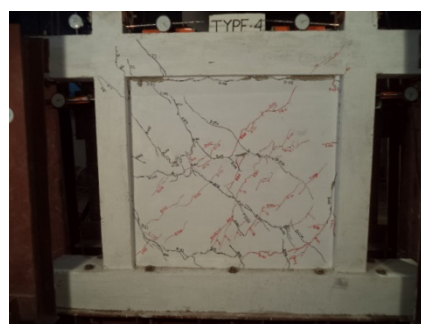
R<1/200 ($\delta < 5.88$ mm), 3rd and 4th cycle,

Max. load: positive 3rd, 11.0ton. 4th, 9.5ton, negative 3rd, 10.0 ton, 4th 9.75ton

Diagonal crack occurred at top of left column at 3rd cycle.

Cracks extended on brick wall.

R<1/200 ($\delta < 5.88\text{mm}$), max. load at positive was 11.0ton, and negative was 10.0 ton. Diagonal crack occurred at top of left column. Cracks extended on brick wall.

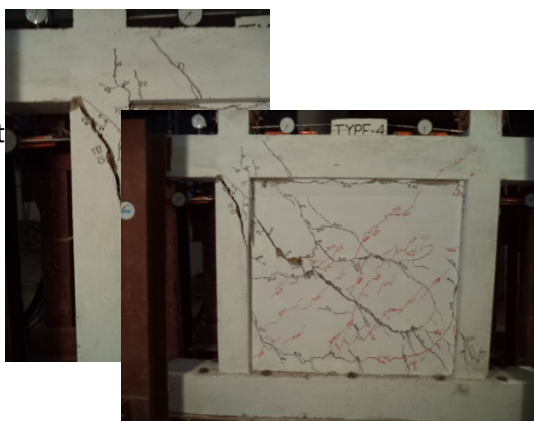
R<1/100 ($\delta < 11.75$ mm), 5th cycle,

Shear failure occurred at left column at R=1/118 (10mm/1175mm) of positive loading.

Horizontal load dropped suddenly from 10ton at R=1/118 to 6.5 ton at R=79 (14.8mm/1175mm), however maintained the vertical load.

R<1/100 ($\delta < 11.75\text{mm}$), Shear failure occurred at left column at (10mm) of positive loading. Big diagonal crack extended on brick wall and bottom of right column. At negative loading, horizontal stiffness decreased and could not support the vertical load.

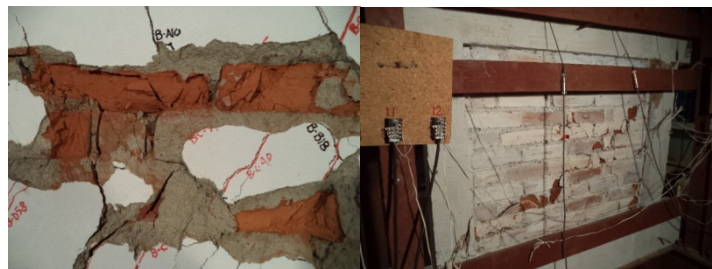
Shear failure of left column

Brick wall (front and rear side)

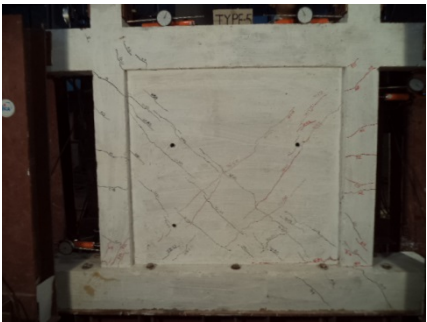
$R = \delta / h < 1/100$, 5rd and 6th cycle, $\delta < 11.75\text{mm}$
5th cycle; positive 23.3ton (jack limitation) at 5.0mm, negative 23.0ton (jack limitation) at 8.5mm. 12 November 2013.

Diagonal crack width of left column is 0.3mm, right column is 0.1mm shear crack of column

R<1/200 ($\delta < 5.88\text{mm}$), max. load was positive 23.3ton(limit of jack, at 4.3mm) and negative was 21.2ton. Horizontal crack observed at left column, diagonal crack developed at wall. Small square hole was provided on the wall at the lab. to reduce the strength, and loaded again. Shear failure occurred at positive loading 19.6 ton at 5.0mm. Axial load started the drop at around 8mm.

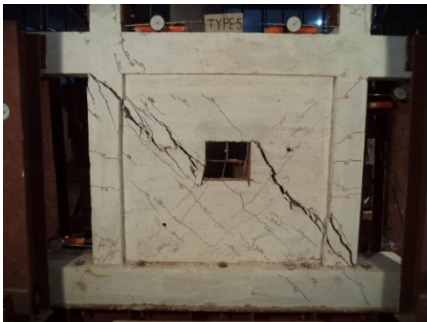
6th cycle, positive loading, shear failure occurred 19.6 ton at 5.0mm, horizontal load reduced from 19.6 ton to 4.5ton at 22.5mm. Axial load dropped from 16ton to 8.5 ton for both columns. Tried to increase axial load to 12 ton, but reduced to 7ton (left column) and

11 ton (right column). Horizontal load reduced to 0.5 ton at 38.5mm.

Shear failure at deflection 22.5mm

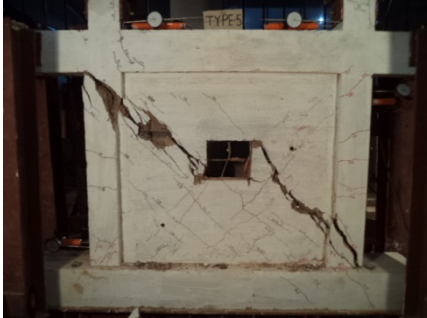
Failure n at deflectio 38.5mm

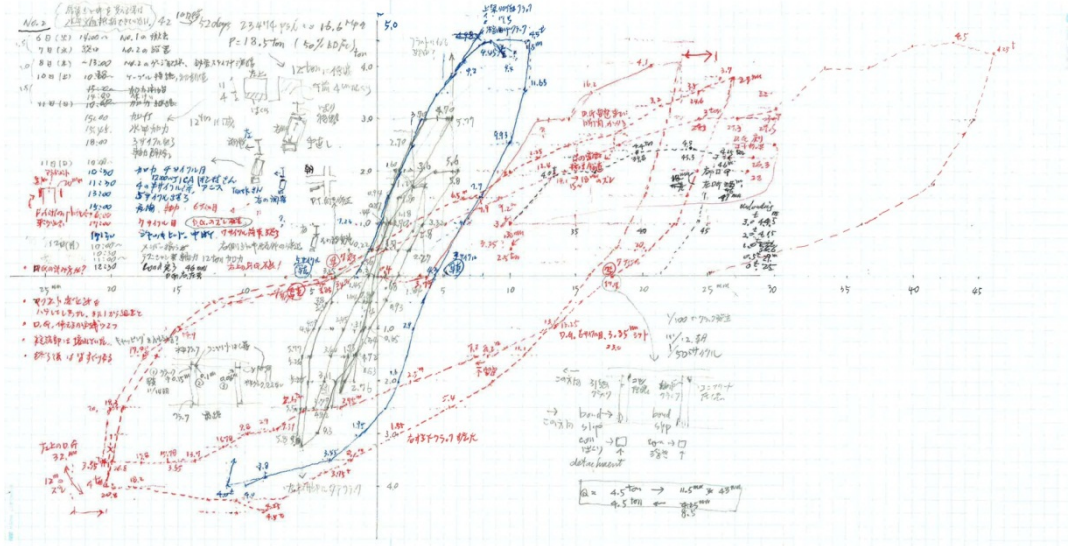
Load- deflection curve, specimen no.2

(a)

No.2,

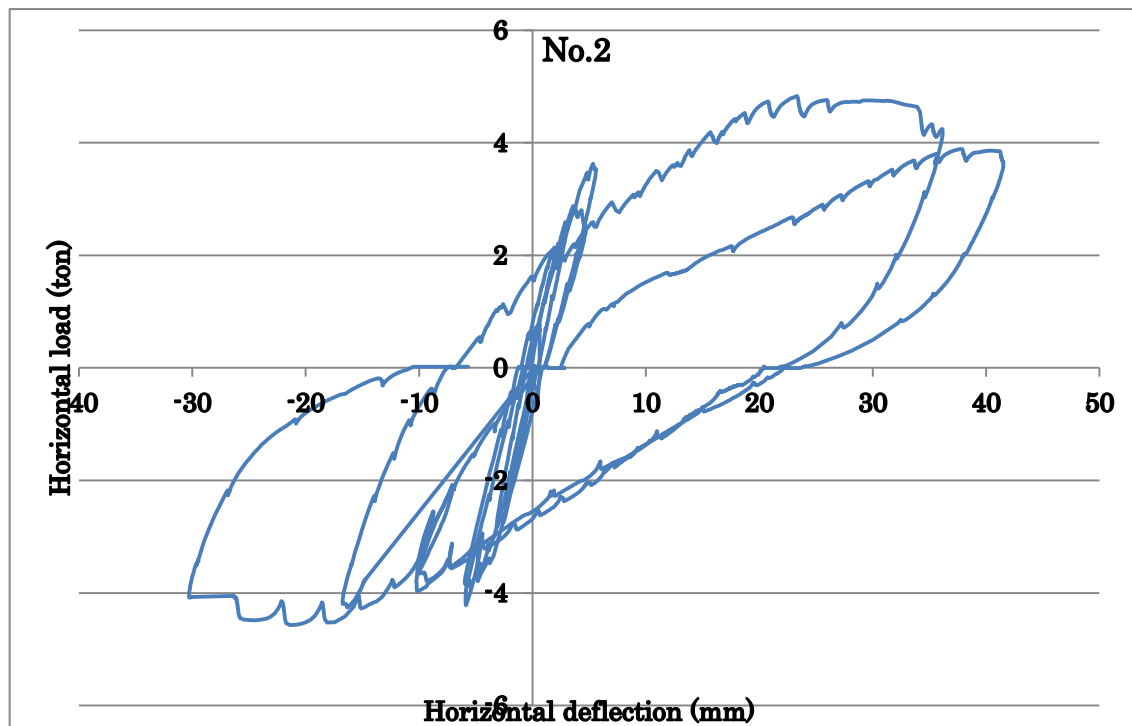
Data of loading cycle R=1/100 (11.5mm), R=1/50 (23mm) are missing.

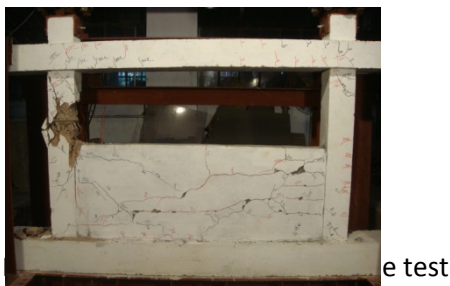
Shear failure occurred at left side column (loading was provided from left to right first). Shear (diagonal) cracks were observed at right column but no serious damage was observed, when left column failed.

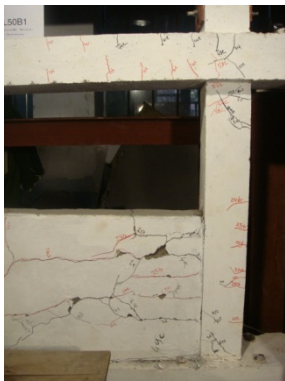
Cracks of joint mortar of brick standing wall (rear side)

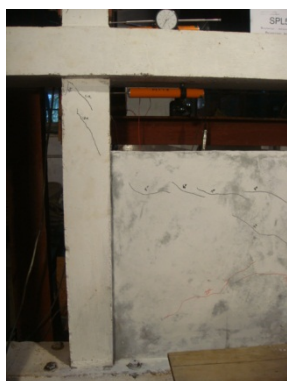
Two diagonal cracks (shear cracks) were observed on top of left column at 1st positive loading. Cracks on standing wall observed.

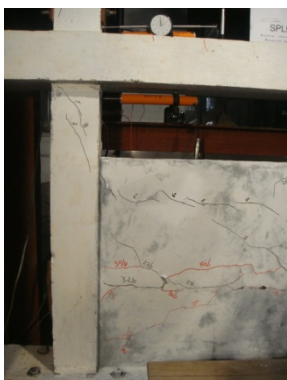
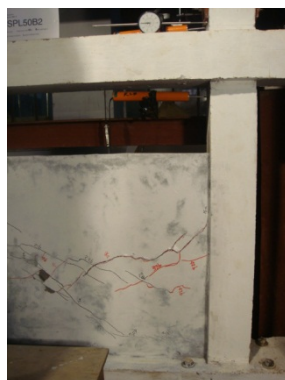
R<1/200 ($\delta < 5.75\text{mm}$), 2nd cycle,

Detachment of finishing mortar on brick standing wall started.

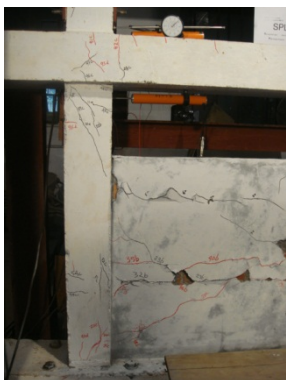
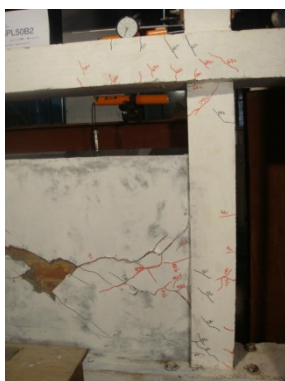
R<1/100 ($\delta < 11.5\text{mm}$), 3rd, 4th cycle,

Vertical crack occurred at lower part of left column at positive loading. Diagonal cracks (shear cracks) were observed on top of right column at positive and negative loading. Flexural cracks at the bottom of right column.

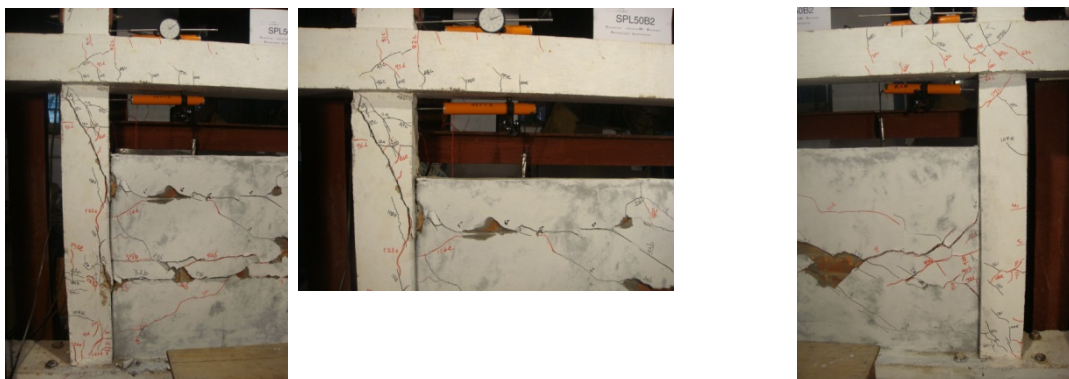
R<1/50 ($\delta < 23\text{mm}$), 5th cycle.

Shear failure of left column occurred during positive loading at deflection angle 1/100, with loading of 4 ton. Brick standing wall was almost collapsed with upward movement at the center.

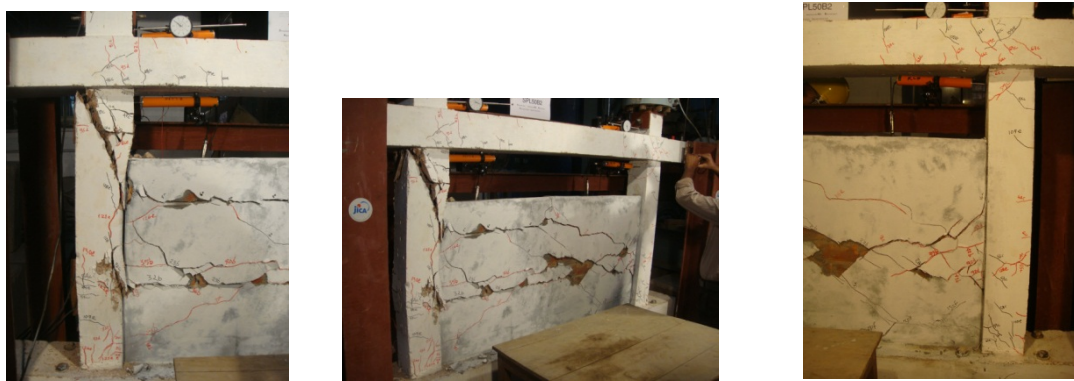
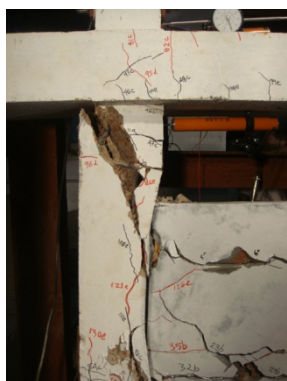
R<1/25 ($\delta < 46\text{mm}$), 7th cycle,

Vertical load carrying capacity of left column reduced from 16ton to 8 ton at horizontal deflection of 30mm and horizontal load 3.5 ton. Vertical load was release ton zero at 35mm/ 2.0ton. Shear cracks were observed for right column but no shear failure was observed.

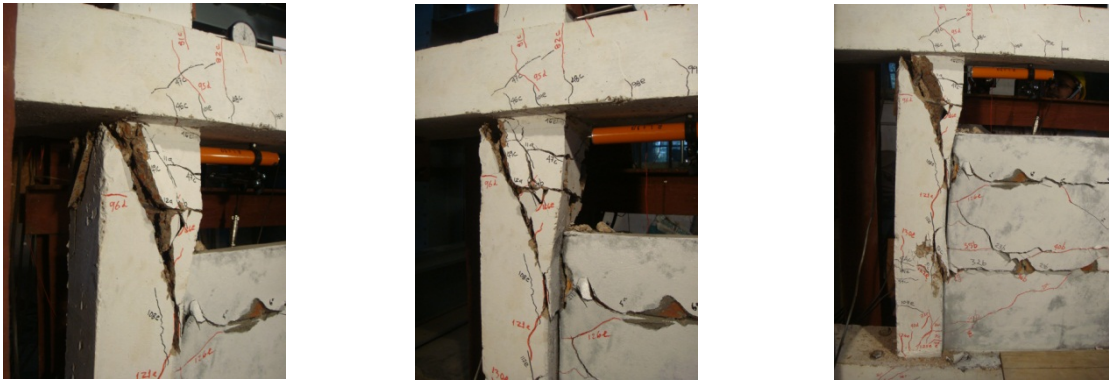
Horizontal crack of mortar joints

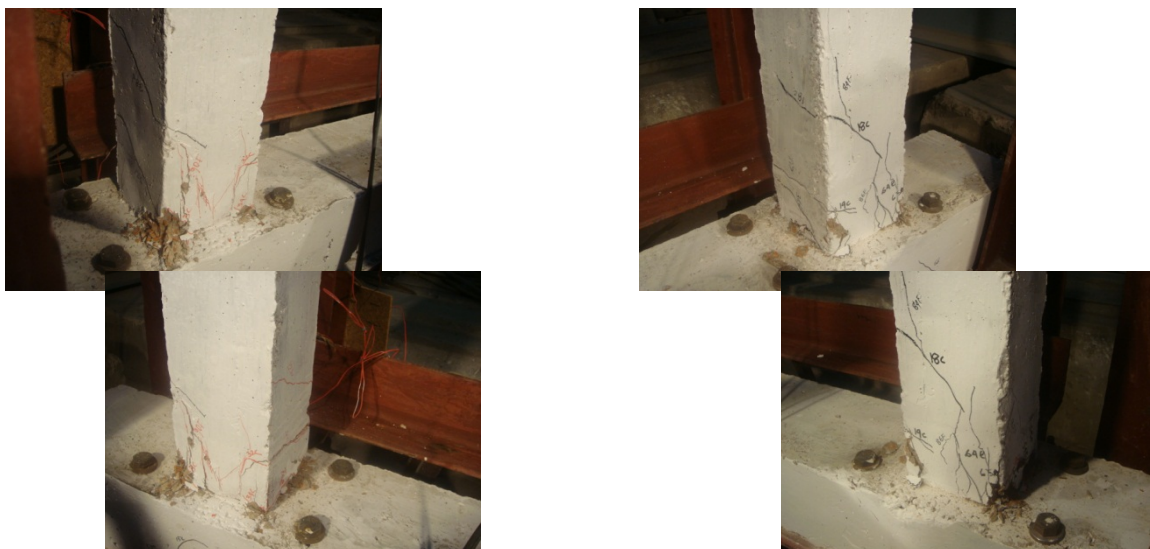
Specimen No.5, Concrete cracks and failure of covering concrete

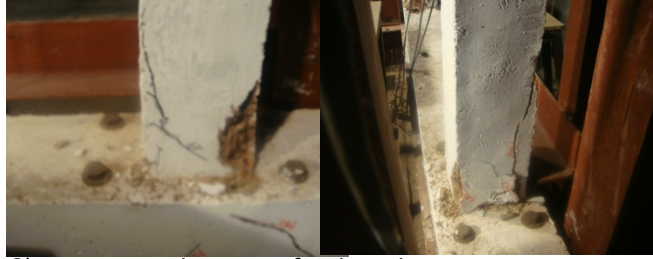
Compressive failure of covering concrete

Bottom of left column (force toward out of plane?)

bottom of right column

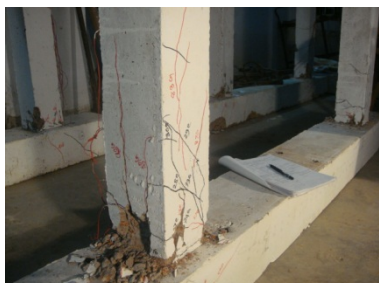
Compressive failure of covering concrete

Compressive failure of covering concrete and split (vertical crack) failure

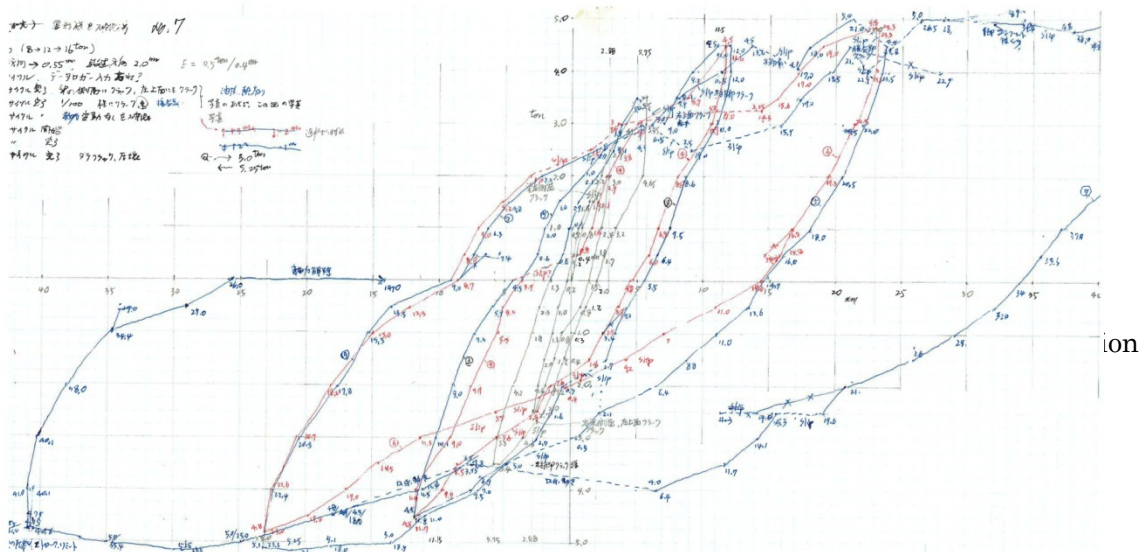
No. 7, load- deflection curve (reading value of hydraulic jacks and dial gauge)

No.7, Simplified Load-deflection curve covering peak values (vertical load; ton, horizontal axis; mm)
