7. Reference

## 7-2. Geotechnical Survey Report (excerpted)

Hisham’s palace is an important archaeological site located five KM north of the town center of Jericho City. It consists of three main parts: a palace, Great bath Hall and an agricultural estate. An elaborate irrigation system provided the complex with water from nearby springs. The most famous artistic aspect of the site is the “tree of life” mosaic in the Diwan of the bath complex, although the mosaic floor of the main Bath Hall is considered the most famous mosaic area in the region.

The designated rehabilitation is to consider building a proper roofing structure to cover the Bath Hall to expose the mosaic flooring for tourism.

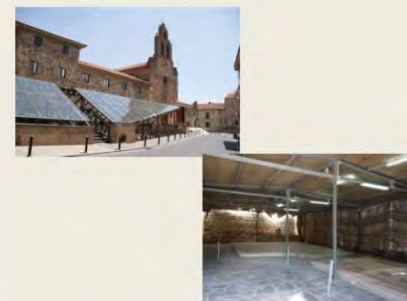
### 5b. Lighting

- Obscure bright space by diffusion light from **translucent membrane**
- There is **no shadow** and this type of lighting is applied to many protecting shelter

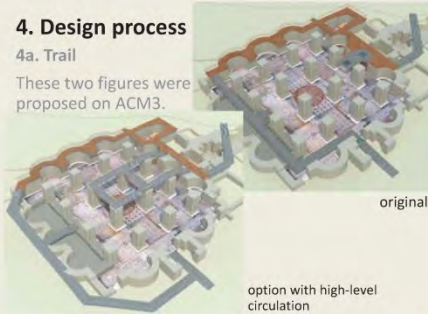
### FINAL TRAIL CIRCULATION

The trail design has been developed with the following idea:

- **High-level trail** is shortened not so as to be seen from the entrance.
- **The direction of entry** is aligned north-south axis so as to ease access from the mosque site.
- **Entrance stage** for information to visitors is added.
- **Exit trail** is not set aside remains.
