ボスニア・ヘルツェゴビナ国 初等学校建設計画 フォローアップ調査報告書

平成 28 年 1 月

独立行政法人
国際協力機構 (JICA)

株式会社 毛利建築設計事務所

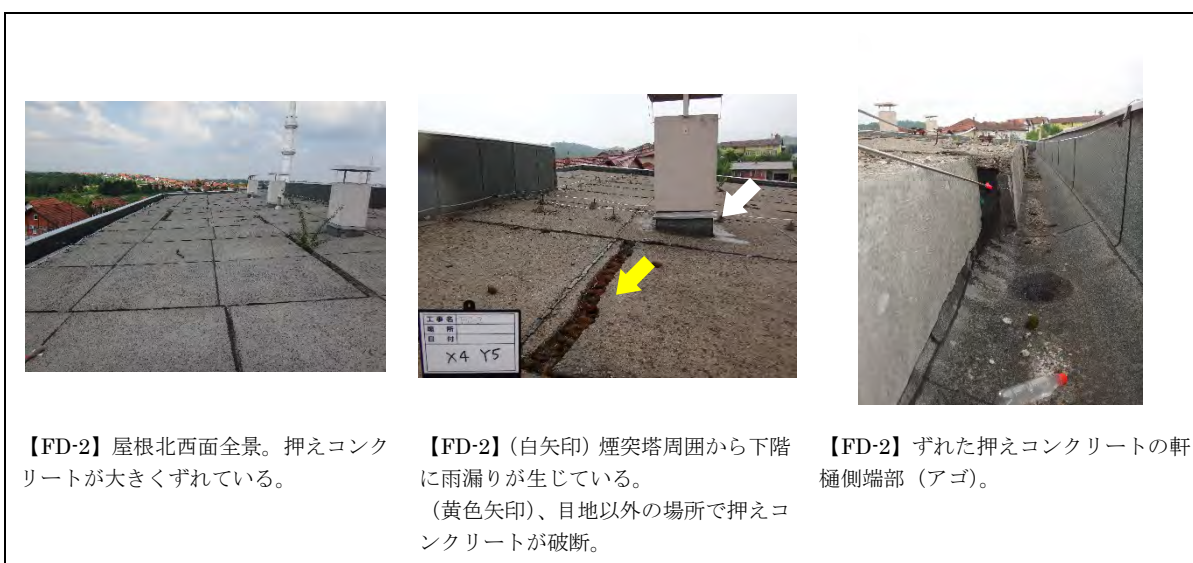
防水保護層（押えコンクリート）が屋根勾配の水下方向にずれており、コンクリート板間の目地が拡大している。押えコンクリートが、膨張・収縮を繰り返すことにより少しずつ移動し、伸縮目地が拡大したり目地以外の場所に亀裂が生じたものと考えられる。また、拡大した伸縮目地や亀裂は、冬の積雪時に水分が凍結・膨張し、更に目地や亀裂を押し広げ、押えコンクリートを水下方向に押す力が働いたと考えられる。

状態が最も深刻な FD-2 校では、目地が 10 cm 以上開いている箇所もあった。ずれが生じているのは押えコンクリートと押えコンクリート下の絶縁用シート (PVC シート) であり、その下に敷設されている断熱層 (スチレンフォーム) および防水層 (アスファルト防水) は押えコンクリートの移動には追従していない。よって、保護層下の防水層は概ね健全な状態であると判断される。

ただし、FD-2 校、FD-7 校では屋根からの雨漏りが確認されており、煙突塔やパラペット等の立ち上り入隅部の防水層に不具合が生じていると思われる。

当該問題に起因する雨漏りが生じているのは現時点では 2 校 (FD-2、FD-7) だけだが、時間の経過と共に、同様の問題が生じている他の 2 校 (FD-3、FD-8) でも雨漏りが発生する可能性があり、また、既に雨漏りが発生している FD-2、FD-7 については雨漏りの状況が深刻化する懸念がある。

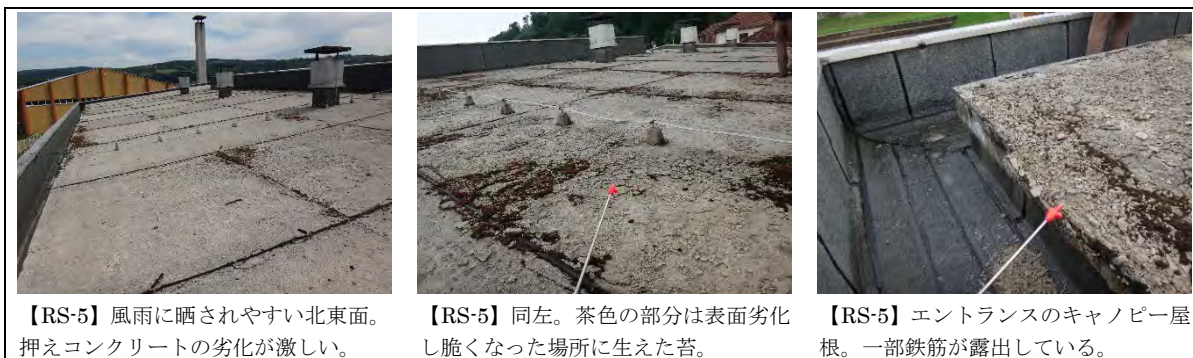
押えコンクリートの表面が劣化し、表面のセメント部分が失われ、骨材や鉄筋が露出している箇所もある。引渡し後の凍害で表面にひび割れ等が生じ、降雨、降雪などにより更なる劣化を招いたと考えられる。

FD-5校では全面、FD-2校、FD-7校、RS-5校の3校では風を伴う雨・雪に晒されやすい側の屋根面の劣化が酷く、コンクリート表面が脆く崩れており、崩れたコンクリート片が雨で押し流されて雨樋内に溜まっているケースが散見された。

防水保護層である押えコンクリートの表面劣化は、屋根の防水性能に直接的な影響を与えるものではないため、表面劣化が軽度であると判定された学校への対応の必要性は高くないと考える。他方、表面劣化の状態が深刻である学校は、崩れたコンクリート片が雨樋のドレインを塞ぎ、雨樋からの雨漏りを誘発する懸念があるほか、経年変化で鉄筋の露出が進むと鉄筋の発錆とコンクリートの中酸化により押えコンクリートの更なる劣化に繋がる可能性がある。

劣化箇所のコンクリート研りとコンクリート片の除去と共に、当該箇所に設置された避雷導線および台座を撤去する。洗浄後、鉄筋の防錆処理とコンクリート補修材等による補修を行い、周辺部の目地補修と、避雷導線の再施工を行う。

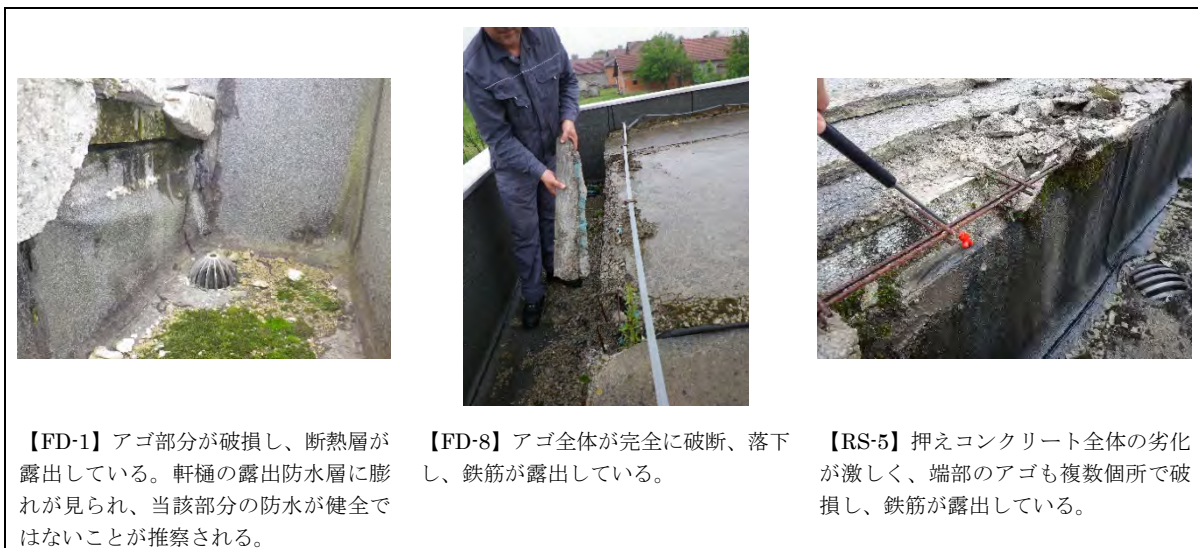
押えコンクリート端部のアゴが劣化により破損して鉄筋が露出したり、アゴ全体が破断し雨樋内に落下しているケースが散見された。上記項目 2 の「屋根押えコンクリートの表面劣化」と同じ原因によると考えられる。

鉄筋が露出している箇所は、鉄筋の発錆とコンクリートの劣化により押えコンクリートの更なる破損、破断を招く可能性がある。また、アゴ部分が大きく破損、破断している箇所は、アゴ下に巻き込まれている防水層の継ぎ目からの雨水侵入も懸念される。

FD-1 校、RS-5 校については、劣化箇所のコンクリート研りとコンクリート片の除去と共に、当該箇所に設置された避雷導線および台座を撤去する。洗浄後に鉄筋の防錆処理を行い、アゴ部分の補修（金物水切の設置）を行うと共に、周辺部の目地補修と、避雷導線の再施工を行う。

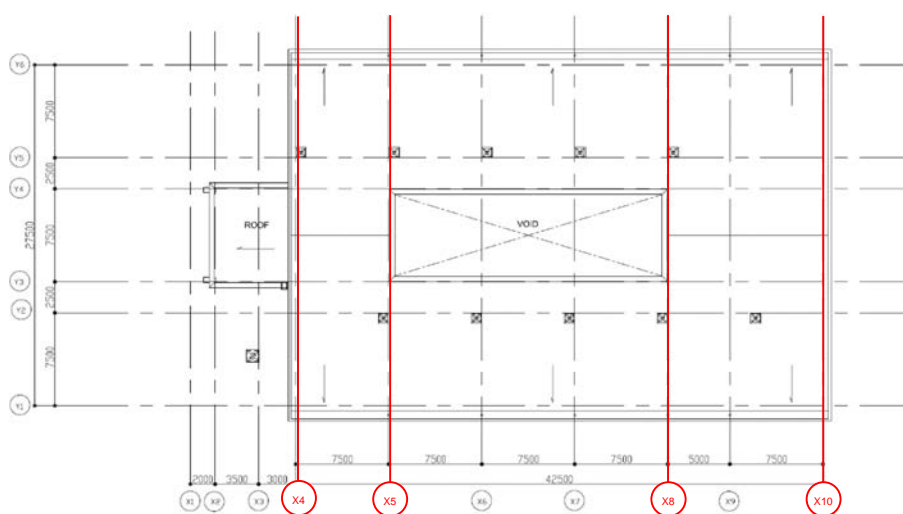
図 2-1 FD-5 校 屋根伏図

FD-5 校の押えコンクリートには、妻壁に平行なパラペット壁沿い（下図赤線通り芯上）を初めとした多数箇所で、コンクリートの熱膨張に起因すると思われる亀裂が生じている。また、亀裂が生じた箇所からコンクリート表面が剥離・損傷し、鉄筋が露出したり、コンクリートが脆く劣化した状態になっている。

コンクリート膨張によるパラペット押し出しとそれに伴う構造躯体や各種仕上面への影響を懸念し、現地調査の結果を国内に持ち帰り検証を行った。その結果、建物内・外に構造クラックを示す兆候は表れていないことから、他の構造および仕上への影響は無いと判断できる。押えコンクリート内部で亀裂が生じたことにより、膨張による圧縮力が吸収されたものと考えられる。

熱膨張による亀裂が進行すると、更にコンクリート表面の剥離、鉄筋の露出、鉄筋の発錆とコンクリートの劣化を招き、将来的に断熱層および防水層に影響が生じる可能性が懸念されるため、補修の必要性は非常に高いと考える。また、設計意図を理解した補修工事の実施のために、精度の高い監理が求められるため、本 F/U 協力に含める妥当性も高い。

上述した項目「(2) 屋根押えコンクリートの表面劣化」の対応と合わせ、屋根押えコンクリートを全面撤去し、金属屋根葺きとする。ただし、現状として、当該校では雨漏りが生じておらず、また押さえコンクリートの大きなずれが生じているわけでもないため、金属屋根葺きの緊急度は、同じ工事を計画している他の 4 校（FD-2、FD-3、FD-7、FD-8）に比べて若干低い。全体金額を考慮し金属屋根葺きが実現できない場合には、日本側での補修工事を行わず、コンクリートの表面補修マニュアルを作成し、学校による部分補修を促すこととしたい。

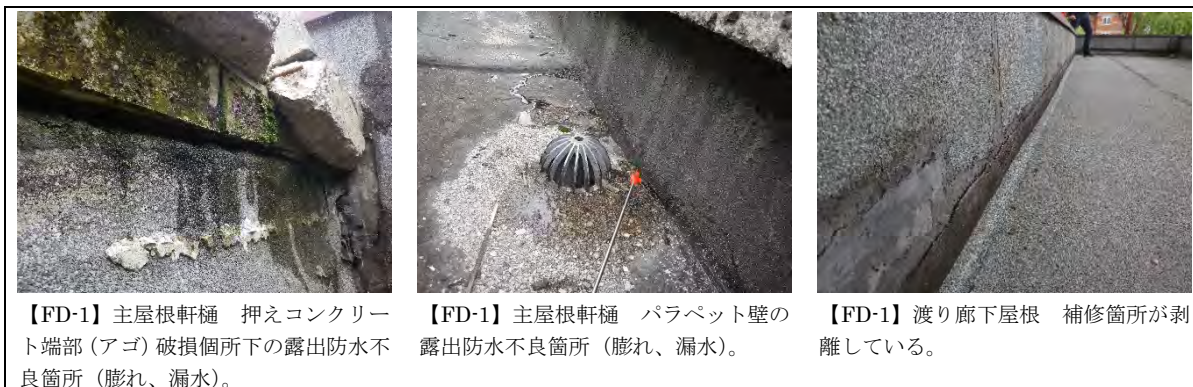
FD-1 校の主屋根の軒樋の露出アスファルト防水は、ほぼ全面的に剥離、膨れの症状が出ており、劣悪な状態であった。膨れた箇所には、内部に水が溜まっている様子が確認された。複数回に渡って補修された跡があったが、部分的な補修方法であったと思われる。ほぼすべてのドレイン、豎樋周辺部から漏水している。

また、既存校舎への渡り廊下屋根は全面が露出アスファルト防水である。引渡し当初から雨漏りが指摘されており、主屋根の軒樋と同様に、複数回にわたって補修工事が行われた。

しかし、こちらも部分的な補修方法であったため補修箇所に剥離等の不具合が見られた。加えて、既存校舍側からの雨漏りも疑われる状況であった。

FD-1 校については、部分的な補修では問題は解消されず、露出防水部分の全面的な補修が必要と思われる。工事費は高額となり、また、補修工事には下地調整や既存防水層との取り合い等、精度の高い設計・監理が求められることから、当該項目の補修工事は本 F/U 協力で実施する必要性は非常に高いと考える。

既存防水層を撤去・清掃後、ドレイン周りのコンクリート部に亀裂がある場合には注入補修し、軒樋床面をモルタルで下地調整（勾配調整）の上、新規に防水工事（露出アスファルト防水仕上）を行う。ドレインの位置は基本的に変更しないこととするが、ストレーナーや集水箱等の金物は必要に応じて交換する。

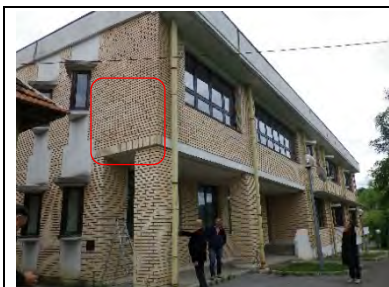
- (ア) FD-1 校の職員室裏のピロティ部の外壁レンガ壁が孕んでおり、その壁を受ける臥梁が構造梁と破断している。当該臥梁部が破断し外側に開いたため、その上部のレンガ壁（2階階高の下半分）が外側に10mm程度孕んだ状態となっている。
- (イ) 階段室2階部分の壁の一部が7~8mm程度孕んだ状態になっている。当該部分の壁は、屋根樋部分からの雨漏り（上記項目「(5) 露出防水層（軒樋等）の防水不良」）に起因していると思われる水染みがあるため、その相関関係が疑われる。
- (ウ) 2階廊下の窓下腰壁にもわずかな孕みが見られ、廊下の2階梁（1階の窓上の梁）のモルタル部に亀裂が生じている。構造クラックの可能性を疑い、現地調査の結果を国内に持ち帰り検証を行った。その結果、構造クラックを示す兆候は無く、レンガ壁受けのコンクリート臥梁とレンガ壁の間の詰めモルタルが剥離して生じた亀裂であると考えられる。

【FD-1】(ア)職員室裏のピロティ。赤枠内のレンガ壁が孕み、壁を受ける臥梁が破断している。

FD-1 校については、(ア) は放置しておくとも 2 階外壁部分の孕みが進行し、最悪の場合にはレンガ壁の崩落に繋がる可能性を否定できないこと、(ウ) は亀裂箇所から雨水侵入が続くと構造的な問題に発展しかねないことから、補修の必要性は非常に高いと考える。補修費用が高額となることや、適切な補修計画に基づいた精度の高い監理が求められる点から、(ア) (ウ) については本 F/U 協力に含める妥当性は高い。

FD-1 校の（ア）は、破断により生じた空隙部分に無収縮モルタルを高圧注入後、破断箇所下部（1 階壁空き部分、幅 1.2m×高さ 3.5m）にレンガ壁を増設する。

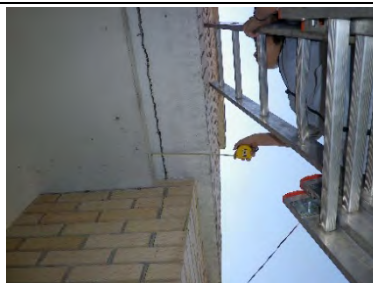
【FD-1】(ア)破断した臥梁。

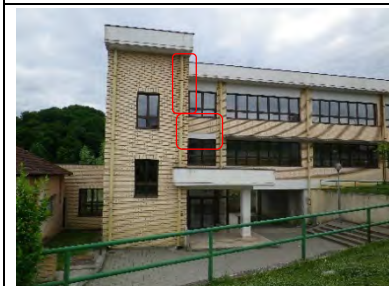
【FD-1】階段室外壁（イ）の一部に孕みが見られる。また、2階廊下梁（ウ）のモルタル部に亀裂が生じている。

（ウ）については、亀裂箇所を U カットし、清掃後、無収縮モルタルにて補修し、補修箇所をモルタル＋塗装で仕上げる。

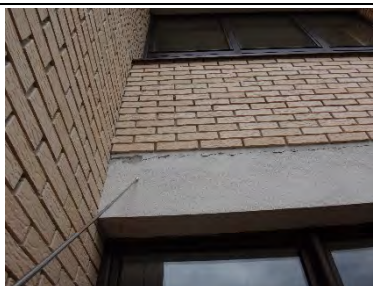
【FD-1】(ウ)2階廊下梁モルタル部の亀裂。

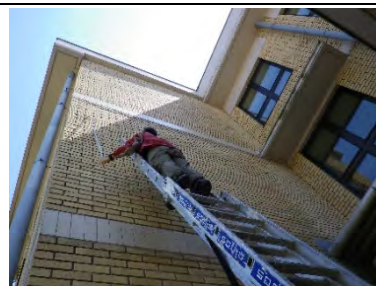
- (エ) RS-2 校では、トイレ外壁の2階部分にごくわずかな孕みが見認された。壁が孕んでいる部分は、トイレからの漏水により水染みが出てきているため、相関関係が疑われる。

【RS-2】(エ)外壁にトイレからの漏水と思われる水染みがあり、壁面がわずかながら不陸状態である。

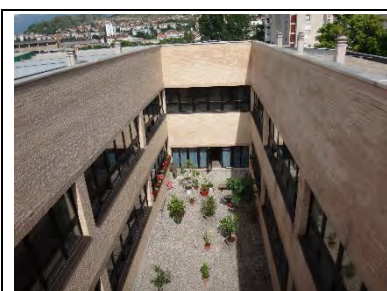
FD-5 校は、中庭に面した壁面四周とも、外壁のレンガ表面およびタイルが、剥離、亀裂、落下等の現象が生じており、危険な状態にある。レンガは、表面が押し出されるような形で割れ、表面部分が既に落下している箇所も少なくない。また、タイルは、レンガ同様に押し出される形で下地モルタルごと壁から浮き上がっている状態が確認された。また、レンガ等が損傷を受けている箇所を中心に、壁に水染みが出来ている様子が確認された。当該問題は中庭だけに生じ、外周壁面には発現していない。その理由は、①中庭は閉じた矩形であり、コンクリートやモルタルの膨張・収縮の動きの逃げが効かなかったため、②外周壁に比して中庭側の壁面は壁面に浸透した雨水の乾きが遅く、低品質のレンガの白華現象が生じたり、レンガ内部に浸透した水分の凍結・融解が繰り返されたことにより、レンガ表面の強度低下に繋がったため、と考えられる。

【FD-5】中庭の外壁面は、四周ともレンガ、タイルの剥離、亀裂、落下が生じている。また、不具合が生じている壁面箇所は水が浸みている。

FD-5 校のレンガ壁は、中庭外壁の適切な位置に伸縮目地を設け、バックアップ材充填の上、弾性シーリングを施す。中庭レンガ壁の表面全面を研り、必要に応じて注入補修を行うと共に、仕上面は防水モルタル+塗装で補修する。鉄筋が爆裂したと思われる箇所は、不具合箇所を撤去し、鉄筋の錆を落とし防錆処理の上、樹脂モルタルで補修する。

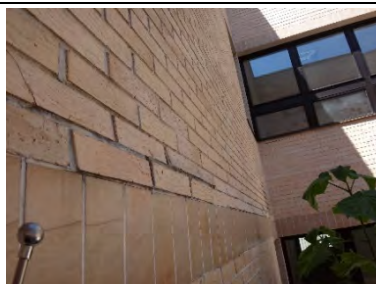
【FD-5】中庭壁面のレンガの表面剥離とタイルの亀裂。

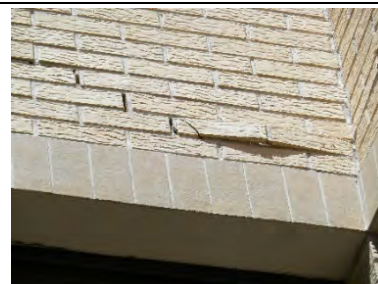
【FD-5】中庭壁面のレンガの表面剥離。

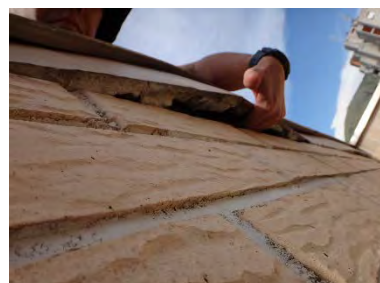
【FD-5】中庭壁頂部（パラペット）の外壁タイルの一部が、コンクリートと共に浮き上がっている。

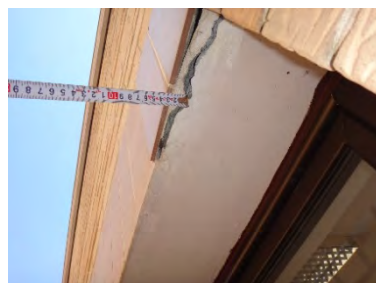
【FD-5】中庭に面した窓上のタイルの一部が、コンクリートと共に浮き上がっている。

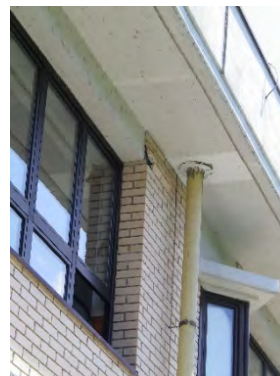
FD-1 校は、数は少ないが、外周壁面のレンガの表面が剥離、落下している箇所が散在していた。FD-1 校の場合は、屋根の軒樋からの雨漏り等（上記項目「(5) 露出防水層（軒樋等）の防水不良」）により壁面に水染みが出来ている箇所のレンガが表面剥離を起こしていることから、レンガ内部に浸透した水分の凍結・融解が繰り返されたことにより、レンガ表面の強度低下に繋がったと考える。

【FD-1】数は多くないが、外周壁面のレンガの表面が剥離、落下している箇所が散在している。

FD-1 校は、屋根軒樋の補修により雨漏りが解消されれば、壁面状態の悪化は回避できると考えられるため大がかりな補修の必要性は高くないと考えるが、既に剥離、落下が生じている箇所は、不具合箇所を研り、必要に応じて注入補修を行うと共に、仕上面はモルタル+塗装で部分補修する。

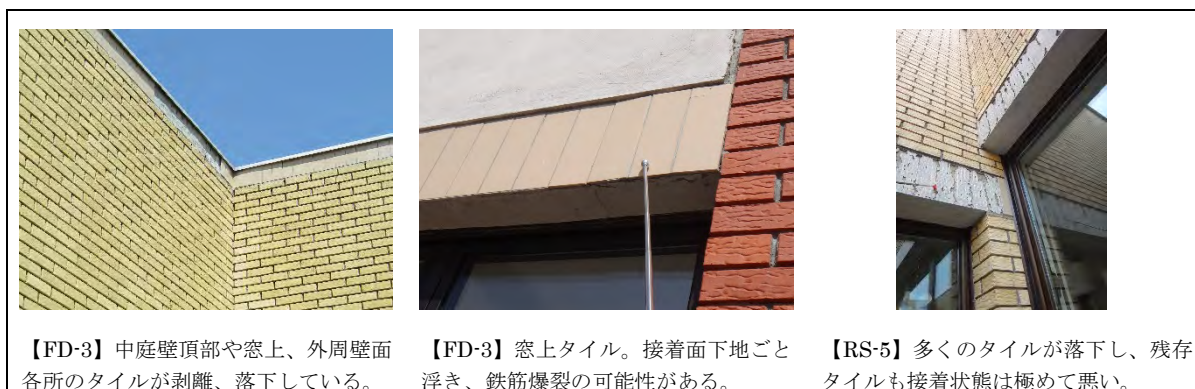
窓上や壁頂部等に貼られた外壁タイルが、複数の学校で広範囲に渡って剥離、落下しており、特に中庭のタイルの状態の悪い学校では、生徒の中庭への立ち入りを禁止する措置を取っている。

現地調査 II の結果、広範囲で剥離や落下が生じていることが確認された 5 校（FD-2 校、FD-3 校、FD-5 校、FD-8 校、RS-5 校）は、全ての外壁タイルを撤去し、モルタル+塗装仕上げとする。その他の 2 校については、不具合箇所周辺のみを補修する。

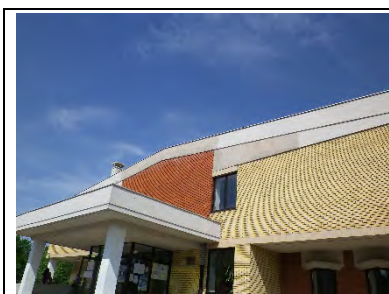
FD-3 校では、エントランス上部の外壁面のモルタルが 2011 年頃に大きく剥離、落下したため学校により補修されていたが、補修した箇所が再び剥離していることを確認した。また、建物裏側のモルタルも大きな面で剥離している。学校による補修箇所が再び剥離している理由は、適切な下地処理や養生が行われなかった可能性が高く、また、一部ではモルタル厚不足による剥離が生じたと思われる。

【FD-3】建物正面外壁。妻壁モルタル面で色が濃い部分が、過去に剥離、落下し、学校により補修された部分。

FD-3 校のエントランス上部の外壁面については、学校の自助努力により補修が行われたが、補修方法が必ずしも適切ではなかったと思われ、結果として、再び剥離、落下の危険が生じている。剥離が進行すると、大きな面のモルタル落下により事故が生じる危険性があるため、補修の必要性は非常に高いと考える。また、学校による補修では適切な監理が行き届かなかった経緯や、補修面積が大きく費用が高額になることから、本 F/U 協力に含める妥当性は非常に高いと考える。

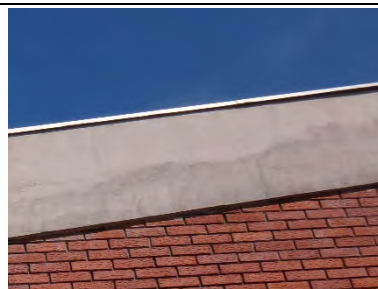
【FD-3】建物正面左側のモルタル補修箇所。多数のヘアクラックがあり、面全体が浮いている。

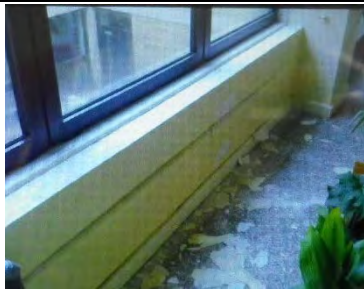
FD-2校(2階建)は2階南側の中庭に面した廊下に被害が集中しており、窓下の腰壁、窓際の柱型に雨漏りの跡があり、特に、窓下腰壁は塗装剥離と補修(外側シーリング、内壁塗装)を何度も繰り返している。現地調査Ⅱにて放水試験及びサッシメーカーへのヒアリングを行い、サッシ下部の構造が雨漏りの主たる原因であると特定した(サッシ本体の水切り部材が無いこと、下部水抜き穴の不良、ガスケットの劣化)。また、窓上方の柱型や梁型にも雨染みが出来ているため、上記項目「(8) 外壁タイルの剥離、落下」と関連し、窓上部の外壁タイルやレンガ壁周辺からの浸水の可能性が考えられる。

【FD-2】雨漏りにより塗装剥離した状態の写真（学校担当者撮影）。

FD-2校の窓下部からの雨漏りについては、学校側に当面の間の応急処置方法を助言した。根本的な問題解決のための補修工事を行う場合、技術的難易度は低く、金額も小さい（約 20 万円）ことから、日本側で補修工事マニュアルを作成の上、学校側での対応を促す方針である。また、窓上部の雨染みについては、外壁タイルの補修によって問題解決する可能性が高い。

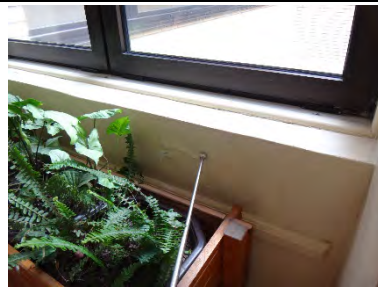
【FD-2】学校による補修後。依然として雨漏りが継続しており、塗装剥離している。

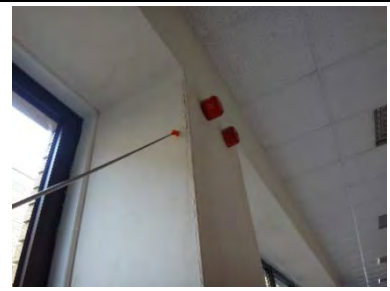
FD-8校(平屋建)については、1階南側の中庭に面した廊下で、窓際の柱型と窓上の梁型に雨染みがある。窓上方の柱型、梁型に雨染みが出来ていることから、窓周りからの雨漏りと共に、壁面からの水の侵入の可能性も考えられる。現地調査Ⅱにて放水試験を行った結果、試験当日及び翌日共に、天井内部に水が浸みた後は確認されず、サッシ本体及び屋根(2010年改修)からの漏水ではないことが確認された。学校関係者からのヒアリングによると、風を伴った強い雨の時のみに壁に水染みが出来るといふ。一方、窓上部の外壁タイルと、レンガ壁の間の目地のモルタルの状態が悪い(上記項目「(8) 外壁タイルの剥離、落下」と関連)ため、この部分からの浸水の可能性が最も高いと考える。

【FD-8】柱型の雨染み。

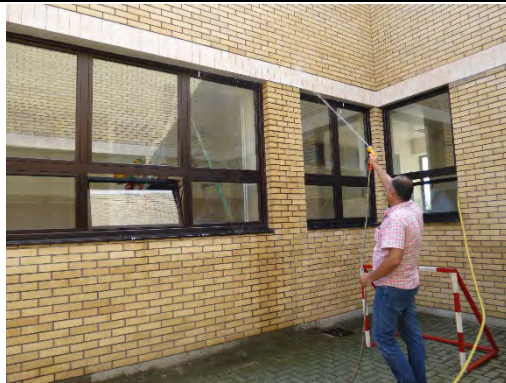
【FD-8】窓周り雨漏り原因・問題箇所特定のための調査

壁面、窓面および屋根面に放水試験を行い、サッシ自体および屋根には大きな問題が無いことを確認した。窓上部のタイルとレンガの隙間の目地の状態が悪く、当該箇所からの浸水が最も疑わしい。2日間に渡って内外部の経過観察を行ったが、絶対的な原因は特定できなかった。

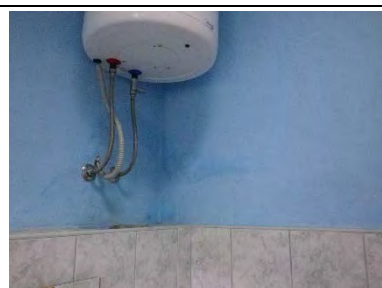
【FD-1】給湯器への給水配管の水漏れによると思われる水染み。

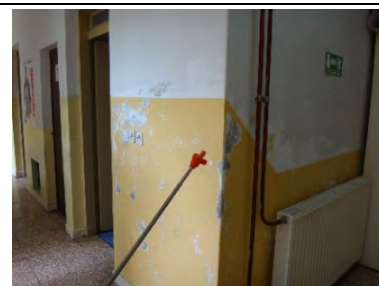
【RS-5】トイレ手洗い用給水配管からの水漏れによると思われる水染み。

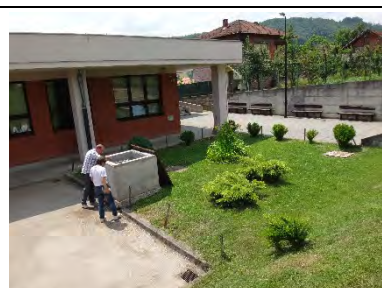
FD-7校のボイラー用の燃料給油システムは、屋外埋設オイルタンクからポンプを經由し、敷地内に埋設された給油管を通してボイラー室建屋内のサービスタンクに自動給油されるシステムであった。しかし、現在は給油システムが使用できない状態である。学校側の説明によると、

【FD-7】オイルタンク（芝生部分に埋設）と給油用ポンプ（コンクリート構造物）の位置。

建物北側・東側には既存埋設物が多く、新たに配管するスペースが無いいため、既存の送油

管ルート上に蓋付 U 字溝を埋設し、その中に新規配管する。一部、建物の基礎下に埋設されている既存管は埋めたままとし、新規配管は建物を迂回させる。

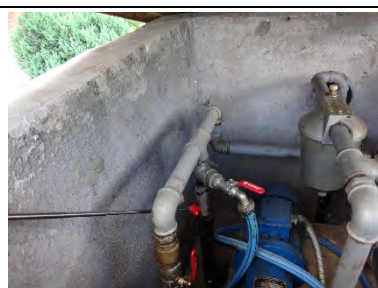
【FD-7】燃料漏れが疑われたため、学校がポンプから給油配管への接続を切り、ホースを使って給油できるように分岐した。

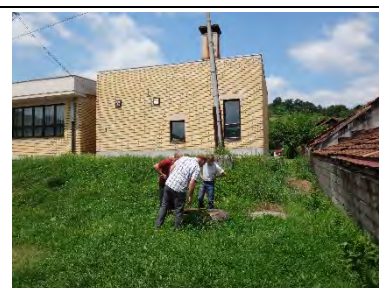
【FD-7】燃料漏れが疑われた際には、学校敷地内、ボイラー室裏の草が枯れたという。

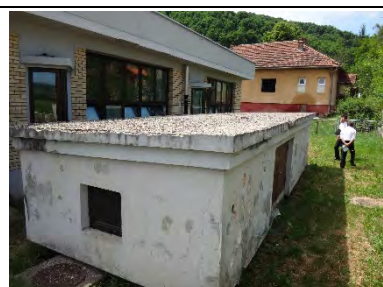
RS-5校は独立したポンプ室を有する。屋根の防水押えコンクリートの劣化が激しく、鉄筋が露出している。壁は、コンクリート壁の外側に断熱材（スチレンフォーム）+モルタル薄塗り仕上げであるが、鳥が巣を作るために断熱材に大きな穴をあけてしまったようである。なお、ポンプ室内の状態は健全で、ポンプ室としての機能に支障は生じていない。屋根は、押えコンクリートが、引渡し後の凍害で表面にひび割れ等が生じ、降雨、降雪などにより更なる劣化を招いたと考えられる。壁は、断熱材の外側の仕上が、十分な仕上厚を持つモルタルではなく、薄塗りであったため、鳥の被害を受けてしまったものと思われる。

【RS-5】ポンプ室。外装が激しく劣化、損傷している。

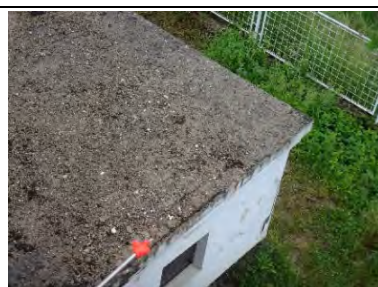
【RS-5】ポンプ室屋根。屋根防水押えコンクリートが劣化しており、鉄筋が露出している。

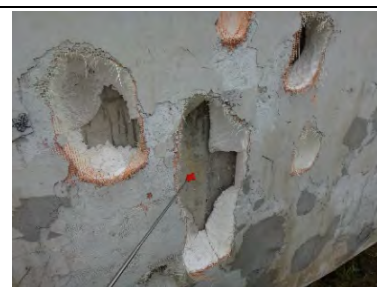
【RS-5】ポンプ室外壁。鳥が断熱材に大きな穴をあけ、コンクリート壁が見えている。

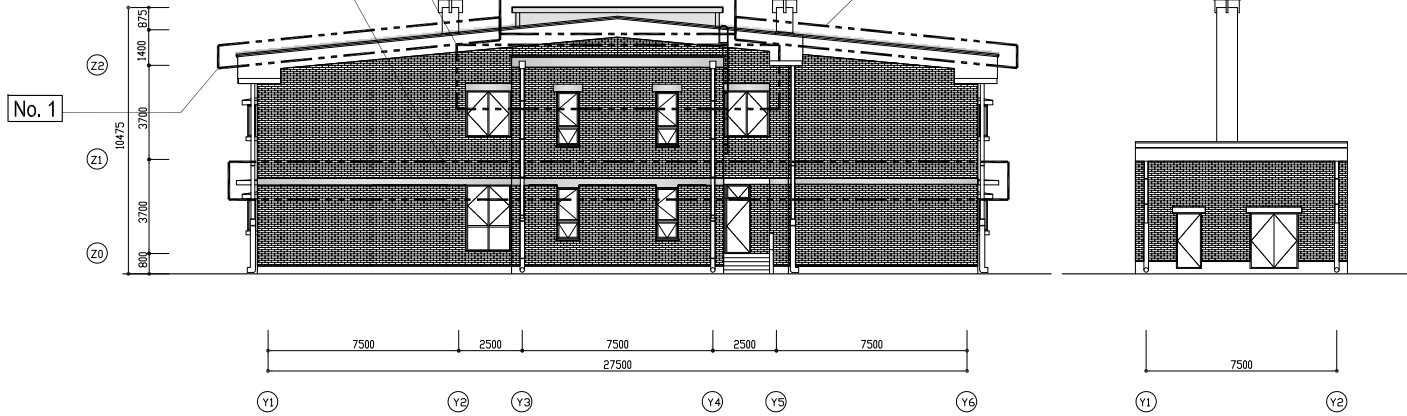
B-ELEVATION

No. 8
WATERPROOFING MORTAR,
ACRYLIC EMULSION PAINT (AEP) FINISH

No. 1
COLORED GALVANIZED ROOFING SHEETS
(0.6mm THICK, PROFILE HEIGHT = 40-50mm)

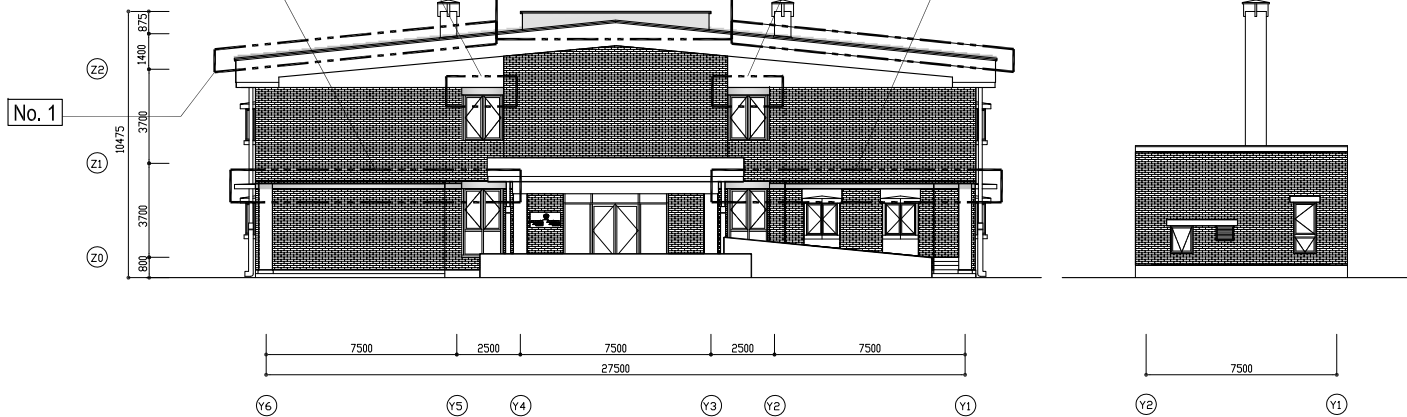
D-ELEVATION

No. 8
WATERPROOFING MORTAR,
ACRYLIC EMULSION PAINT (AEP) FINISH

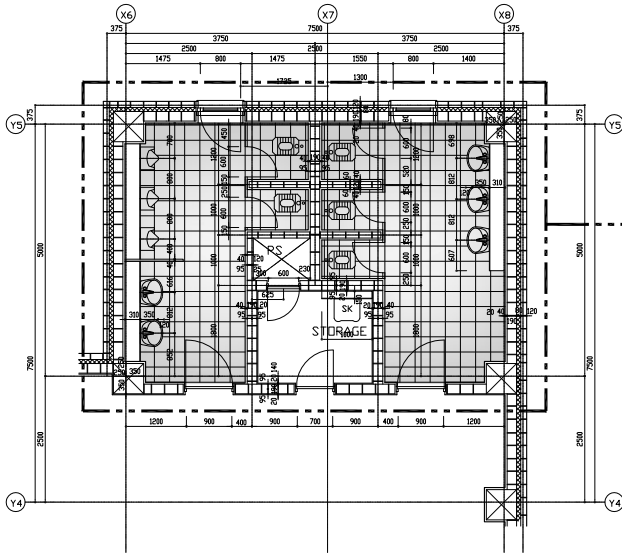
1ST FLR & 2ND FLR
STUDENTS TOILET PLAN

No. 11B

FLOOR TILES AND ALL SANITARY FIXTURES
WILL BE RECONSTRUCTED AFTER REPLACEMENT
OF ALL DRAIN PIPES.

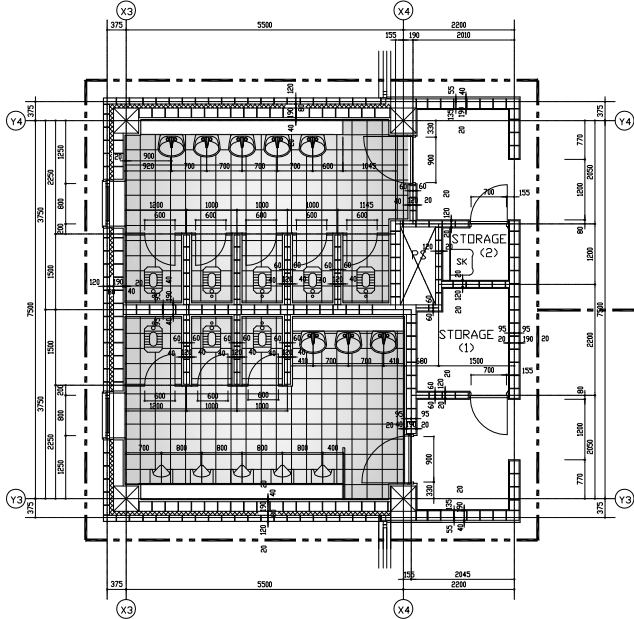
1ST FLOOR STUDENTS
TOILET PLAN

No. 11B

FLOOR TILES AND ALL SANITARY FIXTURES
WILL BE RECONSTRUCTED AFTER REPLACEMENT
OF ALL DRAIN PIPES.

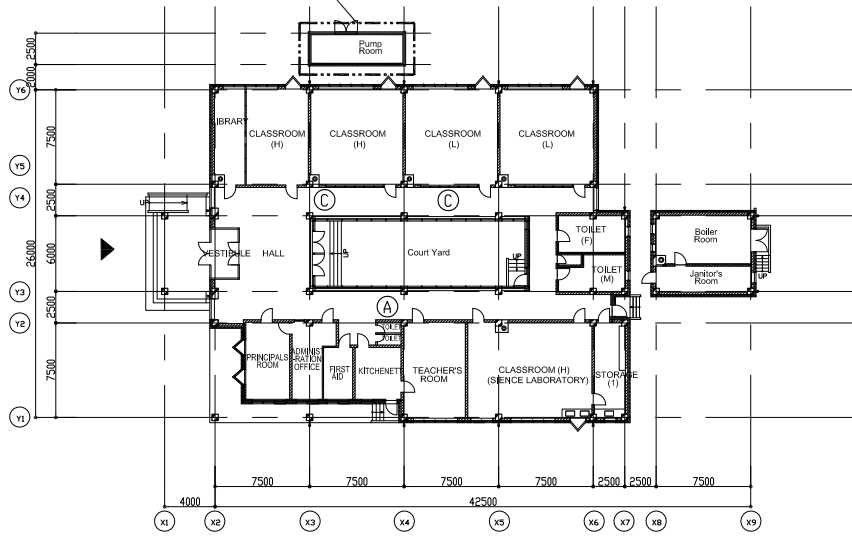
GROUND FLOOR PLAN

No. 2
REPAIR OF PROTECTIVE
CONCRETE BEDDING SURFACE.

No. 3
REPAIR OF PROTECTIVE CONCRETE BEDDING EDGE
WITH ALUMINUM WATER FLASHING.
