**THE STUDY  
FOR  
COASTAL EROSION  
AND FLOOD CONTROL MANAGEMENT  
IN  
THE REPUBLIC OF SEYCHELLES

FINAL REPORT  
SUMMARY**

**MARCH 2014**

**JAPAN INTERNATIONAL COOPERATION AGENCY (JICA)**

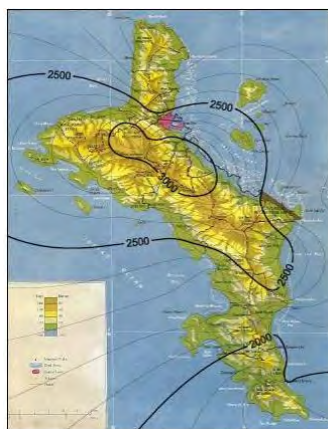
Figure 2-1-1 Yearly cumulative rainfall map for Mahe Island

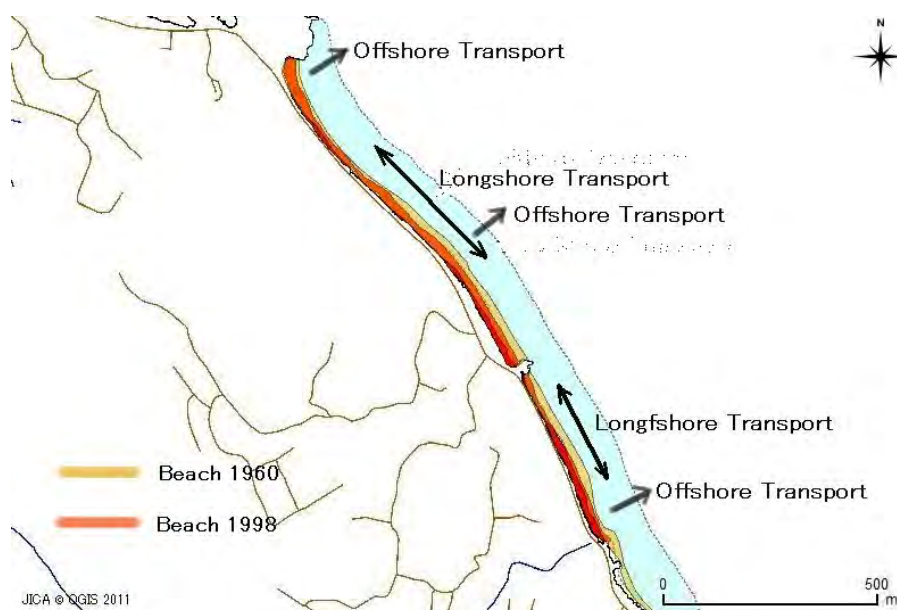
If no action is taken, the beach will be eroded opposite the road. Maintenance of the beach or the construction of a revetment is required. In the long term, the increased erosion and wave overtopping will cause traffic problems and damage to structures. The road needs countermeasures and maintenance such as raising or repairing of the road.

Figure 4-2-1: Estimated Sediment Movements at North East Point

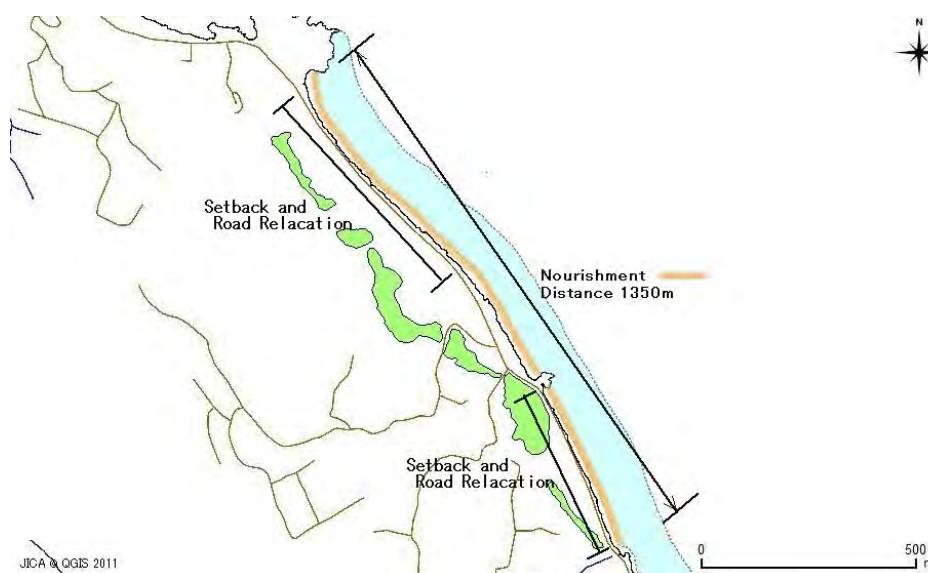
Sand nourishment was proposed for 20m in width for about a 2 km stretch of the beach with maintenance nourishment as shown in Figure 4-2-2. At present, because the cause of the erosion is not clear, the effects of nourishment and the causes are analysed by the pilot project.

Figure 4-2-2: Measures at North East Point

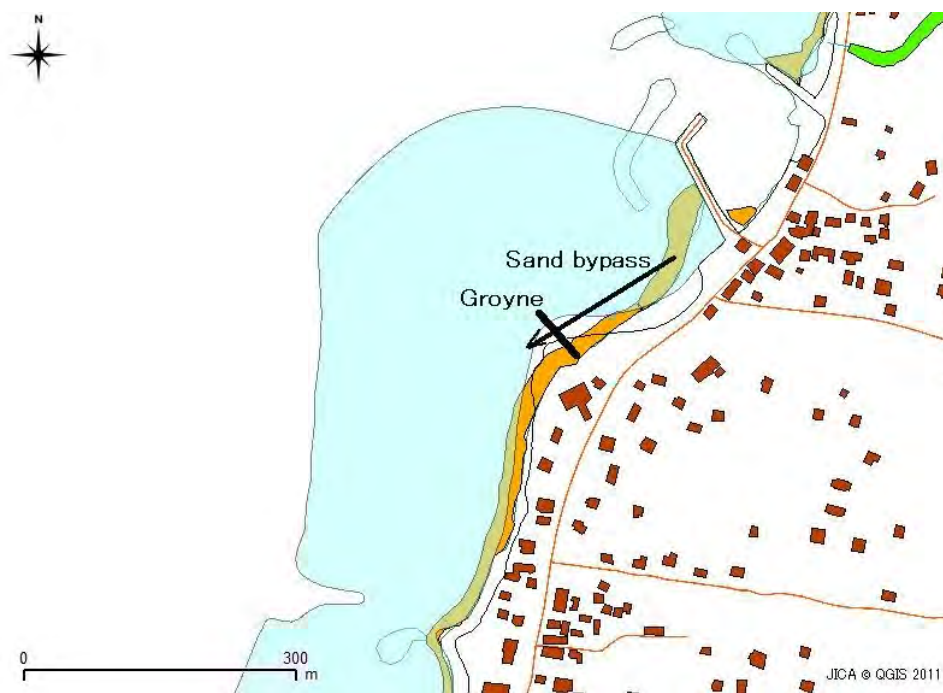
One groyne with sand bypass of 1,000 m<sup>3</sup> of sand from the anchorage to the south beach are proposed as shown in Figure 4-2-8.

Figure 4-2-8: Measures at La Passe

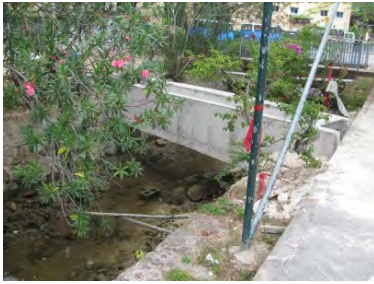
The five rivers have good flow conditions and are well maintained. However, in some locations, the flow capacity of the original sections has been diminished due to obstacles such as concrete structures, cables and pipes as shown below.

**Photo 5-2-1:**  
**Obstacle in River Anglaise**

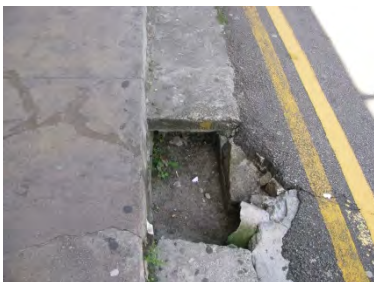
Most of the drains have good flow conditions and are well maintained, but some drains are already settled and are not in proper working condition as shown in Photo 5-2-4. In some locations, obstacles are found in the drains as shown below.

**Photo 5-2-4:**  
**Settled side drain at Market Street**

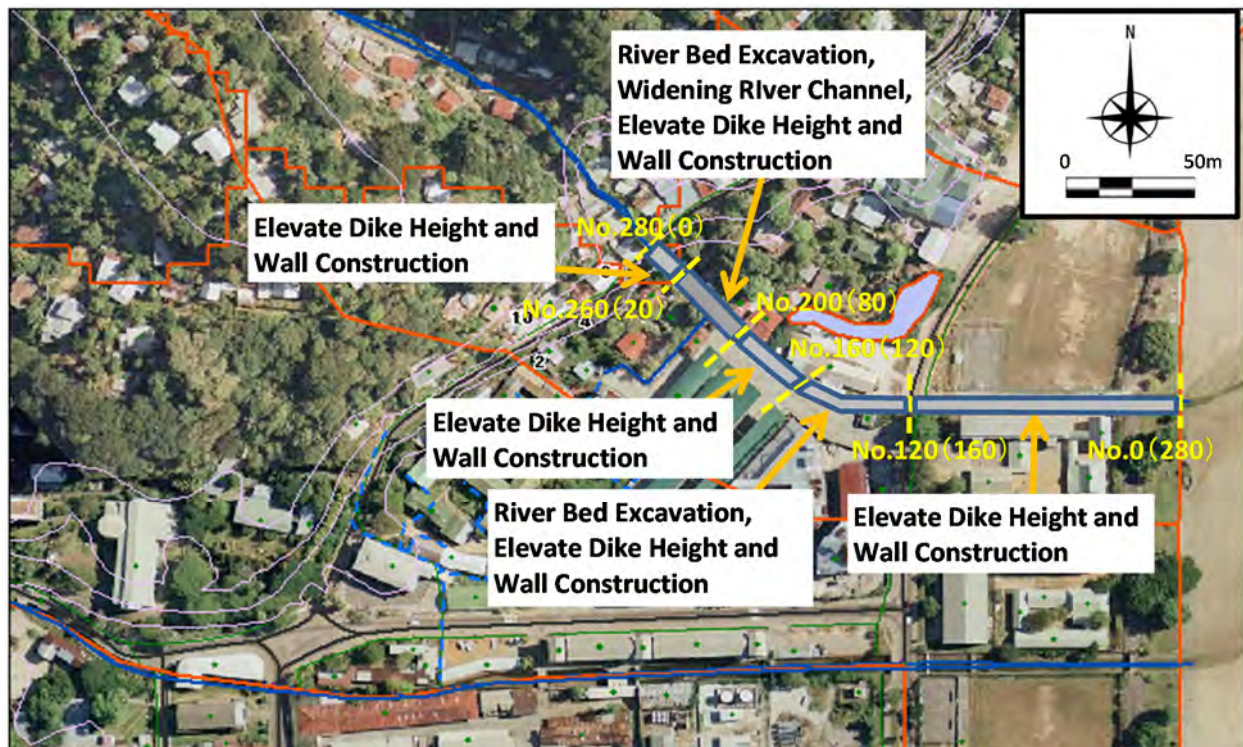
Figure 5-2-7: Location of Proposed Countermeasures in Victoria Town (Anglaise River)

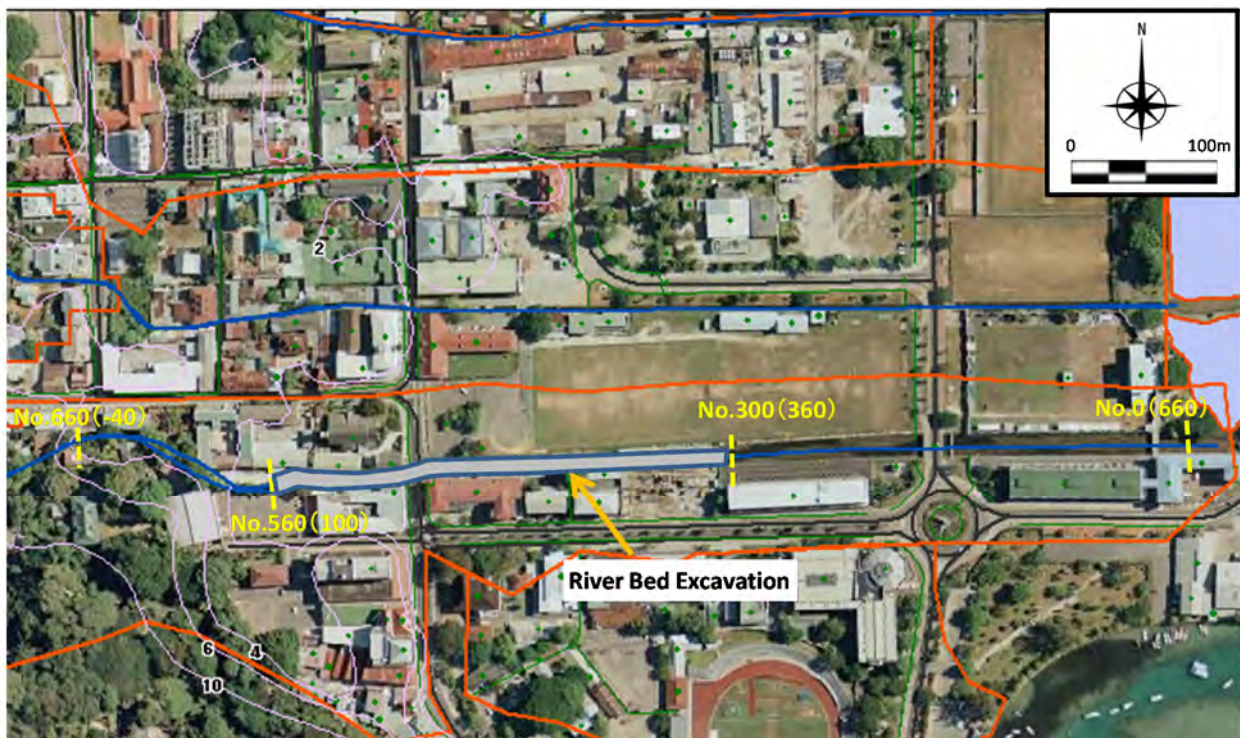
Figure 5-2-10: Location of Proposed Countermeasures in Victoria Town (St. Louis River)

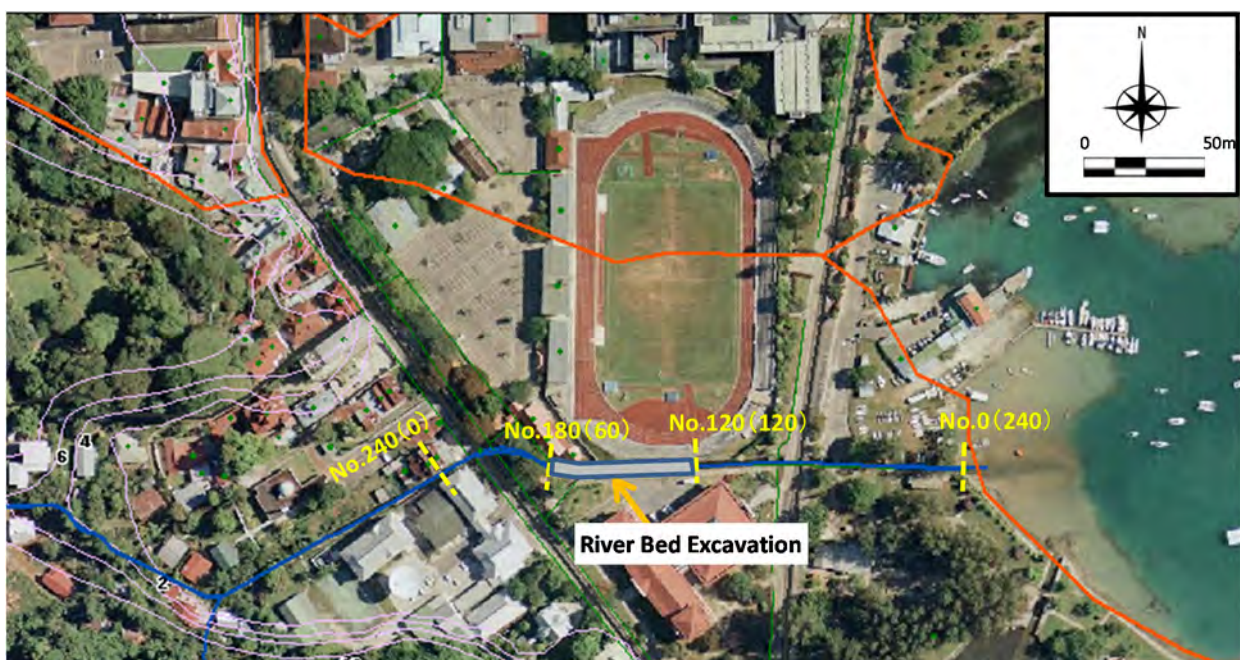
Figure 5-2-11: Location of Proposed Countermeasures in Victoria Town (La Poudriere River)

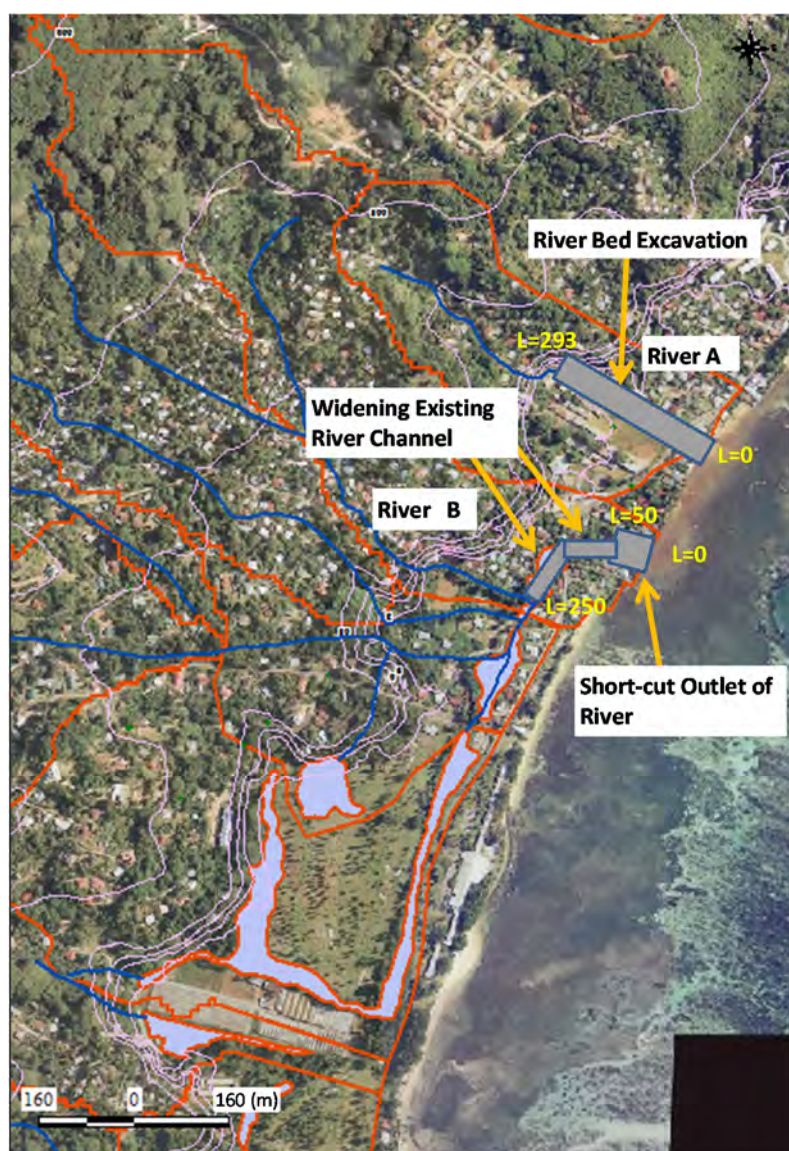
The proposed structural countermeasures at Anse Aux Pins for the short term and medium term are as summarised in Table 5-2-9

Figure 5-2-15: Location of Proposed Countermeasures in Anse Aux Pins

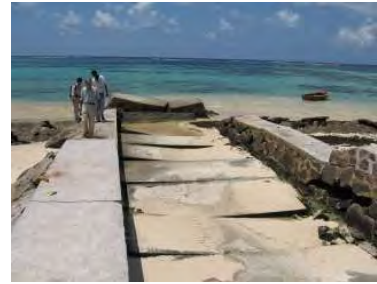
**Photo 5-2-12: Outlet B Structural Damage by Erosion (April 2011)**

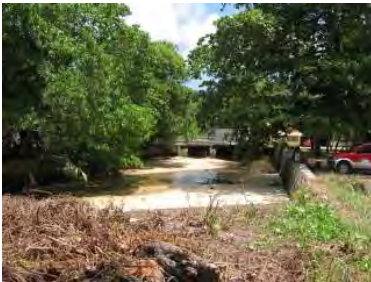
**Photo 5-2-13: Outlet B Reduced width of Outlet (April 2011)**
