**MINISTRY OF ENVIRONMENT AND ENERGY
REPUBLIC OF SEYCHELLES**

**THE STUDY
FOR
COASTAL EROSION
AND FLOOD CONTROL MANAGEMENT
IN
THE REPUBLIC OF SEYCHELLES

FINAL REPORT**

MARCH 2014

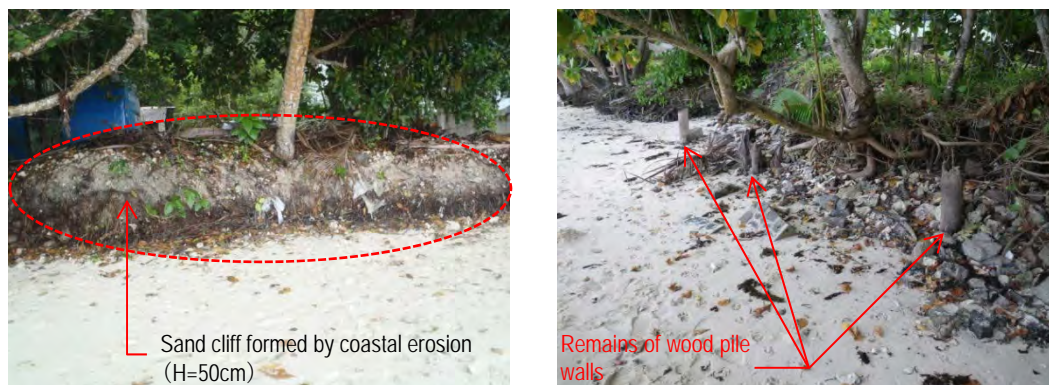
Photo 2-4-4: Beach Scarp and Remains of Revetments and Wooden Piles at Baie Lazare

Stone and wooden pile revetments were constructed in the past and the half-broken remains are left as seen in Photo 2-4-4. Recently, a channel for fishing boats was excavated through the reef. The impact of the channel on the beach is not clear.

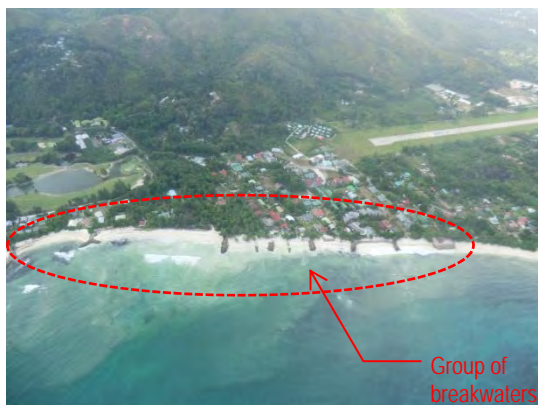
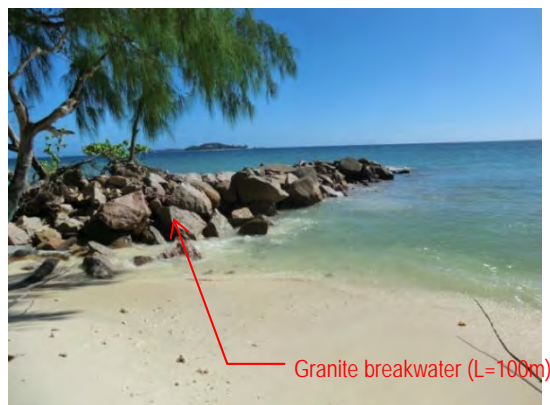
Photo 2-4-10: Groyne at Anse Kerlan on Praslin

Groynes are mostly used at Anse Kerlan on Praslin, while on Mahe some are found at Au Cap and they are intended for the control of beach erosion. The groynes at Anse Kerlan are 100 m to 200 m long and are made of rock armour. The materials are local products such as granite rock and wooden piles.

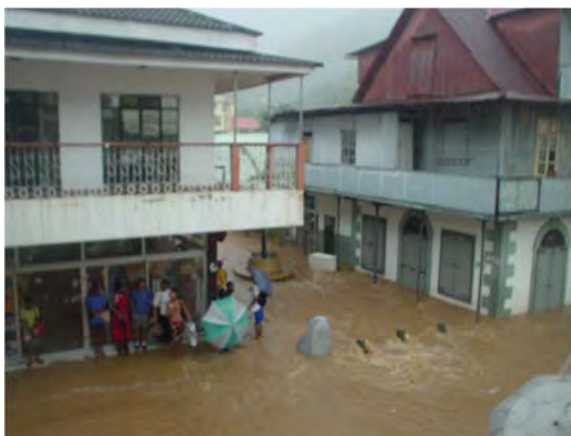
Photo 2-5-1: Photo of Centre of Victoria Town in the 2004 Flood

Photographs of the flood in central Victoria in past reports are material from which the extent of the flood can be comprehended though no information about time or depth is obtained (See Photo 2-5-1).
