## **Chapter 5 The Formulation of Flood a Management Plan**

## **Chapter 5    Flood Management Plan for Priority Areas**

### **5-1        General**

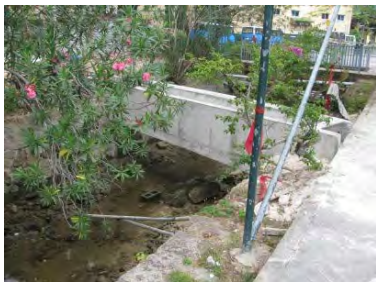
The five rivers have good flow conditions and are well maintained. However, in some locations, the flow capacity of the original sections has been diminished due to obstacles such as concrete structures, cables and pipes as shown below.

**Photo 5-2-1:**  
**Obstacle in River Anglaise**

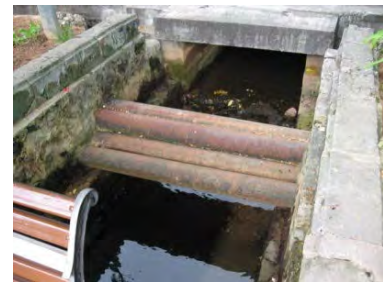
**Photo 5-2-3:**  
**Obstacle in River La Poudriere**

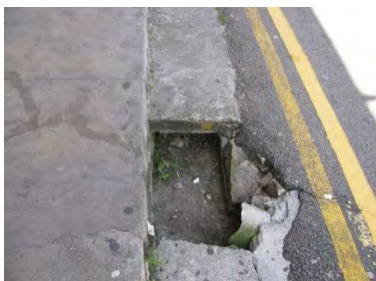
Most of the drains have good flow conditions and are well maintained, but some drains are already present and are not in proper working condition as shown in Photo 5-2-4. In some locations, obstacles are found in the drains as shown below.

**Photo 5-2-4:**  
**Present side drain at Market Street**

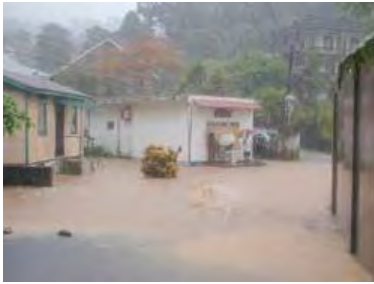
**(1) Photo 5-2-6: Intersection of Market St. and Albert St. (30 December 2004)**

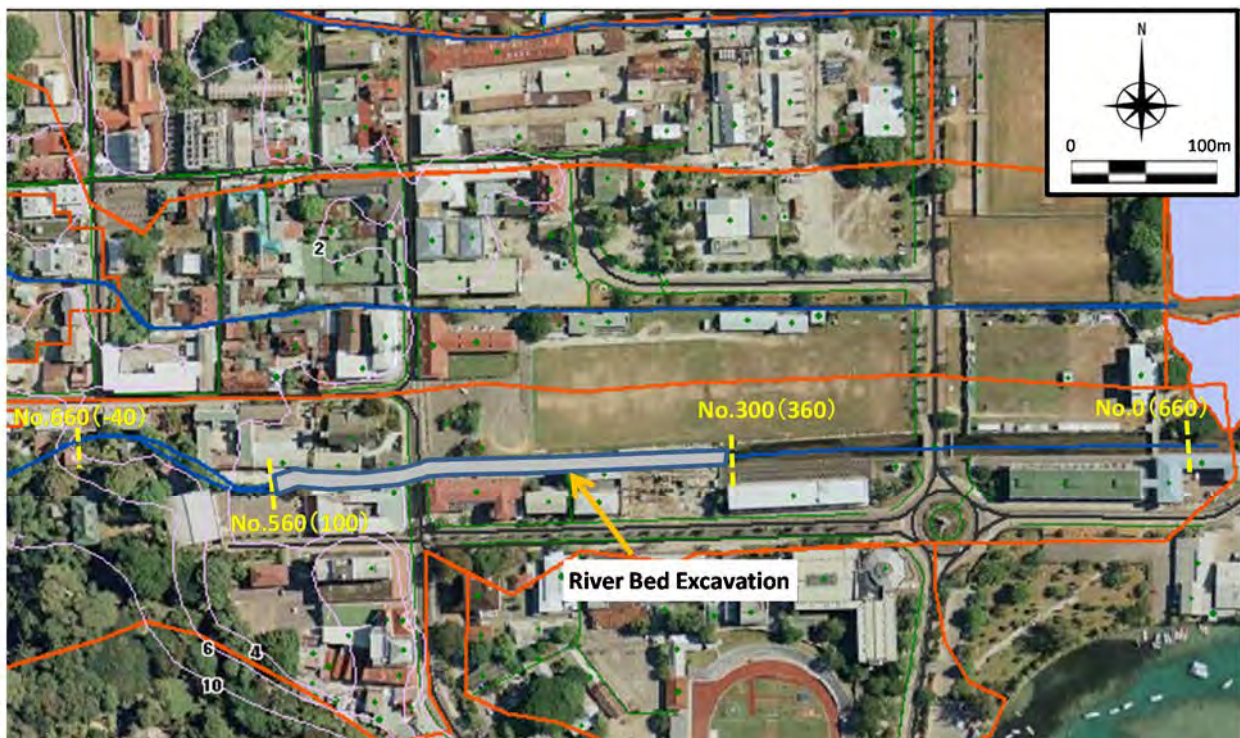
Figure 5-2-13: Location of Proposed Countermeasures in Victoria Town (St. Louis River)

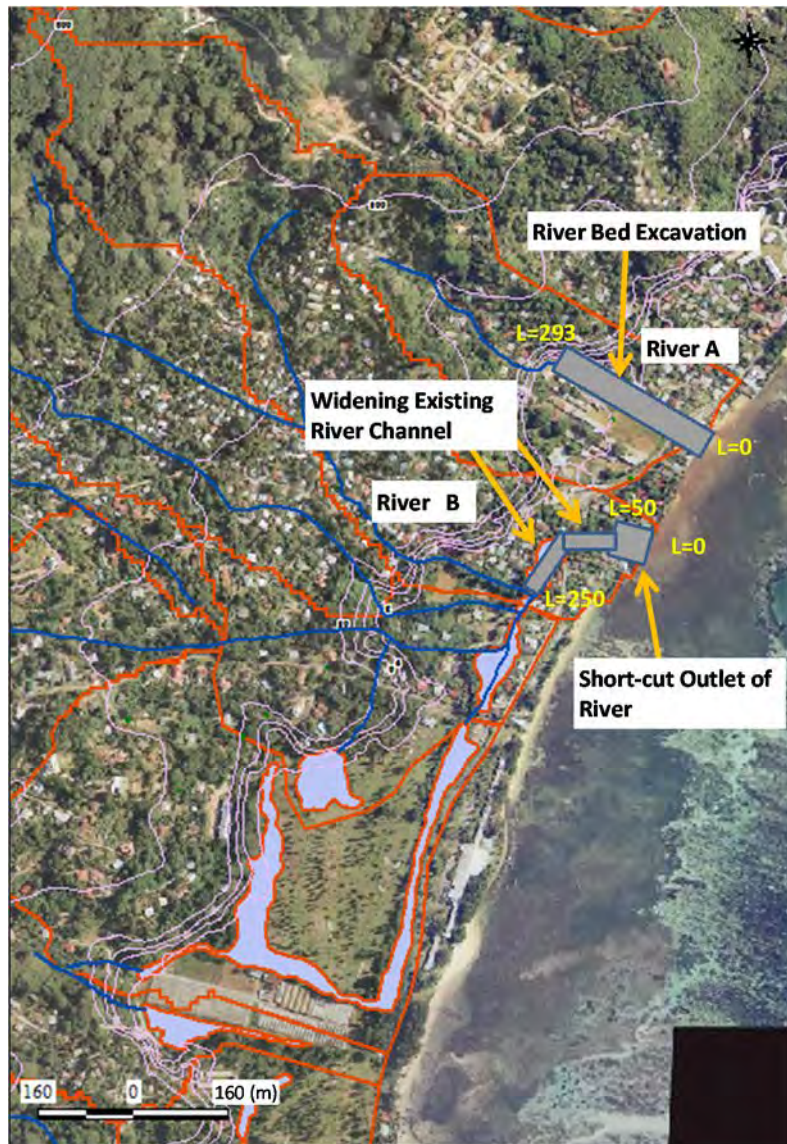
Figure 5-2-18: Location of Proposed Countermeasures in Anse Aux Pins

- Chetty Flat needs new drainage in order to discharge rainwater.
- In Anse Aux Pins A area the highest water level is 2.0 m, which is the same as the ground level. No river improvement is required in the short term. However, riverbed excavation is recommended in order to ensure additional security.
- In Anse Aux Pins B area it was not possible to consider the effectiveness of wetland as a reservoir due to the limited data. The accuracy of the calculation results could not be confirmed, therefore, no structural countermeasures are proposed for the short term.

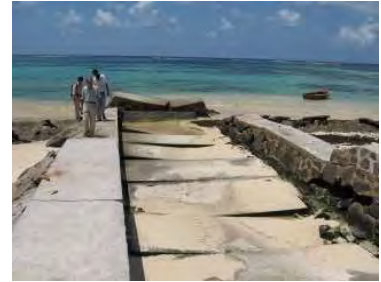
of the outlet. However, the outlet structure is under continuous attack by waves and the foundation has eroded.

**Photo 5-2-21: Outlet B Structural Damage by Erosion (April 2011)**

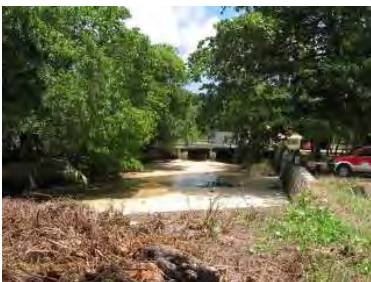
**Photo 5-2-22: Outlet B Reduced width of Outlet (April 2011)**

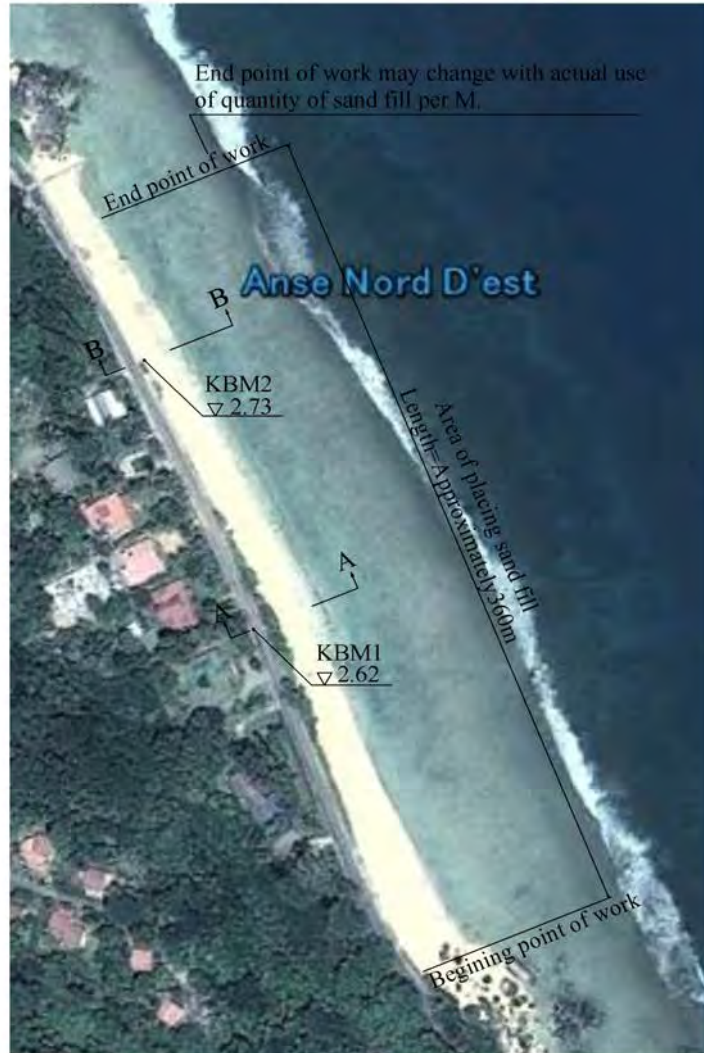
Cross Sectional View

Figure 6-2-2: Plan for Beach Nourishment at North East Point

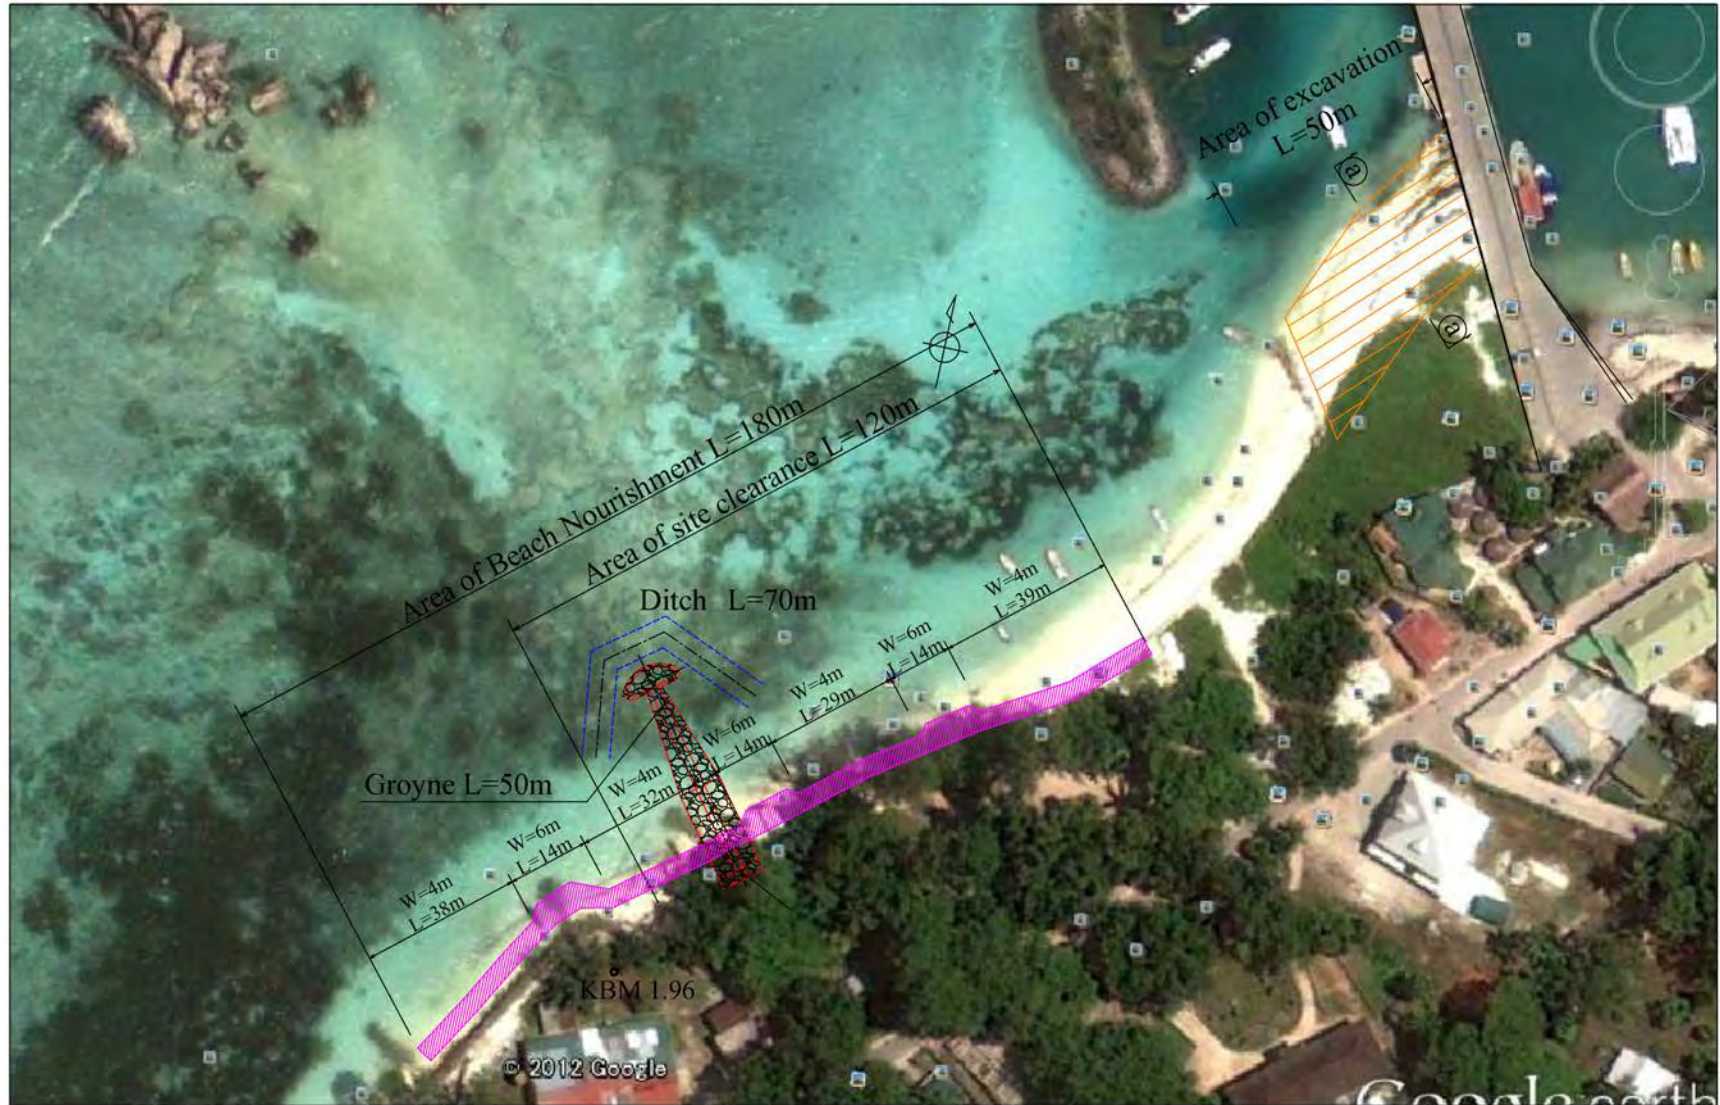
- Length : 50m
- Material : 0.1t of rocks, 400 0 500mm in diameter
- Sectional dimension: Crown width: 2.0m, base width: 8.0m, height: 2.5m, Slope gradient : 1:1.2
- Rock material: 800t

# Groyne & Beach Nourishment Technical Drawing @ La Passe

Figure 6-2-4: Groyne and Nourishment Plan at La Passe

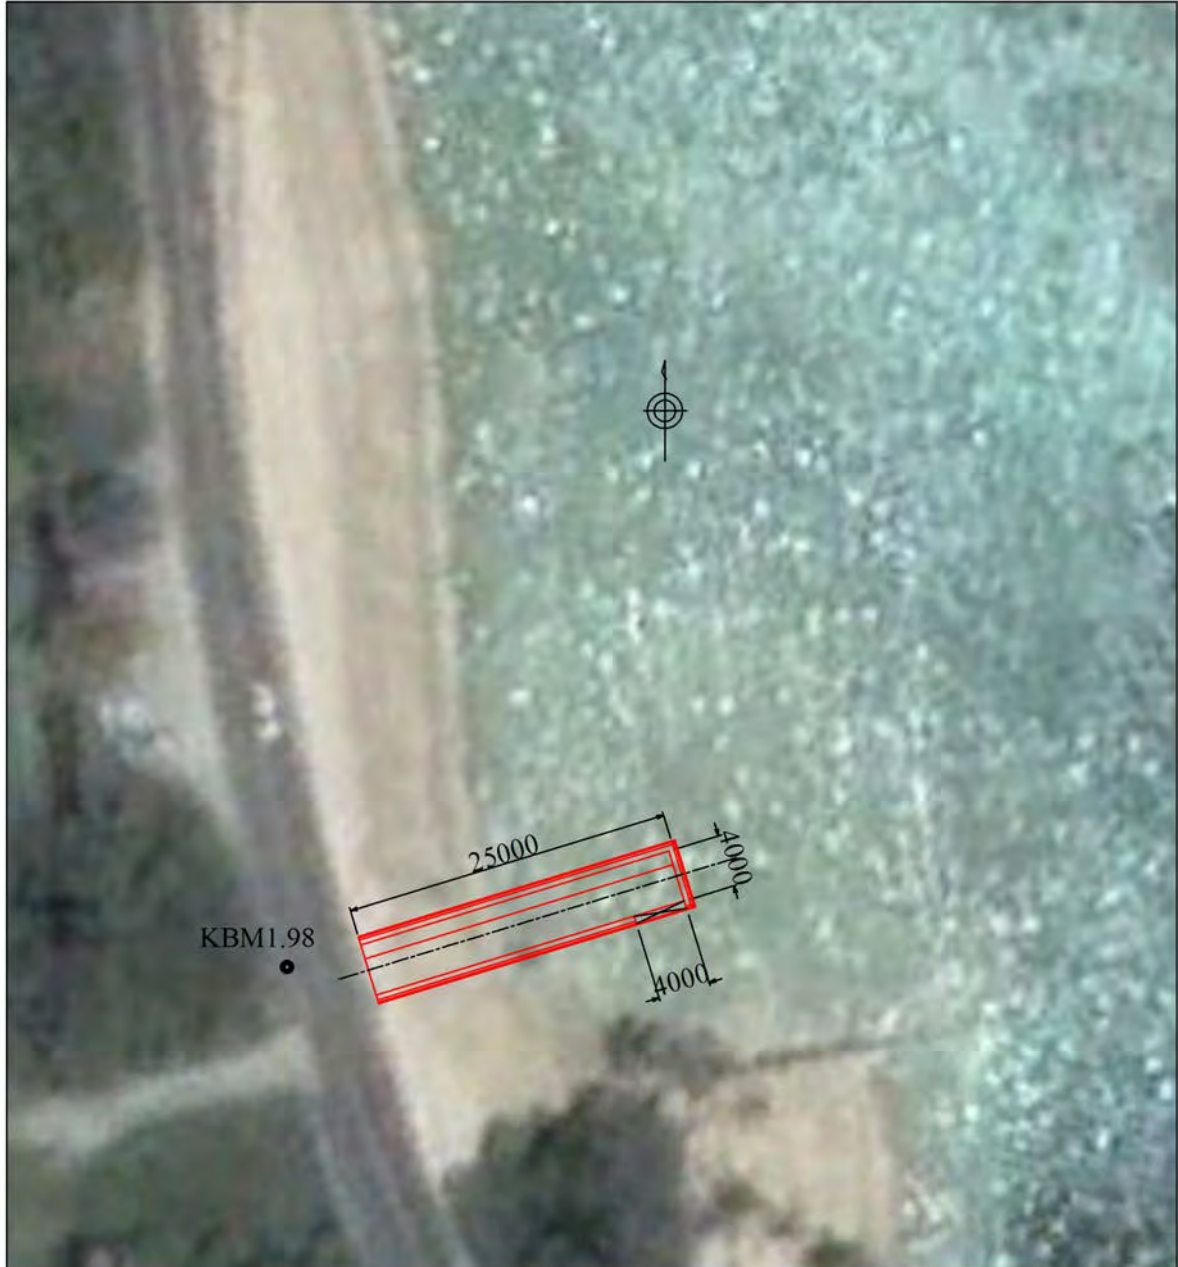
Figure 6-2-13: Plan of Outlet Channel (Au Cap)

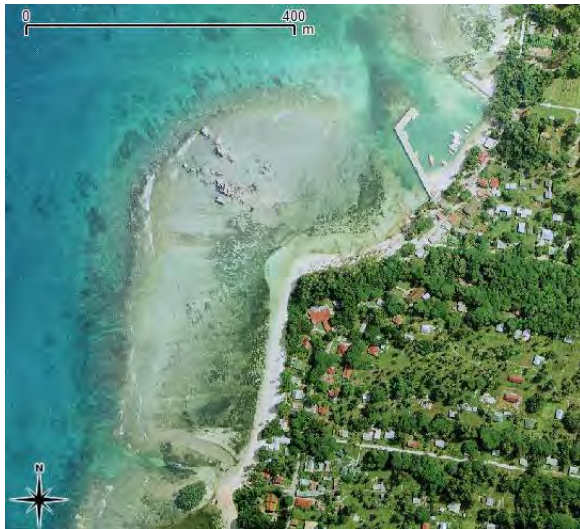
The satellite and aerial photos of the construction of the structures and beach changes from past to present are shown in Figure 6-6-10 to Figure 6-6-13.

Figure 6-6-10: GIS data in 1998

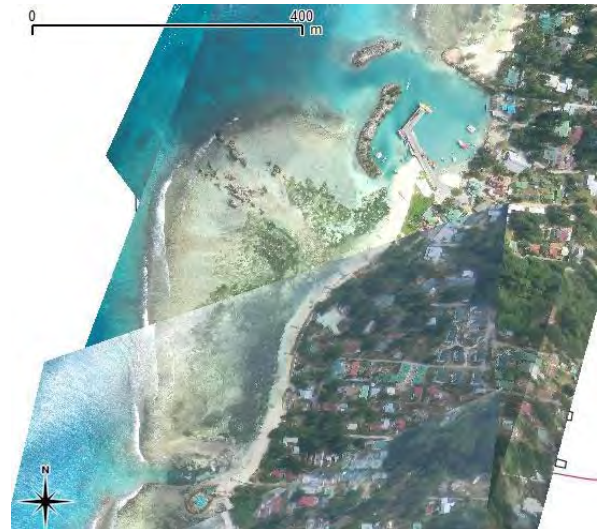
Figure 6-6-11: Aerial Photo in May 2011
